# **Proposed Upgrade of Coffs Harbour Regional Boat Ramp Stages 1 and 2**

Review of Environmental Factors

Transport for NSW

November 2020

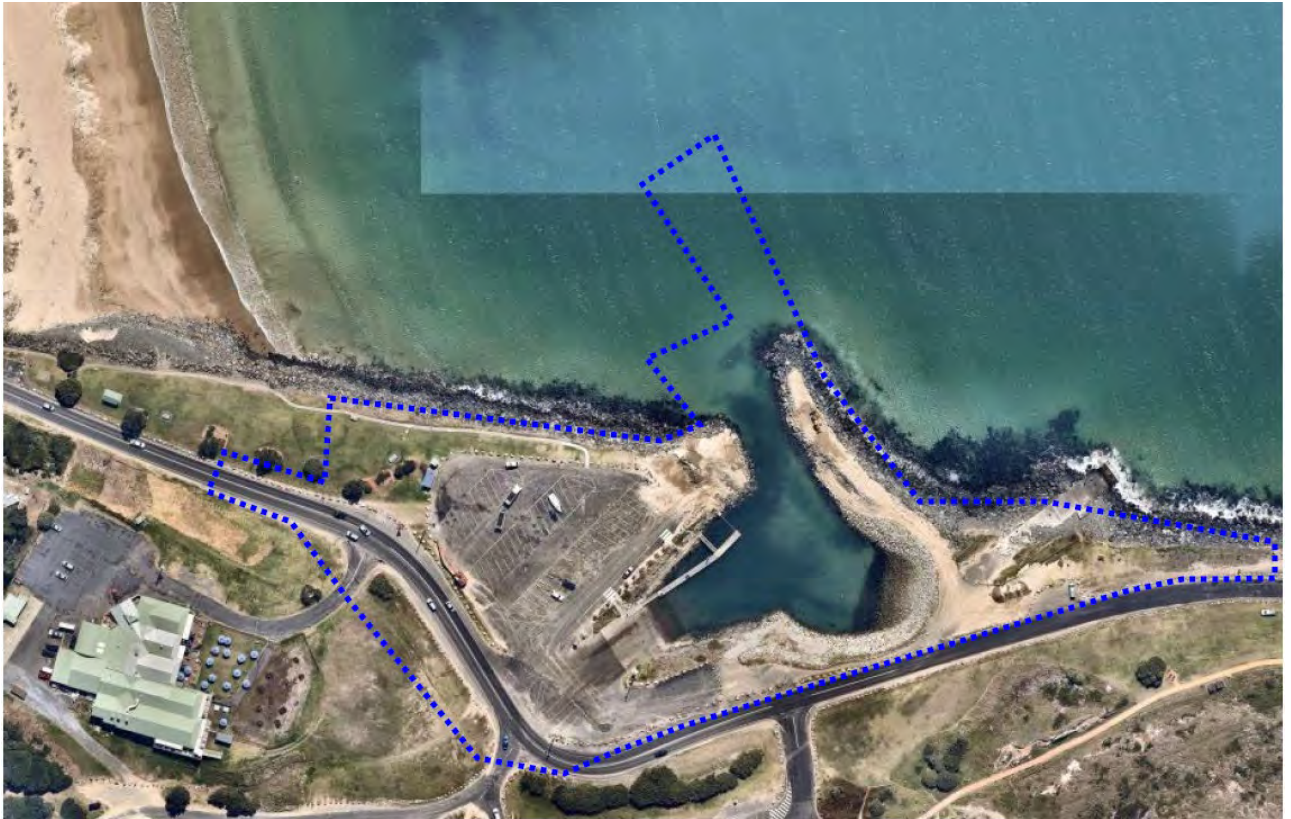
**Figure 2: Proposal footprint**

The proposal footprint encompasses the boat ramp, car parking area, breakwater, part of Jordan Esplanade and a portion of the foreshore reserve as shown in Figure 2 below:

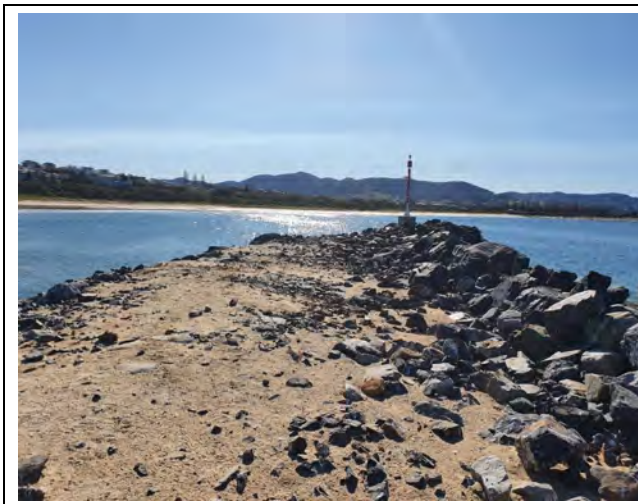
Boat ramp breakwater to the north

The Coffs Harbour Regional Boat Ramp is constructed of concrete, with armour stone rockfill and tyres lining the basin. It has a single pontoon and is protected from direct wave impact by a small armour rock breakwater orientated in a north-west to south-east direction. There are walkways around the perimeter of the basin and along the small breakwater, constructed of both concrete and gravel in variable condition.

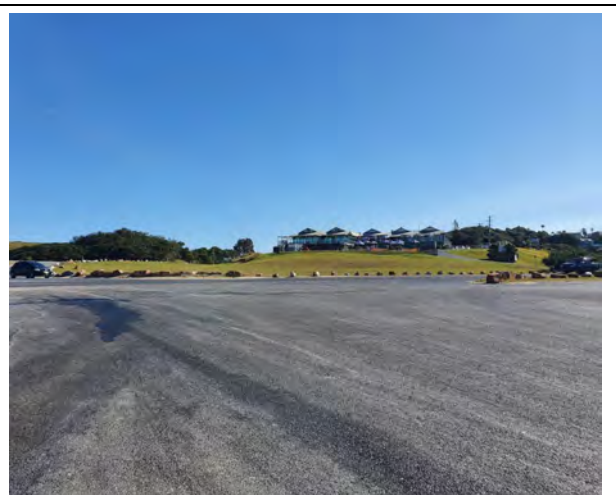
Existing car and trailer parking area

The carpark is sealed and is in moderate condition with some exposure of base materials. Parking spaces are marked but are weathered and in need of re-marking. The carpark provides parking for 49 vehicles with trailers and an additional 10 spaces for light vehicles without trailers immediately south of the boat ramp. A light, power pole and various signs are located on the southern side of the boat ramp.

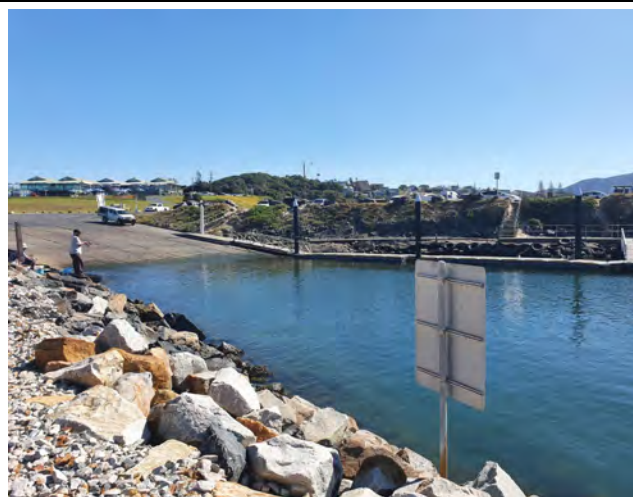
Existing boat ramp, facing south -west

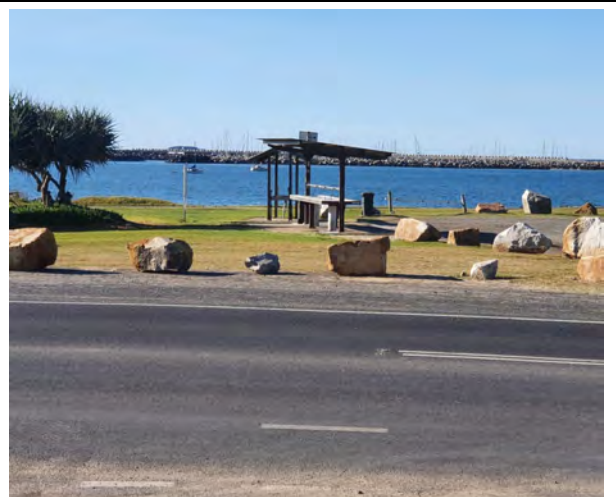
Fish cleaning station on the western side of the carpark

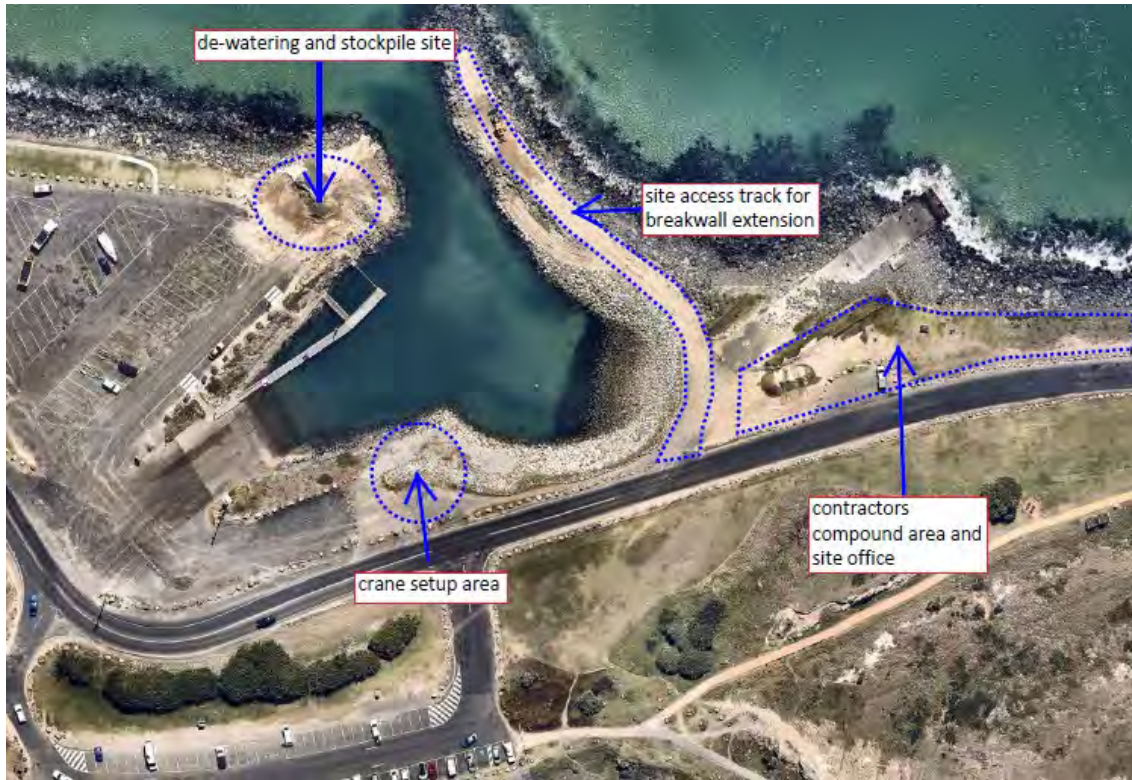
**Figure 6: Location of ancillary facilities**

There is no vegetation required to be removed for the ancillary facilities as they will be located within highly modified, previously disturbed and filled areas as shown in Figure 5 below:

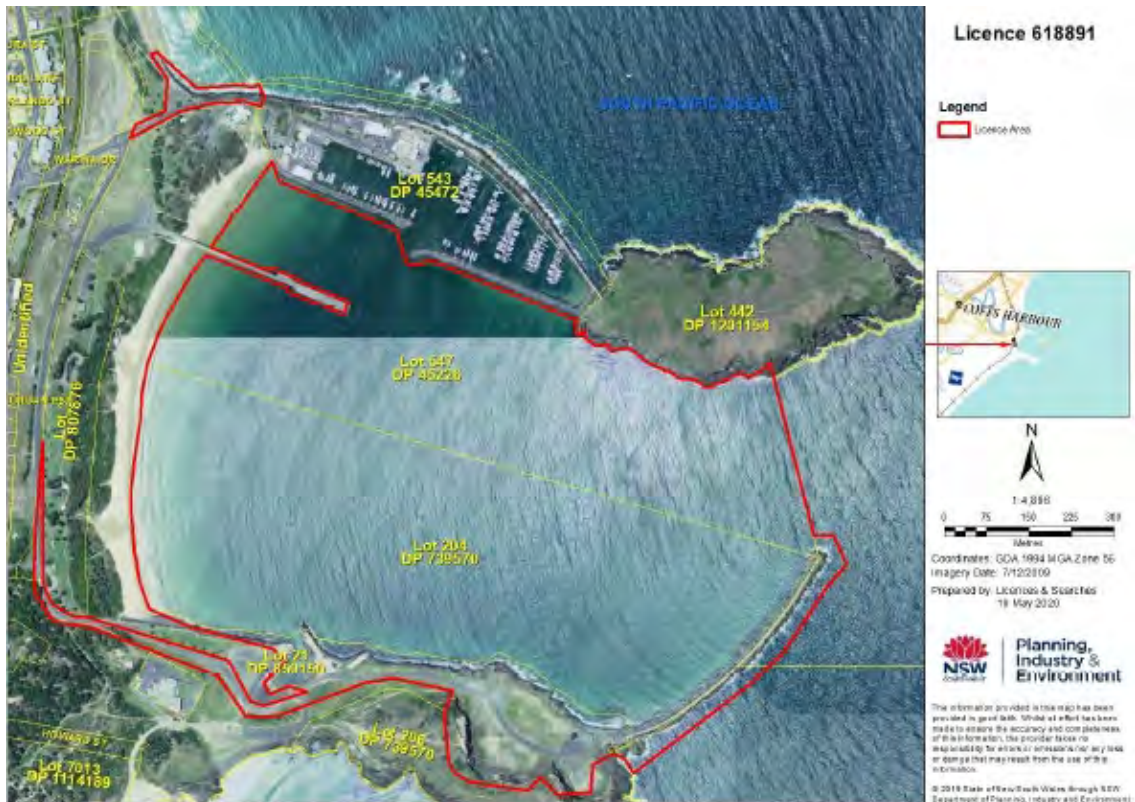
**Figure 8: Combined Crown land licence area**

The Crown Land Management (CLM) Act 2016 provides for the ownership, use and management of the Crown land or a Crown road of NSW. Under Section 2.18 of the CLM Act the Minister may grant a licence over dedicated or reserved Crown land or a Crown road for the purpose of any facility or infrastructure. The proposal area is subject to a combined licence granted to TfNSW by the Minister as shown outlined in red in the diagram below:

Notably, the carpark area is not subject to the combined Crown licence. An amendment to the licence has been sought by TfNSW, but had not been granted at the time of completion of this REF. If the licence has not been amended prior to the commencement of the Stage 2 works, a specific Crown land licence covering the work to the carpark will be required under Section 2.18 of the CLM Act.

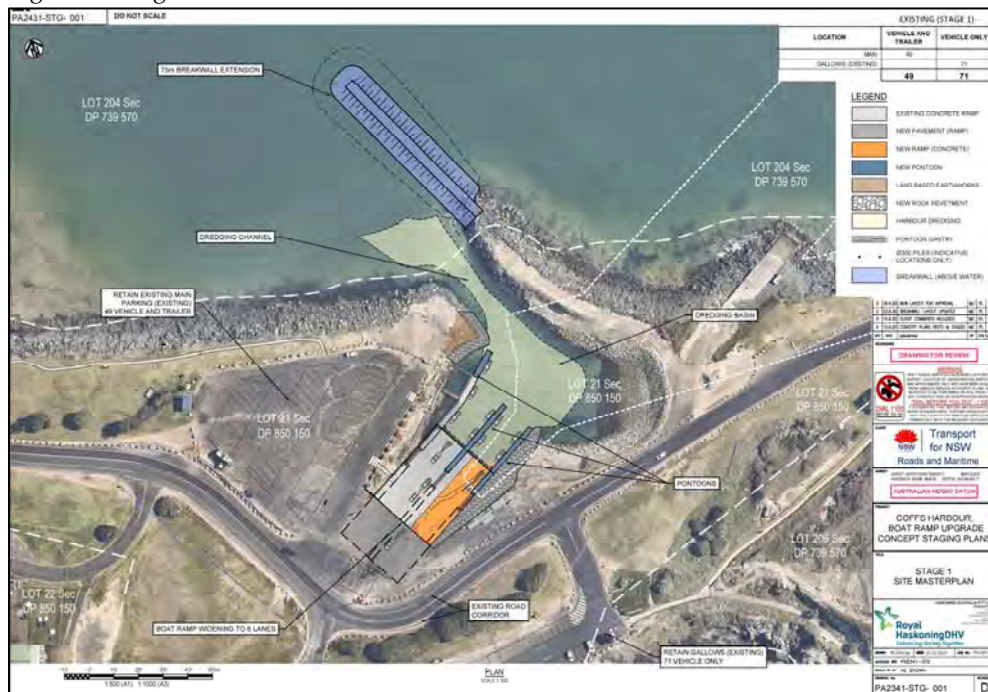
Figure 1.2 Stage 1

- Extension of the existing breakwater by 75m
- Widening of the existing boat ramp with an additional two lanes
- New topping over the existing boat ramp area
- Extension of the existing pontoon
- Two new pontoons
- Dredging of the existing boat ramp basin and channel

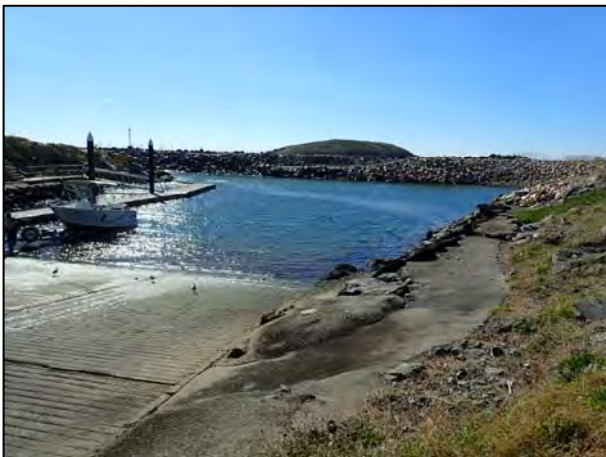
Figure 3.5 Boat ramp facing north east

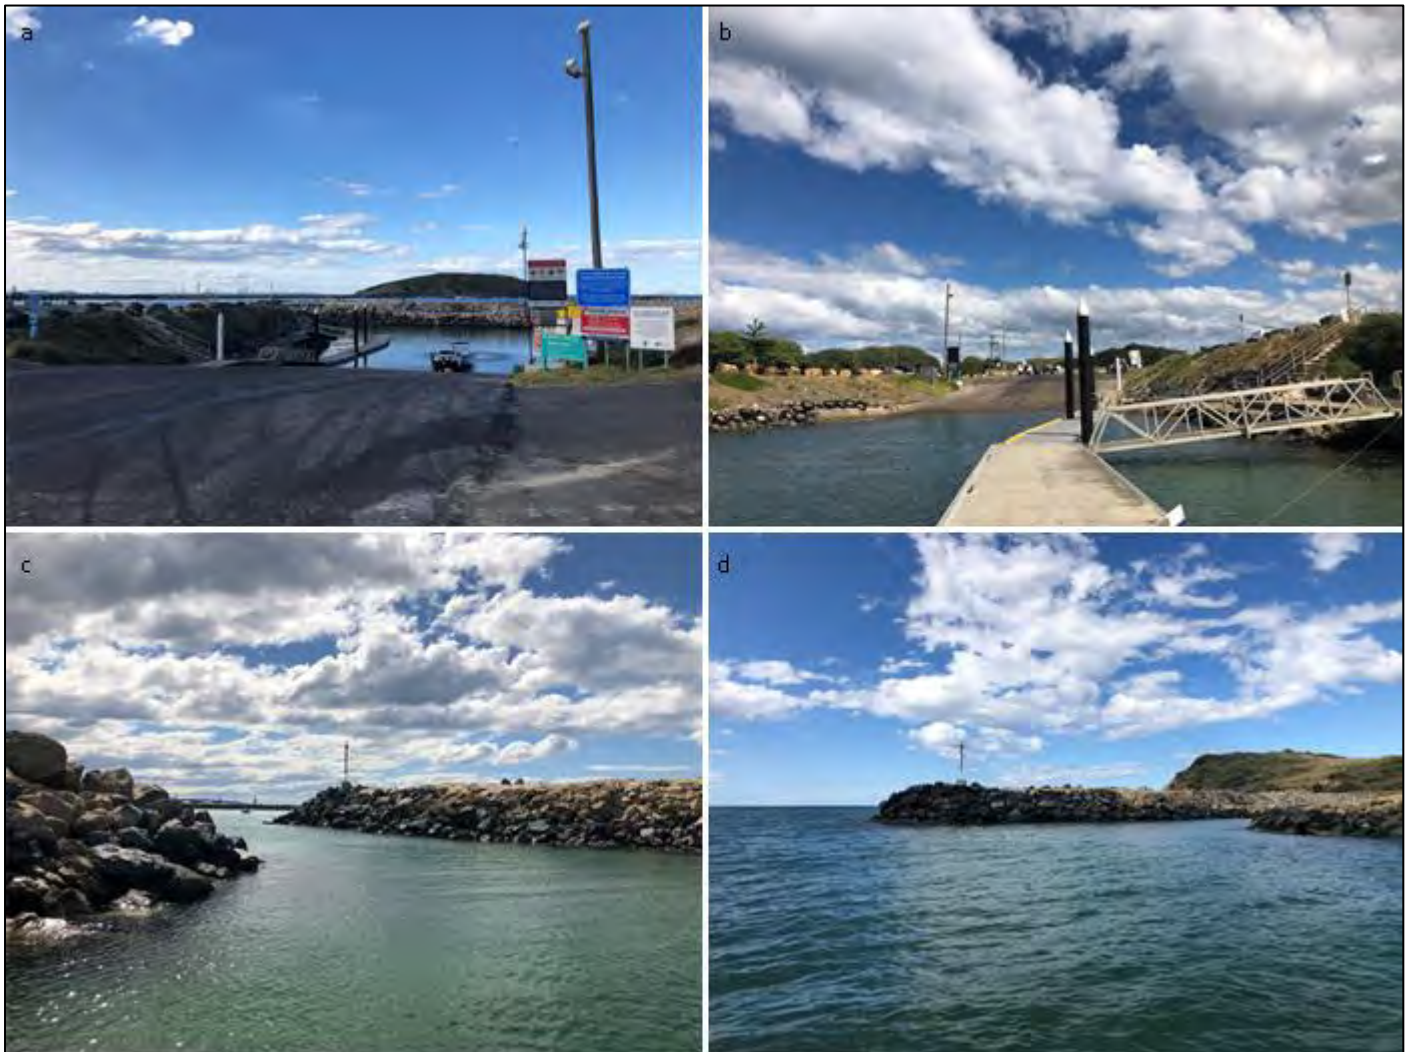
**Plate 1: Existing boat ramp, pontoons, seawalls and breakwater.**

A: Boat ramp, B: existing pontoons, C: basin entry channel and seawalls, and D: eastern breakwater.

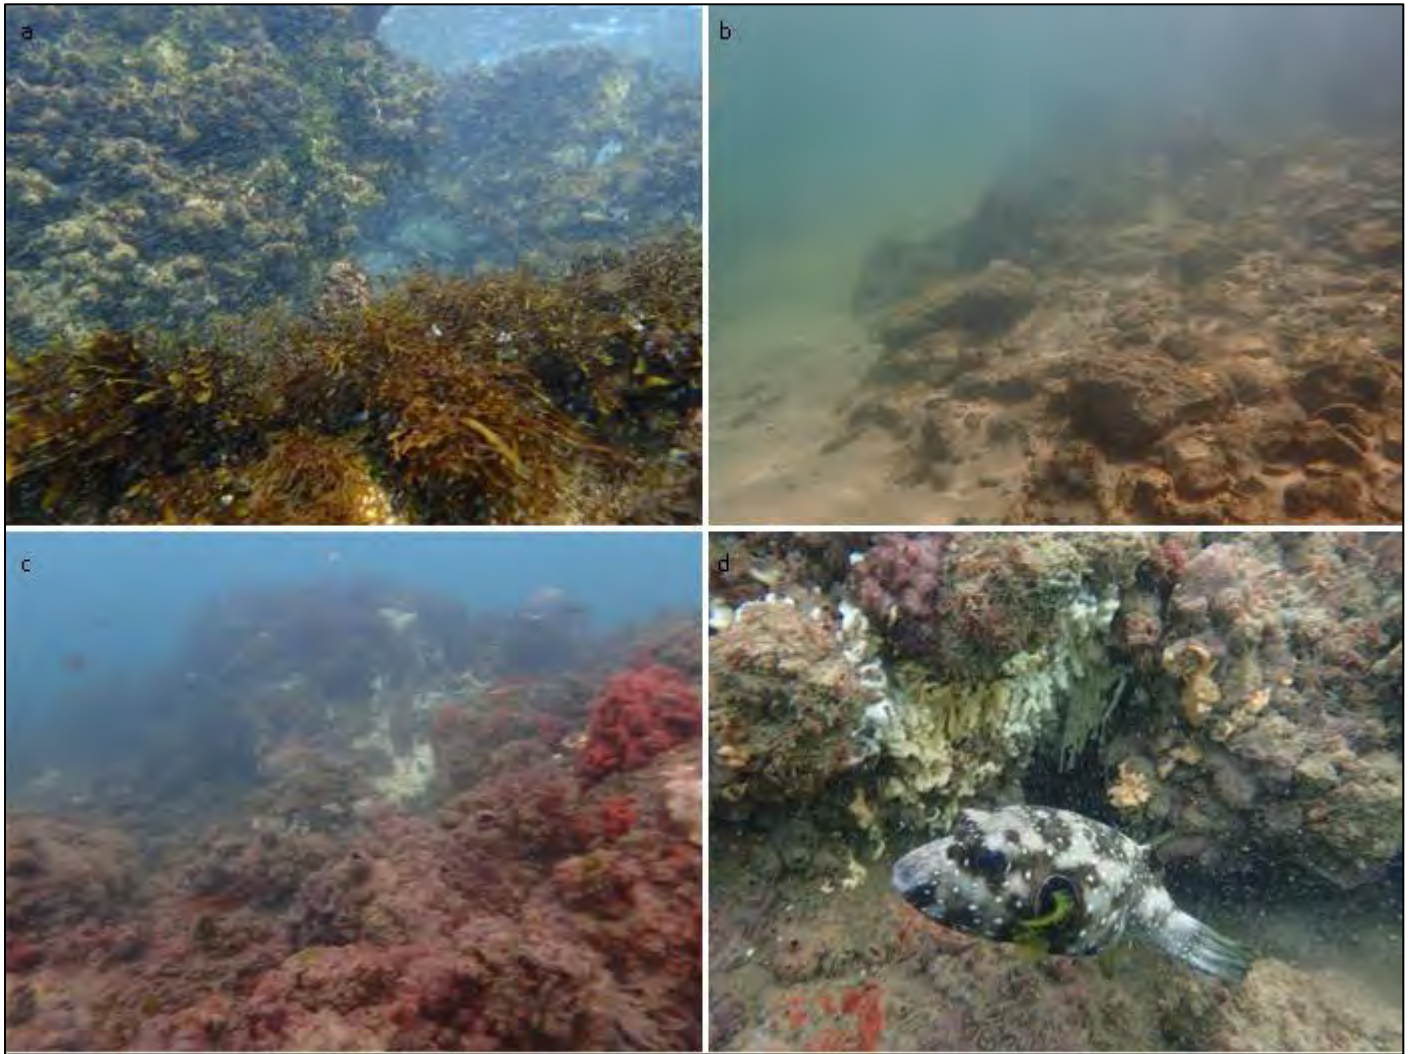
**Plate 4: Sub-tidal habitat in the Study Area.**

A: Brown seaweed *Sargassum* sp. along the edges of the seawalls, B: Sand scoured rock at the toe of the breakwater, C: Turfing algae and sessile invertebrate dominated habitat on the adjacent reef , and D: A puffer fish with encrusting sponges on the adjacent reef.

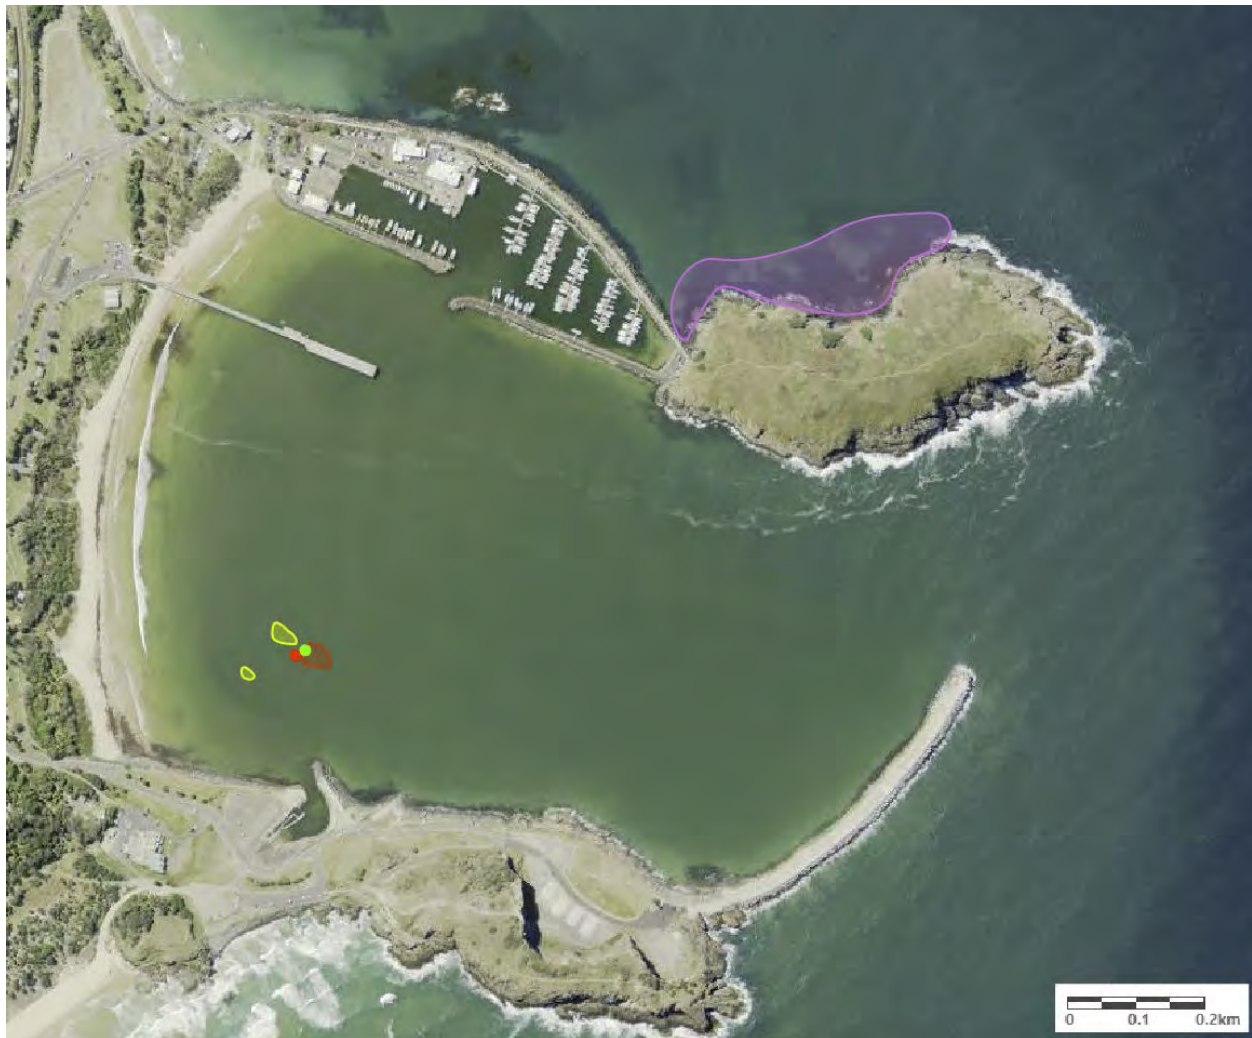
**Figure 1** Map of the inside of Coffs Harbour. The red area highlights the location of permanent patch reefs. The yellow areas are reefs that can temporarily emerge following sand scouring (reef locations provided by Dr David Cummings). The purple area highlights the closest population of *Nereia*. The green dot shows the place where the dive survey began and the red dot shows where it finished.

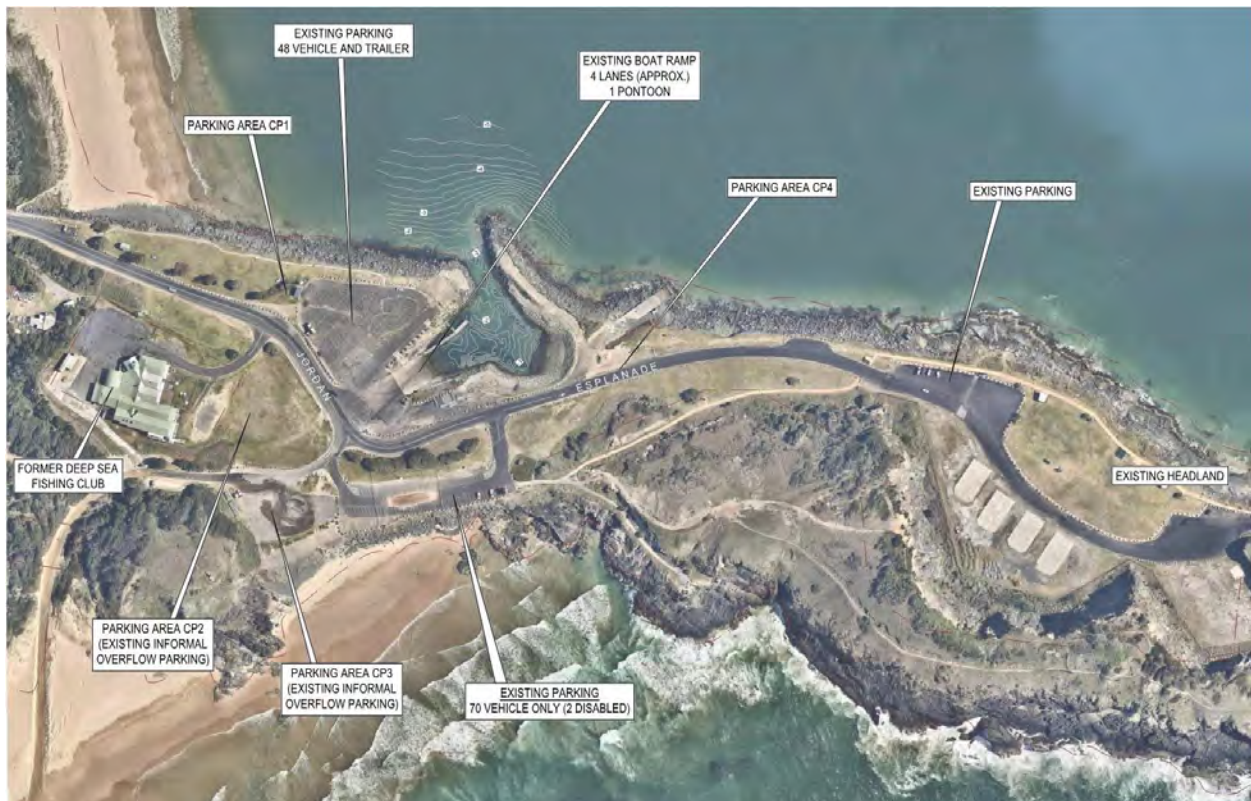
Figure 1 Coffs Harbour Boat Ramp Study Area

Figure 1 provides a summary of the key features within the study area for the investigation.

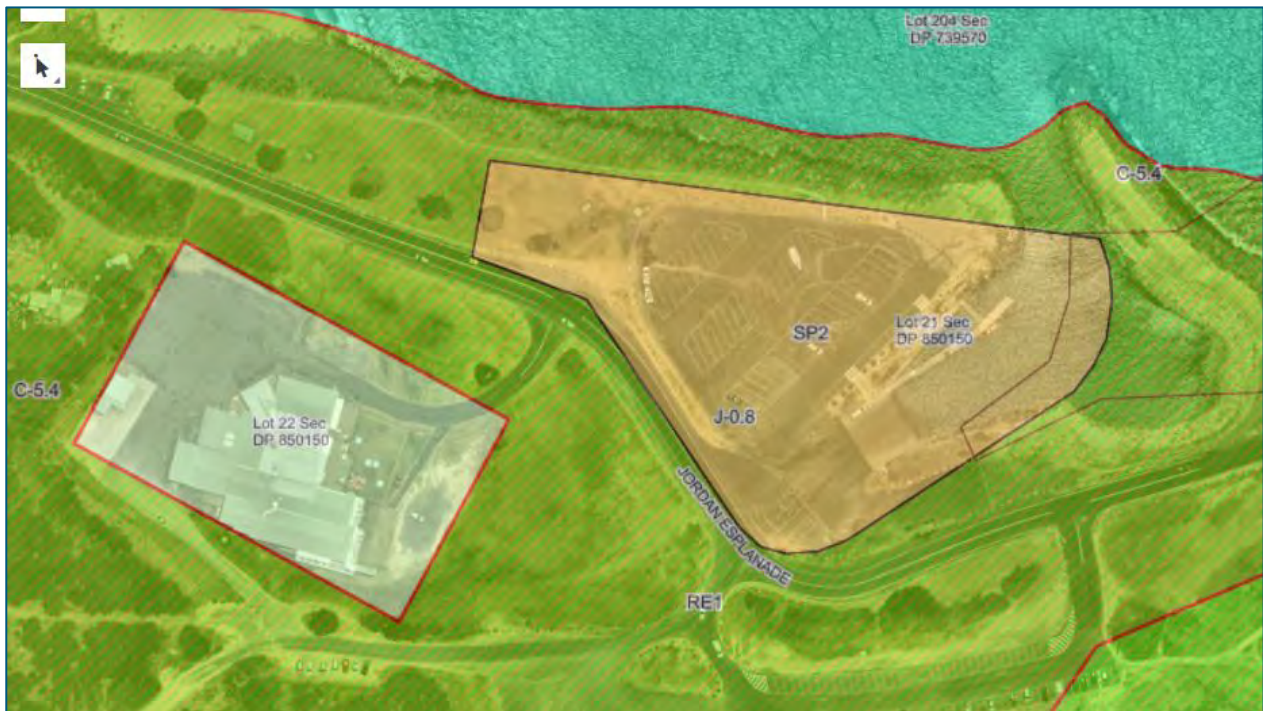
Figure 2 Coffs Harbour LEP (2013), Land Zoning

As shown on Council LEP Mapping (2013) the southern foreshores of Coffs Harbour are for the most part zoned RE1 Public Recreation under the *Coffs Harbour Local Environmental Plan (LEP) 2013*. The Boat Ramp, Harbour and Main Carpark is zoned SP2 Infrastructure.

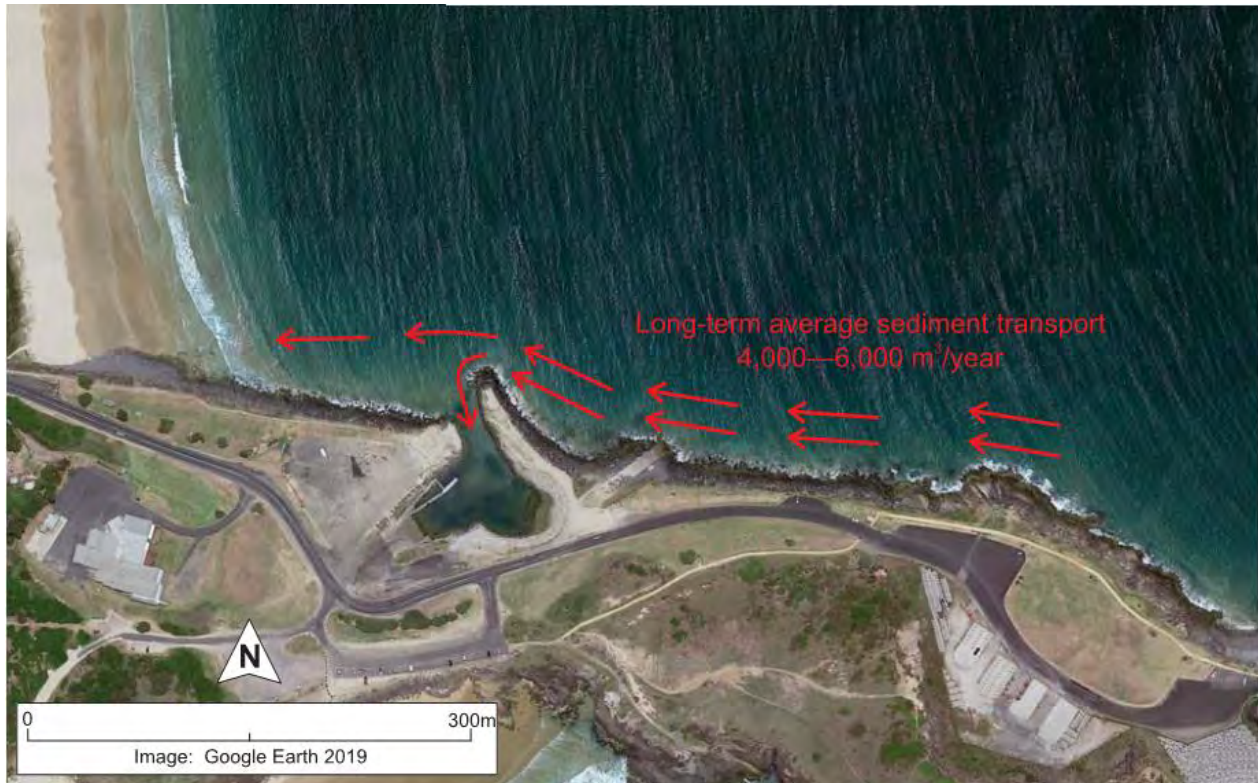
**Figure 6: Existing sediment transport pathway along southern shoreline of Coffs Harbour (Source: MHL 2019)**

No information regarding tidal currents is available for the study area. However, it should be noted that a sediment transport pathway occurs along the southern foreshore of Coff's Harbour towards the southern end of Jetty Beach (**Figure 6**), which in turn causes significant sand shoaling to occur in and around the entrance to the boat ramp basin. This longshore sediment transport rate is currently estimated to be between 4,000 – 6,000 m<sup>3</sup>/year and results in the need for the regular removal of sediment from the entrance to the boat ramp basin by a dredge and/or long reach excavator (MHL, 2019).

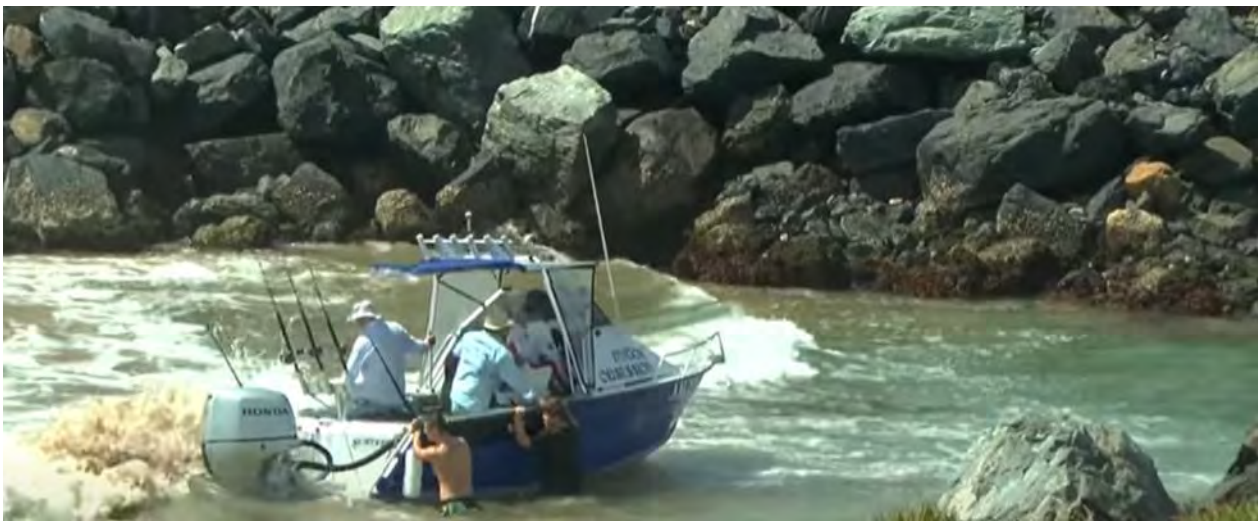
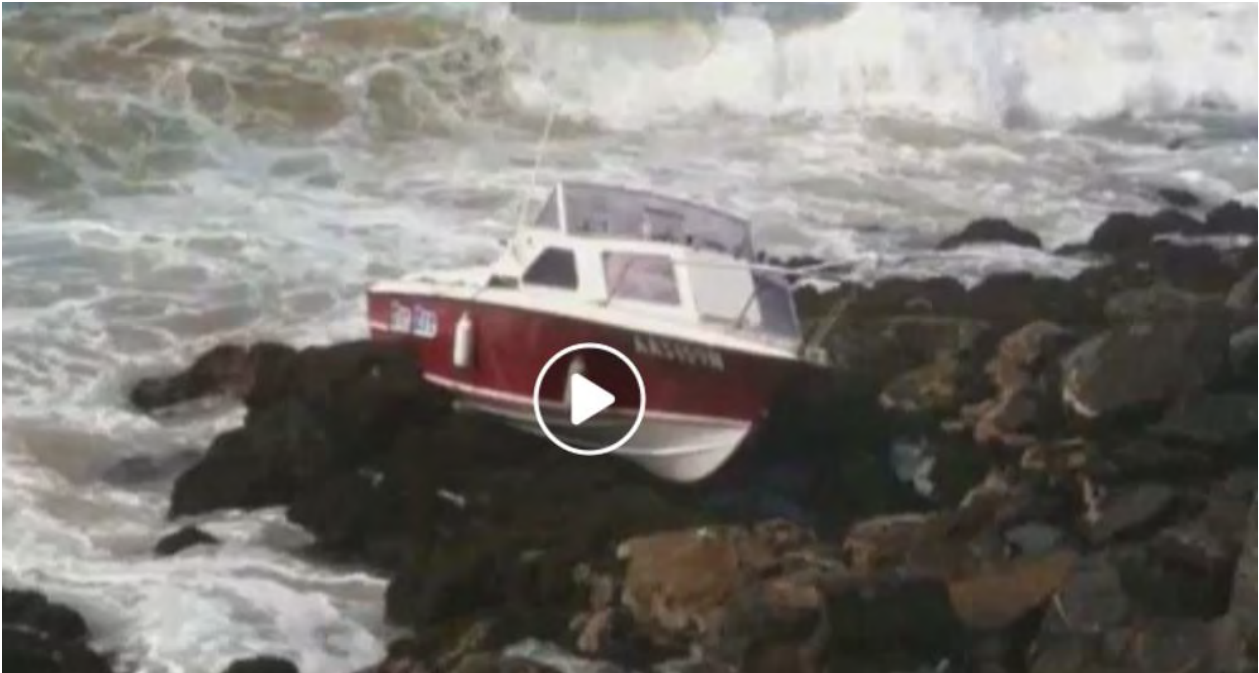
*Figure 7: Images of boats grounding on the entrance shoal at Coffs Harbour boat ramp, and also being subsequently washed onto the rock revetment on the western side of the boat ramp basin entrance.*

This sedimentation (when combined with significant swell conditions and low water levels) has led to several boats broaching / running aground, with numerous injuries, and boats subsequently being washed up on the rocks on the western side of the boat ramp basin. Video footage of a number of these groundings was supplied by John Lawler of the CHRBRPEC, refer **Figure 7**.

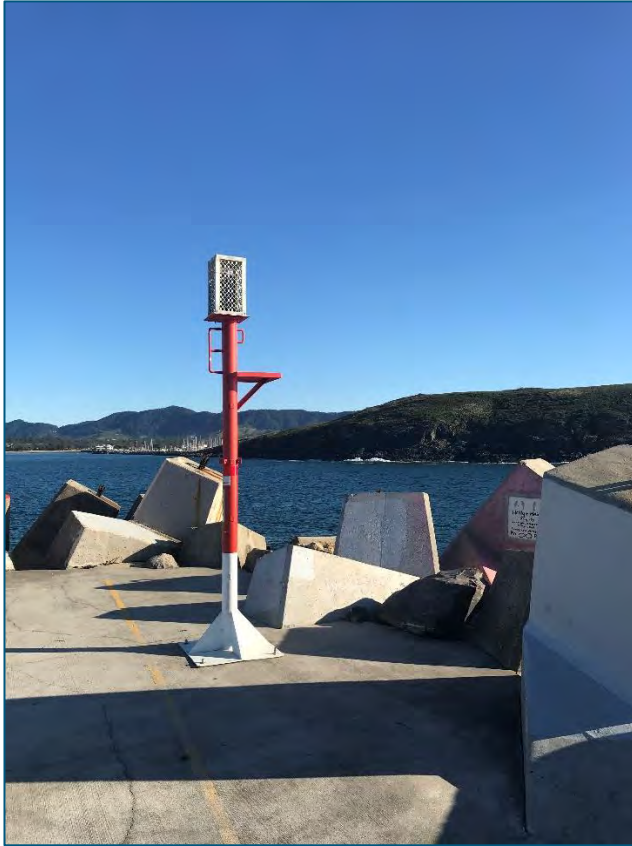
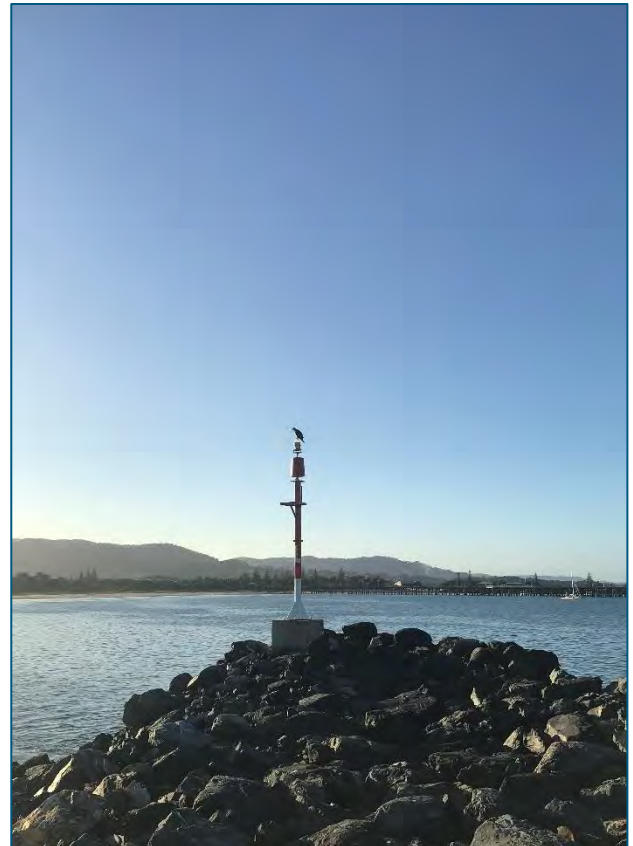
*Figure 9: Coffs Harbour – Port beacon lateral marks (Left) Southern breakwater and (Right) Boat ramp basin entrance*

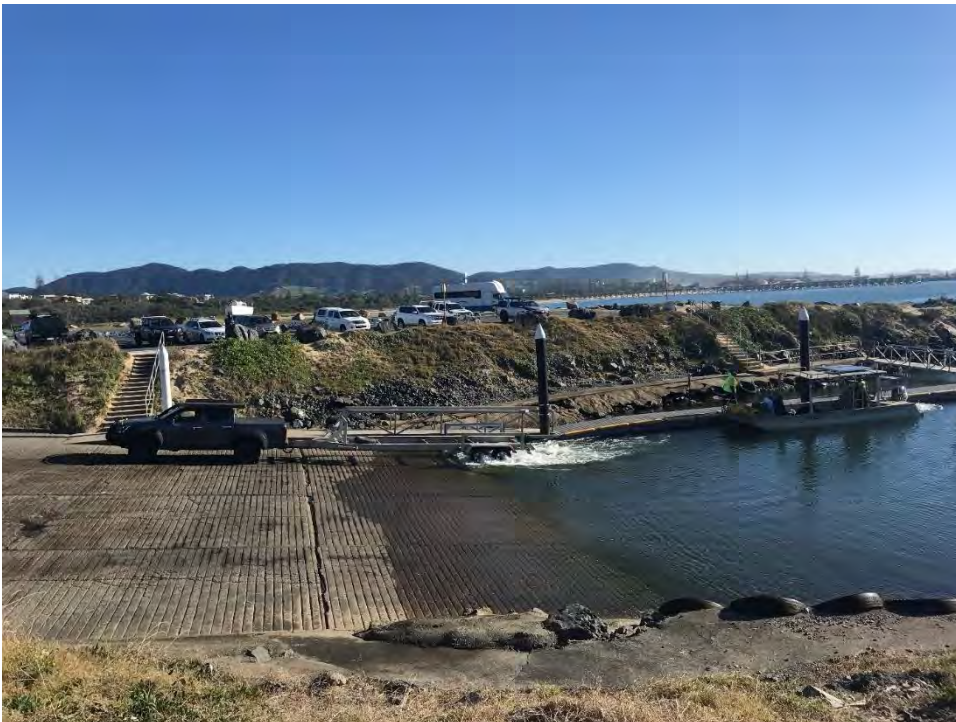
*Figure 11: Coffs Harbour Boat Ramp and Pontoon, showing user “dry” launching, utilising the existing western pontoon*

A single pontoon extending along the western side of the boat ramp basin facilitates dry launching and retrieval for users (**Figure 11**). The pontoon can hold a maximum of four vessels.

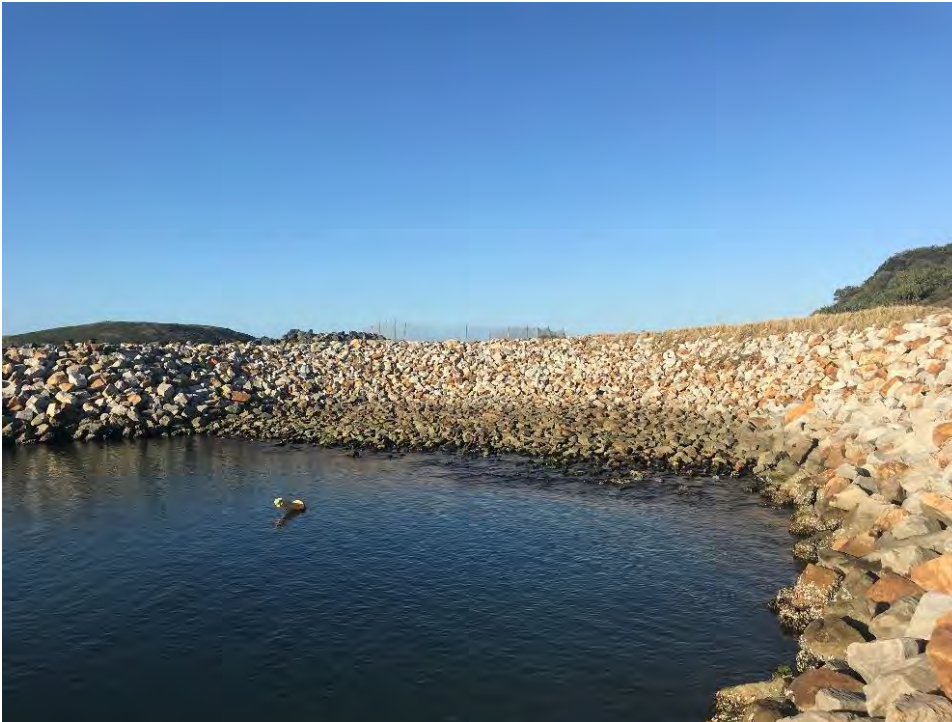
*Figure 12: Photo of the Boat Ramp Basin extension constructed in 2015 to dissipate Seiching energy*

In 2015, NSW Crown Lands (DPIE) commission NSW Public Works to construct an extension of the boat ramp basin to facilitate the dissipation of seiching energy, to reduce the impacts of surge at the ramp. MHL report that through monitoring (pre and post construction), the basin extension has reduced Seiching effects at the ramp by up to 30%. A photo of the structure is shown in **Figure 12**.

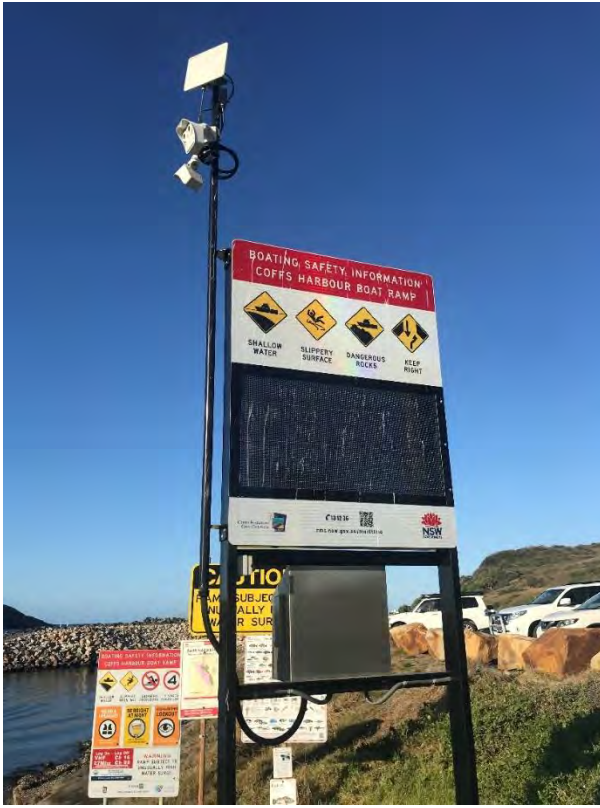
Figure 13: Photo of the automated RMS Boating Safety Information Sign

In addition, a recently constructed automated RMS Boating Safety Information Sign exists on the eastern side of the boat ramp (**Figure 13**). This sign and its electrical feed will need to be relocated as part of the boat ramp upgrade works.

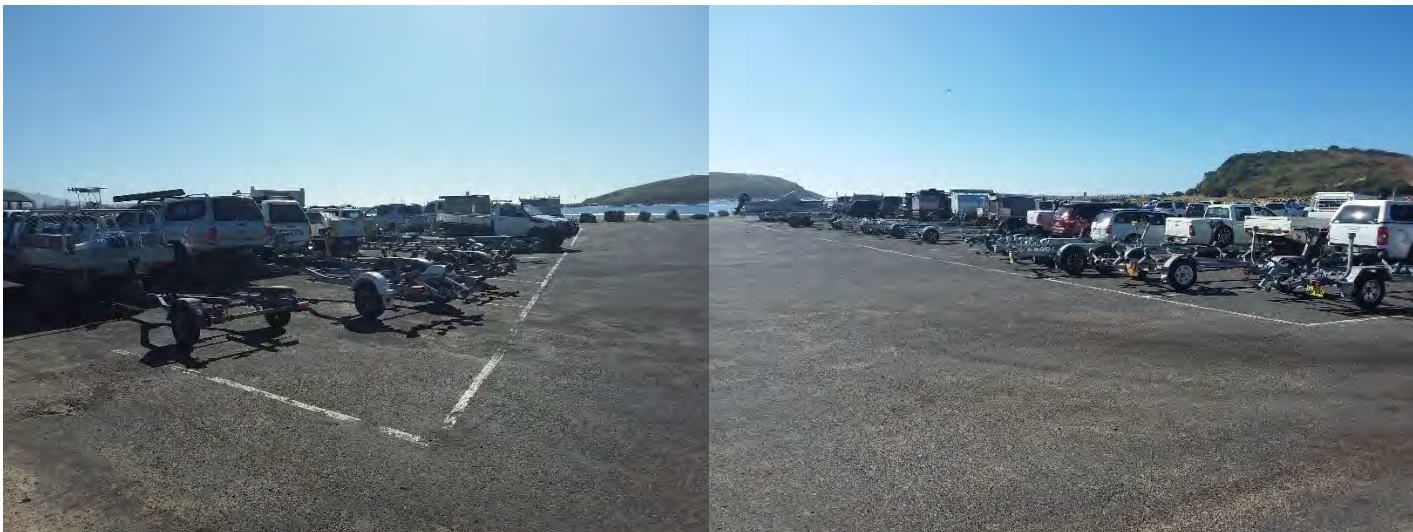
**Figure 14: Photo of the Main Carpark, 10:00am, Sunday 2<sup>nd</sup> August – peak of 77 Car and Trailer or Car only parking (capacity 49 Car and Trailer)**

It must be stated that use of the existing boat ramp facility is constrained by the available parking, lack of pontoons (only the single pontoon), and navigation safety issues primarily associated with the shoaling of the entrance channel under certain conditions (high swell, low tide). RHDHV conclude that should the boat ramp upgrades occur, additional demand will eventuate.

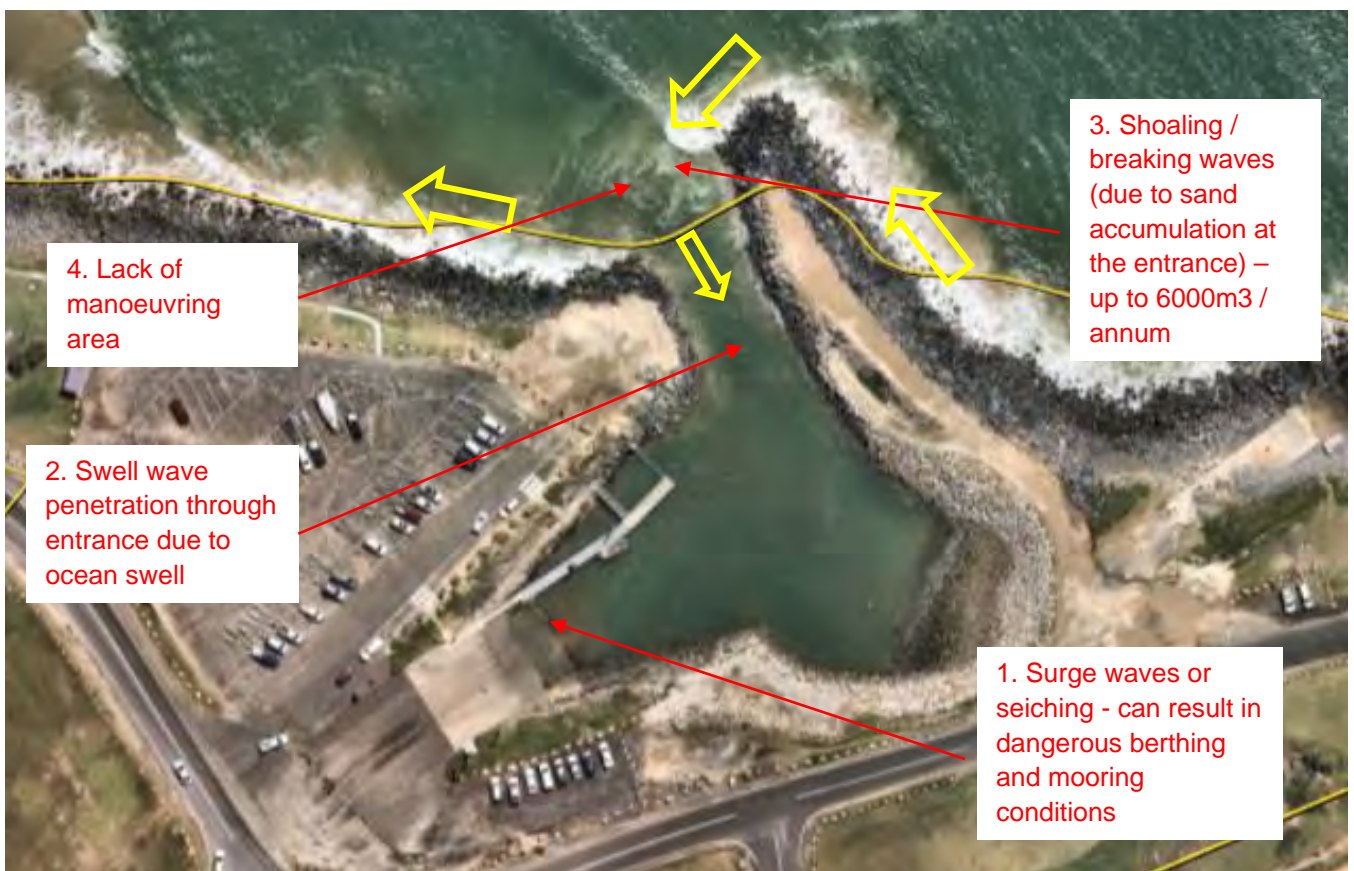
Figure 15: Key Coastal Processes affecting Boating Safety at the Coffs Harbour Boat Ramp facility

4. **Lack of Navigation (“Sea-Room”)** – There is a short distance between the seaward end of the breakwater and the rocky revetment on the leeward (western shoreline). In conditions of low tide, and large swell waves, vessels have been swept onto the rocky revetment on the western side of the boat ramp basin entrance. Therefore, as well as the potential to reduce seiching and swell penetration into the boat harbour, the desire to extend the breakwater is also to allow “sea room”, i.e. navigational space to recover from a broaching or grounding, to allow the vessel to enter the boat ramp basin safely without running aground on the rocky shoreline.

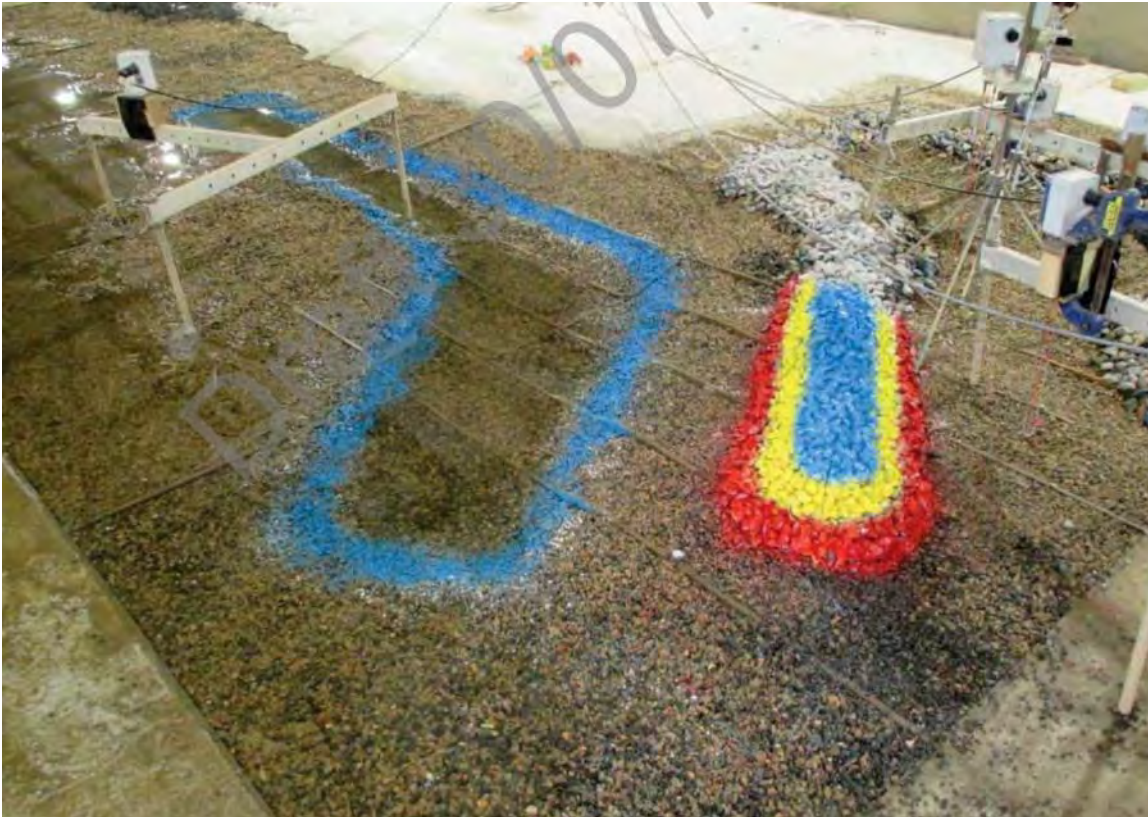
*Figure 17: Physical Model at Manly Hydraulics Laboratory of Proposed Coffs Harbour Boat Ramp Breakwater Extension and Offshore Dredged Sediment Sink Concept (MHL, 2020)*

Due to the significant sedimentation that occurs in the entrance area, MHL also modelled the hydrodynamic effects of creating a large sediment sink off the north-eastern side of the existing breakwater (refer also **Figure 16**). Physical model testing was also undertaken to determine if the proposed deepening of the boat ramp basin and entrance channel to RL -2.5 would have an adverse impact on swell wave penetration into the basin and on seiche action in the basin and at the boat ramp. A photograph of the physical model is provided in **Figure 17**.

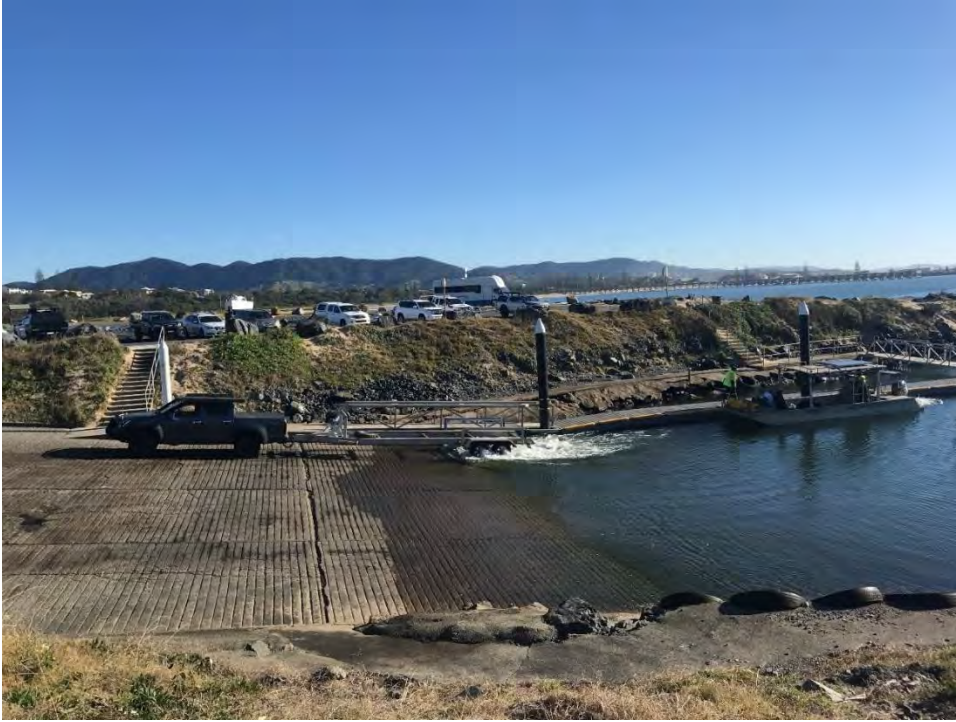
*Figure 18: Coffs Harbour Boat Ramp*

The following observations were made by RHDHV staff during an inspection of the existing Coffs Harbour boat ramp facility in July 2020 (refer **Figure 18**):
