# **Proposed Upgrade of Coffs Harbour Regional Boat Ramp Stages 1 and 2**

Review of Environmental Factors

Transport for NSW

November 2020

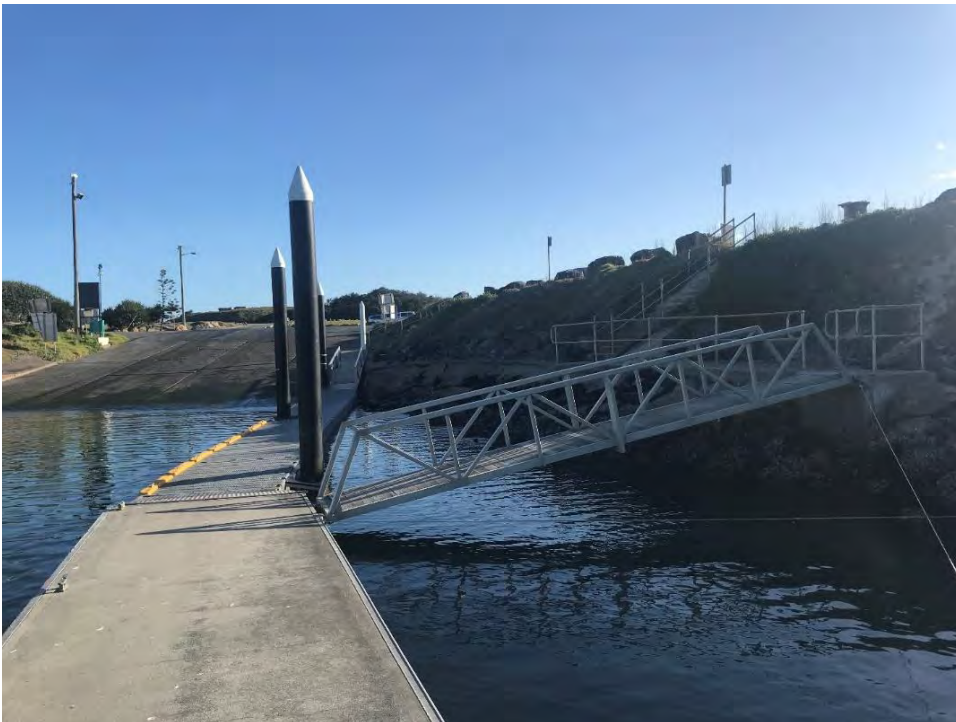
*Figure 19: Existing Pontoon – minor repair works required*

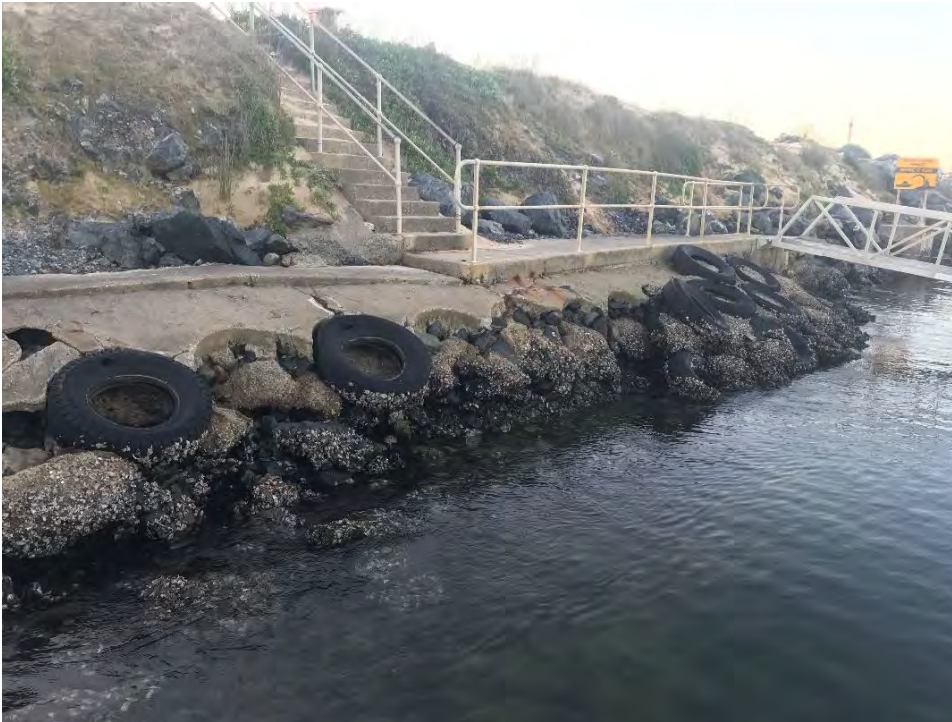
*Figure 20: Existing concrete and tyre revetment in state of significant disrepair*

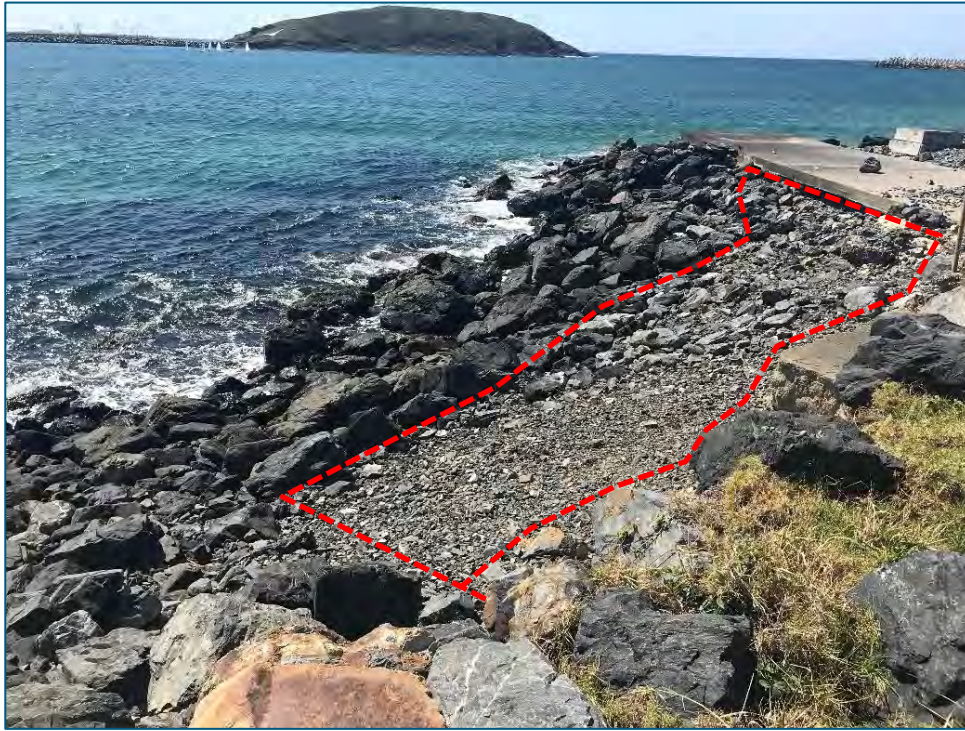
*Figure 21: Damaged area west of existing Material Offloading Ramp*

There is a large area of damaged armour and underlayer at the edge of the existing material offloading ramp and the eastern end of the existing breakwater. RHDHV suggest repairs to this section of the existing breakwater.

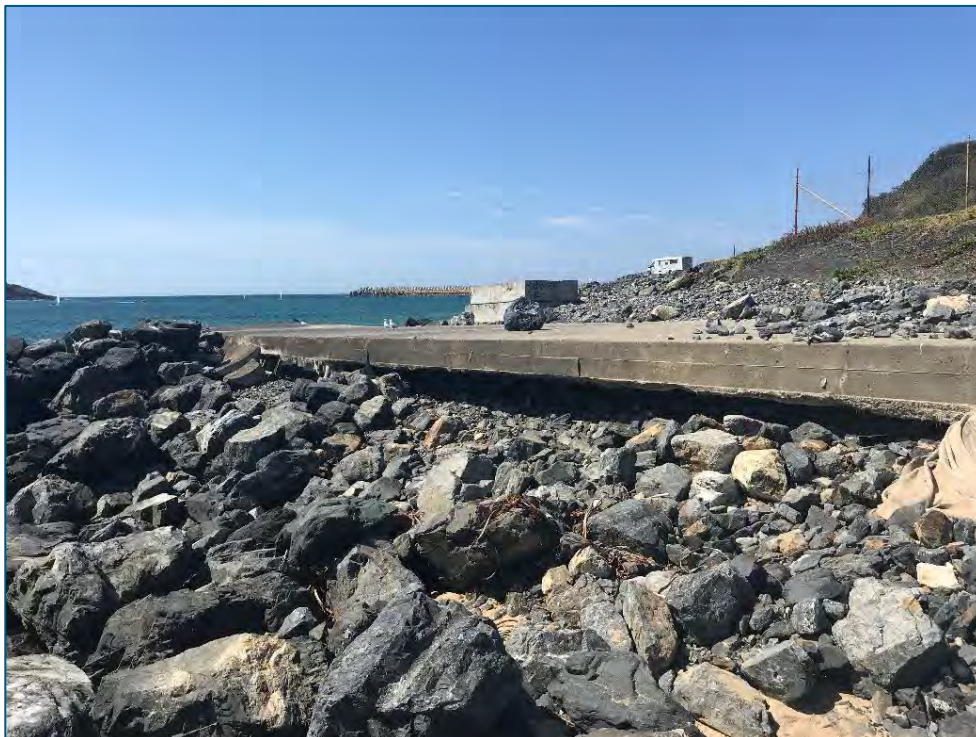
*Figure 22: Damaged area adjacent to the existing Material Offloading Ramp*

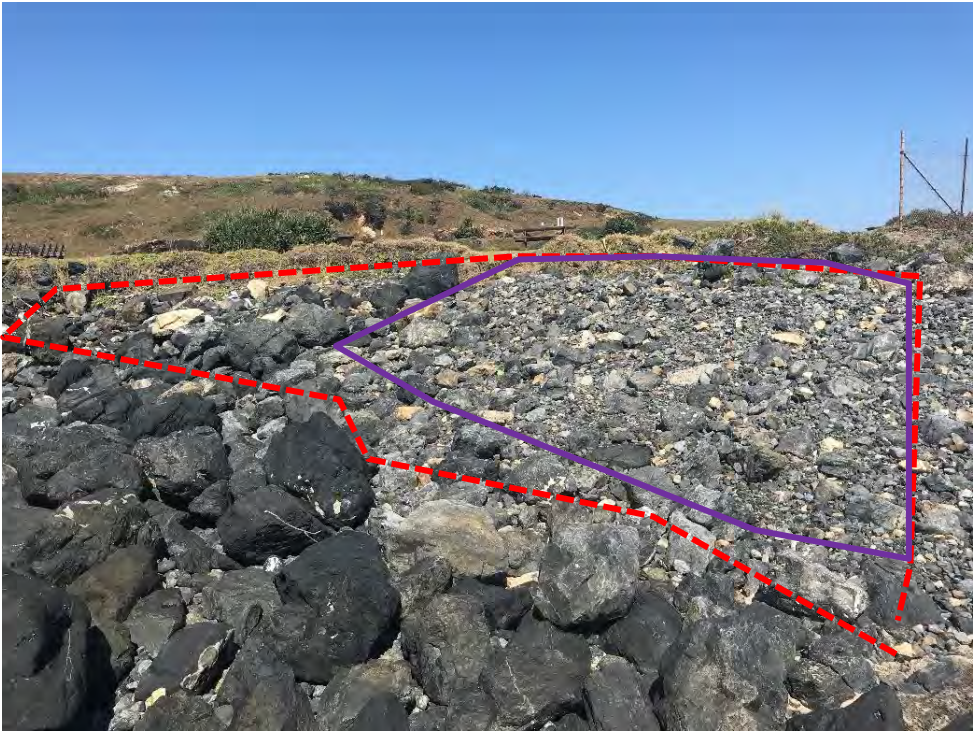
Figure 23: Clear transition between very small core material (purple) exposed and some scattered underlayer. Foreground shows “Floating” larger armour remaining (outside red dashed line).

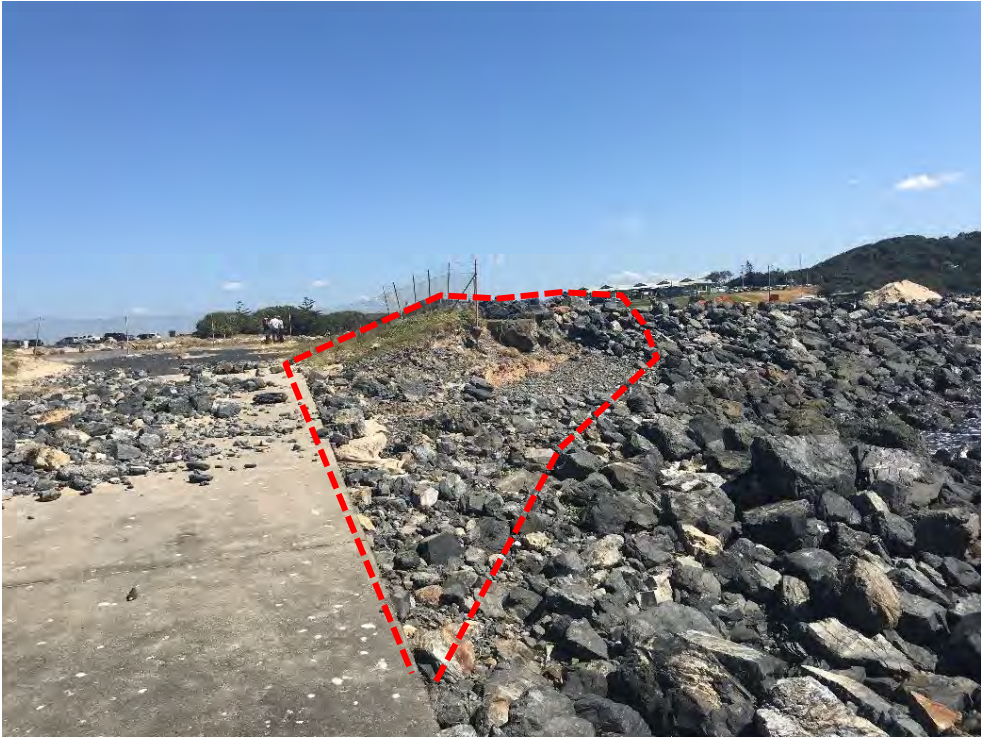
Figure 24: Damaged area – ramp shows “wash-over” material from eastern side of ramp, indicates damage also occurring on eastern side of ramp

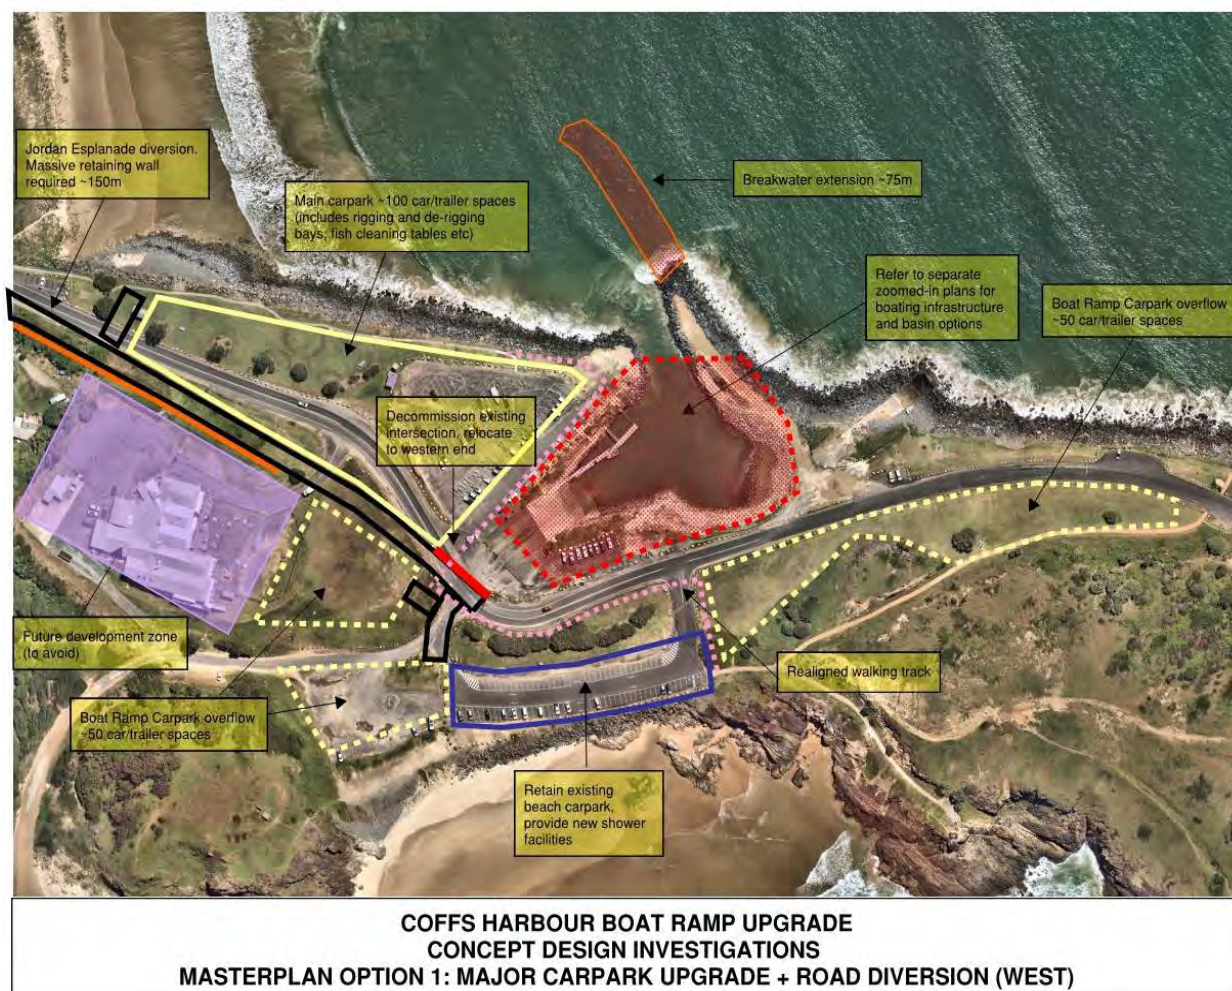
*Figure 25: Masterplan Option 1*

Masterplan Option 1 (**Figure 25**) was developed with a view to diverting Jordan Esplanade to the south on the western side of the of the boat ramp facility. The objective of this approach was to maximise the space available within the main carpark. The option also included carpark upgrades to approximately 100 carparking spaces in the main carpark, which has the obvious advantage of maximising the number of boat and trailer parking spots available immediately adjacent to the boat ramp.

The key disadvantage of this option is that it would require a significant retaining wall along the southern side of Jordan Esplanade, which would be costly and possibly unsightly. The other main disadvantage is that it would encroach significantly towards the former Deep Sea Fishing Club site, which is ear-marked for redevelopment by Property NSW. The option included ancillary overflow parking in the areas to the south of Jordan Esplanade, both to the west and east of the existing Gallows Beach carpark.

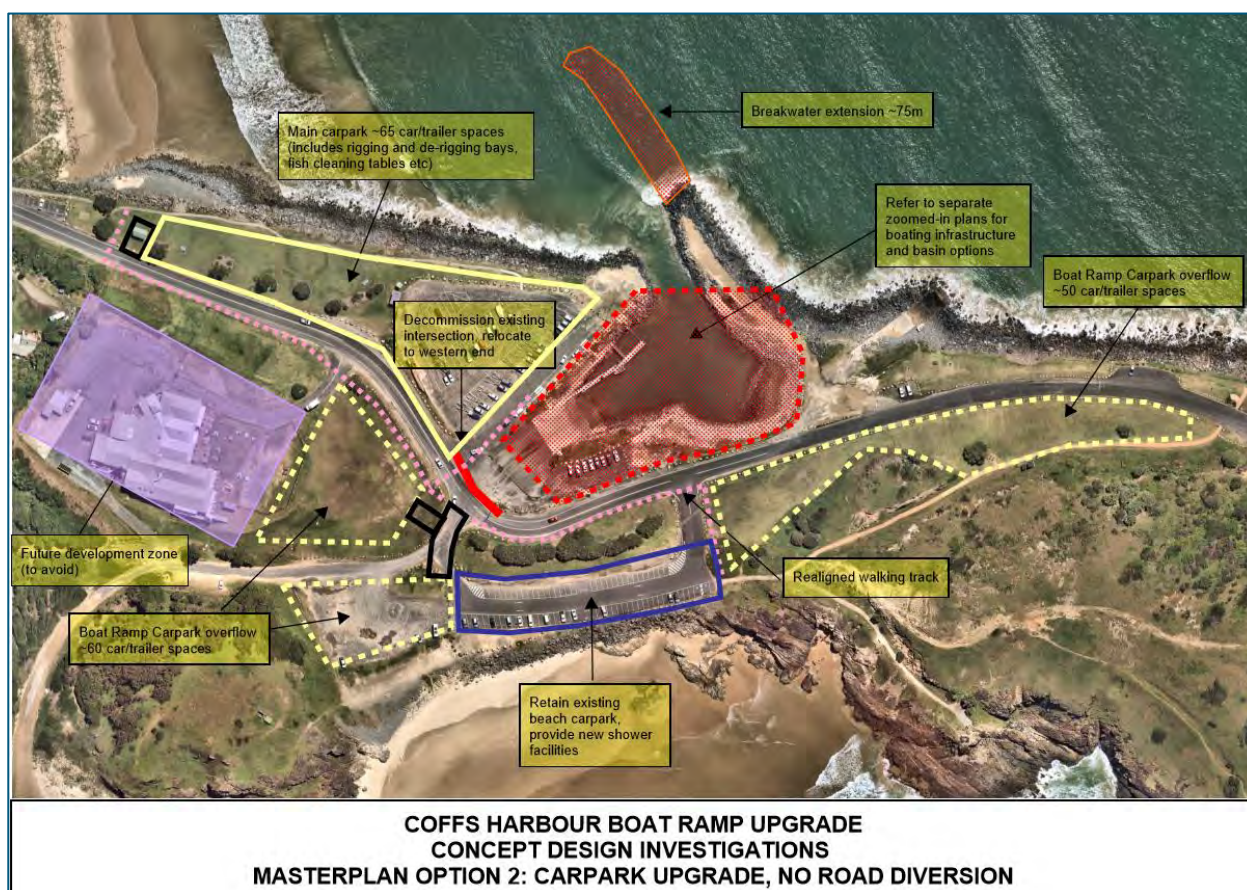
Figure 26: Masterplan Option 2

Masterplan Option 2 (**Figure 26**) was developed with a view to avoiding any diversion of Jordan Esplanade. The objective of this approach was to maximise the space available within the main carpark, without road diversion. This option also included carpark upgrades to approximately 65 carparking spaces in the main carpark, however this would require further encroachment into the existing grassed area to the west.

The key advantages of this option are that it would not require any road diversion or significant retaining walls, and that it would not encroach significantly towards the former Deep Sea Fishing Club site. The option also included ancillary overflow parking in the areas to the south of Jordan Esplanade, both to the west and east of the existing Gallows Beach carpark. The disadvantage is that it encroaches a long way to the west, over valuable foreshore passive open space recreational land, with picnic tables.

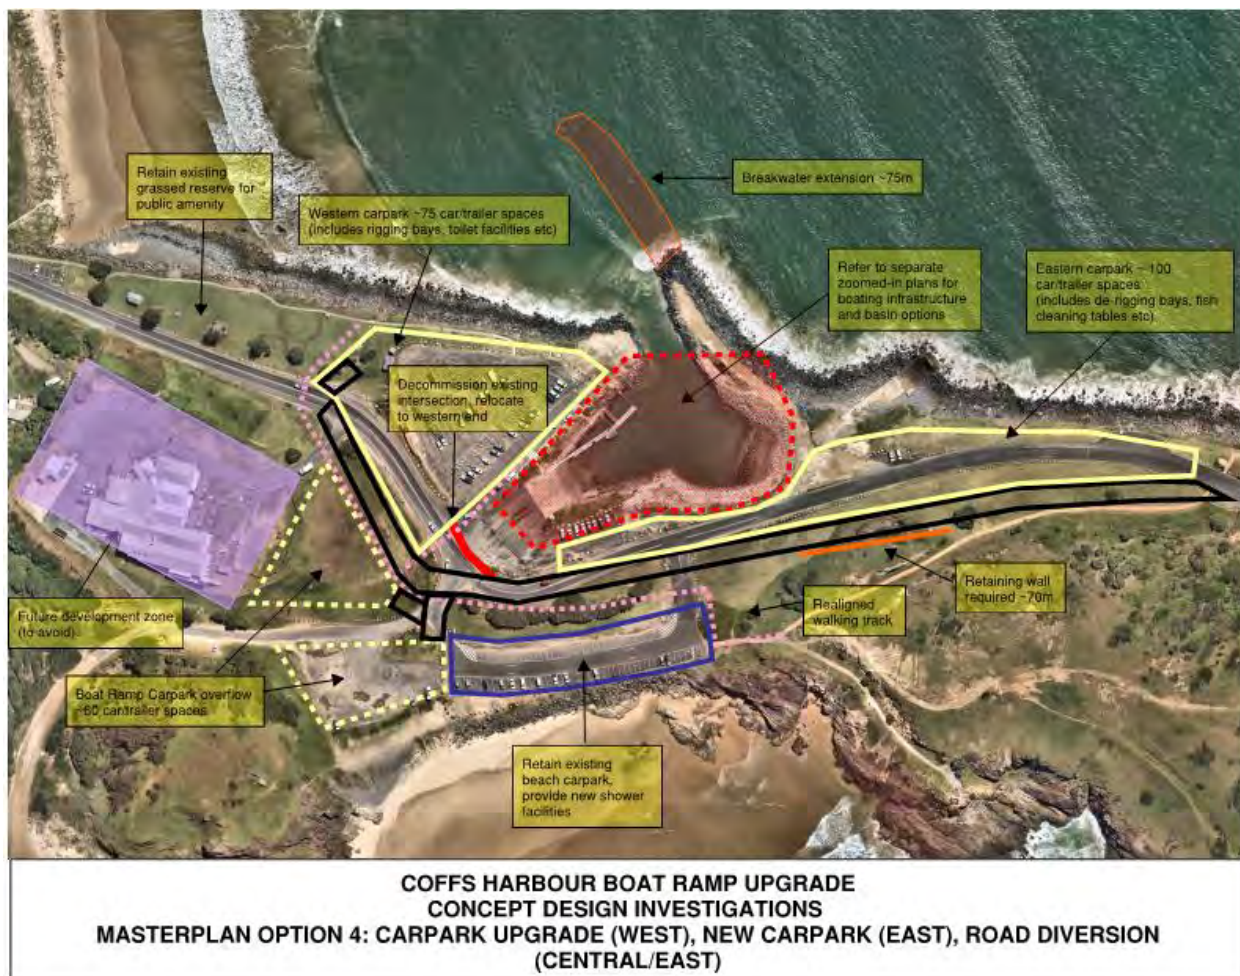
**Figure 28: Masterplan Option 4**

Masterplan Option 4 (**Figure 28**) was developed with a view to diverting Jordan Esplanade to the south immediately adjacent to the boat ramp (to make room for a main carpark upgrade), but also on the eastern side of the of the boat ramp to provide additional formalised carparking. The objective of this approach was that the area to the west of the main carpark was considered valuable open space, and it was considered that encroaching into this area would be problematic for Council.

The option included carpark upgrades to approximately 75 carparking spaces in the main carpark, and a further 50-100 formalised car and trailer spaces in the eastern carpark. This option had the advantage of not encroaching significantly towards the former Deep Sea Fishing Club site, although a minor encroachment would be required into the unused grassed area to north-east of the former Deep Sea Fishing Club. The downside of this option is that it would require a significant length of diversion for Jordan Esplanade, which would be costly and possibly unsightly, leading to a significant length of the foreshore being converted to paved carparking. The option also included ancillary overflow parking in the areas to the south of Jordan Esplanade, on the western side of the existing Gallows Beach carpark.

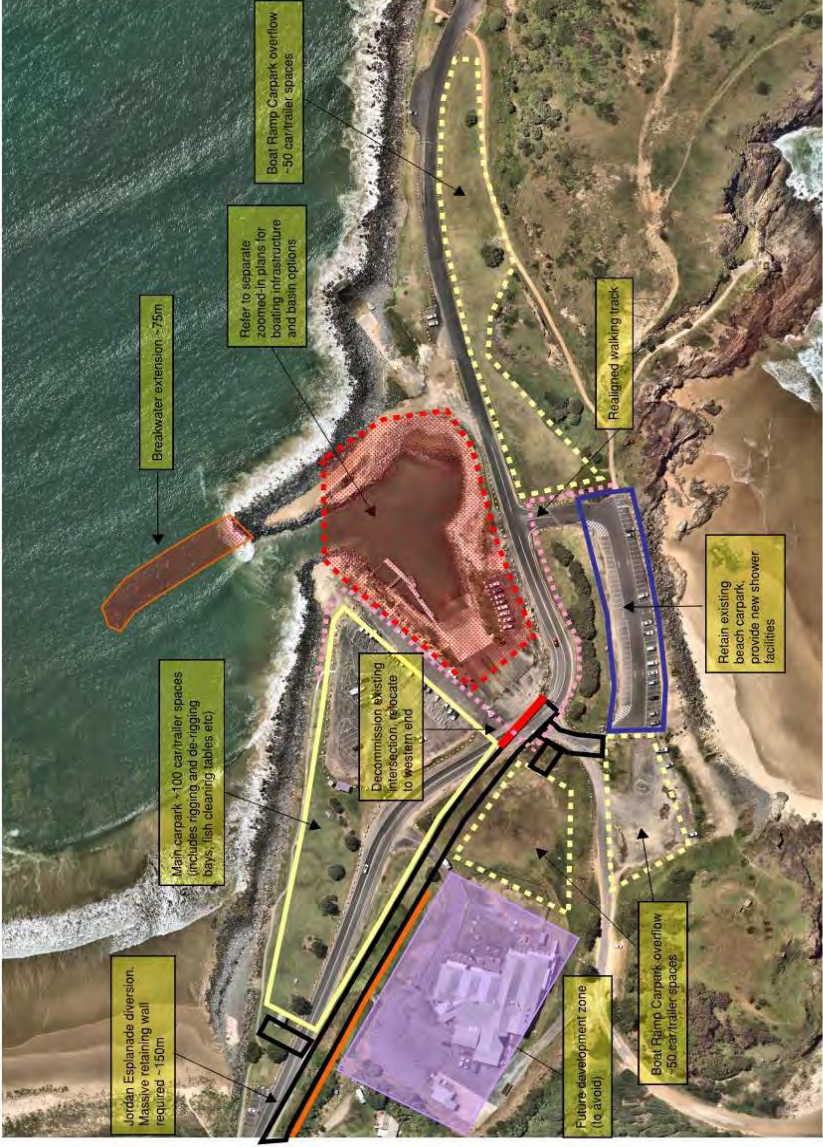
- Jordan Esplanade
- Diversion (West)
- Major Carpark
- Upgrades
- Major retaining wall required
- Encroachment towards former Fishing Club site

COFFS HARBOUR BOAT RAMP UPGRADE  
CONCEPT DESIGN INVESTIGATIONS  
MASTERPLAN OPTION 1: MAJOR CARPARK UPGRADE + ROAD DIVERSION (WEST)

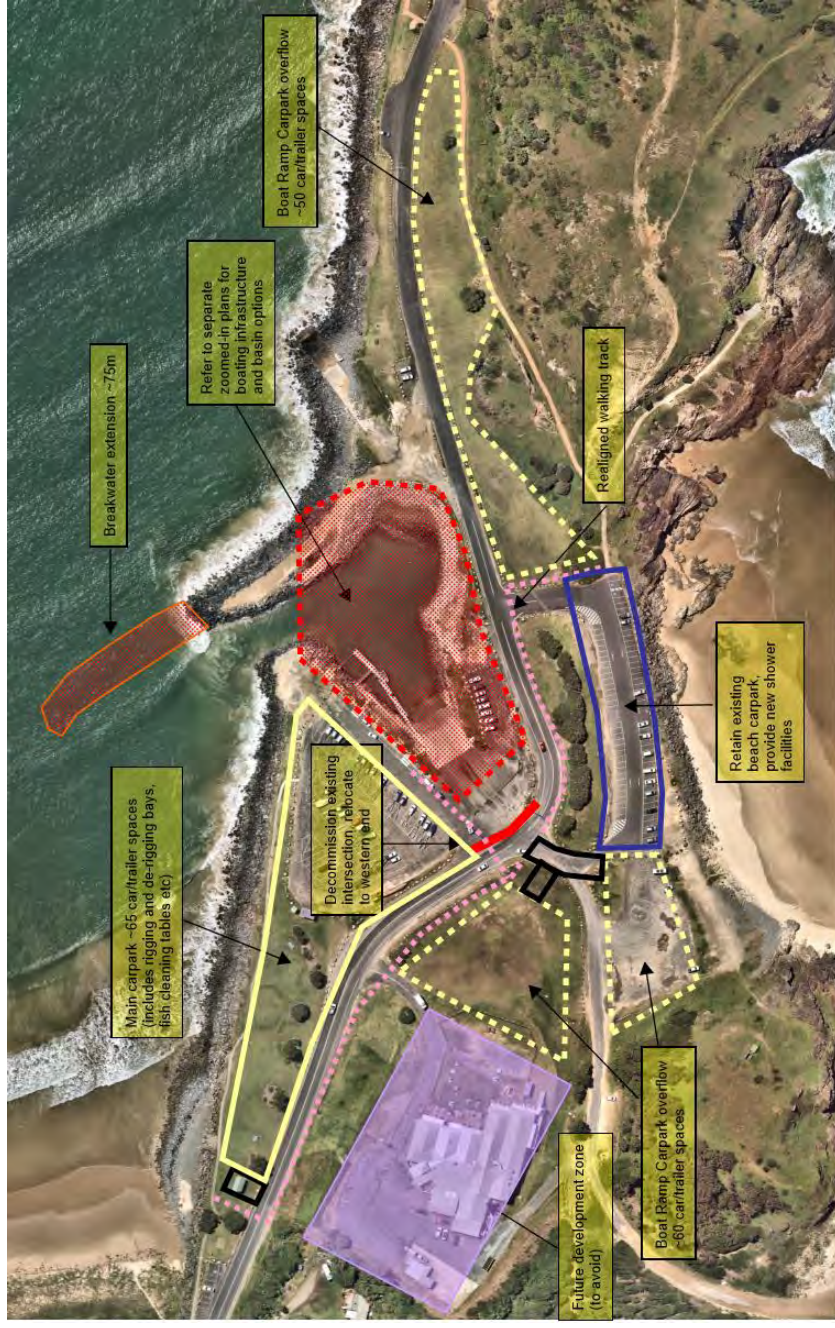
- No Road Diversion
- Major Carpark Upgrades

COFFS HARBOUR BOATRAMP UPGRADE  
CONCEPT DESIGN INVESTIGATIONS  
MASTERPLAN OPTION 2: CARPARK UPGRADE, NO ROAD DIVERSION

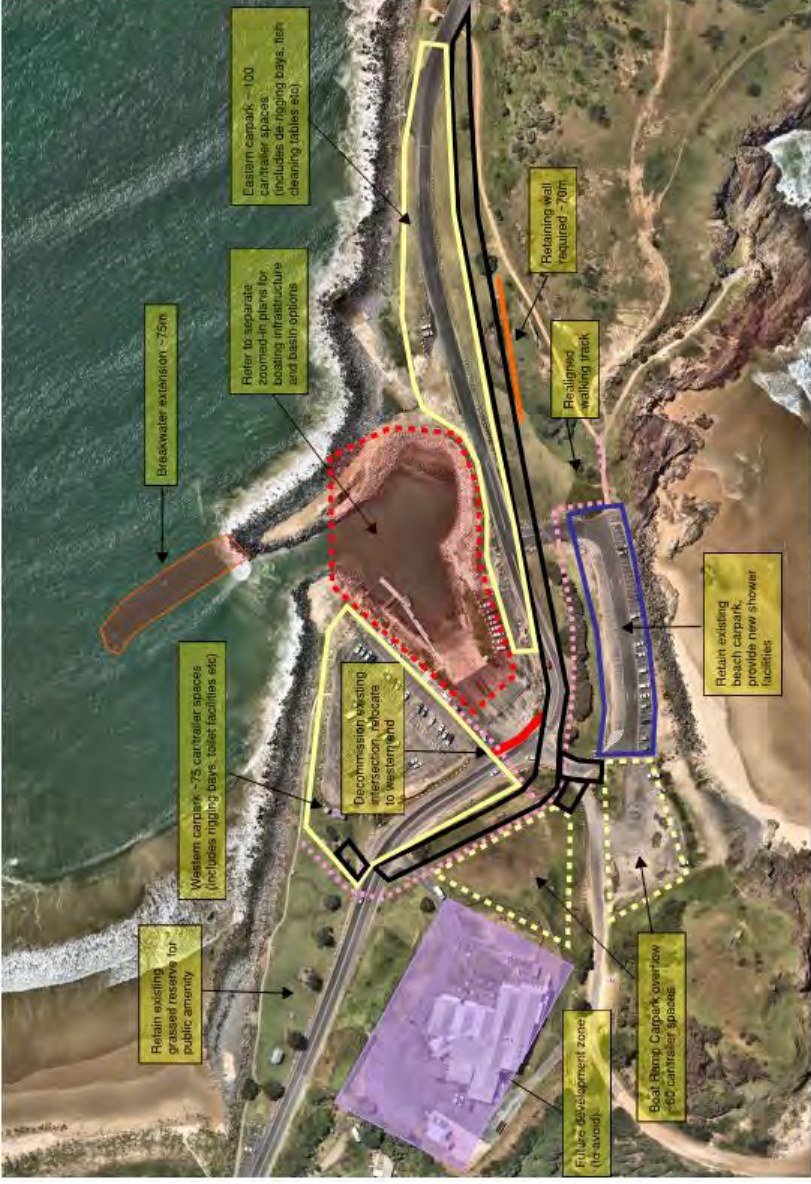
- Jordan Esplanade  
Diversion (central region, avoiding high scarps)
- Major Carpark Upgrades

COFFS HARBOUR BOATRAMP UPGRADE  
CONCEPT DESIGN INVESTIGATIONS  
MASTERPLAN OPTION 4: CARPARK UPGRADE (WEST), NEW CARPARK (EAST), ROAD DIVERSION  
(CENTRAL/EAST)

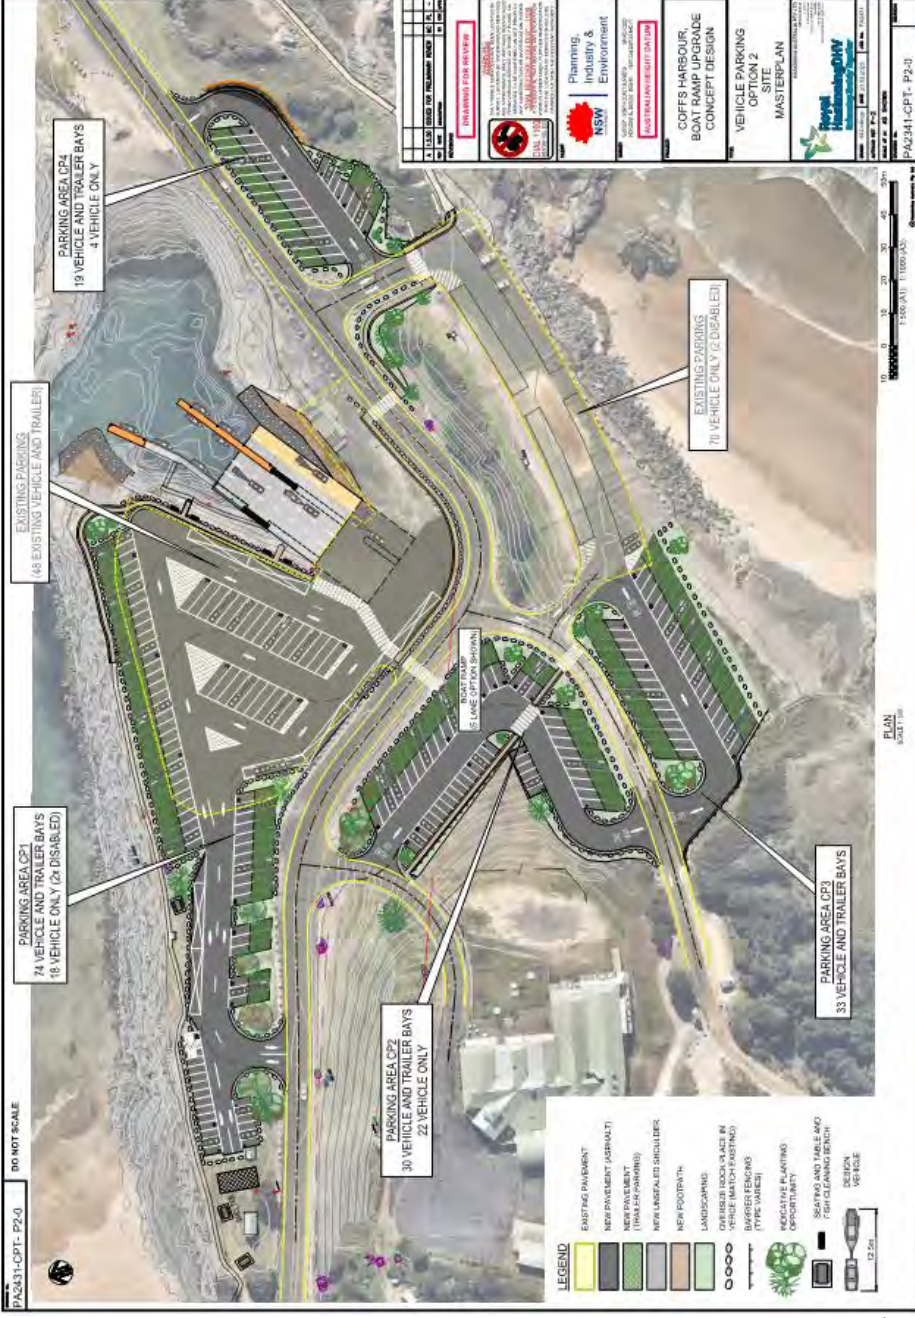
- No Road Diversions
- 1 Large carpark
- Overflow carparks to South and East
- 156 car/trailer spaces (48 currently)

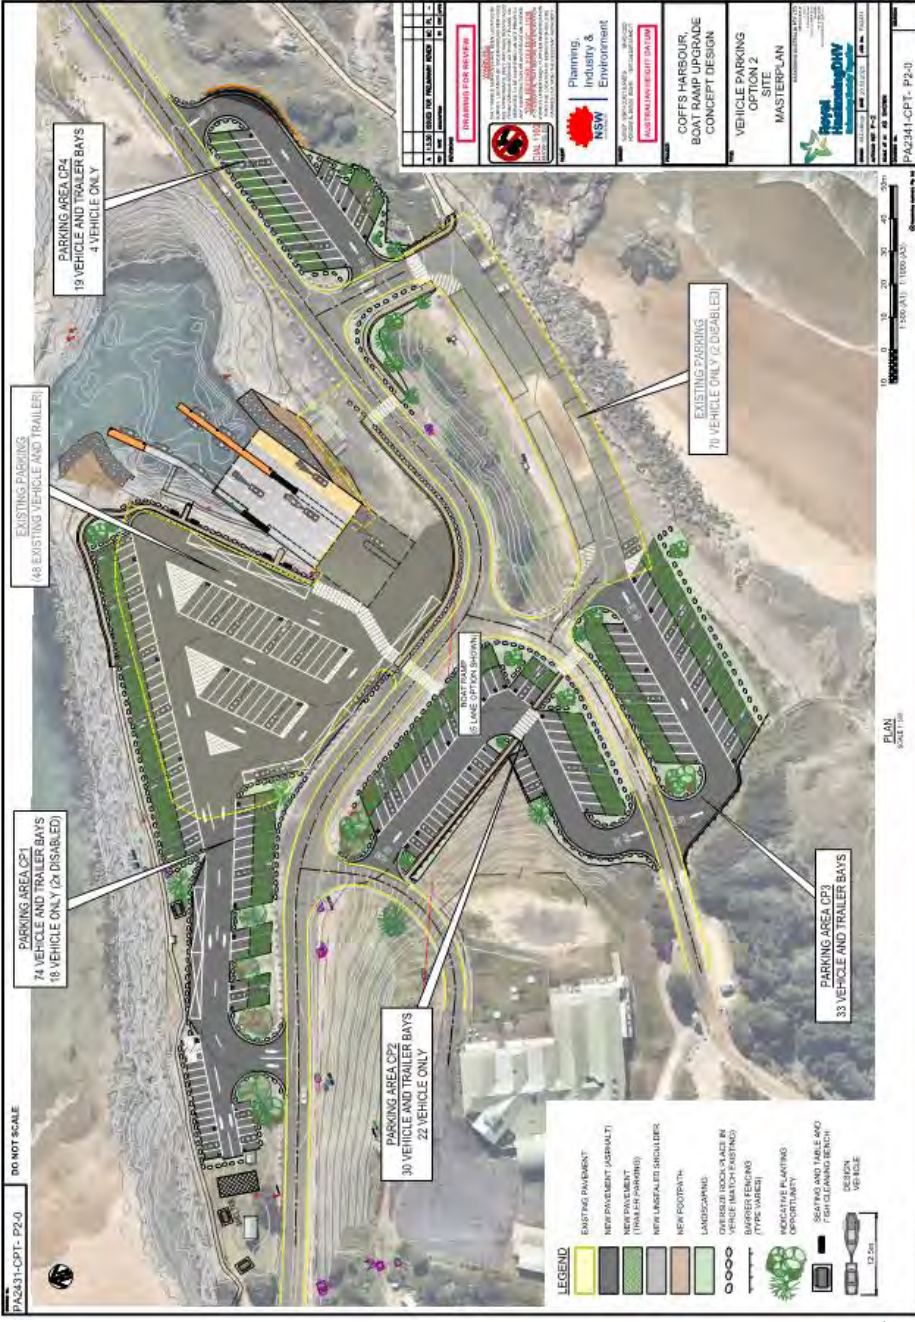
- As per 1b and 2b
- No Road Diversions
- 1 Large carpark
- Overflow carpark to South and East
- 156 car/trailer spaces (48 currently)

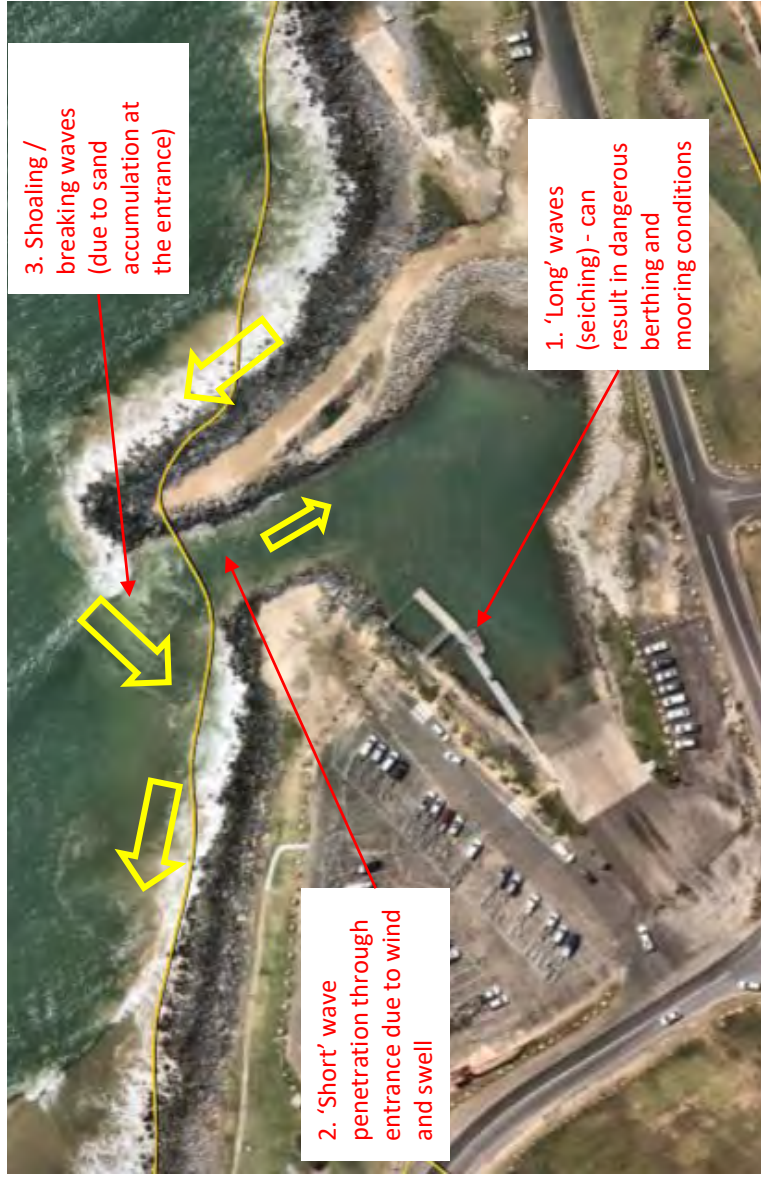
There are three key issues / processes that can affect boating safety:

1. 'Long' waves (seiching) – results in surging/sloshing motions throughout harbour and basin
2. 'Short' waves (swell and wind wave action)
3. Shoaling / breaking waves (due to long-shore sand movement) – **most important**

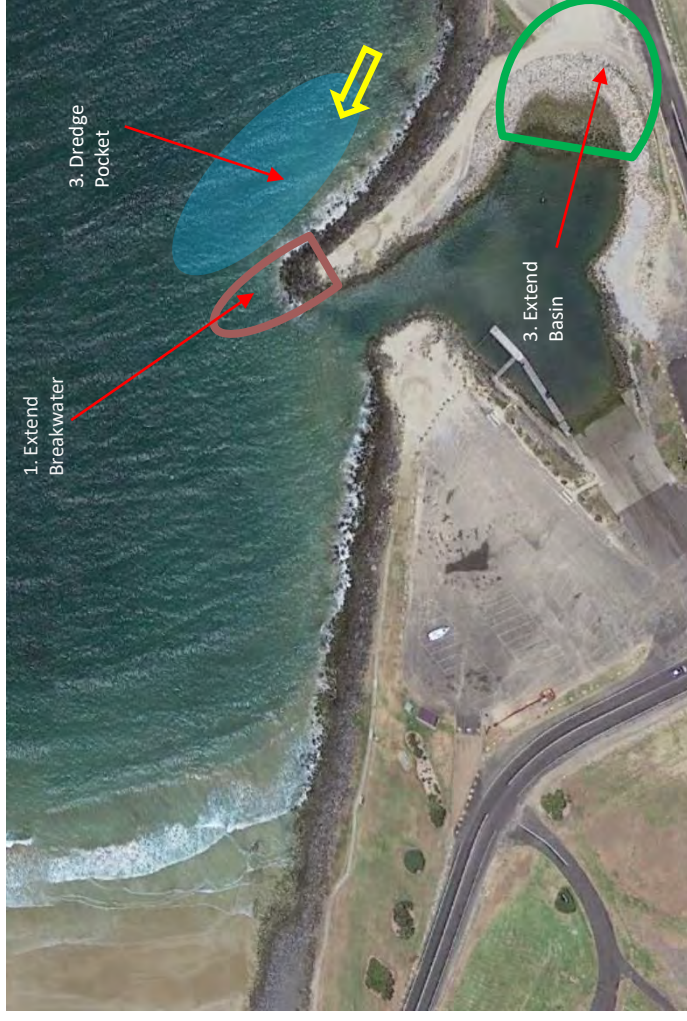
# Coffs Harbour Boatramp Upgrade – Broad options to address key issues / processes

A number of potentially viable solutions that have been previously investigated include:

1. Extend the Breakwater
2. Extend the Spending Beach / Basin further
3. Dredge Pocket to intercept sand arriving at the end of the breakwater (and potentially refract swell wave energy)

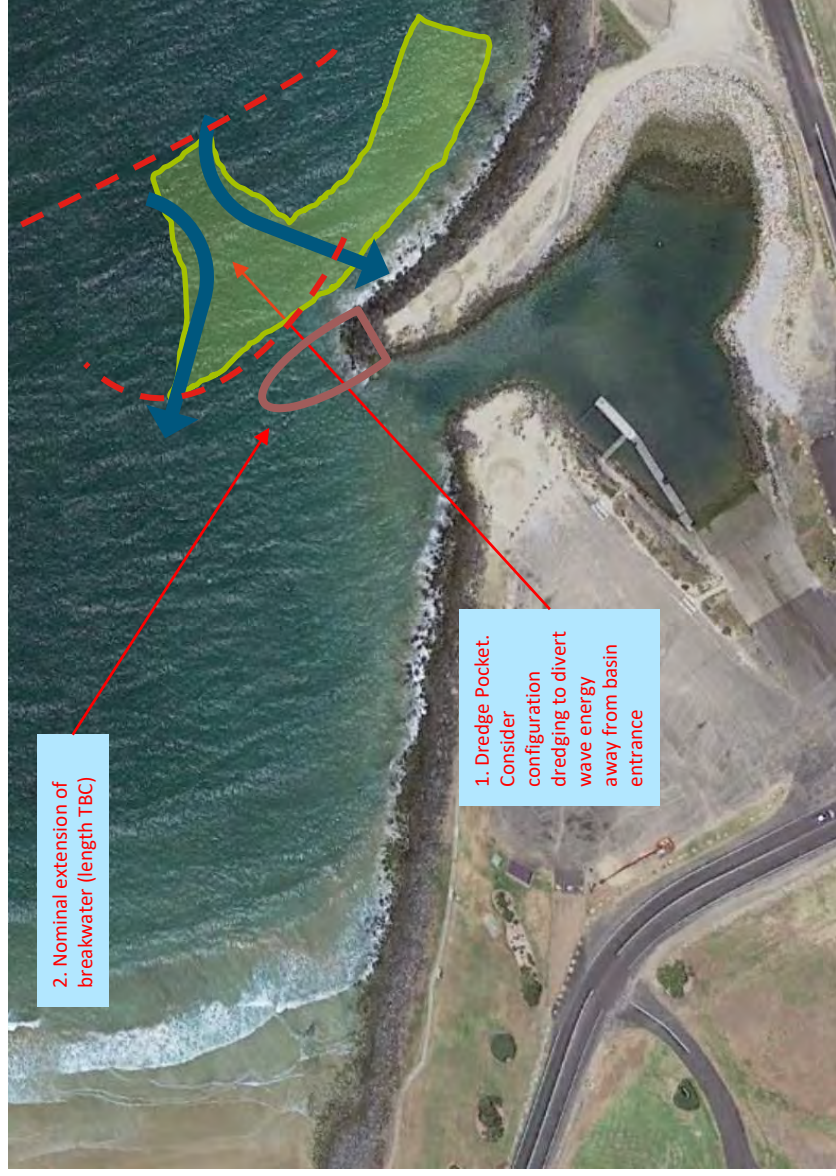
# Coffs Harbour Boatramp Upgrade - Boat Ramp Option 1

- 6 Ramp Lanes
- 3 Pontoons

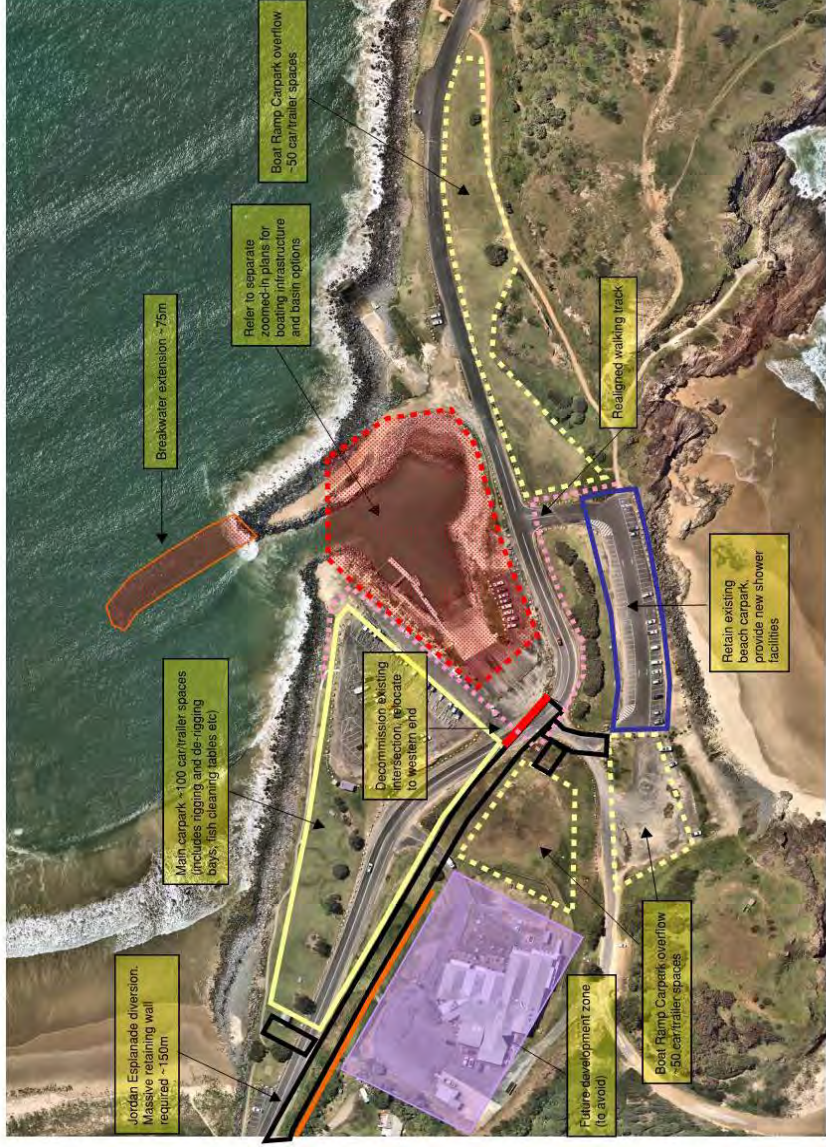
**COFFS HARBOUR BOATRAMP UPGRADE  
CONCEPT DESIGN INVESTIGATIONS  
MASTERPLAN OPTION 1: MAJOR CARPARK UPGRADE + ROAD DIVERSION (WEST)**

# Coffs Harbour Boatramp Upgrade – Masterplan Option 1

- Jordan Esplanade
- Diversion (West)
- Major Carpark
- Upgrades
- Major retaining wall required
- Encroachment towards former Fishing Club site

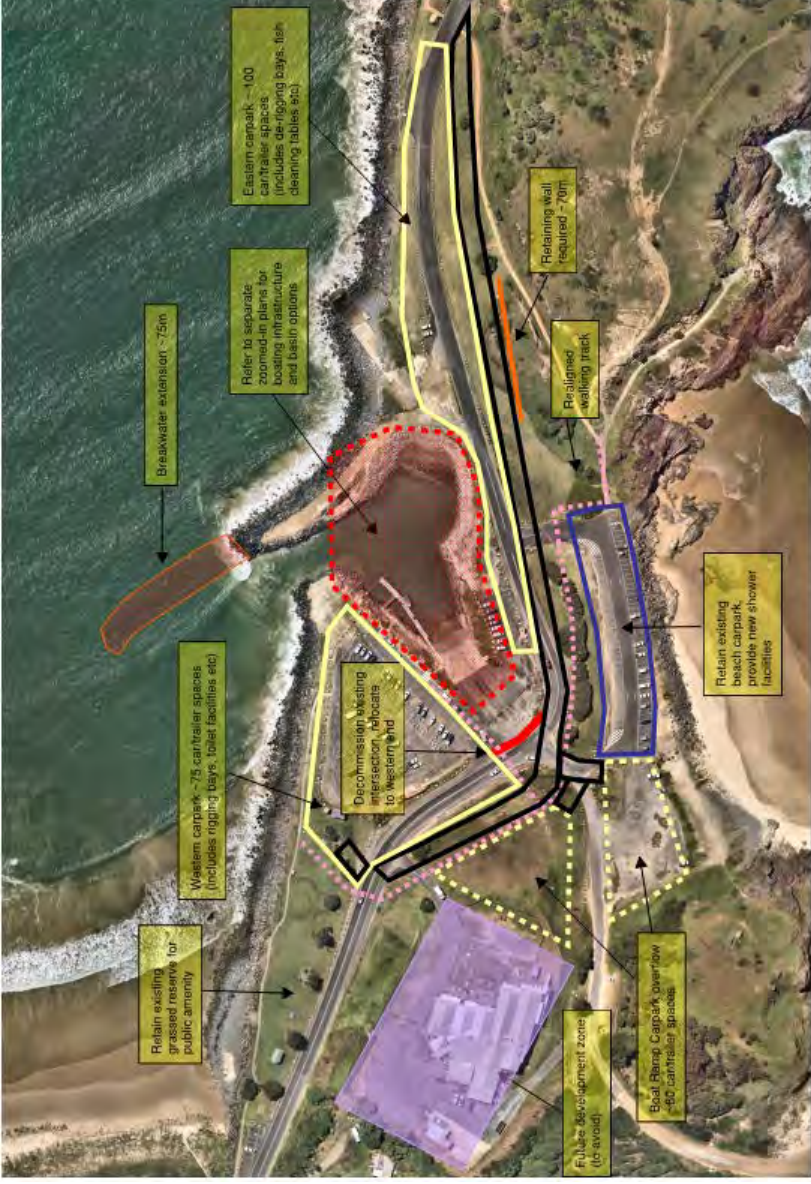
COFFS HARBOUR BOAT RAMP UPGRADE  
CONCEPT DESIGN INVESTIGATIONS  
MASTERPLAN OPTION 4: CARPARK UPGRADE (WEST), NEW CARPARK (EAST), ROAD DIVERSION  
(CENTRAL/EAST)

# Coffs Harbour Boatramp Upgrade – Masterplan Option 4

- Jordan Esplanade
- Diversion (central region, avoiding high scarps)
- Major Carpark Upgrades

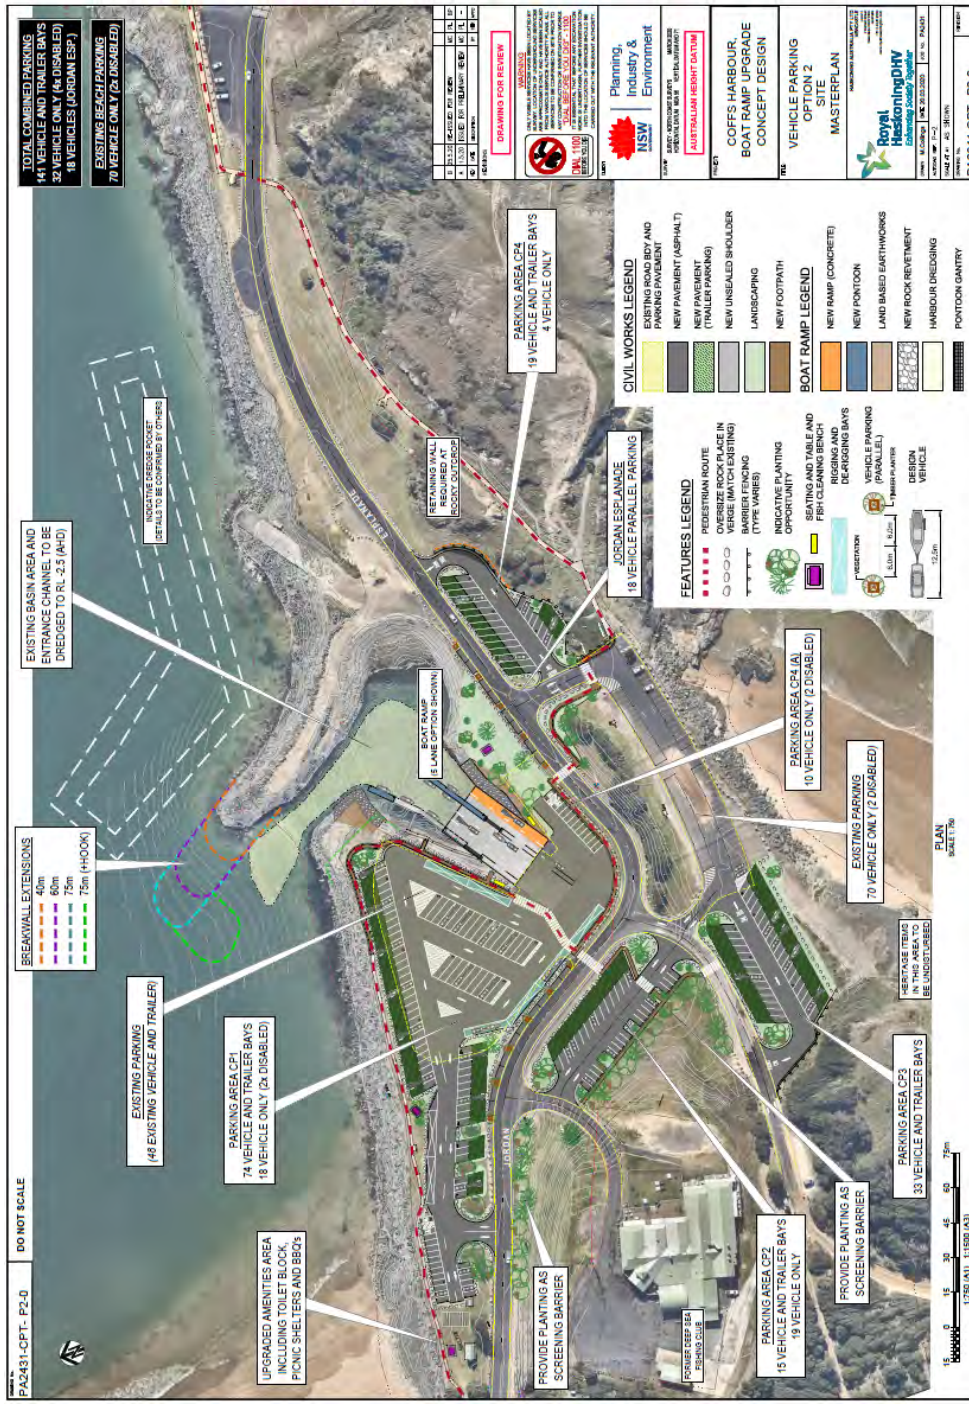
# Current Options – Option 3b – Road and Carpark

- As per 1b and 2b
- No Road Diversions
- 1 Large carpark
- Overflow carpark to South and East
- 141 car/trailer spaces (48 currently)

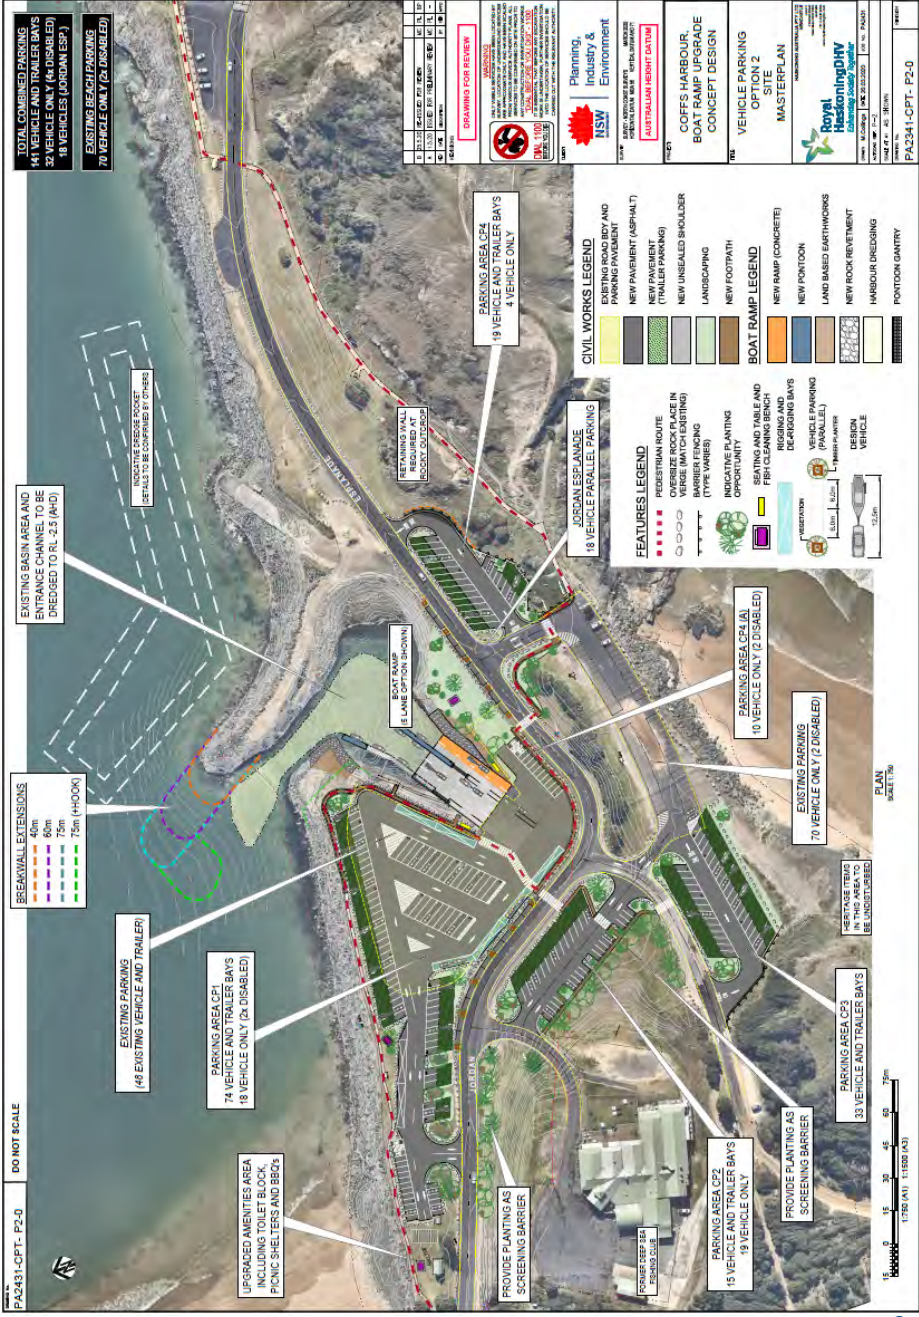
# Preferred Option – Option 1b – Road and Carpark

- **Preferred:**
- **No Road Diversions**
- **1 Large carpark**
- **Overflow carpark to South and East**
- **141 trailer spaces (48 currently)**
- **Total cost - \$9.5 million**

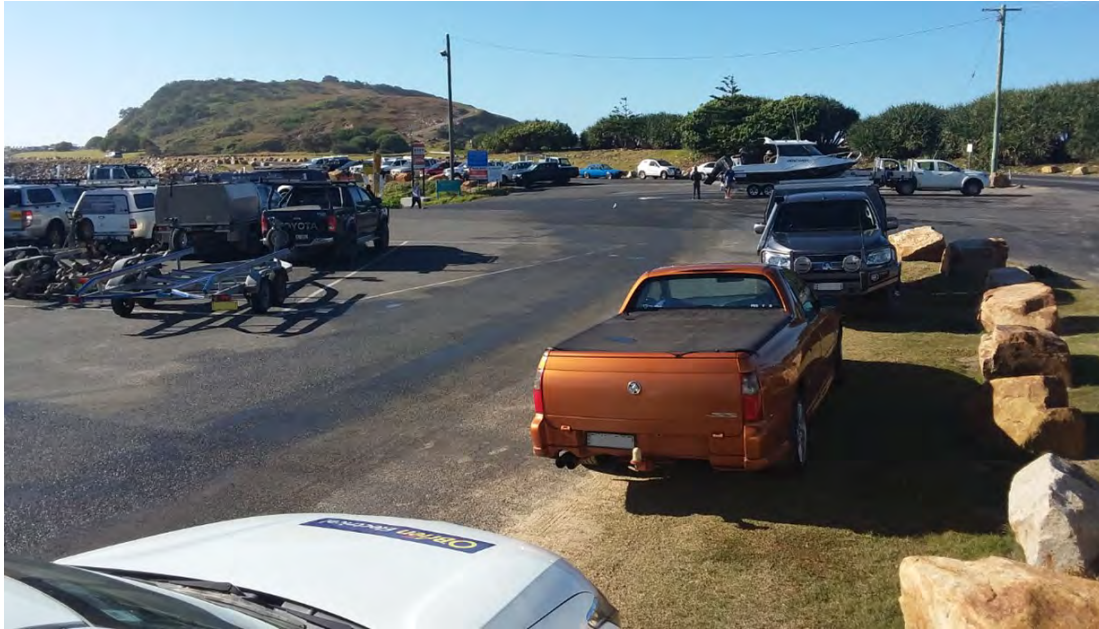
**Figure 4.2: Coffs Harbour Ramp (9am 02/08/2020)**

The peak parking demands varied between eight (8) and 82 spaces. It is noted that the peak demands occurred on Sunday 2<sup>nd</sup> August and exceeded the supply of 50 spaces. TDC identified that this was because of vehicles without trailers informally parking around the main parking area and instances of multiple vehicles (i.e. without trailers) occupying car and trailer bays. There was no specific event on at this time and other surrounding parking areas were underutilised (refer Section 4.1.5). An example of this parking behaviour is shown in a photo taken at the time of the parking survey is presented in Figure 4.2.

The traffic surveys show that the typical parking demands for the boat ramp are usually within the available supply of 50 spaces with an average occupancy of 30 spaces. Instances of higher peak demands were observed (up to 82 spaces), however these were not necessarily all because of boat and trailer parking.
