# **Proposed Upgrade of Coffs Harbour Regional Boat Ramp Stages 1 and 2**

Review of Environmental Factors

Transport for NSW

November 2020

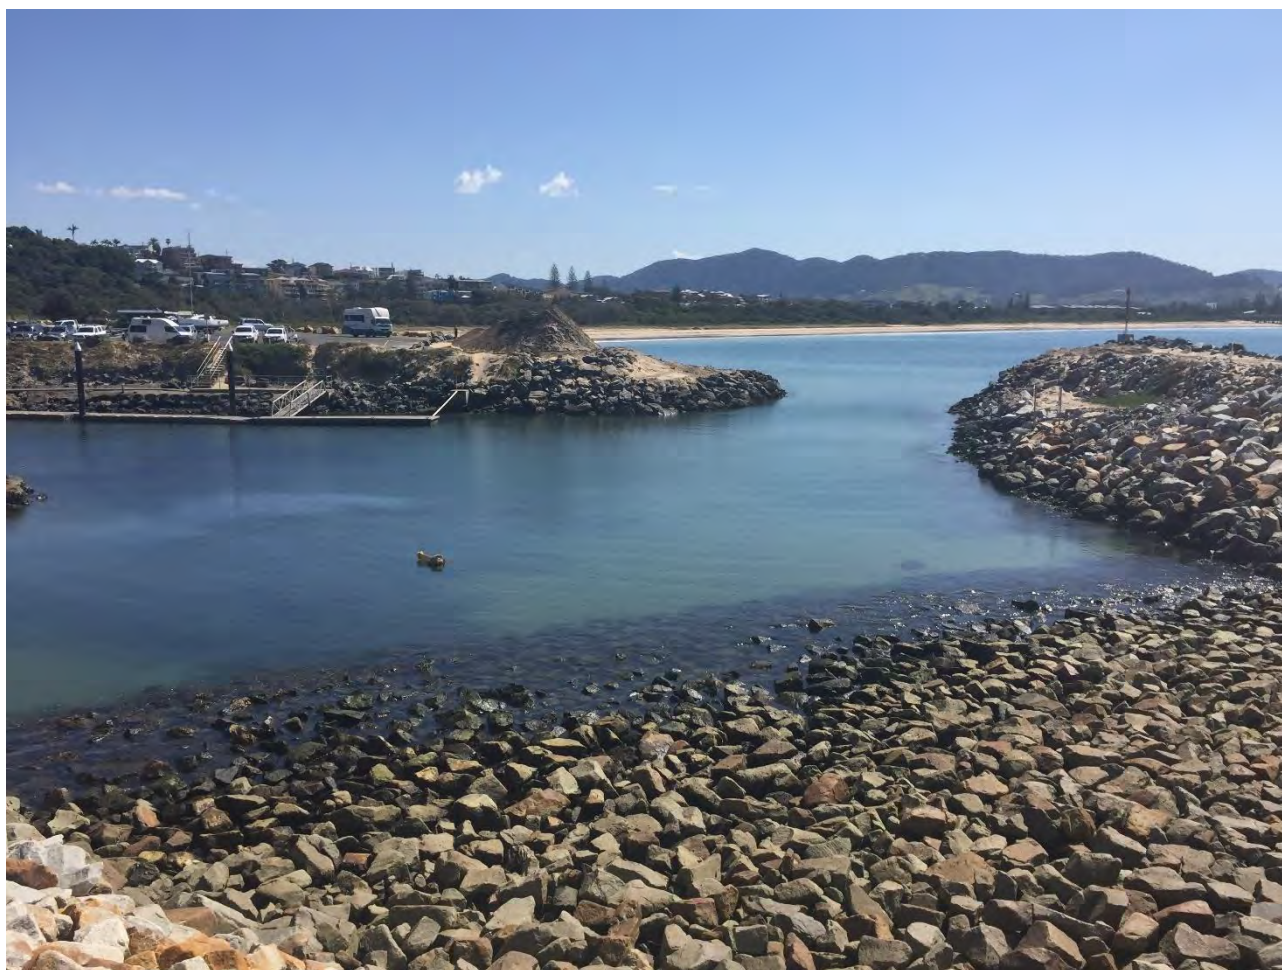
Photo 1: Image of the Boat Ramp Basin

The boat ramp and break wall structures are located in an area of reclaimed land and therefore significant earthworks have been undertaken over the years to develop and modify the area. The boat ramp surface comprises a reinforced concrete slab and is about 14m in width. The ramp is formed at a grade of about 1V to 7H. The ramp experiences significant wave surge to boat users when launching and retrieving vessels. On the western side of the boat ramp a floating dock exists which extends about 40m northwards into the water. The dock is supported (anchored) by piles.

The break wall and boat ramp basin berms are constructed of rockfill materials won from local quarries. The initial construction of the ramp was undertaken using argillite (dark grey colour rock), more recent works associated with widening of the basin were undertaken using the Valla Granite (pale grey coloured rock). Visual assessment of the materials shows both rockfill types to be strong, very high strength be durable. The majority of the rock walls are formed at about 1.5H to 1V. Block sizes of the rocks typically range between 0.5m and 2.0m in dimension.

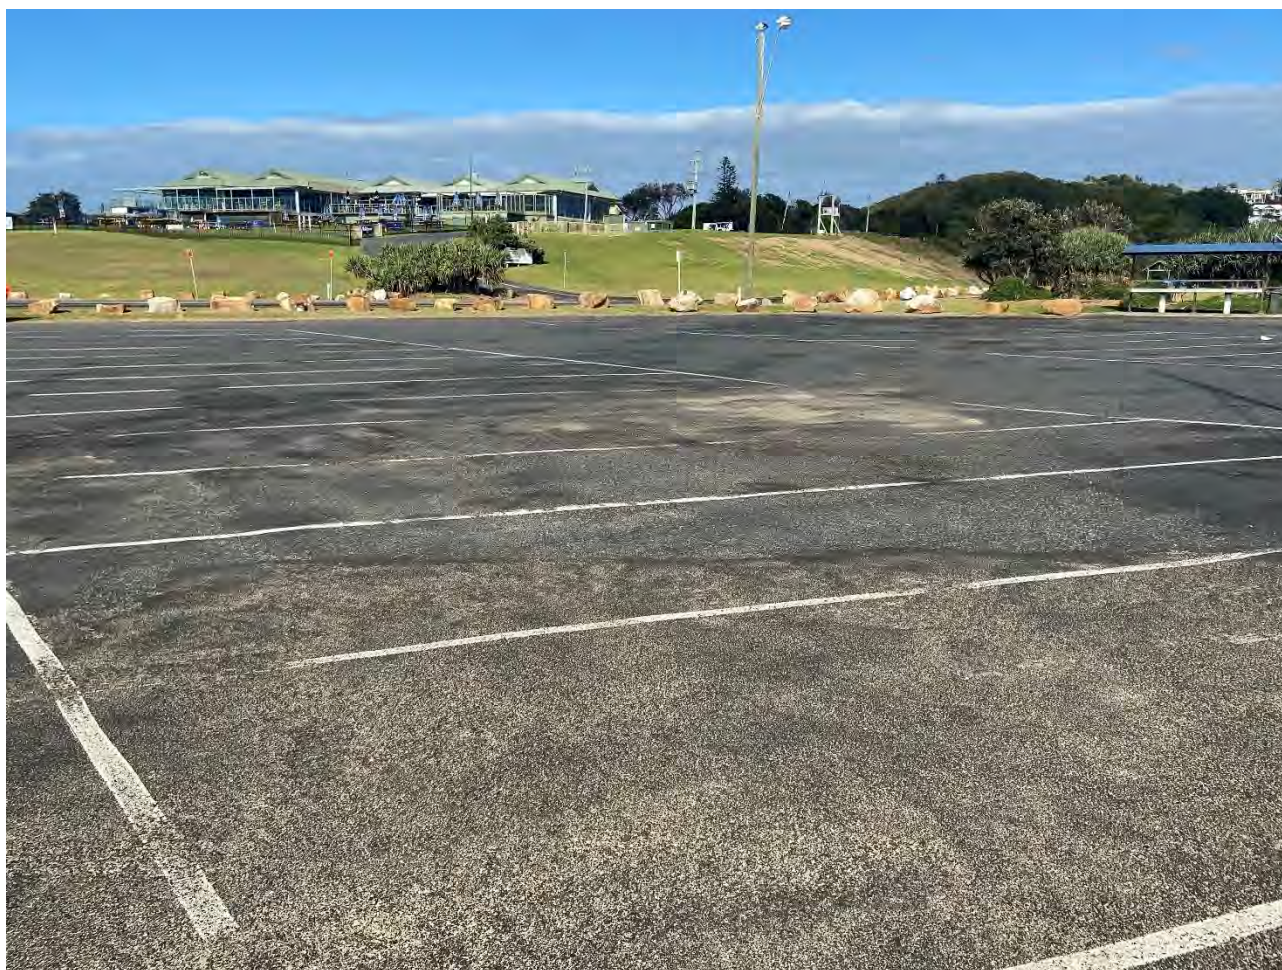
Photo 3: Image of the Boat Ramp Car Park Looking South West

The boat ramp car park is located in an area of reclaimed land, the pavement beneath the car park comprises high to very high strength bridging rock (Argillite) with a spray seal finish. The car park surface seal was in average condition with numerous localised areas of potholing noted. Surface drainage from the car park has been shaped towards the north west and discharges into the boat ramp basin.

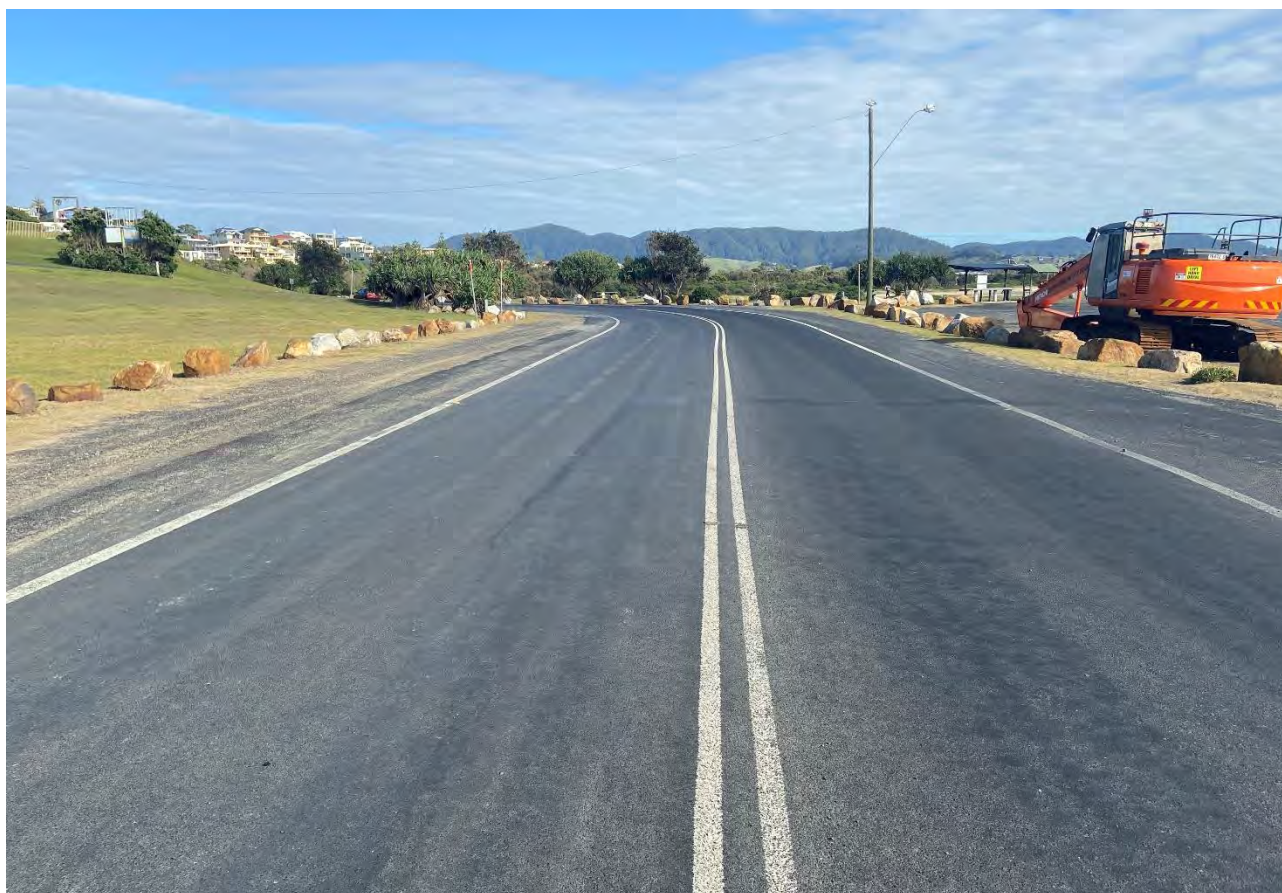
Photo 4: Looking West Along Jordan Esplanade

The pavement along Jordan Esplanade has an Asphaltic Concrete surface. The subgrade comprises mixed fill associated with raising the site levels to reclaim the land. The road surface was in good condition at the time of the investigation.

Drainage comprises sealed and unsealed surface drains which are connected to stormwater pits that discharge northwards to the Jetty Harbour and Jetty Boat Ramp basin.

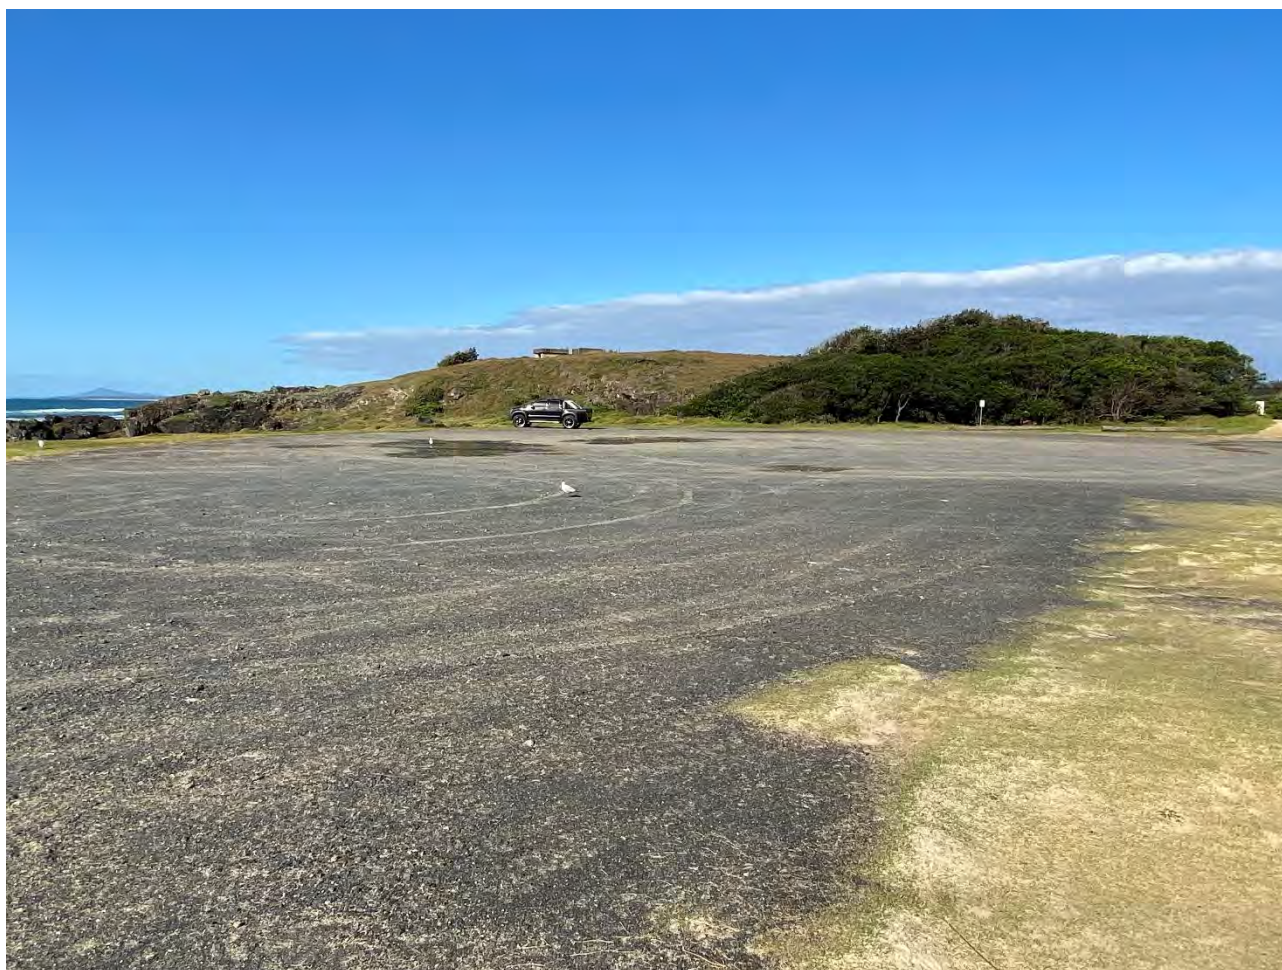
Photo 5: Looking South Across the Unsealed Car Park Area at Gallows Beach

The unsealed car park pavement has a sandy gravel surface, the subgrade comprises mixed fill associated with raising the site levels during the reclamation works. Boambee Beach access roads is located adjacent and west of the unsealed car park. The road is sealed and in poor condition with numerous repatched potholes and pavement deformation.

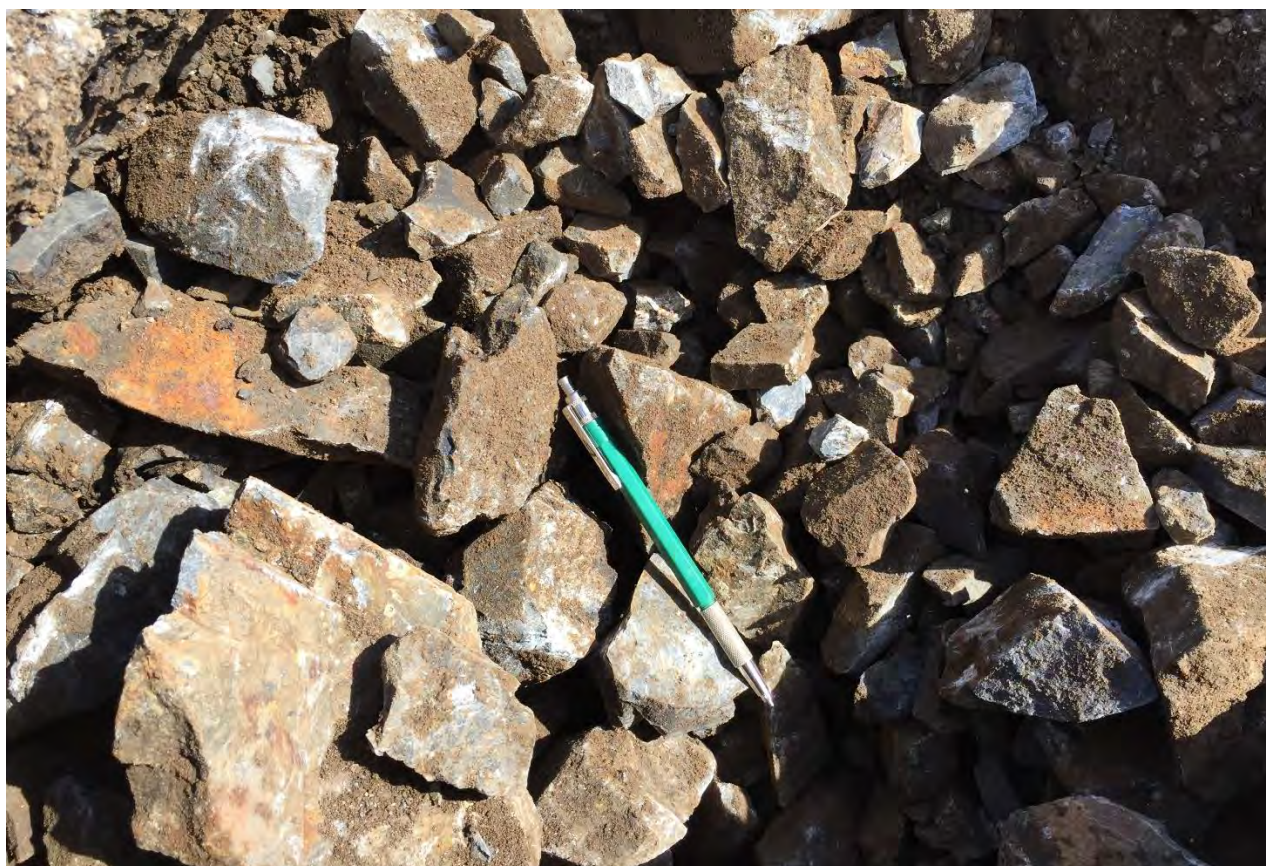
Photo 7: Image of Bridging Rock Beneath the Boat Ramp Car Park

In terms of reuse of materials, the existing pavement materials and rockfill bridging beneath the car parks would be suitable for reuse as a select subgrade material. A photo of the bridging rock encountered beneath the boat ramp car park is presented in Photo 7 below.

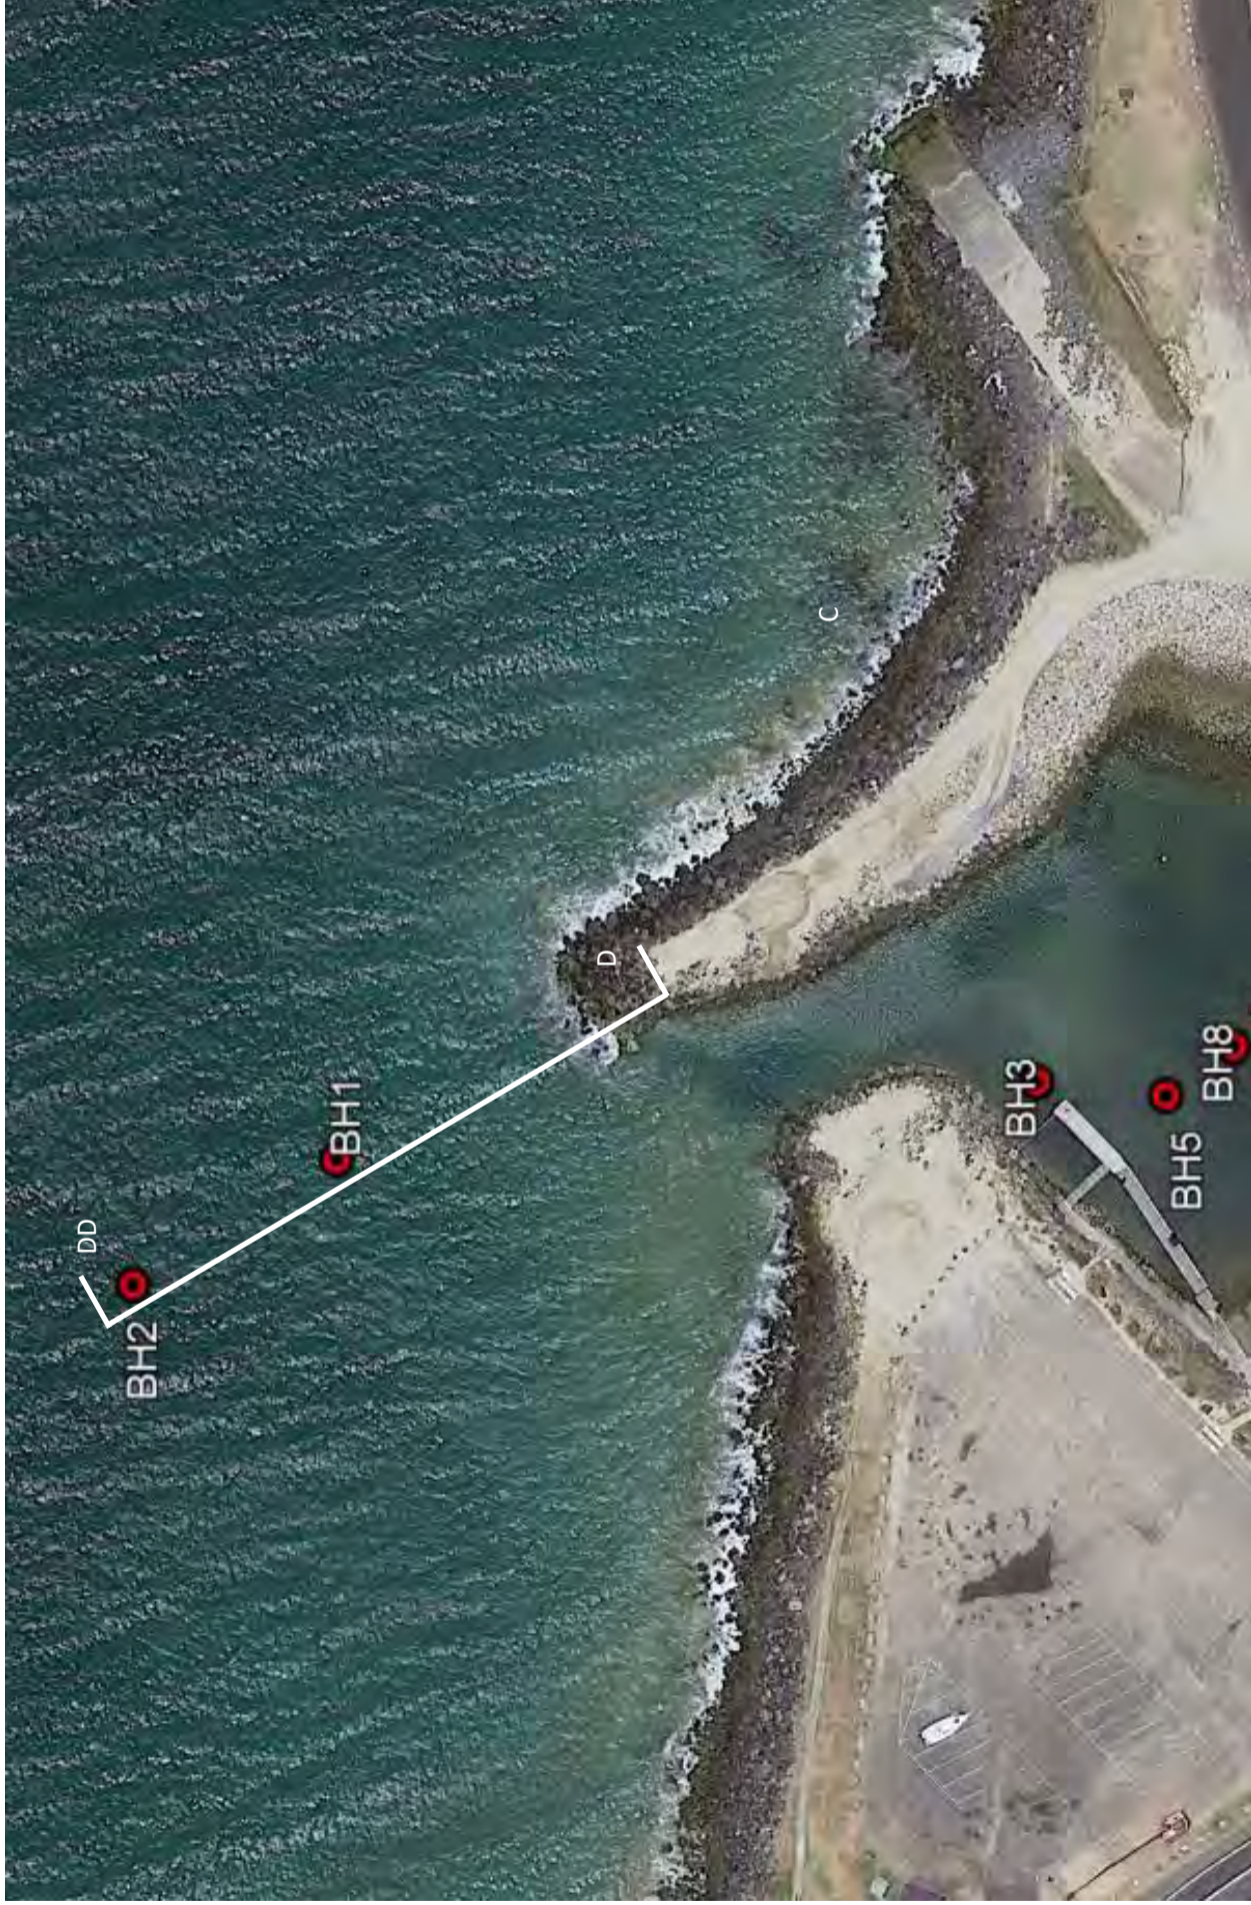
<b>REGIONAL GEOTECHNICAL SOLUTIONS</b>	Client:	Transport for NSW	Job No.	RGS32282.1
	Project:	Coffs Harbour Boat Ramp Upgrade and Precinct Development	Drawn By:	MR
	Title:	Borehole Investigation Plan - Boat Ramp Breakwall	Date:	21.8.20
			Drawing No.	Figure 3

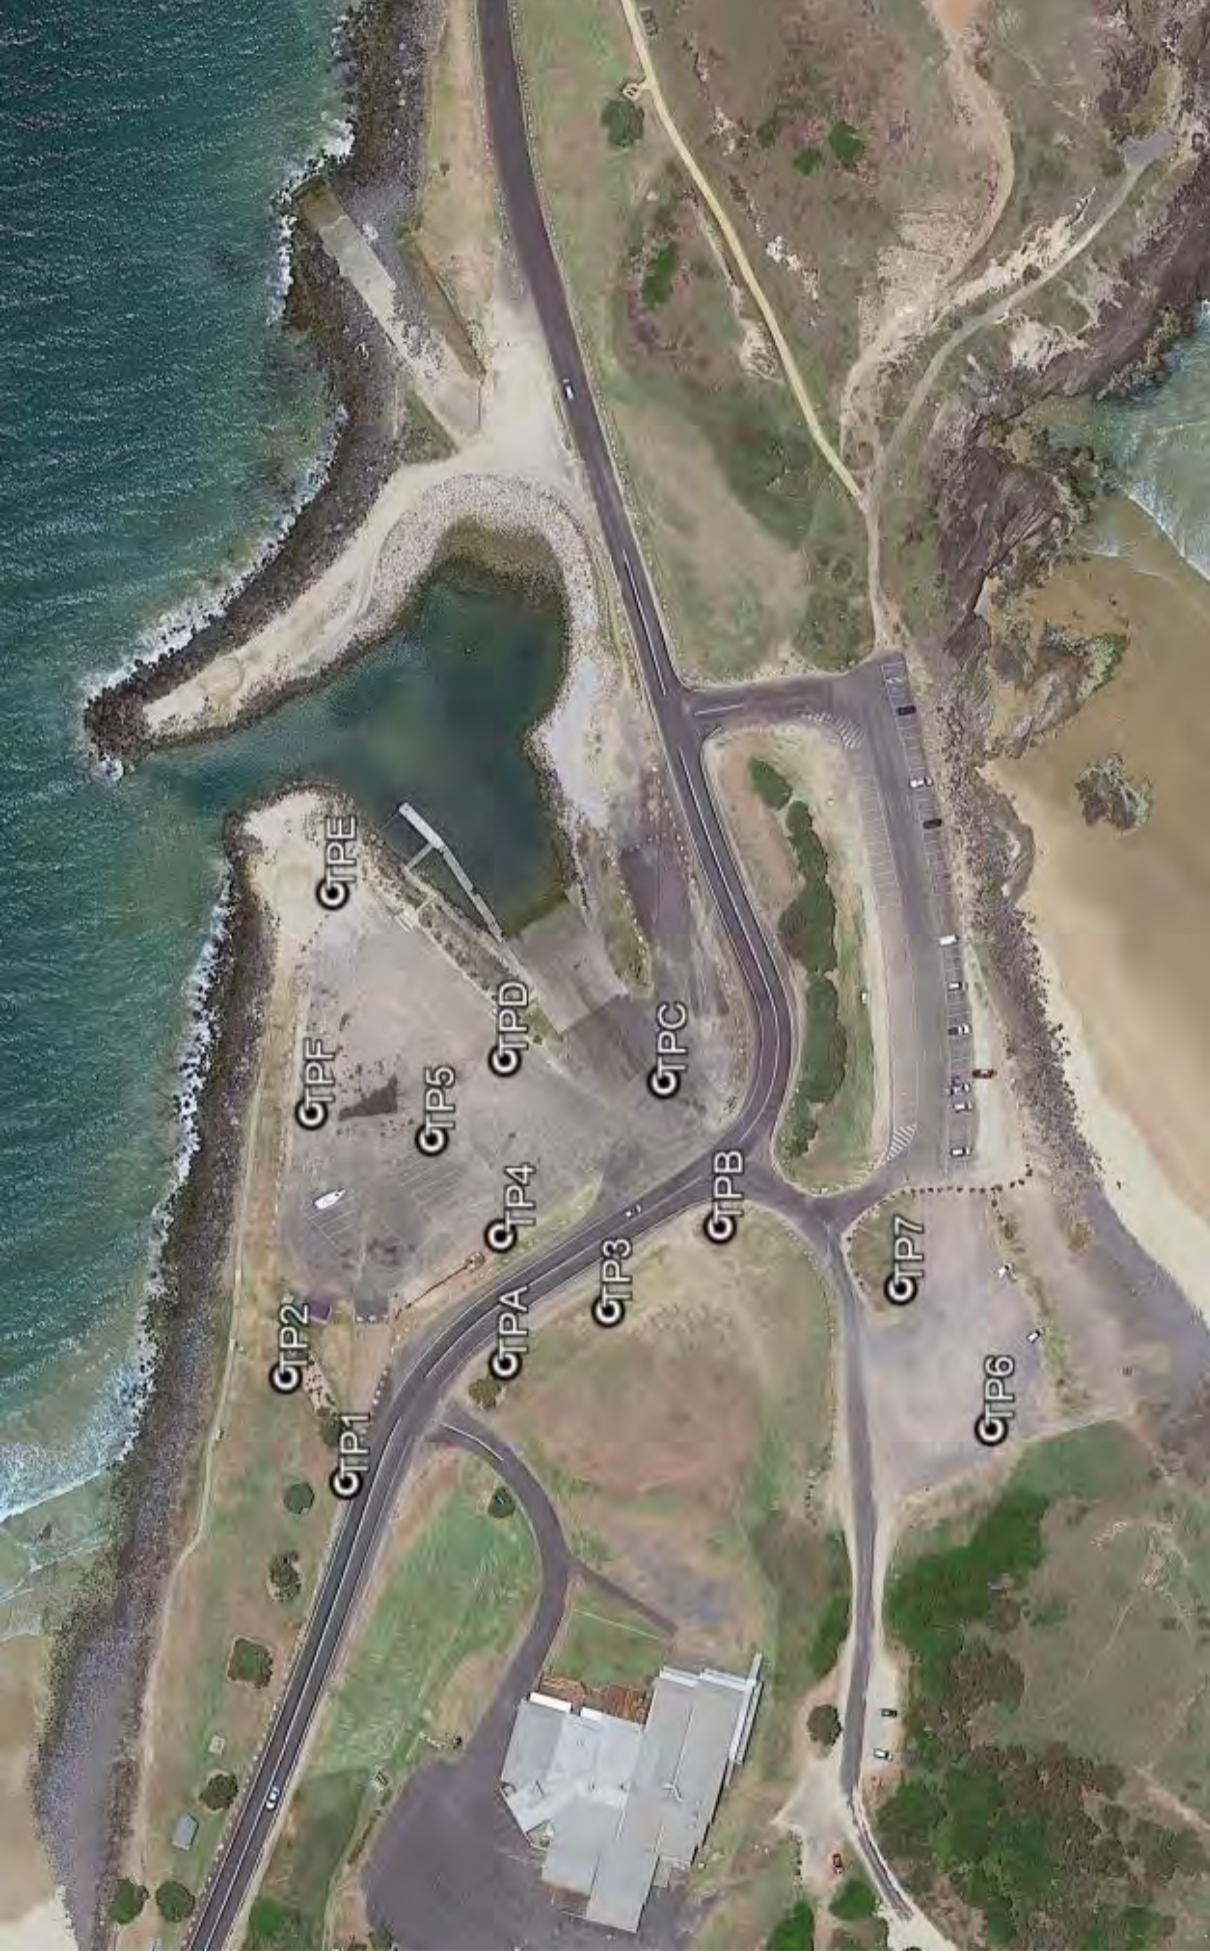
<b>REGIONAL GEOTECHNICAL SOLUTIONS</b>	Client:	Transport for NSW	Job No.	RGS32282.1
	Project:	Coffs Harbour Boat Ramp Upgrade and Precinct Development	Drawn By:	MR
	Title:	Test Pit Plan	Date:	21.8.20
			Drawing No.	Figure 4

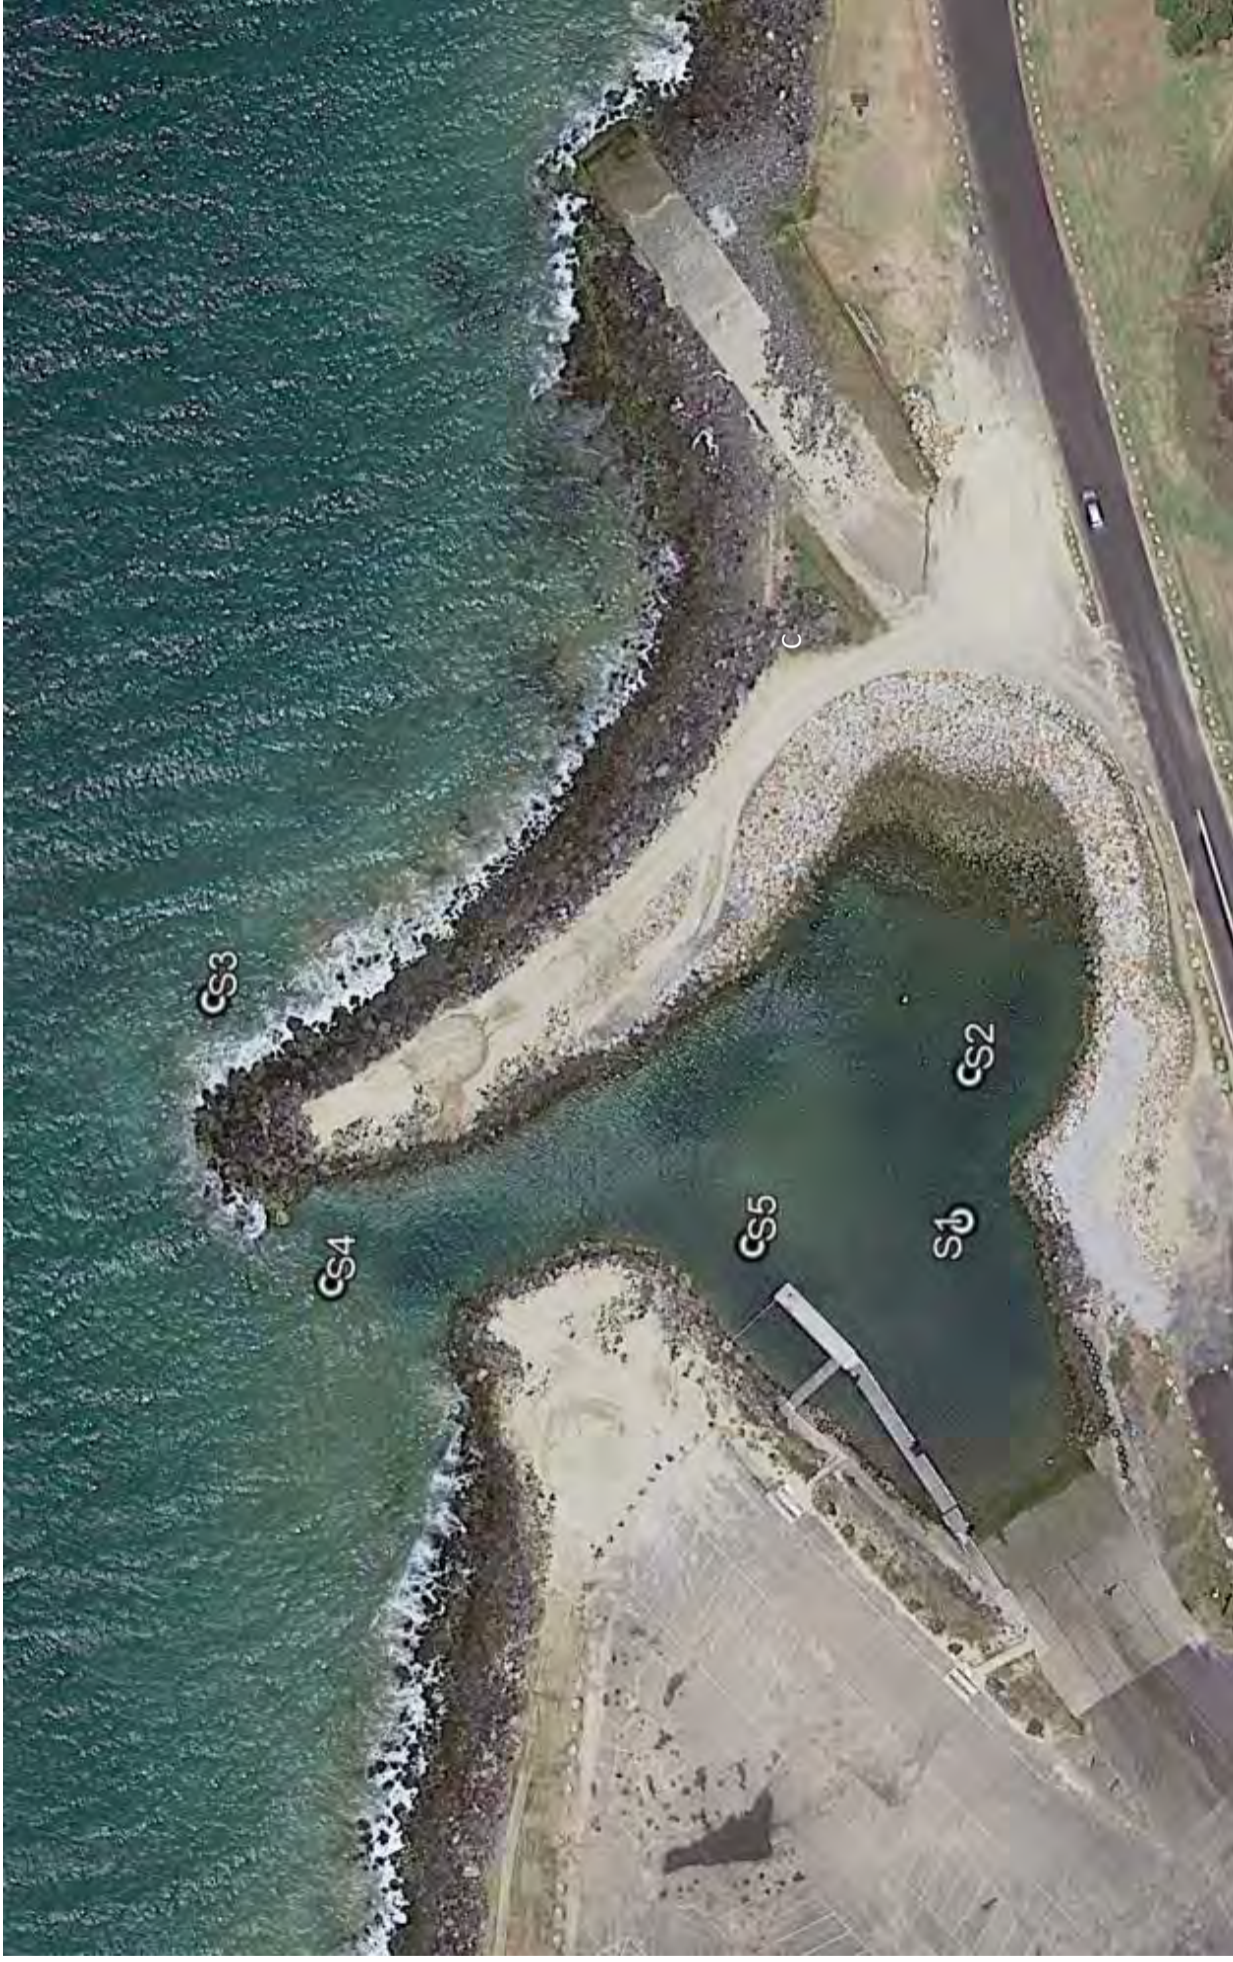
<b>REGIONAL GEOTECHNICAL SOLUTIONS</b>	Client:	Transport for NSW	Job No.	RGS32282.1
	Project:	Coffs Harbour Boat Ramp Upgrade and Precinct Development	Drawn By:	MR
	Title:	Sediment Sampling Plan	Date:	21.8.20
			Drawing No.	Figure 5

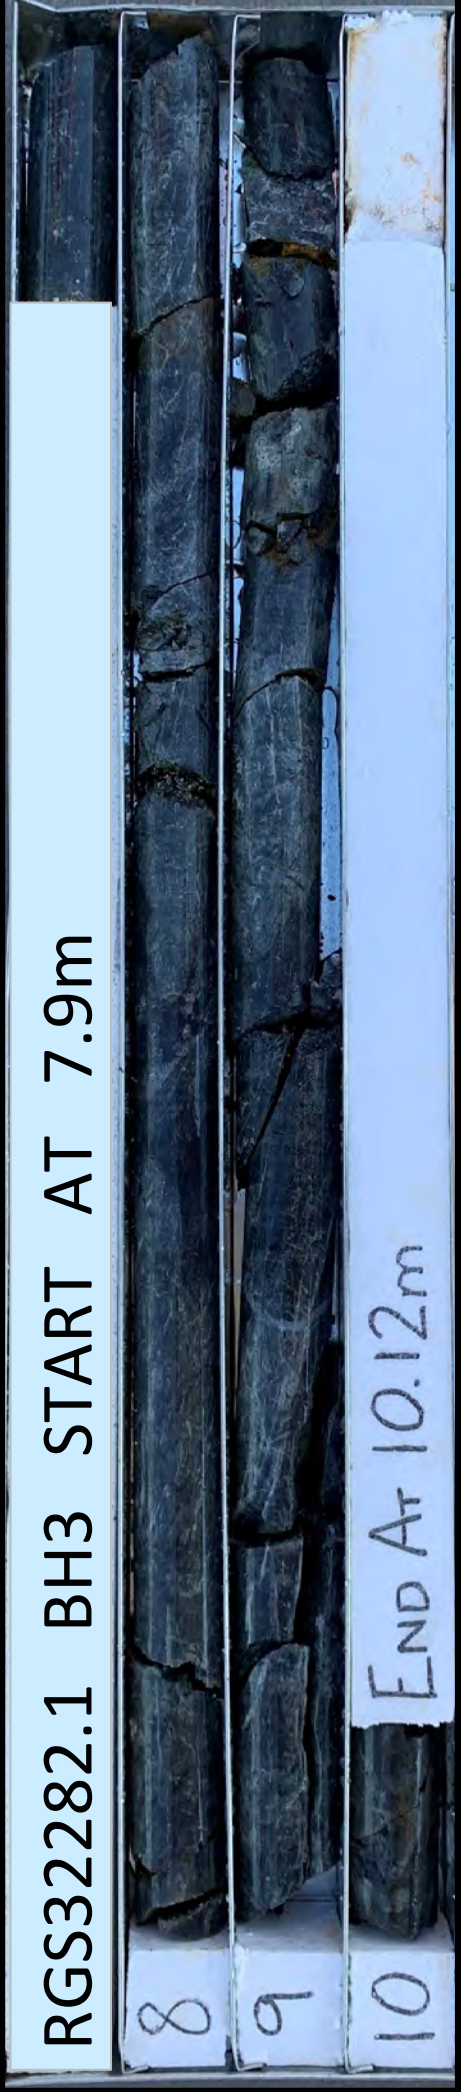
Client:	Transport for NSW	Job No.	RGS32282.1
Project:	Coffs Harbour Boat Ramp Upgrade and Precinct Development	Drawn By:	MR
Title:	BH3 Core Photo 7.9 to 10.12m	Date:	2.10.20
		Core Photo	BH3

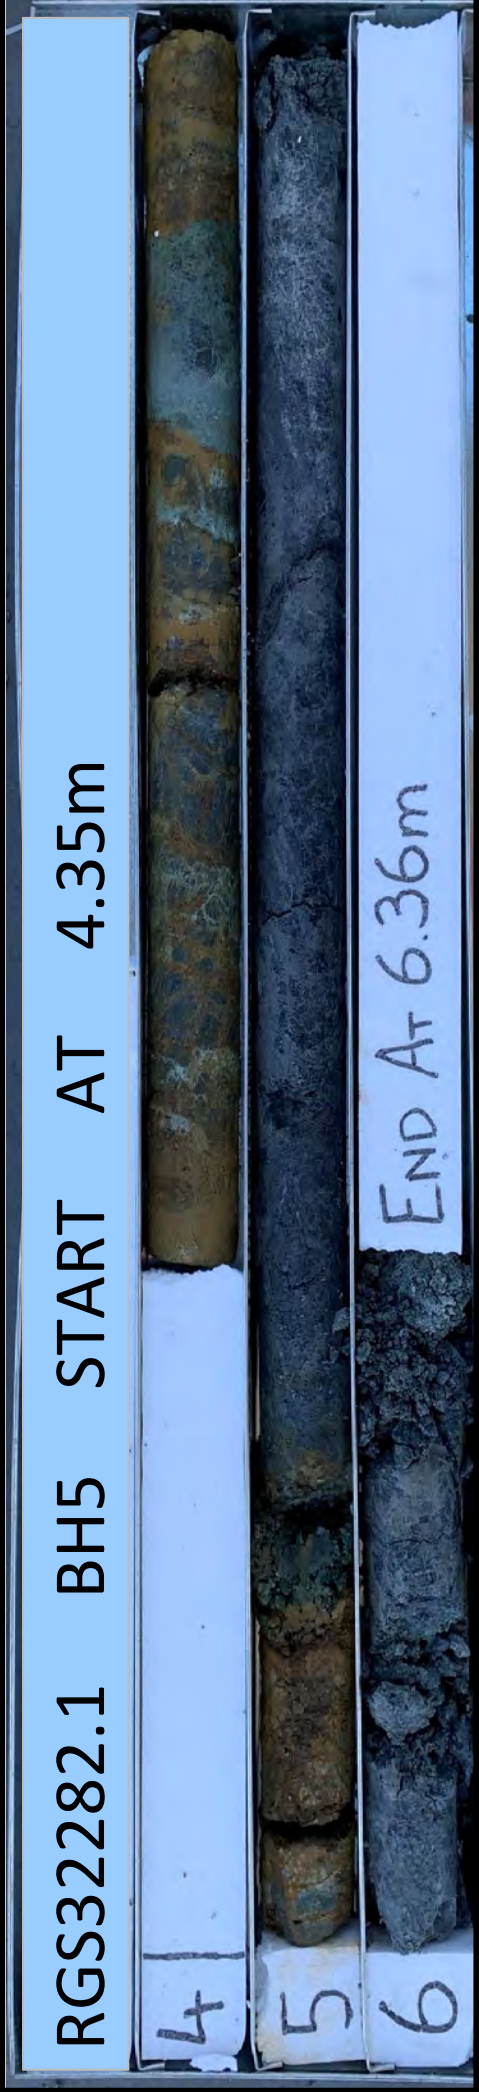
# BH5 4.35m to 6.36m

<b>REGIONAL GEOTECHNICAL SOLUTIONS</b>	Client:	Transport for NSW	Job No.	RGS32282.1
	Project:	Coffs Harbour Boat Ramp Upgrade and Precinct Development	Drawn By:	MR
	Title:	BH5 Core Photo 4.35 to 6.36m	Date:	2.10.20
			Core Photo	BH5

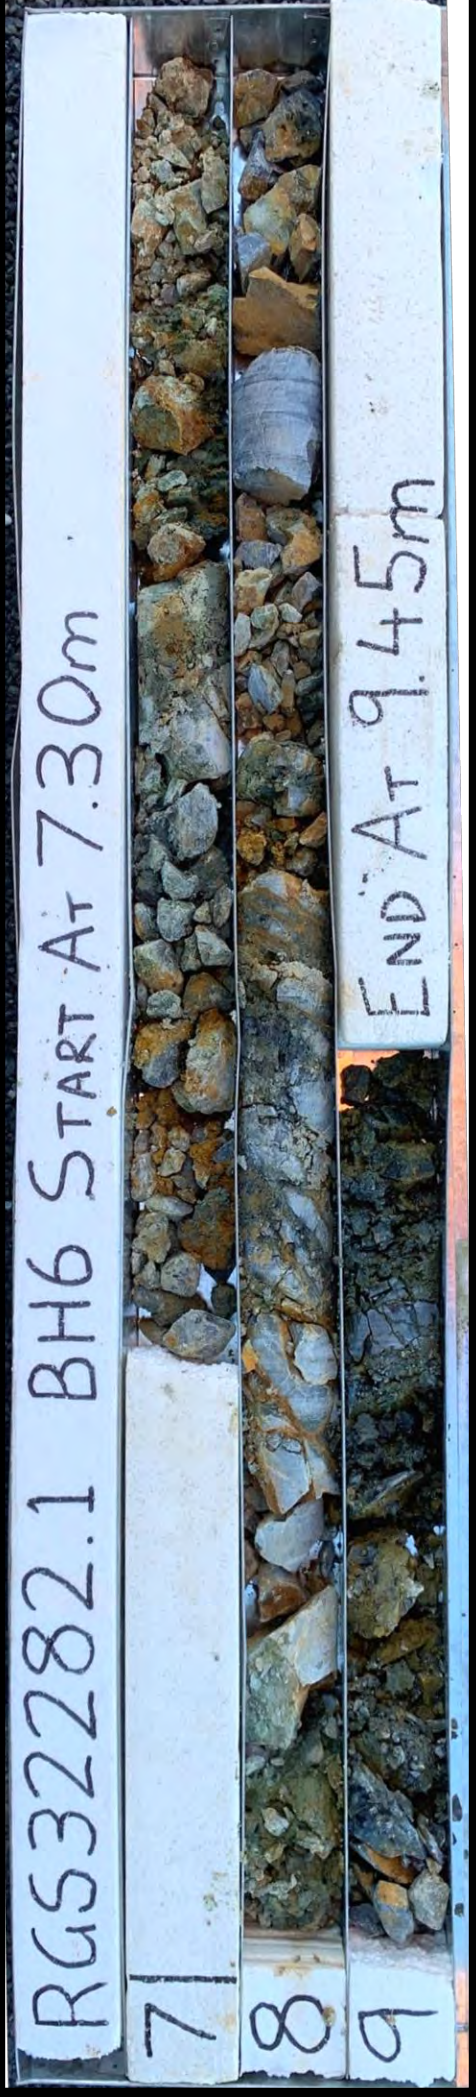
# BH6 7.3m to 9.45m

Client:	Transport for NSW	Job No.	RGS32282.1
	Project:	Coffs Harbour Boat Ramp Upgrade and Precinct Development	Drawn By:	MR
	Title:	BH6 Core Photo 7.3 to 9.45m	Date:	2.10.20
			Core Photo	BH6

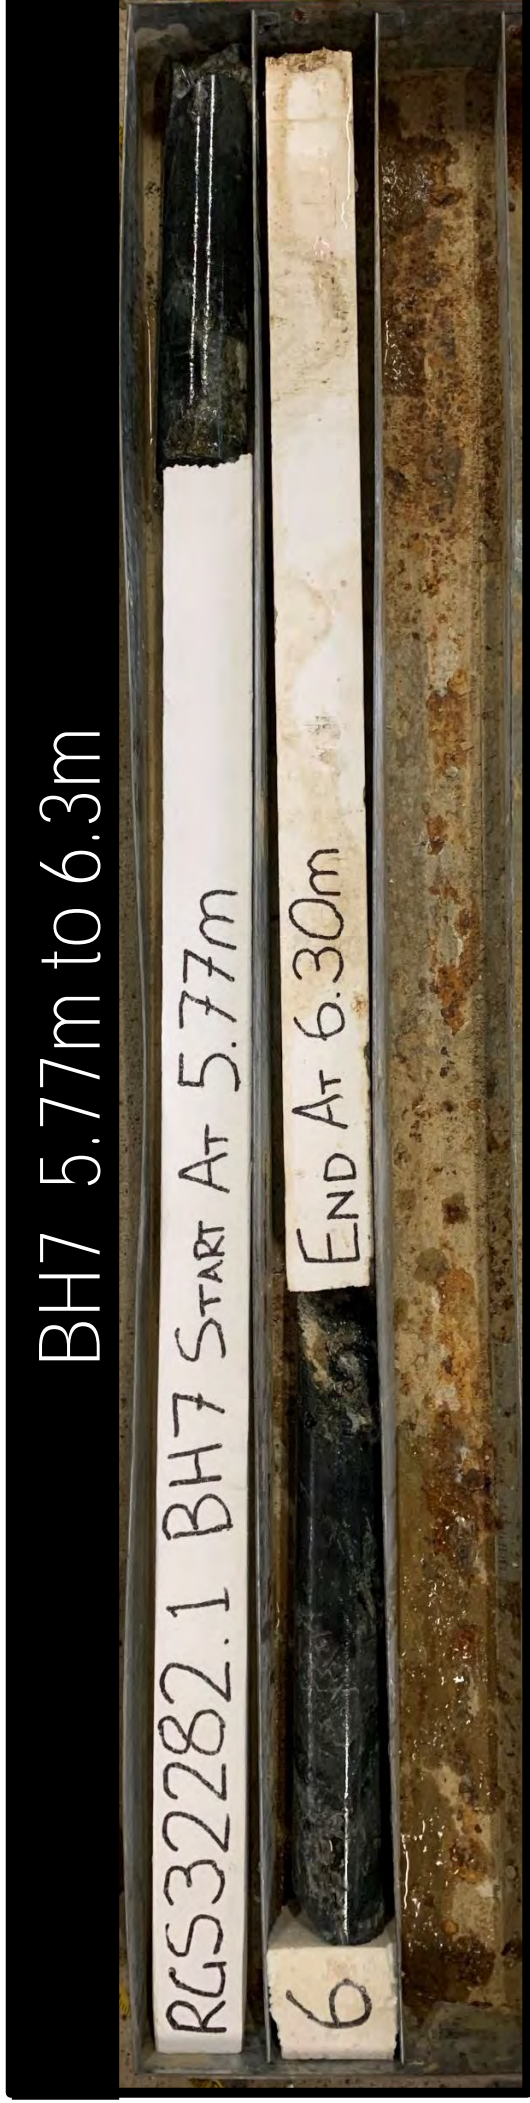
# BH7 5.77m to 6.3m

<b>REGIONAL GEOTECHNICAL SOLUTIONS</b>	Client:	Transport for NSW	Job No.	RGS32282.1
	Project:	Coffs Harbour Boat Ramp Upgrade and Precinct Development	Drawn By:	MR
	Title:	BH7 Core Photo 5.77 to 6.3m	Date:	2.10.20
			Core Photo	BH7

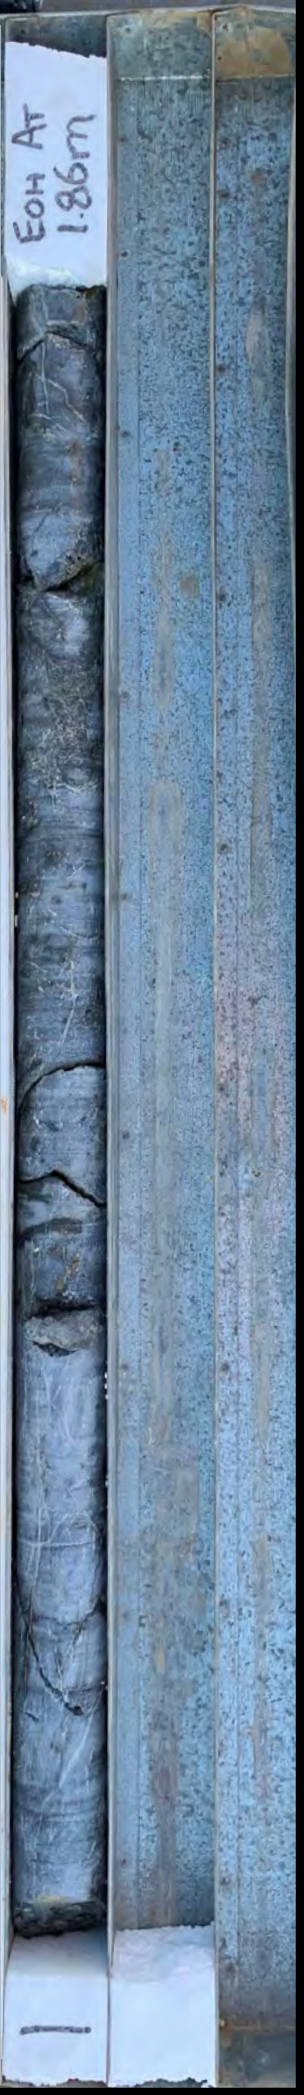
# BH8 1.0m to 1.86m

Client:	Transport for NSW	Job No.	RG32282.1
Project:	Coffs Harbour Boat Ramp Upgrade and Precinct Development	Drawn By:	MR
Title:	BH8 Core Photo 1.0 to 1.86m	Date:	2.10.20
		Core Photo	BH8

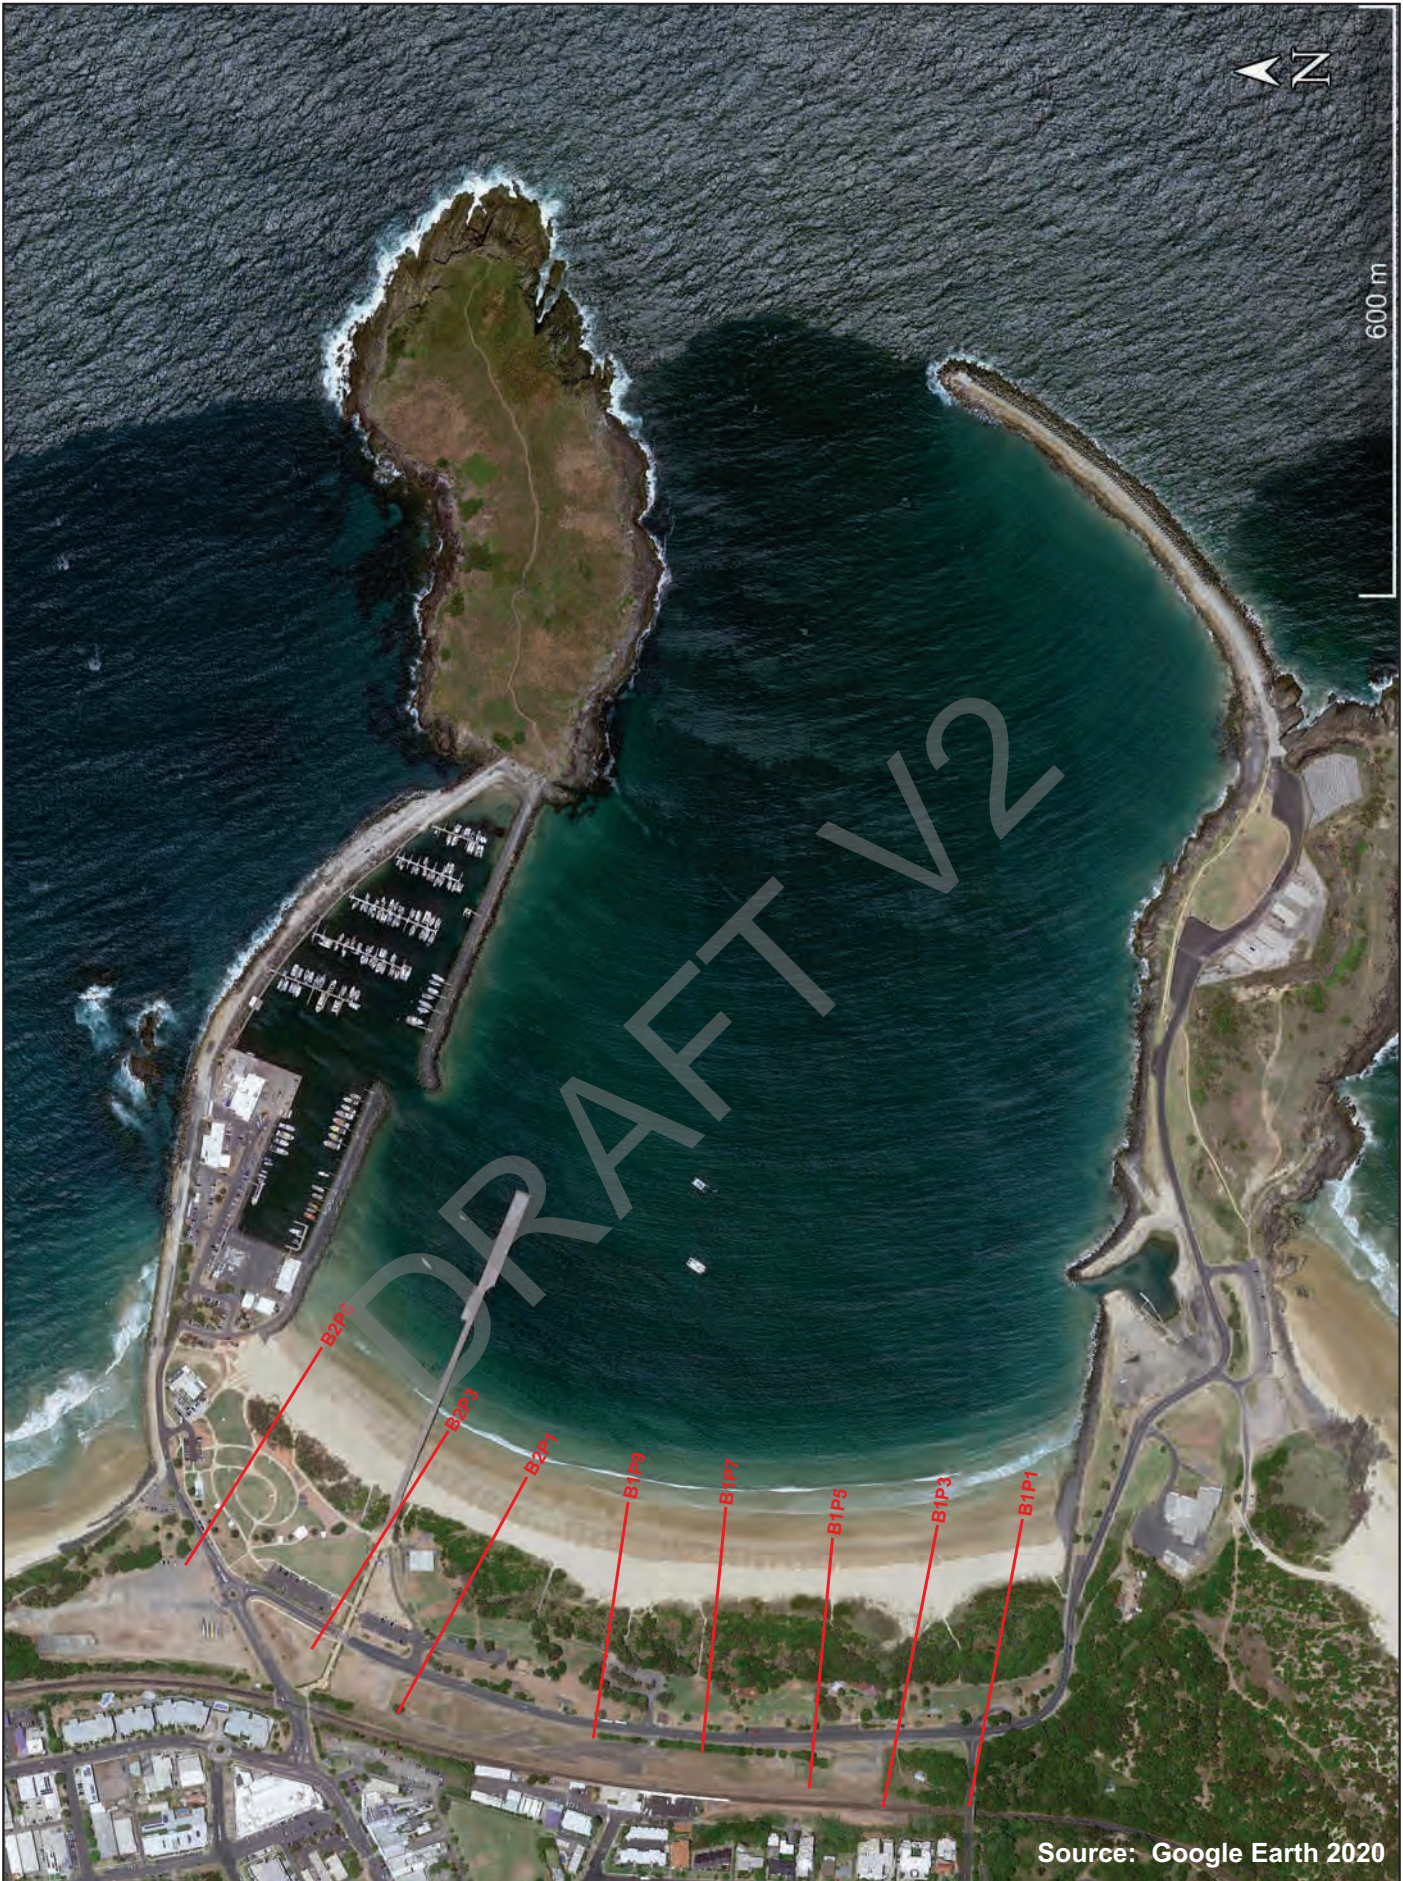
NSW BEACH PROFILE DATABASE  
 SELECTED JETTY BEACH PROFILE
