# **Proposed Upgrade of Coffs Harbour Regional Boat Ramp Stages 1 and 2**

Review of Environmental Factors

Transport for NSW

November 2020

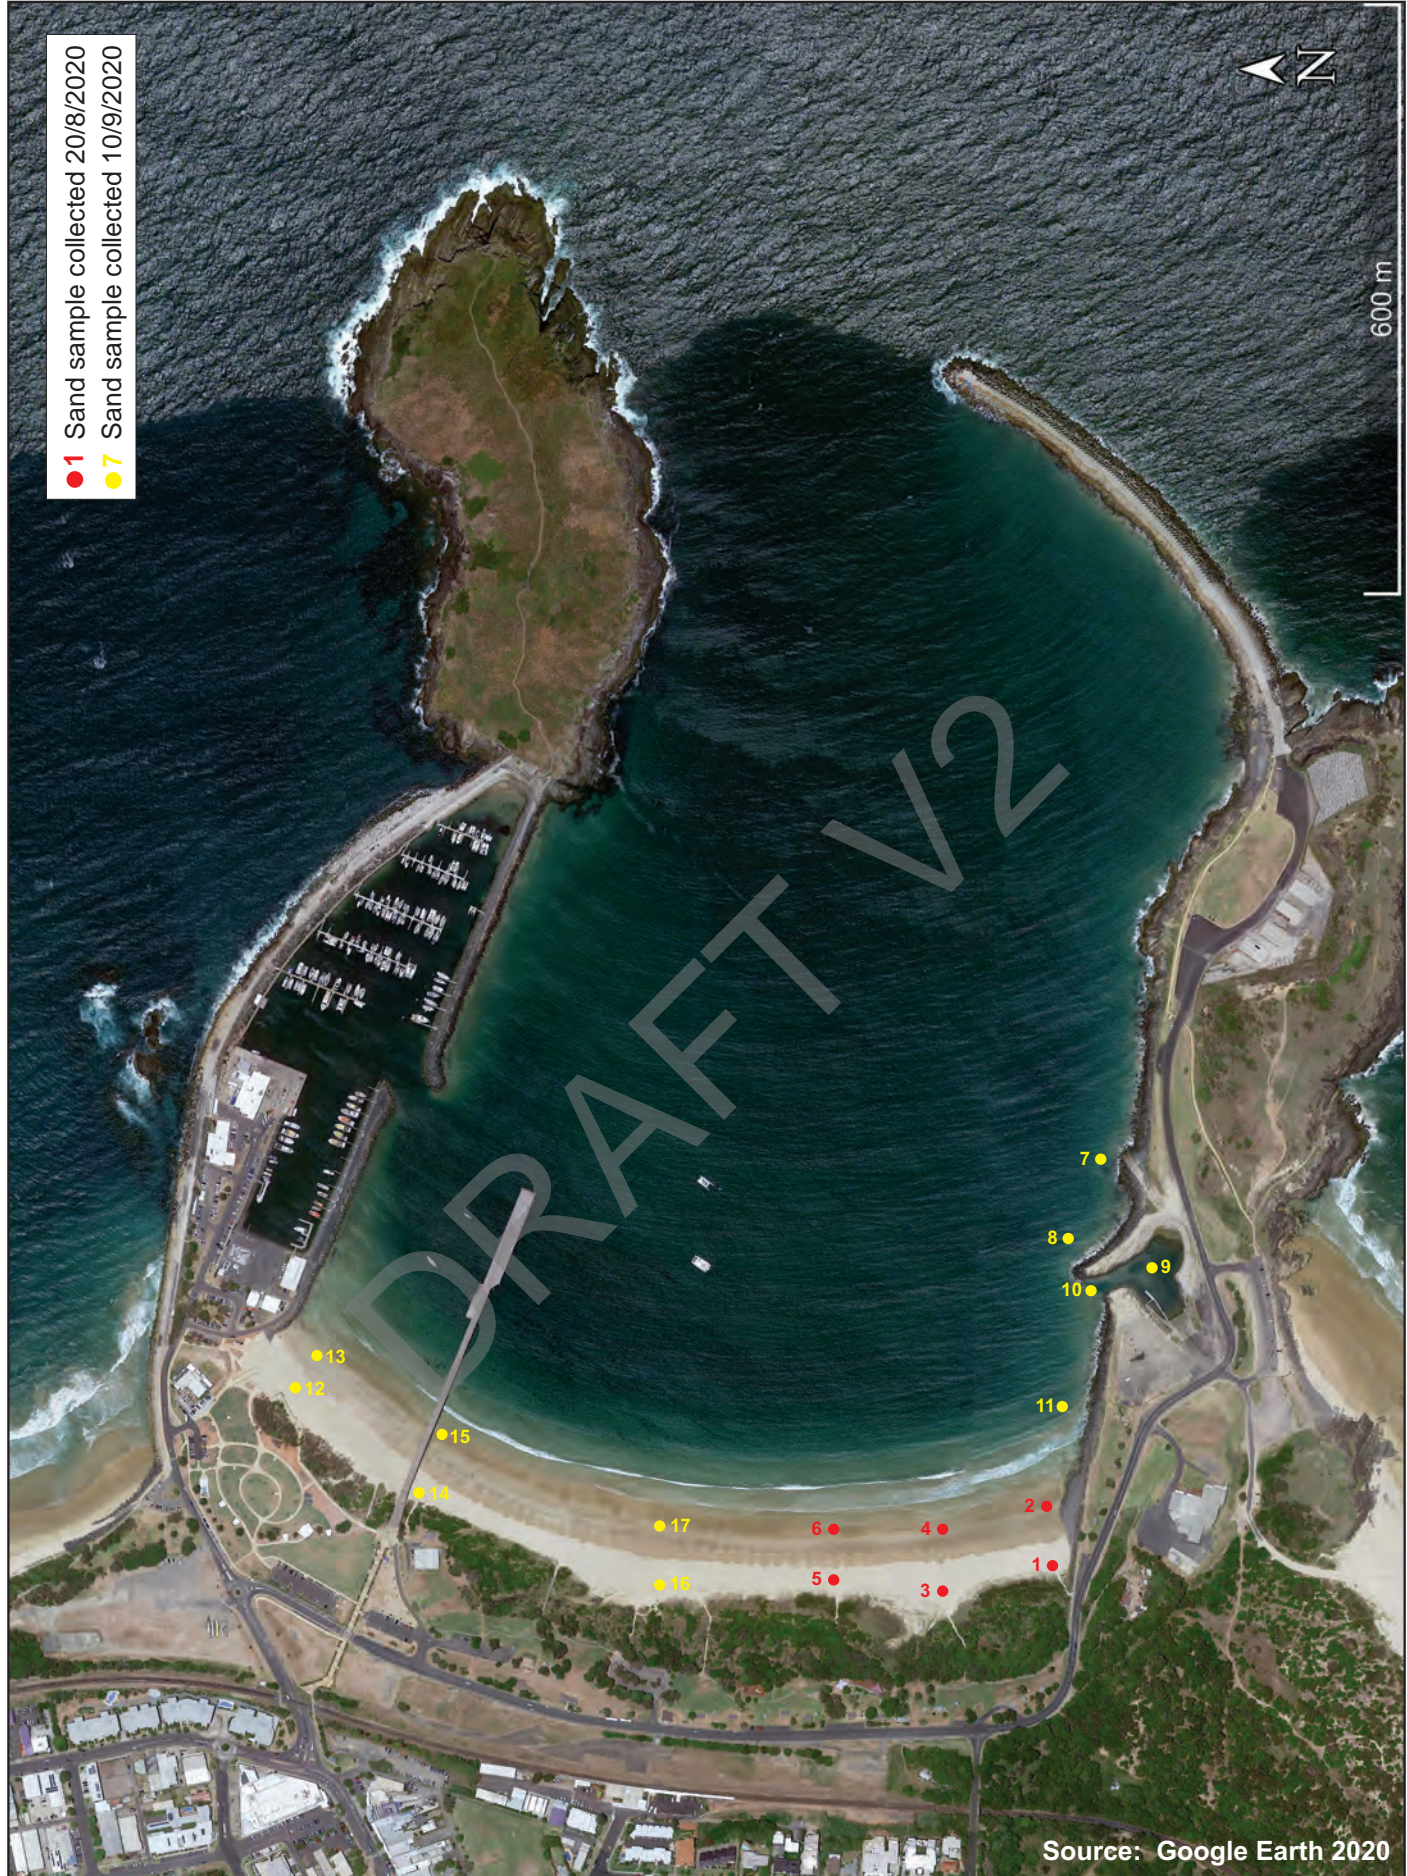
Report MHL2784  
Figure  
4.1

Sediment samples were collected from locations in Coffs Harbour to determine the grain size and basic sediment characteristics and to inform the sediment transport modelling component of the study. The sediment samples were collected by MHL personnel during two field visits on 20 August 2020 and 10 September 2020. Seventeen samples were collected with the location of each sample shown in **Figure 4.1**. The sediment samples were collected from several locations along Jetty Beach from both the middle of the beach berm and in the swash zone. Samples were also collected from shallow water off the Coffs Harbour southern shoreline and in the boat ramp basin and entrance channel. The spatial distribution of the sampling locations was selected to assess if there is any significant differences to the sand characteristics along Jetty Beach and if the beach sand differs from the sand being transported from the eastern breakwater along the southern shore of Coffs Harbour.

- 1 Sand sample collected 20/8/2020
- 7 Sand sample collected 10/9/2020

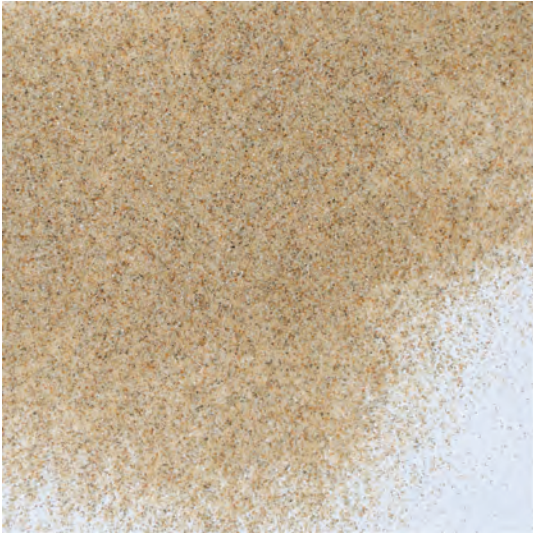
Sample 12 - Jetty Beach north end berm

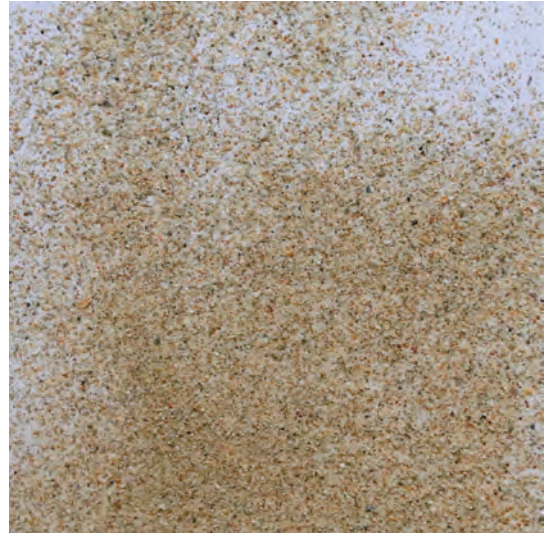
Sample 5 - Jetty Beach 3rd south access berm

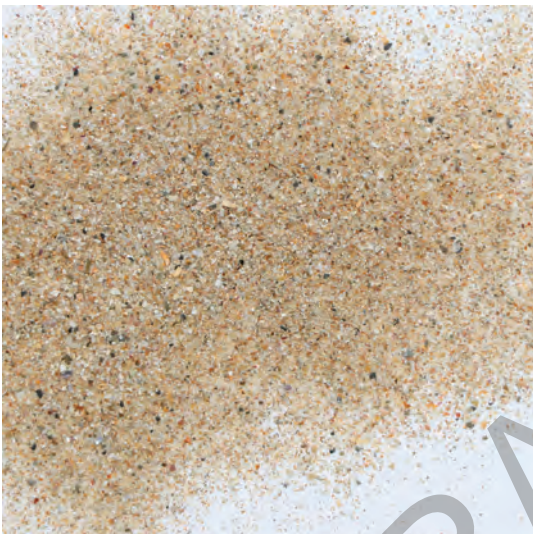
Sample 2- Jetty Beach south end swash

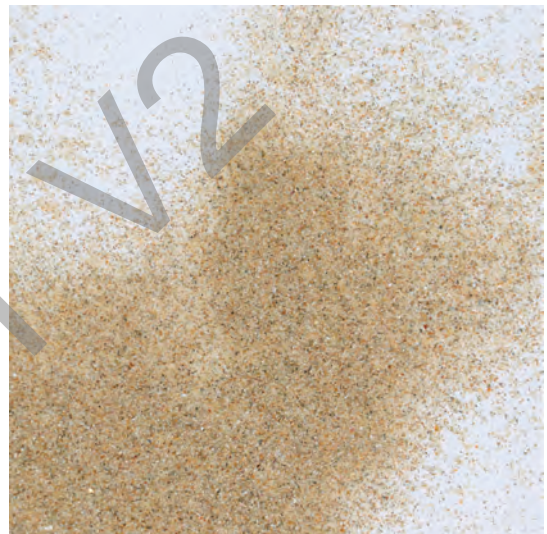
Sample 11 - Jetty Beach south end offshore

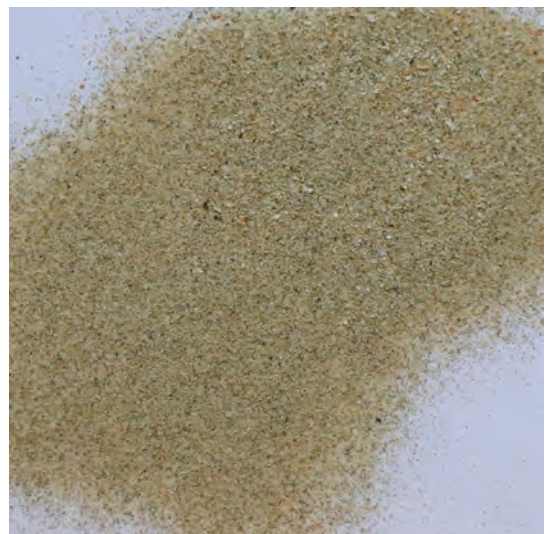
Sample 7 - Coffs Harbour east south shore

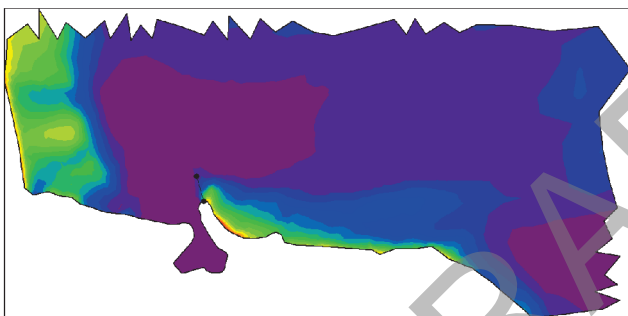
Option 3 - 75m Extension

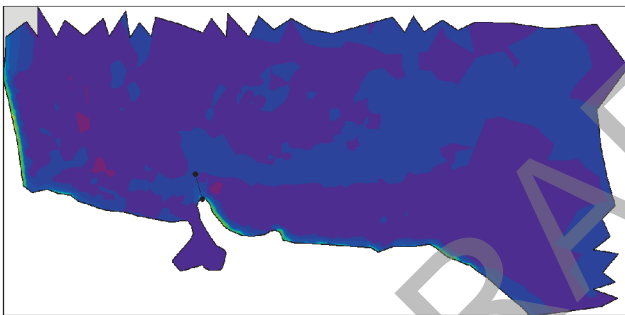
Option 3 - 75m Extension

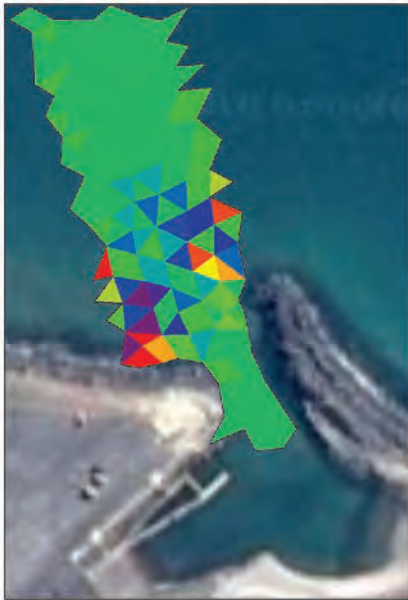
Option 2 - 60m Extension

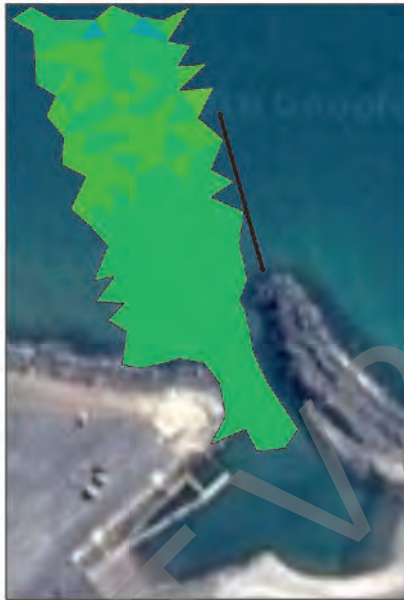
Option 1 - 40m Extension

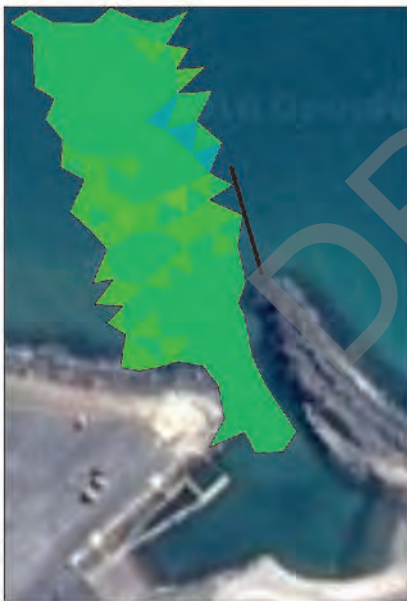
Option 3 - 75m Extension
