PORT MACQUARIE BREAKWALL

TREE IMPACT ASSESSMENT

SEPTEMBER 2022

PORT MACQUARIE SOUTHERN BREAKWATER UPGRADE

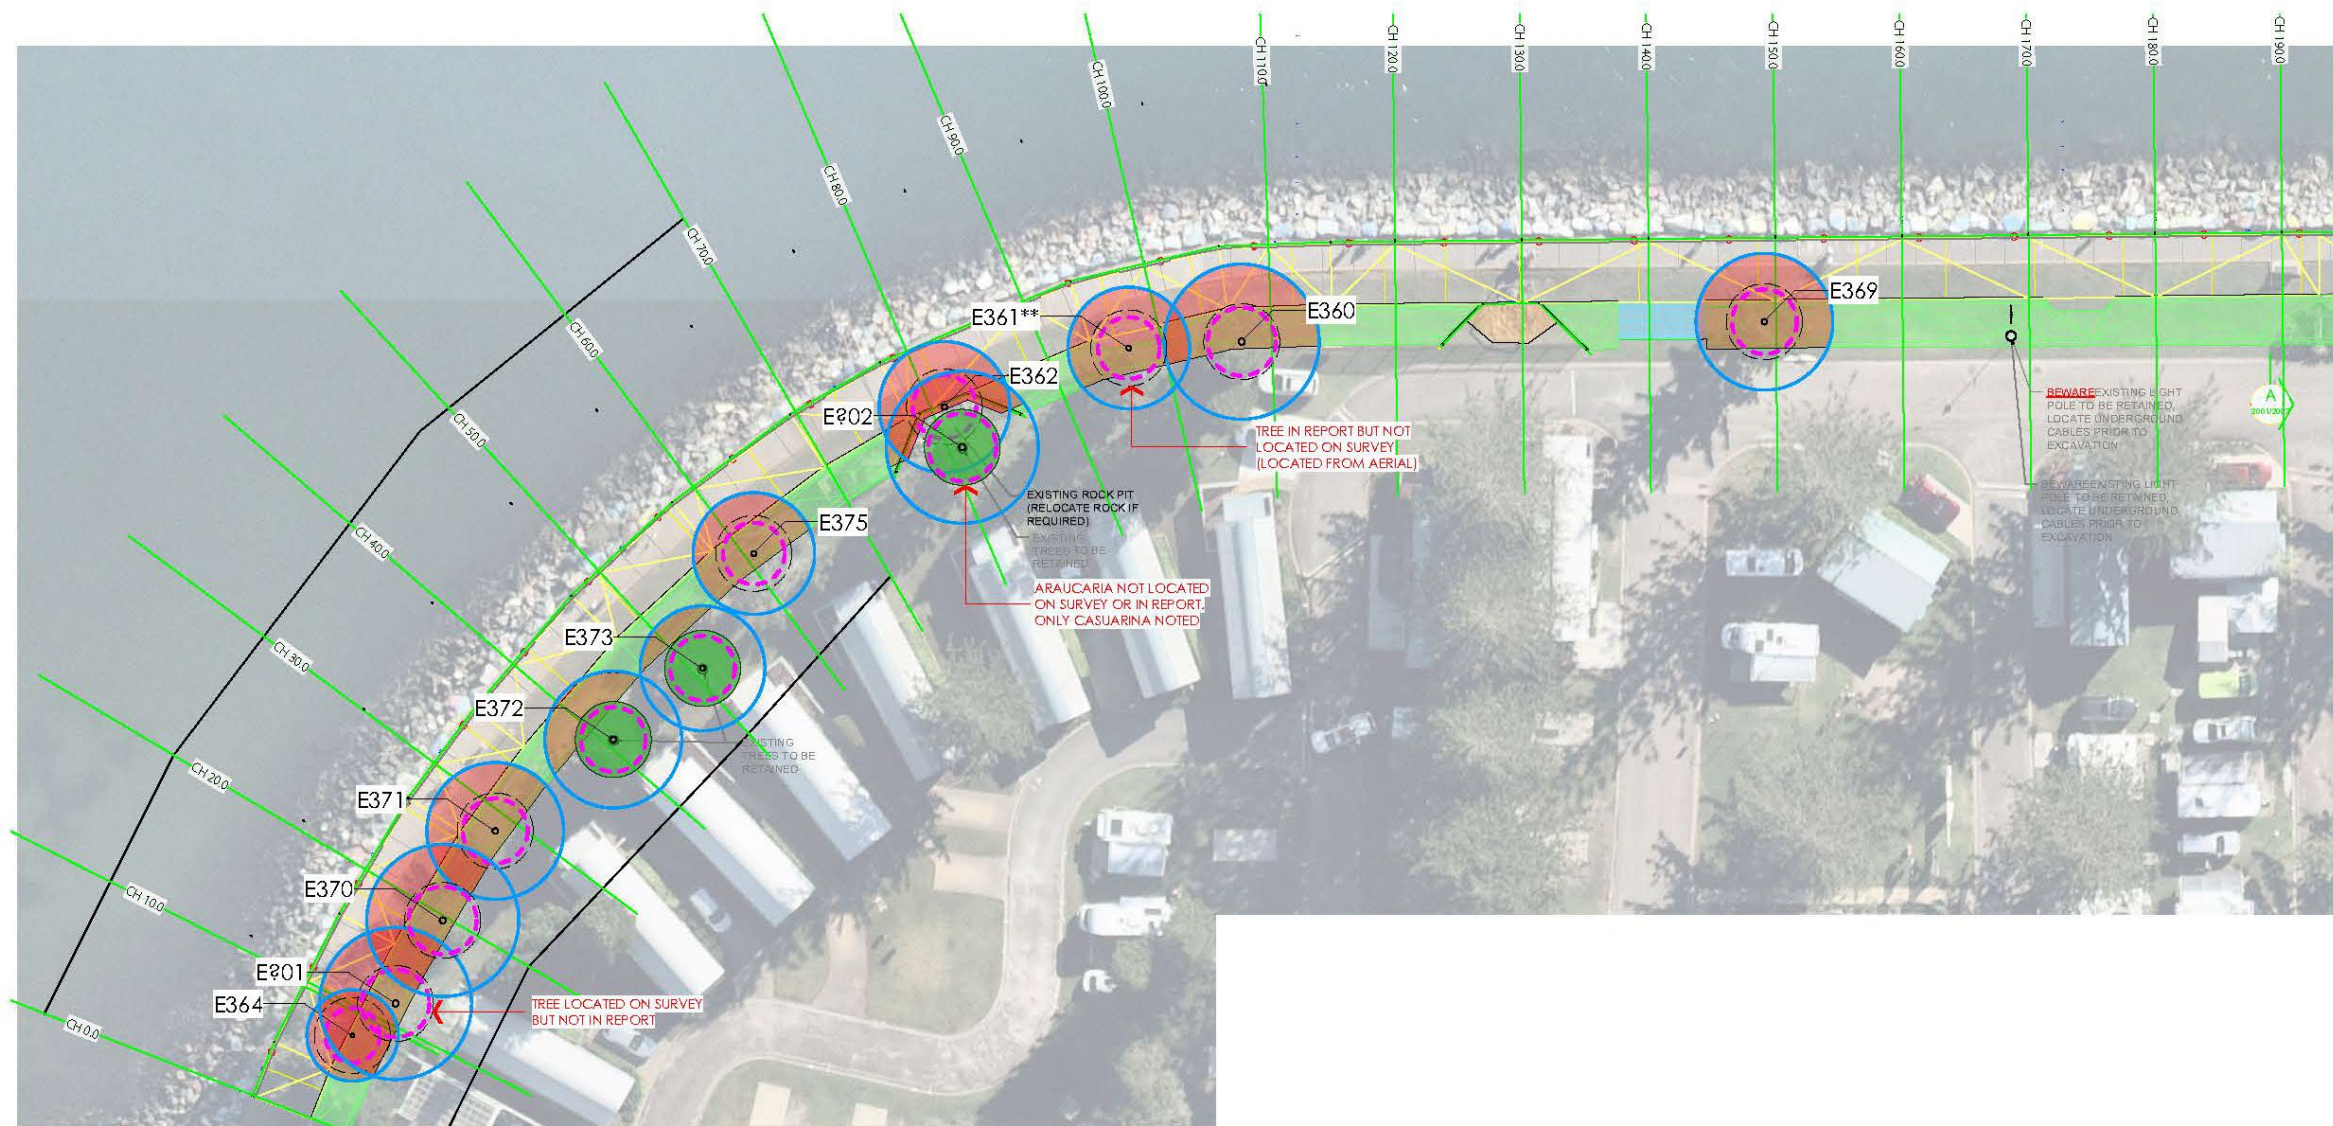
TREE DIAGRAM 001 | L401

1 ARB 001
L401 Scale: 1:500

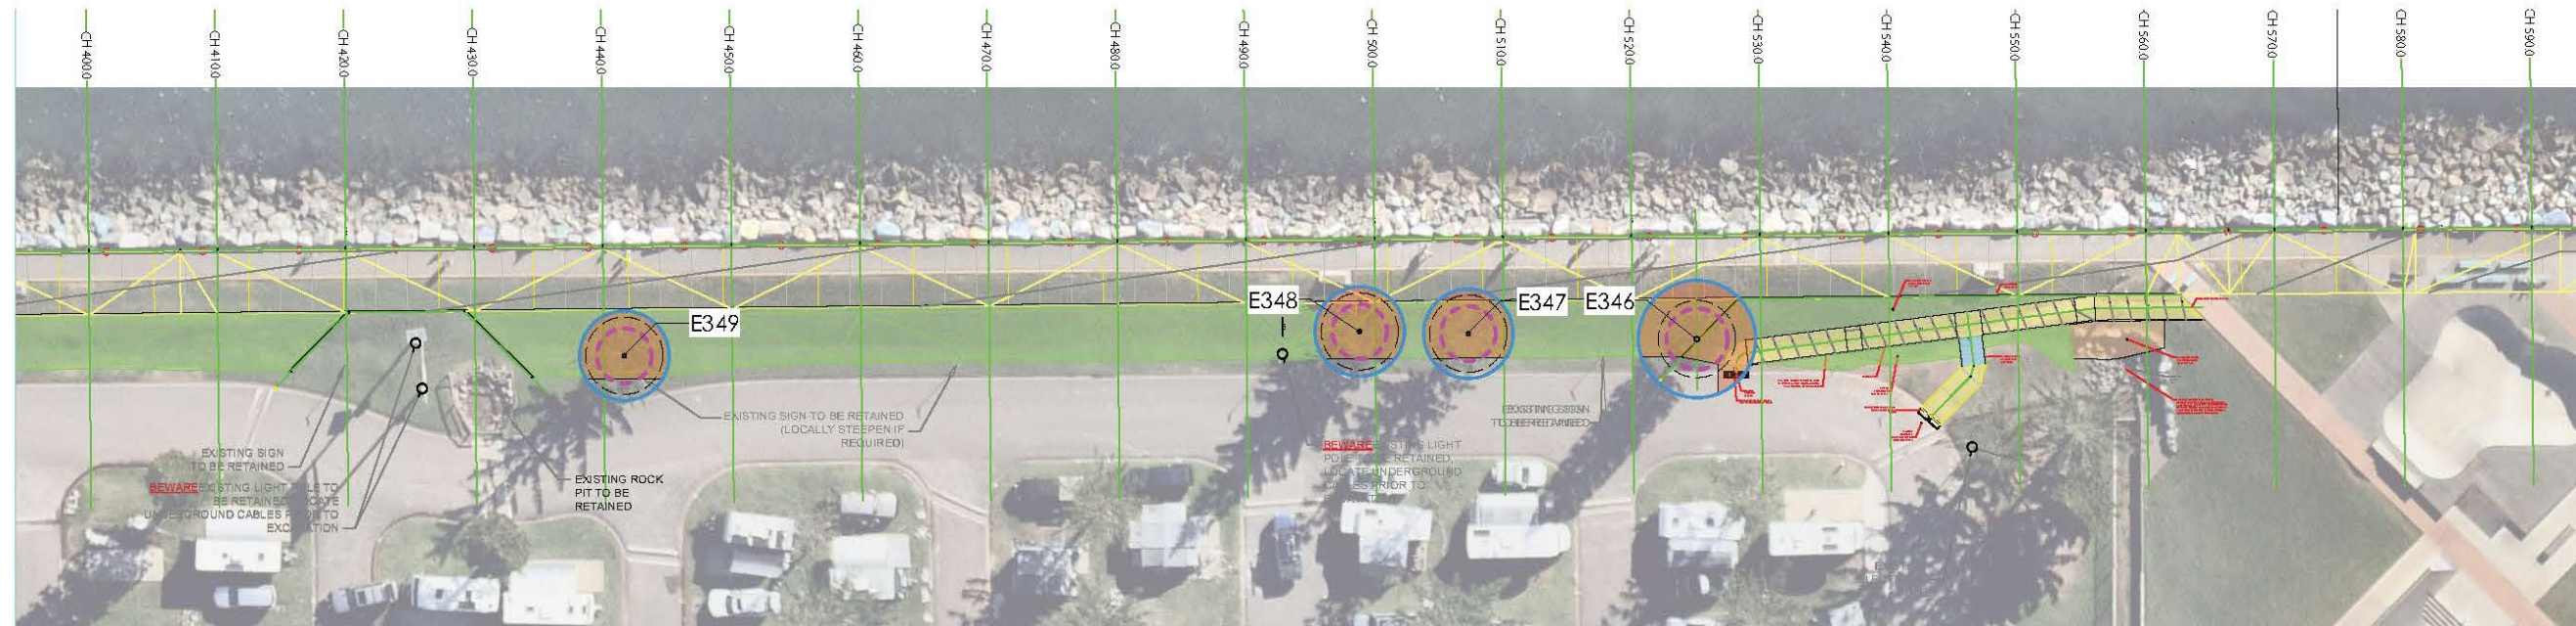
TREE DIAGRAM 003 | L403

1 ABR 003
L403 Scale: 1:500
