# **Tweed Heads Travel Lift Boat Facility**

Addendum Review of Environmental Factors

Transport for NSW

Transport for NSW | August 2022

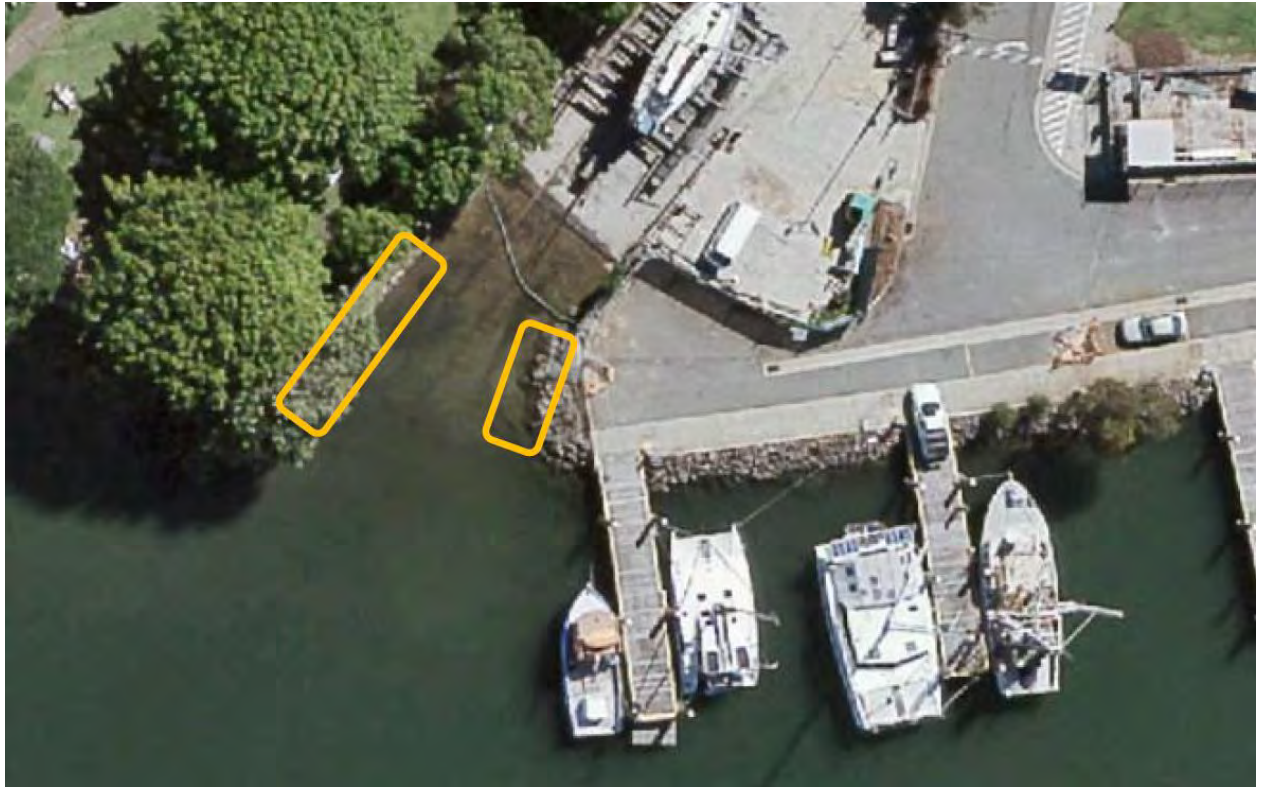
Figure 1-2: Location of mangrove seedling removal

The proposed harm to marine vegetation involves removal of up to twenty four mangrove seedlings that have emerged along the eastern and western edge of the existing slipway (refer Figures 3-1 and 3-2). The seedlings fall within the footprint of the construction works where remediation activities are proposed.

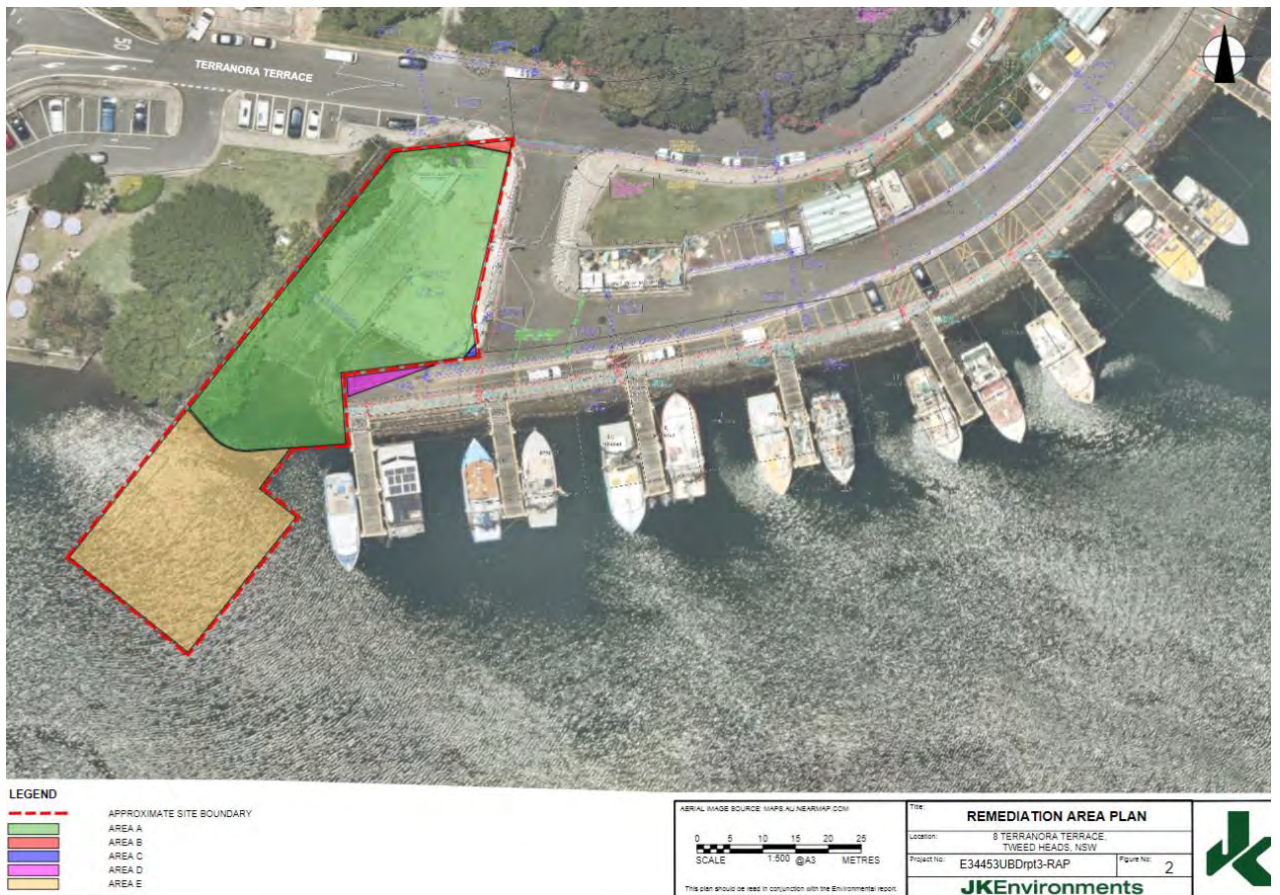
Figure 1-3: Location of design modifications associated with the RAP (green shaded area)

As noted above, the proposed remediation option for the site requires changes to the proposed design. These design changes comprise the inclusion of a high visibility geotextile fabric marker layer and geogrid placed over all exposed subgrade surfaces.

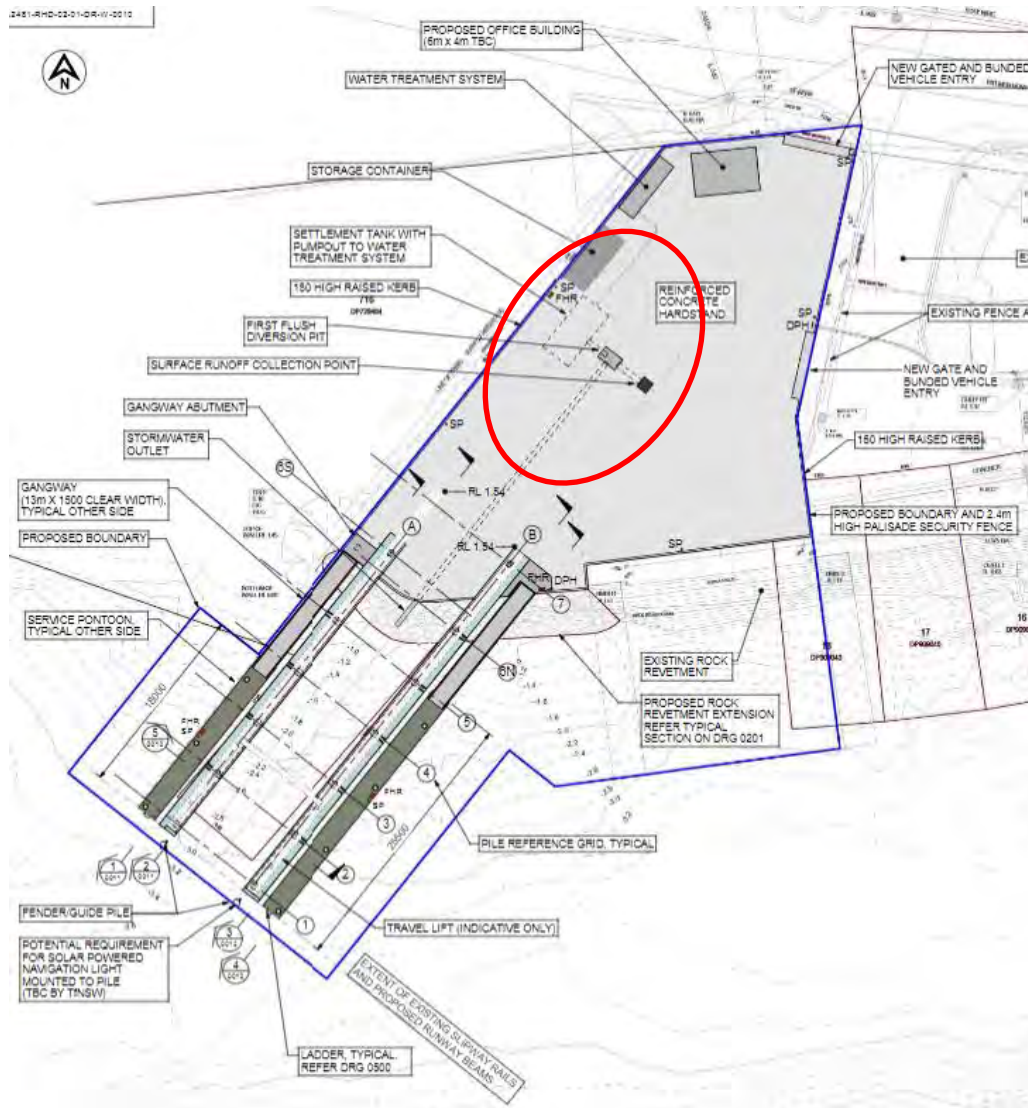
**Figure 1-5: Location of possible dewatering activities**

Dewatering was not expected to be required for the construction activities and the Contractor has advised TfNSW that the construction methodology aims to alleviate the need for dewatering activities during the installation of the wastewater storage tank, associated wastewater junction pit and drainage infrastructure. However, after reviewing the mean high-water level data, the Contractor considers that some of the excavation areas may be underwater during stages of the works (particularly high tide events). Therefore, excavation areas that experience groundwater and/or surface water ingress may require dewatering to assist with the contractor's construction requirements. If dewatering is required, a Dewatering Management Plan (DMP) would be prepared.

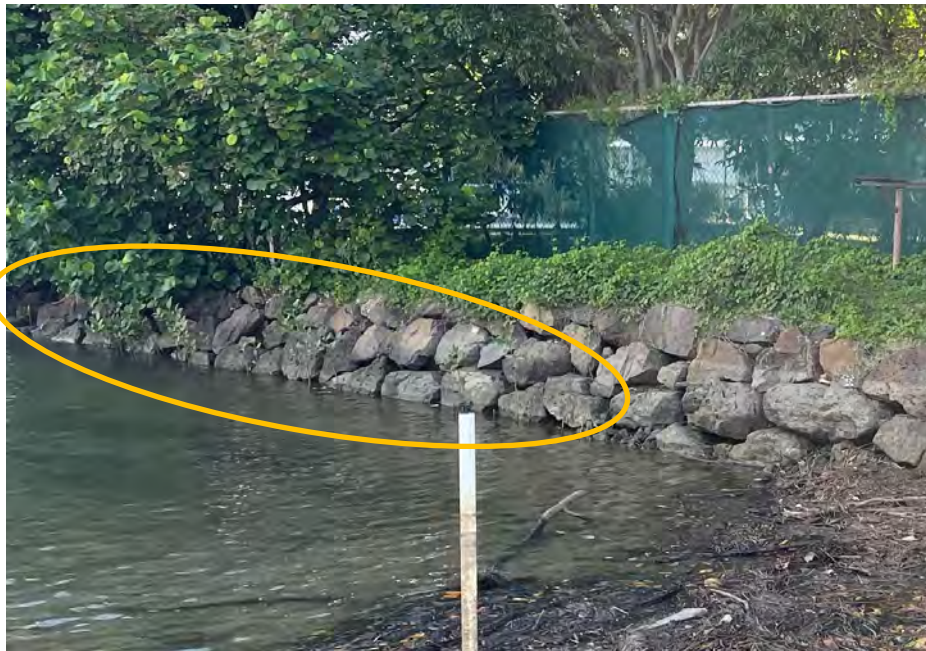
**Figure 3-1: Mangrove seedlings on western edge of slipway**

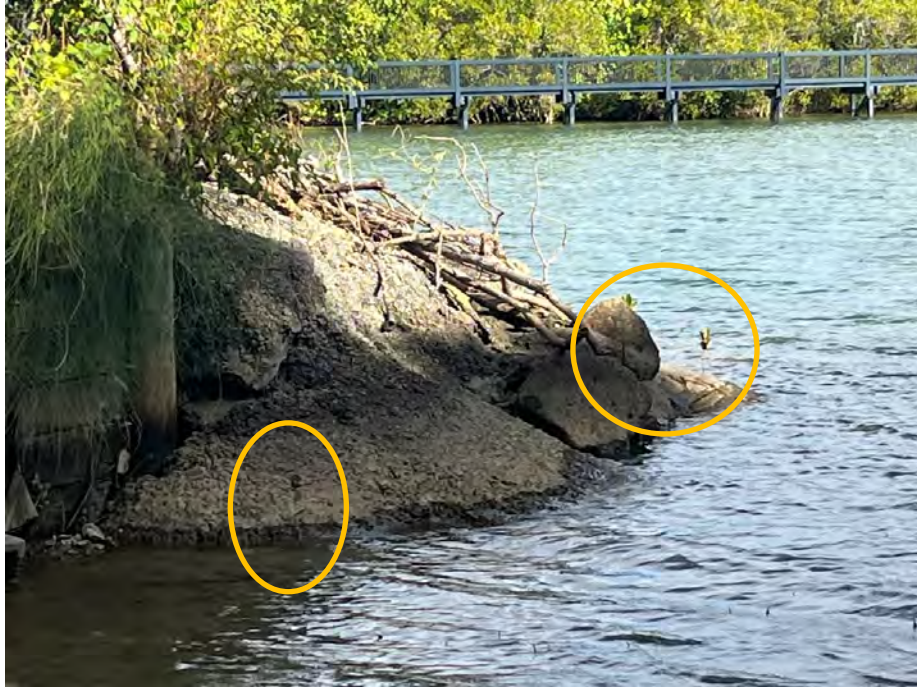
**Figure 3-2: Mangrove seedlings on eastern edge of slipway**

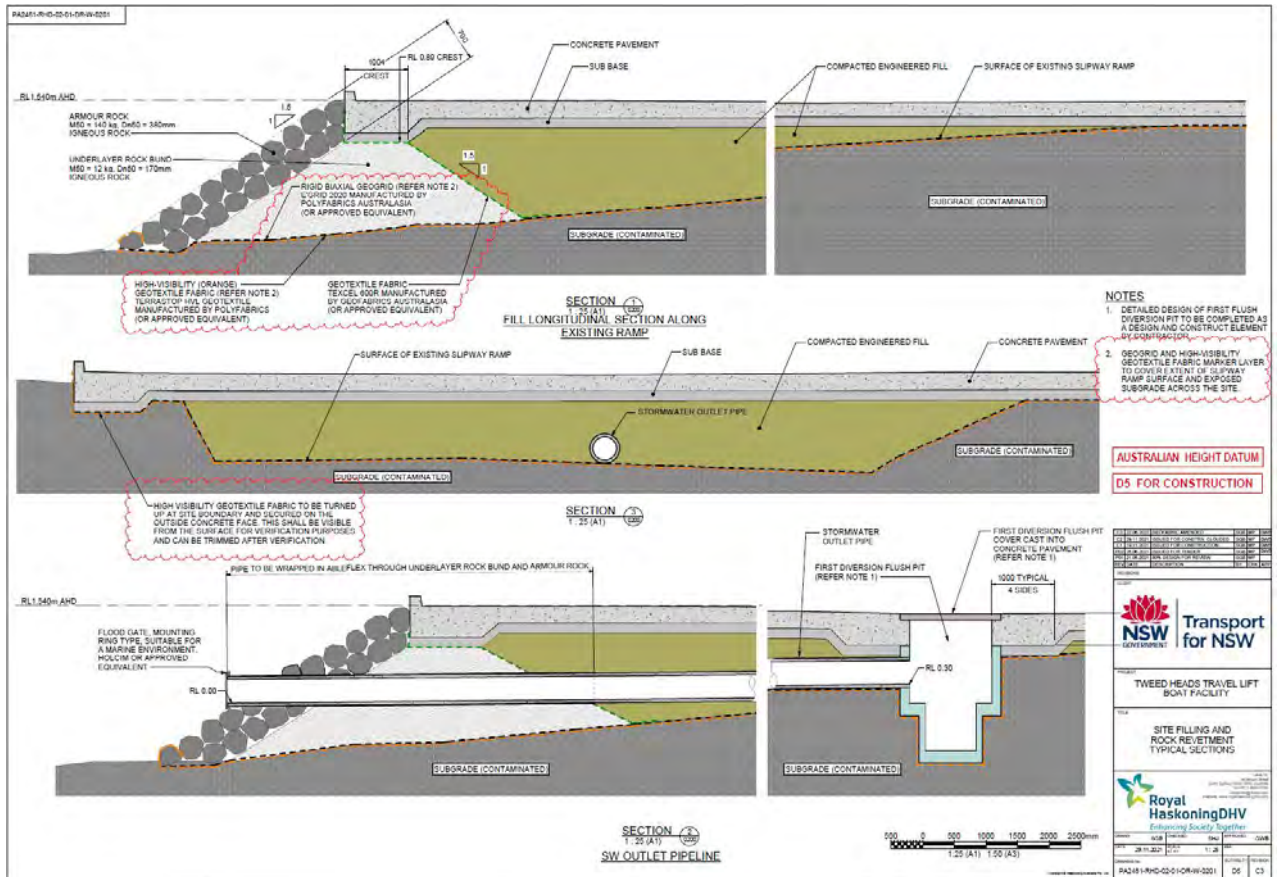
Figure 3-3: Design details of proposed geotextile fabric marker layer and geogrid

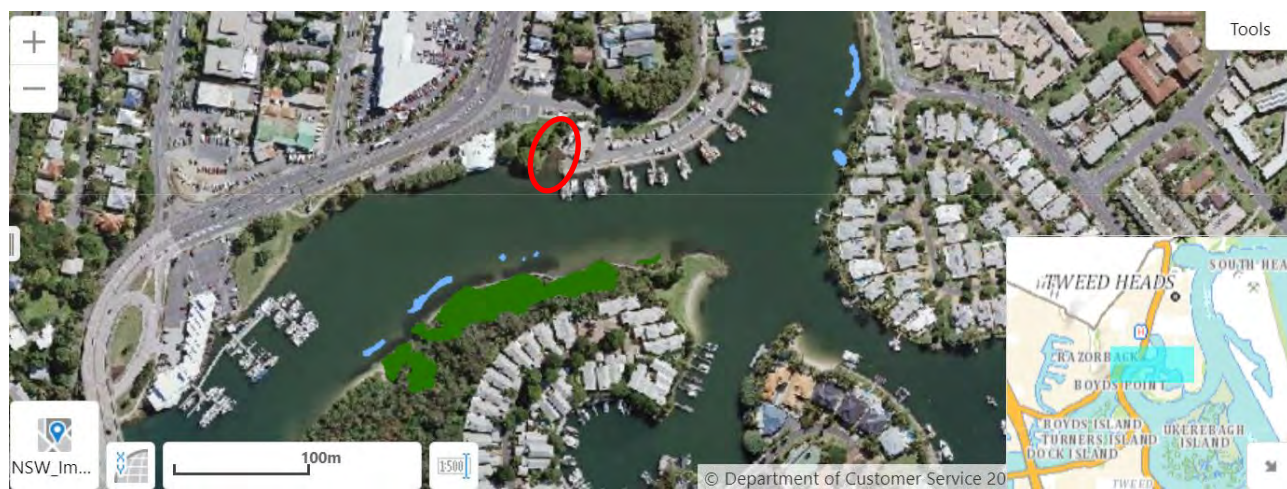
**Figure 6-1: DPI habitat mapping showing mangroves (green shaded area) and seagrass (blue shaded area) with location of mangrove seedlings circled in red.**

No threatened flora or threatened ecological communities were identified within the study area. Up to twenty four mangrove seedlings have emerged along the eastern and western edge of the existing slipway (refer Figure 3-1 and Figure 3-2). The seedlings fall within the footprint of the construction works where remediation activities are proposed.

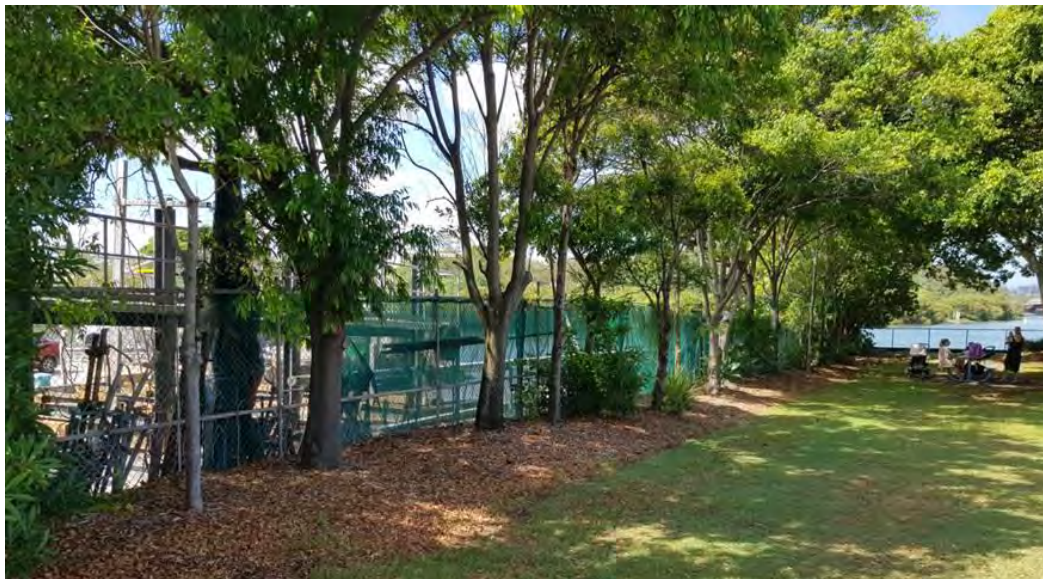
**Figure 6-2: Trees in Marina Park along the eastern boundary of the park adjacent to the existing slipway**

Specialist advice from an arborist indicated that all the trees planted along the fence line are poor examples of their species due to a combination of reasons including rootstock, planting depths and site conditions (refer Figure 6-2). The two *Ficus benjamina* are in very good condition and are heavily utilised by the public visiting the café and for leisure. A list of tree species is included in the arborist's report. None of the trees are protected species. A copy of the arborist's report is included in Appendix E.

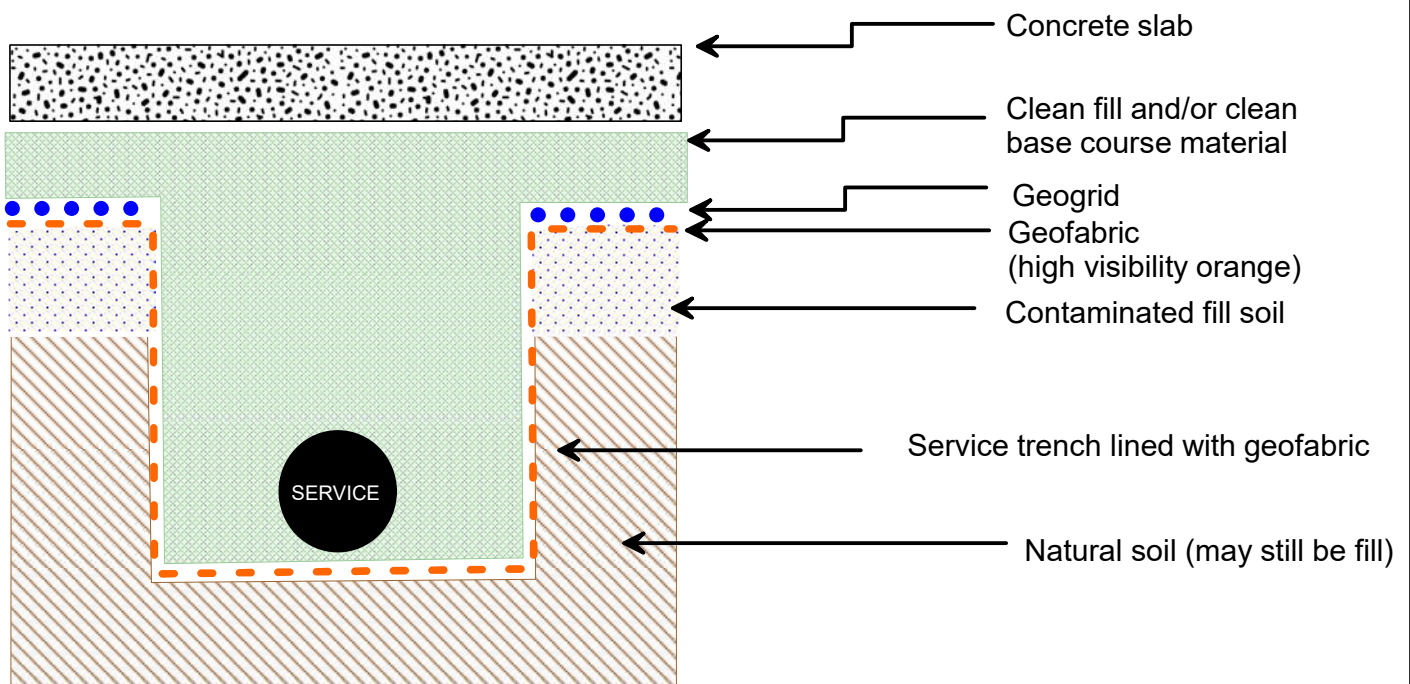
Title: **SCHEMATIC CROSS SECTION OF AREA A CAPPING - TYPICAL SERVICES INSTALLATION**
