Goulburn Wheat Yards Assessment

Offsite Lead Delineation Preliminary Site
Investigation

Project name **Goulburn Wheat Yards Assessment - Offsite Lead Delineation Preliminary Site Investigation**
Project no. **318001660**
Recipient **ARTC**
Document type **Final Report**
Version **1**
Date **7 September 2023**
Prepared by **N. Gilbert**
Checked by **R. Condon / K. Greenfield (CEnvP SC40104)**
Approved by **A. Nolan**
Description **This document presents the results of an environmental assessment to assess the potential offsite risk of lead contamination surrounding the Goulburn Wheat Yards.**

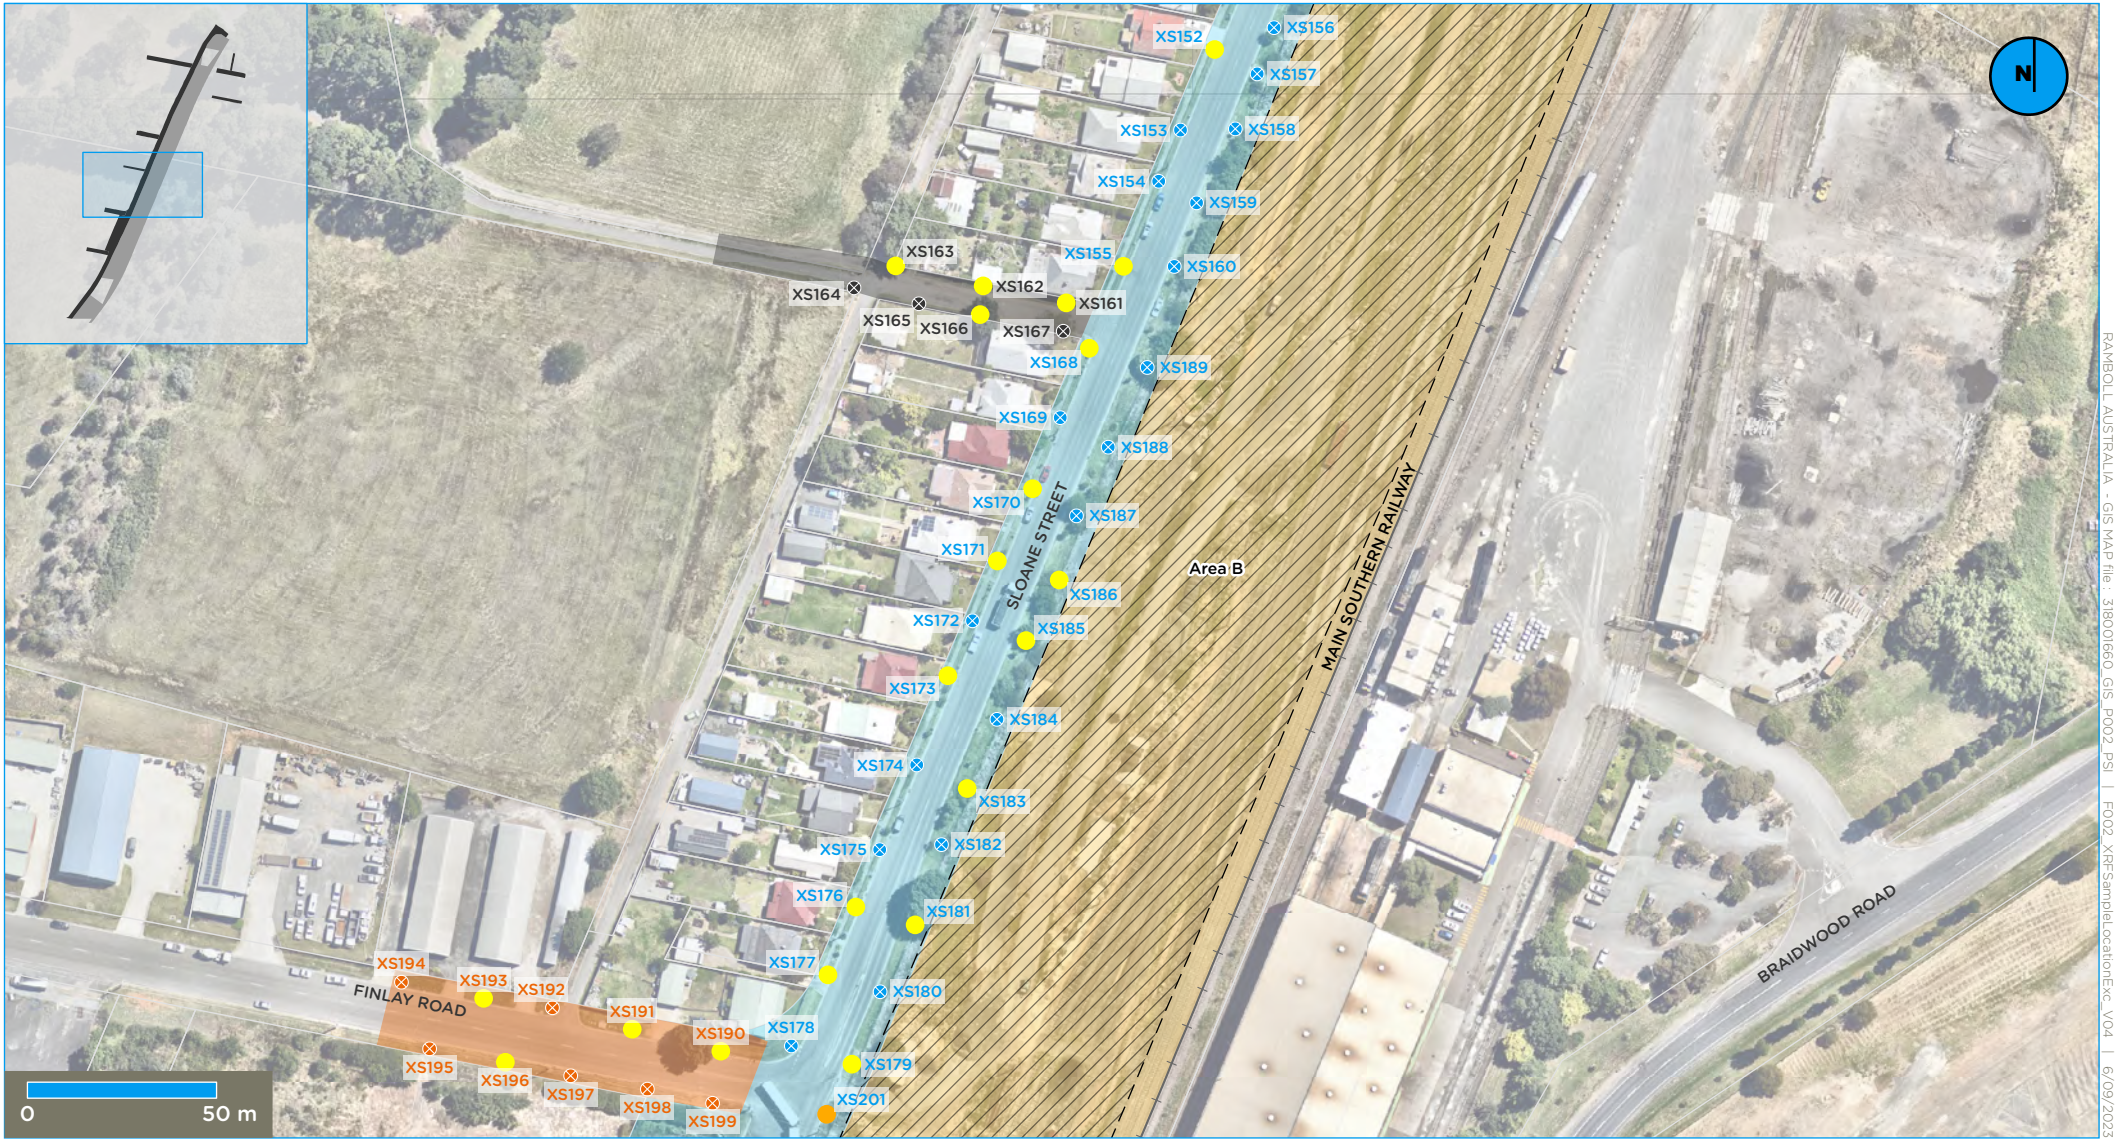
Figure 5b : EIL exceedances
Goulburn Wheat Yards Offsite Lead Delineation PSI

even when taking into account the indicative worst case concentrations. Sample locations with zinc and copper EIL exceedances are presented on **Figures 5a-5e, Appendix 1**, showing their widespread presence across the study area.

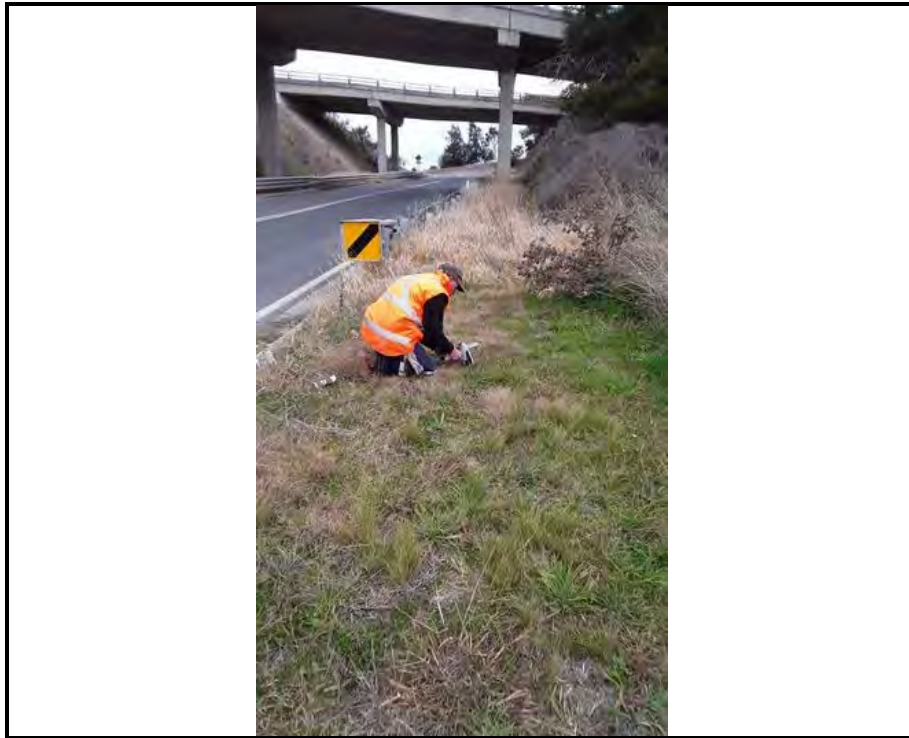
Photo 1: Photograph of XRF sampling at the southern end, north side of Sloane Street at the base of the Hume Hwy facing south. Sample XS001

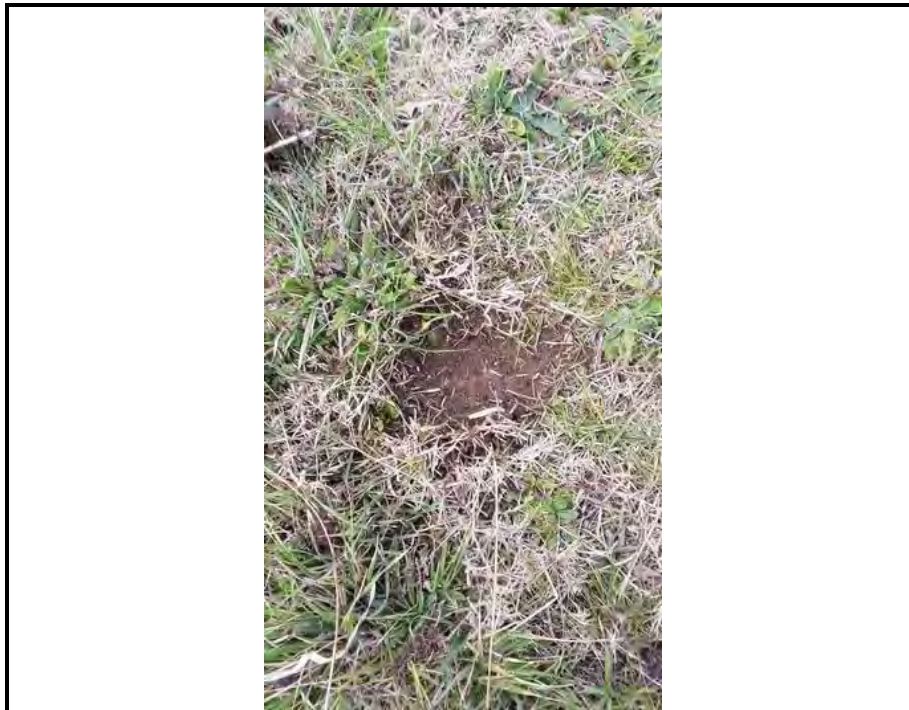
Photo 2: Photograph of the Soil and grass at area of testing in Photo 1. Brown gravelly silt, with some dried patches of grass, however generally healthy.

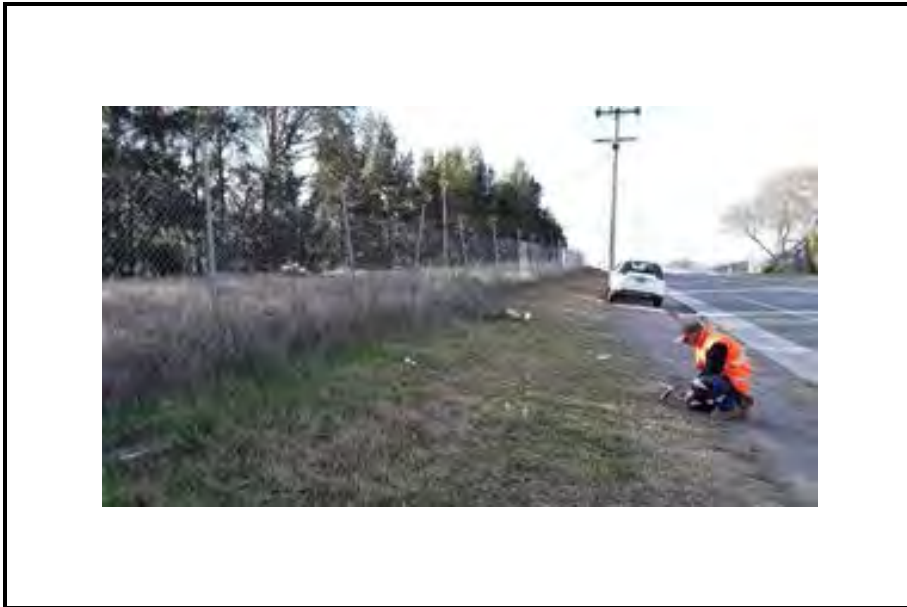
Photo 3: Photo taken sampling with XRF opposite Ampol petrol station on the southern end of Sloane Street 100m Northeast of the Hume. Sample XS009

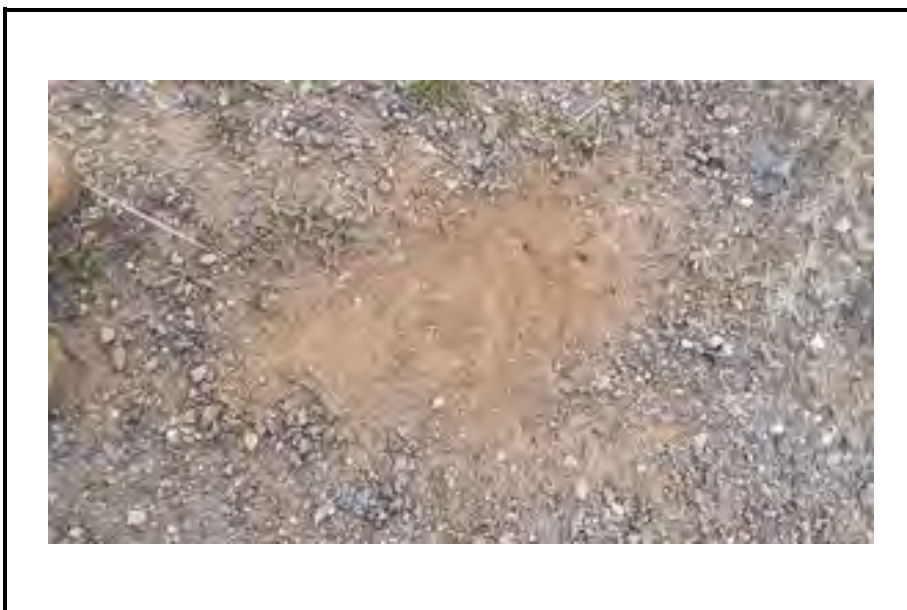
Photo 4: Brown gravelly silt. High percentage of gravel within this area with grass mostly constricted to fence line. Heavy vehicle traffic within this area. Sample XS010

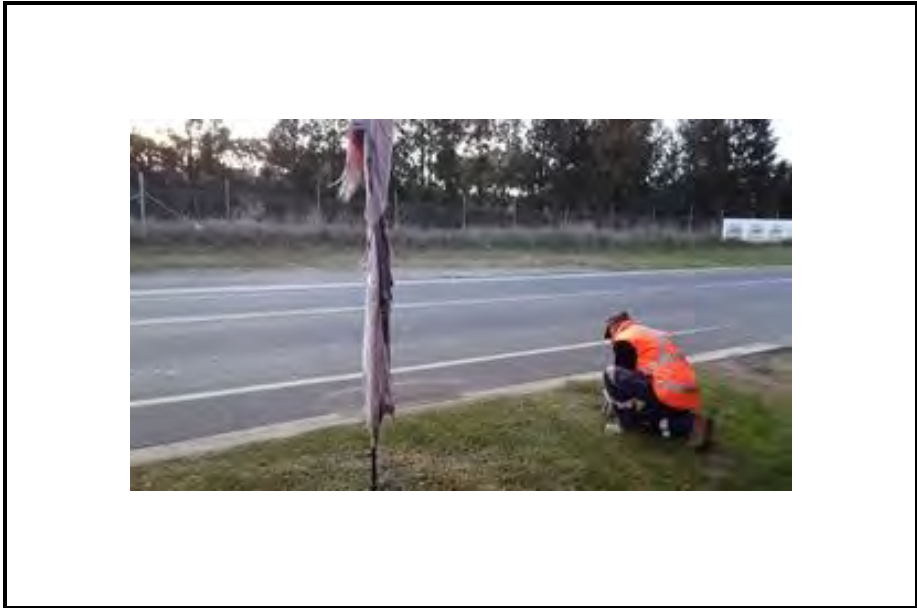
Photo 5: Photo taken XRF sampling on nature strip of Ampol petrol station. Sample XS013. Brown Silt, mostly grass with some bare patches of gravel.

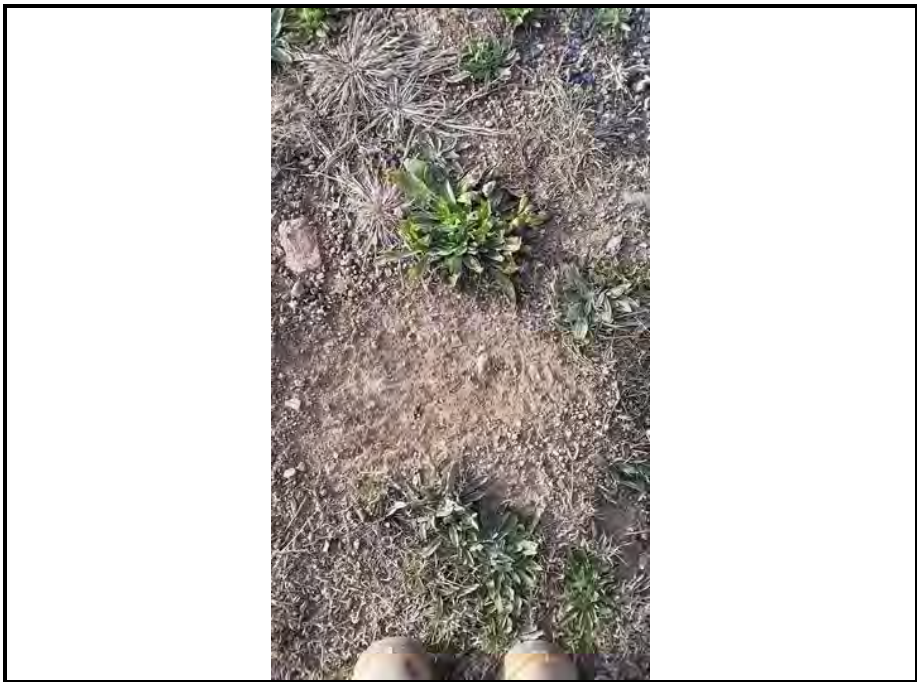
Photo 6: Close up of sample XS014 showing bare patches of gravel.

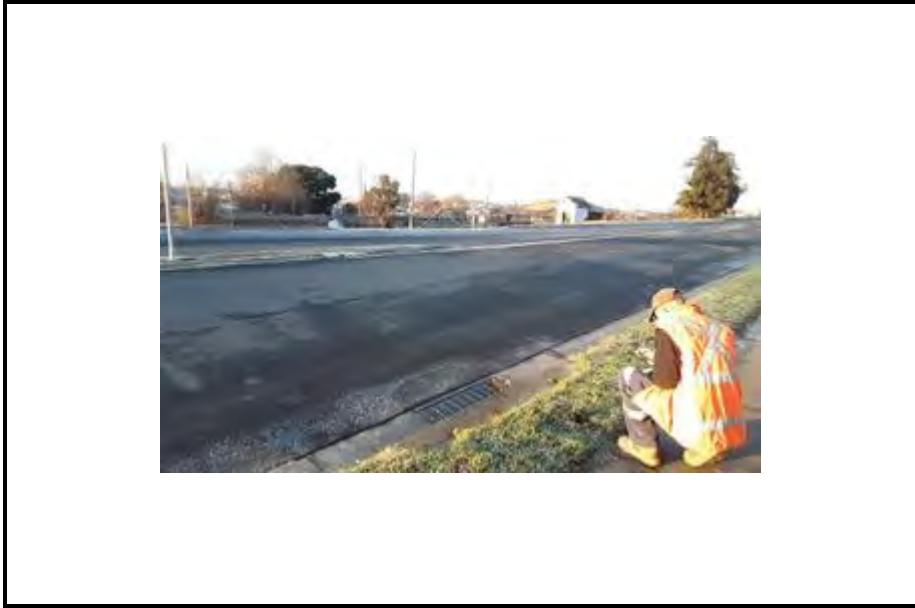
Photo 7: Sample location XS024. Northern end, north side of Sloane Street. Intersection of Mundy Street and Braidwood Rd. Grass is in good condition.

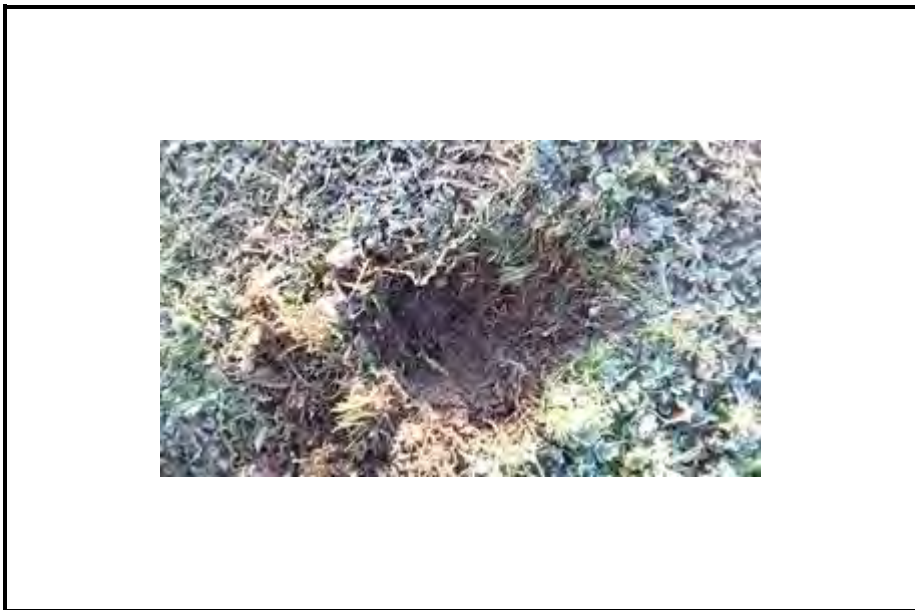
Photo 8: Brown fine topsoil silt from XRF sample XS024. Grass appeared to be in good condition.

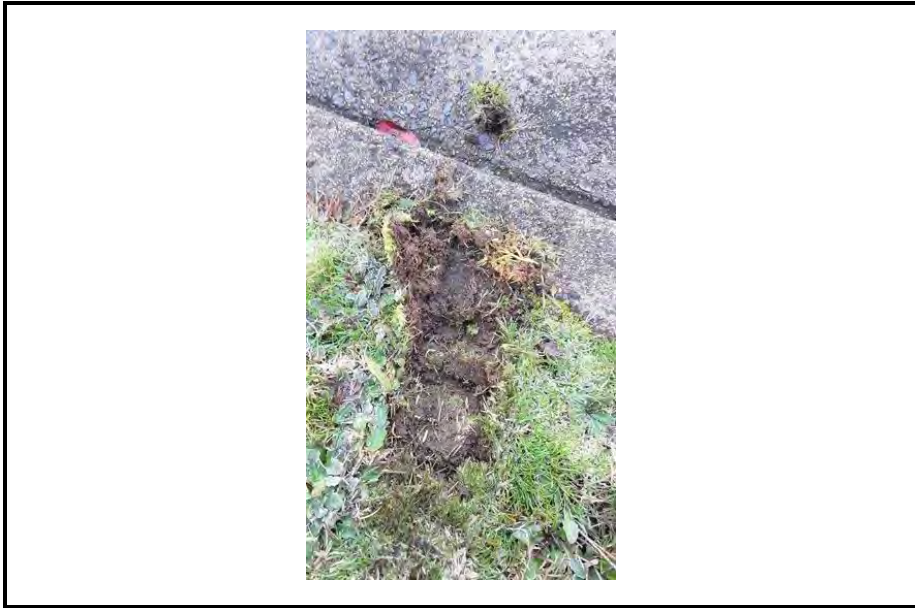
Photo 10: Photograph of sample XS058. Gravely silt dark brown wit healthy green grass surrounding entire area

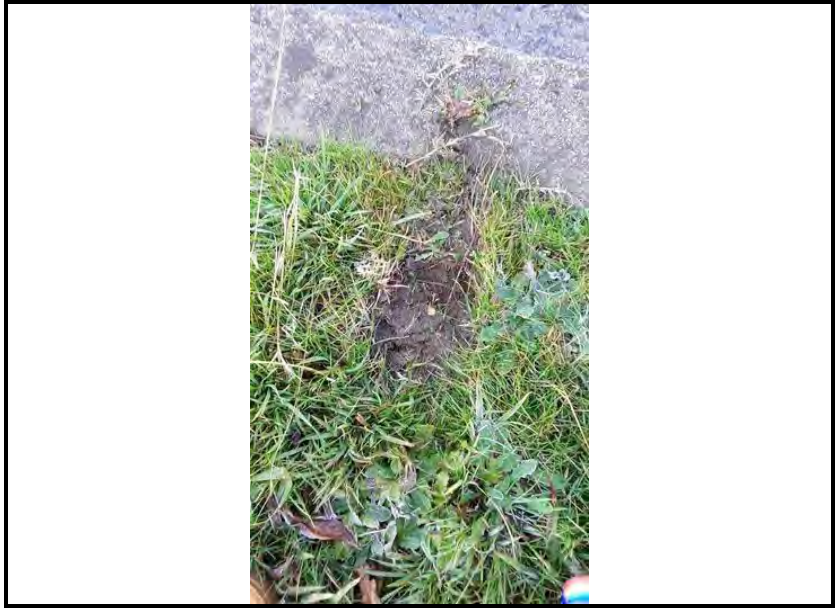
Photo 11: Gravelly silt, dark brown from XRF sampling location XS059 towards the Northern end of Ottiwell Street. Grass appeared to be in good condition.

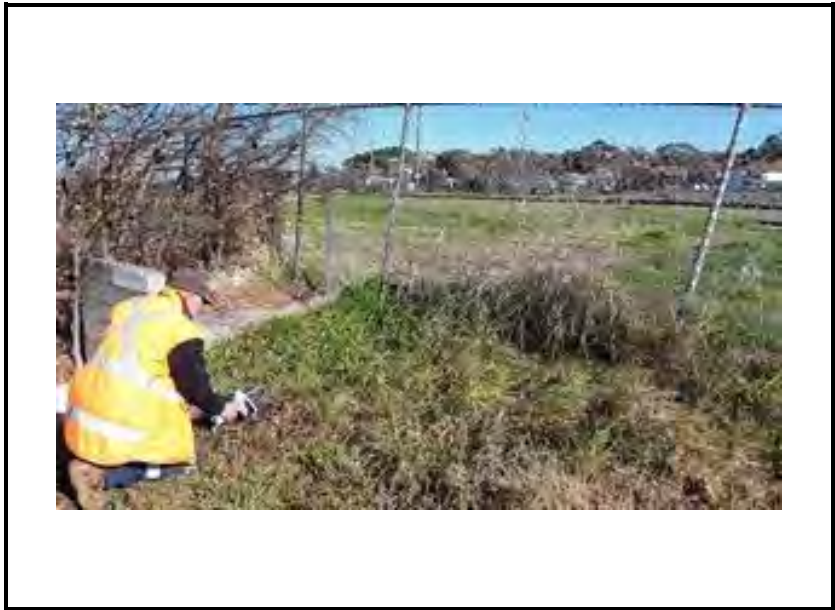
Photo 12: Sample XS073 on the south end of Ottiwell Street East, South of Wheat Yards. Sample was taken near newly installed drain 1m from Fence line. Area contained thick grass in relatively good condition.

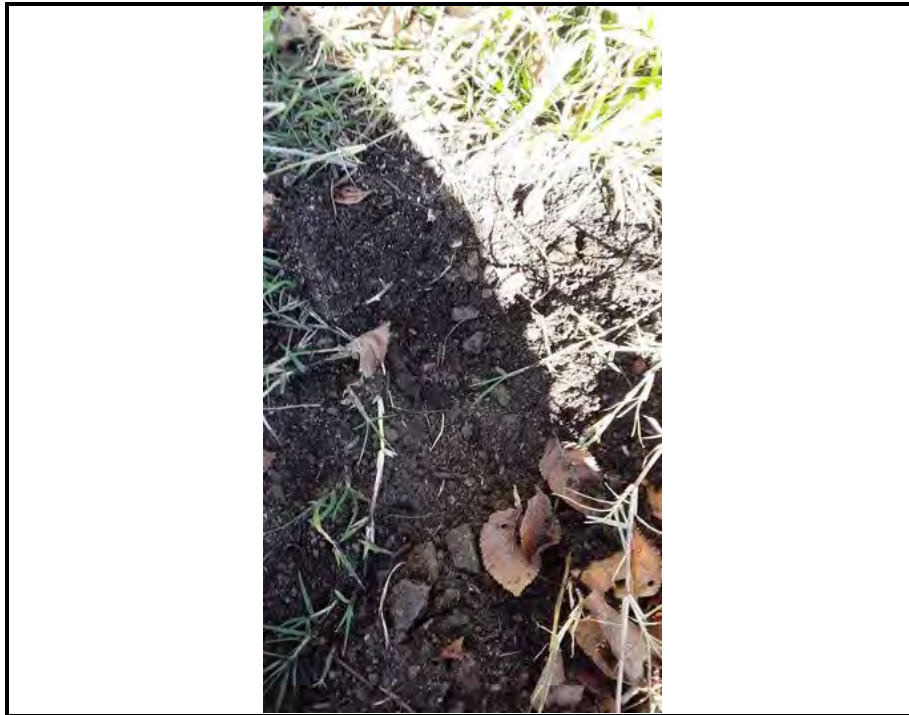
Photo 13: Photograph of soil sample at location XS073 showing gravelly silty sand.

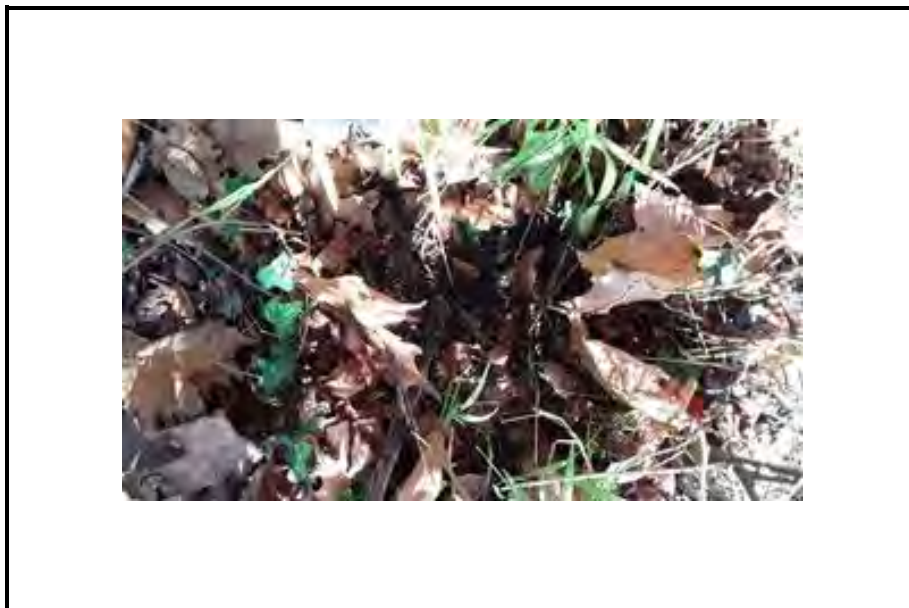
Photo 14: Photograph of sample XS090. High level of leaf coverage and minimal grass. Chicken wire as hammered into the ground over entire sampling location

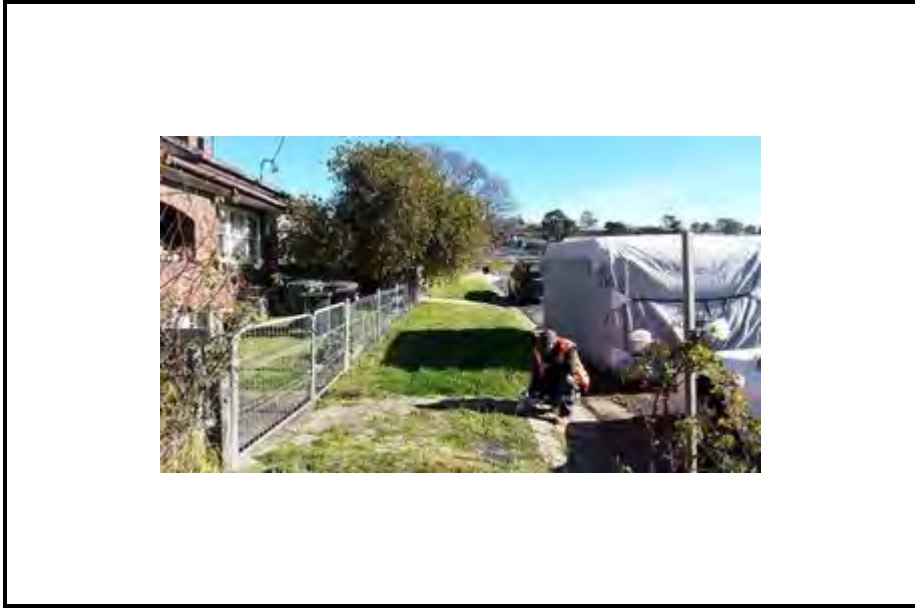
Photo 15: Sample location XS075 halfway down south side Ottiwell Street East, approximately 50m from Wheat Yard site.

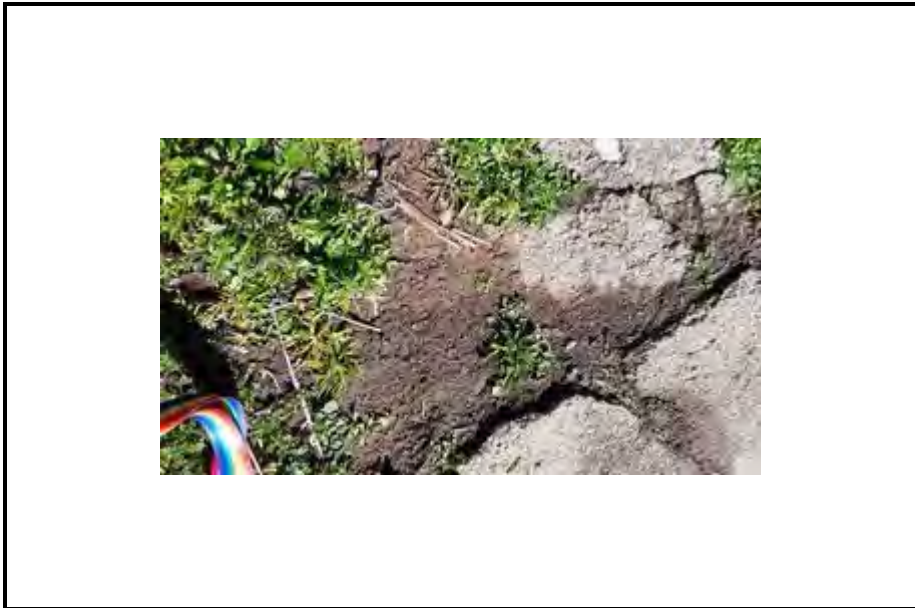
Photo 16: Close up of sample location XS075 showing gravelly silty soil. Bare patches in grass, likely from foot traffic. Silt build up had formulated along the drain way where testing occurred

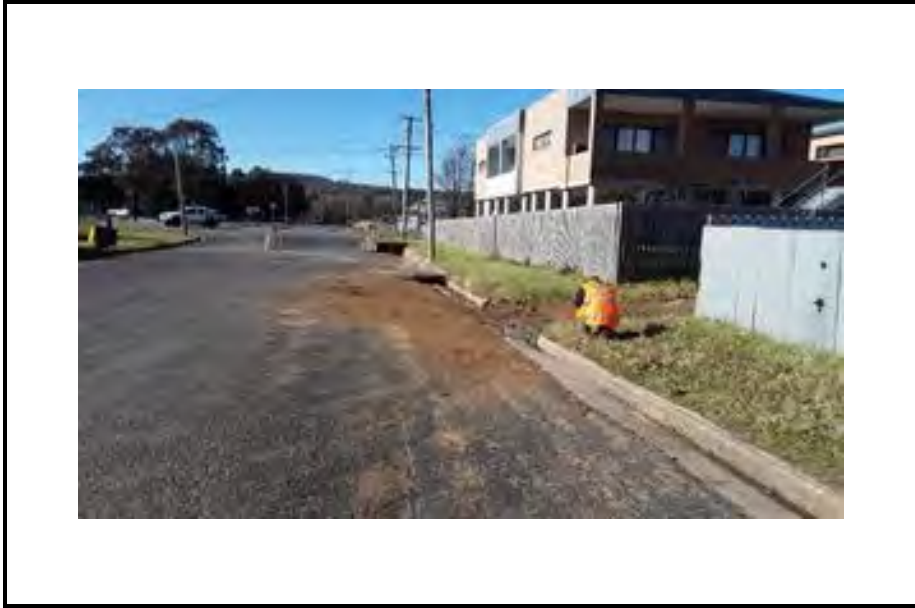
Photo 17: Sampling location XS077. Large amount of sediment near drain and bare patches of grass near driveway. Suspected to be from car and foot traffic.

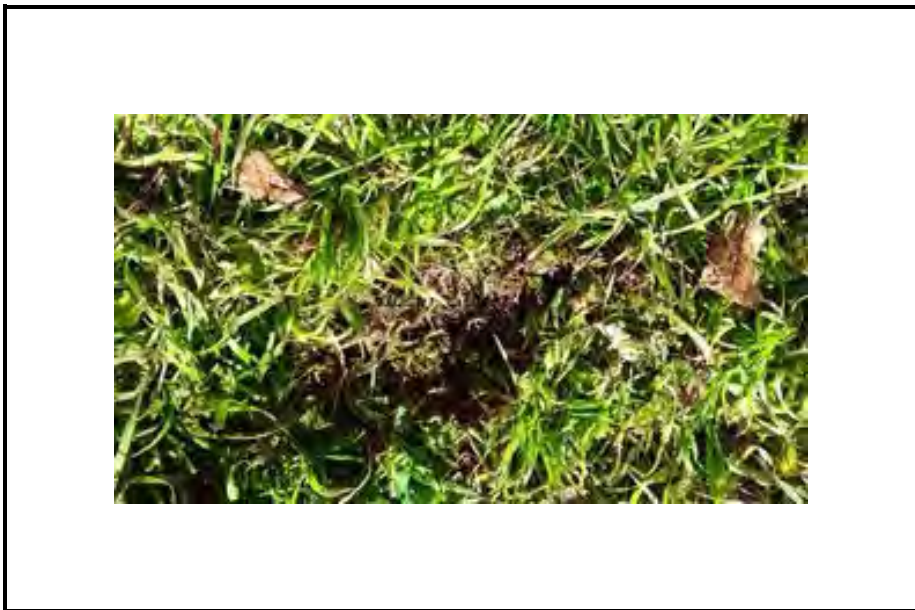
Photo 18: Photograph showing sample XS078. This area contained thick green grass with no visible signs of dead patches

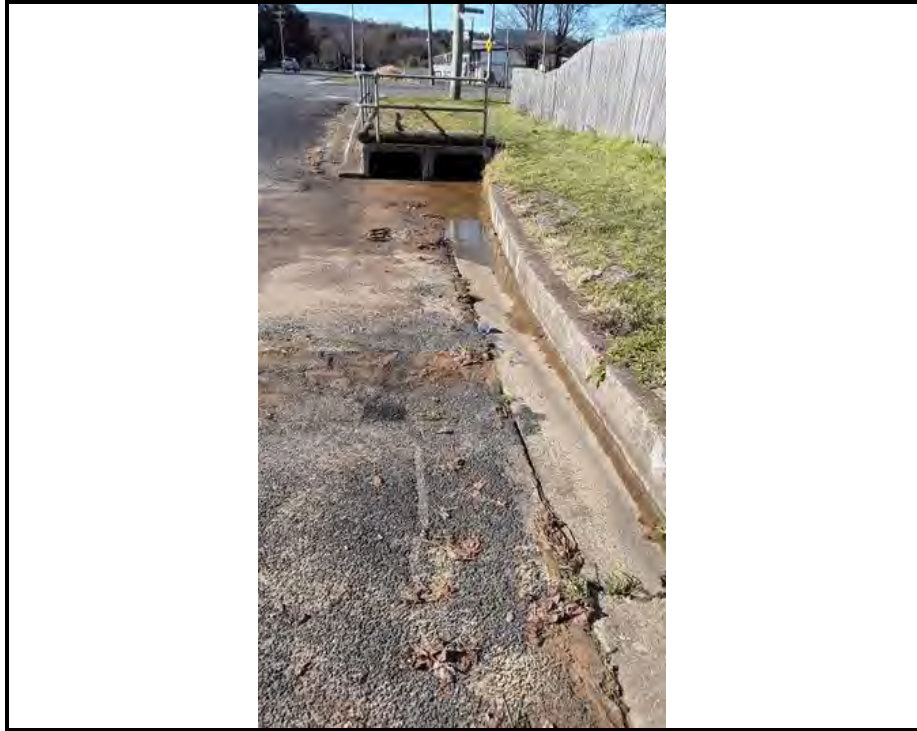
- One open drain and one ephemeral tributary were observed during the site inspection to be leaving/entering the site. The sample of drain sediment analysed during this investigation reported low arsenic, copper, lead and zinc concentrations well below the adopted EILs. The tributary was sampled by Parsons Brinkerhoff in 2011, which reported lead concentrations of 1 µg/L and 2 µg/L. However, the tributary was sampled on the upgradient side of the site. It is considered that there is potential for metals and other CoPCs to be migrating from the site into the drain/tributary and connecting with Mulwaree River, however based on the metals concentrations reported within the offsite study area during this investigation, the potential for this to occur is considered to be low.

Photo 19: Photograph of drain and sediment on the South end of Ottiwell Street, corner of Ottiwell Street and Braidwood Rd.

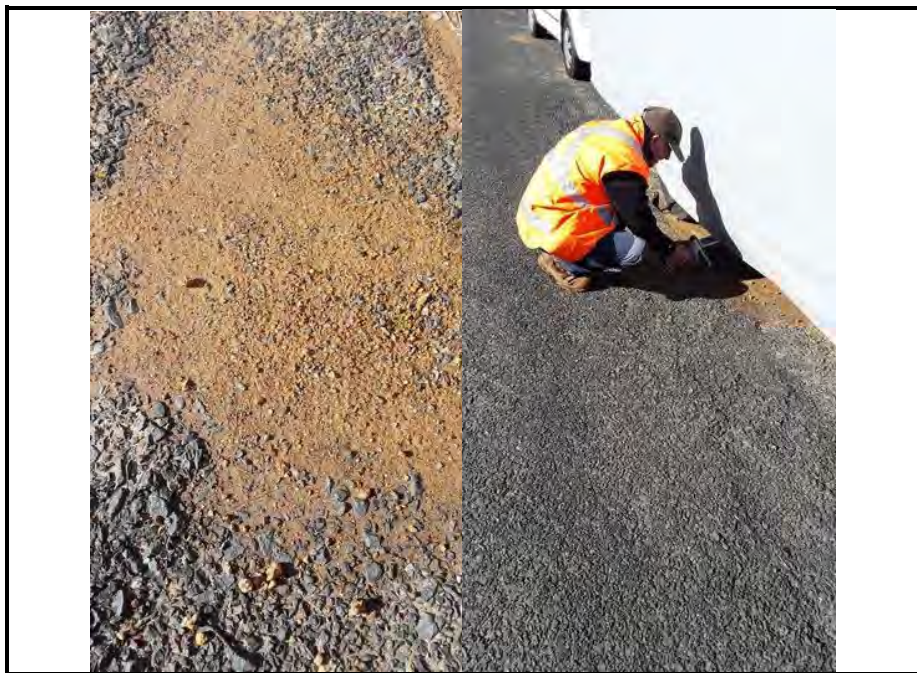
Photo 20: Photograph of the sediment sample DS01 build up on road of Ottiwell St and XRF testing of the sediment

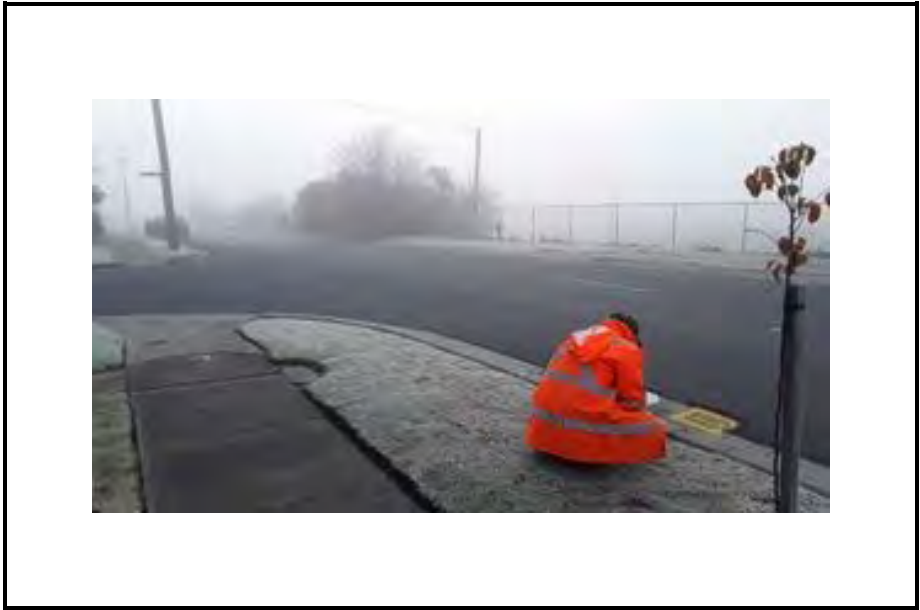
Photo 21: Photograph of XRF sample XS148 on the corner of Lansdowne Street and Sloane Street. Soil described as gravelly silty sand.

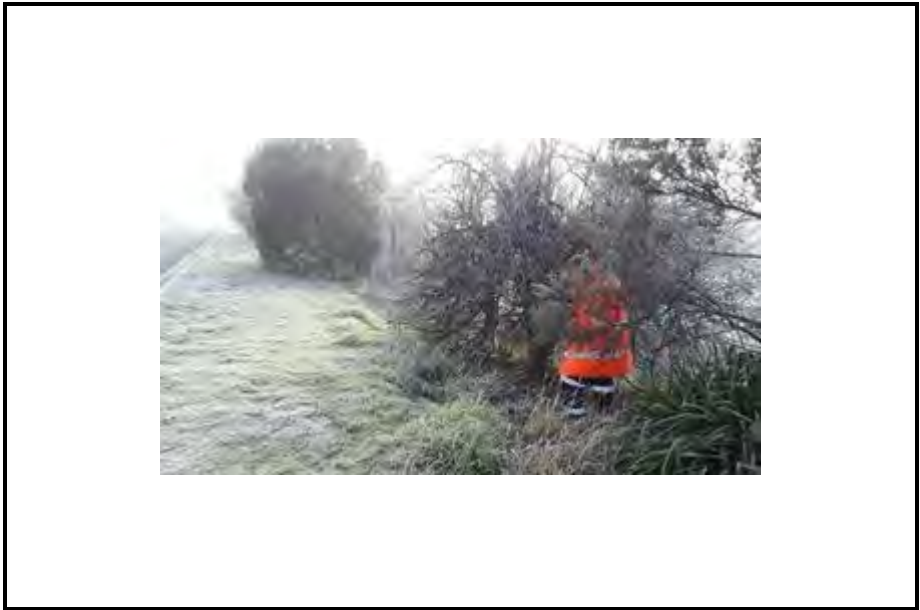
Photo 22: Photograph of sample XS156 on the southern side of Sloane Street against Wheat Yards boundary fence line. Gravel and bare patches of grass observed.

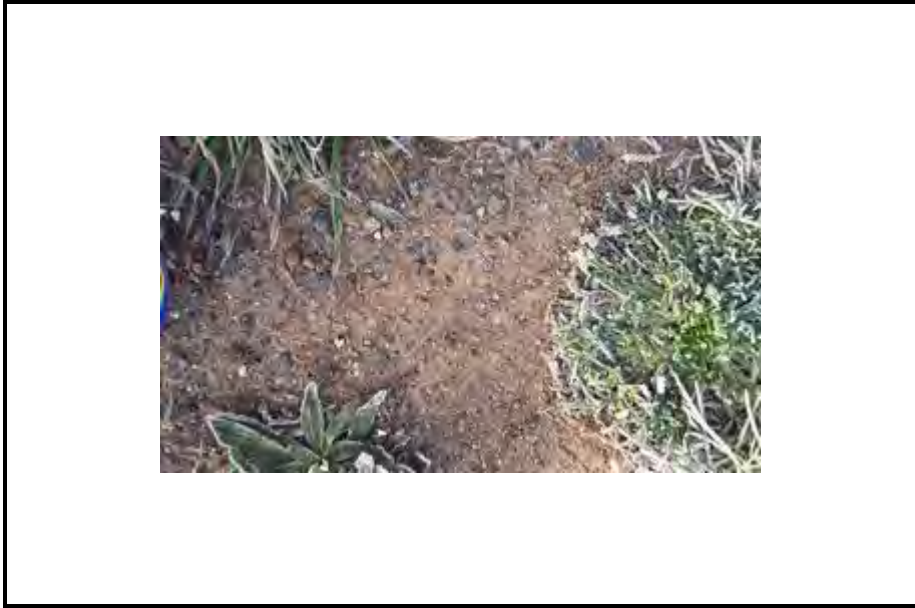
Photo 23: Photograph of soil sample XS158 showing large patch of gravelly silty sand.

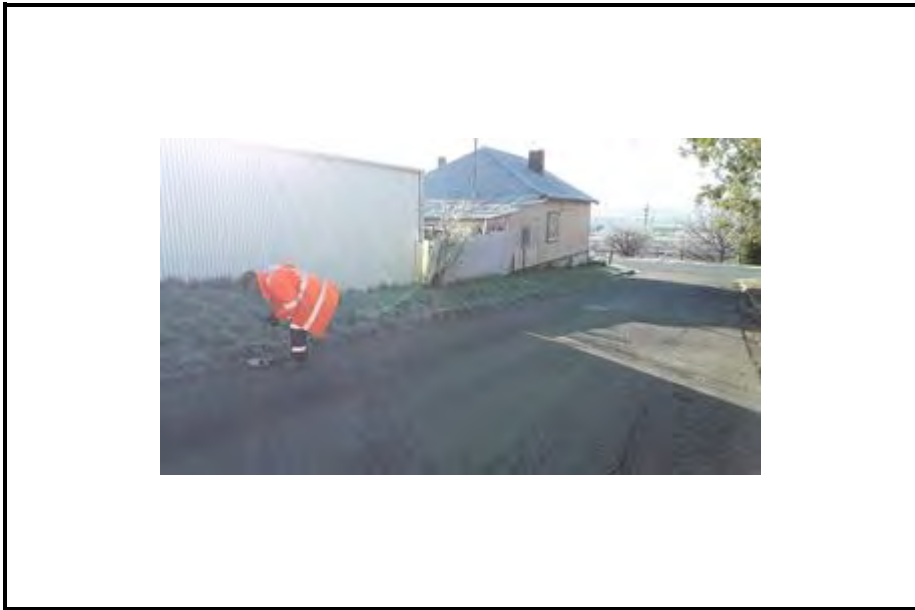
Photo 24: Photograph of XRF sample XS162 on Unnamed Road. This road continued from the boundary line of Wheat Yards. Grass was relatively thick and green.

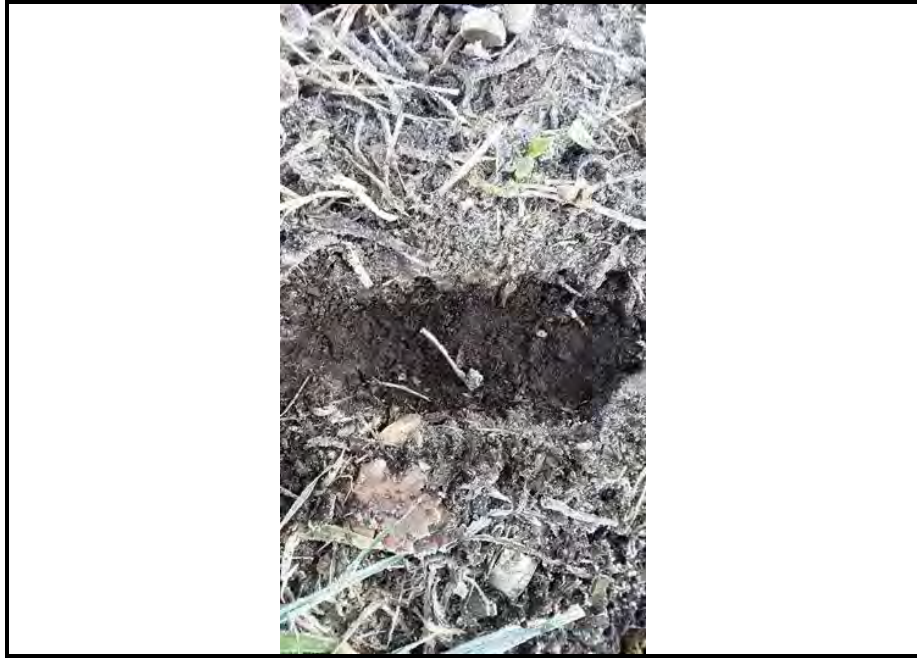
Photo 25: Photograph of soil sample XS163 on unnamed road. Dark brown gravelly silt. Grass appeared to be in good condition.

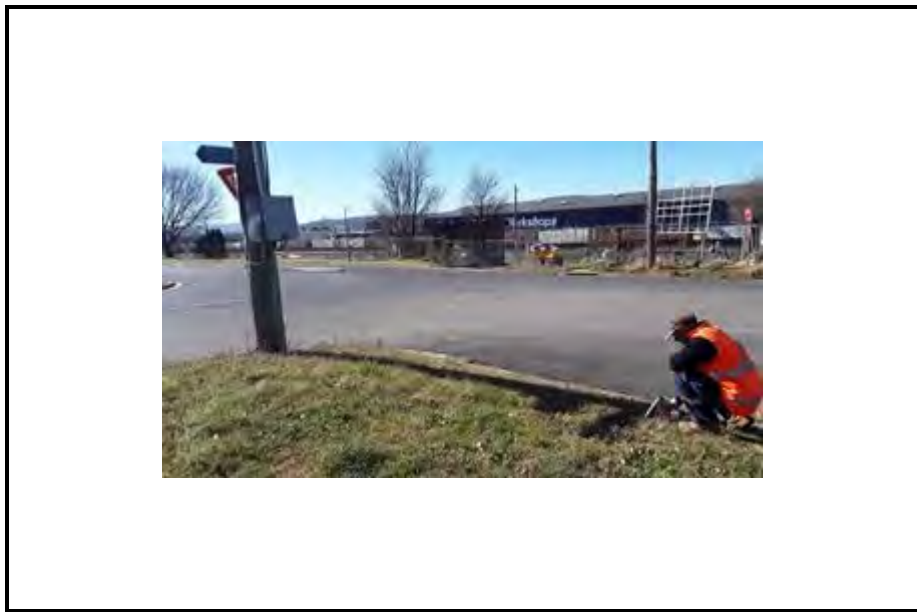
Photo 26: Photograph taken at sample XS200 at the intersection of Finlay Road and Sloane Street. Soil was described as fine, gravelly silt and areas of bare patches of grass were noted. This was the nature strip of a working construction site.

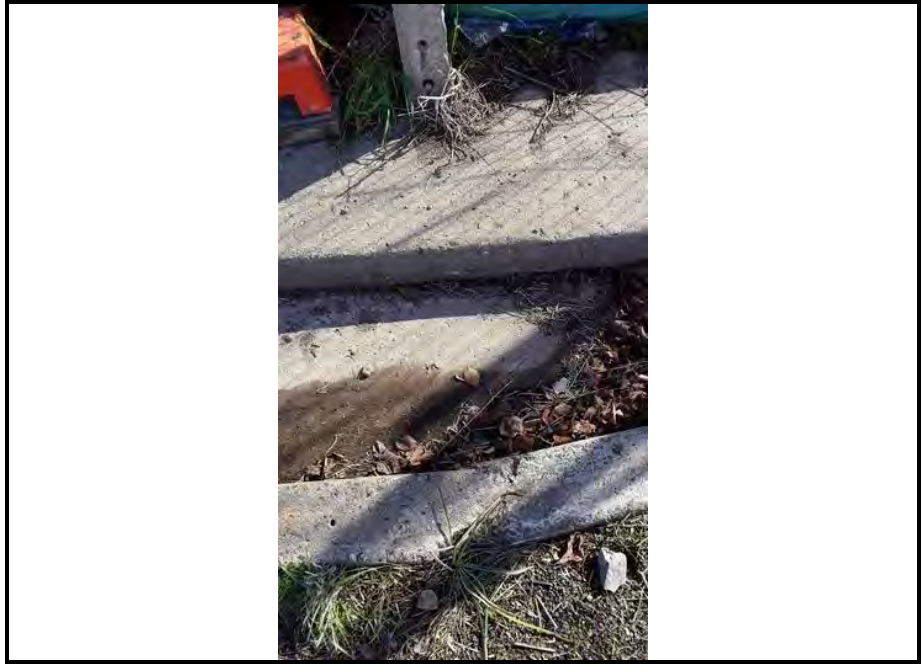
Photo 27: Photograph taken at sample XS211. Sample could not be taken due to asphalt pavement, concrete gutter and a high fence on concrete for construction site.

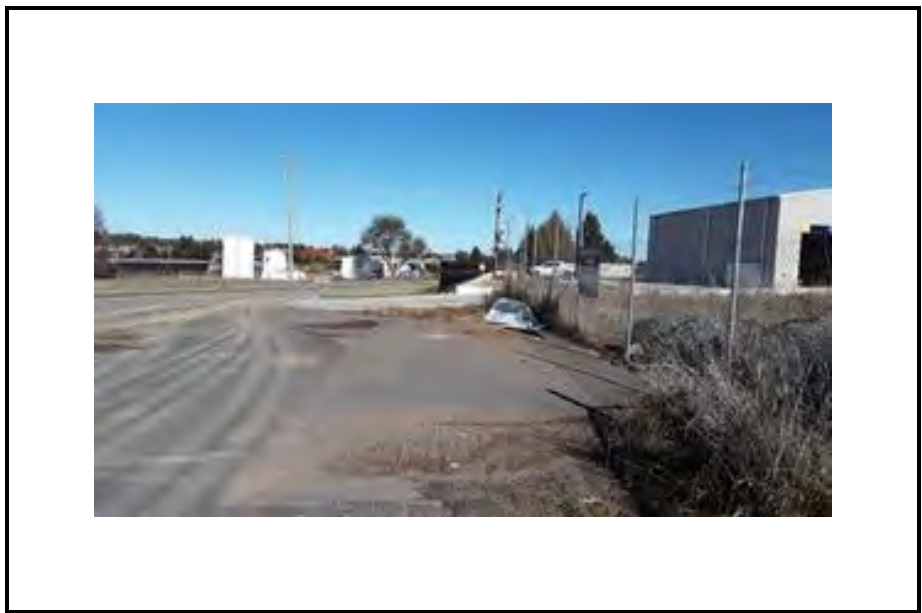
Photo 28: Photograph of heavily concreted area of working construction site at sample location XS211

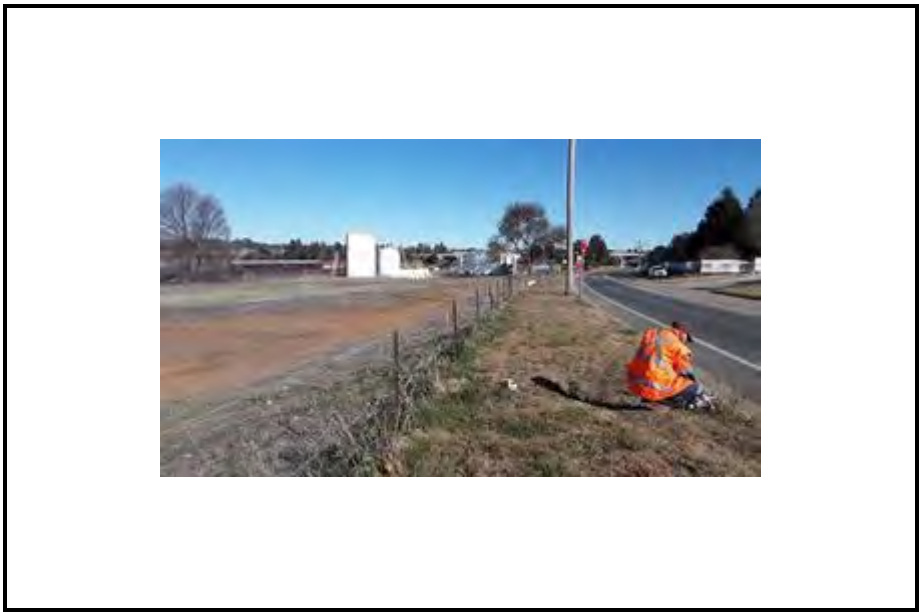
Photo 29: Sample XS225. Photograph taken facing south towards Ampol petrol station and Hume Hwy at the southern boundary of Wheat Yards.

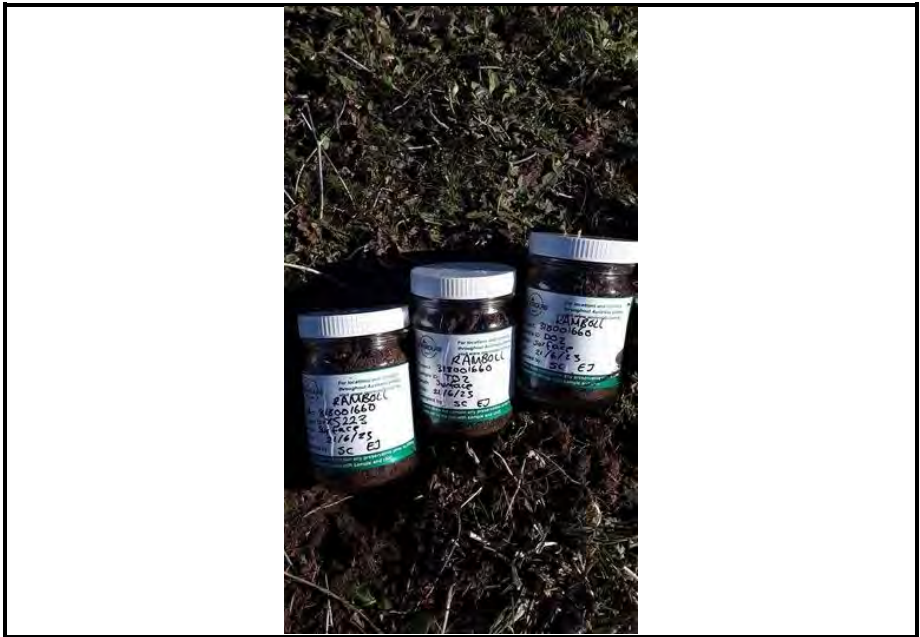
Photo 30: Photograph of soil samples XS223 showing a duplicate and triplicate taken.

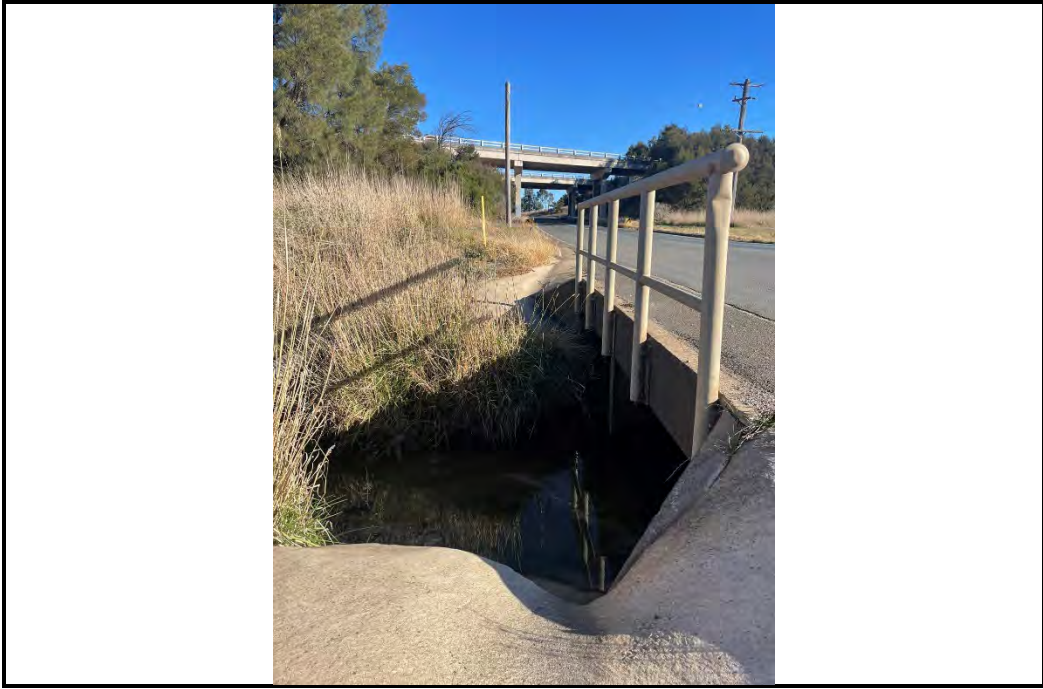
One open drain was observed in the southeast corner of Ottiwell Street (east) and an ephemeral tributary was observed at the southern end of Sloane Street with a culvert under the road (**Figure 4a-4e, Appendix 1**). The open drain is positioned down gradient from the site and likely receives surface water runoff and stormwater from the site. Photographs of the drains and tributary culvert under Sloane Street are shown in **Photos 31 to 34, Appendix 2**. One sample of sediment within the open drain on Ottiwell Street (east) was analysed (DS01). The tributary is located upgradient of the site and flows southeast through the site and connects to Mulwarae River. The tributary was sampled by Parsons Brinkerhoff in 2011 and reported lead concentrations of 1 µg/L and 2 µg/L.

Photo 31: Culvert for ephemeral tributary leading into the Wheat Yards on the southern end of Sloane Street 100m from Hume. Photo is facing South towards Hume Hwy.

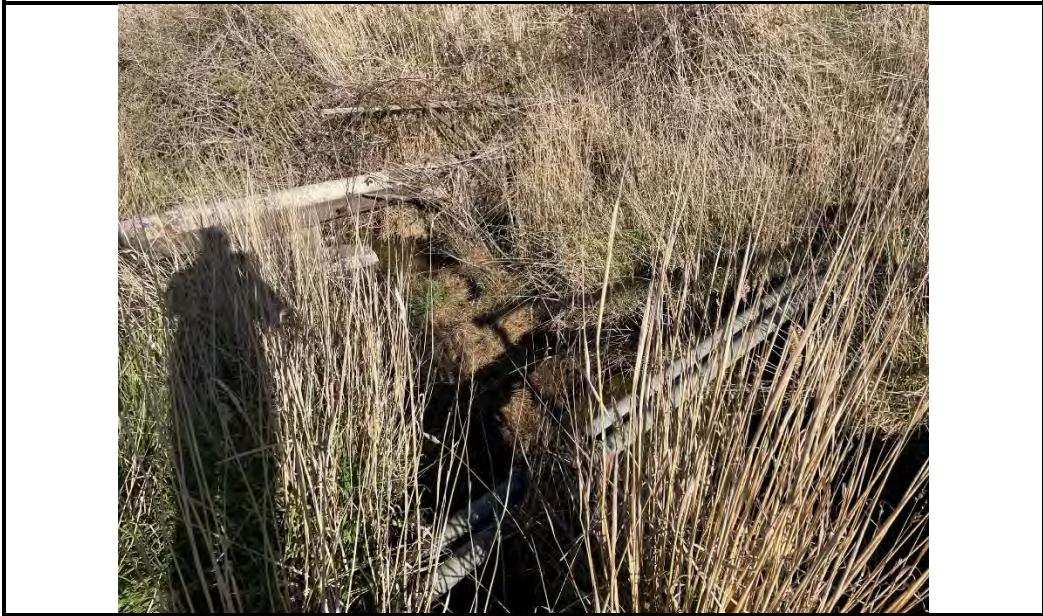
Photo 32: Close up of the ephemeral tributary/drain path towards Wheat Yard on Southern end of Sloane Street 100m from Hume Hwy.

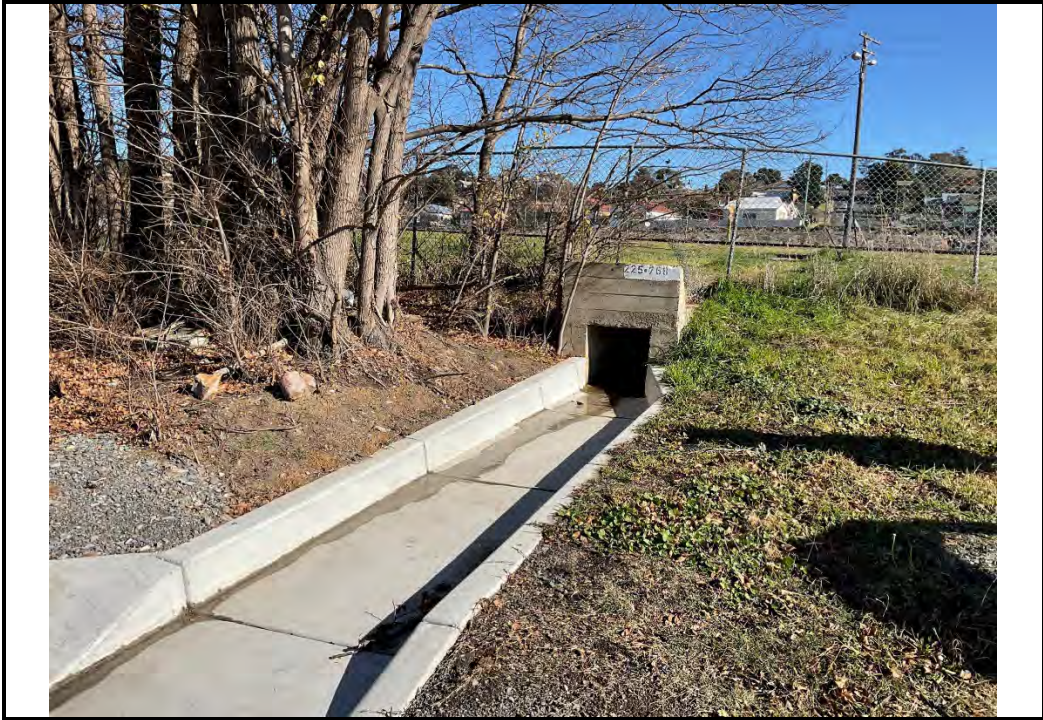
Photo 33: New drain installed on the east end of Ottiwell Street at sample location XS073. Drain appears to run under the train line with no visible starting point, potentially coming from the site.
