Goulburn Wheat Yards Assessment

Offsite Lead Delineation Preliminary Site
Investigation

Project name **Goulburn Wheat Yards Assessment - Offsite Lead Delineation Preliminary Site Investigation**
Project no. **318001660**
Recipient **ARTC**
Document type **Final Report**
Version **1**
Date **7 September 2023**
Prepared by **N. Gilbert**
Checked by **R. Condon / K. Greenfield (CEnvP SC40104)**
Approved by **A. Nolan**
Description **This document presents the results of an environmental assessment to assess the potential offsite risk of lead contamination surrounding the Goulburn Wheat Yards.**

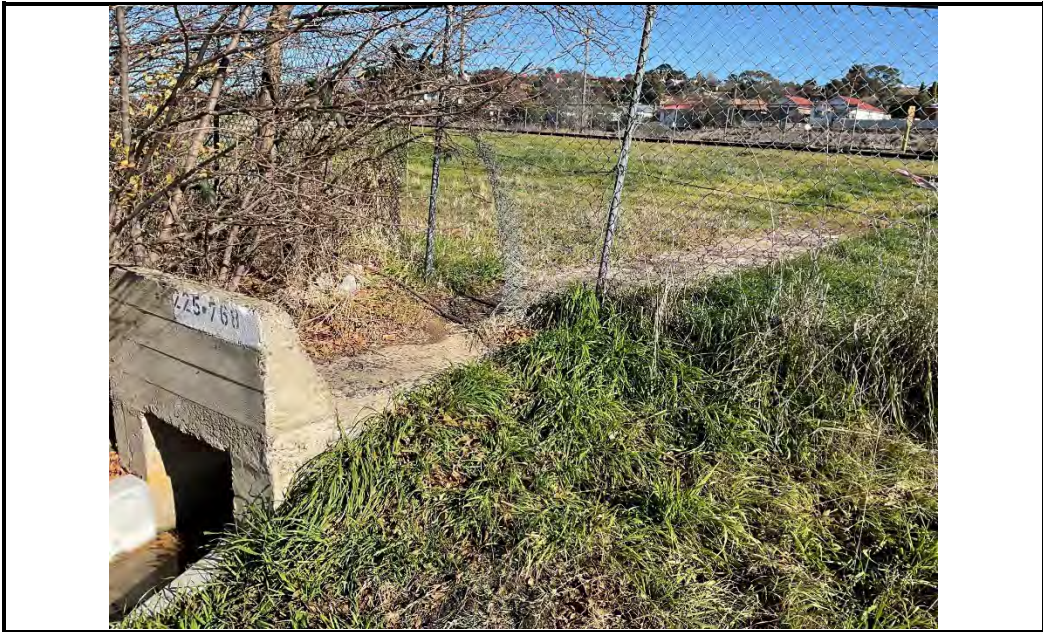
Photo 34: Drain on eastern end of Ottiwell Street on Wheat Yard boundary.

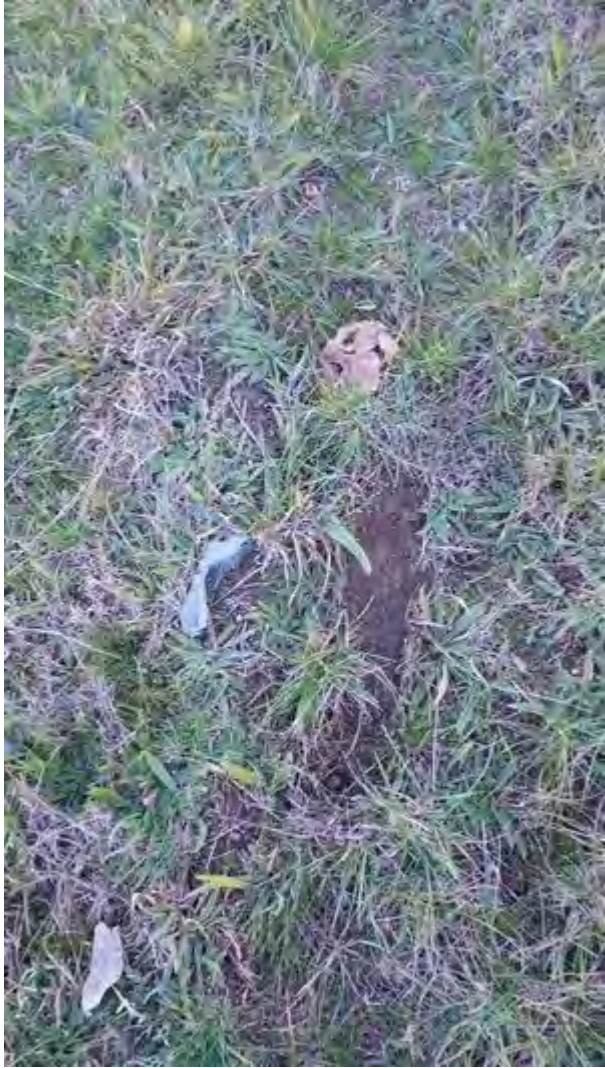
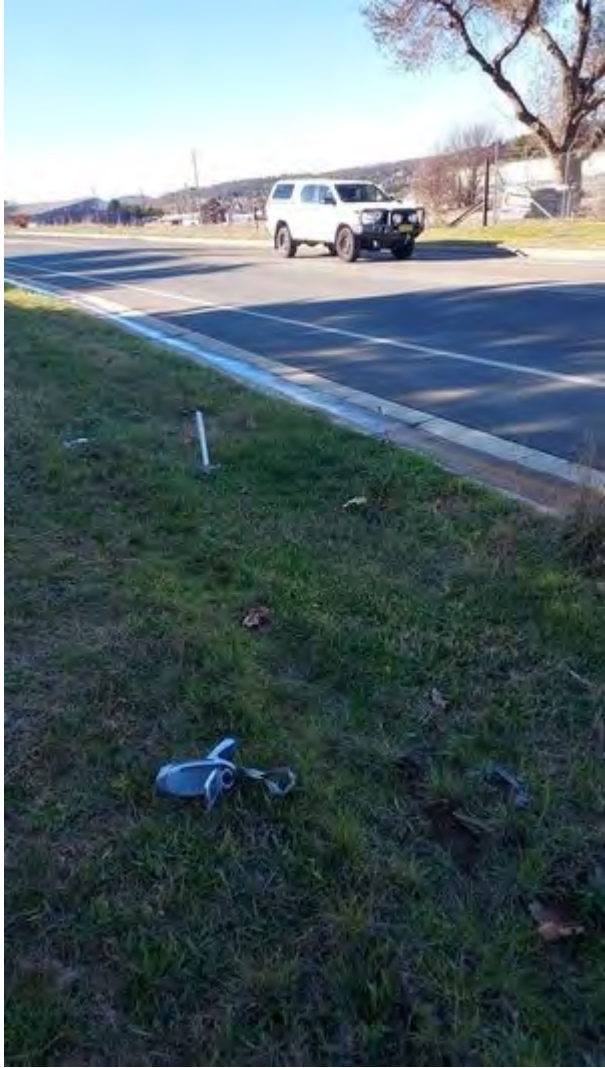
Project no.	318,001,660	Sample ID	XS227
Project name	Goulburn Wheatyards Offsite Lead Delineation	Sample type	XRF
Start time	13:52	End time	
Date	21/06/2023	Operator	Steve Cadman
Sample appearance ND all metals			
Comments Brown silty soil

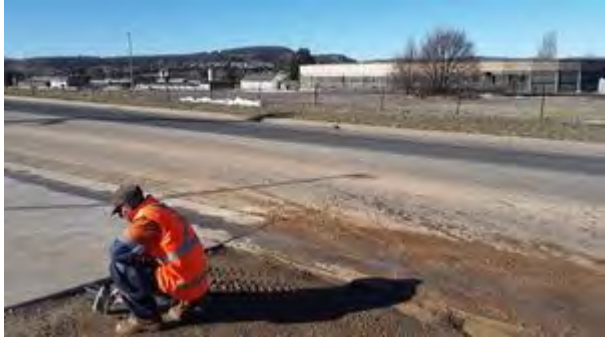
Project no.	318,001,660	Sample ID	XS230
Project name	Goulburn Wheatyard Offsite Lead Delineation	Sample type	XRF
Start time	14:01	End time	14:02
Date	21/06/2023	Operator	Other
Sample appearance Pb 0, Cu 41 , As 0, Zn 22,			
Comments Gravelly sandy fill

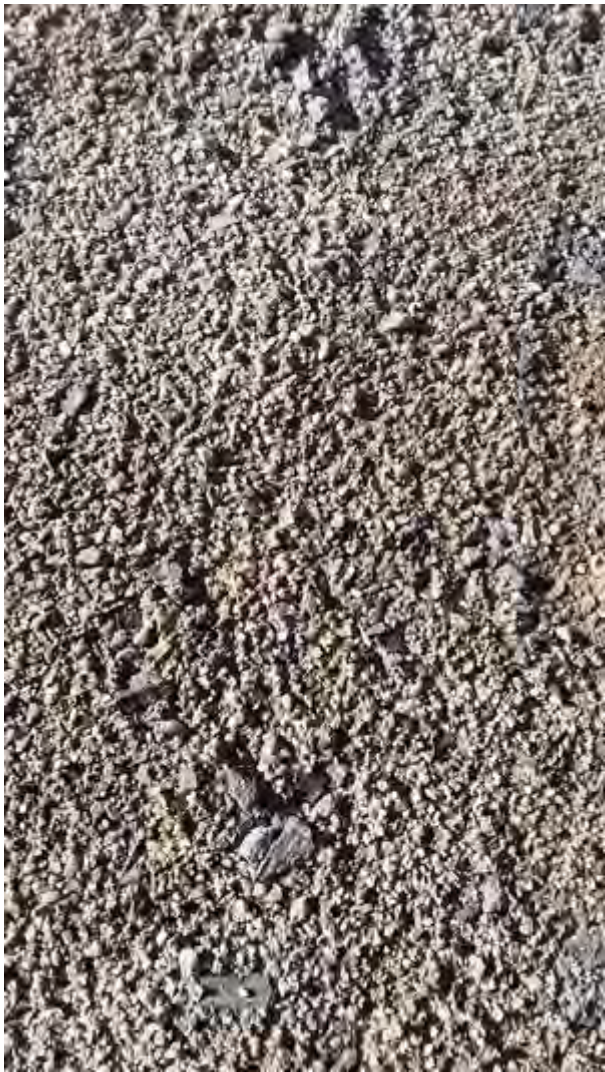
SOIL SAMPLING (XS229)

Project no.	318,001,660	Sample ID	XS229
Project name	Goulburn Wheatyrd Offsite Lead Delineation	Sample type	XRF
Start time	13:58	End time	13:59
Date	21/06/2023	Operator	Other
Sample appearance Pb 0, Cu 56 , As 10, Zn 68,			
Comments Gravelly sandy silt medium gravel

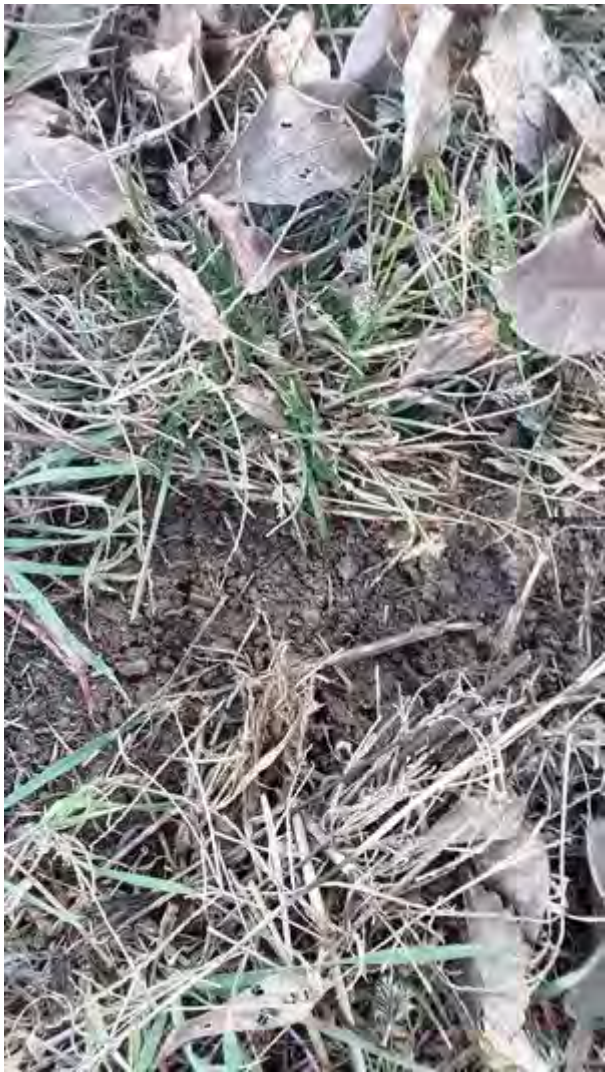
SOIL SAMPLING (XS228)

Project no.	318,001,660	Sample ID	XS228
Project name	Goulburn Wheatyrd Offsite Lead Delineation	Sample type	XRF
Start time	13:57	End time	13:58
Date	21/06/2023	Operator	Other
Sample appearance Pb 0, Cu 0 , As 0, Zn 85,			
Comments Gravelly sandy silt

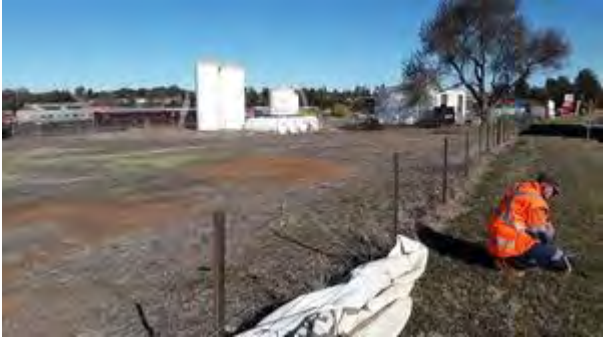
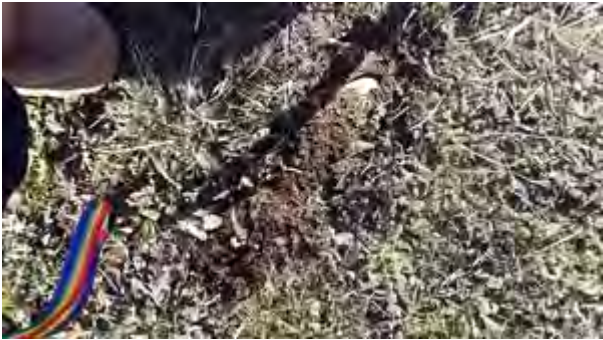
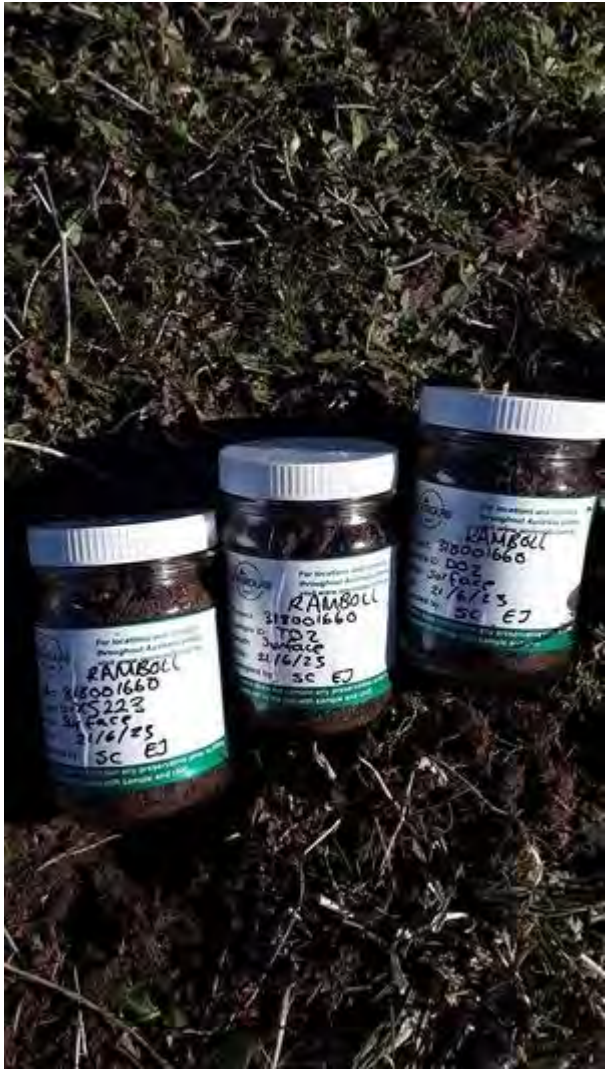
Project no.	318,001,660	Sample ID	XS223
Project name	Goulburn Wheatyrd Offsite Lead Delineation	Sample type	XRF
Start time	13:40	End time	12:41
Date	21/06/2023	Operator	Other
Sample appearance Pb 9, Cu 25 , As 0, Zn 70,			
Comments Gravely sandy silt, sample taken duplicate and triplicate number D02 T02

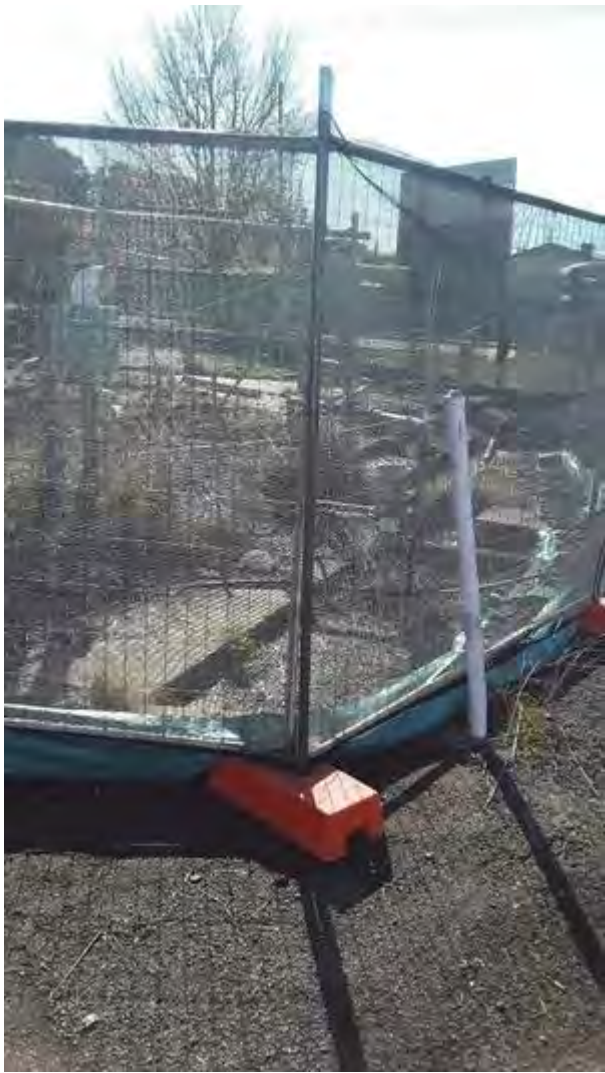
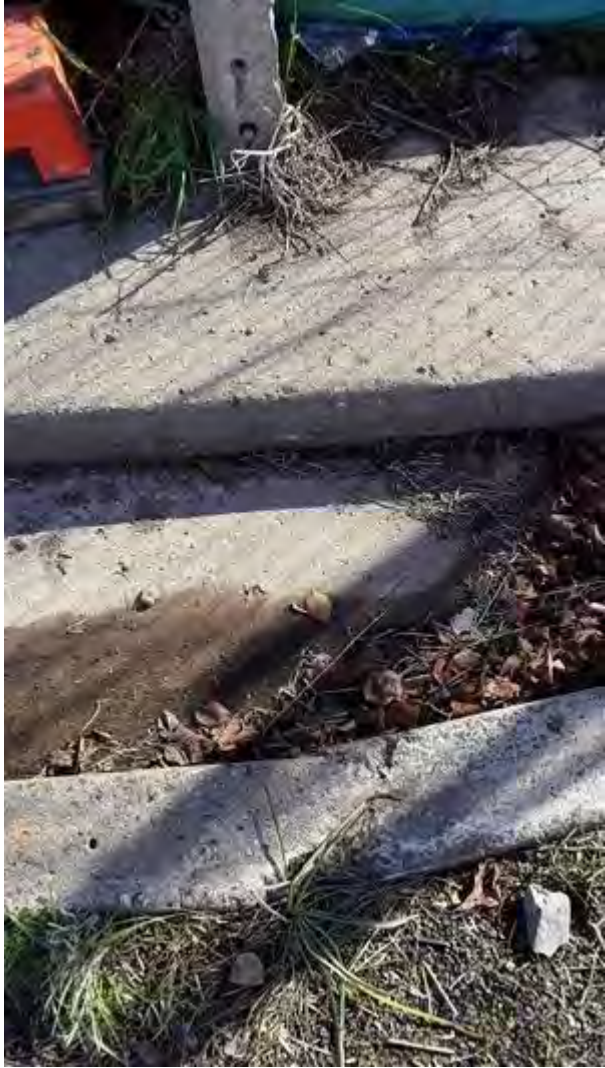
SOIL SAMPLING (XS219)

Project no.	318,001,660	Sample ID	XS219
Project name	Goulburn Wheatyrd Offsite Lead Delineation	Sample type	XRF
Start time	12:36	End time	12:37
Date	21/06/2023	Operator	Other
Sample appearance No sample could be taken			
Comments Sample can not be taken due to ashphalt pavement, concrete gutter and a high fence on concrete

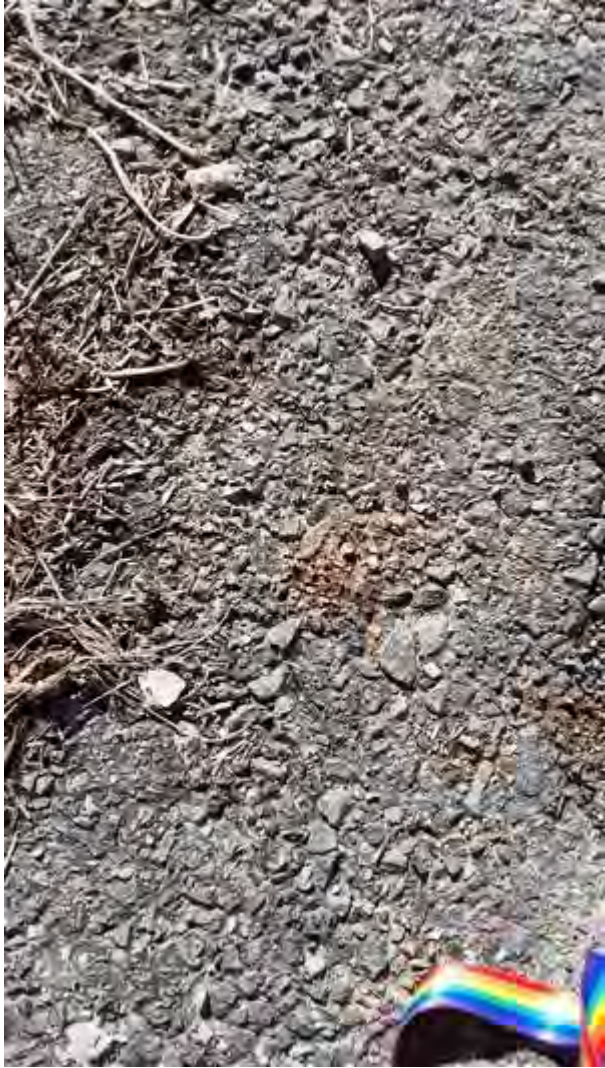
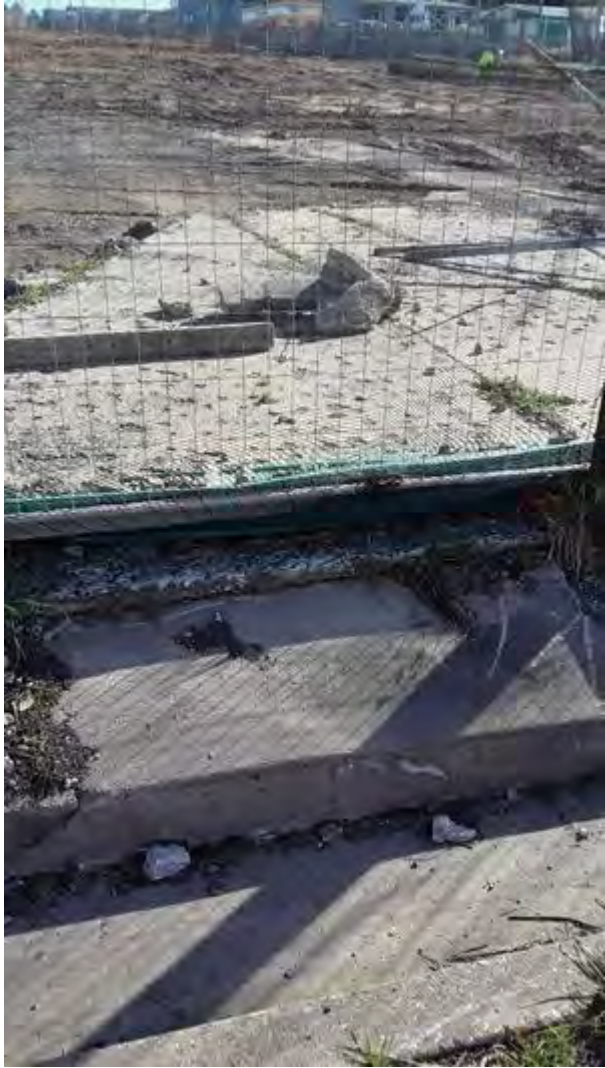
SOIL SAMPLING (XS218)

Project no.	318,001,660	Sample ID	XS218
Project name	Goulburn Wheatyrd Offsite Lead Delineation	Sample type	XRF
Start time	12:35	End time	12:36
Date	21/06/2023	Operator	Other
Sample appearance No sample could be taken			
Comments Sample can not be taken due to ashphalt pavement, concrete gutter and a high fence on concrete

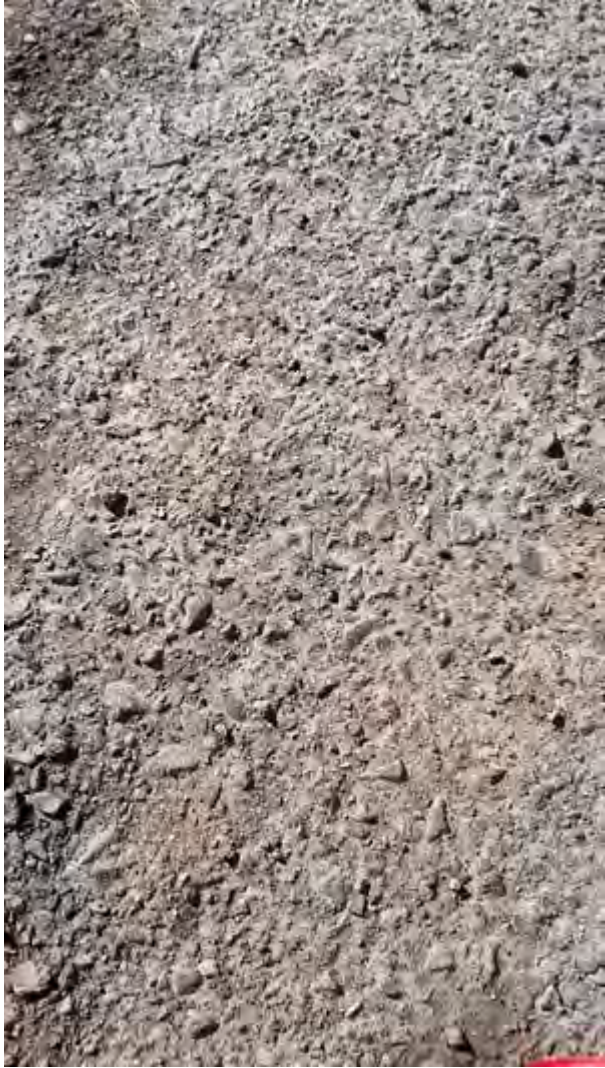
SOIL SAMPLING (XS217)

Project no.	318,001,660	Sample ID	XS217
Project name	Goulburn Wheatyard Offsite Lead Delineation	Sample type	XRF
Start time	12:33	End time	12:33
Date	21/06/2023	Operator	Other
Sample appearance No sample could be taken			
Comments Sample can not be taken due to asphalt pavement, concrete gutter and a high fence on concrete

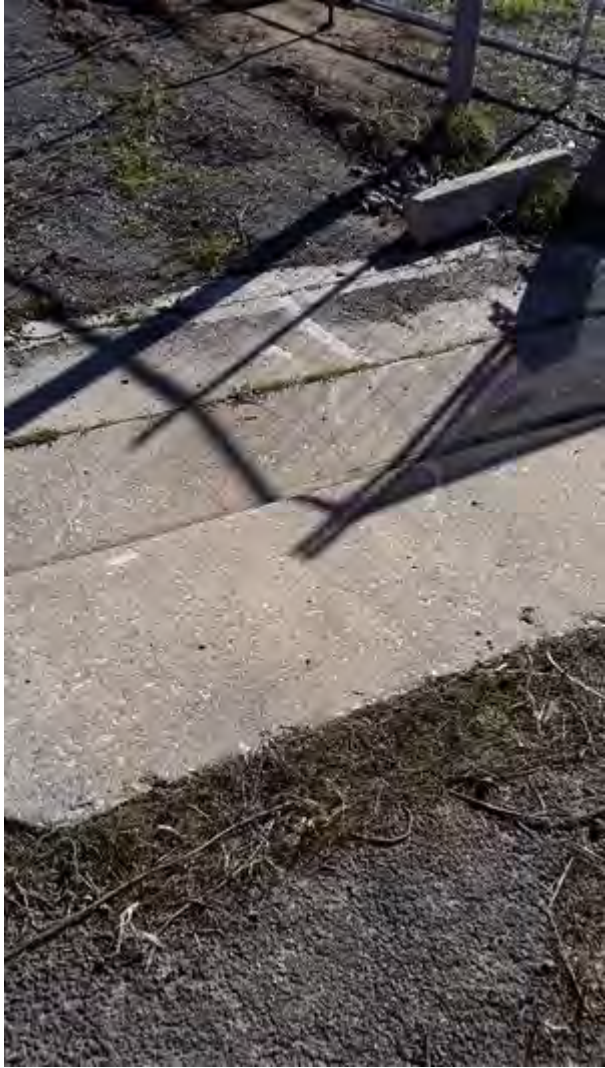
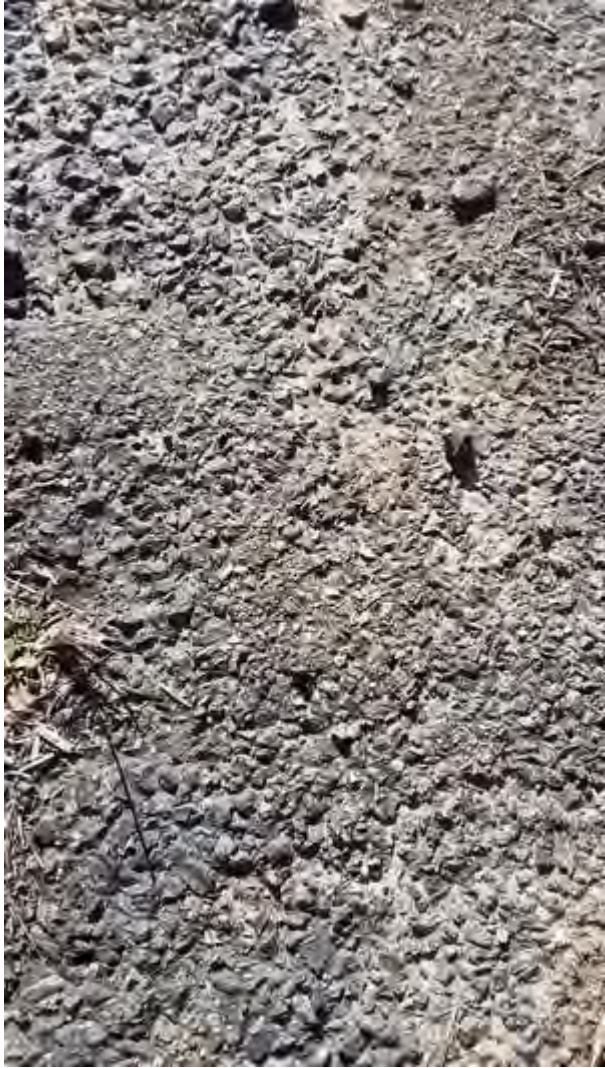
SOIL SAMPLING (XS216)

Project no.	318,001,660	Sample ID	XS216
Project name	Goulburn Wheatyrd Offsite Lead Delineation	Sample type	XRF
Start time	12:33	End time	12:33
Date	21/06/2023	Operator	Other
Sample appearance No sample could be taken			
Comments Sample can not be taken due to ashphalt pavement, concrete gutter and a high fence on concrete

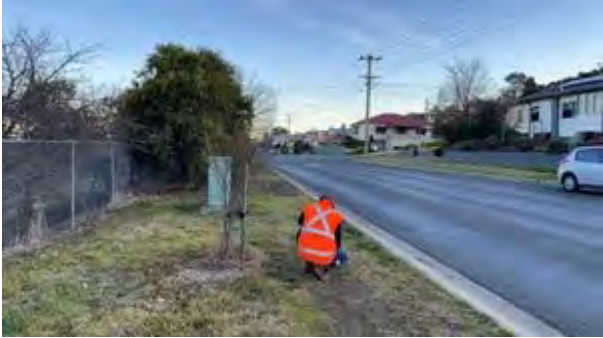
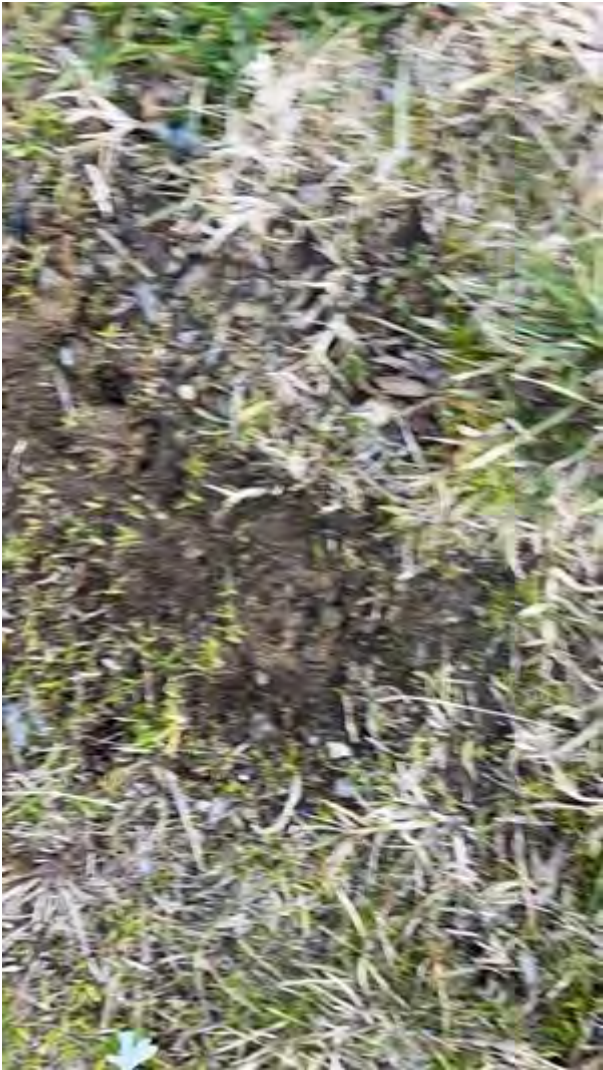
SOIL SAMPLING (XS142)

Project no.	318,001,660	Sample ID	XS142
Project name	Goulburn wheatyards offsite lead deliniation	Sample type	Hand auger
Start time	16:36	End time	16:37
Date	20/06/2023	Operator	Other
Sample appearance gravely silty sand			
Comments Pb 0, Cu 0, Zn 0, As 0

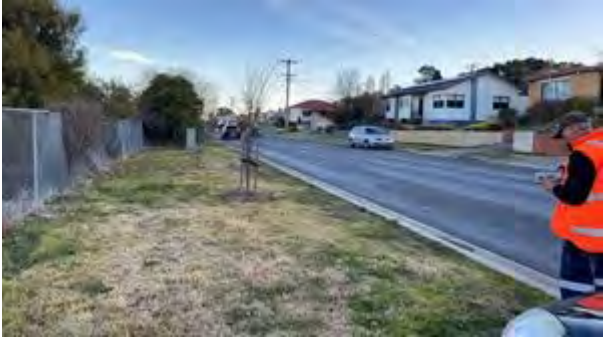
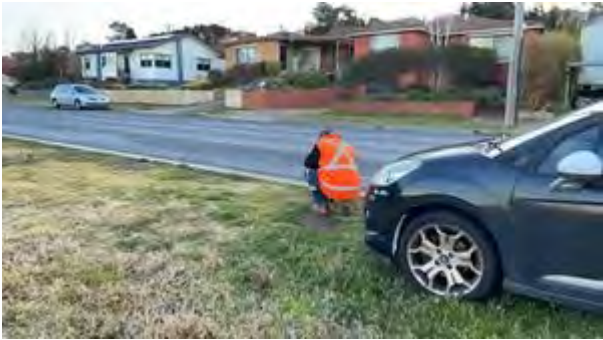
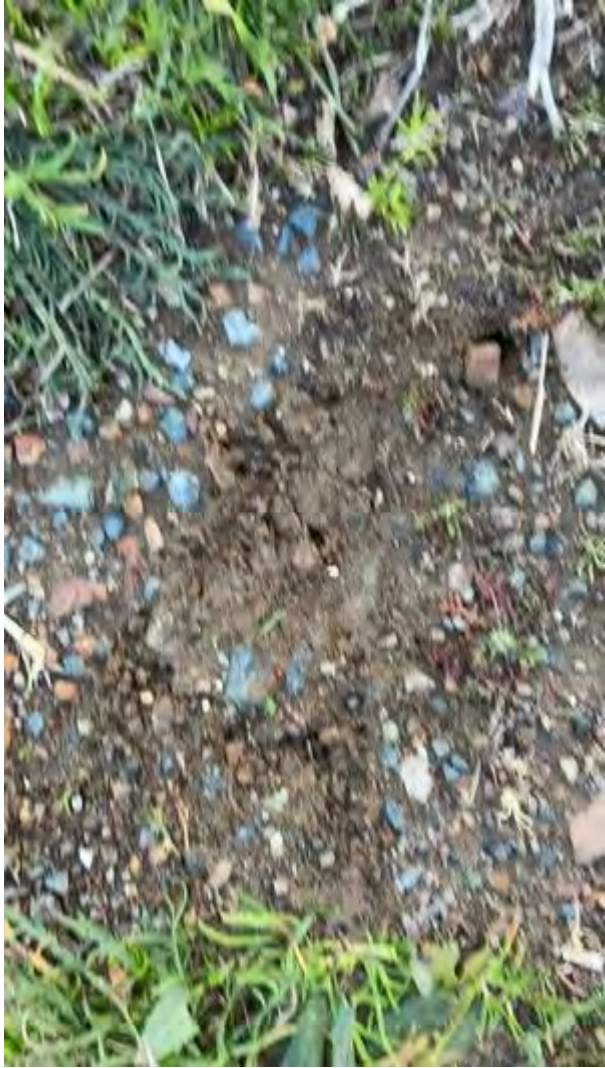
SOIL SAMPLING (XS141)

Project no.	318,001,660	Sample ID	XS141
Project name	Goulburn wheatyards offsite lead deliniation	Sample type	Hand auger
Start time	16:34	End time	16:35
Date	20/06/2023	Operator	Other
Sample appearance gravely silty sand			
Comments Pb 0, Cu 0, Zn 0, As 0

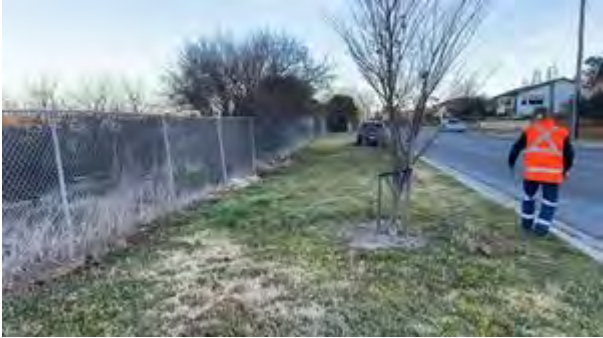
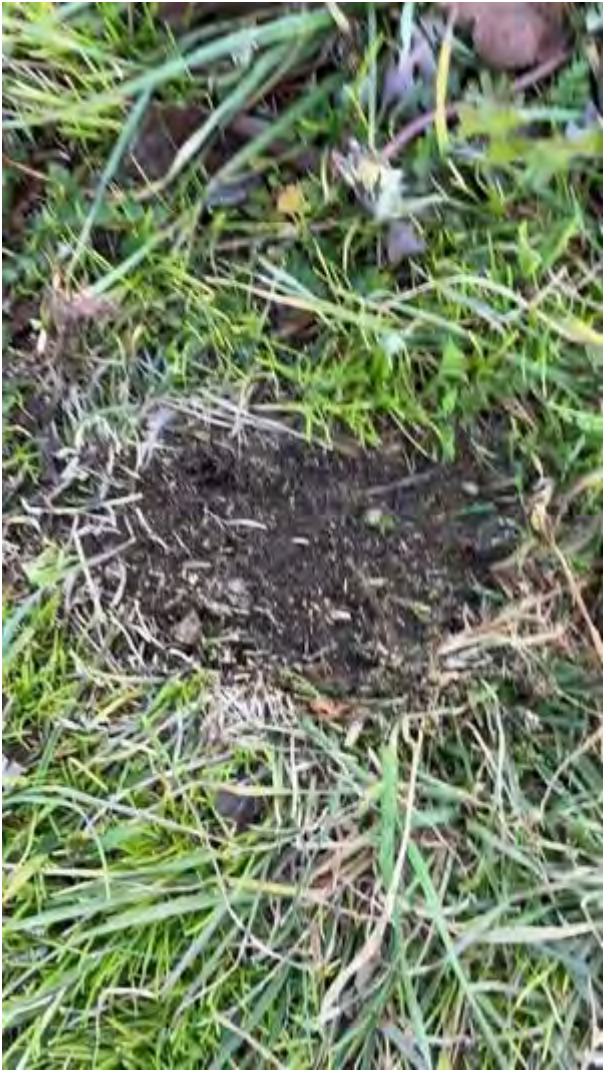
SOIL SAMPLING (XS140)

Project no.	318,001,660	Sample ID	XS140
Project name	Goulburn wheatyards offsite lead deliniation	Sample type	Hand auger
Start time	16:20	End time	16:22
Date	20/06/2023	Operator	Other
Sample appearance gravely silty sand medium sized light brown sample taken			
Comments Pb 18, Cu 7, Zn 132, As 0

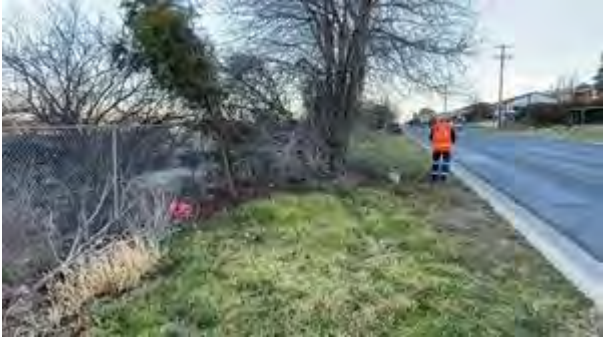
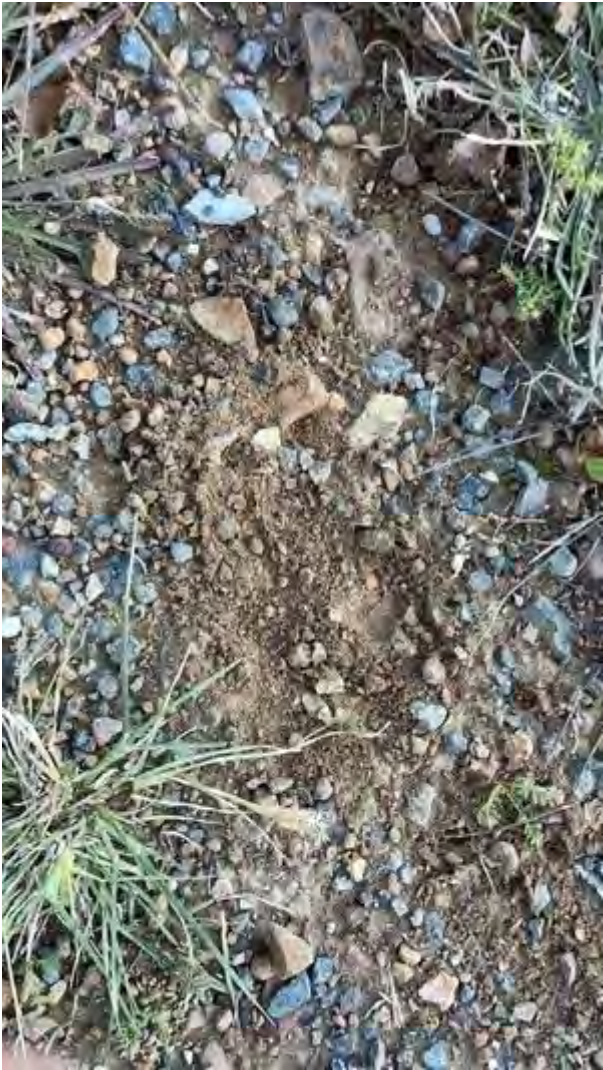
SOIL SAMPLING (XS139)

Project no.	318,001,660	Sample ID	XS139
Project name	Goulburn wheatyards offsite lead deliniation	Sample type	Hand auger
Start time	16:18	End time	16:19
Date	20/06/2023	Operator	Other
Sample appearance gravely silty sand medium sized light brown			
Comments Pb 0, Cu 0, Zn 0, As 0

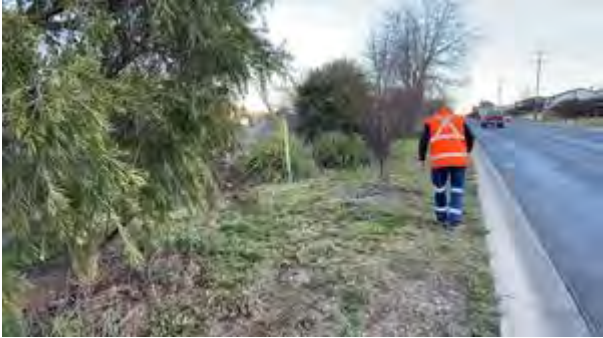
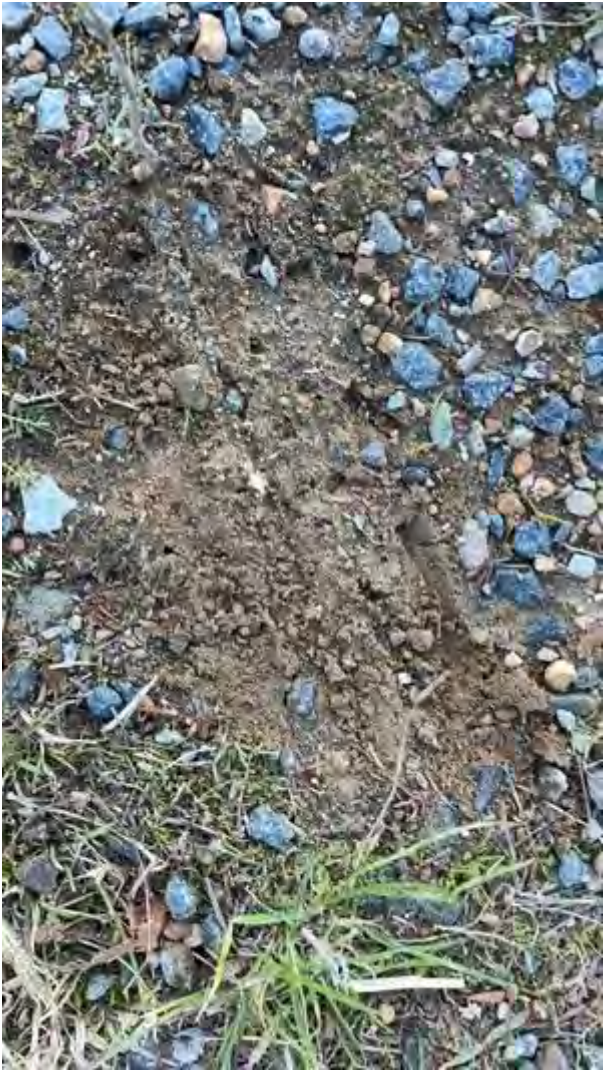
SOIL SAMPLING (XS138)

Project no.	318,001,660	Sample ID	XS138
Project name	Goulburn wheatyards offsite lead deliniation	Sample type	Hand auger
Start time	16:15	End time	16:16
Date	20/06/2023	Operator	Other
Sample appearance gravely silty sand medium sized gravel			
Comments Pb 0, Cu 0, Zn 0, As 0

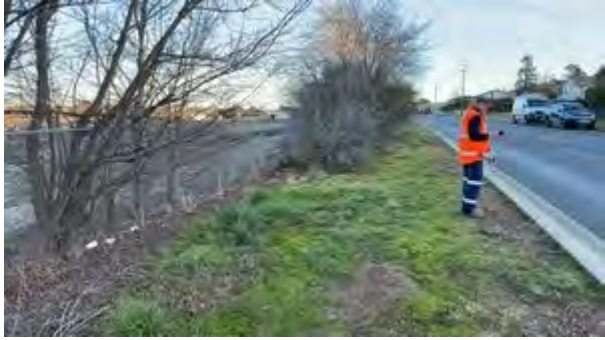
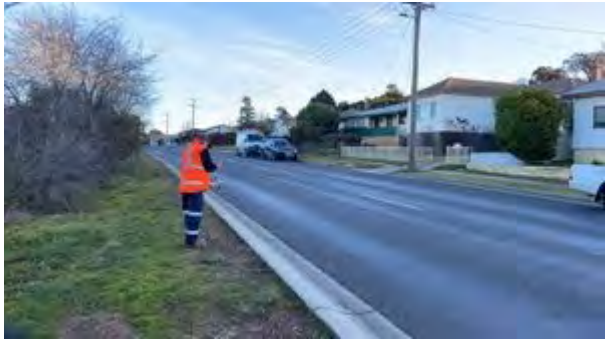
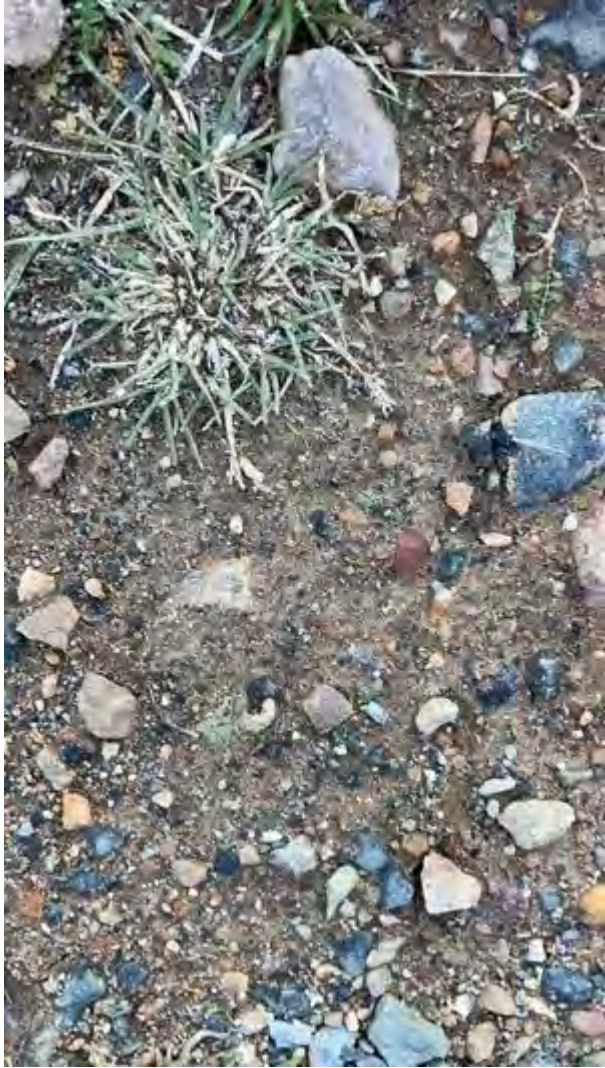
SOIL SAMPLING (XS137)

Project no.	318,001,660	Sample ID	XS137
Project name	Goulburn wheatyards offsite lead deliniation	Sample type	Hand auger
Start time	16:13	End time	16:14
Date	20/06/2023	Operator	Other
Sample appearance gravely silty sand medium sized gravel			
Comments Pb 28, Cu 0, Zn 53, As 0

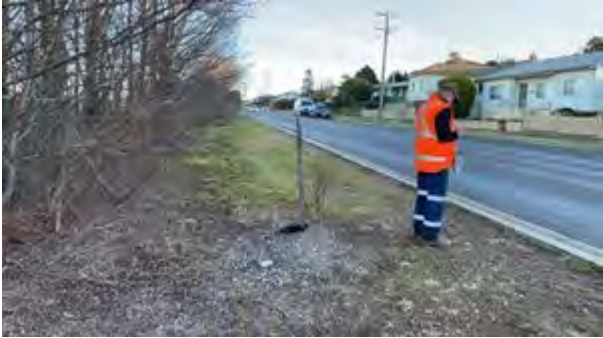
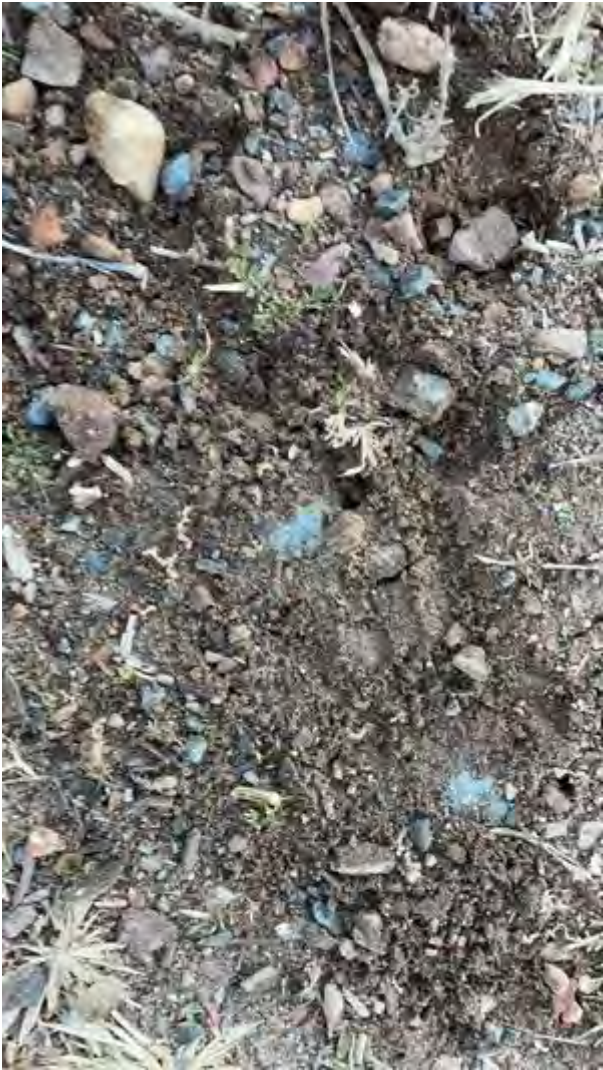
SOIL SAMPLING (XS136)

Project no.	318,001,660	Sample ID	XS136
Project name	Goulburn wheatyards offsite lead deliniation	Sample type	Hand auger
Start time	16:11	End time	16:12
Date	20/06/2023	Operator	Other
Sample appearance gravely silty sand medium sized gravel			
Comments Pb 0, Cu 0, Zn 30, As 0

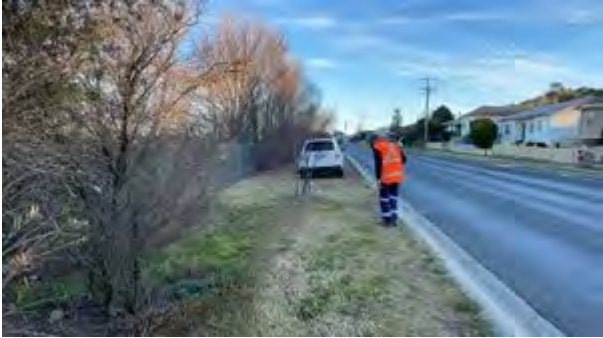
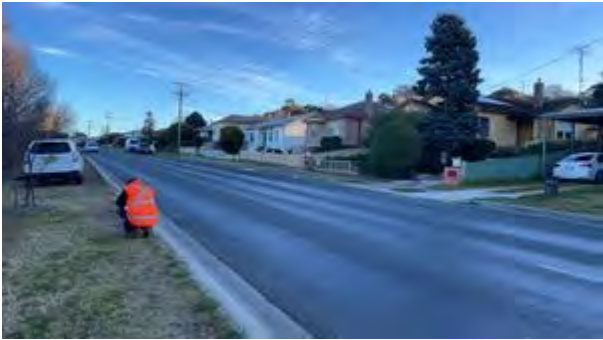
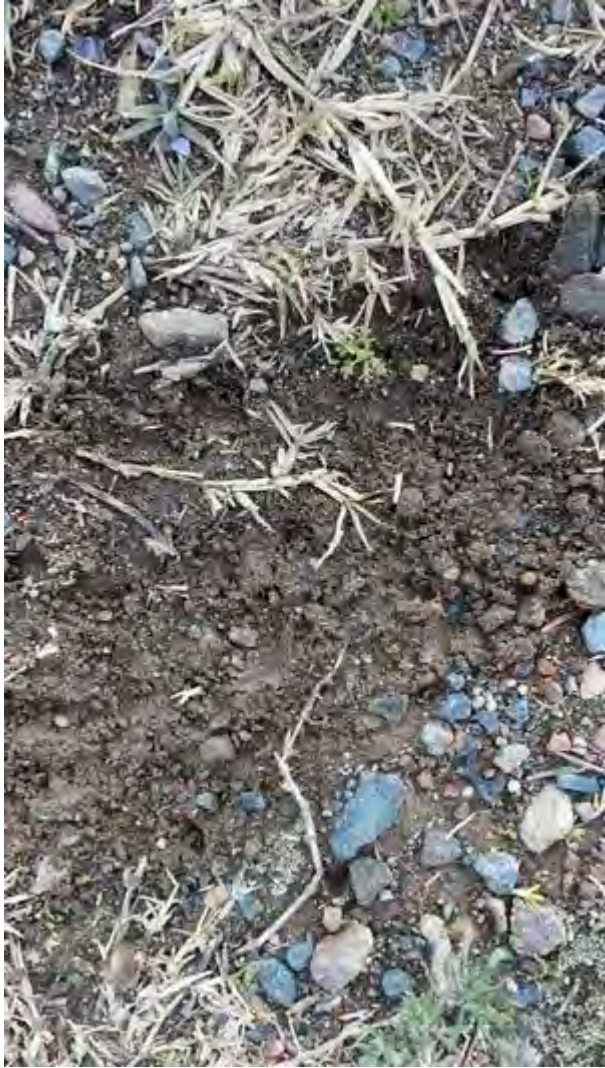
SOIL SAMPLING (XS135)

Project no.	318,001,660	Sample ID	XS135
Project name	Goulburn wheatyards offsite lead deliniation	Sample type	Hand auger
Start time	16:09	End time	16:10
Date	20/06/2023	Operator	Other
Sample appearance gravely silty sand			
Comments Pb 13, Cu 0, Zn 73, As 0

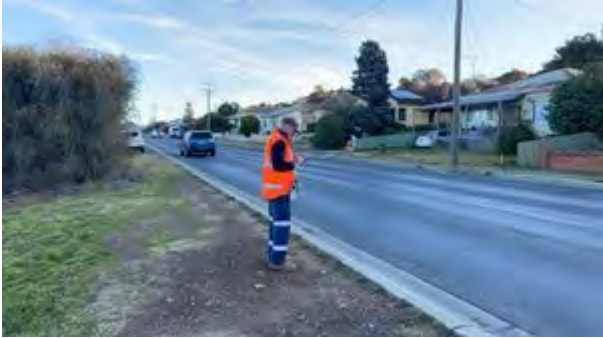
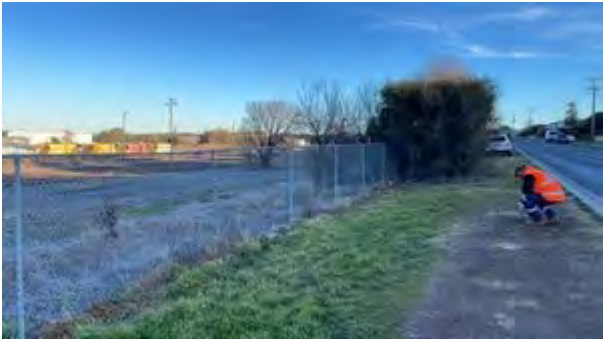
SOIL SAMPLING (XS134)

Project no.	318,001,660	Sample ID	XS134
Project name	Goulburn wheatyards offsite lead deliniation	Sample type	Hand auger
Start time	16:07	End time	16:08
Date	20/06/2023	Operator	Other
Sample appearance gravely silty sand medium gravel			
Comments Pb 0, Cu 0, Zn 0, As 0

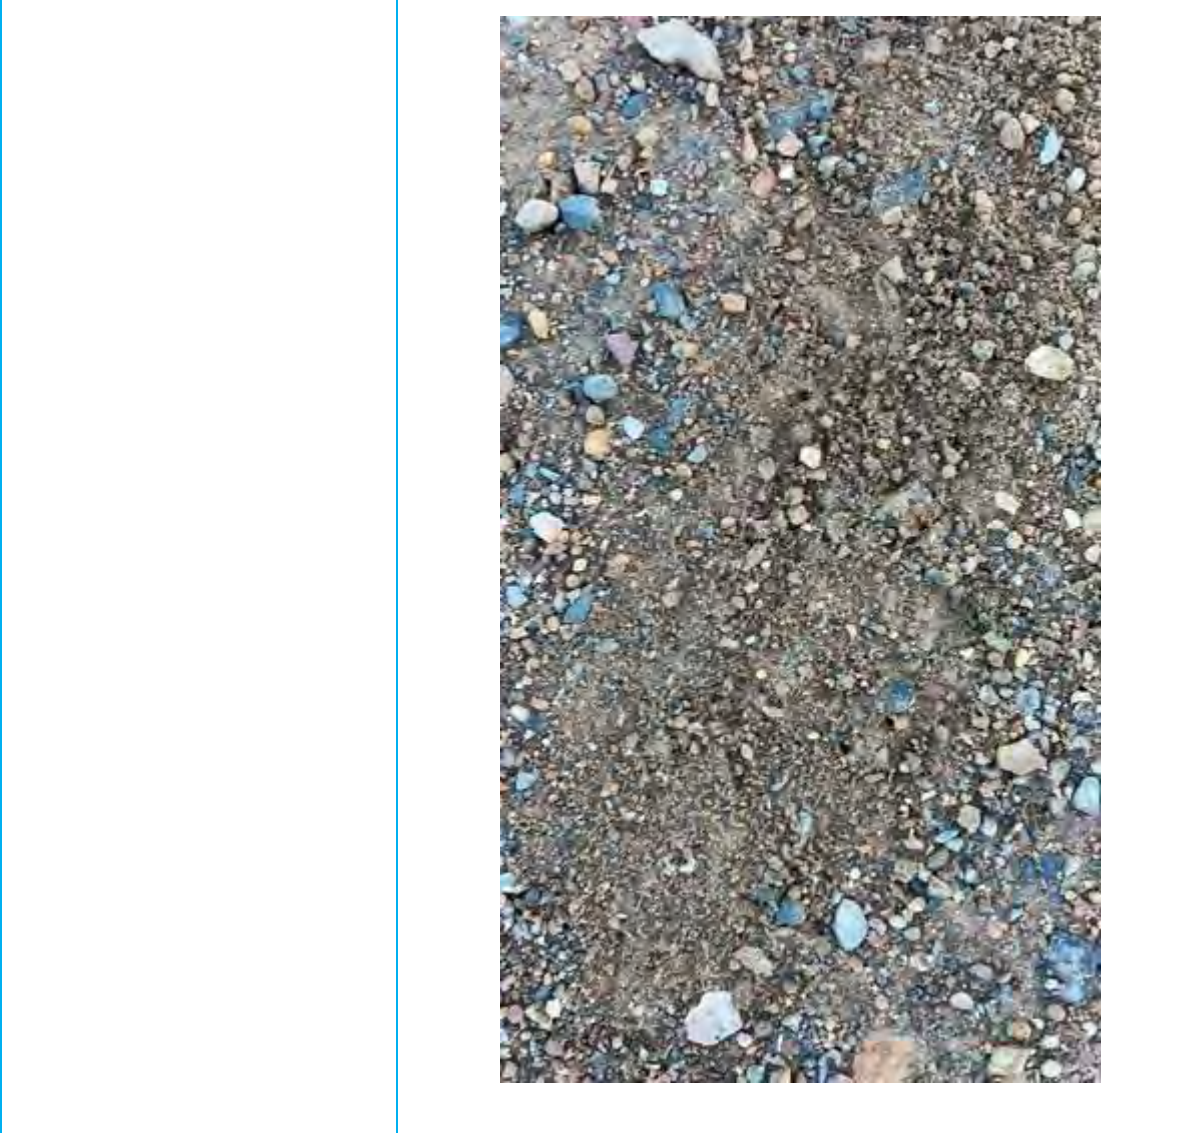
SOIL SAMPLING (XS133)

Project no.	318,001,660	Sample ID	XS133
Project name	Goulburn wheatyards offsite lead deliniation	Sample type	XRF
Start time	16:04	End time	16:05
Date	20/06/2023	Operator	Other
Sample appearance gravely silty sand			
Comments Pb 26, Cu 0, Zn 50, As 0

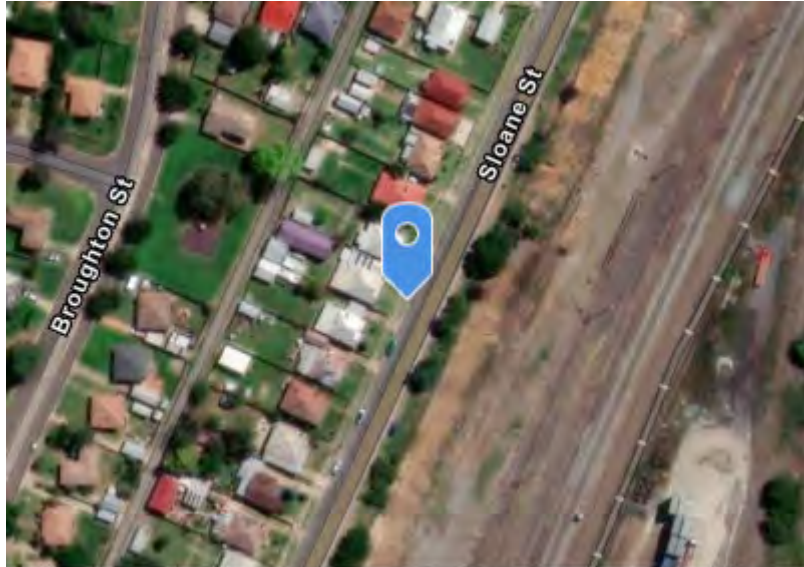
SOIL SAMPLING (XS131)

Project no.	318,001,660	Sample ID	XS131
Project name	Goulburn wheatyards offsite lead deliniation	Sample type	XRF
Start time	16:00	End time	16:01
Date	20/06/2023	Operator	Other
Sample appearance Fine gravely silty sand			
Comments Pb 16, Cu 0, Zn 25, As 0

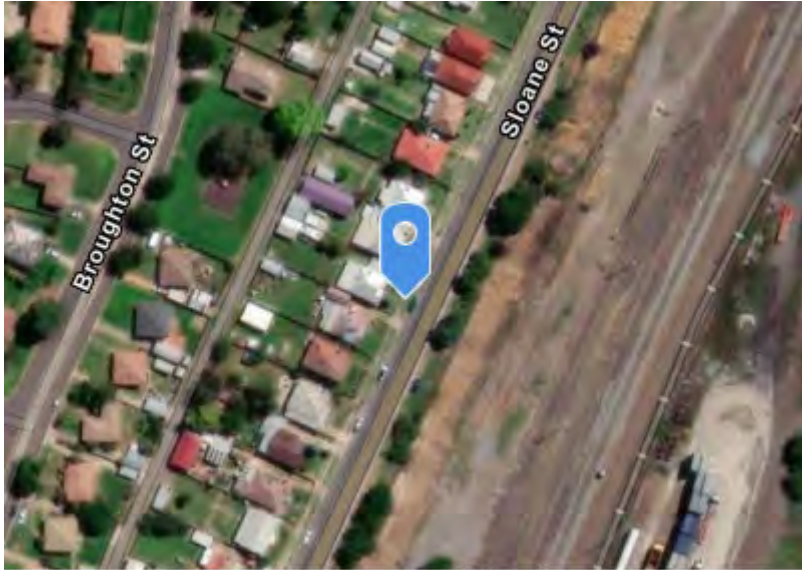
SOIL SAMPLING (XS130)

Project no.	318,001,660	Sample ID	XS130
Project name	Goulburn wheatyards offsite lead deliniation	Sample type	XRF
Start time	15:49	End time	15:50
Date	20/06/2023	Operator	Other
Sample appearance Fine gravely silty sand sample taken			
Comments Pb 20, Cu 23, Zn 233, As 0

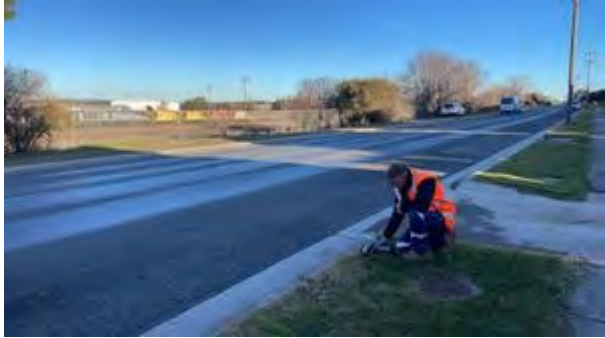
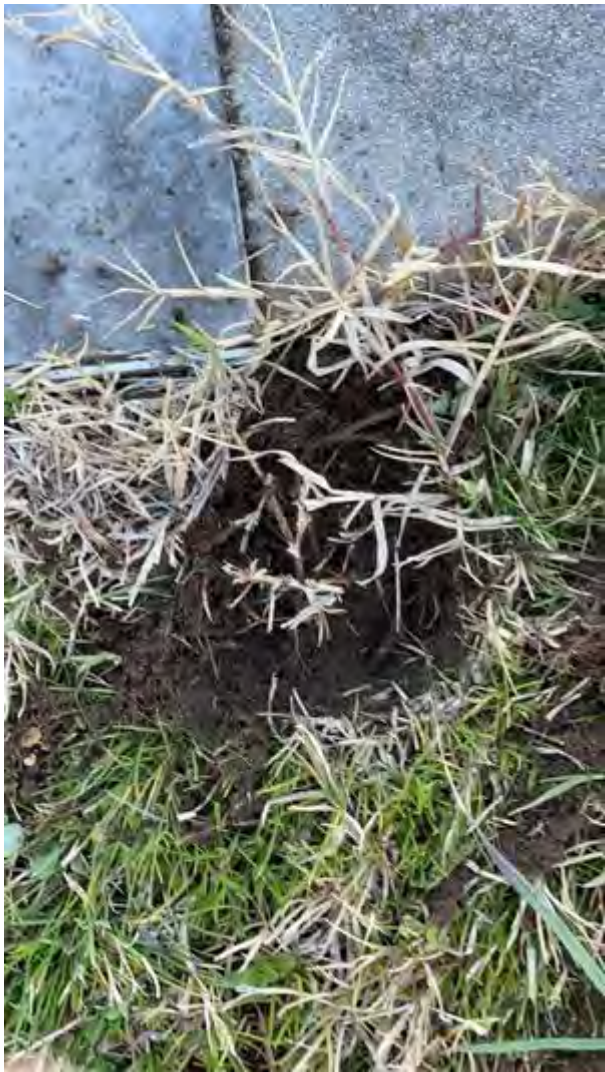
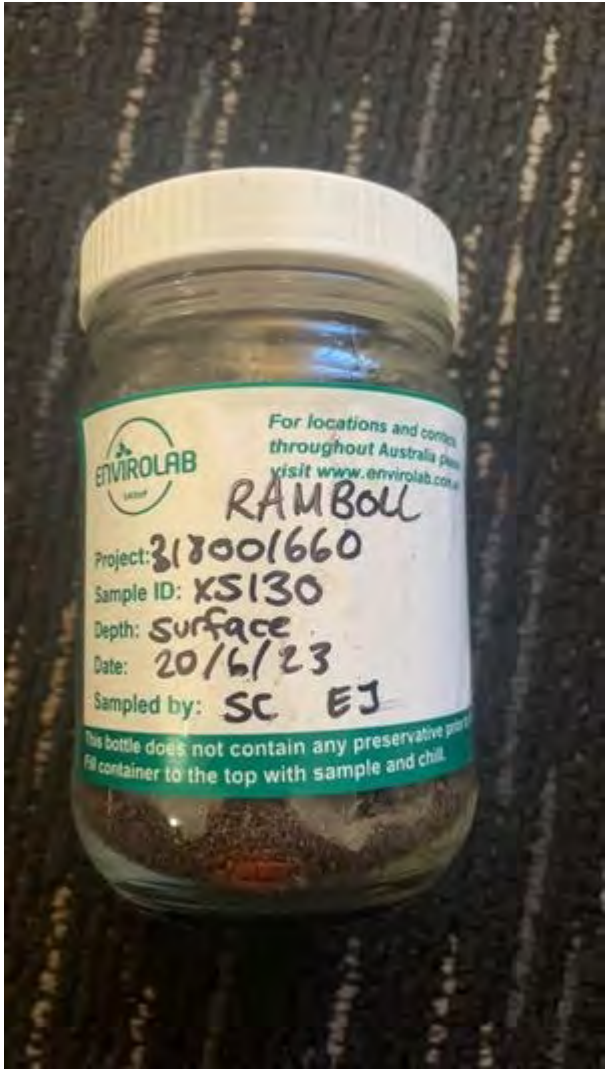
SOIL SAMPLING (XS129)

Project no.	318,001,660	Sample ID	XS129
Project name	Goulburn wheatyards offsite lead deliniation	Sample type	XRF
Start time	15:46	End time	15:47
Date	20/06/2023	Operator	Other
Sample appearance Fine gravely silty sand			
Comments Pb 0, Cu 0, Zn 32, As 0

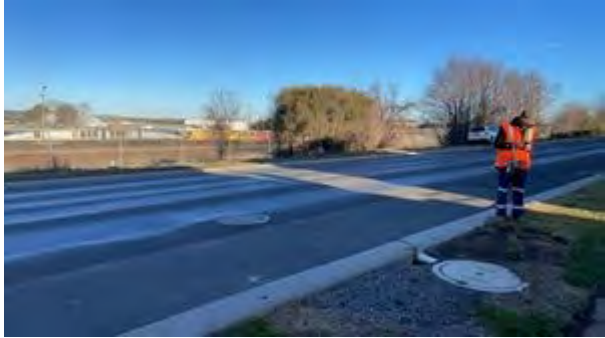
SOIL SAMPLING (XS128)

Project no.	318,001,660	Sample ID	XS128
Project name	Goulburn wheatyards offsite lead deliniation	Sample type	XRF
Start time	15:44	End time	15:45
Date	20/06/2023	Operator	Other
Sample appearance Fine gravely silty sand			
Comments Pb 13, Cu 0, Zn 133, As 5
