Goulburn Wheat Yards Assessment

Offsite Lead Delineation Preliminary Site
Investigation

Project name **Goulburn Wheat Yards Assessment - Offsite Lead Delineation Preliminary Site Investigation**
Project no. **318001660**
Recipient **ARTC**
Document type **Final Report**
Version **1**
Date **7 September 2023**
Prepared by **N. Gilbert**
Checked by **R. Condon / K. Greenfield (CEnvP SC40104)**
Approved by **A. Nolan**
Description **This document presents the results of an environmental assessment to assess the potential offsite risk of lead contamination surrounding the Goulburn Wheat Yards.**

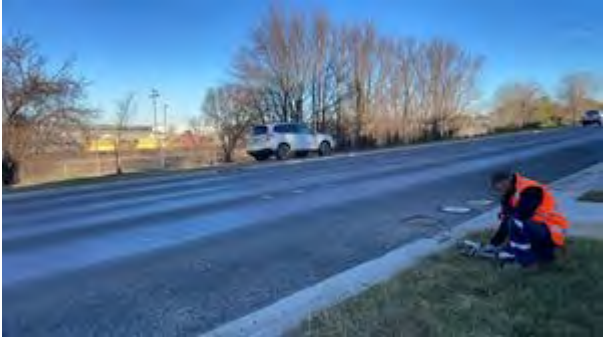
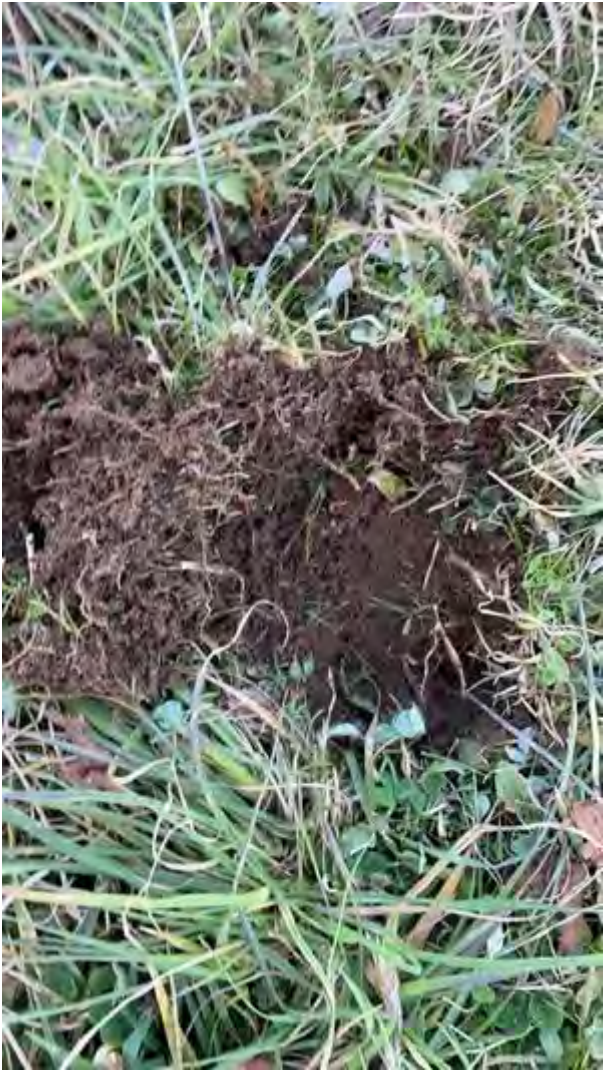
SOIL SAMPLING (XS127)

Project no.	318,001,660	Sample ID	XS127
Project name	Goulburn wheatyards offsite lead deliniation	Sample type	XRF
Start time	15:42	End time	15:43
Date	20/06/2023	Operator	Other
Sample appearance Fine gravely silty sand			
Comments Pb 0, Cu 0, Zn 42, As 0

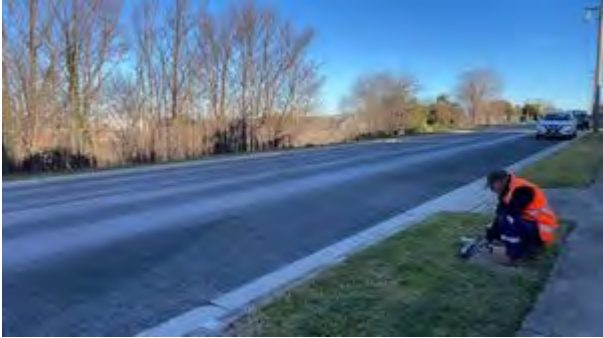
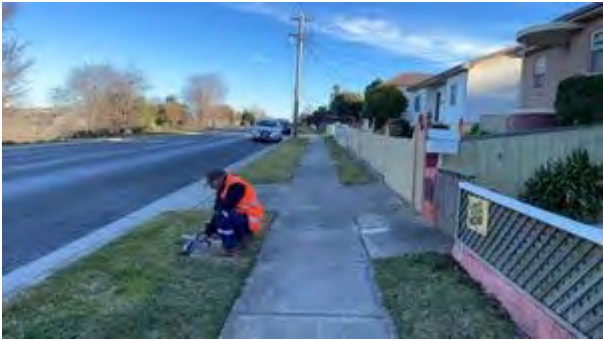
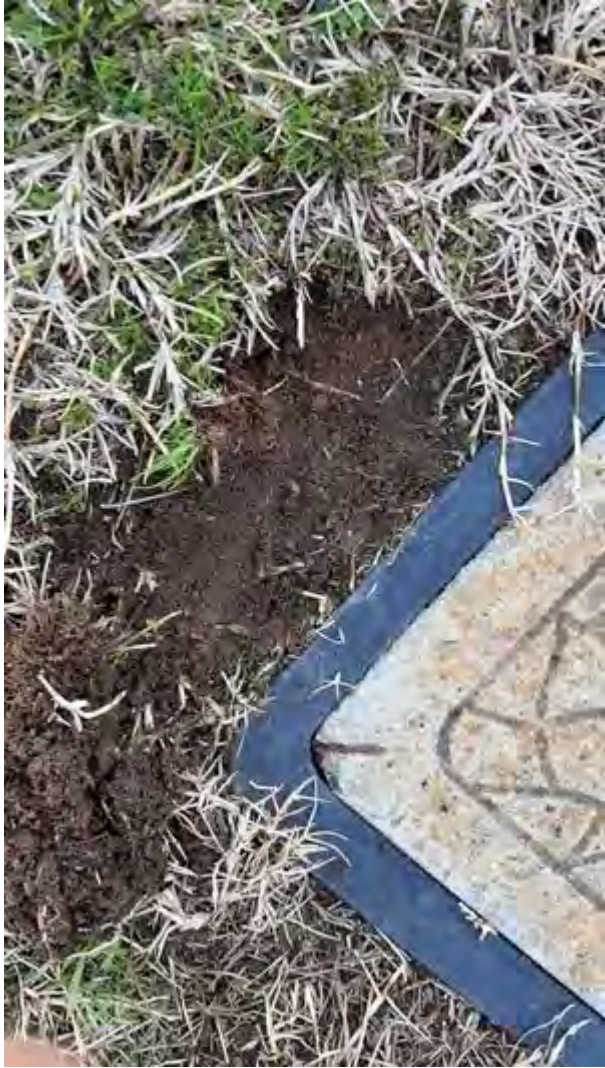
SOIL SAMPLING (XS126)

Project no.	318,001,660	Sample ID	XS126
Project name	Goulburn wheatyards offsite lead deliniation	Sample type	XRF
Start time	15:40	End time	15:41
Date	20/06/2023	Operator	Other
Sample appearance Gravelly silty sand			
Comments Pb 0, Cu 0, Zn 33, As 0

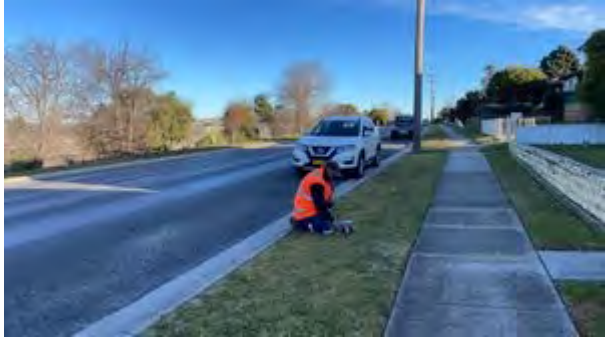
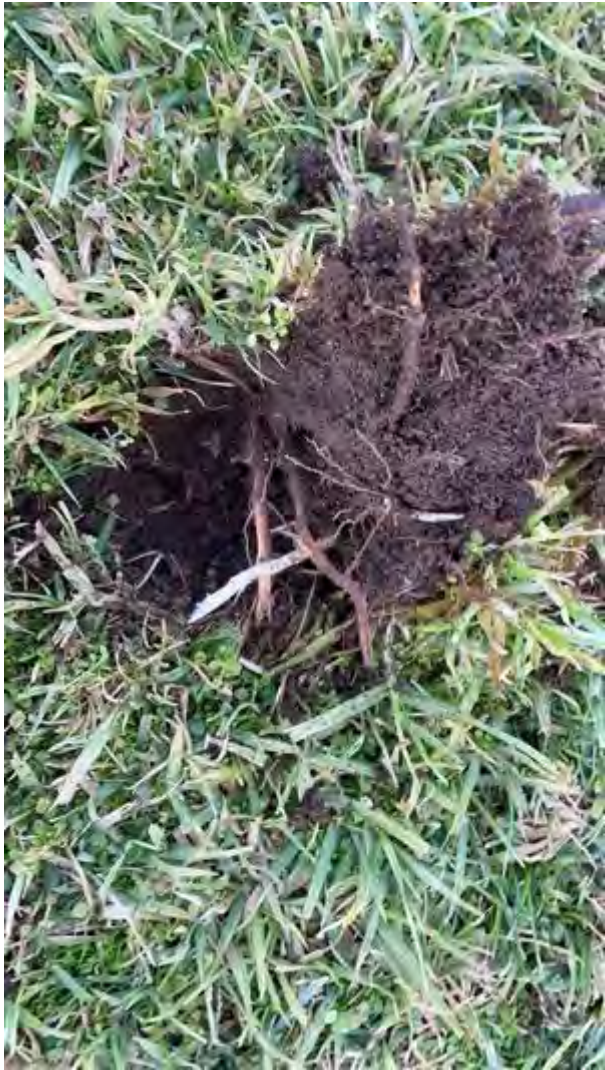
SOIL SAMPLING (XS125)

Project no.	318,001,660	Sample ID	XS125
Project name	Goulburn wheatyards offsite lead deliniation	Sample type	XRF
Start time	15:38	End time	15:39
Date	20/06/2023	Operator	Other
Sample appearance Gravelly silty sand			
Comments Pb 0, Cu 0, Zn 68, As 0

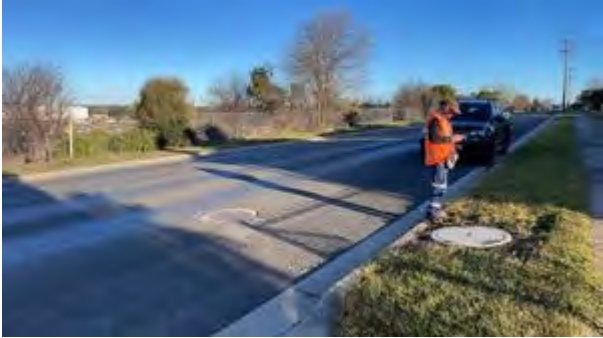
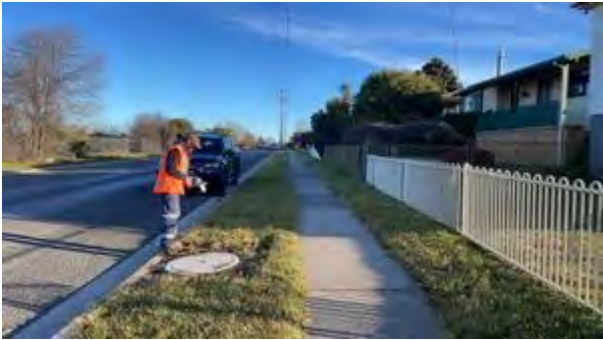
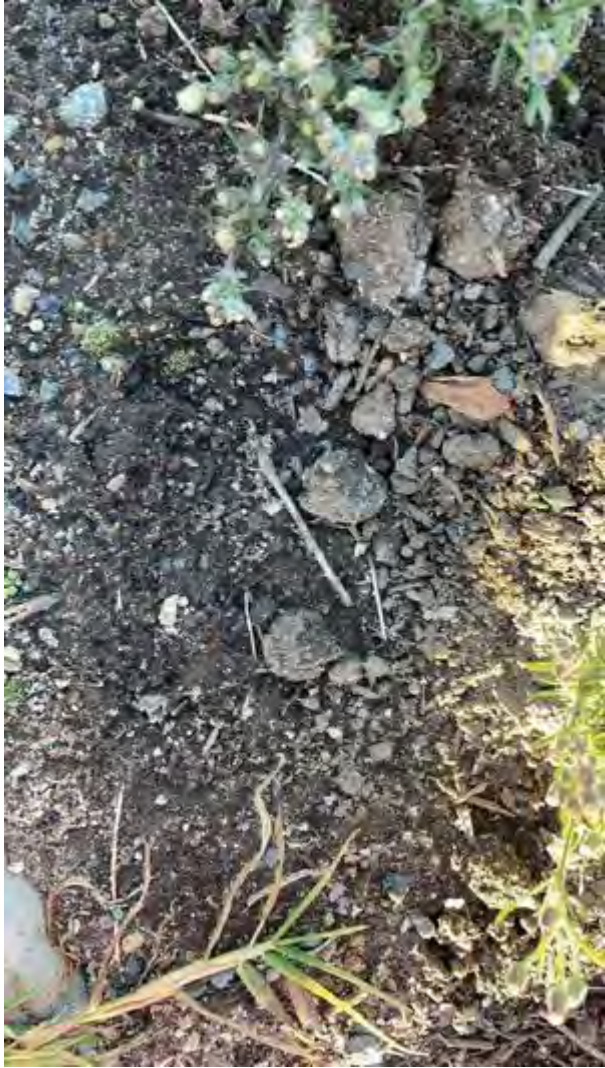
SOIL SAMPLING (XS124)

Project no.	318,001,660	Sample ID	XS124
Project name	Goulburn wheatyards offsite lead deliniation	Sample type	XRF
Start time	15:37	End time	15:38
Date	20/06/2023	Operator	Other
Sample appearance Gravelly silty sand			
Comments Pb 0, Cu 0, Zn 44, As 0

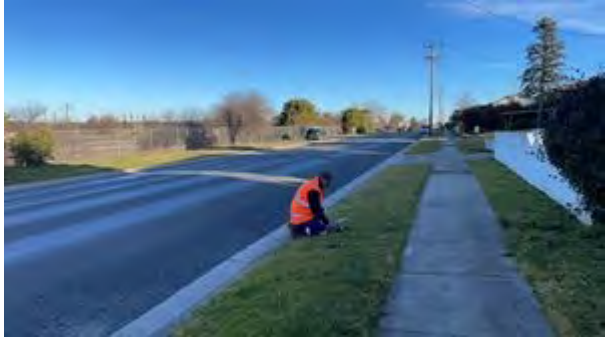
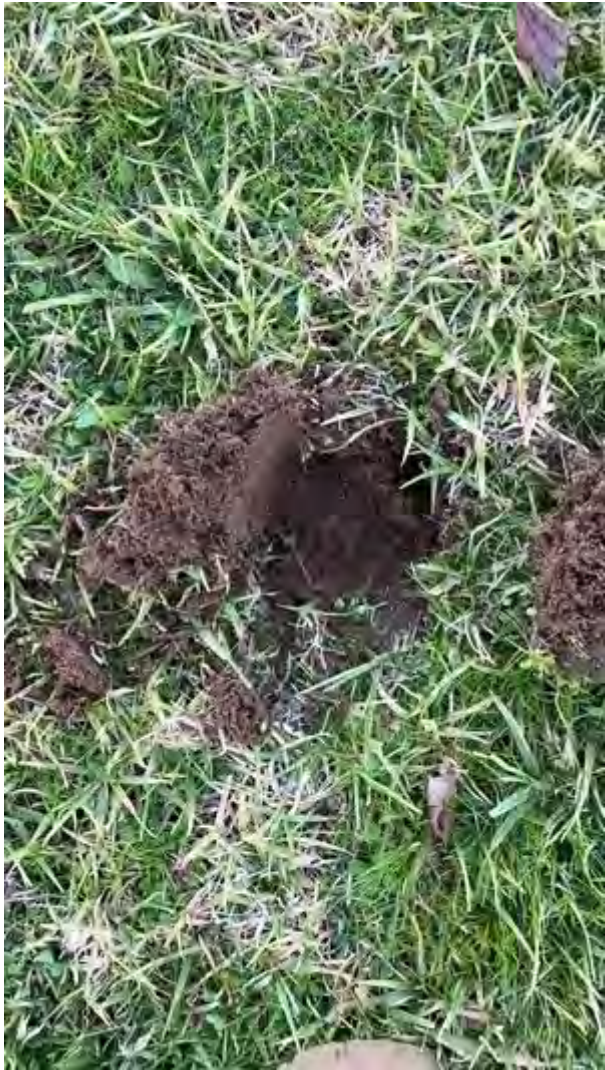
SOIL SAMPLING (XS123)

Project no.	318,001,660	Sample ID	XS123
Project name	Goulburn wheatyards offsite lead deliniation	Sample type	XRF
Start time	15:34	End time	15:35
Date	20/06/2023	Operator	Other
Sample appearance Gravelly silty sand			
Comments Pb 11, Cu 24, Zn 107, As 0

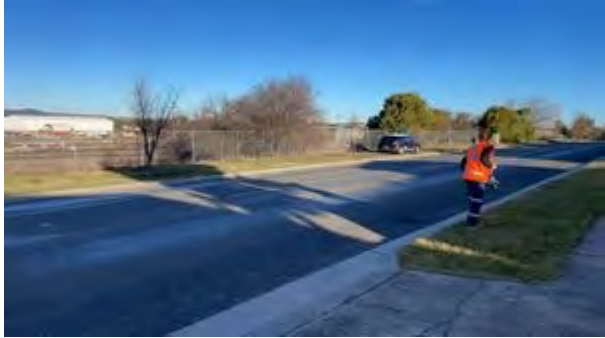
SOIL SAMPLING (XS122)

Project no.	318,001,660	Sample ID	XS122
Project name	Goulburn wheatyards offsite lead deliniation	Sample type	XRF
Start time	15:32	End time	15:33
Date	20/06/2023	Operator	Other
Sample appearance Gravelly silty sand			
Comments Pb 12, Cu 0, Zn 199, As 0

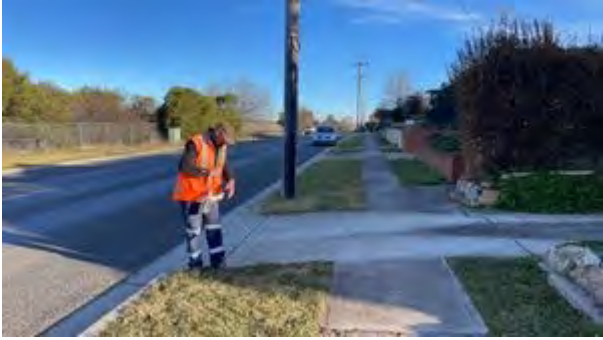
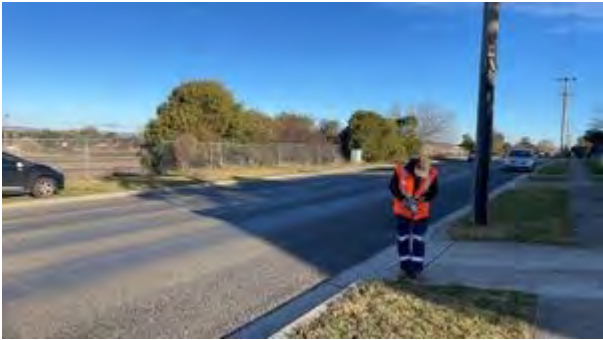
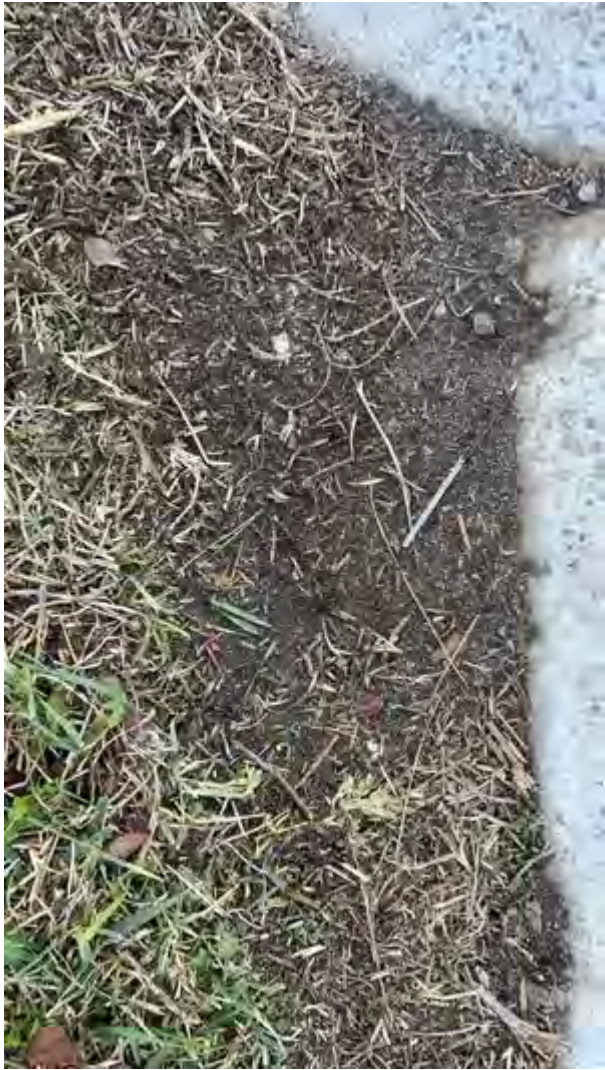
SOIL SAMPLING (XS121)

Project no.	318,001,660	Sample ID	XS121
Project name	Goulburn wheatyards offsite lead deliniation	Sample type	XRF
Start time	15:30	End time	15:31
Date	20/06/2023	Operator	Other
Sample appearance Gravelly silty sand			
Comments Pb 0, Cu 17, Zn 158, As 4

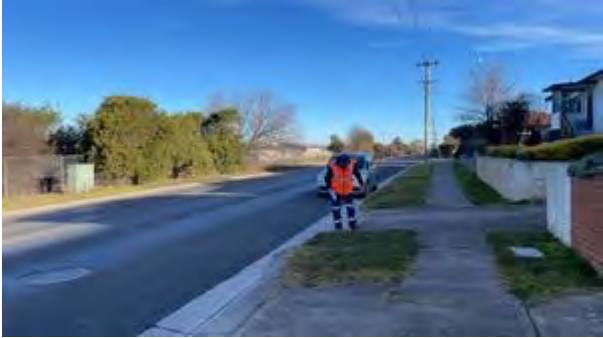
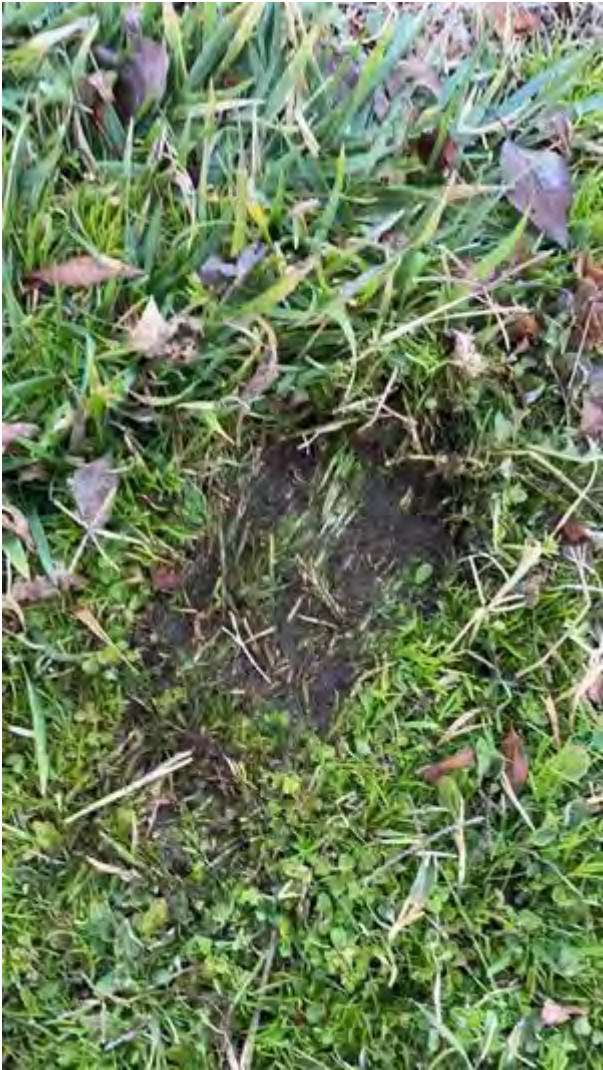
SOIL SAMPLING (XS120)

Project no.	318,001,660	Sample ID	XS120
Project name	Goulburn wheatyards offsite lead deliniation	Sample type	XRF
Start time	15:19	End time	15:20
Date	20/06/2023	Operator	Other
Sample appearance Gravelly silty sand sample taken			
Comments Pb 27, Cu 0, Zn 107, As 0

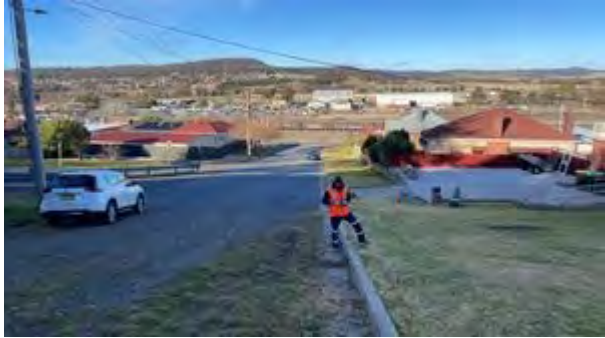
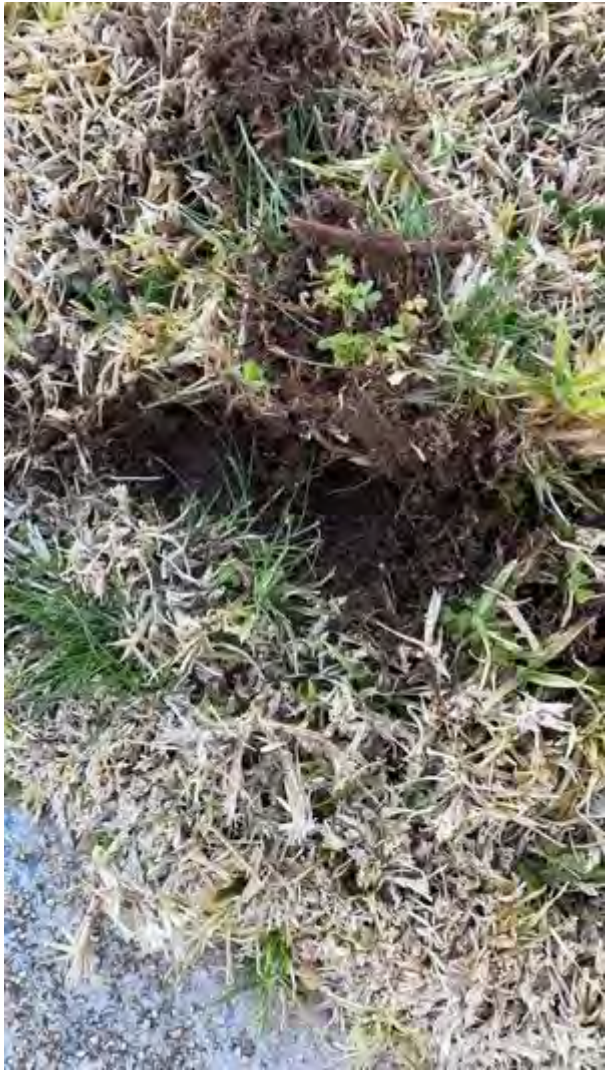
SOIL SAMPLING (XS118)

Project no.	318,001,660	Sample ID	XS118
Project name	Goulburn wheatyards offsite lead deliniation	Sample type	XRF
Start time	15:08	End time	15:09
Date	20/06/2023	Operator	Other
Sample appearance Gravelly silt			
Comments Pb 0, Cu 0, Zn 0, As 0

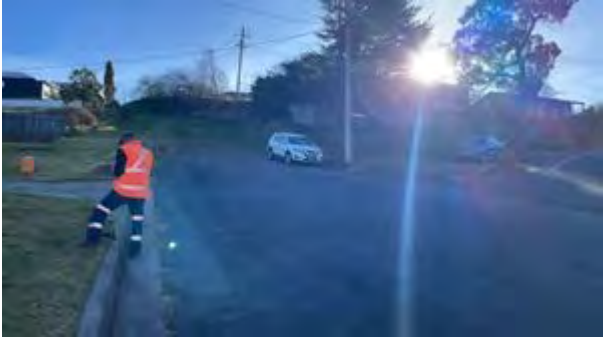
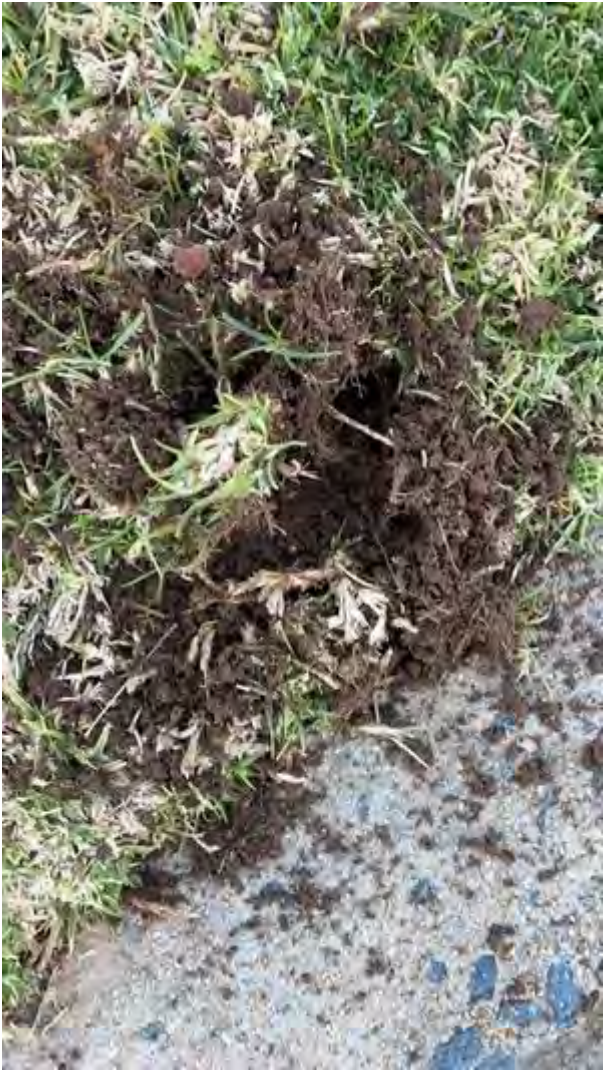
SOIL SAMPLING (XS117)

Project no.	318,001,660	Sample ID	XS117
Project name	Goulburn wheatyards offsite lead deliniation	Sample type	XRF
Start time	15:05	End time	15:06
Date	20/06/2023	Operator	Other
Sample appearance Gravelly silt			
Comments Pb 16, Cu 0, Zn 32, As 0

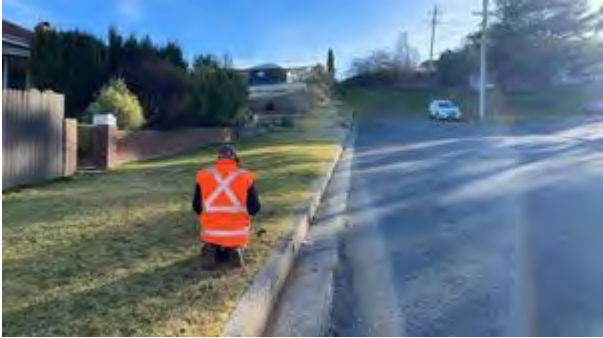
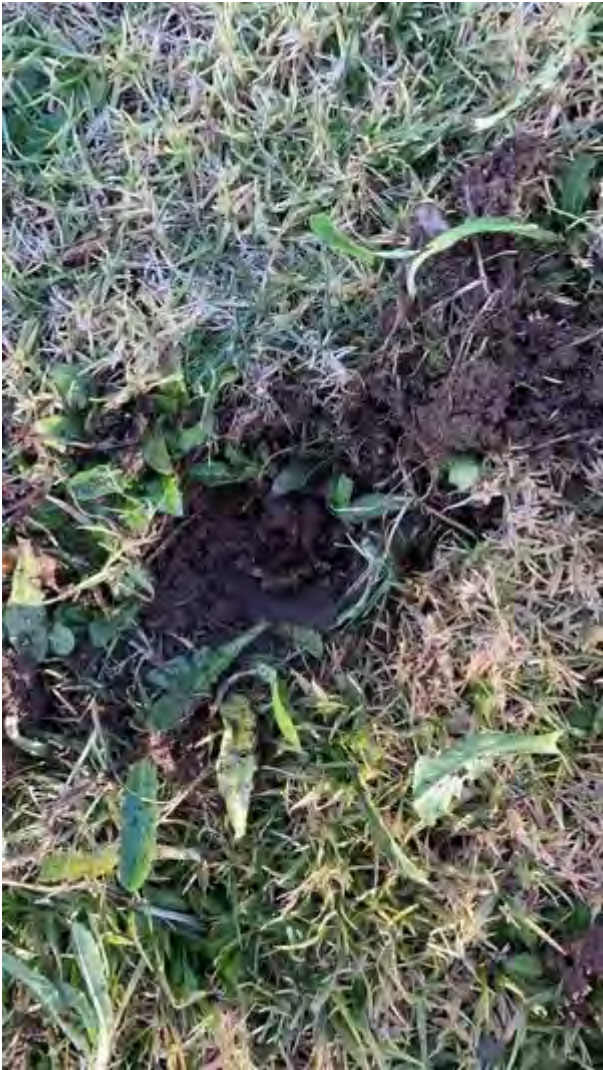
SOIL SAMPLING (XS116)

Project no.	318,001,660	Sample ID	XS116
Project name	Goulburn wheatyards offsite lead deliniation	Sample type	XRF
Start time	15:02	End time	15:03
Date	20/06/2023	Operator	Other
Sample appearance Gravelly silt			
Comments Pb 0, Cu 0, Zn 60, As 0

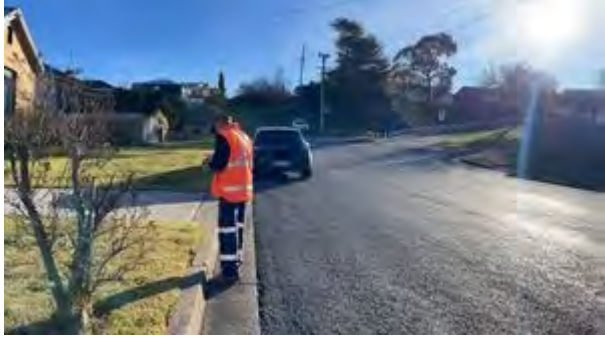
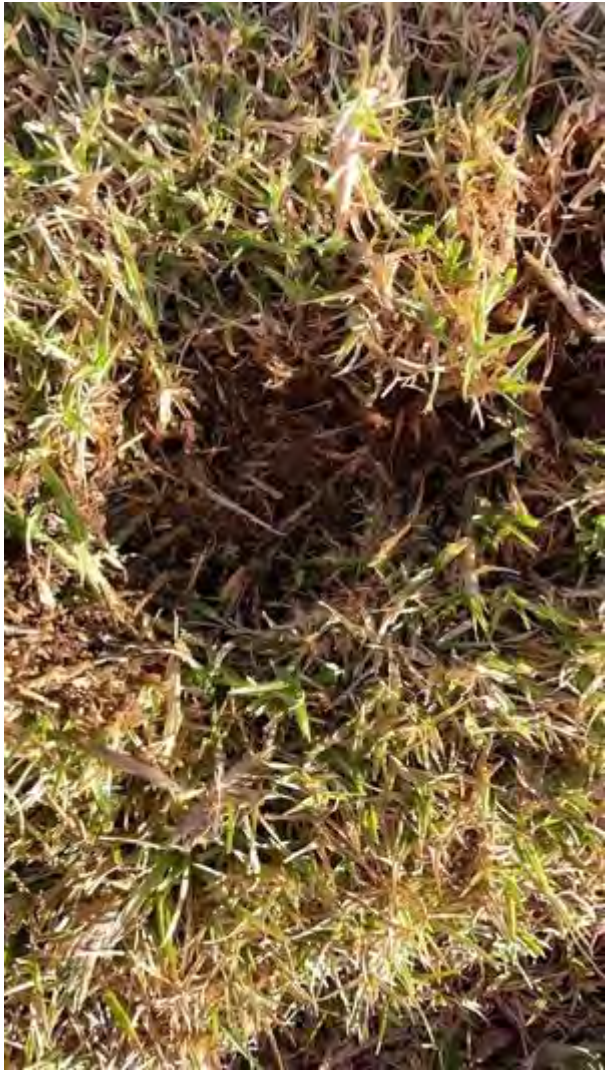
SOIL SAMPLING (XS115)

Project no.	318,001,660	Sample ID	XS115
Project name	Goulburn wheatyards offsite lead deliniation	Sample type	XRF
Start time	15:00	End time	15:01
Date	20/06/2023	Operator	Other
Sample appearance Gravelly silt			
Comments Pb 13, Cu 0, Zn 52, As 0

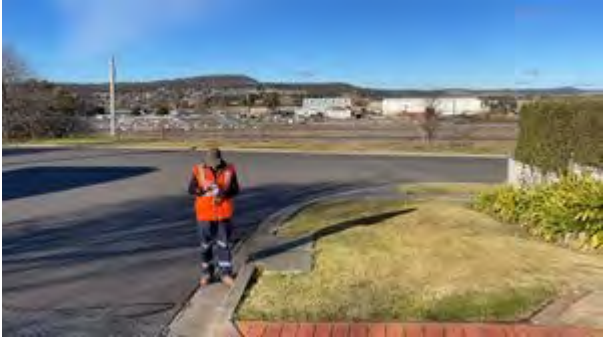
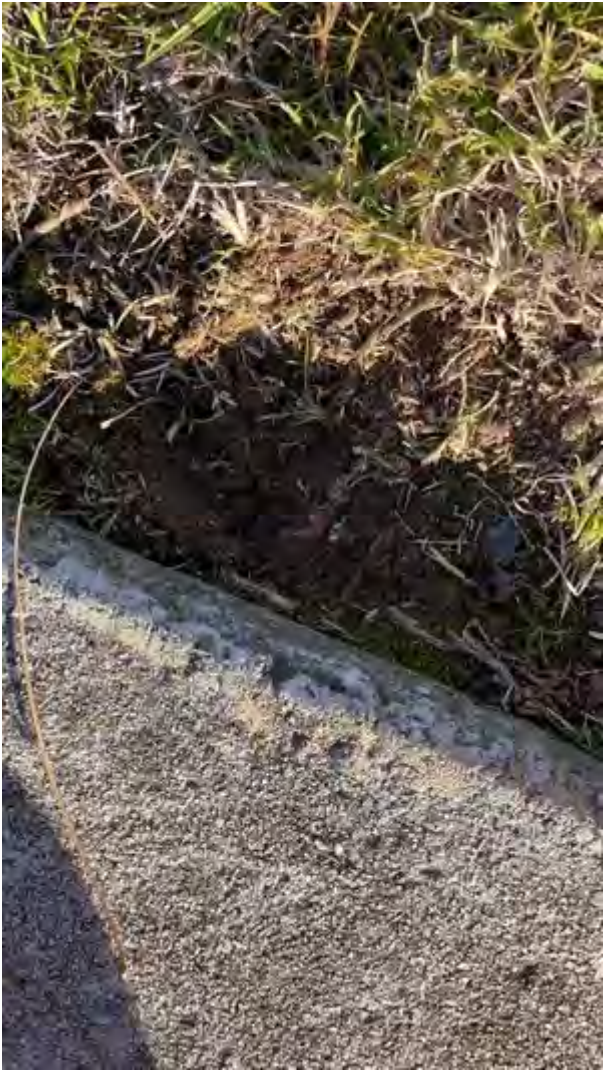
SOIL SAMPLING (XS114)

Project no.	318,001,660	Sample ID	XS114
Project name	Goulburn wheatyards offsite lead deliniation	Sample type	XRF
Start time	14:58	End time	14:59
Date	20/06/2023	Operator	Other
Sample appearance Gravelly silt			
Comments Pb 40, Cu 0, Zn 87, As 0

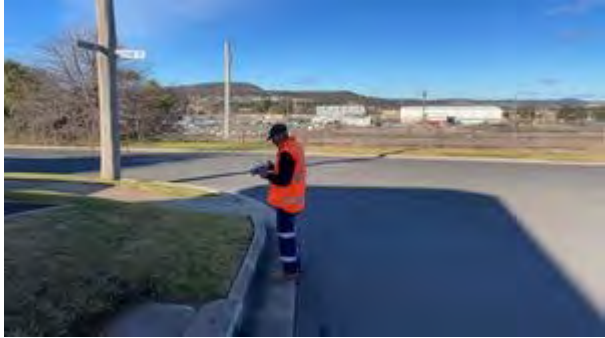
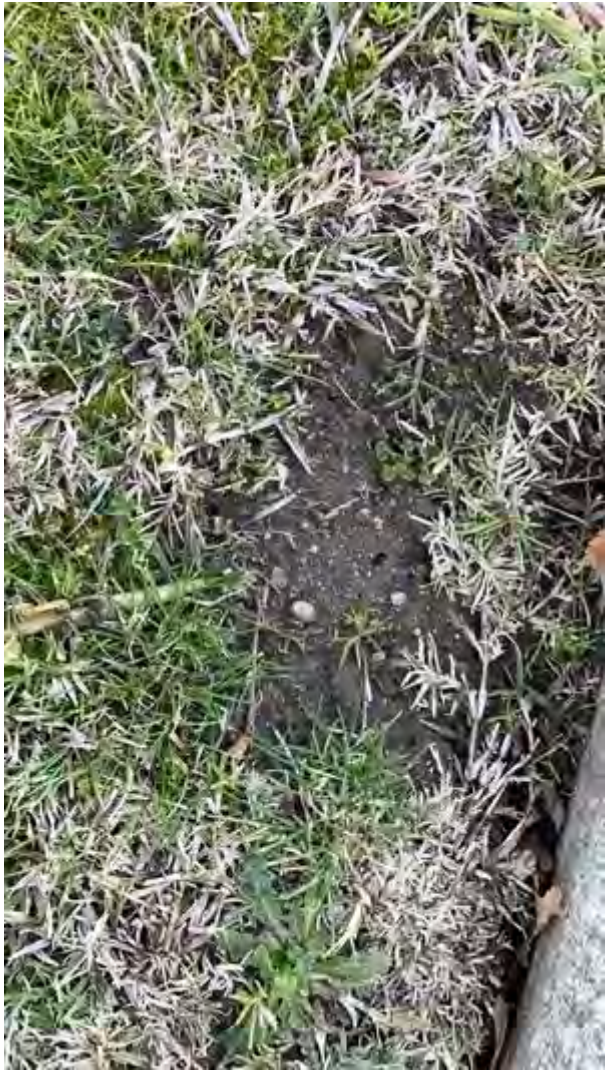
SOIL SAMPLING (XS113)

Project no.	318,001,660	Sample ID	XS113
Project name	Goulburn wheatyards offsite lead deliniation	Sample type	XRF
Start time	14:56	End time	14:57
Date	20/06/2023	Operator	Other
Sample appearance Gravelly silt			
Comments Pb 21, Cu 0, Zn 49, As 0

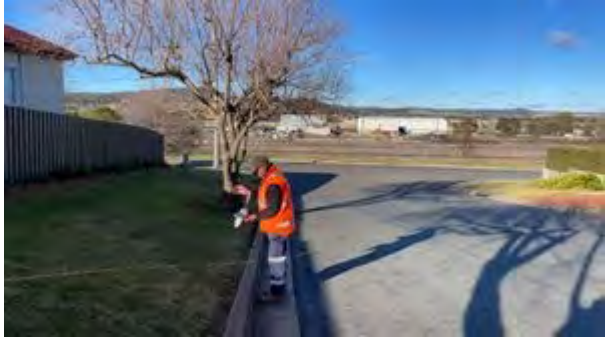
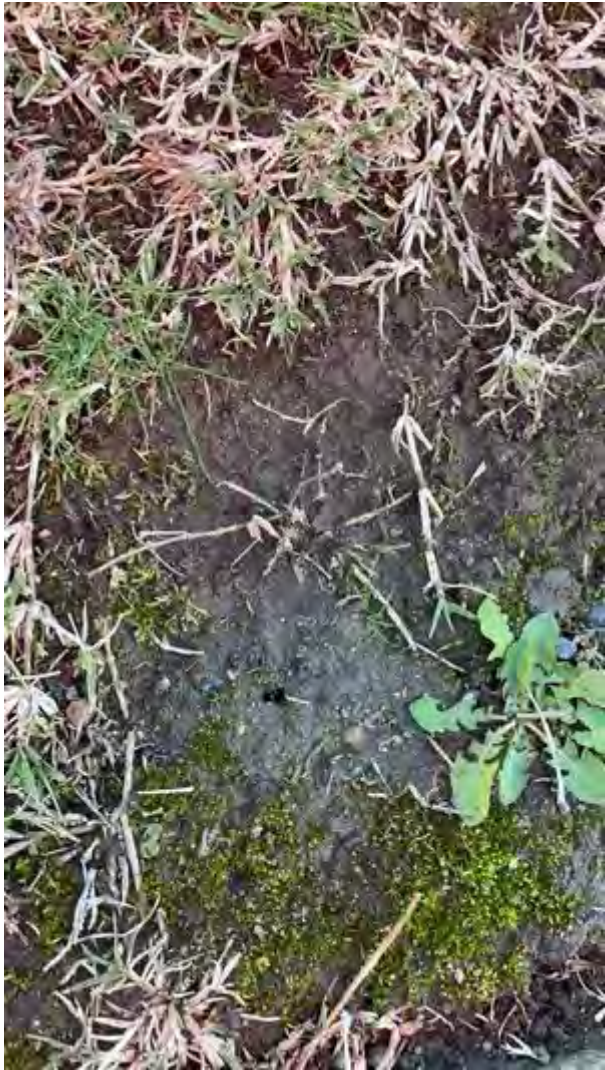
SOIL SAMPLING (XS112)

Project no.	318,001,660	Sample ID	XS112
Project name	Goulburn wheatyards offsite lead deliniation	Sample type	XRF
Start time	14:54	End time	14:55
Date	20/06/2023	Operator	Other
Sample appearance Gravelly silt			
Comments Pb 43, Cu 0, Zn 86, As 0

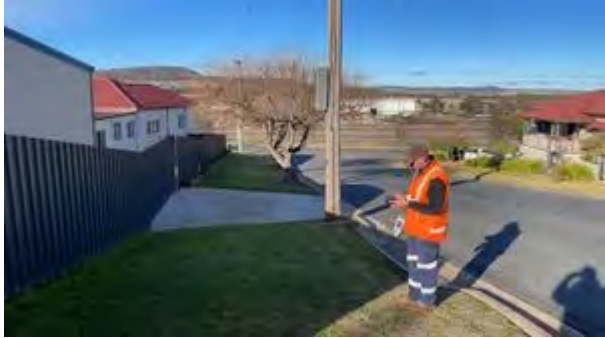
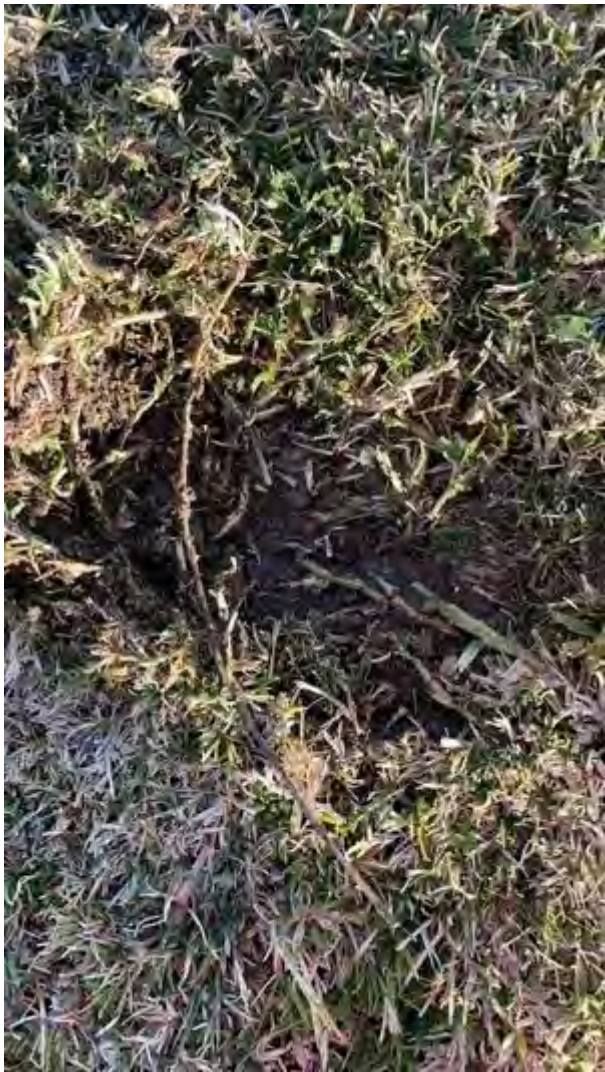
SOIL SAMPLING (XS111)

Project no.	318,001,660	Sample ID	XS111
Project name	Goulburn wheatyards offsite lead deliniation	Sample type	XRF
Start time	14:50	End time	14:51
Date	20/06/2023	Operator	Other
Sample appearance Gravelly silt			
Comments Pb 20, Cu 15, Zn 295, As 6

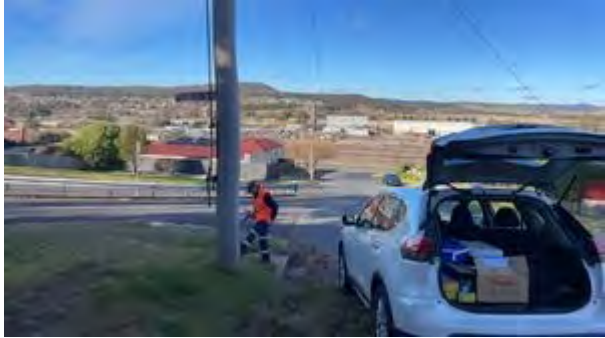
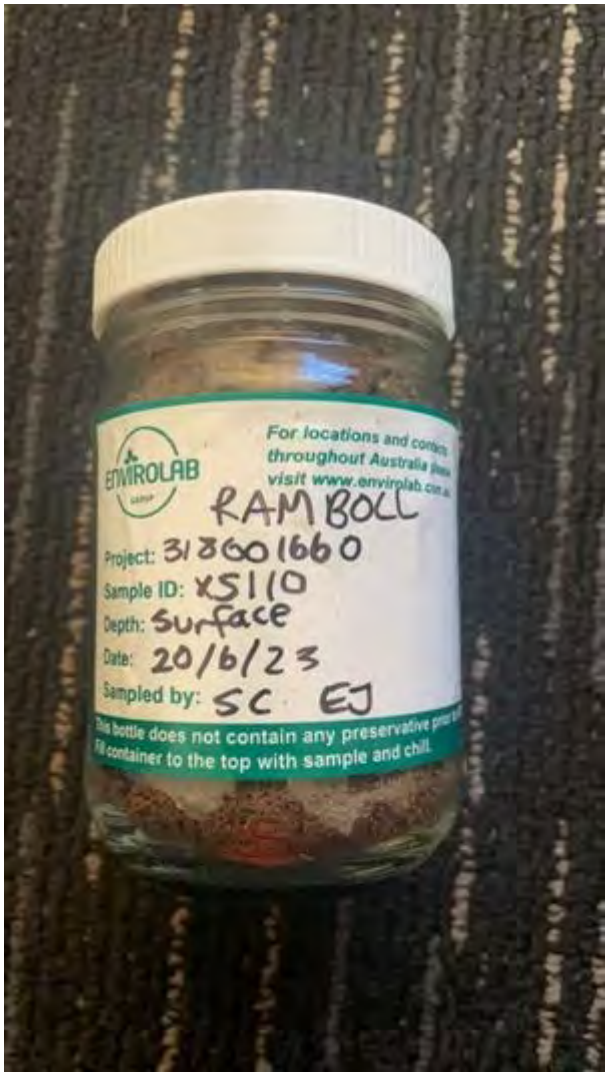
SOIL SAMPLING (XS110)

Project no.	318,001,660	Sample ID	XS110
Project name	Goulburn wheatyards offsite lead deliniation	Sample type	XRF
Start time	14:42	End time	14:43
Date	20/06/2023	Operator	Other
Sample appearance Gravelly silt sample taken			
Comments Pb 0, Cu 44, Zn 201, As 0

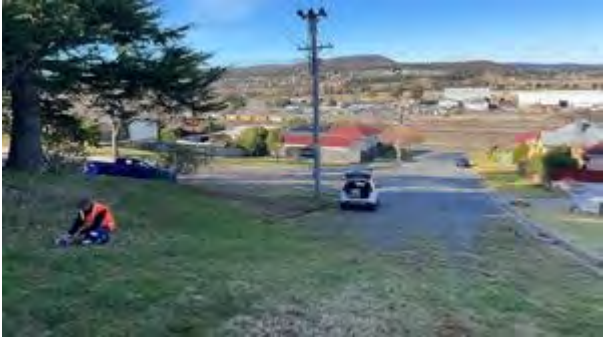
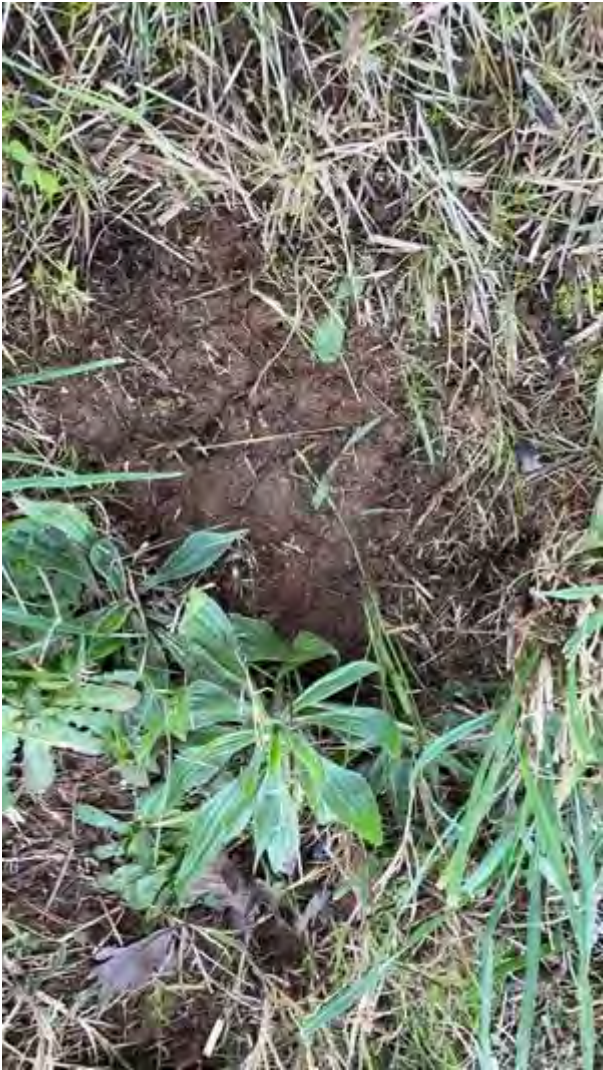
SOIL SAMPLING (XS109)

Project no.	318,001,660	Sample ID	XS109
Project name	Goulburn wheatyards offsite lead deliniation	Sample type	XRF
Start time	14:40	End time	14:41
Date	20/06/2023	Operator	Other
Sample appearance Gravelly silt			
Comments Pb 0, Cu 0 , Zn 25, As 0

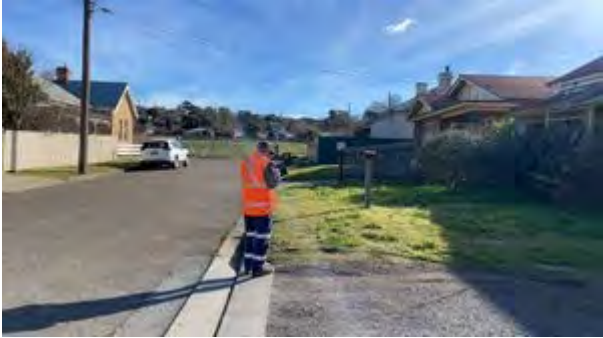
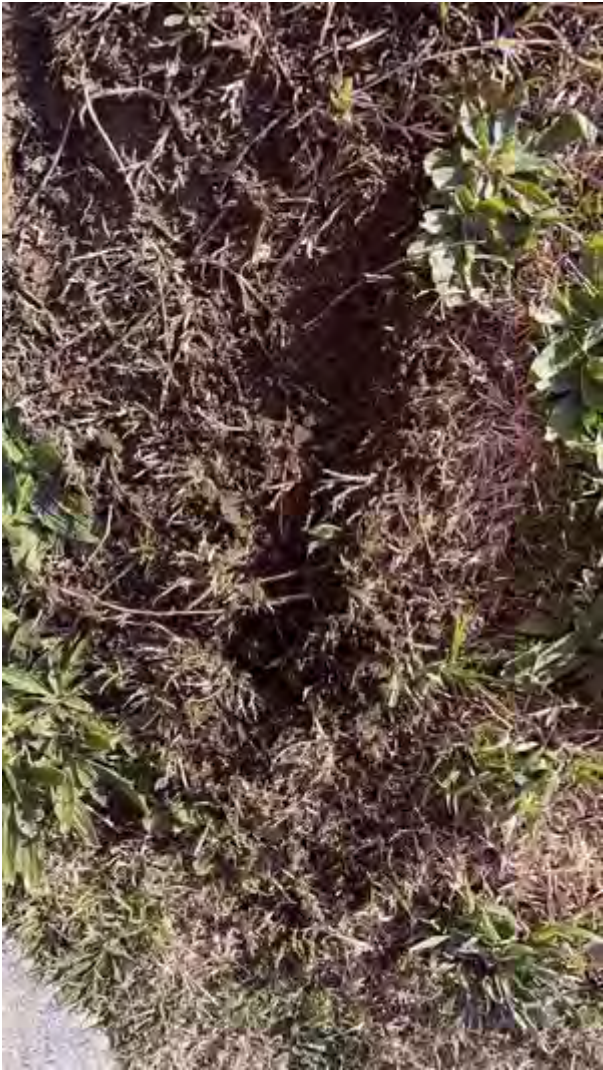
Project no.	318,001,660	Sample ID	XS107
Project name	Goulburn wheatyards offsite lead deliniation	Sample type	XRF
Start time	13:56	End time	13:57
Date	20/06/2023	Operator	Other
Sample appearance Gravelly silt			
Comments Pb 17, Cu 0 , Zn 106, As 0

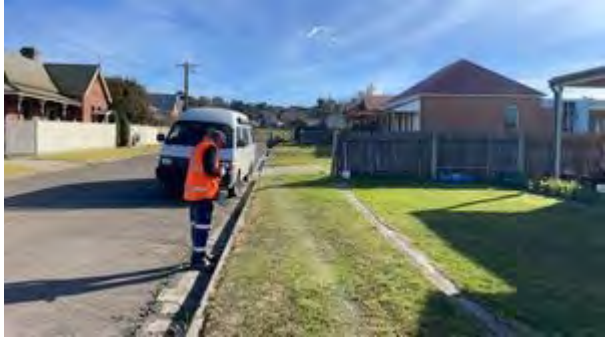
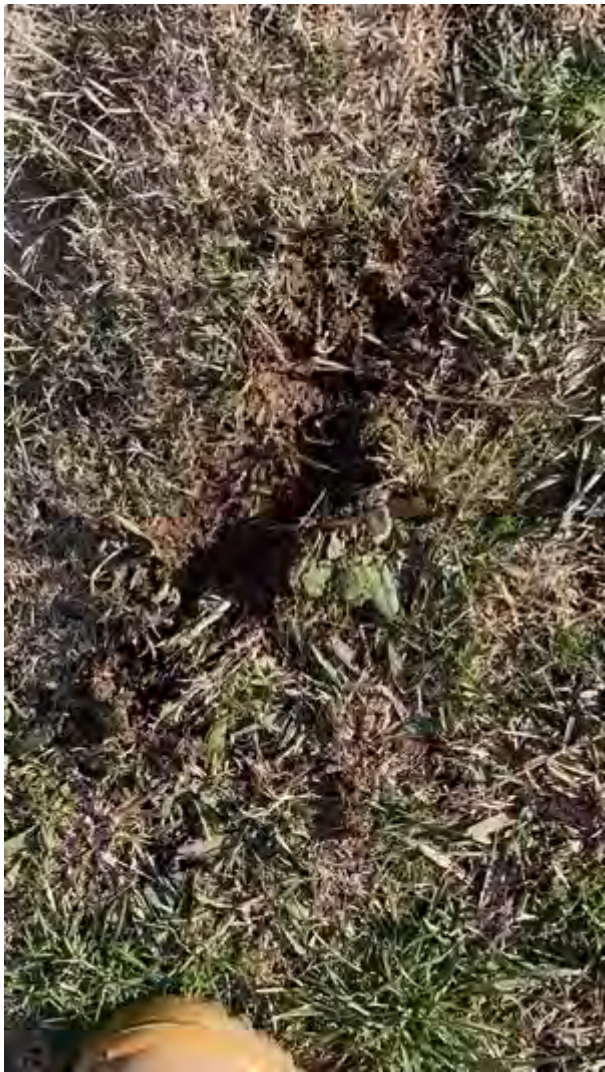
SOIL SAMPLING (XS106)

Project no.	318,001,660	Sample ID	XS106
Project name	Goulburn wheatyards offsite lead deliniation	Sample type	XRF
Start time	13:54	End time	13:55
Date	20/06/2023	Operator	Other
Sample appearance Gravelly silt			
Comments Pb 30, Cu 0 , Zn 90, As 0

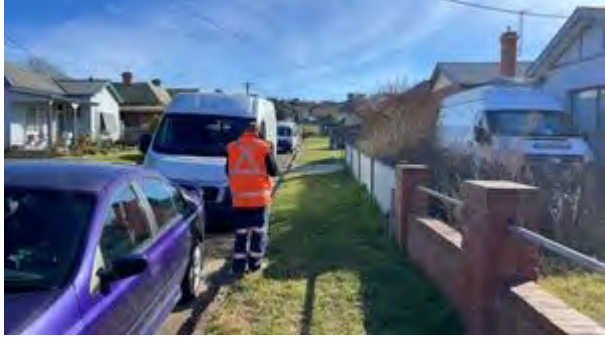
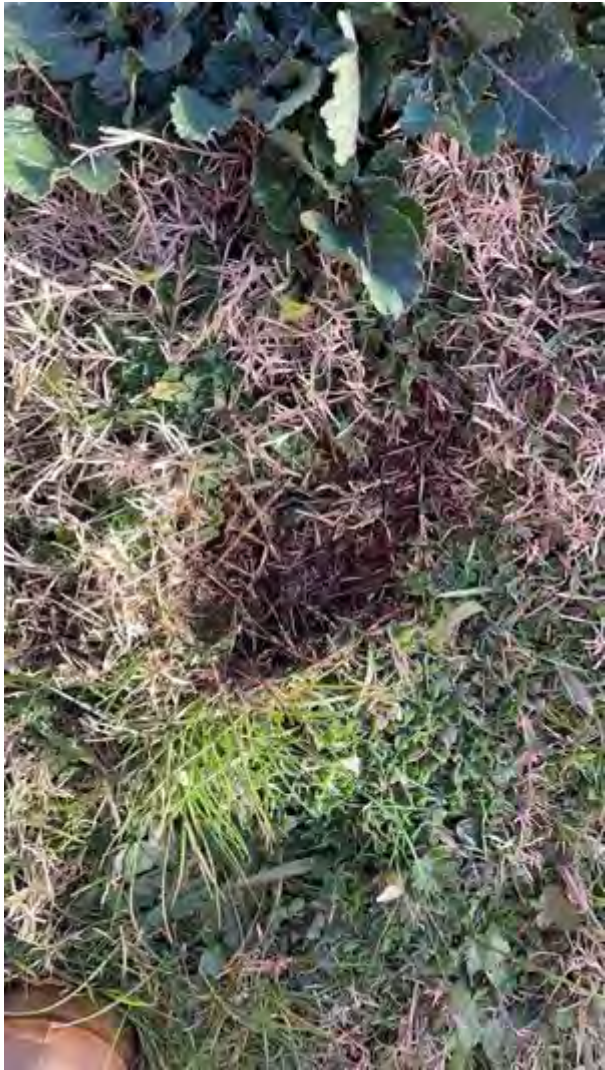
SOIL SAMPLING (XS105)

Project no.	318,001,660	Sample ID	XS105
Project name	Goulburn wheatyards offsite lead deliniation	Sample type	XRF
Start time	13:51	End time	13:52
Date	20/06/2023	Operator	Other
Sample appearance Gravelly silt			
Comments Pb 0, Cu 0 , Zn 0, As 0

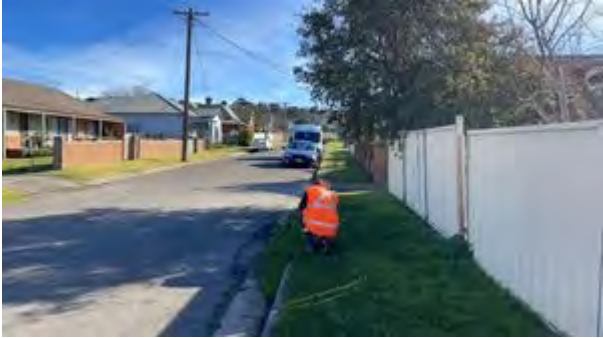
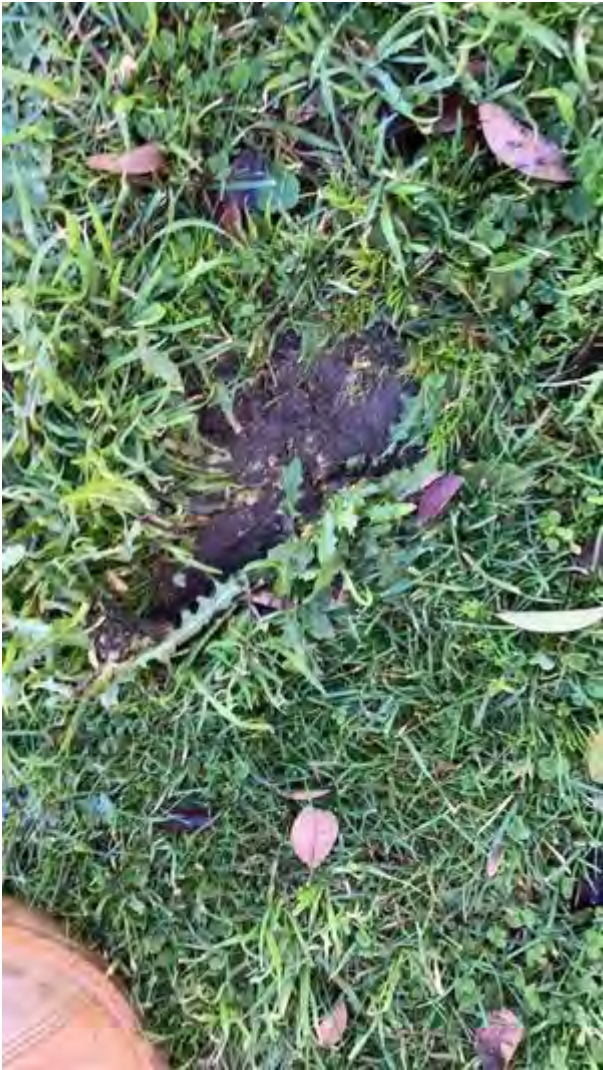
Photos

Project no.	318,001,660	Sample ID	XS104
Project name	Goulburn wheatyards offsite lead deliniation	Sample type	XRF
Start time	13:49	End time	13:50
Date	20/06/2023	Operator	Other
Sample appearance Gravelly silt			
Comments Pb 0, Cu 0 , Zn 43, As 0

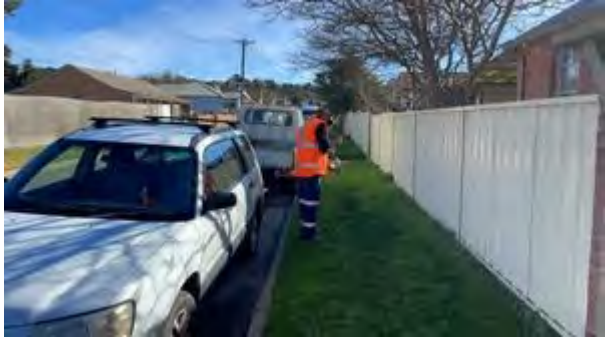
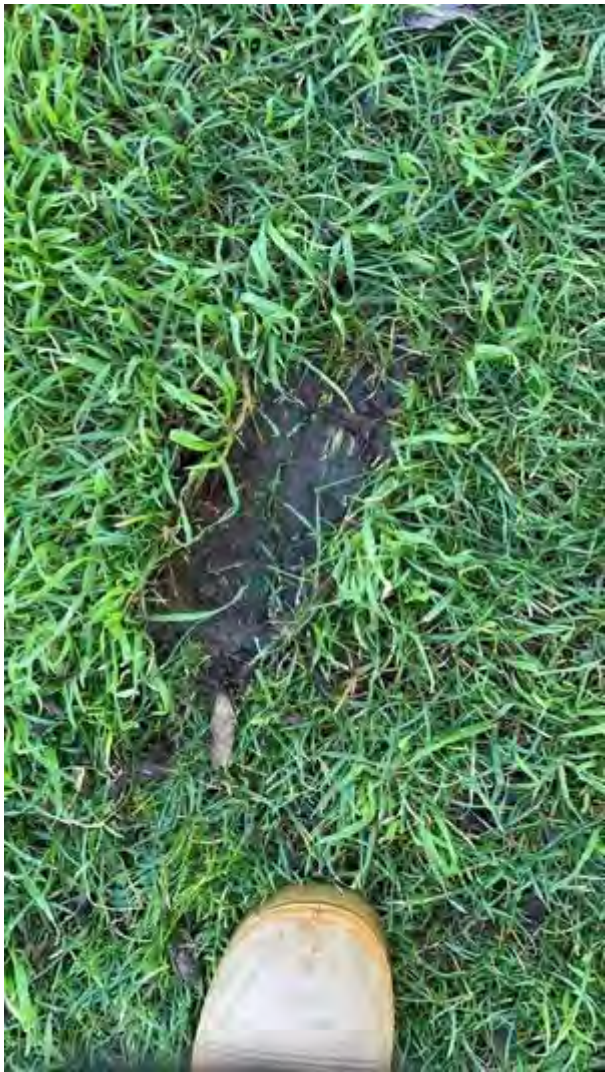
Photos

Project no.	318,001,660	Sample ID	XS103
Project name	Goulburn wheatyards offsite lead deliniation	Sample type	XRF
Start time	13:47	End time	13:48
Date	20/06/2023	Operator	Other
Sample appearance Gravelly silt			
Comments Pb 15 , Cu 0 , Zn 0, As 0

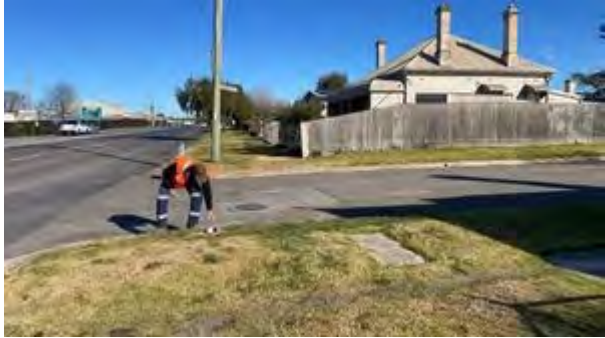
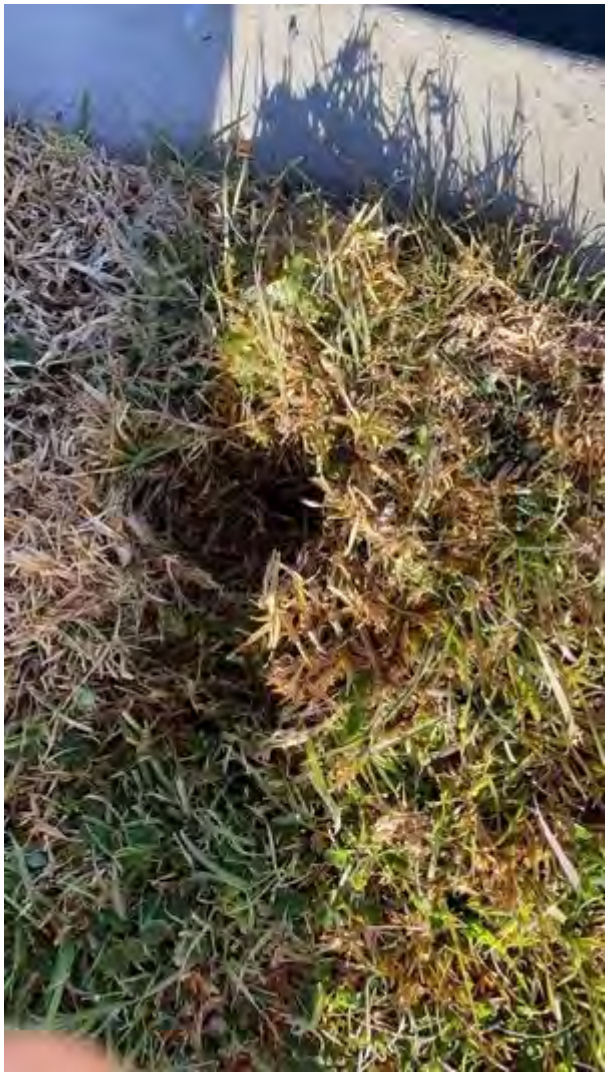
Photos

Project no.	318,001,660	Sample ID	XS102
Project name	Goulburn wheatyards offsite lead deliniation	Sample type	XRF
Start time	13:45	End time	13:46
Date	20/06/2023	Operator	Other
Sample appearance Gravelly silt			
Comments Pb 0 , Cu 0 , Zn 107, As 0
