Goulburn Wheat Yards Assessment

Offsite Lead Delineation Preliminary Site
Investigation

Project name **Goulburn Wheat Yards Assessment - Offsite Lead Delineation Preliminary Site Investigation**
Project no. **318001660**
Recipient **ARTC**
Document type **Final Report**
Version **1**
Date **7 September 2023**
Prepared by **N. Gilbert**
Checked by **R. Condon / K. Greenfield (CEnvP SC40104)**
Approved by **A. Nolan**
Description **This document presents the results of an environmental assessment to assess the potential offsite risk of lead contamination surrounding the Goulburn Wheat Yards.**

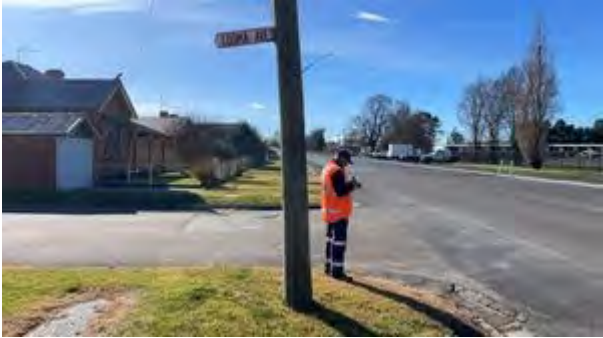
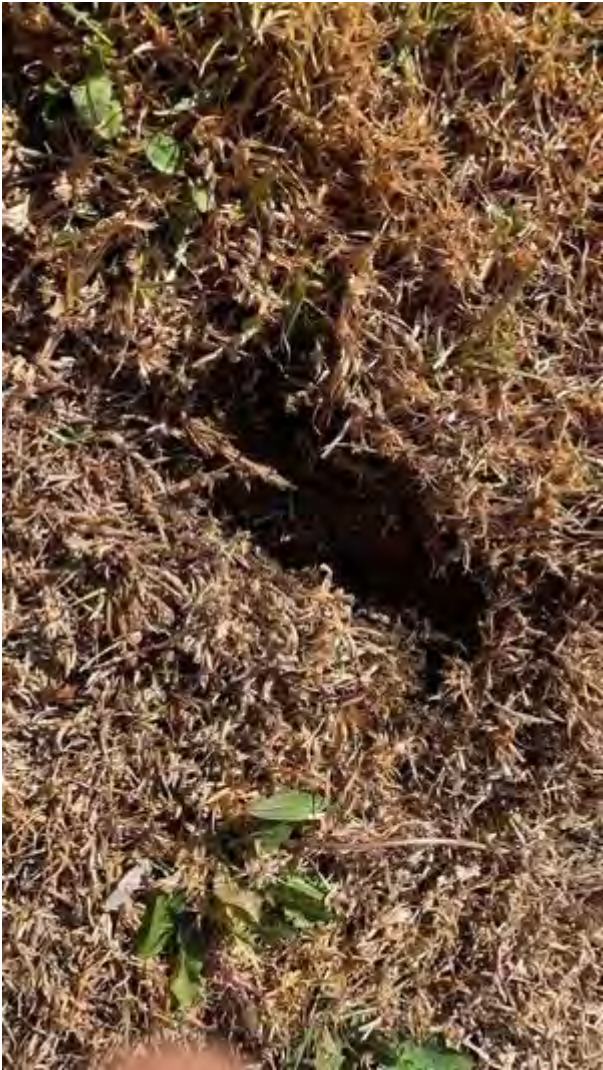
Photos

Project no.	318,001,660	Sample ID	XS101
Project name	Goulburn wheatyards offsite lead deliniation	Sample type	XRF
Start time	13:42	End time	13:43
Date	20/06/2023	Operator	Other
Sample appearance Gravelly silt			
Comments Pb 0 , Cu 0 , Zn 154, As 0

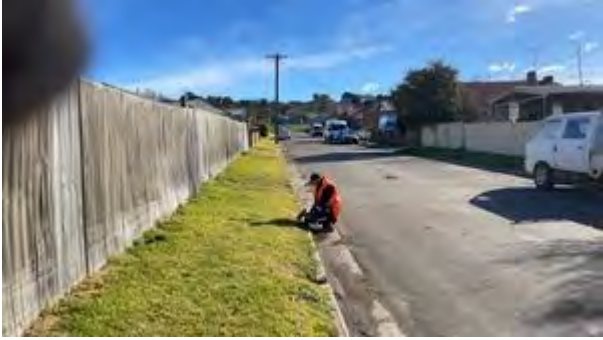
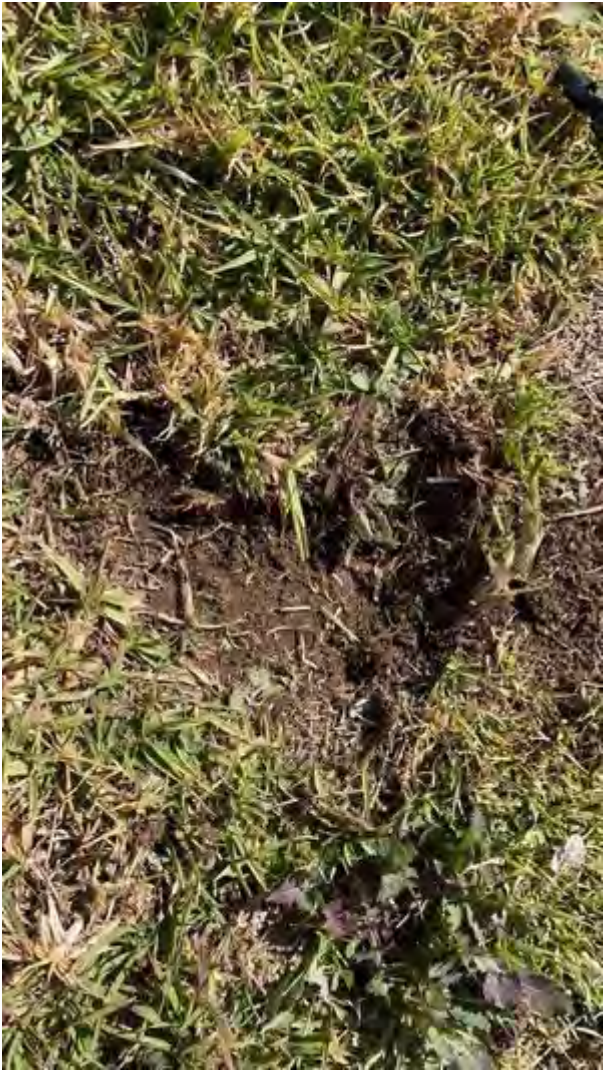
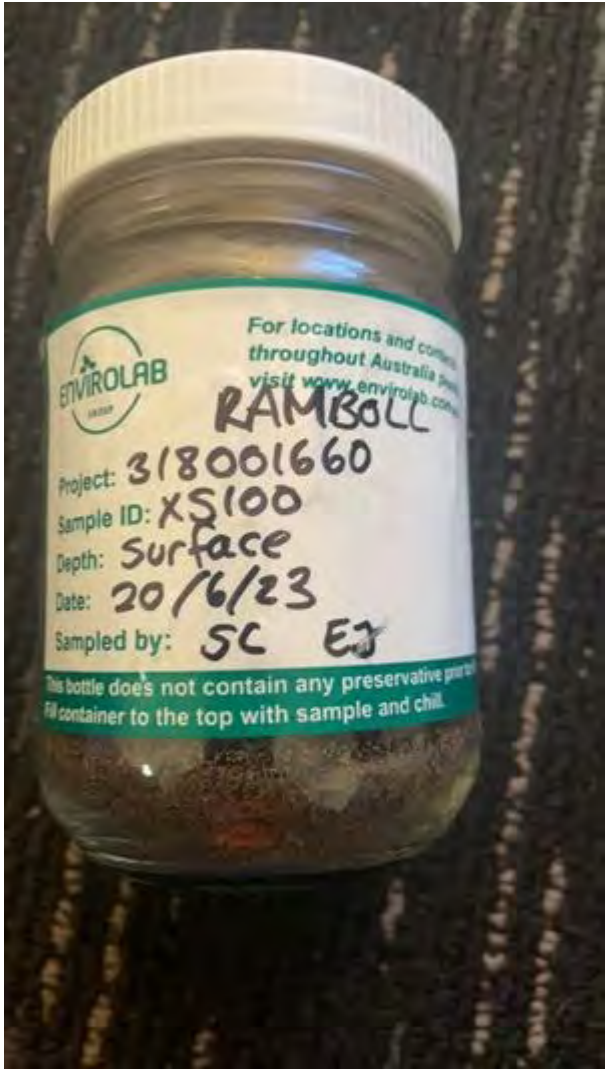
Photos

Project no.	318,001,660	Sample ID	XS100
Project name	Goulburn wheatyards offsite lead deliniation	Sample type	XRF
Start time	13:29	End time	13:30
Date	20/06/2023	Operator	Other
Sample appearance Gravelly silt sample taken			
Comments Pb 100 , Cu 27 , Zn 172 , As 0

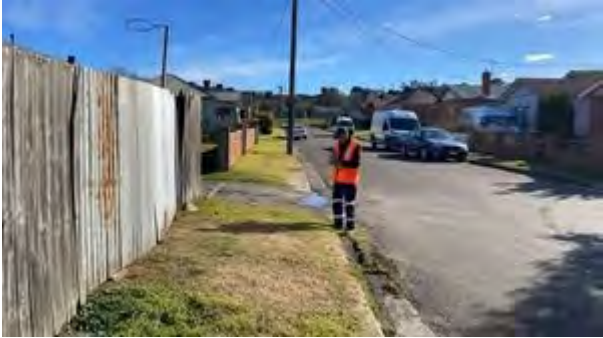
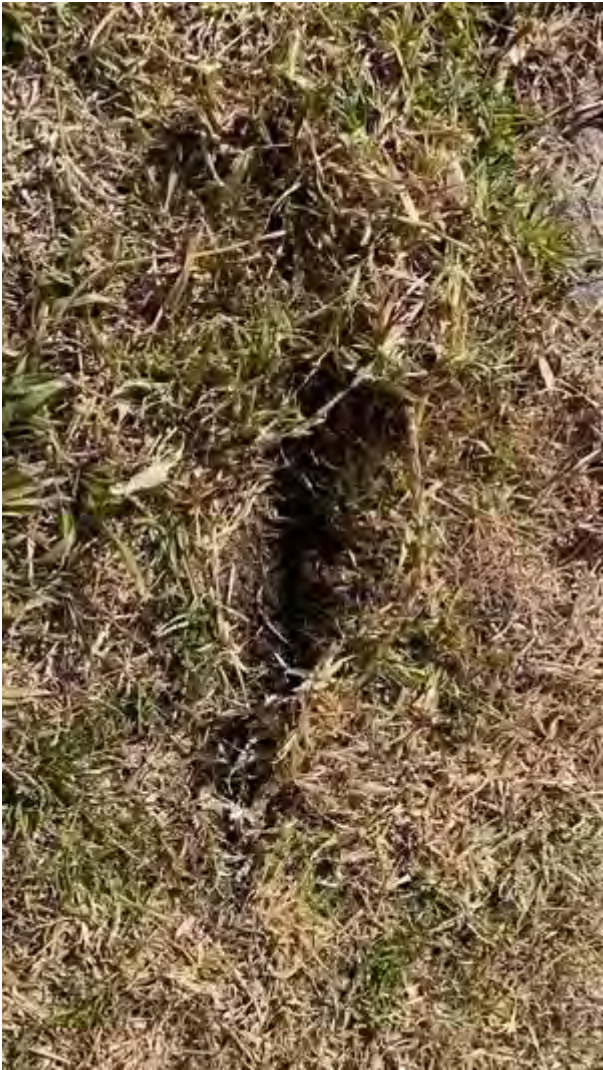
Photos

Project no.	318,001,660	Sample ID	XS099
Project name	Goulburn wheatyards offsite lead deliniation	Sample type	XRF
Start time	13:27	End time	13:28
Date	20/06/2023	Operator	Other
Sample appearance Gravelly silt			
Comments Pb 24 , Cu 38 , Zn 67 , As 0

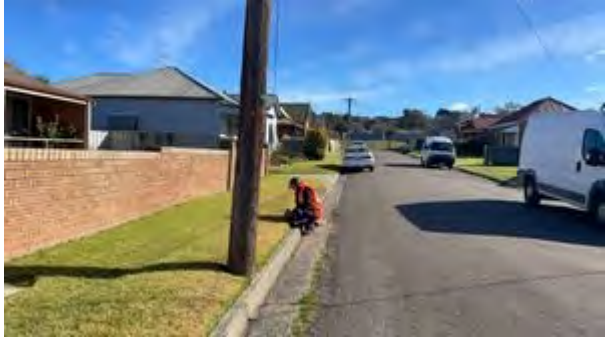
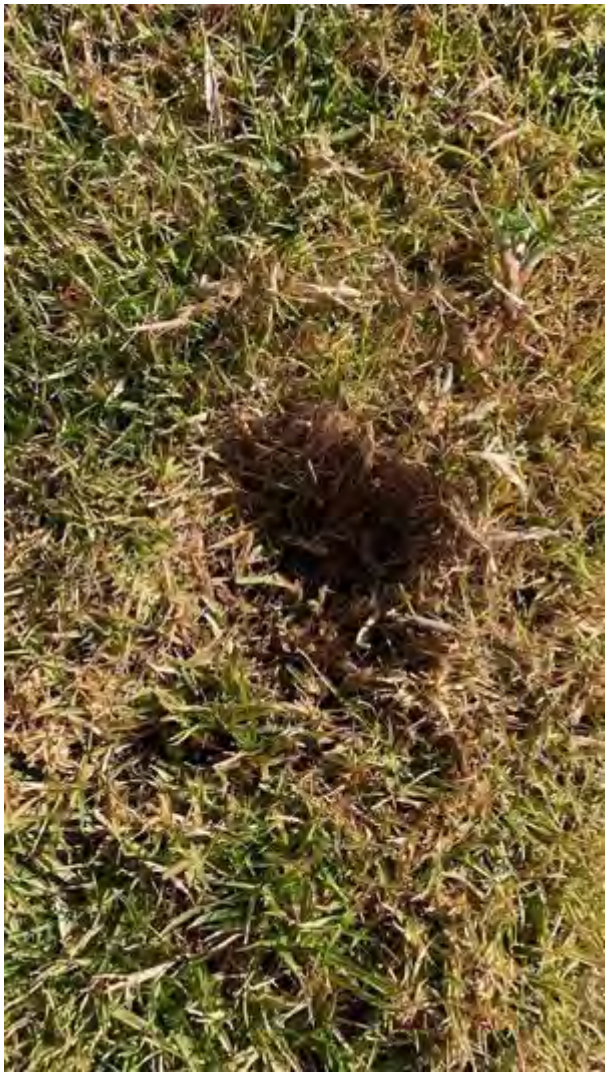
Photos

Project no.	318,001,660	Sample ID	XS098
Project name	Goulburn wheatyards offsite lead deliniation	Sample type	XRF
Start time	13:24	End time	13:25
Date	20/06/2023	Operator	Other
Sample appearance Gravelly silt			
Comments Pb 10, Cu 27, Zn 74, As 0

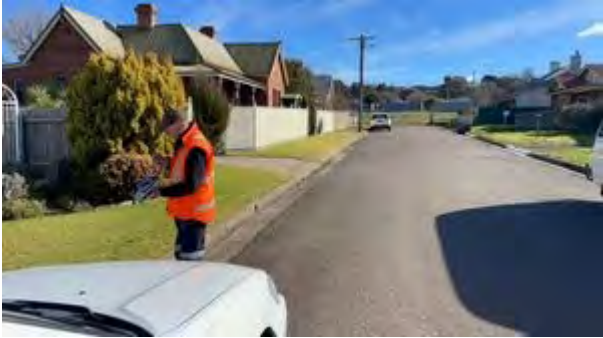
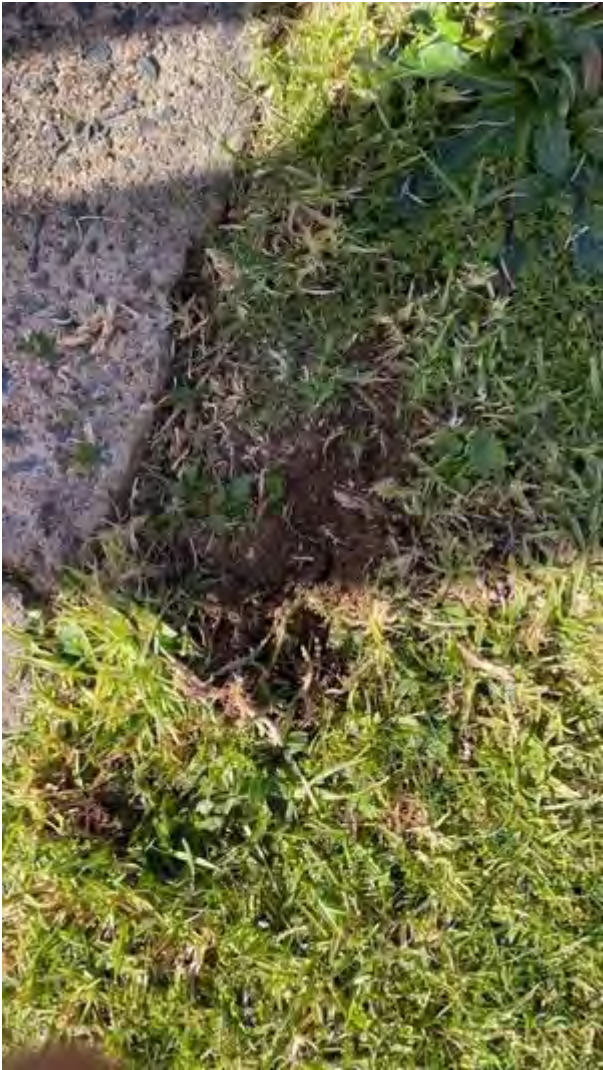
Photos

Project no.	318,001,660	Sample ID	XS097
Project name	Goulburn wheatyards offsite lead deliniation	Sample type	XRF
Start time	13:22	End time	13:23
Date	20/06/2023	Operator	Other
Sample appearance Gravelly silt			
Comments Pb 50, Cu 38, Zn 92, As 0

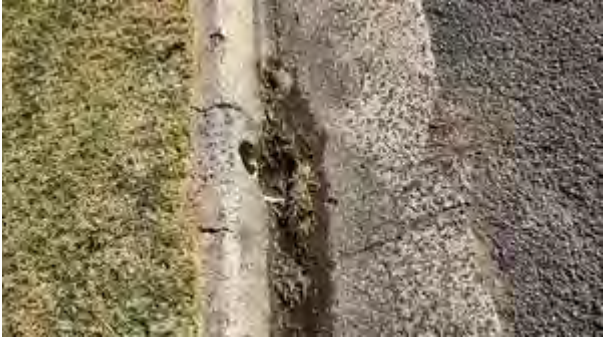
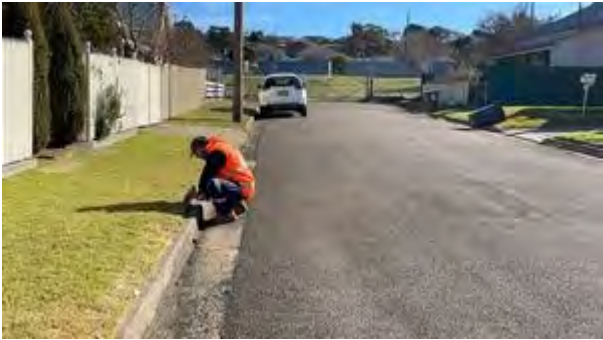
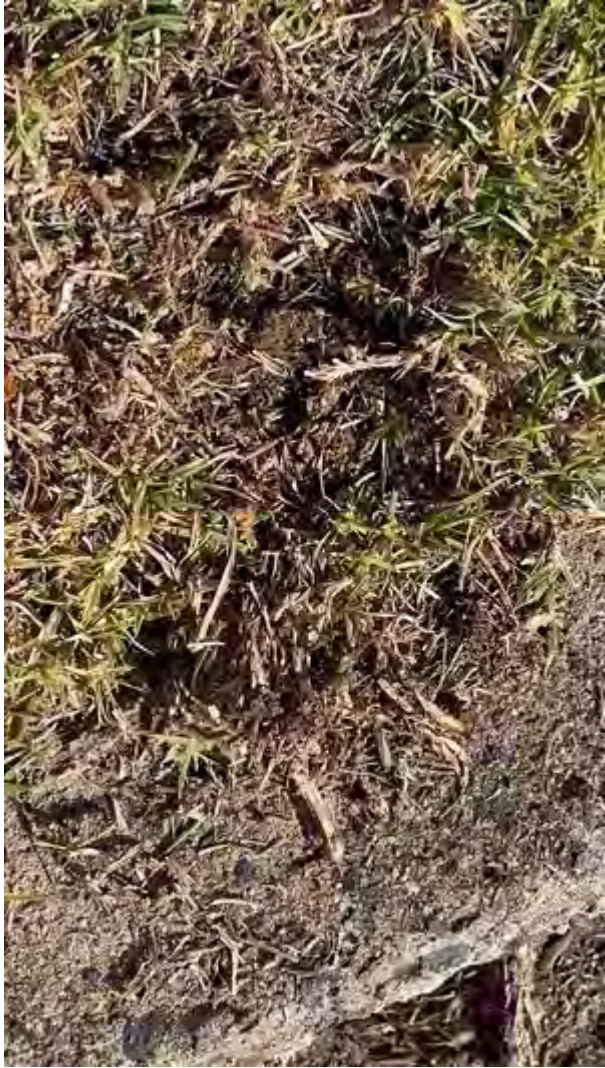
Photos

Project no.	318,001,660	Sample ID	XS096
Project name	Goulburn wheatyards offsite lead deliniation	Sample type	XRF
Start time	13:19	End time	13:20
Date	20/06/2023	Operator	Other
Sample appearance Gravelly silt			
Comments Pb 58, Cu 0, Zn 106, As 0

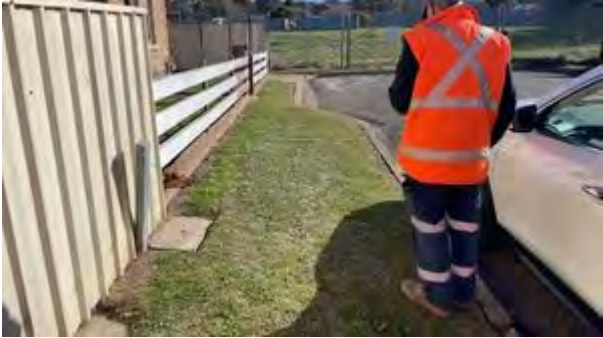
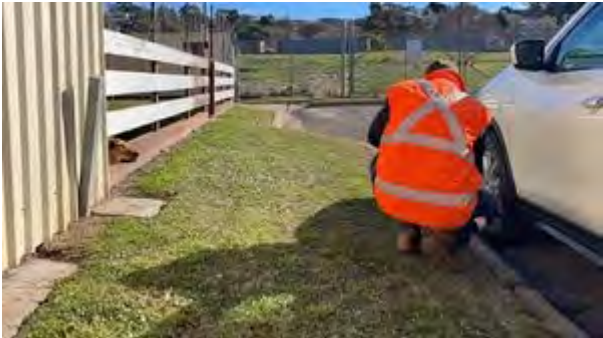
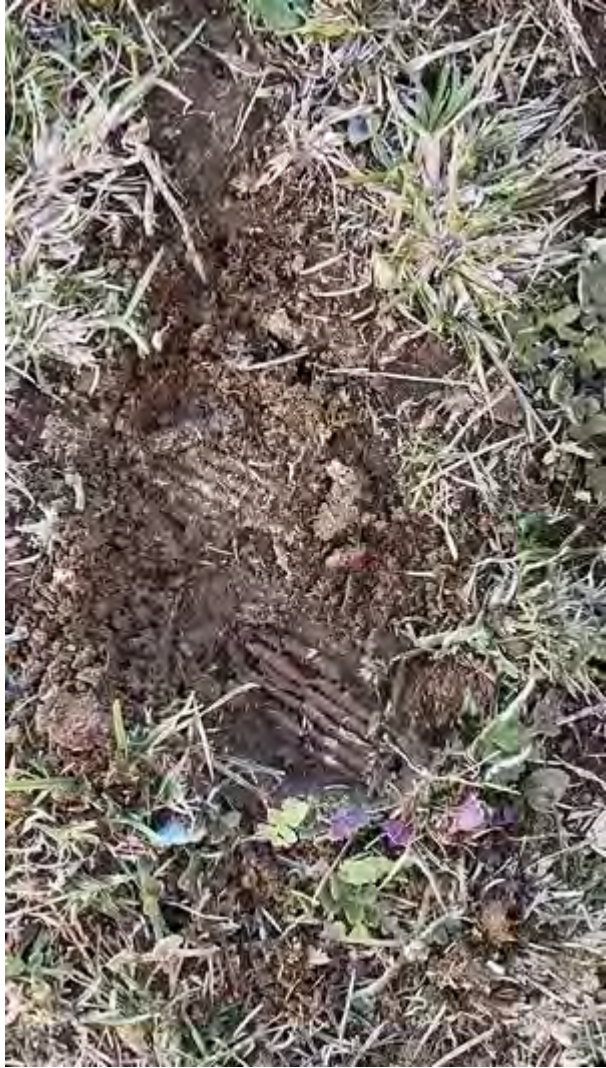
Photos

Project no.	318,001,660	Sample ID	XS095
Project name	Goulburn wheatyards offsite lead deliniation	Sample type	XRF
Start time	13:17	End time	13:18
Date	20/06/2023	Operator	Other
Sample appearance Gravelly silt			
Comments Pb 30, Cu 0, Zn 0, As 0

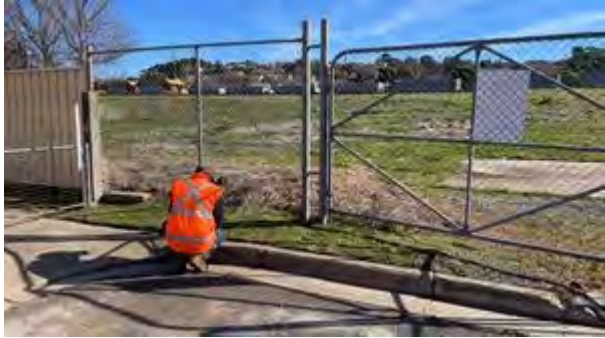
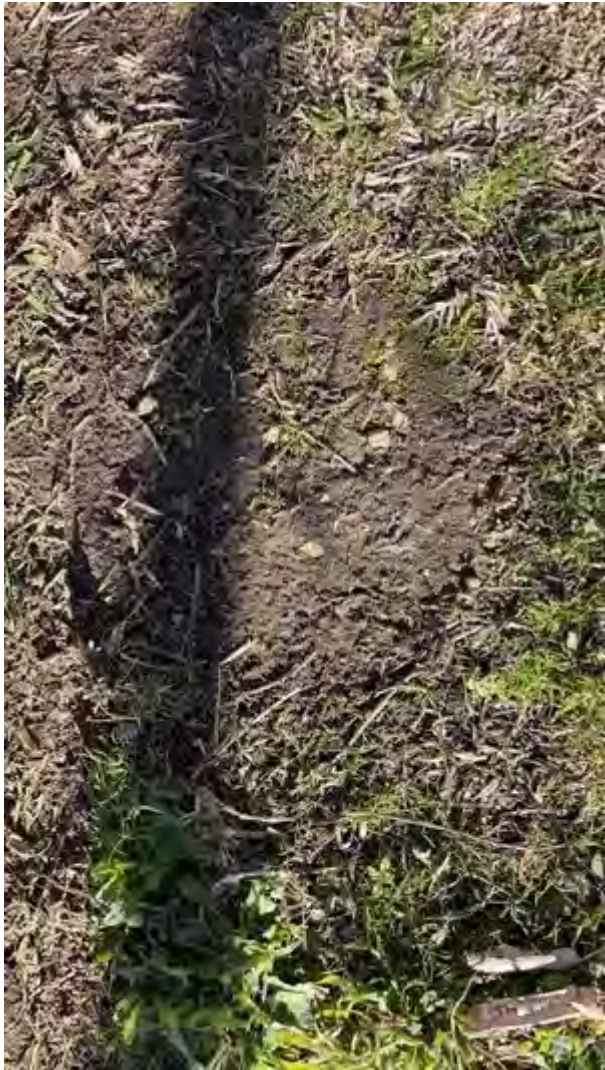
Photos

Project no.	318,001,660	Sample ID	XS094
Project name	Goulburn wheatyards offsite lead deliniation	Sample type	XRF
Start time	13:15	End time	13:16
Date	20/06/2023	Operator	Other
Sample appearance Gravelly silt			
Comments Pb 46, Cu 0, Zn 126, As 0

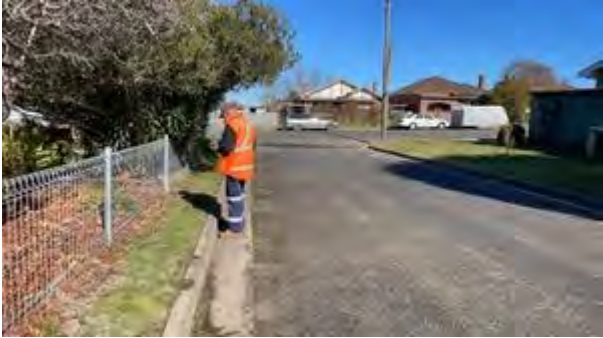
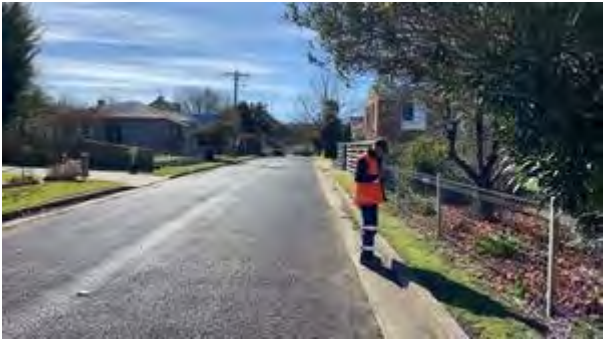
Photos

Project no.	318,001,660	Sample ID	XS093
Project name	Goulburn wheatyards offsite lead deliniation	Sample type	XRF
Start time	12:47	End time	12:48
Date	20/06/2023	Operator	Other
Sample appearance silty sand			
Comments Pb 66, Cu 22, Zn 147, As 0

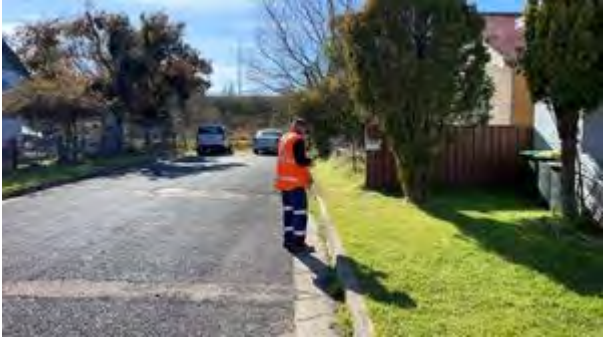
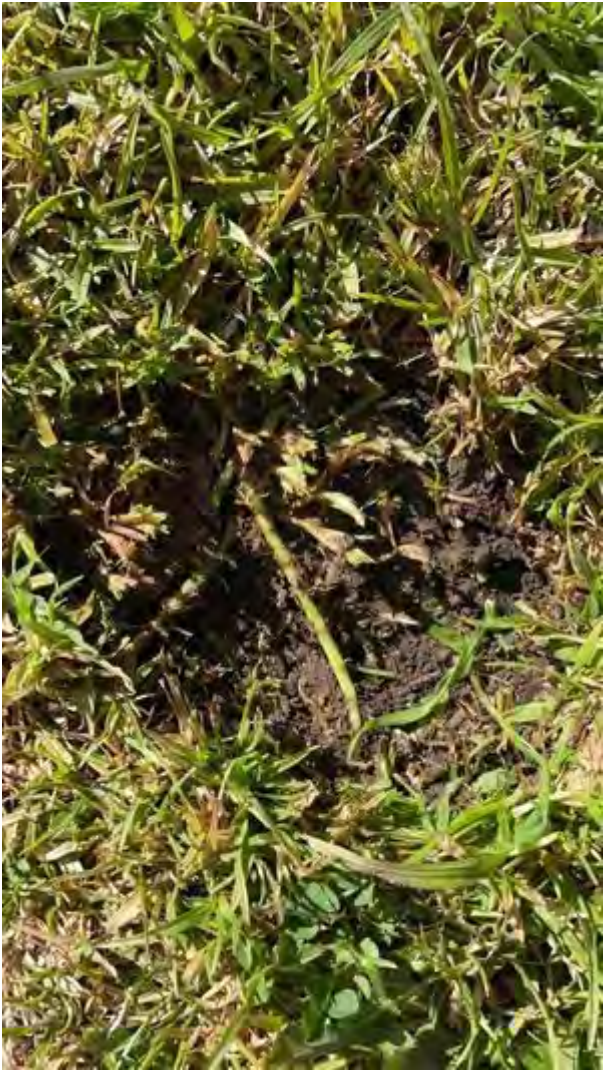
SOIL SAMPLING (XS091)

Project no.	318,001,660	Sample ID	XS091
Project name	Goulburn wheatyards offsite lead deliniation	Sample type	XRF
Start time	12:41	End time	12:42
Date	20/06/2023	Operator	Other
Sample appearance Gravelly silty sand			
Comments Pb 60, Cu 0, Zn 139, As 0

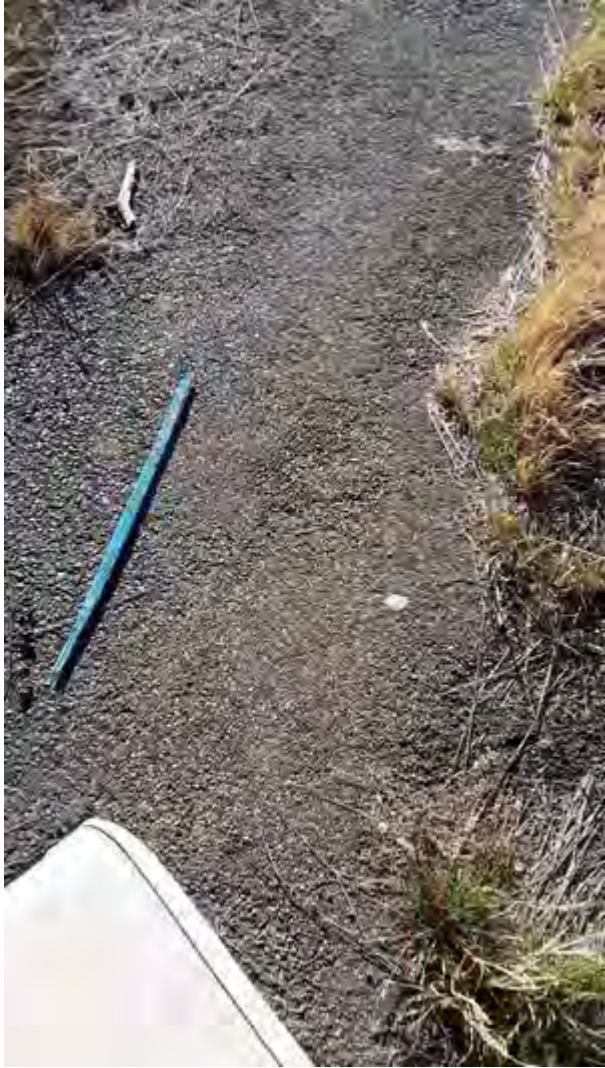
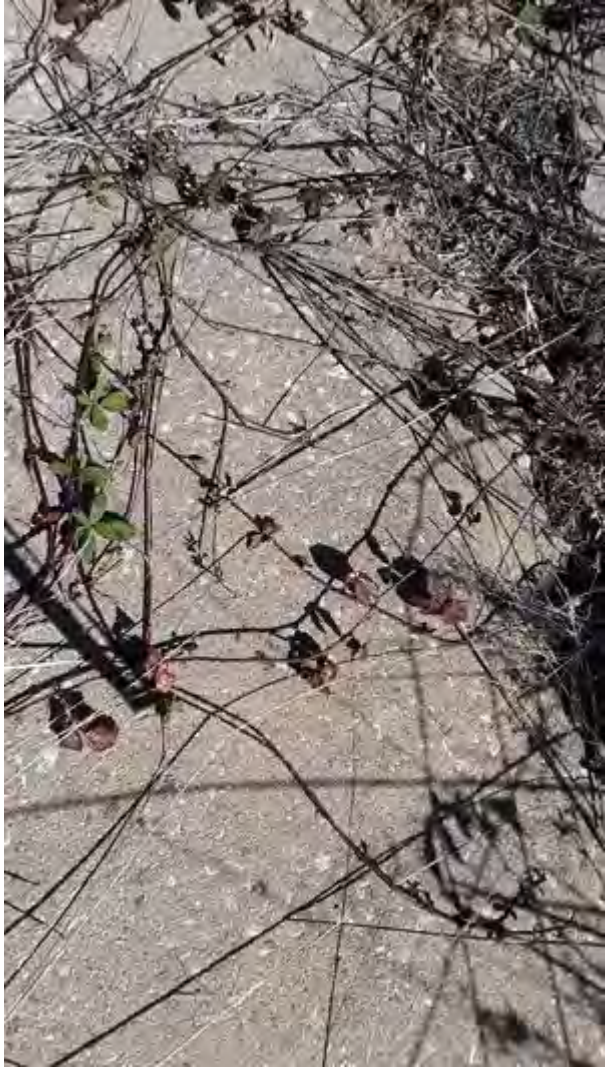
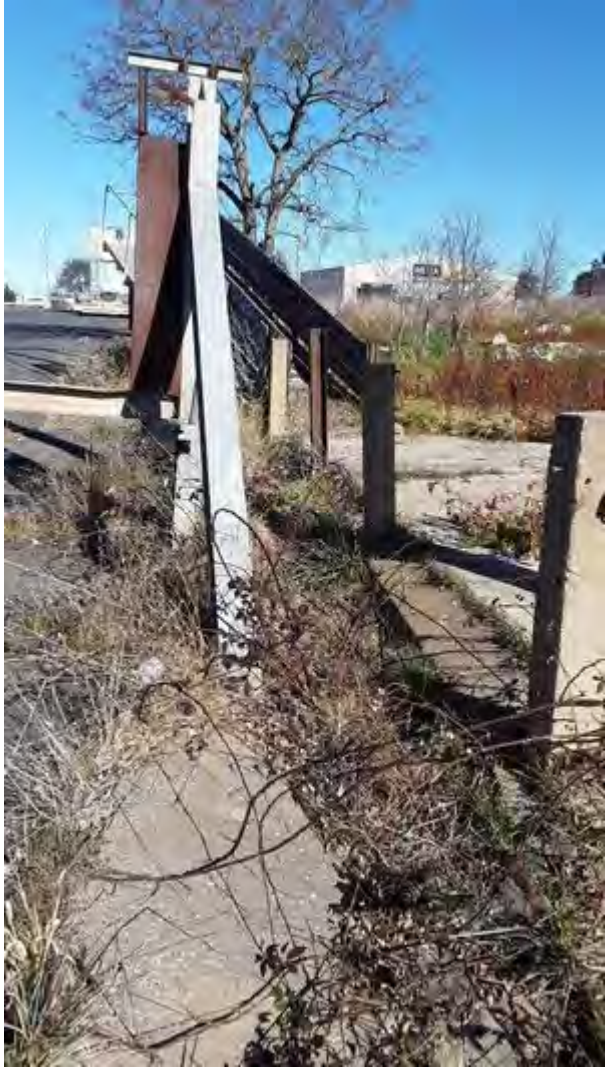
SOIL SAMPLING (XS215)

Project no.	318,001,660	Sample ID	XS215
Project name	Goulburn Wheatyrd Offsite Lead Delineation	Sample type	XRF
Start time	12:31	End time	12:32
Date	21/06/2023	Operator	Other
Sample appearance No sample could be taken			
Comments Sample can not be taken due to ashphalt pavement, concrete gutter and a high fence on concrete

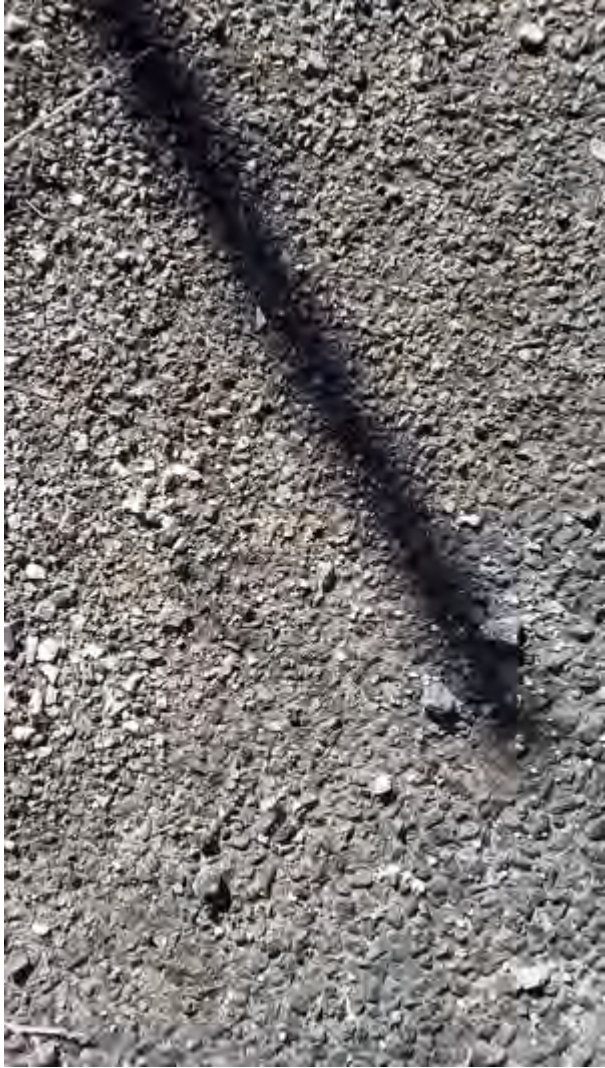
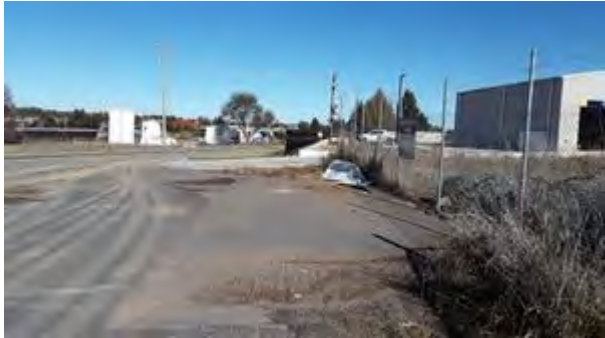
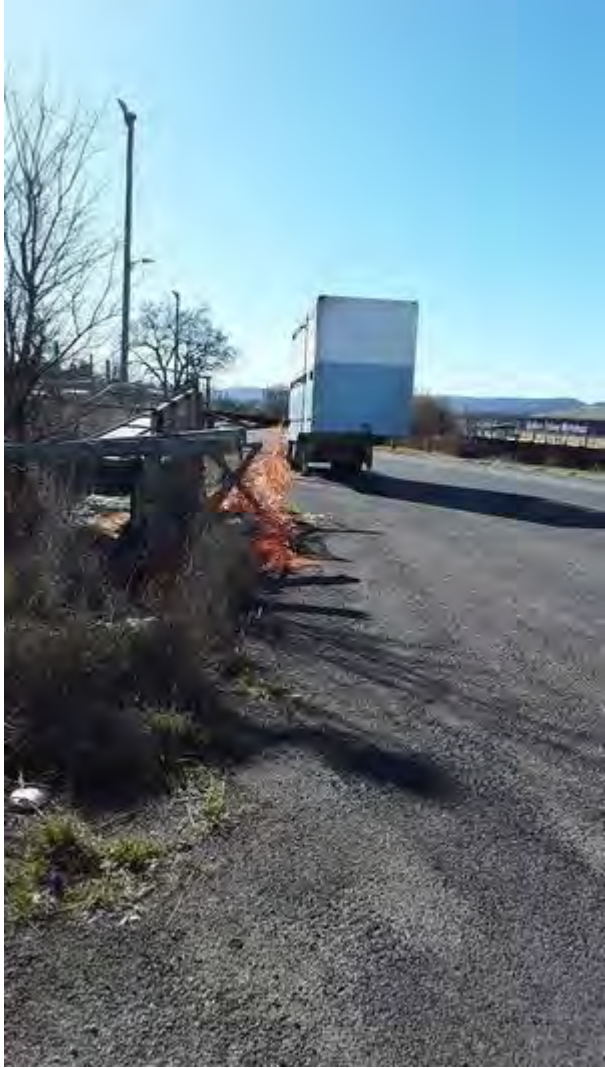
SOIL SAMPLING (XS211)

Project no.	318,001,660	Sample ID	XS211
Project name	Goulburn Wheatyrd Offsite Lead Delineation	Sample type	XRF
Start time	12:23	End time	12:24
Date	21/06/2023	Operator	Other
Sample appearance No sample could be taken			
Comments Sample can not be taken due to ashphalt pavement, concrete gutter and a high fence on concrete

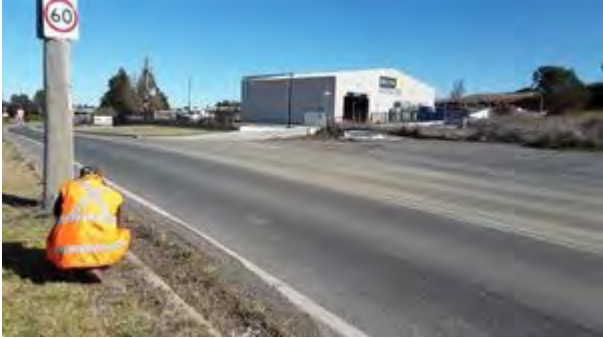
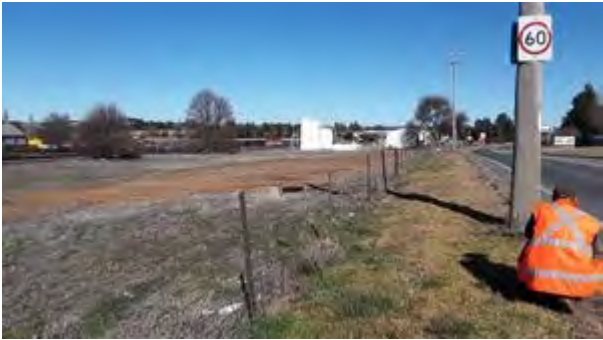
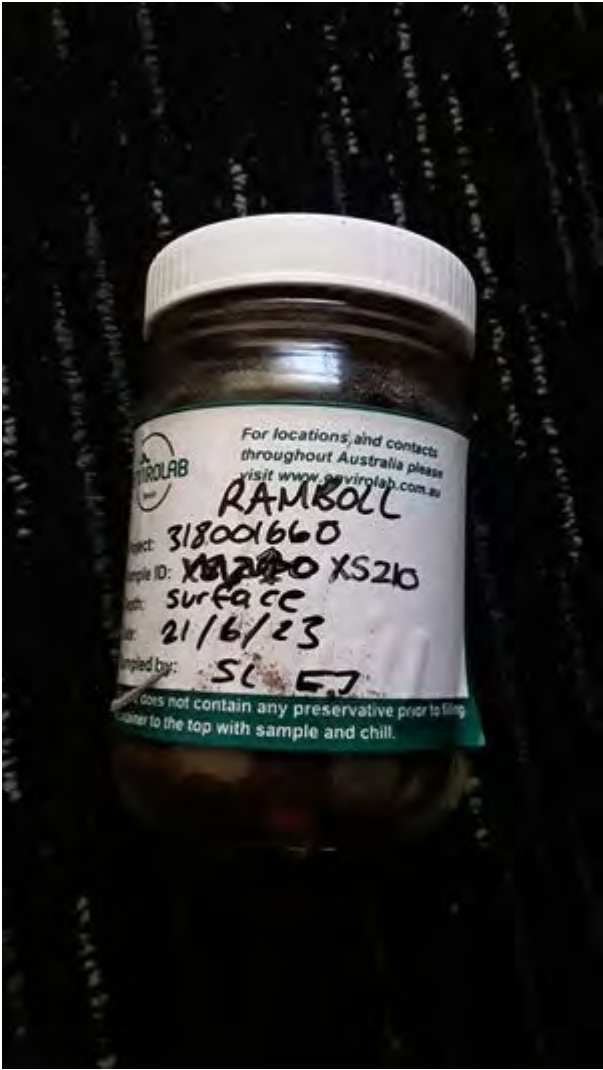
SOIL SAMPLING (XS210)

Project no.	318,001,660	Sample ID	XS210
Project name	Goulburn Wheatyrd Offsite Lead Delineation	Sample type	XRF
Start time	12:05	End time	12:06
Date	21/06/2023	Operator	Other
Sample appearance Pb 0, Cu 0 , Zn 87 , As 0			
Comments Fine gravely sandy silt, sample taken

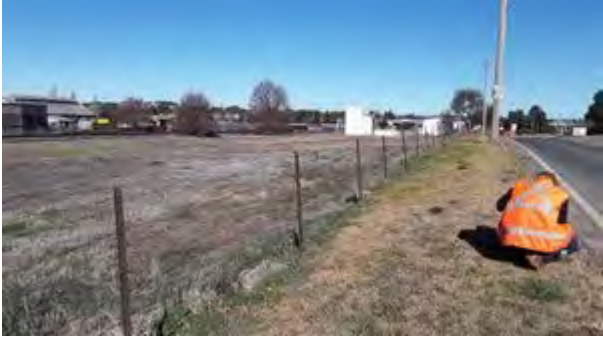
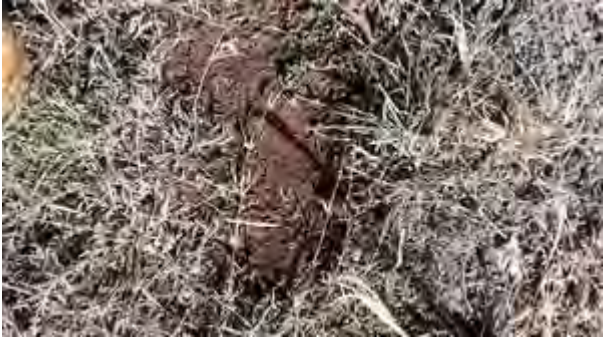
SOIL SAMPLING (XS209)

Project no.	318,001,660	Sample ID	XS209
Project name	Goulburn Wheatyrd Offsite Lead Delineation	Sample type	XRF
Start time	12:03	End time	12:04
Date	21/06/2023	Operator	Other
Sample appearance Pb 14, Cu 0 , Zn 42 , As 0			
Comments Fine gravely sandy silt

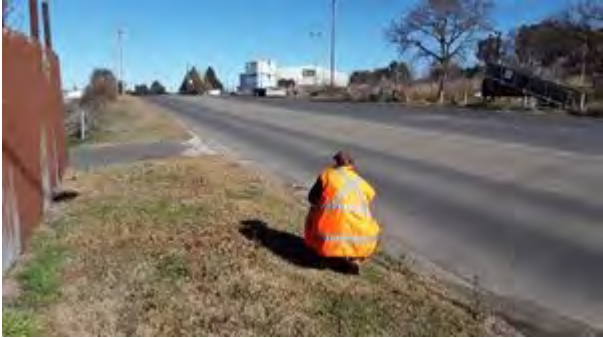
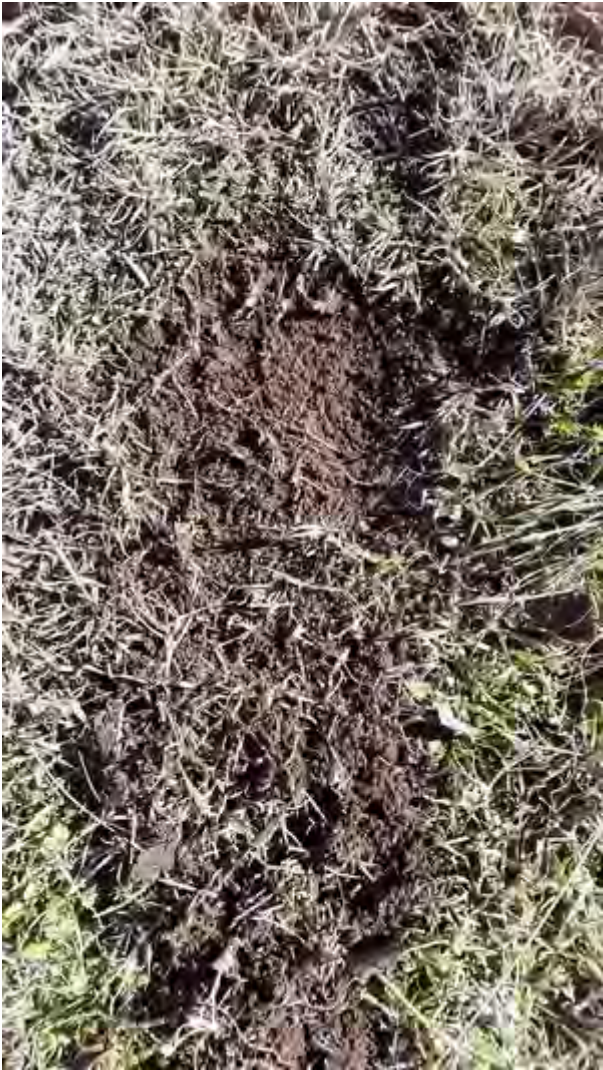
SOIL SAMPLING (XS206)

Project no.	318,001,660	Sample ID	XS206
Project name	Goulburn Wheatyrd Offsite Lead Delineation	Sample type	XRF
Start time	11:56	End time	11:57
Date	21/06/2023	Operator	Other
Sample appearance Pb 33, Cu 0 , Zn 120 , As 0			
Comments Fine gravely sandy silt

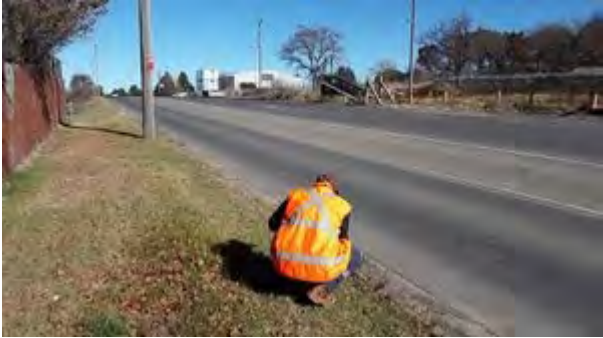
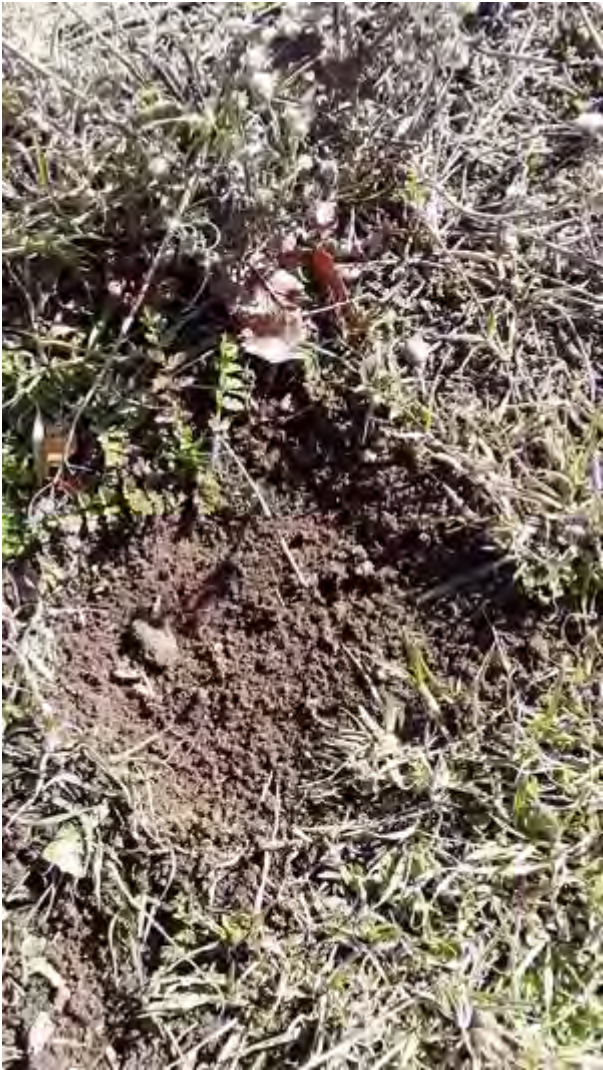
SOIL SAMPLING (XS205)

Project no.	318,001,660	Sample ID	XS205
Project name	Goulburn Wheatyrd Offsite Lead Delineation	Sample type	XRF
Start time	11:54	End time	11:55
Date	21/06/2023	Operator	Other
Sample appearance Pb 35, Cu 0 , Zn 73 , As 0			
Comments Fine gravely sandy silt

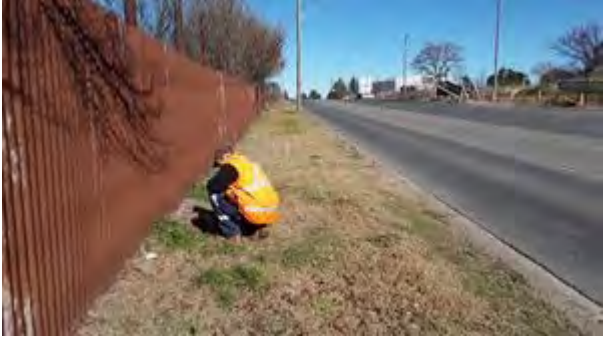
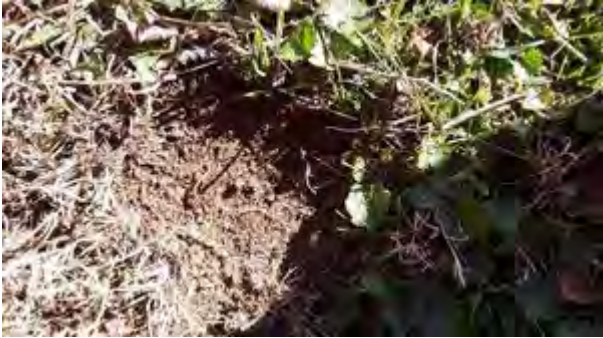
SOIL SAMPLING (XS204)

Project no.	318,001,660	Sample ID	XS204
Project name	Goulburn Wheatyrd Offsite Lead Delineation	Sample type	XRF
Start time	11:52	End time	11:53
Date	21/06/2023	Operator	Other
Sample appearance Pb 0, Cu 0 , Zn 107 , As 0			
Comments Fine gravely sandy silt

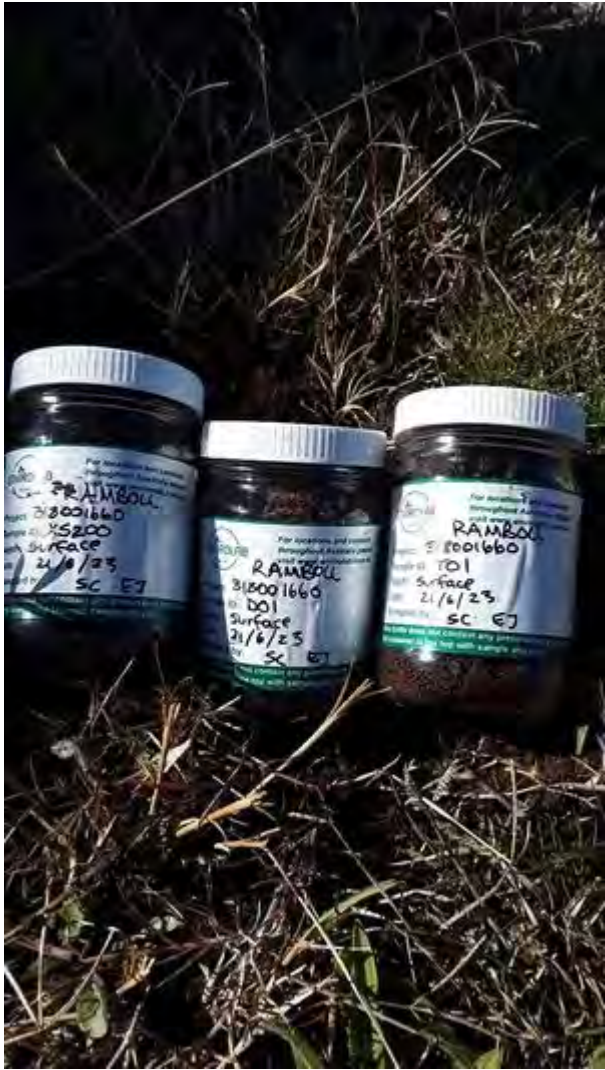
SOIL SAMPLING (XS199)

Project no.	318,001,660	Sample ID	XS199
Project name	Goulburn Wheatyrd Offsite Lead Delineation	Sample type	XRF
Start time	11:29	End time	11:30
Date	21/06/2023	Operator	Other
Sample appearance Pb 71, Cu 0 , Zn 0 , As 0			
Comments Fine gravely silt

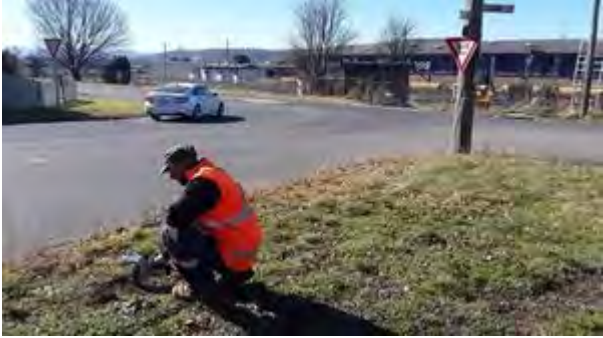
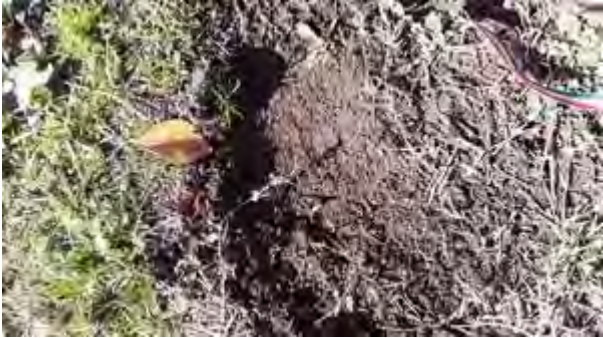
SOIL SAMPLING (XS198)

Project no.	318,001,660	Sample ID	XS198
Project name	Goulburn Wheatyard Offsite Lead Delineation	Sample type	XRF
Start time	11:27	End time	11:28
Date	21/06/2023	Operator	Other
Sample appearance Pb 99, Cu 0 , Zn 0 , As 0			
Comments Gravelly silty sand

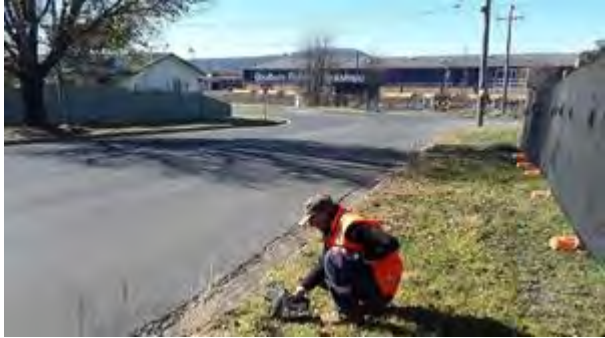
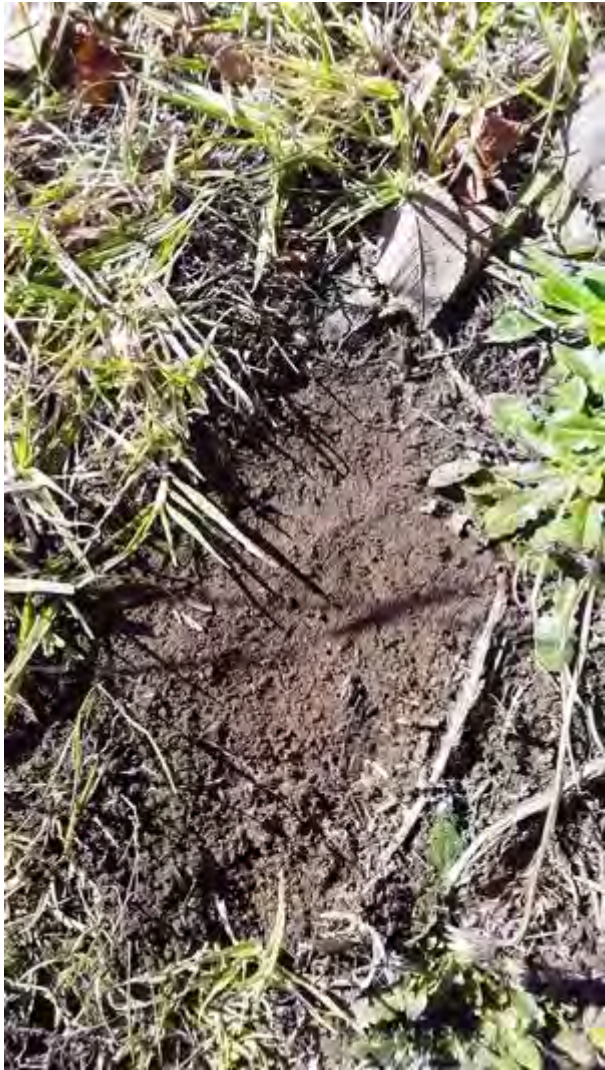
SOIL SAMPLING (XS197)

Project no.	318,001,660	Sample ID	XS197
Project name	Goulburn Wheatyrd Offsite Lead Delineation	Sample type	XRF
Start time	11:25	End time	11:26
Date	21/06/2023	Operator	Other
Sample appearance Pb 83, Cu 0 , Zn 0 , As 0			
Comments Gravelly silty sand

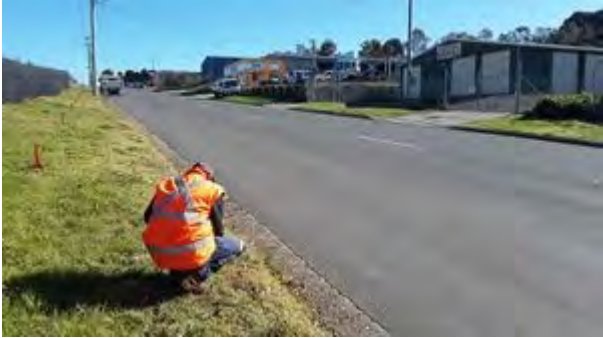
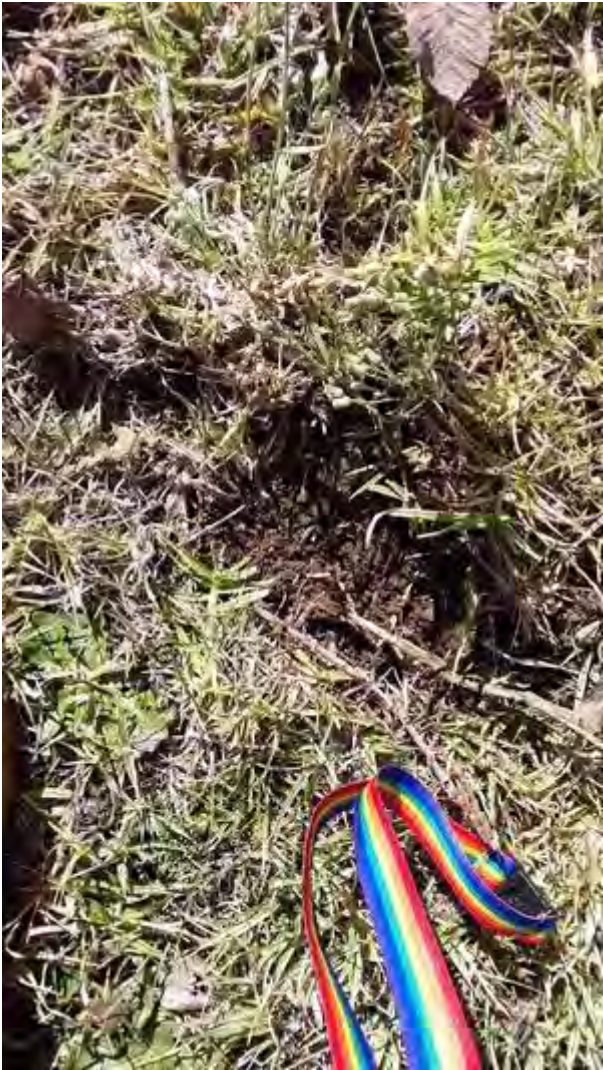
SOIL SAMPLING (XS195)

Project no.	318,001,660	Sample ID	XS195
Project name	Goulburn Wheatyrd Offsite Lead Delineation	Sample type	XRF
Start time	11:21	End time	11:22
Date	21/06/2023	Operator	Other
Sample appearance Pb 71, Cu 0 , Zn 0 , As 0			
Comments Gravelly silty sand

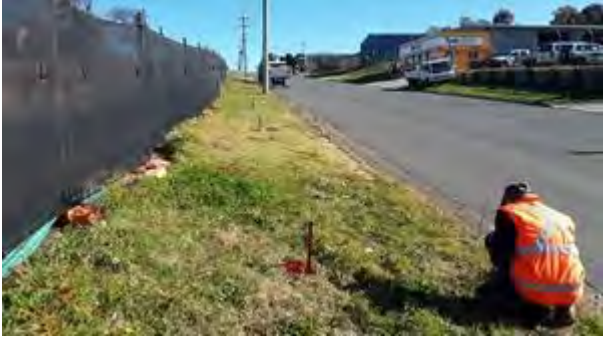
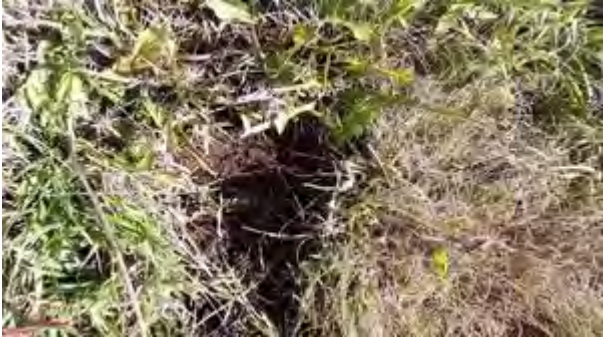
SOIL SAMPLING (XS194)

Project no.	318,001,660	Sample ID	XS194
Project name	Goulburn Wheatyrd Offsite Lead Delineation	Sample type	XRF
Start time	11:19	End time	11:20
Date	21/06/2023	Operator	Other
Sample appearance Pb 0, Cu 36 , Zn 53 , As 0			
Comments Gravely silty sand

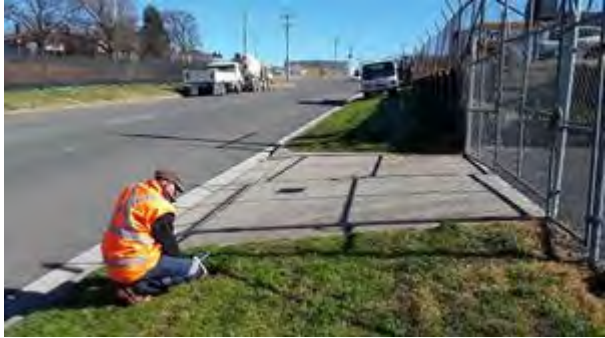
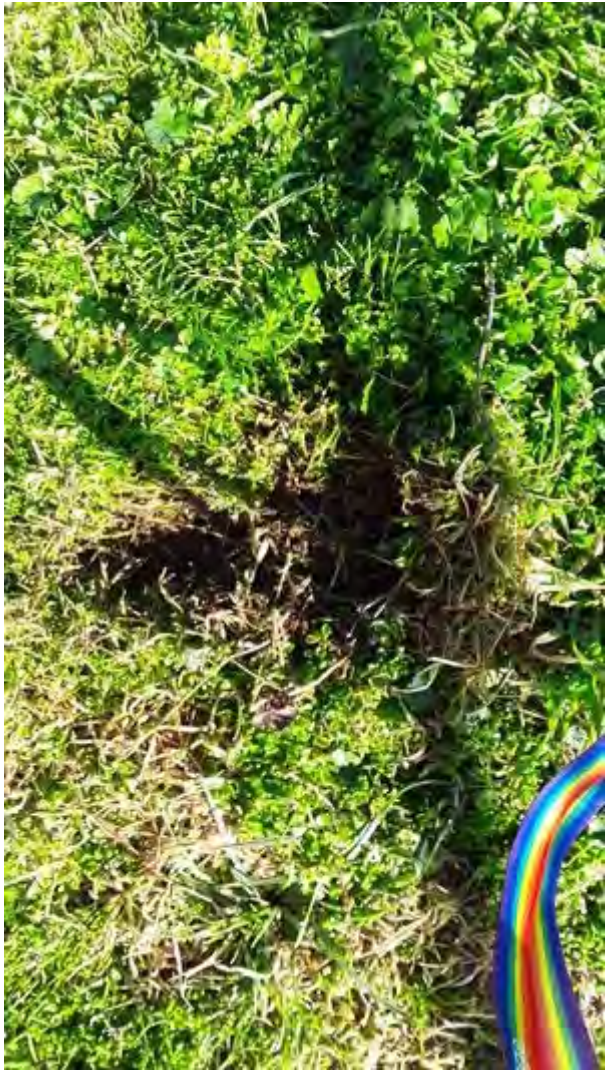
SOIL SAMPLING (XS193)

Project no.	318,001,660	Sample ID	XS193
Project name	Goulburn Wheatyrd Offsite Lead Delineation	Sample type	XRF
Start time	11:17	End time	11:18
Date	21/06/2023	Operator	Other
Sample appearance Pb 0, Cu 0 , Zn 107 , As 0			
Comments Gravelly silty sand

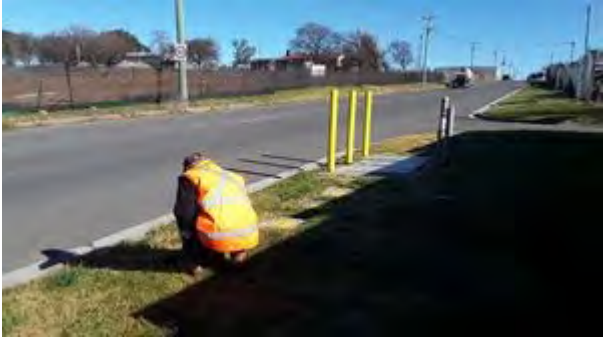
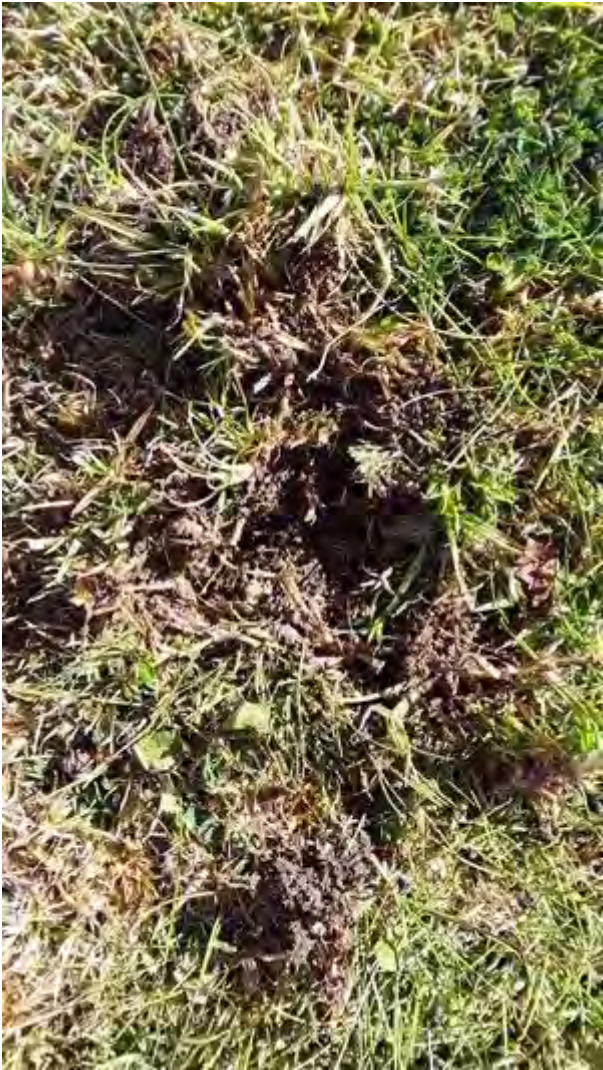
SOIL SAMPLING (XS189)

Project no.	318,001,660	Sample ID	XS189
Project name	Goulburn Wheatyard Offsite Lead Delineation	Sample type	XRF
Start time	11:01	End time	11:02
Date	21/06/2023	Operator	Other
Sample appearance Pb 15, Cu 0 , Zn 0 , As 0			
Comments Gravelly silty sand light brown
