Goulburn Wheat Yards Assessment

Offsite Lead Delineation Preliminary Site
Investigation

Project name **Goulburn Wheat Yards Assessment - Offsite Lead Delineation Preliminary Site Investigation**
Project no. **318001660**
Recipient **ARTC**
Document type **Final Report**
Version **1**
Date **7 September 2023**
Prepared by **N. Gilbert**
Checked by **R. Condon / K. Greenfield (CEnvP SC40104)**
Approved by **A. Nolan**
Description **This document presents the results of an environmental assessment to assess the potential offsite risk of lead contamination surrounding the Goulburn Wheat Yards.**

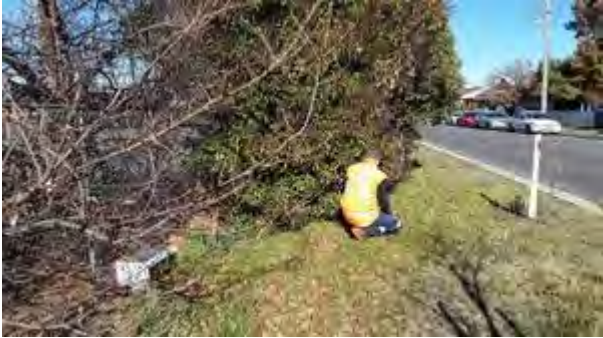
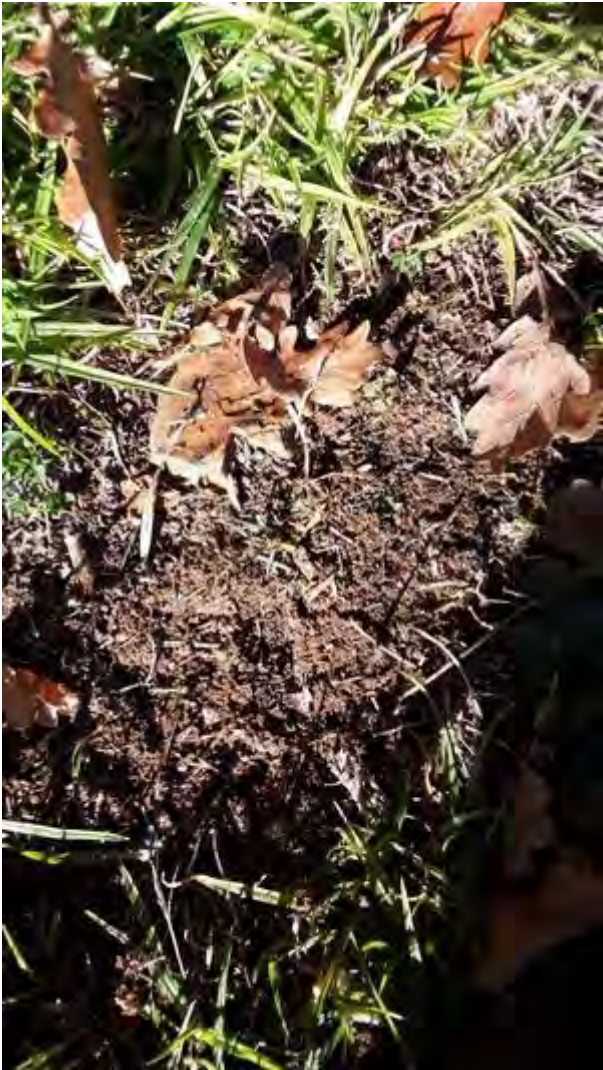
SOIL SAMPLING (XS188)

Project no.	318,001,660	Sample ID	XS188
Project name	Goulburn Wheatyrd Offsite Lead Delineation	Sample type	XRF
Start time	10:59	End time	11:00
Date	21/06/2023	Operator	Other
Sample appearance Pb 0, Cu 0 , Zn 0 , As 0			
Comments Gravelly silty sand light brown

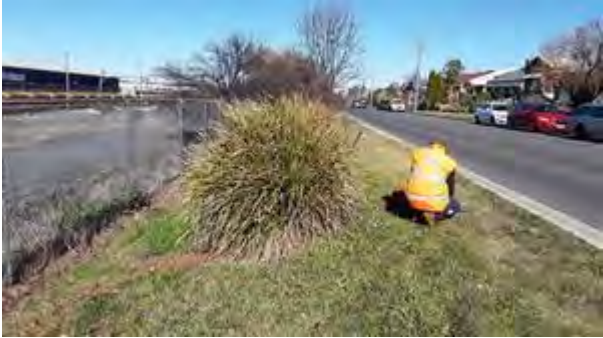
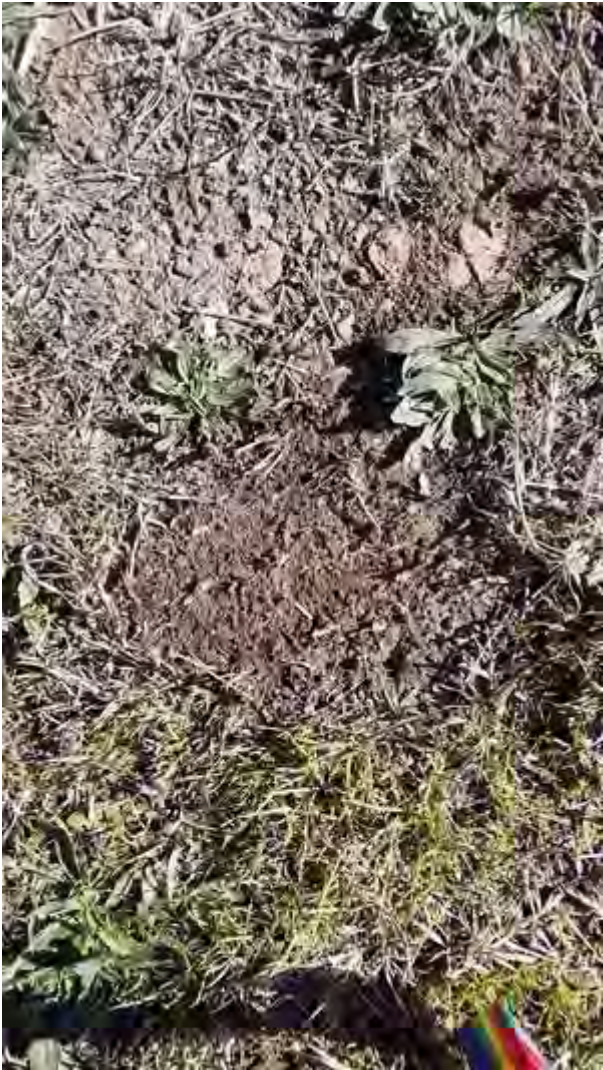
SOIL SAMPLING (XS187)

Project no.	318,001,660	Sample ID	XS187
Project name	Goulburn Wheatyard Offsite Lead Delineation	Sample type	XRF
Start time	10:57	End time	10:58
Date	21/06/2023	Operator	Other
Sample appearance Pb 23, Cu 0 , Zn34 , As 0			
Comments Gravelly silty sand dark brown

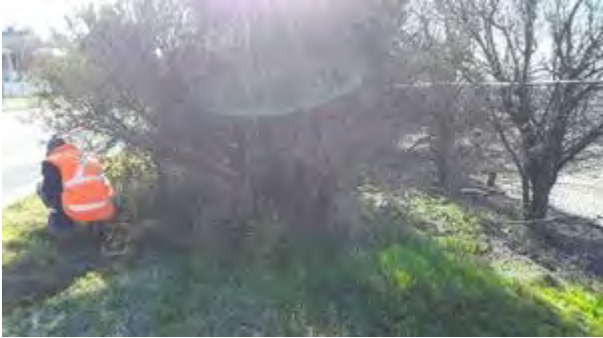
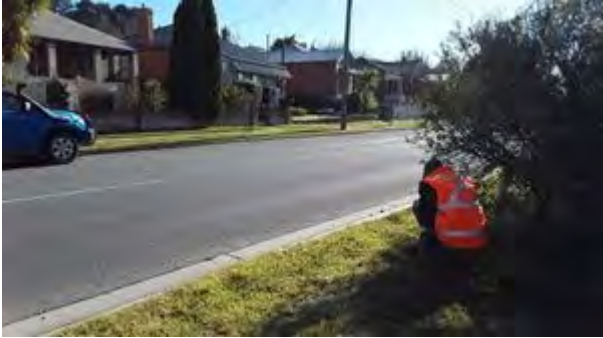
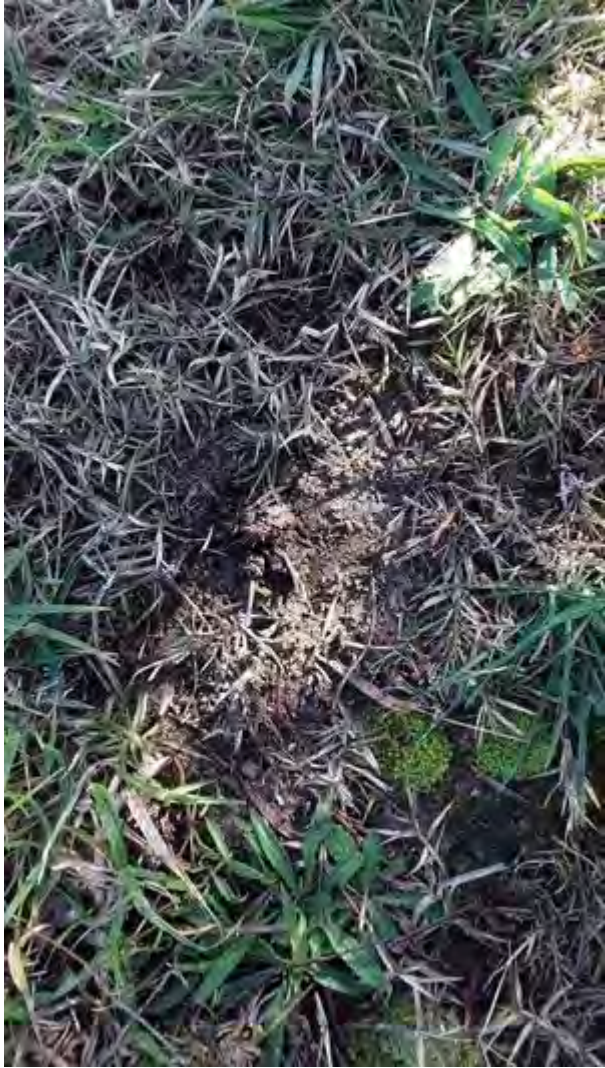
SOIL SAMPLING (XS183)

Project no.	318,001,660	Sample ID	XS183
Project name	Goulburn Wheatyrd Offsite Lead Delineation	Sample type	XRF
Start time	10:48	End time	10:49
Date	21/06/2023	Operator	Other
Sample appearance Pb 19, Cu 0 , Zn 112, As 0			
Comments Gravelly silty sand dark brown

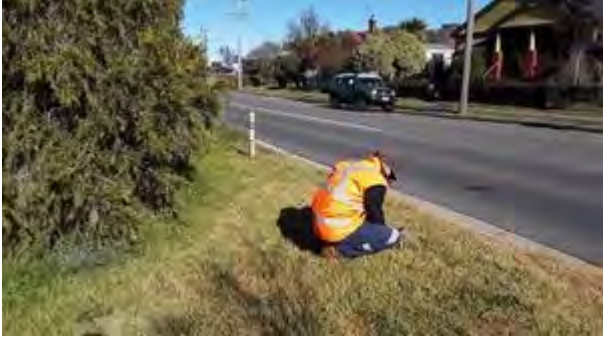
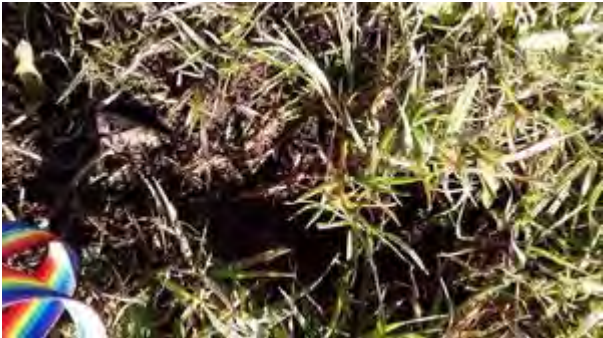
SOIL SAMPLING (XS182)

Project no.	318,001,660	Sample ID	XS182
Project name	Goulburn Wheatyard Offsite Lead Delineation	Sample type	XRF
Start time	10:45	End time	10:46
Date	21/06/2023	Operator	Other
Sample appearance Pb 0, Cu 0 , Zn 0, As 0			
Comments Gravelly silty sand dark brown

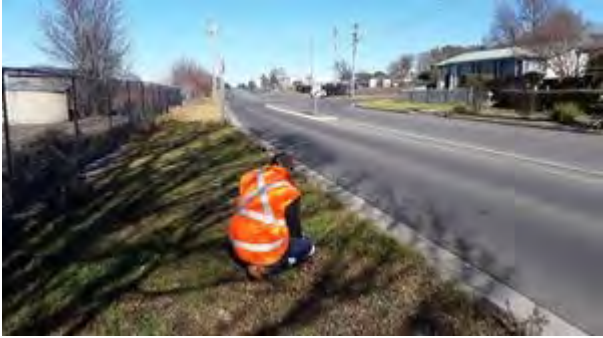
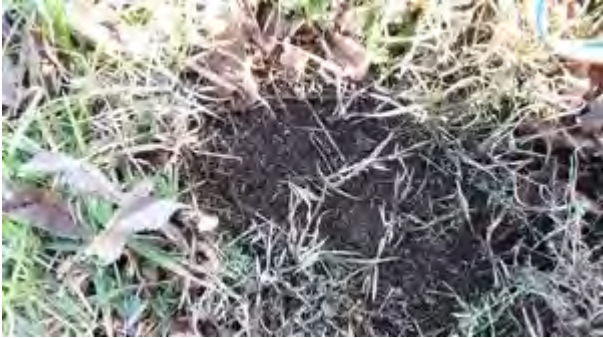
SOIL SAMPLING (XS180)

Project no.	318,001,660	Sample ID	XS180
Project name	Goulburn Wheatyrd Offsite Lead Delineation	Sample type	XRF
Start time	09:47	End time	09:48
Date	21/06/2023	Operator	Other
Sample appearance Pb 0, Cu 0 , Zn 0, As 22			
Comments Gravelly silty sand

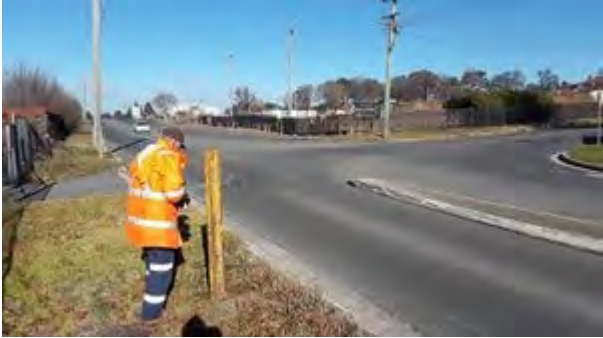
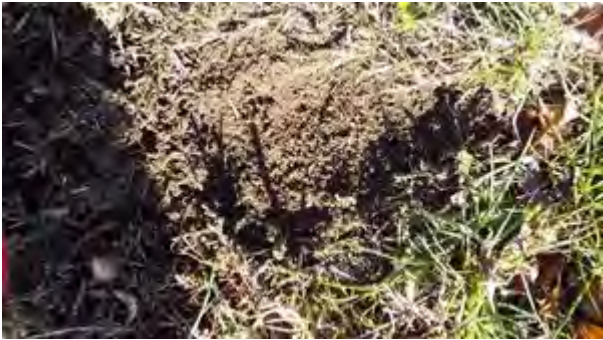
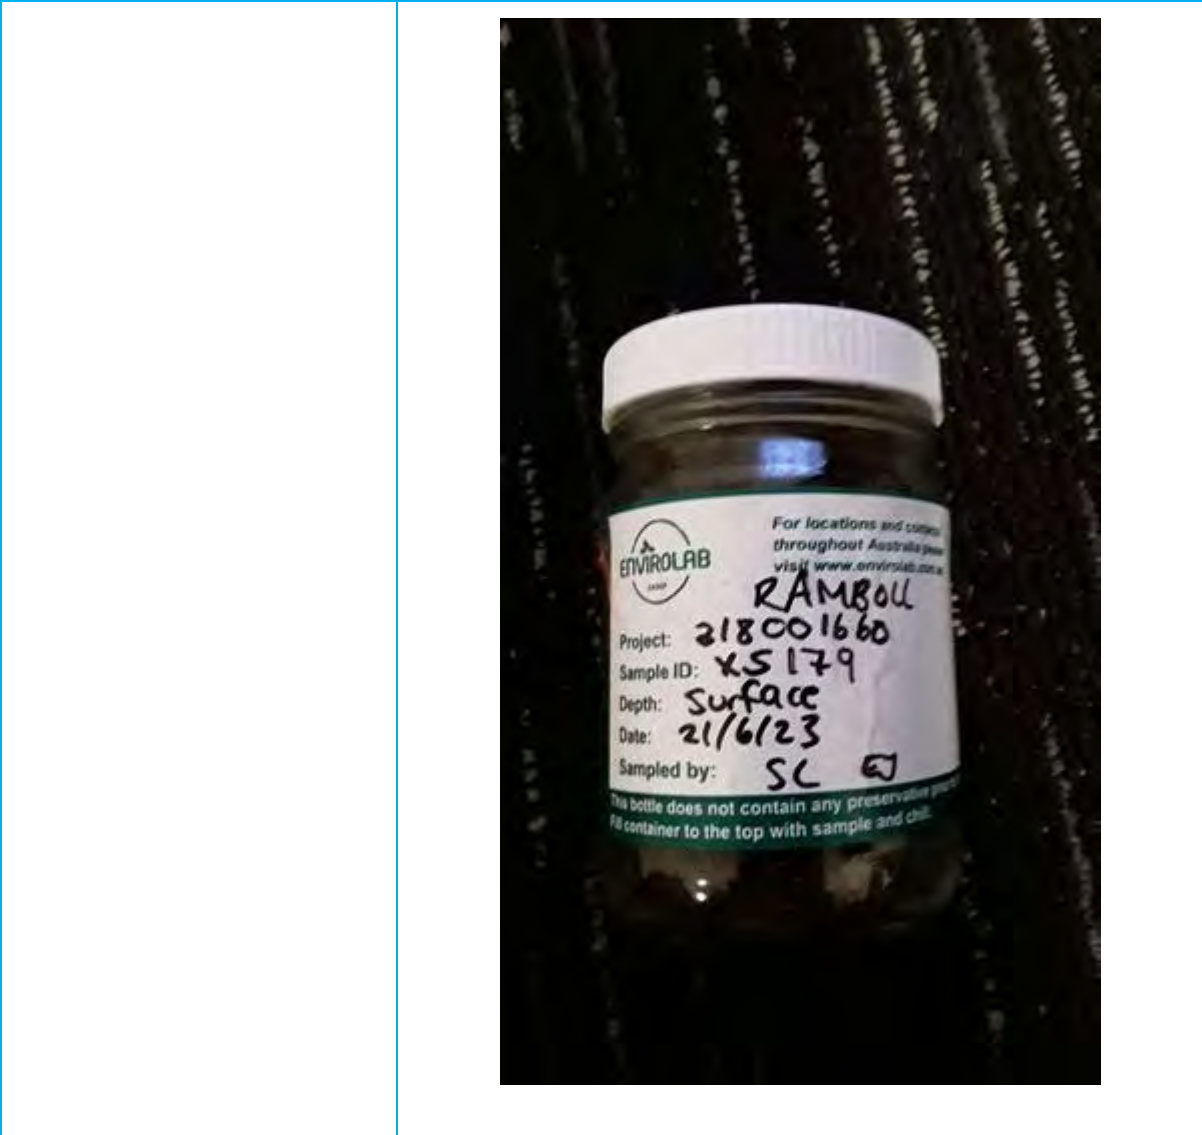
Project no.	318,001,660	Sample ID	XS178
Project name	Goulburn Wheatyrd Offsite Lead Delineation	Sample type	XRF
Start time	09:41	End time	09:43
Date	21/06/2023	Operator	Other
Sample appearance Pb 0, Cu 0 , Zn 0, As 0			
Comments Gravely silty sand

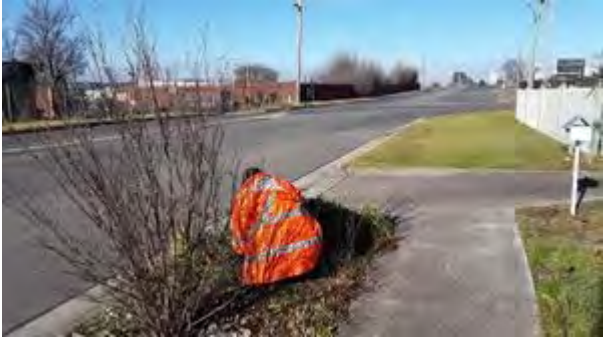
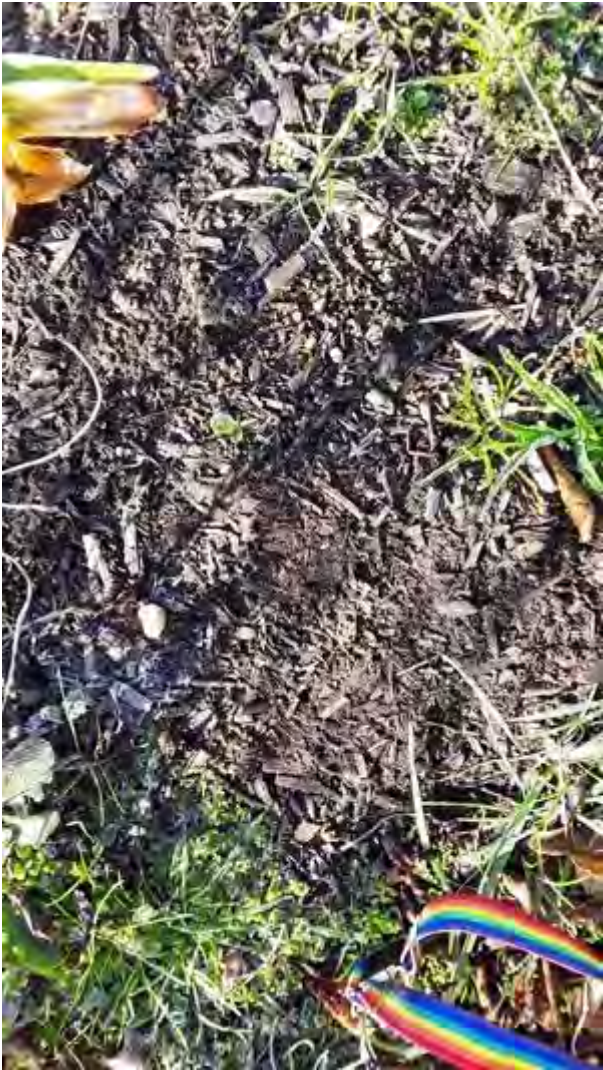
SOIL SAMPLING (XS176)

Project no.	318,001,660	Sample ID	XS176
Project name	Goulburn Wheatyrd Offsite Lead Delineation	Sample type	XRF
Start time	09:34	End time	09:35
Date	21/06/2023	Operator	Other
Sample appearance Pb 45, Cu 0 , Zn 112, As 0			
Comments Gravelly silty sand

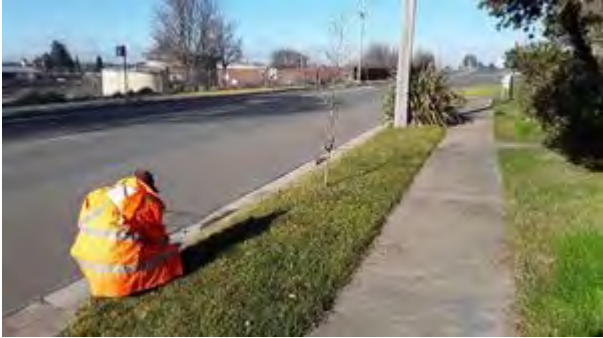
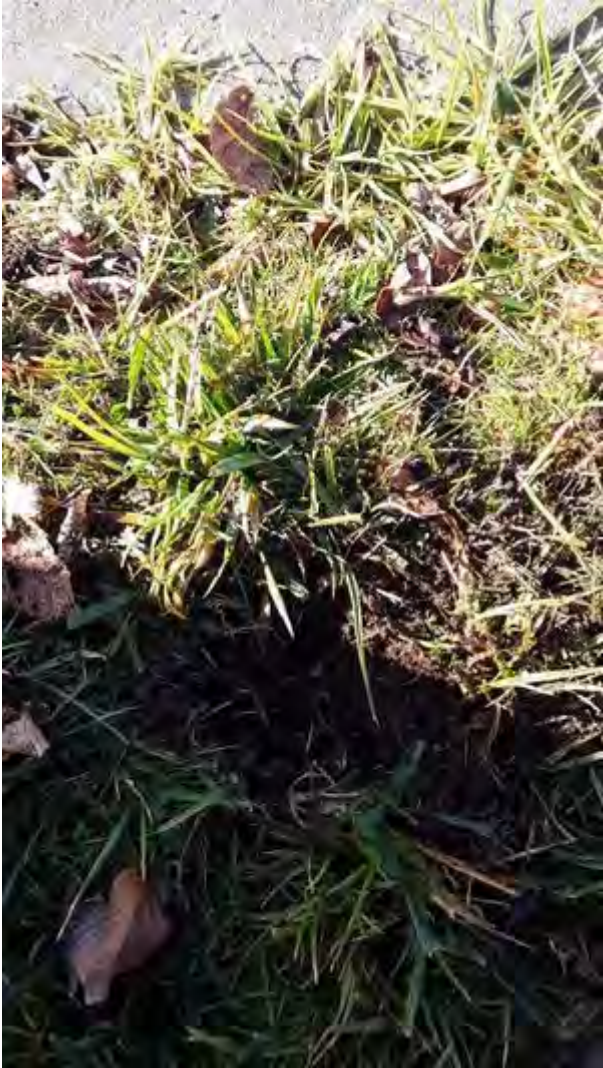
SOIL SAMPLING (XS175)

Project no.	318,001,660	Sample ID	XS175
Project name	Goulburn Wheatyard Offsite Lead Delineation	Sample type	XRF
Start time	09:31	End time	09:32
Date	21/06/2023	Operator	Other
Sample appearance Pb 0, Cu 0 , Zn 0, As 0			
Comments Gravelly silty sand

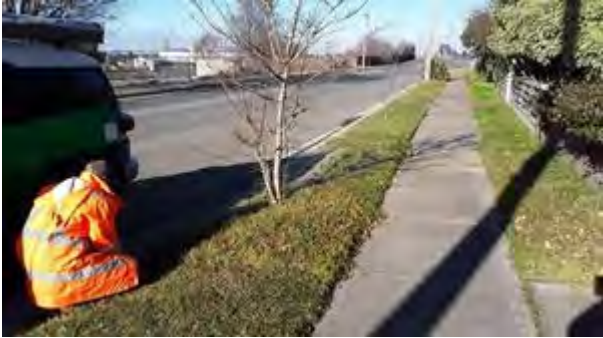
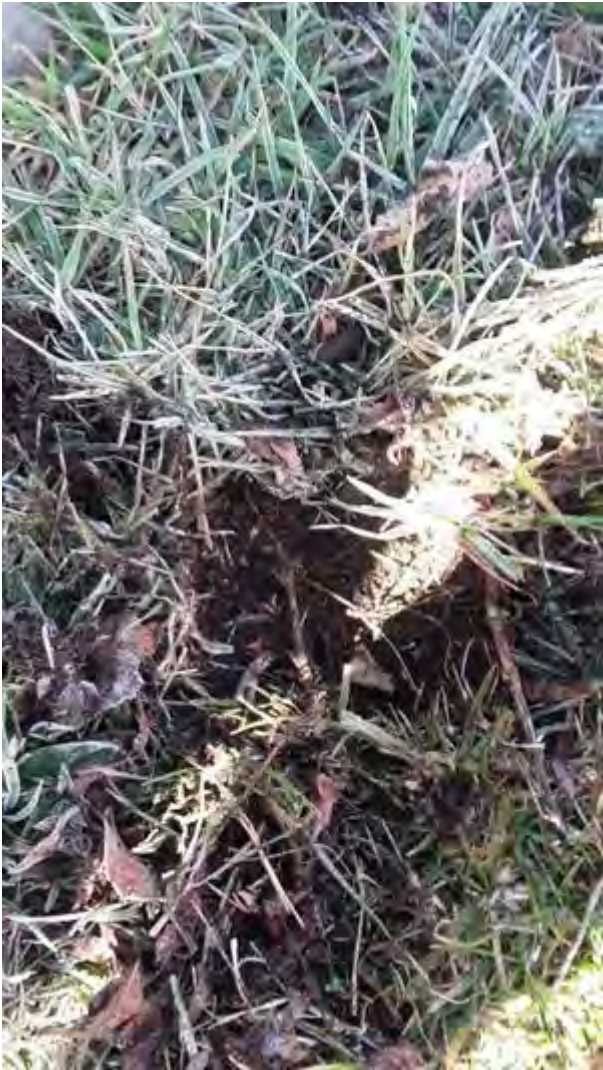
SOIL SAMPLING (XS174)

Project no.	318,001,660	Sample ID	XS174
Project name	Goulburn Wheatyrd Offsite Lead Delineation	Sample type	XRF
Start time	09:28	End time	09:29
Date	21/06/2023	Operator	Other
Sample appearance Pb 0, Cu 0 , Zn 0, As 23			
Comments Gravelly silty sand

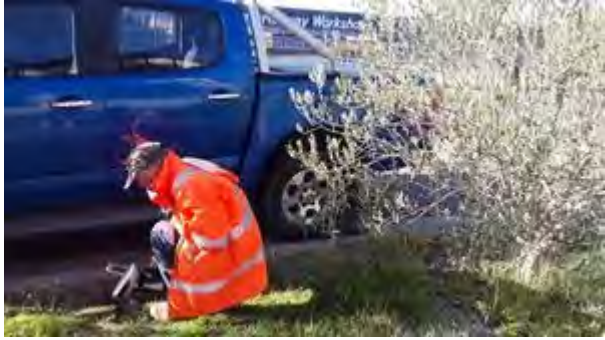
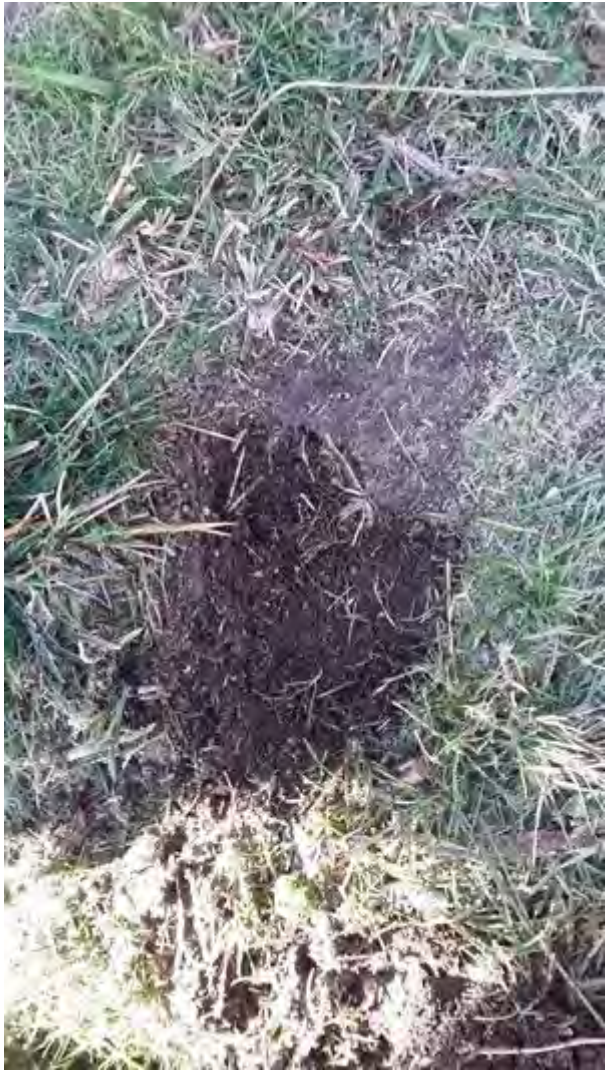
SOIL SAMPLING (XS172)

Project no.	318,001,660	Sample ID	XS172
Project name	Goulburn Wheatyrd Offsite Lead Delineation	Sample type	XRF
Start time	09:23	End time	09:24
Date	21/06/2023	Operator	Other
Sample appearance Pb 0, Cu 0 , Zn 0, As 0			
Comments Gravely silty sand

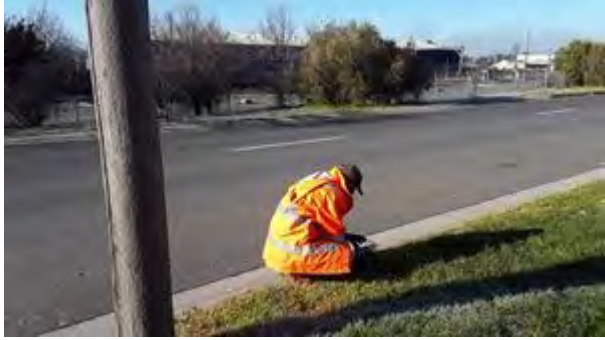
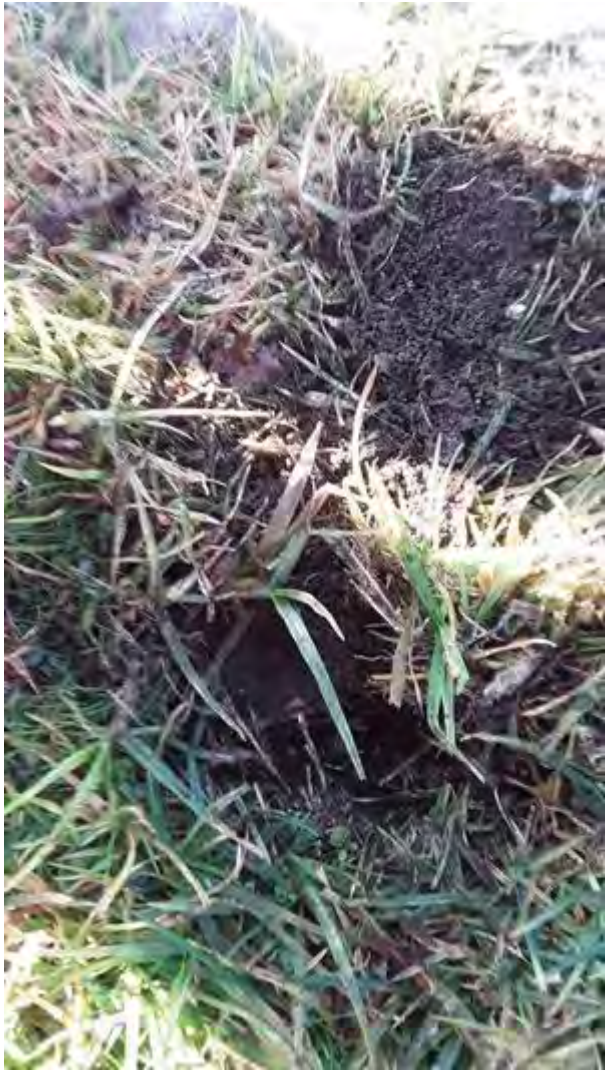
SOIL SAMPLING (XS171)

Project no.	318,001,660	Sample ID	XS171
Project name	Goulburn Wheatyrd Offsite Lead Delineation	Sample type	XRF
Start time	09:20	End time	09:21
Date	21/06/2023	Operator	Other
Sample appearance Pb 91, Cu 0 , Zn 155, As 0			
Comments Gravelly silty sand

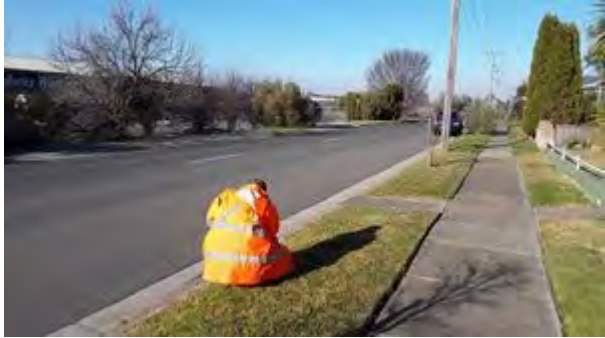
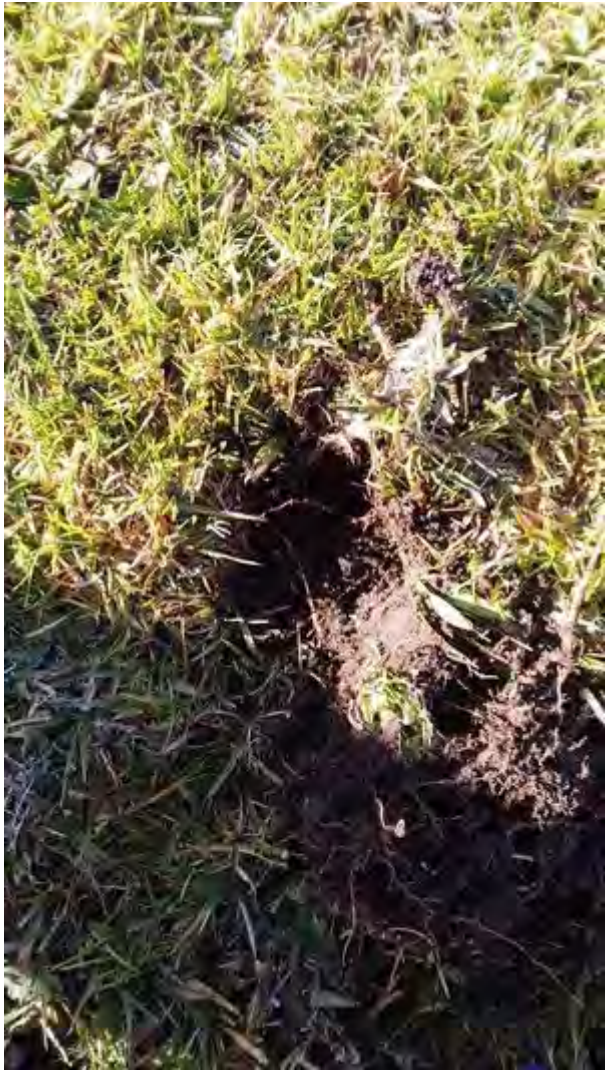
SOIL SAMPLING (XS170)

Project no.	318,001,660	Sample ID	XS170
Project name	Goulburn Wheatyrd Offsite Lead Delineation	Sample type	XRF
Start time	09:12	End time	09:13
Date	21/06/2023	Operator	Other
Sample appearance Pb 0, Cu 0 , Zn 0, As 0			
Comments Gravelly silty sand sample taken

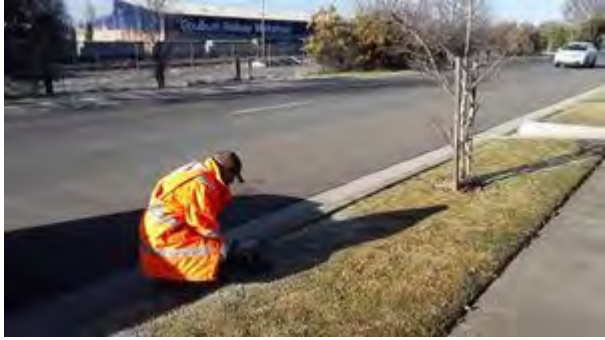
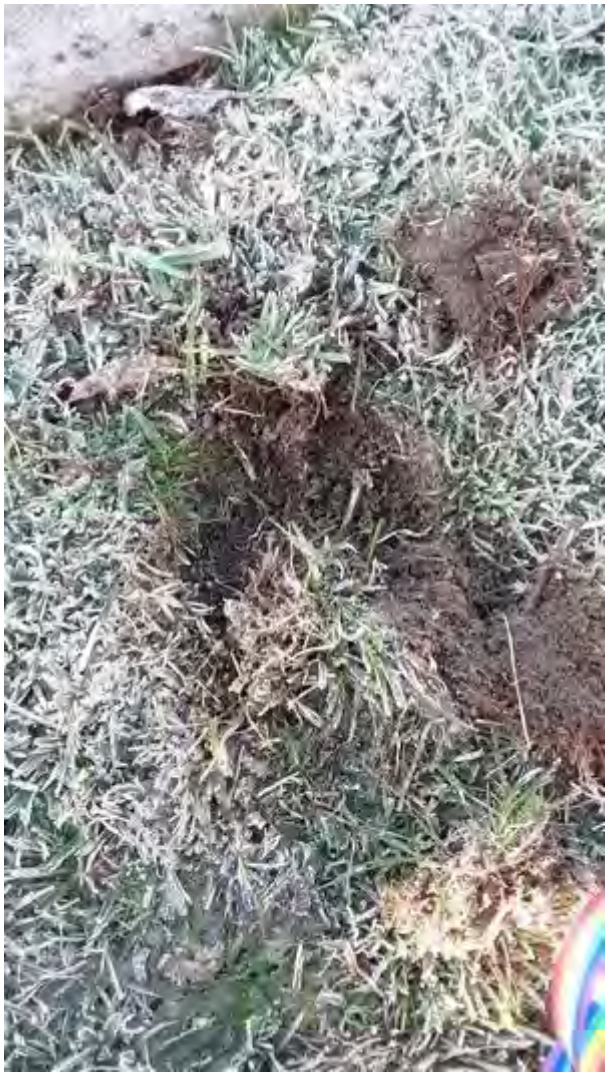
SOIL SAMPLING (XS169)

Project no.	318,001,660	Sample ID	XS169
Project name	Goulburn Wheatyard Offsite Lead Delineation	Sample type	XRF
Start time	09:09	End time	09:10
Date	21/06/2023	Operator	Other
Sample appearance Pb 13, Cu 0 , Zn 52, As 12			
Comments Gravelly silty sand

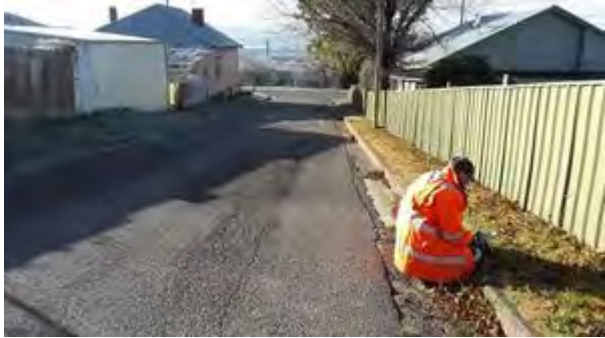
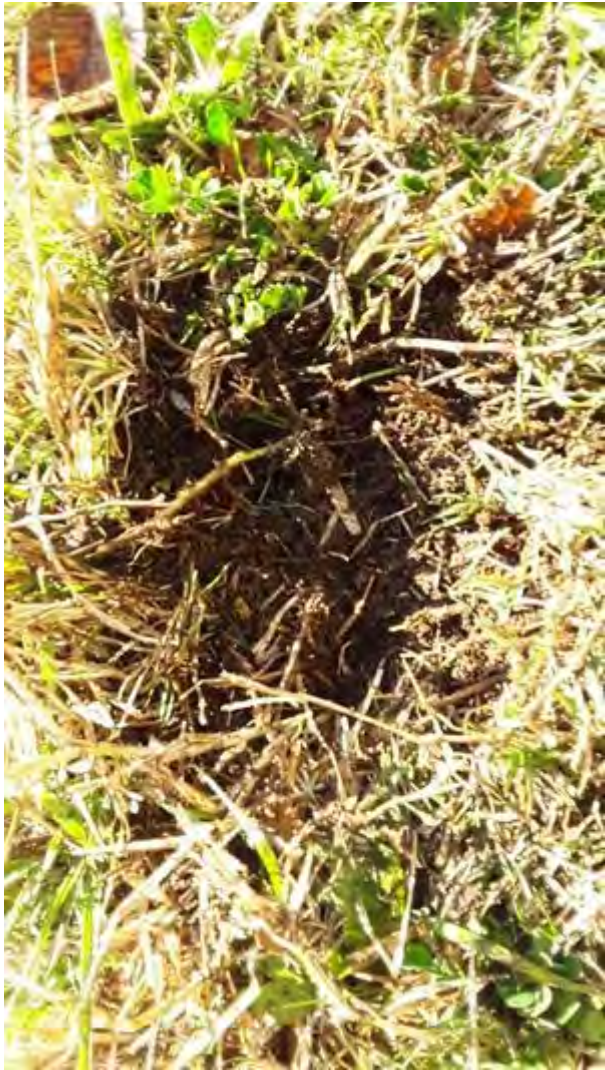
SOIL SAMPLING (XS164)

Project no.	318,001,660	Sample ID	XS164
Project name	Goulburn Wheatyrd Offsite Lead Delineation	Sample type	XRF
Start time	08:54	End time	08:55
Date	21/06/2023	Operator	Other
Sample appearance Pb 0, Cu 76 , Zn 0, As 0			
Comments Gravelly silt

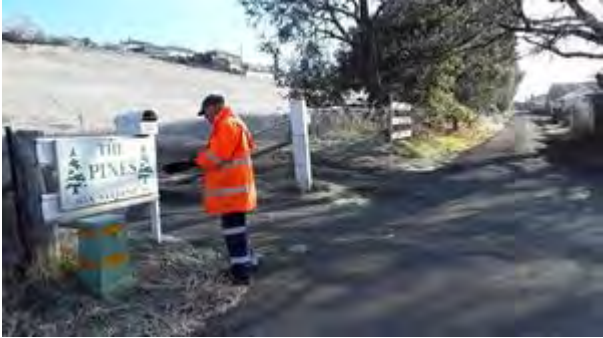
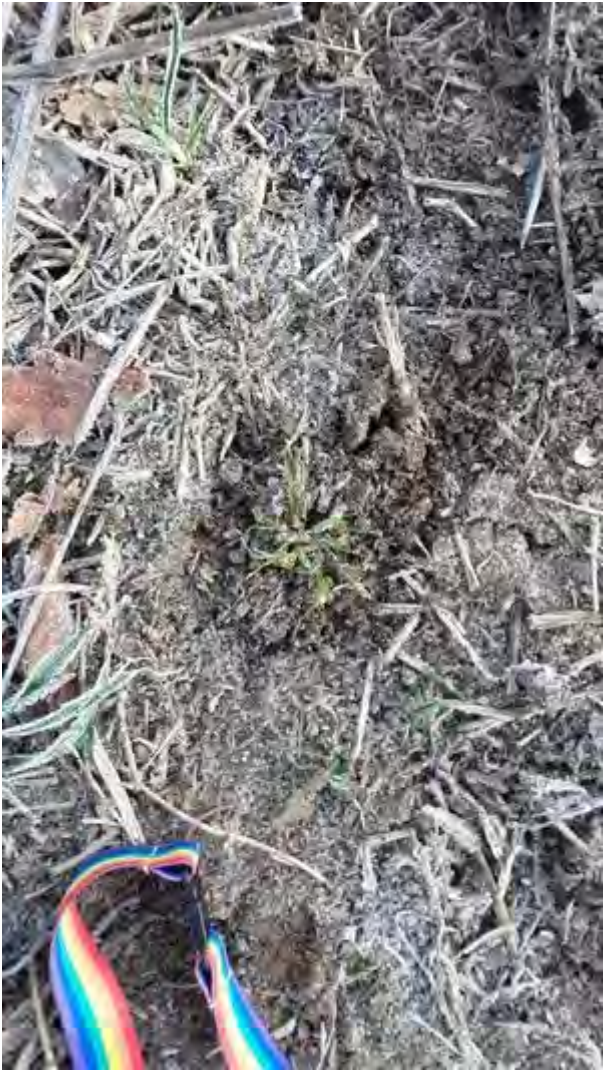
SOIL SAMPLING (XS163)

Project no.	318,001,660	Sample ID	XS163
Project name	Goulburn Wheatyrd Offsite Lead Delineation	Sample type	XRF
Start time	08:51	End time	08:52
Date	21/06/2023	Operator	Other
Sample appearance Pb 36, Cu 40 , Zn 121, As 0			
Comments Gravelly silt

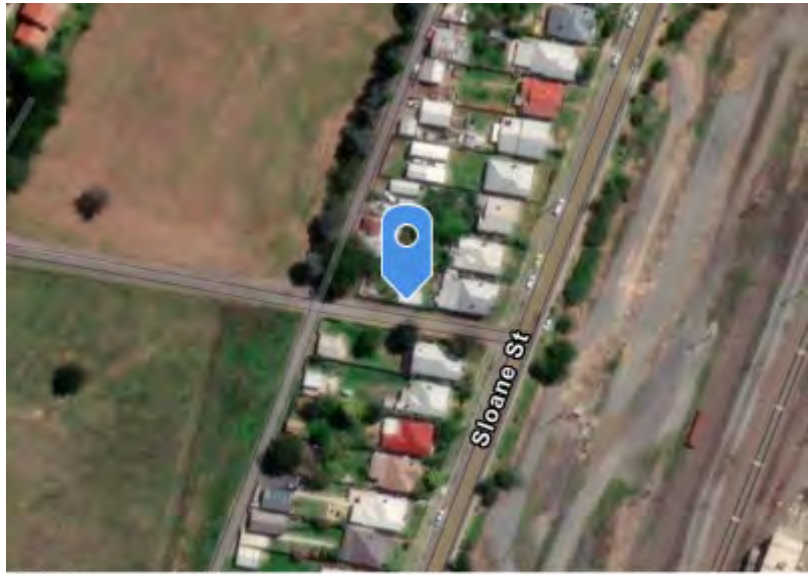
Location

Project no.	318,001,660	Sample ID	XS162
Project name	Goulburn Wheatyrd Offsite Lead Delineation	Sample type	XRF
Start time	08:49	End time	08:50
Date	21/06/2023	Operator	Other
Sample appearance Pb 0, Cu 0 , Zn 183, As 0			
Comments Gravelly silt

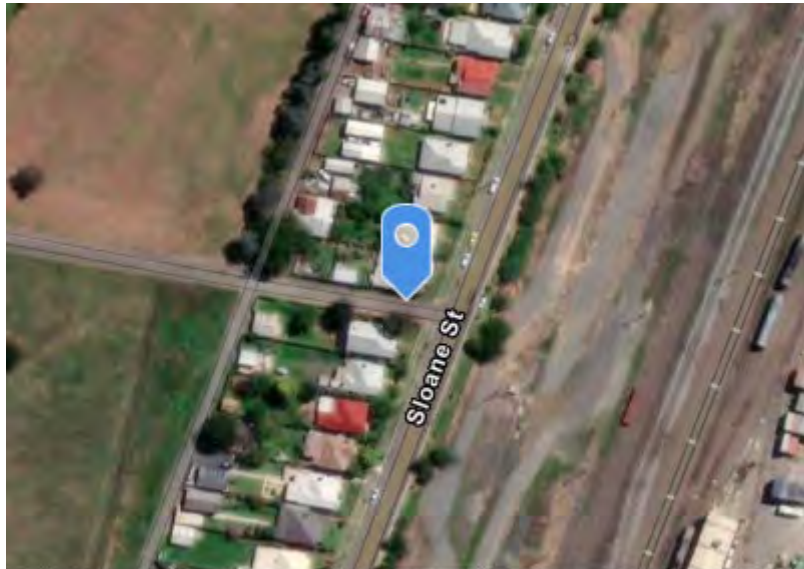
Location

Project no.	318,001,660	Sample ID	XS161
Project name	Goulburn Wheatyrd Offsite Lead Delineation	Sample type	XRF
Start time	08:46	End time	08:47
Date	21/06/2023	Operator	Other
Sample appearance Pb 27, Cu 0 , Zn 164, As 0			
Comments Gravelly silty sand

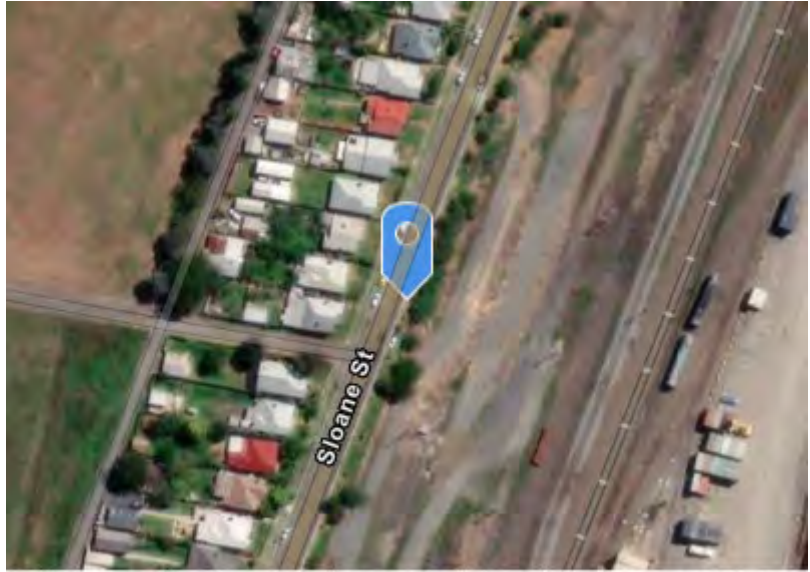
Location

Project no.	318,001,660	Sample ID	XS160
Project name	Goulburn Wheatyrd Offsite Lead Delineation	Sample type	XRF
Start time	08:20	End time	08:21
Date	21/06/2023	Operator	Other
Sample appearance Pb 0, Cu 0 , Zn 0, As 0			
Comments Gravelly silty sand sample taken

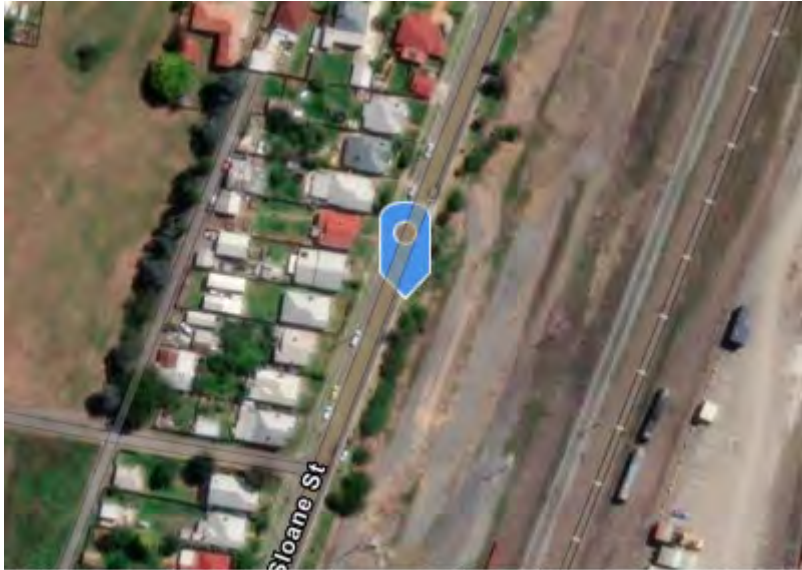
Location

Project no.	318,001,660	Sample ID	XS158
Project name	Goulburn Wheatyrd Offsite Lead Delineation	Sample type	XRF
Start time	08:14	End time	08:15
Date	21/06/2023	Operator	Other
Sample appearance Pb 0, Cu 0 , Zn 41, As 14			
Comments Gravelly silty sand

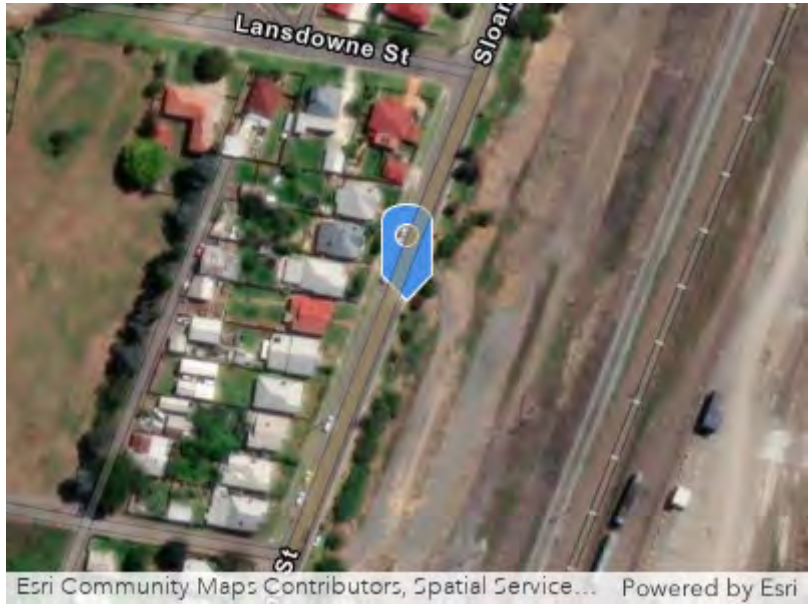
Location

Project no.	318,001,660	Sample ID	XS156
Project name	Goulburn Wheatyrd Offsite Lead Delineation	Sample type	XRF
Start time	08:08	End time	08:09
Date	21/06/2023	Operator	Other
Sample appearance Pb 0, Cu 0 , Zn 0, As 0			
Comments Gravelly silty sand

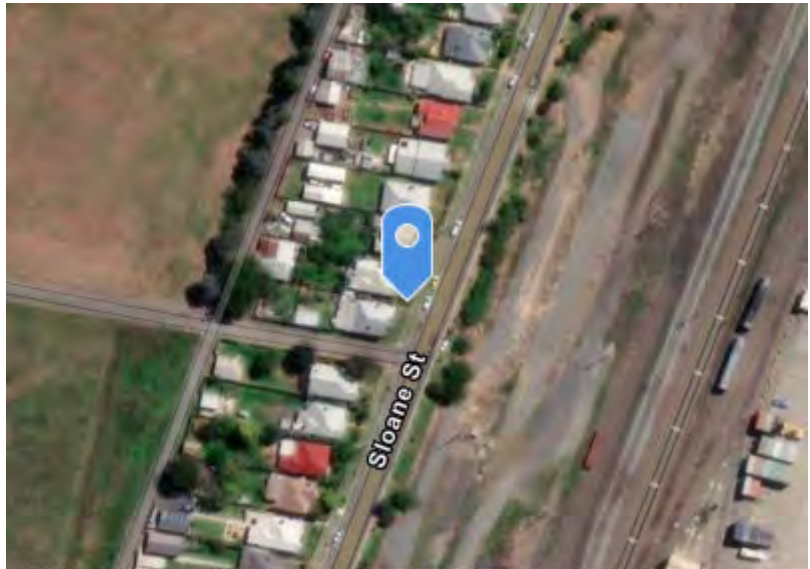
Location

Project no.	318,001,660	Sample ID	XS155
Project name	Goulburn Wheatyrd Offsite Lead Delineation	Sample type	XRF
Start time	08:01	End time	08:03
Date	21/06/2023	Operator	Other
Sample appearance Pb 86, Cu 0 , Zn 148, As 0			
Comments Gravelly silty sand

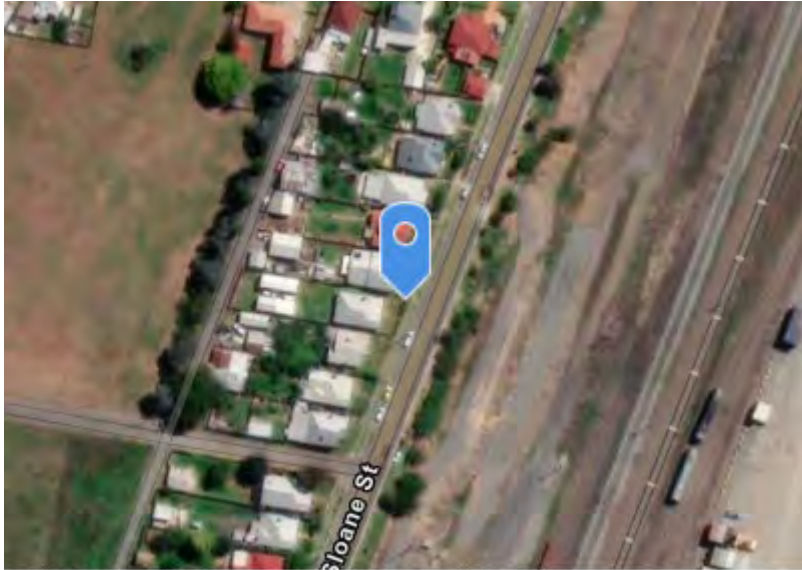
Location

Project no.	318,001,660	Sample ID	XS153
Project name	Goulburn Wheatyrd Offsite Lead Delineation	Sample type	XRF
Start time	07:55	End time	07:56
Date	21/06/2023	Operator	Other
Sample appearance Pb 0, Cu 0 , Zn 0, As 0			
Comments Gravely silty sand

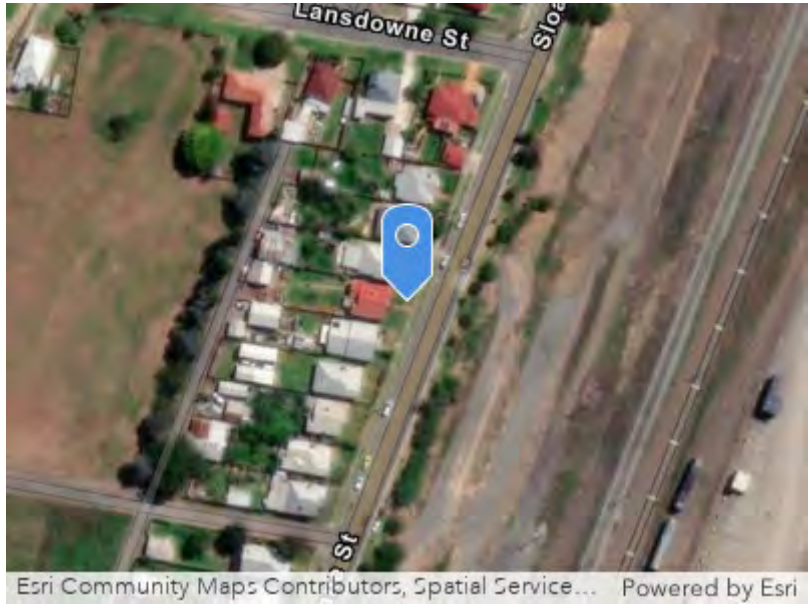
Location

Project no.	318,001,660	Sample ID	XS152
Project name	Goulburn Wheatyrd Offsite Lead Delineation	Sample type	XRF
Start time	07:52	End time	07:53
Date	21/06/2023	Operator	Other
Sample appearance Pb 0, Cu 0 , Zn 61, As 0			
Comments Gravely silty sand

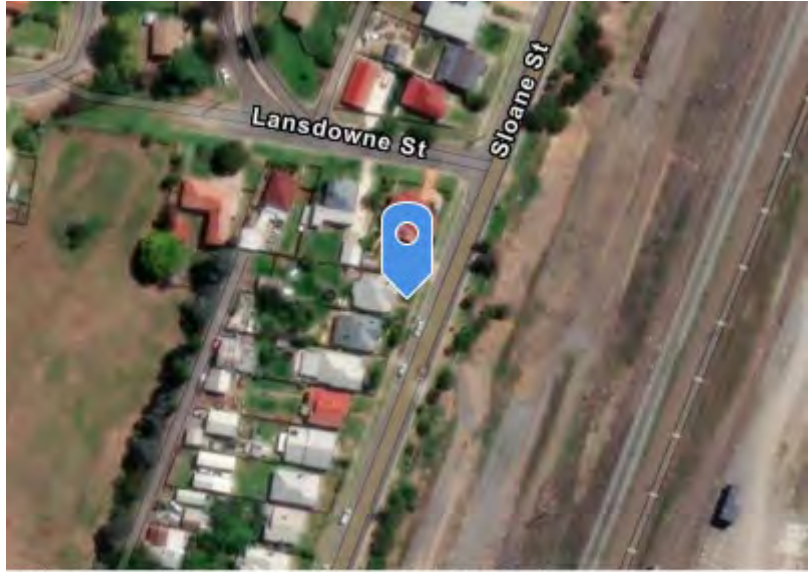
Location

Project no.	318,001,660	Sample ID	XS150
Project name	Goulburn Wheatyrd Offsite Lead Delineation	Sample type	XRF
Start time	07:37	End time	07:38
Date	21/06/2023	Operator	Other
Sample appearance Pb 0, Cu 0 , Zn 159, As 0			
Comments Gravelly silty sand sample taken

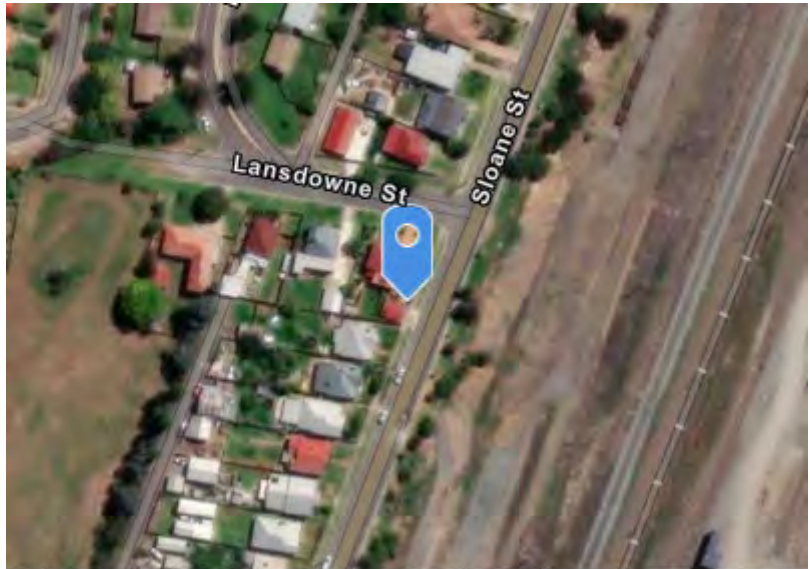
Location

Project no.	318,001,660	Sample ID	XS149
Project name	Goulburn Wheatyrd Offsite Lead Delineation	Sample type	XRF
Start time	07:34	End time	07:35
Date	21/06/2023	Operator	Other
Sample appearance Pb 10, Cu 34 , Zn 187, As 0			
Comments Gravelly silty sand

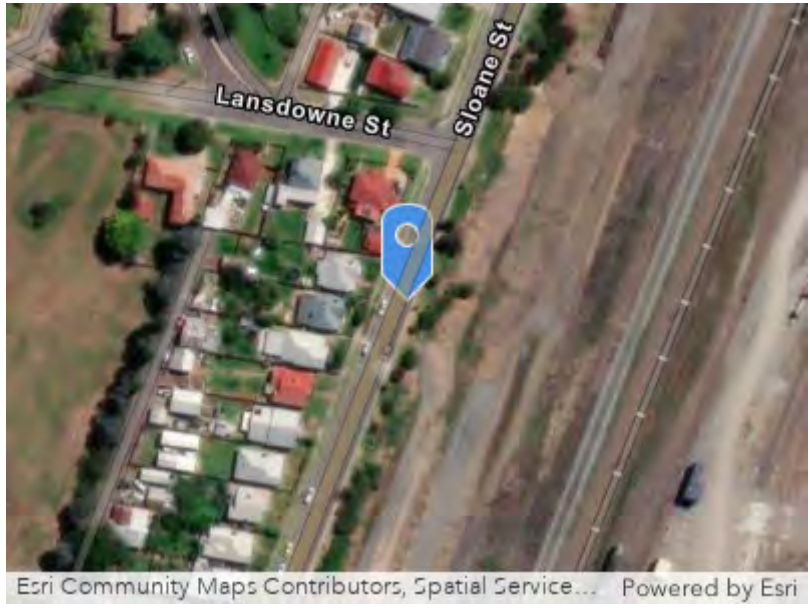
Location

Project no.	318,001,660	Sample ID	XS147
Project name	Goulburn Wheatyrd Offsite Lead Delineation	Sample type	XRF
Start time	07:28	End time	07:29
Date	21/06/2023	Operator	Other
Sample appearance Pb 0, Cu 87 , Zn 0, As 0			
Comments Gravely silty sand

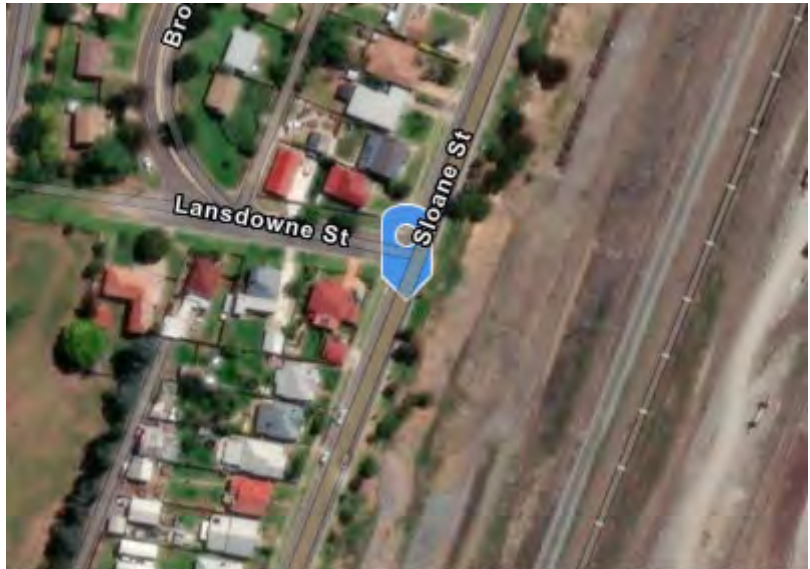
Location

Project no.	318,001,660	Sample ID	XS145
Project name	Goulburn Wheatyrd Offsite Lead Delineation	Sample type	XRF
Start time	07:22	End time	07:23
Date	21/06/2023	Operator	Other
Sample appearance Pb 0, Cu0 , Zn 59, As 0			
Comments Gravelly sandy silt

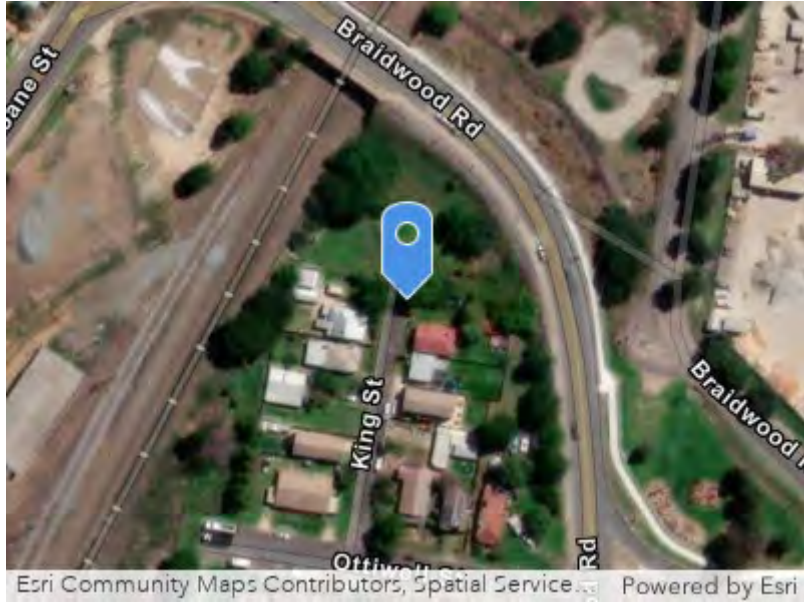
Location

Project no.	318,001,660	Sample ID	XS090
Project name	Goulburn Wheatyrd Offsite Lead Delineation	Sample type	XRF
Start time	12:24	End time	12:26
Date	20/06/2023	Operator	Other
Sample appearance Pb 52, Cu 26, Zn 287, As 0			
Comments Gravely silt sample taken

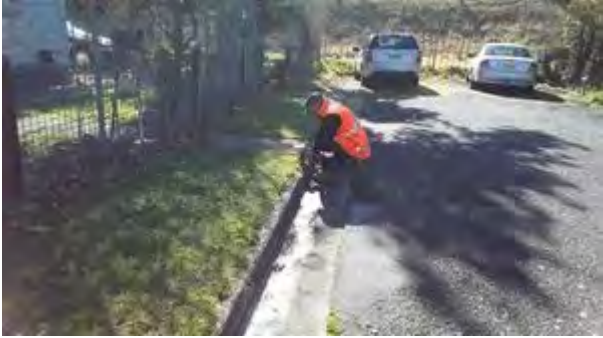
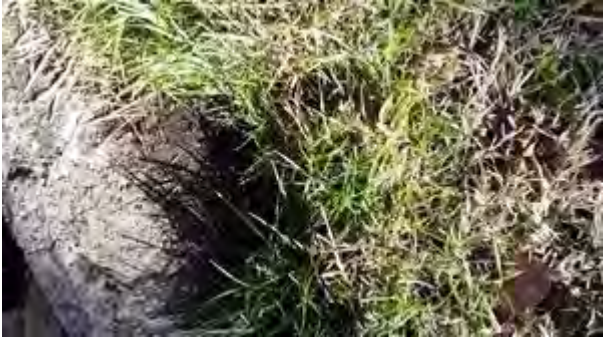
Project no.	318,001,660	Sample ID	XS089
Project name	Goulburn Wheatyrd Offsite Lead Delineation	Sample type	XRF
Start time	12:21	End time	12:22
Date	20/06/2023	Operator	Other
Sample appearance Pb 16, Cu 0, Zn 448, As 0			
Comments Gravelly silt

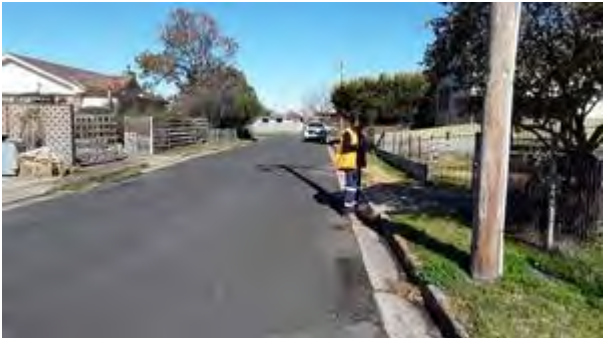
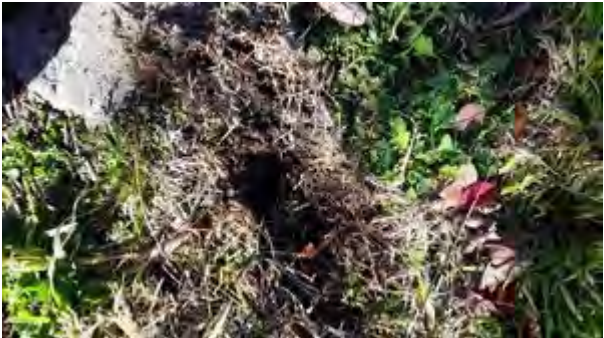
SOIL SAMPLING (XS088)

Project no.	318,001,660	Sample ID	XS088
Project name	Goulburn Wheatyrd Offsite Lead Delineation	Sample type	XRF
Start time	12:16	End time	12:17
Date	20/06/2023	Operator	Other
Sample appearance Pb 72, Cu 0, Zn 294, As 0			
Comments Gravelly silt
