Goulburn Wheat Yards Assessment

Offsite Lead Delineation Preliminary Site
Investigation

Project name **Goulburn Wheat Yards Assessment - Offsite Lead Delineation Preliminary Site Investigation**
Project no. **318001660**
Recipient **ARTC**
Document type **Final Report**
Version **1**
Date **7 September 2023**
Prepared by **N. Gilbert**
Checked by **R. Condon / K. Greenfield (CEnvP SC40104)**
Approved by **A. Nolan**
Description **This document presents the results of an environmental assessment to assess the potential offsite risk of lead contamination surrounding the Goulburn Wheat Yards.**

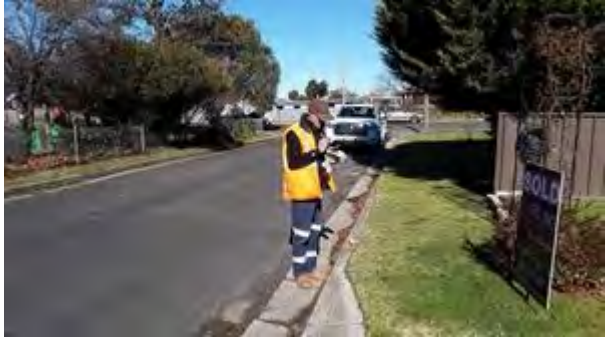
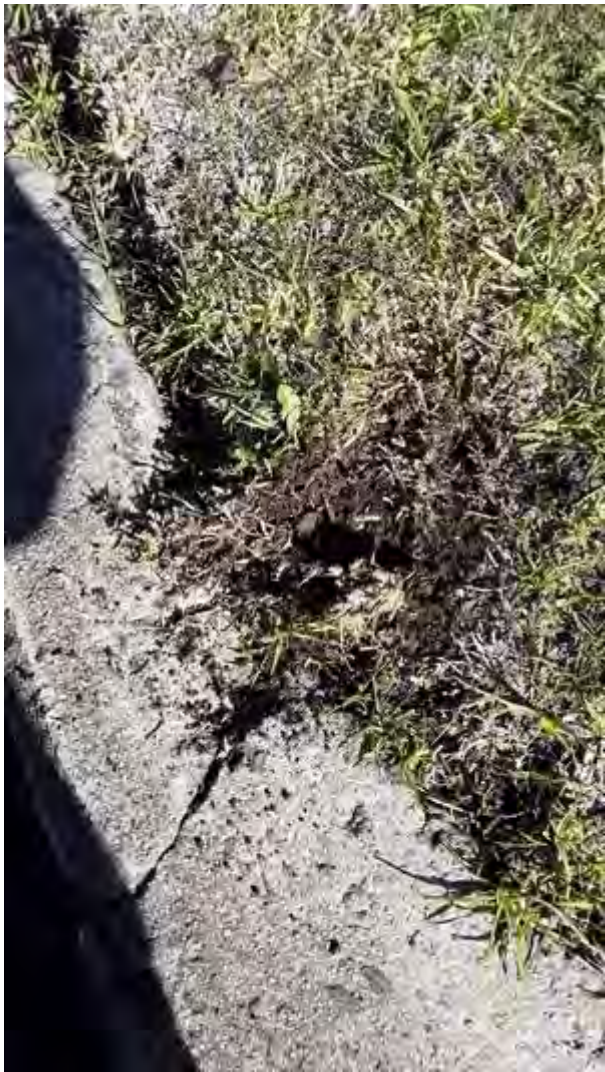
SOIL SAMPLING (XS087)

Project no.	318,001,660	Sample ID	XS087
Project name	Goulburn Wheatyrd Offsite Lead Delineation	Sample type	XRF
Start time	12:14	End time	12:15
Date	20/06/2023	Operator	Other
Sample appearance Pb 25, Cu 0, Zn 81, As 0			
Comments Gravelly silt

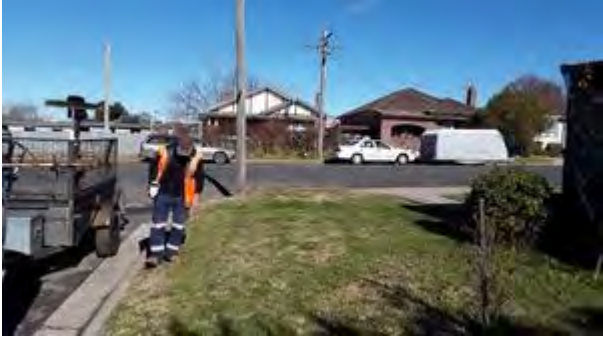
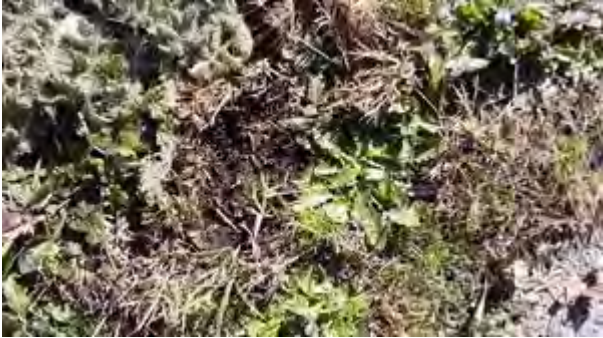
SOIL SAMPLING (XS086)

Project no.	318,001,660	Sample ID	XS086
Project name	Goulburn Wheatyrd Offsite Lead Delineation	Sample type	XRF
Start time	12:12	End time	12:13
Date	20/06/2023	Operator	Other
Sample appearance Pb 38, Cu 0, Zn 152, As 0			
Comments Silty sand

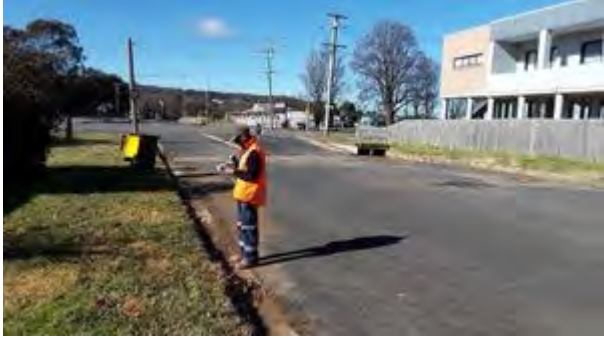
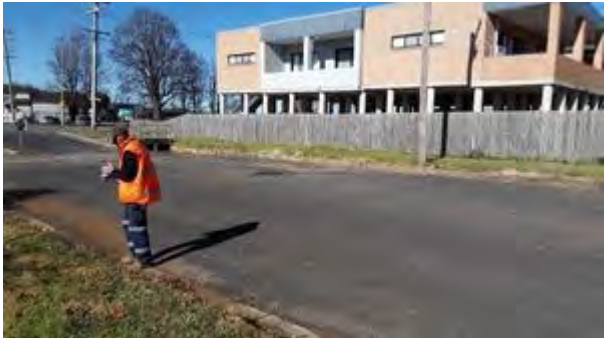
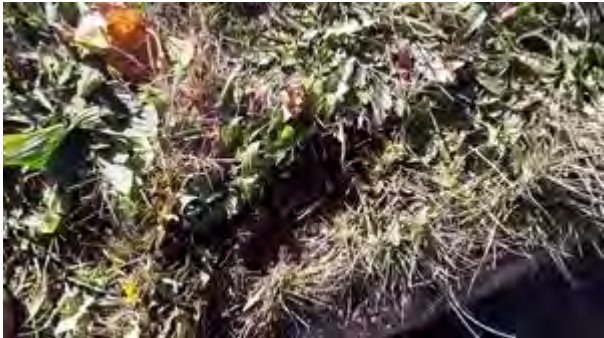
Project no.	318,001,660	Sample ID	XS084
Project name	Goulburn Wheatyrd Offsite Lead Delineation	Sample type	XRF
Start time	00:04	End time	00:06
Date	20/06/2023	Operator	Other
Sample appearance Pb 28, Cu 0, Zn 186, As 0			
Comments Silty gravely sand

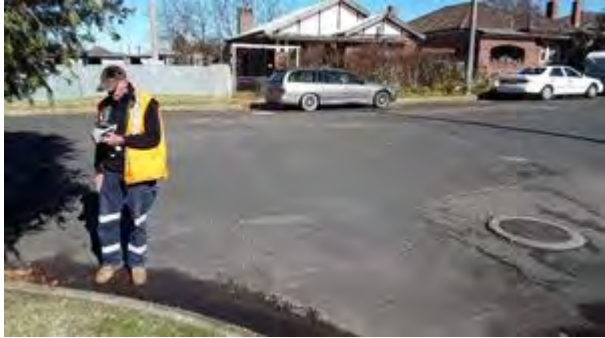
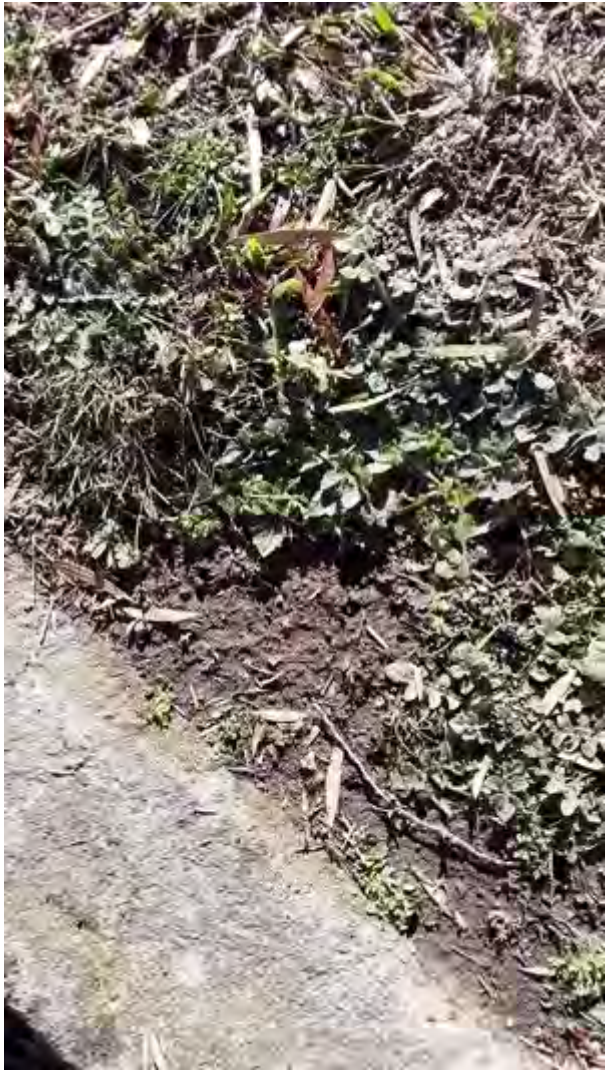
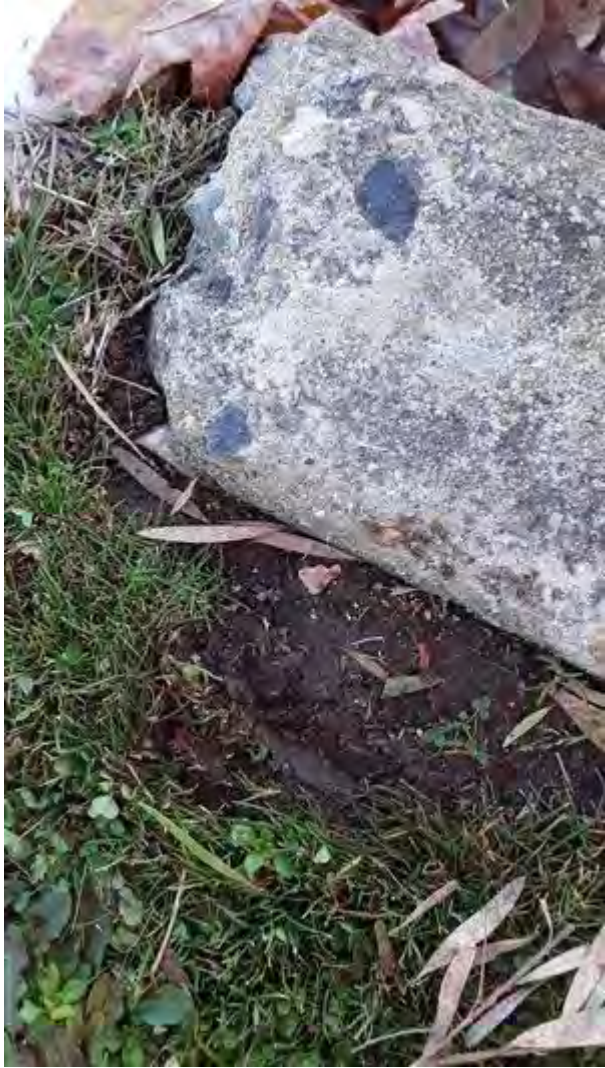
SOIL SAMPLING (XS083)

Project no.	318,001,660	Sample ID	XS083
Project name	Goulburn Wheatyrd Offsite Lead Delineation	Sample type	XRF
Start time	00:01	End time	00:02
Date	20/06/2023	Operator	Other
Sample appearance Pb 36, Cu 0, Zn 119, As 0			
Comments Silty gravely sand

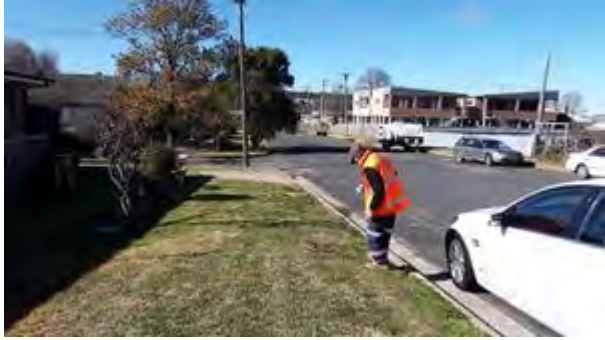
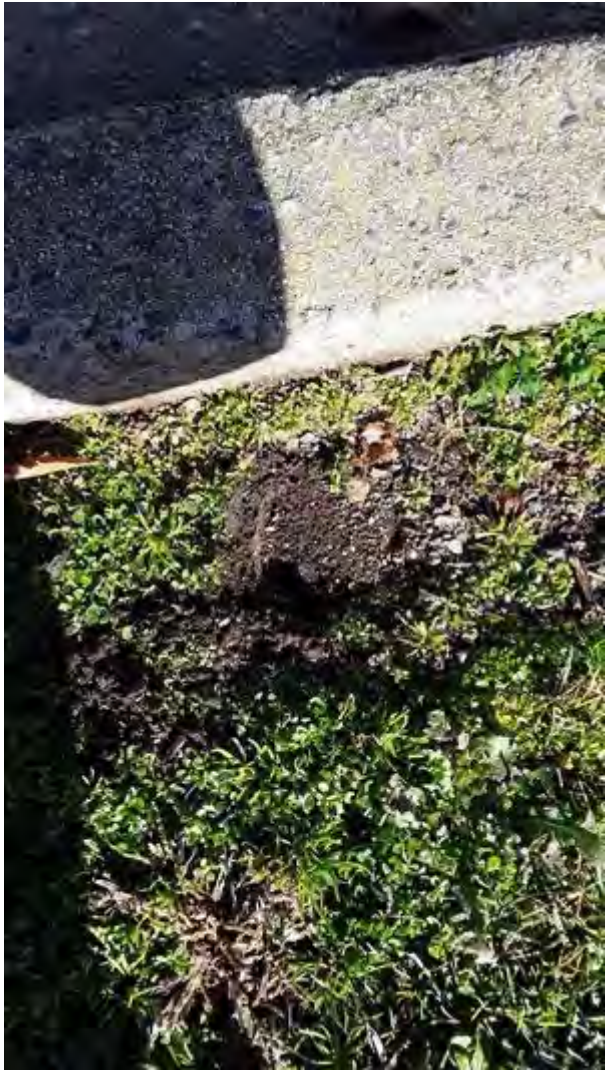
SOIL SAMPLING (XS081)

Project no.	318,001,660	Sample ID	XS081
Project name	Goulburn Wheatyard Offsite Lead Delineation	Sample type	XRF
Start time	11:56	End time	11:57
Date	20/06/2023	Operator	Other
Sample appearance Pb 0, Cu 0, Zn 0, As 0			
Comments Silty gravely sand

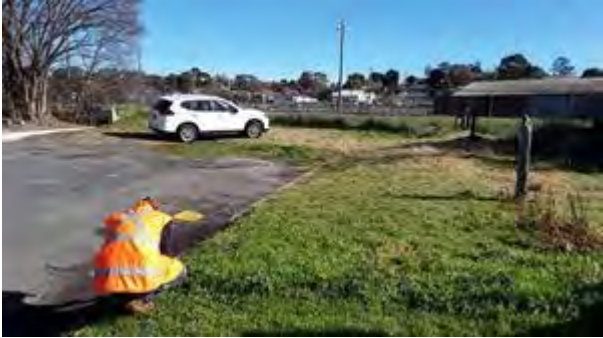
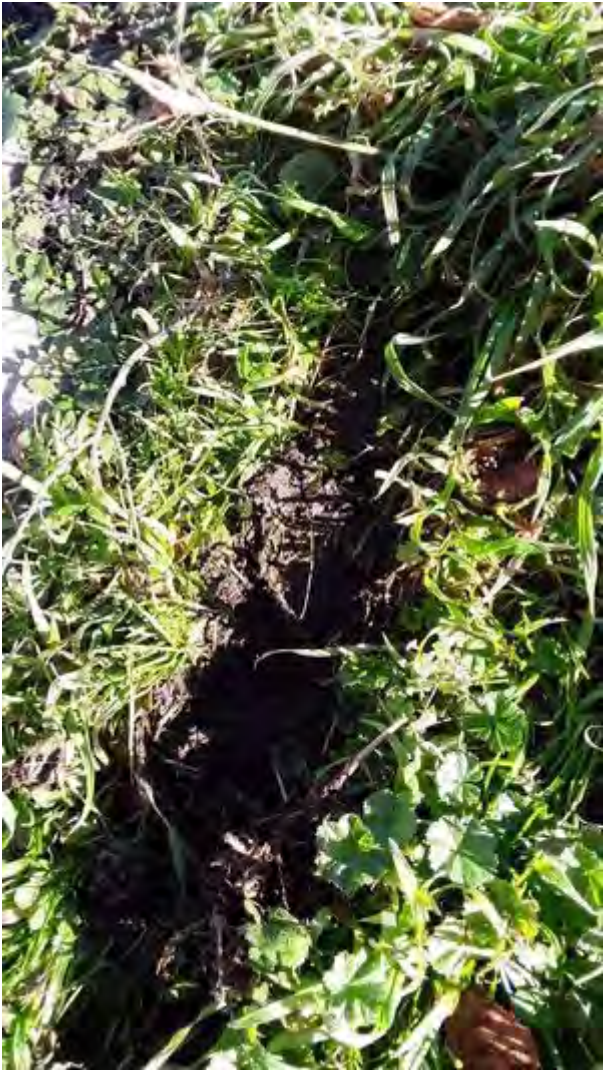
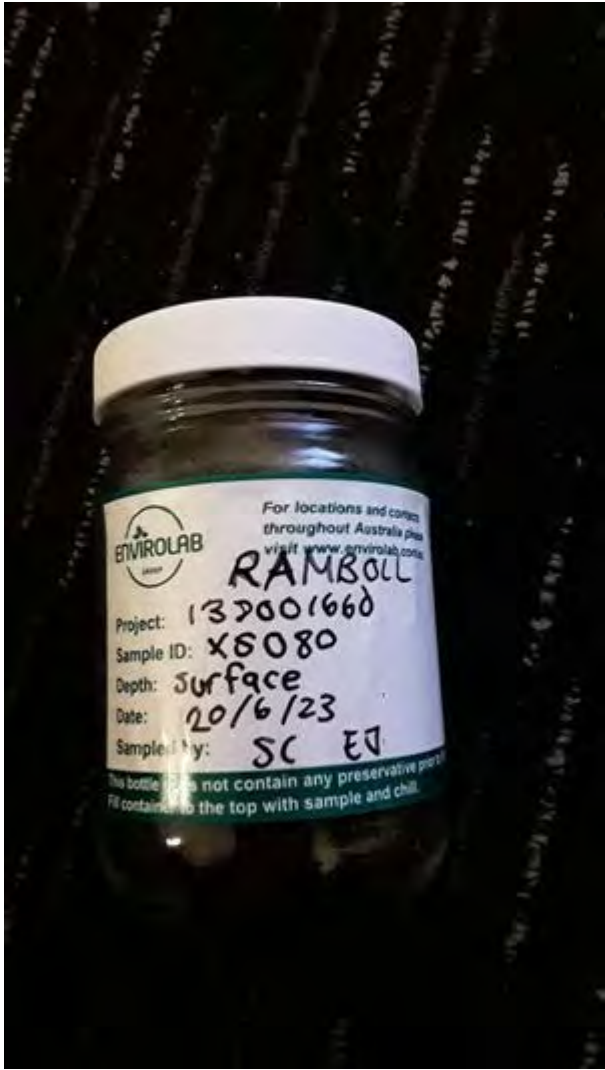
SOIL SAMPLING (XS080)

Project no.	318,001,660	Sample ID	XS080
Project name	Goulburn Wheatyrd Offsite Lead Delineation	Sample type	XRF
Start time	11:41	End time	11:42
Date	20/06/2023	Operator	Other
Sample appearance Pb 104, Cu 47, Zn 365, As 0			
Comments Silty gravely sand sample taken

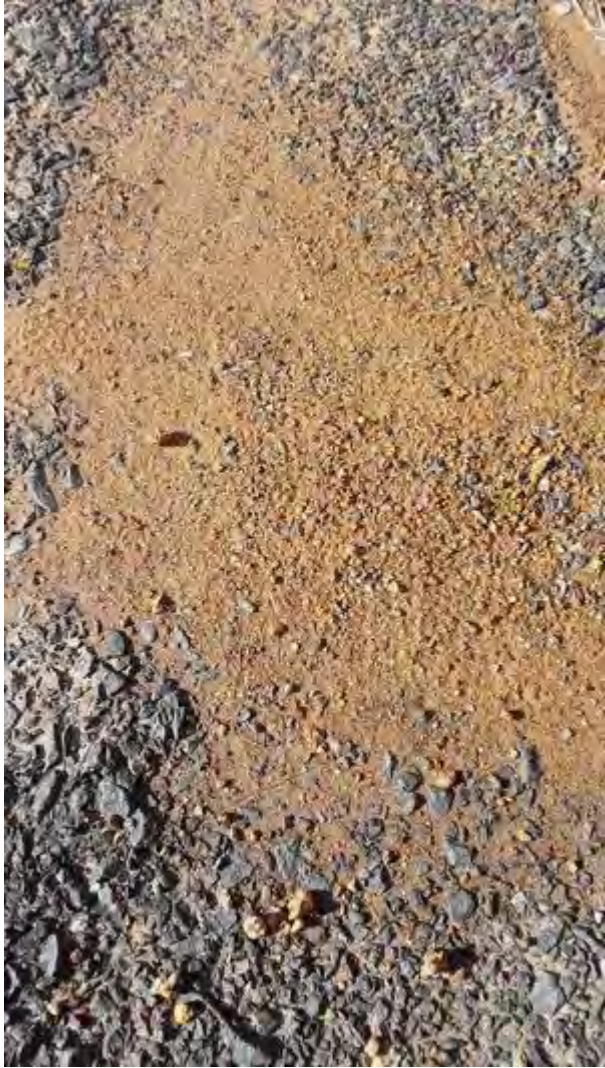
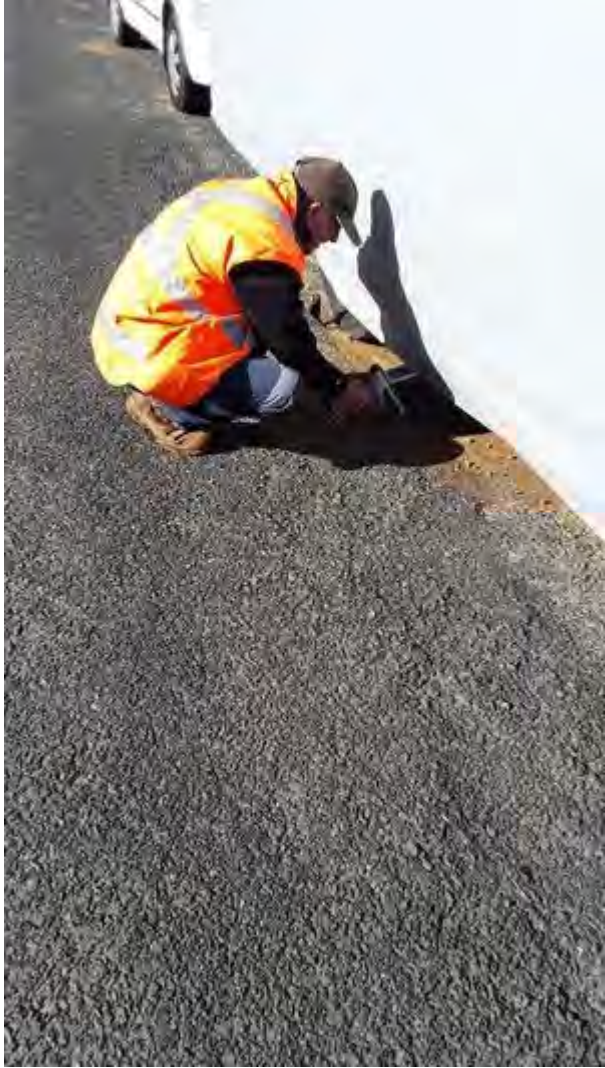
SOIL SAMPLING (DS01)

Project no.	318,001,660	Sample ID	DS01
Project name	Goulburn Wheatyrd Offsite Lead Delineation	Sample type	XRF
Start time	11:39	End time	11:40
Date	20/06/2023	Operator	Other
Sample appearance Pb 28, Cu 0, Zn 0, As 0			
Comments Sediment from drain DS

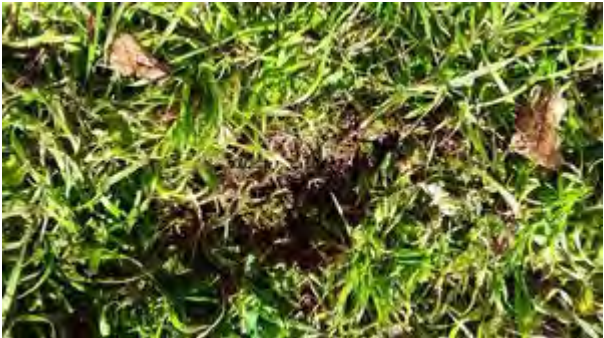
SOIL SAMPLING (XS079)

Project no.	318,001,660	Sample ID	XS079
Project name	Goulburn Wheatyrd Offsite Lead Delineation	Sample type	XRF
Start time	11:32	End time	11:34
Date	20/06/2023	Operator	Other
Sample appearance Pb 0, Cu 35, Zn 42, As 0			
Comments gravely silt

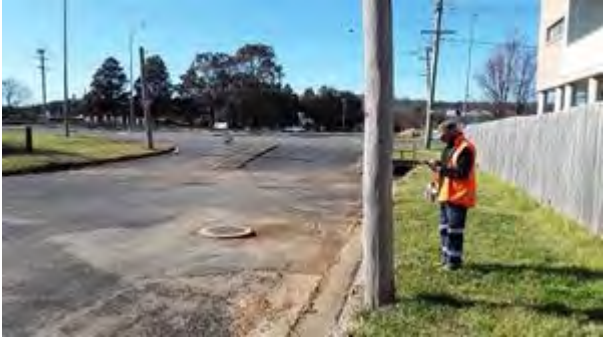
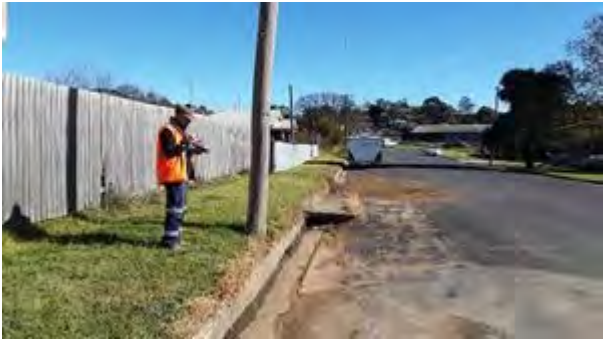
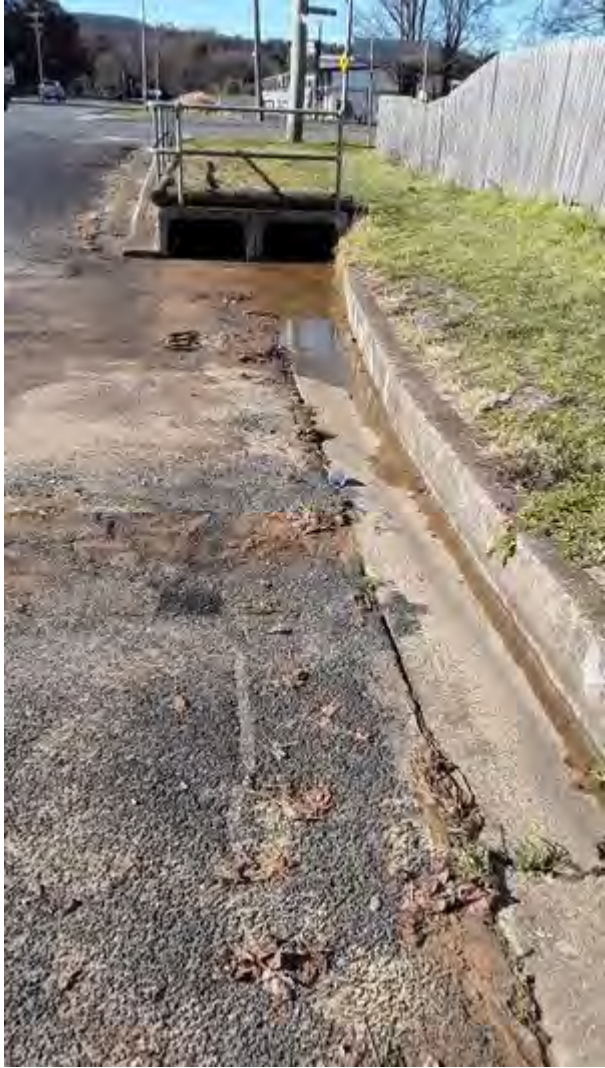
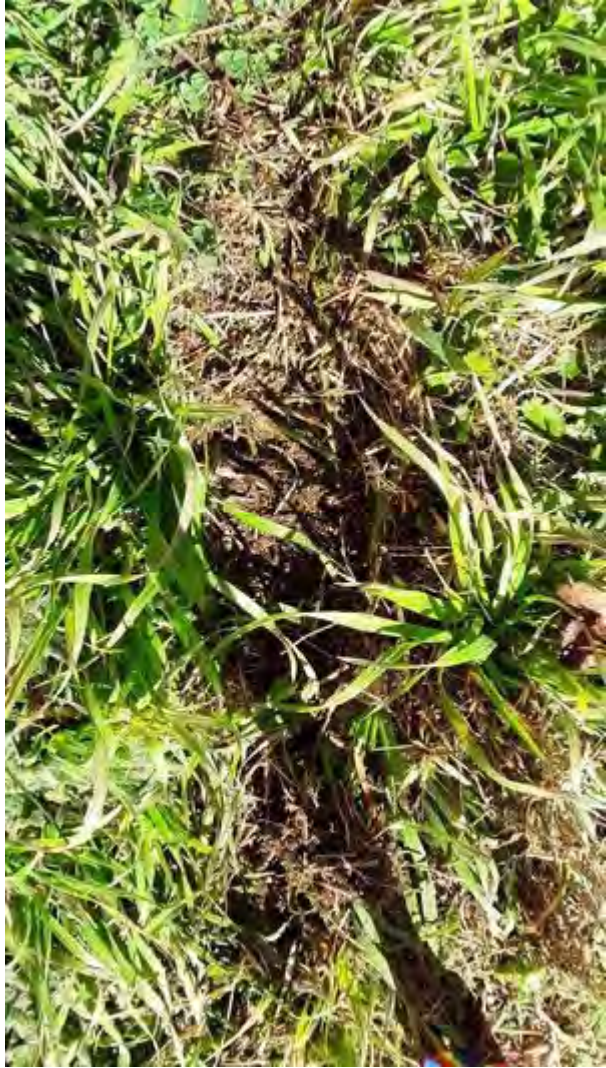
SOIL SAMPLING (XS078)

Project no.	318,001,660	Sample ID	XS078
Project name	Goulburn Wheatyrd Offsite Lead Delineation	Sample type	XRF
Start time	11:29	End time	11:31
Date	20/06/2023	Operator	Other
Sample appearance Pb 72, Cu 25, Zn 254, As 12			
Comments gravely silty sand

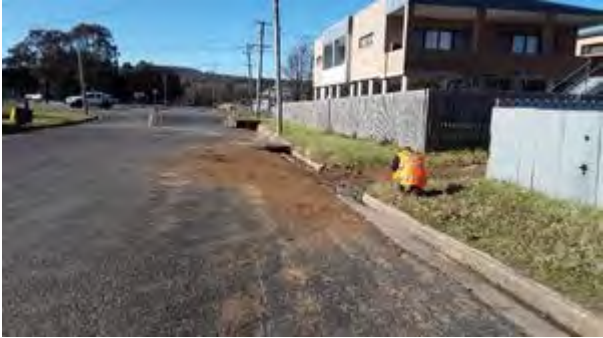
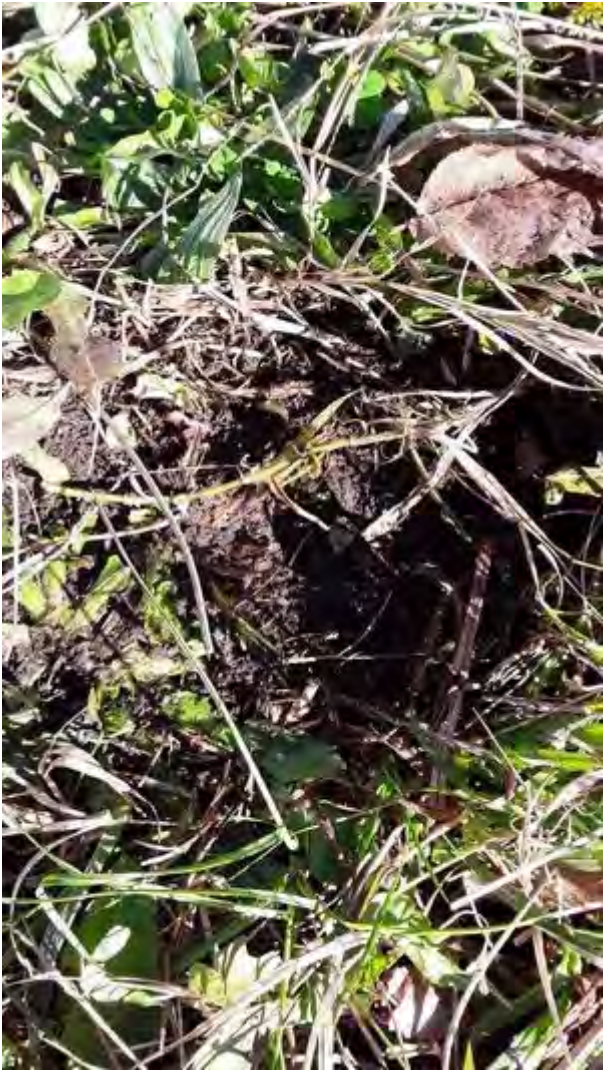
SOIL SAMPLING (XS077)

Project no.	318,001,660	Sample ID	XS077
Project name	Goulburn Wheatyrd Offsite Lead Delineation	Sample type	XRF
Start time	11:27	End time	11:28
Date	20/06/2023	Operator	Other
Sample appearance Pb 49, Cu 43, Zn 218, As 0			
Comments gravely silty sand

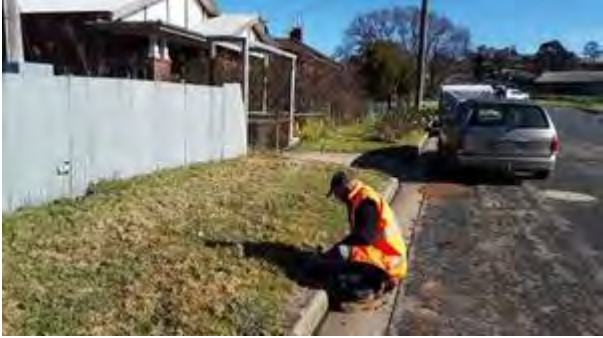
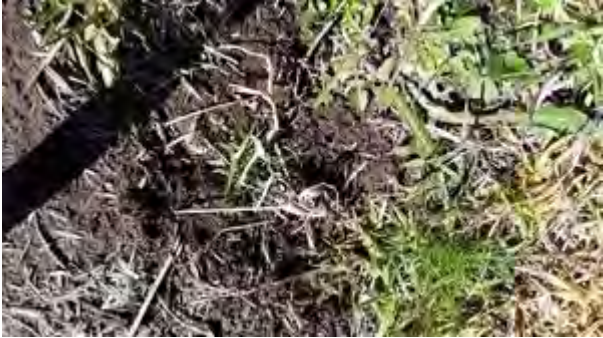
Project no.	318,001,660	Sample ID	XS076
Project name	Goulburn Wheatyrd Offsite Lead Delineation	Sample type	XRF
Start time	11:25	End time	11:26
Date	20/06/2023	Operator	Other
Sample appearance Pb 28, Cu 0, Zn 110, As 11			
Comments gravely silt

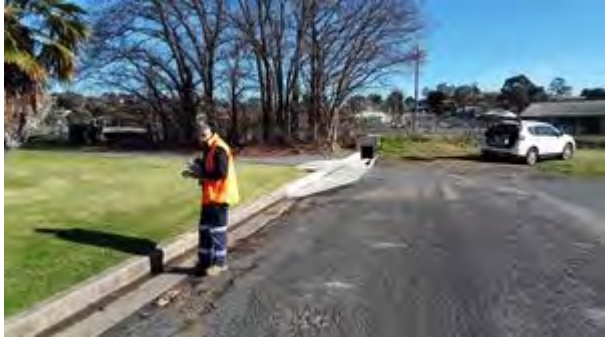
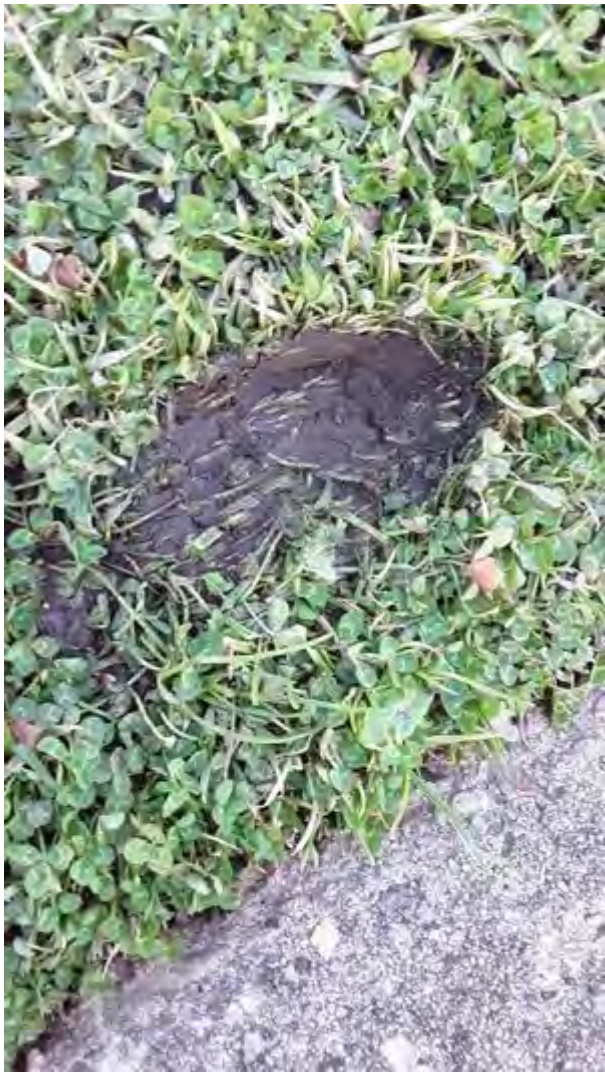
Project no.	318,001,660	Sample ID	XS074
Project name	Goulburn Wheatyrd Offsite Lead Delineation	Sample type	XRF
Start time	11:20	End time	11:21
Date	20/06/2023	Operator	Other
Sample appearance Pb 32, Cu 21, Zn 88, As 0			
Comments gravely silt

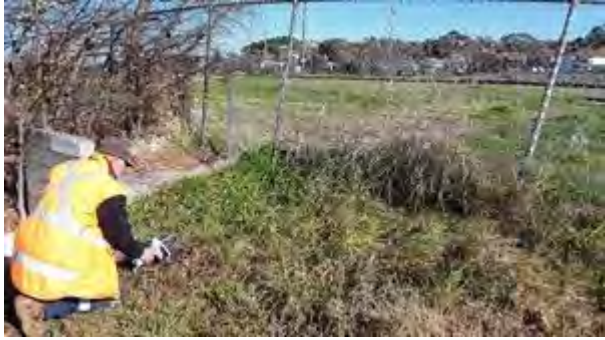
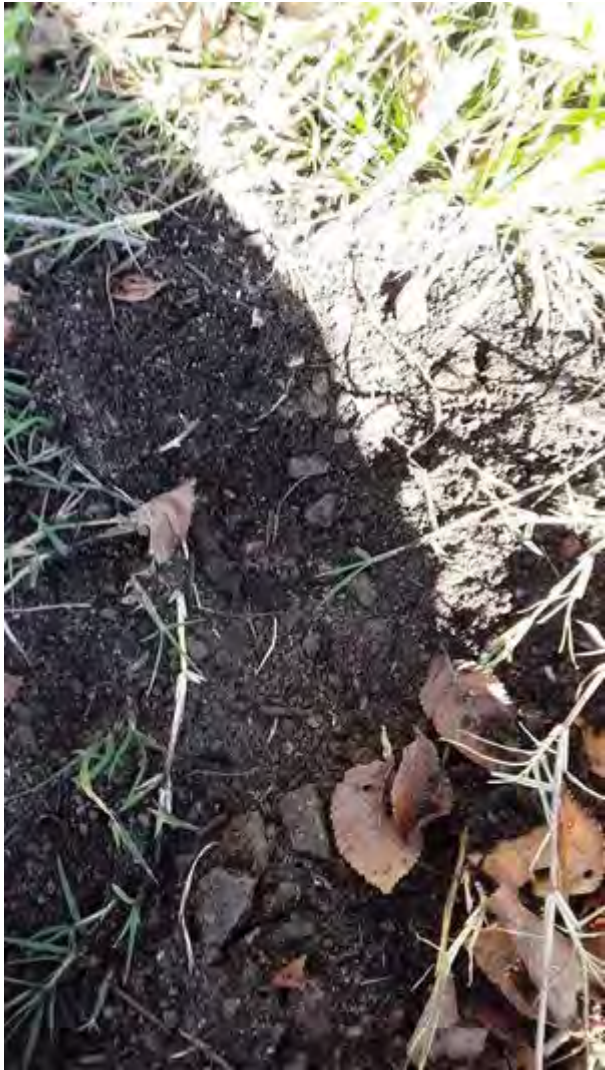
SOIL SAMPLING (XS073)

Project no.	318,001,660	Sample ID	XS073
Project name	Goulburn Wheatyrd Offsite Lead Delineation	Sample type	XRF
Start time	11:16	End time	11:18
Date	20/06/2023	Operator	Other
Sample appearance Pb 62, Cu 46, Zn 284, As 0			
Comments gravely silty sand

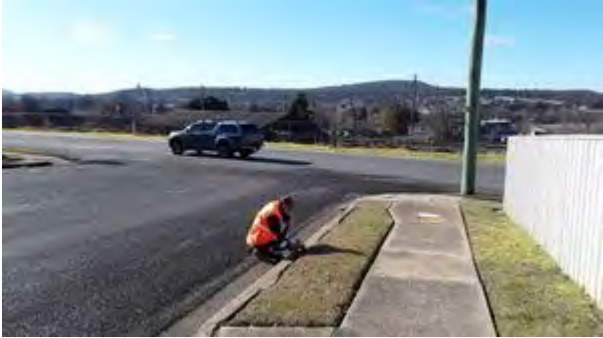
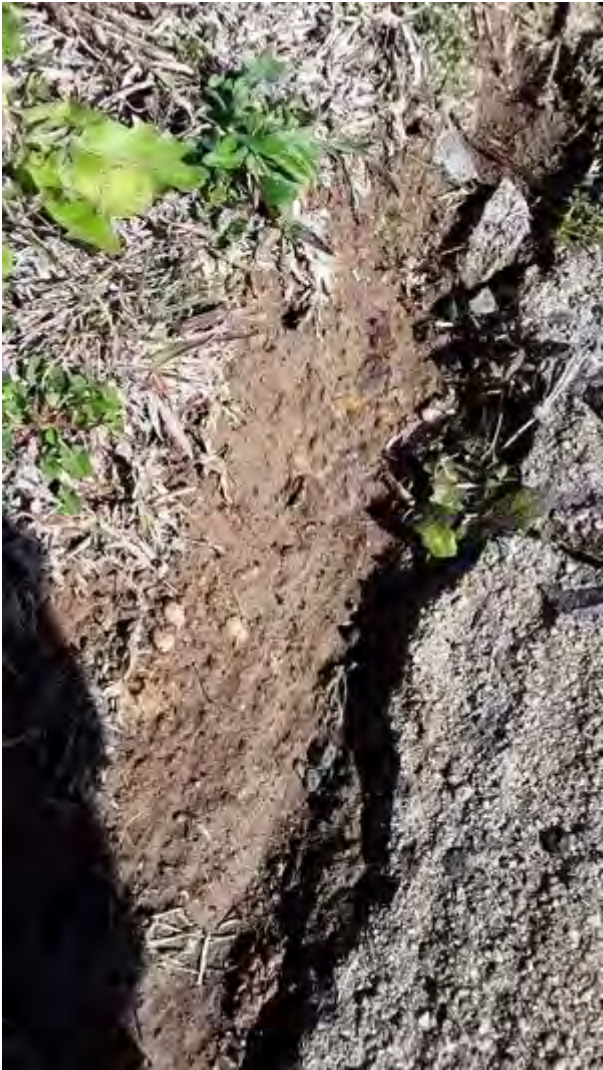
SOIL SAMPLING (XS072)

Project no.	318,001,660	Sample ID	XS072
Project name	Goulburn Wheatyrd Offsite Lead Delineation	Sample type	XRF
Start time	10:21	End time	10:22
Date	20/06/2023	Operator	Other
Sample appearance Pb 24, Cu 0, Zn 27, As 0			
Comments gravely silt

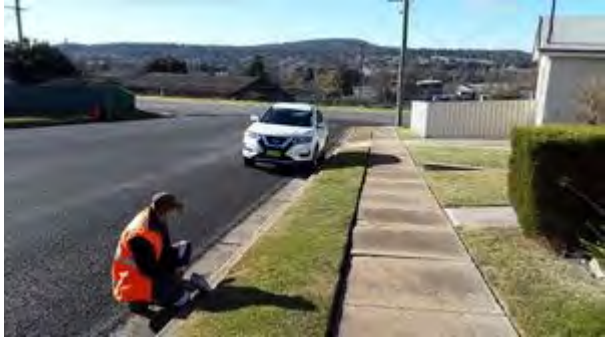
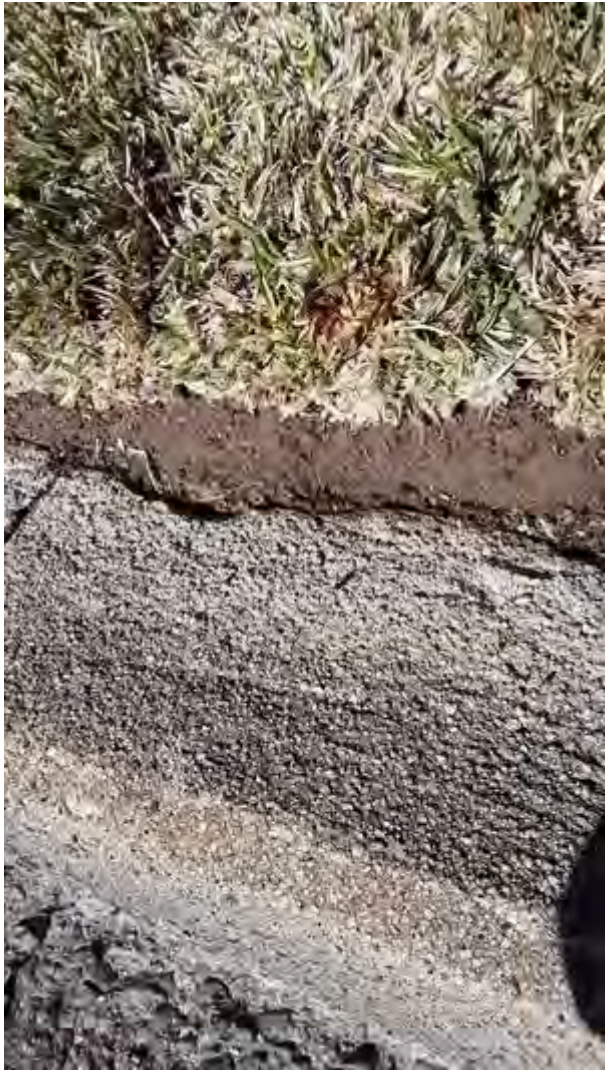
SOIL SAMPLING (XS071)

Project no.	318,001,660	Sample ID	XS071
Project name	Goulburn Wheatyrd Offsite Lead Delineation	Sample type	XRF
Start time	10:18	End time	10:20
Date	20/06/2023	Operator	Other
Sample appearance Pb 0, Cu 0, Zn 0, As 0			
Comments gravely silt

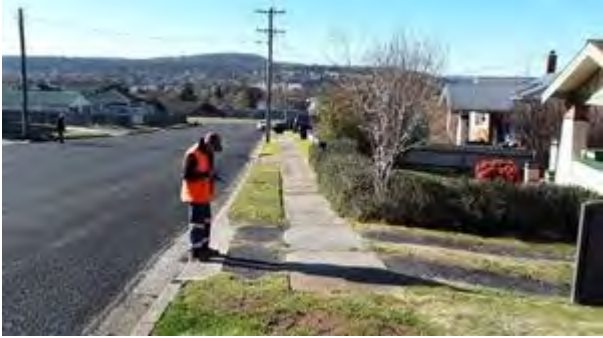
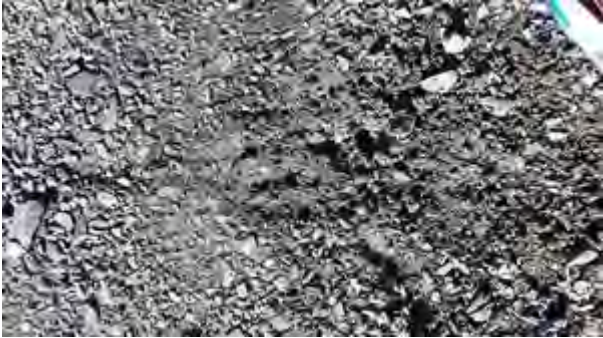
SOIL SAMPLING (XS068)

Project no.	318,001,660	Sample ID	XS068
Project name	Goulburn Wheatyrd Offsite Lead Delineation	Sample type	XRF
Start time	10:07	End time	10:08
Date	20/06/2023	Operator	Other
Sample appearance Pb 0, Cu 0, Zn 15, As 0			
Comments gravely silt medium gravel

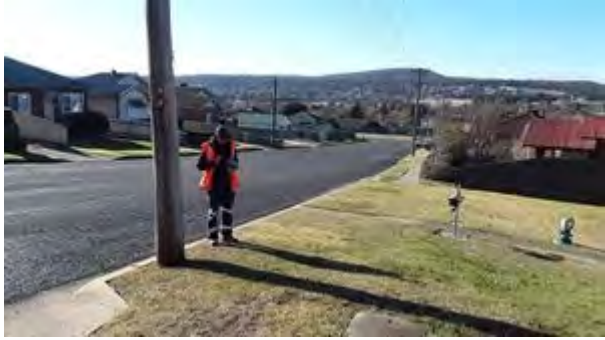
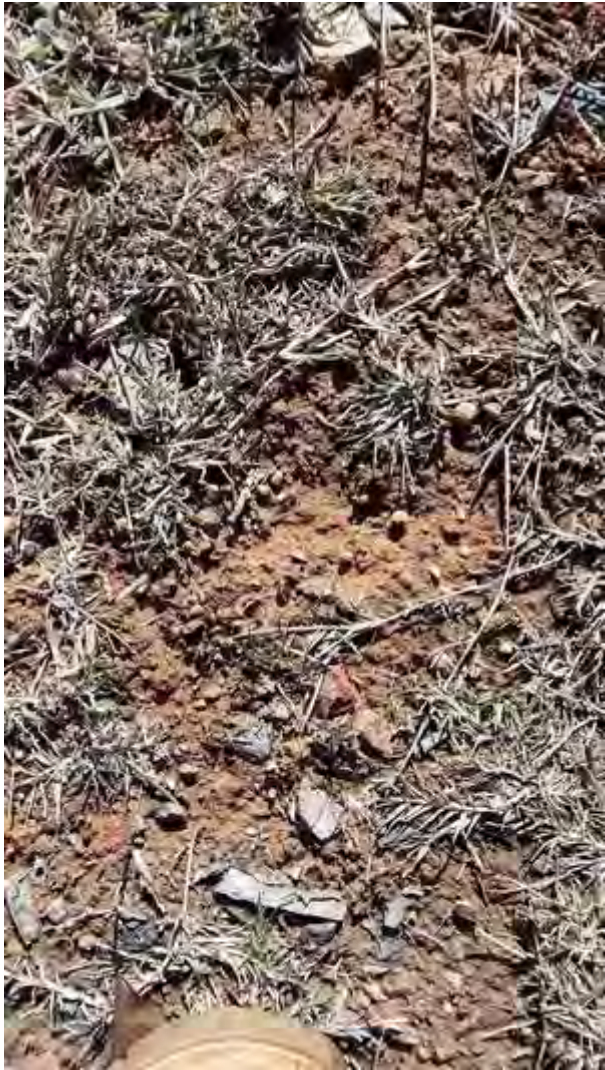
SOIL SAMPLING (XS067)

Project no.	318,001,660	Sample ID	XS067
Project name	Goulburn Wheatyrd Offsite Lead Delineation	Sample type	XRF
Start time	10:04	End time	10:05
Date	20/06/2023	Operator	Other
Sample appearance Pb 0, Cu 0, Zn 76, As 0			
Comments gravely silty sand light brown small gravel pieces

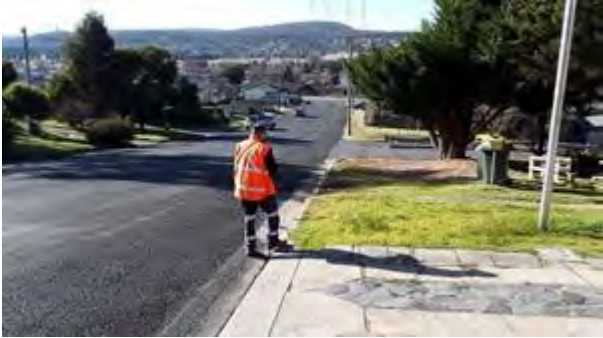
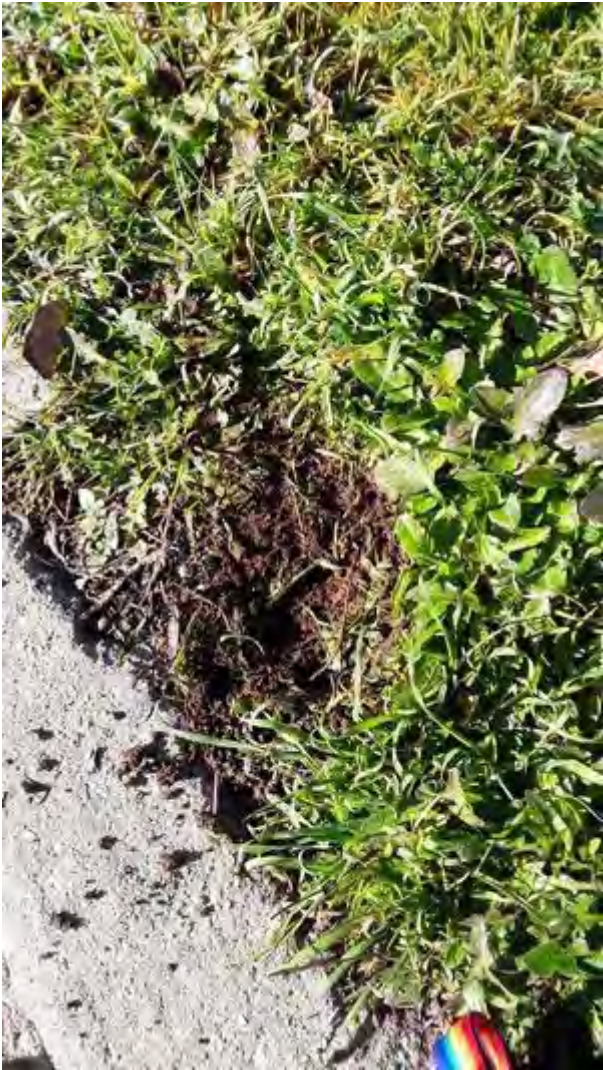
Project no.	318,001,660	Sample ID	XS065
Project name	Goulburn Wheatyrd Offsite Lead Delineation	Sample type	XRF
Start time	09:59	End time	10:00
Date	20/06/2023	Operator	Other
Sample appearance Pb 33, Cu 44, Zn 38, As 0			
Comments gravely silty sand

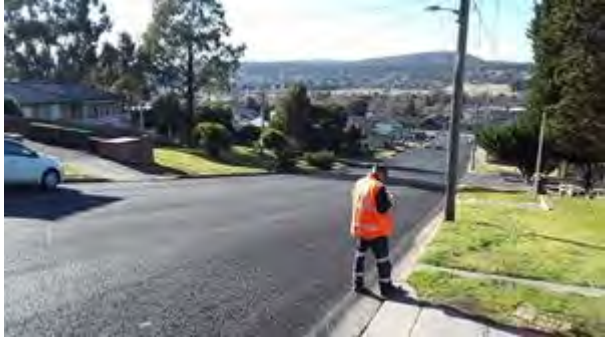
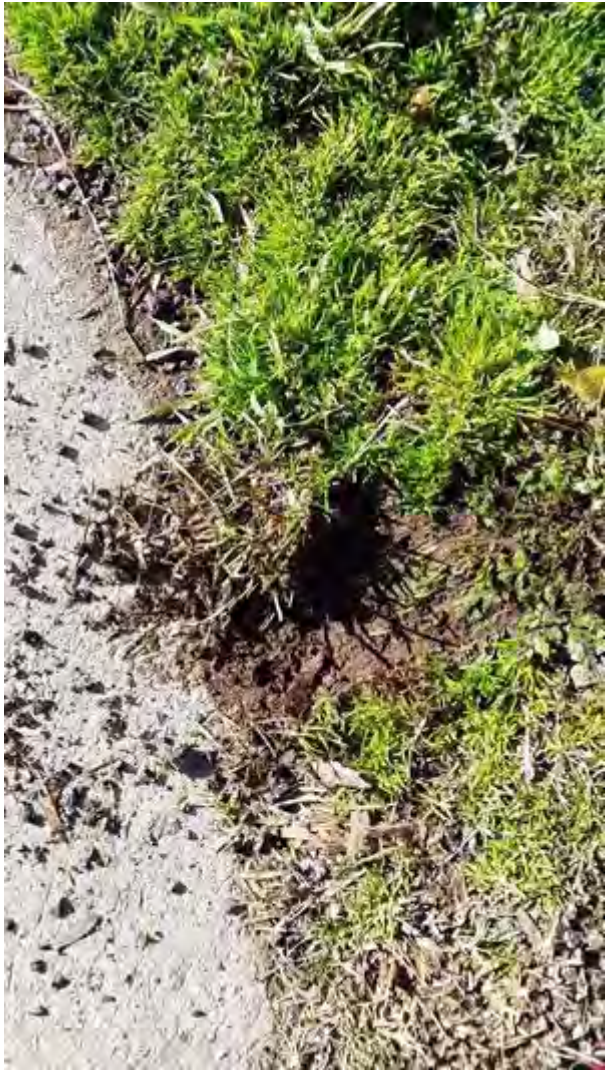
SOIL SAMPLING (XS064)

Project no.	318,001,660	Sample ID	XS064
Project name	Goulburn Wheatyrd Offsite Lead Delineation	Sample type	XRF
Start time	09:56	End time	09:57
Date	20/06/2023	Operator	Other
Sample appearance Pb 0, Cu 0, Zn 42, As 0			
Comments gravely silty sand

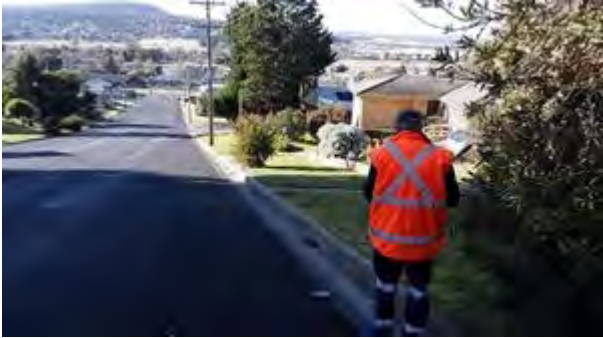
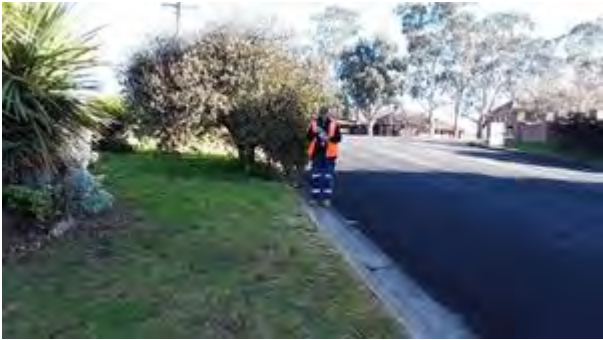
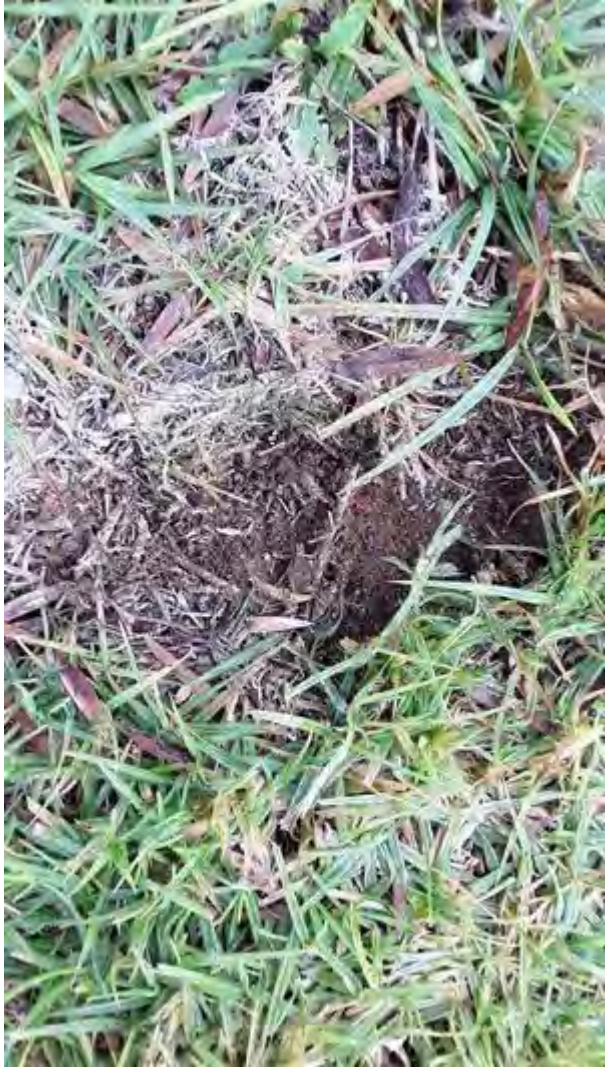
SOIL SAMPLING (XS063)

Project no.	318,001,660	Sample ID	XS063
Project name	Goulburn Wheatyrd Offsite Lead Delineation	Sample type	XRF
Start time	09:54	End time	09:55
Date	20/06/2023	Operator	Other
Sample appearance Pb 13, Cu 0, Zn 28, As 0			
Comments gravely silty sand

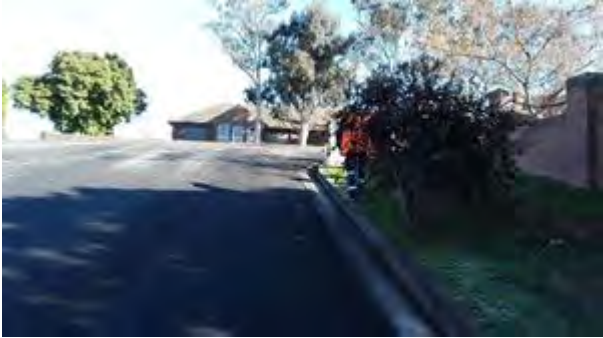
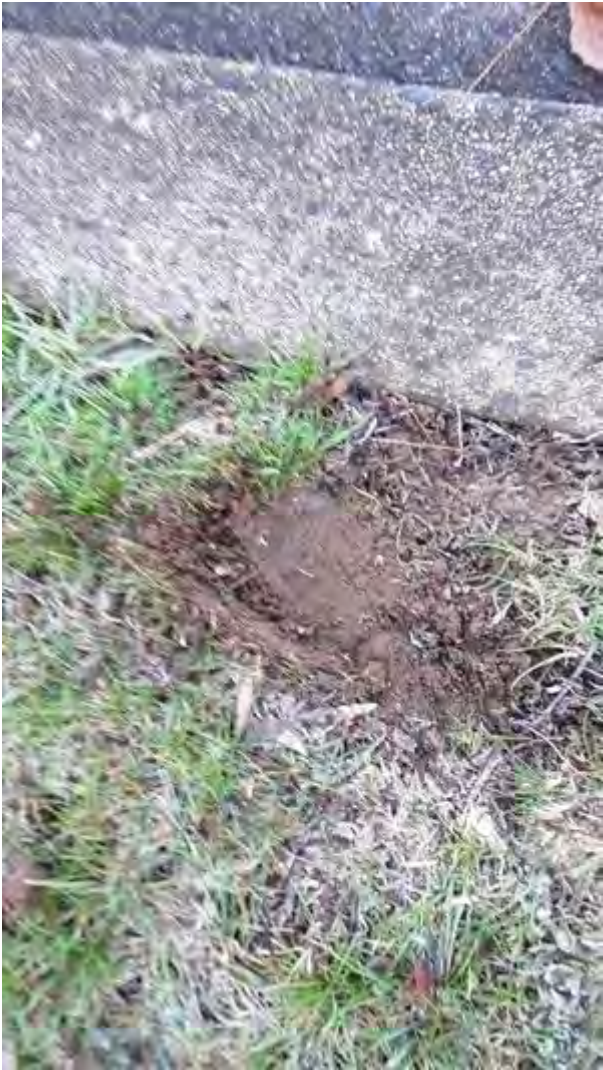
SOIL SAMPLING (XS062)

Project no.	318,001,660	Sample ID	XS062
Project name	Goulburn Wheatyrd Offsite Lead Delineation	Sample type	XRF
Start time	09:51	End time	09:53
Date	20/06/2023	Operator	Other
Sample appearance Pb 26, Cu 0, Zn 42, As 0			
Comments gravely silty sand

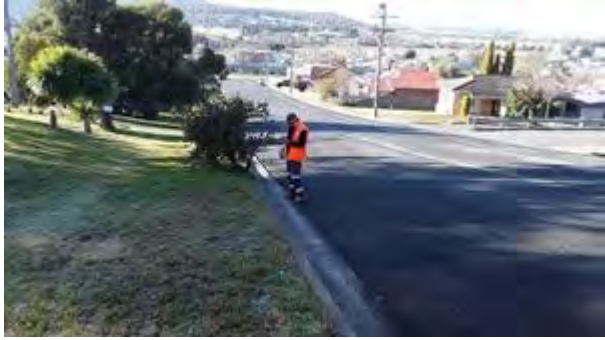
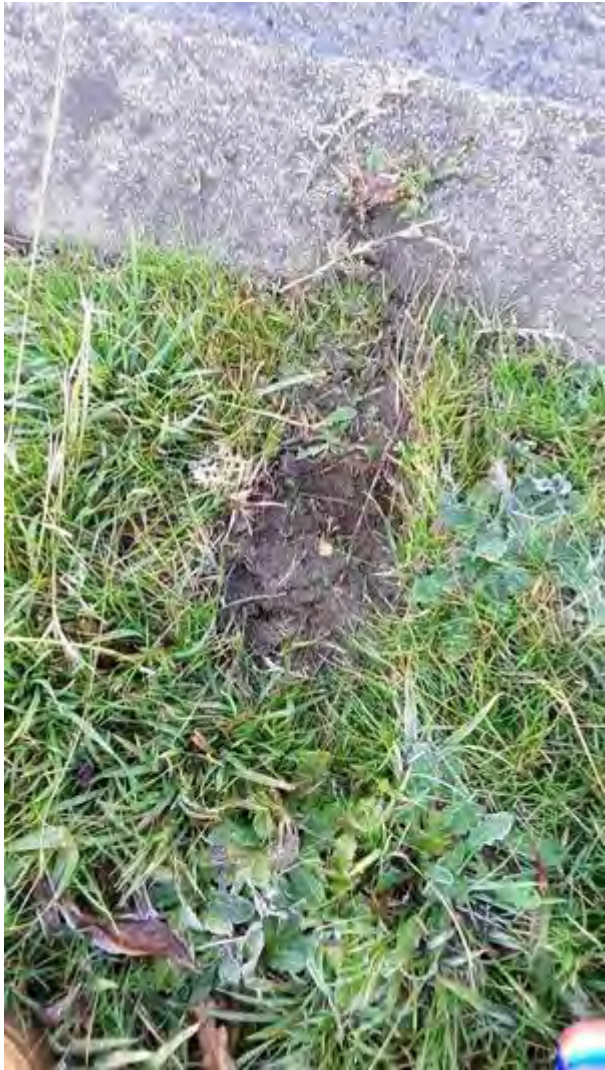
SOIL SAMPLING (XS058)

Project no.	318,001,660	Sample ID	XS058
Project name	Goulburn Wheatyrd Offsite Lead Delineation	Sample type	XRF
Start time	09:31	End time	09:32
Date	20/06/2023	Operator	Other
Sample appearance Pb 13, Cu 0, Zn 44, As 0			
Comments gravely silt dark brown

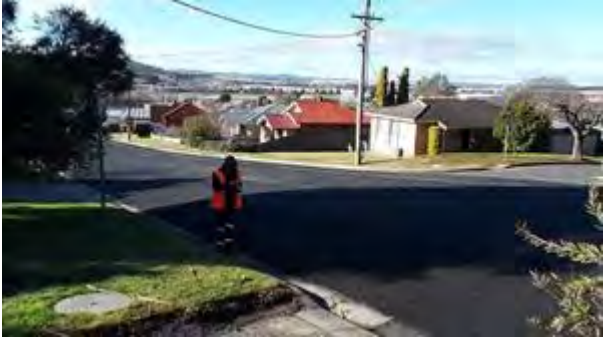
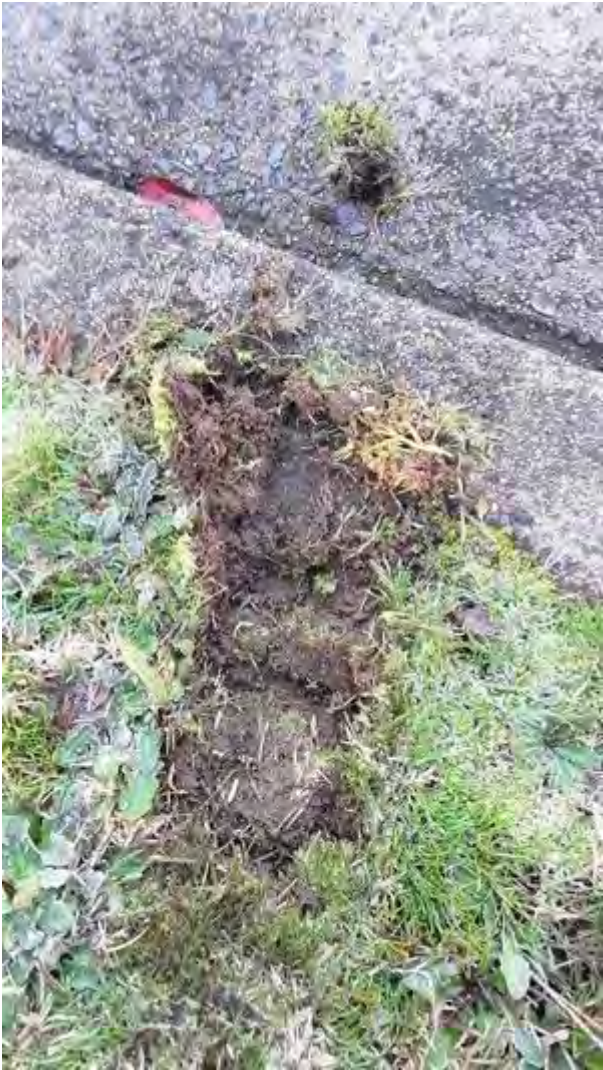
SOIL SAMPLING (XS057)

Project no.	318,001,660	Sample ID	XS057
Project name	Goulburn Wheatyrd Offsite Lead Delineation	Sample type	XRF
Start time	09:28	End time	09:29
Date	20/06/2023	Operator	Other
Sample appearance Pb 0, Cu 0, Zn 33, As 0			
Comments gravely silt dark brown

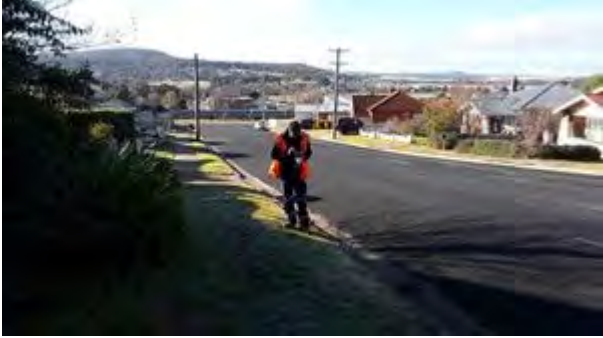
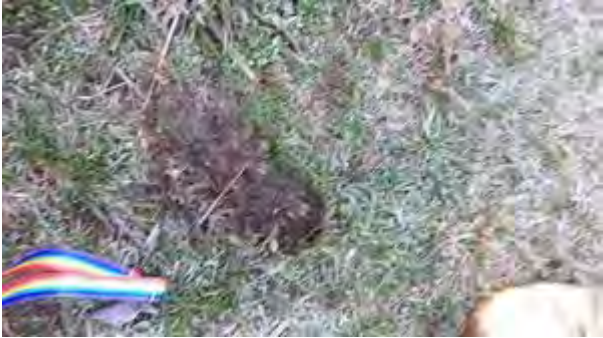
SOIL SAMPLING (XS056)

Project no.	318,001,660	Sample ID	XS056
Project name	Goulburn Wheatyrd Offsite Lead Delineation	Sample type	XRF
Start time	09:24	End time	09:25
Date	20/06/2023	Operator	Other
Sample appearance Pb 0, Cu 0, Zn 32, As 0			
Comments gravely silty sand
