Goulburn Wheat Yards Assessment

Offsite Lead Delineation Preliminary Site
Investigation

Project name **Goulburn Wheat Yards Assessment - Offsite Lead Delineation Preliminary Site Investigation**
Project no. **318001660**
Recipient **ARTC**
Document type **Final Report**
Version **1**
Date **7 September 2023**
Prepared by **N. Gilbert**
Checked by **R. Condon / K. Greenfield (CEnvP SC40104)**
Approved by **A. Nolan**
Description **This document presents the results of an environmental assessment to assess the potential offsite risk of lead contamination surrounding the Goulburn Wheat Yards.**

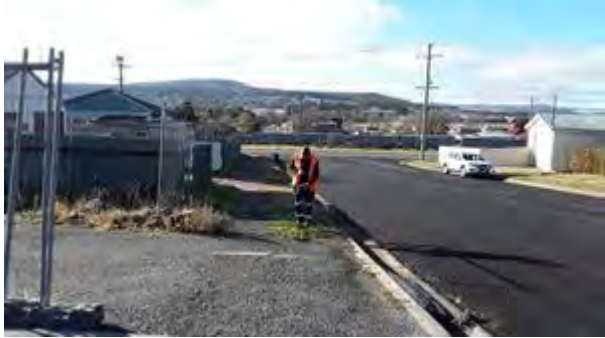
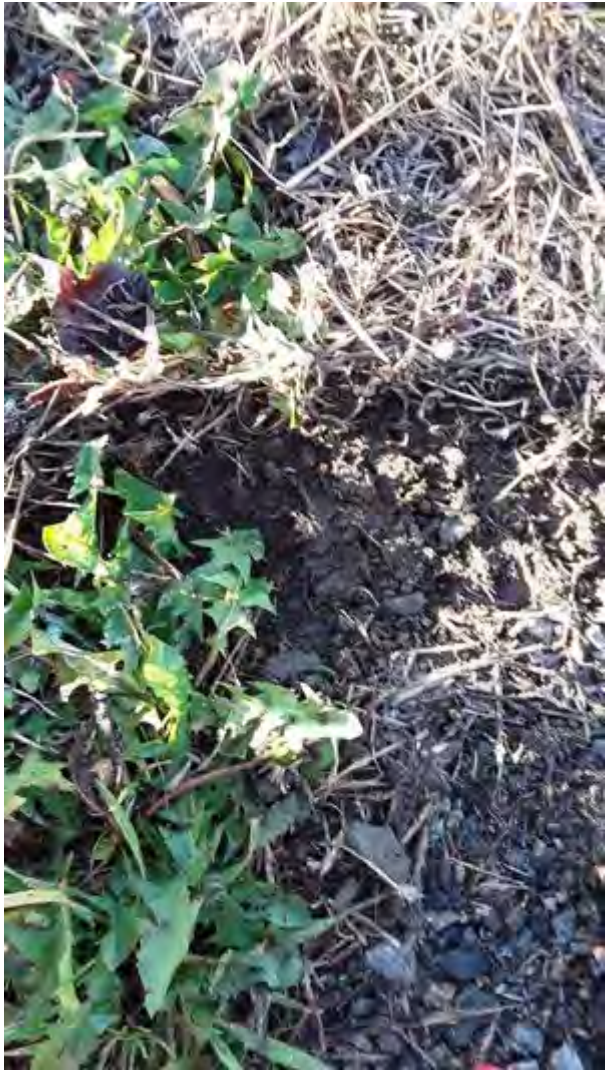
SOIL SAMPLING (XS053)

Project no.	318,001,660	Sample ID	XS053
Project name	Goulburn Wheatyrd Offsite Lead Delineation	Sample type	XRF
Start time	09:15	End time	09:16
Date	20/06/2023	Operator	Other
Sample appearance Pb 13, Cu 0, Zn 44, As 0			
Comments gravely silty sand

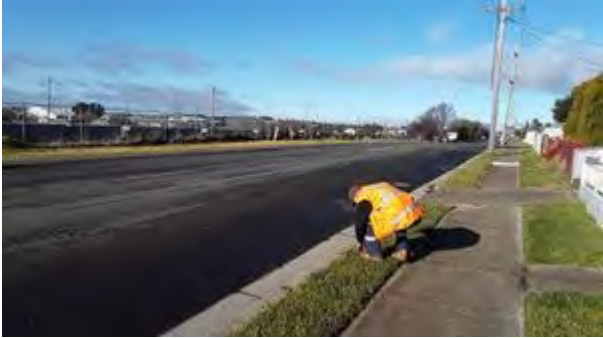
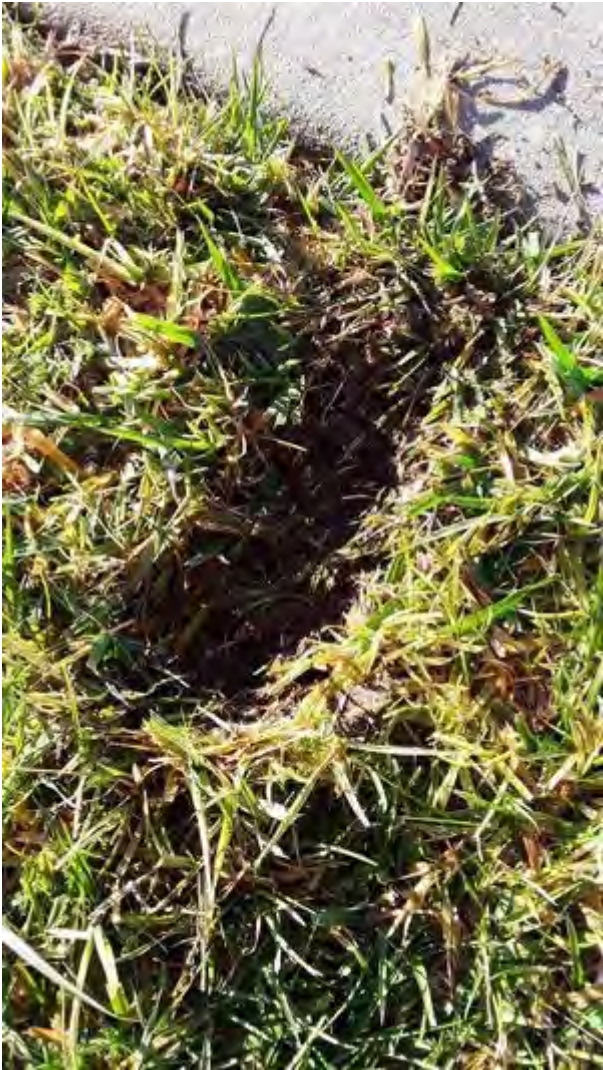
SOIL SAMPLING (XS051)

Project no.	318,001,660	Sample ID	XS051
Project name	Goulburn Wheatyrd Offsite Lead Delineation	Sample type	XRF
Start time	09:05	End time	09:06
Date	20/06/2023	Operator	Other
Sample appearance Pb 0, Cu 0, Zn 25, As 0			
Comments gravely silty sand

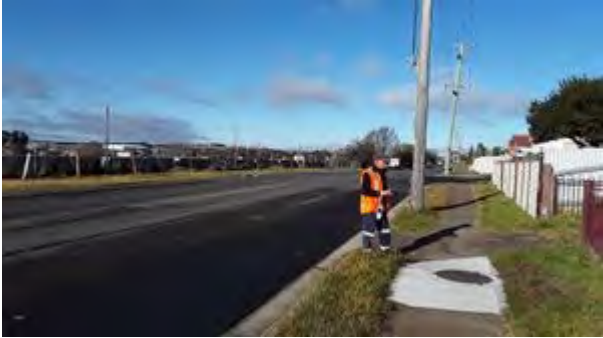
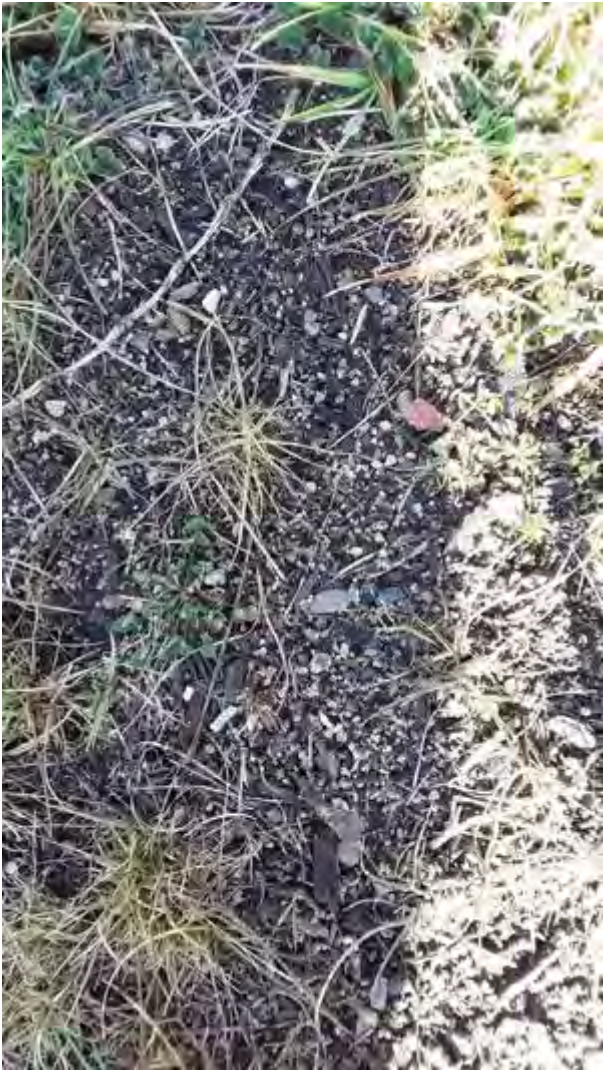
SOIL SAMPLING (XS050)

Project no.	318,001,660	Sample ID	XS050
Project name	Goulburn Wheatyrd Offsite Lead Delineation	Sample type	XRF
Start time	08:57	End time	08:59
Date	20/06/2023	Operator	Other
Sample appearance Pb 14, Cu 0, Zn 92, As 6			
Comments fine gravely silt brown sample taken

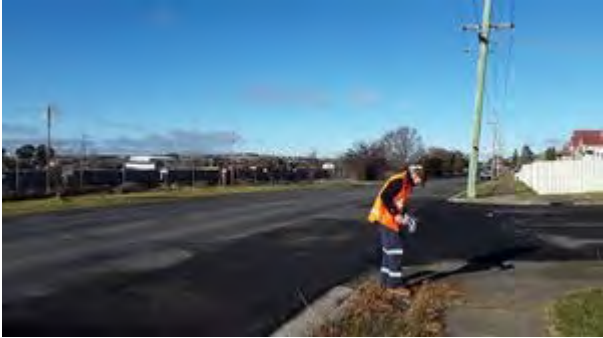
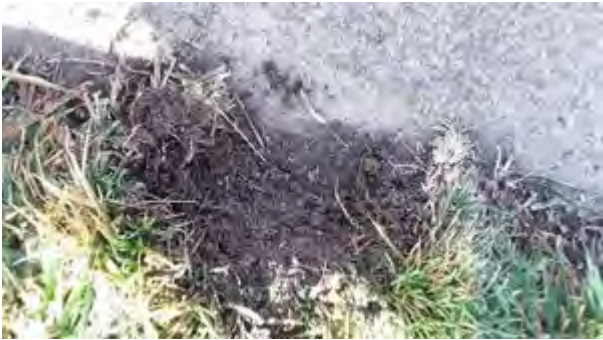
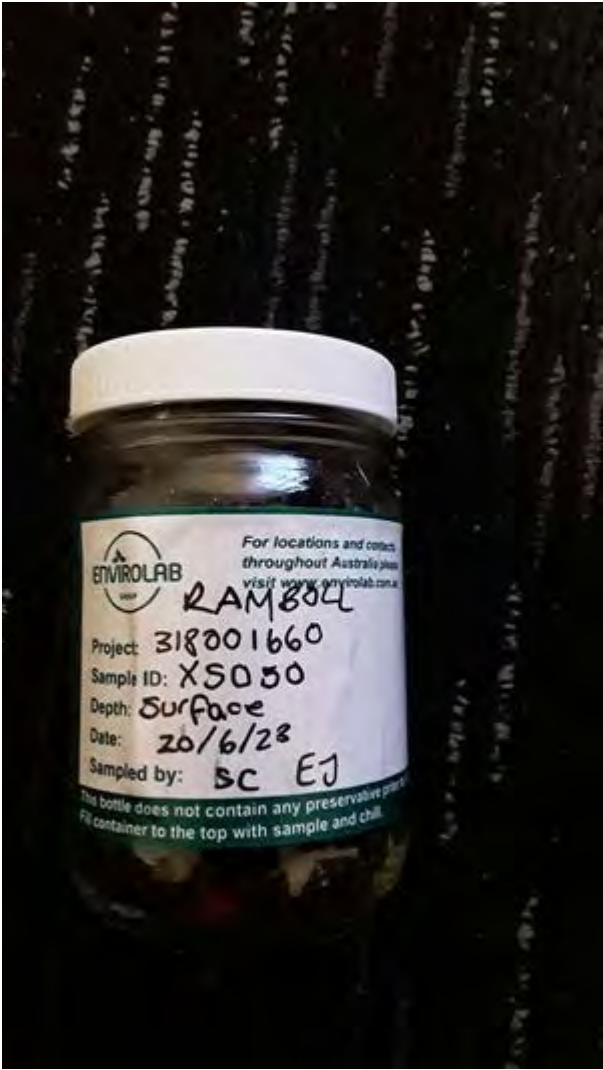
SOIL SAMPLING (XS049)

Project no.	318,001,660	Sample ID	XS049
Project name	Goulburn Wheatyrd Offsite Lead Delineation	Sample type	XRF
Start time	08:54	End time	08:55
Date	20/06/2023	Operator	Other
Sample appearance Pb 0, Cu 0, Zn 0, As 0			
Comments fine gravely silt brown

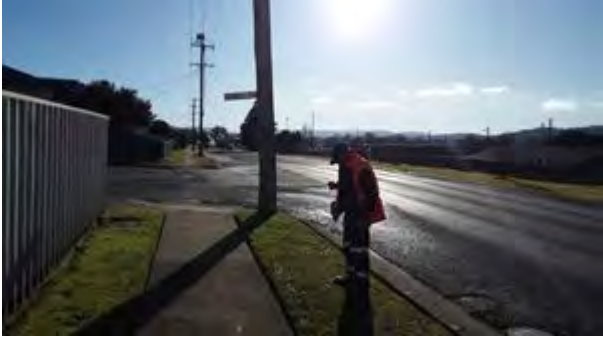
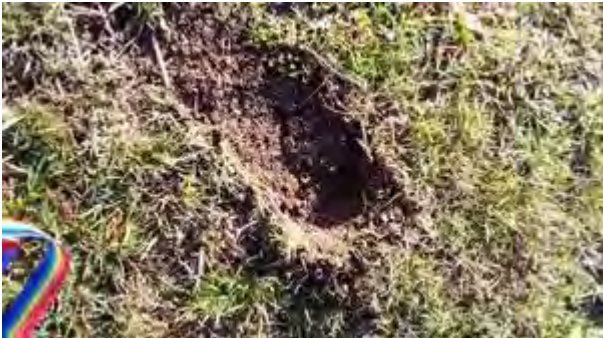
SOIL SAMPLING (XS047)

Project no.	318,001,660	Sample ID	XS047
Project name	Goulburn Wheatyrd Offsite Lead Delineation	Sample type	XRF
Start time	08:49	End time	08:50
Date	20/06/2023	Operator	Other
Sample appearance Pb 0, Cu 0, Zn 41 , As 0			
Comments fine gravely silt brown

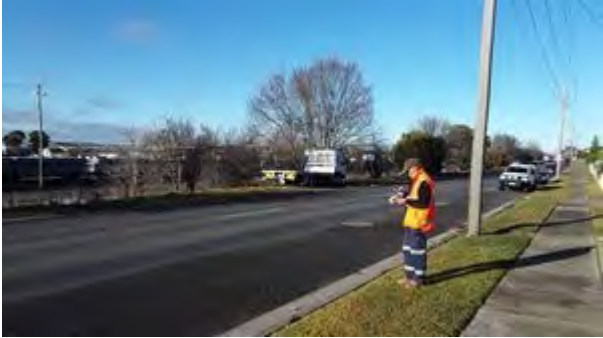
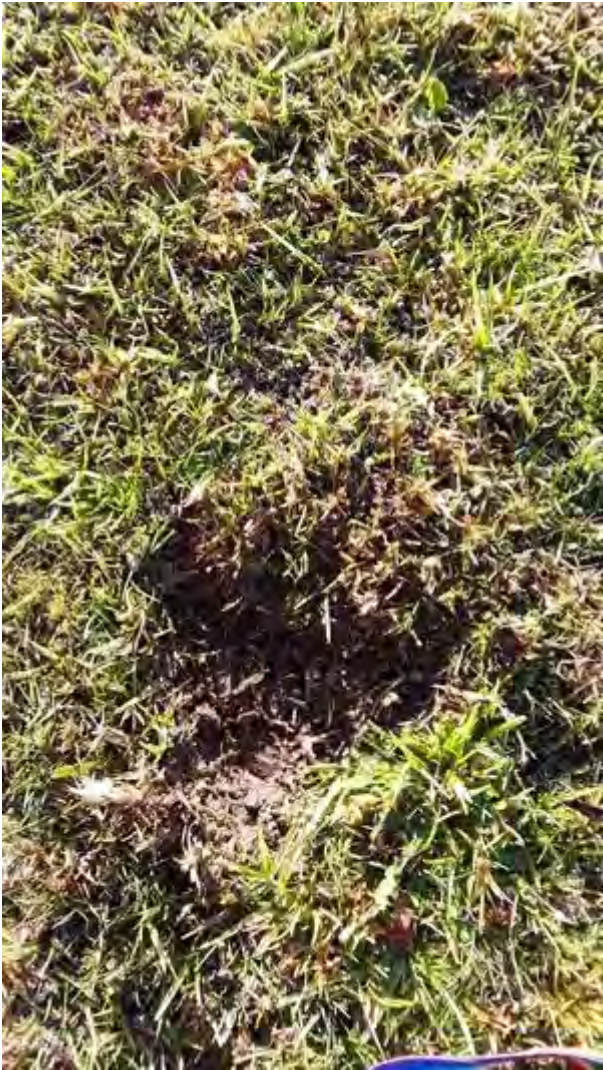
SOIL SAMPLING (XS046)

Project no.	318,001,660	Sample ID	XS046
Project name	Goulburn Wheatyrd Offsite Lead Delineation	Sample type	XRF
Start time	08:46	End time	08:47
Date	20/06/2023	Operator	Other
Sample appearance Pb 0, Cu 0, Zn 43 , As 0			
Comments fine gravely silt brown

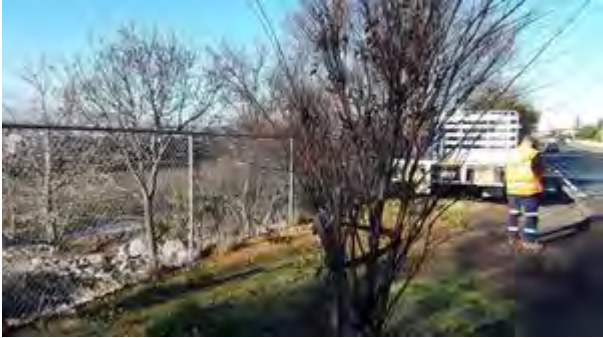
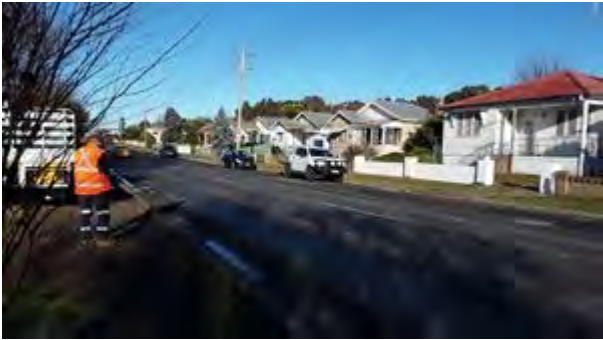
SOIL SAMPLING (XS042)

Project no.	318,001,660	Sample ID	XS042
Project name	Goulburn Wheatyrd Offsite Lead Delineation	Sample type	XRF
Start time	08:36	End time	08:38
Date	20/06/2023	Operator	Other
Sample appearance Pb 0, Cu 0, Zn 0 , As 0			
Comments Gravelly silty sand brown medium sized gravel

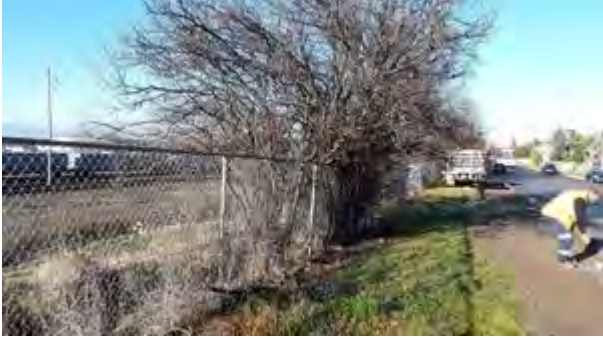
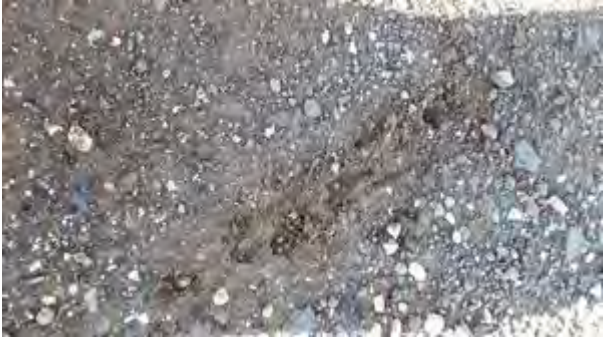
SOIL SAMPLING (XS041)

Project no.	318,001,660	Sample ID	XS041
Project name	Goulburn Wheatyrd Offsite Lead Delineation	Sample type	XRF
Start time	08:33	End time	08:35
Date	20/06/2023	Operator	Other
Sample appearance Pb 0, Cu 88, Zn0 , As 0			
Comments Gravely silty sand brown

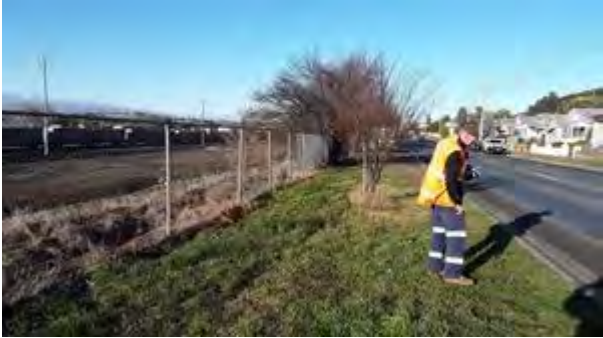
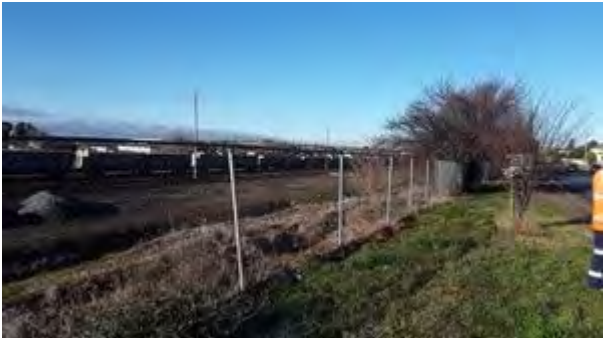
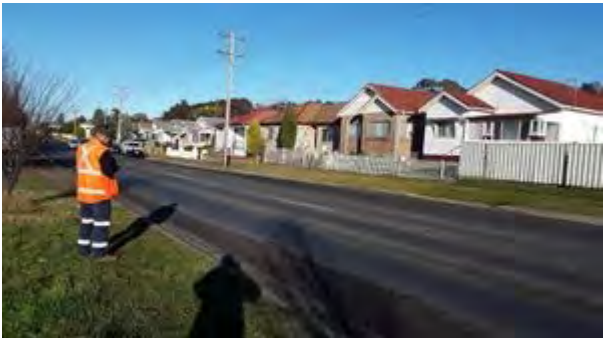
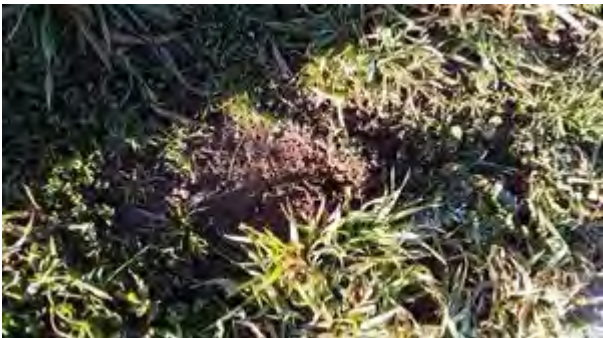
SOIL SAMPLING (XS040)

Project no.	318,001,660	Sample ID	XS040
Project name	Goulburn Wheatyrd Offsite Lead Delineation	Sample type	XRF
Start time	08:16	End time	08:18
Date	20/06/2023	Operator	Other
Sample appearance Pb 0, Cu 0, Zn 31 , As 0			
Comments Gravely silty sand brown

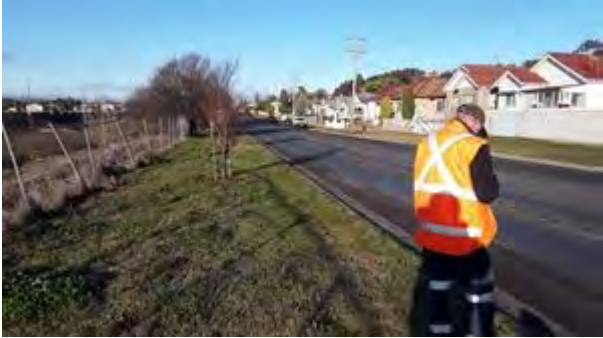
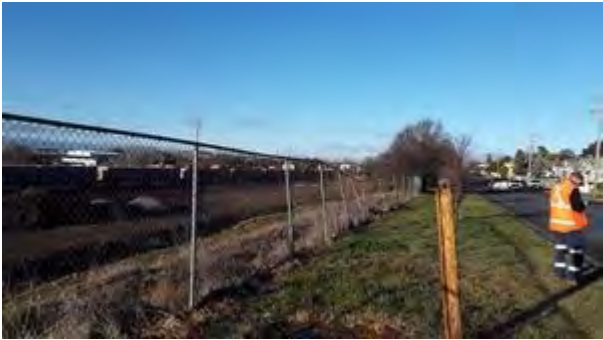
SOIL SAMPLING (XS039)

Project no.	318,001,660	Sample ID	XS039
Project name	Goulburn Wheatyrd Offsite Lead Delineation	Sample type	XRF
Start time	08:14	End time	08:15
Date	20/06/2023	Operator	Other
Sample appearance Pb 21, Cu 44, Zn62 , As 10			
Comments Gravelly silty sand brown sample taken

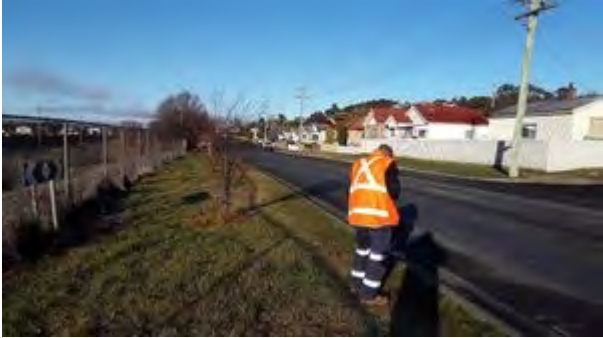
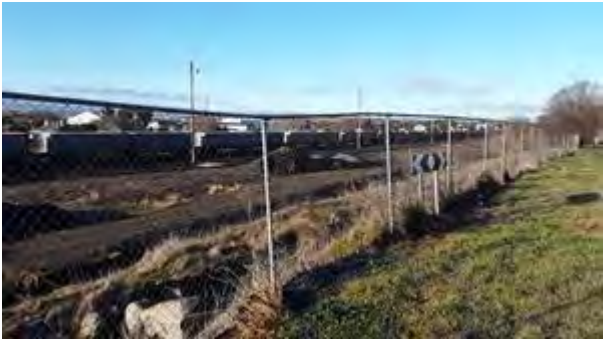
SOIL SAMPLING (XS038)

Project no.	318,001,660	Sample ID	XS038
Project name	Goulburn Wheatyrd Offsite Lead Delineation	Sample type	XRF
Start time	08:12	End time	08:13
Date	20/06/2023	Operator	Other
Sample appearance Pb 0, Cu 39, Zn 31 , As 0			
Comments Gravelly silt brown

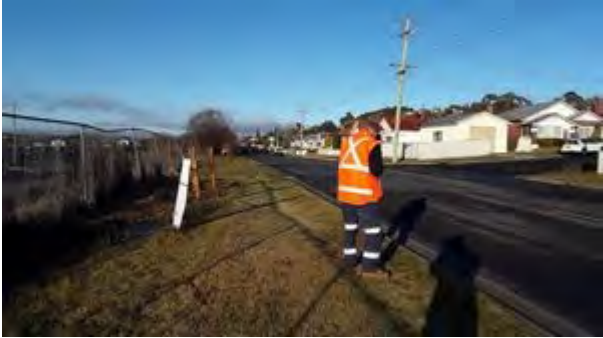
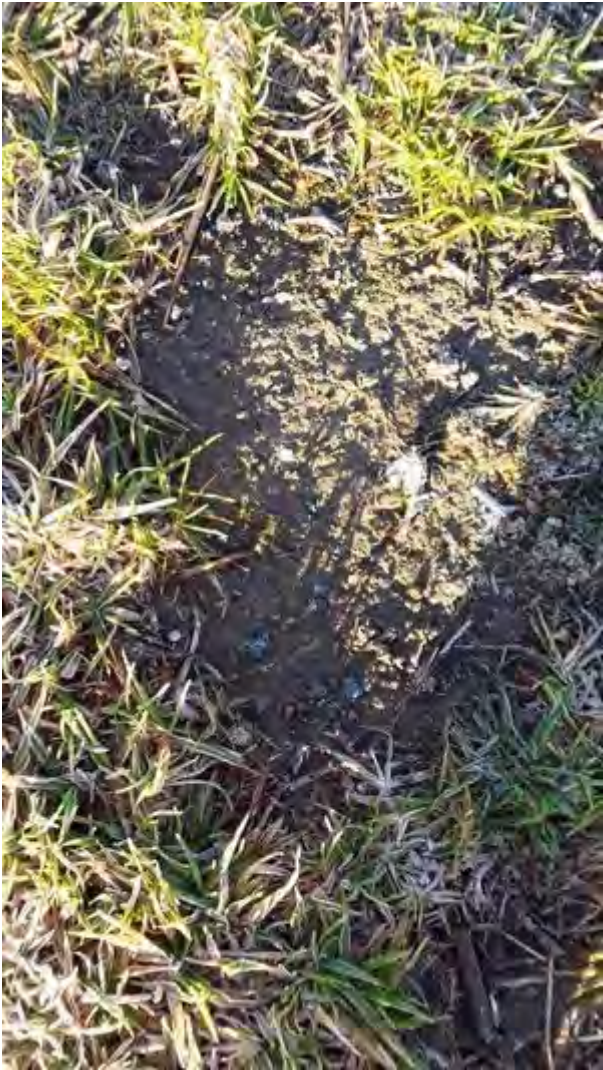
SOIL SAMPLING (XS037)

Project no.	318,001,660	Sample ID	XS037
Project name	Goulburn Wheatyrd Offsite Lead Delineation	Sample type	XRF
Start time	08:10	End time	08:11
Date	20/06/2023	Operator	Other
Sample appearance Pb 0, Cu 49, Zn 0 , As 0			
Comments Gravely silty sand brown

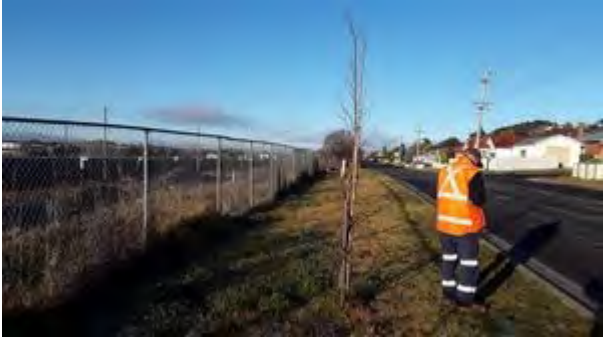
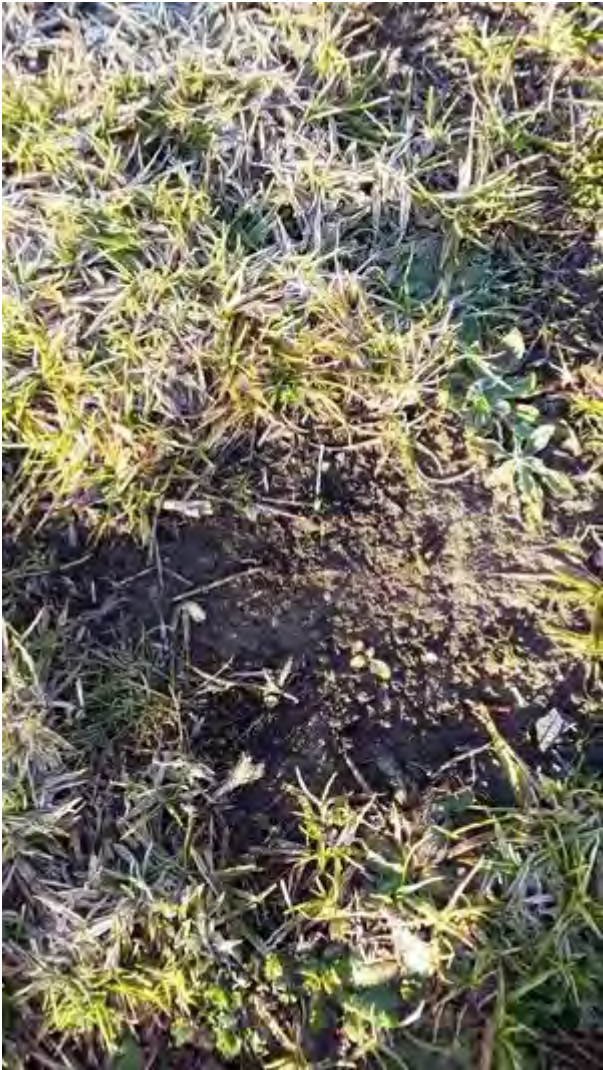
SOIL SAMPLING (XS036)

Project no.	318,001,660	Sample ID	XS036
Project name	Goulburn Wheatyrd Offsite Lead Delineation	Sample type	XRF
Start time	08:07	End time	08:08
Date	20/06/2023	Operator	Other
Sample appearance Pb 0, Cu 0, Zn 0 , As 0			
Comments Gravely silty sand brown

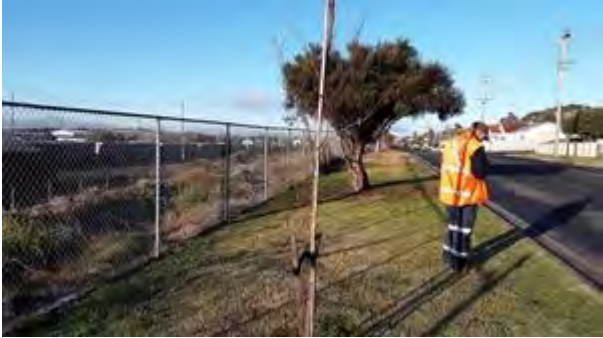
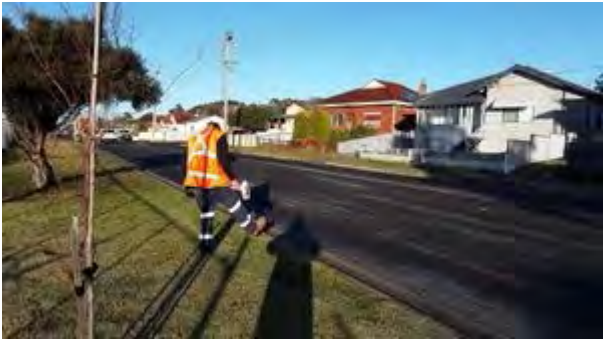
SOIL SAMPLING (XS035)

Project no.	318,001,660	Sample ID	XS035
Project name	Goulburn Wheatyrd Offsite Lead Delineation	Sample type	XRF
Start time	08:05	End time	08:06
Date	20/06/2023	Operator	Other
Sample appearance Pb 0, Cu 0, Zn 19 , As 0			
Comments Gravely silty sand brown

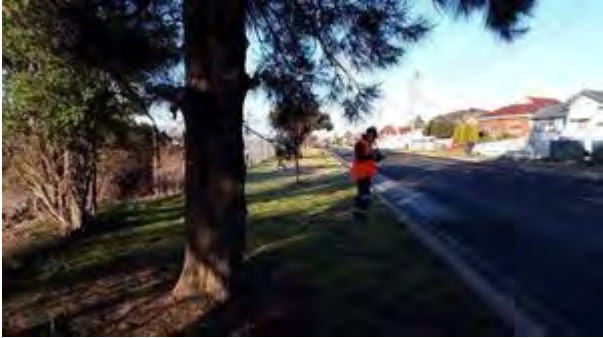
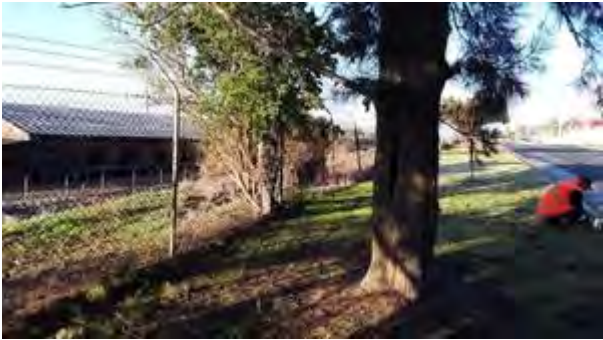
SOIL SAMPLING (XS034)

Project no.	318,001,660	Sample ID	XS034
Project name	Goulburn Wheatyrd Offsite Lead Delineation	Sample type	XRF
Start time	08:02	End time	08:03
Date	20/06/2023	Operator	Other
Sample appearance Pb 0, Cu 0, Zn 28 , As 0			
Comments Gravelly silt grey brown colour

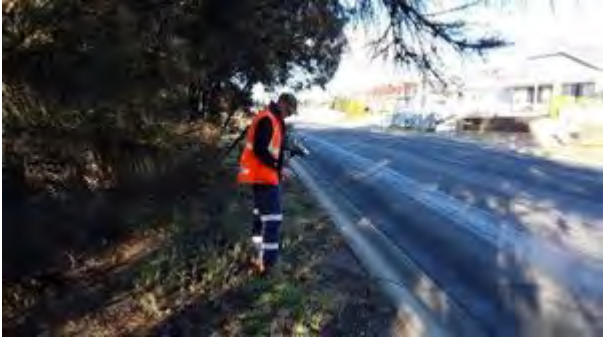
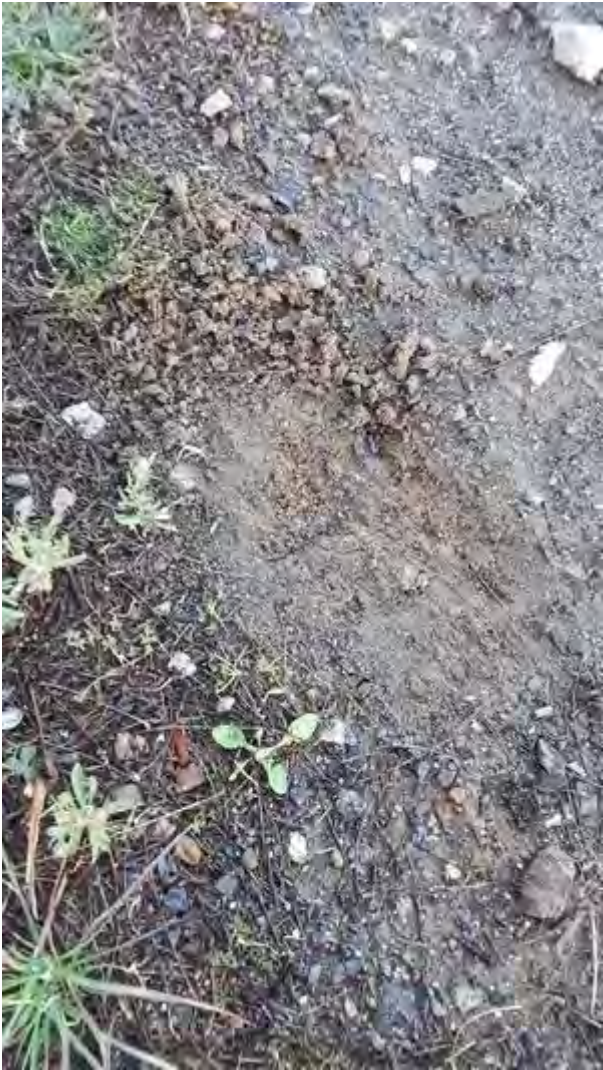
SOIL SAMPLING (XS033)

Project no.	318,001,660	Sample ID	XS033
Project name	Goulburn Wheatyrd Offsite Lead Delineation	Sample type	XRF
Start time	08:00	End time	08:01
Date	20/06/2023	Operator	Other
Sample appearance Pb 0, Cu 0, Zn 0 , As 0			
Comments Gravelly silty sand medium sized stones

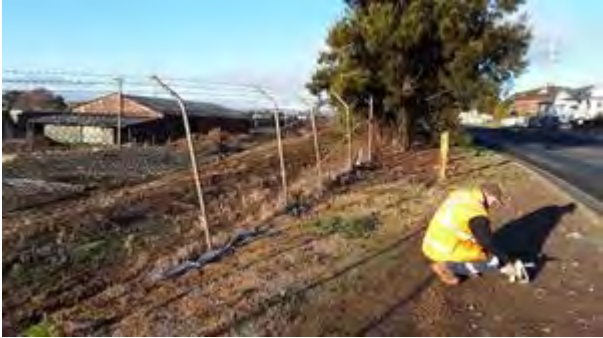
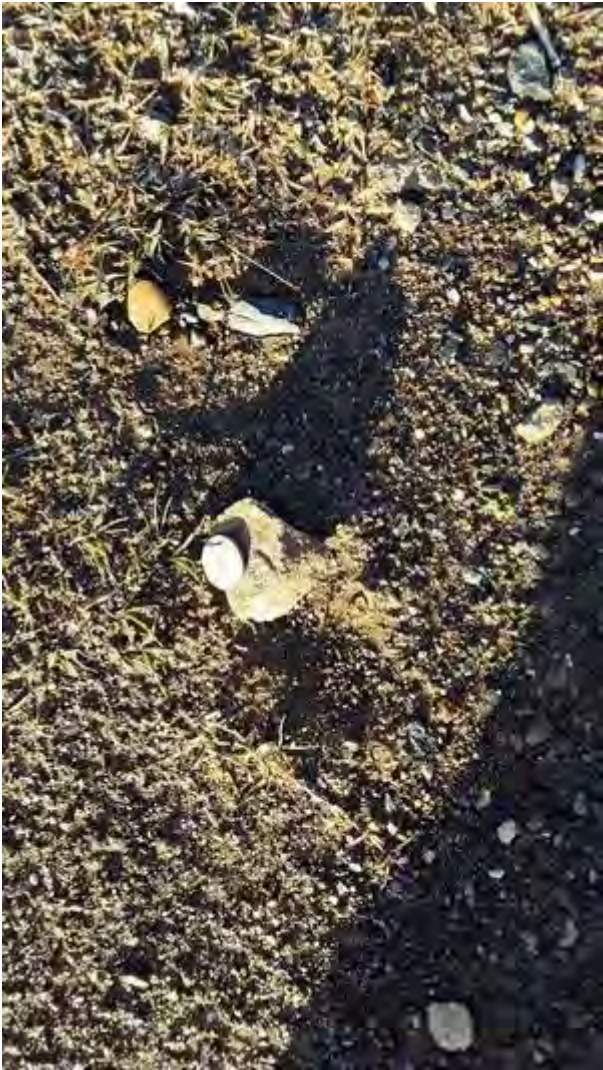
SOIL SAMPLING (XS032)

Project no.	318,001,660	Sample ID	XS032
Project name	Goulburn Wheatyrd Offsite Lead Delineation	Sample type	XRF
Start time	07:58	End time	08:00
Date	20/06/2023	Operator	Other
Sample appearance Pb 0, Cu 0, Zn 0 , As 0			
Comments Gravelly silty sand

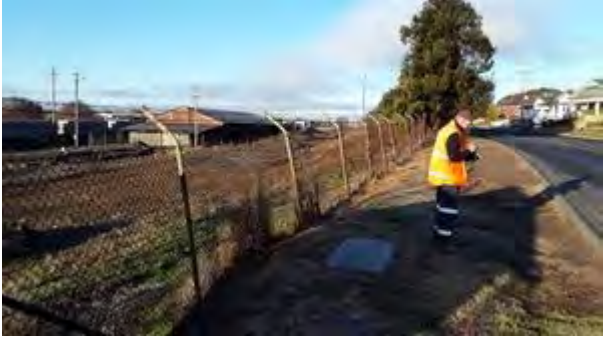
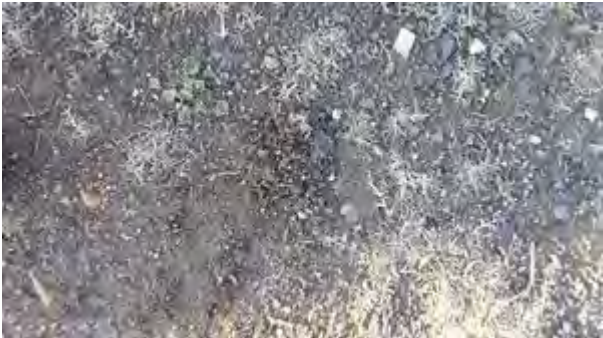
SOIL SAMPLING (XS031)

Project no.	318,001,660	Sample ID	XS031
Project name	Goulburn Wheatyrd Offsite Lead Delineation	Sample type	XRF
Start time	07:55	End time	07:57
Date	20/06/2023	Operator	Other
Sample appearance Pb 0, Cu 0, Zn 142 , As 0			
Comments Brown fine top soil silt

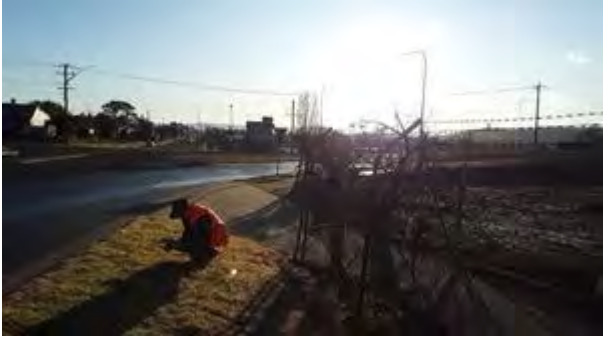
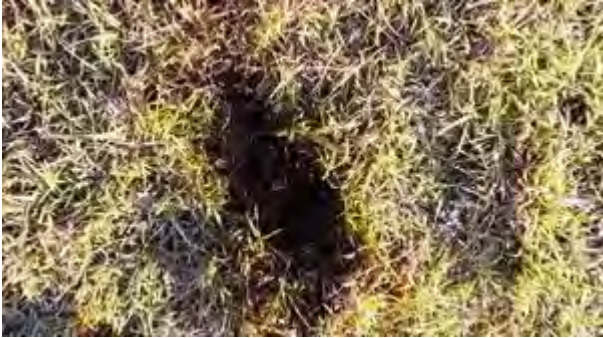
SOIL SAMPLING (XS030)

Project no.	318,001,660	Sample ID	XS030
Project name	Goulburn Wheatyrd Offsite Lead Delineation	Sample type	XRF
Start time	07:41	End time	07:43
Date	20/06/2023	Operator	Other
Sample appearance Pb 12, Cu39, Zn 109 , As 0			
Comments Brown fine top soil silt sample taken

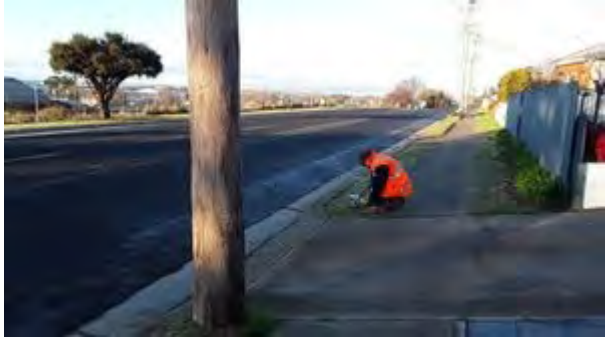
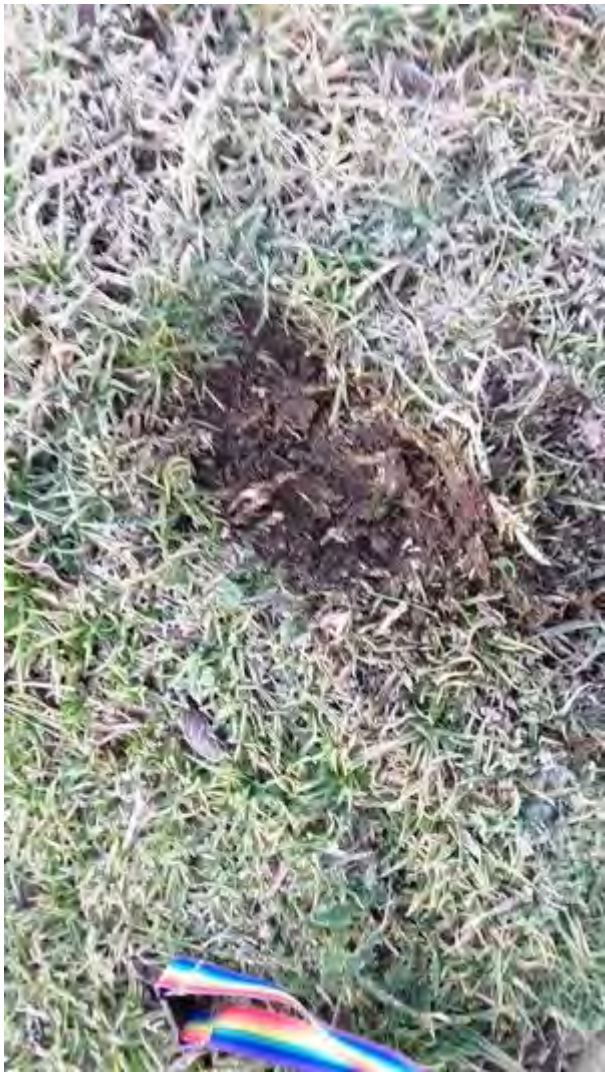
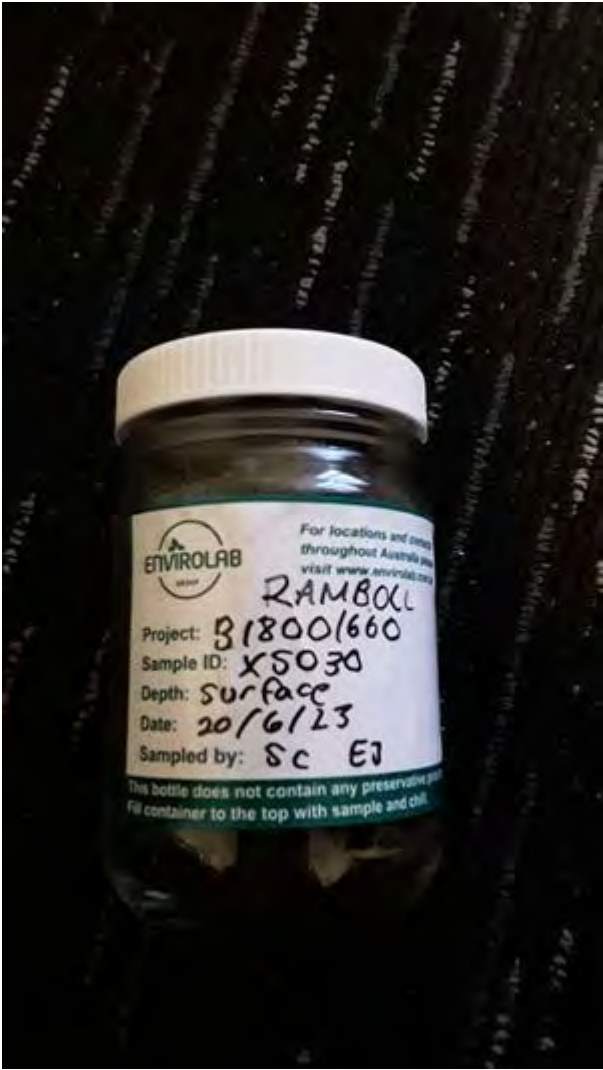
SOIL SAMPLING (XS029)

Project no.	318,001,660	Sample ID	XS029
Project name	Goulburn Wheatyrd Offsite Lead Delineation	Sample type	XRF
Start time	07:39	End time	07:40
Date	20/06/2023	Operator	Other
Sample appearance Pb 0, Cu 0, Zn 40 , As 0			
Comments Brown fine top soil silt

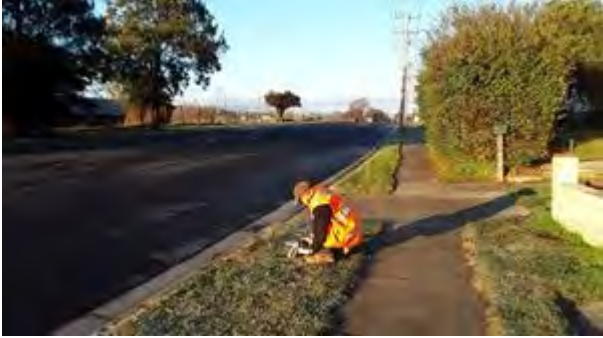
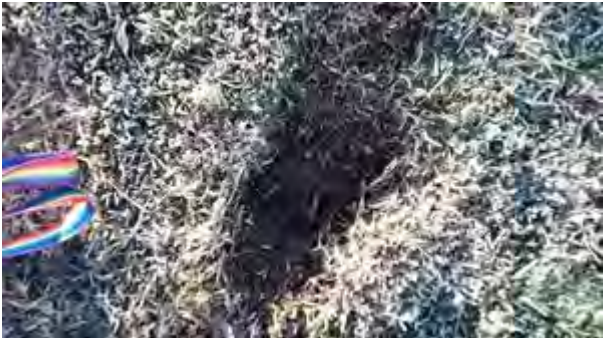
SOIL SAMPLING (XS027)

Project no.	318,001,660	Sample ID	XS027
Project name	Goulburn Wheatyrd Offsite Lead Delineation	Sample type	XRF
Start time	07:31	End time	07:33
Date	20/06/2023	Operator	Other
Sample appearance Pb 0, Cu 118, Zn 0 , As 0			
Comments Brown fine top soil silt

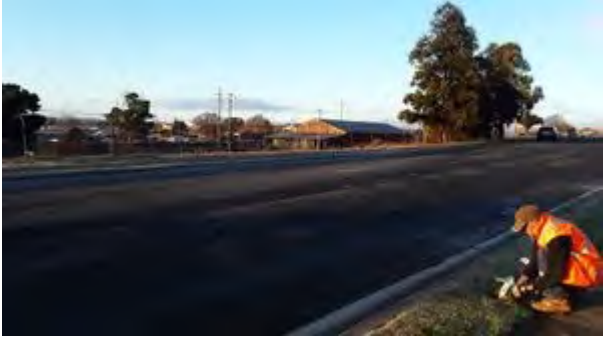
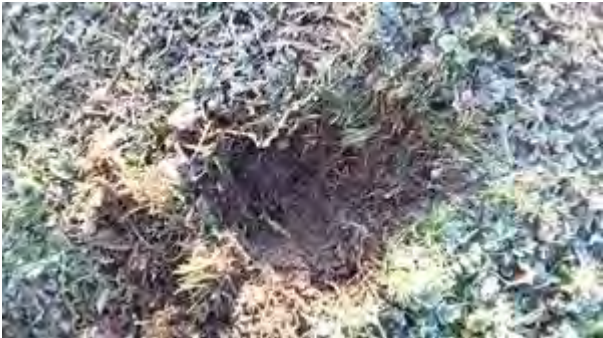
SOIL SAMPLING (XS025)

Project no.	318,001,660	Sample ID	XS025
Project name	Goulburn Wheatyrd Offsite Lead Delineation	Sample type	XRF
Start time	07:26	End time	07:28
Date	20/06/2023	Operator	Other
Sample appearance Pb 0, Cu 0, Zn 96 , As 0			
Comments Brown fine top soil silt

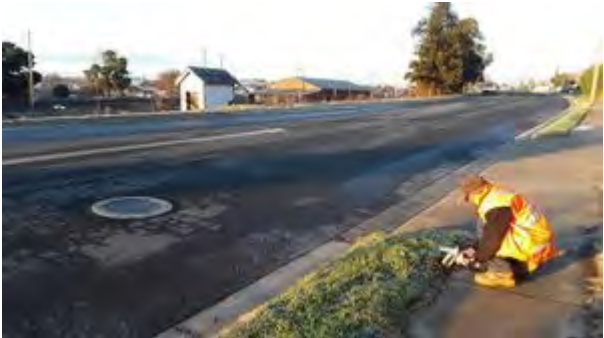
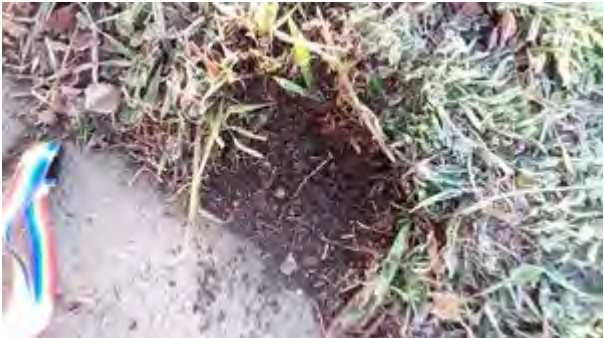
SOIL SAMPLING (XS024)

Project no.	318,001,660	Sample ID	XS024
Project name	Goulburn Wheatyrd Offsite Lead Delineation	Sample type	XRF
Start time	07:23	End time	07:25
Date	20/06/2023	Operator	Other
Sample appearance Pb 35, Cu 0, Zn 136 , As 0			
Comments Brown fine top soil silt

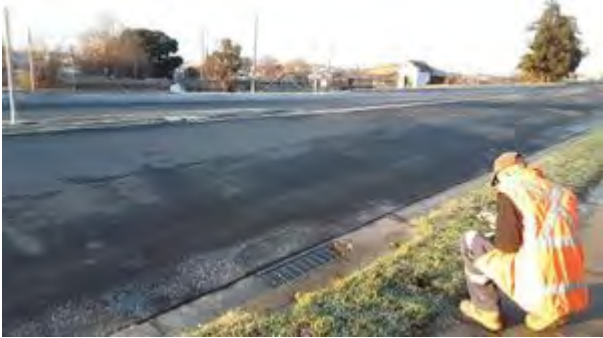
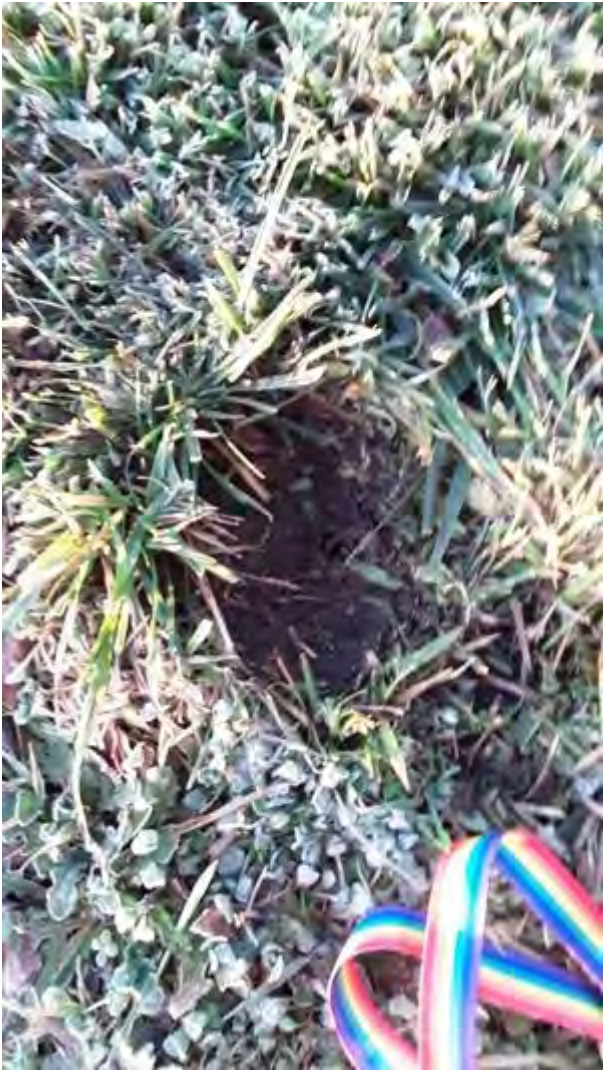
SOIL SAMPLING (XS023)

Project no.	318,001,660	Sample ID	XS023
Project name	Goulburn Wheatyrd Offsite Lead Delineation	Sample type	XRF
Start time	07:20	End time	07:23
Date	20/06/2023	Operator	Other
Sample appearance Pb 24, Cu 0, Zn 92 , As 0			
Comments Brown fine top soil silt

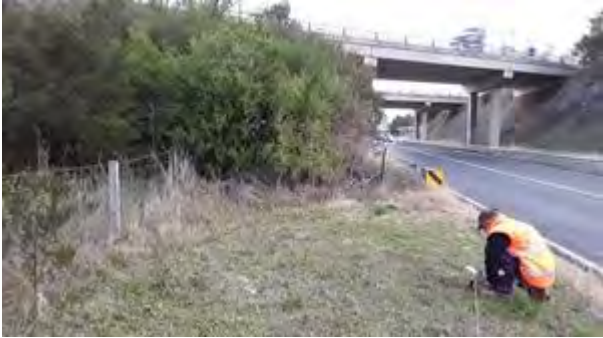
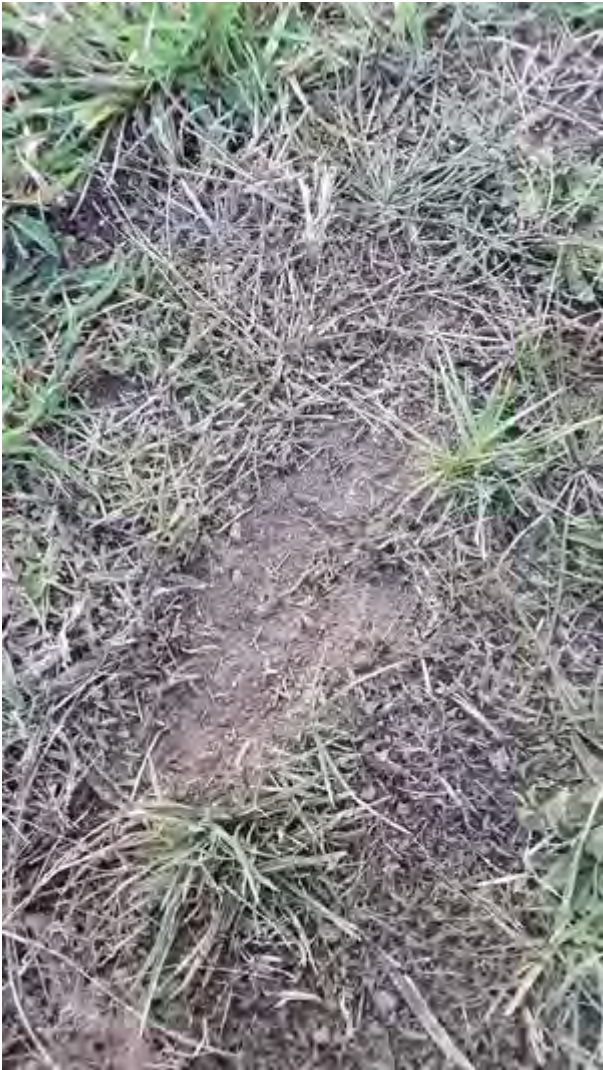
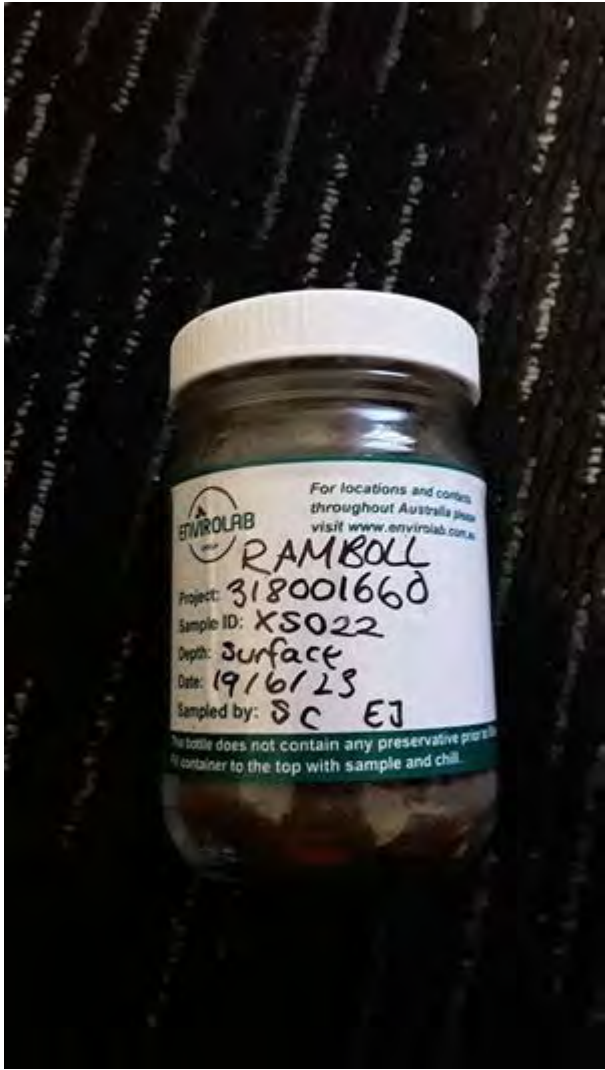
SOIL SAMPLING (XS021)

Project no.	318,001,660	Sample ID	XS021
Project name	Goulburn Wheatyrd Offsite Lead Delineation	Sample type	XRF
Start time	16:30	End time	16:32
Date	19/06/2023	Operator	Other
Sample appearance Pb 0, Cu 48, Zn 72 , As 10			
Comments Brown gravely silt

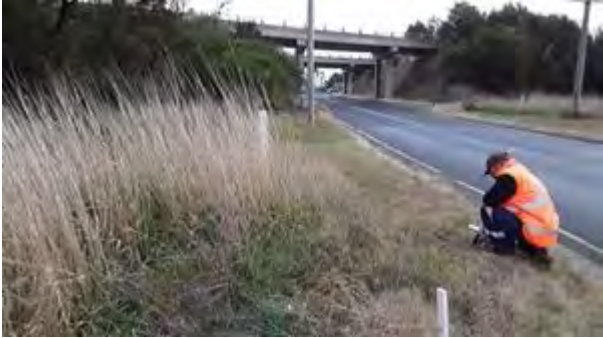
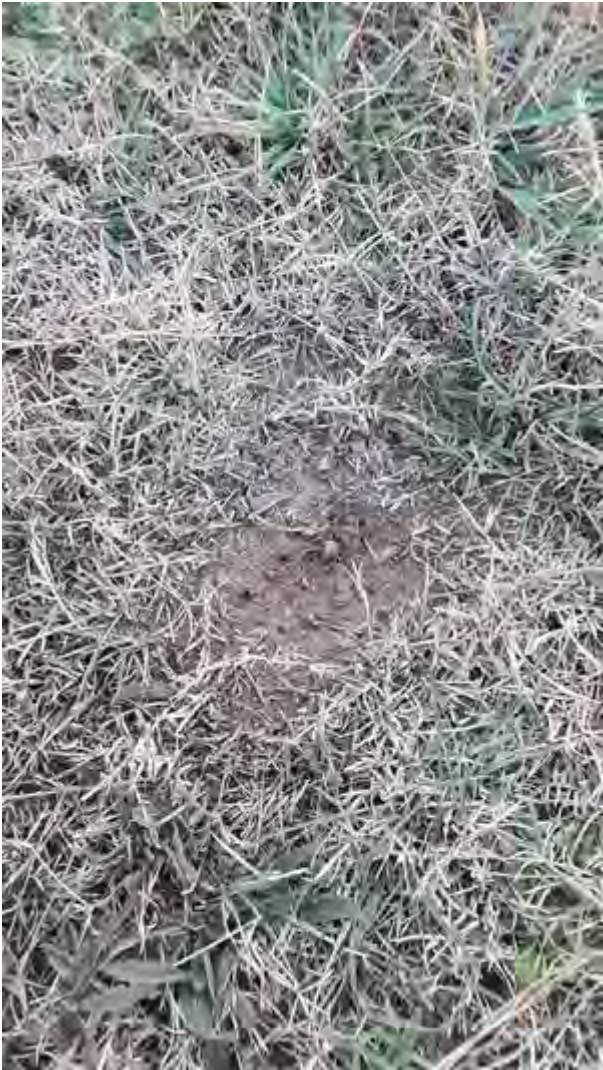
SOIL SAMPLING (XS020)

Project no.	318,001,660	Sample ID	XS020
Project name	Goulburn Wheatyrd Offsite Lead Delineation	Sample type	XRF
Start time	16:28	End time	16:30
Date	19/06/2023	Operator	Other
Sample appearance Pb 0, Cu 26, Zn 102 , As 4			
Comments Brown gravely silt

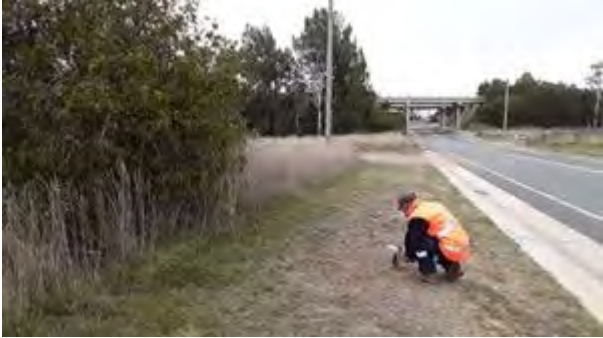
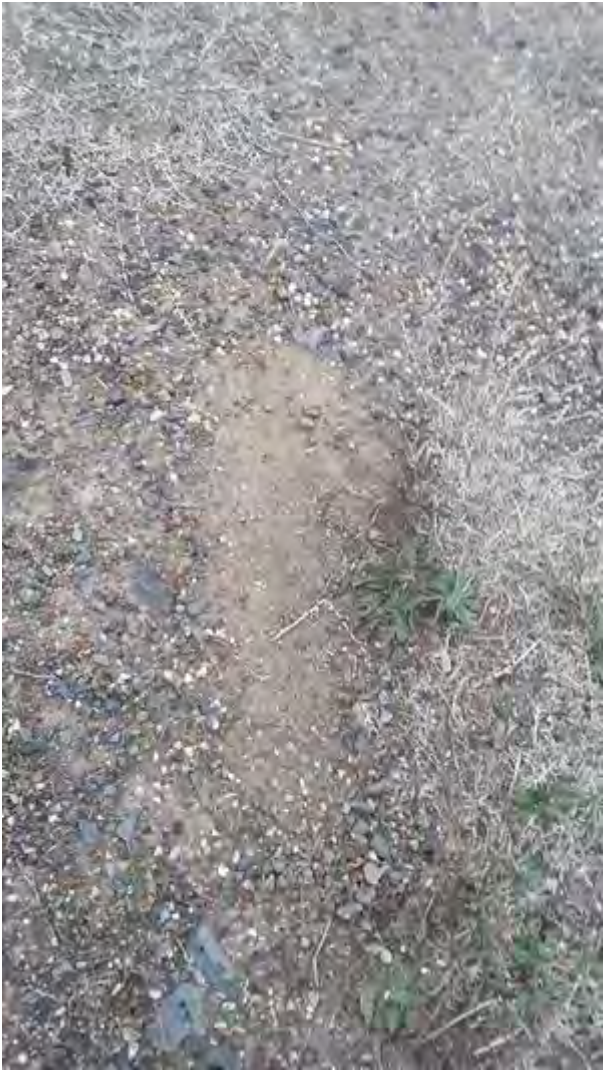
SOIL SAMPLING (XS017)

Project no.	318,001,660	Sample ID	XS017
Project name	Goulburn Wheatyard Offsite Lead Delineation	Sample type	XRF
Start time	16:23	End time	16:24
Date	19/06/2023	Operator	Other
Sample appearance Pb 0, Cu 45, Zn 94 , As0			
Comments Brown gravely silt

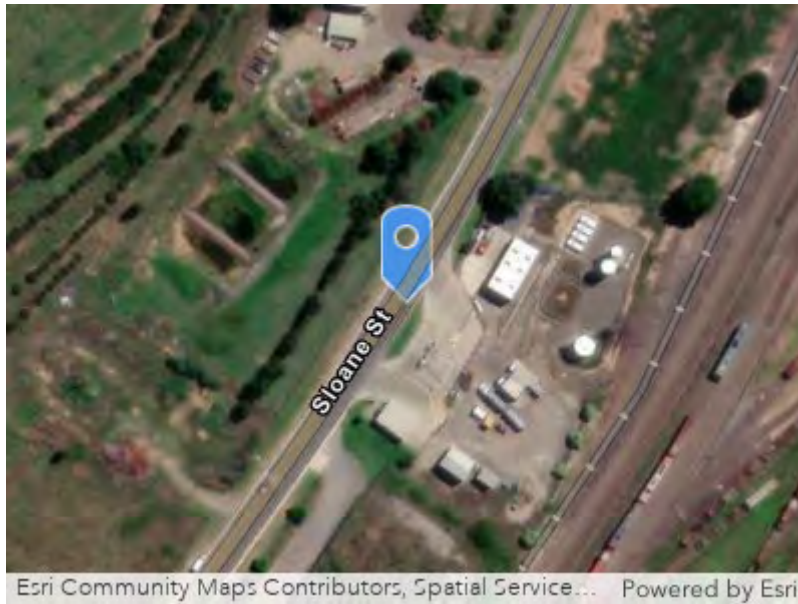
SOIL SAMPLING (XS013)

Project no.	318,001,660	Sample ID	XS013
Project name	Goulburn Wheatyrd Offsite Lead Delineation	Sample type	XRF
Start time	16:10	End time	16:15
Date	19/06/2023	Operator	Other
Sample appearance Pb 0, Cu 0, Zn368, As 0			
Comments Brown silt

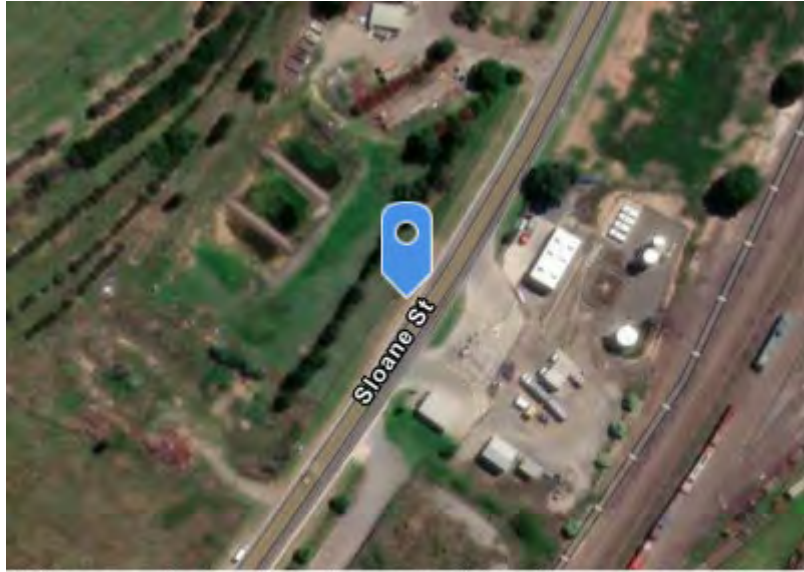
SOIL SAMPLING (XS010)

Project no.	318,001,660	Sample ID	XS010
Project name	Goulburn Wheatyrd Offsite Lead Delineation	Sample type	XRF
Start time	15:13	End time	15:15
Date	19/06/2023	Operator	Other
Sample appearance Pb 0, Cu 0, Zn 0, As 0			
Comments Brown gravely silt

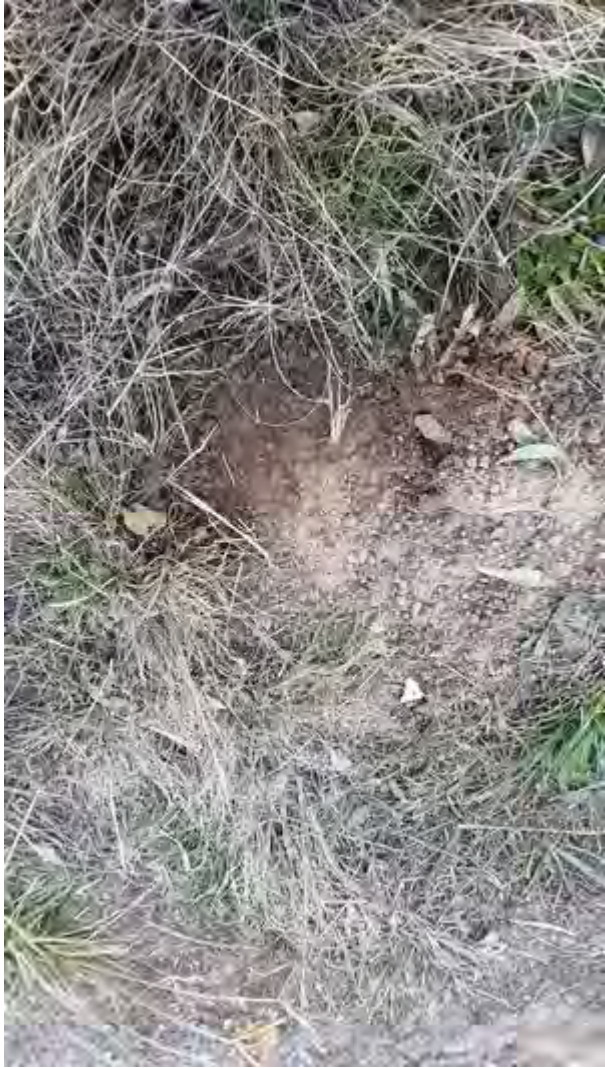
SOIL SAMPLING (XS009)

Project no.	318,001,660	Sample ID	XS009
Project name	Goulburn Wheatyrd Offsite Lead Delineation	Sample type	XRF
Start time	15:07	End time	15:09
Date	19/06/2023	Operator	Other
Sample appearance Pb 0, Cu 0, Zn 0, As 0			
Comments Brown gravely silt
