Goulburn Wheat Yards Assessment

Offsite Lead Delineation Preliminary Site
Investigation

Project name **Goulburn Wheat Yards Assessment - Offsite Lead Delineation Preliminary Site Investigation**
Project no. **318001660**
Recipient **ARTC**
Document type **Final Report**
Version **1**
Date **7 September 2023**
Prepared by **N. Gilbert**
Checked by **R. Condon / K. Greenfield (CEnvP SC40104)**
Approved by **A. Nolan**
Description **This document presents the results of an environmental assessment to assess the potential offsite risk of lead contamination surrounding the Goulburn Wheat Yards.**

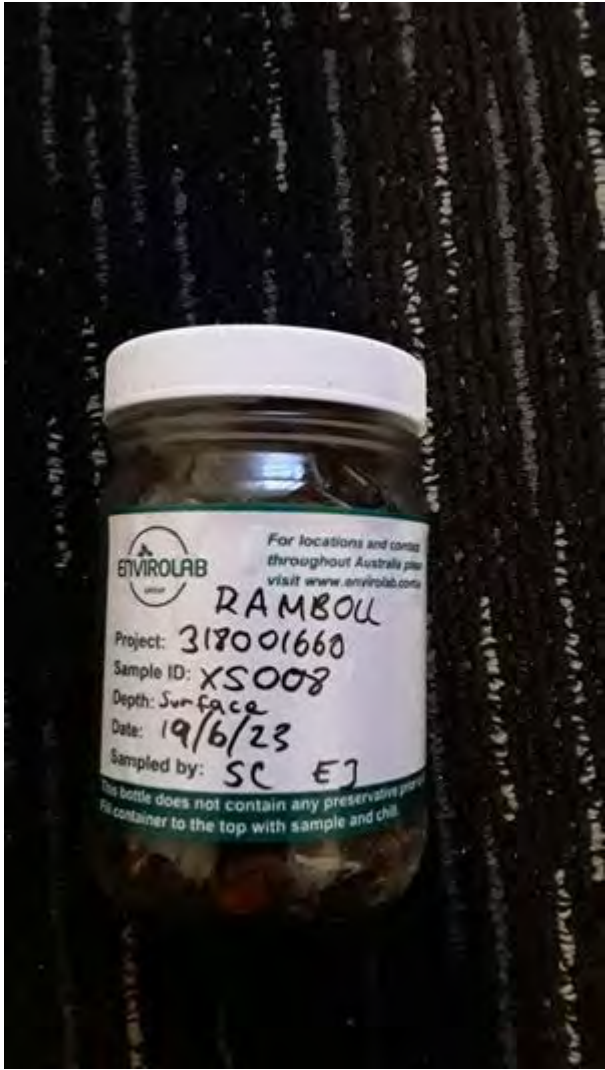
SOIL SAMPLING (XS007)

Project no.	318,001,660	Sample ID	XS007
Project name	Goulburn Wheatyrd Offsite Lead Delineation	Sample type	XRF
Start time	15:02	End time	15:04
Date	19/06/2023	Operator	Other
Sample appearance Pb 0, Cu 0, Zn 0, As 16			
Comments Brown silt

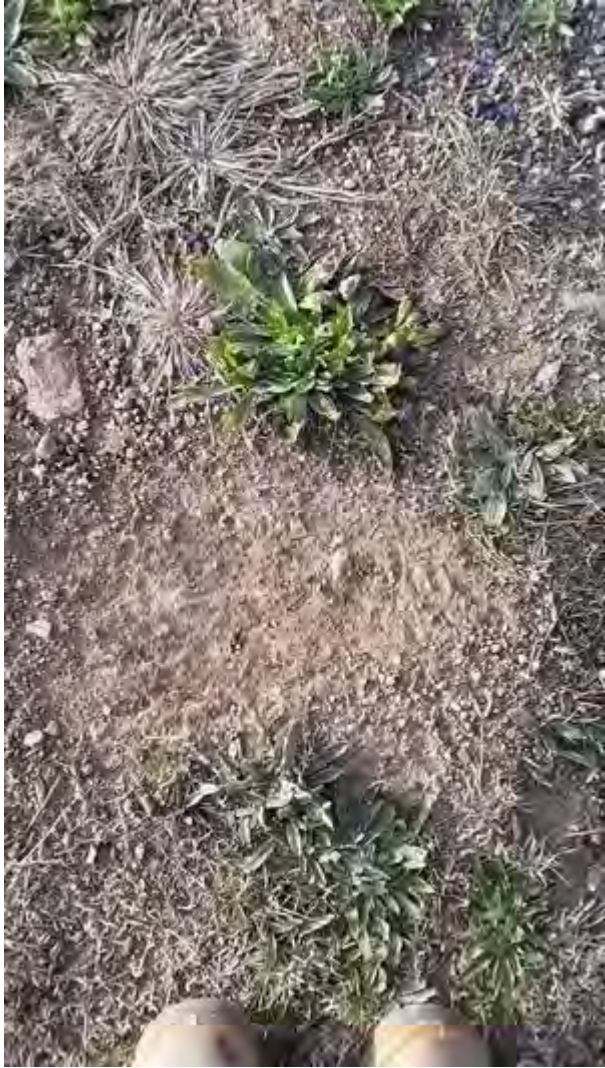
SOIL SAMPLING (XS005)

Project no.	318,001,660	Sample ID	XS005
Project name	Goulburn Wheatyrd Offsite Lead Delineation	Sample type	XRF
Start time	14:56	End time	14:58
Date	19/06/2023	Operator	Other
Sample appearance Pb 12, Cu 0, Zn 18, As 0			
Comments Light brown silt

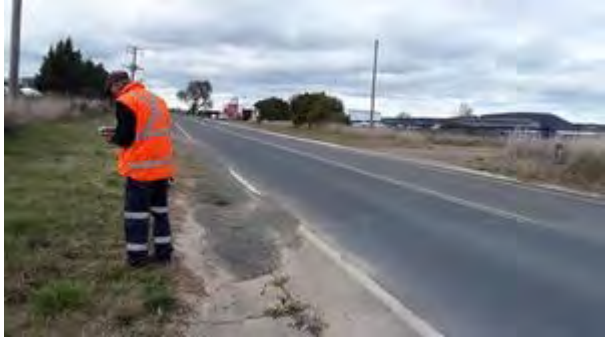
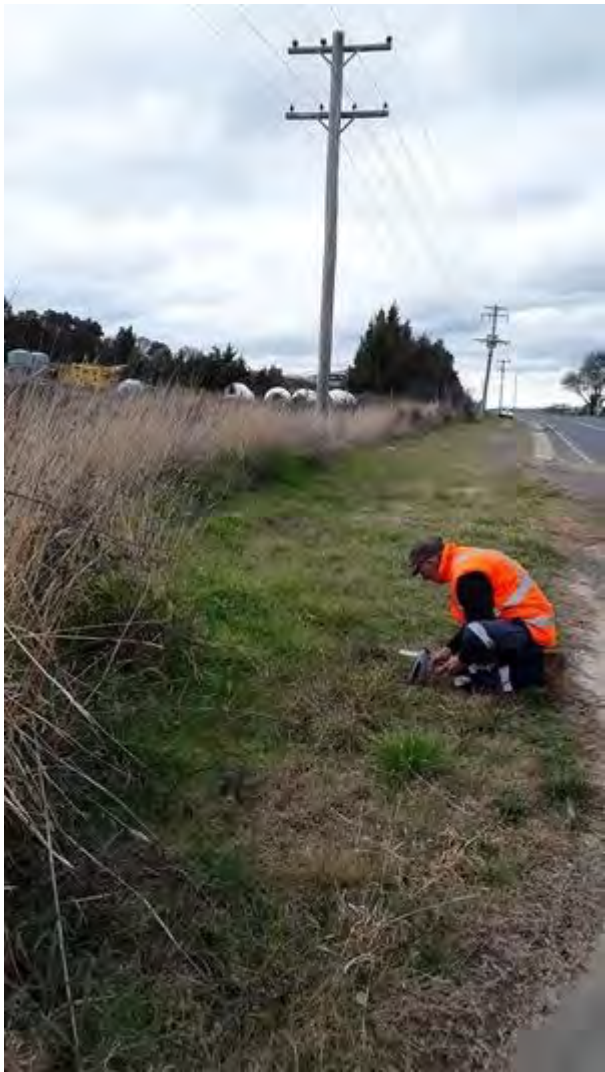
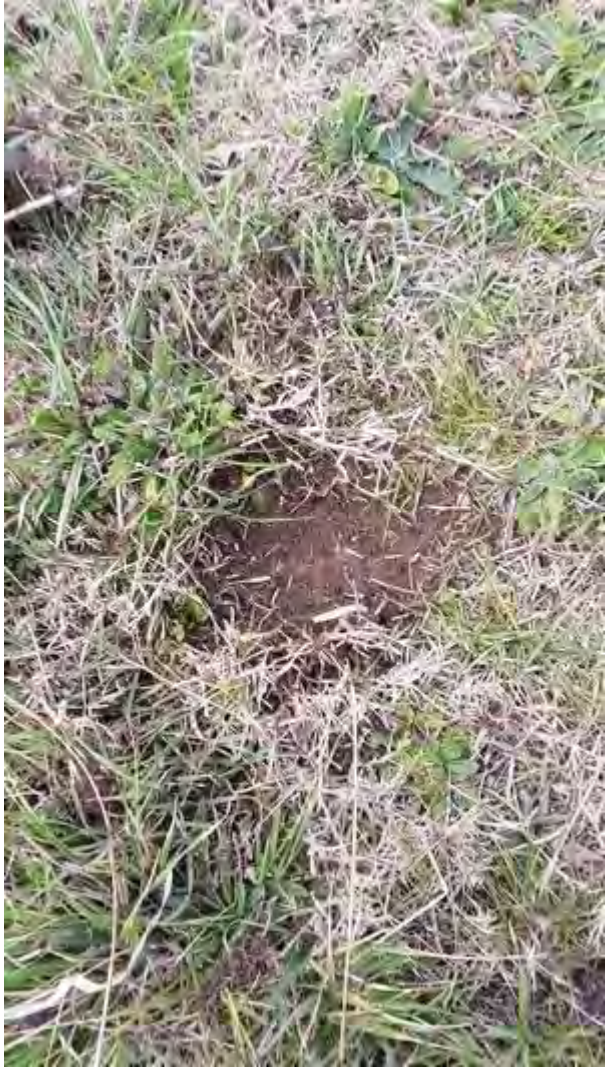
SOIL SAMPLING (XS003)

Project no.	318,001,660	Sample ID	XS003
Project name	Goulburn Wheatyrd Offsite Lead Delineation	Sample type	XRF
Start time	14:50	End time	14:52
Date	19/06/2023	Operator	Other
Sample appearance Pb 0, Cu 0, Zn 51, As 9			
Comments Brown silt

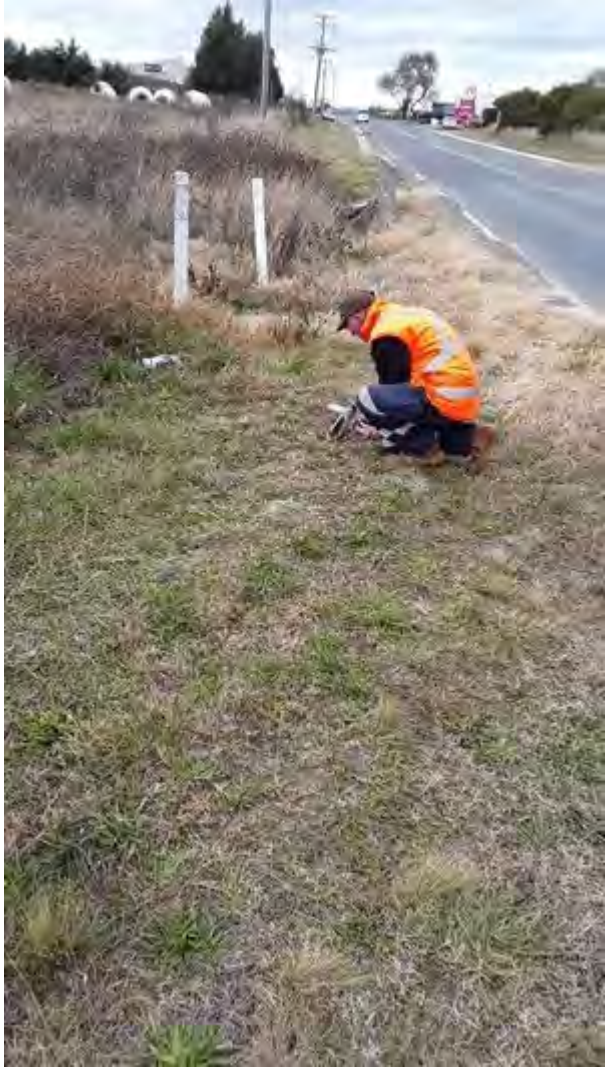
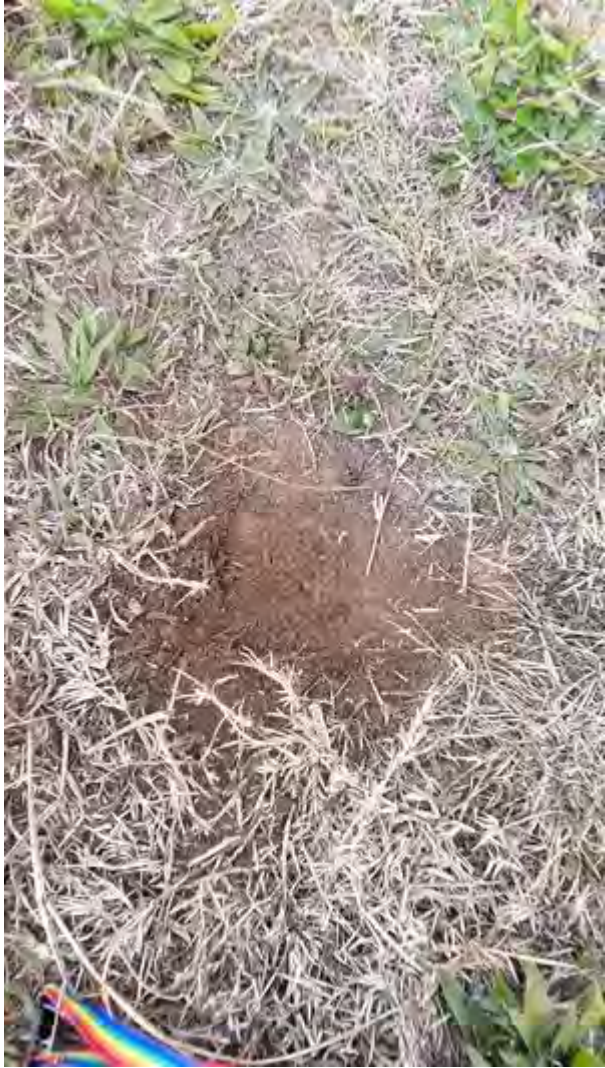
SOIL SAMPLING (XS002)

Project no.	318,001,660	Sample ID	XS002
Project name	Goulburn Wheatyrd Offsite Lead Delineation	Sample type	XRF
Start time	14:46	End time	14:48
Date	19/06/2023	Operator	Other
Sample appearance Pb 0, Cu 0, Zn 0, As 0			
Comments Brown silt

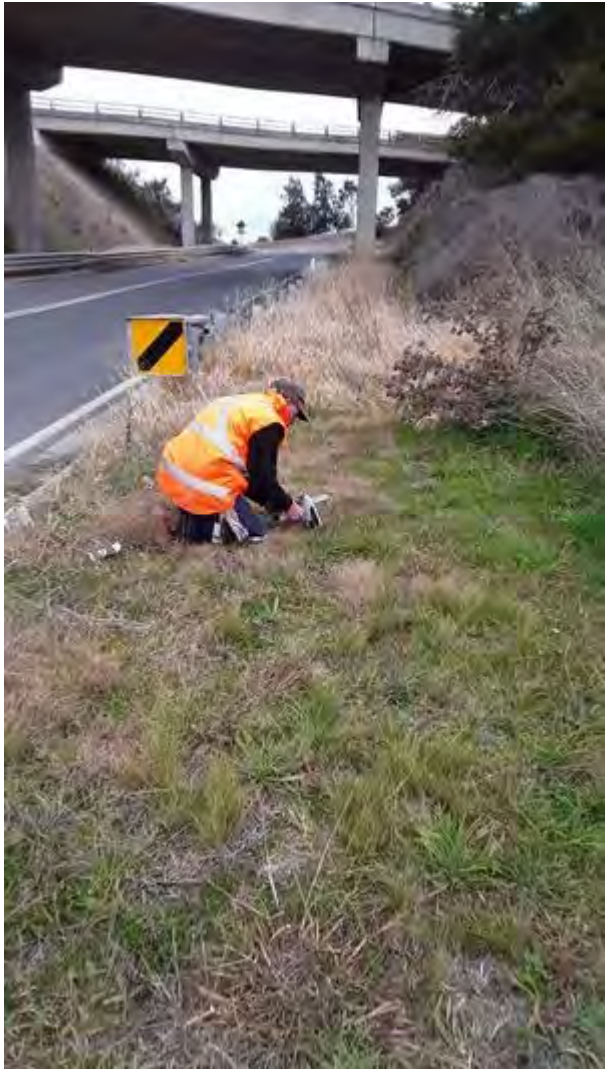
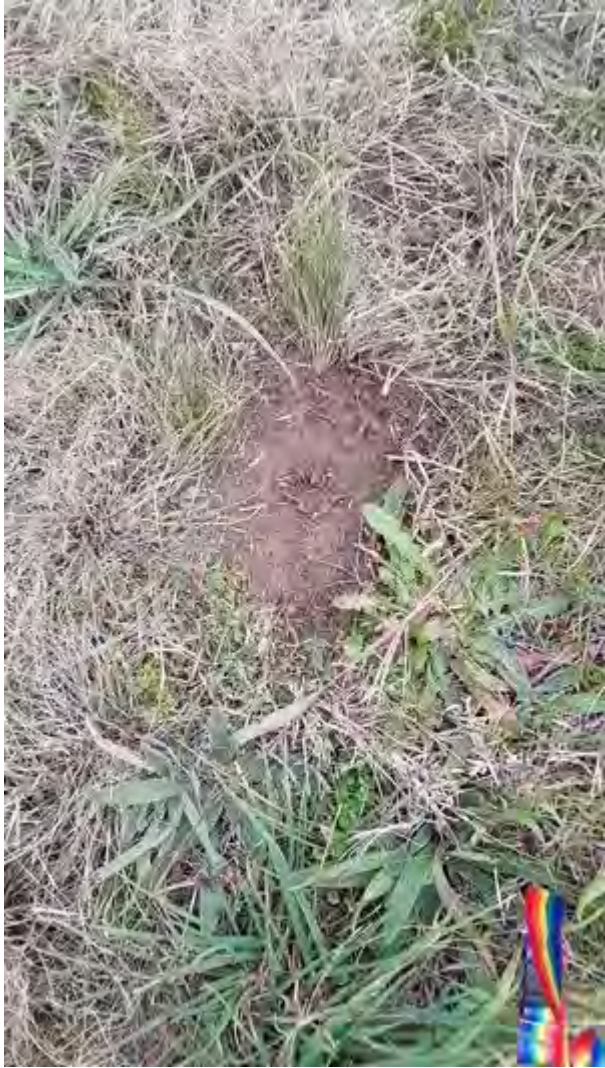
SOIL SAMPLING (XS001)

Project no.	318,001,660	Sample ID	XS001
Project name	Goulburn Wheatyrd Offsite Lead Delineation	Sample type	XRF
Start time	14:43	End time	14:45
Date	19/06/2023	Operator	Other
Sample appearance Pb0, Cu 0, Zn 0, As 0			
Comments Brown silty sand

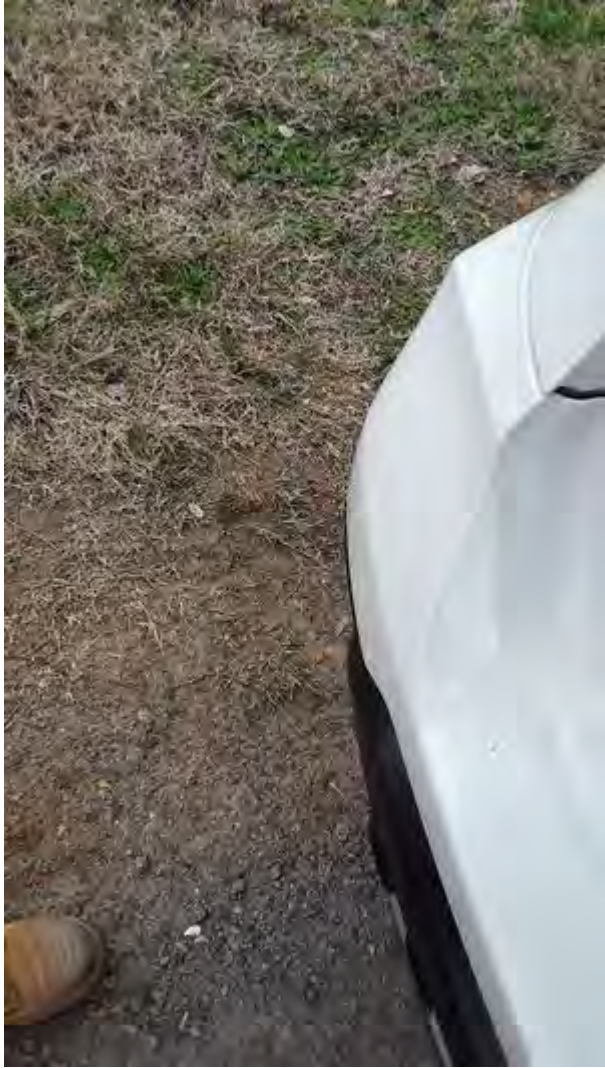
SOIL SAMPLING (Test001)

Project no.	318,001,660	Sample ID	Test001
Project name	Goulburn Wheatyrd Offsite Lead Delineation	Sample type	XRF
Start time	14:31	End time	
Date	19/06/2023	Operator	Other
Sample appearance Pb 300, Cu 45, Zn 478, As 43			
Comments Brown silty sand
