Kamay Wharf Project

Preliminary Site Investigation – Kurnell Site

6 December 2022

Project No.: 0564417

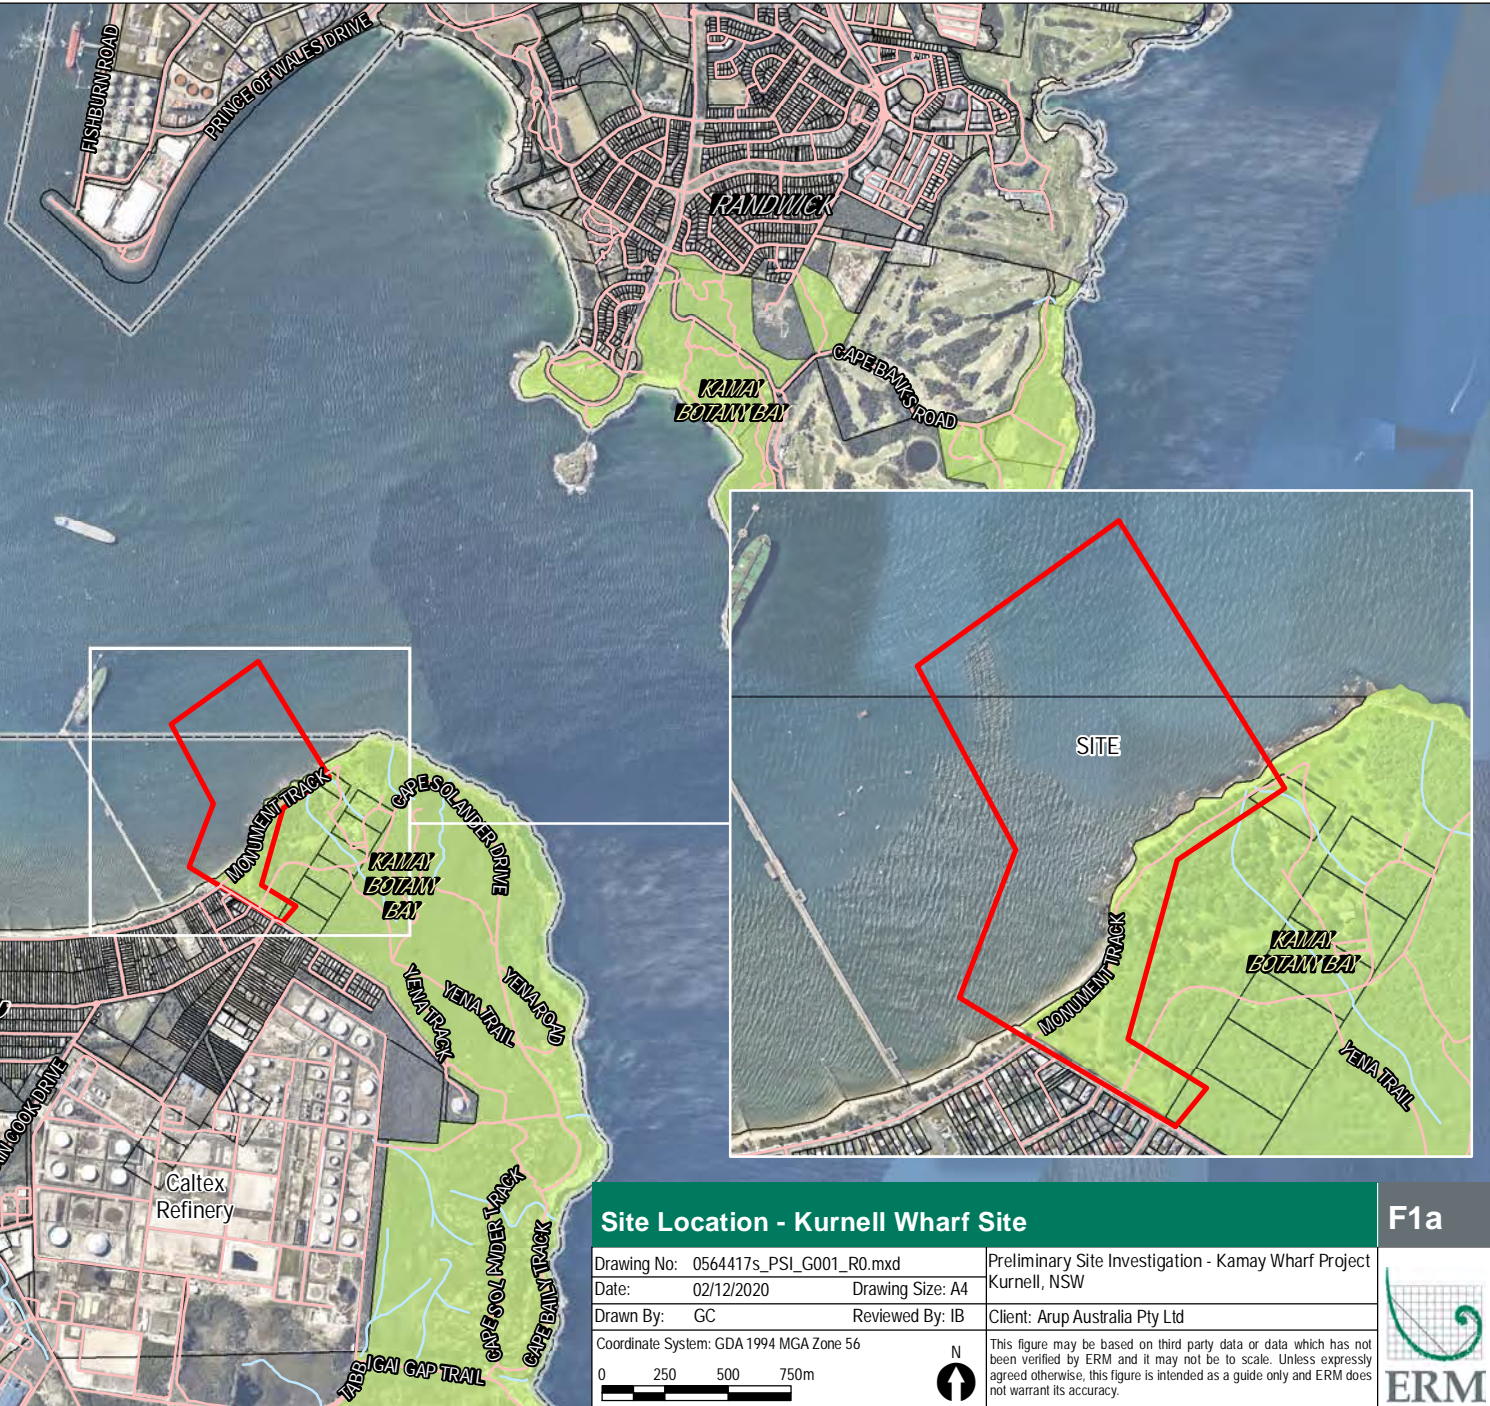
A site inspection to confirm that nature of current land uses was undertaken on 30 July 2020 by Ian Batterley, a suitably qualified and experienced ERM environmental scientist. Observed site features are presented on **Figure 2**.

- During inspection works, the Project Area was generally flat with a slight slope to the north in the direction of Botany Bay. While no surface waters (on the landside portion of the Project Area) were present during the Project Area inspection, during periods of rainfall it is considered likely that surface waters present within sealed portions of the Project Area would likely be directed to stormwater infrastructure located along Captain Cook Drive. Surface waters within unsealed portions of the Project Area would likely infiltrate the Project Area surface or flow towards Botany Bay located immediately north of the land portion of the Project Area.

- During the Project Area inspection, no evidence (vents, risers, filler points etc.) of fuel / chemical storage or illegal waste disposal / buried drums etc. was noted.
