Site Audit Report

Kamay Wharf, Captain Cook Drive, Kurnell and Anzac Parade, La Perouse

Audit Number: MP186

7 July 2023

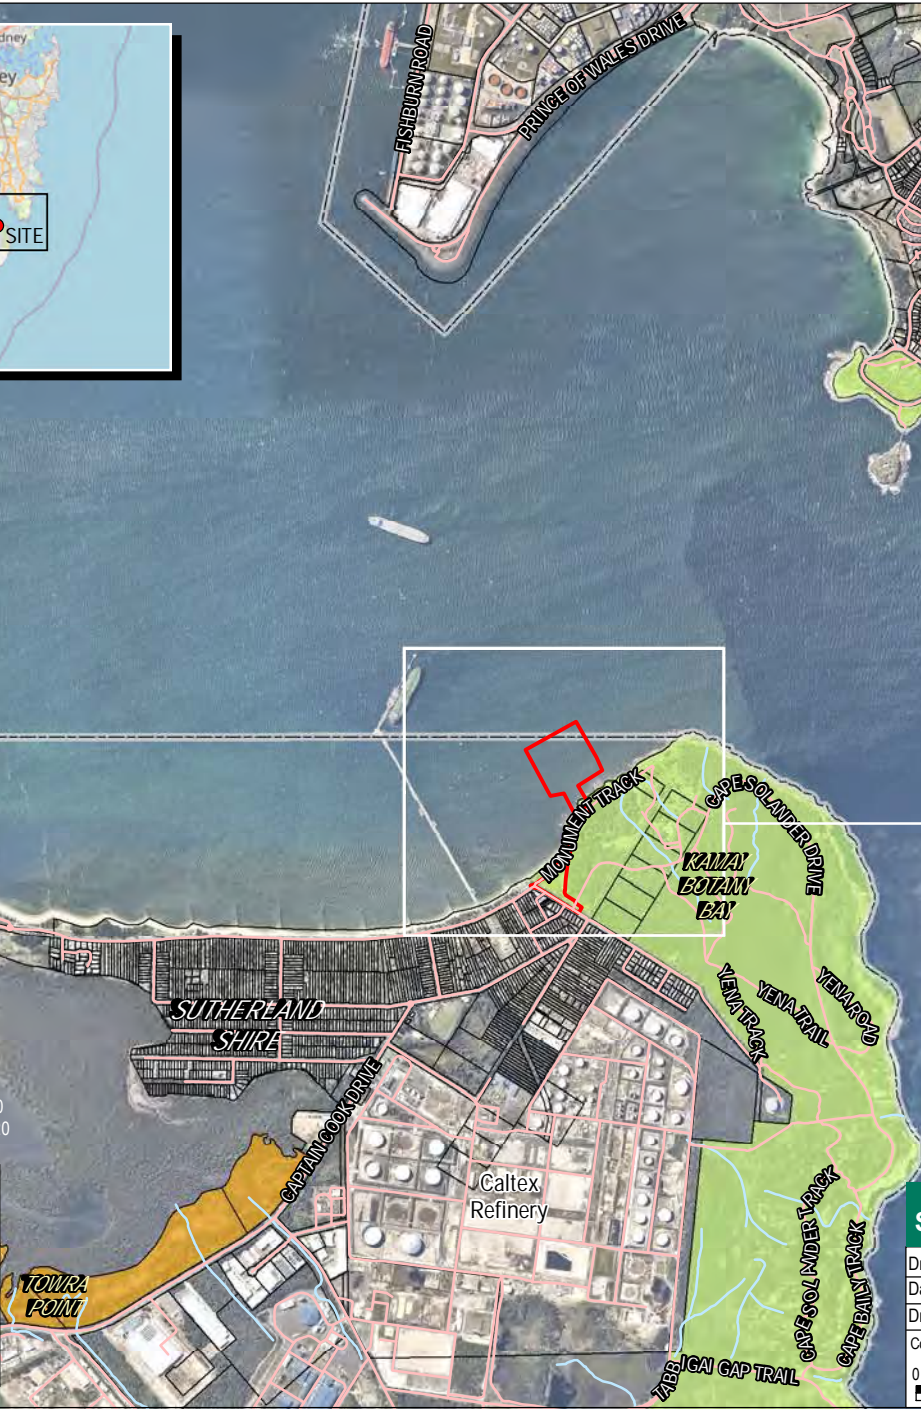
Site Location - Kurnell Wharf Site		F1a
Drawing No: 0564417s_SAQP_G001_R1.mxd	Kamay Wharf Project Sediment Investigation	
Date: 1/10/2020	Drawing Size: A4	
Drawn By: GC	Reviewed By: IB	Client: Arup Australia Pty Ltd
Coordinate System: GDA 1994 MGA Zone 56		
		This figure may be based on third party data or data which has not been verified by ERM and it may not be to scale. Unless expressly agreed otherwise, this figure is intended as a guide only and ERM does not warrant its accuracy.

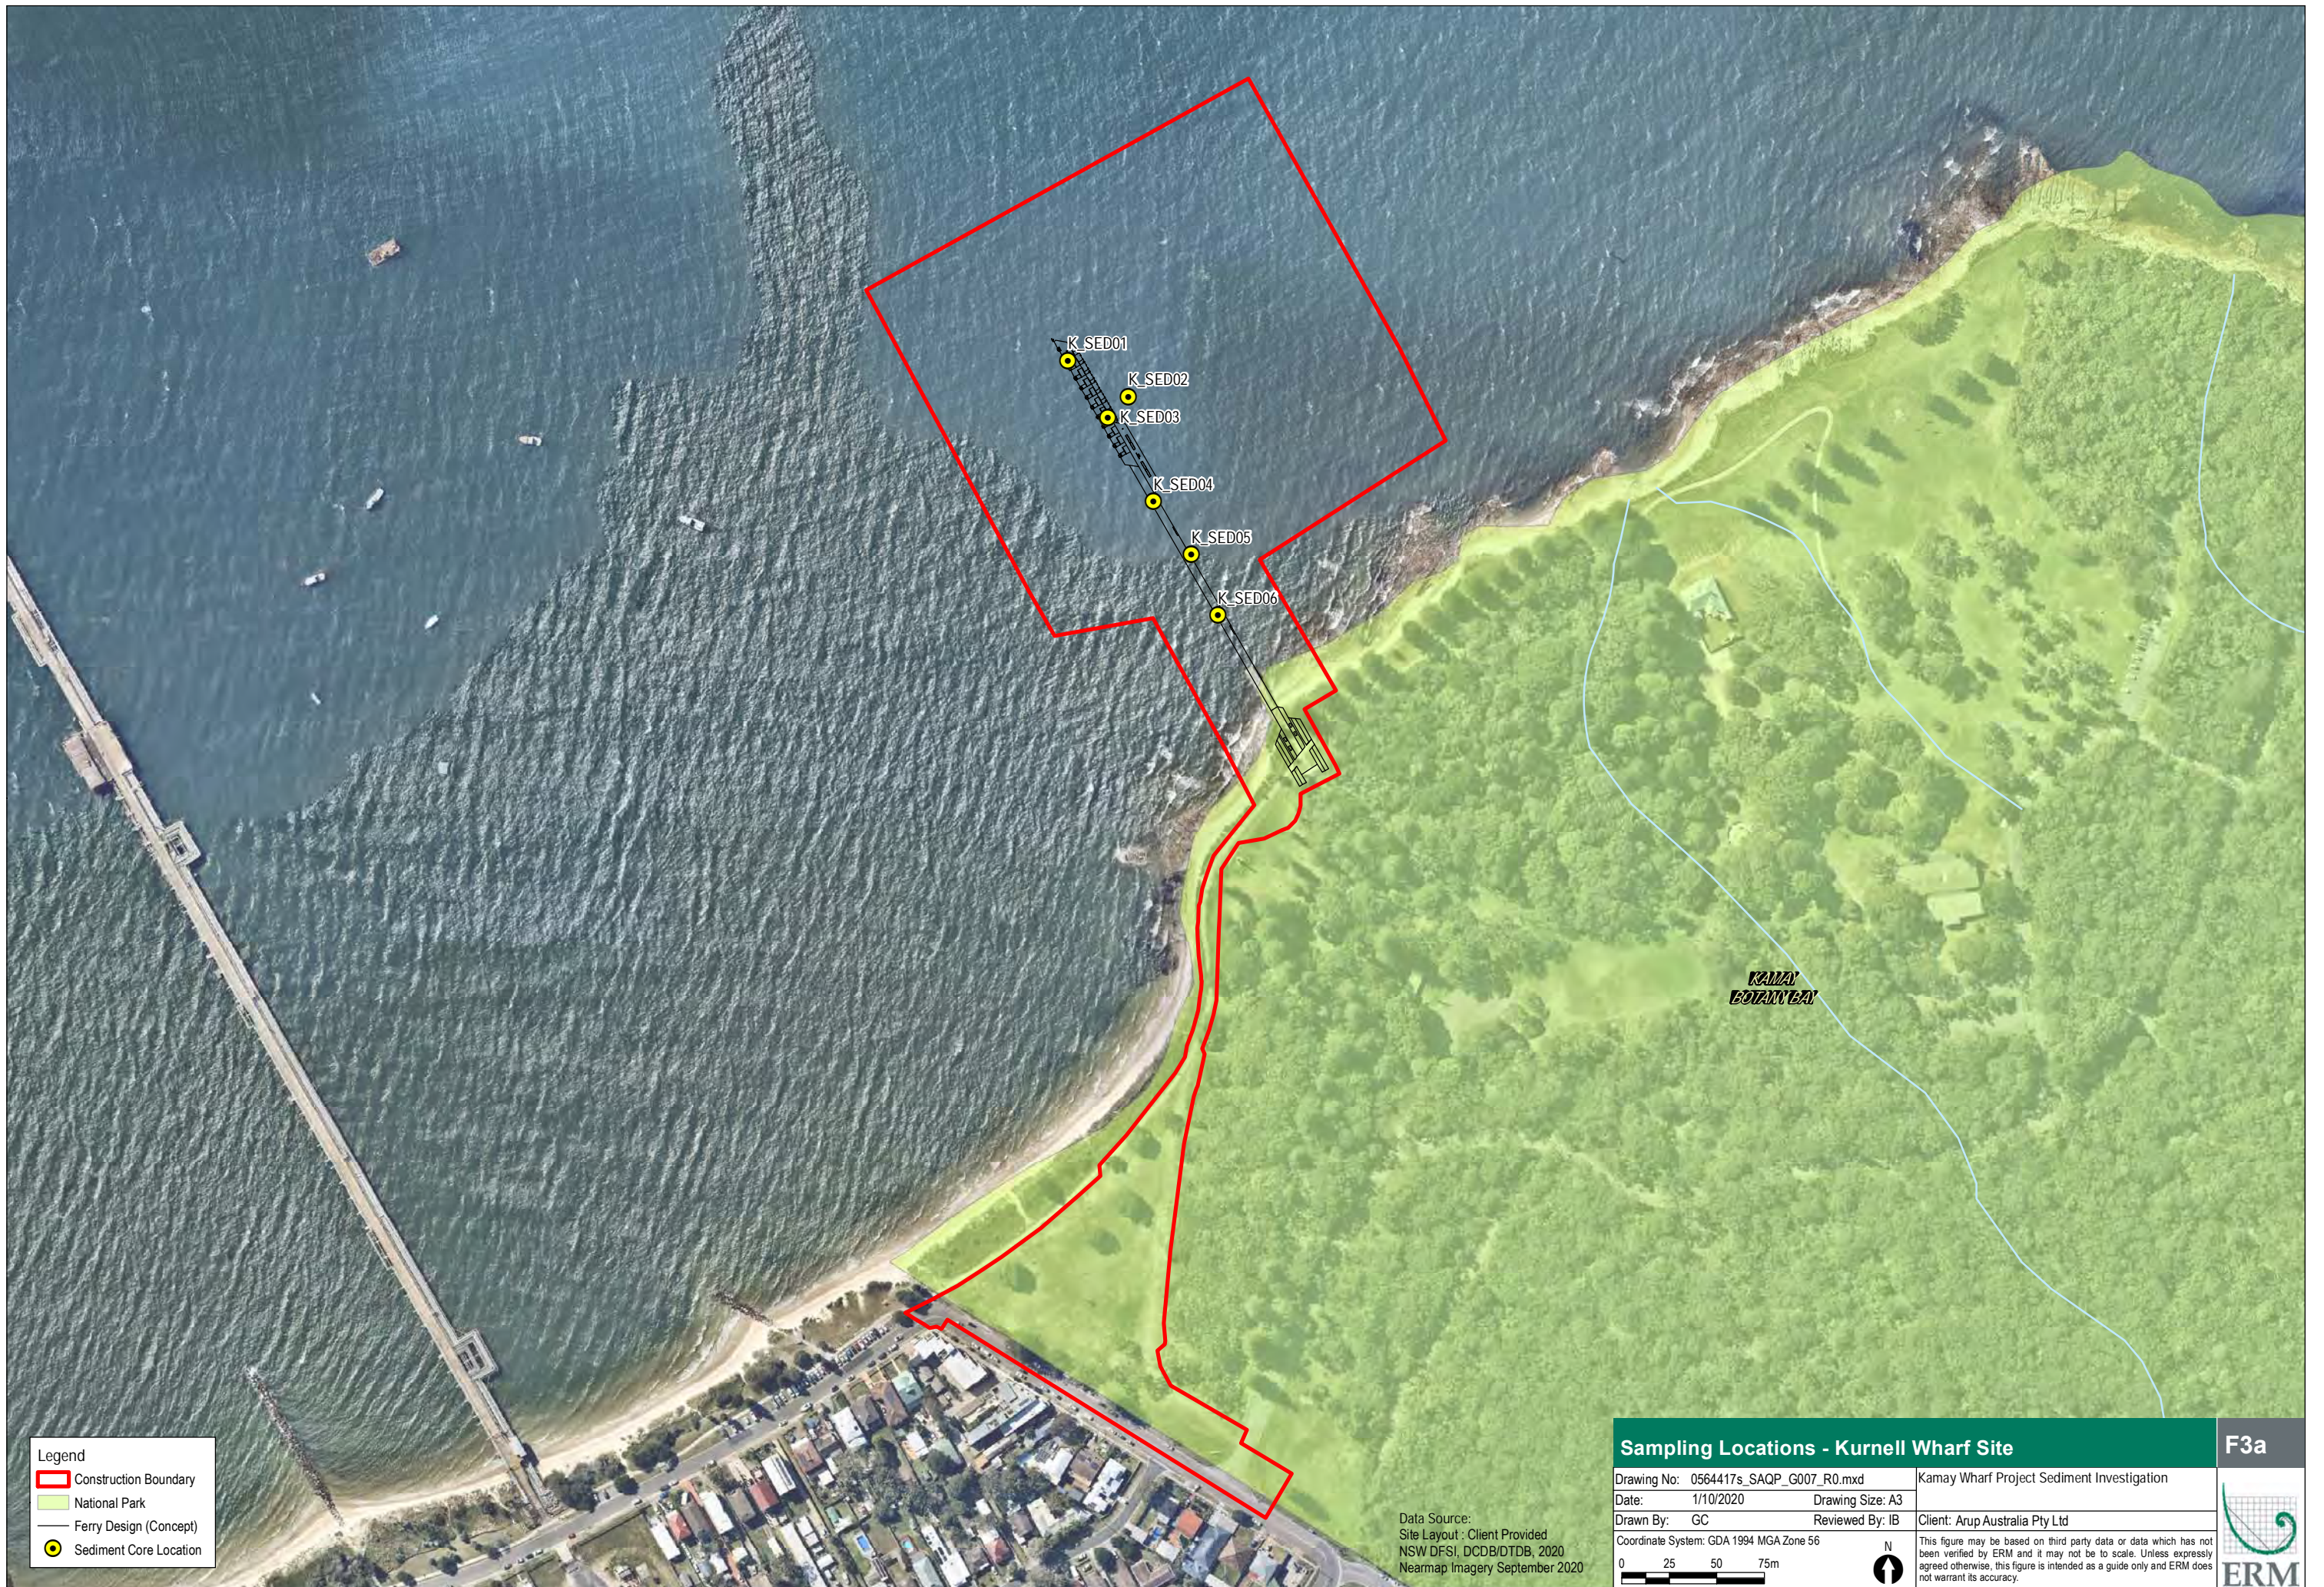
Sampling Locations - La Perouse Wharf Site		F3b
Drawing No: 0564417s_DSI_G006_R0.mxd	Detailed Site Investigation - Kamay Wharf Project	
Date: 20/12/2022	Drawing Size: A3	La Perouse, NSW
Drawn By: GC	Reviewed By: IB	Client: Arup Australia Pty Ltd
Coordinate System: GDA 1994 MGA Zone 56		
		<small>This figure may be based on third party data or data which has not been verified by ERM and it may not be to scale. Unless expressly agreed otherwise, this figure is intended as a guide only and ERM does not warrant its accuracy.</small>

Construction Boundary
	National Park
	Ferry Design (Concept)
	Sediment Core Location
