HW29 Spring Creek Bridge Replacement

Review of Environmental Factors

12 May 2023

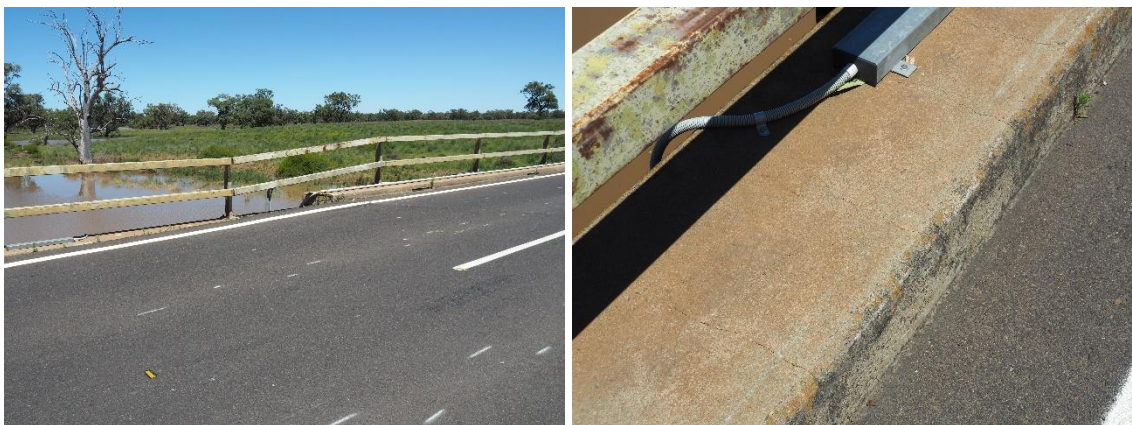
There is a significant difference in the horizontal plane of the rails at the segment joint due to the differential settlement between the two segments. As the rail length matches the spacing of the post centres, there is a joint in the rail at each post that eliminates any continuous barrier rails over the structure. Due to the construction methodology adopted for the rails, the rails have accommodated the settlement without any significant distress to the barrier.

Figure 3-1 View of traffic barrier and kerb (Source: FBE)

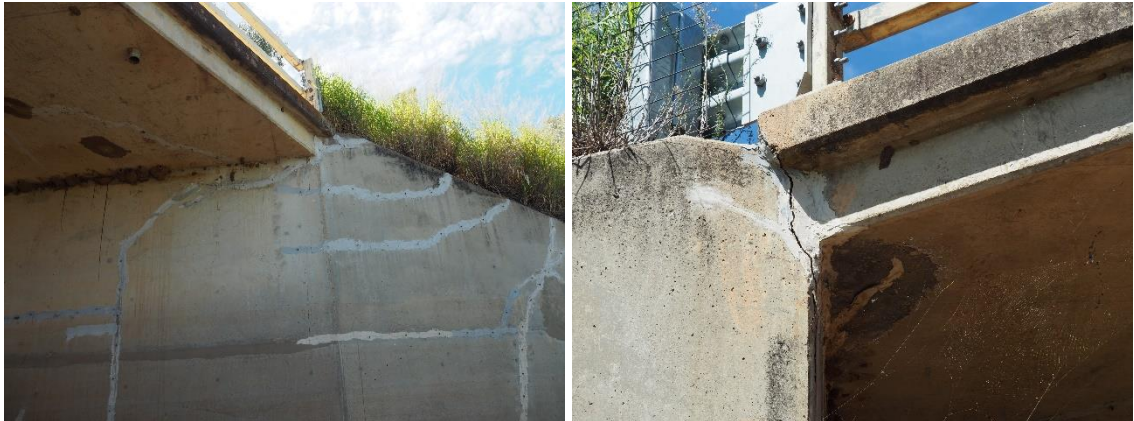
A comprehensive crack map has been provided in TfNSW L3 report. Refer to Appendix B for the TfNSW L3 Inspection and Structural Assessment Report.

Figure 3-2 Abutment and wing wall cracks (Source: FBE)

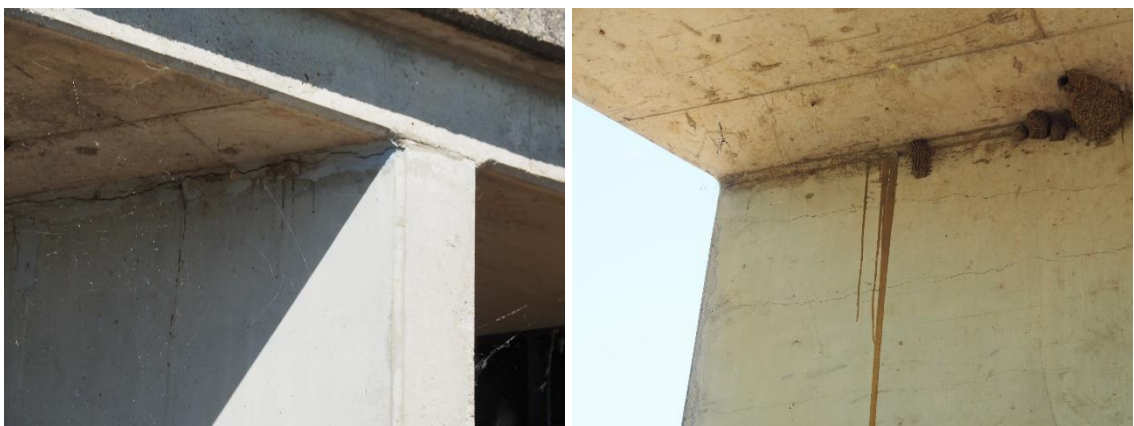
Similar to the abutment and wing walls, the cell walls and soffit of the crown slab of all cells have a significant amount of vertical and horizontal cracks evident. Based on defect mapping by TfNSW, it is noted that most cracks were existing and had been previously sealed. Some cracks were existing and previously treated for sealing but never sealed. There are also cracks varying from 0.05 mm to 0.2 mm throughout the structure that may have developed in the recent settlement events.

Figure 3-3 Cell wall cracks (Source: FBE)

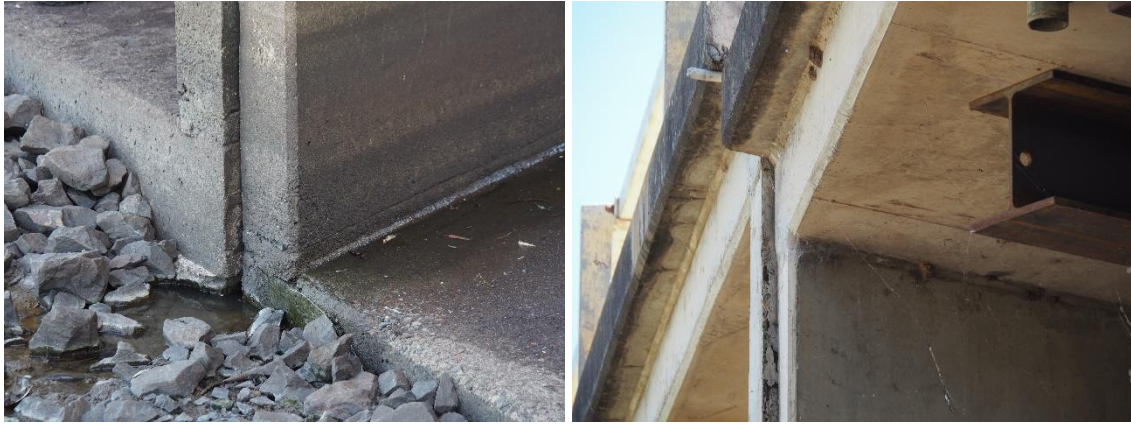
Due to the settlement, there is also a significant misalignment between the segments at the vertical joint between Cell 4 and 5.

Figure 3-4 Segment misalignment (Source: FBE)

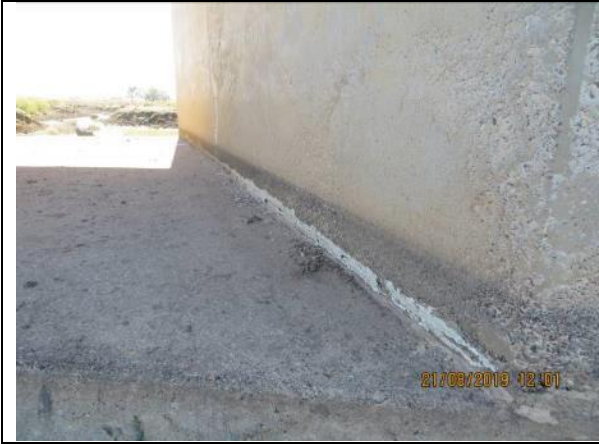
Photo 13 (73) Cell 5 invert slab and wall interface with crack reappear after sealing

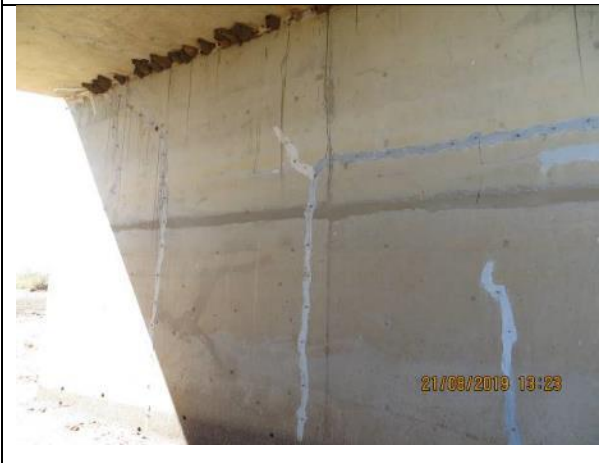
Photo 17 (86)_Cell1_Wall A_Abt A previous cracks sealed and still intact_new fine horizontal cracks

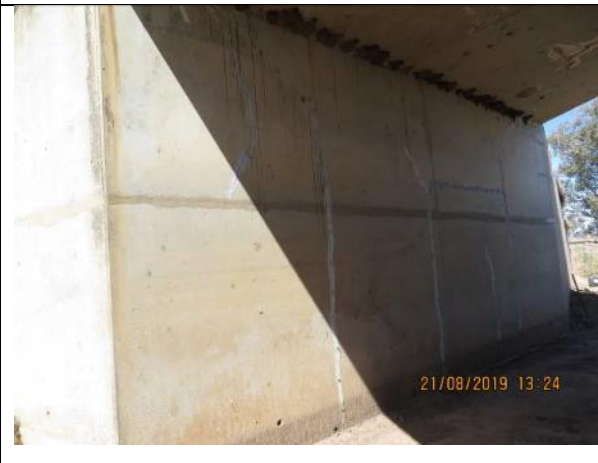
Photo 18 (87)_Cell1A_AbtA previous cracks sealed intact_new fine horizontal cracks

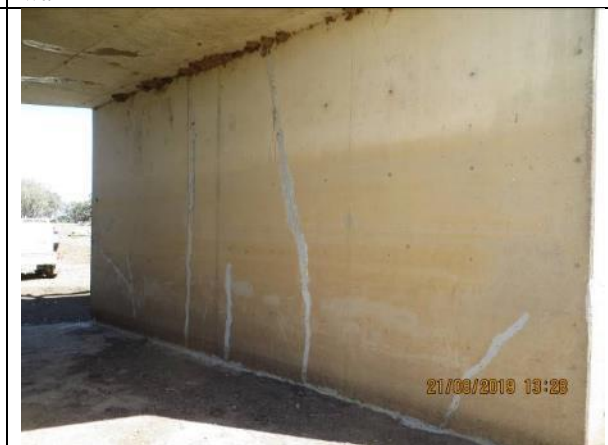
Photo 22 (99)_Cell 1_Wall B, vertical cracks previously identified still intact

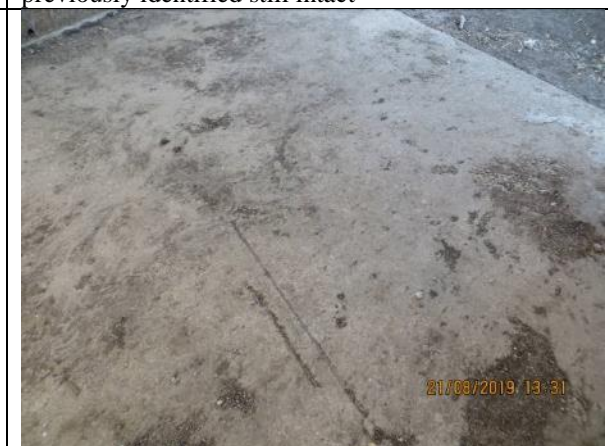
Photo 24 (104)_Cell 1 Base slab

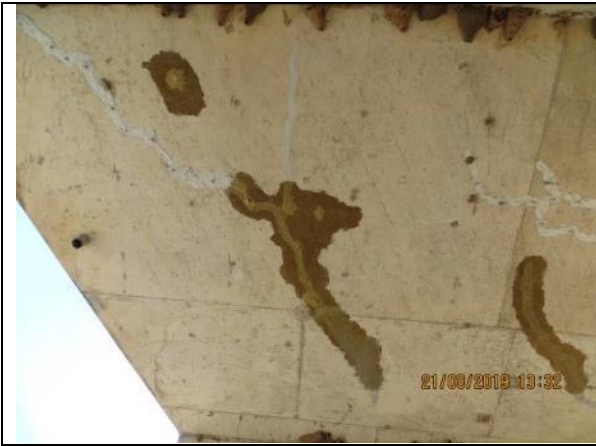
Photo 25 (107)_Cell 1_Deck Soffit mesh/ transverse and irregular cracks

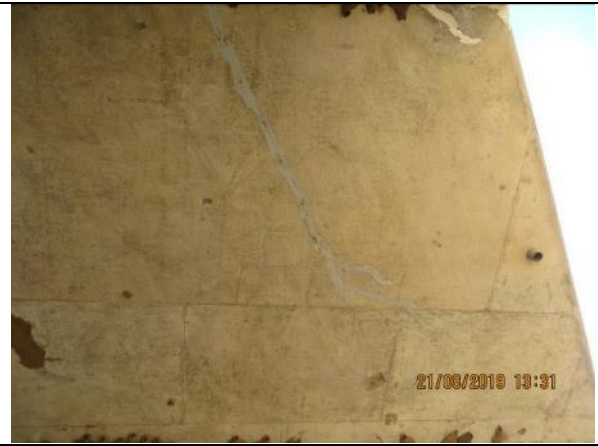
Photo 26 (105)_Cell 1_Deck Soffit mesh/ transverse and irregular cracks

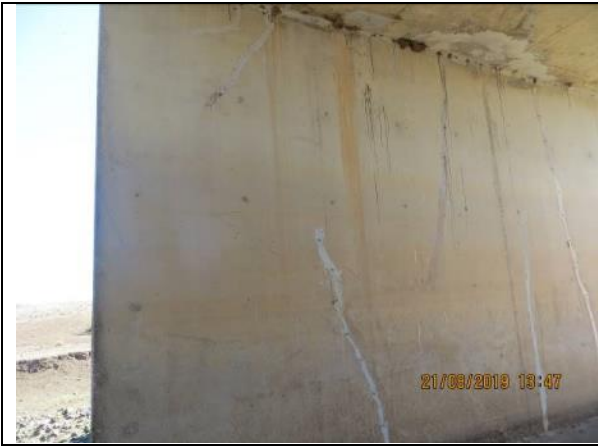
Photo 37 (136)_Cell3_Wall B cracks sealed and still intact

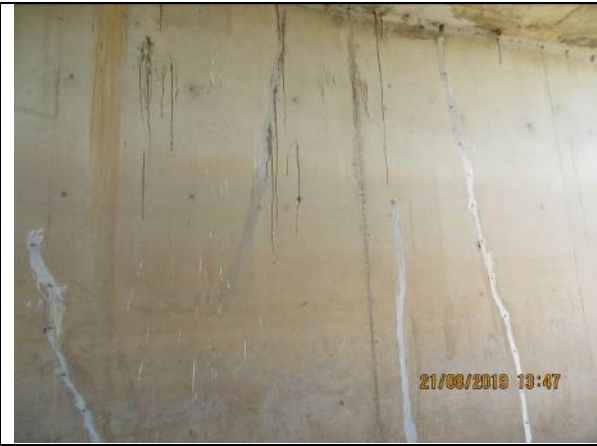
Photo 38 (137)_Cell 3_Wall B cracks sealed and still intact

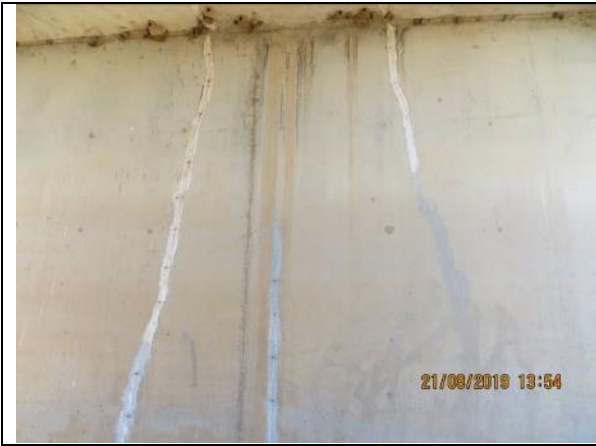
Photo 43 (153)_Cell 4_Wall A vertical cracks sealed and still intact

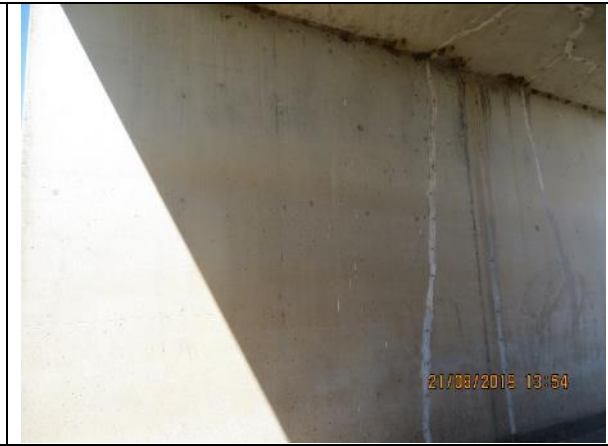
Photo 44 (155)_Cell 4_Wall A vertical cracks sealed and still intact

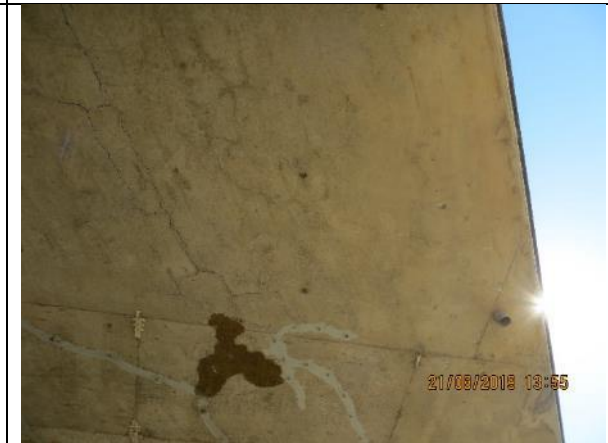
Photo 46 (161)_Cell 4_Deck soffit with longitudinal and irregular cracks

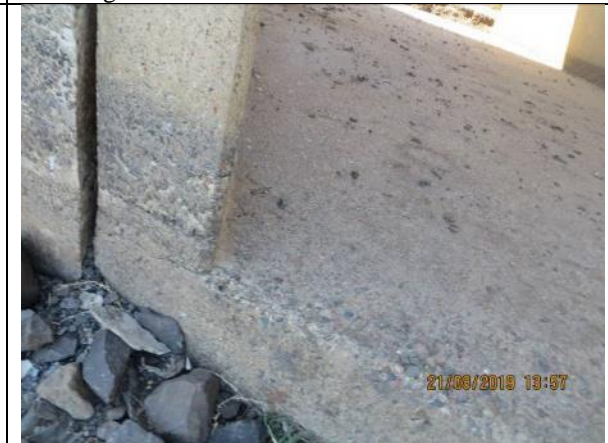
Photo 48 (169)_Cell 4_Wall B interface with base slab no cracks, D/S

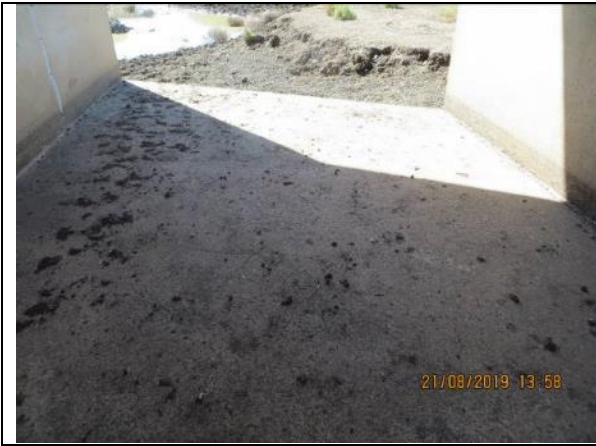
Photo 49 (0170)_Cell 4_Base slab with no visible cracks

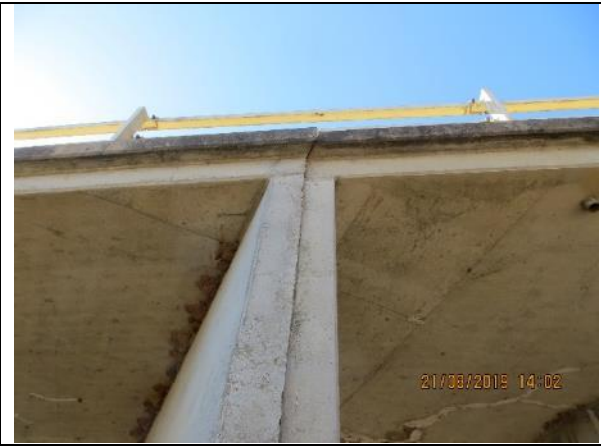
Photo 50 (174)_Cell 4_Walls at joint DS

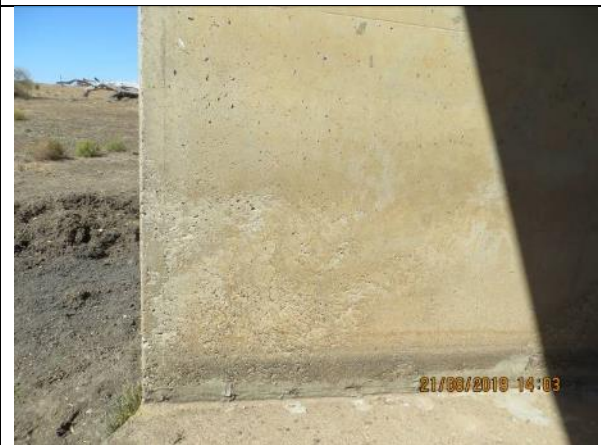
Photo 52 (178)_Cell 5_Wall A, Poor concrete patch on US

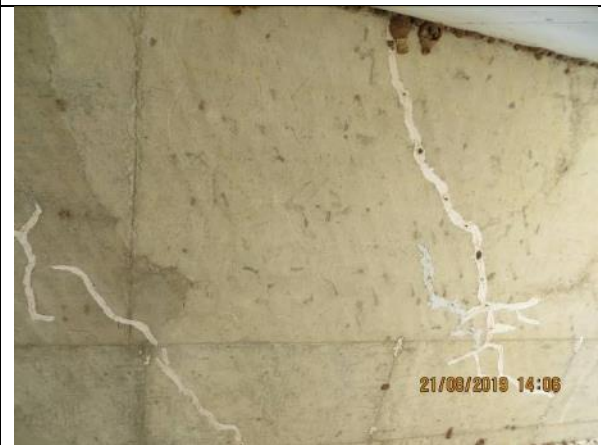
Photo 54 (187)_Cell 5_Deck soffit longitudinal cracks repaired and some irregular cracks

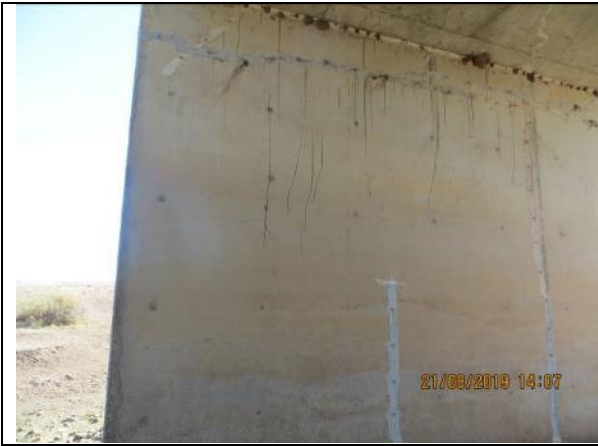
Photo 55 (189)_Cell 5_Wall B vertical cracks sealed and intact

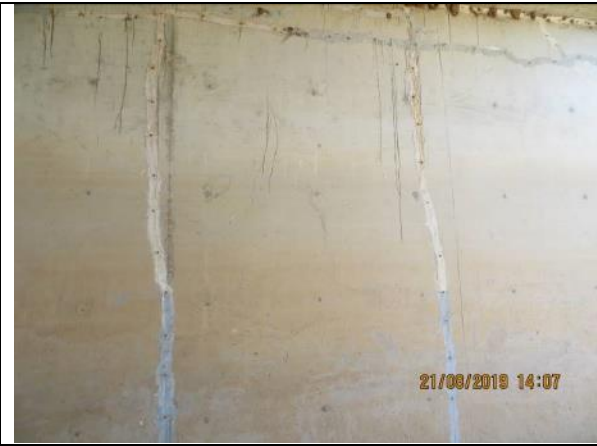
Photo 56 (191)_Cell 5_Wall B vertical cracks sealed and intact

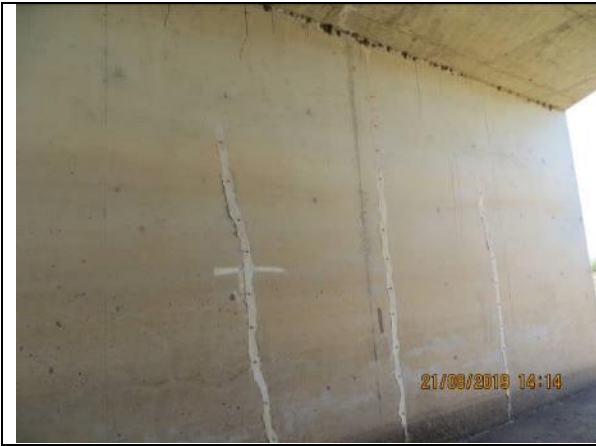
Photo 61 (213)_Cell 6_Wall B vertical crack sealed

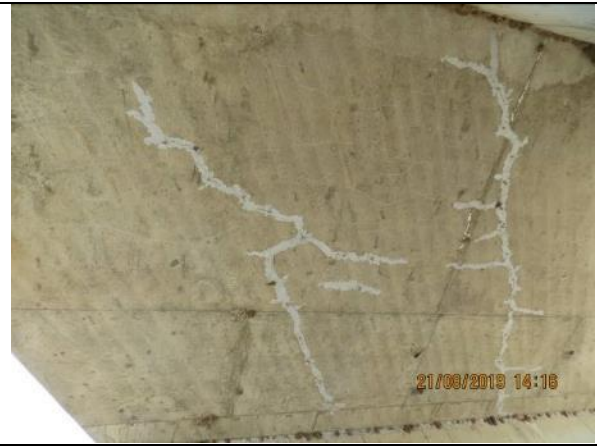
Photo 62 (221)_Cell 6_Deck soffit, longitudinal cracks primarily sealed and still intact, traverse cracks appear in mesh pattern

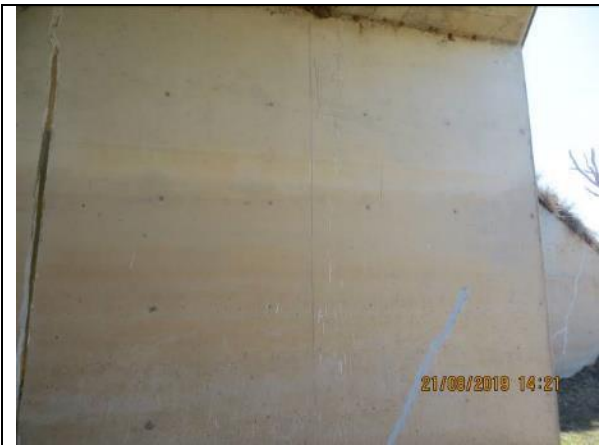
Photo 67 (231)_Cell 7_Wall B vertical cracks sealed and still intact

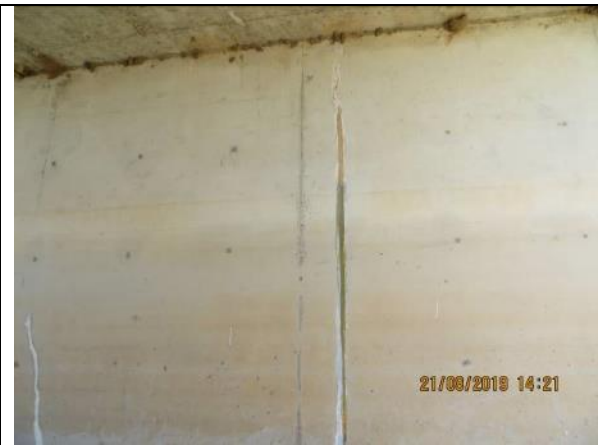
Photo 68 (232)_Cell 7_Wall B vertical cracks sealed and still intact

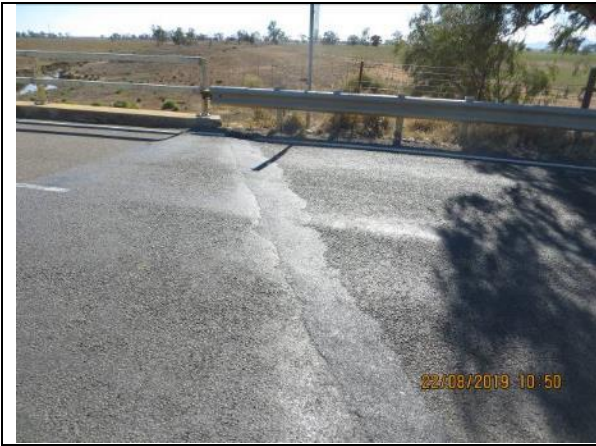
Photo 79 (285)_Above deck joint A, hump in Abt A joint

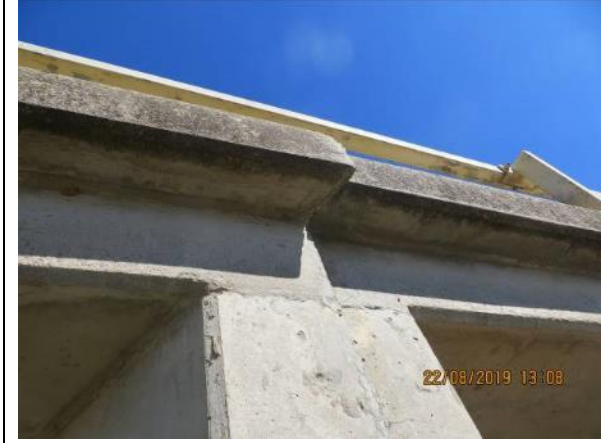
Photo 89 (0348)_Wall between Cell 4 and Cell 5_Gap decreasing down towards_Fine cracks on face of US wall

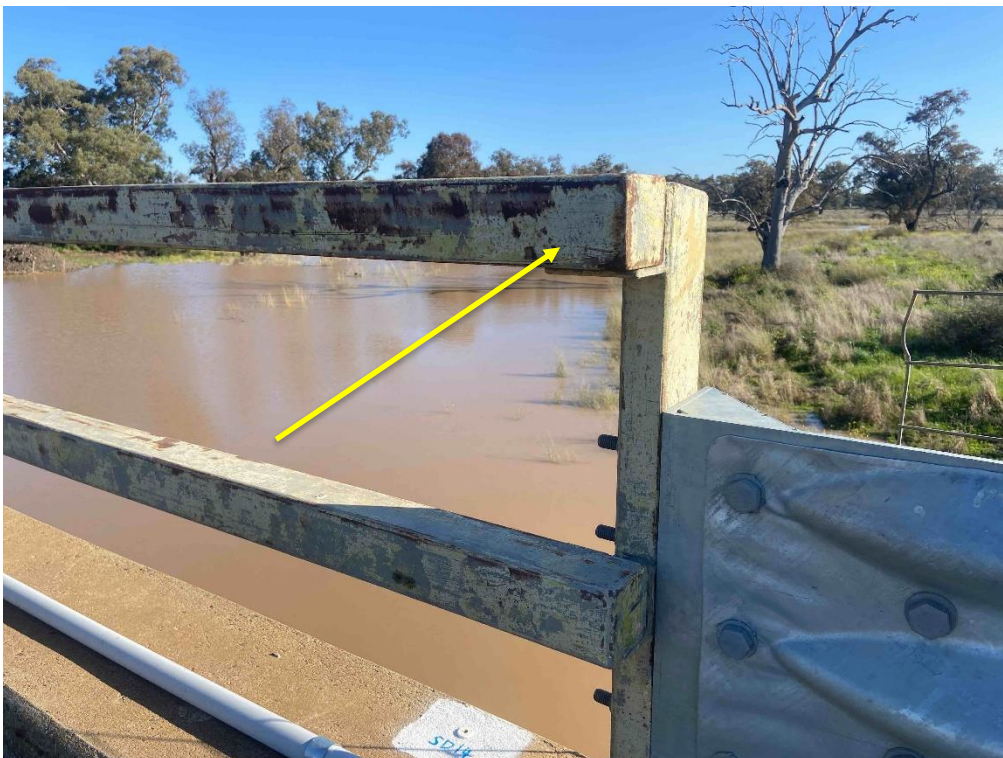
Photo 6 Spring Creek Bridge B3858 over Spring Creek. Sample location L2 – Yellow paint to south rail. Although the lead content in the sample collected on the south rail is below the assessment criteria 0.1% w/w, due to the homogenous nature of paint, demolition recommendations for sample ID 'L1' should be applied for the south rail post as a precaution.

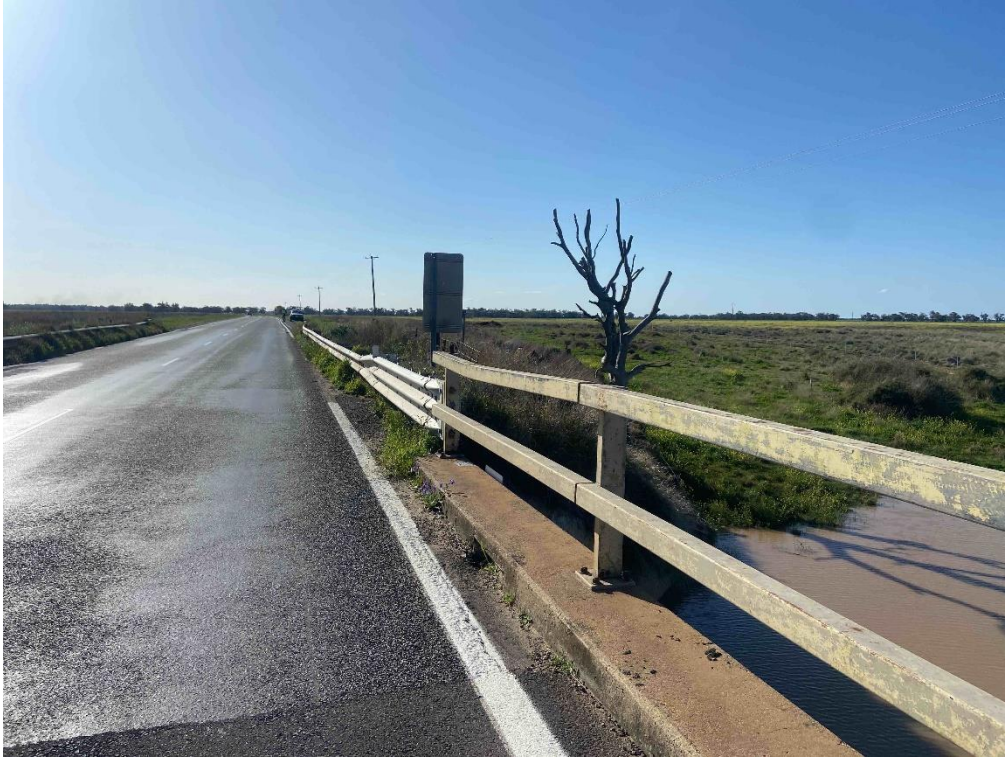
Photo 7 Spring Creek Bridge B3858 over Spring Creek. Yellow paint to metal rails on both ends of the bridge. Due to the homogenous nature of the paint, all yellow paint should be assumed to contain lead content exceeding the assessment criteria of 0.1%w/w. Paint was found in fair condition.

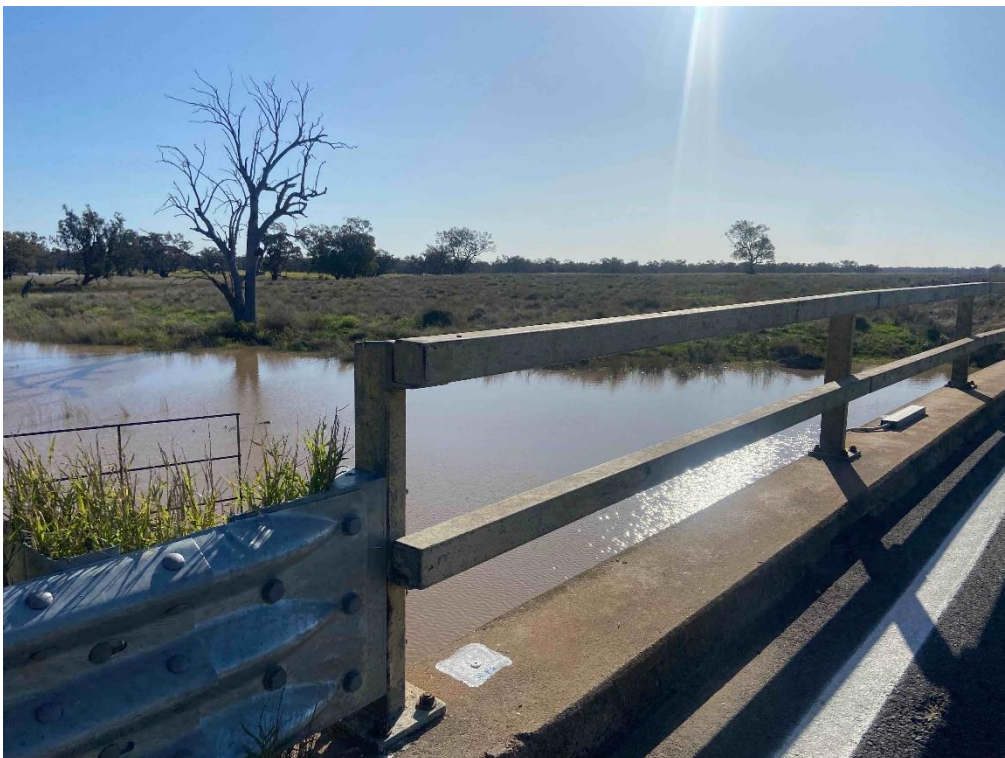
Photo 8 Spring Creek Bridge B3858 over Spring Creek. Yellow paint to metal rails on both ends of the bridge. Due to the homogenous nature of the paint, all yellow paint should be assumed to contain lead content exceeding the assessment criteria of 0.1%w/w. Paint was found in fair condition.

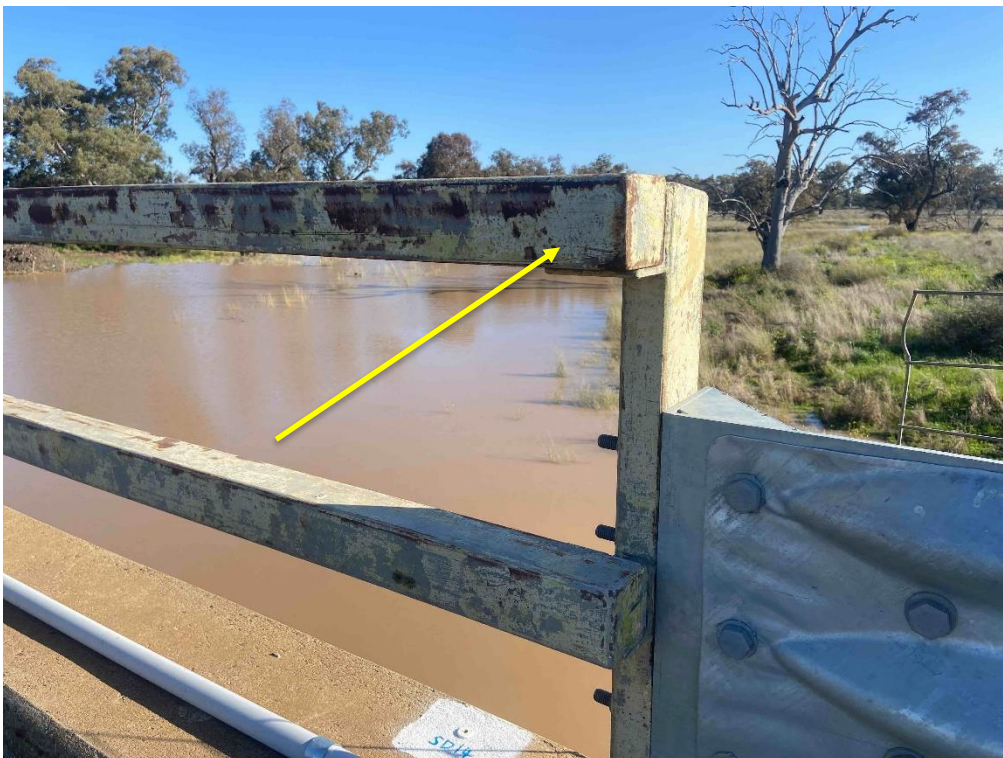
Photo 6 Spring Creek Bridge B3858 over Spring Creek. Sample location L2 – Yellow paint to south rail. Although the lead content in the sample collected on the south rail is below the assessment criteria 0.1% w/w, due to the homogenous nature of paint, demolition recommendations for sample ID 'L1' should be applied for the south rail post as a precaution.

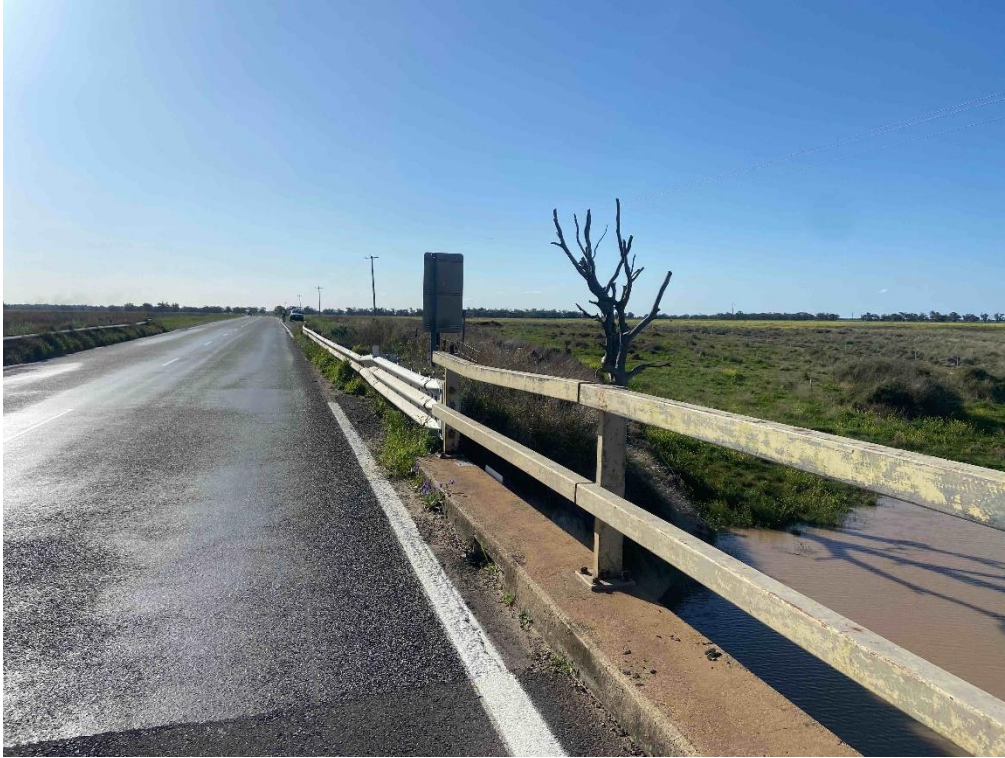
Photo 7 Spring Creek Bridge B3858 over Spring Creek. Yellow paint to metal rails on both ends of the bridge. Due to the homogenous nature of the paint, all yellow paint should be assumed to contain lead content exceeding the assessment criteria of 0.1%w/w. Paint was found in fair condition.

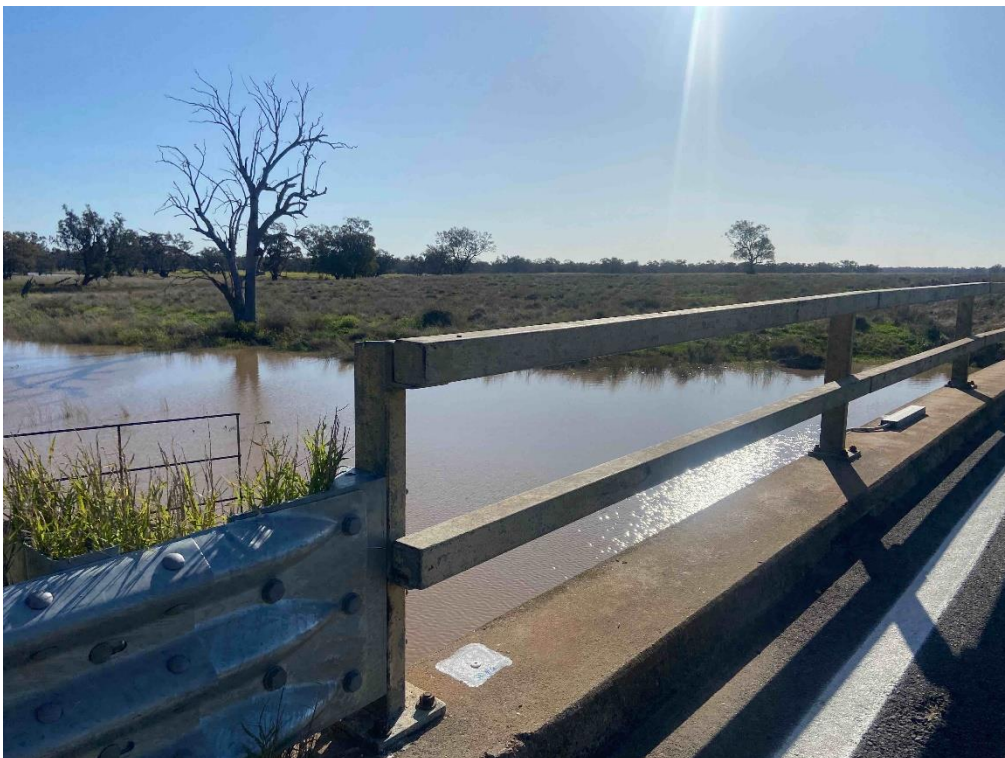
Photo 8 Spring Creek Bridge B3858 over Spring Creek. Yellow paint to metal rails on both ends of the bridge. Due to the homogenous nature of the paint, all yellow paint should be assumed to contain lead content exceeding the assessment criteria of 0.1%w/w. Paint was found in fair condition.
