## Tarago Former Station Master's Cottage and Woodlawn Siding Community Session

September 2023

## Remediation Options Assessment Update Woodlawn Siding

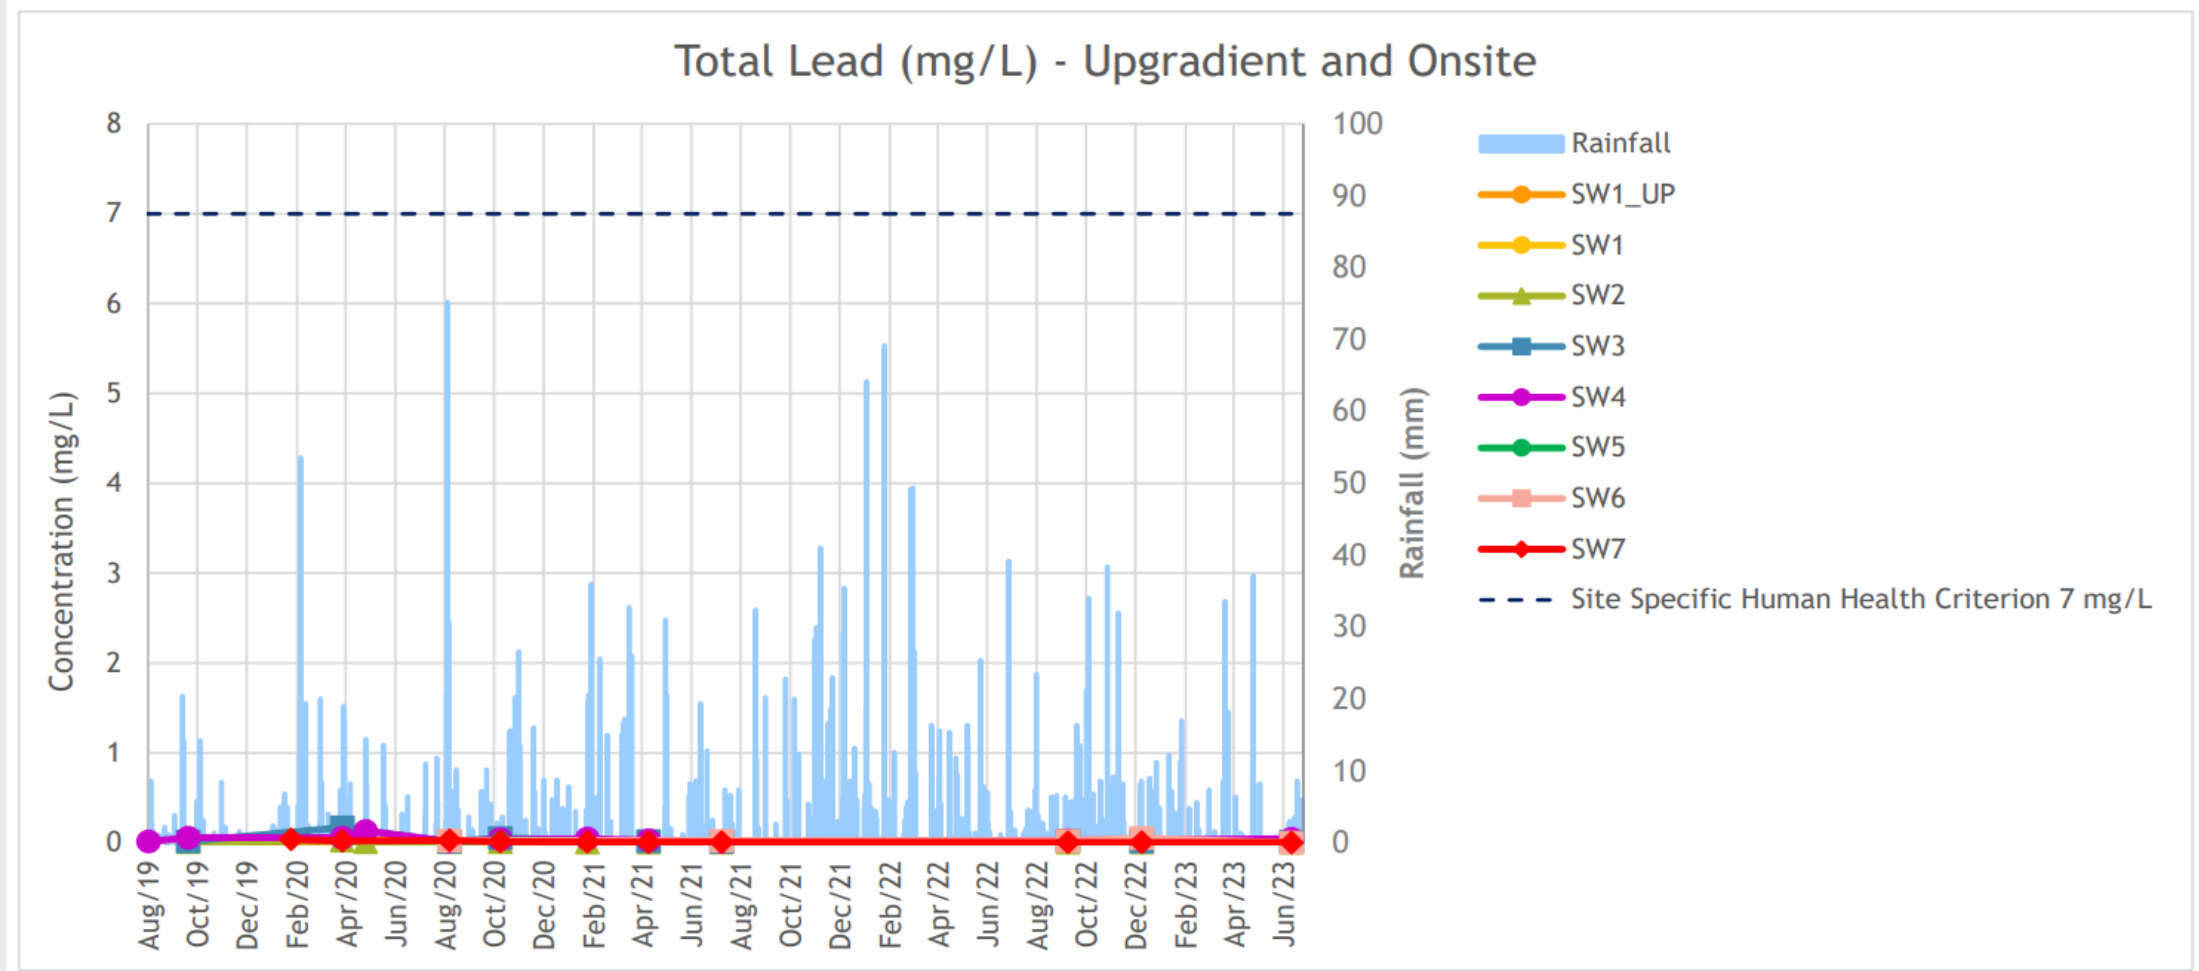
Monitoring results reported no exceedances of adopted human health or ecological criteria for the contaminants of concern.

- Monitoring results indicate no evidence of offsite migration of contaminants in surface water greater than human health or ecological criteria, and no increasing trends in concentrations that would represent an unacceptable risk to human health or ecology.
- Lead concentrations in surface water recorded on and near the site are more than 40-times lower than the adopted human health criteria.
- Concentrations of copper and zinc observed in the Mulwaree River are consistent with background concentrations and do not indicate impacts from the Site.

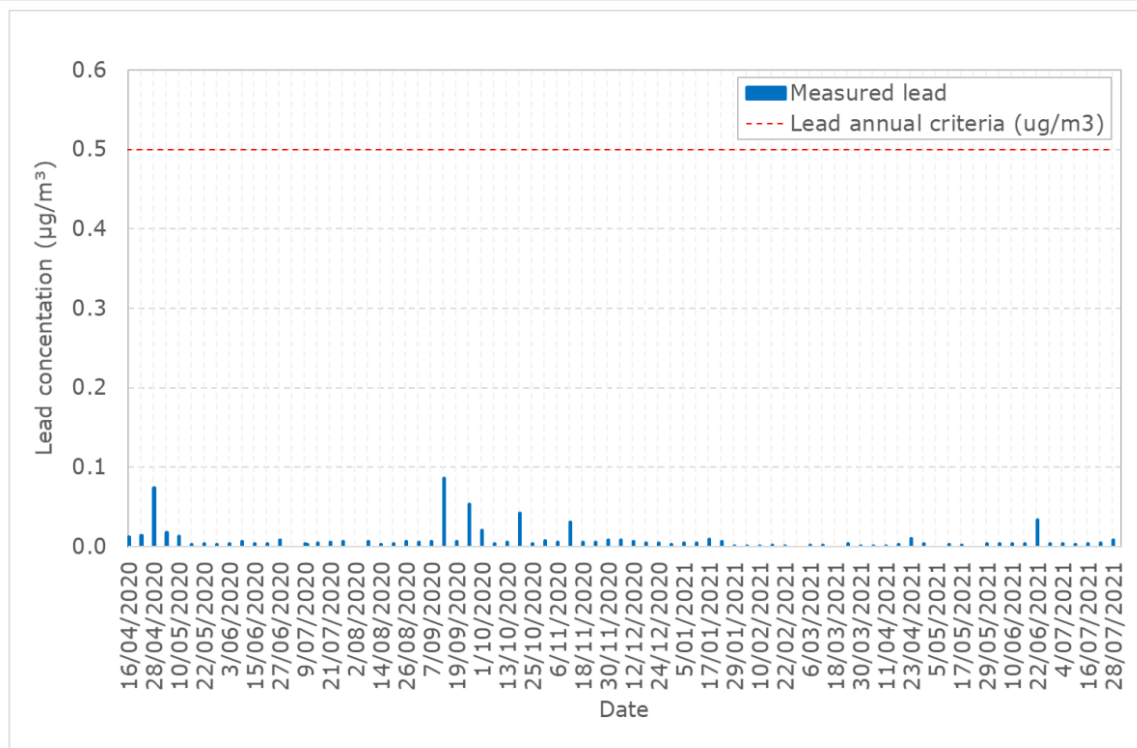
Lead in air quality monitoring samples was significantly below the criteria for all monitoring periods.

Figure 3-2: Measured 24-hour average lead concentration, one day in six since program commissioning

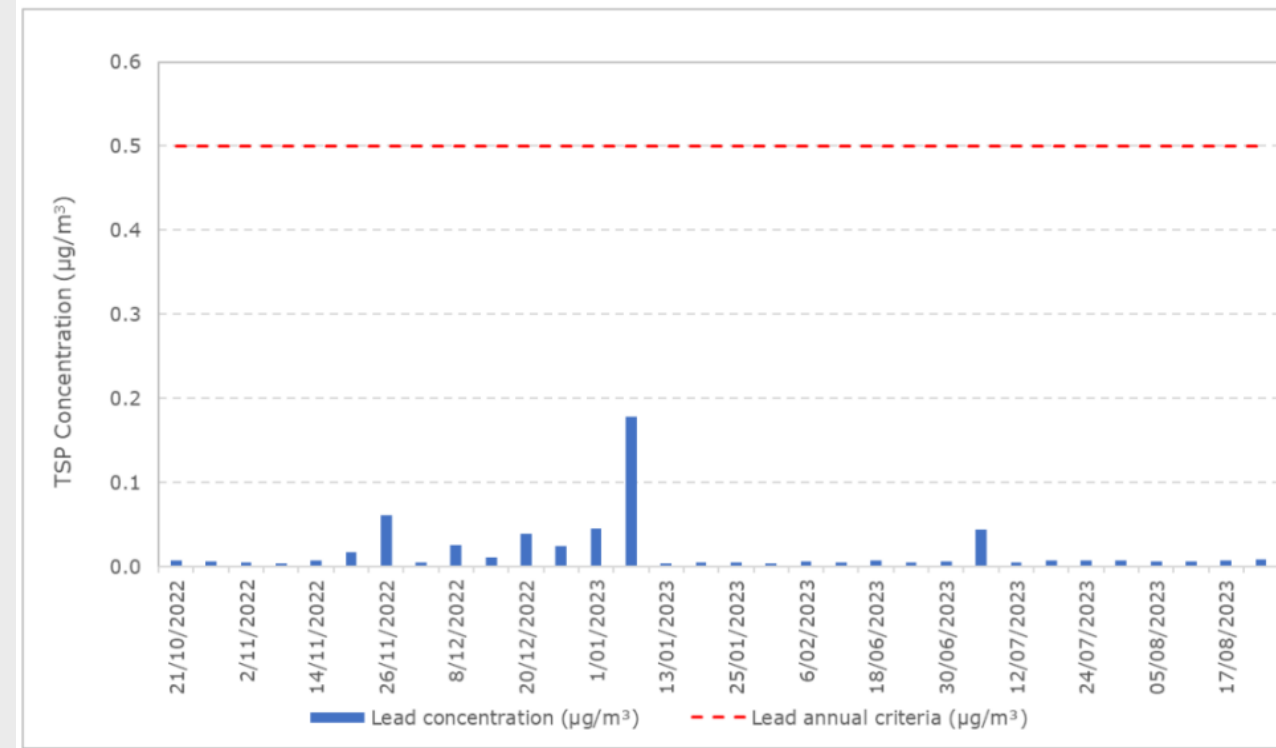
Figure 3-2: Measured 24-hour average lead concentrations, one day in six since program commissioning
