MTMS Waterfall Stabling Yard and Platform  
Extension- Arboricultural Impact Assessment

**Transport for NSW**

<b>Project Name</b>	MTMS Waterfall Stabling Yard and Platform Extension - Arboricultural Impact Assessment
<b>Project Number</b>	18WOL-12101
<b>Project Manager</b>	Alex Gorey
<b>Prepared by</b>	Elizabeth Hannon
<b>Reviewed by</b>	Beth Medway
<b>Approved by</b>	Meredith Henderson
<b>Status</b>	<b>Draft</b>
<b>Version Number</b>	<b>v2</b>
<b>Last saved on</b>	<b>4 September 2019</b>

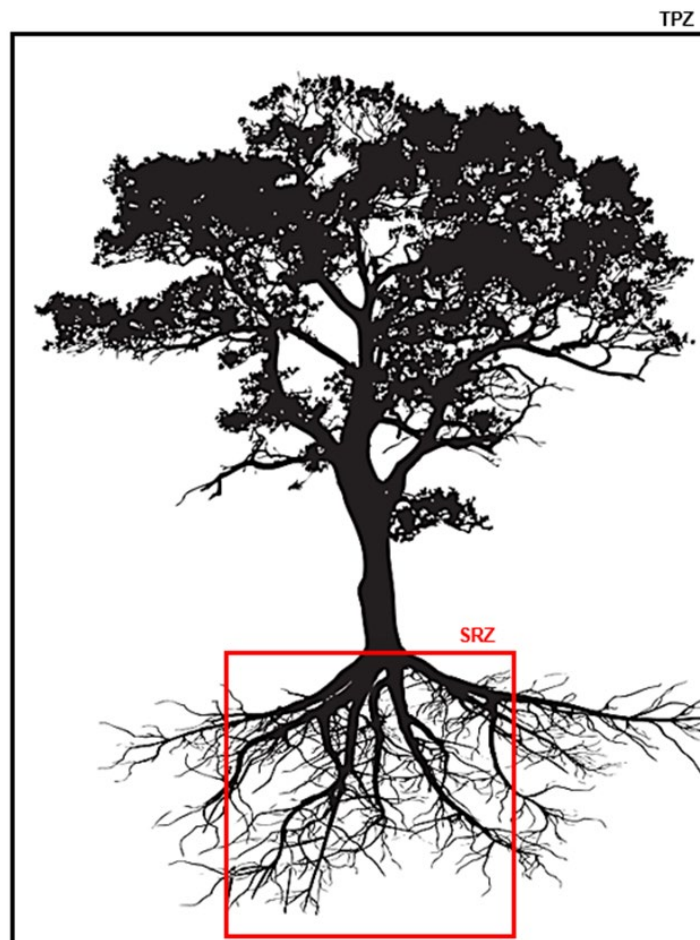
Figure 1: Indicative TPZ and SRZ

The TPZ is the combination of crown and root area (as defined by AS 4970-2009) that requires restriction of access during the construction process. Tree sensitive construction measures must be implemented if works are to proceed within the TPZ.

The SRZ is the area of the root system (as defined by AS 4970-2009) used for stability, mechanical support and anchorage of the tree. It is critical for the support and stability of trees. Severance of roots within the SRZ is not recommended as it may lead to the destabilisation and/or decline of the tree.

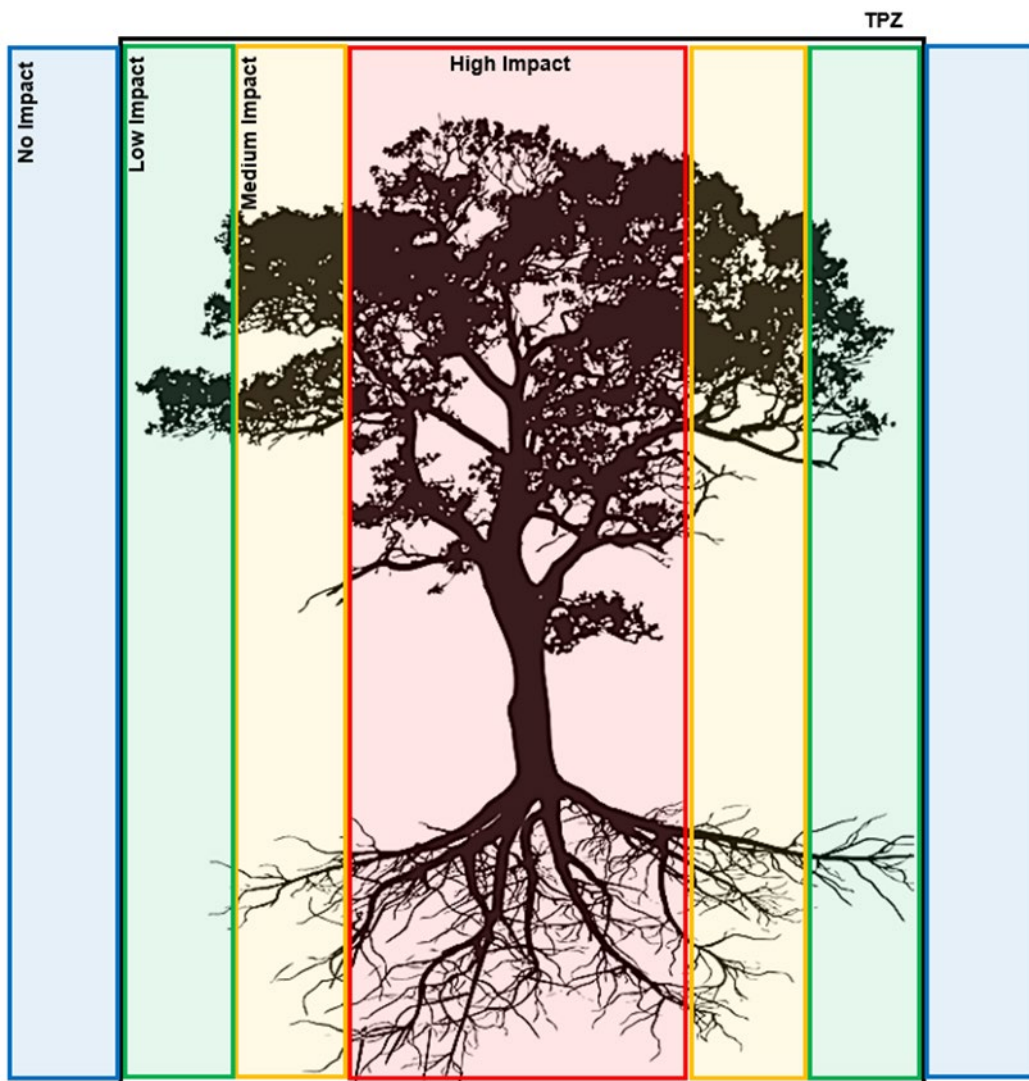
Figure 2: Indicative zones of impact

Trees may be impacted by cutting or damaging roots or branches. Impacts to the tree protection zones are determined by the percentage of the area that the development incurs into the tree protection zone. The following are the definition of these impacts:

- **High impact:** The SRZ may be impacted if the proposed encroachment is greater than 20 % of the TPZ. Trees may not remain viable if they are subject to high impact.
- **Medium impact:** If the proposed encroachment is greater than 10% of the TPZ and outside of the SRZ, the project arborist may require detailed root investigation to demonstrate that the tree(s) would remain viable.
- **Low impact:** If the proposed encroachment is less than 10% (total area) of the TPZ, and outside of the SRZ, detailed root investigations should not be required.
- **No impact:** No likely or foreseeable encroachment within the TPZ.

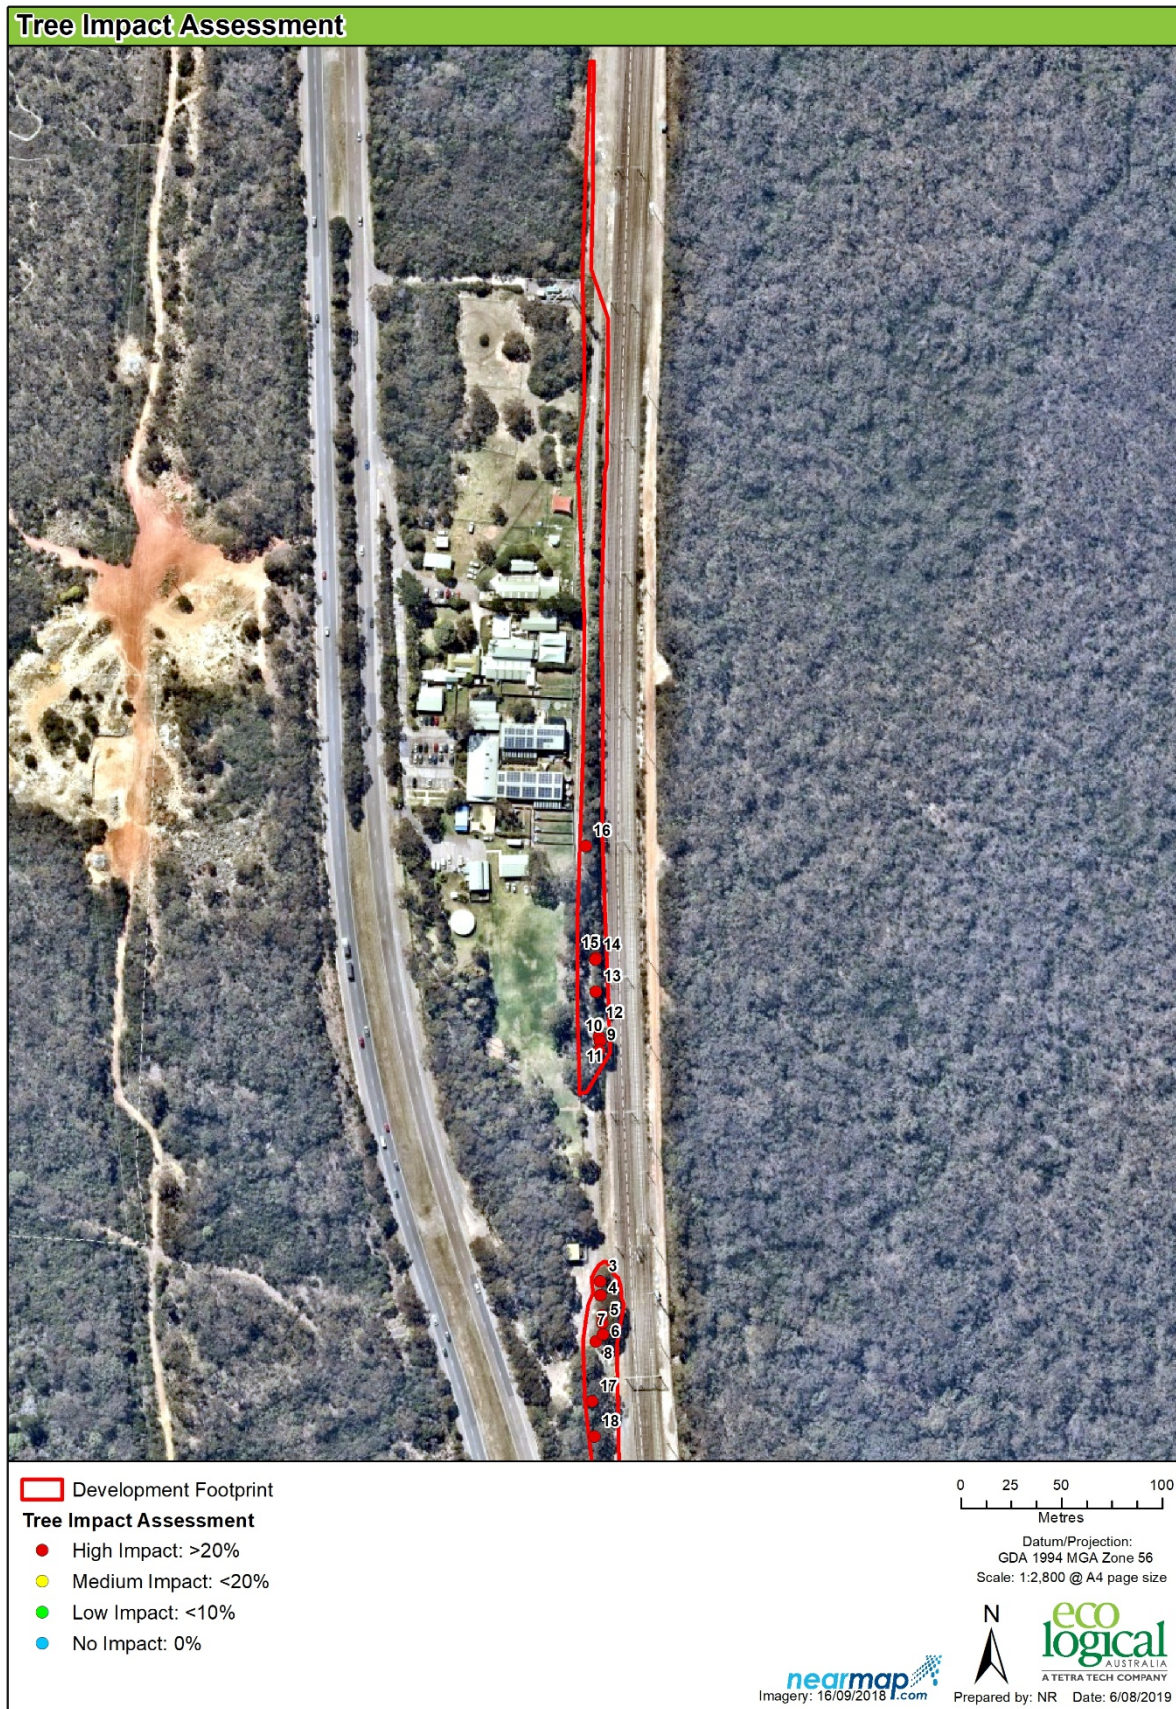
Figure 3: Tree impact map (northern section)

Results of the arboricultural assessment are tabulated and mapped in Appendix A and Table 1.
