Timber Truss Bridges

Study of Relative Heritage Significance of All
Timber Truss Road Bridges in NSW

1998

HISTORY OF TIMBER TRUSS BRIDGES IN NSW

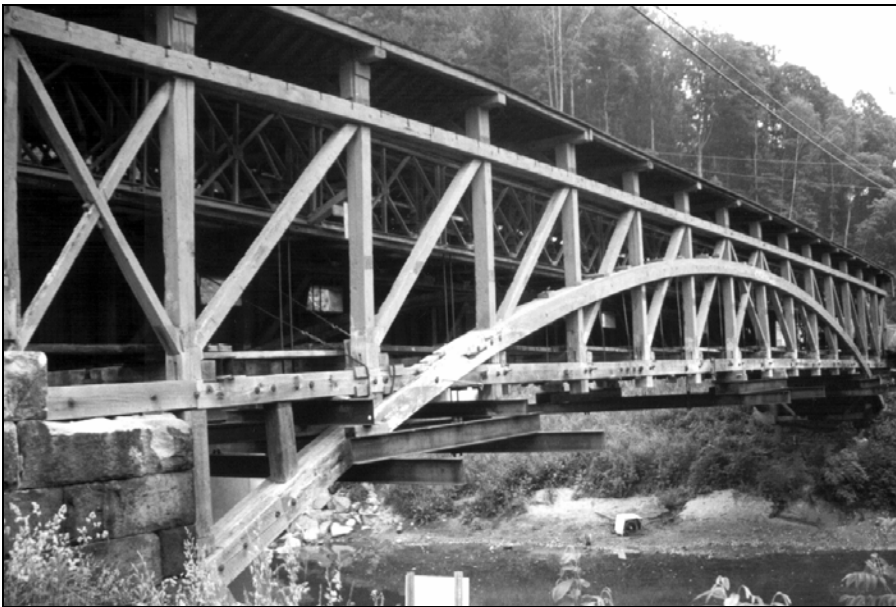
Figure I.3.1e – A typical Burr truss exposed during restoration work, Barrickville, West Virginia

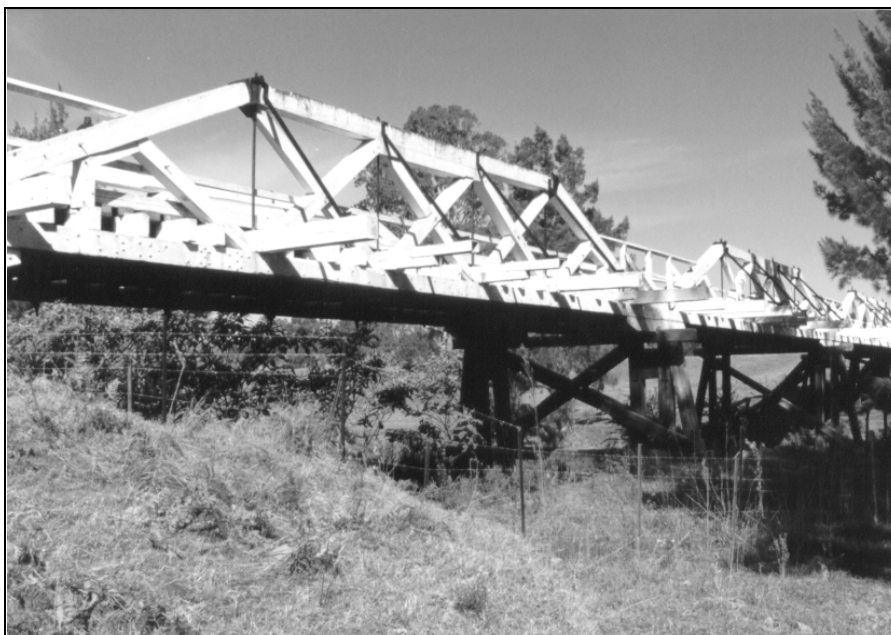
Figure 1.3.2c – Typical Old PWD truss
(Monkerai Bridge over the Karuah River)

In 1860, Capt. Martindale, shown in Figure 1.3.2a, recorded in his *4th Report on Inland Communications* that there were seven Queen Post truss bridges, with spans ranging from 35 to 68 feet (10 - 21 metres). But it was under William C Bennett, Commissioner for Roads and Bridges (Public Works Department) 1862–1889 (Figure 1.3.2b), that large improvements were made. During his tenure in office and despite the lion's share of the PWD budget going to the railways, he oversaw the construction of 6,000 miles (9,600 kms) of main roads and 4,000 miles (6,400 kms) of other roads and the building of 40 miles of bridges, mostly timber beam bridges and a few iron lattice bridges^{R10}. The bridges also included timber truss spans, ranging from 55 to 100 feet, at 147 sites representing an average construction rate of 5 per year. This timber Queen Post truss bridge, so favoured by the PWD from 1860 to 1886, has become known as the OLD PWD truss. A typical truss of this design is shown in Figure 1.3.2c.

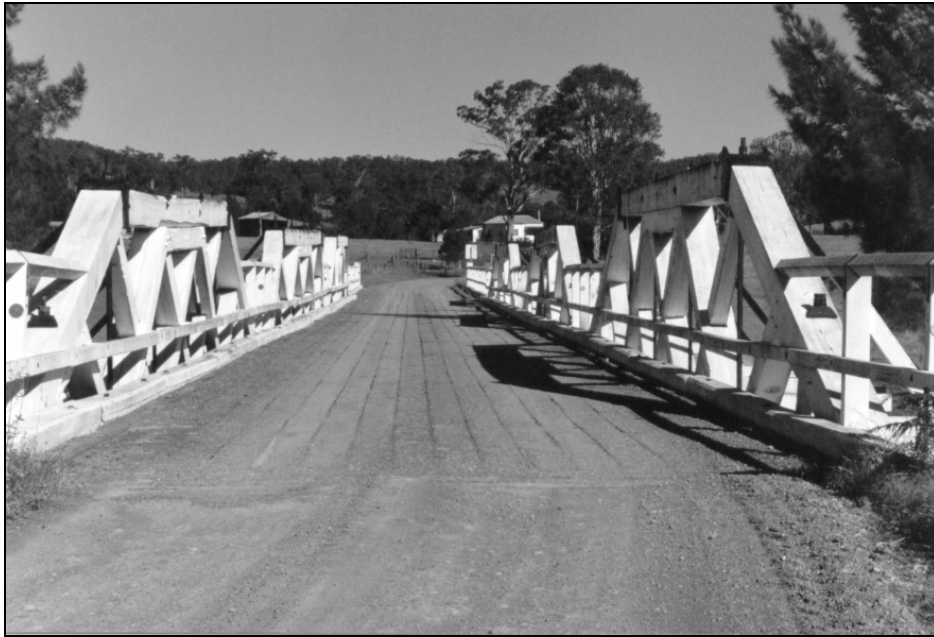
Figure I.3.2d - Deck view of the Monkerai Bridge over the Karuah River which has large timber sections typical of the Old PWD design

- the segmental arch components of the truss were all made from single large-sized timbers which were both hard to obtain and difficult to handle and install. Figure 1.3.2d shows a deck view of the Monkerai Bridge over the Karuah River which utilises these large sections.

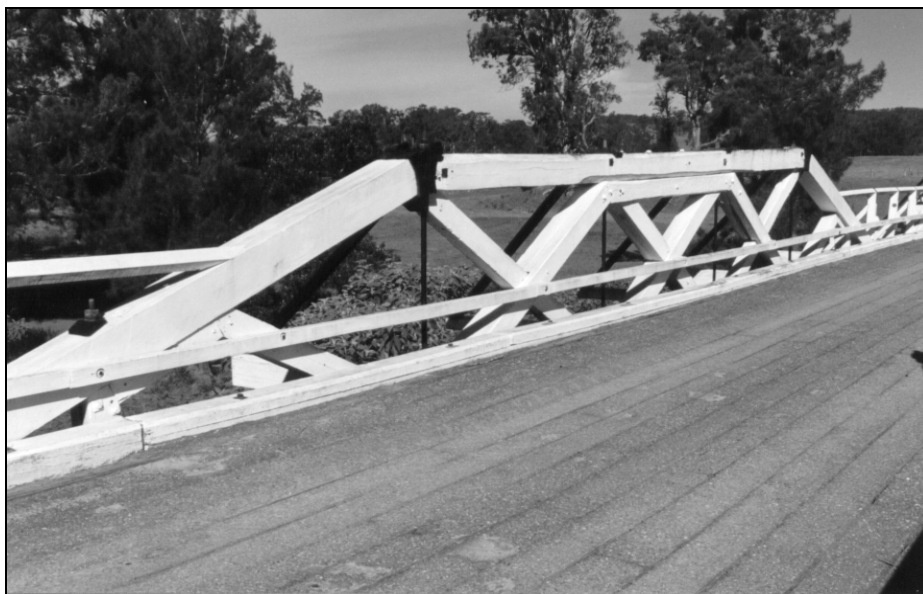
Figure I.3.2e – Typical interior view of an Old PWD Truss with an inner truss at mid-span.

- it was extremely difficult to renew such members, particularly the lower inner piece of the top chord in long spans (see Figure I.3.2e), because taking the defective member out immediately destroyed the structural integrity of the truss so it had to be temporarily supported or even taken out of service until the work was completed. This could impose great inconvenience to road traffic where the next available bridge was many miles away.
- the vertical iron rods connecting the top and bottom horizontal timbers were comprised of single rods installed through the middles of these timbers as shown in

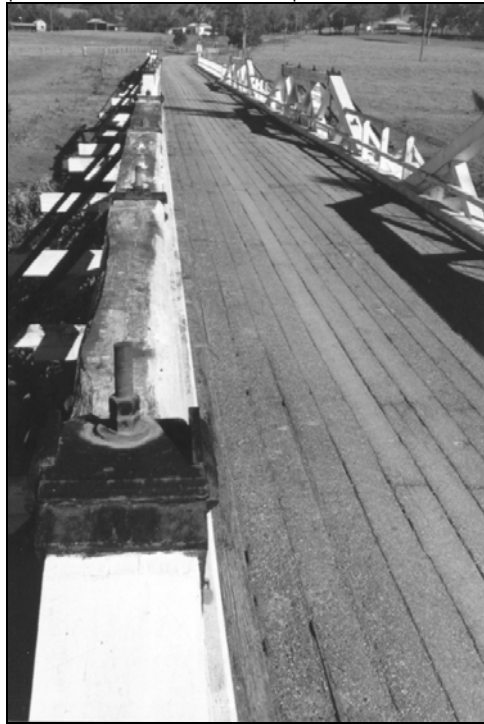
Figure 1.3.2f – View of truss showing single rods all of which are the same size

Figure 1.3.2f. Had the theory of structures been applied, it would have shown that loads applied to the rods are larger near the ends of each truss. It is not surprising then that there were frequent breakages of the single rods which seriously weakened the truss span and incurred unexpected and recurring repair costs.

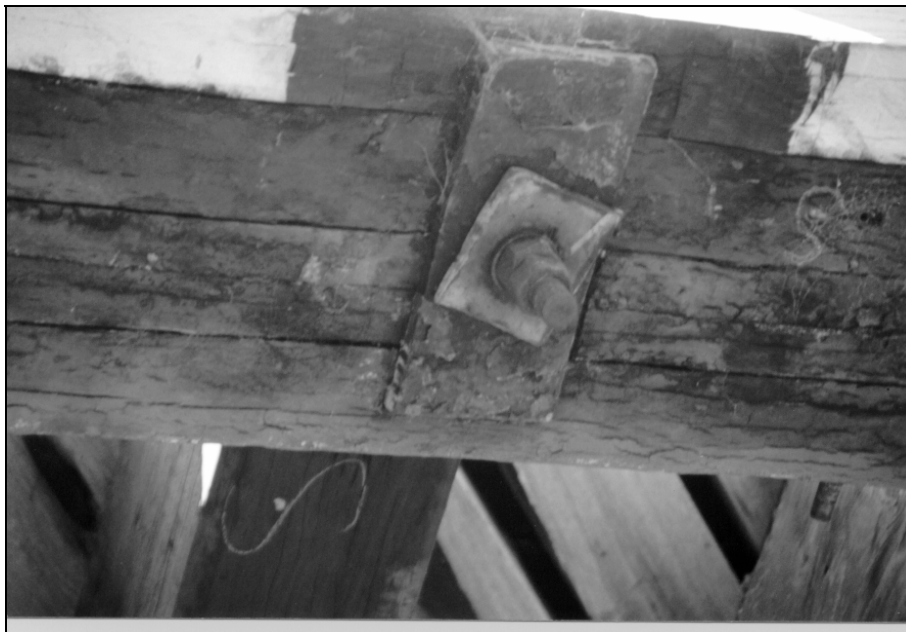
Figure 1.3.2g –Four flitch bottom chord - View from underside

- the bottom chords were made from four flitches or planks placed side by side on edge and cross bolted together (see Figure 1.3.2g). This was equivalent to vertical rather than the horizontal laminations applied at the earlier arch bridges. The same flaw existed for each arrangement of laminates, in that when the inner laminates

deteriorated, it was extremely difficult to renew them and a completely new assembly of fitches was required.

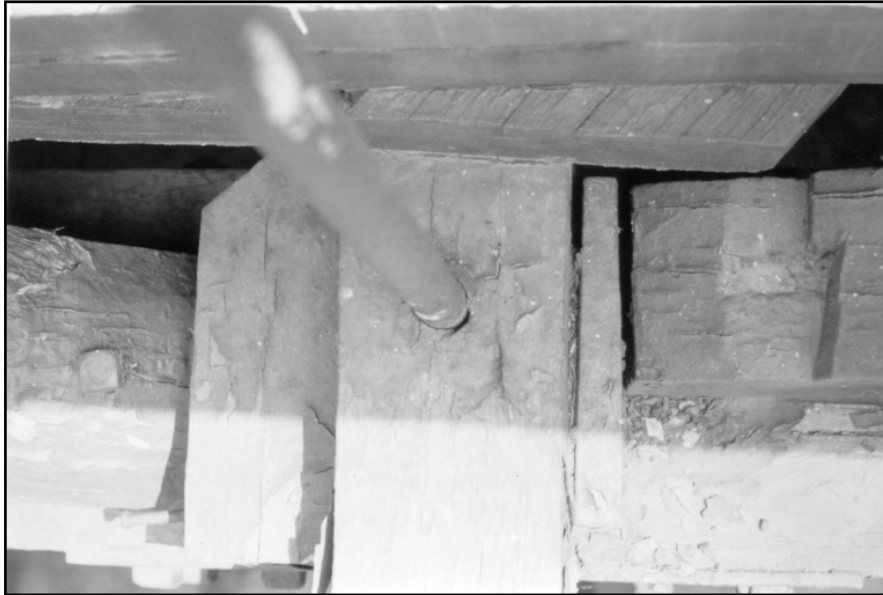
Figure 1.3.2h – Packing at bottom chord was used to help counter the effects of shrinkage.

- shrinkage of the local hardwoods caused joints to open up such that the truss developed excessive sag or deflection. Packing at the bottom chord joint as shown in Figure 1.3.2h alleviated the problem but required regular adjustments as the shrinkage continued over many years.

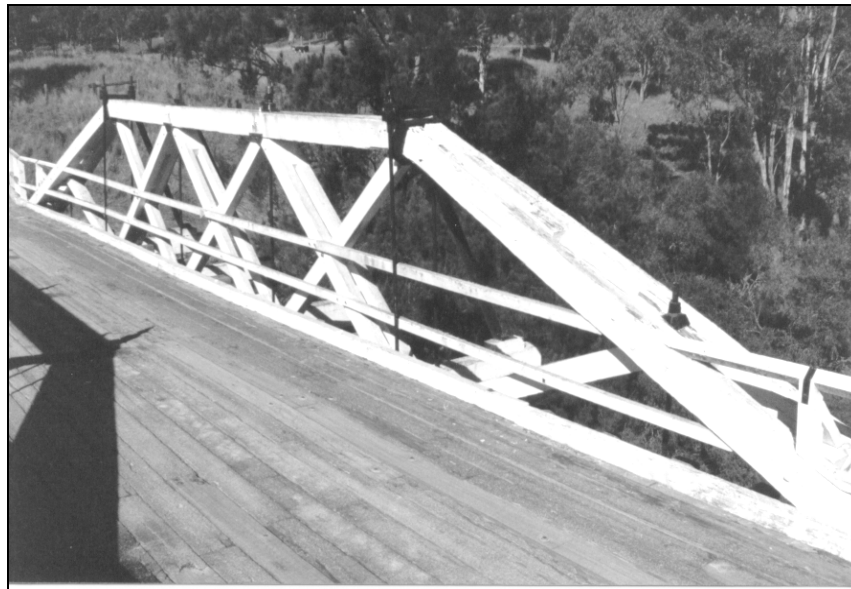
Figure 1.3.3b – The single thickness top chord was part of McDonald's improvement to the OLD PWD trusses.

- elimination of the double thickness top chord for the longer span trusses (see Figure 1.3.3b).

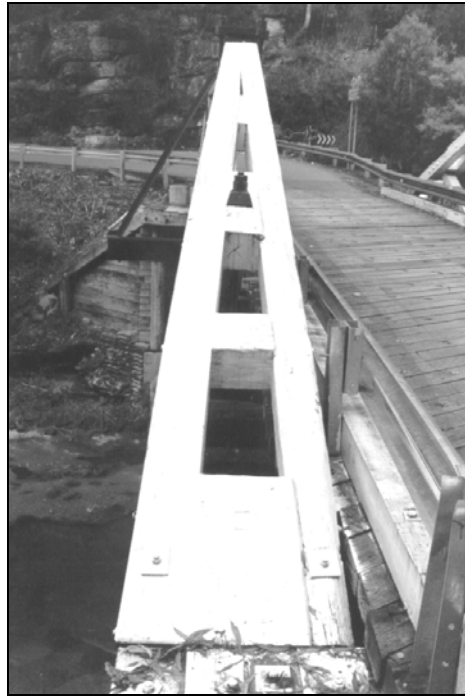
Figure I.3.3c – Splayed end members increased the stability of the truss.

- the splaying of the sloping end member so as to increase stability of the compression top chord which was prone to buckling. (Figure I.3.3c)
- the vertical rods at the ends of the his trusses were placed outside the chord timbers and held in place by cast iron cradles as in Figure 2.3.3d. This eliminated the need to drill through the chord members so the number of rods was doubled and larger sizes could be easily incorporated and kept tight.

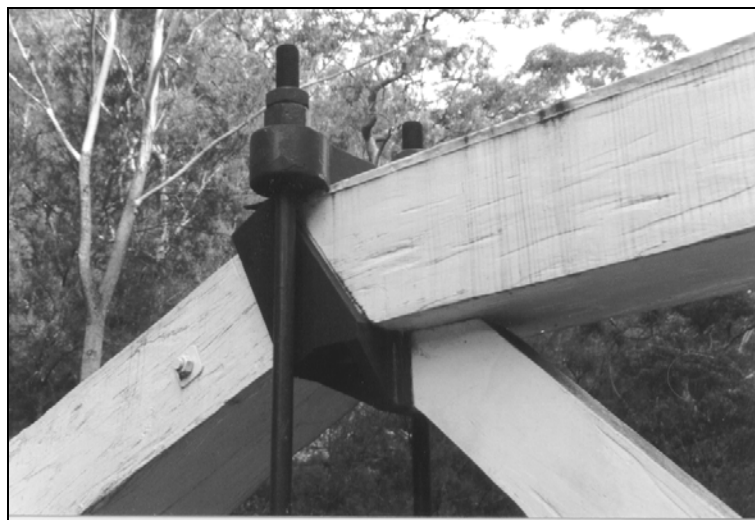
Figure I.3.3d – Vertical rods placed outside the truss faces eliminated the need to drill through the top chord.

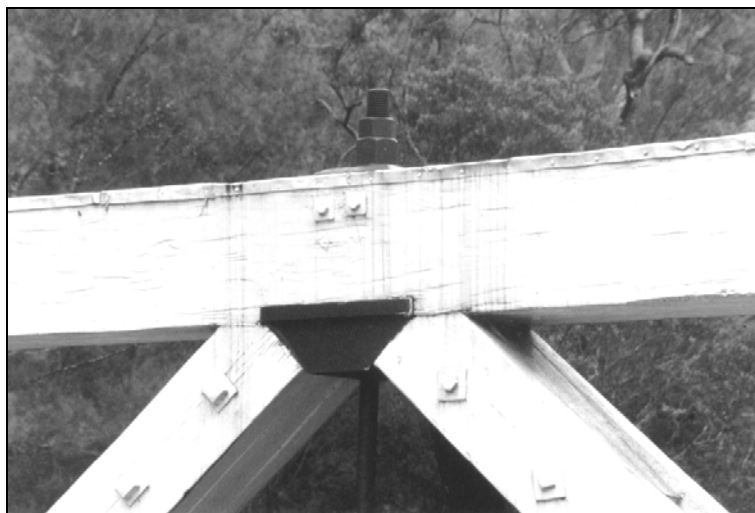
Figure 1.3.3e – Connection of diagonals to top chord via cast iron plates provided a superior transfer of force.

- the diagonal timbers were fitted into cast iron plates (refer Figure 1.3.3e) at their junctions with the top chord timbers so as to give good force transfer at the joints.

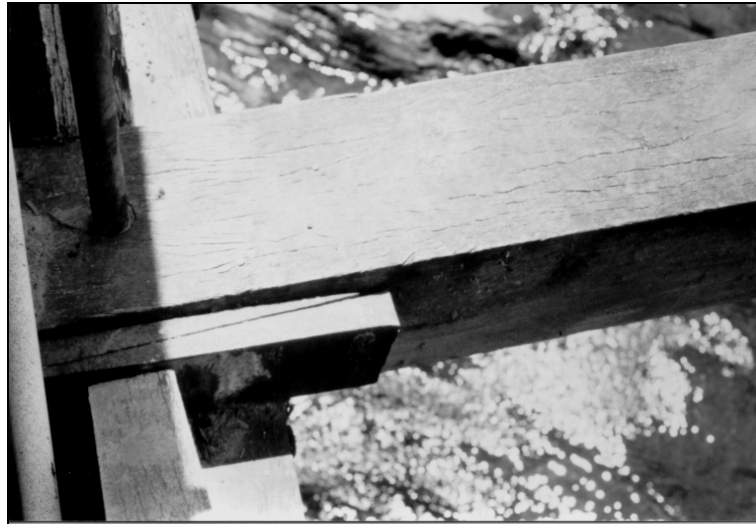
Figure I.3.3f – Steel fox wedges were used to counter shrinkage effects and provided a simple means for regular adjustments.

- where the diagonal timbers met the bottom chord joints, opposing steel "fox" wedges were installed (see Figure 1.3.3f) so that regular hammering would keep the shrinkage gap filled, thereby reducing long-term deflections.

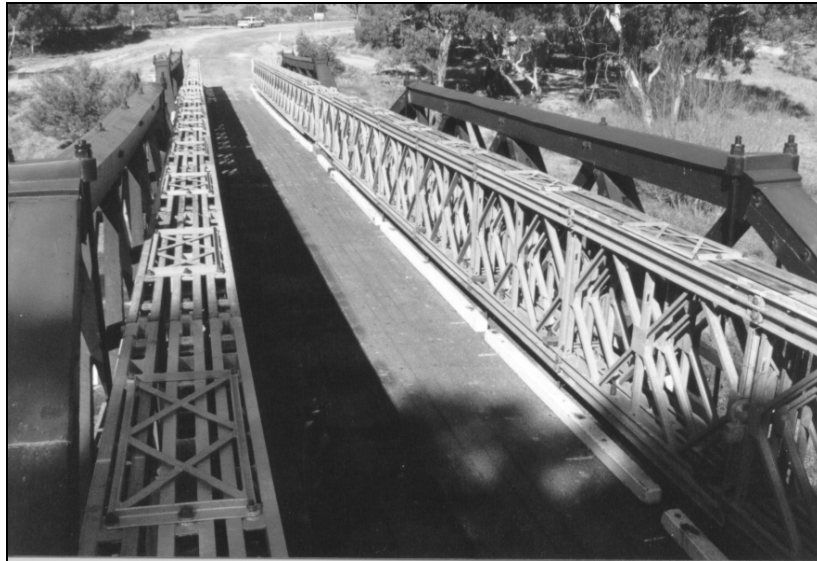
Figure 1.3.3h – Bailey Bridges became the preferred method of temporary support during maintenance and rectification works.

- methods were devised whereby combinations of chains and a minimum of temporary timber supports (see Figure 1.3.3g) could be used to create an alternate internal load path thereby relieving a defective timber of load. This allowed its easy removal and replacement without taking the bridge out of service and with little interference to traffic. After WWII the Bailey bridge largely superseded these methods of temporary support, see Figure 1.3.3h.

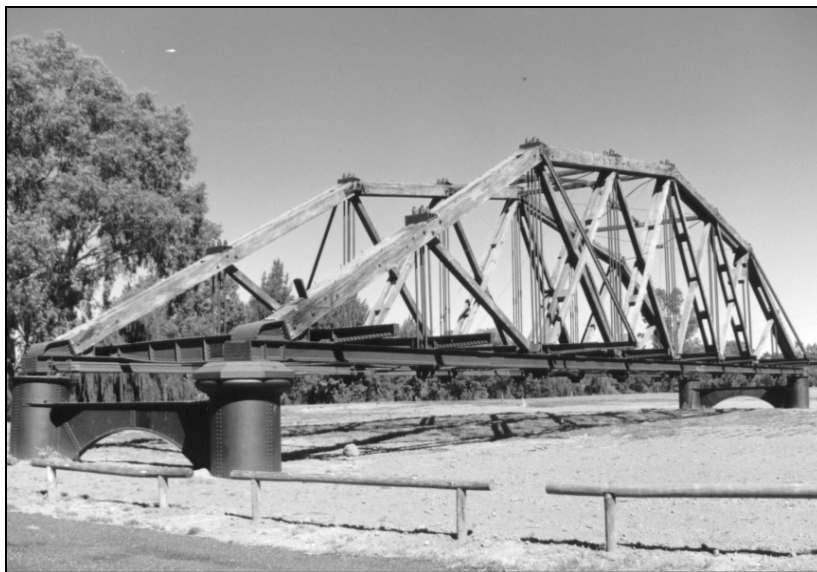
Figure 1.3.3i – A span of the original Lachlan River Bridge at Cowra on display at a nearby riverside park. The bridge utilised steel tension members and timber compression members in an early example of composite design.

McDonald's crowning achievement, however, was his pioneering of the new technology of composite trusses where timber and steel were used to their best purposes. The bulky and relatively lower-strength timbers were best suited to members in compression, hence the top chord, end sloping members and the diagonals were timber members. The higher strength of steel made it more suitable for slender tension members, the verticals and the bottom chord. In his design for the 3-spans trusses over the Lachlan River at Cowra in 1893 he demonstrated the potential for composite construction with a span of 160 feet, almost double the previous longest span of 100 feet. The bridge served 93 years and was replaced in 1986. One span was saved and is on display in a nearby riverside park (see Figure 1.3.3i). Note that typical McDonald trusses had timber bottom chords.

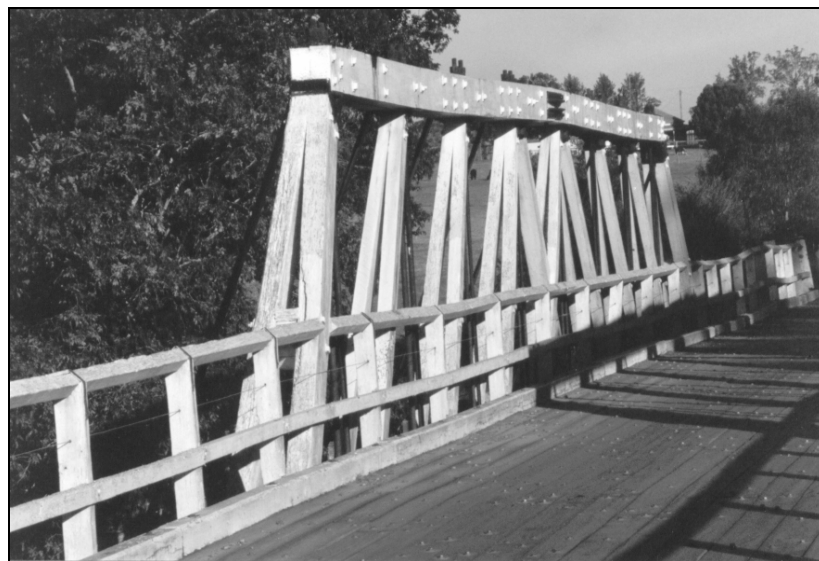
Figure I.3.4c – Parallel pairs of members held apart by timber spacers were used to improve load characteristics, aid painting and prevent the collection of water.

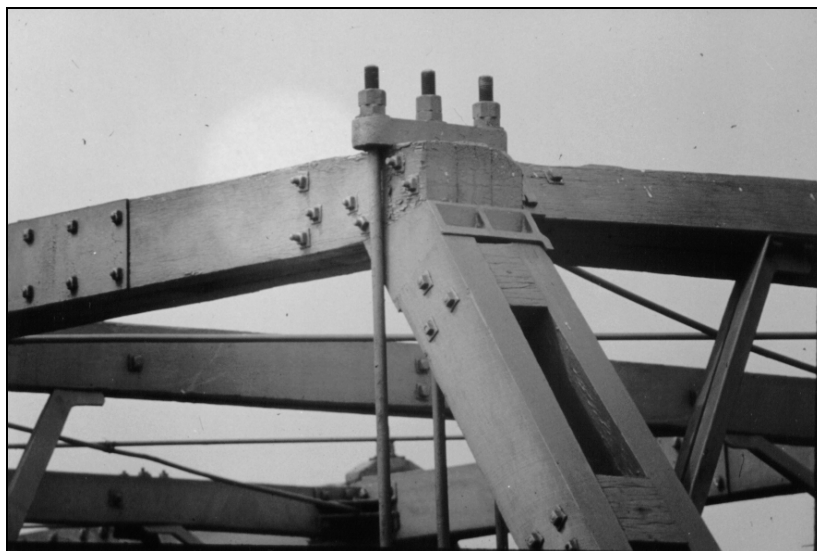
Figure 1.3.4d – The simple truss shape allows tightening via the nuts on the top chord to combat shrinkage effects. One, two, or even three vertical rods were possible due to the separated members. The cast iron shoes allowed good transfer of forces at truss joints.

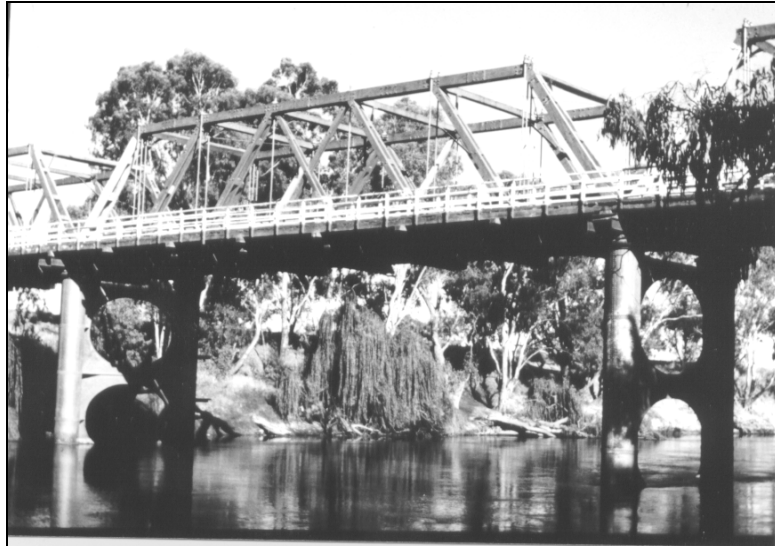
Figure I.3.4e – Hampden Bridge, Wagga Wagga.
The first of Allan's large overhead through truss bridges with 3 truss spans, each of 110ft (33.5m).

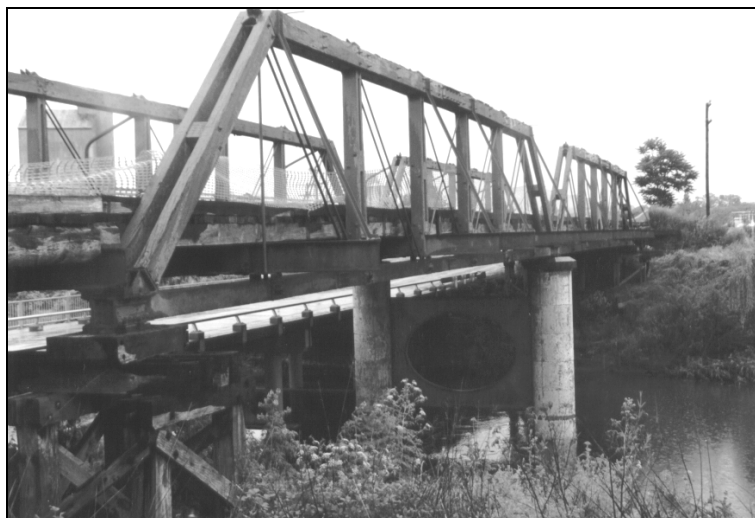
Figure 1.3.5b – The bridge over the MacIntyre River at Inverell was one of DeBurgh's early Pratt trusses with sloping end members.

This first composite Pratt truss bridge was replaced by a prestressed concrete structure in 1975 but an example of its type with sloping ends is extant over the MacIntyre River at Inverell (see Figure 1.3.5b). It provided access to the railway yard nearby but is out of service next to a new concrete bridge.

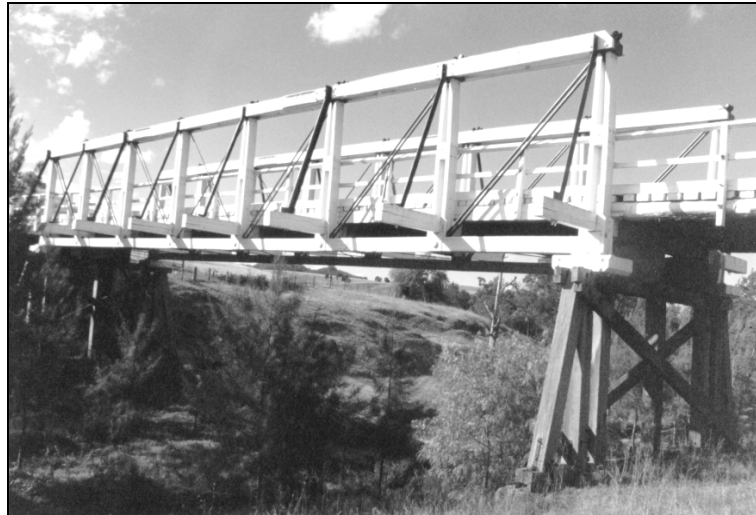
Figure 1.3.5c – The square ends that are typical of the DeBurgh truss.

A minor technical change was subsequently made whereby the sloping end members were replaced by a conventional rectangular Pratt panel. Henceforth all DeBurgh trusses have had the familiar squared ends (see Figure 1.3.5c). In 1998 there are nine of these bridges in service. His greatest achievement was the 165 feet deck span over the Lane Cove River on the North Ryde to Gordon Road pictured in Figure 1.3.5d. It was opened on 20 December 1900 and officially named the DeBurgh Bridge on 23 February 1901. Unfortunately it was destroyed by the bush fires of January 1994.

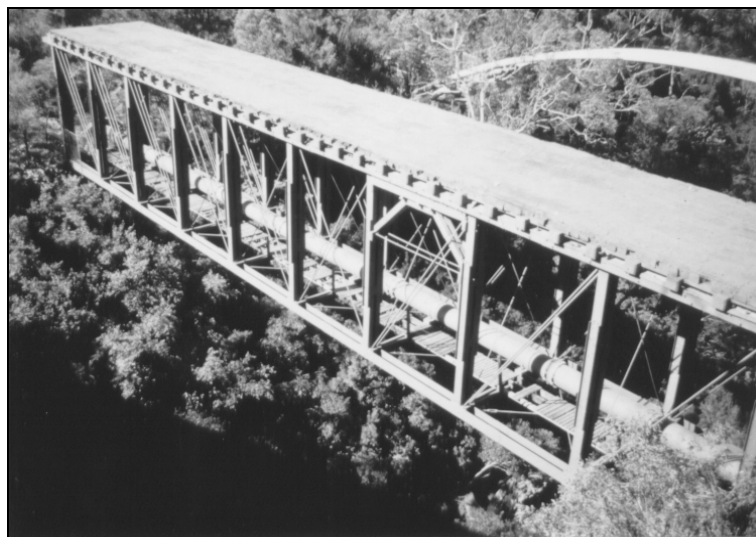
Figure 1.3.5d – The 1901 DeBurgh Bridge over Lane Cove River. DeBurgh's greatest achievement with a 165ft (50.3m) deck span was damaged in the 1994 bush fires.

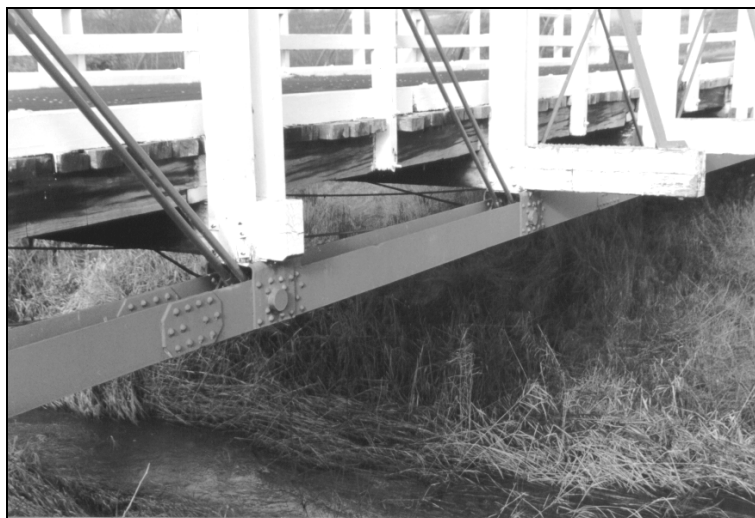
Figure 1.3.5e – Pins along the bottom chord facilitated speedier construction but later lost favour due to the difficulties experienced in maintenance and strengthening works.

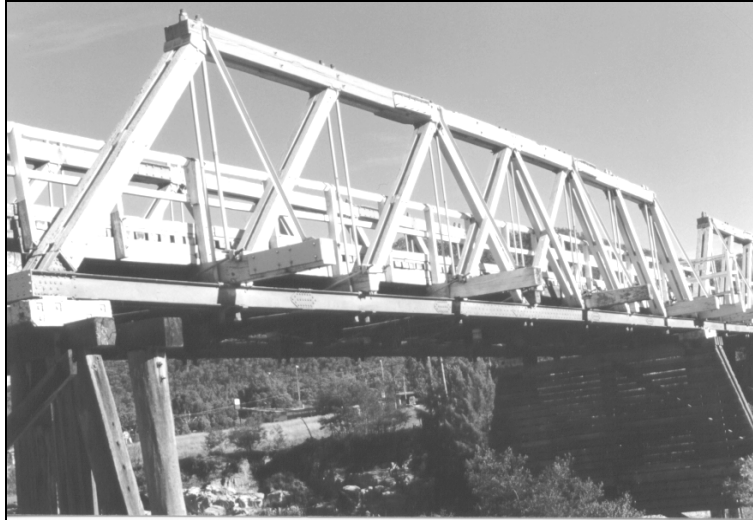
Figure 1.3.6a – Bulga Bridge over Wollombi Brook is typical of Dare's design.

This was the most successful composite truss, having a construction period from 1905 to 1936. In 1903 the 36-year old bridge designer, Harvey Dare, was in charge of highway bridge design and took the opportunity to change the composite truss. He returned to the Howe truss arrangement of the Allan truss but substituted a pair of steel channels for the timber bottom chord (see Figures 1.3.6a & b) and redesigned the bottom chord joints to eliminate the pins of the DeBurgh truss. He achieved further simplicity in member replacements thereby creating the most cost-effective timber truss, at the end of this evolutionary process. The Dare truss bridges have the highest survival rate, 24 are extant in 1998 of the 44 built. In fact the first one, completed in 1905, is extant over the MacDonald River at Bendemeer being used as a footbridge.

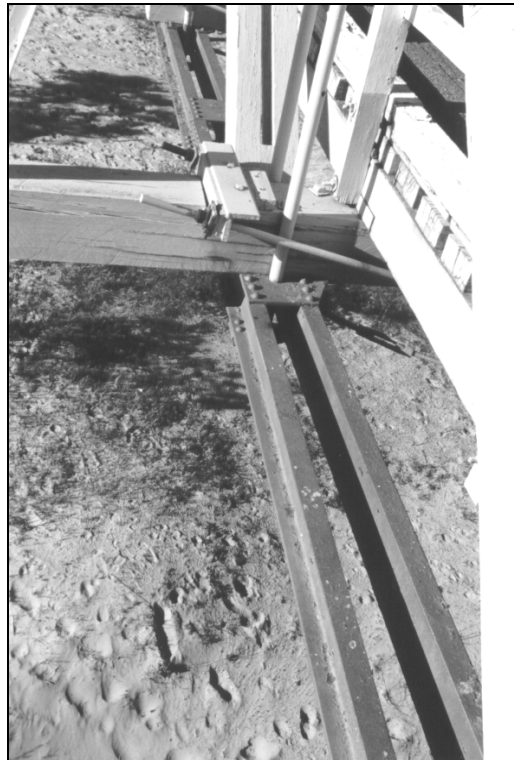
Figure 1.3.6b – The pair of steel channels that made up the bottom chord utilised the tension characteristics of steel along with the compression characteristics of the timber.
