Elizabeth Drive - East Upgrade

Phase 1 Contamination Assessment

08-Sep-2023
Preliminary Contamination Investigation Report

Client: Transport for NSW

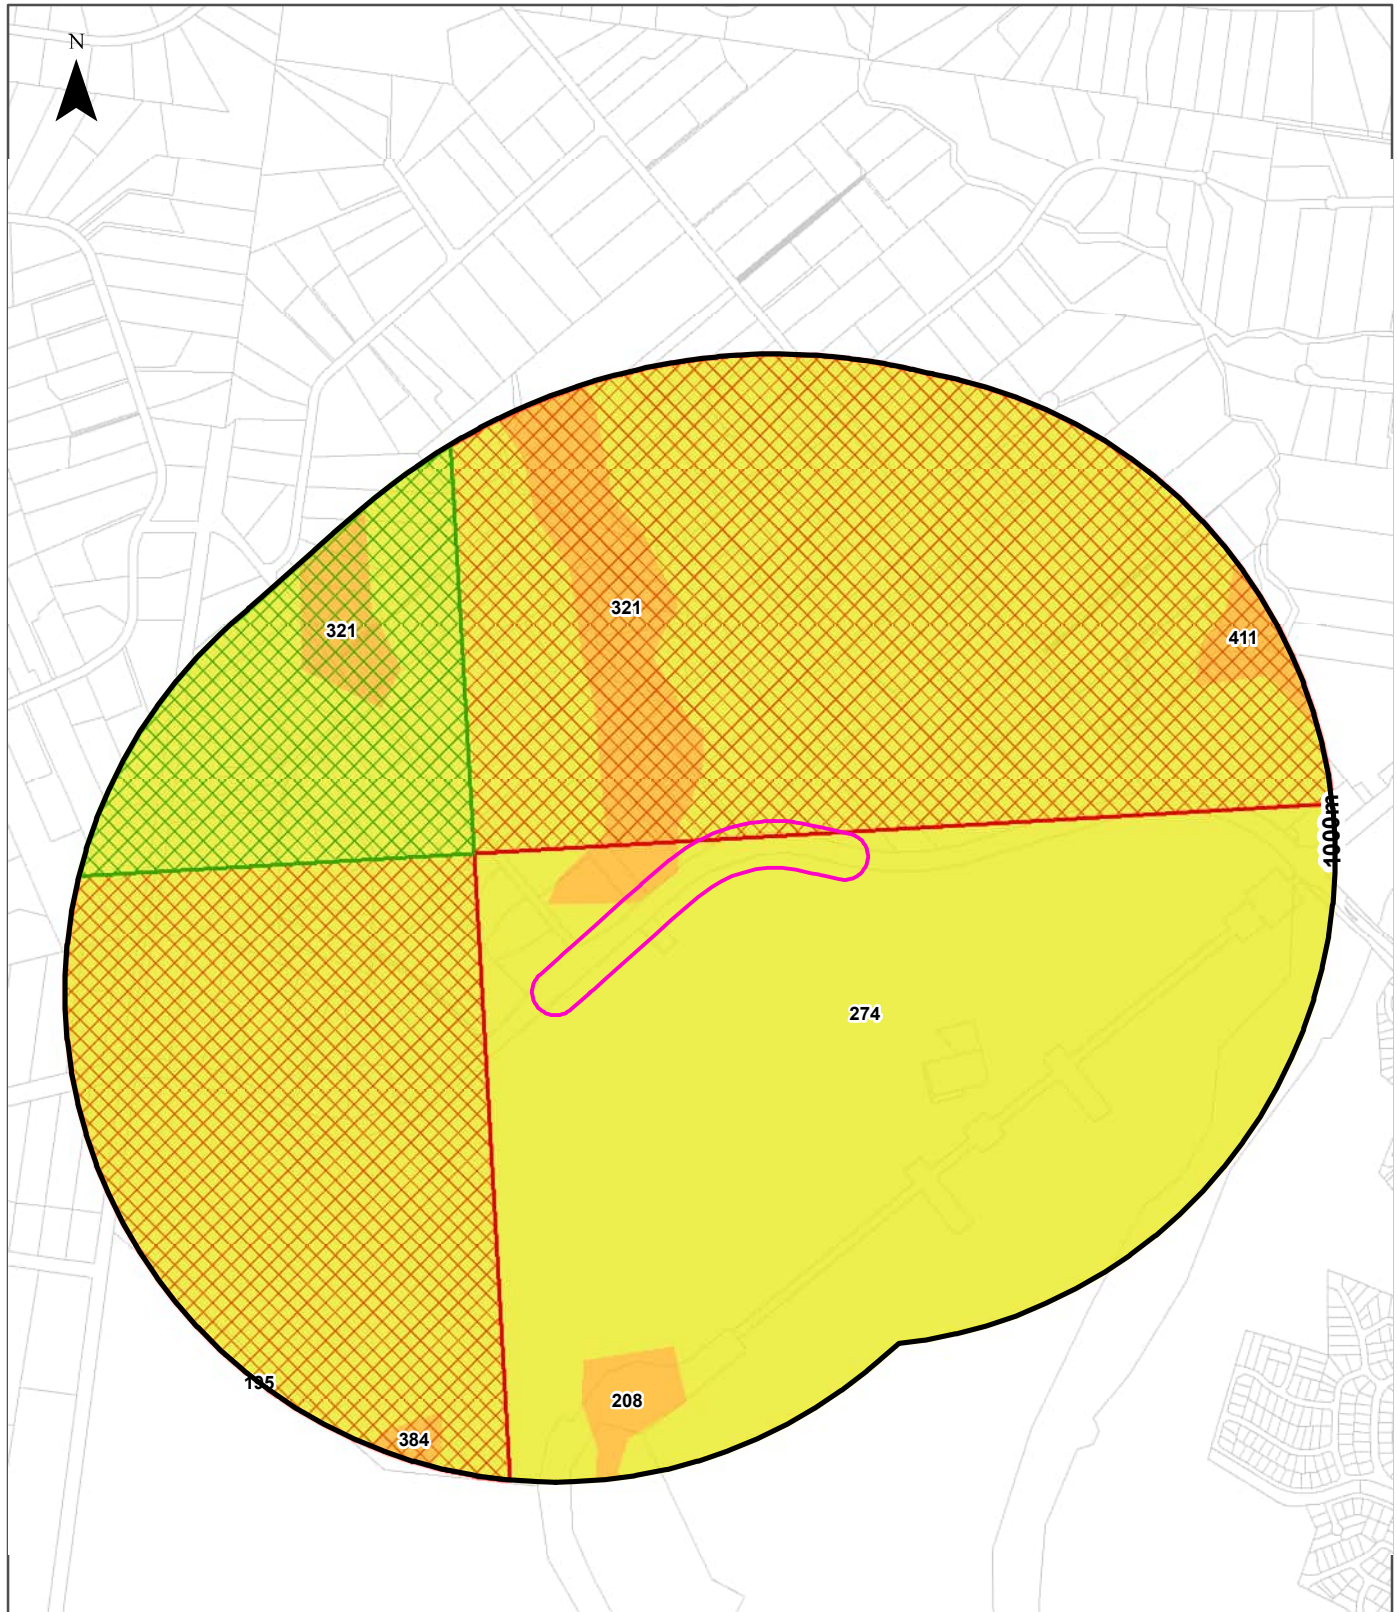
Dryland Salinity

Assessment 2000	Assessment 2020	Assessment 2050	Distance	Direction
High hazard or risk	High hazard or risk	High hazard or risk	0m	On-site
Delineated risk area but no high hazard or risk rating	Delineated risk area but no high hazard or risk rating	Delineated risk area but no high hazard or risk rating	290m	North West

In many cases where a high risk is indicated, less than 100% of the area will have a high hazard or risk.

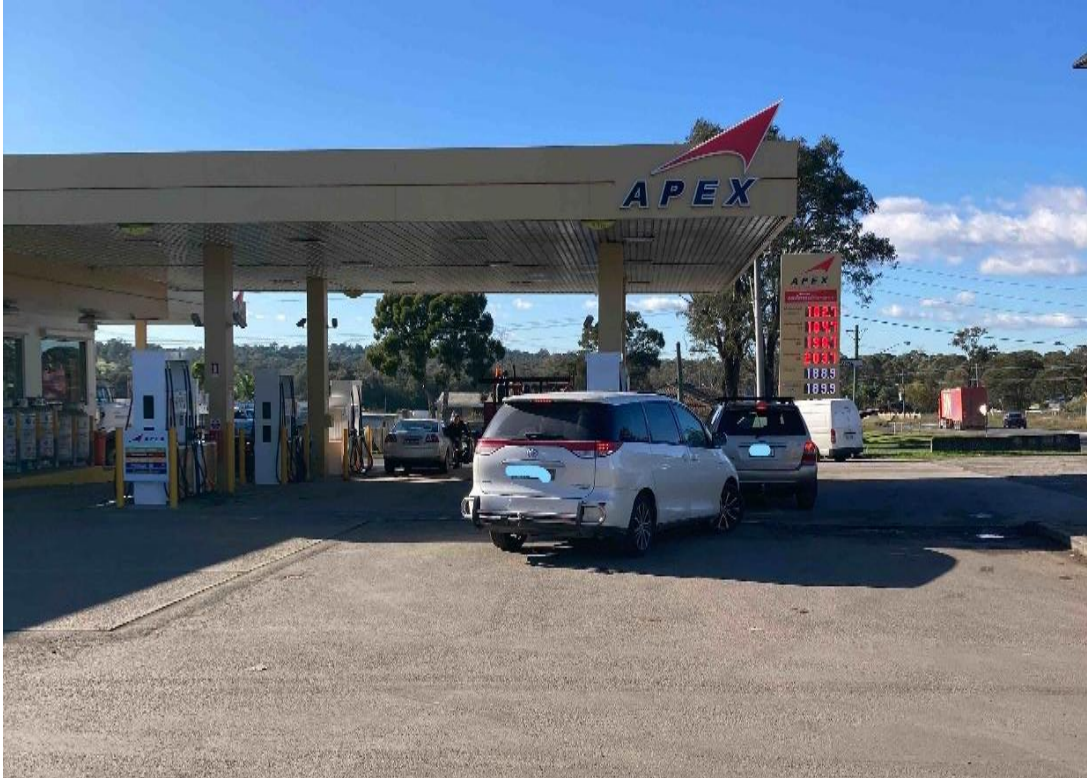
Client Name: Transport for NSW		Site Location: Elizabeth Drive East	Project No. 60641411
Photo No. 1	Date: 31/05/2022

Location	Observations
Apex Petroleum (Plate 1)	<p>Forecourt fully paved and in good condition and gravel noted between forecourt and road edge.</p> <p>The canopy extends out from the sales building and generally covers three filling bays where two bowser islands are located</p> <p>There is a slight hump (bund) that borders the forecourt area to contain any spills within the forecourt area</p> <p>No significant staining or odours were noted.</p>
United Petroleum (Plate 2)	<p>Forecourt fully paved and in good condition and muddy gravel noted between forecourt and road edge.</p> <p>The canopy extends out from the sales building and generally covers three filling bays where two bowser islands are located</p> <p>A separate canopy and bowser island is present west of the sales building to service heavy vehicles</p> <p>It was noted that numerous trucks were parked at the time of the inspection</p>

Description: Apex Petroleum

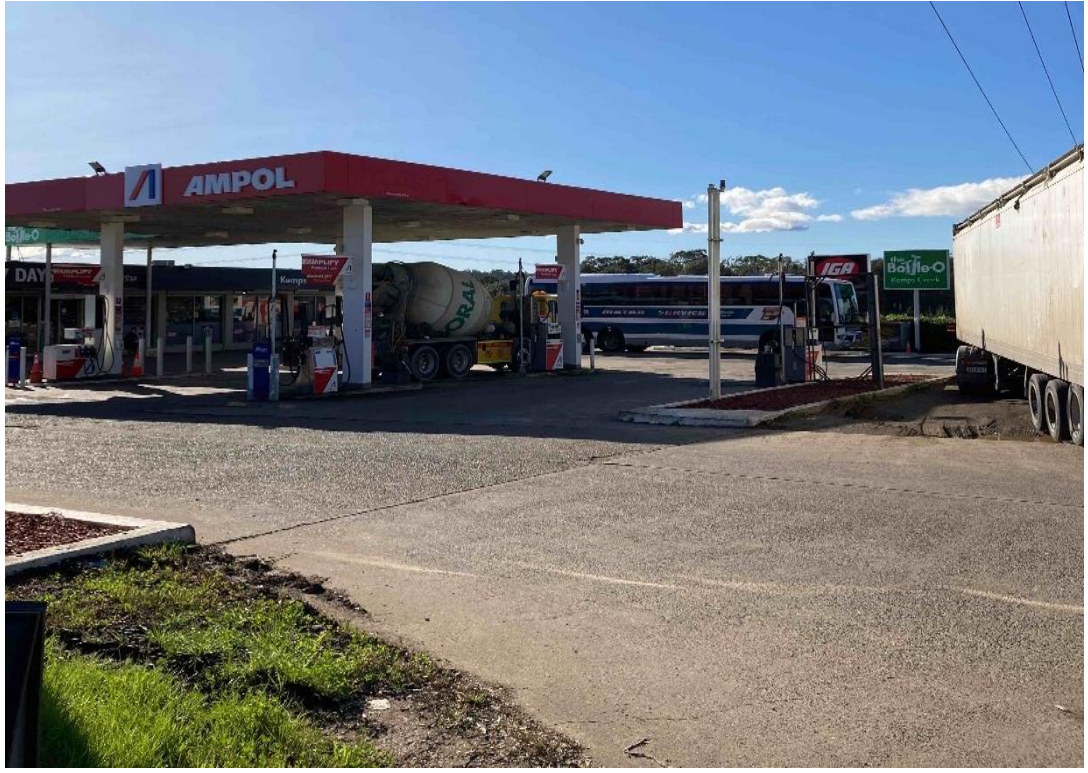
Client Name: Transport for NSW		Site Location: Elizabeth Drive East	Project No. 60641411
Photo No. 3	Date: 31/05/2022

Location	Observations
	<p>There is a slight hump (bund) that borders the forecourt area to contain any spills within the forecourt area</p> <p>No significant staining or odours were noted.</p>
Caltex (Ampol) Service Station (Plate 3)	<p>Forecourt fully paved and in good condition</p> <p>The canopy extends out from the sales building and generally covers three filling bays where two bowser islands are located</p> <p>No obvious hump/bund was observed to contain any spills within the forecourt area</p> <p>No significant staining or odours were noted.</p> <p>Waste drums were noted on the verge in front of the property next door, labelling was present on the drums but could not be discerned from the publicly accessible area (Plate 4)</p>
Sydney Recycling Park operated by Hi Quality Group	<p>The entrance comprised a paved driveway extending several hundred metres into the property, no obvious signs of contamination were observed from the entrance.</p> <p>This property extends well off Elizabeth Drive so none of the recycling park features could be observed from the road.</p>

<p>A photograph of an Ampol service station. The station has a red canopy with the Ampol logo. There are several fuel pumps, a concrete mixer truck, and a white semi-trailer. The sky is blue with some clouds.</p>	
Description: Ampol Service Station

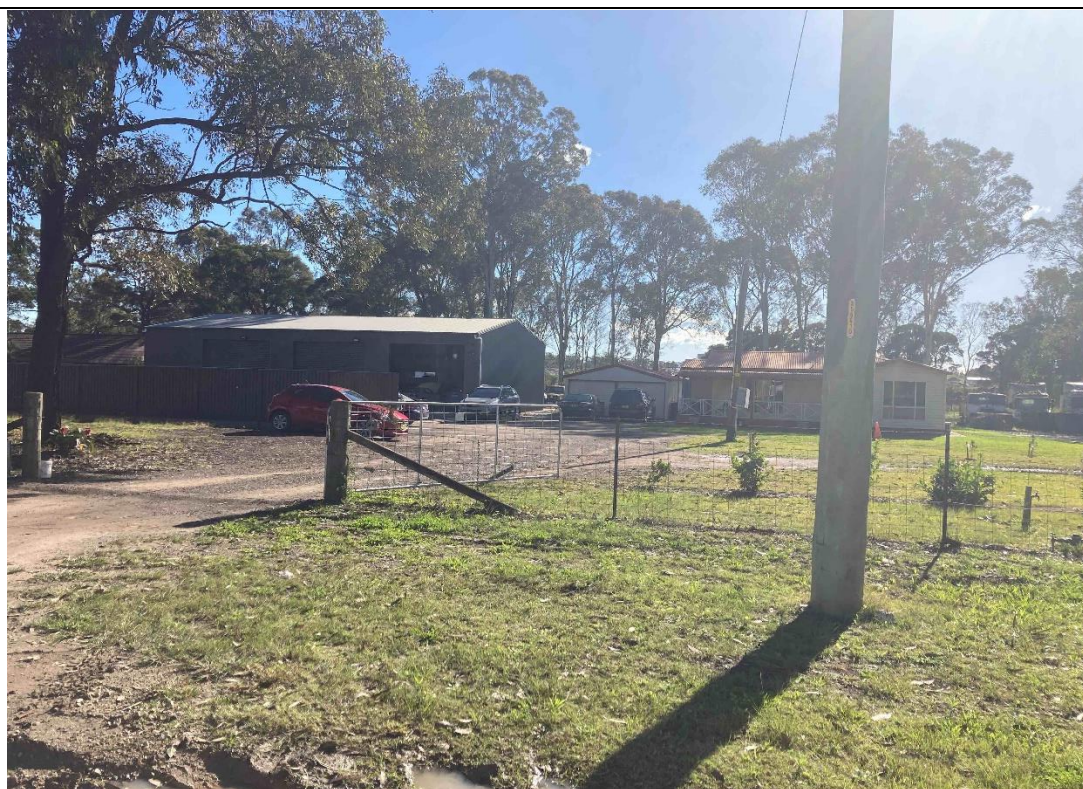
Photo No. 5	Date: 31/05/2022
------------------------------	----------------------------

Luddenham Auto Repairs (Plate 5-6)	<p>A gravel road extends from off Elizabeth Drive and into the property. There is a junction that extends to the east and on the eastern side of the property a large truck parking area was observed (Plate 6).</p> <p>This property extends off Elizabeth Drive and it appears the main work area is within a large shed located on the western side of the property</p> <p>The property is unpaved and the surface is grassed with some vegetation. No obvious signs of contamination were observed from the publicly accessible area used to view this location.</p>

Description:
Luddenham Auto Repairs - west

- Sydney Recycling Park operated by Hi-Quality group located at 1503-1519 Elizabeth Drive Kemps Creek
 - Luddenham Auto Repairs located 1489 Elizabeth Drive Kemps Creek.

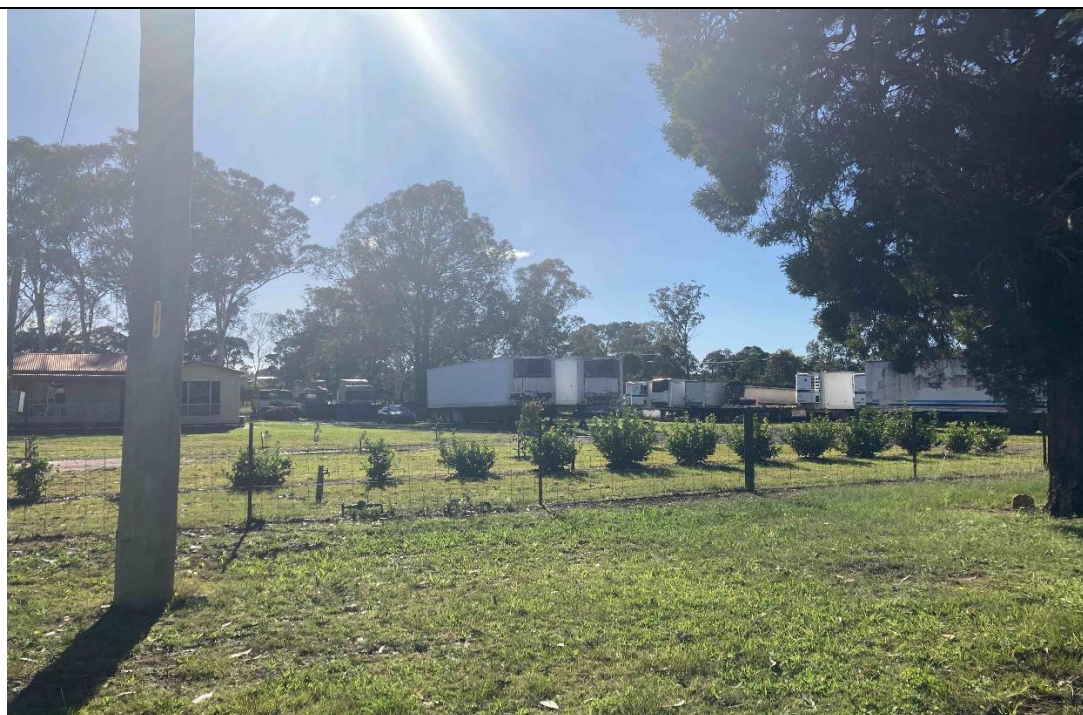
Photo No. 6	Date: 31/05/2022
------------------------------	----------------------------

Description:
Luddenham Auto Repairs - east
