Appendix B: Road Mortality Data, Bonville

Appendix C: Monitoring of Fauna Movement Structures at Bonville

Remote Surveillance Monitoring, Bonville 2008-2011

Appendix D: Koala Home-ranges, Bonville

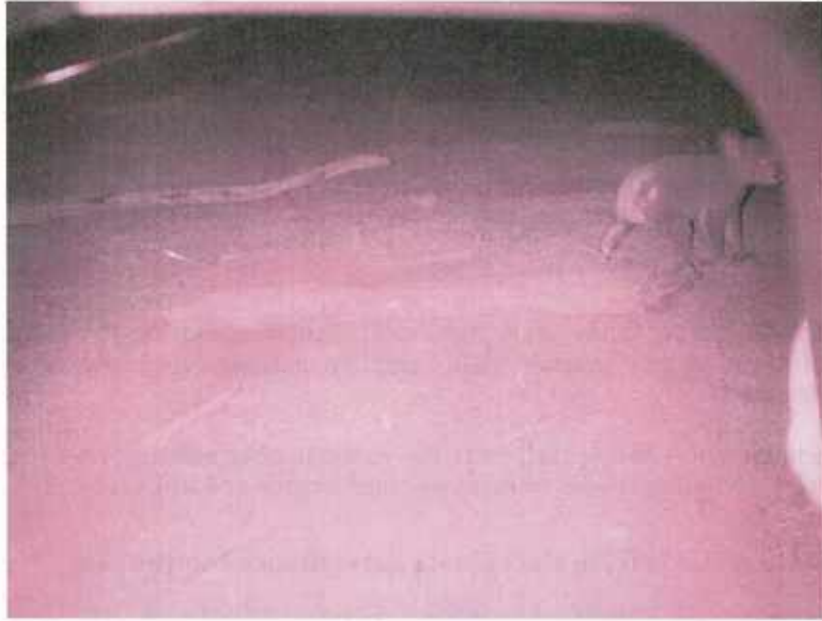
Plate E1. Koala photographed on 01/05/2009 at the Infra 2 underpass

One Koala was recorded in the centre of the Infra 2 underpass on 5 January 2009 at 03:14 (Plate E1). The Koala did not have a radio-collar or ear tag. The Koala appears to have been moving from the eastern side of the highway to the western side.

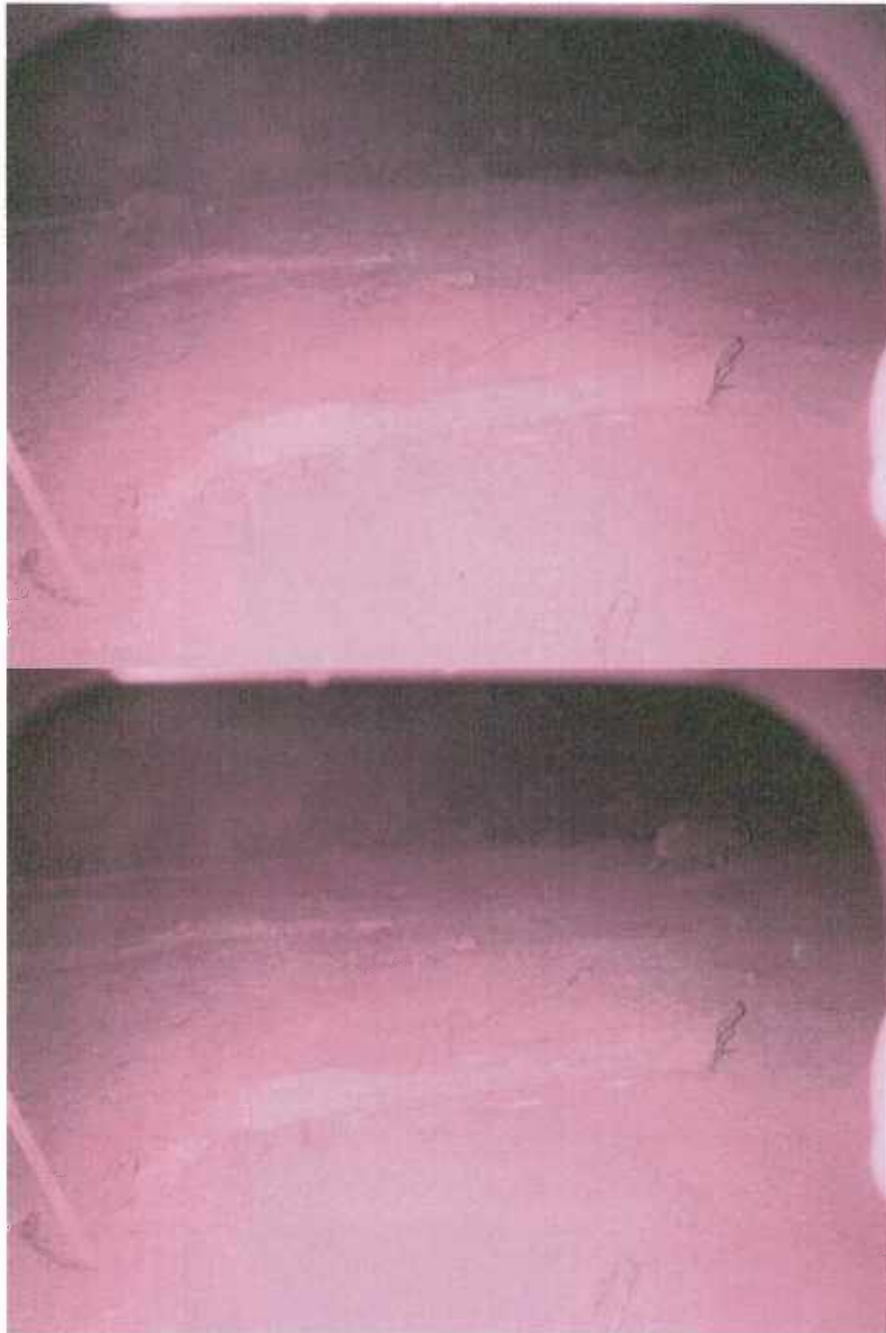
Plate E5. Koala photographed on 27/09/2009 at the Infra 2 underpass.

The second was photographed on 27 September 2009 at 02:37, and was travelling from the eastern side of the study area to the west (Plate E5). No ear tags or radio-collars were visible from the photographs.

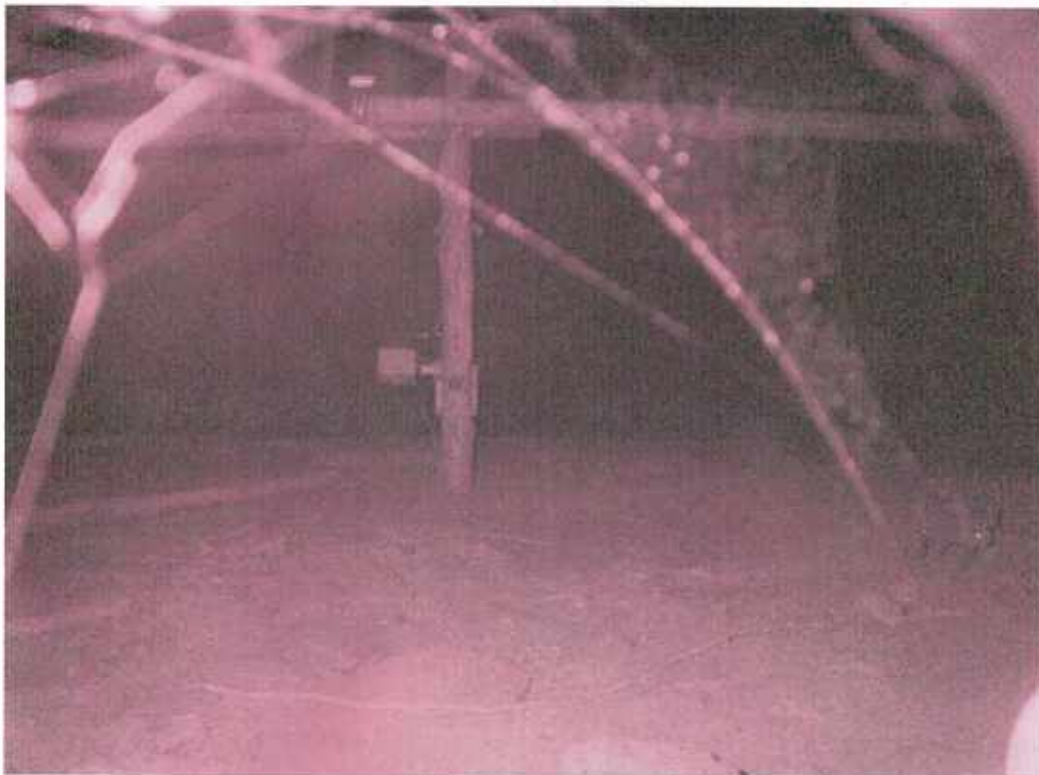
Plate E1. Koala photographed on 24/10/2009 at the Infra 2 underpass.

One Koala was photographed in the centre of the Infra 2 underpass on 24 October 2009 at 20:15 (Plate E7). It was photographed on the northern camera moving from the eastern side of the study area to the west, on 24 October 2009 at 18:15. No ear tags or radio-collars were visible from the photographs.

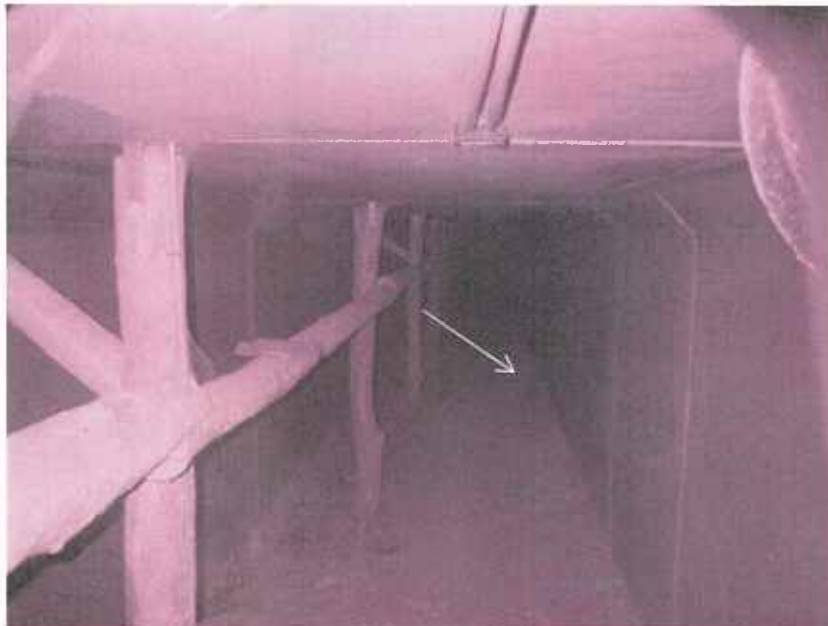
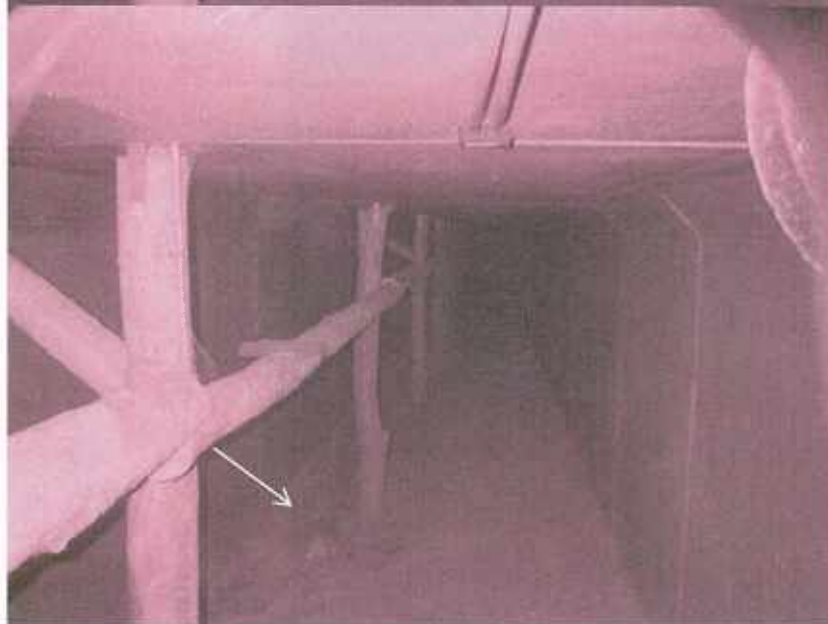
Five series of Koala photographs were recorded at Raleigh west on 16 October 2009. The first series was taken at 20:53 which show the Koala entering the box culvert and exiting at 20:54 (Plates D8, D9). At 21:33 a Koala is photographed entering the box culvert (Plate E10), and possibly exiting at 21:36. although the photograph is inconclusive. At 22:28 a Koala is photographed entering the box culvert again and is clearly photographed exiting at approximately 22:29 (Plate E11). At 3:21am on 17 October a Koala is photographed entering again (Plate E12) but is not photographed exiting in the following five photographs (it is likely that the Koala triggered the camera but exited during the delay between photographs). At 03:36 a Koala is photographed entering the box culvert and is possibly photographed exiting at although the photograph is inconclusive.

Interpretation of this photographic series suggests it is likely it was the same Koala being photographed entering and exiting the underpass, mainly due to the short time between each photographic series. No photographs were taken at Raleigh east close to this time that could be interpreted as the Koala exiting. It is likely that the Koala did not make a complete passage through the box culvert.

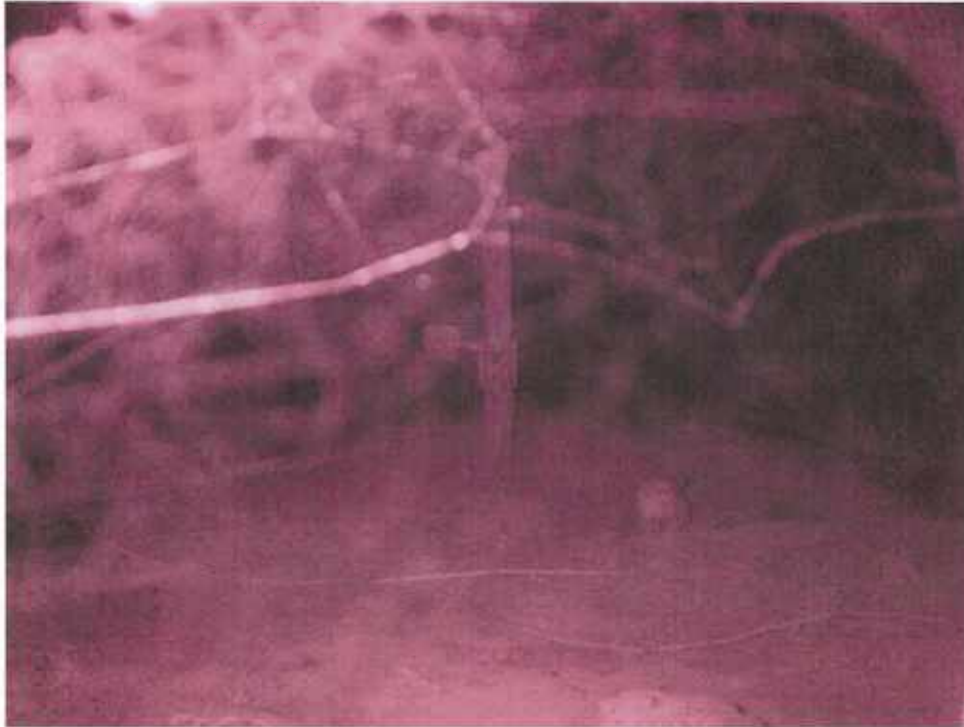
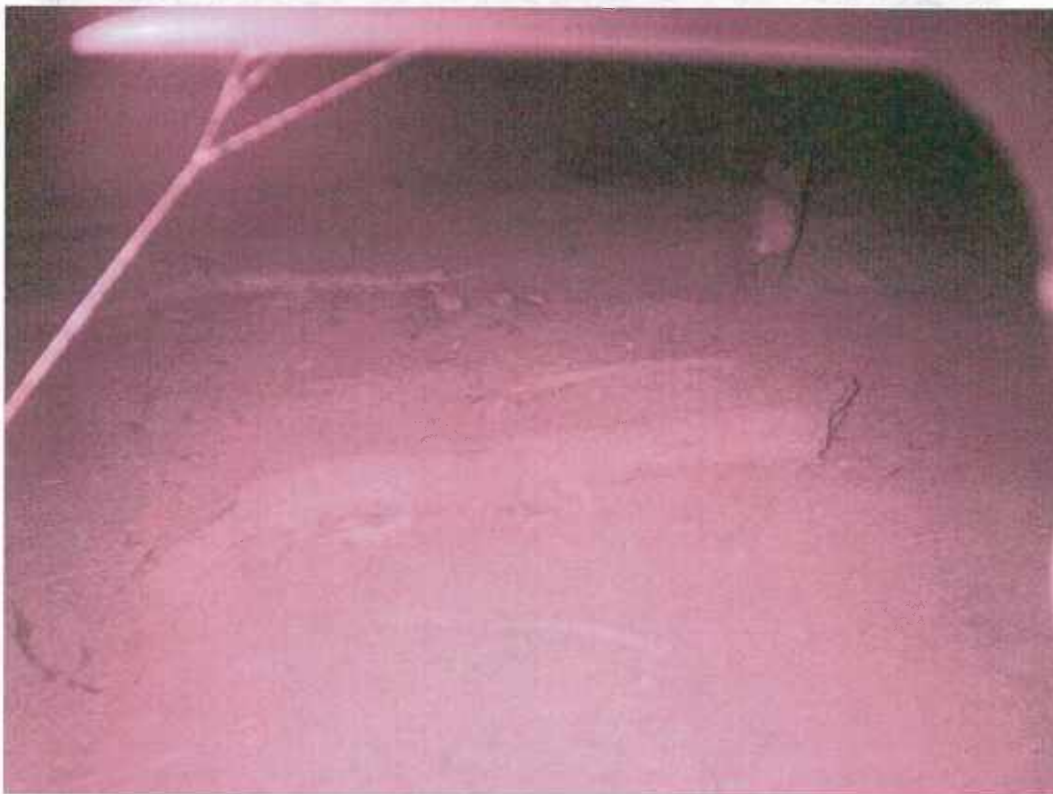
Plate E7. Koala photographed in the Infra 2 underpass on 10/09/2010 (above and below)

One Koala was photographed in the centre of the Infra 2 underpass at 00:49 on 10 September 2010 (Plate E13, D14). It was initially photographed in a series of four photographs in which the Koala appears to be moving from the eastern side of the highway to the western side. The Koala moves toward the wooden furniture and pauses for three of these photographs near the Infra 2 south camera. There is one photograph of the Koala walking away from the Infra 2 south camera. The Koala did not appear to have a radio-collar or ear tag.

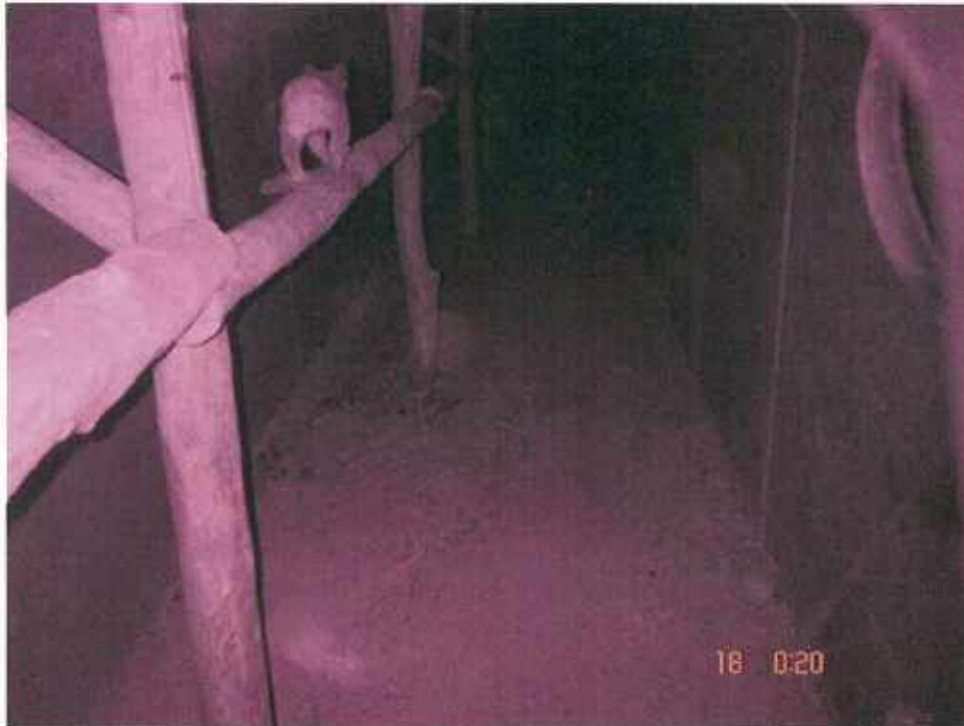
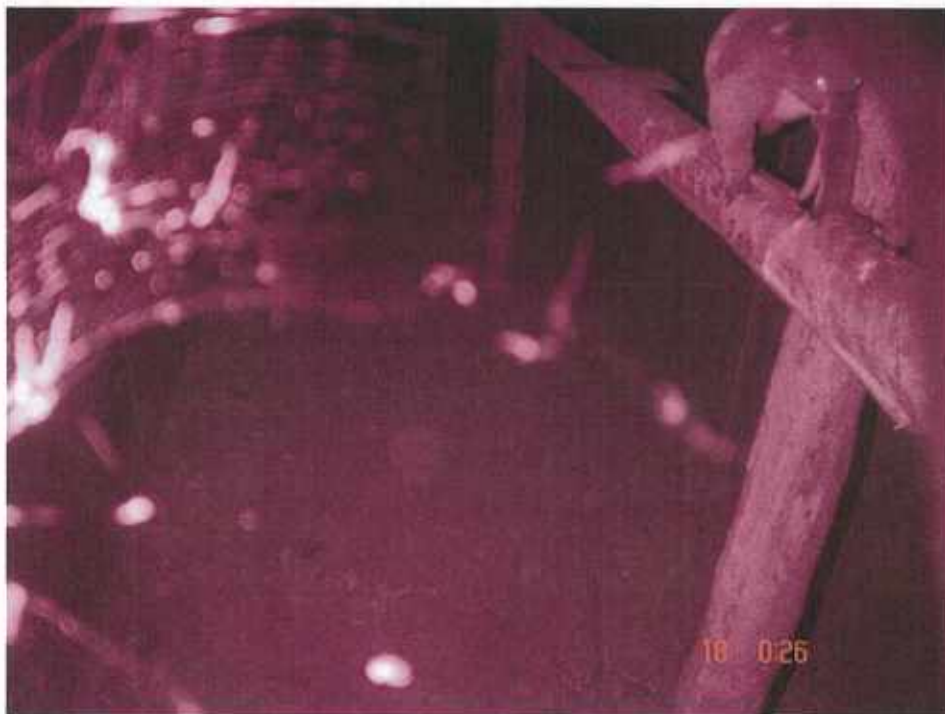
Plate E9. Koala photographed on 18/09/2010 entering and exiting the Raleigh underpass

One Koala was photographed at Raleigh west on 18 September 2010 at 00:20 (Plate E15). It was entering the underpass on the wooden furniture. At 00:26 a Koala was photographed at Raleigh east, exiting the underpass on the wooden furniture. Interpretation of this photographic series suggests it is likely it was the same Koala photographed on each occasion, and therefore made a complete passage through the underpass. No ear tag or radio-collar was visible from the photographs.

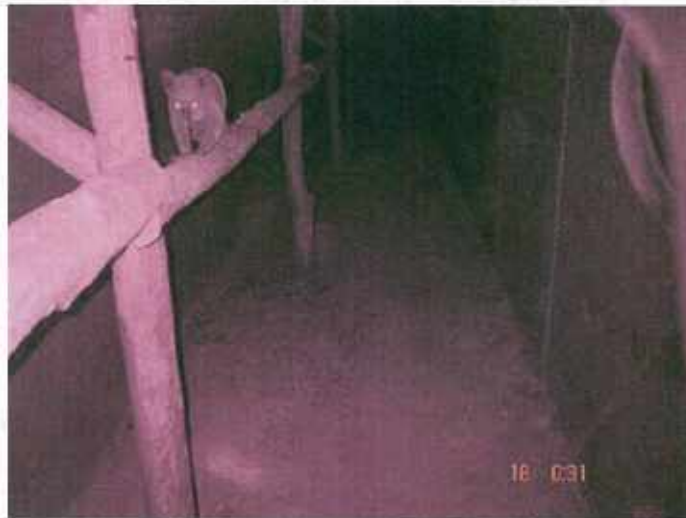
Plate E10. Koala photographed on 18/09/2010 at Raleigh west

The first was taken at 00:31 at Raleigh west, in which the Koala appears to be exiting the underpass on the wooden furniture (Plate E16). There was no photo of a Koala entering the underpass at Raleigh east, so it is likely this individual entered at Raleigh west, triggered the sensor and quickly turned, and was subsequently photographed during exit.

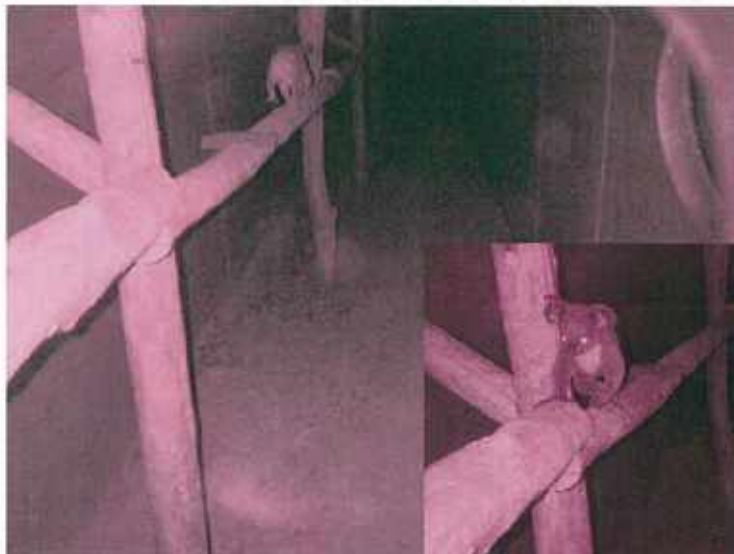
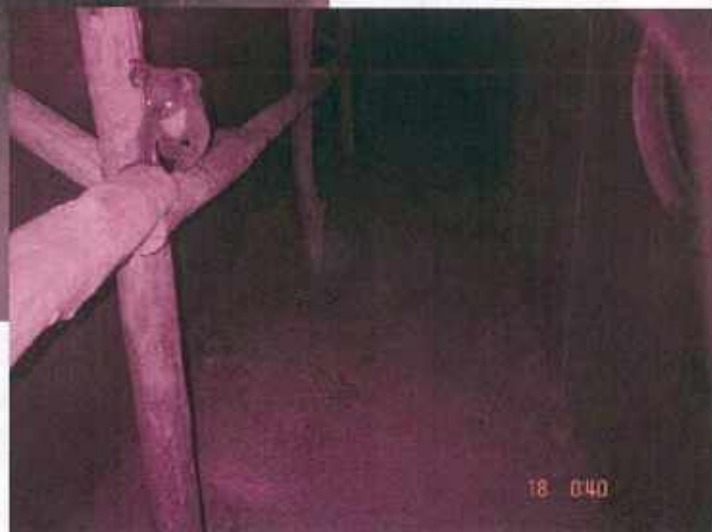
Plate E11. Koala photographed on 18/09/2010 entering and exiting at Raleigh west

At 00:32 on 18 September 2010, a Koala was photographed at Raleigh west entering the underpass on the wooden furniture, and eight minutes later (at 00:40) a Koala was photographed exiting at Raleigh west on the wooden furniture (Plate E17). There was no photo of a Koala entering the underpass at Raleigh east so it is likely it is the same individual that was photographed entering and exiting.

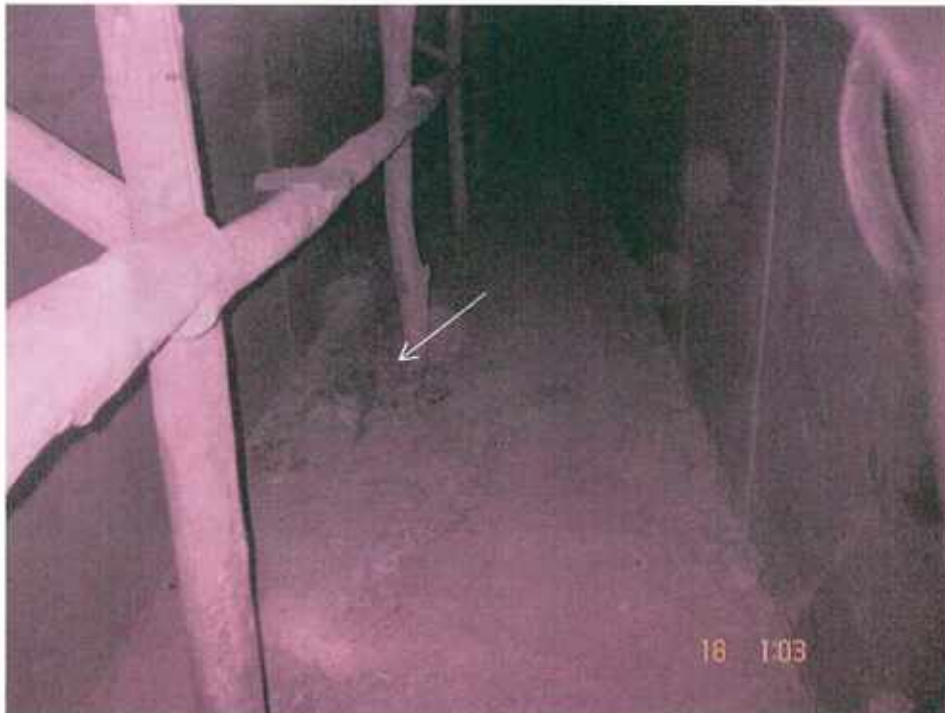
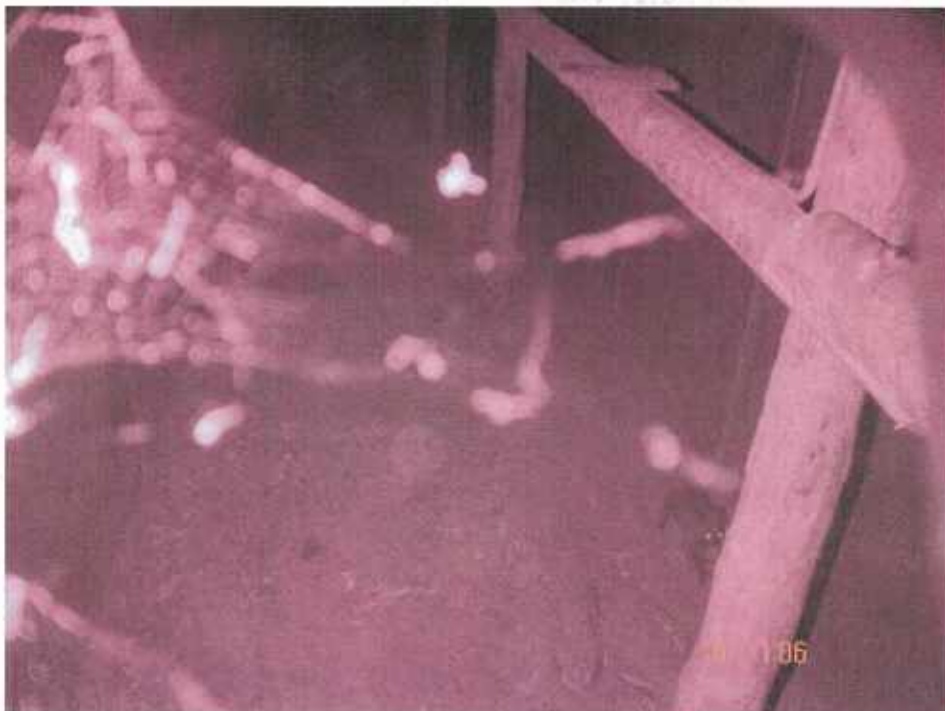
Plate E12. Koala photographed on 18/09/2010 entering and exiting the Raleigh underpass

At 01:03 a Koala was photographed at Raleigh west entering the underpass on the ground, and three minutes later a Koala was photographed at Raleigh east exiting the underpass on the ground (Plate E18).

Interpretation of this photographic series suggests it is likely it was the same Koala in all photographs, mainly due to the short time frame between each photographic series. It appears the Koala entered and exited the Raleigh underpass twice, and on the third occasion made a complete passage as it was photographed at both ends.

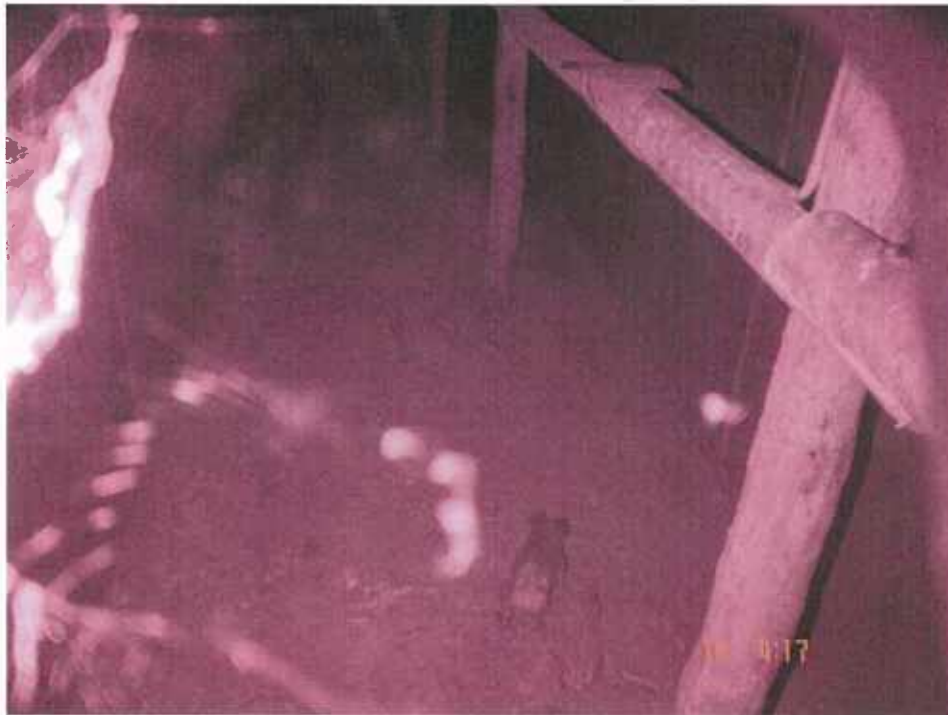
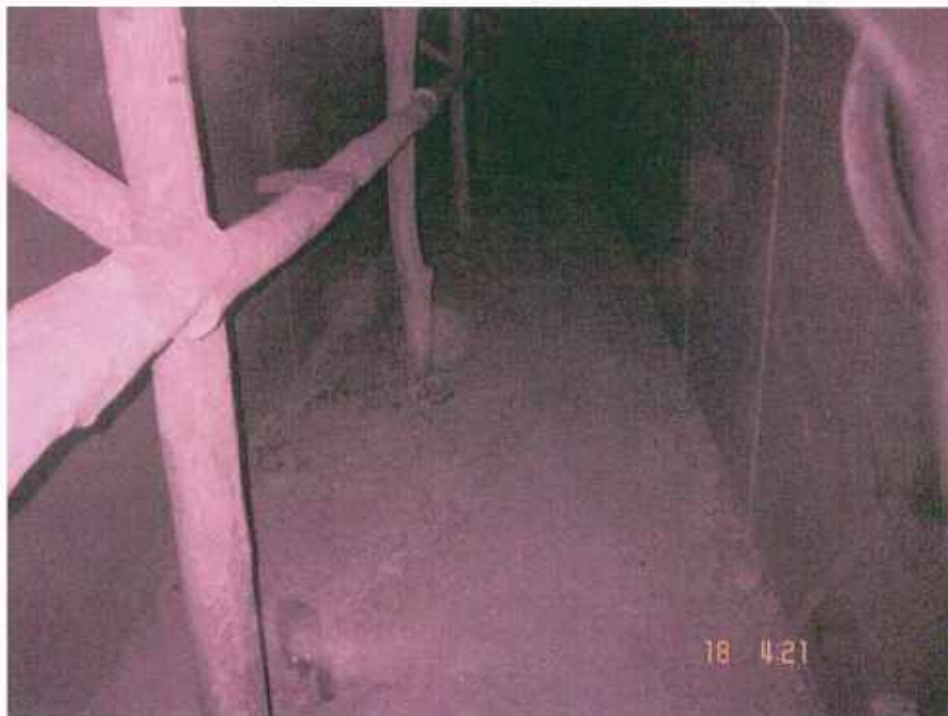
Plate E13. Koala photographed on 18/09/2010 entering and exiting the Raleigh underpass

One Koala was photographed at Raleigh east on 18 September 2010 at 04:17. It was entering the underpass on the ground. Three minutes later (at 04:21) a Koala was photographed at Raleigh west, exiting the underpass. Interpretation of this photographic series suggests it is likely it was the same Koala photographed on each occasion, and therefore made a complete passage through the underpass (Plate E19). No ear tag or radio-collar was visible from the photographs.
