Kempsey Bypass Alliance Fauna Monitoring

Underpass Monitoring Report, Autumn 2014

Leighton Contractors Pty Ltd

November 2014

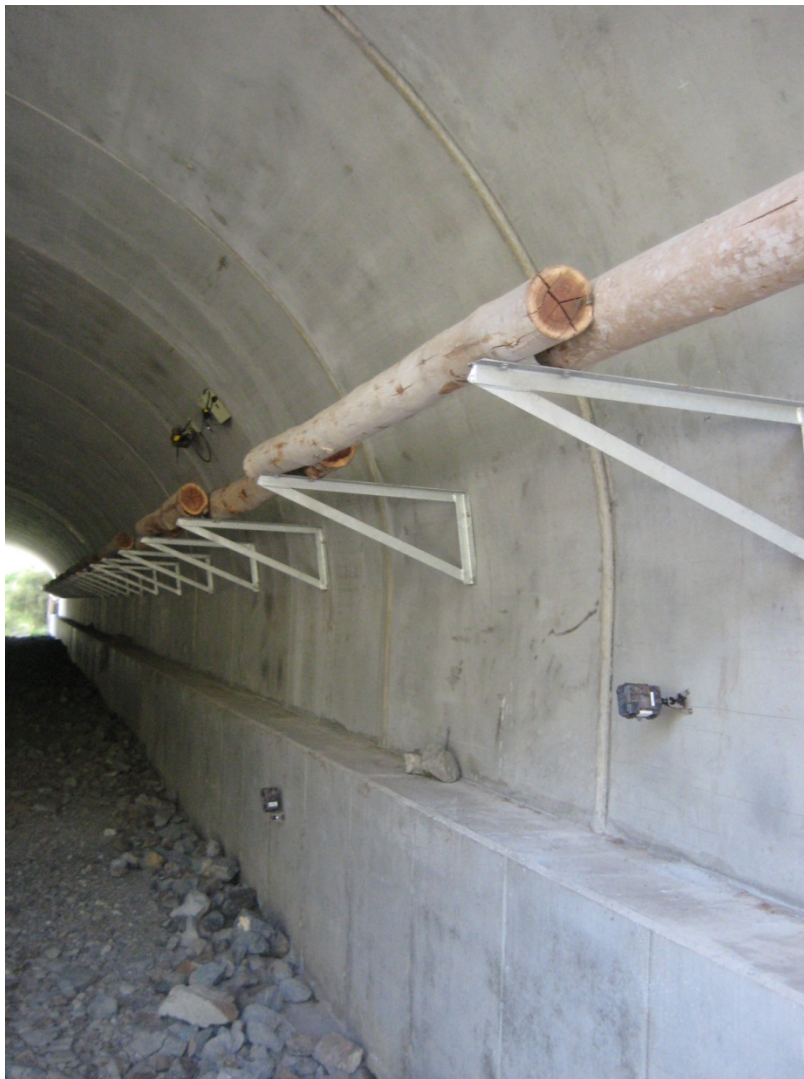
Boat Harbour Creek is a large arch shaped underpass with the creek running through the centre. A total of ten cameras were installed, which were divided between the eastern and western ends to provide coverage of the whole width of the underpass (refer to *Photograph 2.1*).

Photograph 2.1 West Side of Boat Harbour Creek Showing Three Cameras Trained on the Ground, Concrete Bench and Fauna Furniture

Three BuckEye X7 cameras and seven UOVISION (UV565) cameras were selected for this underpass, provided by specialist fauna equipment suppliers Faunatech Ltd. Faunatech also provided custom mounting brackets and external batteries to allow the continuous operation of the cameras as well as an aerial to allow the transmission of captured photographs for the X7 cameras. The cameras were positioned as follows:

- two cameras at either end (east and west) of the fauna furniture;
- two cameras at either end of the northern concrete bench;
- two cameras at either end of the southern concrete bench;
- two cameras at either end on the ground on the northern side of the creek;
and
- two cameras at either end on the ground on the southern side of the creek.

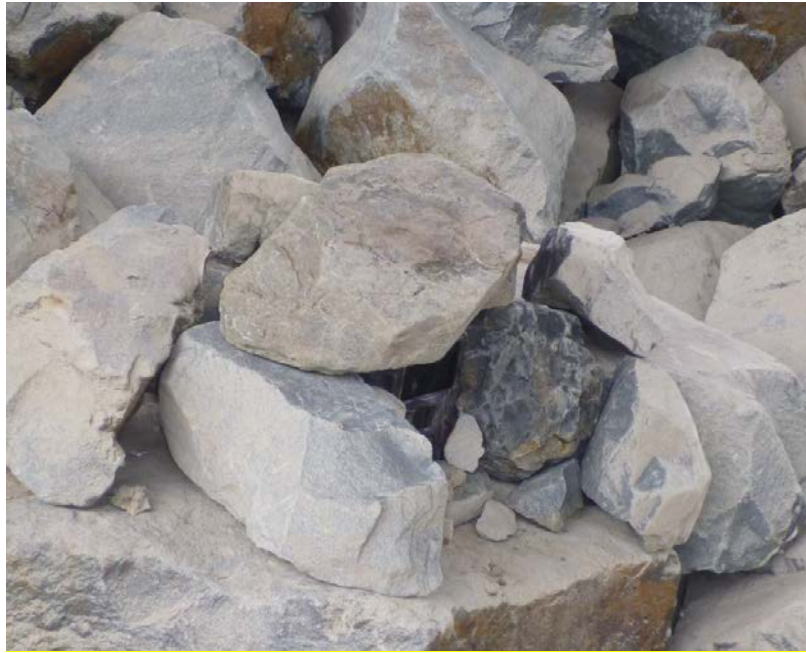
During the planning phase it was identified that the Pola Creek underpass had few fixed attachment points suitable for the cameras that would obtain the desired field of view. If the cameras were attached to the underside of the bridge, the trigger length focussing on the ground below would be too distant to trigger photo capture. Four UOVISION (UV565) cameras were placed in among the large rocks adjacent to the rock platform. Smaller rocks were then used to conceal the camera (refer to *Photograph 2.2*). The field of view was over the rock platform designed for fauna passage. Cameras were placed at eastern and western ends of the underpass in order to detect complete passage of fauna from one side to the other. This set up was duplicated on both the north and south sides of Pola Creek which passes through the centre of the underpass.

Photograph 2.2 UOVISION Camera, Located in Rocks at Pola Creek

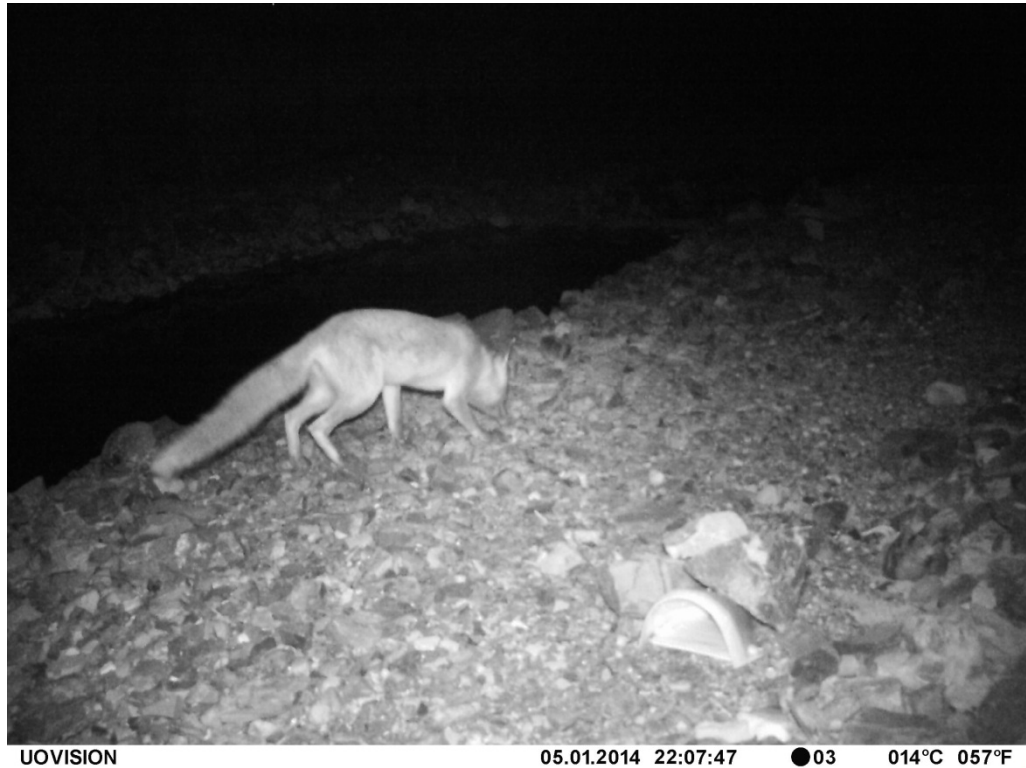
Photograph 3.1 European Red Fox (Vulpes vulpes) Photographed at Boat Harbour Creek

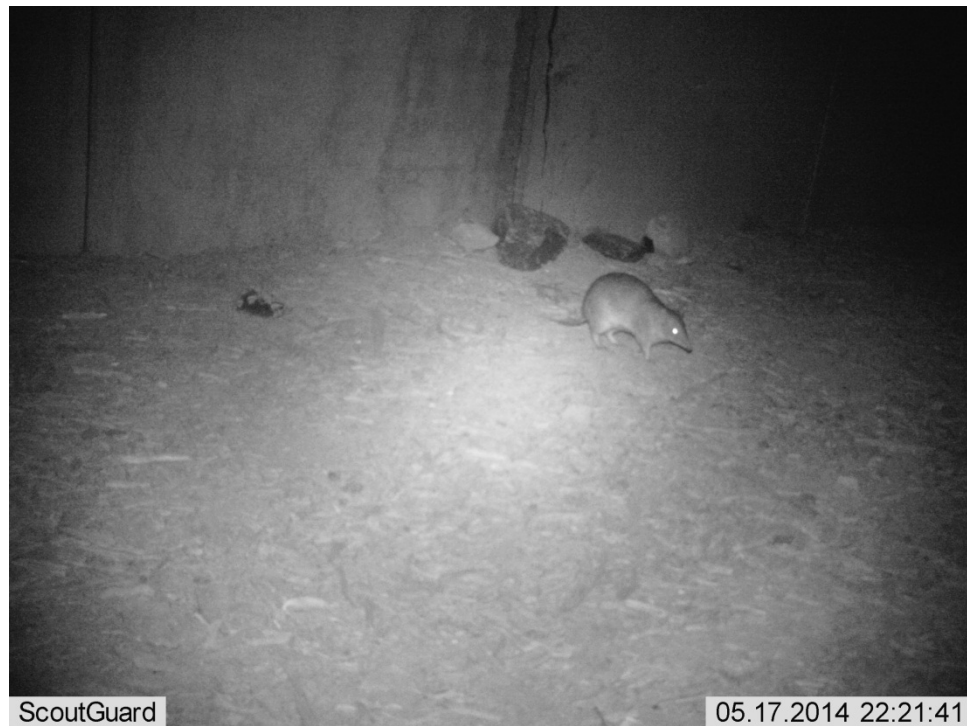
A total of five native species were recorded using the underpass, four species were recorded on the ground including the Lace Monitor (*Varanus varius*), Brown Antechinus, Northern Brown Bandicoot (*Photograph 3.2*) and an unidentified Macropod species. The Brushtail Possum was the only native species recorded using the fauna furniture.

Photograph 3.2 Northern Brown Bandicoot (Isoodon macrourus) Photographed at Bingis Lane.

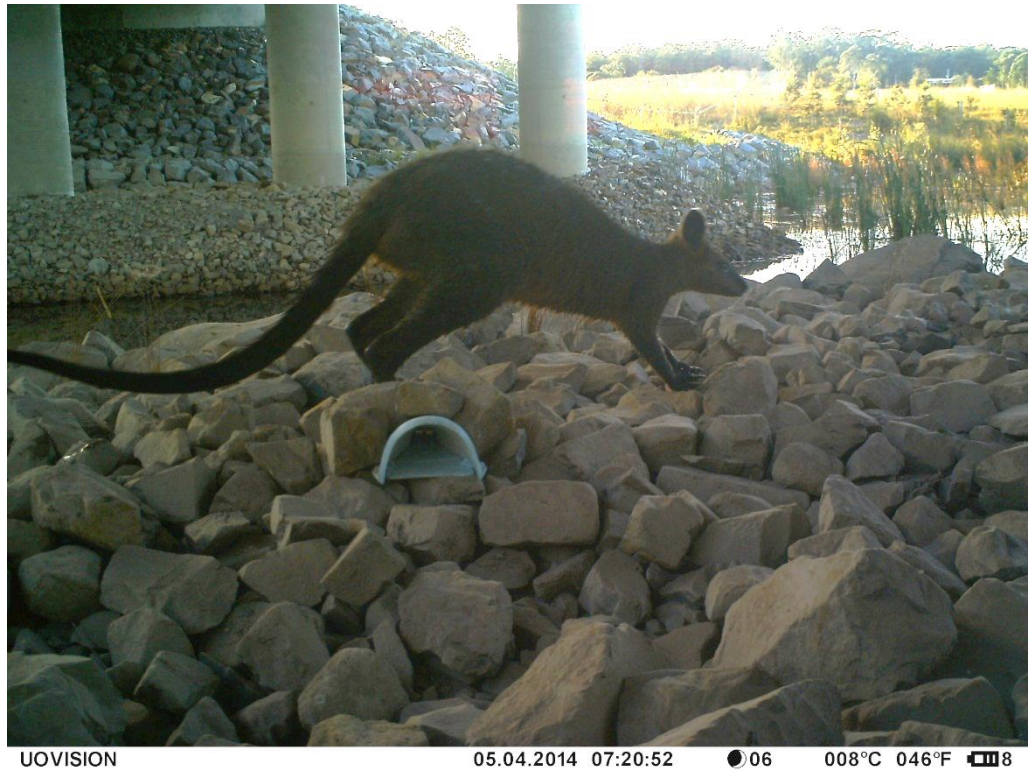
Three native species were recorded at Pola Creek, the Swamp Wallaby (*Photograph 3.3*), Ringtail Possum and Brushtail Possum. Exotic species recorded included Domestic Dog, European Red Fox, Black Rat and House Mouse. In the absence of fauna furniture at this site, all of the records were from the ground.

Photograph 3.3 Swamp Wallaby (Wallabia bicolor) Photographed at Pola Creek.

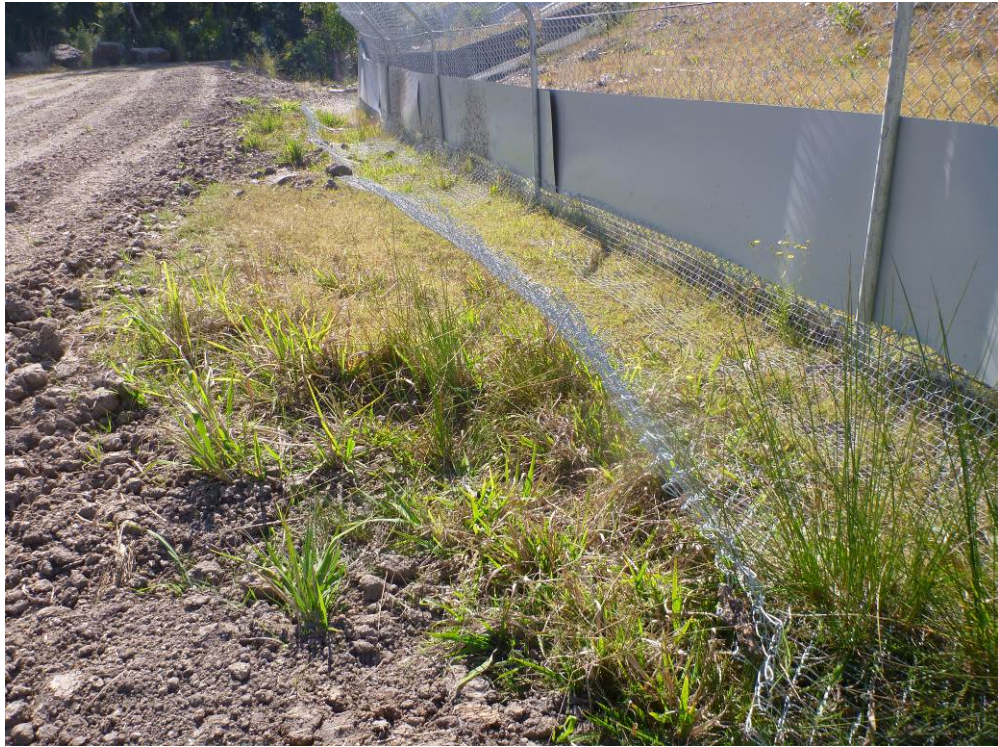
Photograph 3.4 below shows the fauna fence as constructed with the floppy top grid mesh, metal panelling and fine mesh at the base. The grid mesh is bent towards the fauna habitat at the base (away from the highway).

Photograph 3.4 *Complete Fauna Fencing At Boat Harbour Creek with Floppy Top Grid Mesh, Fine Mesh and Metal Panels*

It was observed that at the base of the fauna fencing the chain mesh typically was bent back along the ground towards fauna habitat side (ie away from the carriageway side) (refer to *Photograph 3.4*). This would deter many species from passing through the fence however; it was often flicked up at the edge, providing potential for burrowing species to pass underneath the fencing. Two Eastern Snake-necked Turtle (*Chelodina longicollis*) carcasses have been recorded to date, one was recorded during the Summer 2014 monitoring, with the second recorded during this most recent monitoring event. On both occasions the turtles have become wedged under the lip of the fencing. Pegging down the edge of the fence would help to prevent this mortality and also reduce the chance of animals burying underneath.

A modification of the fencing design is also recommended, pegging the edge of the fauna fence to the ground. Currently the lip of the fauna fence flicks up, in any many areas. There is the potential for fauna to force themselves underneath the fence and this has resulted in the mortality of two Eastern Snake-necked Turtles, which had become trapped beneath the fence. Pegging down this edge of the fencing may also reduce the ability of burying animals to force their way beneath the fence.

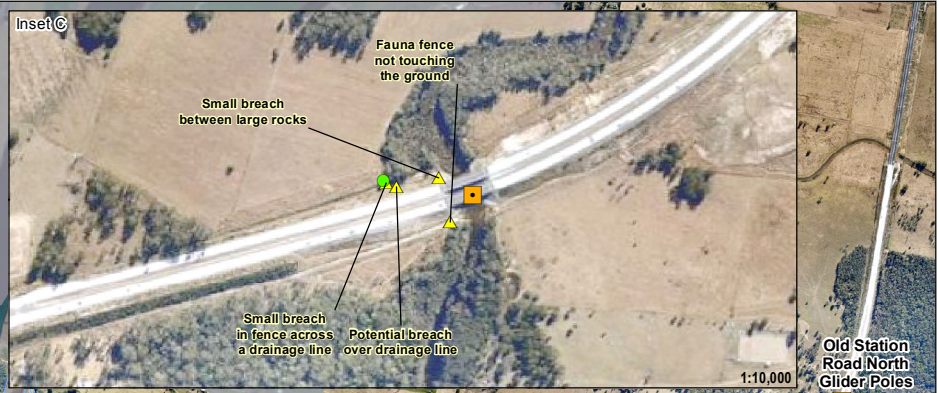
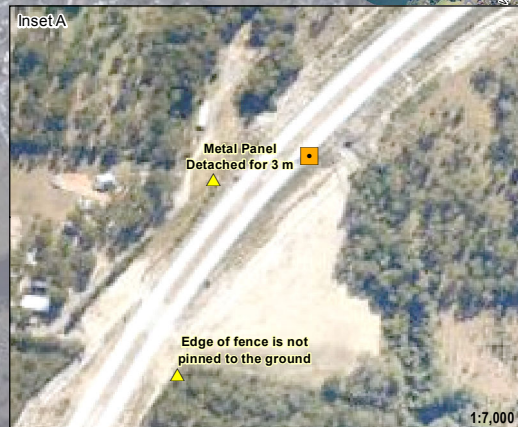
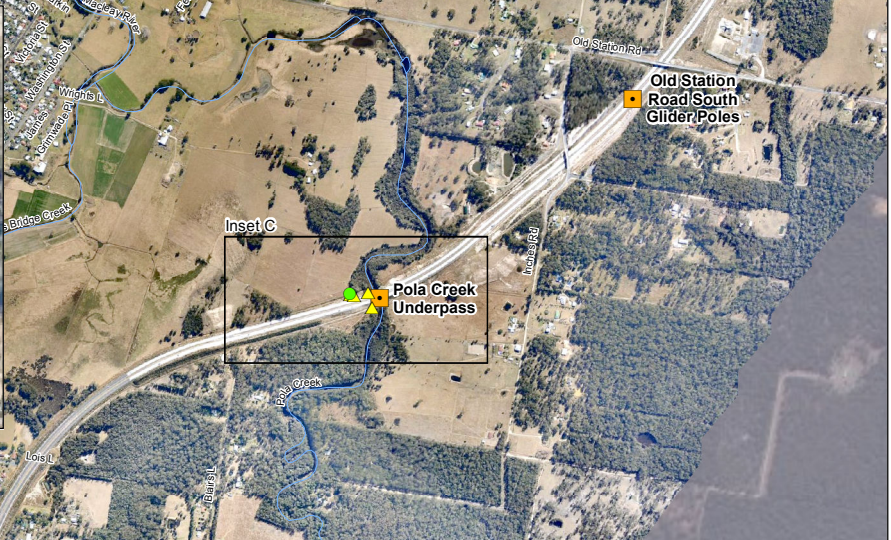
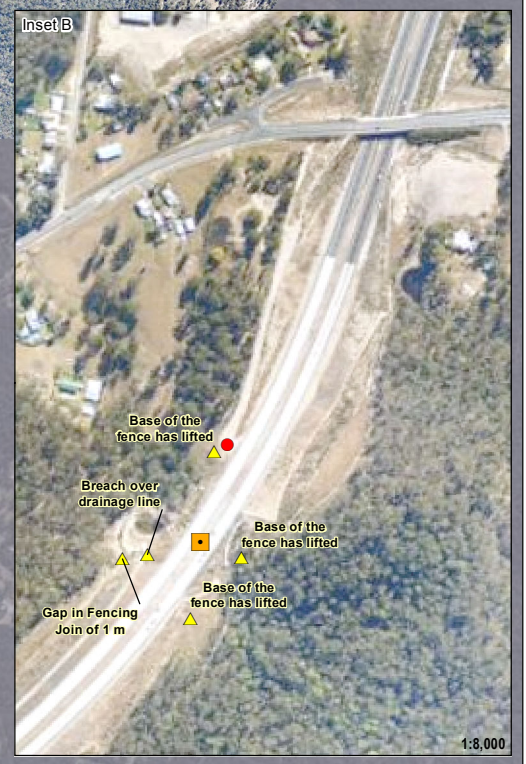
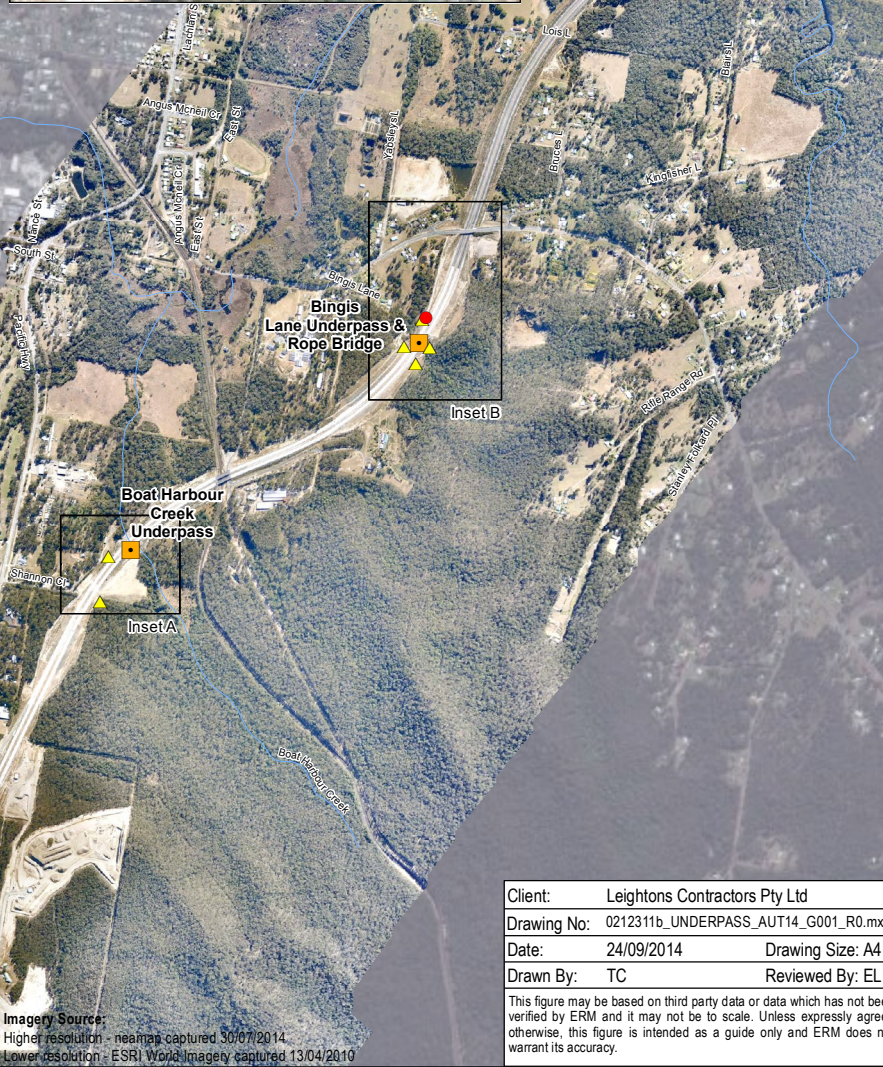
Figure 3.1 - Fauna Fence and Road Kill Monitoring Results

The fauna fencing was assessed for 250m either side of each underpass. *Figure 3.1* shows the results of the survey with the location of any breaches in the fencing identified.

A number of potential breaches were identified and the base of the fence was poorly secured to the ground for almost the entirety of the fence on the western side of the highway at Boat Harbour Creek (refer to *Figure 3.1, Insert A*). Bandicoot diggings were common along the mulched areas adjacent to the woodland on the northern side. A number of eastern grey kangaroos were observed within adjacent woodland at this location.

A number of potential breaches were located and the edge of the fence was poorly secured to the ground for almost the entirety of the fence on the eastern side of the highway at Boat Harbour Creek (refer to *Figure 3.1, Insert A*).

A number of potential breaches were located and the edge of the fence was poorly secured to the ground for almost the entirety of the fence on the western side of the highway at Bingis Lane (refer to *Figure 3.1, Insert B*). Bandicoot diggings were common along the mulched areas adjacent to the woodland.

A number of potential breaches were located and the edge of the fence was poorly secured to the ground for almost the entirety of the fence on the eastern side of the highway at Bingis Lane (refer to *Figure 3.1, Insert B*).

There were several small breaches within the fencing at Pola Creek (refer to *Figure 3.1, Insert C*). One dead Eastern Snake-necked Turtle (*Chelodina longicollis*) was recorded trapped under the fauna fence (refer to *Figure 3.1, Insert C*).

The third carcass was an unidentified macropod which still had some tissue and fur present but the state of the carcass (dismembered) made it difficult to identify to species level. It is likely to be a Red-necked Wallaby. This carcass was recorded approximately 81 m north of the Bingis Lane underpass, on the western side of the highway. Refer to *Figure 3.1* for location of the macropod carcass and its relative location to the fauna fencing.

Several defects were found with the fauna fencing, which may allow the fencing to be breached by some species, however the length of the gaps/maintenance issues were small and could be readily fixed (refer to *Figure 3.1*).

Recommended maintenance actions are:
