5. Vertical lift span bridge entries

5.1 BREWARRINA BRIDGE

5.1.1 Description of the Bridge

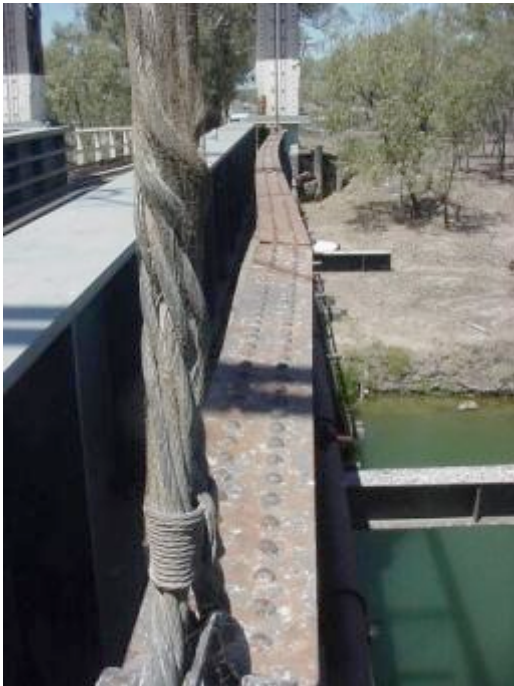
Figure 5.4 Steel girder supporting damaged movable span (Source: RMS)

In 2000 overloading of the lift span resulted in severe damage to the trusses. The overloading caused critical buckling of the top chords (Figure 5.4) as well as collateral damage to other members. As a result of the damage to the lift span trusses large steel girders were installed adjacent to each lift span truss.

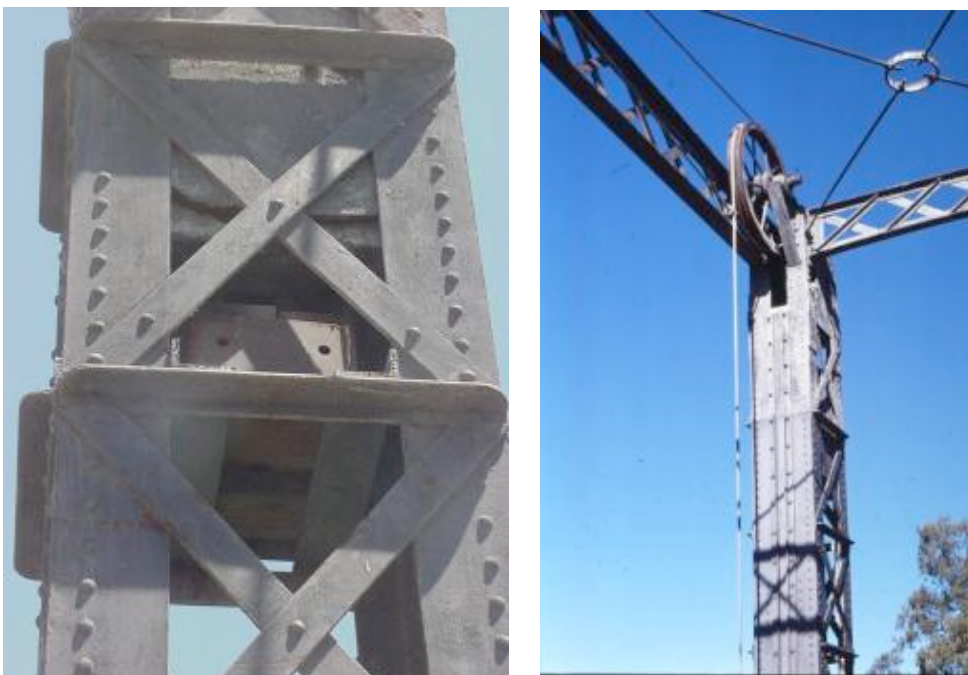
Figure 5.7 Propped counterweights and attached cables (Source: RMS)

The counterweights are still in place attached to the cables. However, on closer inspection it would appear that the counter weights have been supported by angled sections as shown in Figure 5.7. This is believed to be a safety feature in case the cabling or attachments deteriorate and fail. However, it is only slightly obtrusive and does not take away from the impression that the lift system is operational.

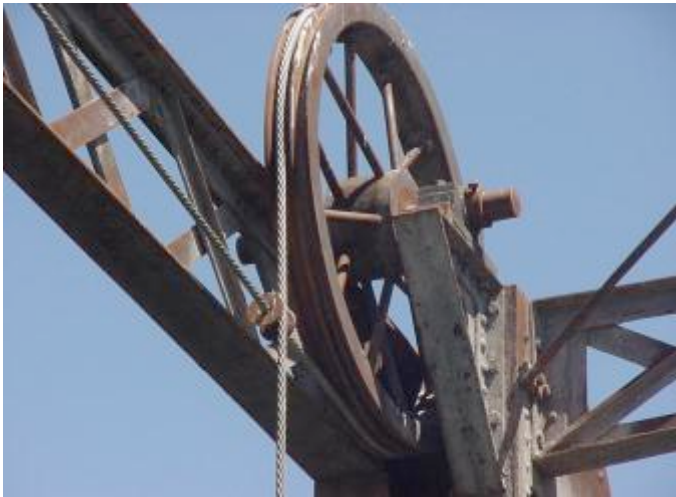
Figure 5.9 Brewarrina Bridge sheaf and cable components (Source: RMS)

The bridge was upgraded in 1896 which resulted in the chain wheels being replaced with new sheaves that supported wire ropes (Figure 5.9).

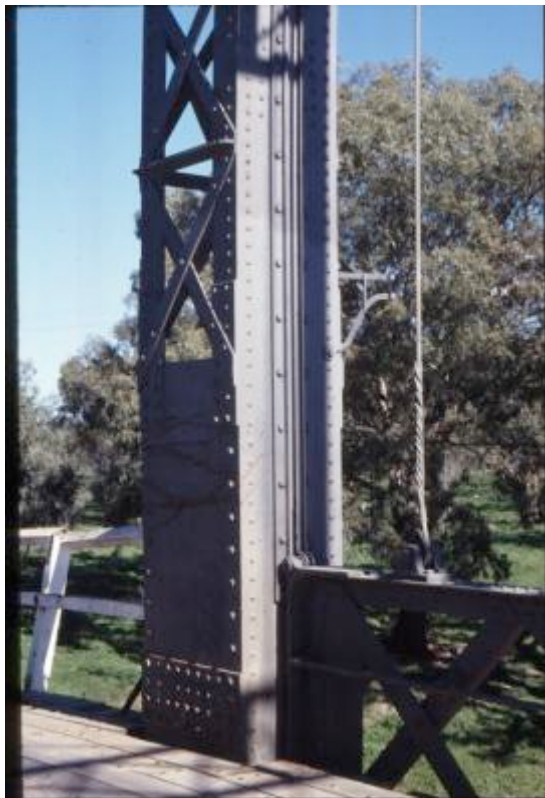
Figure 5.11 Tower and rope connection to movable span (Source: RMS)

The ropes control the lift (Figure 5.11) however there is no available information on their construction. Due to the advanced age of the ropes these are now in very poor condition and well past their serviceable life.

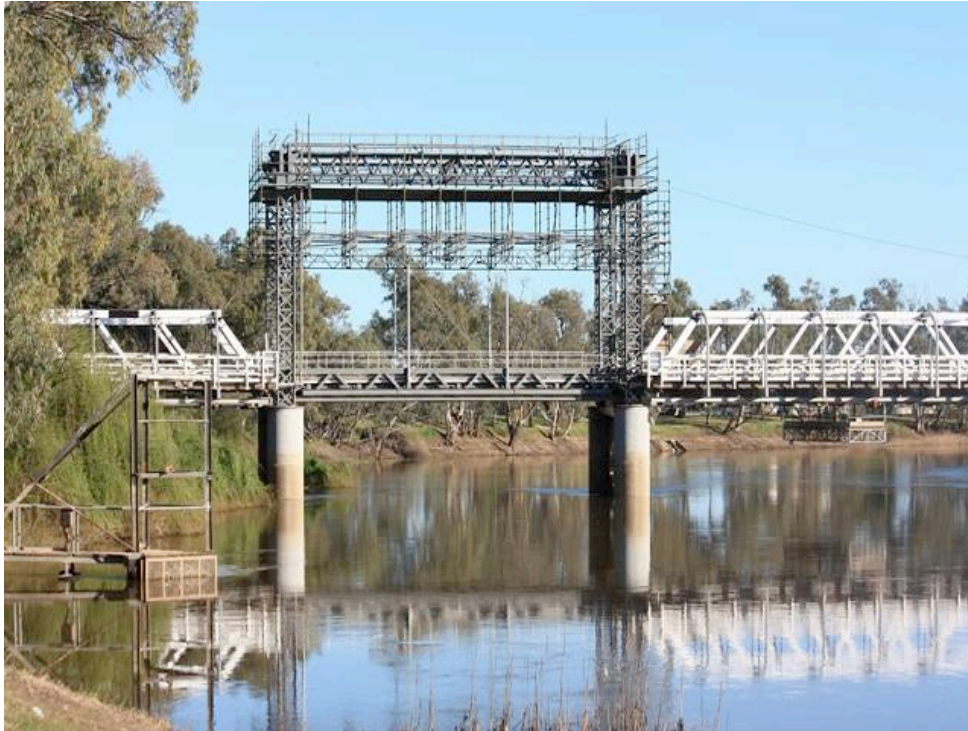
Figure 5.19 View of the scaffolding in place on the bridge between 2009 and 2012 to facilitate repainting of lift tower and replacement of mechanical components

Following a failed attempt to raise the lift span in 2007 (see above) an extensive repair and replacement program was commenced in August 2008. To counter the onset of rust a re-painting project was undertaken when the hazardous red lead paint coating was removed from the lift span towers within a plastic containment, and a new modern paint system applied. Extensive planning for mechanical repairs commenced at this time, and involved redesign, and complex fabrication processes to ensure components and systems met heritage requirements and current mechanical standards.

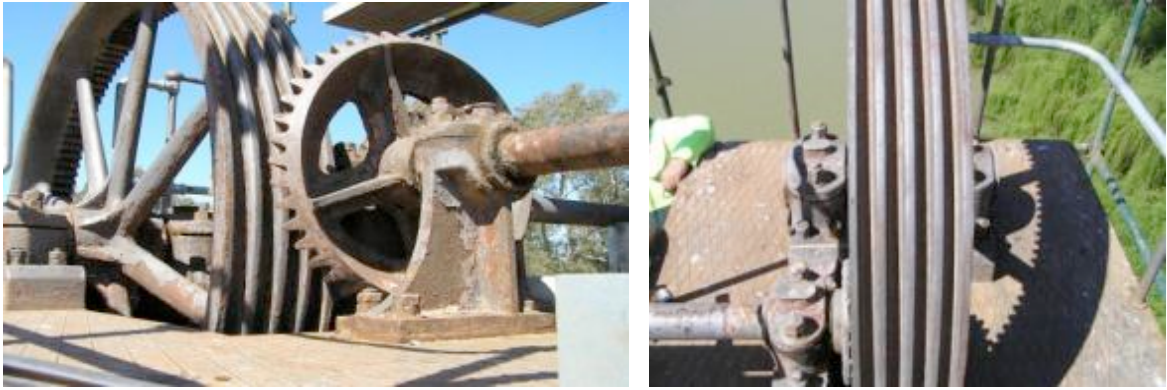
Figure 5.26 2nd motion shaft and sheaves on VIC side down stream (Source: RMS)

arrangement also allows for the single person operation of the lifting bridge. All mechanical components were refurbished or replaced like for like in 2012.

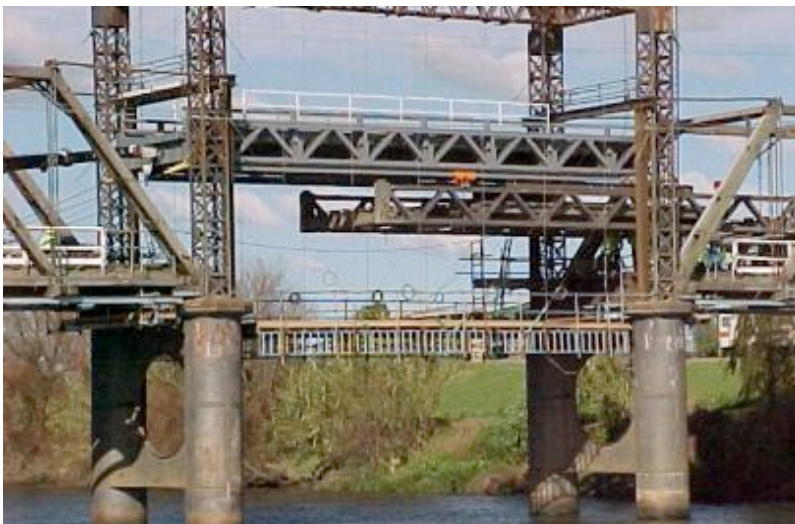
Figure 5.35 Replacement of Dunmore Bridge movable span (Source: RMS)

The movable span has since been replaced (Figure 5.35).

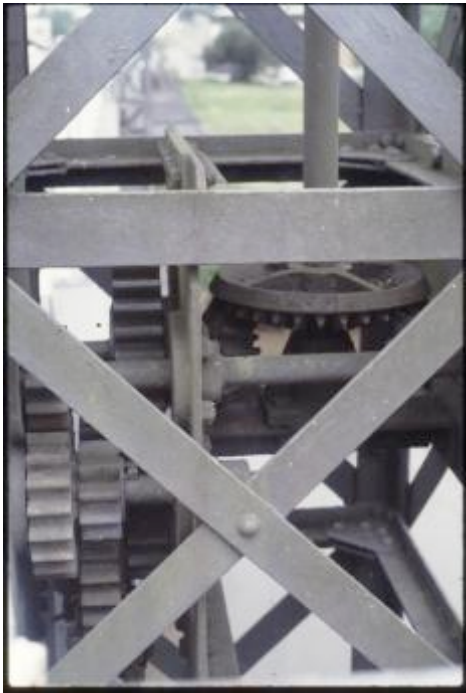
Figure 5.43 Hand operated winch mechanism (Source: RMS)

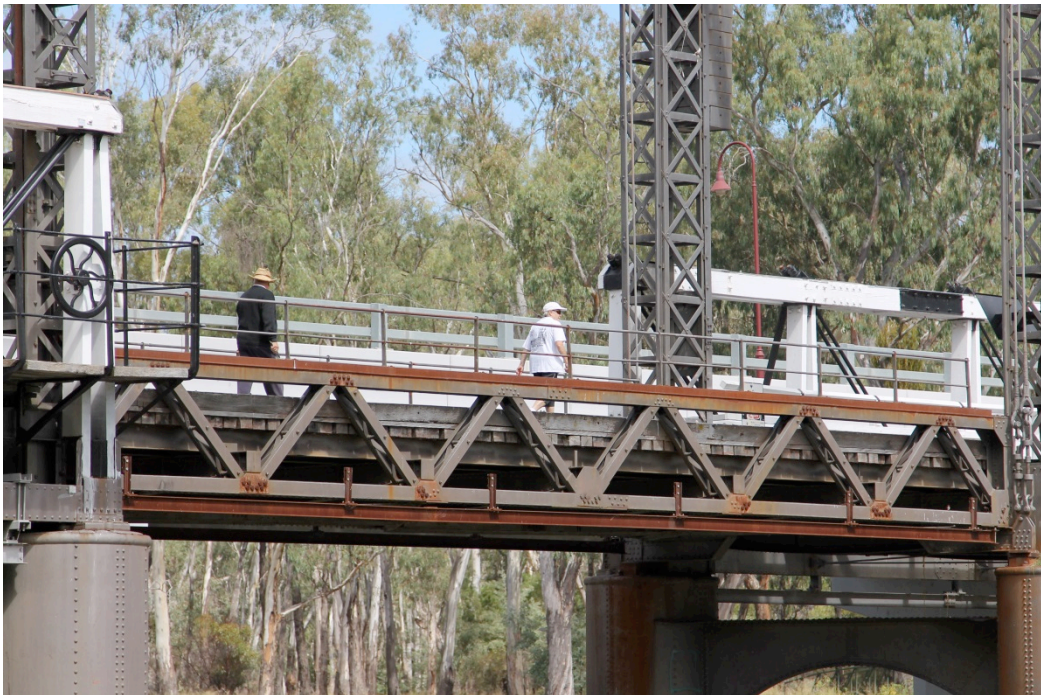
Figure 5.50 Side view of movable span; the steel beams attached in 2001 for reinforcement have corroded noticeably

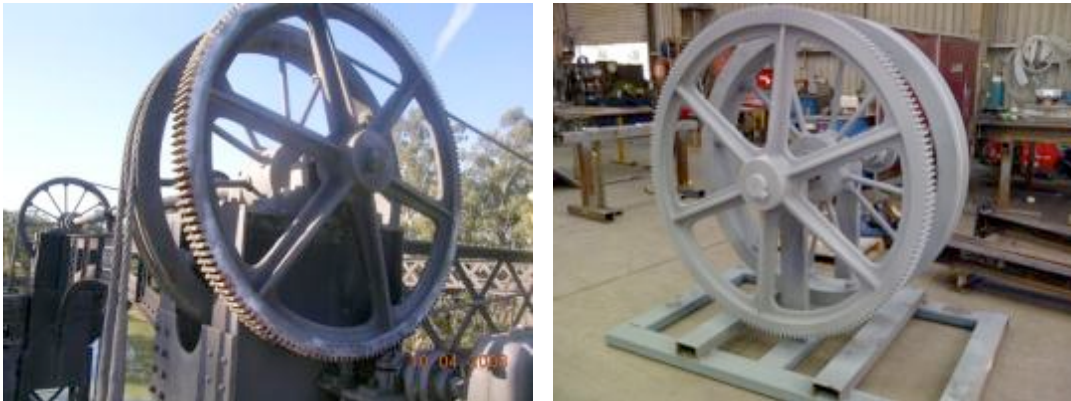
Figure 5.64 Sheave wheel testing on Barham Bridge

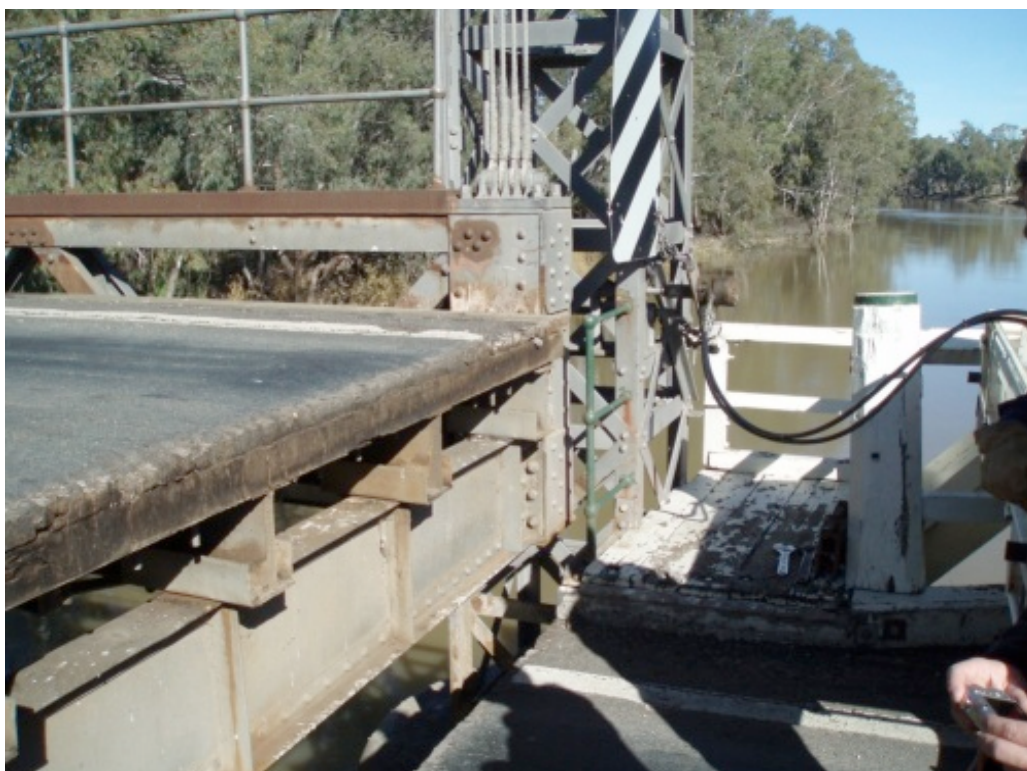
Figure 5.91 Portable motor fitted to Tooleybuc Bridge to raise the span

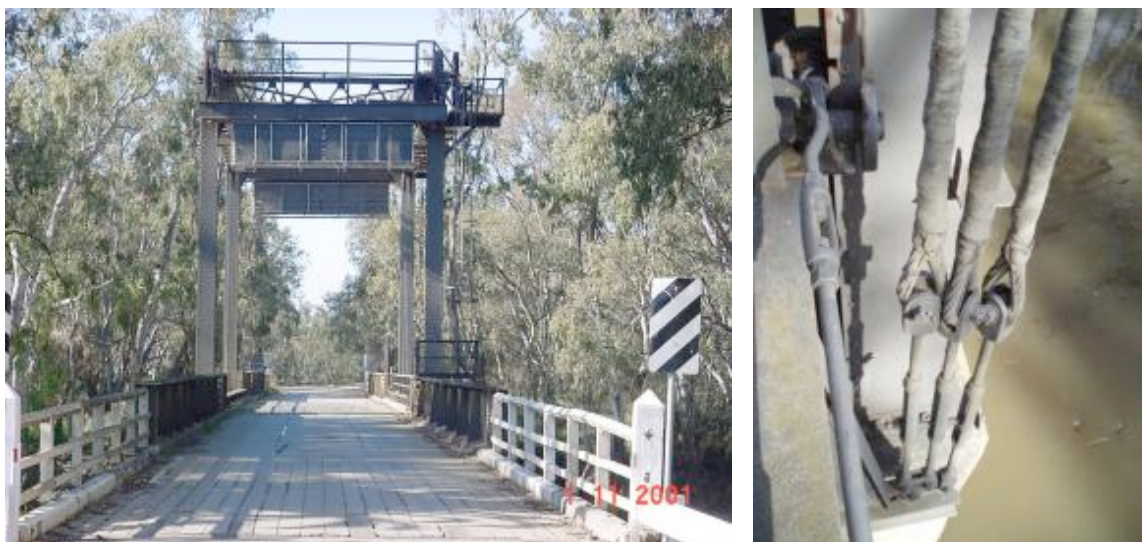
Figure 5.97 Bridge deck and Compensating bracket (Source: GHD)

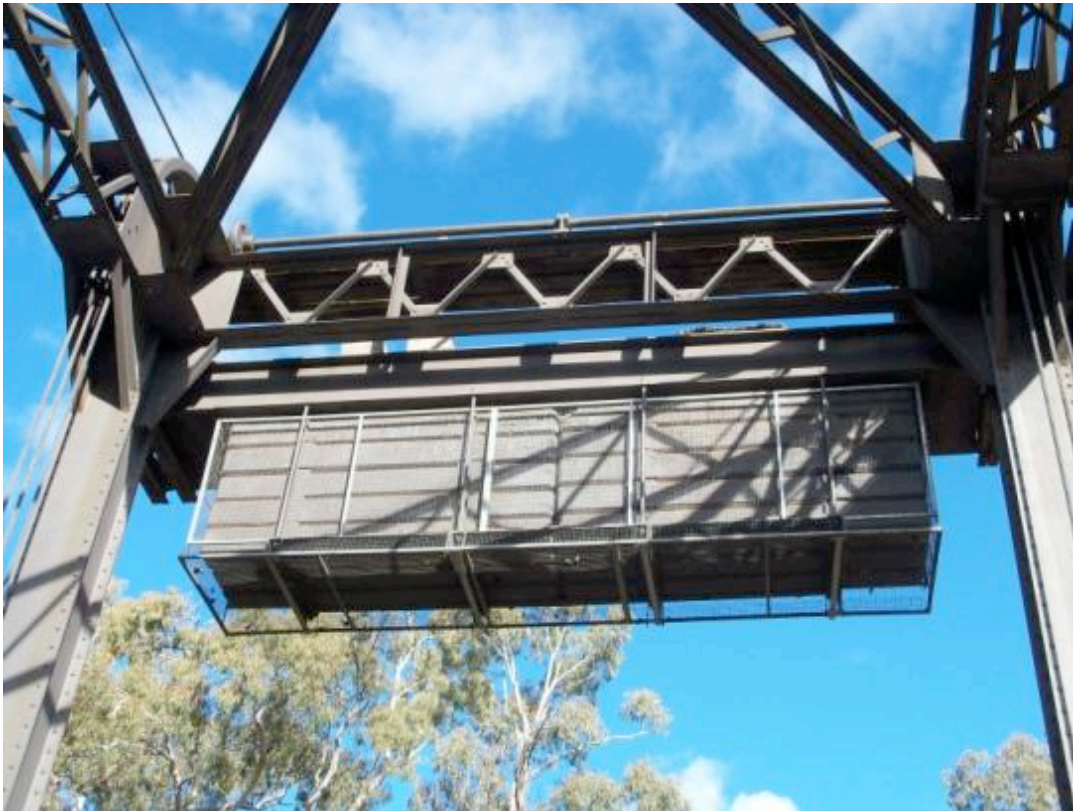
Figure 5.98 Gonn Crossing counterweights (Source: RMS)
