# Pacific Highway Upgrade: Nambucca Heads to Urunga.

Underpass Monitoring – Year 1  
(Construction Phase – Year 3)

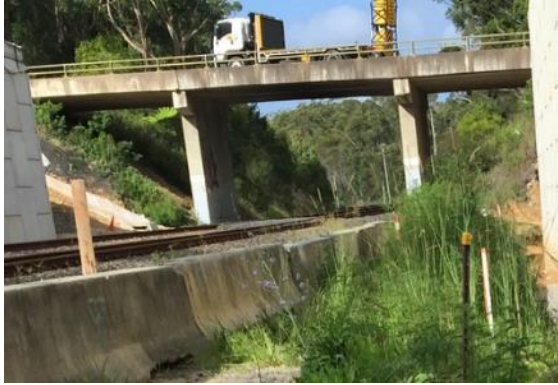
**Plate 1:** Habitat adjoining railway corridor underpass (ch.61800) on east side. Habitat was similar on both sides of the alignment.

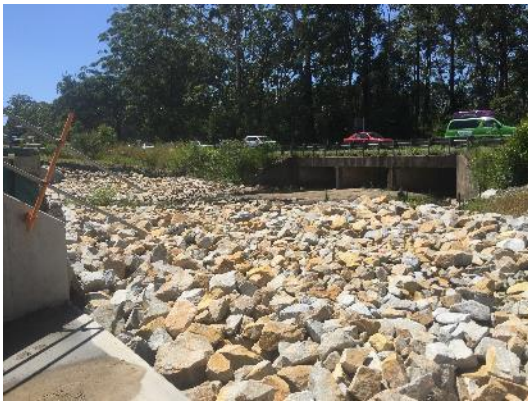
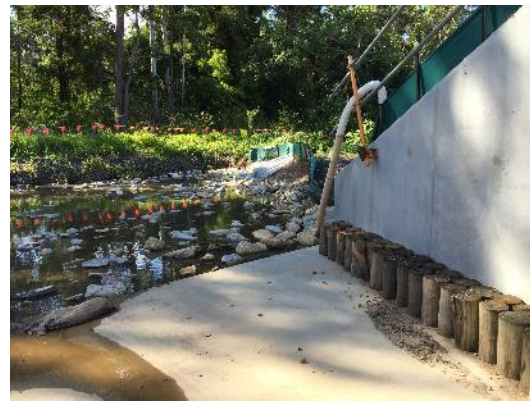
**Plate 2:** Habitat adjoining the east (left) and west (right) entrance of Burkes Lane fauna underpass (ch.68470).

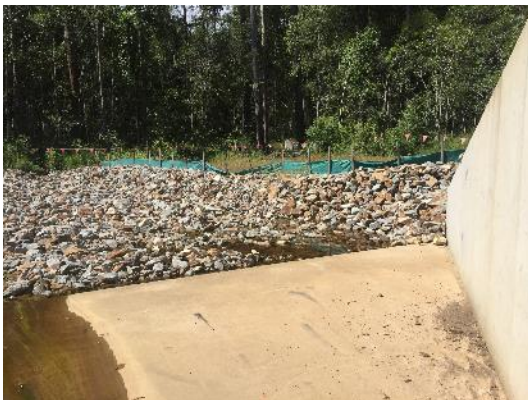
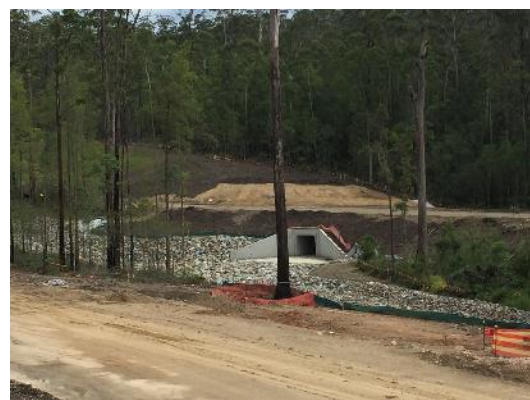
**Plate 3:** Habitat adjoining the east (left) and west (right) entrance of Dalhousie Creek fauna underpass (ch.73800). Habitat was similar on both sides of the alignment.

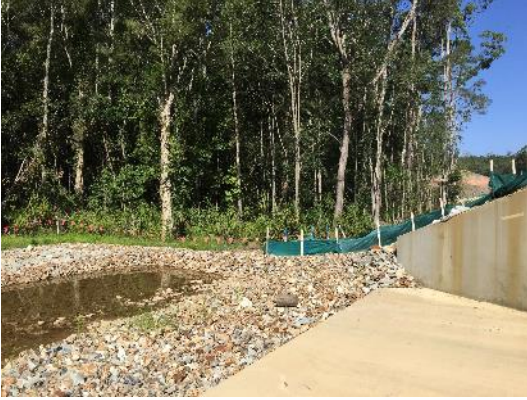
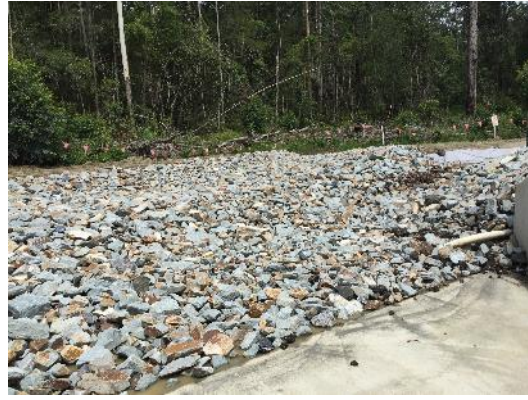
**Plate 4:** Habitat adjoining the east (left) and west (right) entrance of Martells Road south fauna underpass (ch.75250).

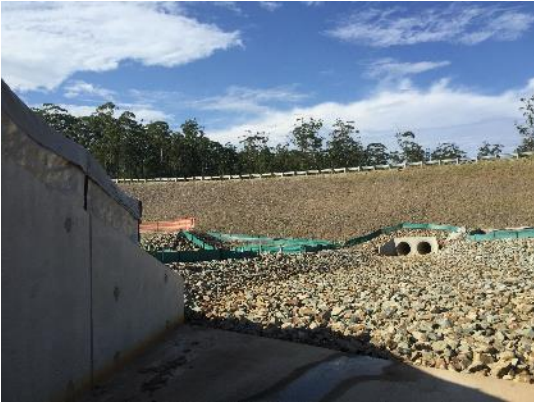
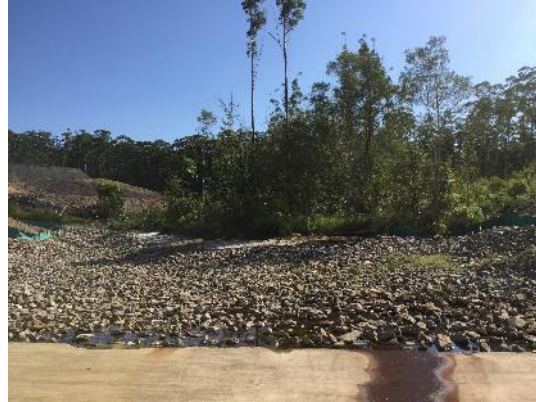
**Plate 5:** Habitat adjoining the east (left) and west (right) entrance of Martells Road north fauna underpass (ch.75800).

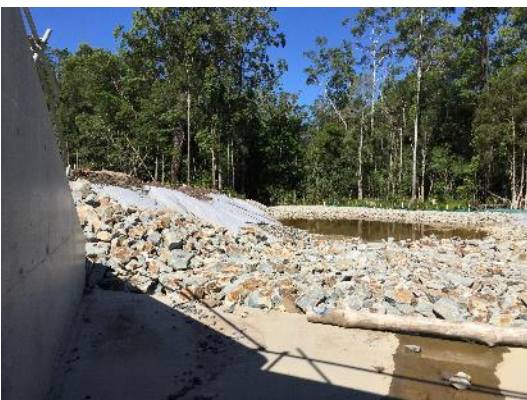
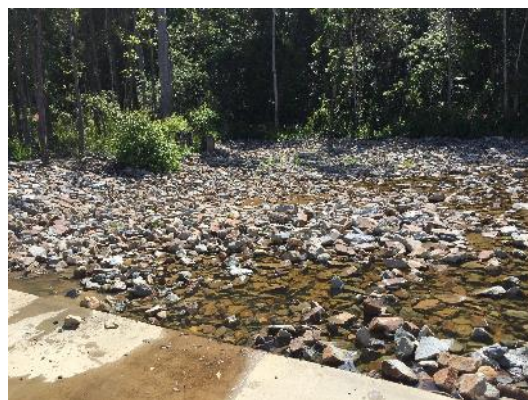
**Plate 6:** Habitat adjoining the east (left) and west (right) entrance of Access Road G fauna underpass (ch.78800).

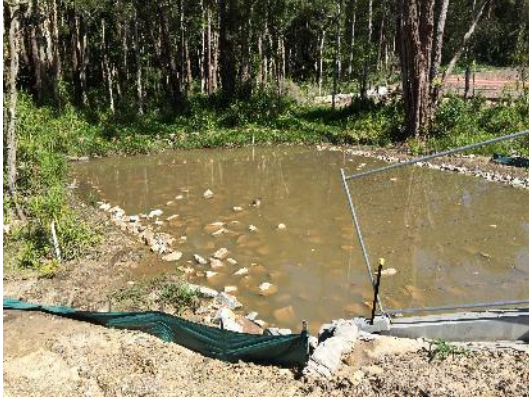
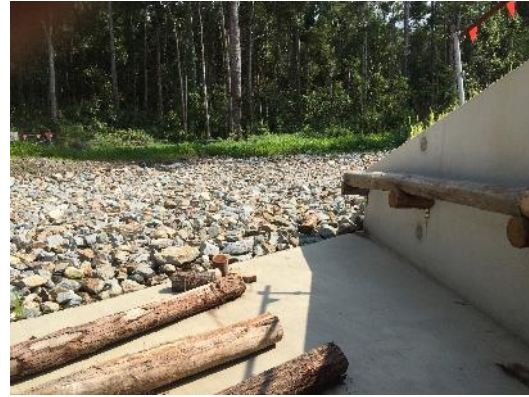
**Plate 7:** Habitat adjoining the east (left) and west (right) entrance of Tyson's Flat fauna underpass (ch.80220).

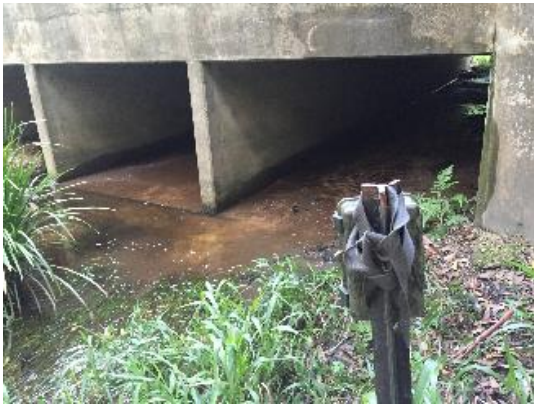
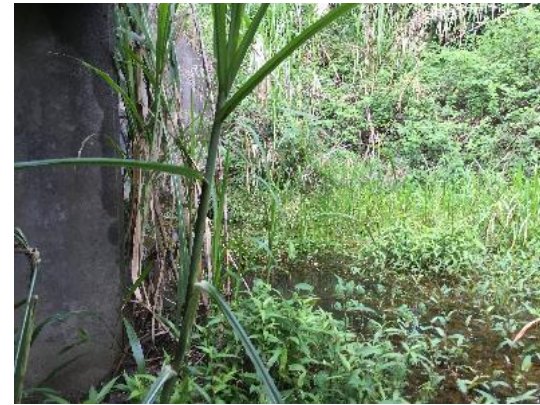
**Plate 8:** Habitat adjoining the east (left) and west (right) entrance of McGraths Creek fauna underpass (off site).

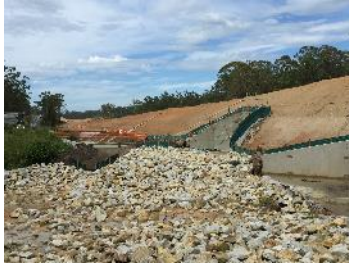
**Plate 10:** Design features and construction progress for Burkes Lane fauna underpass. Photo on top row was taken during spring 2014 sampling and photos on the bottom row taken during summer/autumn 2015 sampling.

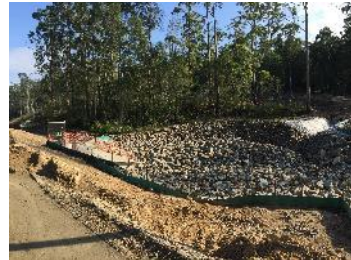
**Plate 11:** Design features and construction progress for Dalhousie Creek fauna underpass. Photos on top row were taken during spring 2014 sampling and photos on the bottom row taken during summer/autumn 2015 sampling.

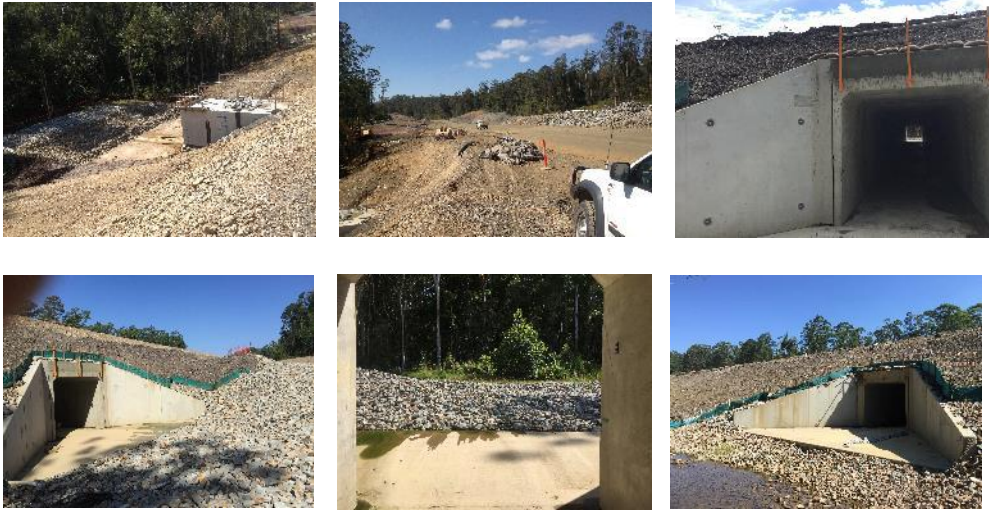
**Plate 12:** Design features and construction progress for Martells Road south fauna underpass. Photos on top row were taken during spring 2014 sampling and photos on the bottom row taken during summer/autumn 2015 sampling.

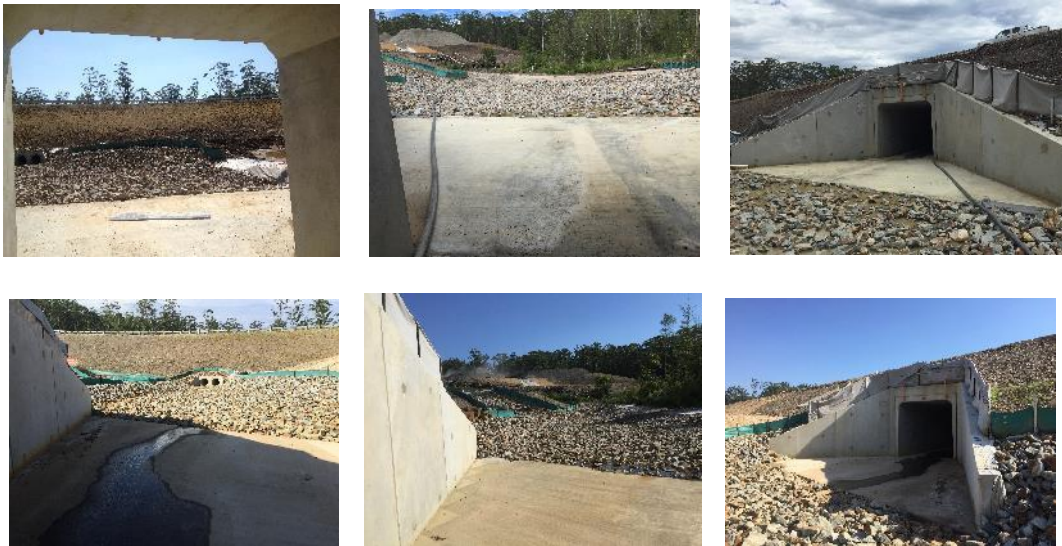
**Plate 13:** Design features and construction progress for Martells Road north fauna underpass. Photos on top row were taken during spring 2014 sampling and photos on the bottom row taken during summer/autumn 2015 sampling.

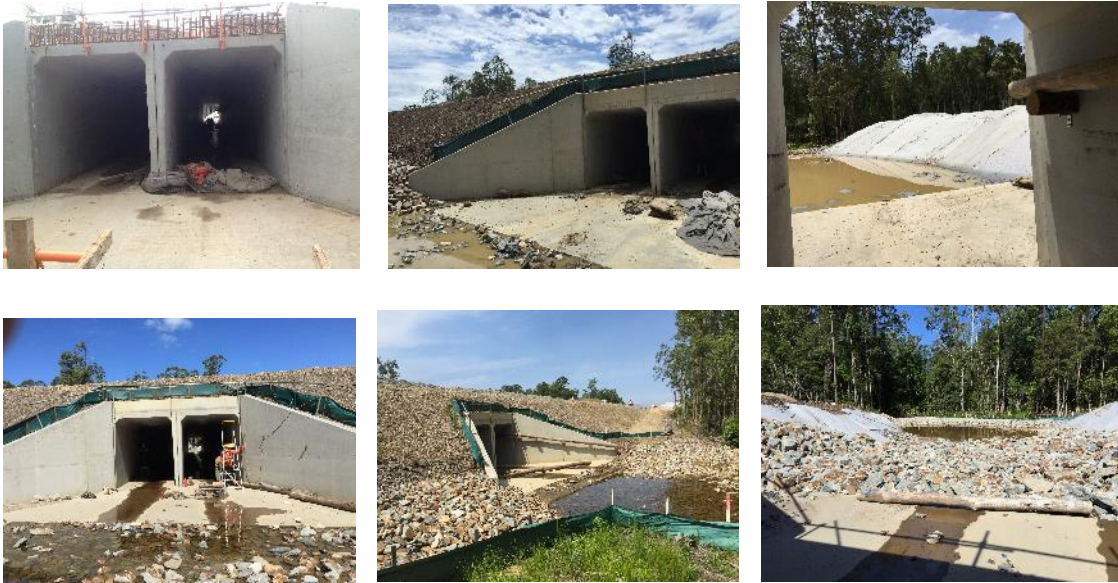
**Plate 14:** Design features and construction progress for Access Road G fauna underpass. Photos on top row were taken during spring 2014 sampling and photos on the bottom row taken during summer/autumn 2015 sampling.

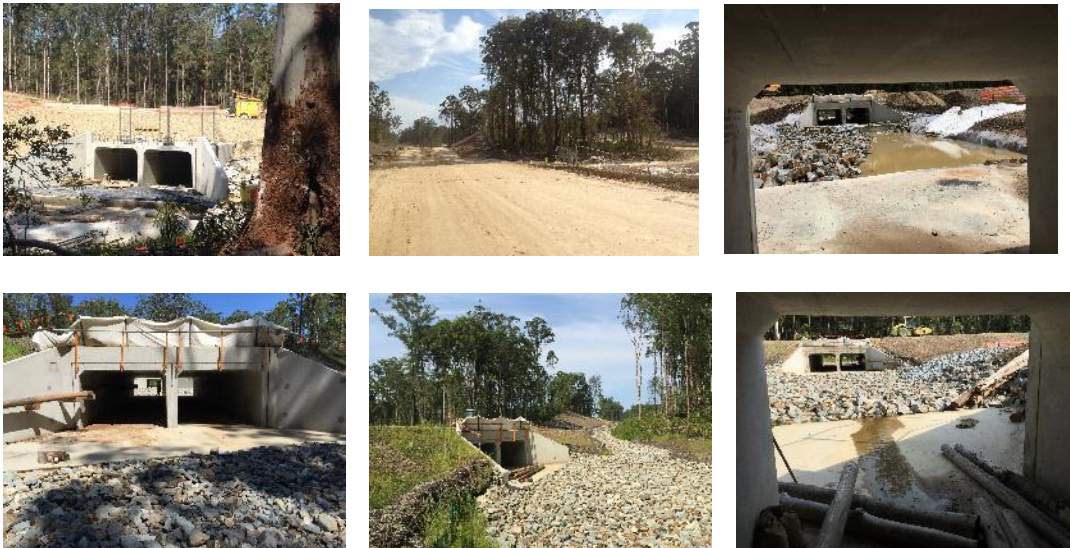
**Plate 15:** Design features and construction progress for Tyson's Flat fauna underpass. Photos on top row were taken during spring 2014 sampling and photos on the bottom row taken during summer/autumn 2015 sampling.

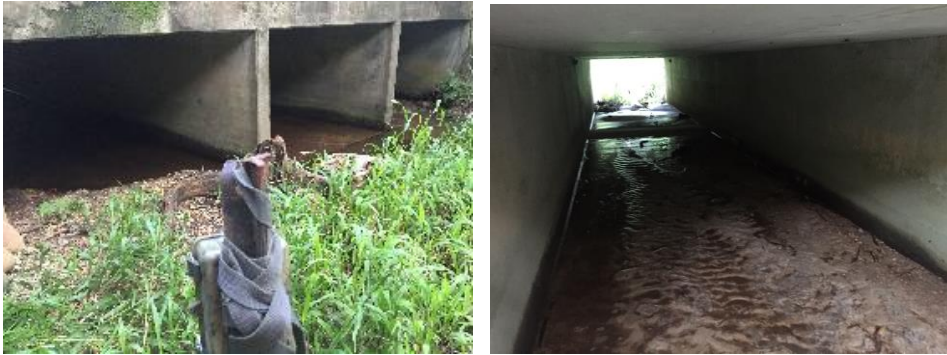
**Plate 16:** Design features of triple-cell culverts at McGraths Creek.

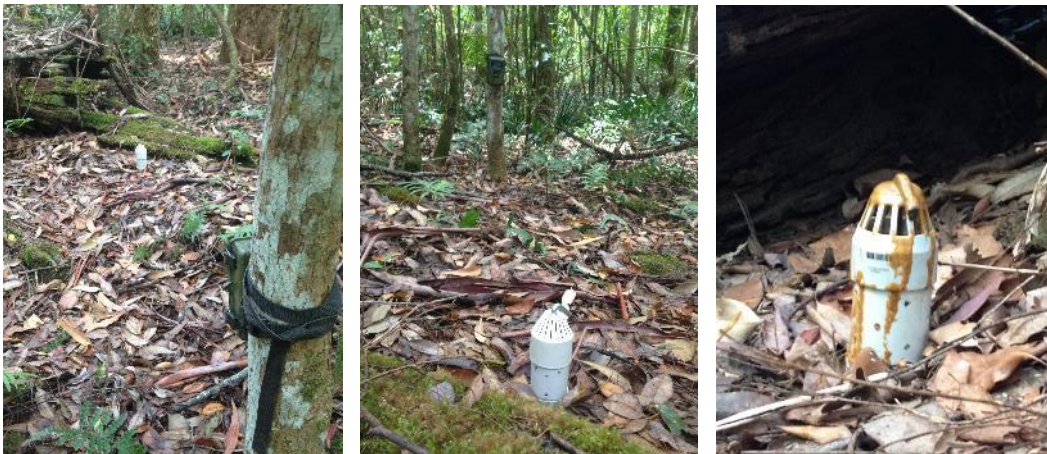
**Plate 17:** Camera bait stations featured a Scoutguard KG680V strapped to a tree at ~1m high and focused on a bait chamber containing chicken wings ~2m away (L & M). Chambers were drizzled with fish sauce to serve as an additional attractant (R).

Camera bait stations were installed on both sides of impact and control sites to sample fauna in adjoining habitat. Bait stations were positioned ~50m from each culvert entrance. Each station featured a Scoutguard KG680V infra-red (IR) camera strapped to a tree or post at ~1m high and focused on a bait chamber ~2m away (Plate 17). Bait chambers were 150mm long PVC pipe (50mm diameter) capped at both ends and perforated with numerous holes. Chambers were baited with chicken wings and anchored to the ground with a tent peg. Fish sauce was drizzled over bait chambers to serve as an additional attractant (Plate 17). Cameras were set on med-high sensitivity and programmed to take 3 pictures/activation.

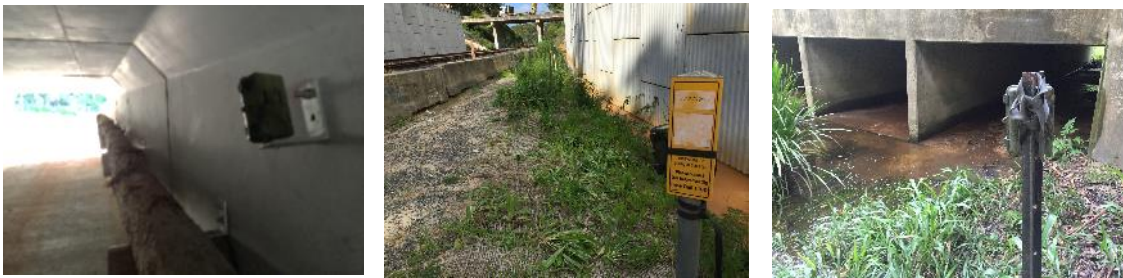
**Plate 18:** Underpass cameras were mounted on steel brackets & orientated to capture fauna moving along either the floor or rail (if present) of the culvert (L). Cameras were positioned either side of the rail track and inside the retaining walls during summer underpass monitoring (M). Underpass cameras needed to be positioned outside of the McGrath's creek culverts due to risk of inundation (R).

A Scoutguard KG680V IR camera was positioned inside both entrances of each culvert cell at the beginning of each eight-week sampling period. Cameras were mounted to the cell wall with a steel bracket at a height of 1800-2600mm. Cameras were positioned 5-10m from the culvert entrance and orientated inwards. At the vegetated median sites (Dalhousie Ck and Tyson's Flat), each cell received a single camera in the centre of the culvert (Plate 18). At railway, a camera mounted on a star picket (or equivalent) at ~1200mm height was positioned on the north and south side of the rail lines next to where the retaining walls were proposed to be (spring) and where they were constructed (summer; Plate 18). At McGraths Creek, a camera mounted on a star picket at ~1200mm height was positioned 5m north-east and 5m south-east of the culvert entrance (Plate 18). Cameras could not be positioned inside the culvert cells at McGraths Creek due to risk of inundation. Cameras were checked on a number of occasions during each sampling period and retrieved after 8 weeks.

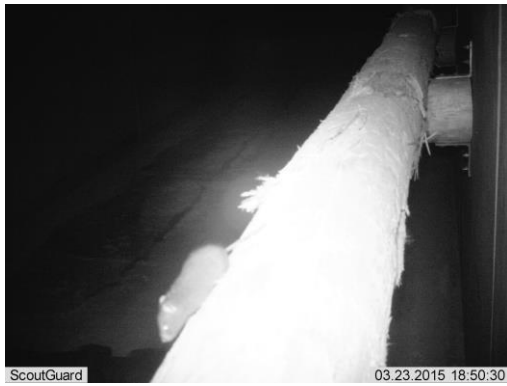
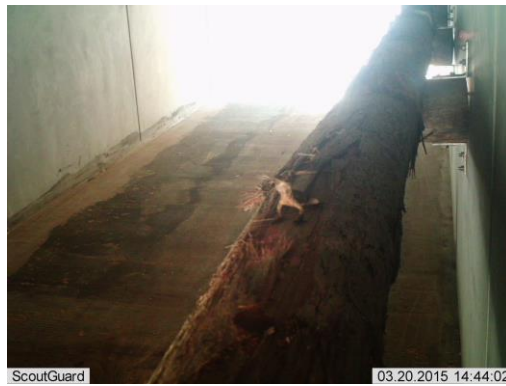
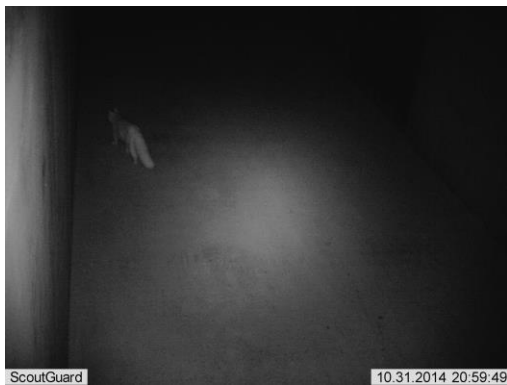
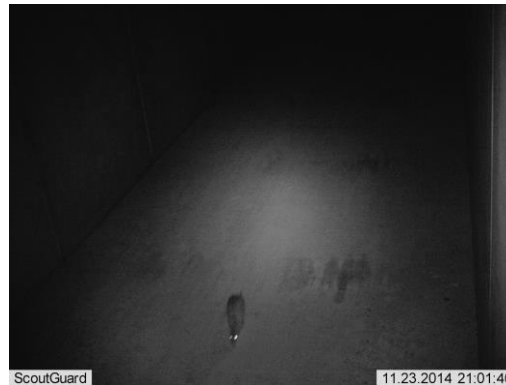
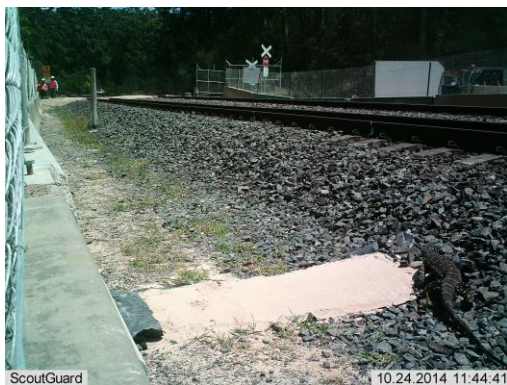
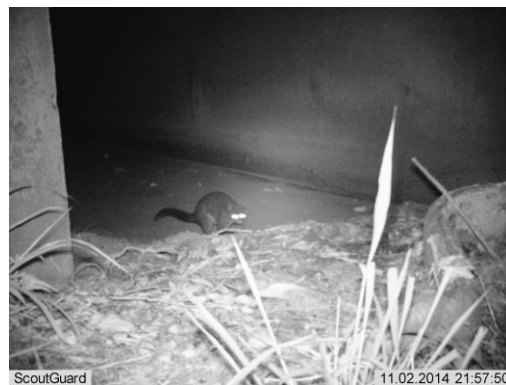
**Plate 22:** A range of fauna were detected using fauna underpasses along the N2U upgrade. Swamp rat (top L) and eastern water dragon (top R) were photographed on the wooden rail in the southbound underpass at Tyson’s Flat. Cat (middle L) and northern brown bandicoot (middle R) were photographed using the Martells Road north underpass. Lace monitor was photographed at Railway (bottom L) and short-eared brushtail possum was observed exiting one of the cells of the McGraths Creek underpass (bottom R).

Cameras detected seven vertebrate species using underpasses at the seven impact sites and 13 at the control site. Species detected at impact sites included eastern water dragon, swamp rat, black rat (probable), northern brown bandicoot, lace monitor, fox and cat (Table 10; Plate 22). The cat was the most commonly detected user and was recorded at five of the seven impact sites. Native vertebrates were each recorded at a single site only except lace monitor which was recorded at Martells Road north and Railway. By comparison, at least 10 native vertebrate species were detected at the McGraths Creek control site (Table 10). While crossings could only be confirmed for cat, it is likely that native species made complete crossings except yellow-face whip snake and northern brown bandicoot which were only photographed near the underpass entrance.

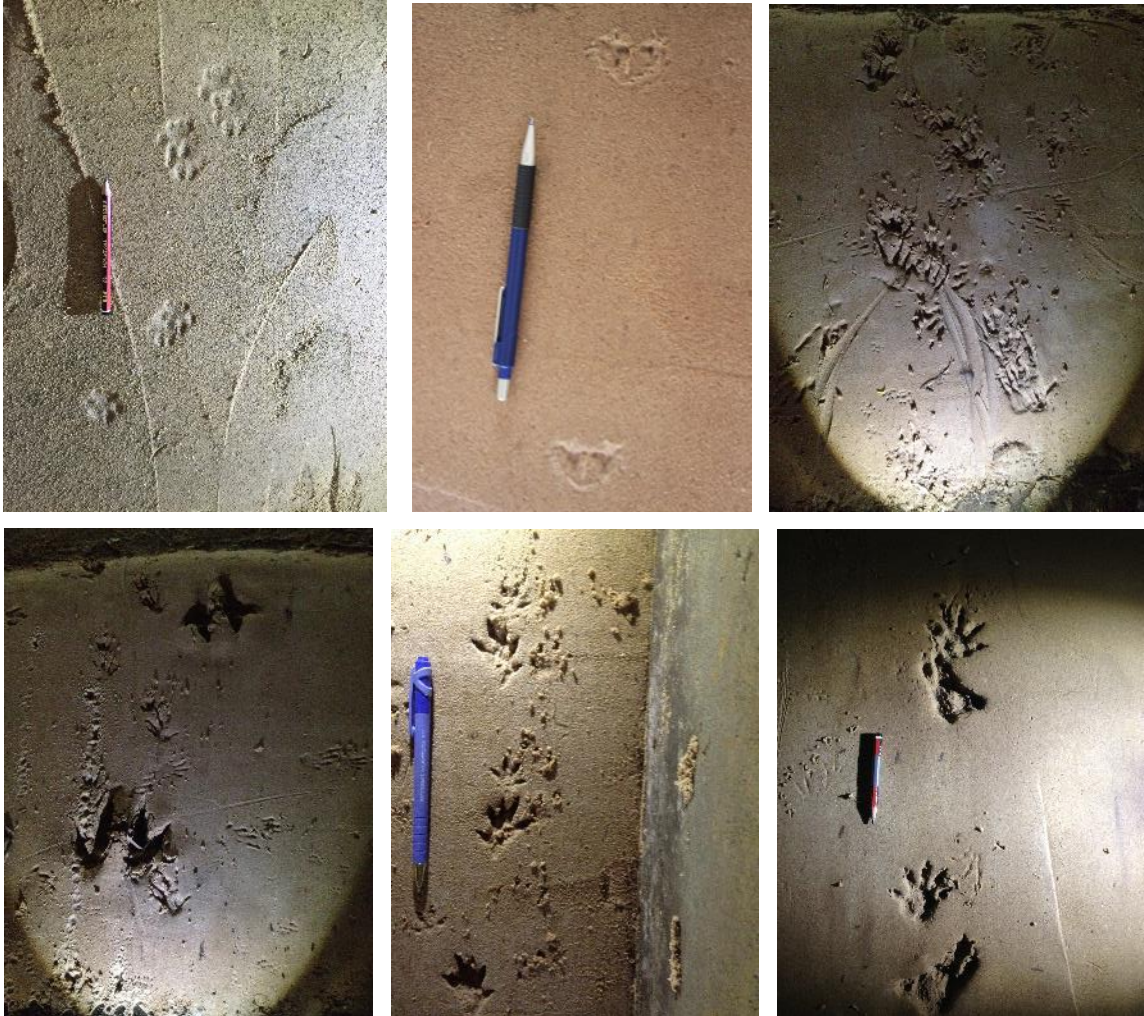
**Plate 23:** A range of fauna were detected in sand traps placed in the center of fauna underpasses along the N2U upgrade, including cat (top L), frog (top M), lace monitor (& water dragon & rodent) (top R), wallaby (& rodent & water dragon) (bottom L), water rat (bottom M) and brushtail possum (bottom R).

Sand pads remained in-tact during the spring sampling period although regular drying out of sand occurred at all sites except Access Road G, Martells Road south and McGraths Creek. Sand pads typically form hard crusts as they dry out reducing their receptiveness to foot prints. During summer sampling, regular rain events caused sand wash-out at all sites resulting in loss of some track data. Sand pads were regularly reinstalled.

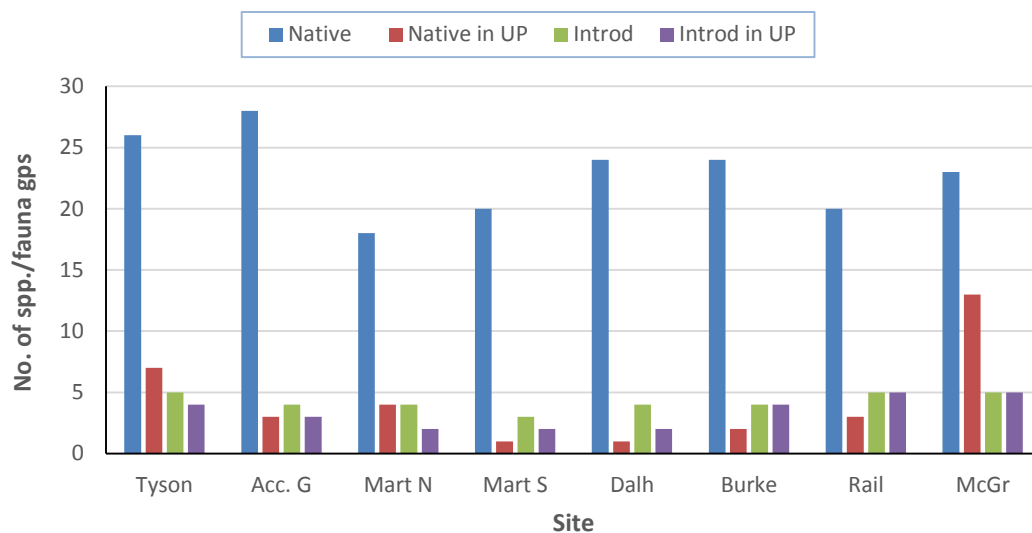
**Figure 3.** A site comparison of number of native and introduced species/fauna groups detected at each site and number recorded using the respective underpass.
