Victoria Bridge at Picton

Conservation Management Plan

Roads and Maritime Services | October 2018

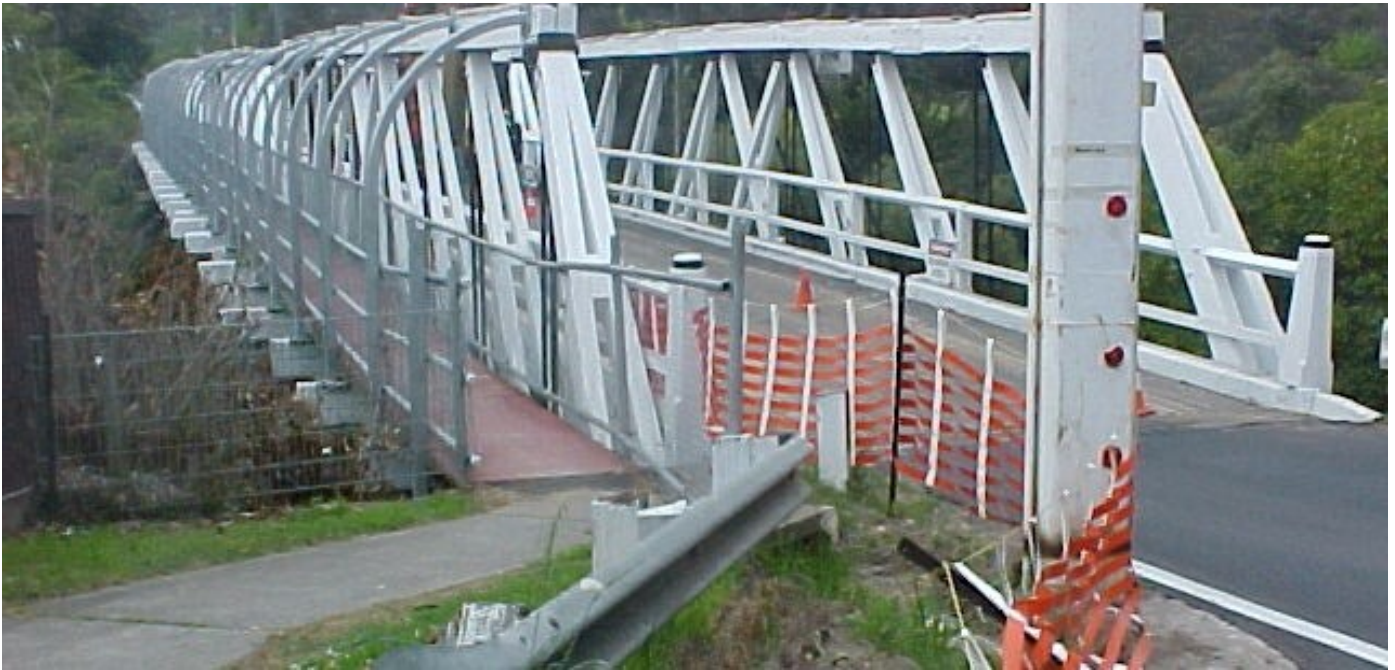
Figure 2-46: Temporary external footway during 2004 repairs

While it was seven months before the bridge could be reopened to vehicular traffic, provision was made for pedestrians a little earlier by moving the footway temporarily from the inside of the truss to the outside (the temporary external footway provided after the 2003 fire is shown in Figure 2.46). This was achieved by replacing the short cross girders with longer cross girders as well as removing the original sway braces and installing a larger number of modified sway braces.

It is possible that the sway braces are original fabric, but a higher level of deterioration would be expected for metal of that age, so they may have been replaced with new sway braces to the original design. It is known that the sway braces have been removed in the past (for example, see Figure 2.46 showing temporary replacement of straight sway braces with curved sway braces).

- The provision of a suitably designed visually recessive permanent external footway would remove the need to install the visually intrusive temporary external footway every time there is a long closure required for bridge repairs (see Figure 2.46).

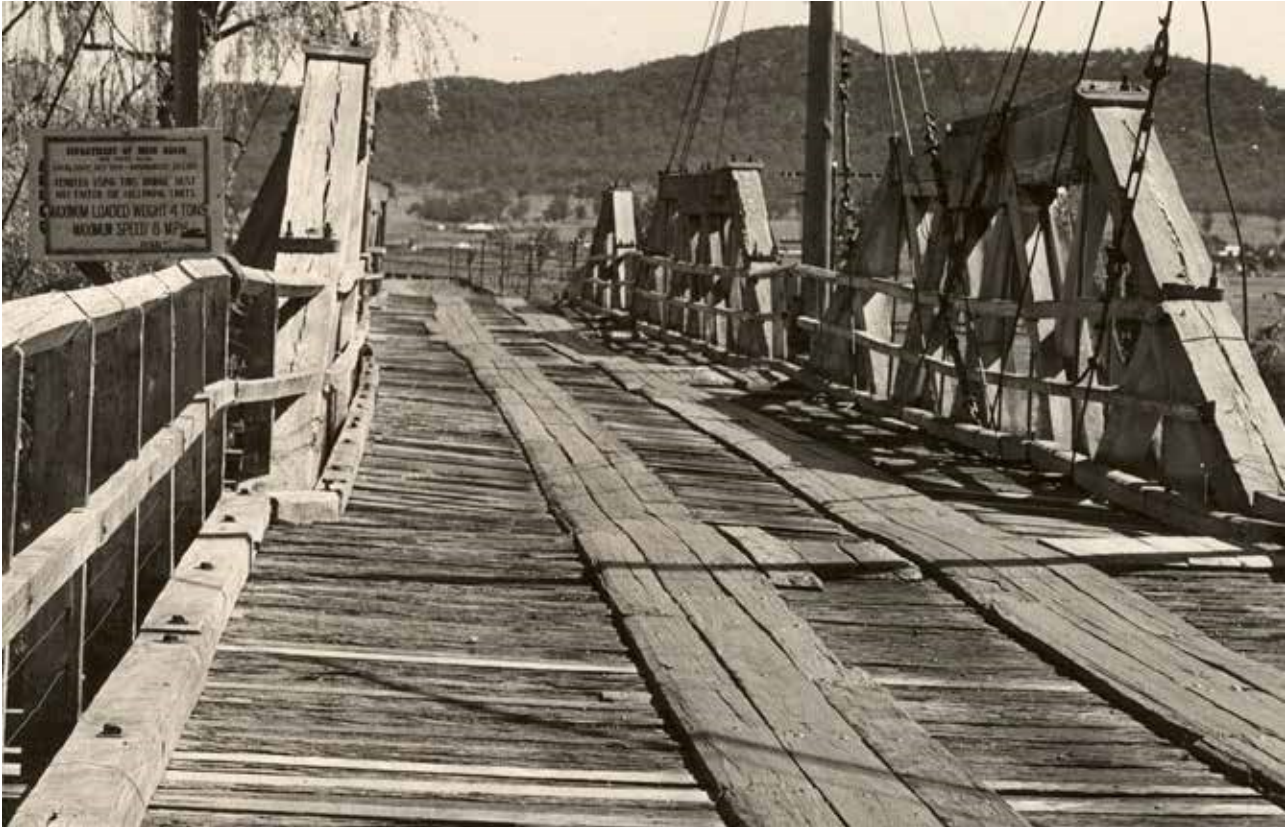
Figure 2-50: Typical Running Planks on Timber Bridge

Due to accidents occurring on running planks on various timber bridges throughout the State these did not stay long, and were replaced with the new standard full width longitudinal sheeting at Victoria Bridge in 1964.¹¹⁴

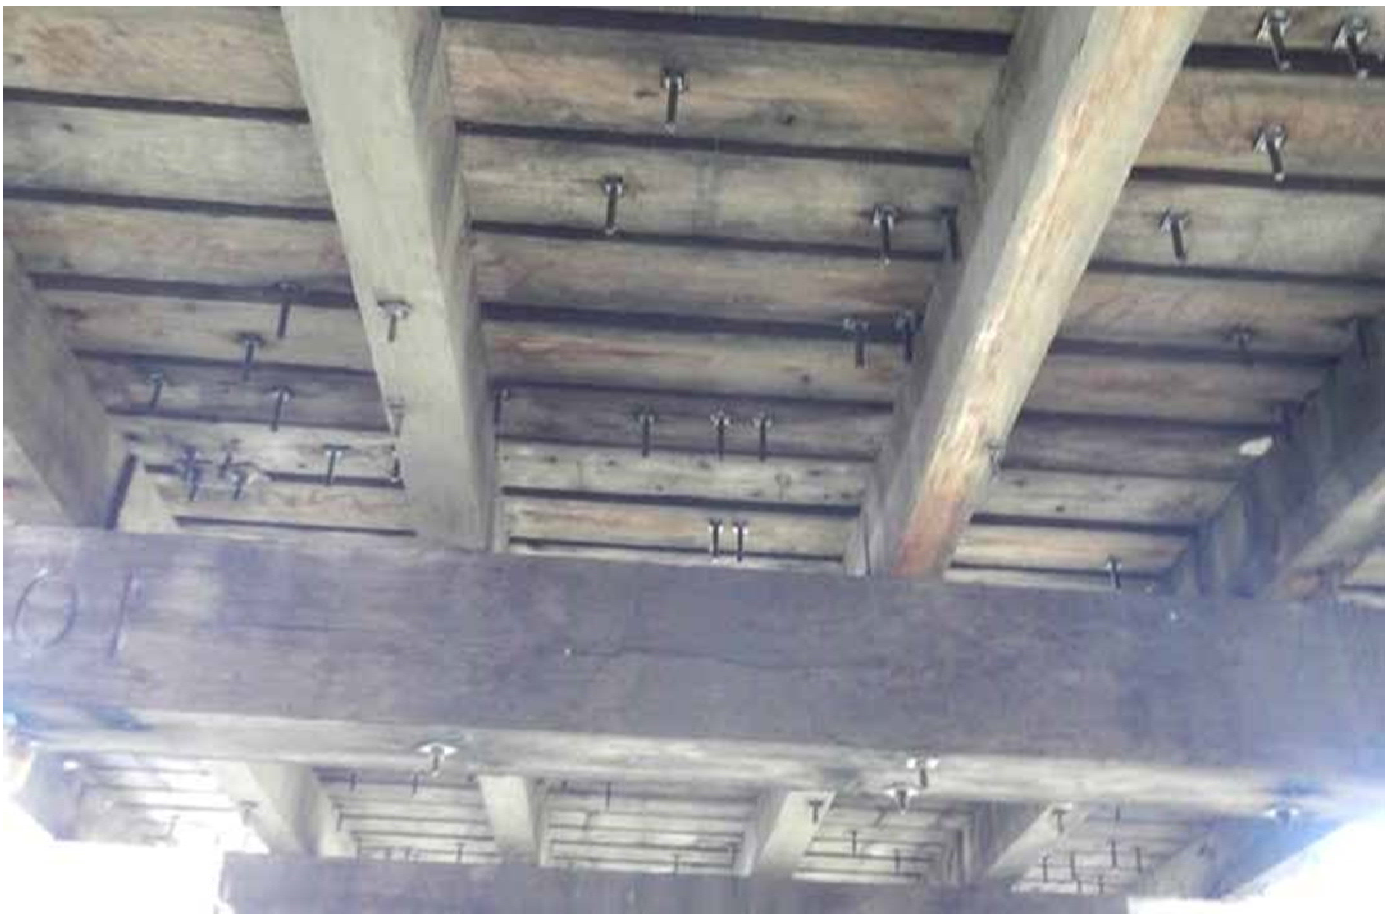
Figure 2-51: View of existing bolted deck from beneath Victoria Bridge

Despite these modifications to the deck, complaints regarding noise have continued with records of complaints having been received by the local Council in 1982 and again as recently as February 2016.¹¹⁶

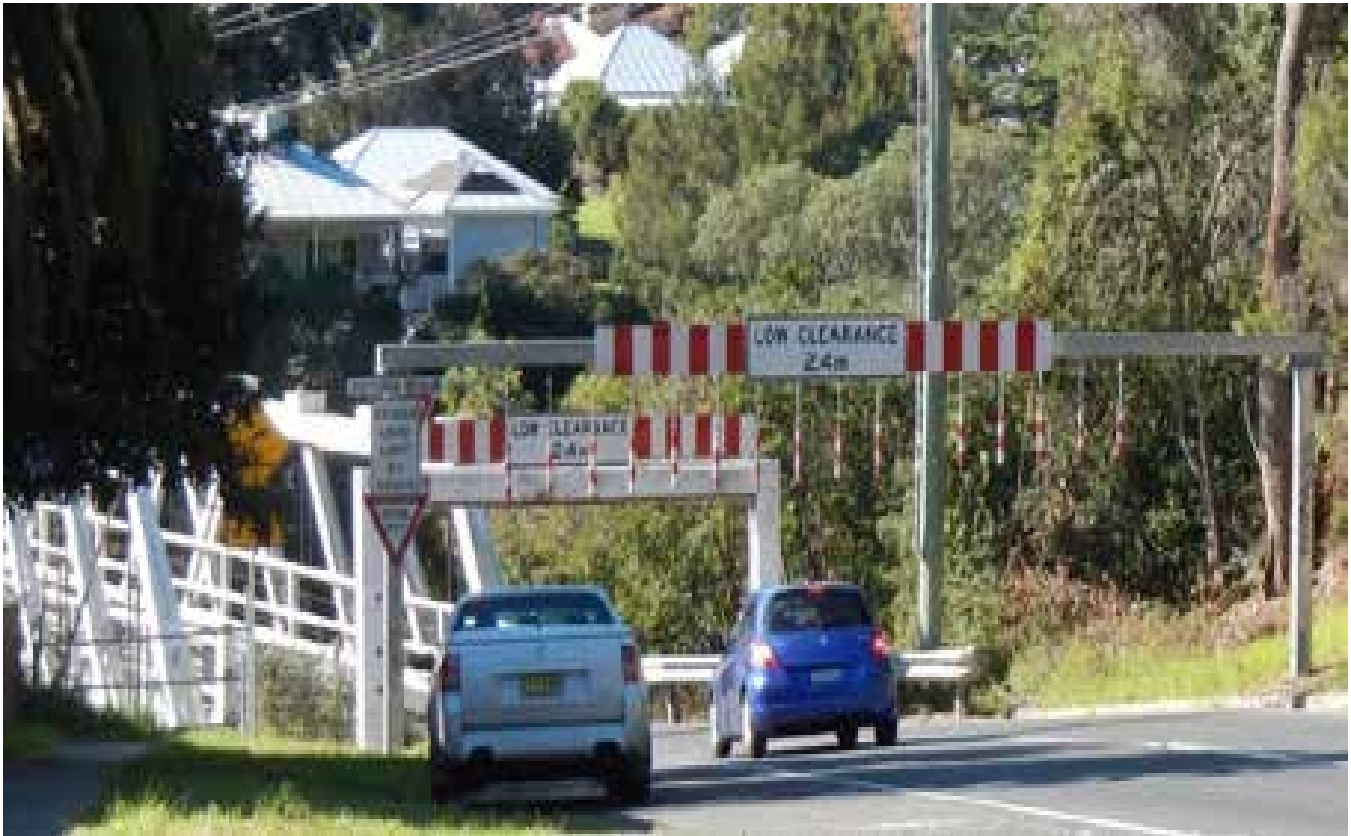
Figure 2-53: Height restriction portals

Heritage interested residents realise that some deterrents are necessary to stop the occasional “rogue” truck / semi-trailer drivers, otherwise even the renovated bridge structure may be weakened. But instead of the previous, ugly, “Christmas decoration” deterrent structures being replaced we are keen to have more heritage sensitive deterrents.”¹²¹

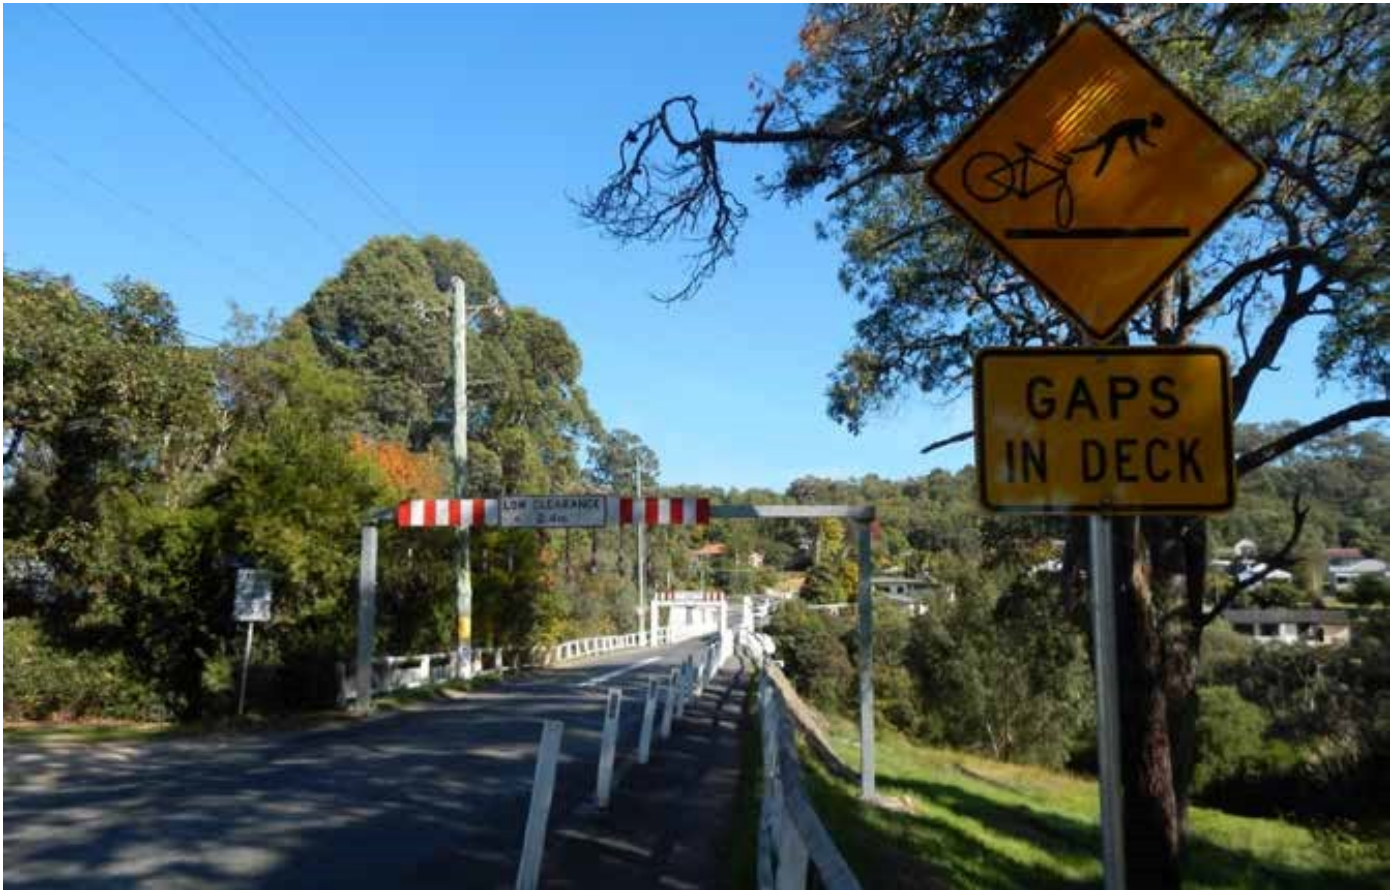
Figure 2-54: Safety Warnings, Load Limits and Height restriction portals

The narrow width of the bridge restricts it to a single lane of traffic, and with sustained population growth, congestion continues to increase especially in the morning and afternoon peaks, causing increased risks of incidents on the bridge and in the vicinity as well as increased difficulty in accessing the bridge in order to carry out necessary maintenance works.

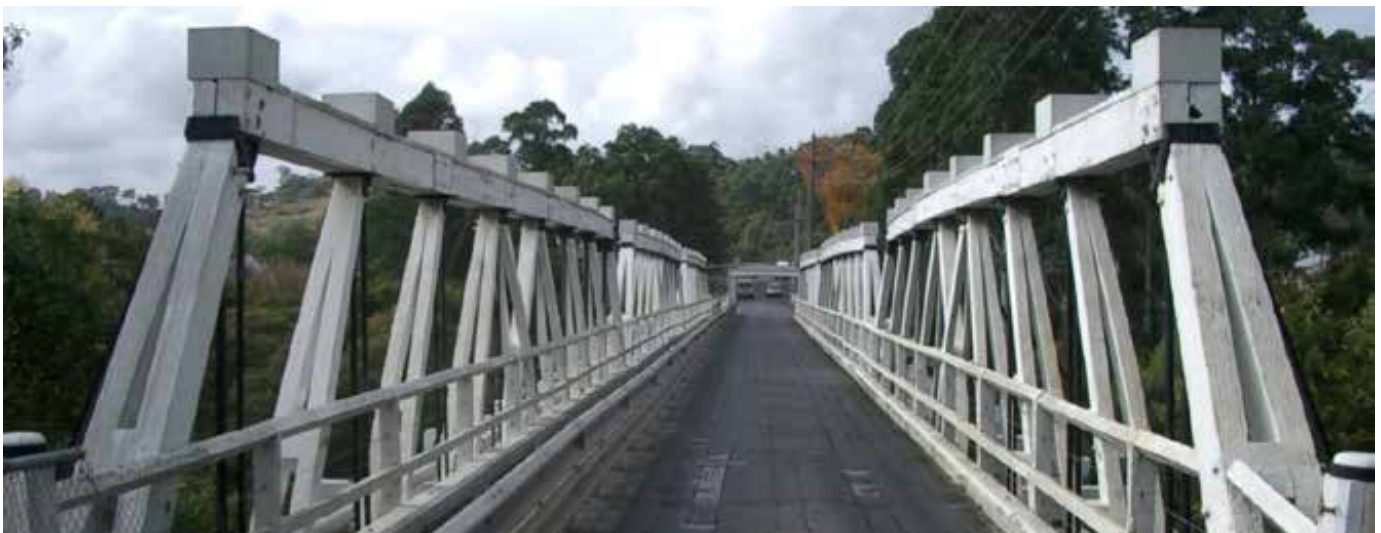
Figure 2-58: Visually dominant “castellated” flashing on top chords

The flashing adversely impacts on the aesthetics of Victoria Bridge, particularly due to the large boxes which have been provided at tension rod locations, giving a castellated effect to the top chord which detracts considerably from the graceful curves of the original Allan truss design.

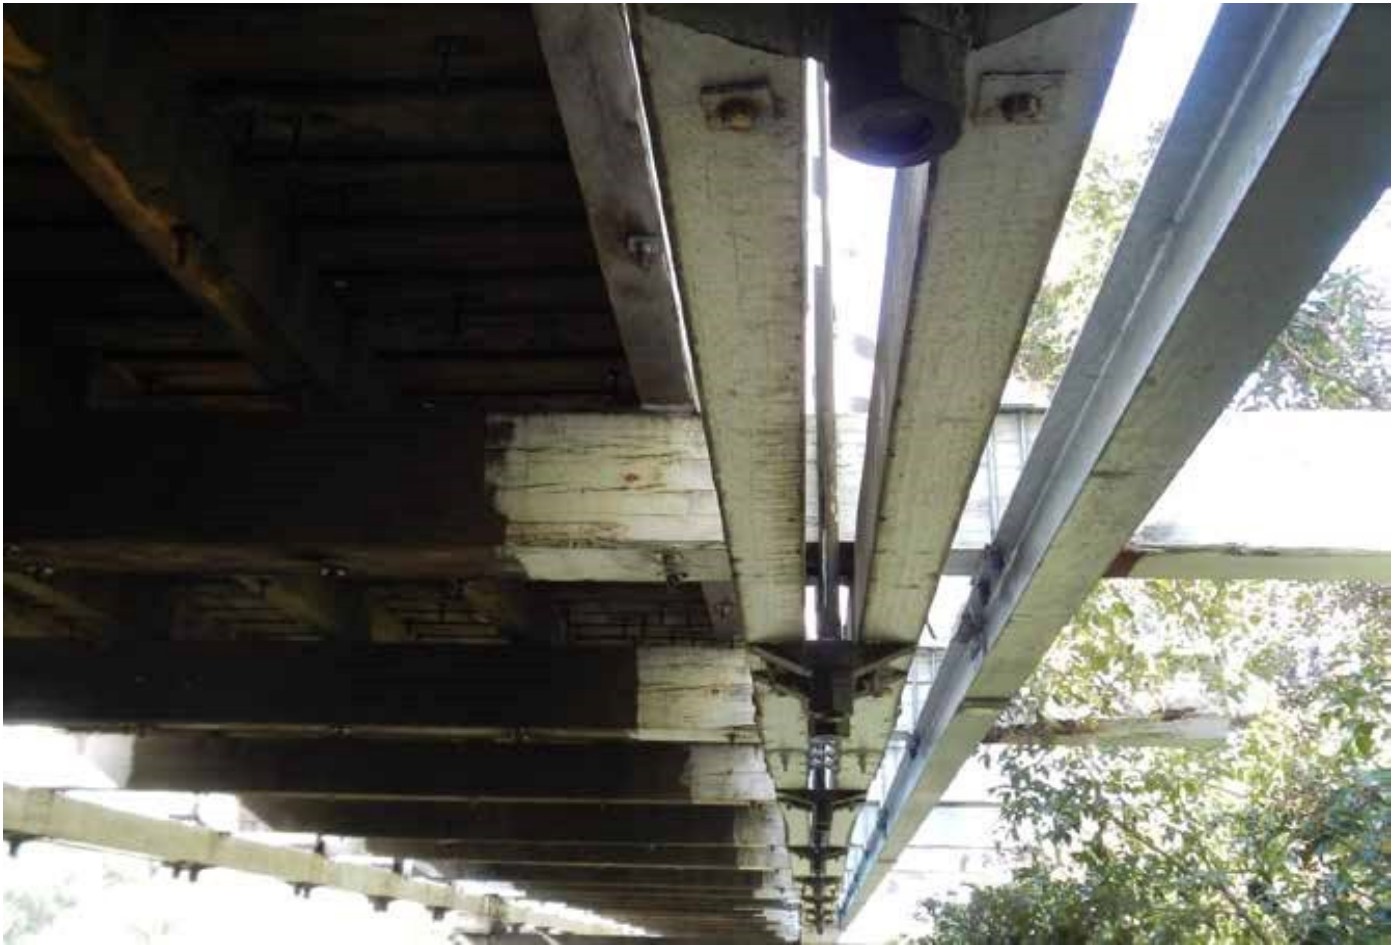
Figure 2-60: Photograph of timber bottom chord taken from under bridge

The second issue is that the original lengths are no longer easily procurable, and so in some bridges additional splices have been added, thereby increasing the risk of failure of the truss.

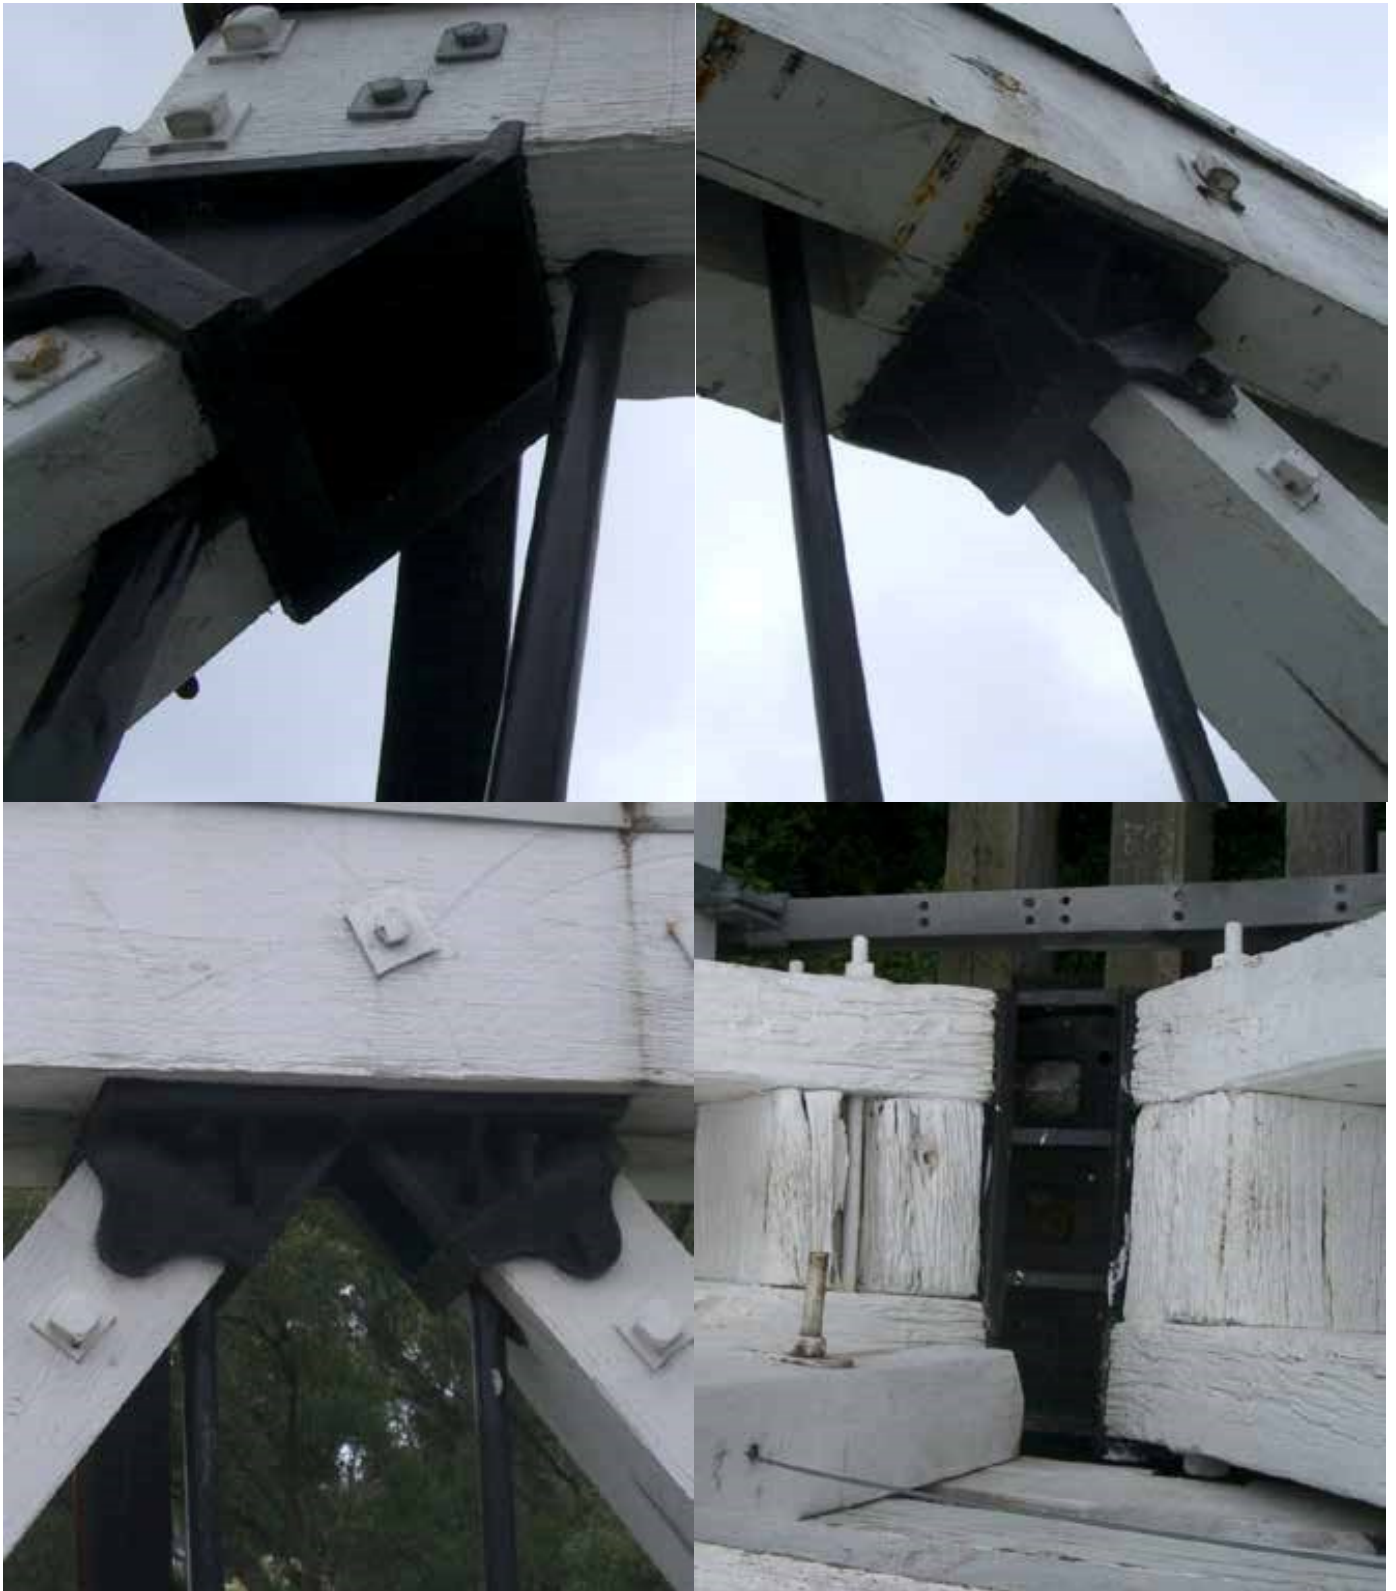
Figure 2-67: Photographs of various cast iron shoes at Victoria Bridge

Some of the cast iron shoes are probably original fabric. According to the most recent inspection most of the cast iron shoes are in condition state 1, although five are in condition state 2, two are in condition state 3 and one is in condition state 4 (this refers to a broken bottom chord shoe in Span 3). Problems reported with regard to cast iron shoes in the most recent inspection include minor cracking, loss of coach screws or bolts, looseness in connections and gaps opening up. Overall, the cast iron shoes appear to be in fair condition but the looseness is a structural concern.

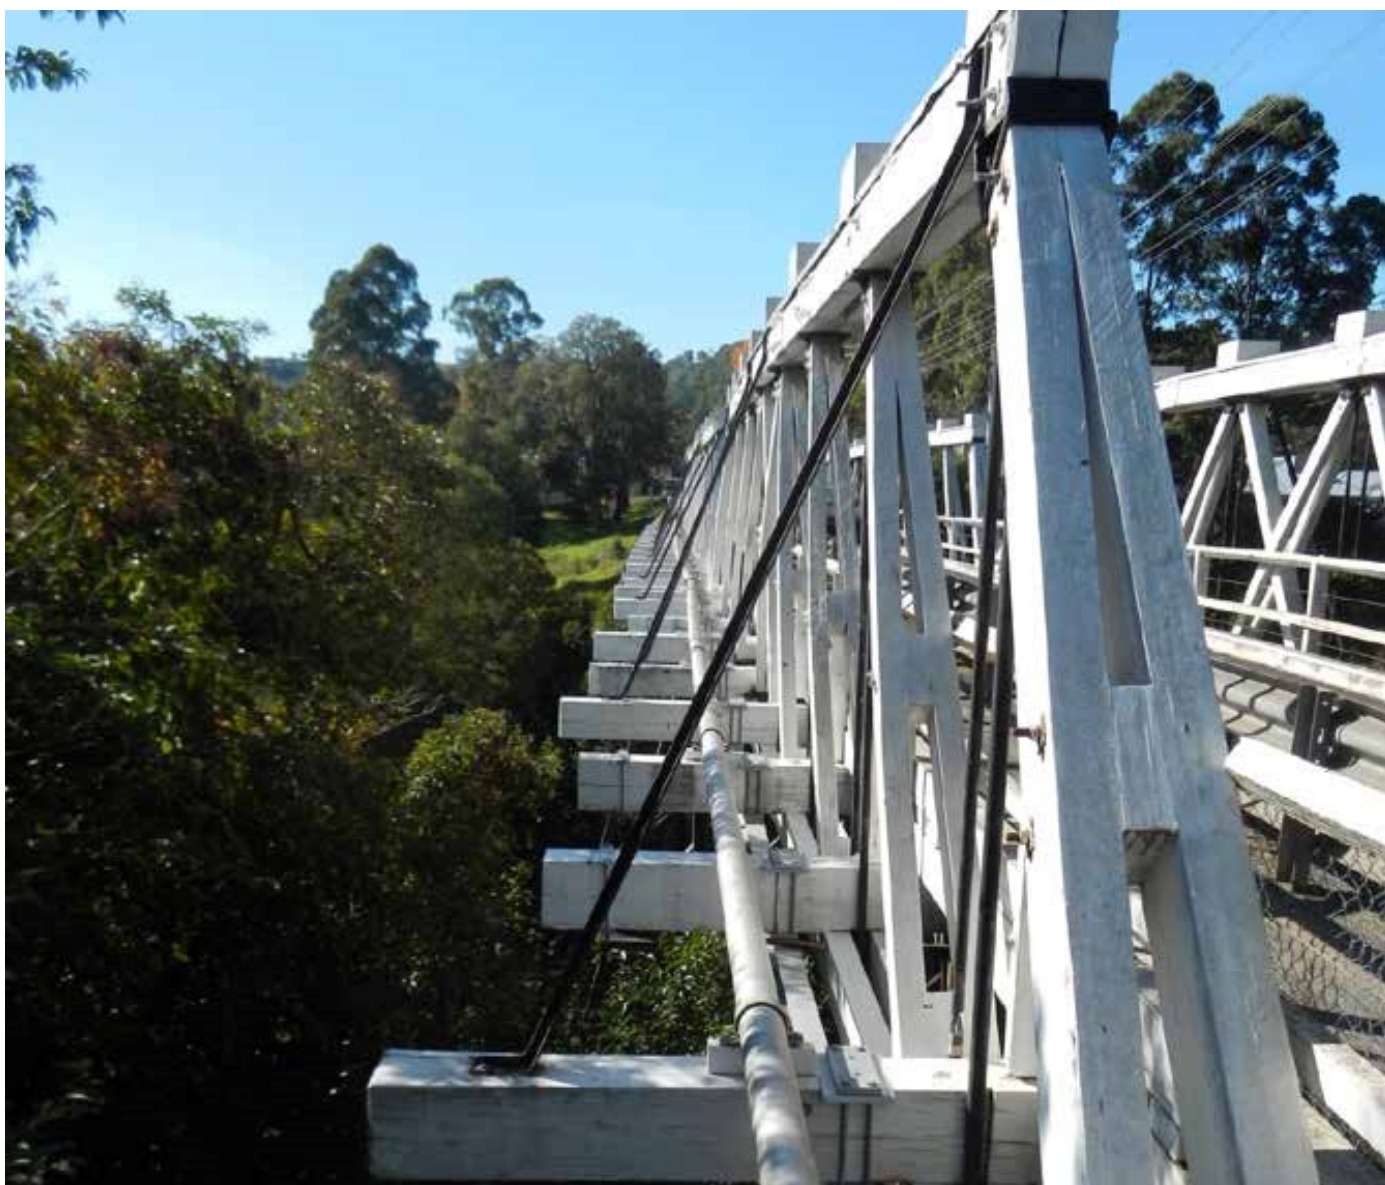
Figure 2-69: Photographs of upstream sway braces at Victoria Bridge

The sway braces at Victoria Bridge at Picton appear to be of the original design dimensions, and they are located in their original locations (ie. no additional sway braces have been added, and sway braces have not been lengthened as has been attempted on other bridge). The sway braces were not covered in the most recent inspection, but they appear to be in good condition.

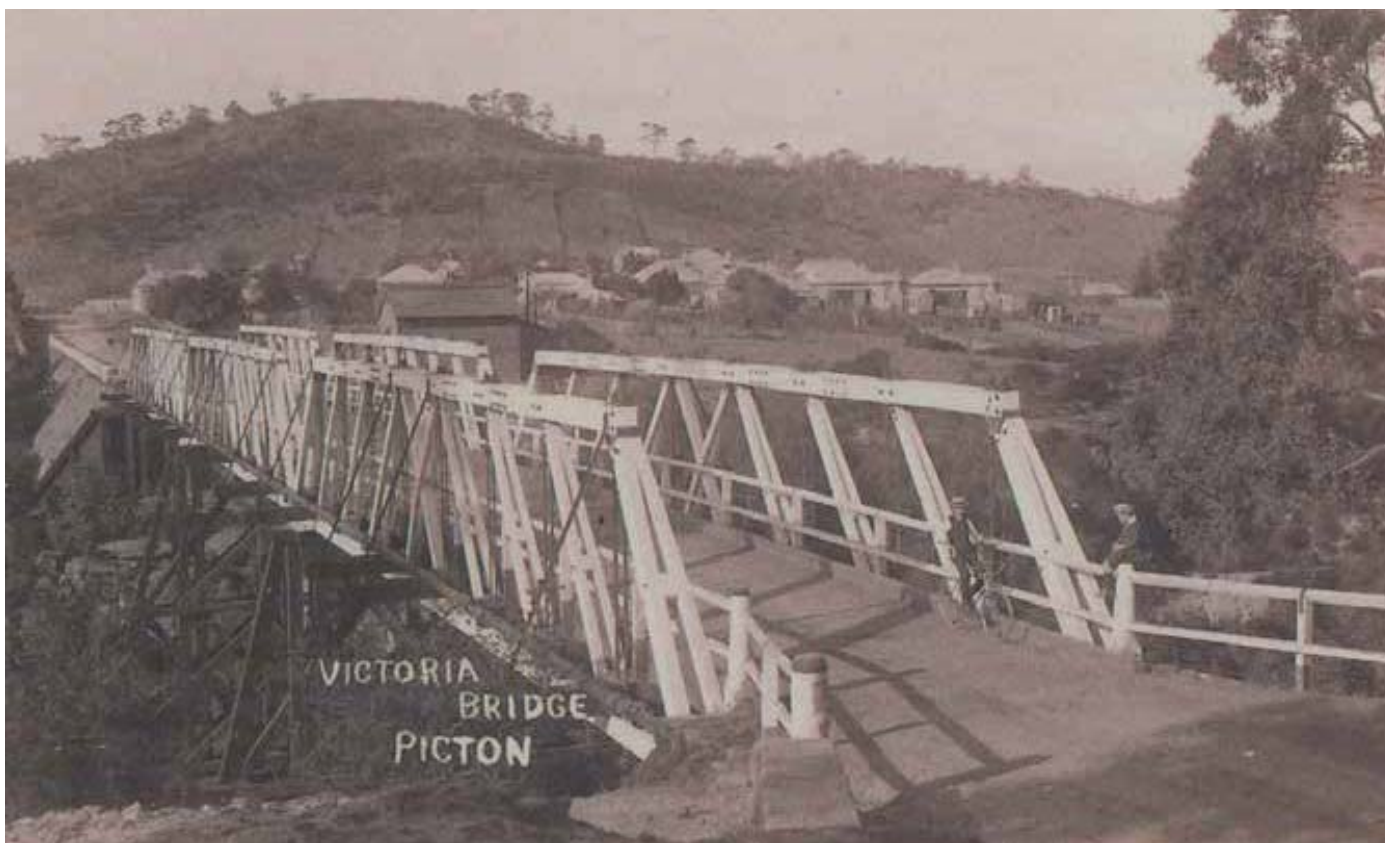
Figure 2-73: Early photo with cross girders, undated

Not only have many cross girders been replaced with wider cross girders as can be seen in Figure 2.72, but also the shorter cross girders have been replaced with longer cross girders and painted white so that the view of the side of the bridge is considerably changed (compare Figures 2.73-74). The reasons for the longer cross girders include support of the maintenance monorail (Figure 2.75) as well as provision for external footways to be economically provided during maintenance works.

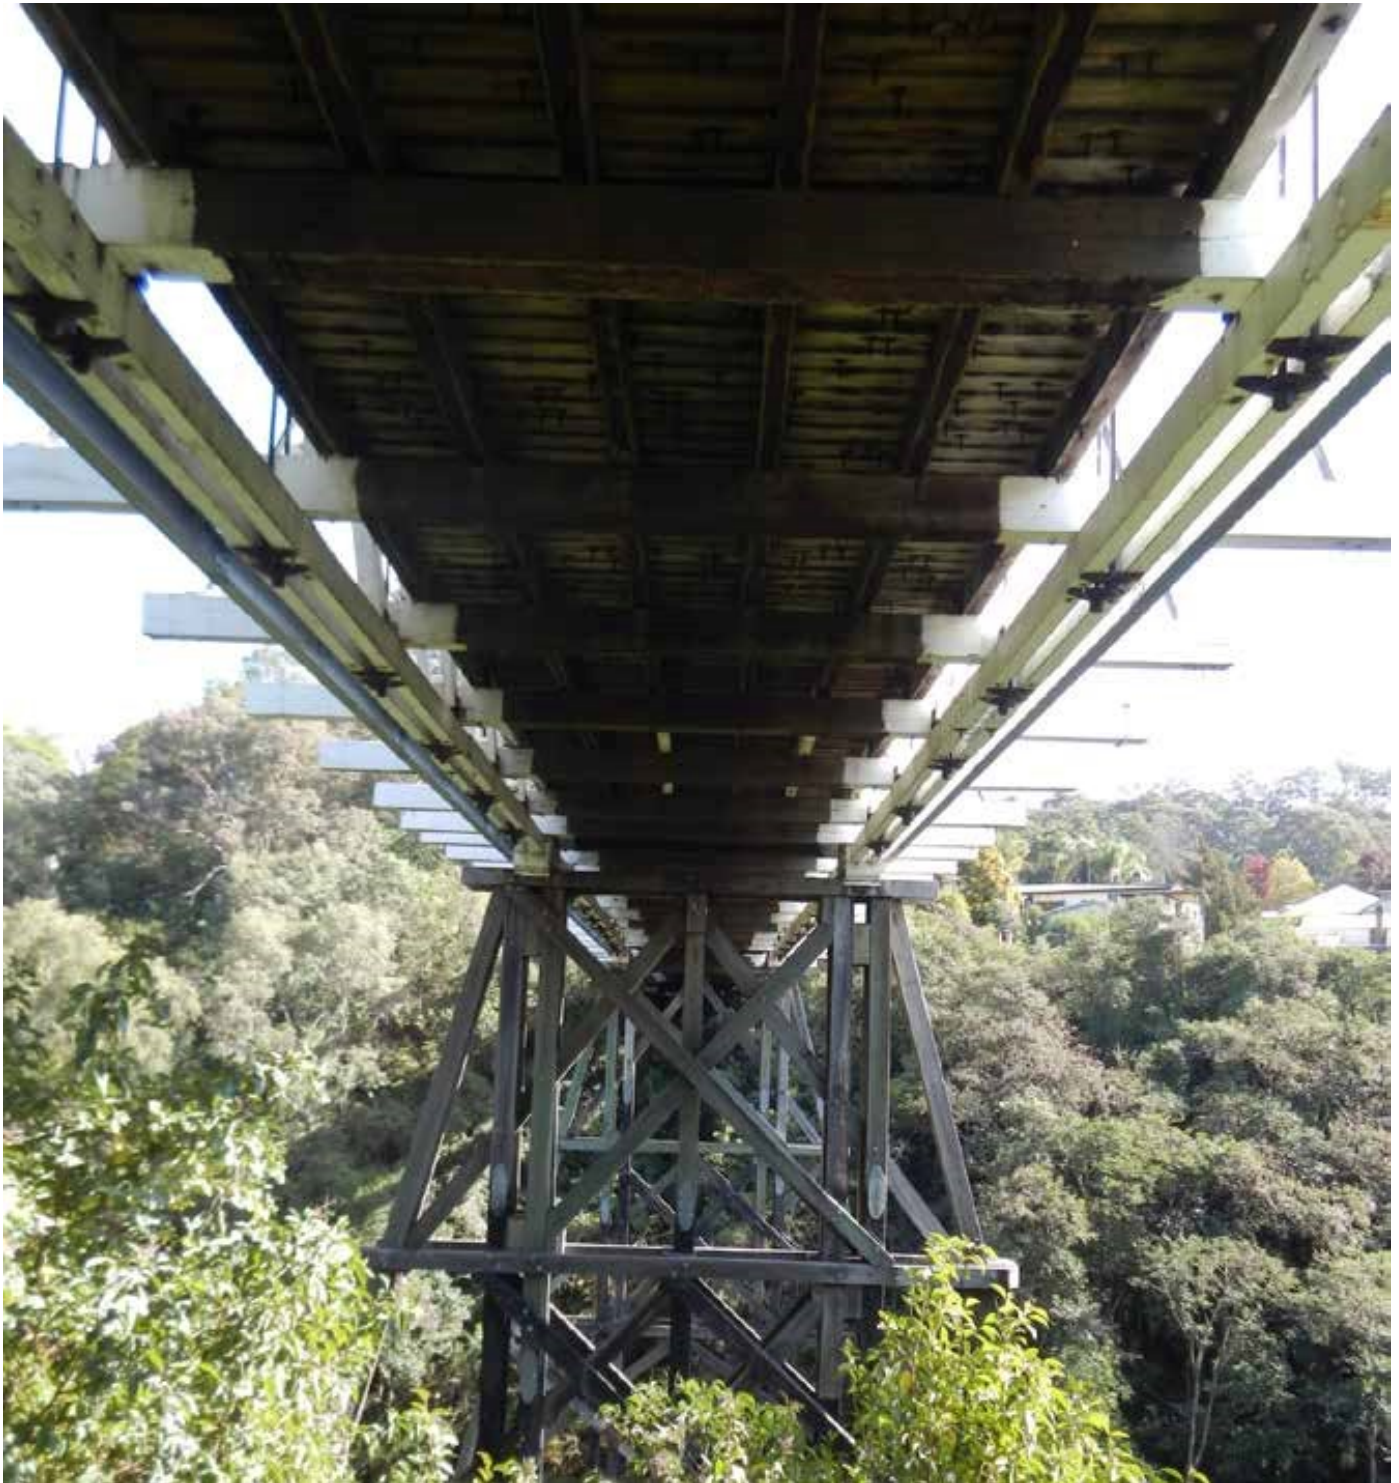
Figure 2-78: Photo of existing stringers and spaced transverse decking

The stringers and especially the decking have been considerably modified so that they currently reflect very little of the original design intent or the original aesthetic of the Allan trusses. The heritage integrity is very poor, with a number of intrusive modifications as outlined below. While the stringers (which can be seen in Figure 2.78 below) still consist of six rows of sawn timbers, the original sizes have been lost along with the cambered deck Allan took such care to provide.

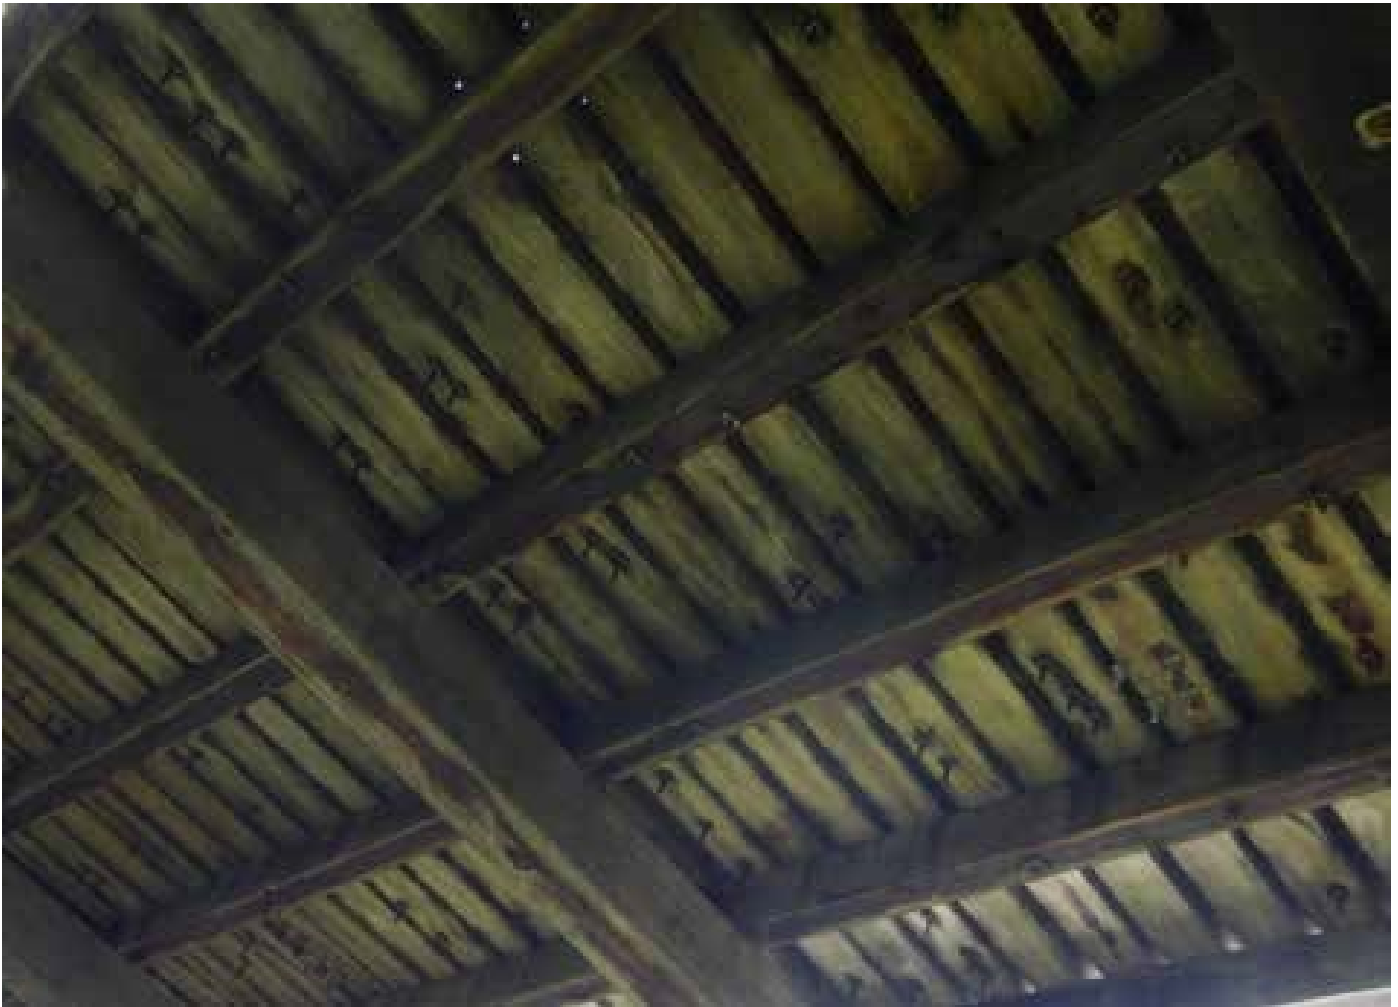
Figure 2-79: Bolted and spaced decking

Originally the deck was tightly spaced (allowing no light through) and completely smooth with a 38 mm camber for drainage and a black tar surface on top. The iron spikes which connected the decking to the stringers and cross girders were hammered flush with the top of the timber and were covered with the tar thereby making them effectively invisible. Currently the decking is spaced, allowing some light (and much water) through the deck, and a large number of bolts have been added, as can be seen in Figure 2.79. The current decking competes somewhat with the aesthetic of the trusses with the strong longitudinal lines of the sheeting and the irregular spacing of the protruding bolt heads and joints in the sheeting when viewed from above.

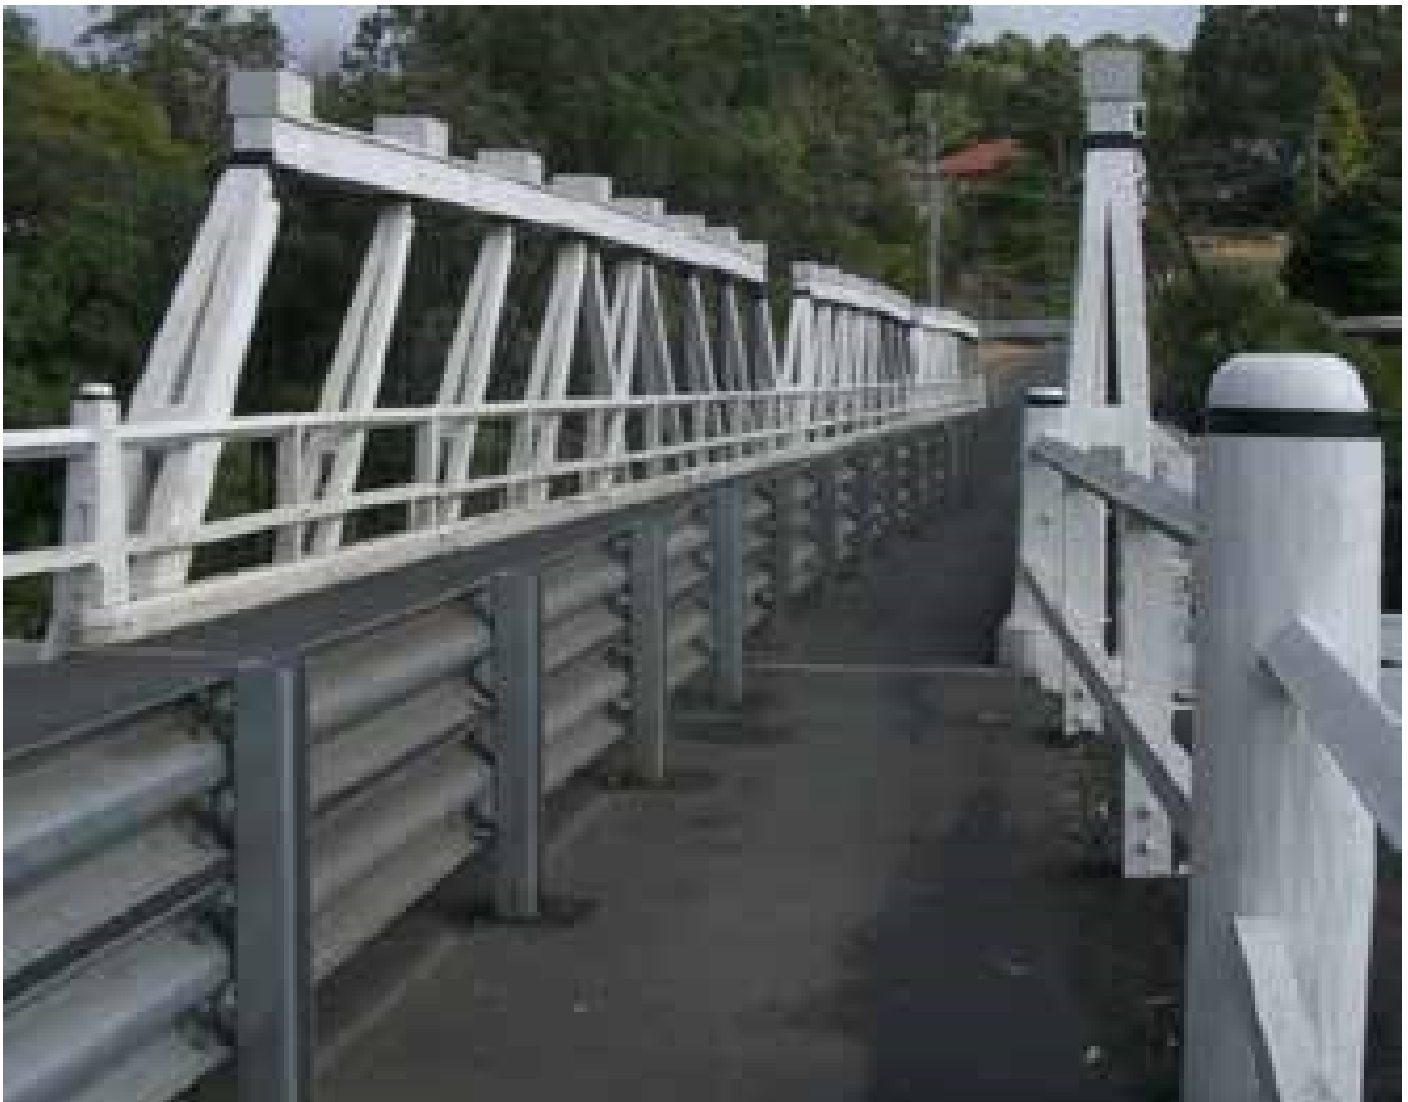
Figure 2-81: Guardrail

As can be seen in Figure 2.81, by far the most considerable modification to the railings is the addition of a modern steel guardrail along the length of the bridge to provide a safe passage for pedestrians. The guardrail consists of two W-beams attached to metal posts. This is a non-original feature which detracts from the aesthetics of the bridge. Furthermore, since the guardrail is a flexible barrier system, it has very limited ability to redirect an errant vehicle, and so its function is more delineation than protection of pedestrians.

- A suitably designed visually recessive external footway would allow the removal of the existing visually intrusive internal footway which was installed in 1979 (see Figure 2.81).

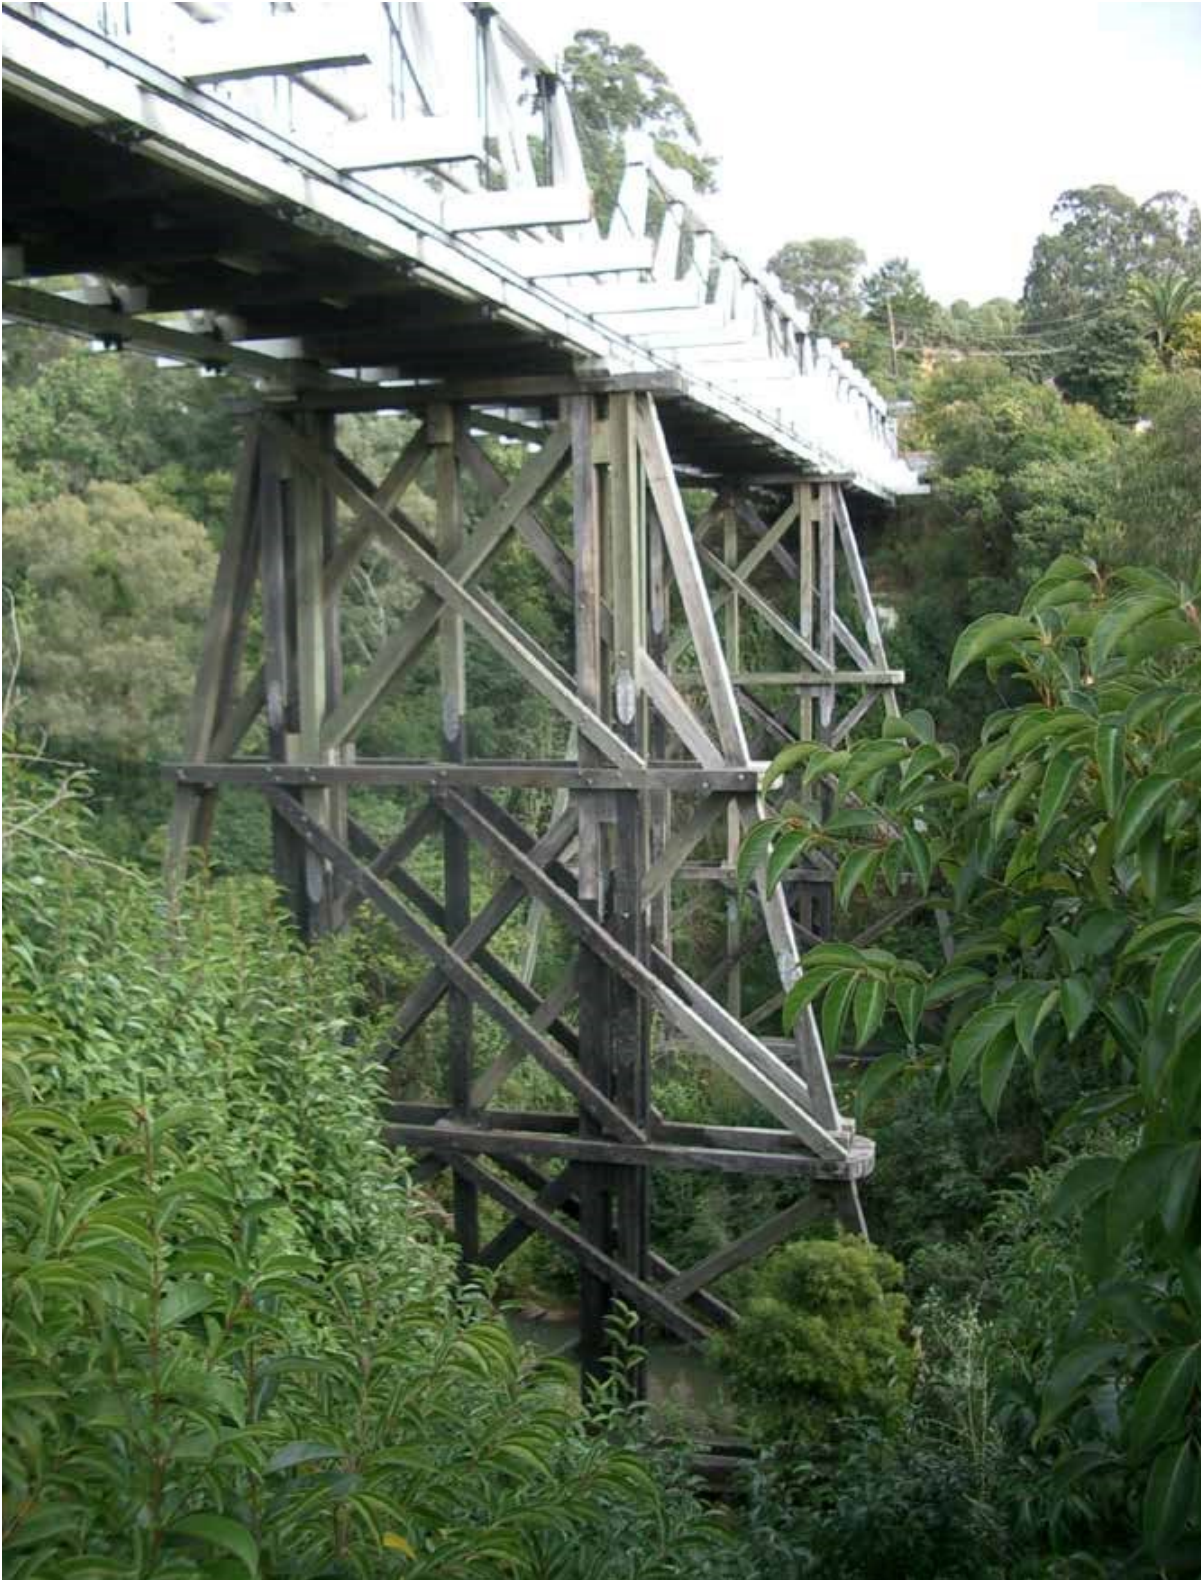
Figure 2-86: Timber double trestle piers at Victoria Bridge

The two piers appear to be largely original in configuration, although a number of additional splices have been added (due to difficulties in obtaining timber) and spacer blocks modified. Galvanised welded metal brackets have been added at the base of each pier rather than mortise and tenon joints. These modifications detract from the structural integrity and heritage integrity of the bridge.
