Victoria Bridge at Picton

Conservation Management Plan

Roads and Maritime Services | October 2018

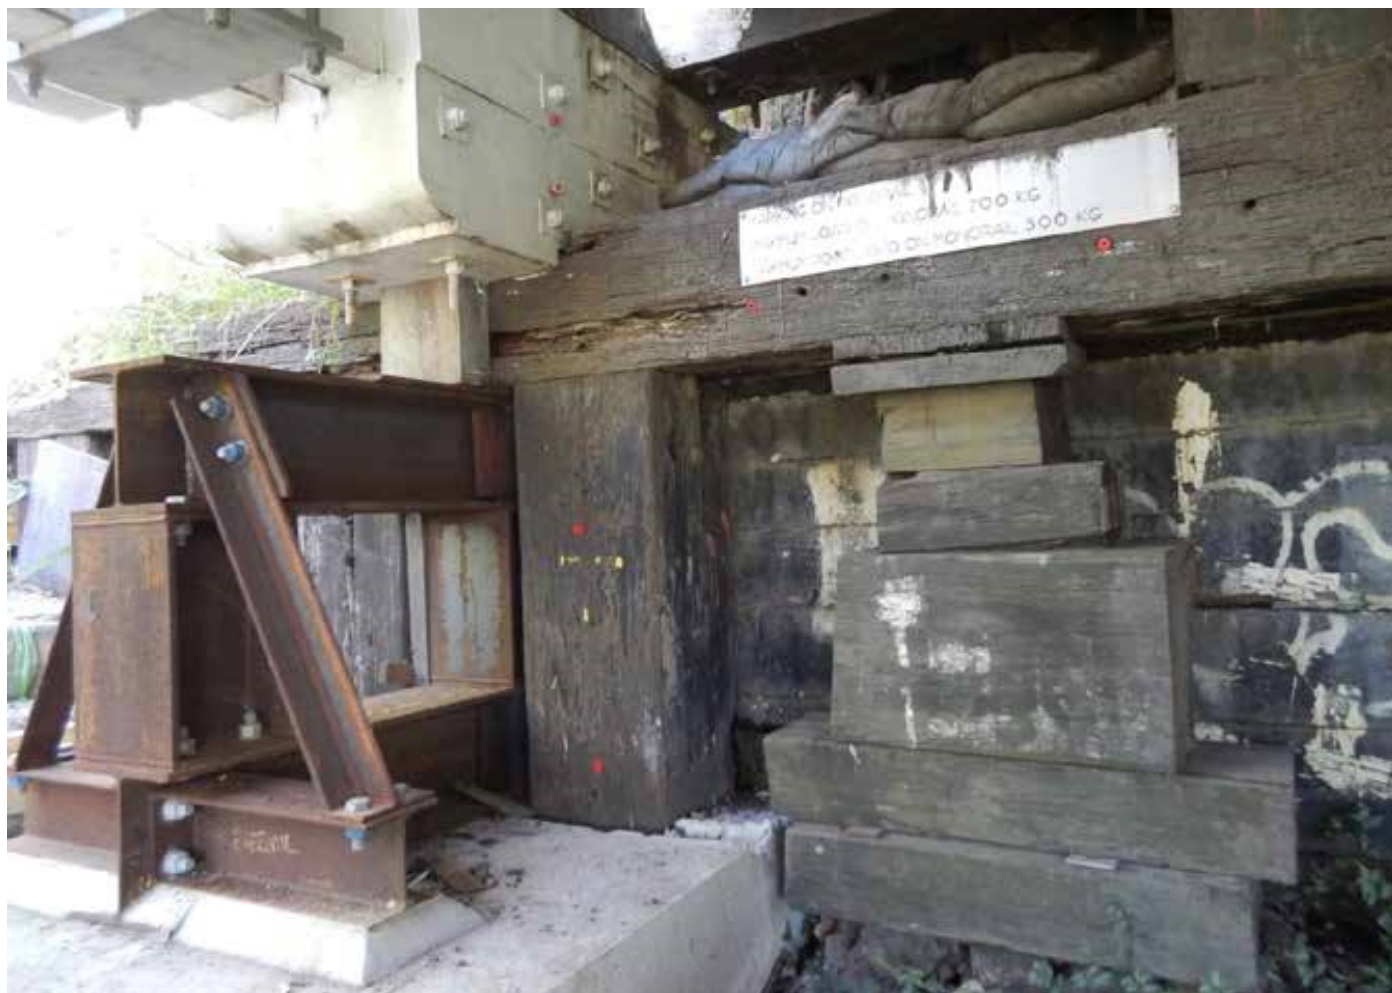
Figure 2-88: Photograph of Victoria Bridge Abutment A downstream side

Abutment A is a much less visible and accessible abutment, being considerably shorter than Abutment B, and also being located in a cutting, rather than an embankment, so it is rather hidden. Modifications to Abutment A include addition of concrete at the bases of some piles and also under some temporary props. There are also fabricated steel props as well as piles of timber packing and sand bags. Due to deterioration and various modifications, the ends of the bottom chord on the upstream side is currently somewhat buried in sediment and therefore at risk of deterioration.
