Woolgoolga to Ballina (W2B) Pacific Highway Upgrade

Koala Monitoring Program - Year 2 (2018/19) Annual Report

Final Report – Version 2
27 August 2019

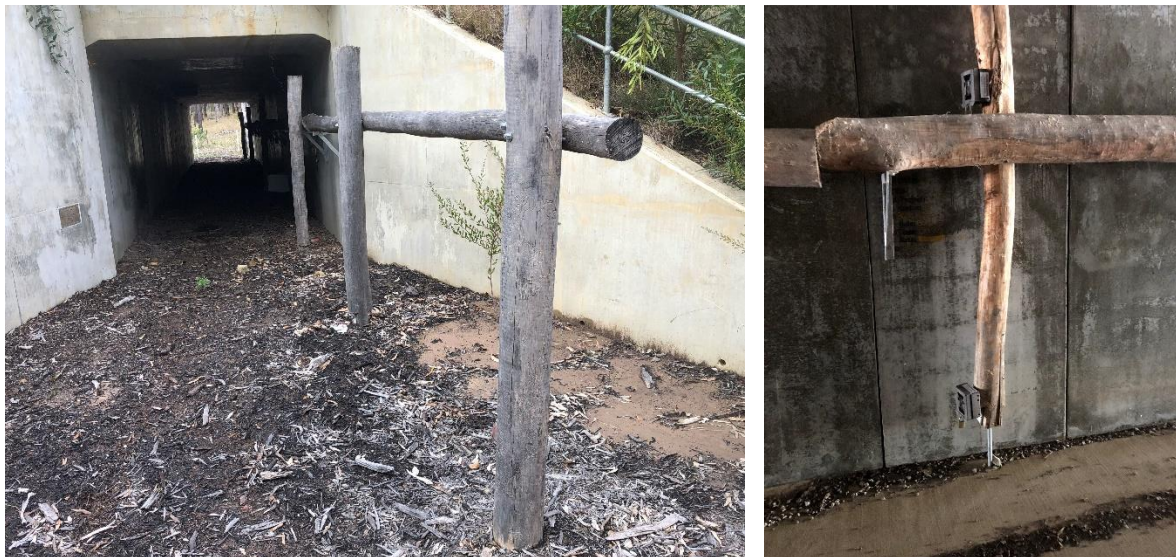
All box culverts featured timber post-and-rail (fauna) furniture through their length (Plate 1). Floor substrate included concrete (K2), concrete and raised gravel path (K1, K8-K11), timber mulch on concrete floor (K3-K6, K12) and a combination of gravel and loose soil (K7). Culvert lengths ranged from 16m at the split northern median (K10) to 72.8m at Dirty Creek range (K2).

Plate 1: All monitored box culverts contained fauna furniture and some featured mulch spread over the concrete floor (left). Cameras were installed on the center post within each culvert – one viewing along the rail and the other along the floor (right).

Culverts were monitored with either Swift 3C or Swift Enduro cameras (*Outdoor Cameras Australia*) for three months during spring/summer 2018. Two cameras were mounted on the central post of the fauna furniture – one positioned to capture animals moving along the furniture and the other positioned approximately 400mm above ground level to capture animals moving along the floor (Plate 1). Both cameras were oriented east. All cameras were contained in security cases with padlocks.

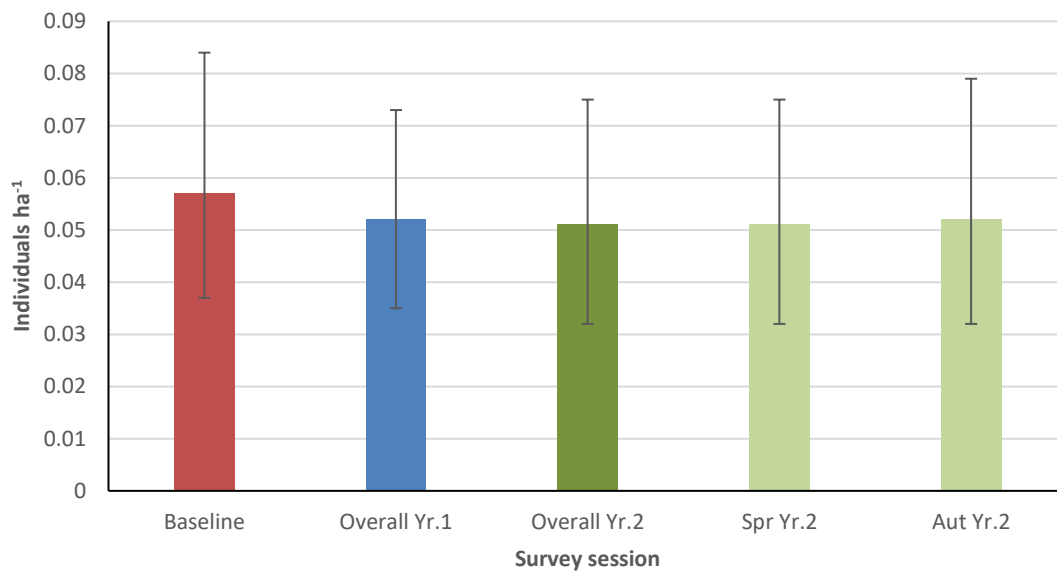
Based on the Bayesian estimation analysis, the density estimate for spring was 0.051 koalas ha⁻¹ (95%CI: 0.032-0.075) and autumn was 0.052 koalas ha⁻¹ (95%CI: 0.032-0.079). Overall, the Year 2 density estimate for Broadwater was 0.051 koalas ha⁻¹ (95%CI: 0.032-0.075). This compares to a revised baseline density estimate of 0.057 (95%CI: 0.037-0.084) koalas ha⁻¹ (Figure 7).

Figure 7: Comparison of Broadwater focal area density estimates (\pm 95%CI) for baseline year (2015), year 1 overall, year 2 overall, year 2 spring and year 2 autumn.

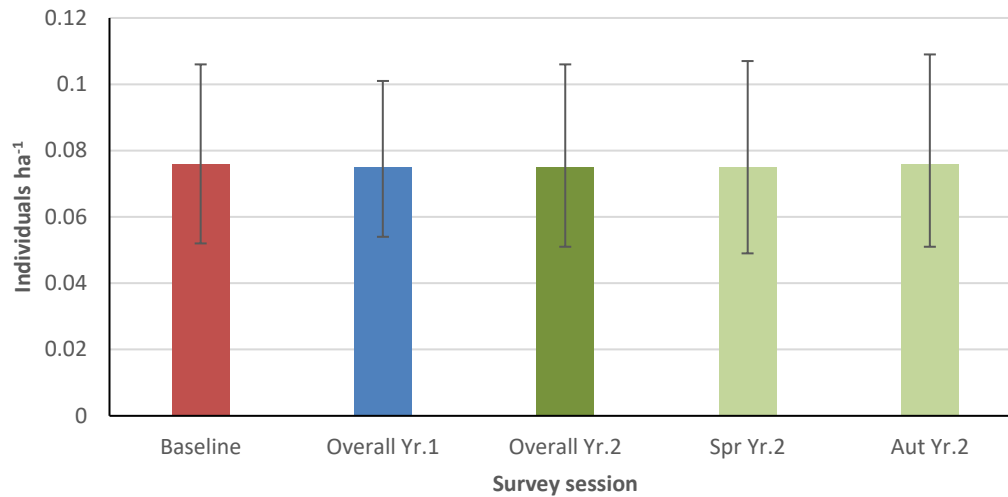
Based on the Bayesian estimation analysis, the density estimate at Bagotville for spring was 0.075 koalas ha⁻¹ (95%CI: 0.049-0.107) and for autumn was 0.076 koalas ha⁻¹ (95%CI: 0.051-0.109). The overall Year 2 density estimate was 0.075 koalas ha⁻¹ (95%CI: 0.051-0.106). This compares to a revised baseline density estimate of 0.076 (95%CI: 0.052-0.106) koalas ha⁻¹ (Figure 8).

Figure 8: Comparison of Bagotville focal area density estimates (\pm 95%CI) for baseline year (2015), year 1 overall, year 2 overall, year 2 spring and year 2 autumn.

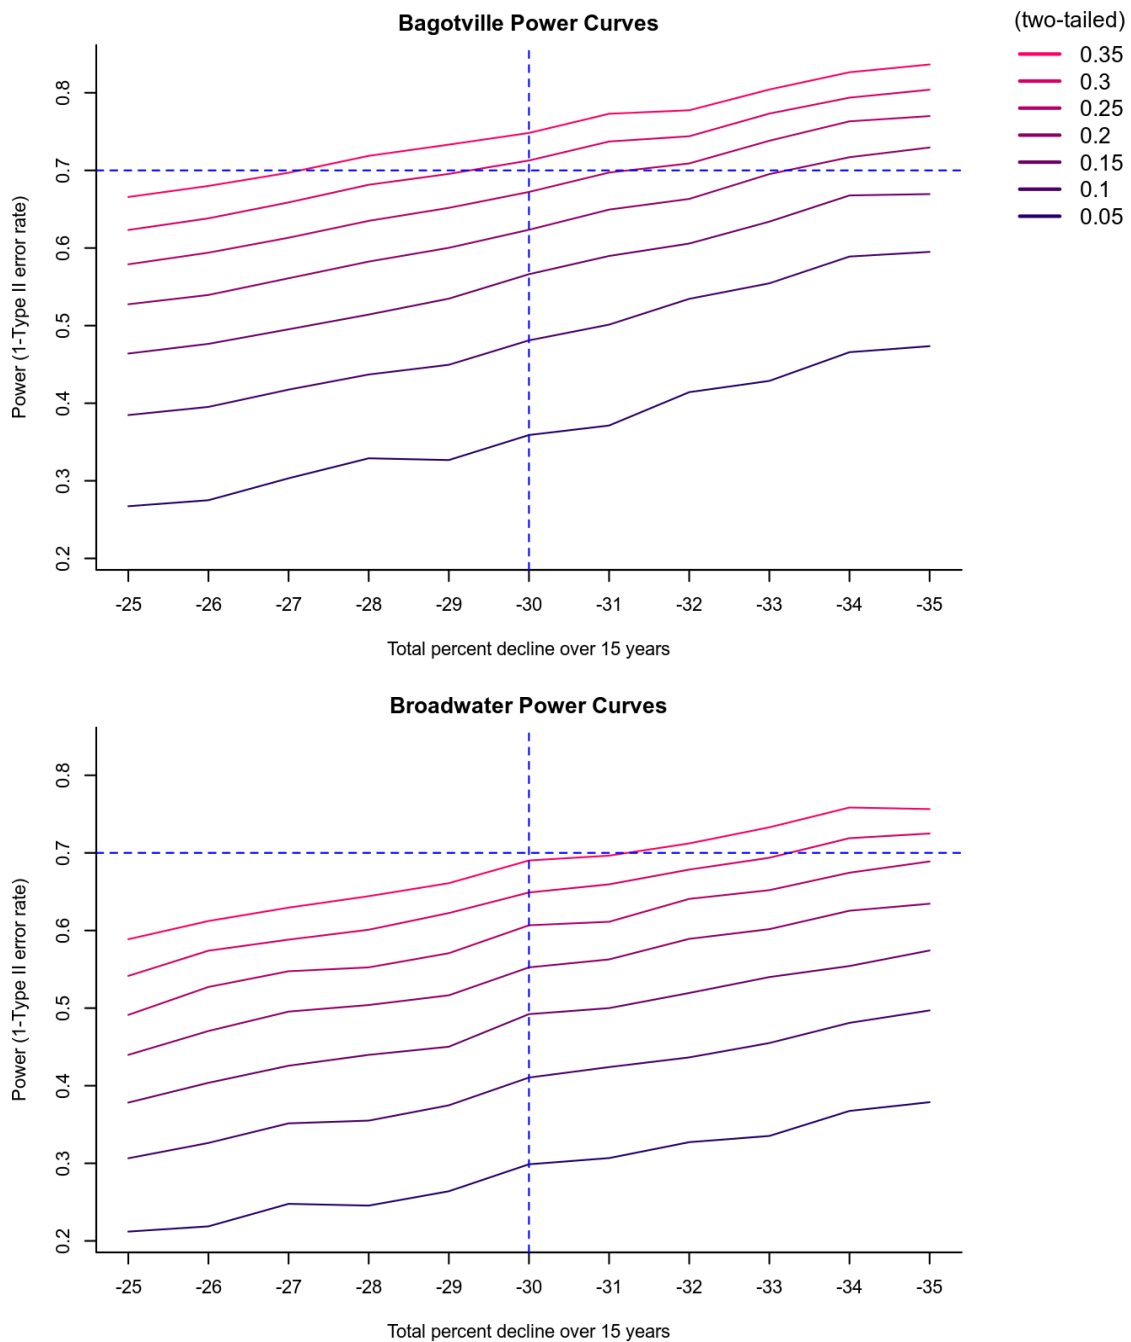
For a maximum Type-I error rate of 0.3, the estimated power at Bagotville and Broadwater were 0.713 and 0.649 respectively (Figure 9). For a maximum Type-I error rate of 0.35, the estimated power for Bagotville and Broadwater were 0.748 and 0.690 respectively.

Figure 9: Statistical power to detect a -30% drop in baseline densities versus Year 15 of the monitoring program for different maximum levels of Type-I errors (lines).

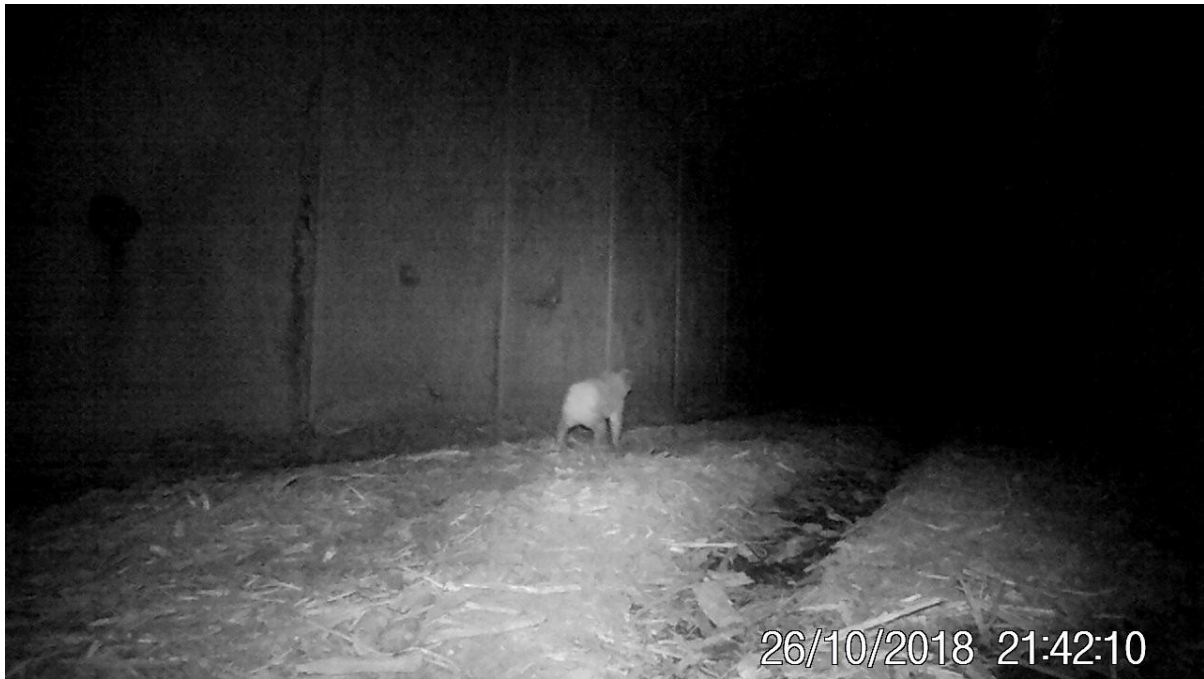
A koala was recorded making a complete crossing of K5 on 26/10/2018 (Plate 2). The view of the individual was from the rear so sex could not be determined. However, the size of the individual suggests it was an adult and its bottom did not show obvious signs of cystitis (i.e. wet/stained). Other threatened species including the brush-tailed phascogale (*Phascogale tapoatafa*), rufous bettong (*Aepyprymnus rufescens*), long-nosed potoroo (*Potorous tridactylus*) and Stephens banded snake (*Haplocephalus stephensii*) were recorded during the monitoring period (Plate 3; Table 6).

Plate 2: Koala detected making a complete eastward crossing at K5 on 26 October 2018.

The record of a complete crossing of culvert K5 by a koala on one occasion (26/10/2018) is an encouraging start to crossing structure monitoring particularly as koalas are in low abundance in sections 1 and 2. Indeed, no koalas were observed during the clearing phase in the section one area (Sandpiper 2016). Further, no scats or scratches were detected in habitat surrounding underpass entrances. Koalas were not detected during concurrent winter and late summer threatened mammal monitoring of 10 of the 12 koala culverts (Sandpiper 2019b).

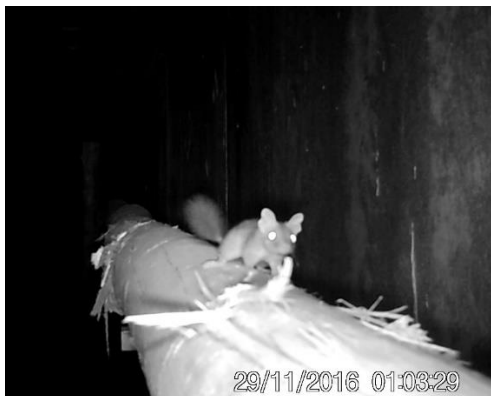
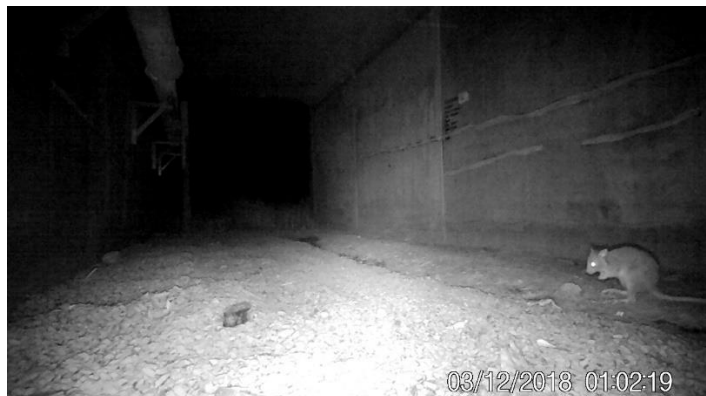
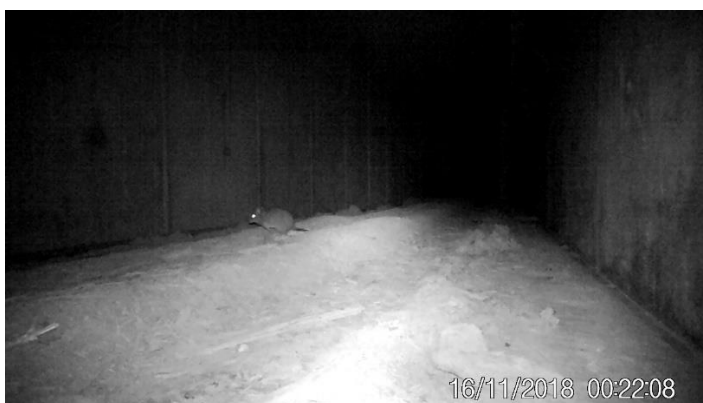
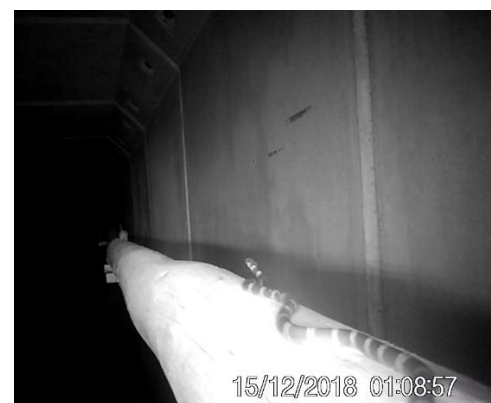
Plate 3: Several other threatened mammal species and a threatened reptile were detected using culverts during the monitoring period including brush-tailed phascogale (top left), rufous bettong (top right), long-nosed potoroo (bottom left) and Stephen's banded snake (bottom right), observed in possible pursuit of an *Antechinus* sp.

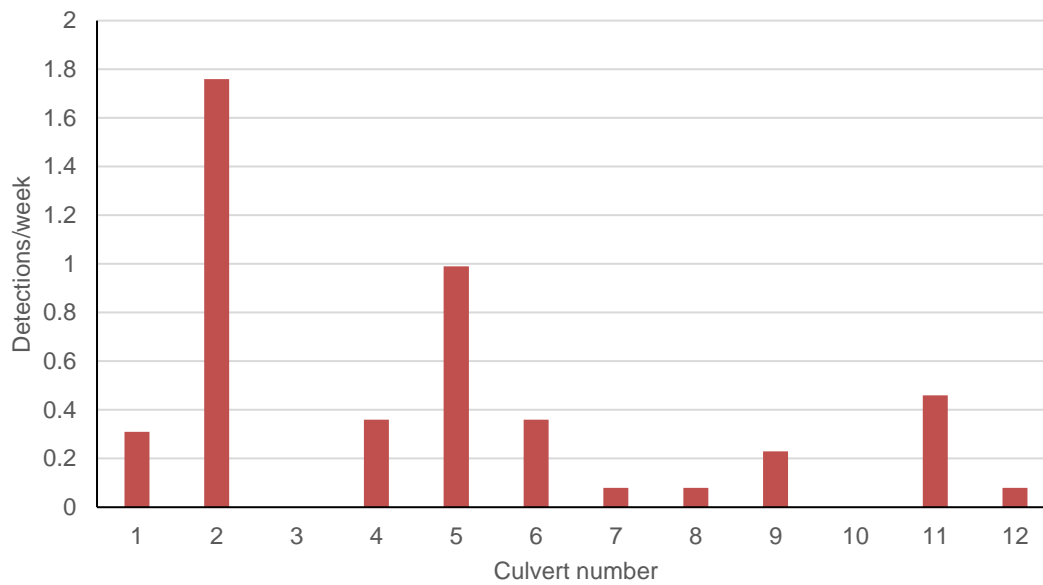
Exotic predators were detected at 10 of the 12 culverts but only accounted for 5.4% of all fauna detections (Table 6; Figure 10). Cats (*Felis catus*) accounted for 93.5% of all predator detections and were detected at eight culvert sites – K1, K2, K4-K7, K9, K11. Dog (*Canis lupus familiaris*) and fox (*Vulpes vulpes*) were each detected on two occasions at K8 and K11 and K2 and K12, respectively. Detection frequency ranged between no detections (K3, K10) and 1.76 detections/week at K2, mostly by cats (Figure 10). No footage showed evidence of predation and no evidence of predation was observed during scat and scratch searches.

Figure 10: Exotic predator (i.e. cat, dog, fox) detections by culvert site. Detections = sum of complete and incomplete crossings.

Exotic predators were detected at most sites (i.e. 10 of the 12 culverts) albeit at relatively low intensity (i.e. 5.4% of all fauna detections). Further, the majority of these records (i.e. 93.5%) were of cats with few records attributed to canids. No footage showed evidence of predation and no evidence was observed at culvert sites. It is likely that cats pose a very low koala predation risk and we are not aware of any reports of koala predation by cats. Notwithstanding, a large feral cat could conceivably take a small back-young.
