NEWCASTLE INNER CITY BYPASS: RANKIN PARK TO JESMOND (SSI-6888)
ENVIRONMENTAL REPRESENTATIVE MONTHLY REPORT
March 2024

Reporting Period: 1 to 31 March 2024.

Attachment: Site Images – March 2024

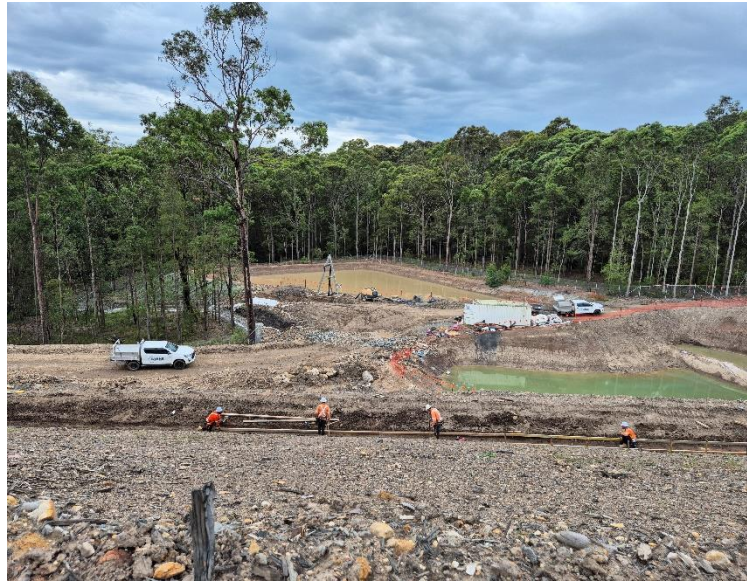
Image 2: Mainline storage basin (background) and sediment basin (foreground). The sediment basin has recently been cleaned out and returned to capacity.

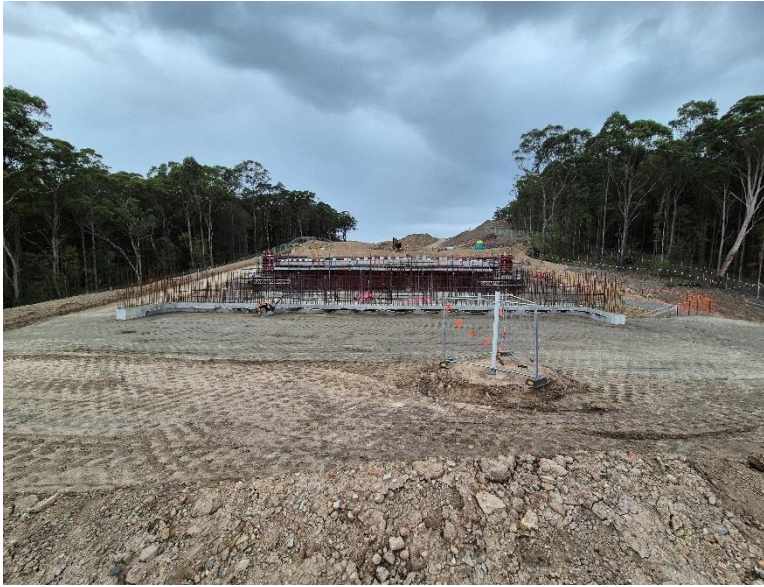
Image 3: Mainline at Fauna underpass. View looking South.

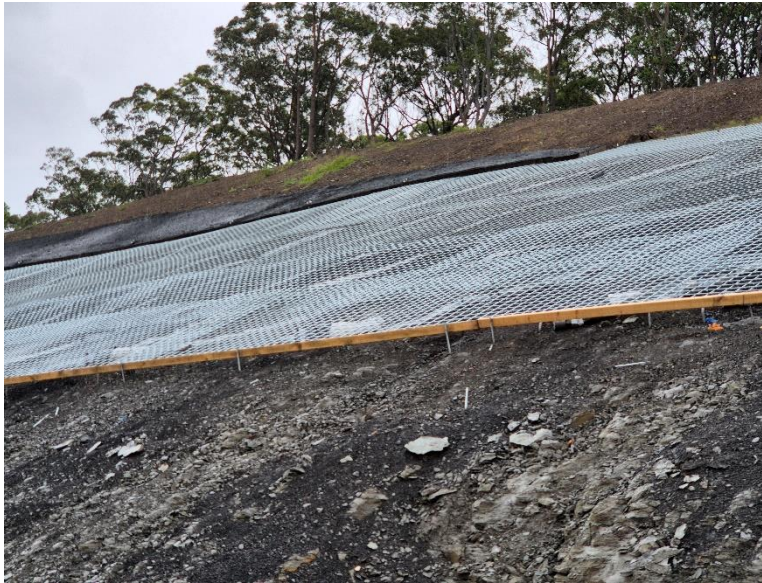
Image 5: Western batter on the mainline showing the formwork prior to application of shotcrete. No. 1

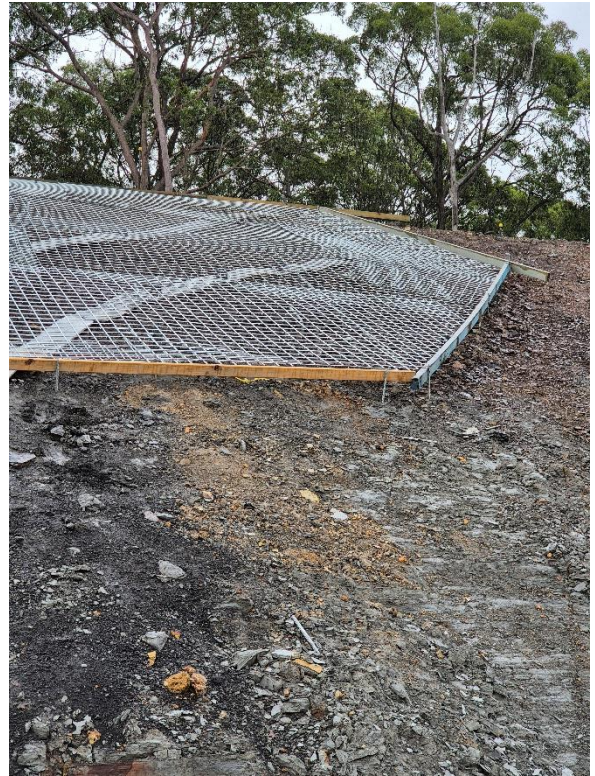
Image 6: Western batter on the mainline showing the formwork prior to application of shotcrete. No. 2

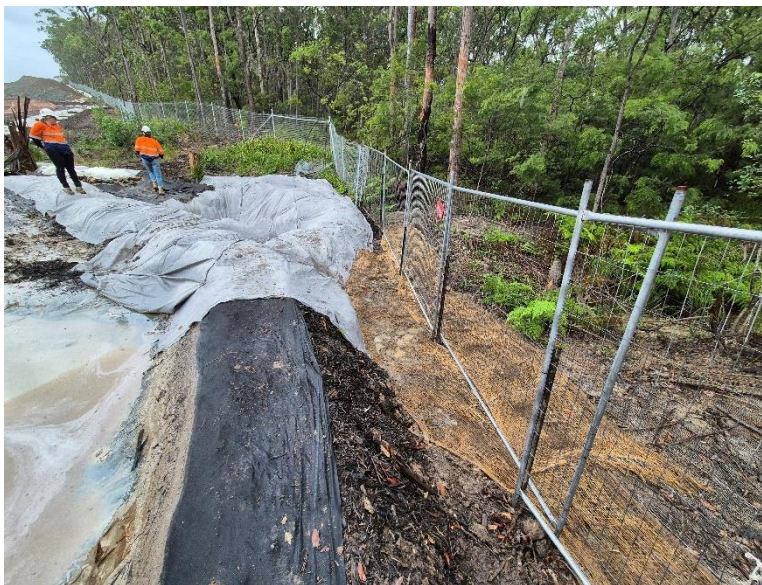
Image 7: Mainline near Creek 3 showing repairs to ErSed controls and remediation of surrounding area following major rain event.

The site environment project team continue to work hard with the difficult weather conditions and have had challenges this month with access to sediment basins, damaged ErSed controls with large amounts of storm weather to deal with.

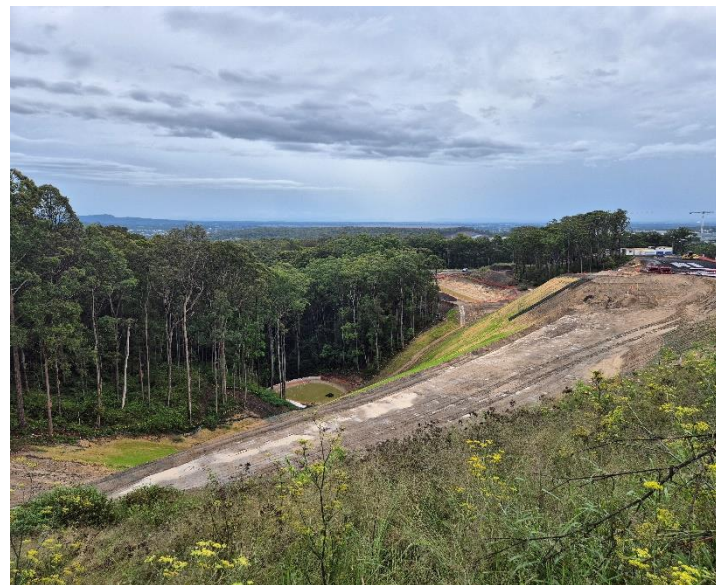
Image 8: View of the Southern Interchange looking north from Lookout Road. The light green on the batter is recent revegetation using MacMat and hydromulch.
