Preliminary Site Investigation

Hawkesbury-Nepean Valley Flood Evacuation Road Resilience Program Improvements on The Northern Road and Londonderry Road Flood Evacuation Routes

Client Project No.: P.0078303
Client Reference No. 22.0000139271.1313
Prepared for: Transport for NSW
14 June 2024

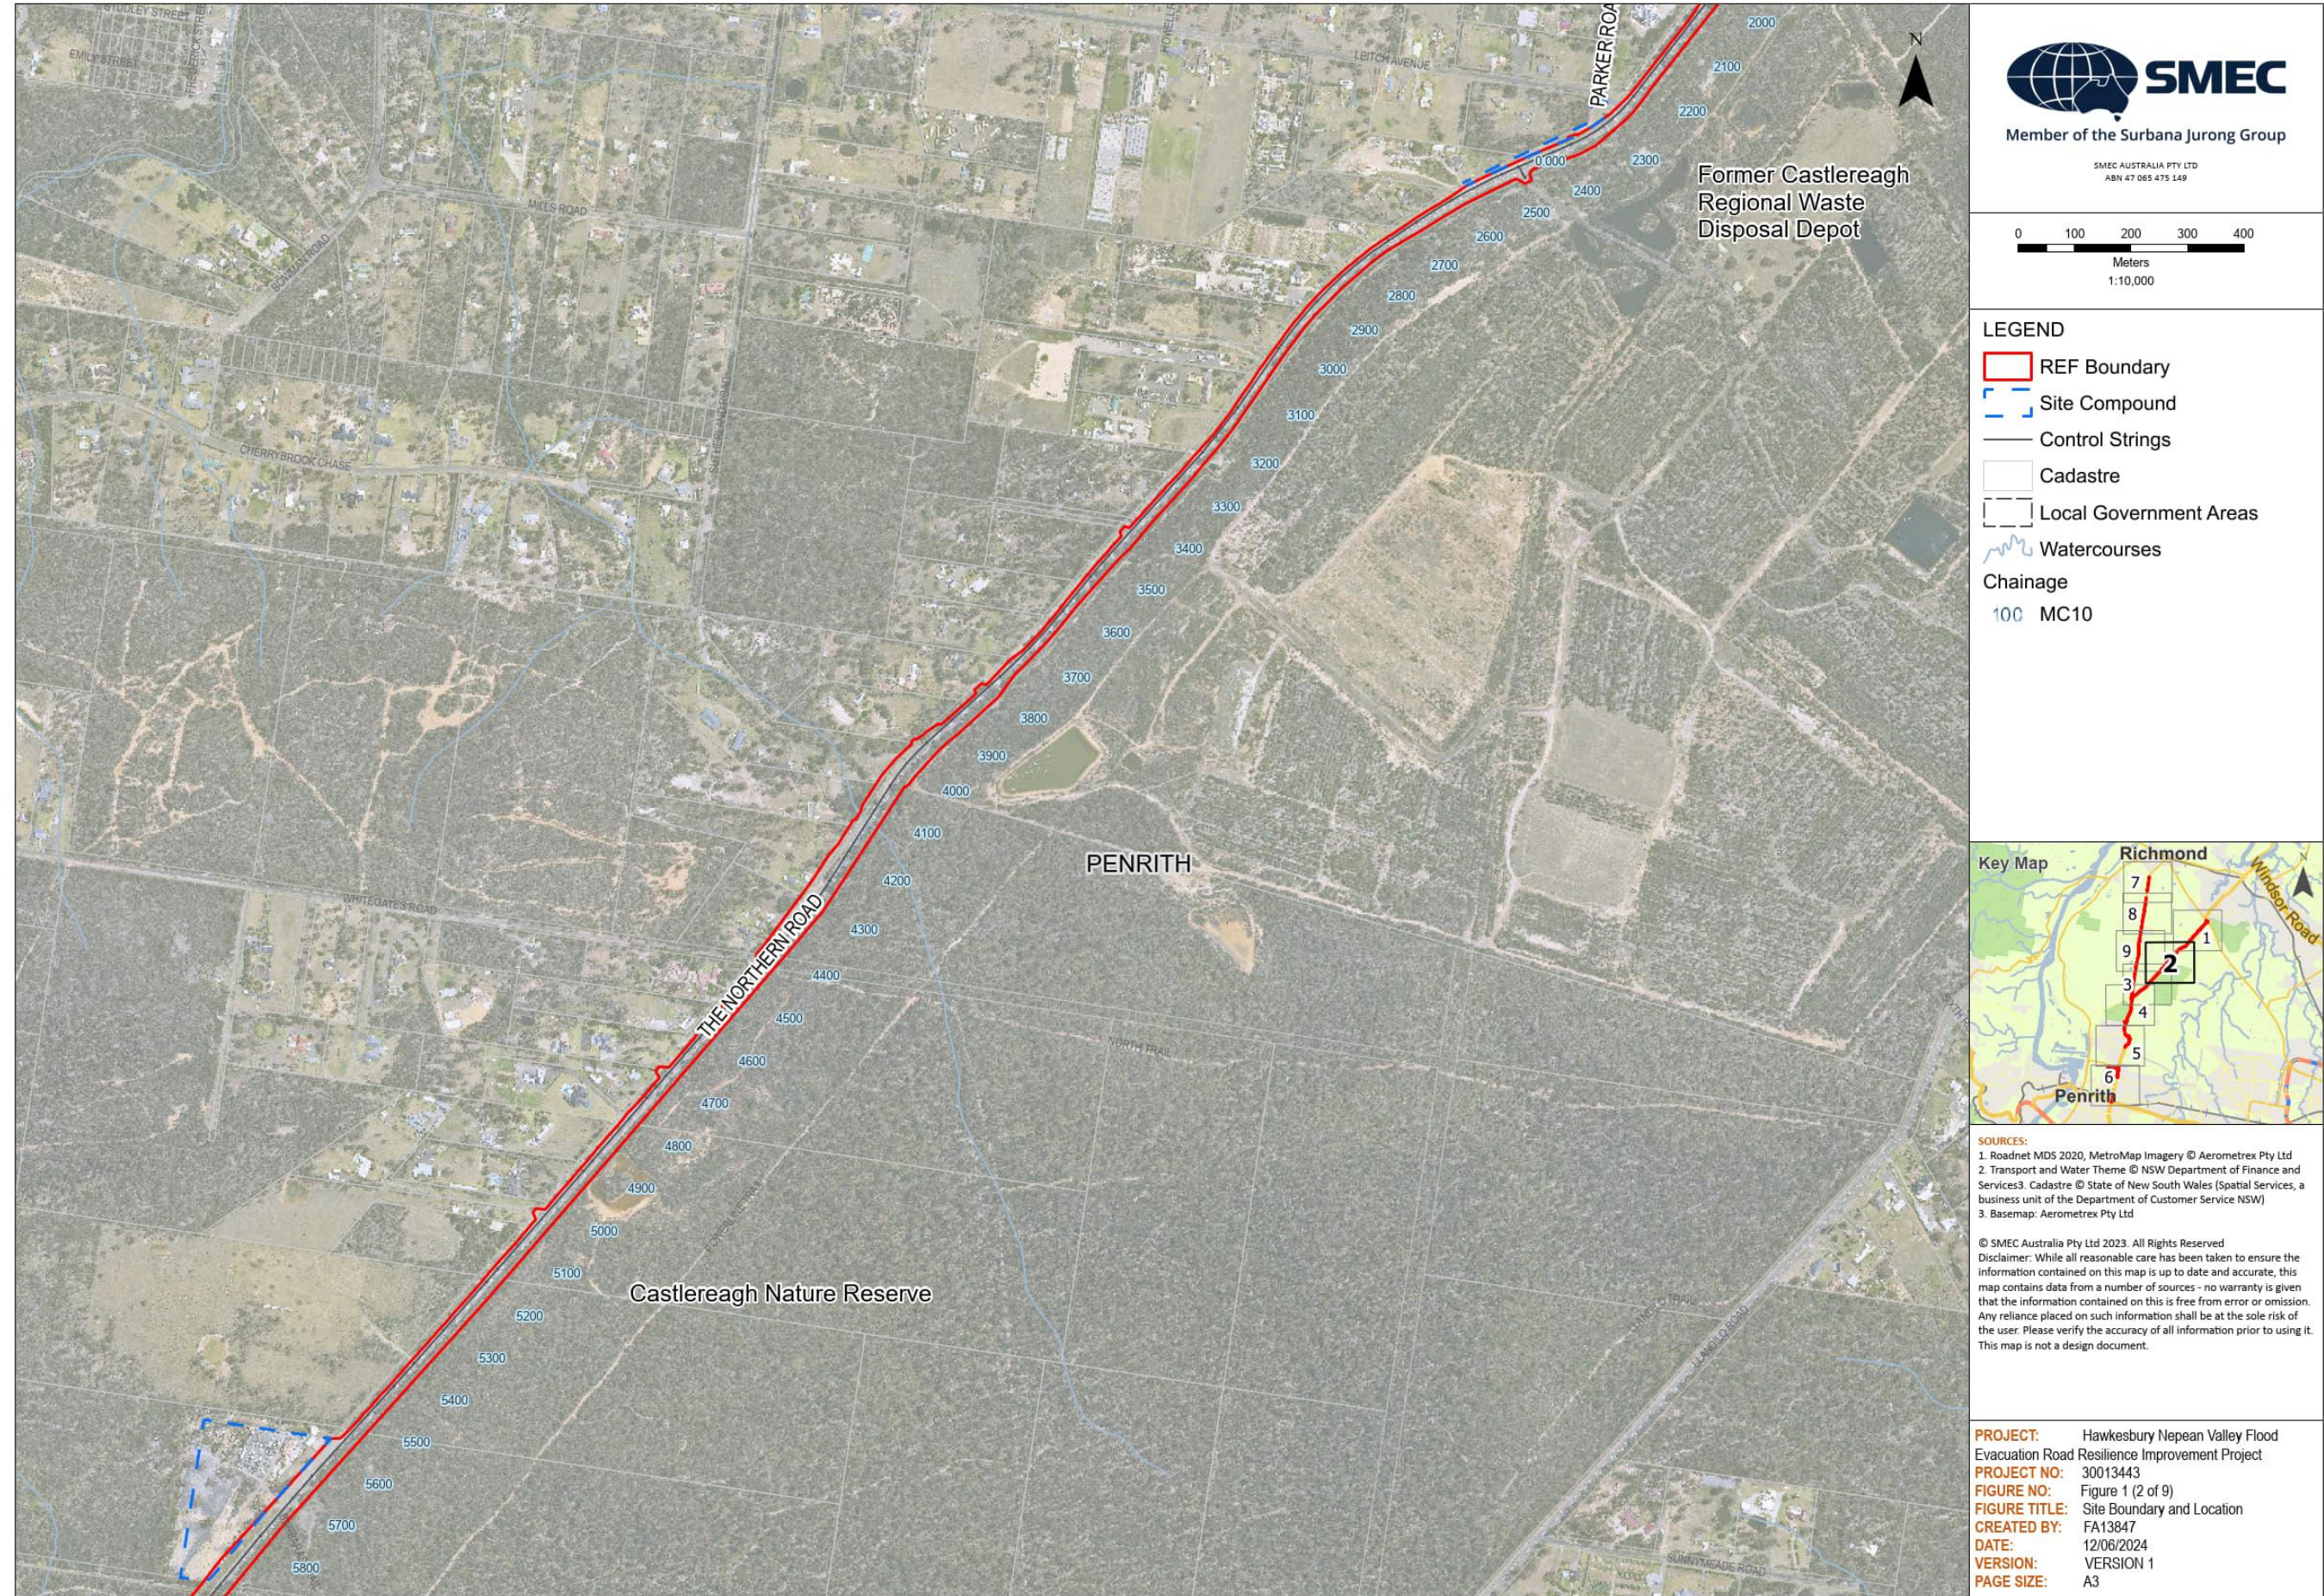
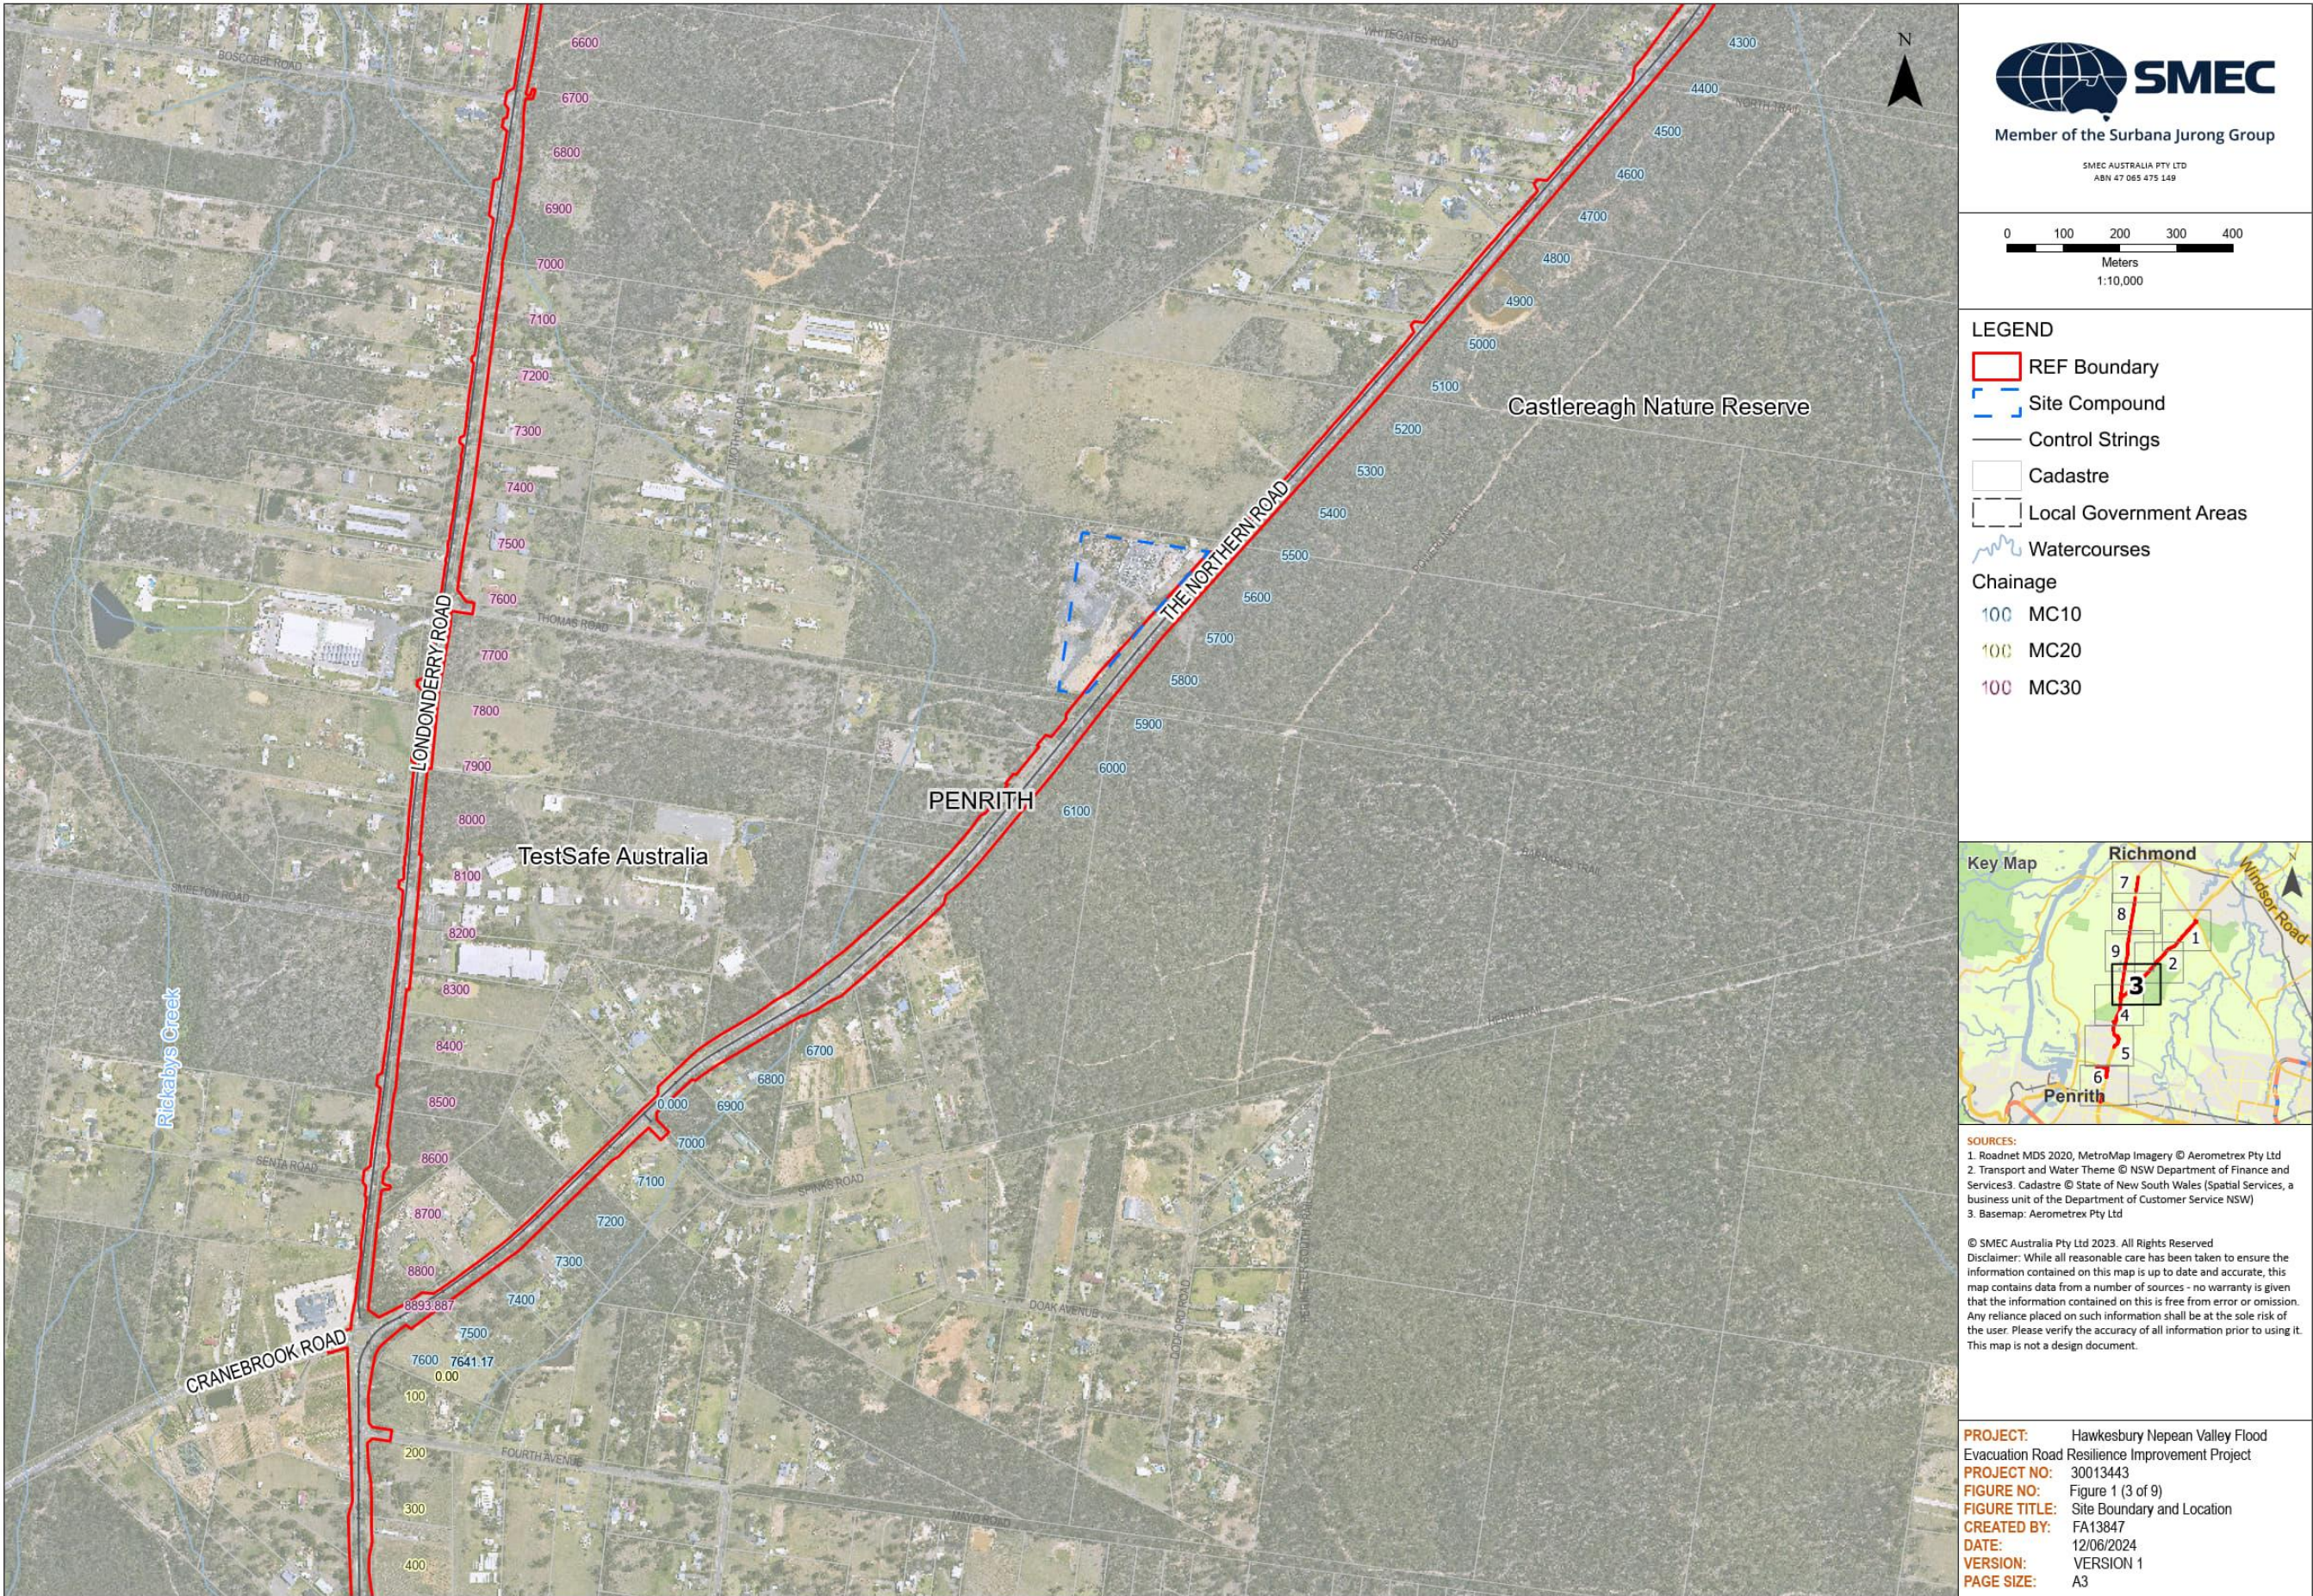
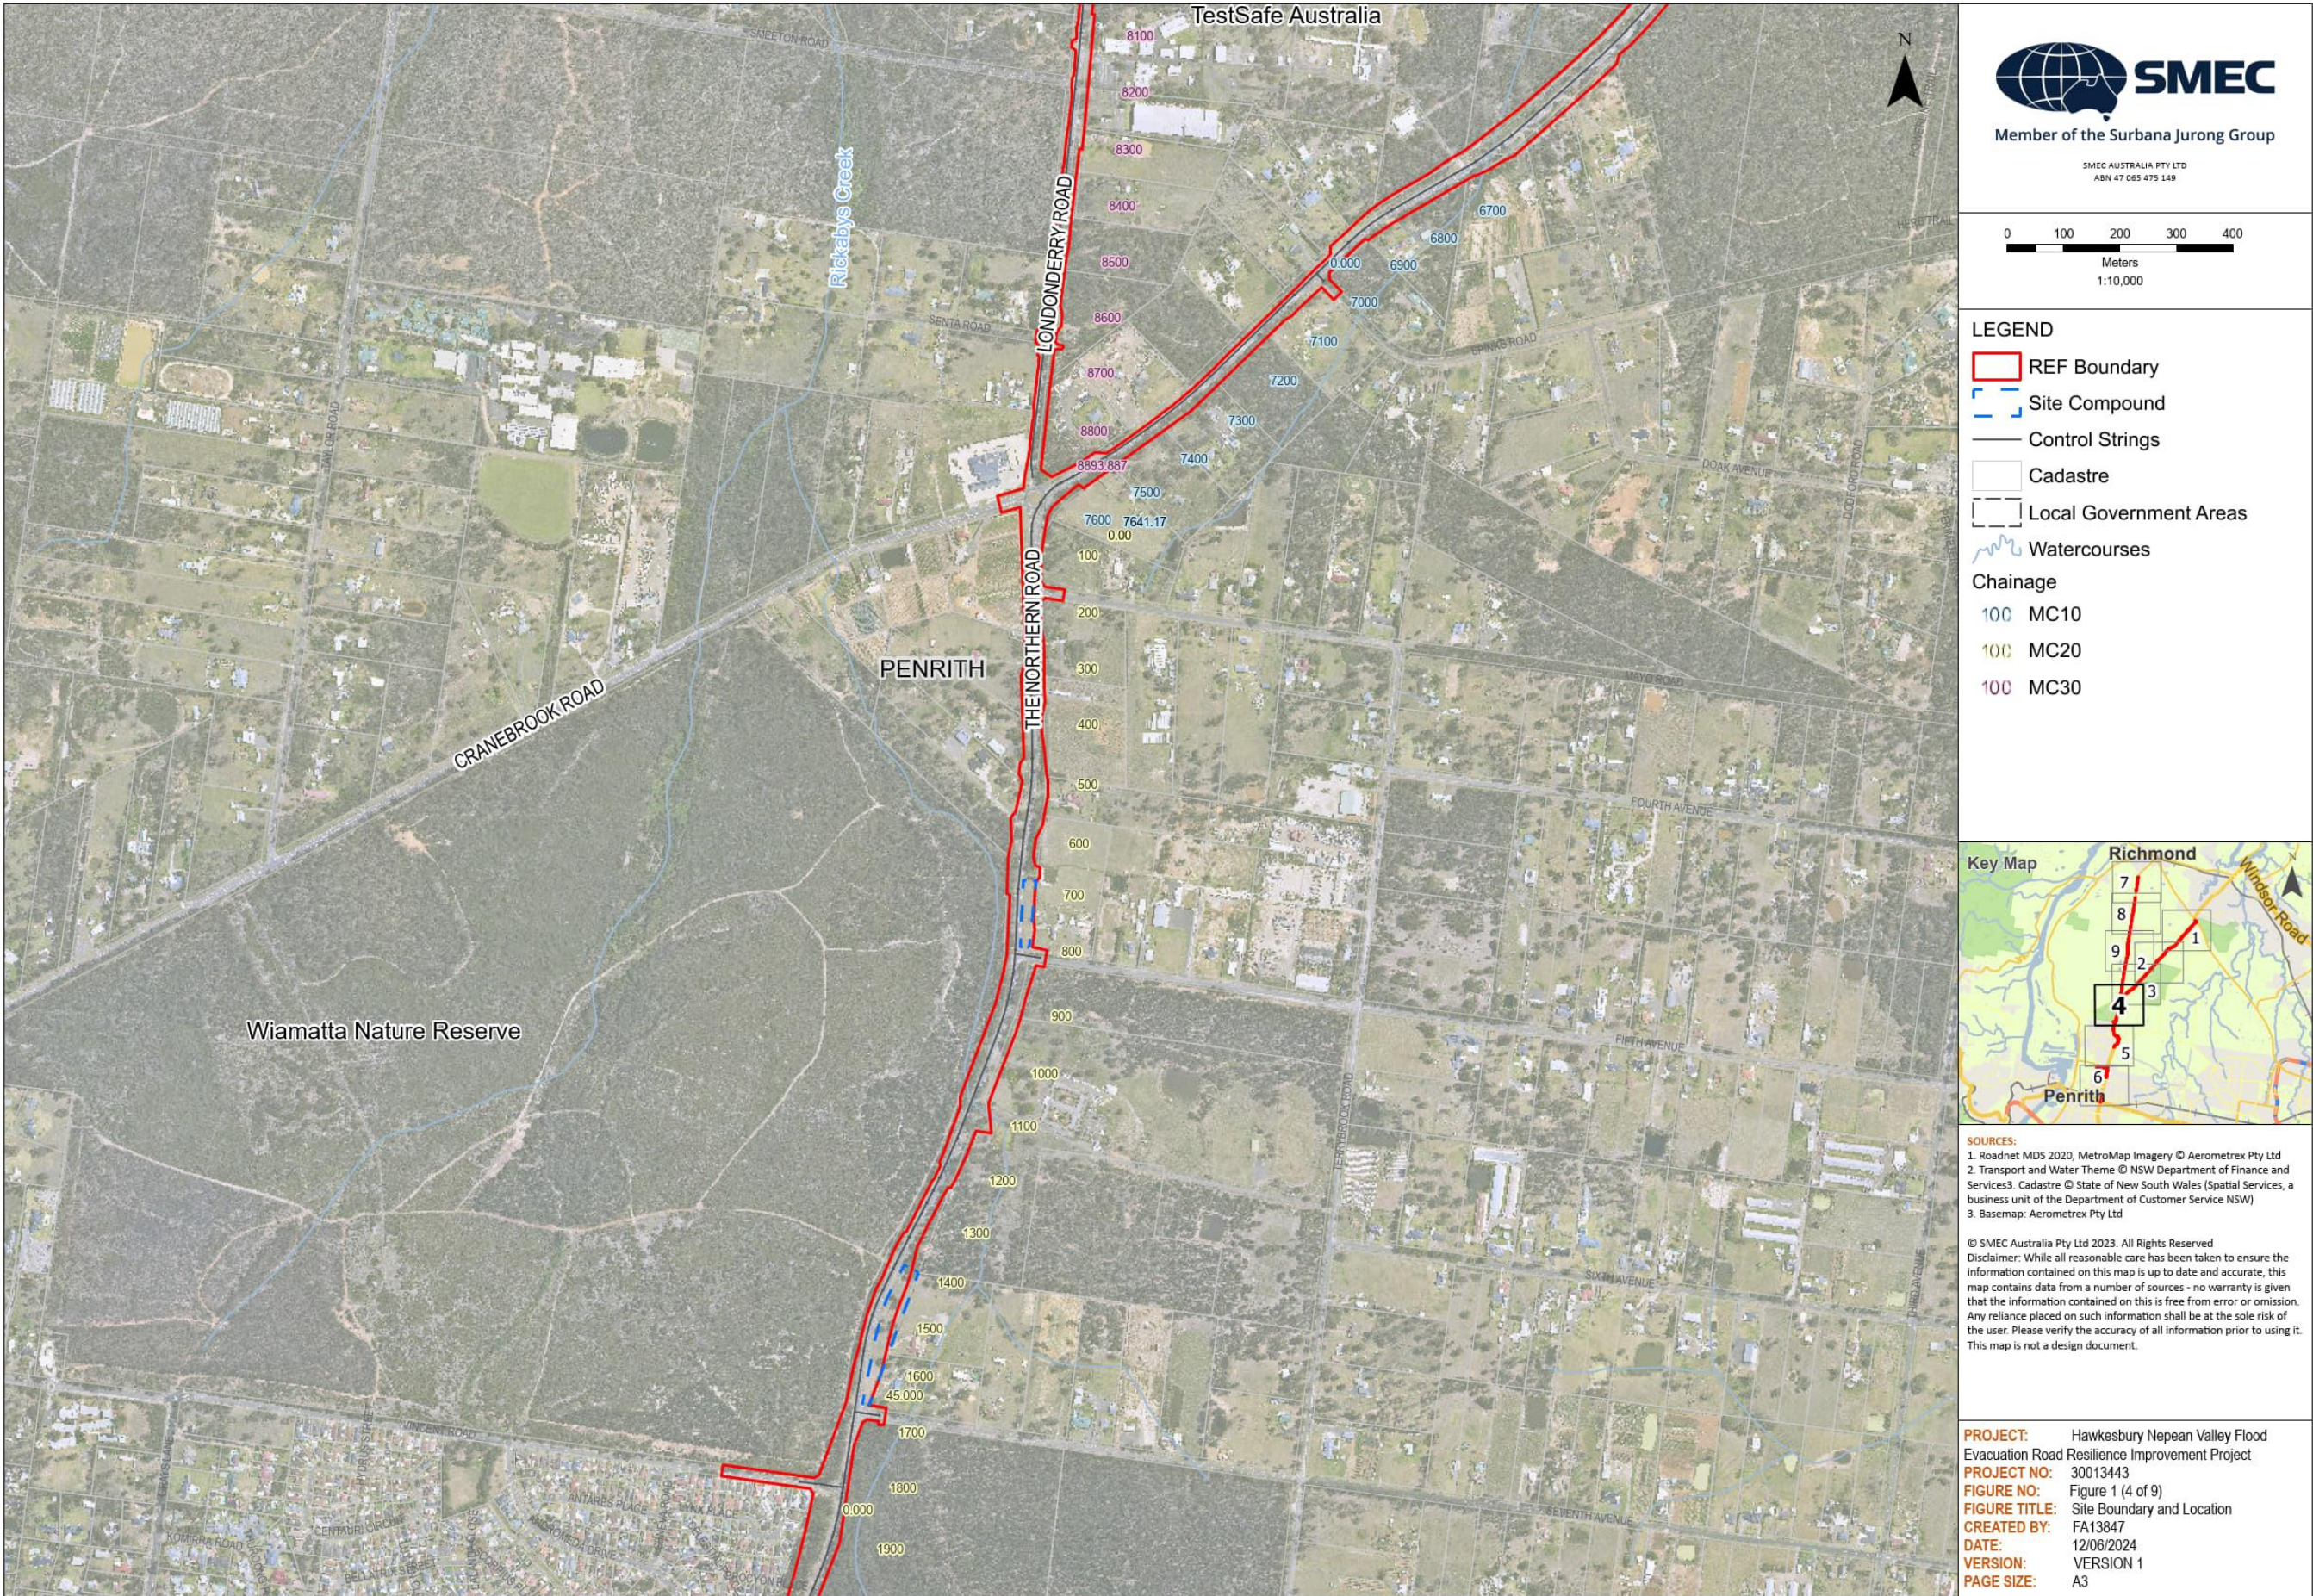
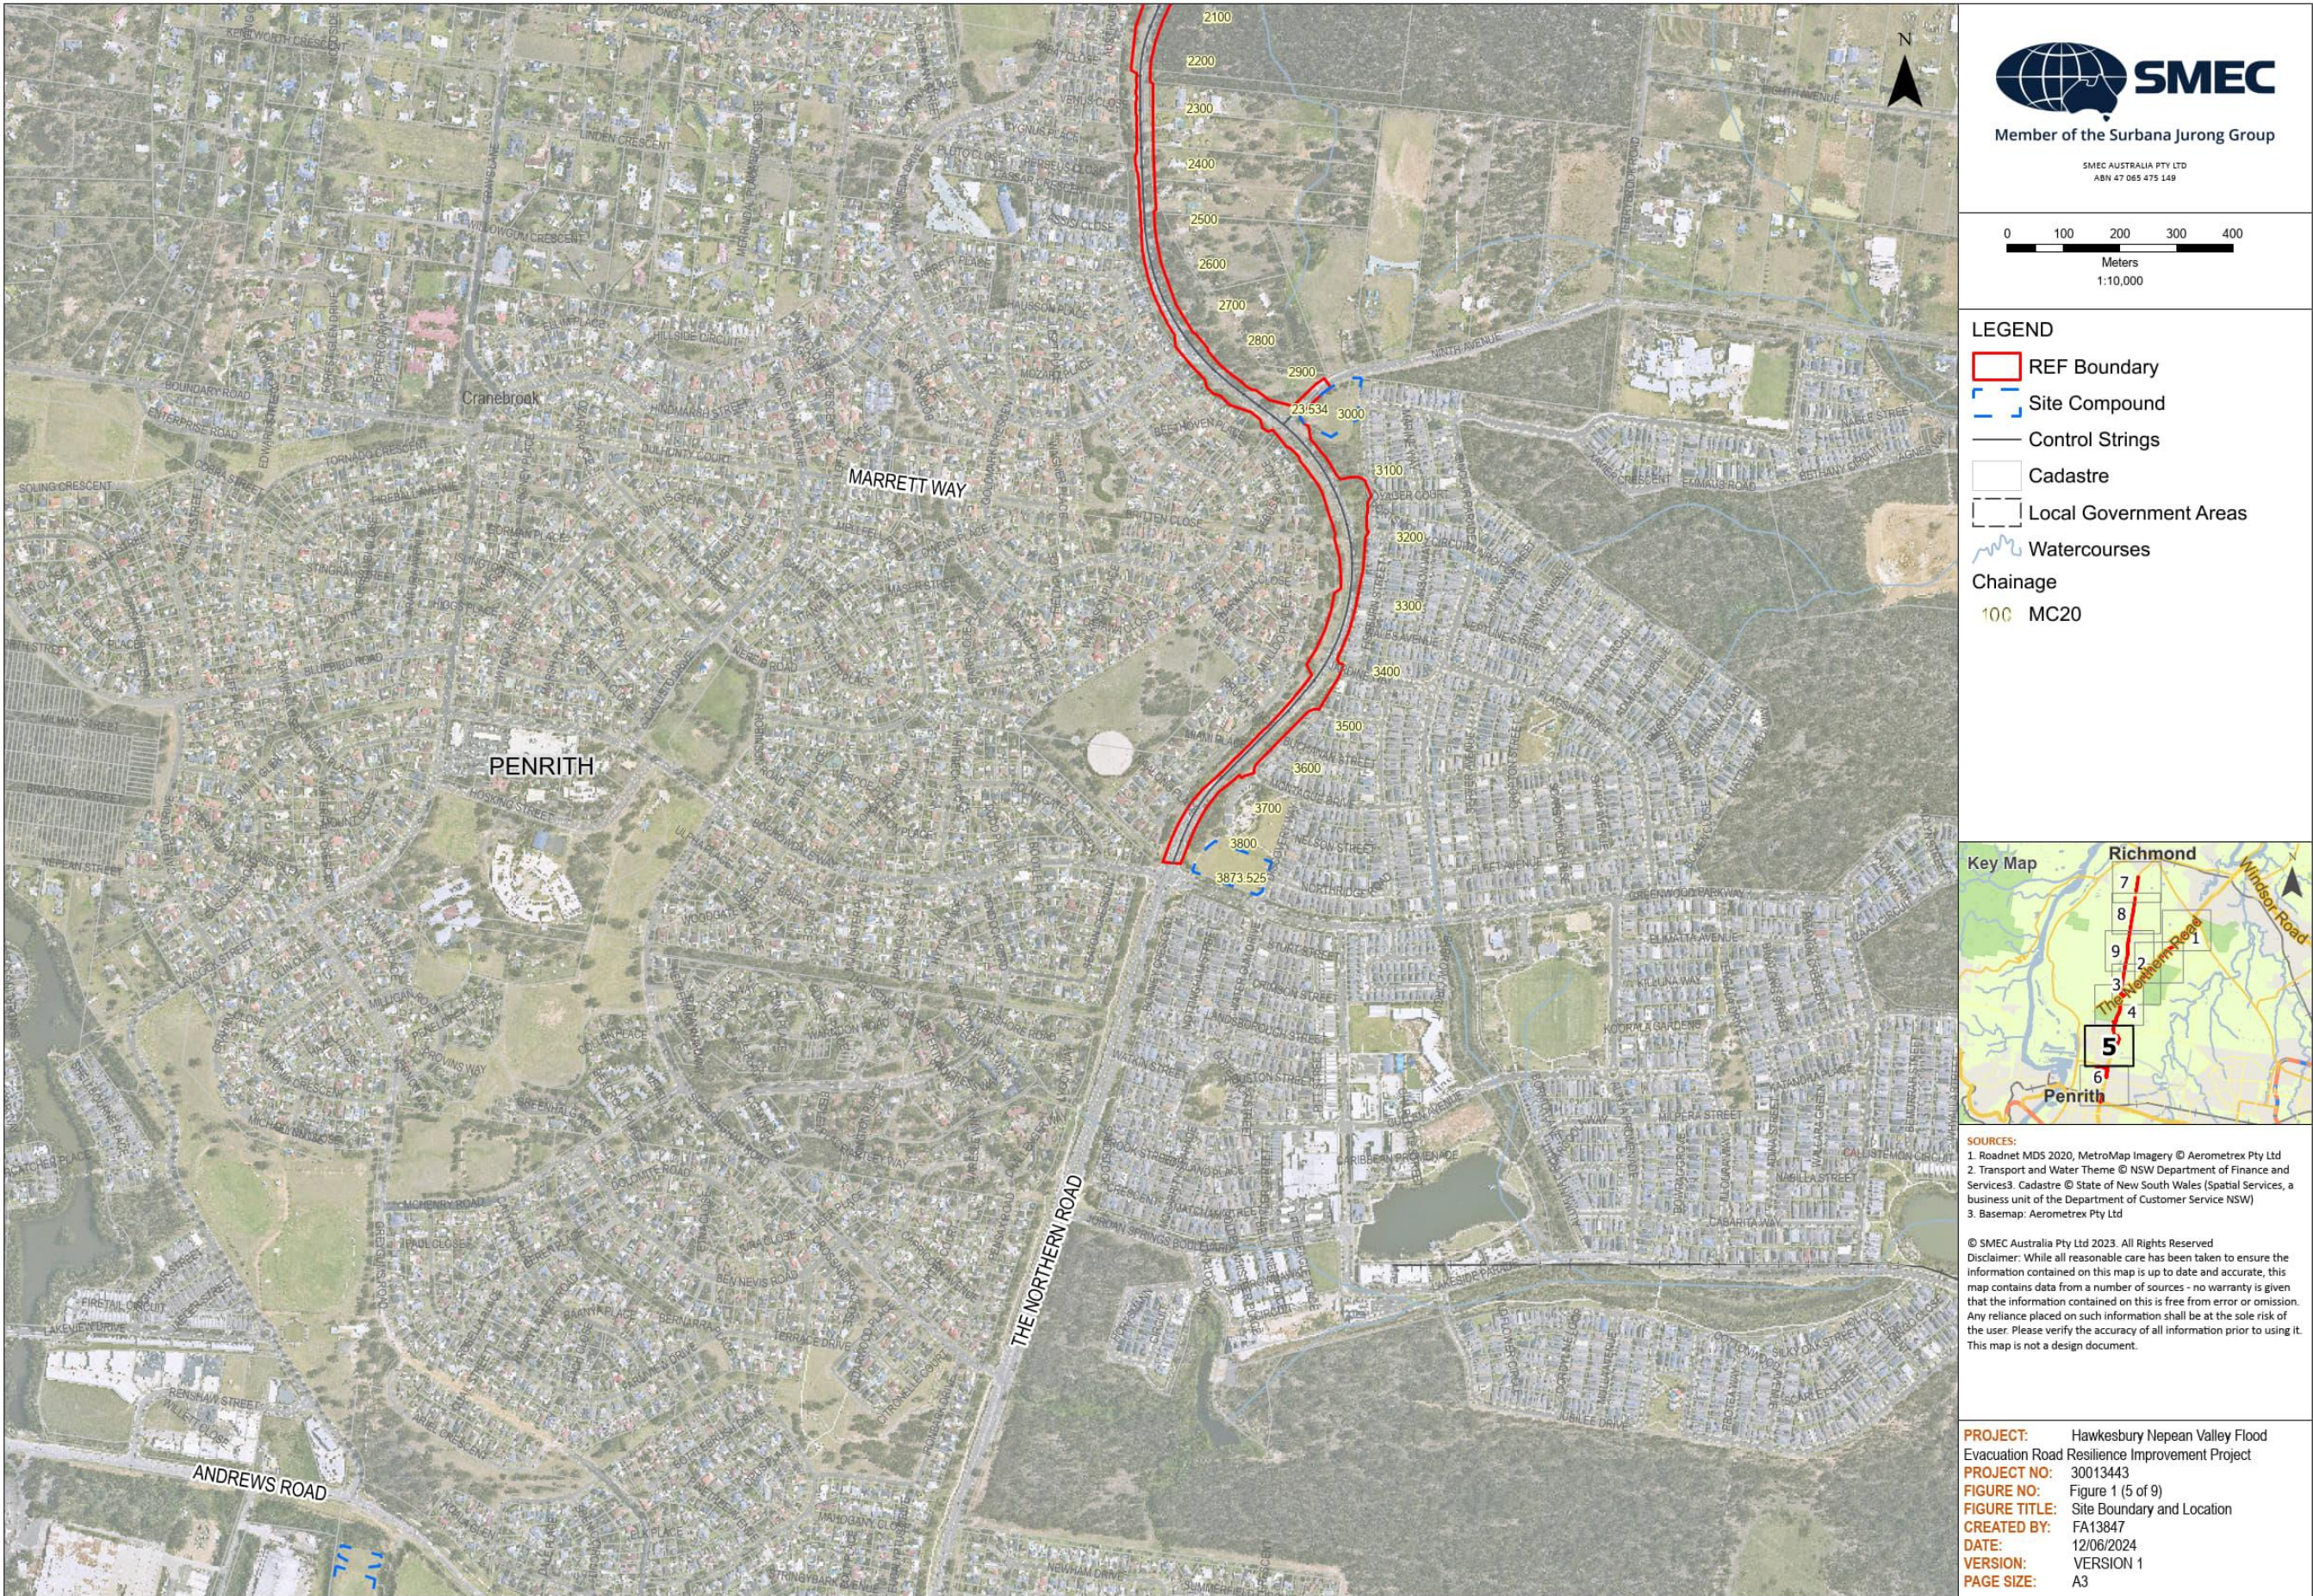
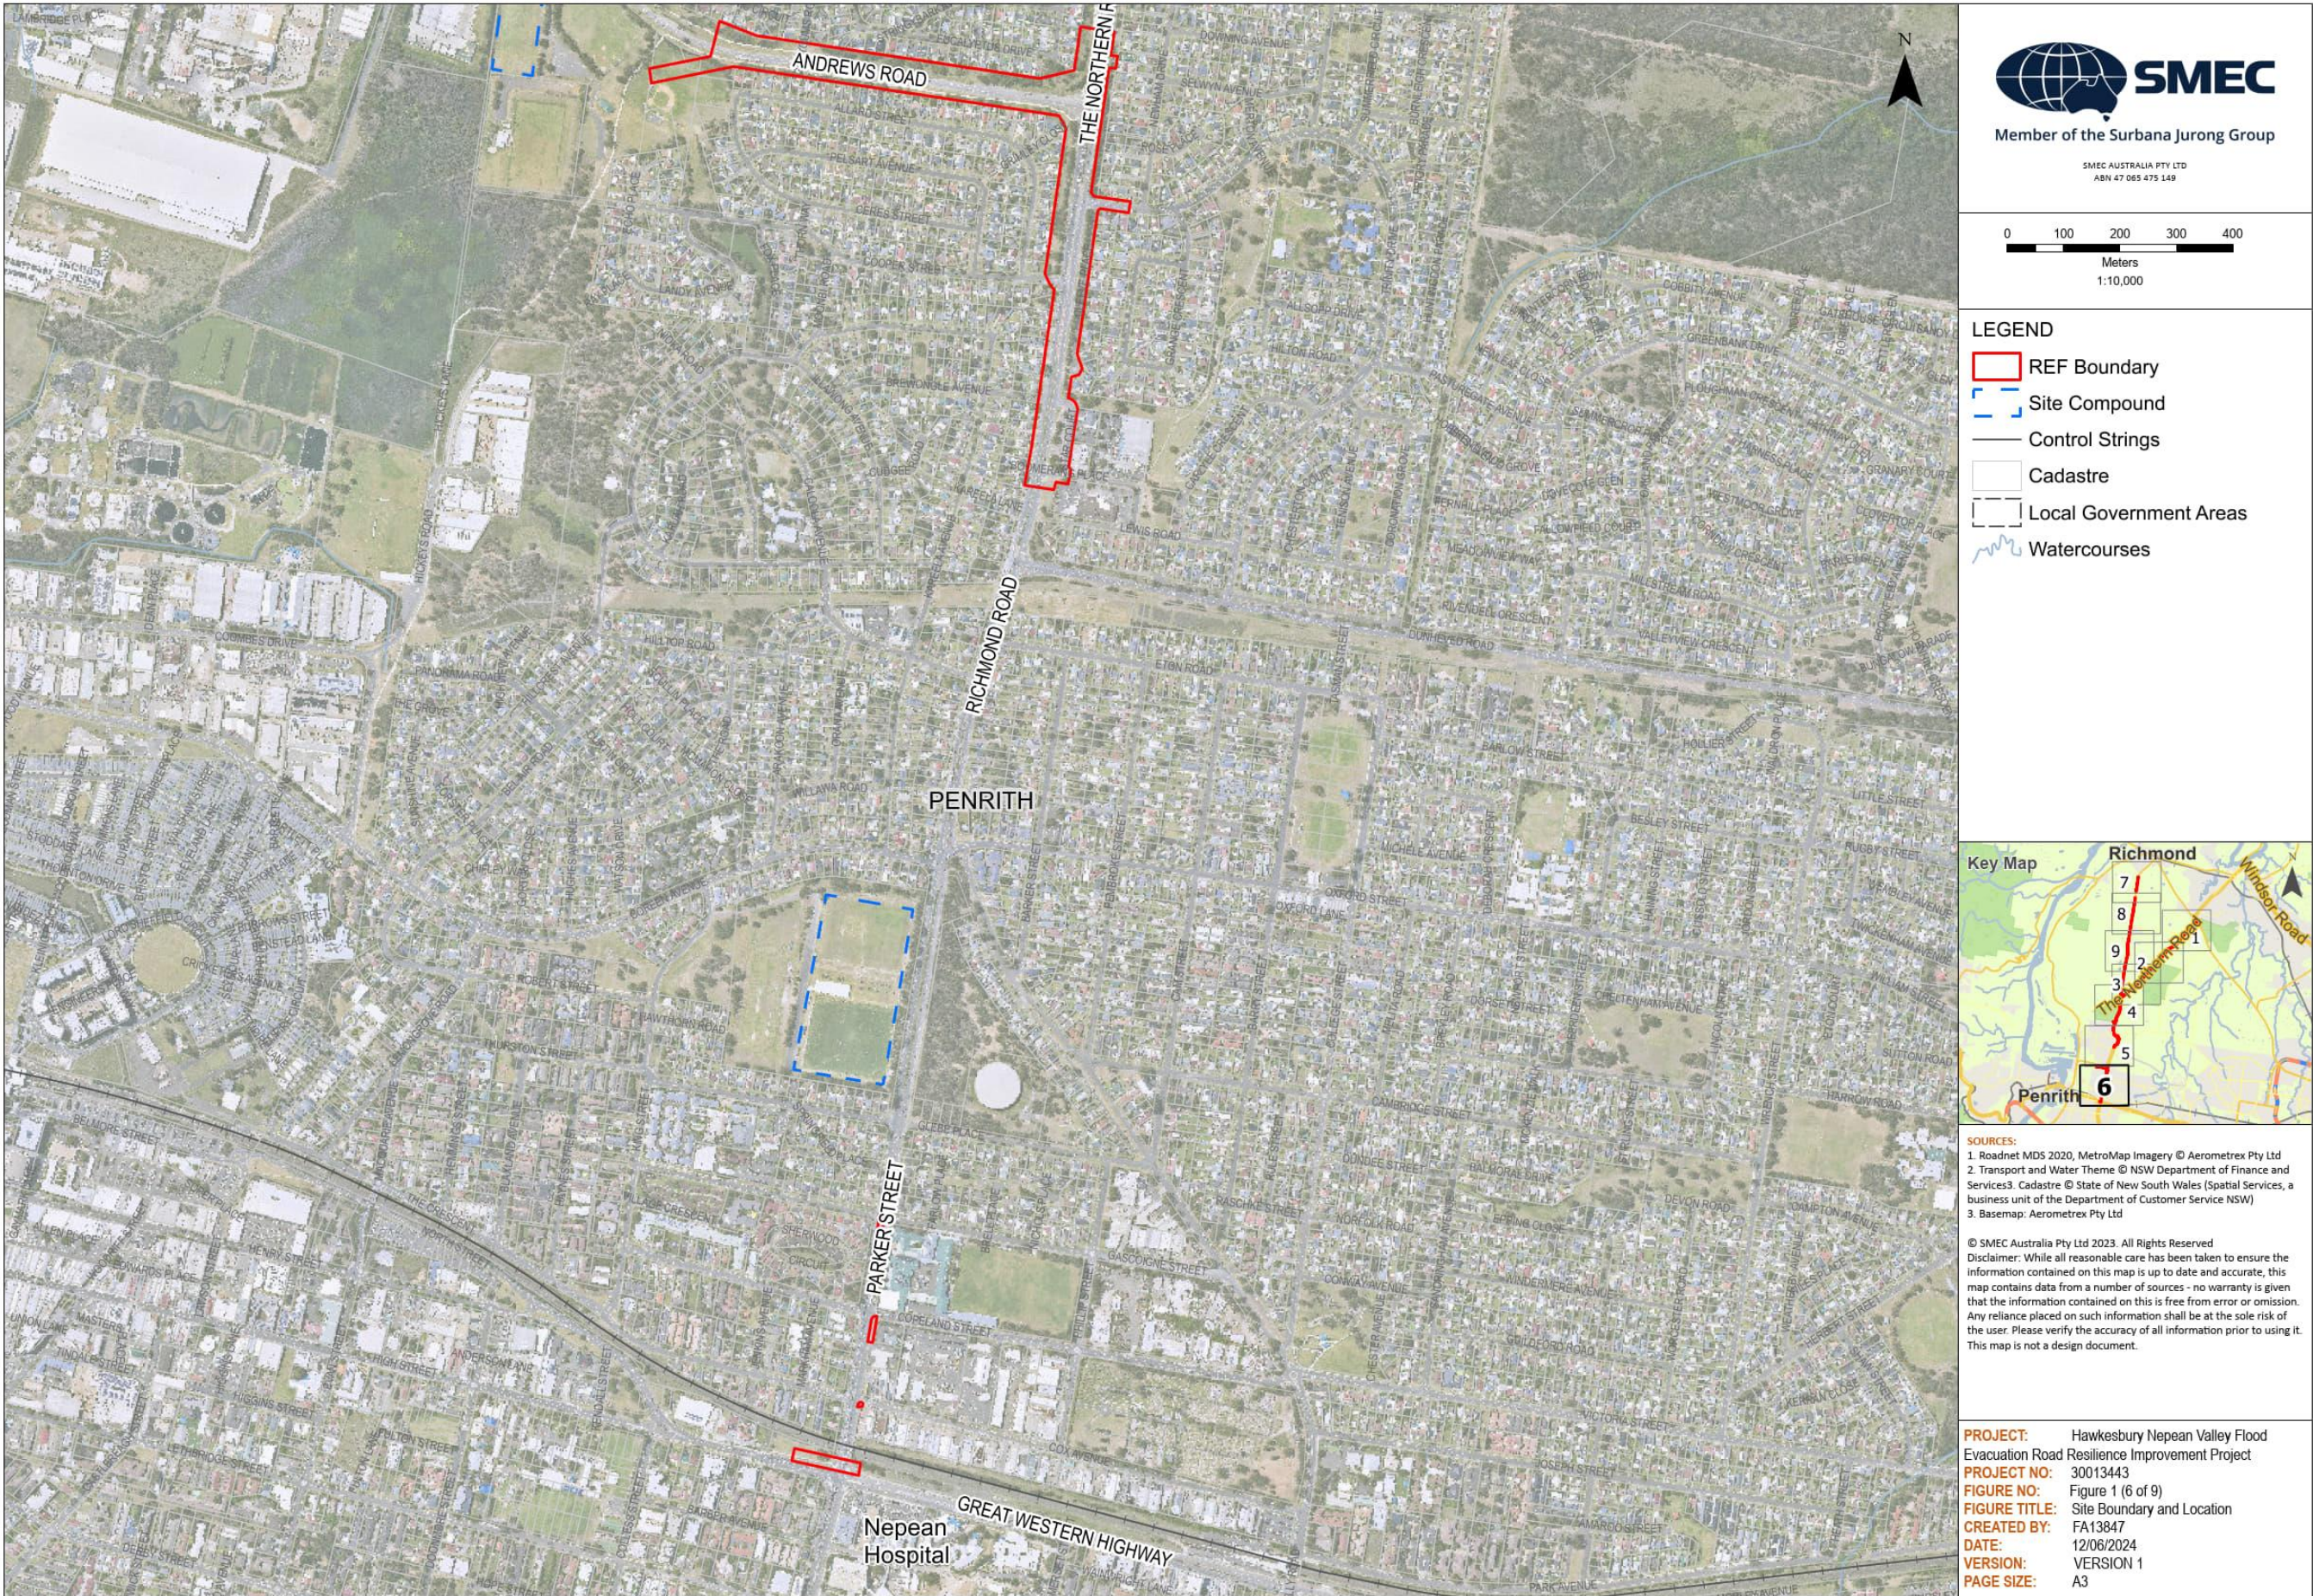
Figure 1 – Site Boundary and Location

Note that this figure comprises 9 sheets
