Preliminary Site Investigation

Hawkesbury-Nepean Valley Flood Evacuation Road Resilience Program Improvements on The Northern Road and Londonderry Road Flood Evacuation Routes

Client Project No.: P.0078303
Client Reference No. 22.0000139271.1313
Prepared for: Transport for NSW
14 June 2024

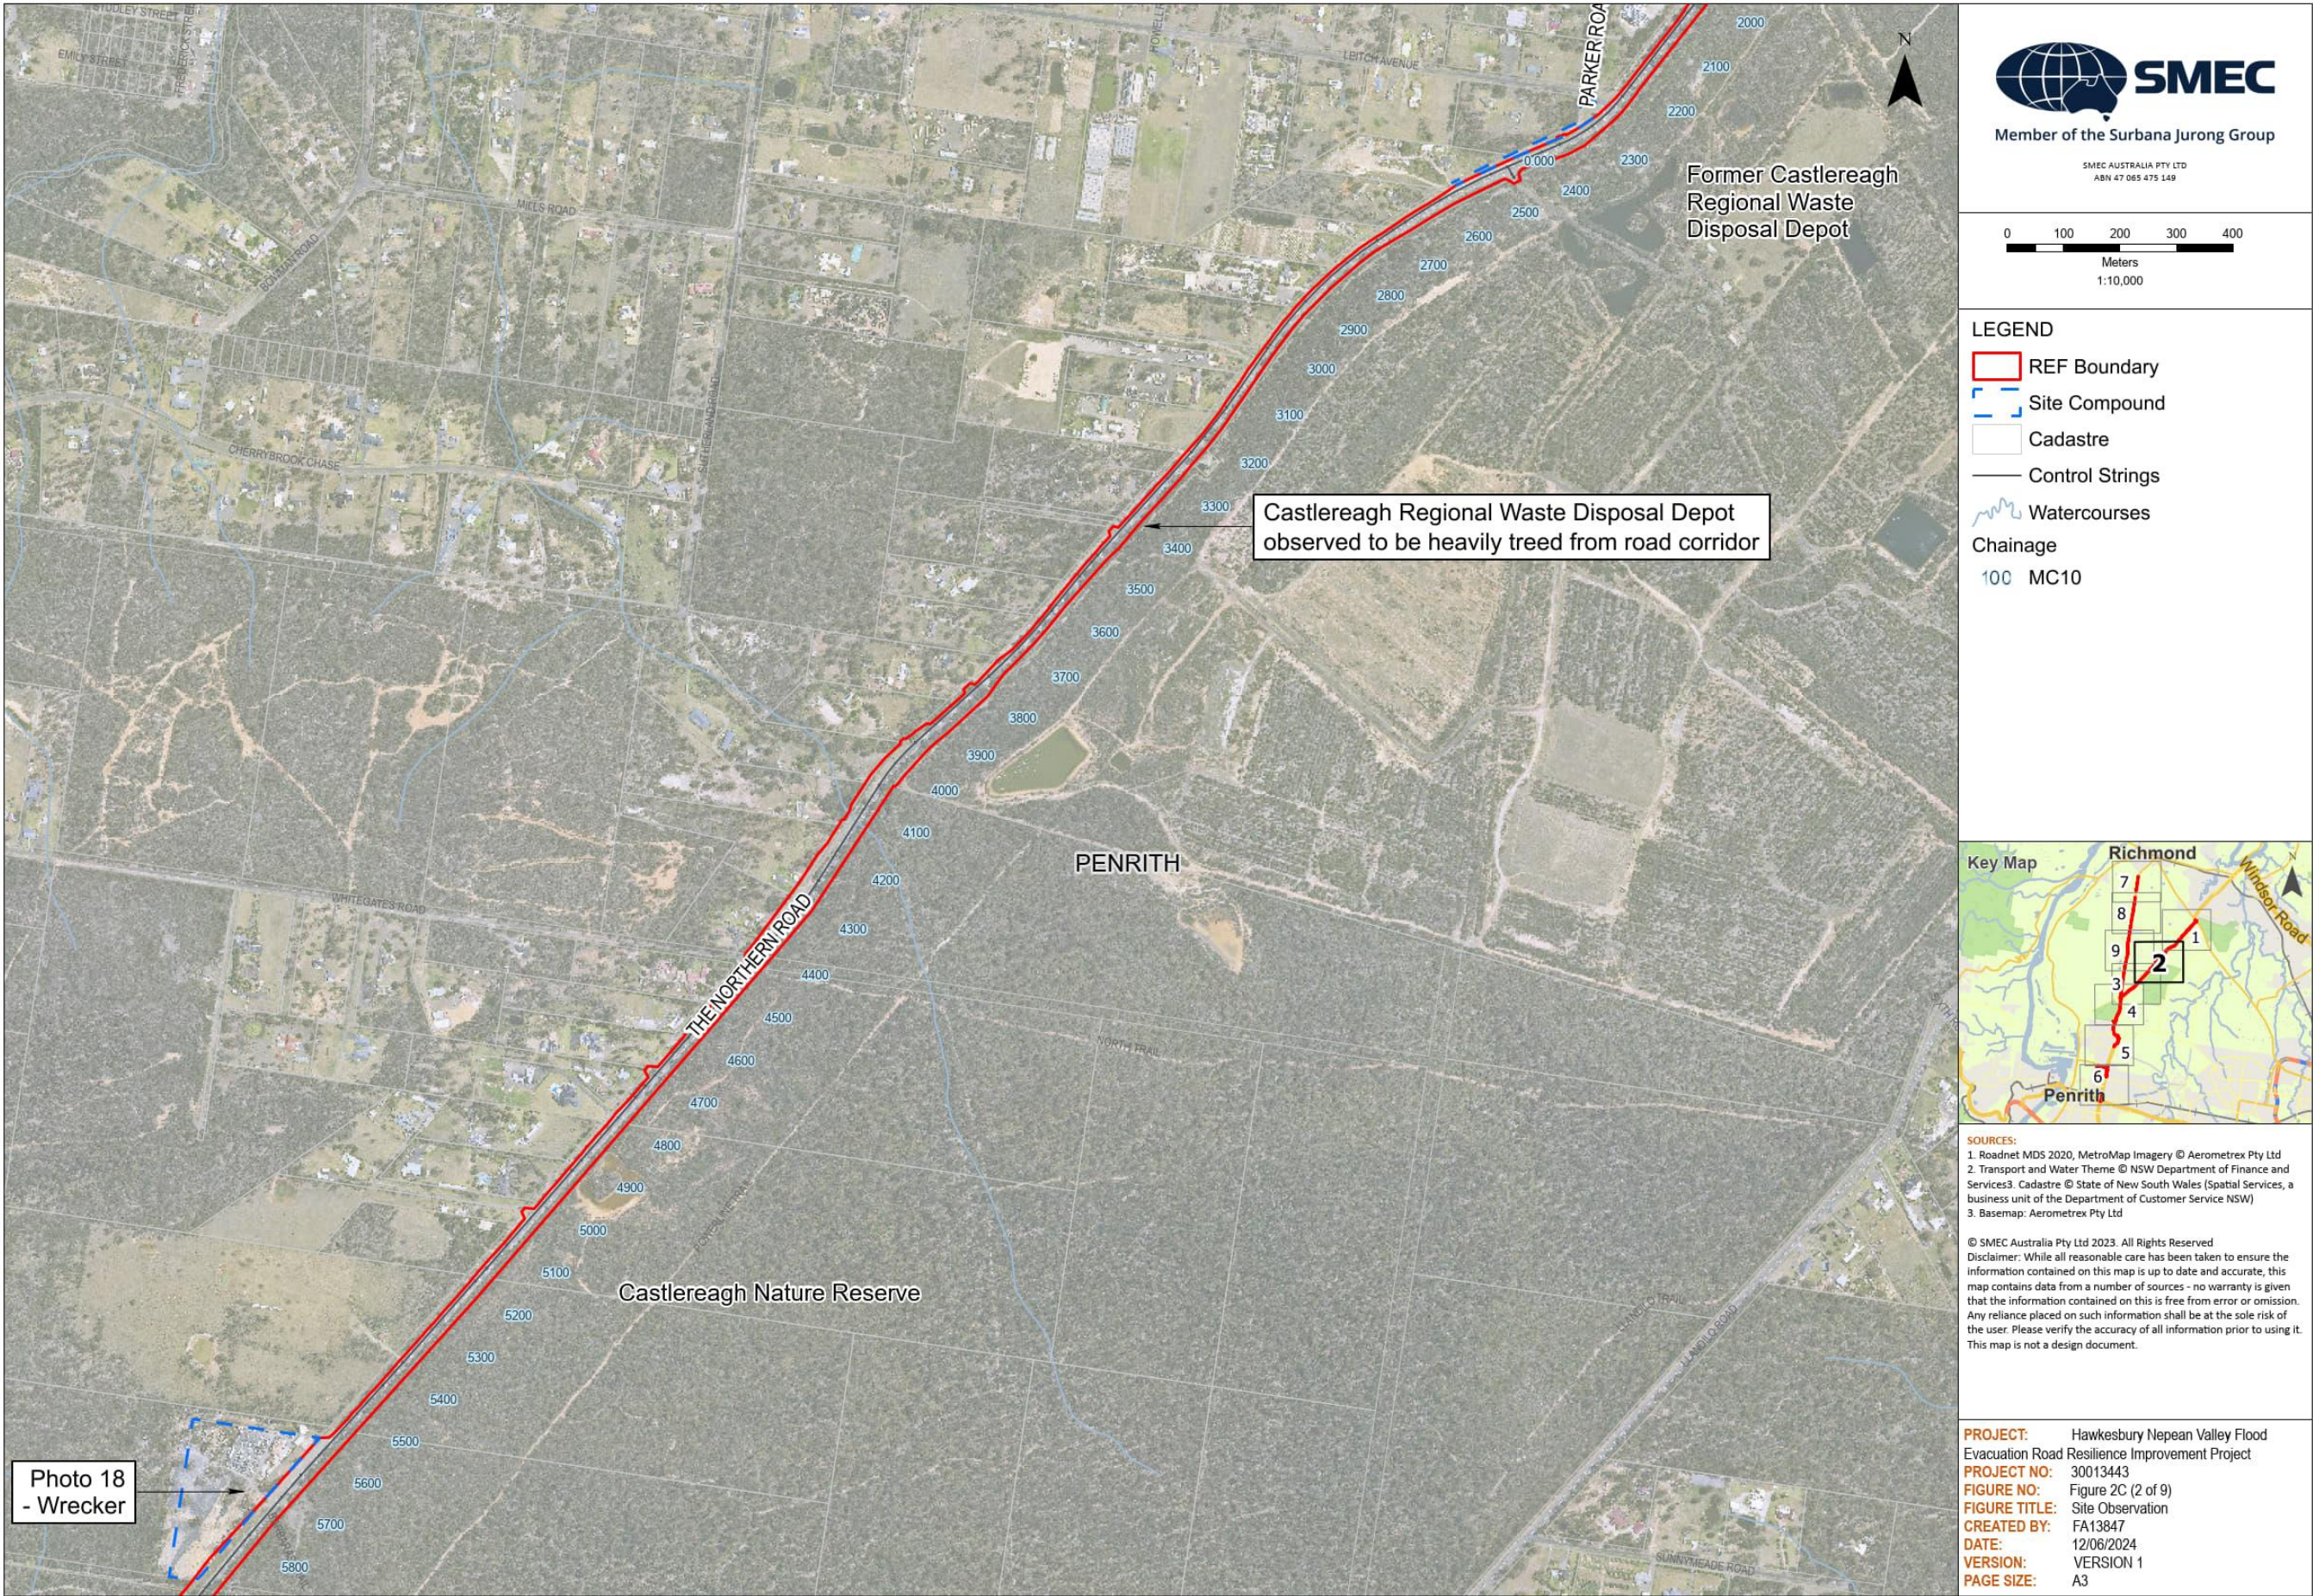
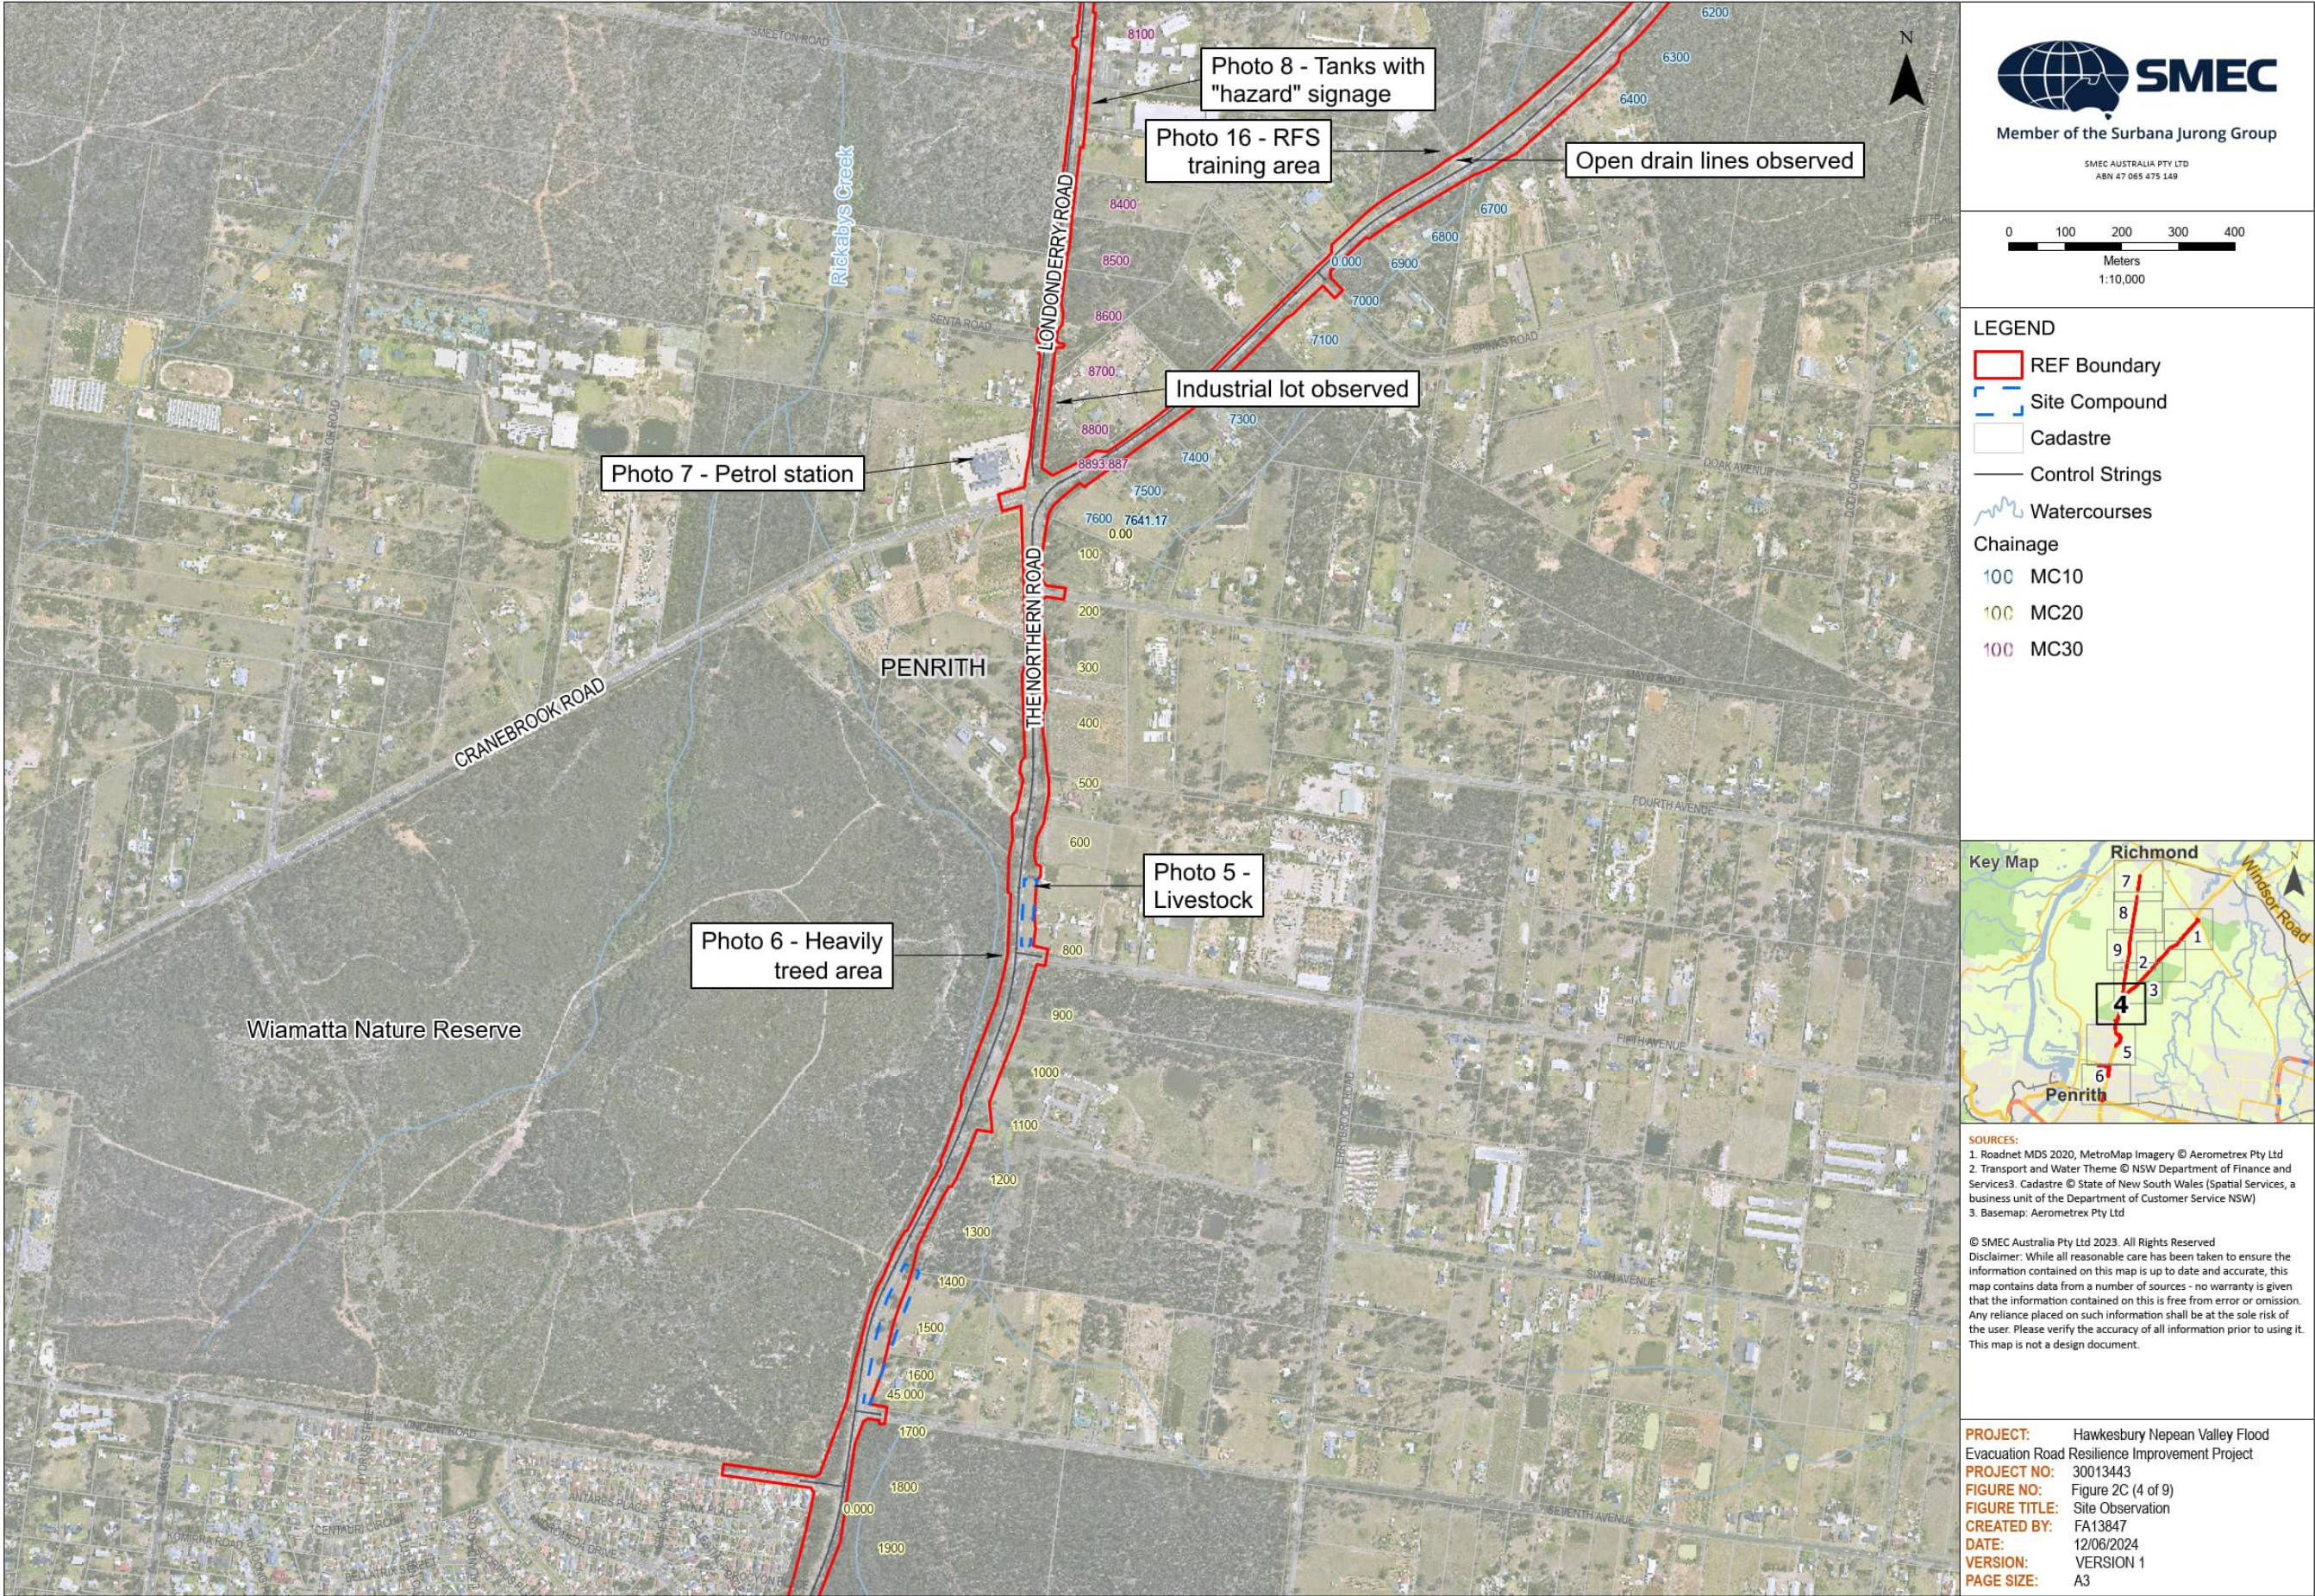
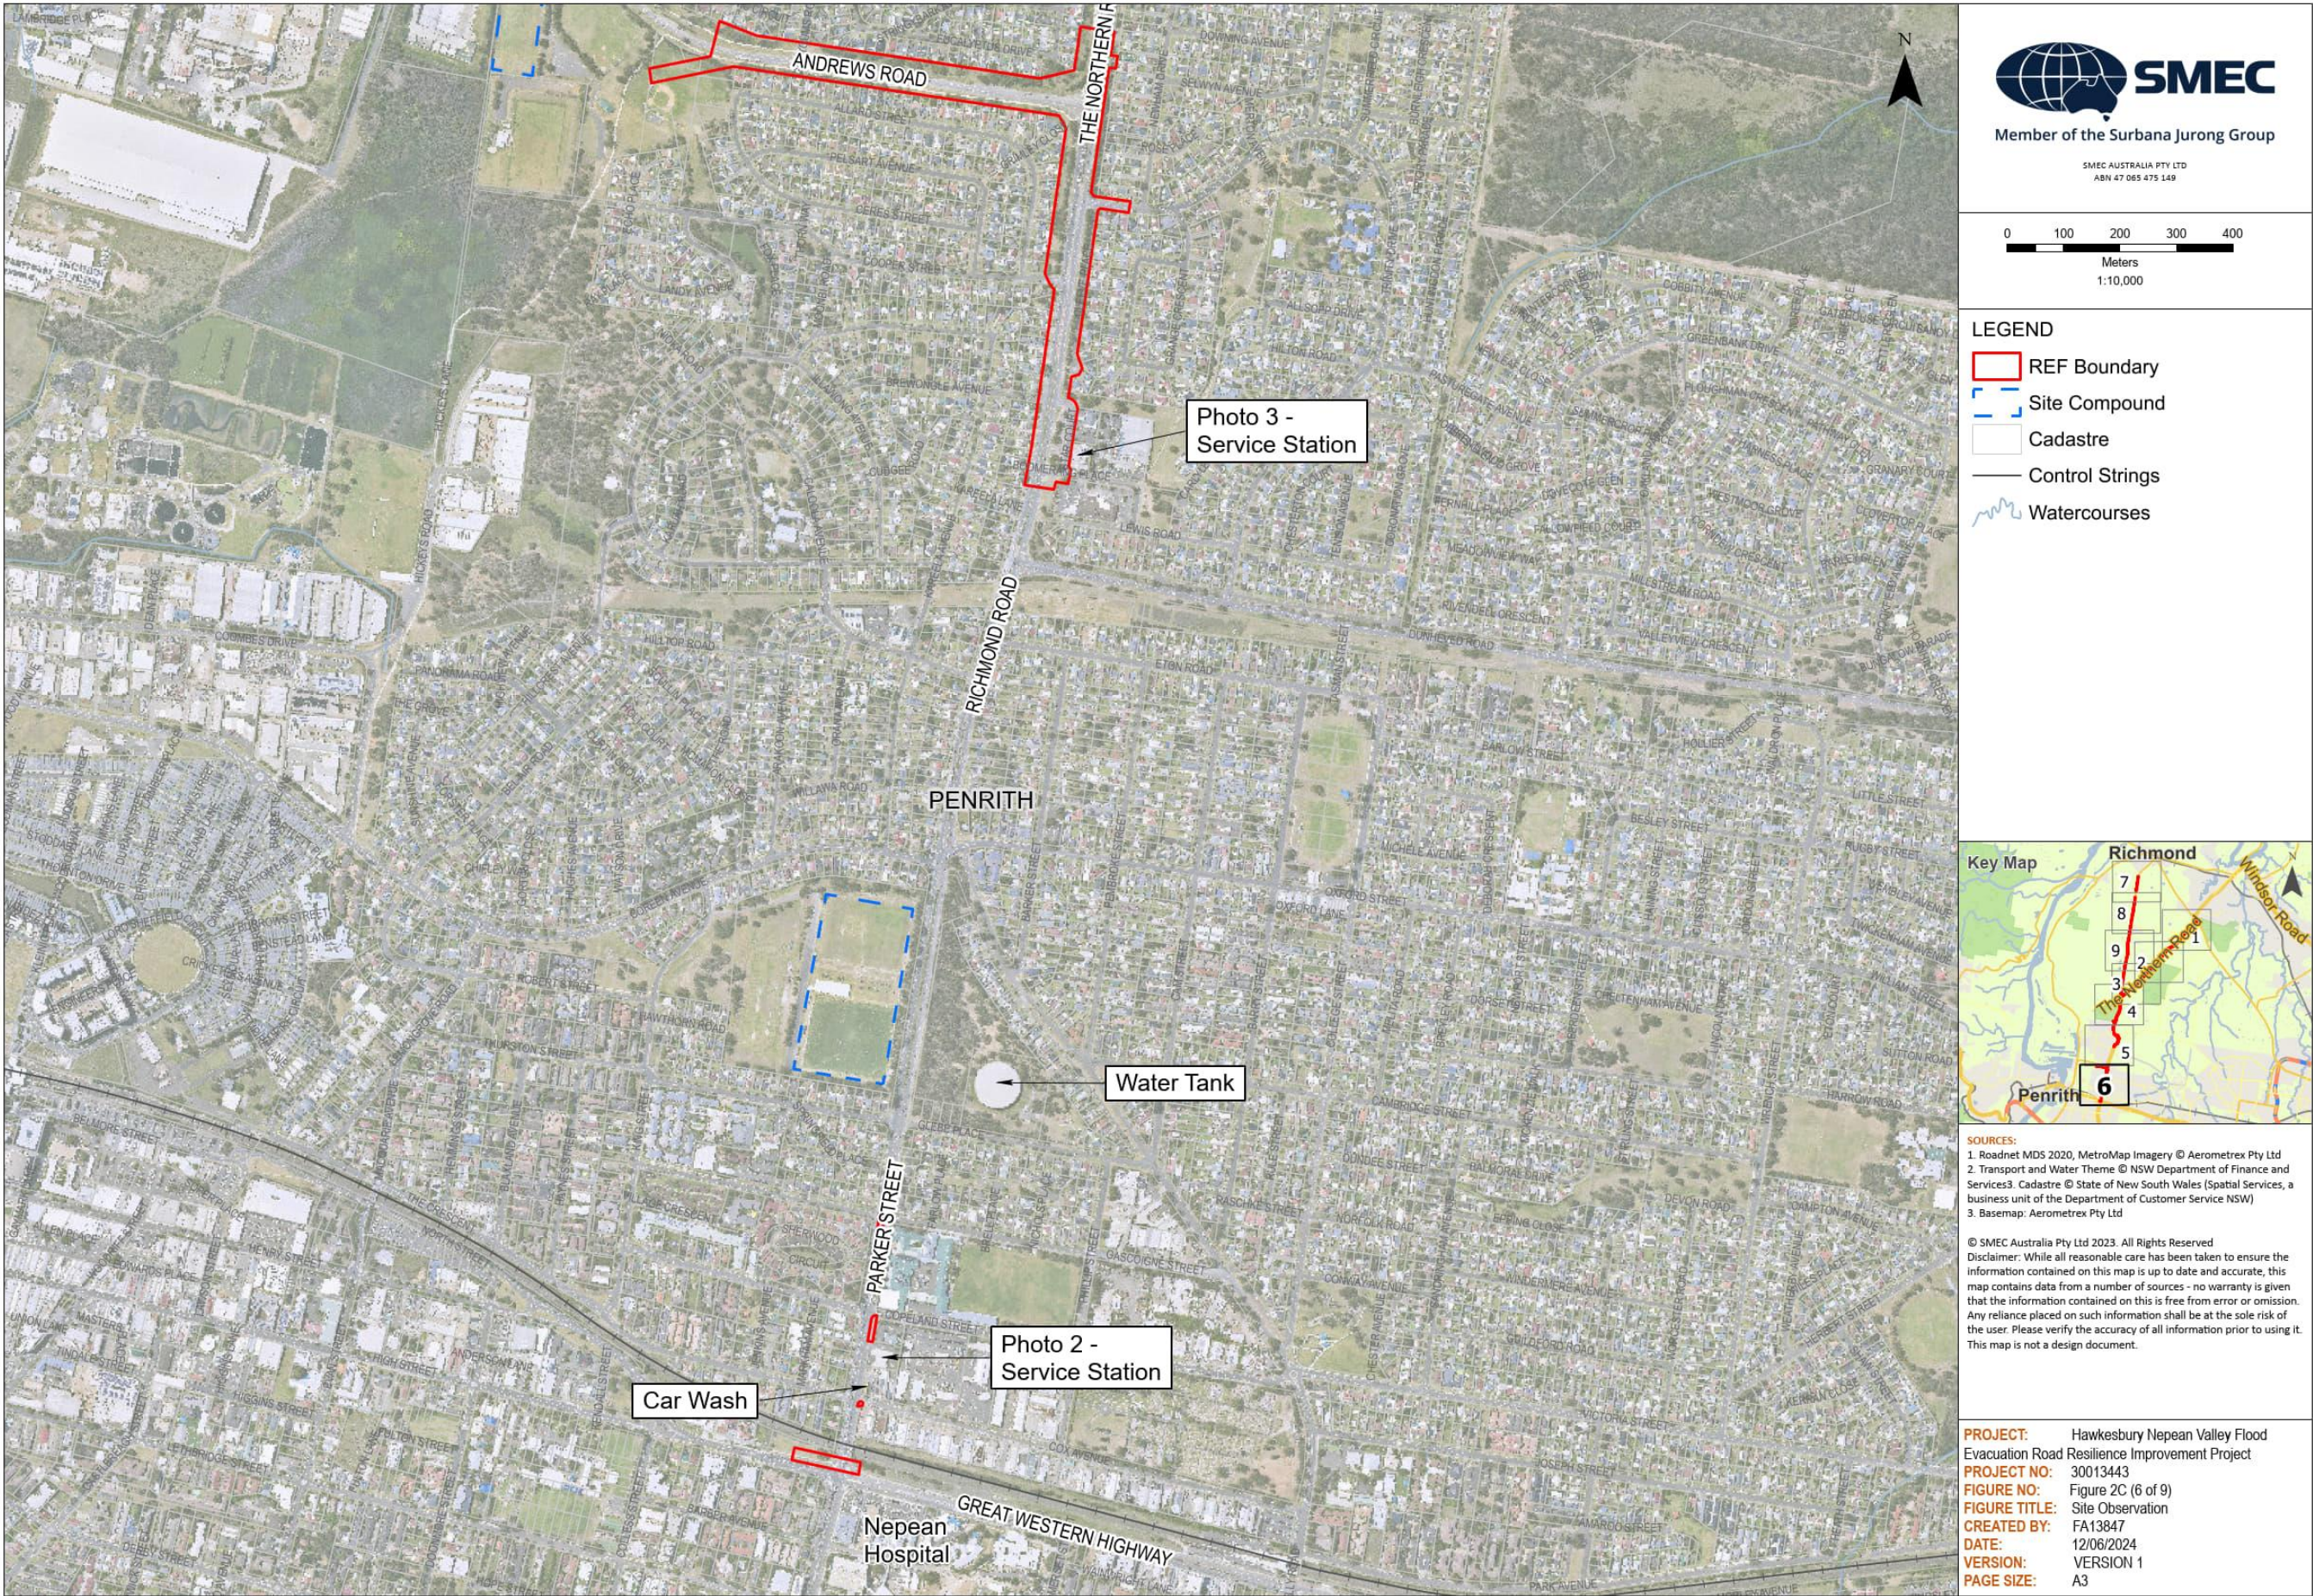
Figure 2C – Site Observation

- A service station and car wash were observed between Cox Avenue and Copeland Street (refer to Figure 2C (6 of 9), Appendix A and Photo 2, Appendix C)

- A tank (suspected water storage) was observed east of the Site near Glebe Place (refer to Figure 2C (6 of 9), Appendix A)
- The area south of the road corridor sloped southward along Andrews Road. A hill was observed along the north side of the road corridor (refer to Figure 2C (6 of 9), Appendix A)

- A tank (suspected water storage) was observed west of the road corridor, north of Borrowdale Way (refer to Figure 2C (5 of 9), Appendix A and Photo 4, Appendix C)

- The Northern Road, north of the Londonderry Road intersection, was predominately flat with some gentle undulation along the road corridor
- A RFS training area was observed west of The Northern Road and appeared fenced off (refer to Figure 2C (3 of 9), Appendix A and Photo 16, Appendix C)

- Castlereagh Nature Reserve (east of the Site) was observed to be heavily treed (refer to Figure 2C (3 of 9), Appendix A and Photo 17, Appendix C)
- A wrecker was observed on the west side of The Northern Road, opposite the south end of the Castlereagh Nature Reserve (refer to Figure 2C (3 of 9), Appendix A and Photo 18, Appendix C)

- The area east of Site used as the Castlereagh Regional Waste Disposal Depot was observed to be heavily vegetated and at the same elevation as the road corridor. No apparent batters, mounding or surface waste was observed. The landfill extent was unable to be visually determined (refer to Figure 2C (2 of 9), Appendix A)
