Preliminary Site Investigation

Hawkesbury-Nepean Valley Flood Evacuation Road Resilience Program Improvements on The Northern Road and Londonderry Road Flood Evacuation Routes

Client Project No.: P.0078303
Client Reference No. 22.0000139271.1313
Prepared for: Transport for NSW
14 June 2024

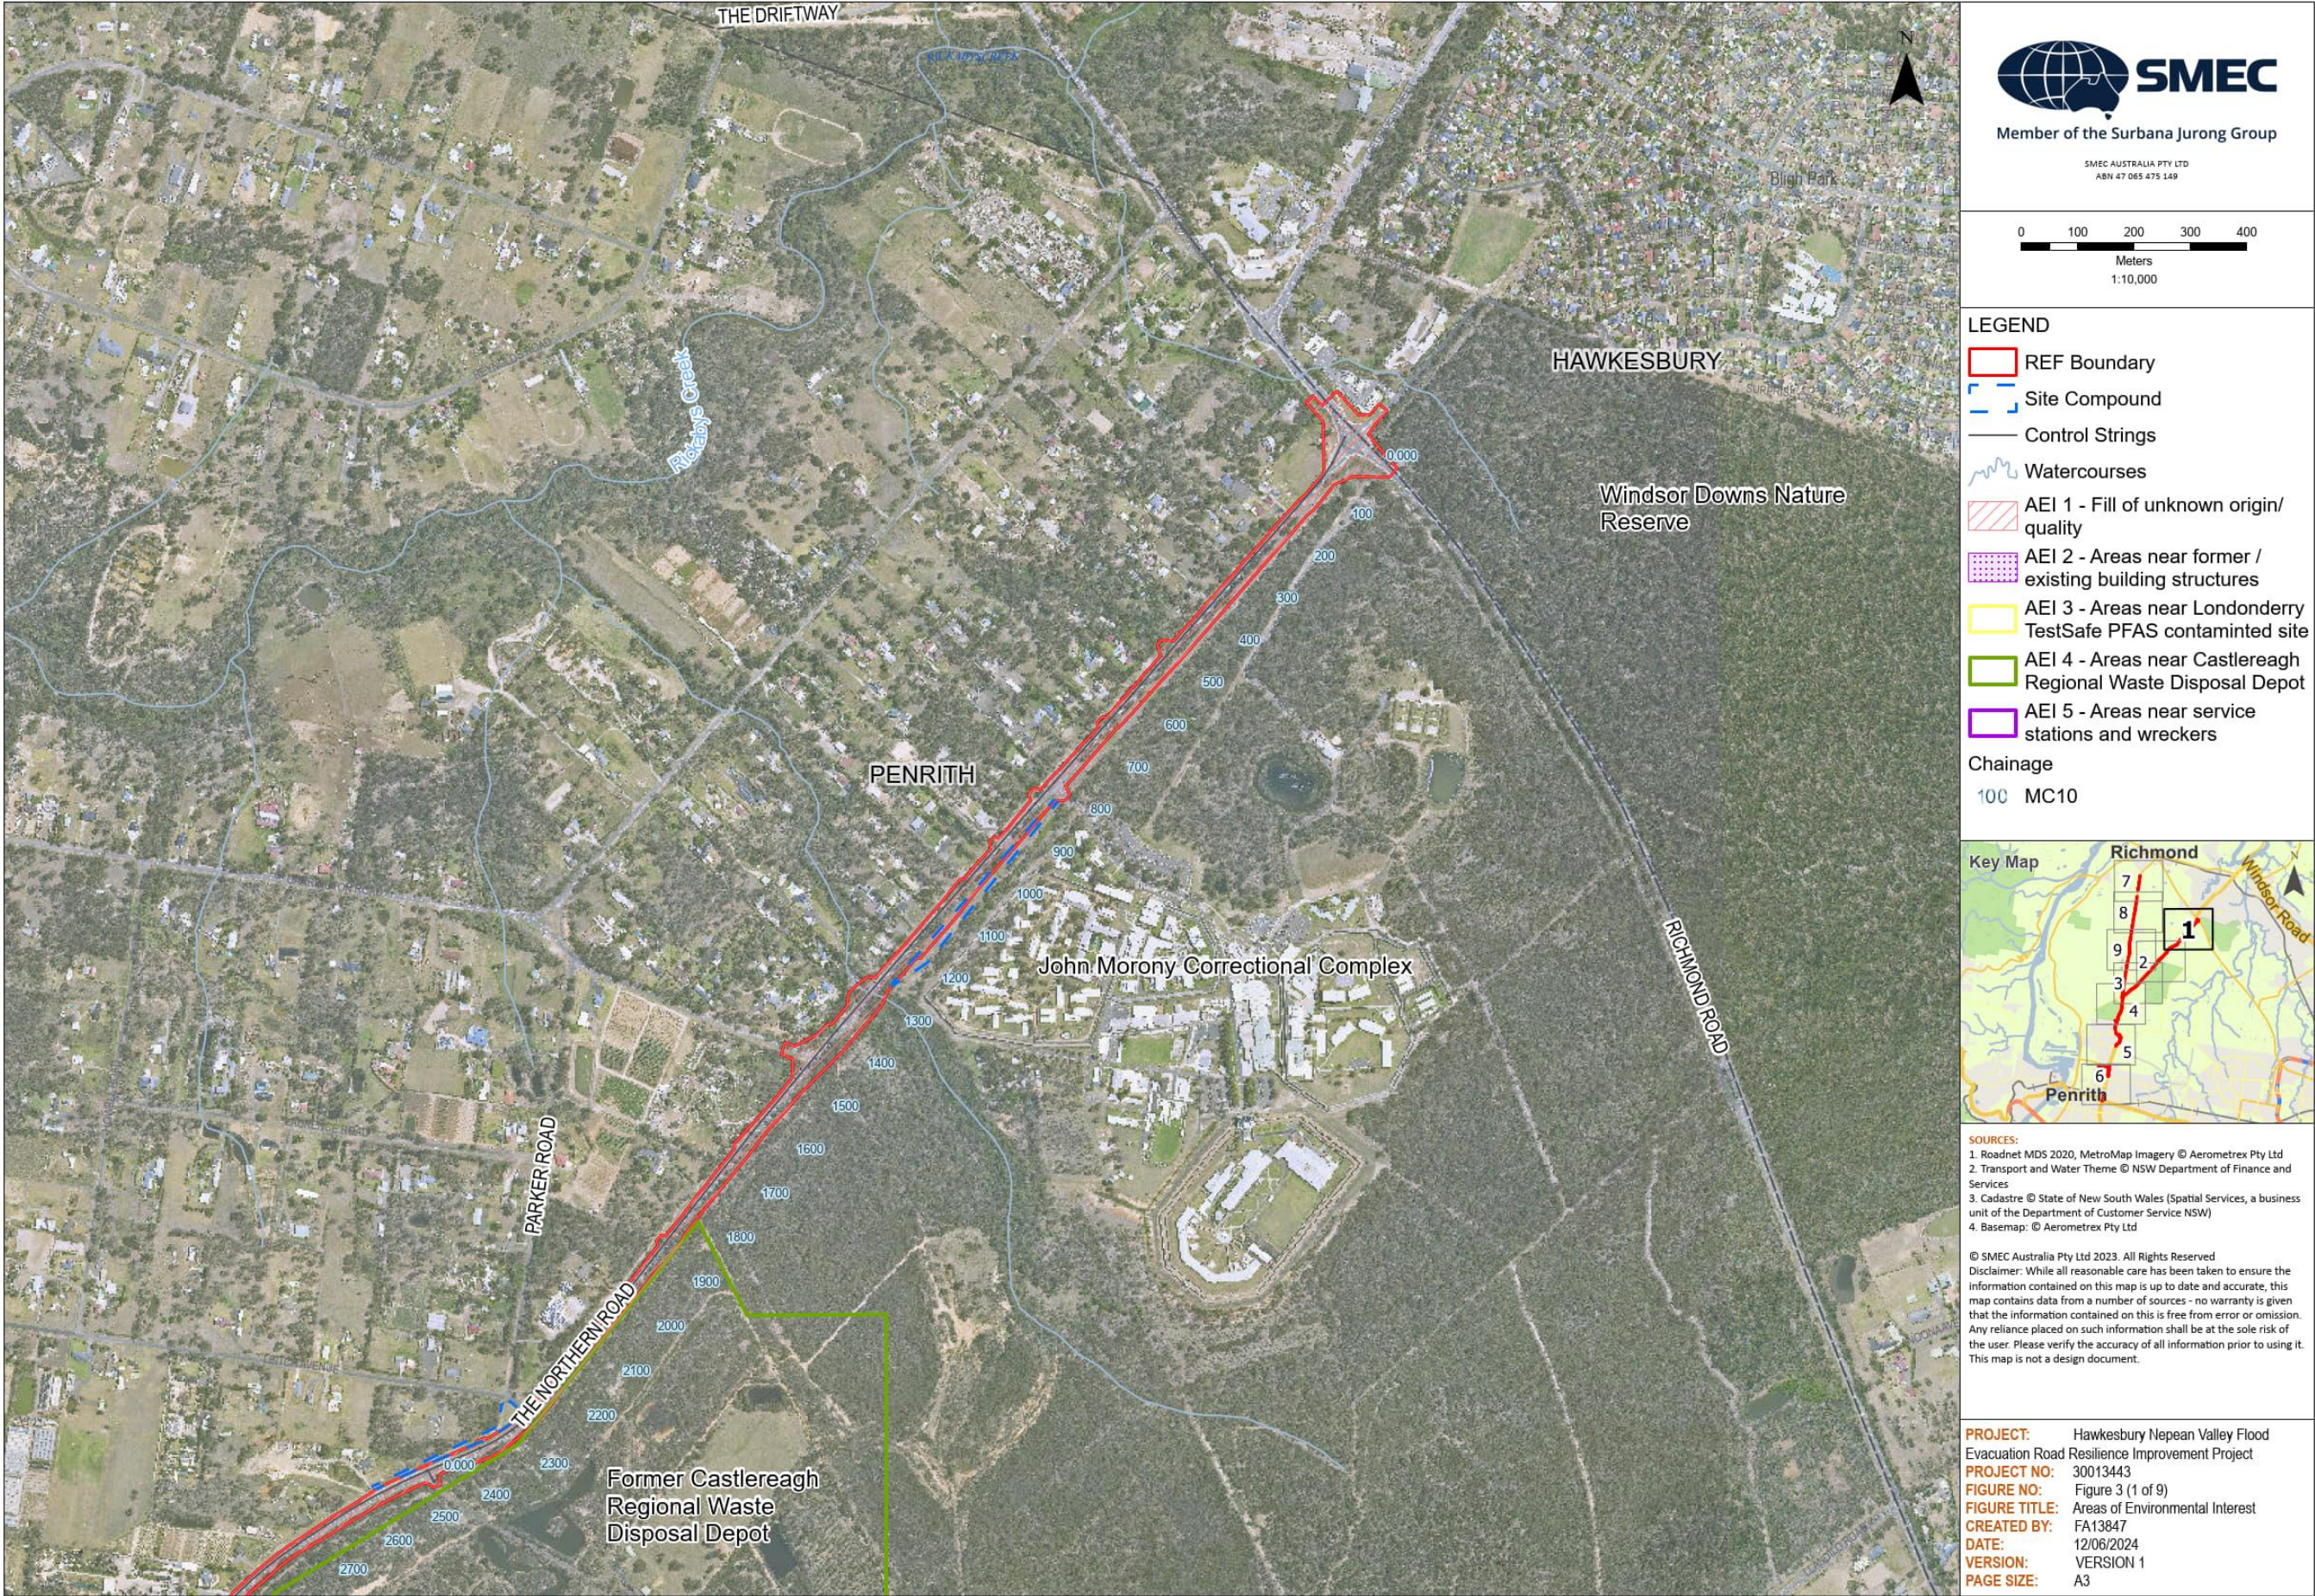
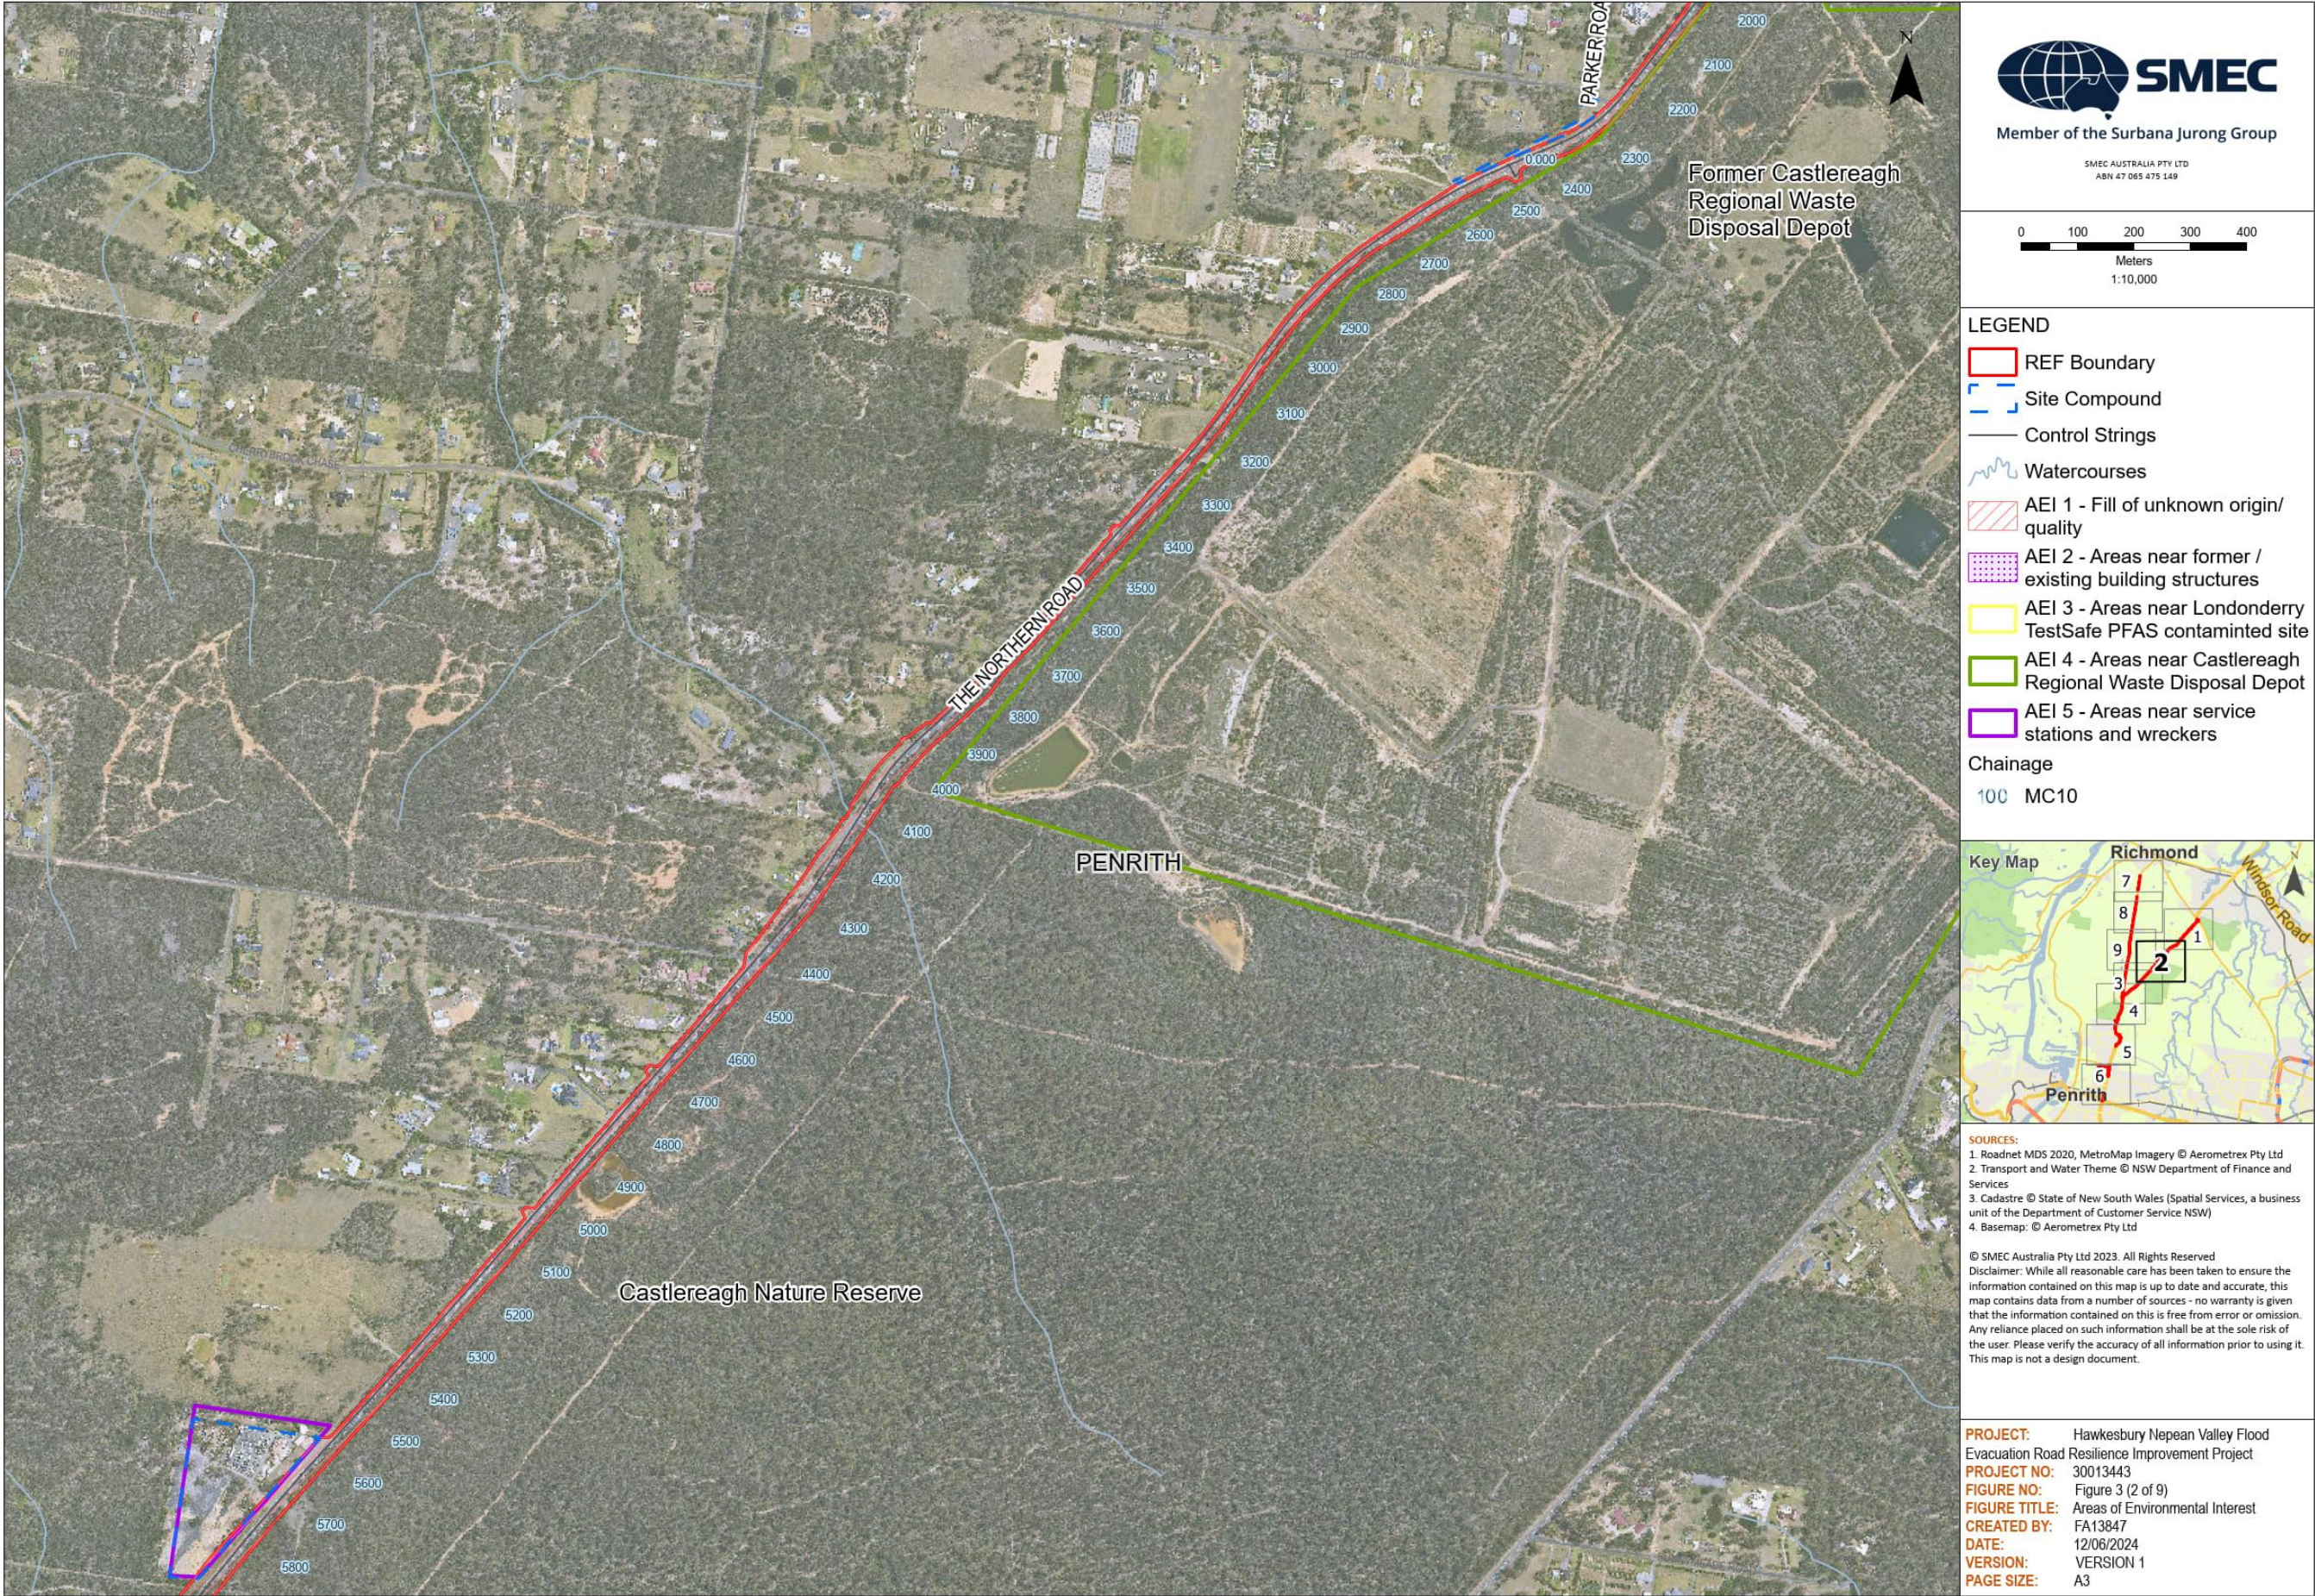
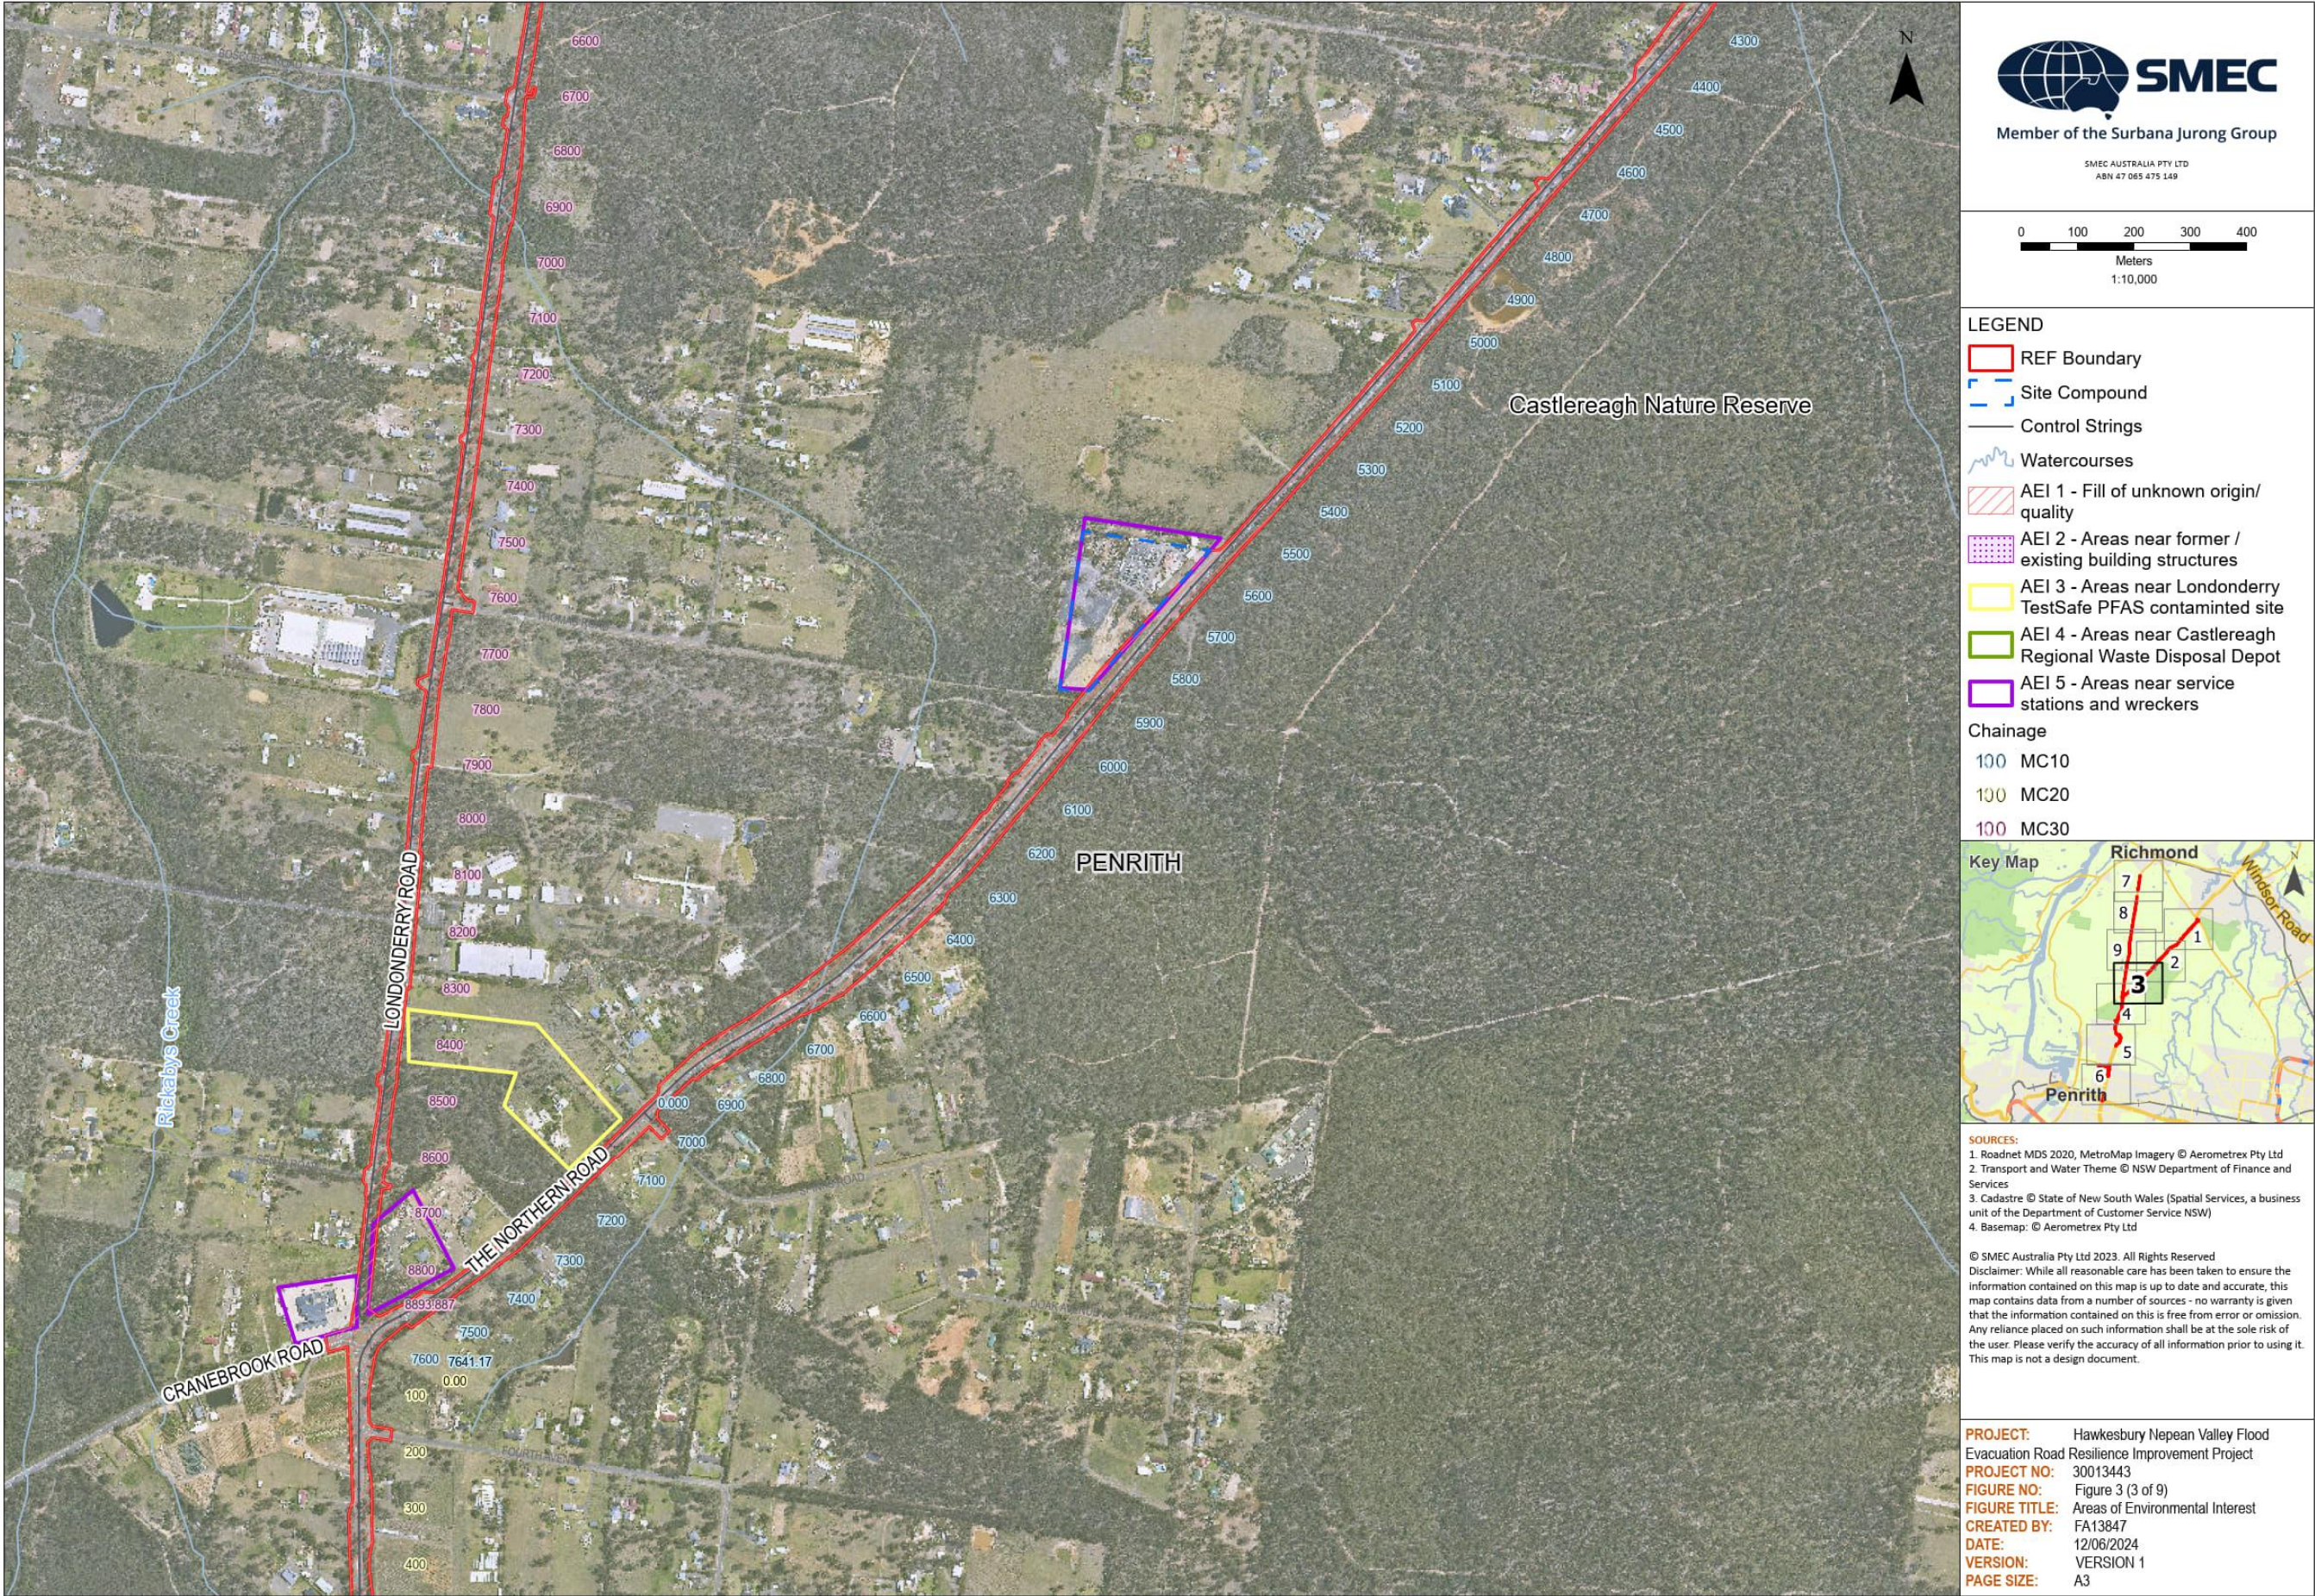
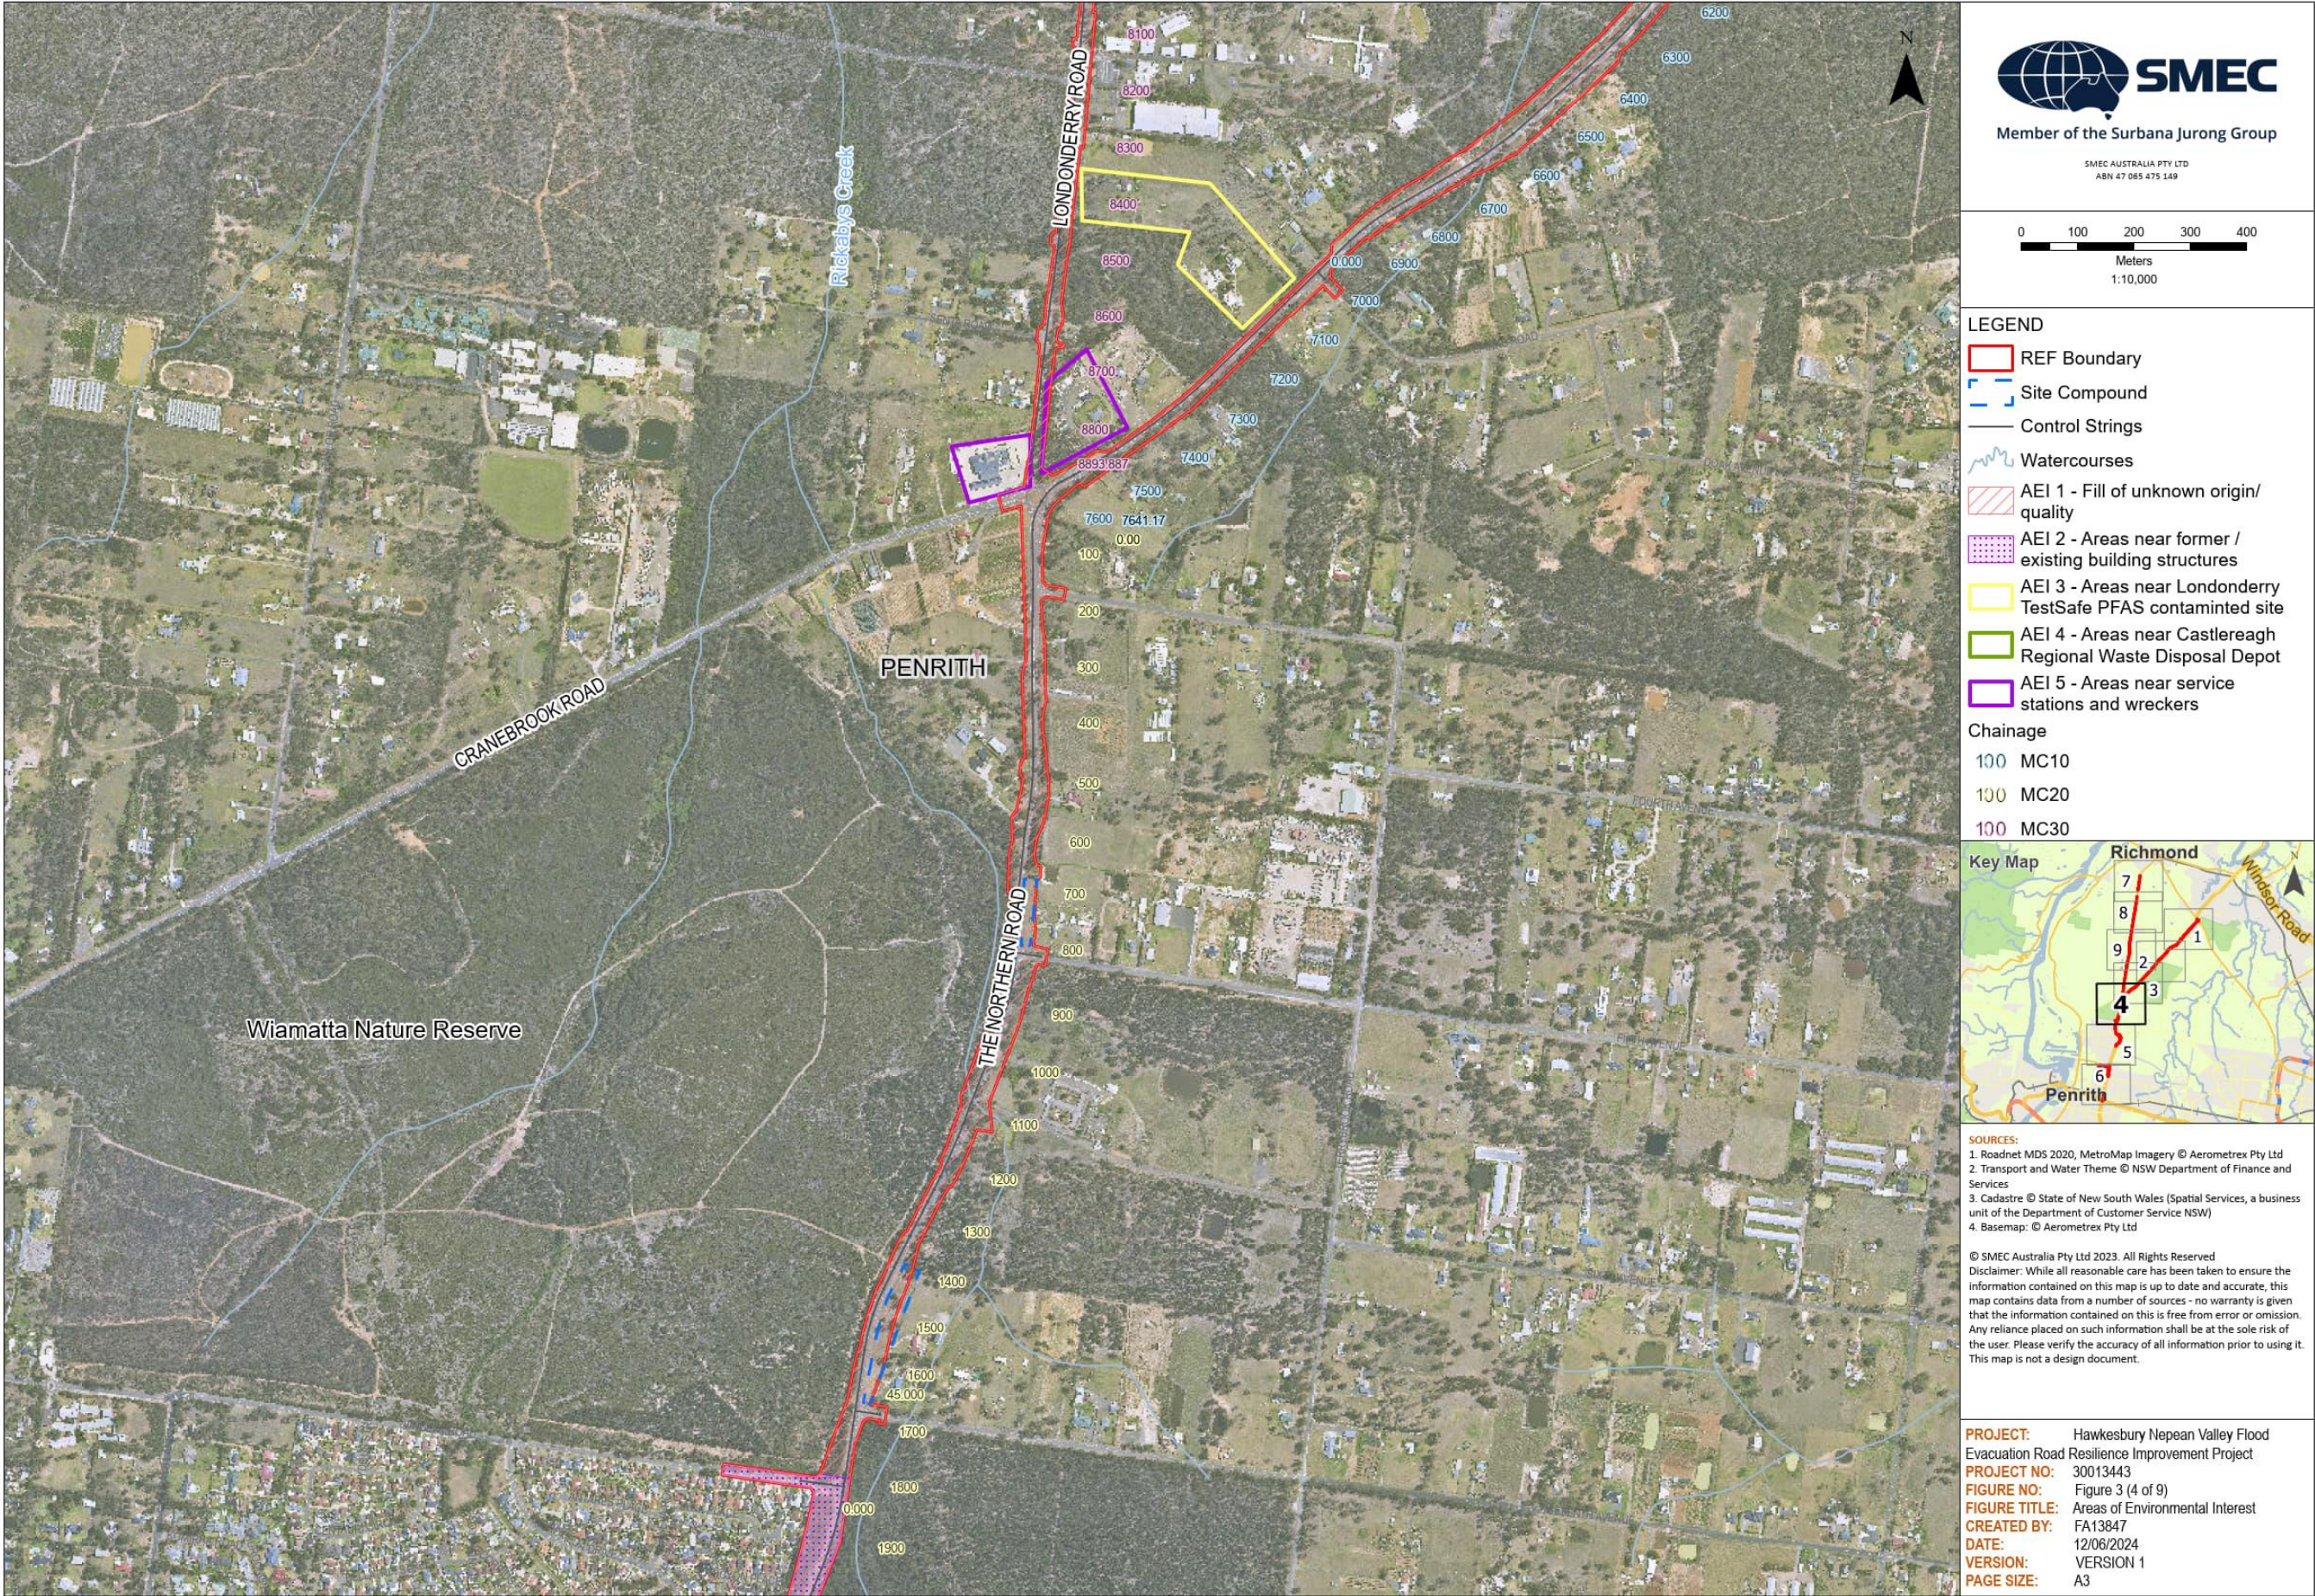
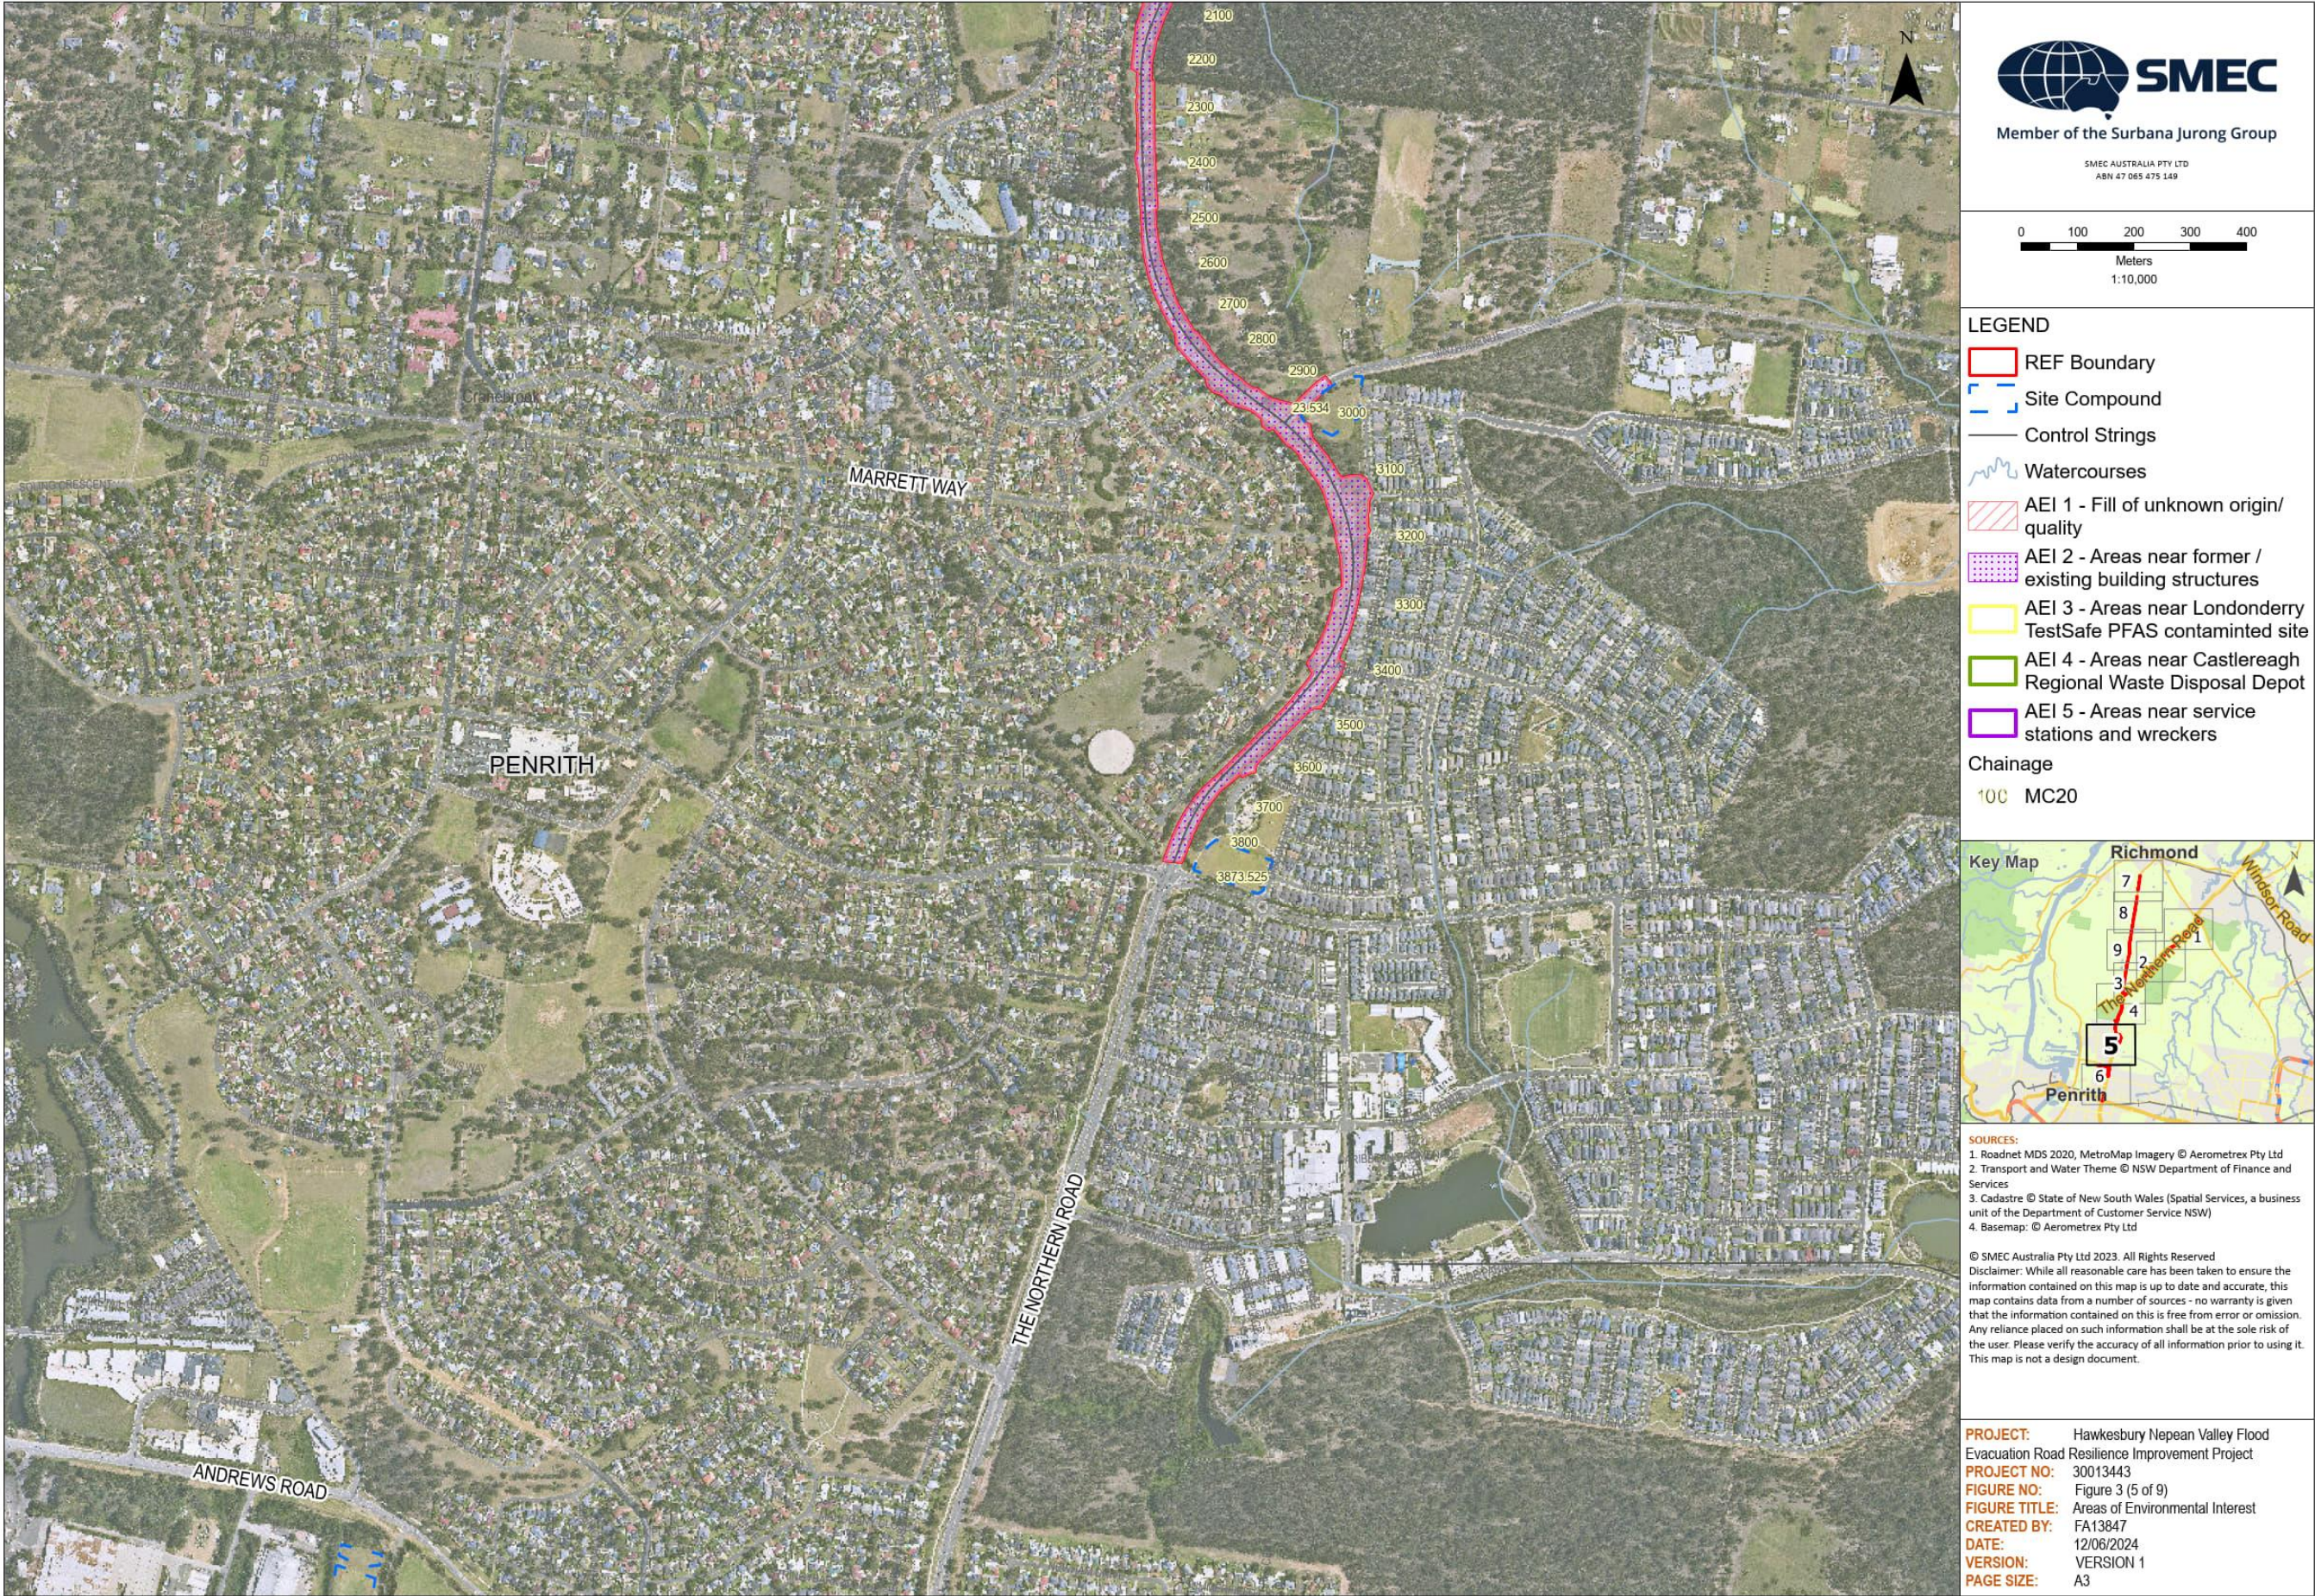
Figure 3 – Areas of Environmental Interest

Based on the Site history and Site observations, five Areas of Environmental Interest (AEI) (presented in Figure 3, Appendix A) and potentially contamination sources were identified including:

Note that this figure comprises 9 sheets

Identified AEIs and CoPC are summarised in Table 4–1 below. AEIs identified are presented in Figure 3, Appendix A.

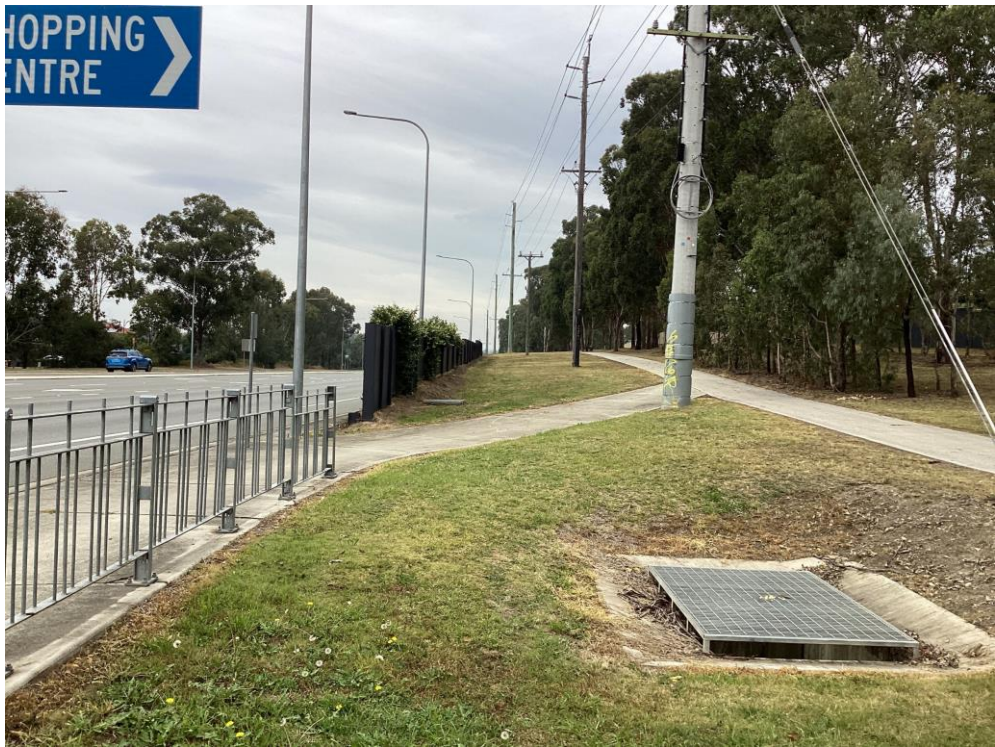
Photo 1 – Example of the stormwater drain on the site of road corridor

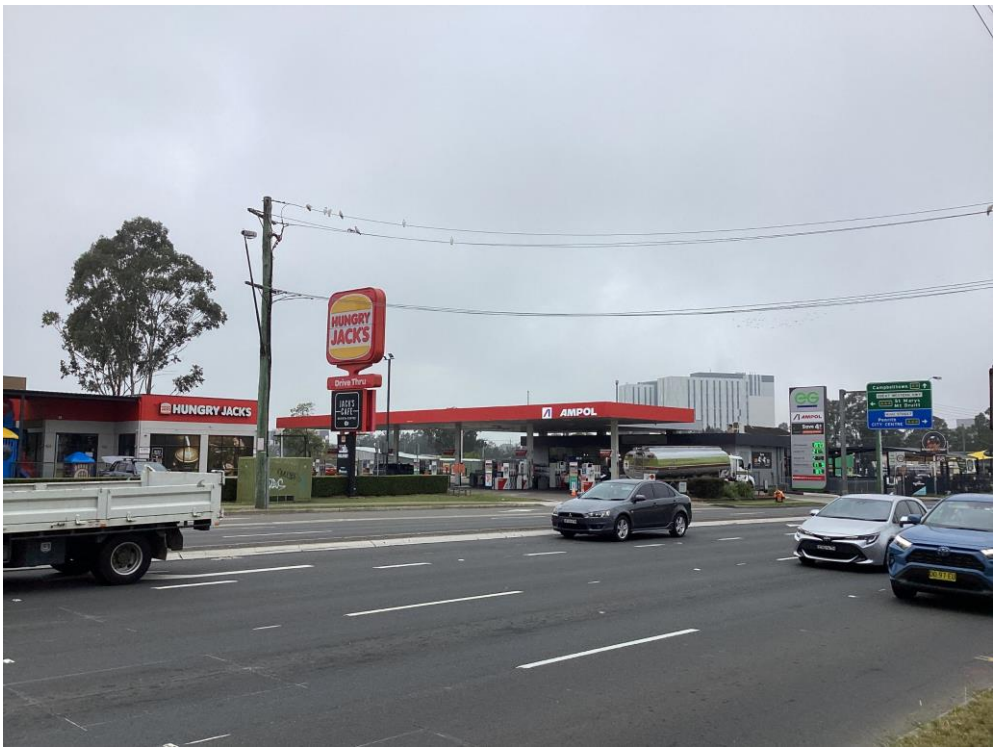
Photo 2 – Service station and car wash were located between Cox Avenue and Copeland Street

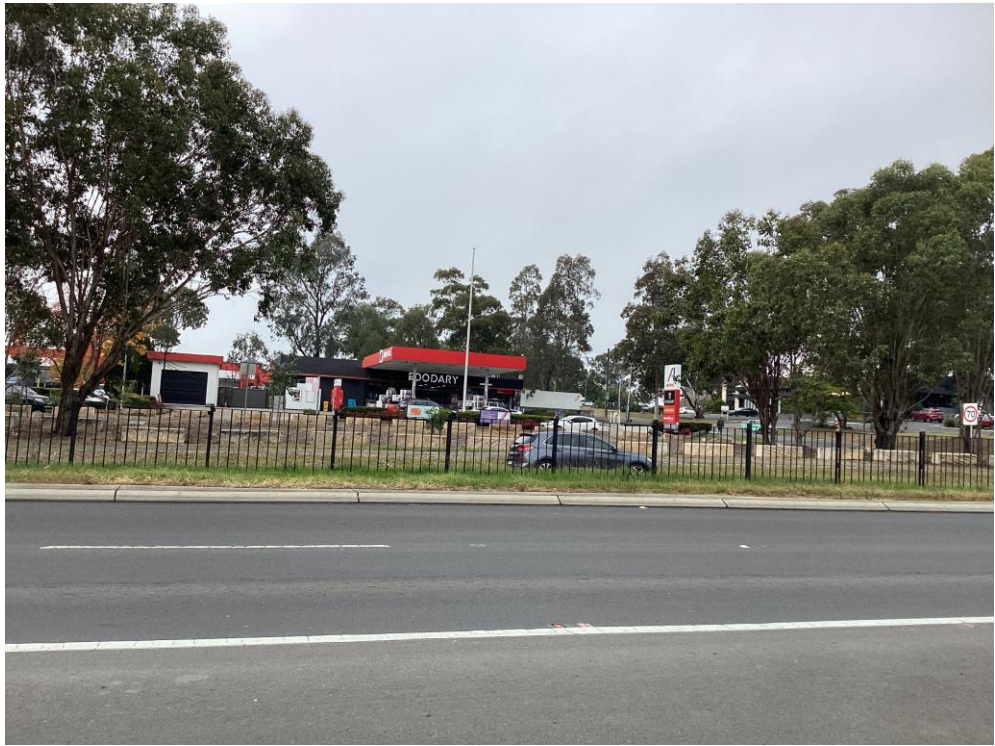
- A petrol station was observed adjacent to Boomerang Place and Star Crescent, east of the Site (refer to Figure 2C (6 of 9), Appendix A and Photo 3, Appendix C)

Photo 3 – Petrol station located adjacent to Boomerang Place and Star Crescent, east of the Site

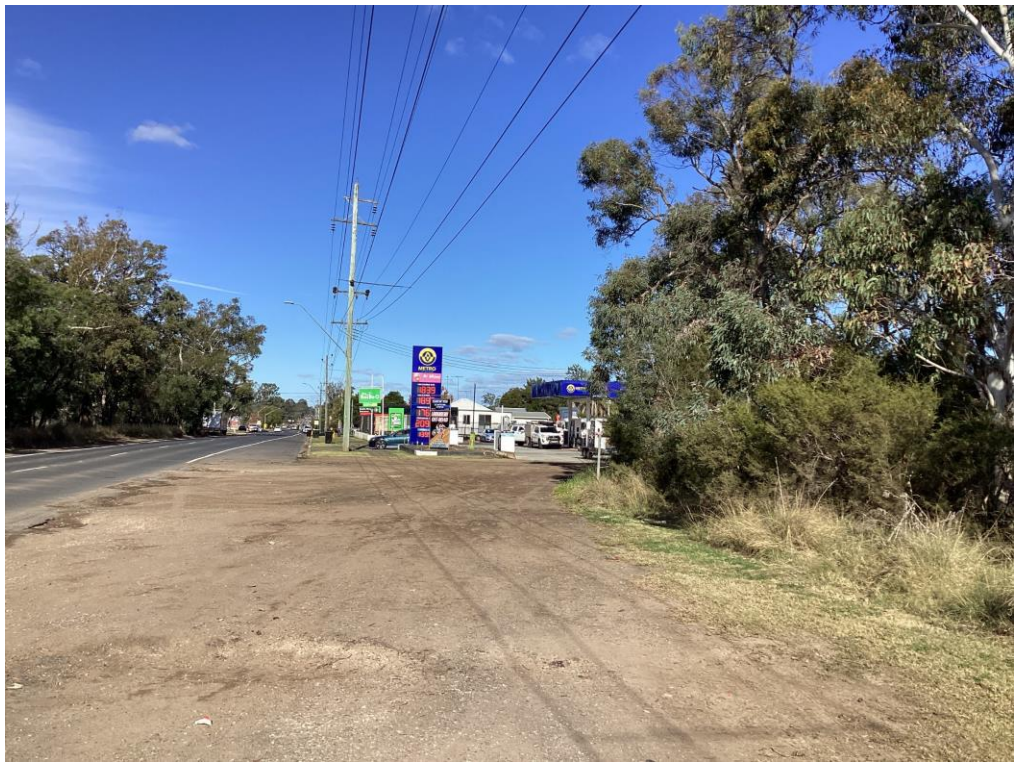
- A petrol station was observed west of the road corridor, opposite to the Londonderry RAAF base (refer to Figure 2C (8 of 9), Appendix A and Photo 11, Appendix C)
- At the RAAF base area, Londonderry Road was predominately flat with a slight slope away from the road corridor to the east (refer to Figure 2C (8 of 9), Appendix A and Photo 12, Appendix C)
- A property north of The Driftway was observed to be used as a university “Climate Change Research” area. Some relatively large above ground tanks (unknown use) were observed in the north of this property (refer to Figure 2C (7 of 9), Appendix A and Photo 13 and 14, Appendix C)
- The areas either side of the road corridor, north of The Driftway, were observed to be densely vegetated to the west, and grassed fields to the east (refer to Figure 2C (7 of 9), Appendix A)

Photo 11 – Petrol station located west of the Site, opposite to the RAAF Base Londonderry

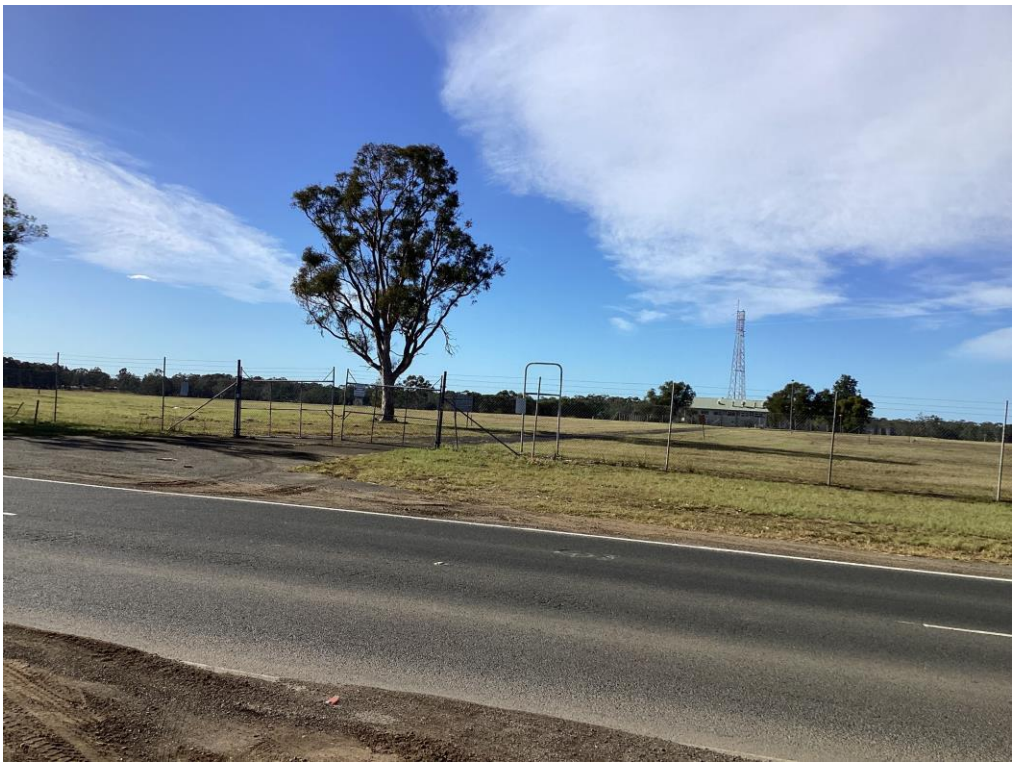
Photo 12 – Londonderry RAAF Base, located east of the Site
