Preliminary Site Investigation

Hawkesbury-Nepean Valley Flood Evacuation Road Resilience Program Improvements on The Northern Road and Londonderry Road Flood Evacuation Routes

Client Project No.: P.0078303
Client Reference No. 22.0000139271.1313
Prepared for: Transport for NSW
14 June 2024

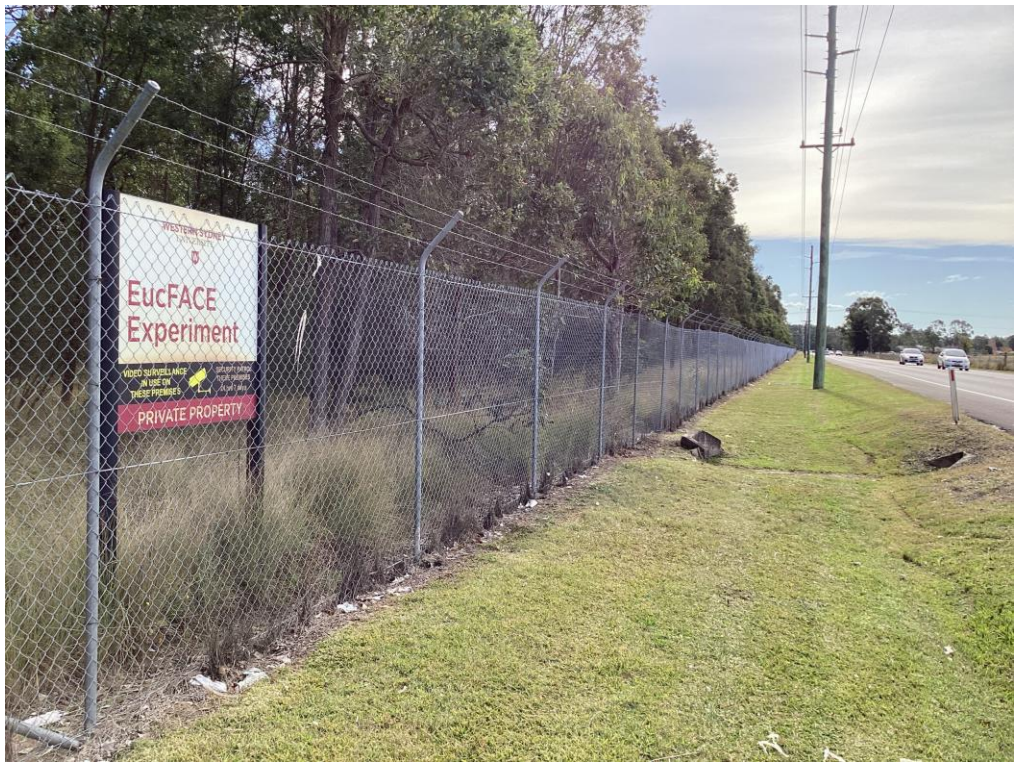
Photo 13 – “Climate Change Research” area, west of the Site

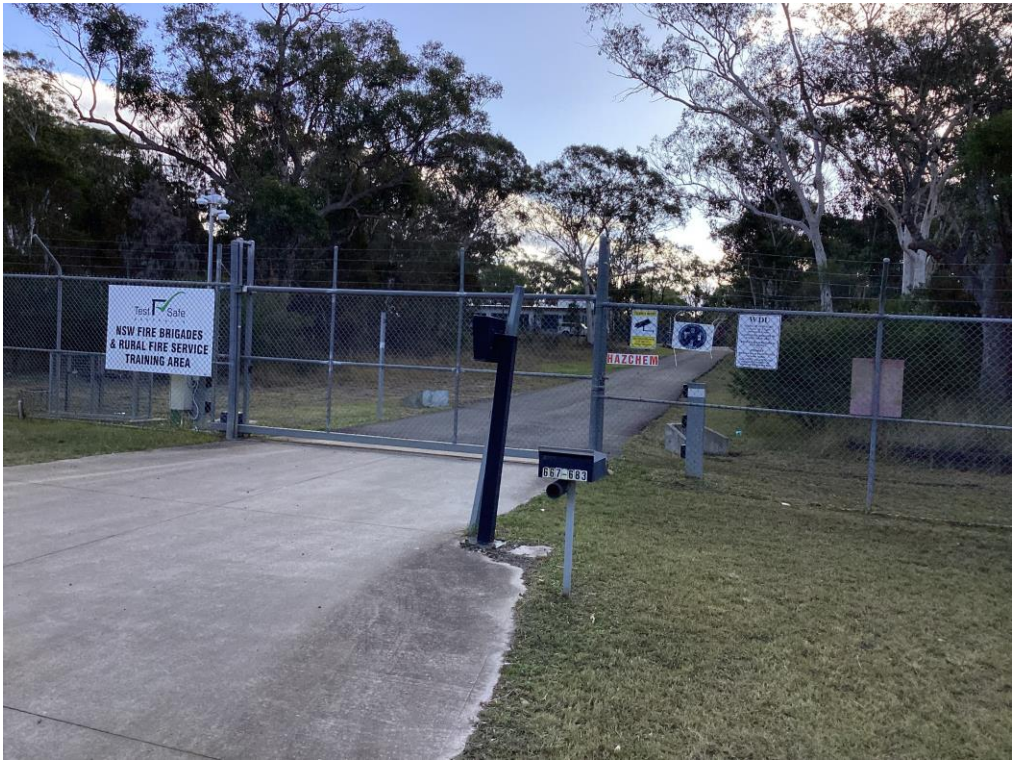
- The Northern Road, north of the Londonderry Road intersection, was predominately flat with some gentle undulation along the road corridor
- A RFS training area was observed west of The Northern Road and appeared fenced off (refer to Figure 2C (3 of 9), Appendix A and Photo 16, Appendix C)

Photo 16 – RFS training area (TestSafe)

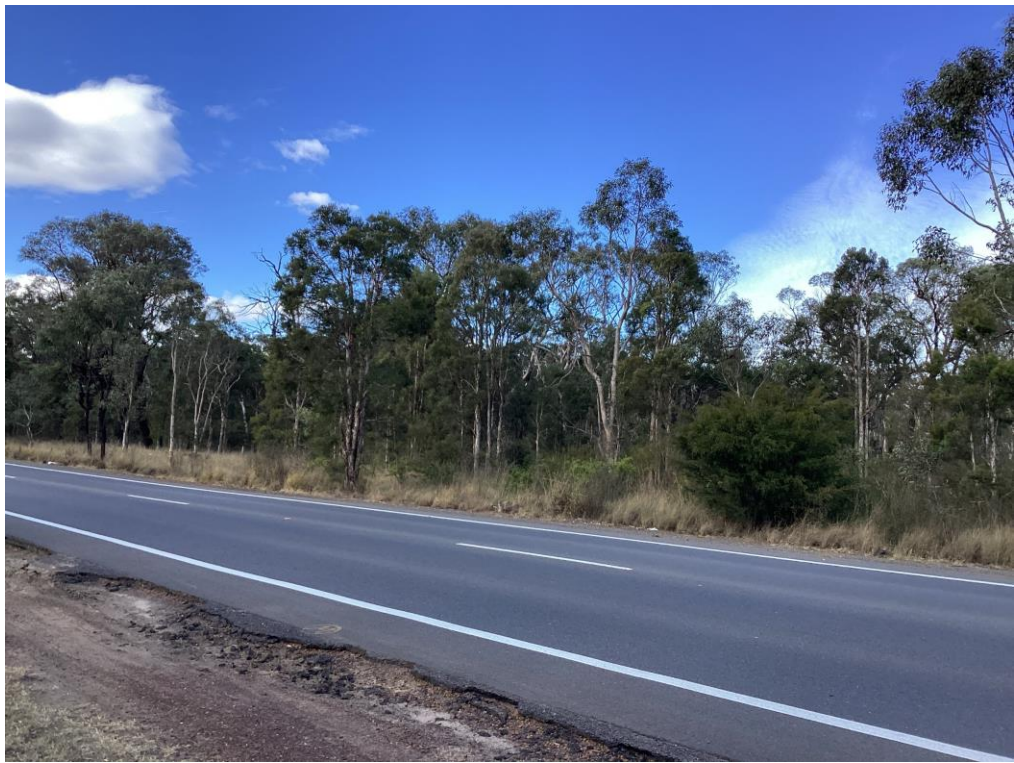
- Castlereagh Nature Reserve (east of the Site) was observed to be heavily treed (refer to Figure 2C (3 of 9), Appendix A and Photo 17, Appendix C)
- A wrecker was observed on the west side of The Northern Road, opposite the south end of the Castlereagh Nature Reserve (refer to Figure 2C (3 of 9), Appendix A and Photo 18, Appendix C)

Photo 17 – Heavily treed Castlereagh Nature Reserve

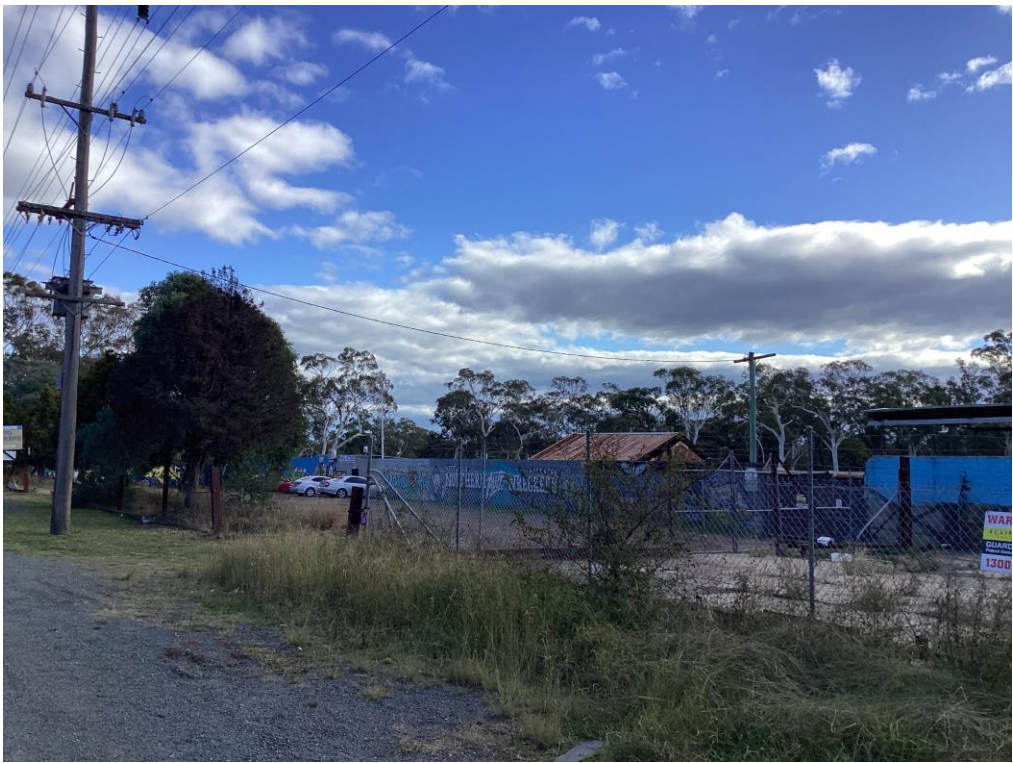
Photo 18 – Wrecker located west of the Site

- AEI 5 – Areas adjacent to service stations, wreckers and commercial/industrial areas (refer to Figure 2C and 3, Appendix A for locations) from activities such as storage and dispensing of fuels, mechanical repairs, use of oils, lubricants, degreasers, waste material storage etc. Also includes a portion of a hospital and RAAF Base Londonderry (due to data gaps).
