Captains Flat to Bungendore – Rail Corridor XRF Survey

Bungendore, NSW

5 February 2024

Project No.: 0608750

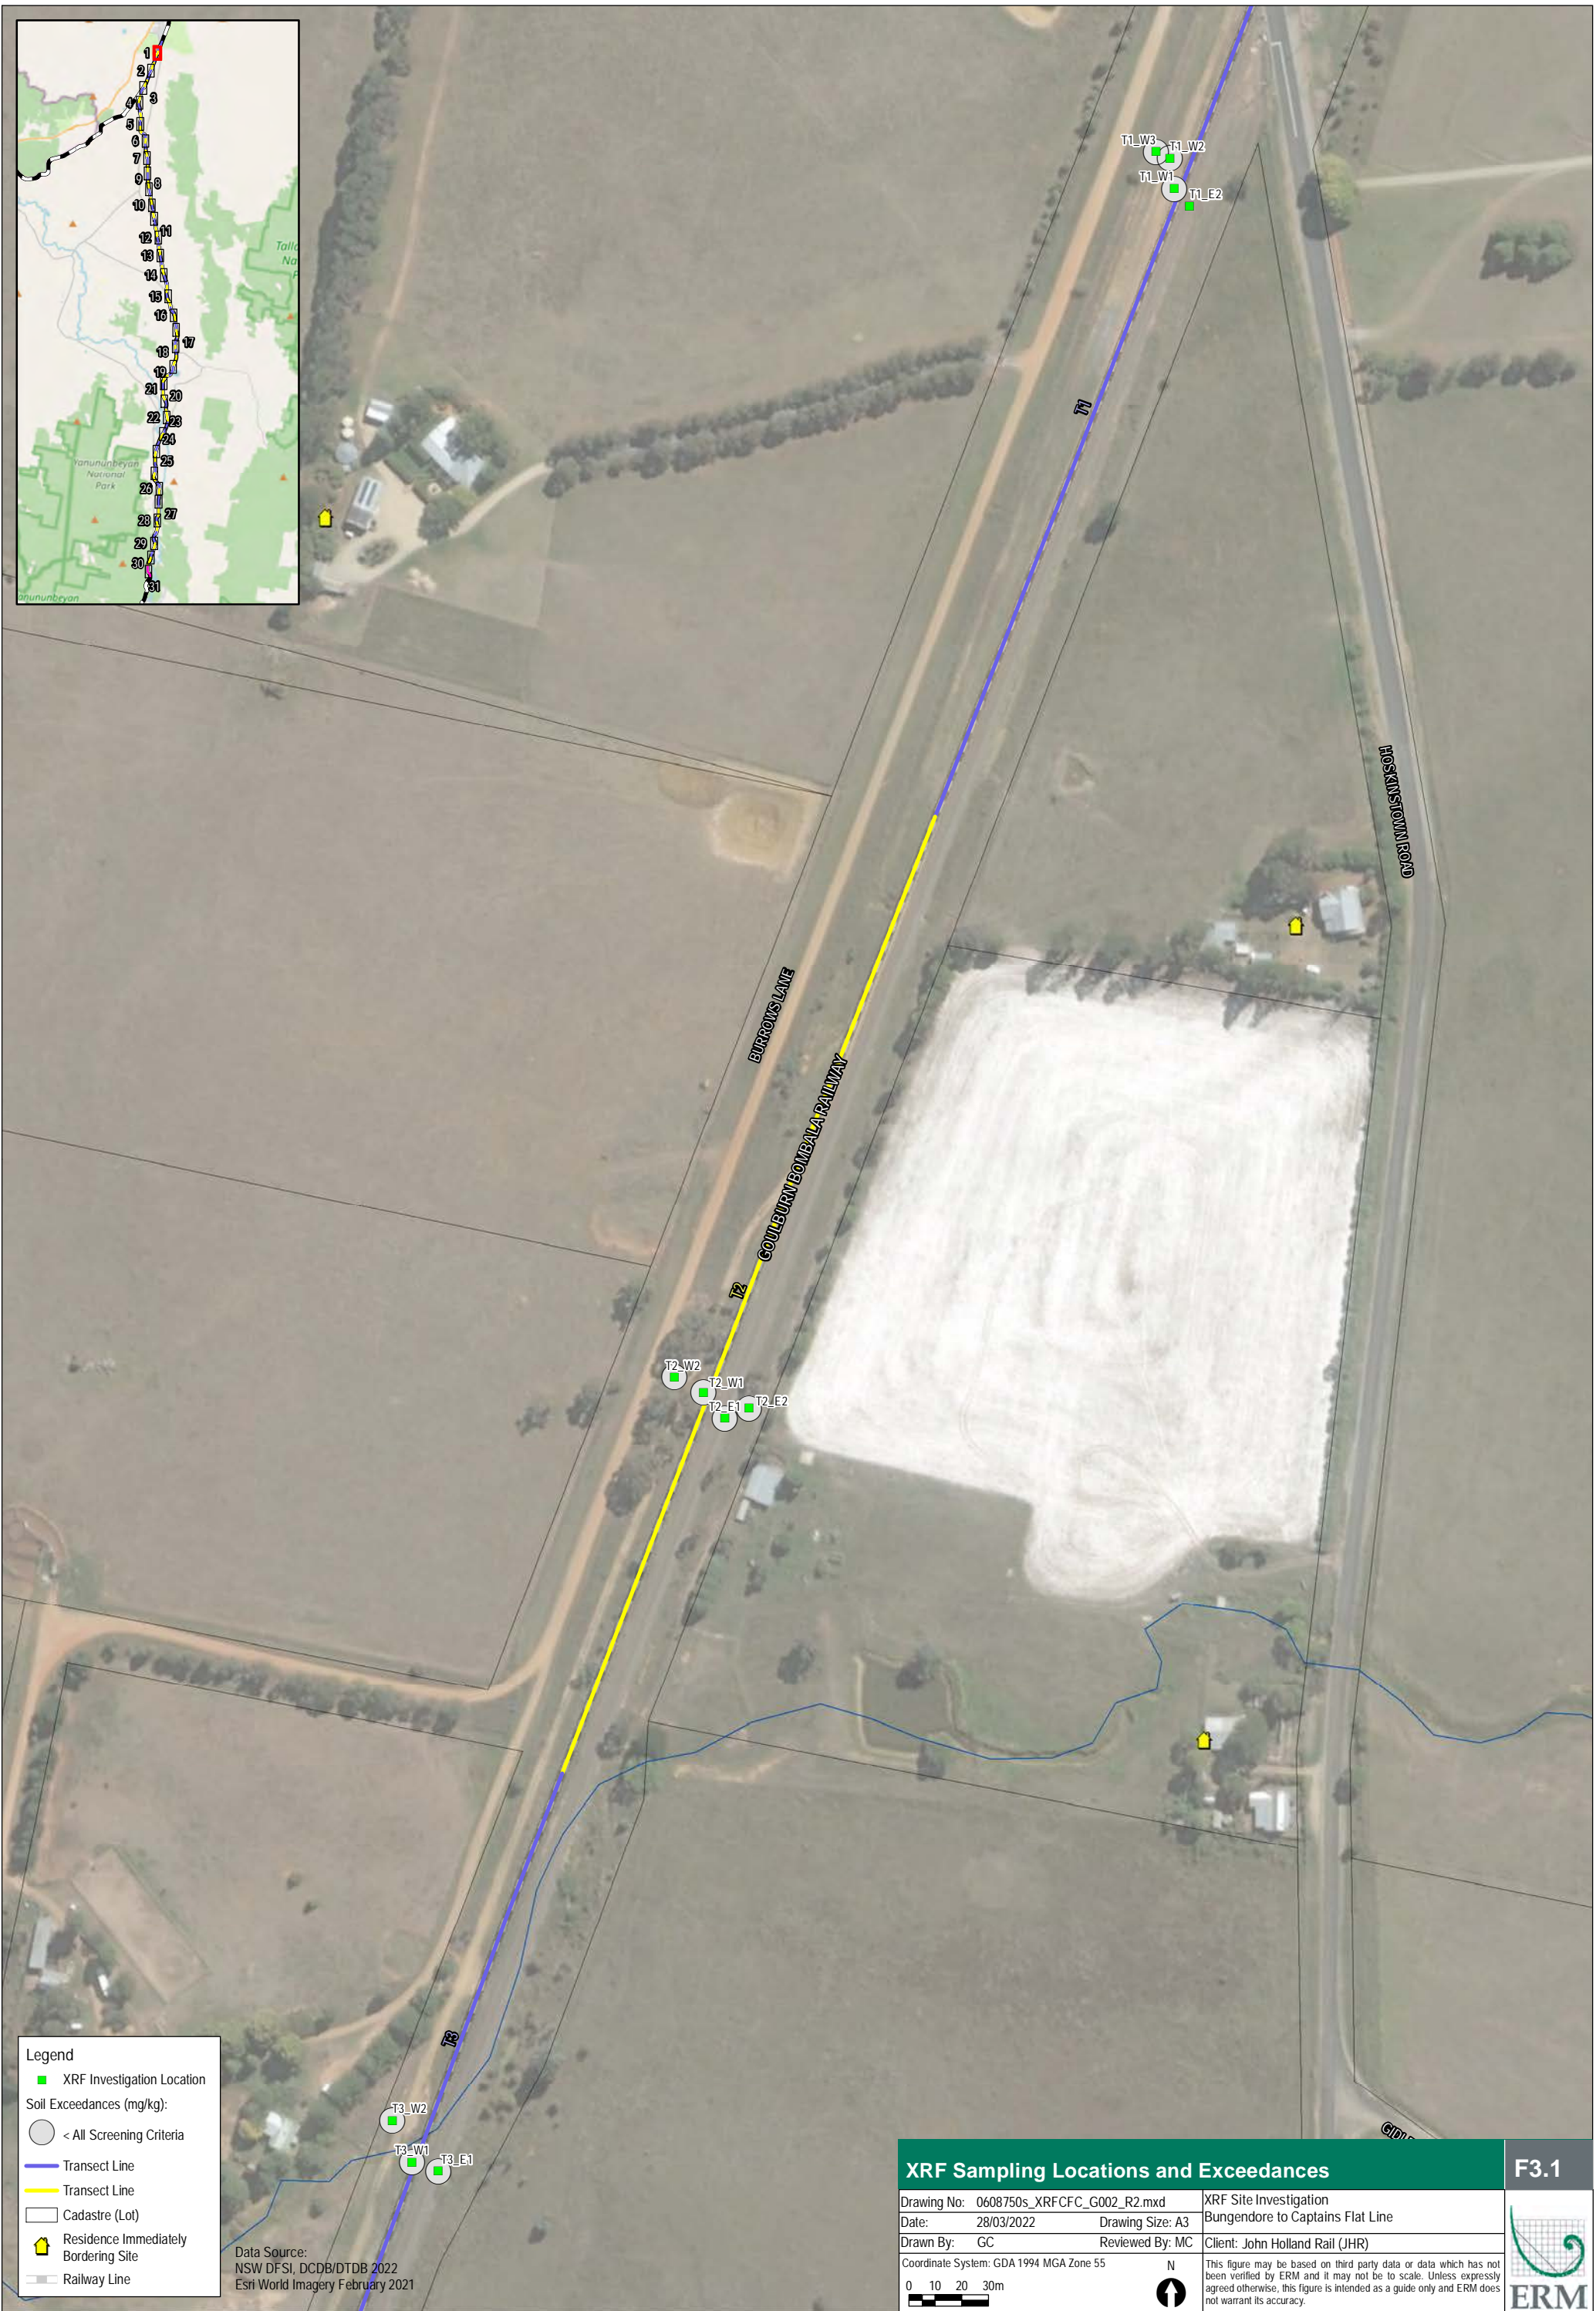
XRF Sampling Locations and Exceedances			F3.2
Drawing No: 0608750s_XRFCFC_G002_R2.mxd		XRF Site Investigation	
Date: 28/03/2022		Drawing Size: A3	
Drawn By: GC		Reviewed By: MC	
Coordinate System: GDA 1994 MGA Zone 55		Client: John Holland Rail (JHR)	
0 10 20 30m		N	
		This figure may be based on third party data or data which has not been verified by ERM and it may not be to scale. Unless expressly agreed otherwise, this figure is intended as a guide only and ERM does not warrant its accuracy.

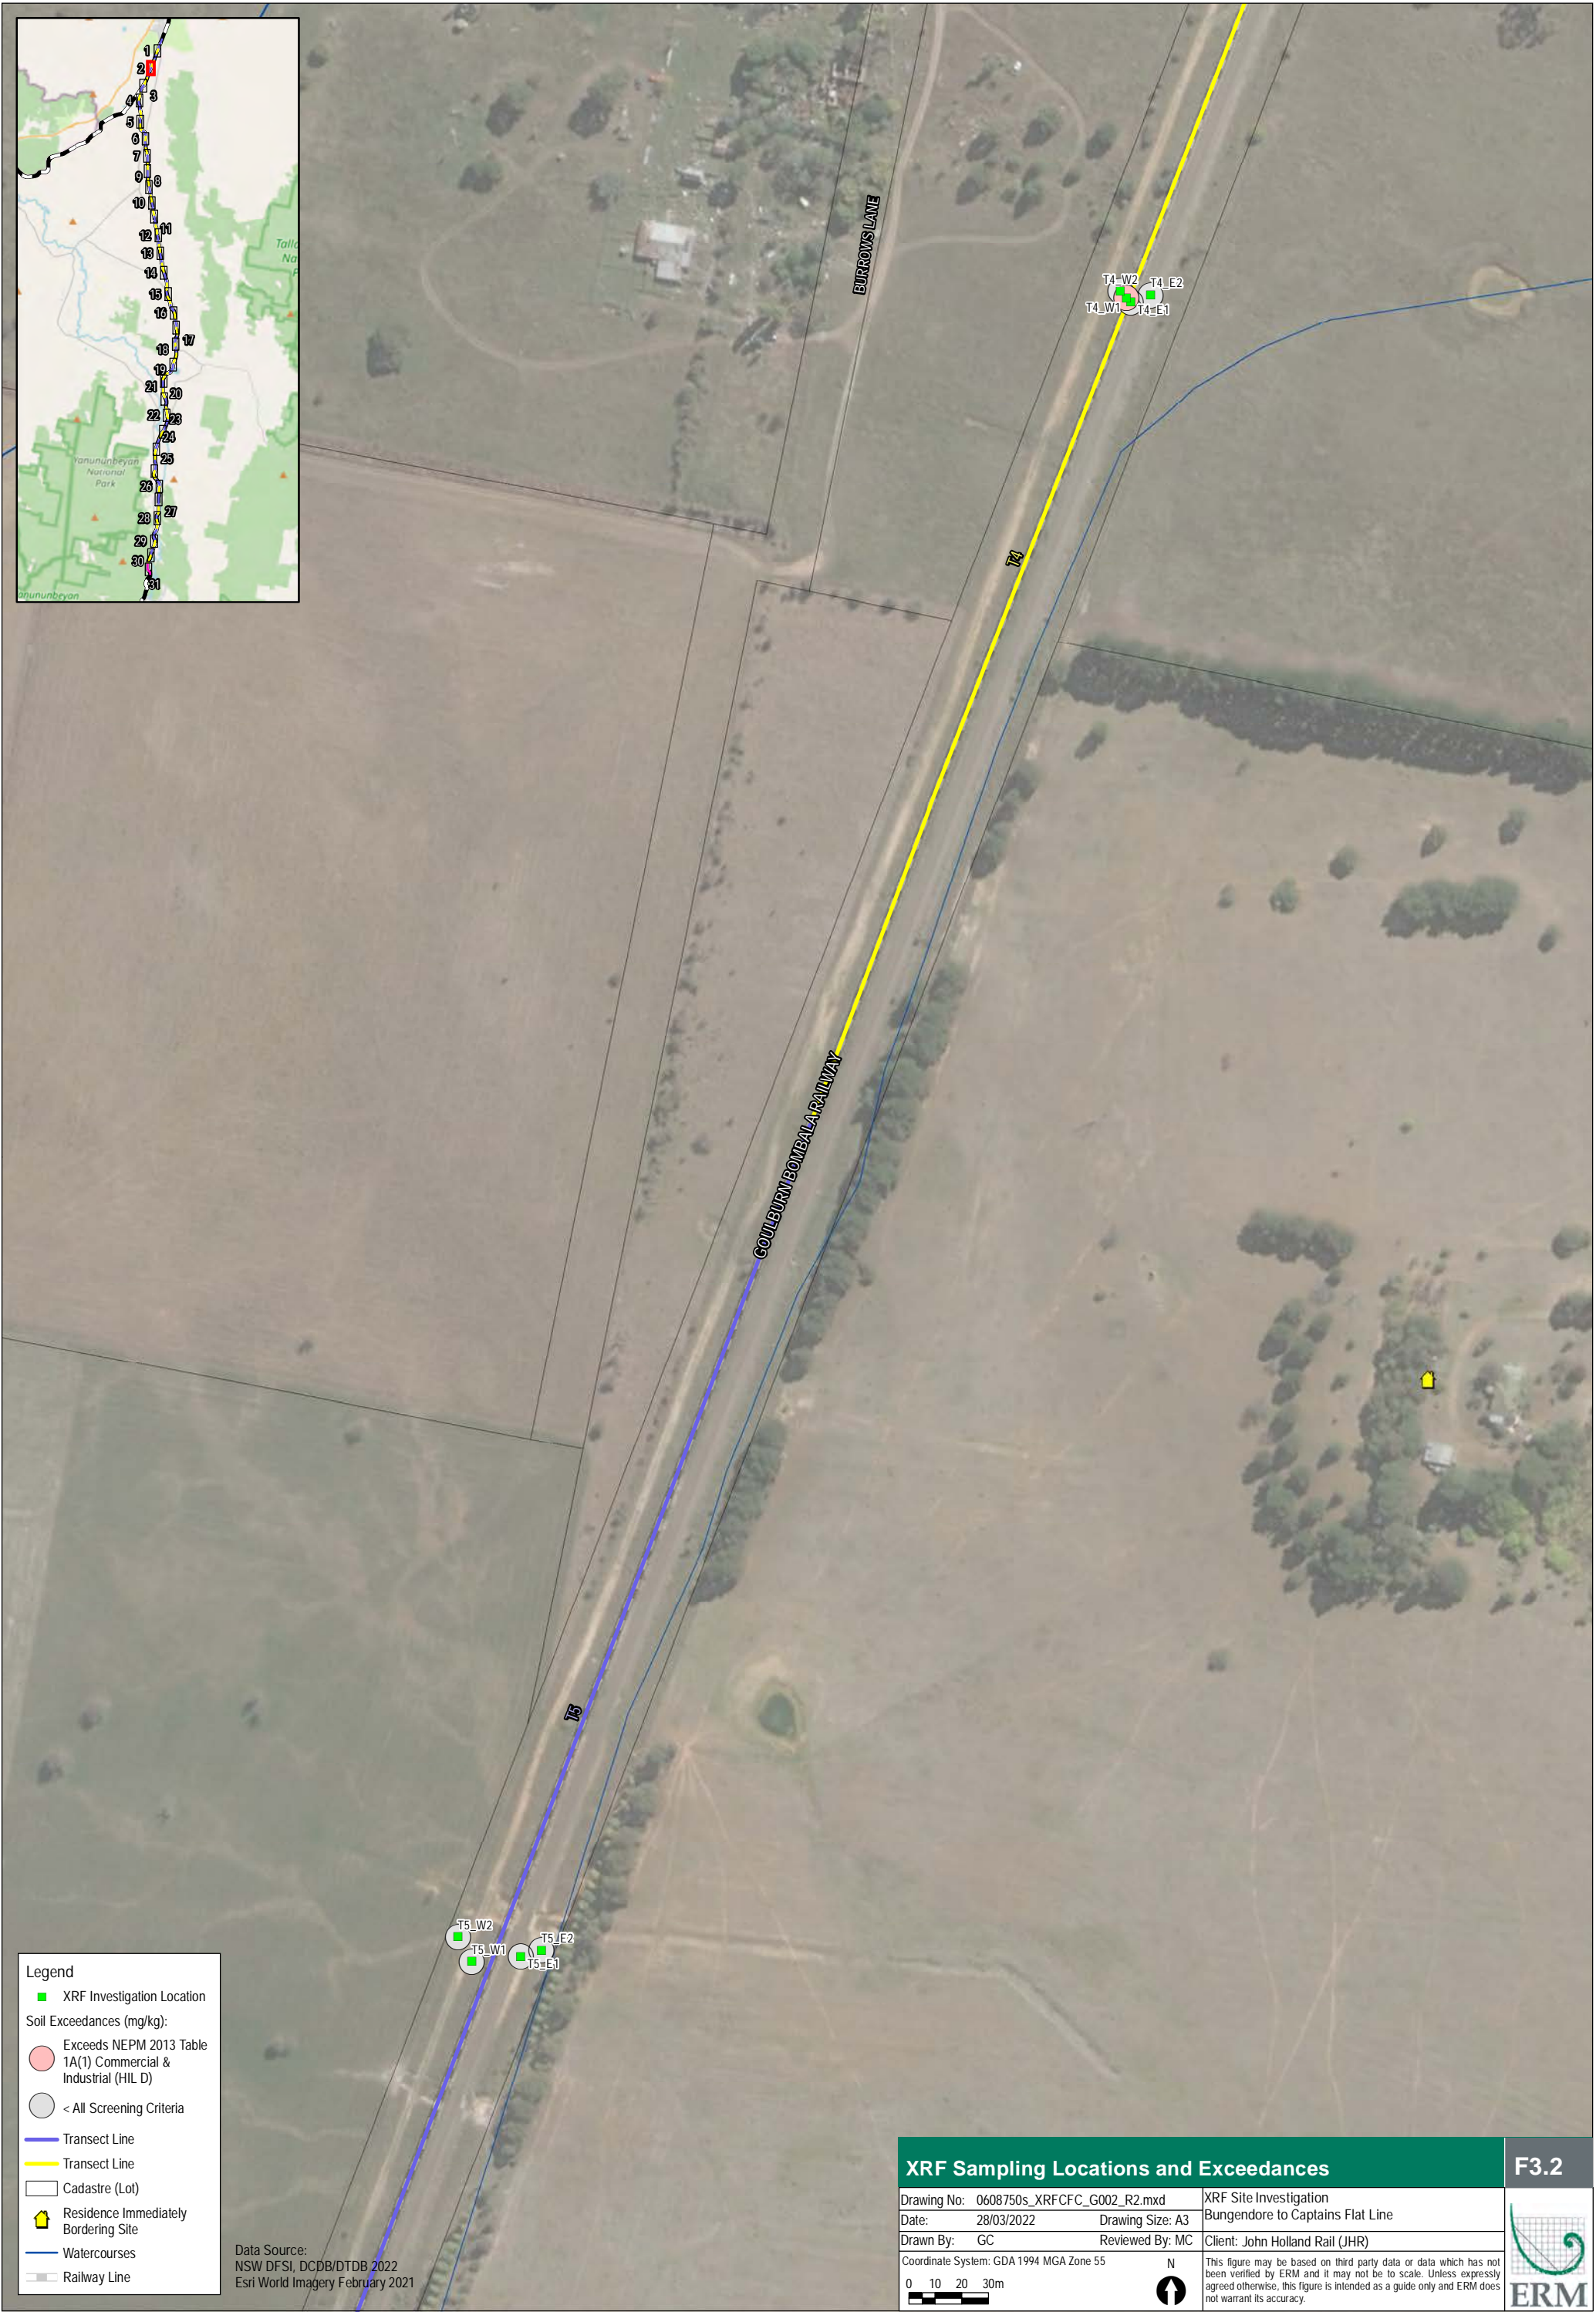
- XRF Investigation Location
- Soil Exceedances (mg/kg):
 - Exceeds NEPM 2013 Table 1A(1) Commercial & Industrial (HIL D)
 - < All Screening Criteria
- Transect Line
- Transect Line
- Cadastral (Lot)
- Residence Immediately Bordering Site
- Watercourses
- Railway Line

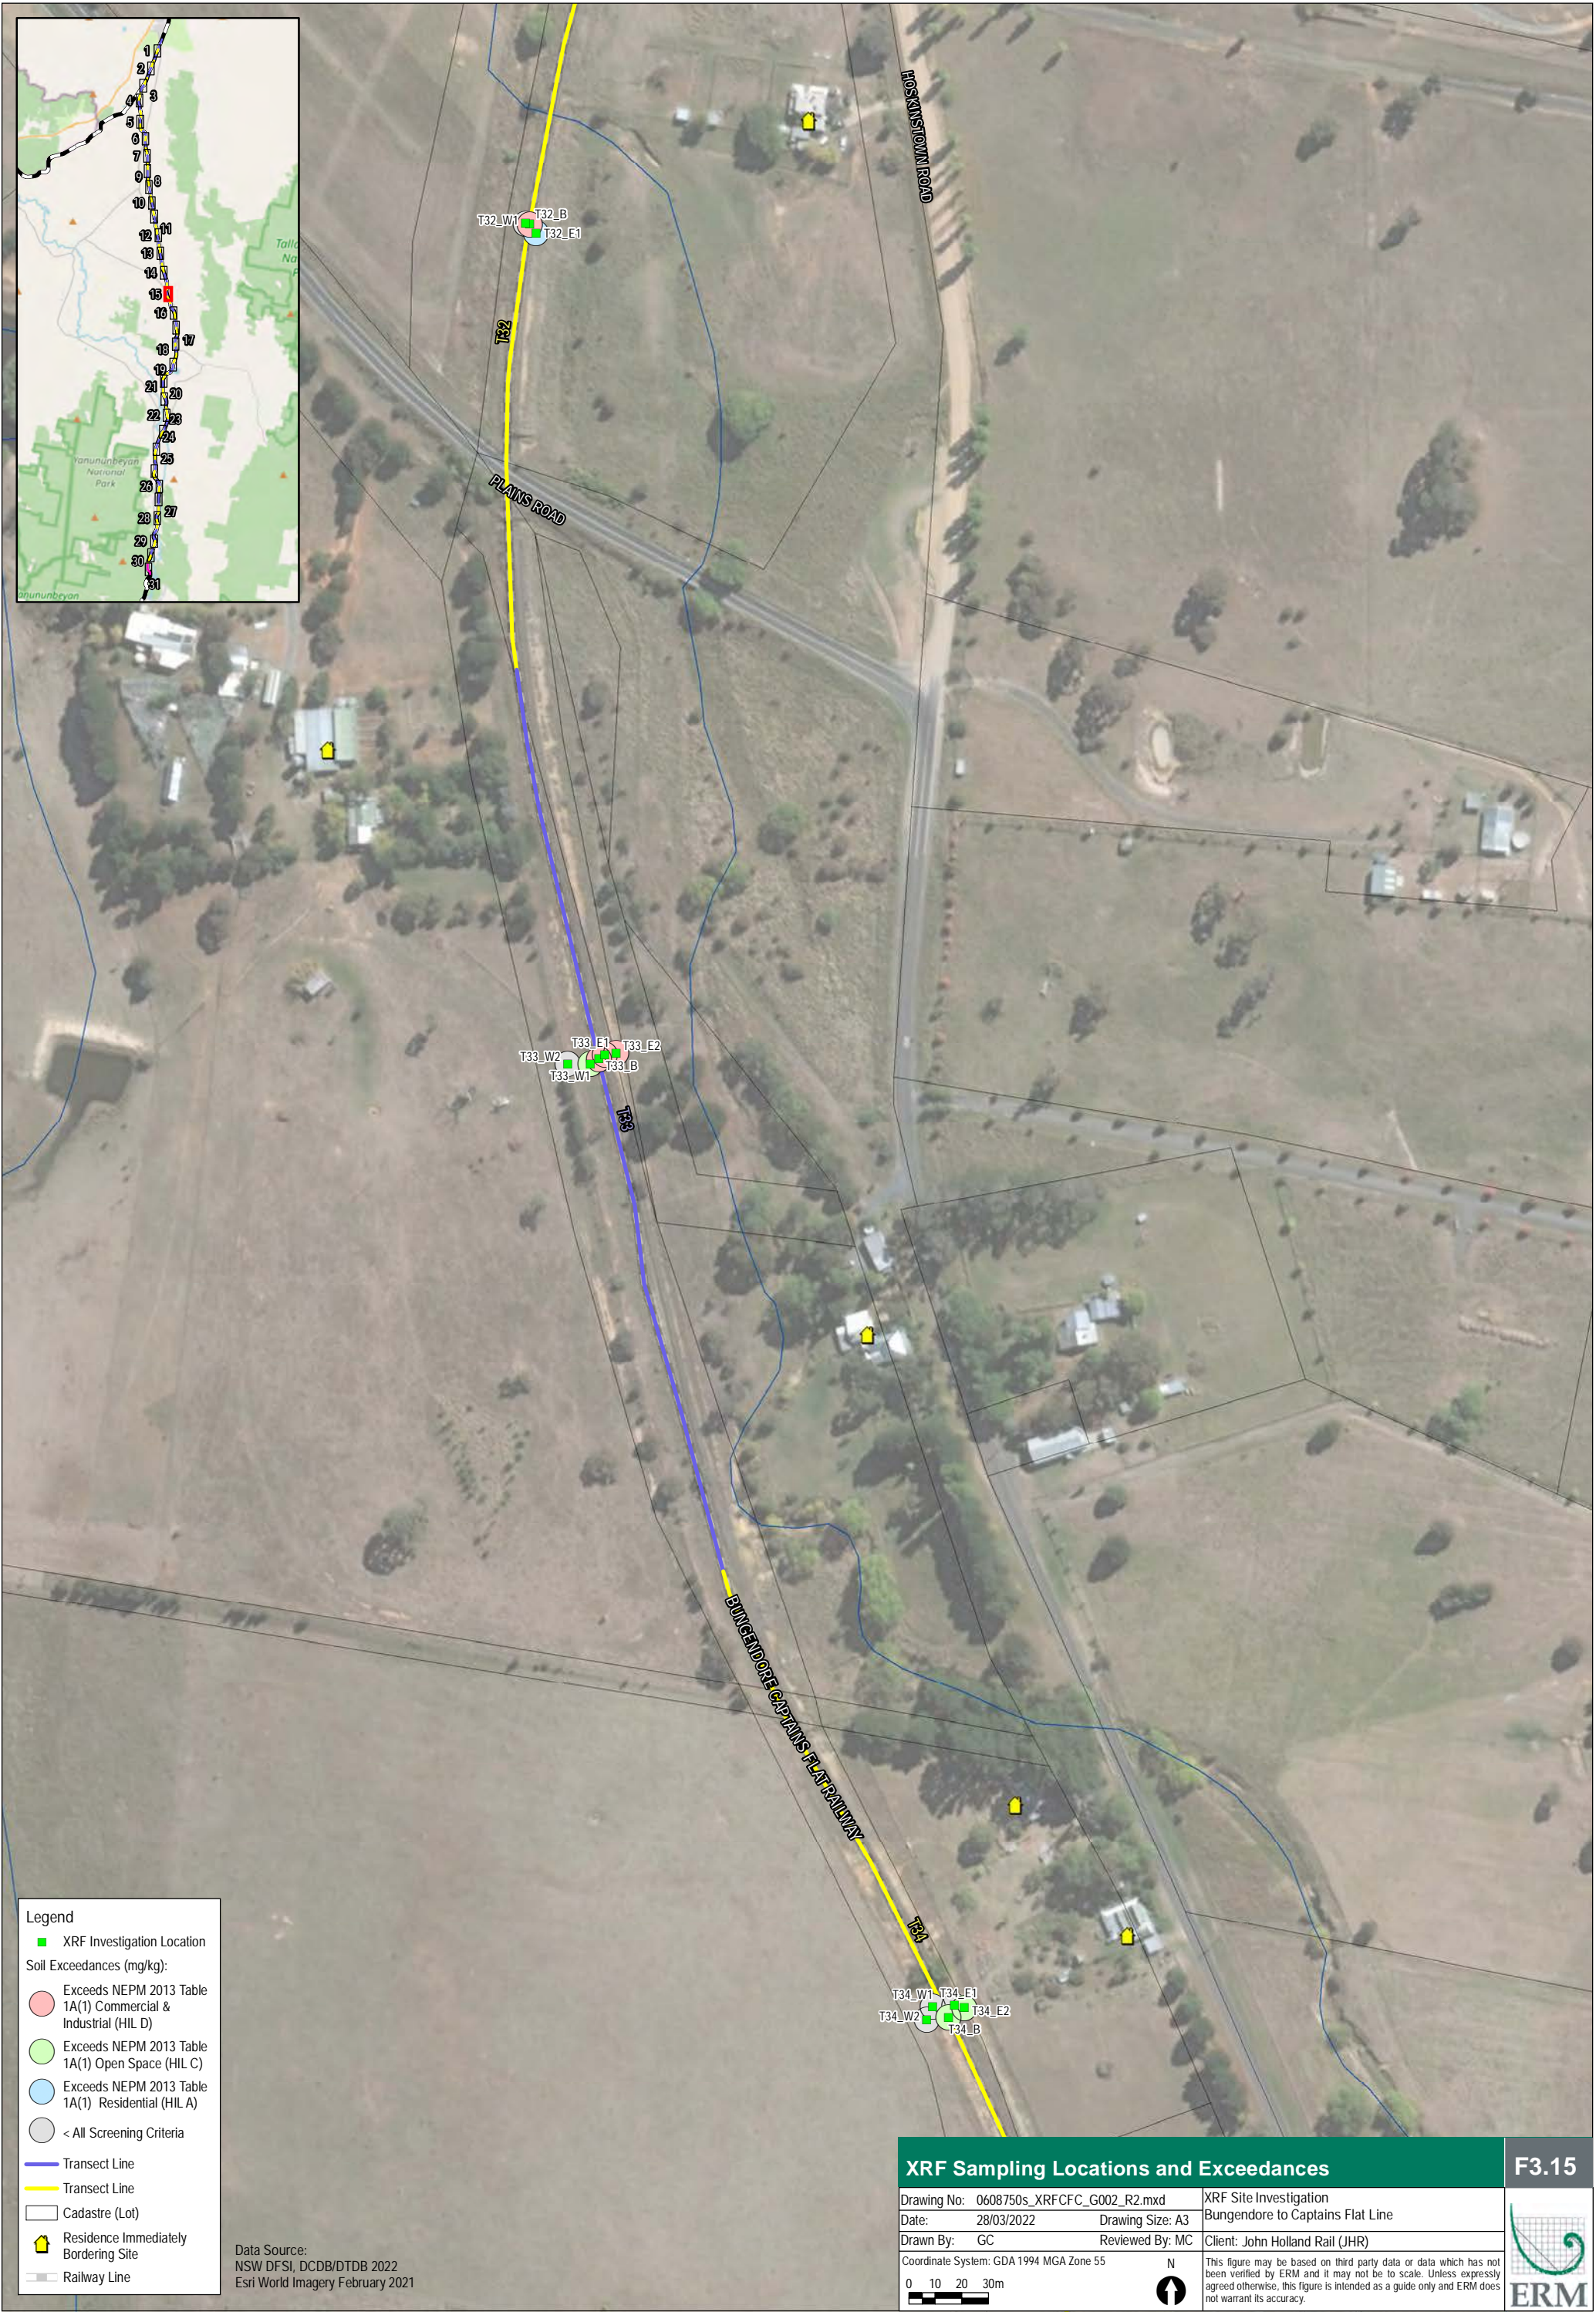
F3.15

XRF Sampling Locations and Exceedances

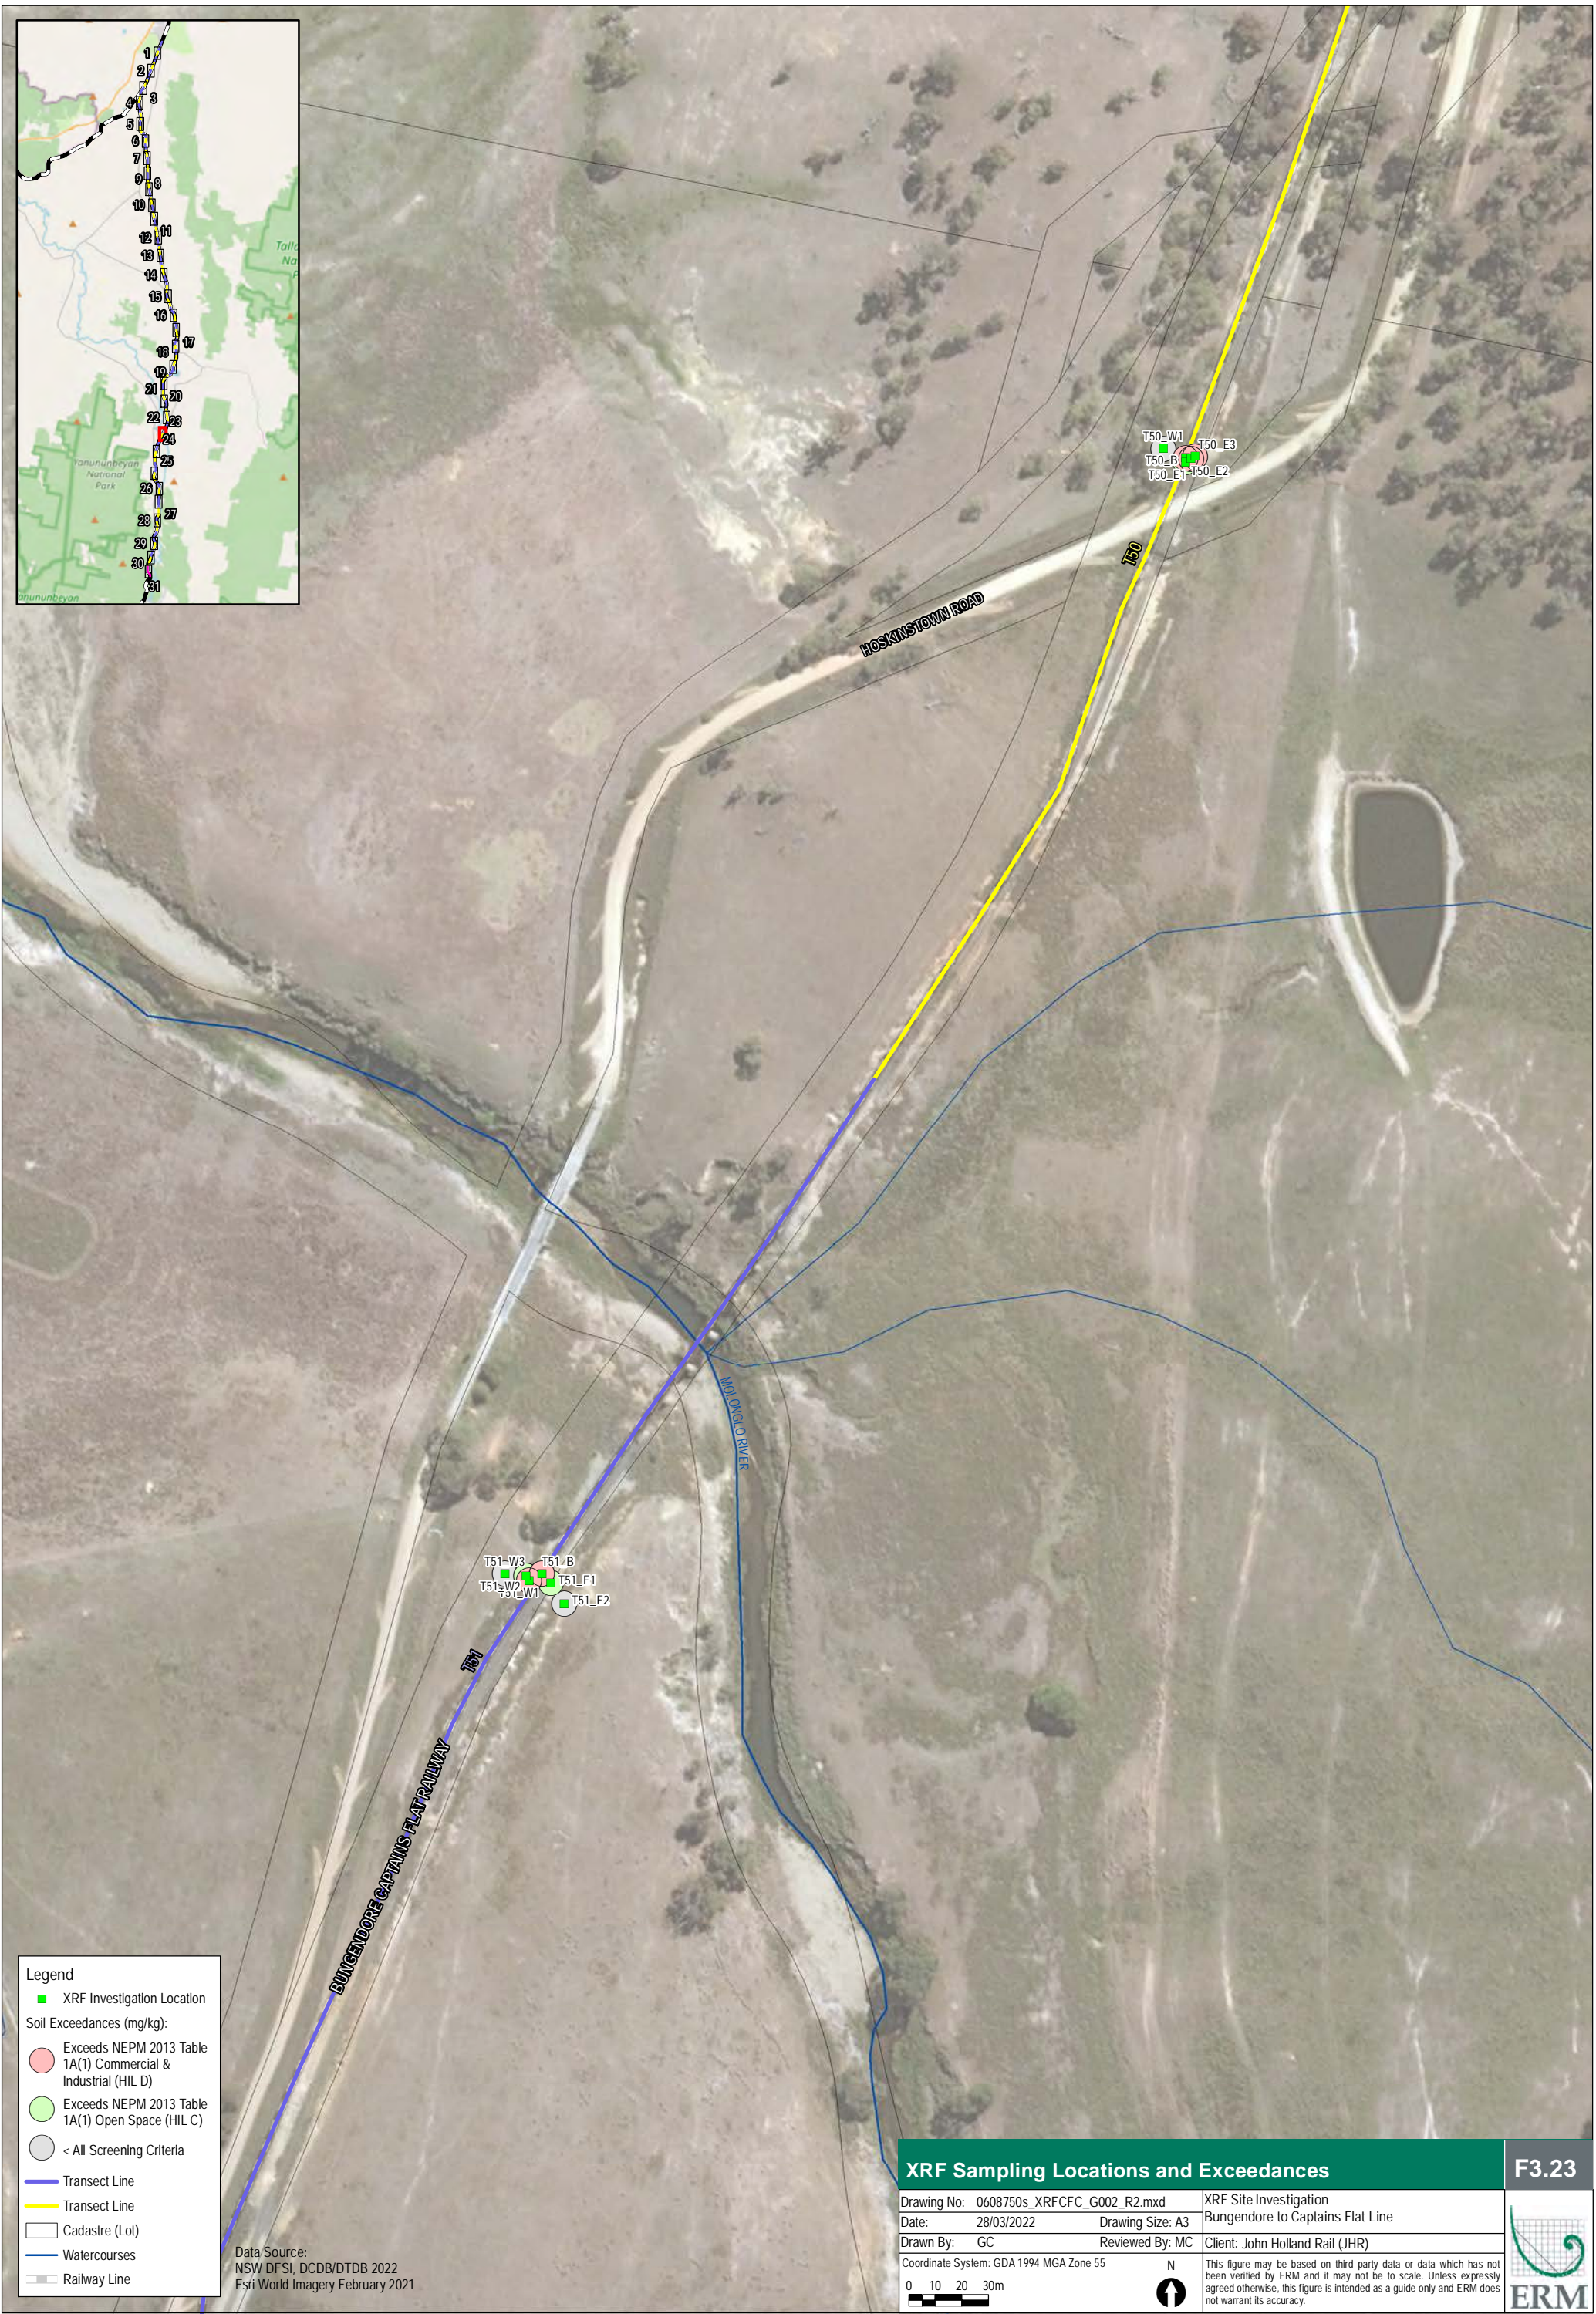
- XRF Investigation Location
- Soil Exceedances (mg/kg):
 - Exceeds NEPM 2013 Table 1A(1) Commercial & Industrial (HIL D)
 - Exceeds NEPM 2013 Table 1A(1) Open Space (HIL C)
 - < All Screening Criteria
- Transect Line
- Transect Line
- Cadastre (Lot)
- Watercourses
- Railway Line

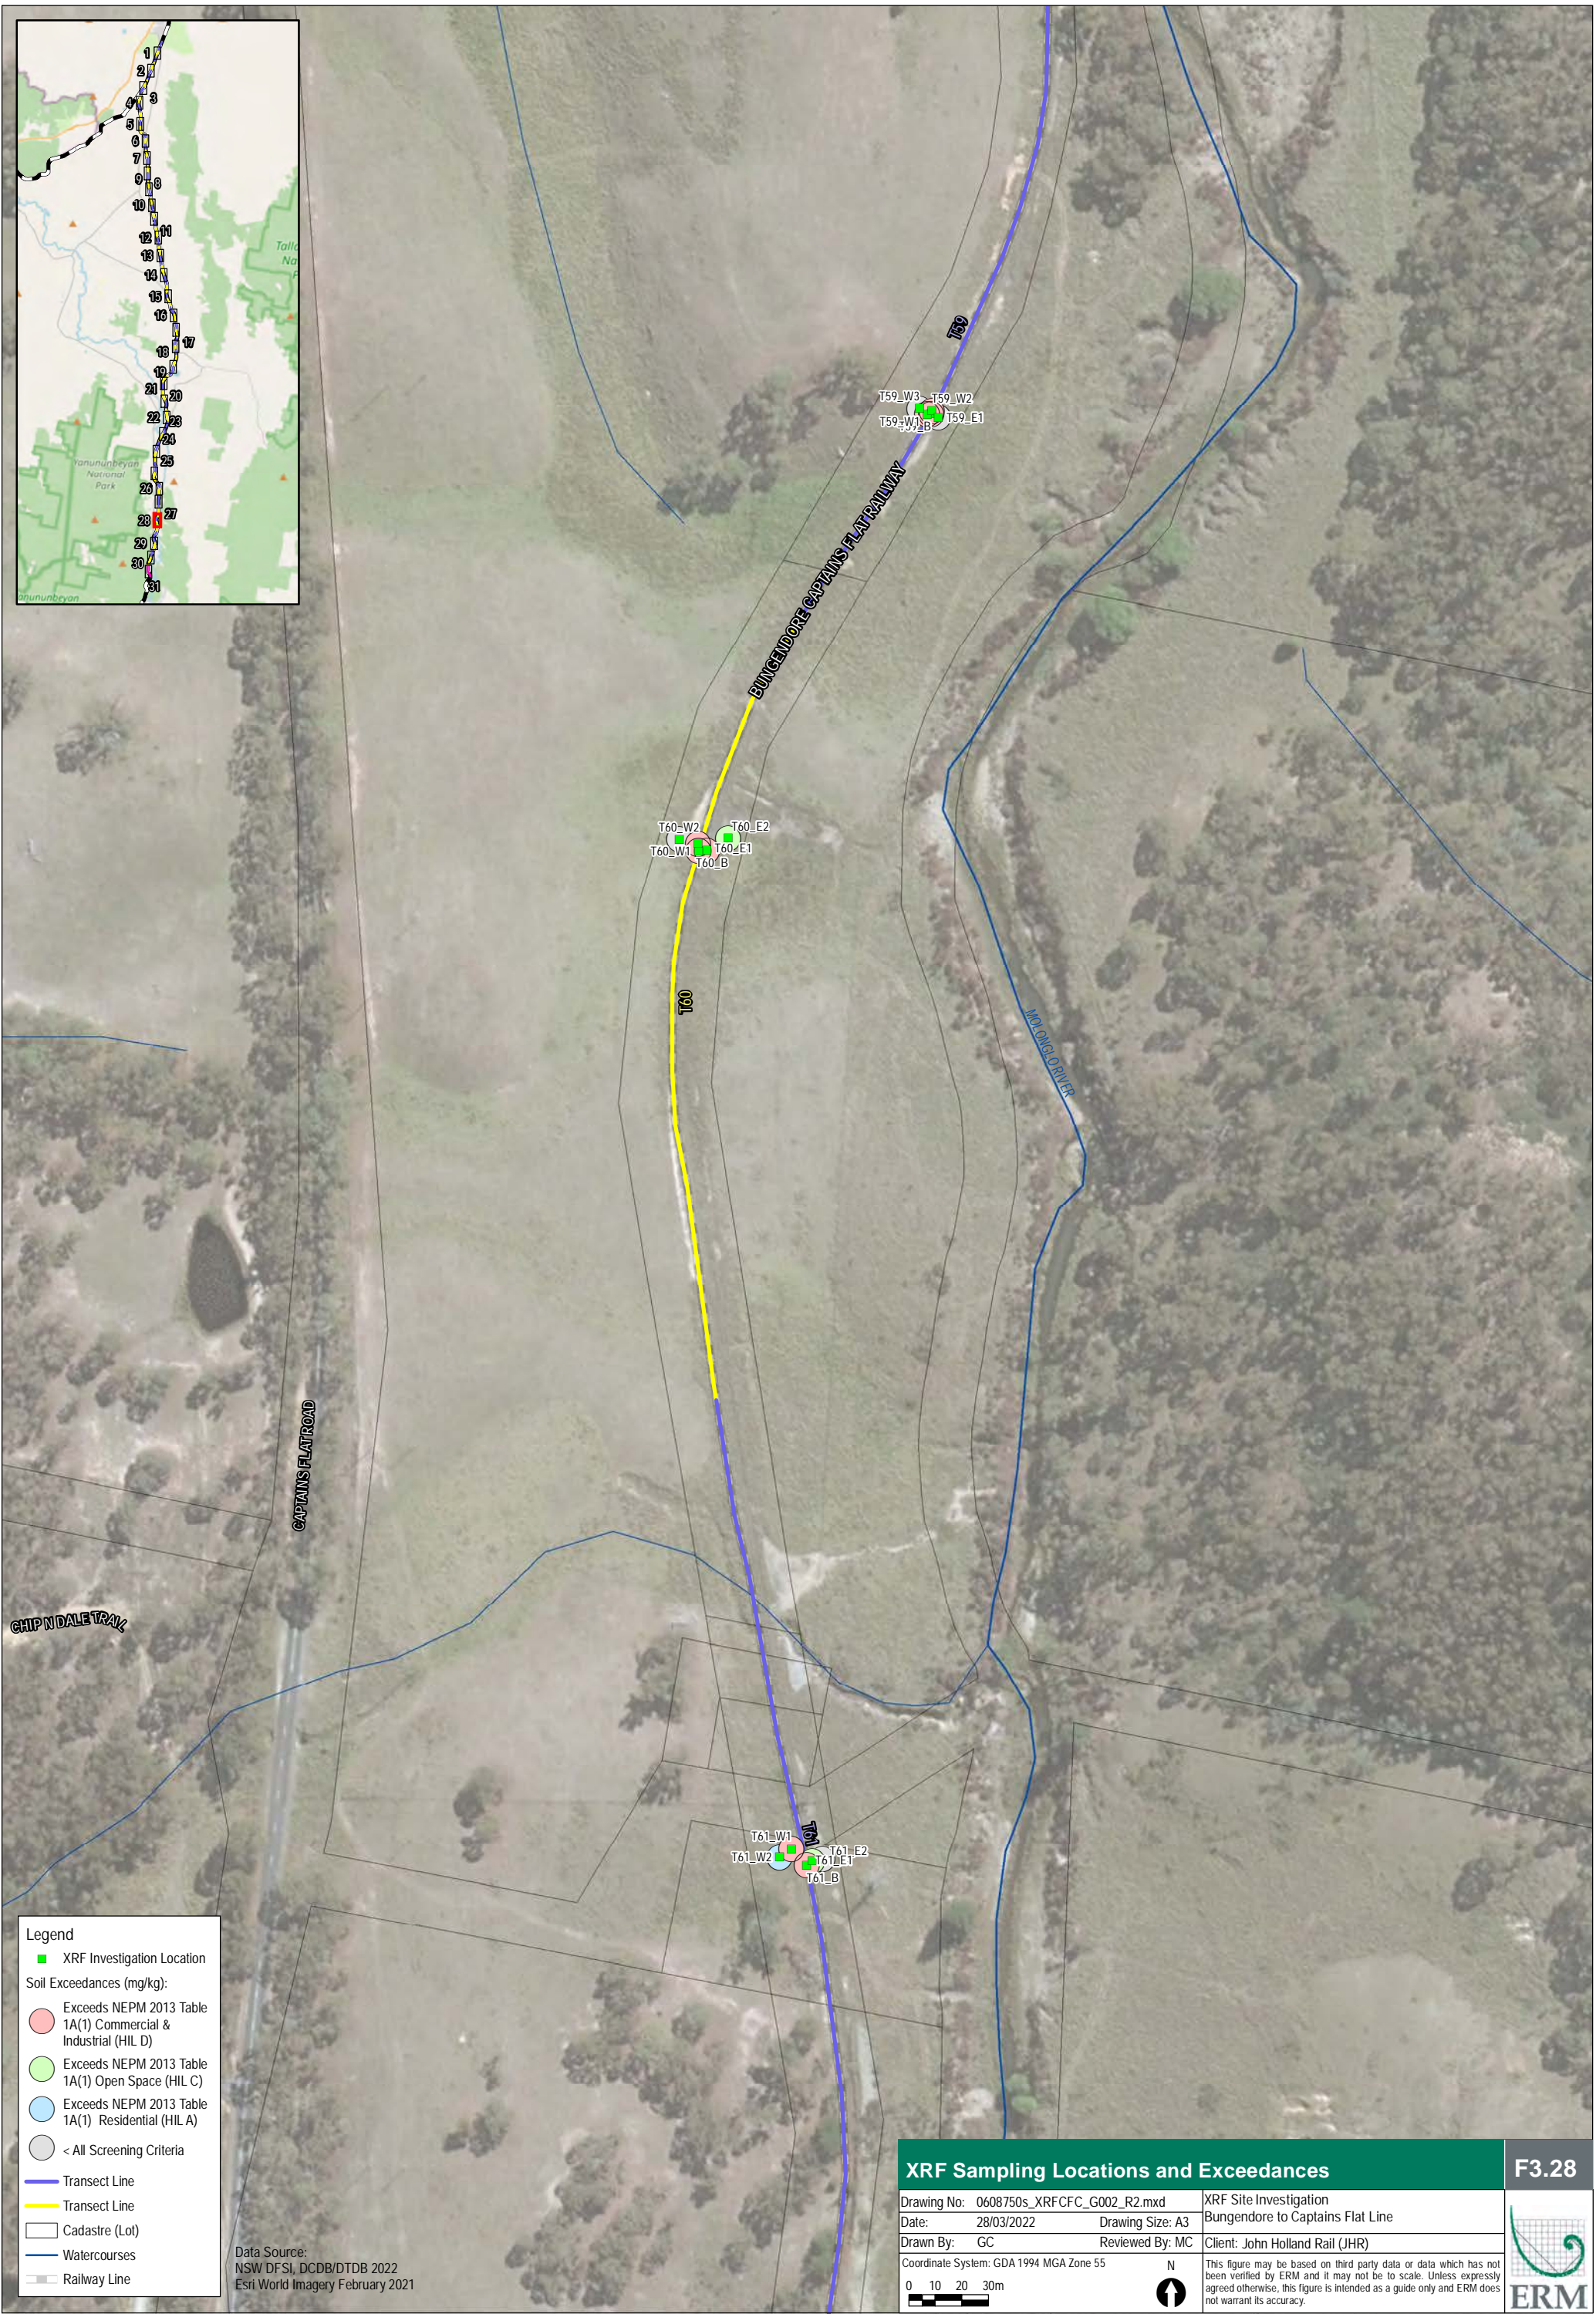
XRF Sampling Locations and Exceedances		F3.28
Drawing No: 0608750s_XRFCFC_G002_R2.mxd	XRF Site Investigation	
Date: 28/03/2022	Drawing Size: A3	Bungendore to Captains Flat Line
Drawn By: GC	Reviewed By: MC	Client: John Holland Rail (JHR)
Coordinate System: GDA 1994 MGA Zone 55

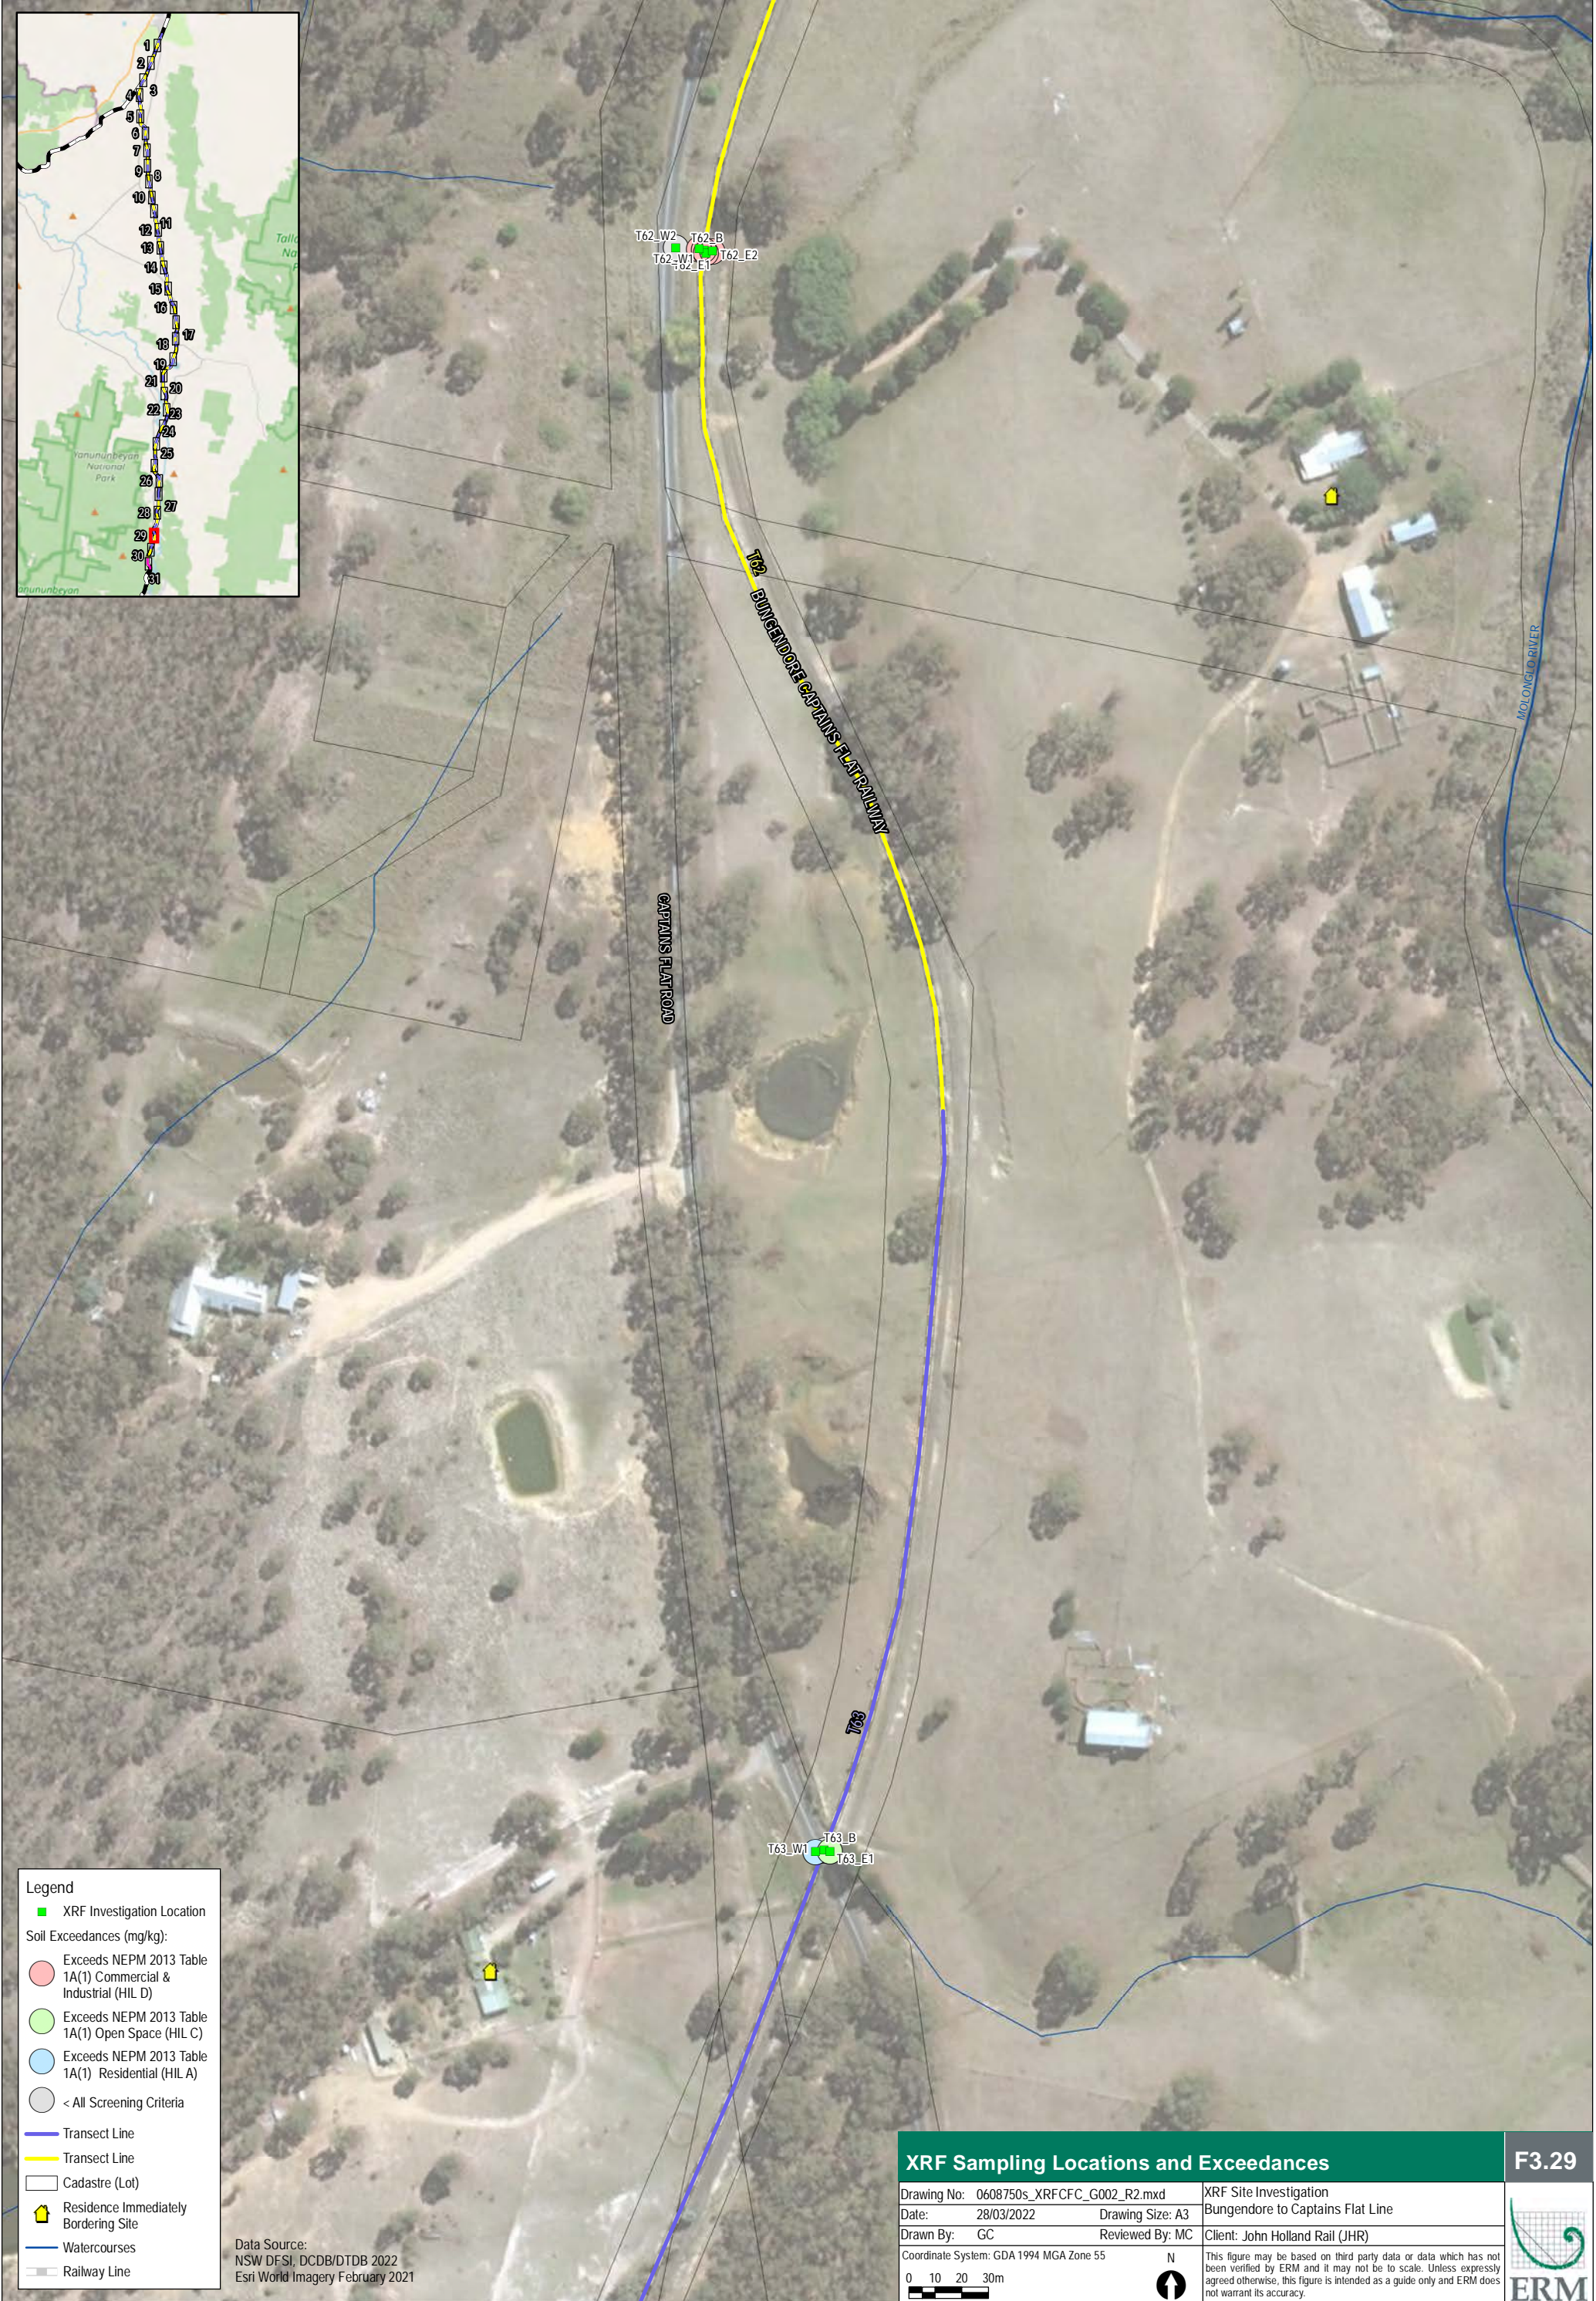
XRF Sampling Locations and Exceedances		F3.29
Drawing No: 0608750s_XRFCFC_G002_R2.mxd	XRF Site Investigation	
Date: 28/03/2022	Drawing Size: A3	Bungendore to Captains Flat Line
Drawn By: GC	Reviewed By: MC	Client: John Holland Rail (JHR)
Coordinate System: GDA 1994 MGA Zone 55		<div><div></div><div>N</div><div></div></div> <div>This figure may be based on third party data or data which has not been verified by ERM and it may not be to scale. Unless expressly agreed otherwise, this figure is intended as a guide only and ERM does not warrant its accuracy.</div>
<div><div>0102030m</div><div></div></div>		
		<div><div></div><div>ERM</div></div>
