Captains Flat to Bungendore – Rail Corridor XRF Survey

Bungendore, NSW

5 February 2024

Project No.: 0608750

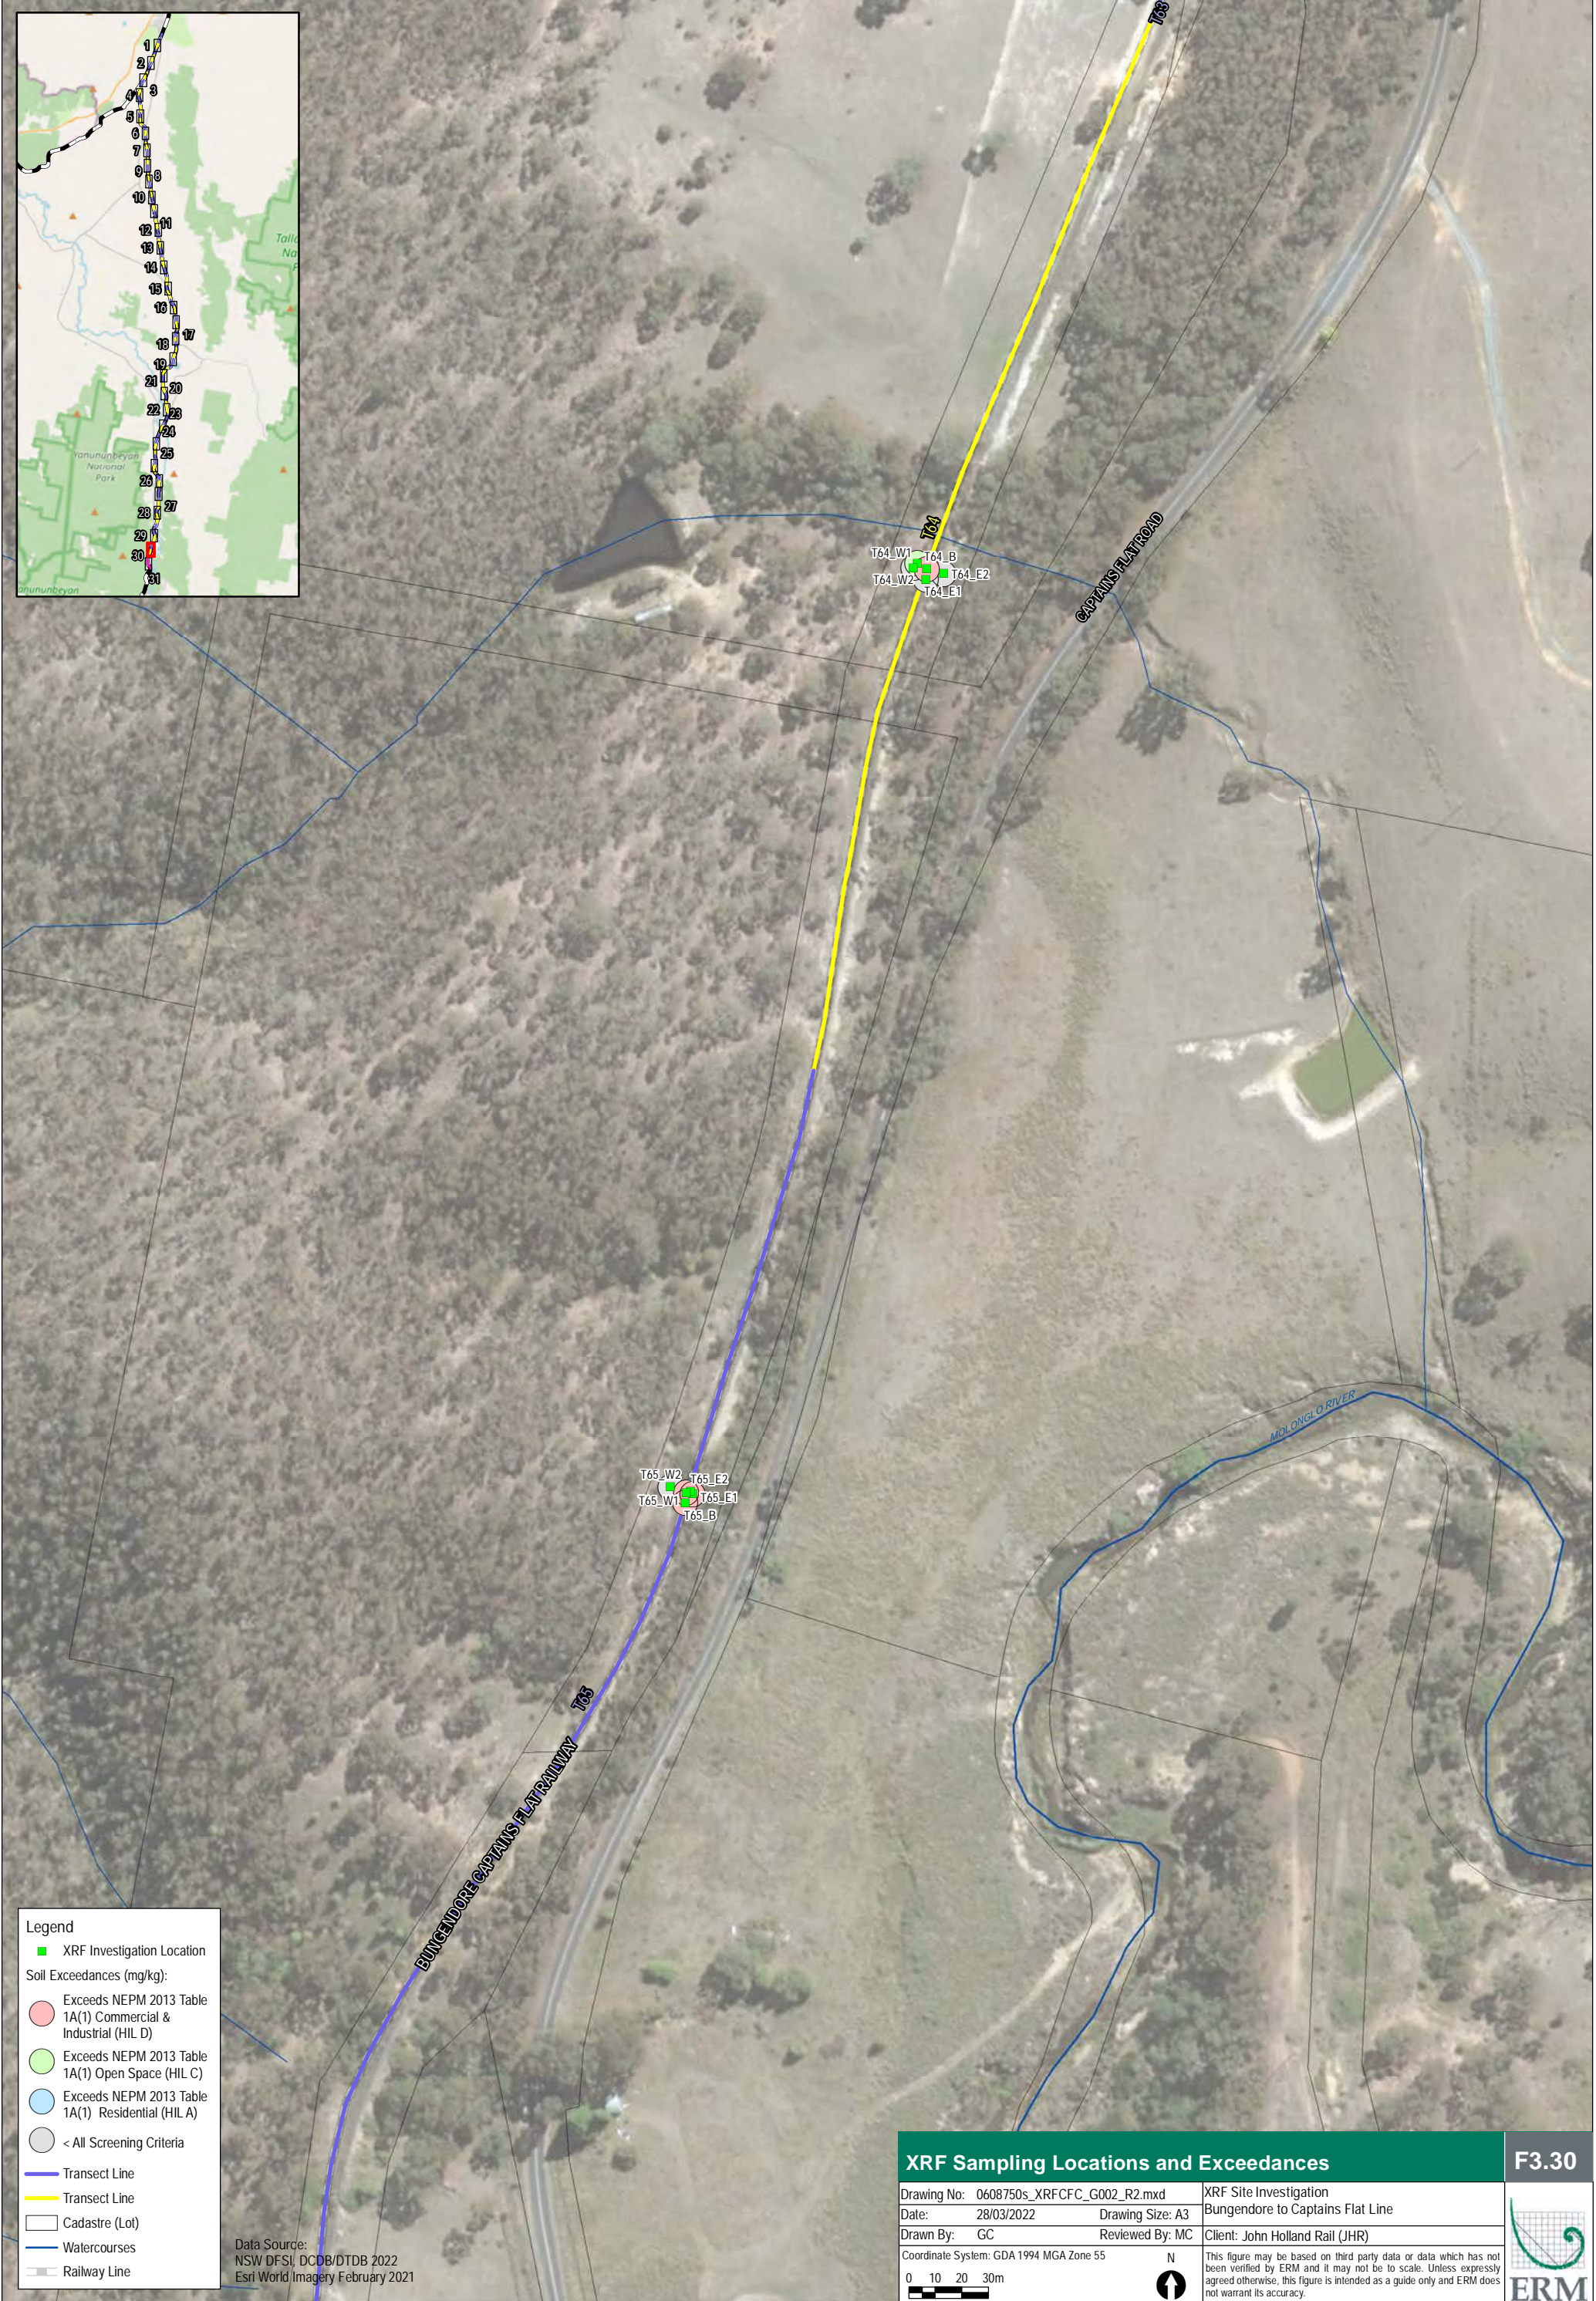
XRF Sampling Locations and Exceedances		F3.30
Drawing No: 0608750s_XRFCFC_G002_R2.mxd		XRF Site Investigation
Date: 28/03/2022		Bungendore to Captains Flat Line
Drawn By: GC	Reviewed By: MC	Client: John Holland Rail (JHR)
Coordinate System: GDA 1994 MGA Zone 55		<div>This figure may be based on third party data or data which has not been verified by ERM and it may not be to scale. Unless expressly agreed otherwise, this figure is intended as a guide only and ERM does not warrant its accuracy.</div> <div></div>
<div>0 10 20 30m</div> <div></div>

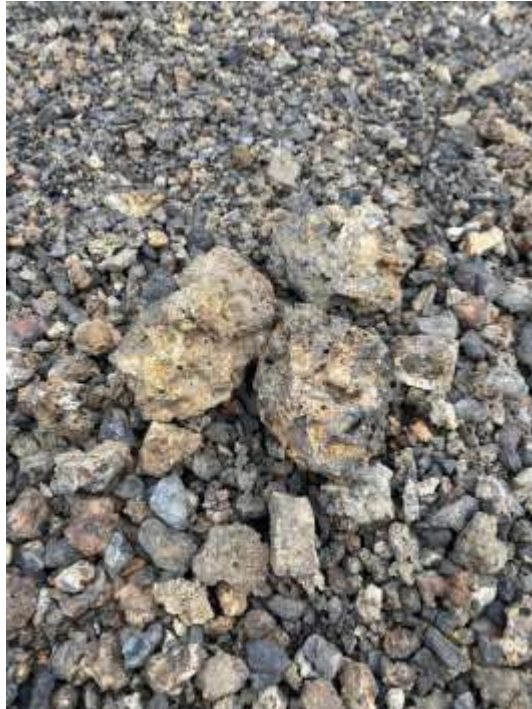
Photo No.
2

An eroded section of the line where ballast material has been washed into a drainage channel.

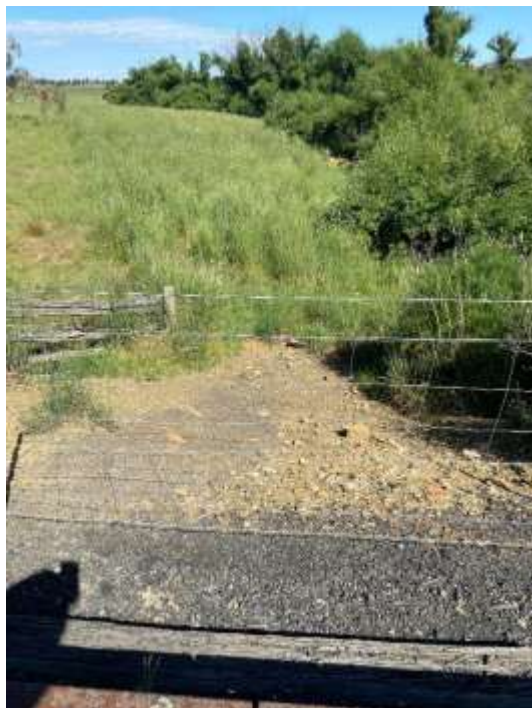
Photographs taken of the ballast material are included in *Appendix E*. However, the occasional washed out area was observed where the ballast gravels had migrated towards drainage channels which passed through the corridor. The ballast was underlain by road base like fill material, which formed the bulk of the embankment.

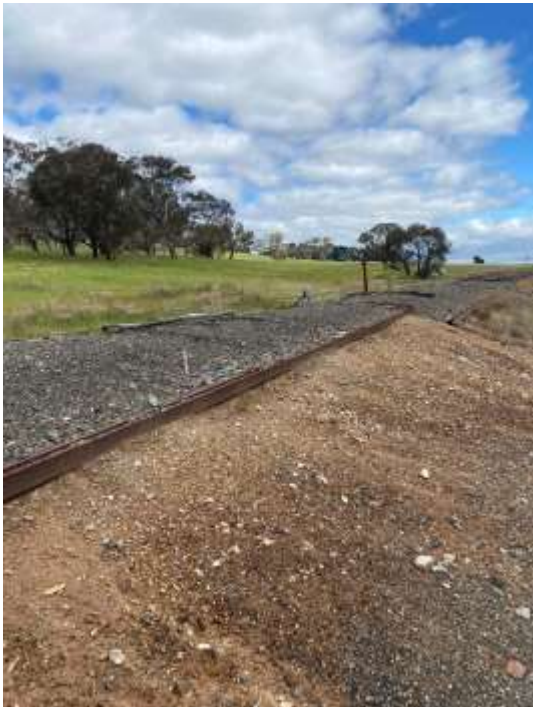
Photo No. 5	Date:

Direction Photo Taken: SE		
Description: A section of the line where the rail has folded outwards and is holding in dark grey fill material. Spilled fill material is also noted at the foot of the slope in the bottom right corner of the image.

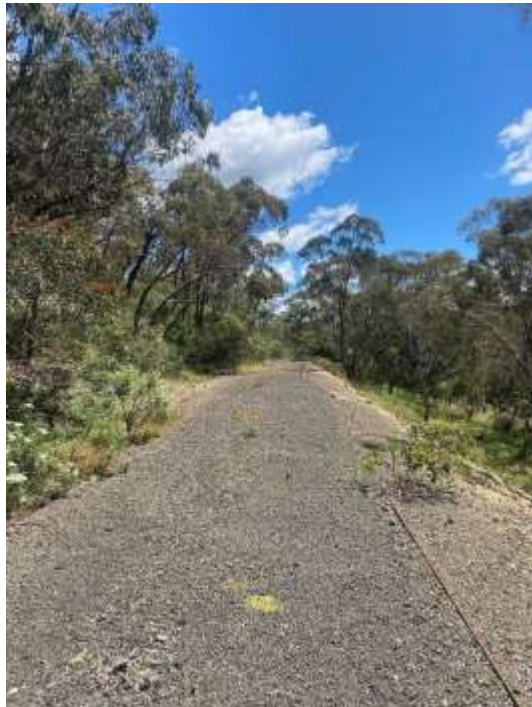
Photo No. 9	Date:

Direction Photo Taken: N		
Description: A section of the line where the rails have folded outwards and are containing dark fill material. An amount of the material has also spilled outwards. Vegetation is lacking through this section of corridor.
