## **Arboricultural Impact Assessment Report**

Safe Accessible Transport program  
Chester Hill Station  
CHESTER HILL, NSW

Aurecon P/L  
C/- Transport for NSW

D5494

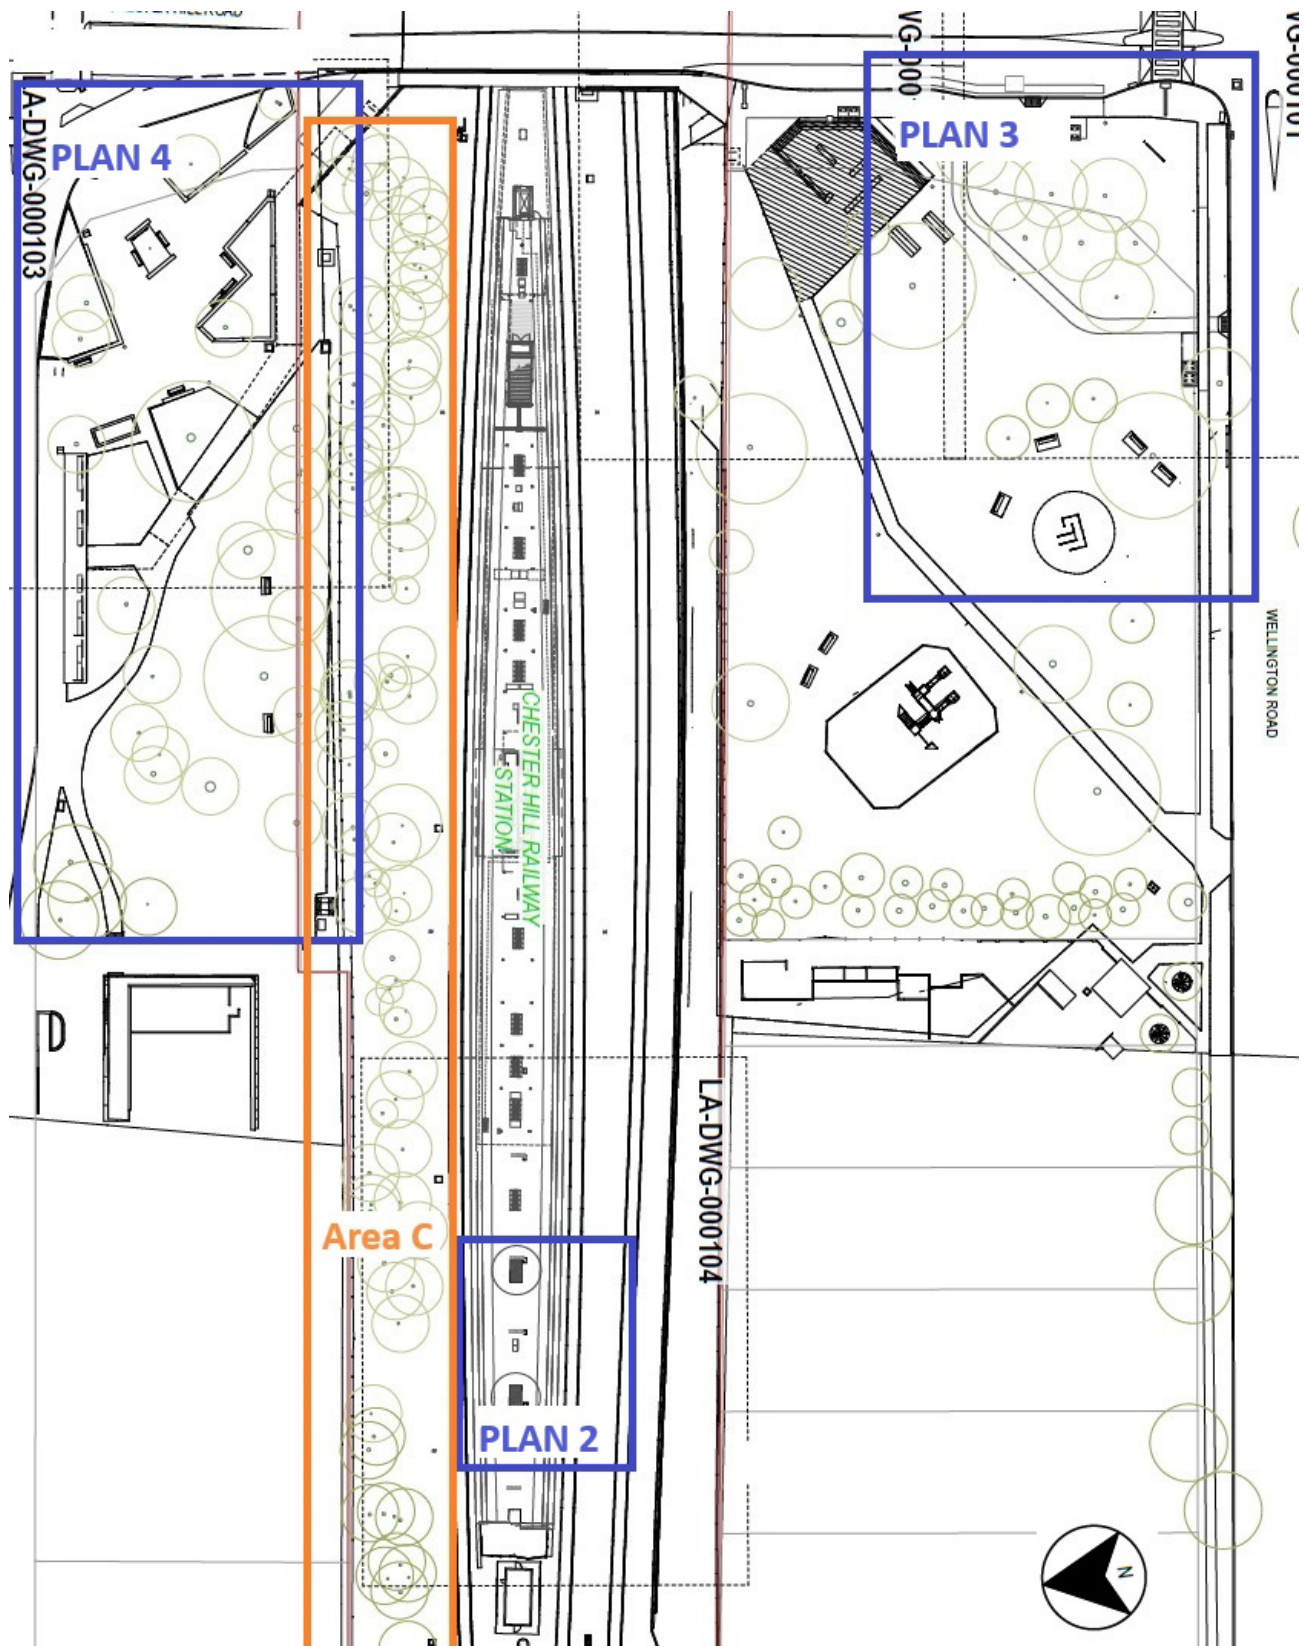
## 5.0 Plan 1; Area of assessment

Area C, See Section 7.0

Source: Adapted from Aurecon Design Inc., see Section 4.4.2.

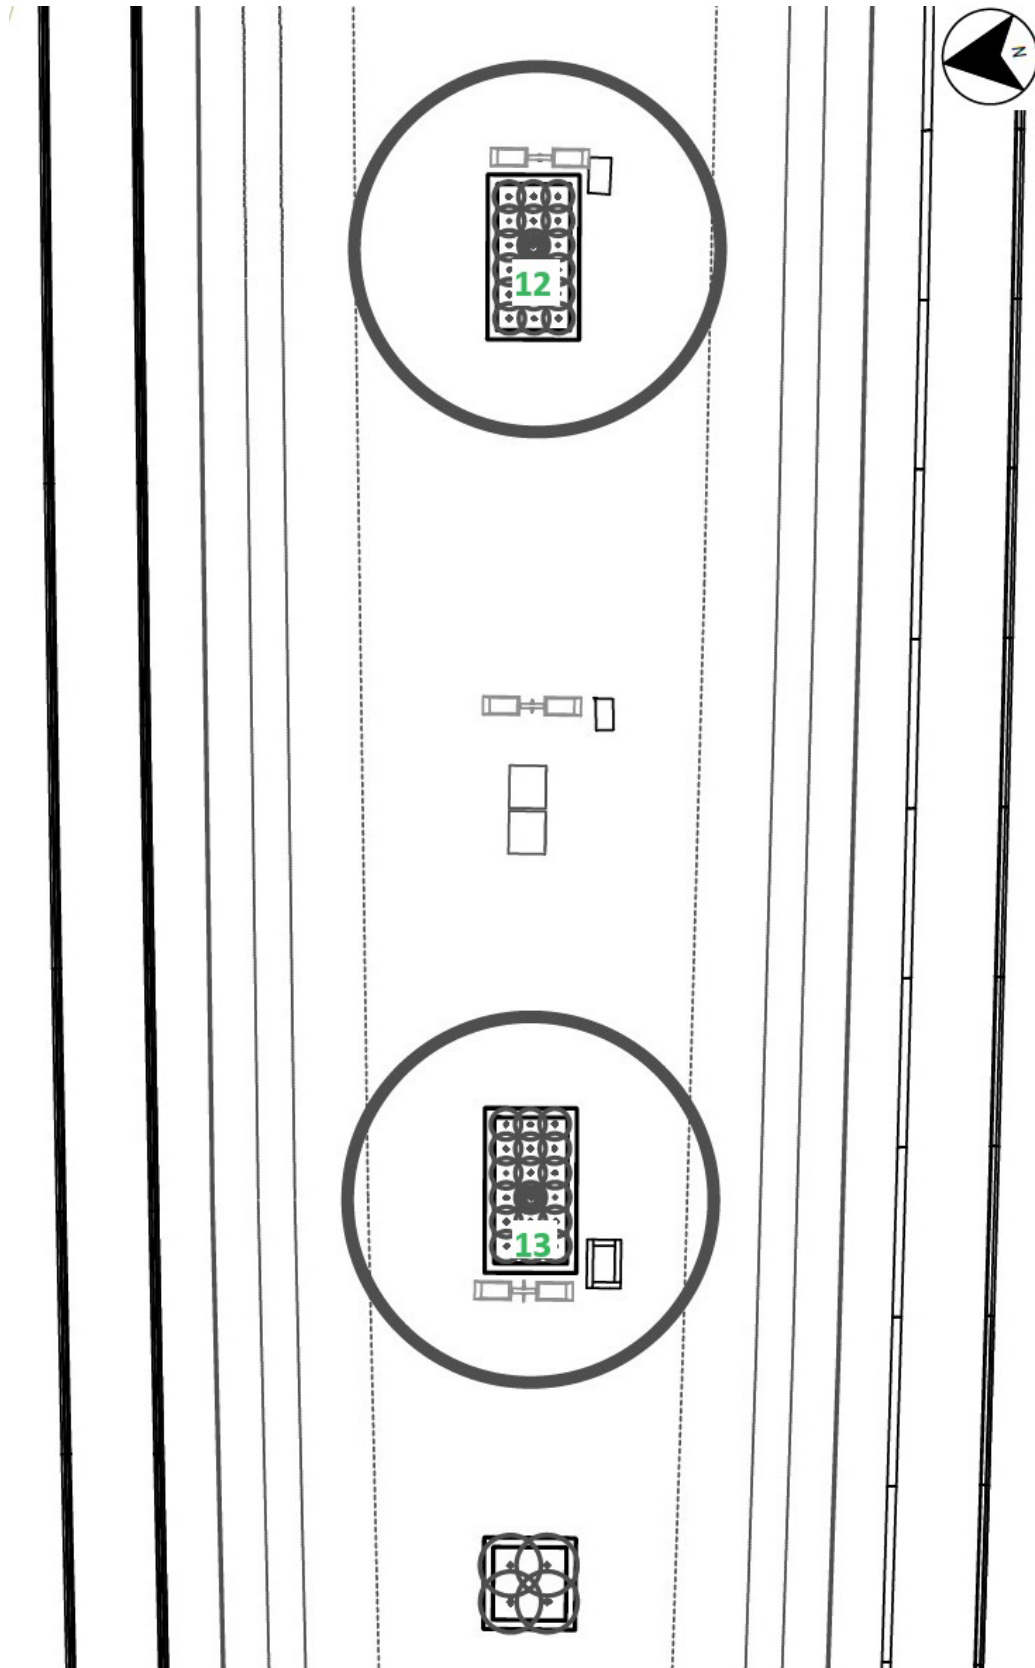
**5.1 Plan 2; Area of assessment illustrating tree location**

Indicative only, subject to detailed design

Source: Adapted from *Aurecon Design Inc.*, see Section 4.4.2.

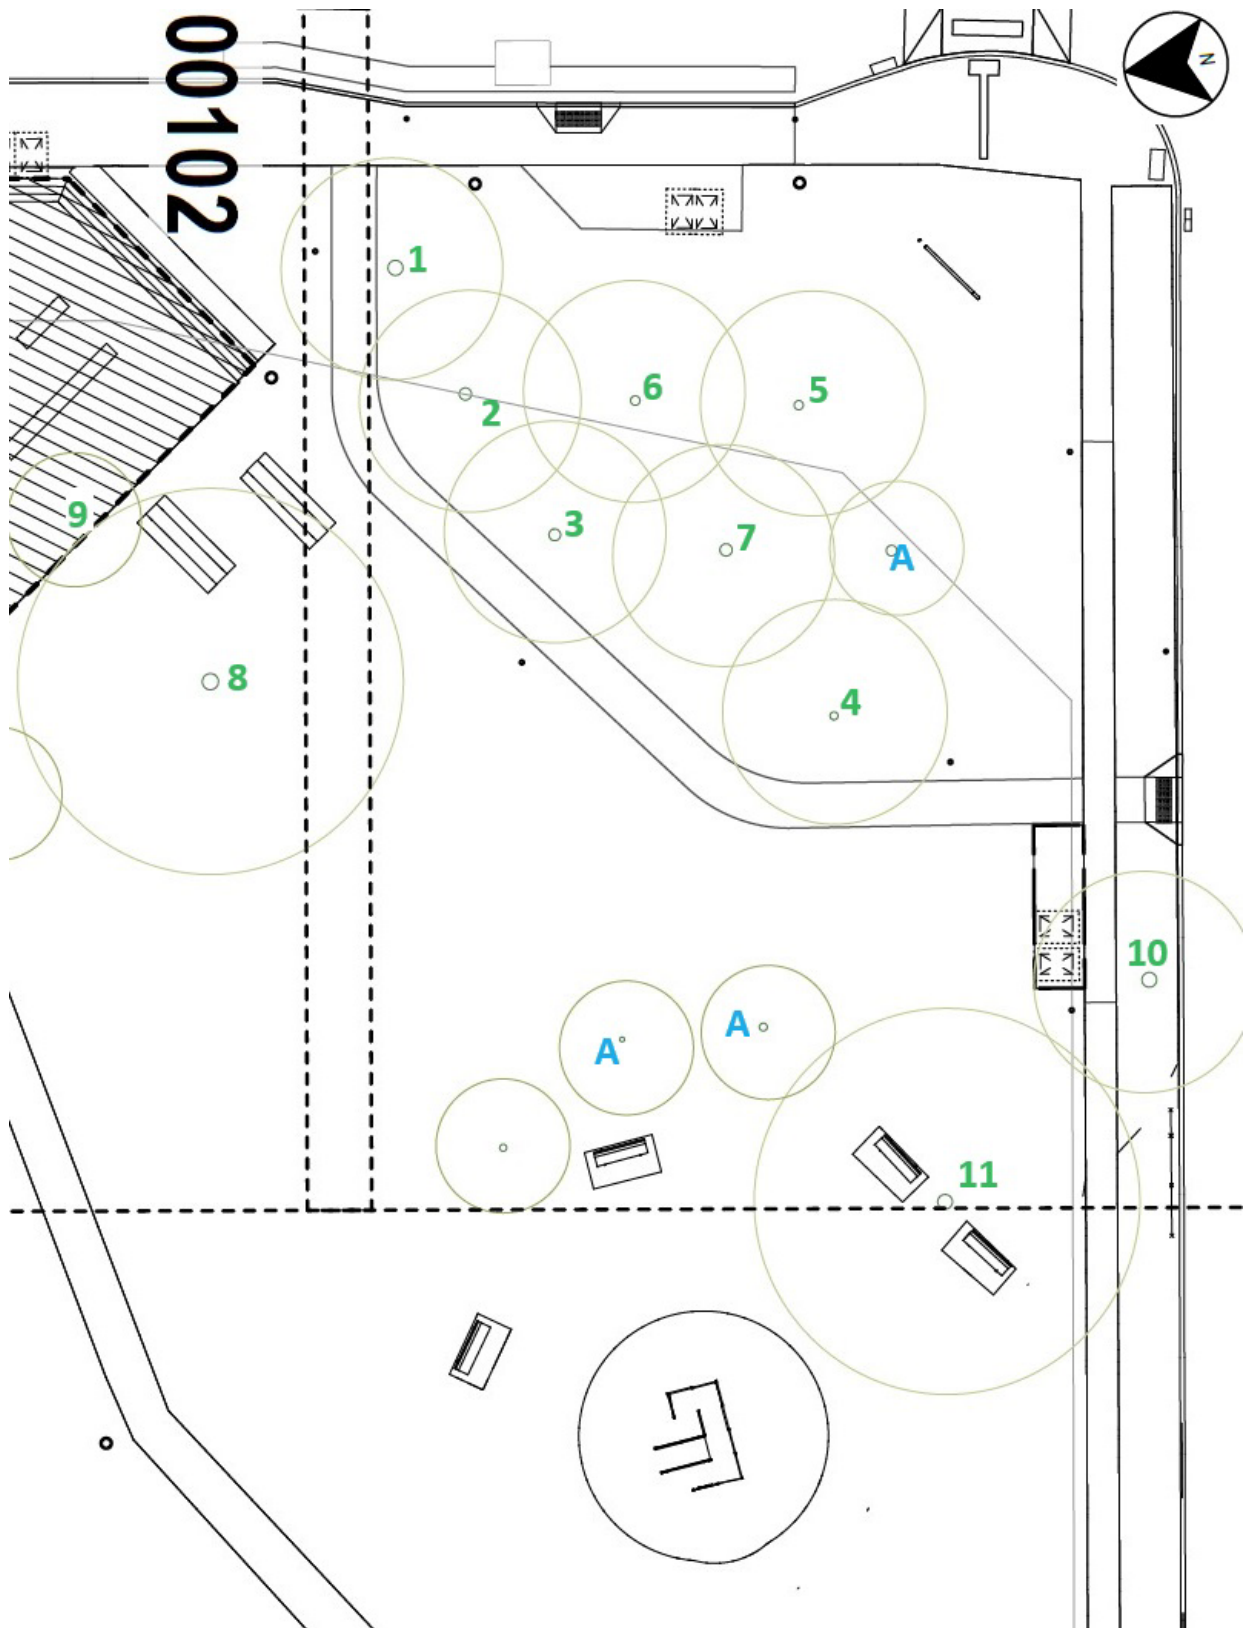
## 5.2 Plan 3; Area of assessment illustrating tree location

Indicative only, subject to detailed design

Trees labelled A, see Section 7.0.

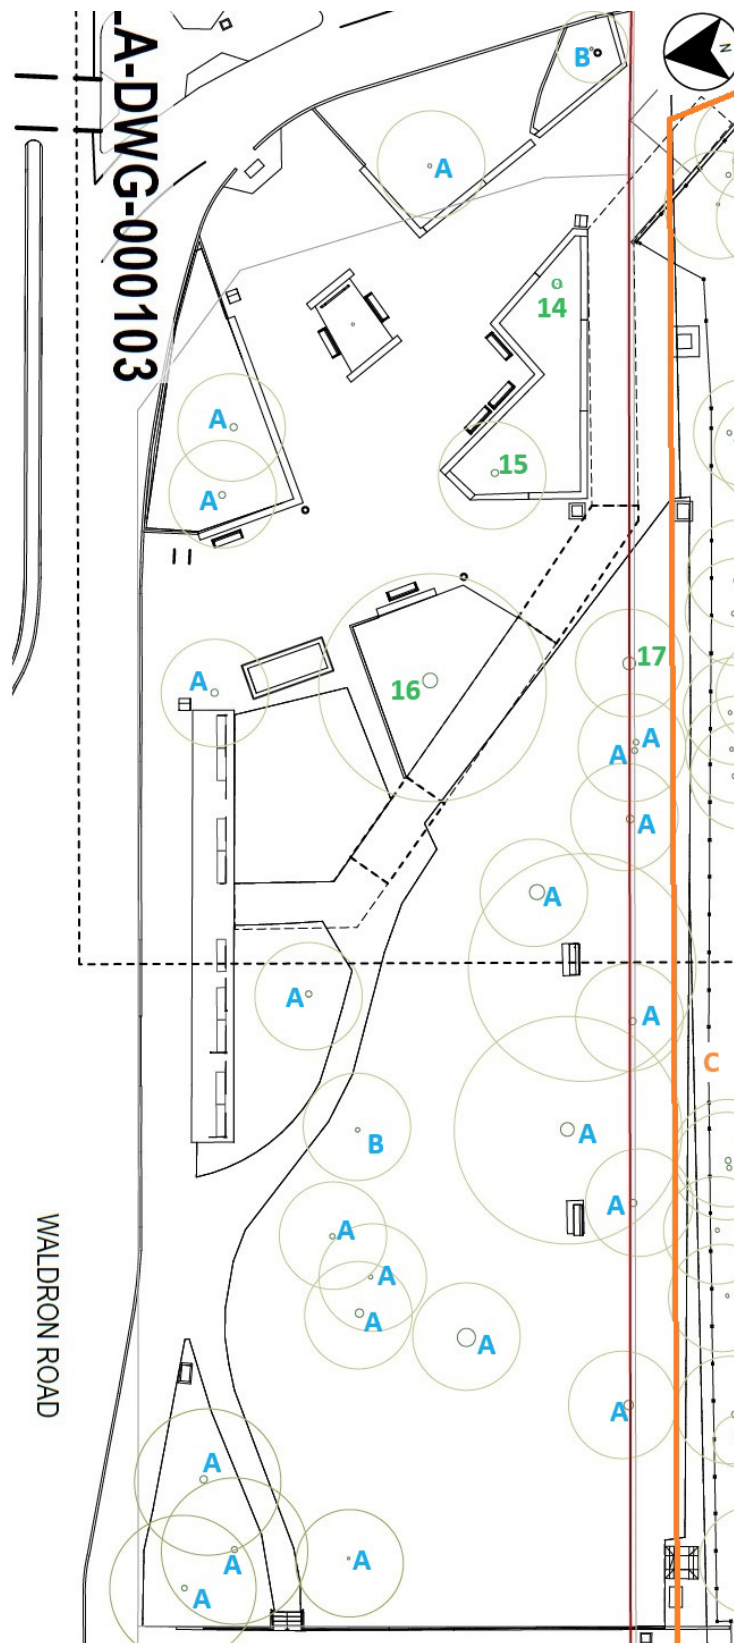
### 5.3 Plan 4; Area of assessment illustrating tree location

Indicative only, subject to detailed design

Trees labelled A and B, and comments for Area C, see Section 7.0.

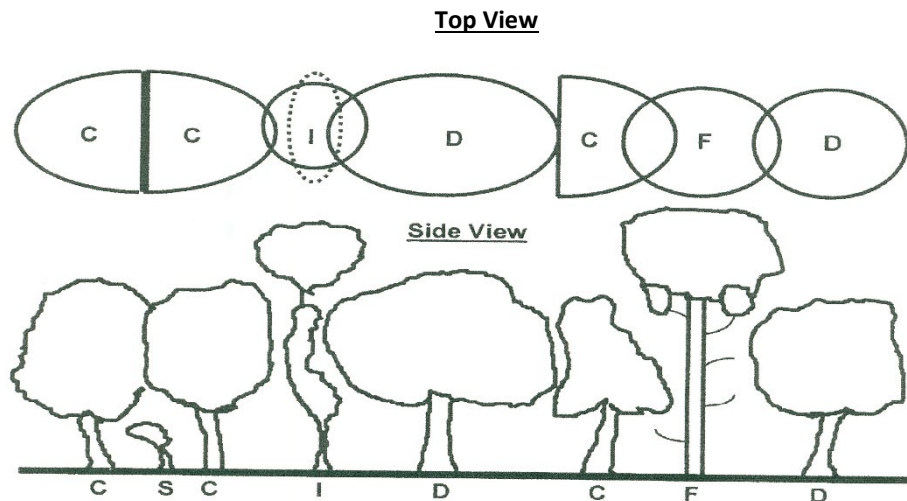
<b>D</b> – <i>Dominant</i>	Crown is receiving uninterrupted light from above and sides, also known as emergent.
<b>C</b> – <i>Codominant</i>	Crown is receiving light from above and one side of the crown.
<b>I</b> – <i>Intermediate</i>	Crown is receiving light from above but not the sides of the crown.
<b>S</b> – <i>Suppressed</i>	Crown has been shadowed by the surrounding elements and receives no light from above or sides.
<b>F</b> – <i>Forest</i>	Characterised by an erect, straight stem (usually excurrent) with little stem taper and virtually no branching over the majority of the stem except for the top of the tree which has a small concentrated branch structure making up the crown.

D C, I & S, and side view, after (Matheny, N. & Clark, J. R. 1998, Trees Development, Published by International Society of Arboriculture, P.O. Box 3129, Champaign IL 61826-3129 USA, p.20, adapted from the Hazard Tree Assessment Program, Recreation and Park Department, City of San Francisco, California).

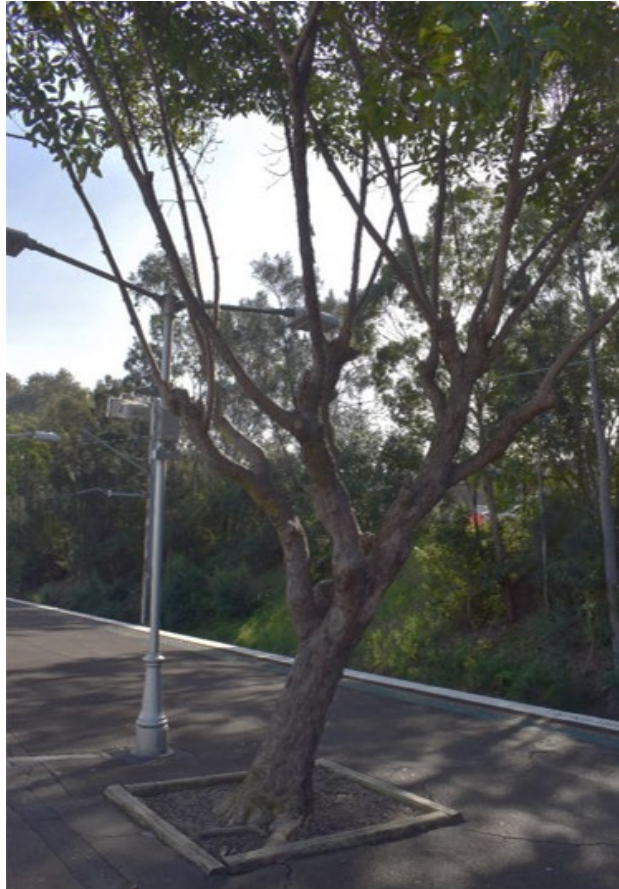
Photo 1; Tree No 12

Trees No. 12 and 13, Chester Hill Station platform (see Appendix B); this is a highly modified area, where these two planted trees located within the platform, are planted within large planters, and coupled with lack of irrigation and scant maintenance, the growing conditions are expected to be significantly harsh.

These trees are located within the existing platform and the drawings supplied (sheet 9 of 44) advise the "entire platform regraded". The landscape drawing indicates these trees are to be removed and replaced with new plantings (*Tristanopsis laurina*). Neither Tree No. 12 or 13<sup>9</sup> presents sufficient significance for retention in the long term based on the size related to maturity.

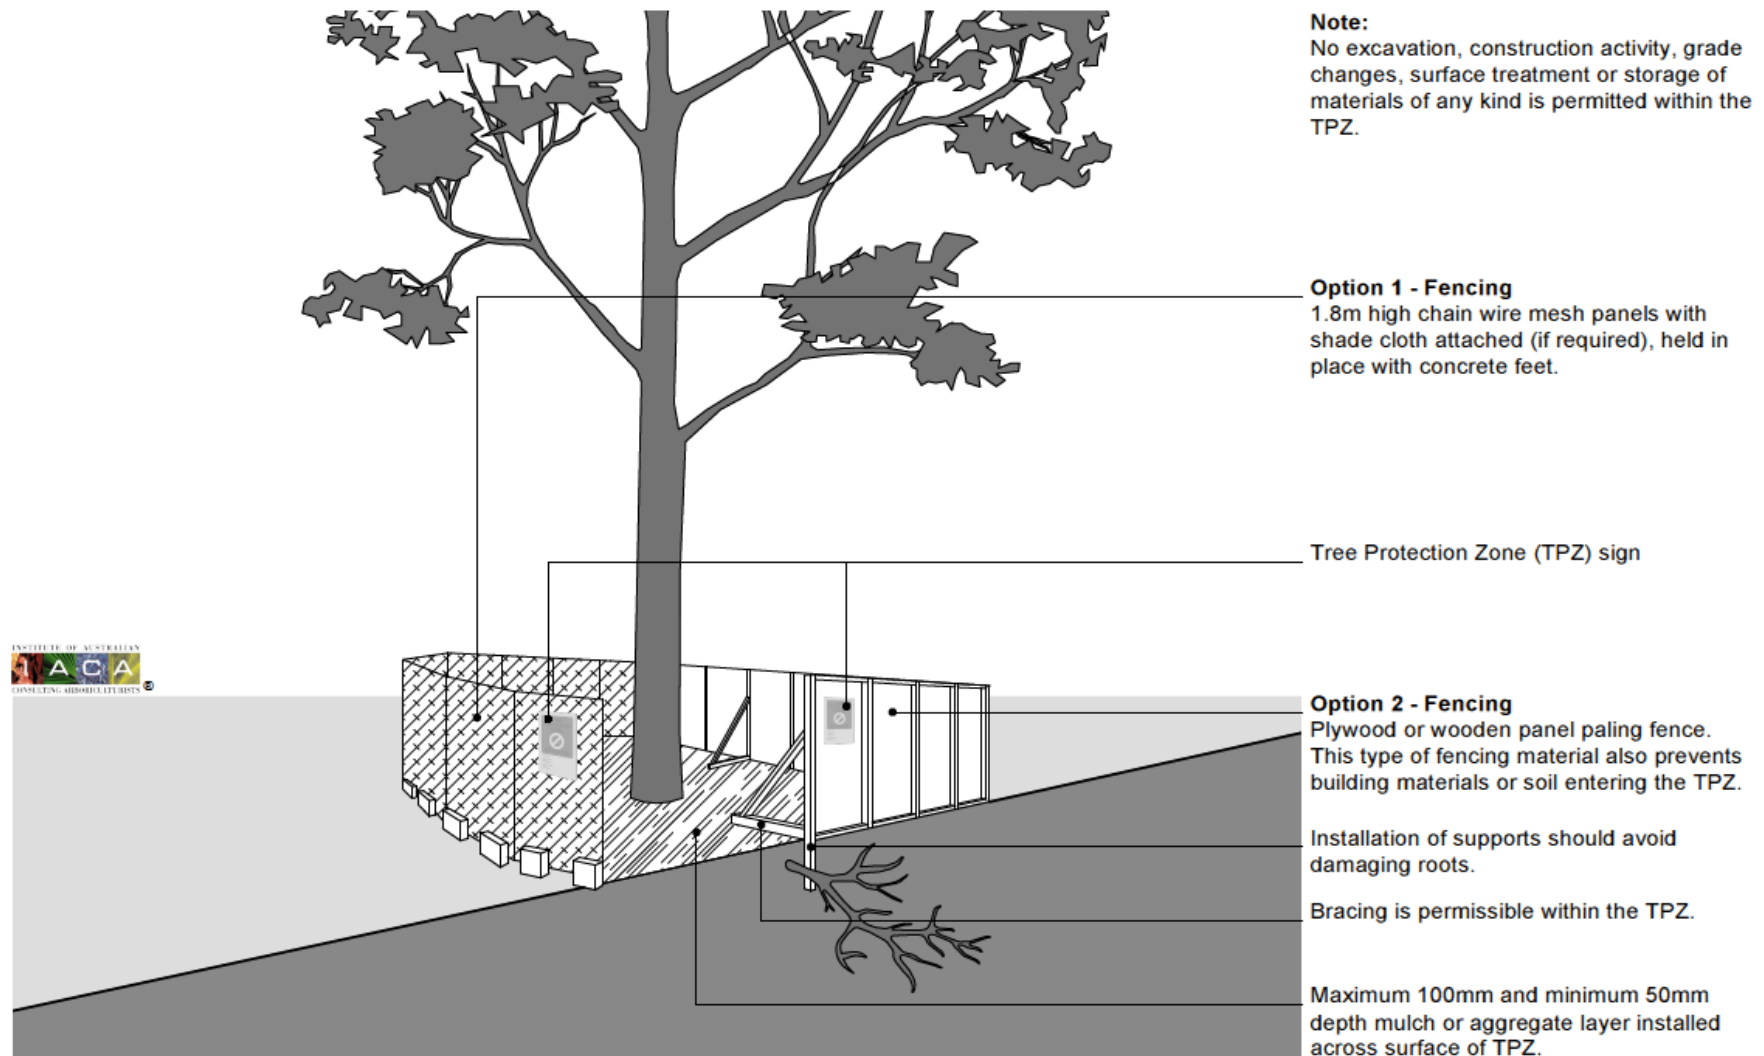
## Appendix C- Protection measures; Protective fence

A protective fence is required to be installed to protect the TPZ from all site-related work and are recommended to be located in accordance with the requirements of the AS 4970, listed in Appendix C. The fence is required to be secured to the ground with pegs to avoid movement during construction. This must be installed prior to the commencement of any demolition, excavation or construction works and shall be maintained throughout the entire construction phase of the development, and until landscaping works and installation of the drive/cross-overs is required.
