Chester Hill Station Upgrade – Safe Accessible Transport program

Statement of Heritage Impact

Report to Aurecon

August 2024

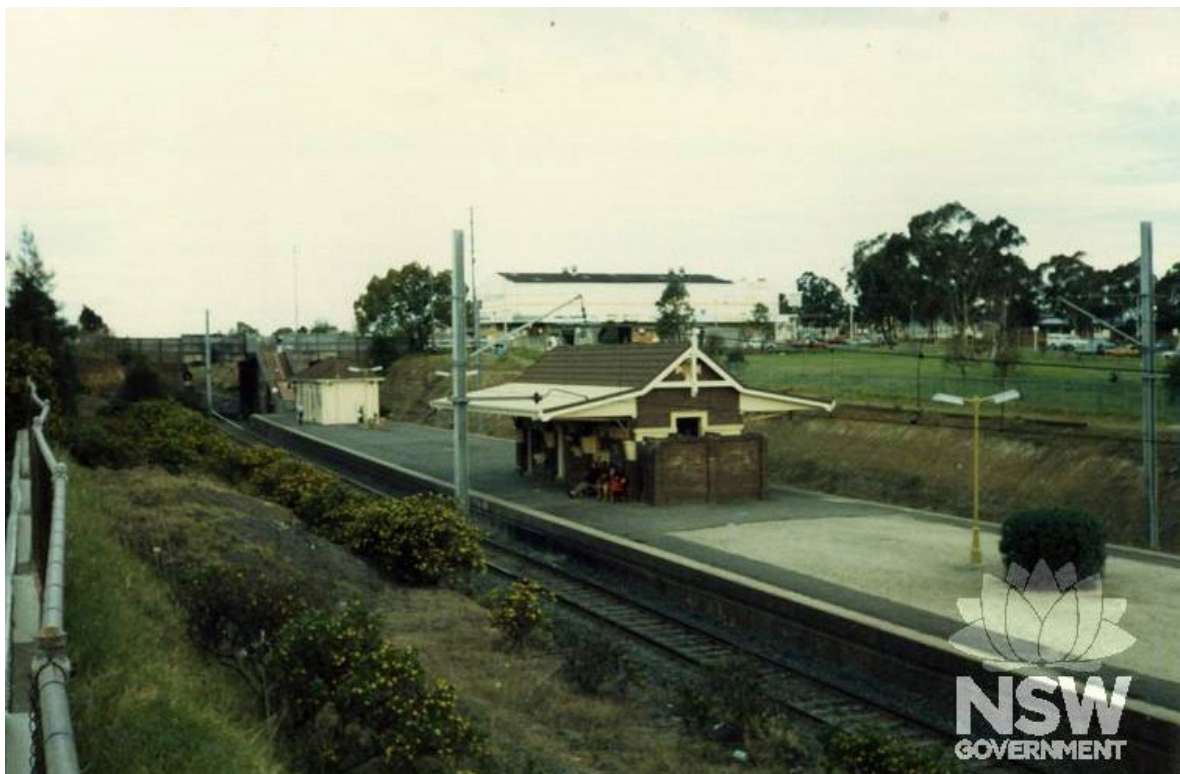
Figure 17. View of station in 1980s. Note brick screen leading to bathroom and concrete slab or weatherboard building near overpass (Heritage NSW).

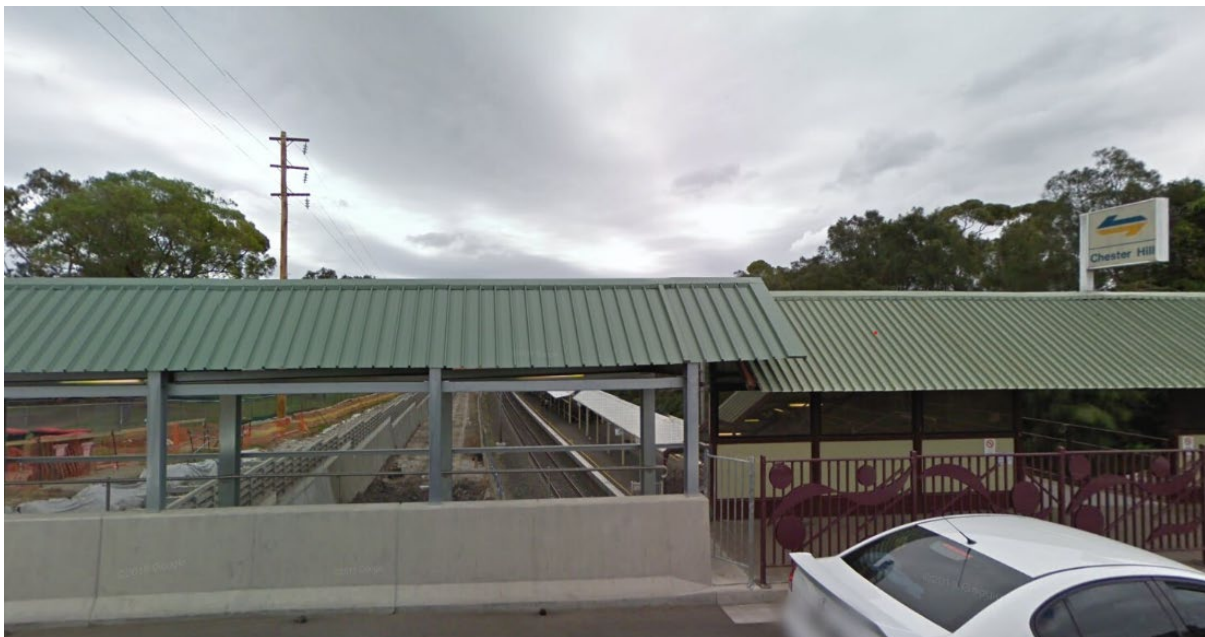
Figure 21. View of station from overbridge in 2009. Note construction of retaining wall and CityRail Chester Hill sign (Google Maps Street View).

In 2009, the concrete retaining wall that runs along the western extent of the rail corridor at Chester Hill was constructed, as shown in the contemporaneous photo in Figure 21. Prior to the construction of the retaining wall, the corridor was edged by a grassy embankment and wire fence (Figure 18 & Figure 20). A section of paneled balustrade on the western end of the pedestrian overbridge was replaced between 2007 and 2009. A small CityRail sign bearing the name 'Chester Hill' was present on the canopy of the overbridge in 2009. With the dissolution of CityRail in 2013, the sign was

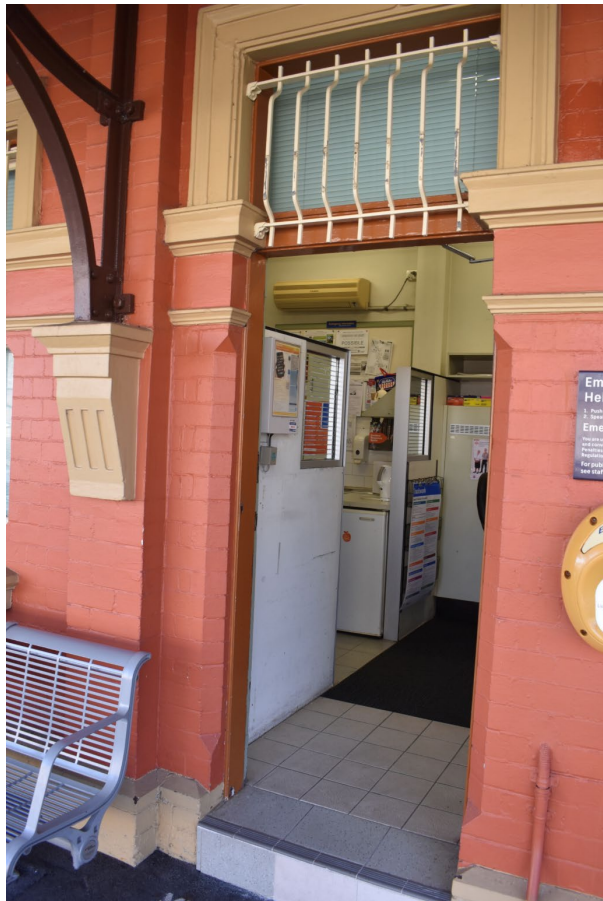
Figure 39. South elevation. Close up of entry to storeroom. Grilles have been installed in front of window openings.

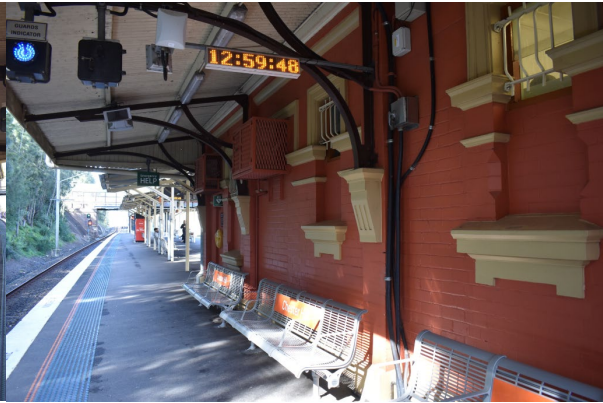
Figure 41. View looking towards the northeast corner of the platform station building. Flush doors are featured throughout painted maroon externally.

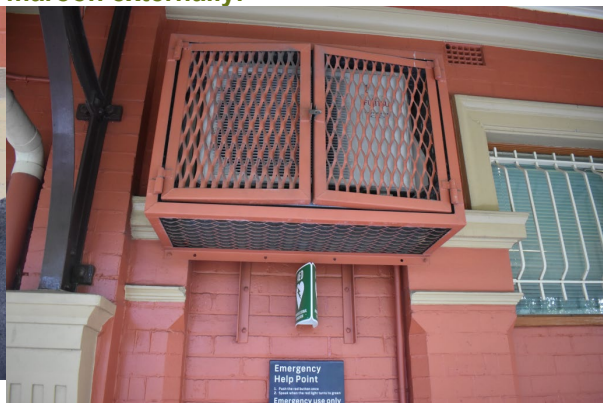
Figure 43. North elevation. Air conditioning unit protruding from the exterior wall concealed within metal hutches.

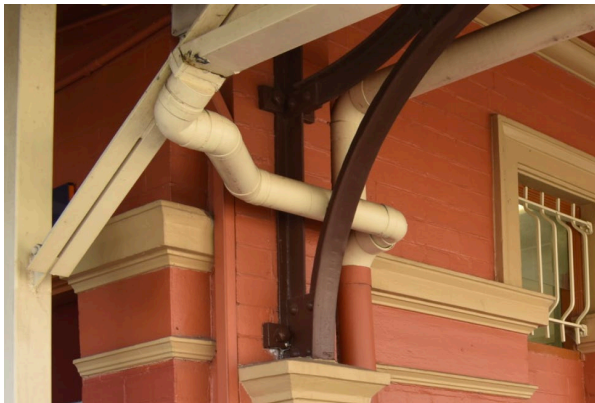
Figure 44. Close up of southwest corner. Standard double bowed steel brackets supporting the canopies have been painted mission brown. Downpipes run across the canopies and are fixed to the north and south elevations.

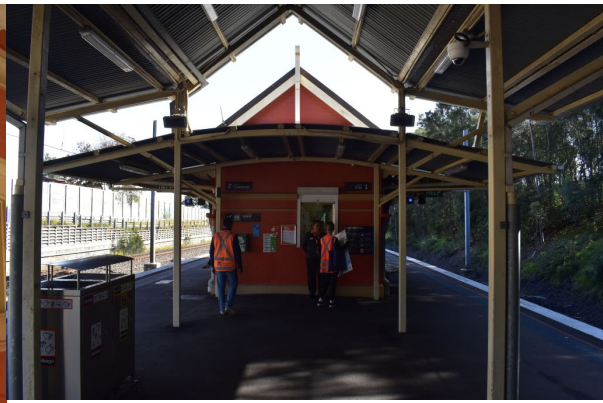
Figure 45. East elevation. A new standard ticket window is located in the centre.

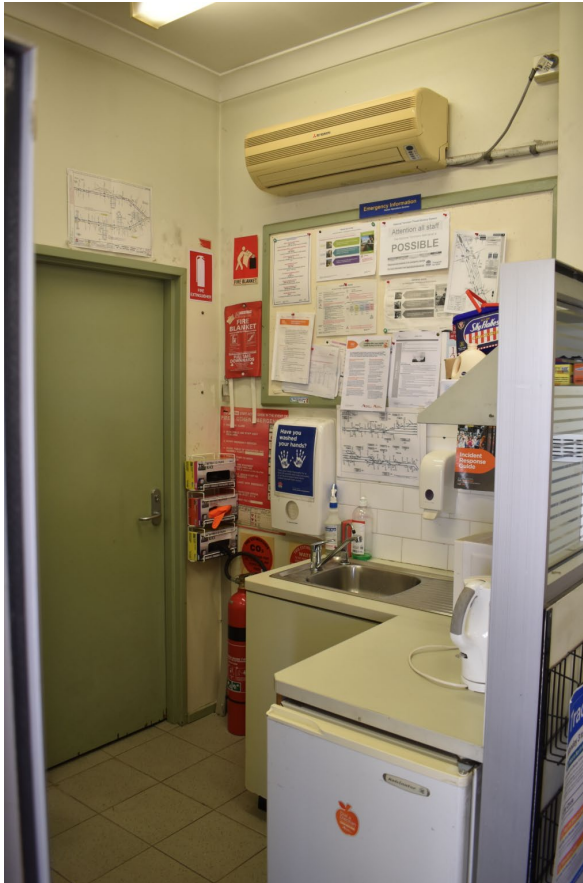
Figure 46. Booking office, facing west. Joinery Figure 47. Booking office, facing east. and internal flush door are painted green. Floor features tiles.

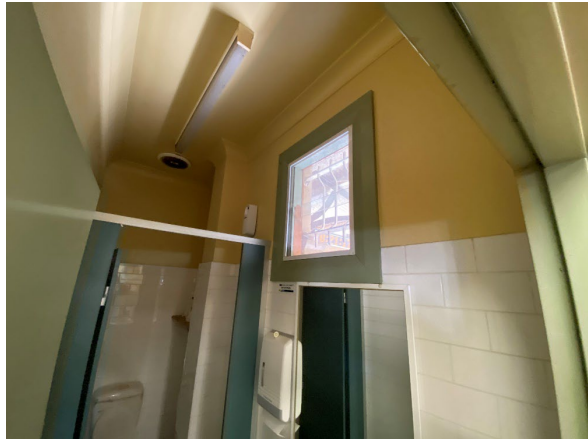
Figure 49. Staff toilet, facing northwest from toilet - office threshold. Subway tiles to internal walls running approximately 2m in height.

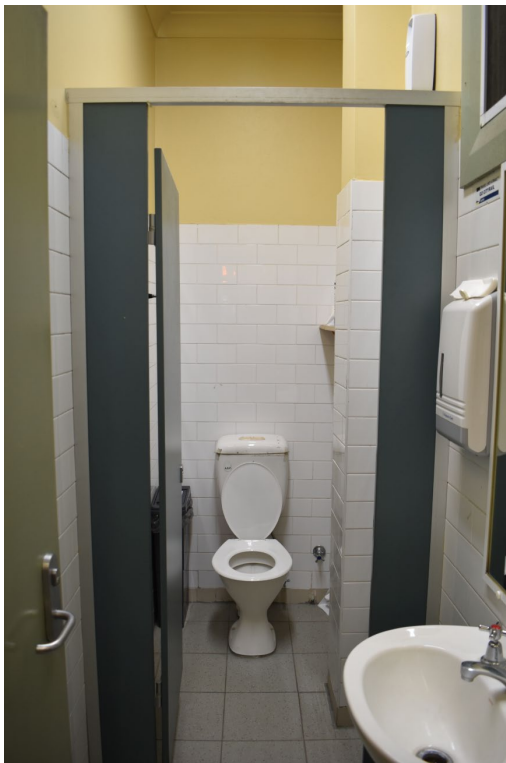
Figure 50. Staff toilet, facing west. A metal frame and timber partition has been inserted for the toilet.

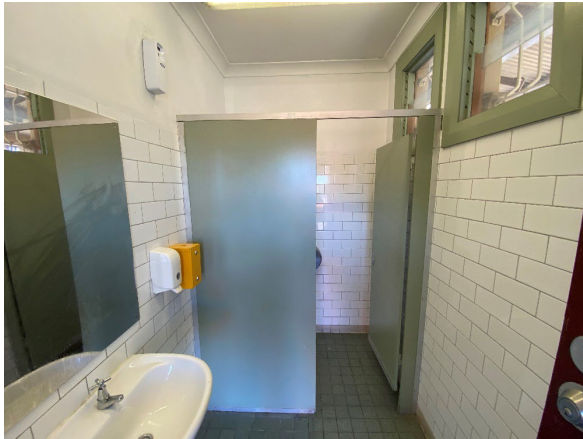
Figure 55. Unisex WC, facing east. Internal walls feature subway tiles to approximately 2m in height. Floor is tiled. A thin metal frame and timber partition has been inserted for the toilet.

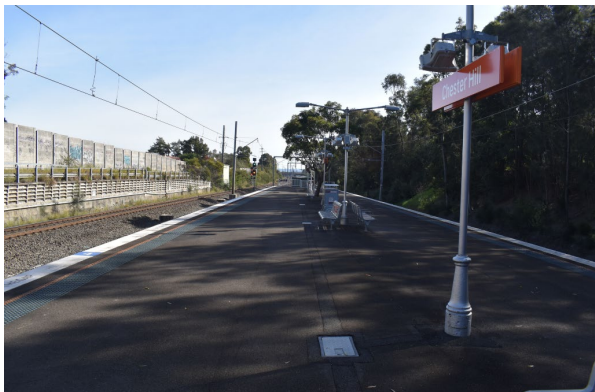
Figure 57. View of the island platform facing west. Seating, lighting and tree plantings are centrally positioned along the length of the platform. Surface is asphalt.

The station contains an island platform which has been brick faced and finished with an asphalt surface. Several tree plantings are found on the platform in line with the lampposts.²²

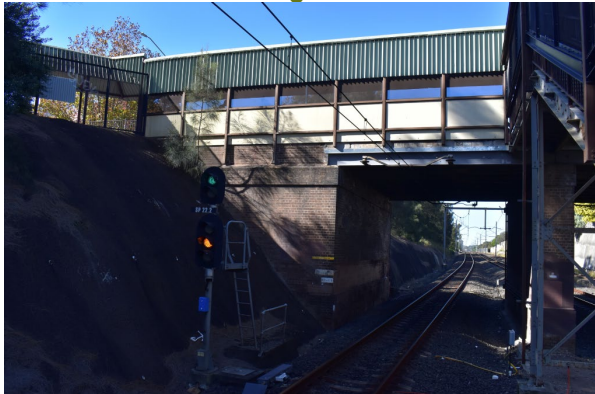
Figure 64. Close up of the tracks and underside of the overbridge.

The overbridge is a jack-arch and steel girder structure supported by brick piers and brick abutments. It originally had brick parapets which have recently been replaced by safety rails made of steel and toughened, opaque glass. A series of gabled roof modern canopies cover the pavement sections of the overbridge along Chester Hill Road. A set of stairs leads down to the platforms from the overbridge. The stairs are a standard 1920s structure constructed as part of the original station with steel beams and supported by iron angle trestles. The treads are compressed fibre cement and may have replaced earlier timber treads. The stairs have modern metal balustrades and are covered by a combination of skillion roofed and gabled roof corrugated steel canopies.²⁴

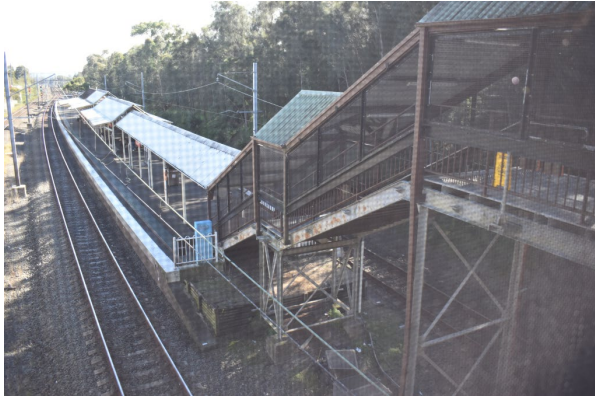
Figure 66. View facing west from the overbridge towards the station. The various canopies connect to run the length the platform from the stairway structure to the platform building.

The modern canopies are steel framed structures with corrugated steel roofing and are of different shapes along the length of the platform. Curved canopies sit immediately adjacent to the east and west elevations of the platform building. In the space between the platform building and the stairs there are two canopies which have been designed to match some of the details of the platform building. The roofs of these canopies follow the shape of the platform building, a gabled roof with integrated shallower awnings. The eastern most canopy which leads all the way to the stairs is a simple gable structure with no awnings.²³

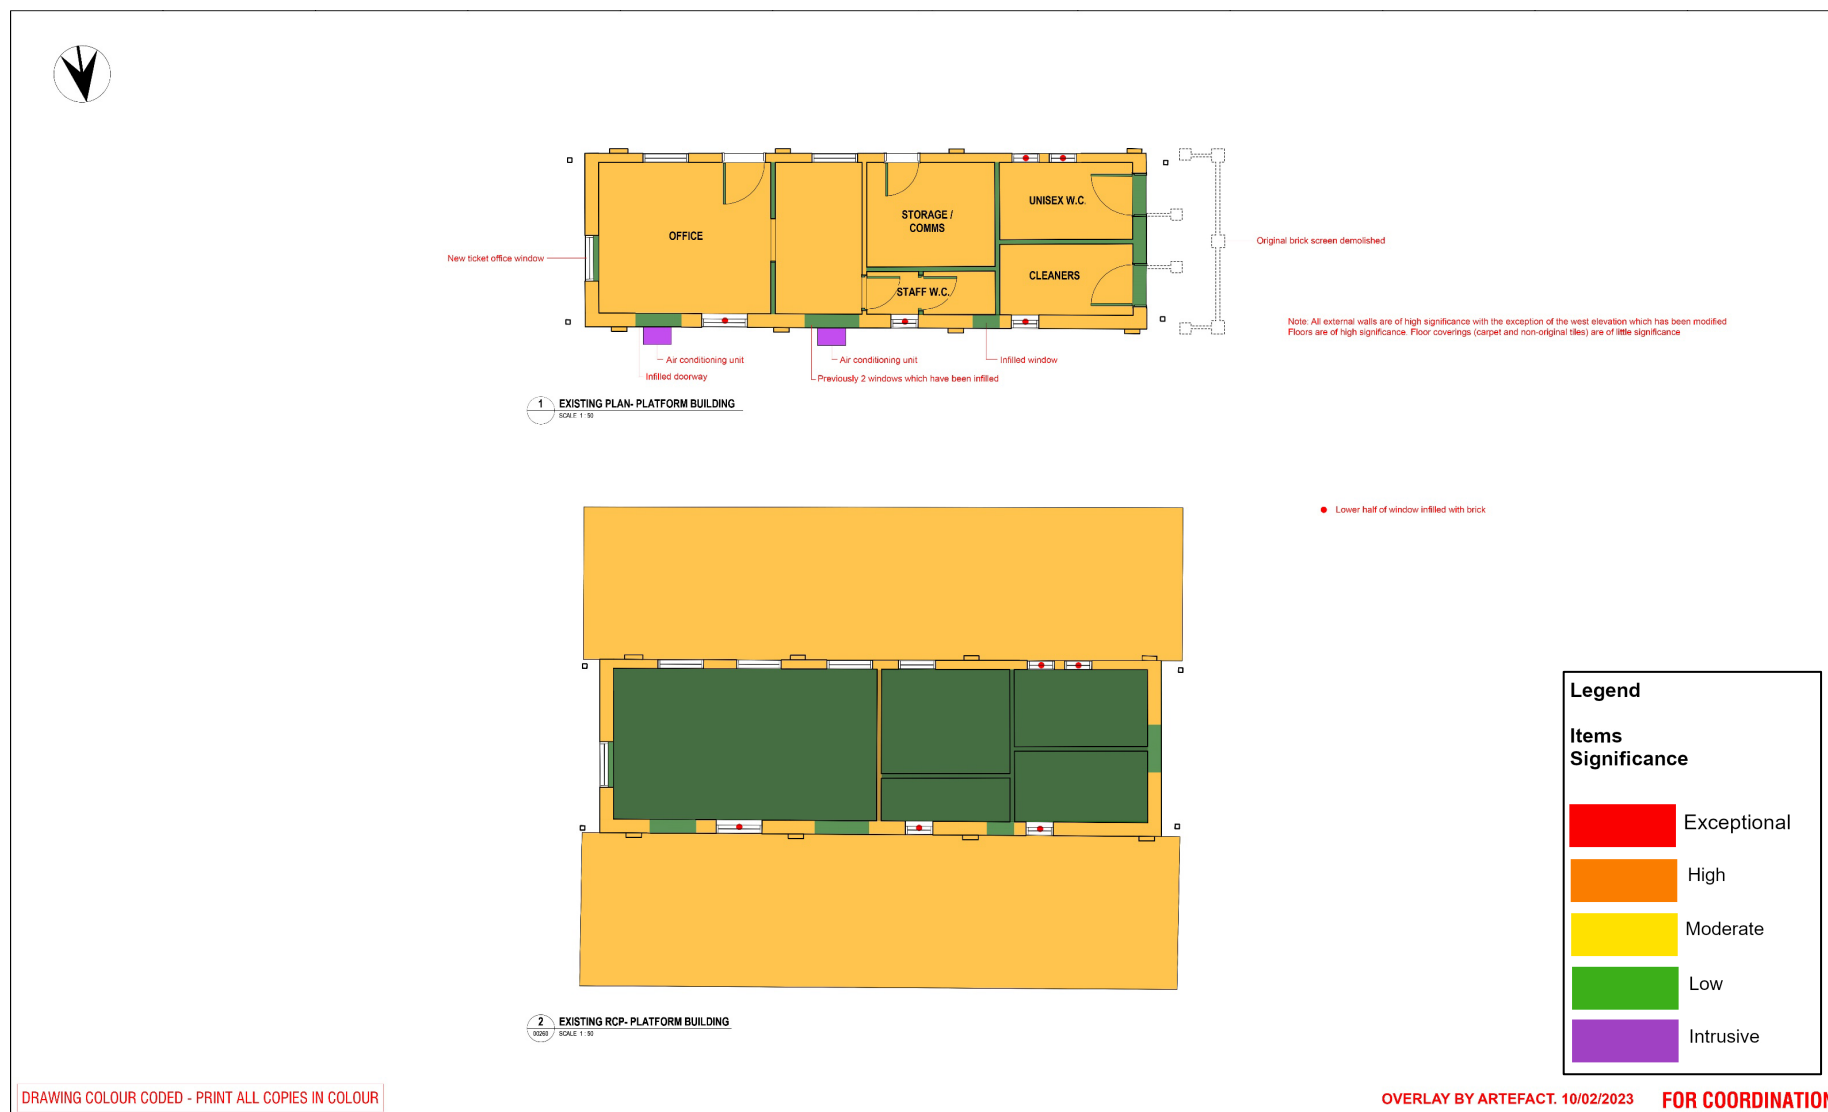
Figure 70. Gradings of significance – existing floor plan of the platform building and reflected ceiling plan, not to scale (Source: HDR [Design Inc with Artefact overlay]).

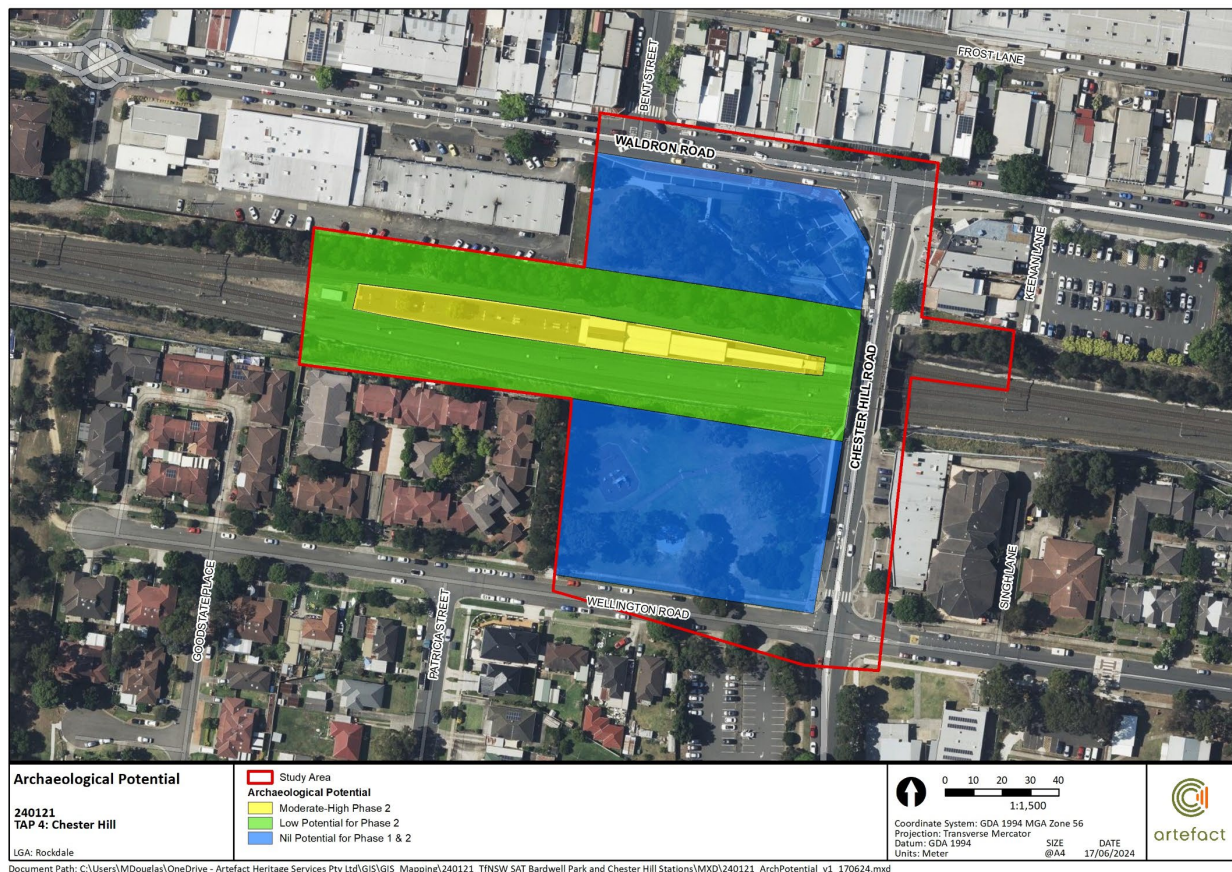
Figure 71. Archaeological potential within study area.

Based on the review of the information obtained from historical sources, previous heritage assessments and the current condition of the site, it can be concluded that the study area has **Nil-Low potential** to contain historical archaeological remains **associated with Phase 1**. The archaeological fabric for this phase may consist of evidence of agricultural and timber felling activity which would likely have been impacted by the construction of the station. As for **Phase 2** there is a **Moderate-High potential** for remains to be present. These likely would consist of redundant services (including former pits), brick or sandstone foundations and rail and timber sleepers. Remains for Phase 3 are extant and not considered to be archaeological.
