Transport
for NSW

Galston Road Bridge BN390 Rehabilitation

Review of Environmental Factors

November 2024

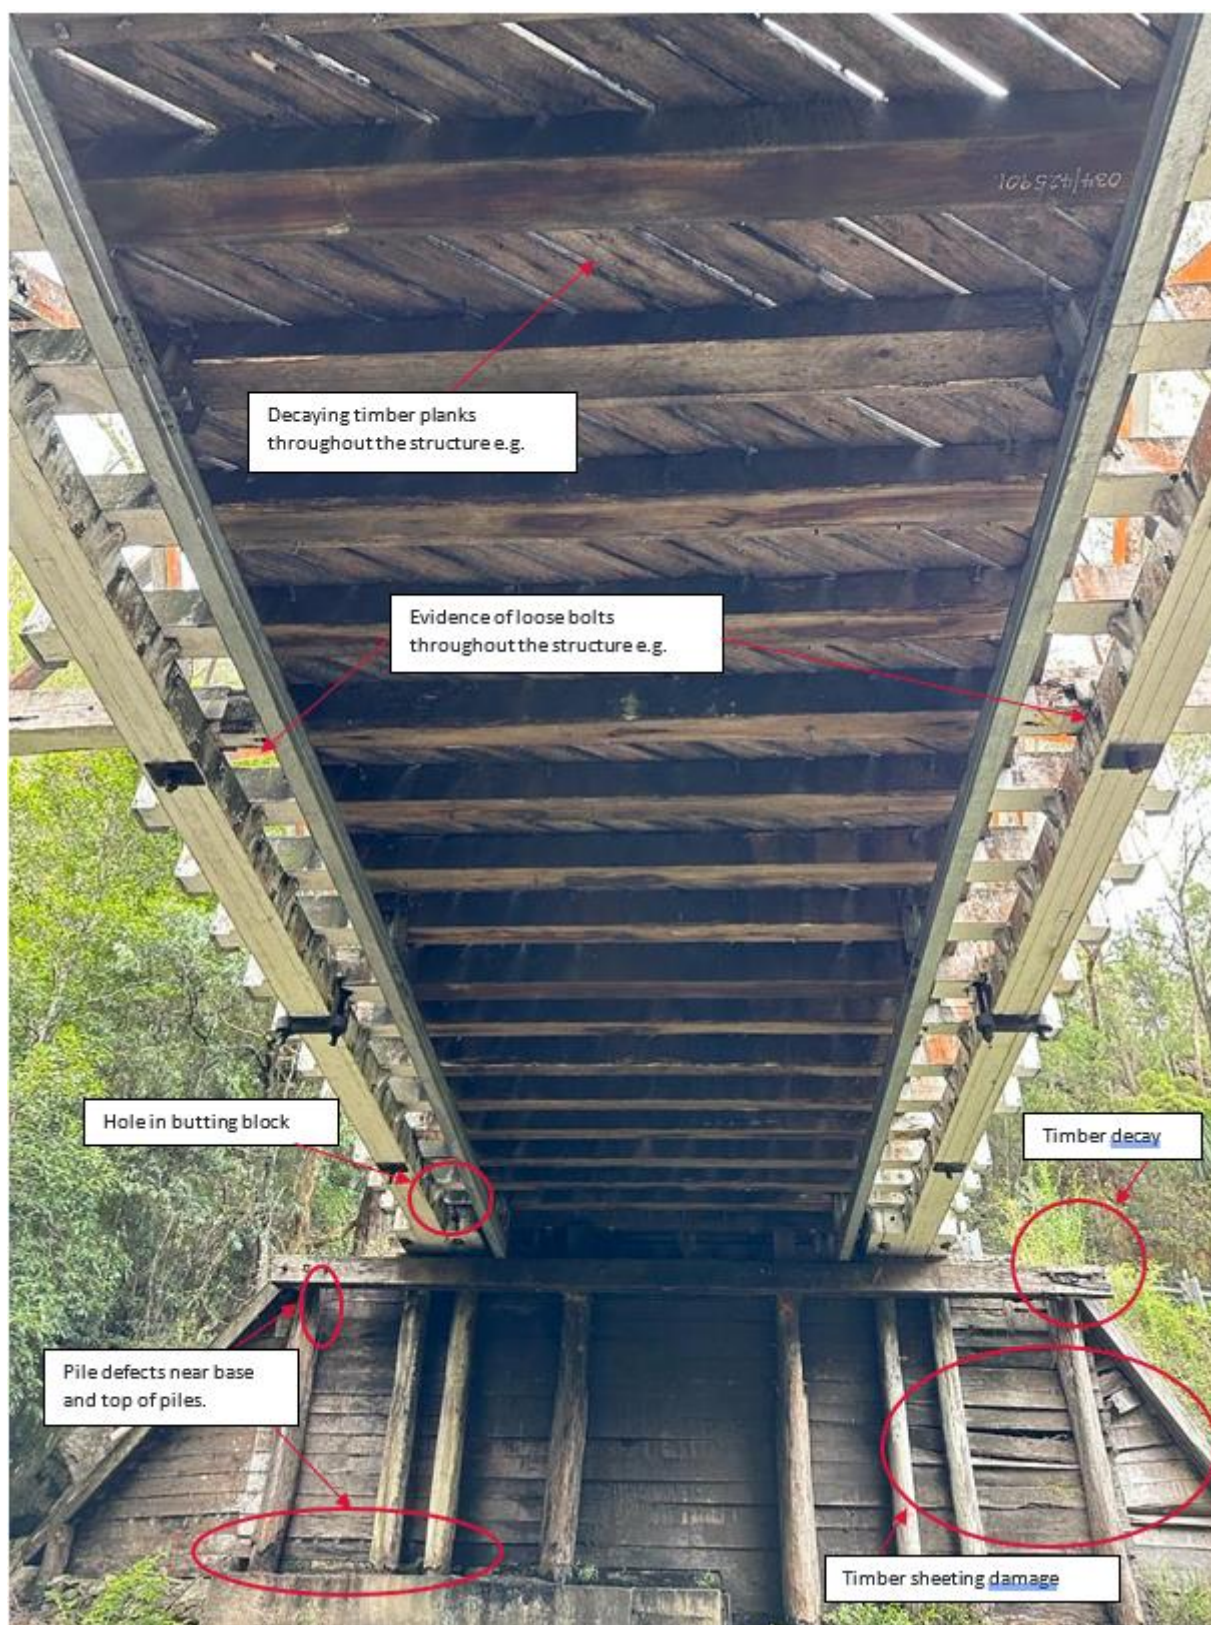
Examples of key defects to be repaired or elements replaced

Detailed inspection of the Bridge has identified several areas of deterioration that are currently affecting the structural integrity of BN390. Examples of defects that can be seen on the bridge are shown in Figure 2-1 and some of these have already been completed as part of stage 2 works. Details of critical elements of the Bridge that required replacement or refurbishment during stage 3 are listed below:

- The paint on the existing structure shows evidence of mould which requires treatment to protect against further damage to the timbers and steel elements.

- Decaying timber cross girders require replacement, this being the critical component for load capacity. Up to 7 cross girders are nominated for replacement these are predominantly the primary cross girders which are more susceptible to deterioration due to the tension rods running through the centre.

- There are 84 off deck planks, of which 65 are full size across the deck. Approximately 50 off these timber deck planks (which is 60% of all planks) have defects and are proposed to be replaced. Note, Section 4.5.1.4 of RTA Timber Bridge Manual 4 states that, if more than 30-40% of timber sheeting (deck planks) requires replacement, all the sheeting shall be replaced.

- There is evidence of defects, decay and rotting in the 130x90 sacrificial timber member (corbel) where the timber deck planks are fixed.
- A hole in the Abutment B butting blocks is noted, with extensive section loss on the upstream end. Prevention of water ingress around and above the butting block and additional protective coatings will assist in reducing further decay.

- The degraded timber abutment sheeting requires temporary repair and or replacement during Stage 3.

The bridge was originally built in 1893 and has a current Bridge Health Index (BHI) rating of “Poor”, initially due to the condition of the abutment wale braces. Further detailed inspection has found that the cross-girders, butting blocks and abutment sheeting are deteriorating, bringing these components also into Poor condition. Detailed inspection of the Bridge has identified several areas of deterioration that are currently affecting the structural integrity of BN390. Examples of defects that can be seen on the bridge are shown in Figure 2-1.

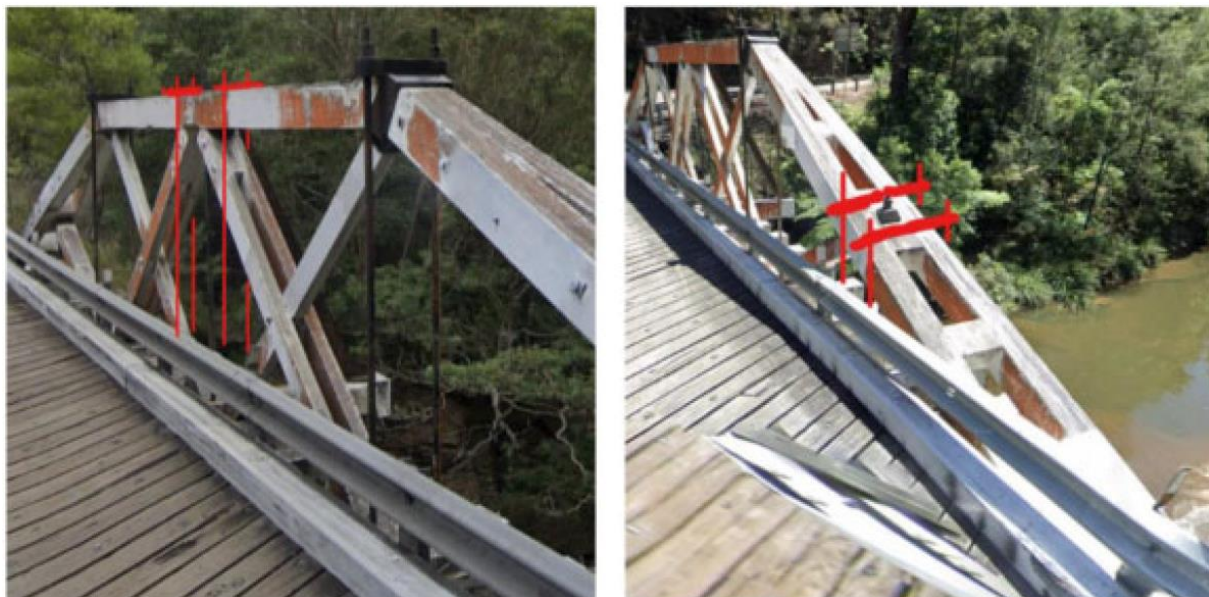
After the hangers have been installed the new cross girder will be placed via a crane from the roadway. Once in place the temporary steel beam placed in Stage 2 can be removed and the permanent tension hangers can be reinstated.

Figure 3-9 Temporary hanger bracket locations (Source: Contractor Works Methodology (August 2024))

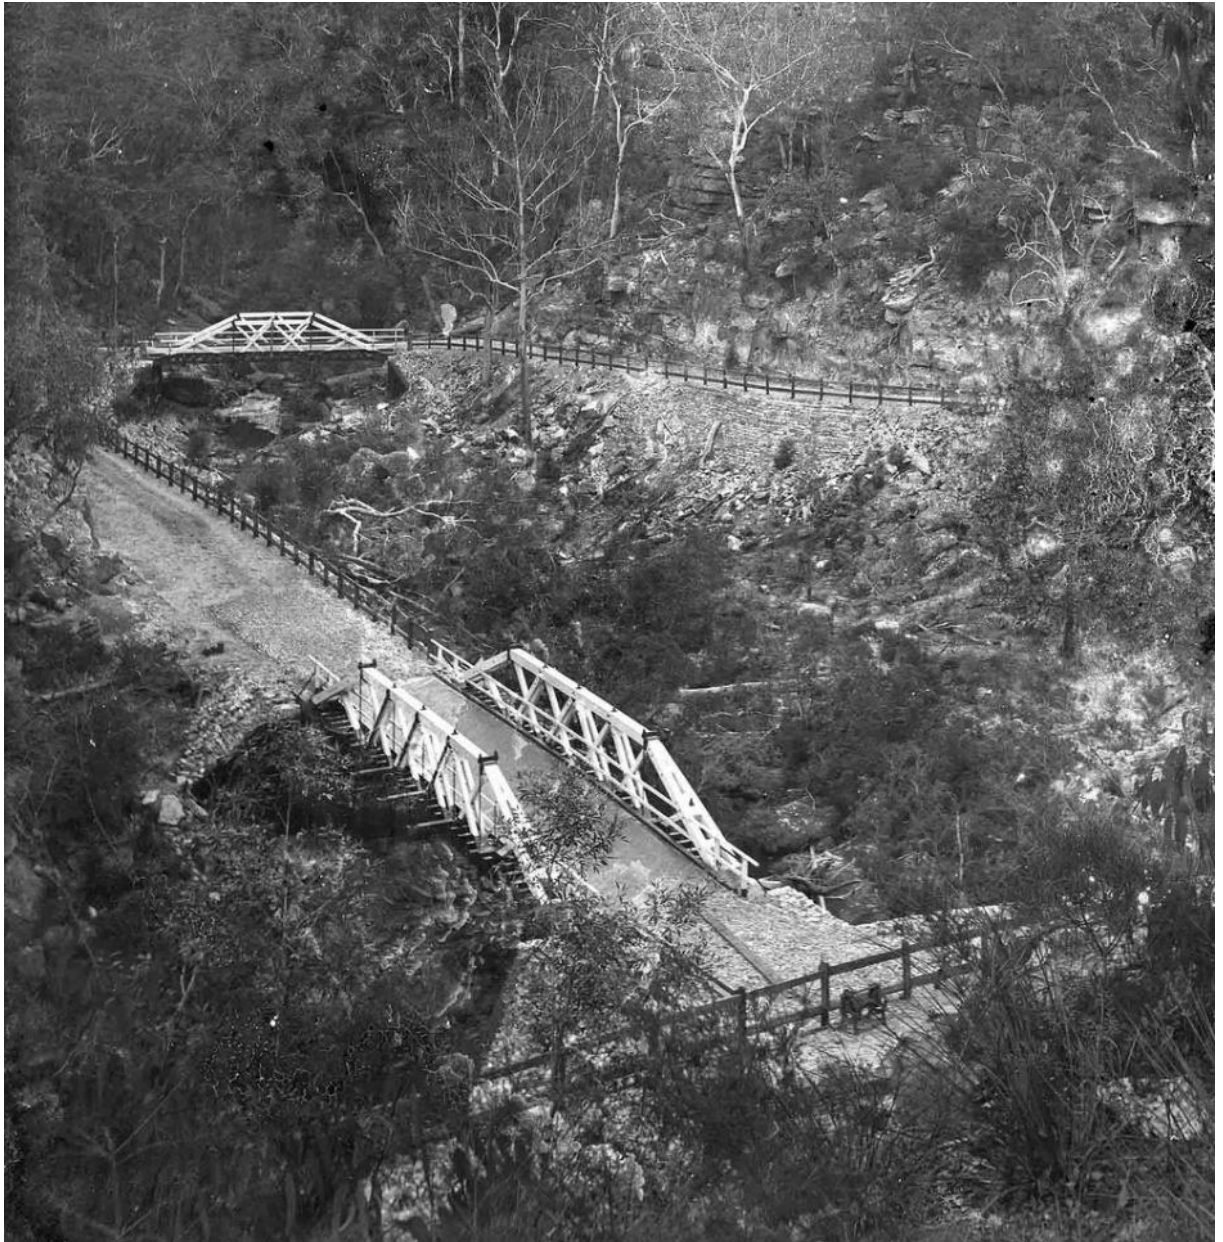
Galston Timber Bridge is a single span, timber truss bridge approximately 20m long and 6.4m wide and the former bridge over Berowra Creek was also a single span, timber truss bridge which was over 27m long. A concrete bridge replaced the longer bridge over Berowra Creek in the 1930s after it was washed away during a flood. This left Galston Timber Bridge one of the last remaining examples of the shortest of the standard McDonald Truss designs. Records that it is one of four remaining in NSW as of 2018.

Figure 6-2 Two McDonald Truss bridges at Galston Gorge provided examples of the longest and shortest of the standard McDonald Truss designs, the former Berowra Creek Bridge at 27.4 metres (bottom) and the remaining Galston Timber Bridge (Tunks Creek Bridge) at 19.8m.

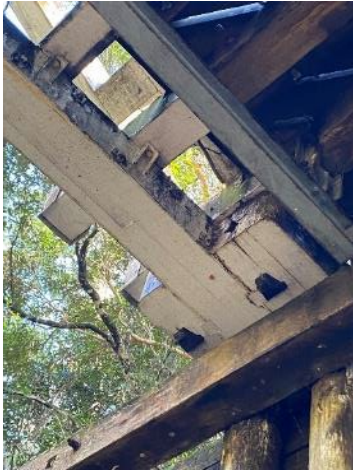
Figure 4-19: View of butting timber block to be repaired, on eastern side of bridge attached to North Abutment (B)

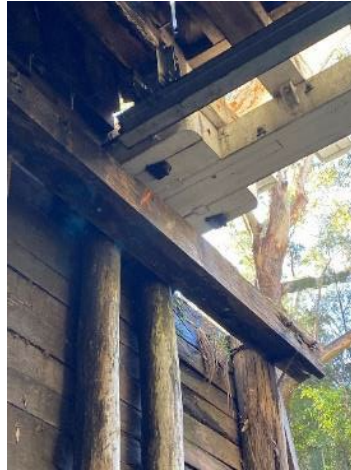
Figure 4-20 View of butting timber block to be replace, on western side of bridge attached to North Abutment (B)

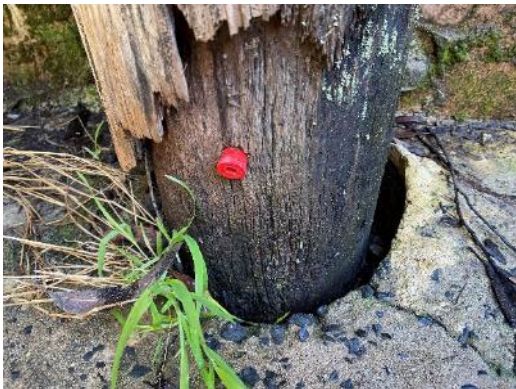
Figure 4-23: Example of pile encased in concrete, experiencing timber rot

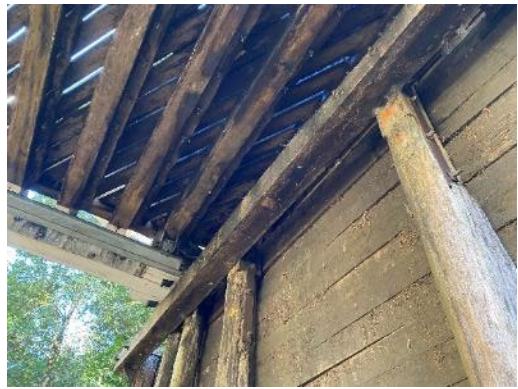
Figure 4-24: Example of spliced piles, top section of two piles in foreground of North Abutment (B)

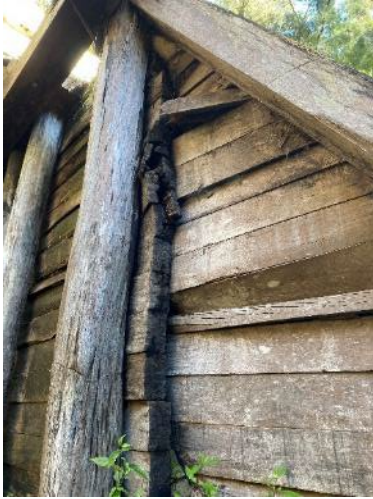
Figure 4-25: Example of timber displacement where previously replaced in wings of North Abutment (B)

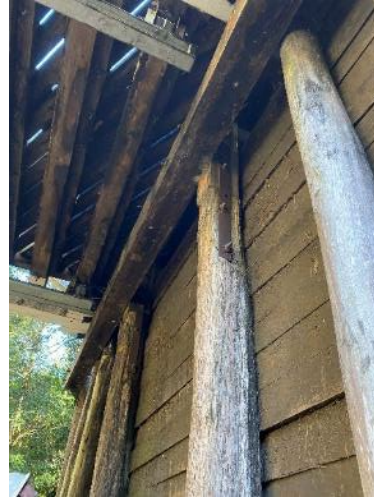
Figure 4-26: Closer view of spliced piles, top section of two piles in foreground of North Abutment (B)

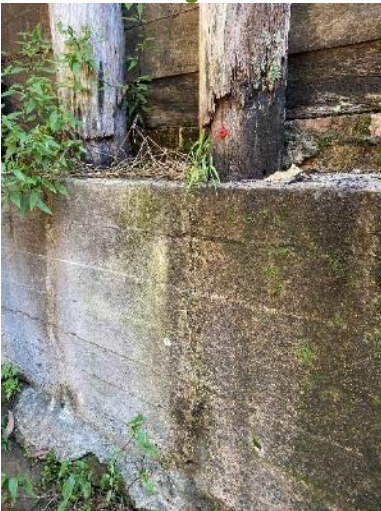
Figure 4-29: Example view of concrete casing experiencing cracking directly beneath each pile

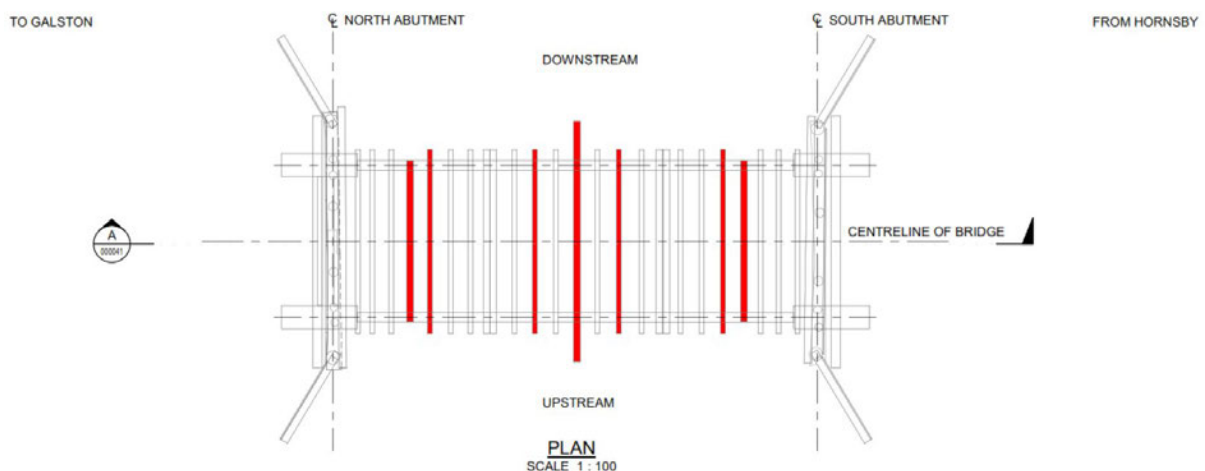
The proposed cross girders for replacement are highlighted in red in Figures 7.1 and 7.2 that follow.

Figure 7-1: Plan indicating cross girders for replacement shaded red. (Source: 520212TP-AURC-B00390-ST-DRG-000041, 100% Design drawings, Aurecon 2023)

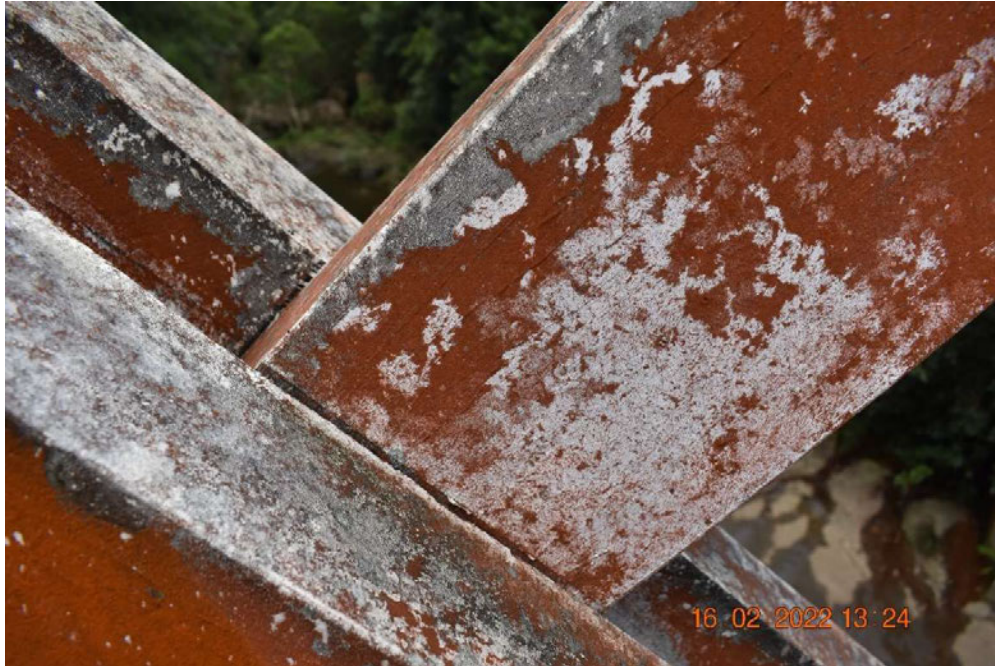
Picture 24 Mould, Lichen & Mildew

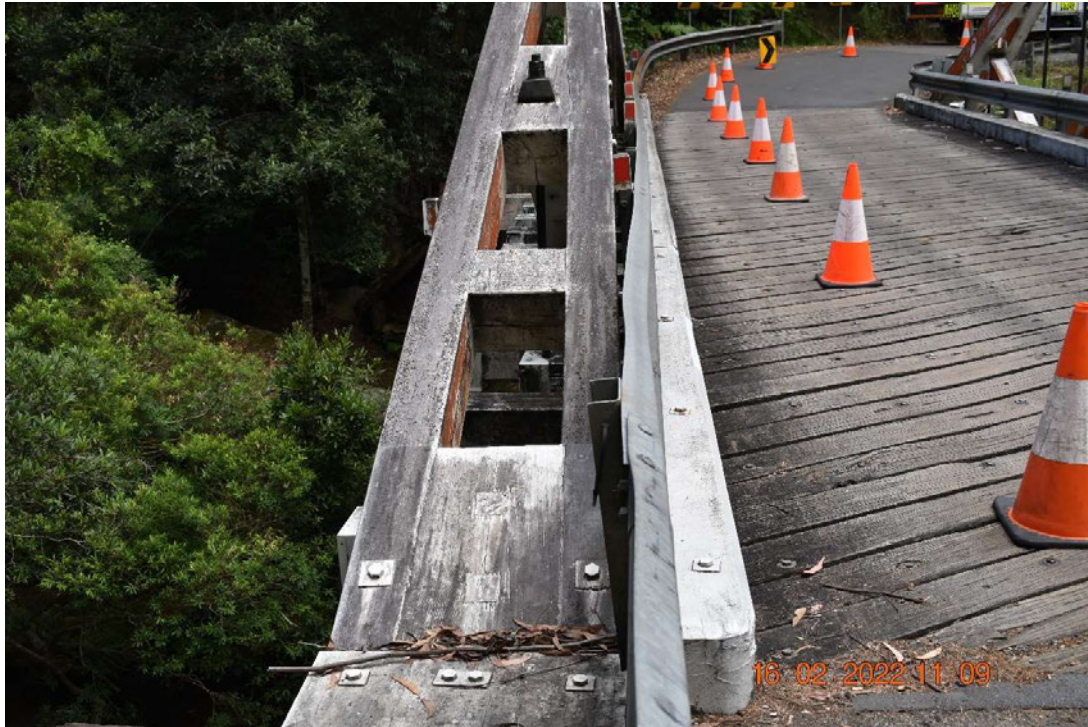
Picture 26 Mould on white painted timbers

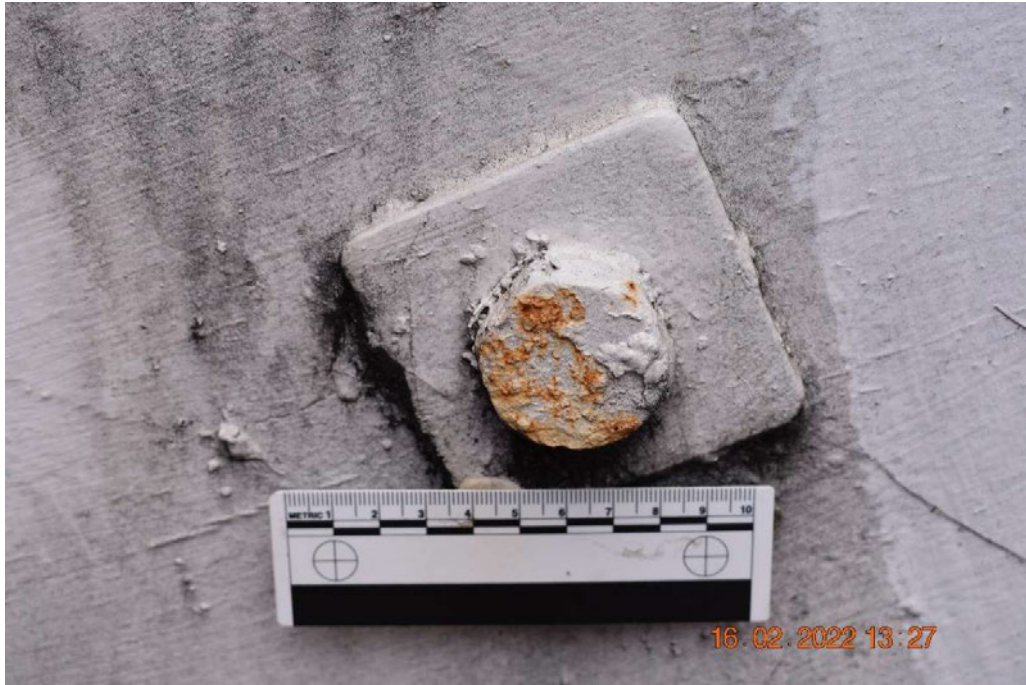
Picture 27 General corrosion on bolt

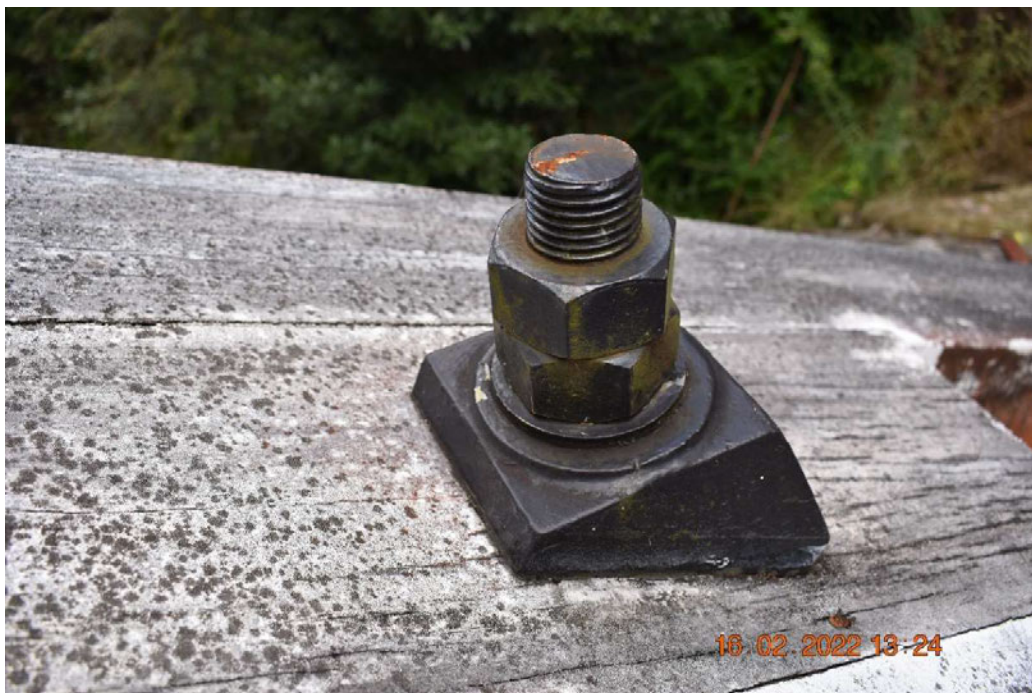
Picture 28 General corrosion on bolt

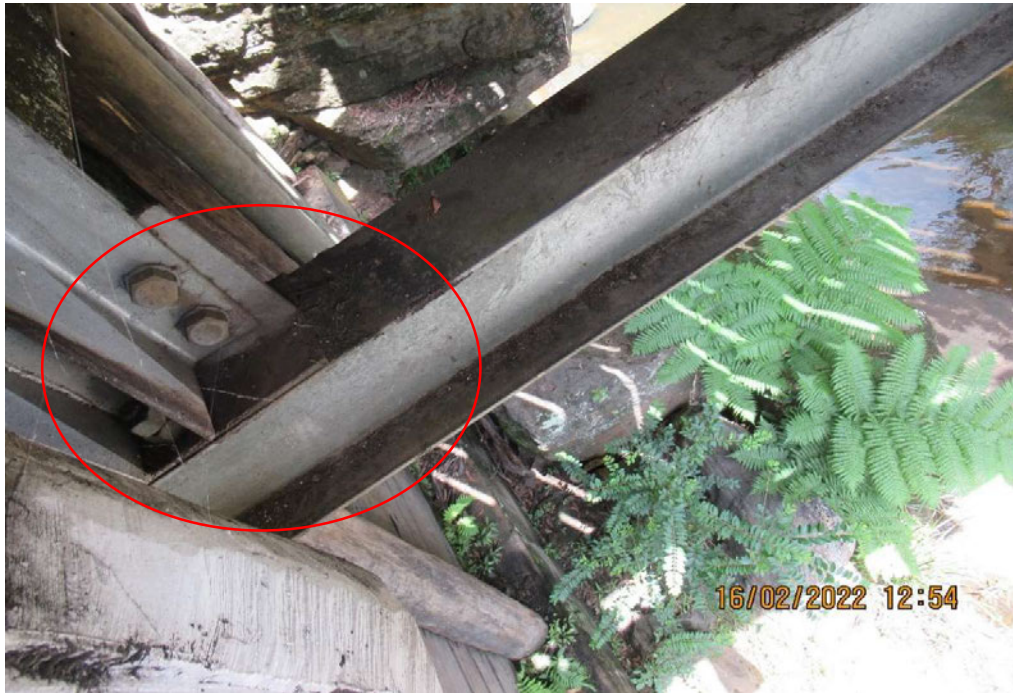
Picture 29 General corrosion on I beams and bolts

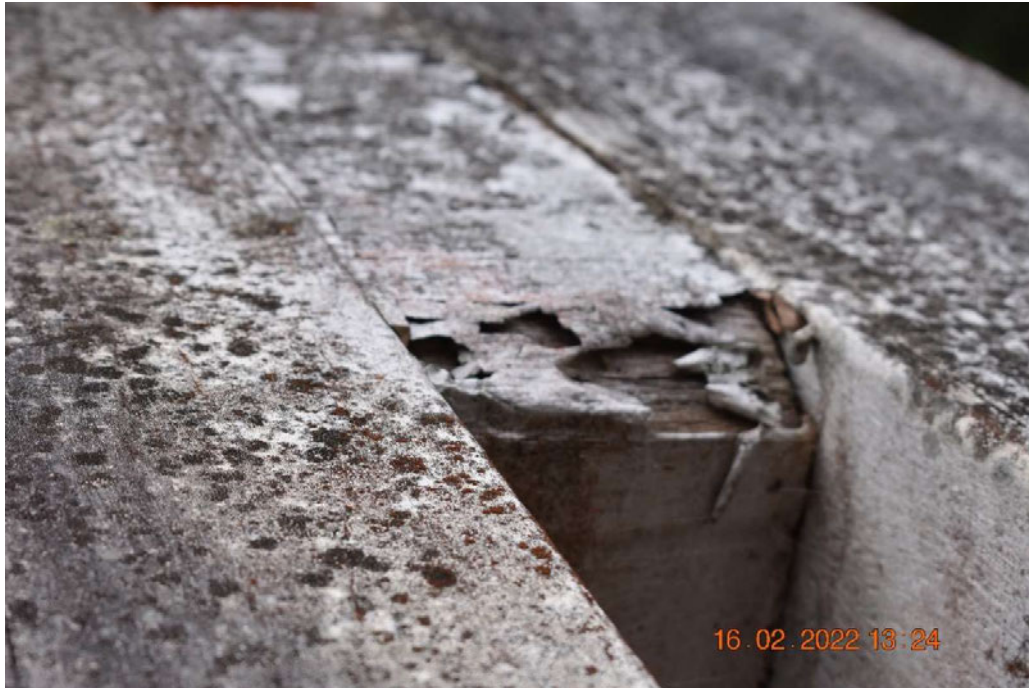
Picture 30 – Timber Rot and Paint delamination

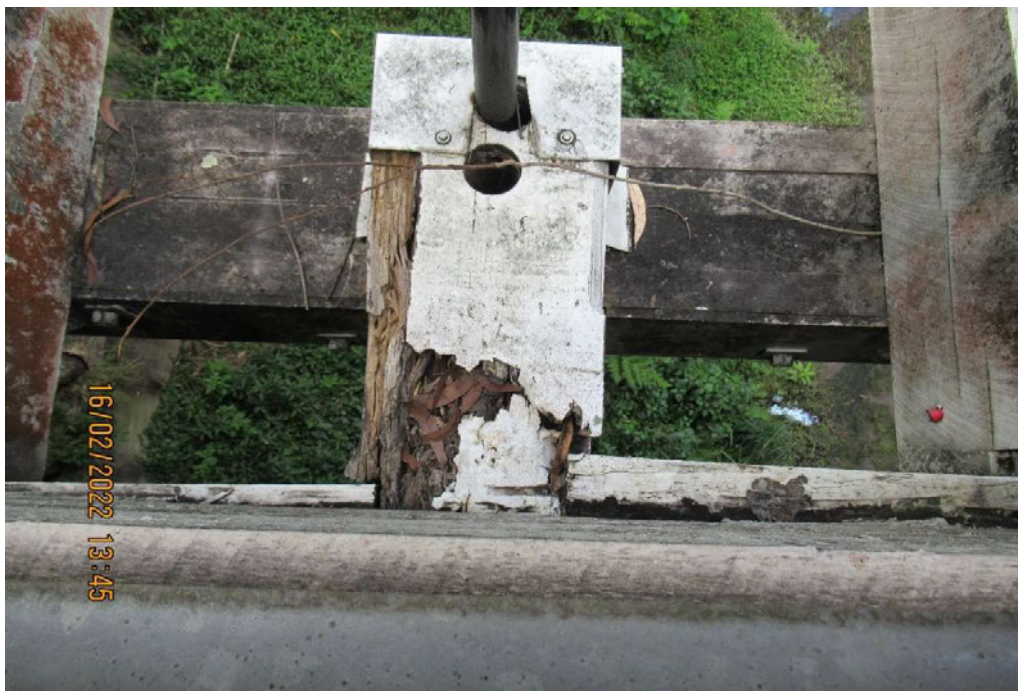
Picture 31 Timber Rot

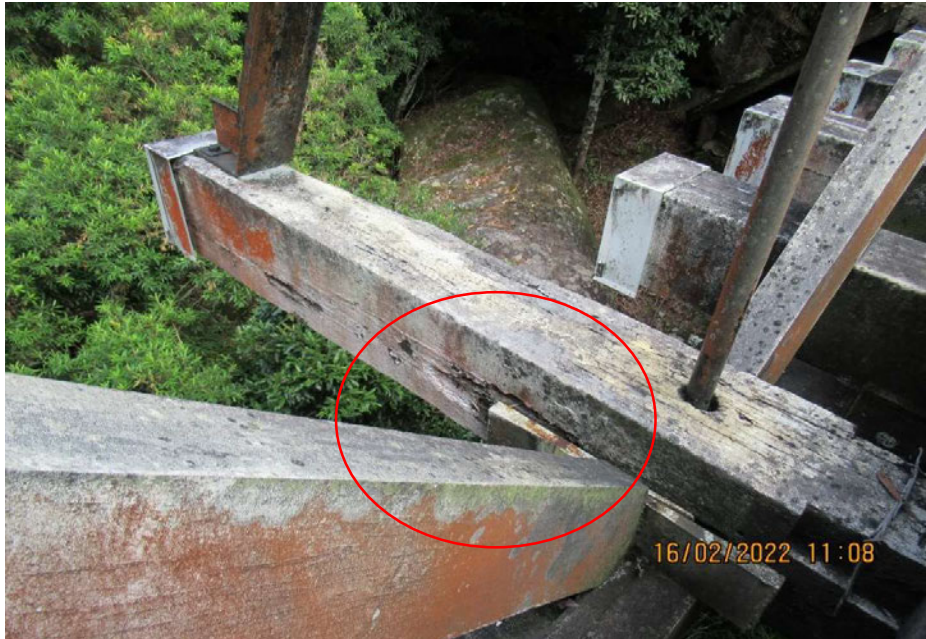
Picture 32 Timber Rot

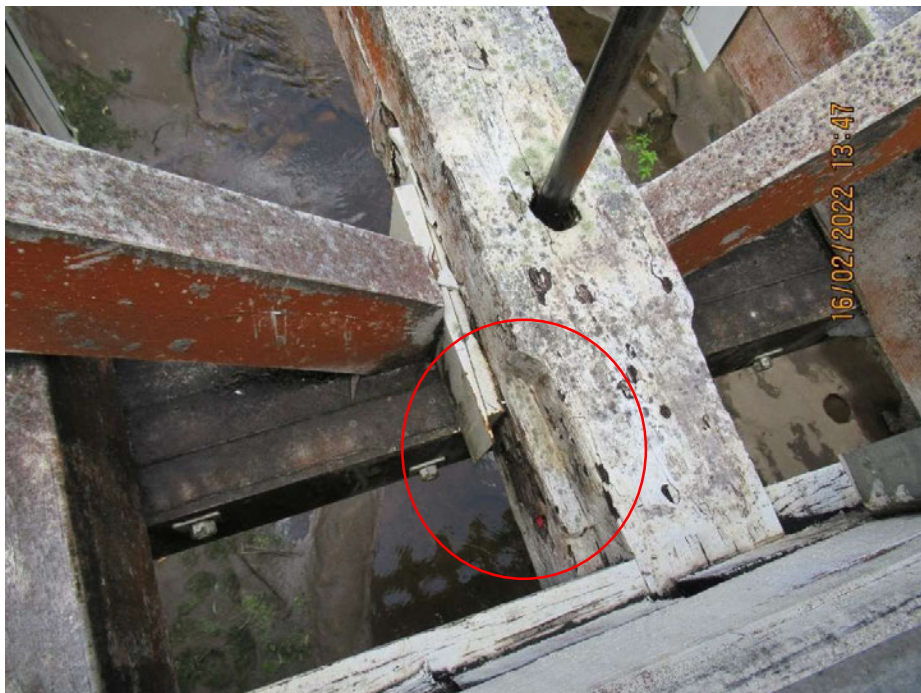
Picture 33 Timber Rot

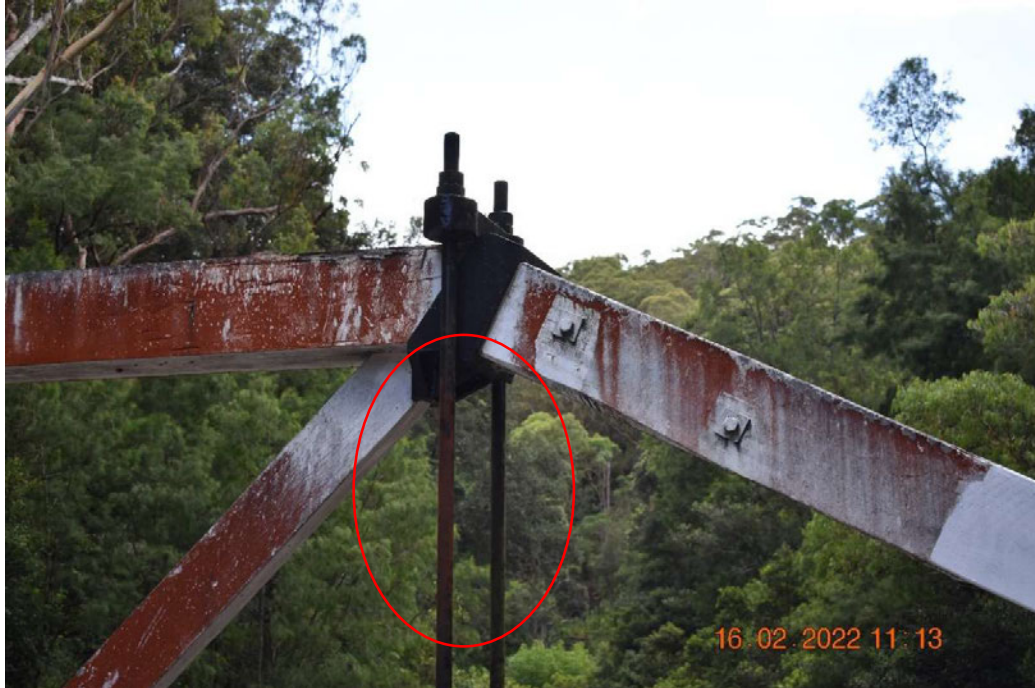
Picture 35 Corrosion on black metal poles

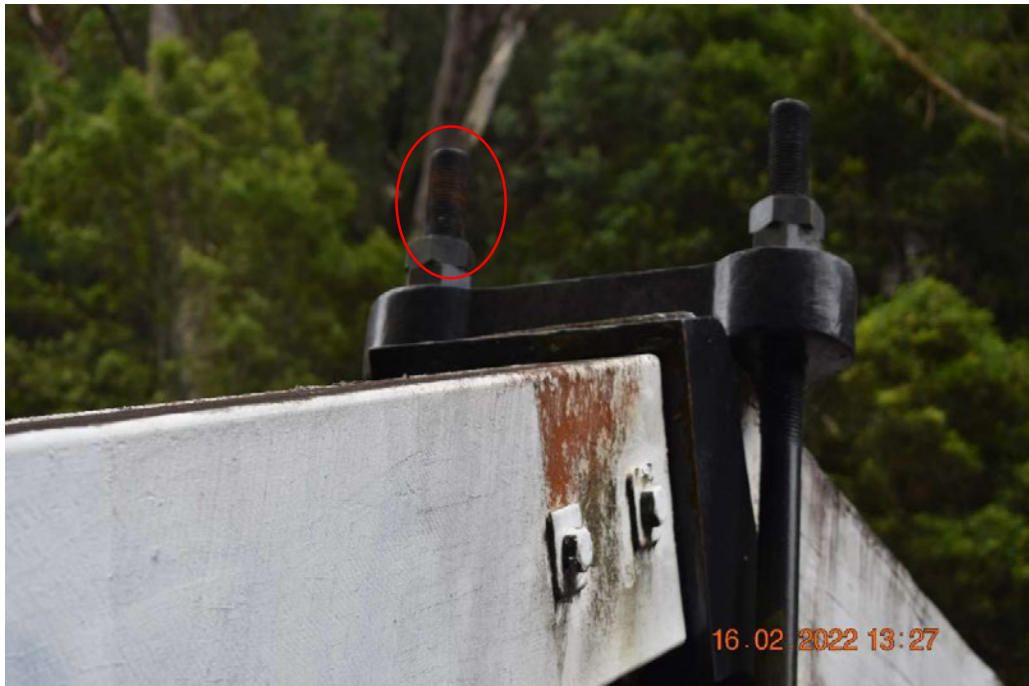
Picture 36 Corrosion on black metal pole

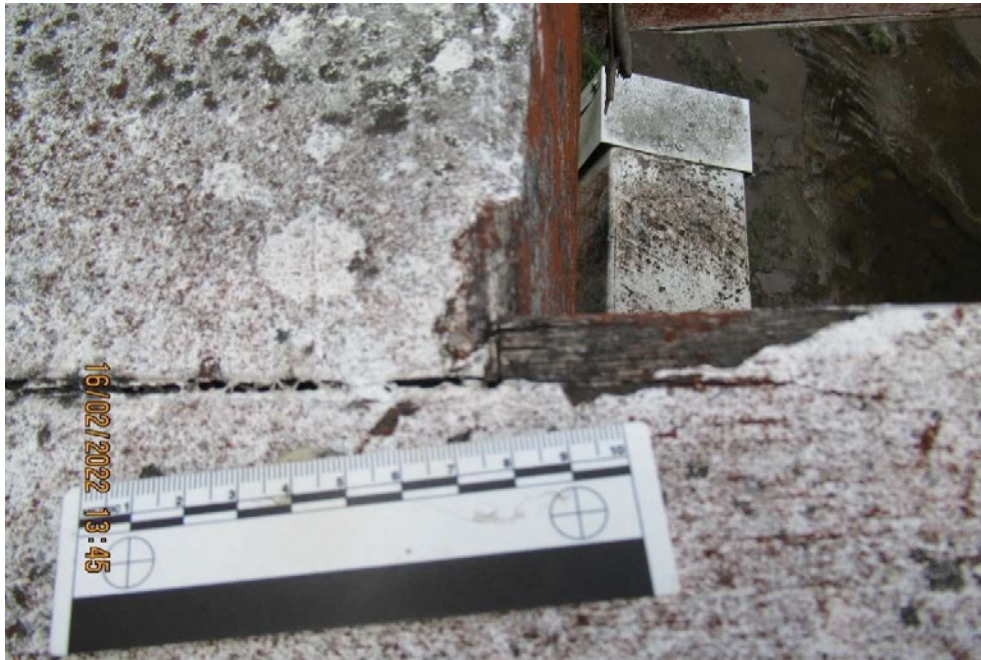
Picture 37 Paint Delamination
