## **Arboricultural Impact Assessment Report**

Safe Accessible Transport Program  
Macquarie Fields Station  
MACQUARIE FIELDS, NSW

Aurecon P/L  
C/- Transport for NSW

D5495

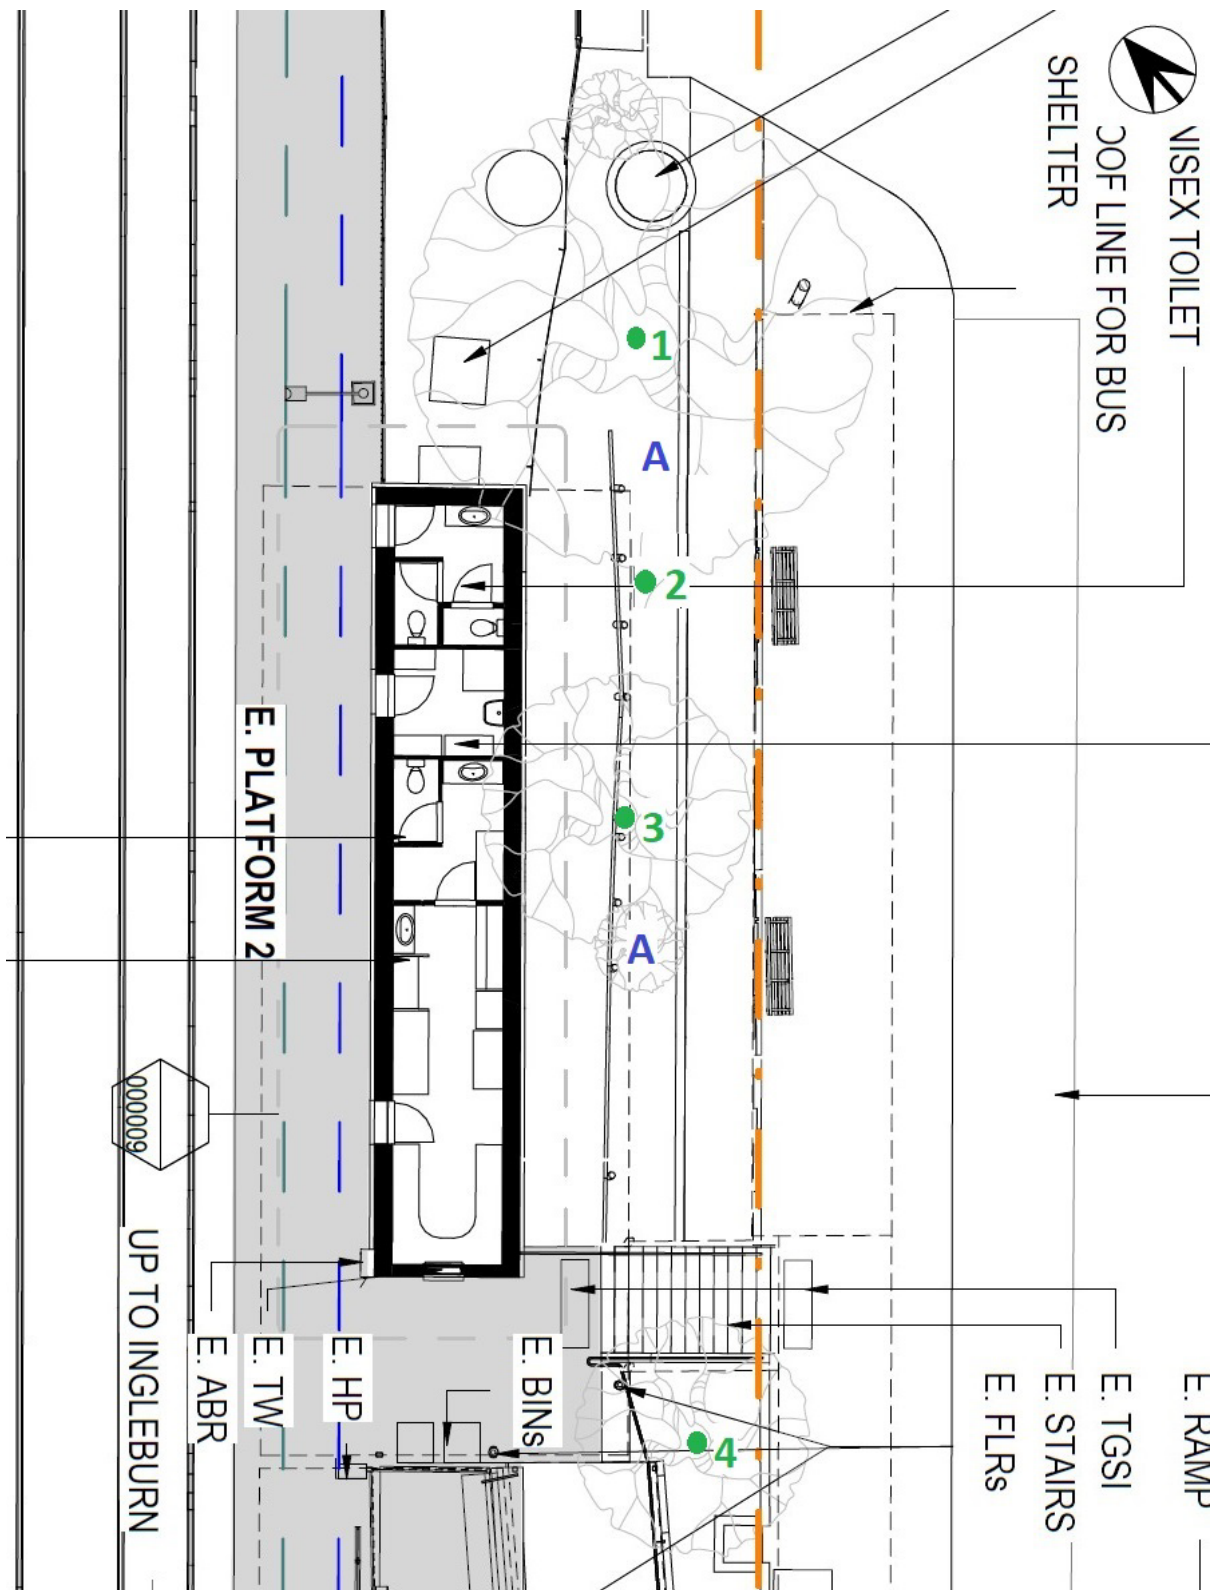
### 5.1 Plan 2; Area of assessment illustrating tree location

Trees Labelled 'A', see Section 7.0.

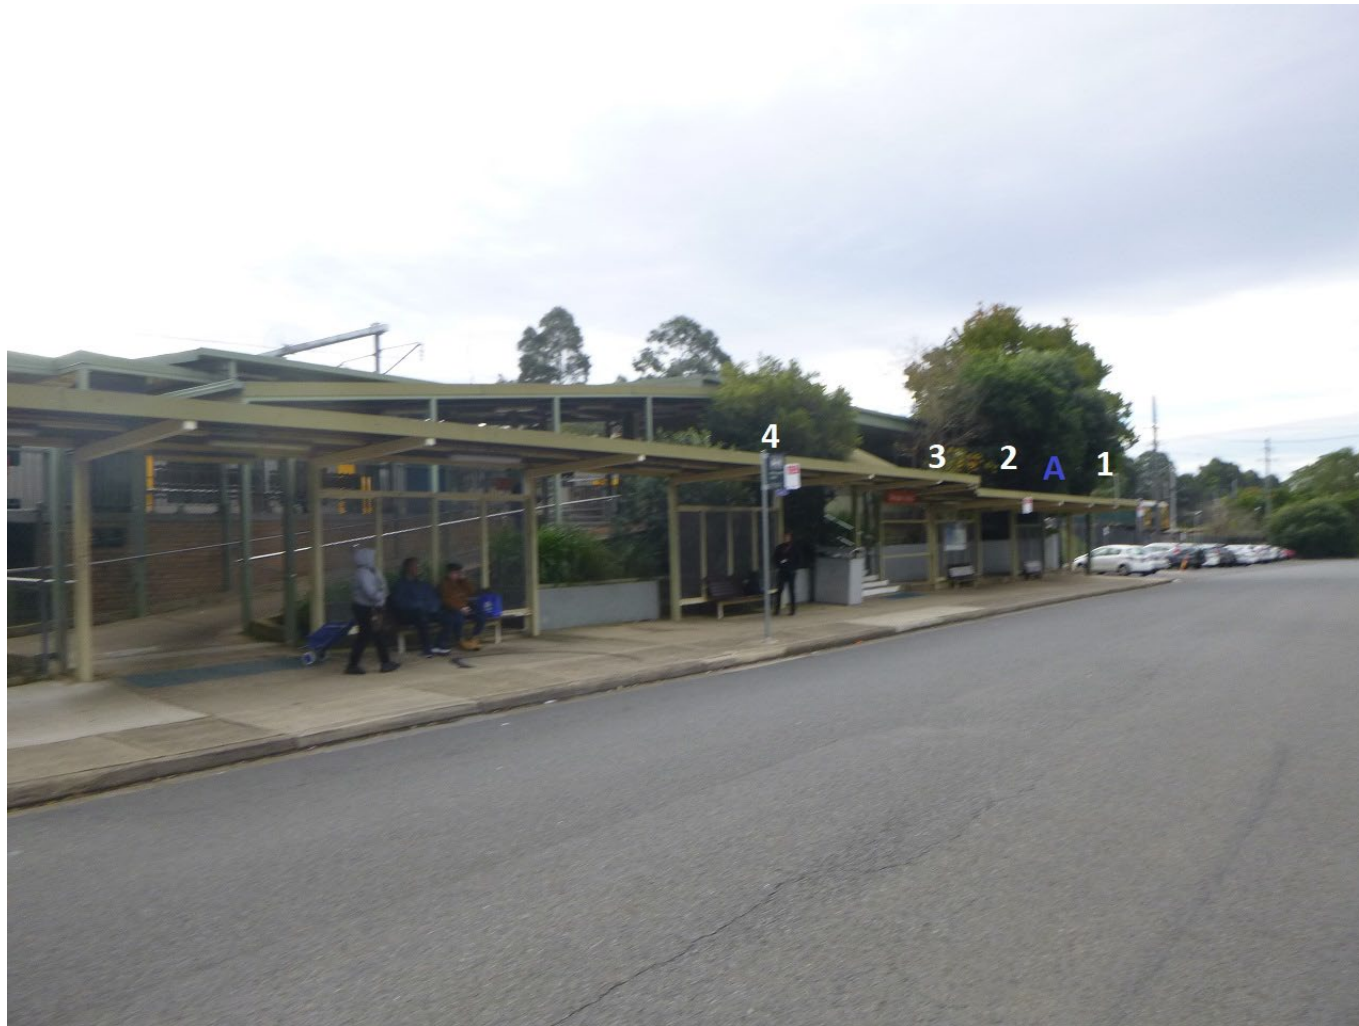
Photo 1, Trees No. 1-4, facing north.

Trees No. 1-3 and 5 provide poor form and all trees present insufficient significance to retain and amend the design to allow for retention.

These trees are located in the footprint of the proposed design and would require removal based on this premise alone. The conflict is the footprint of the proposed works/ demolition area.

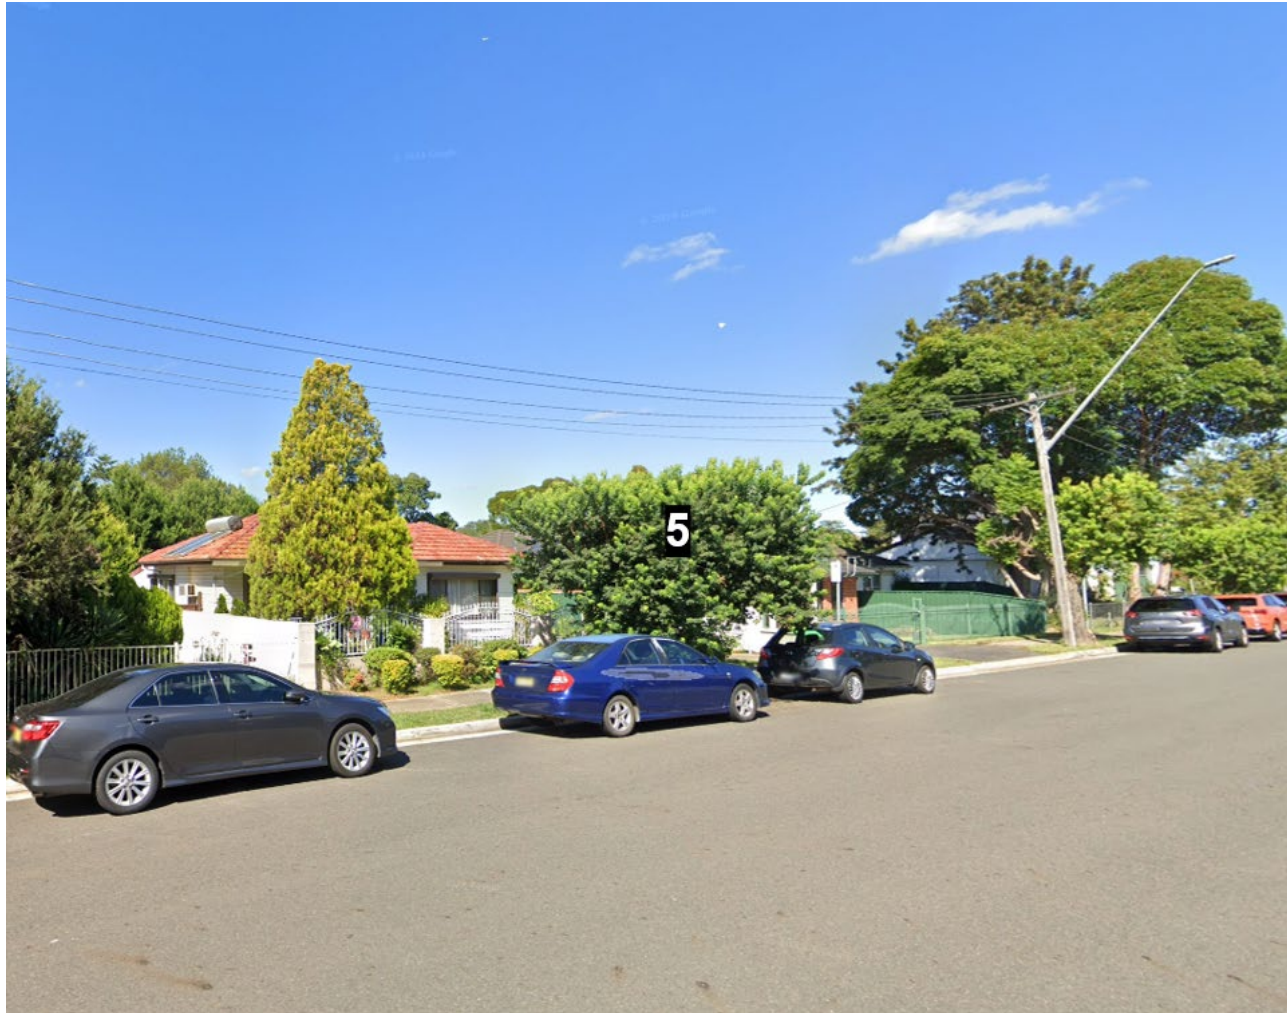
Photo 3, Tree 5, facing south. (Google Earth, 2024)

5	<i>Triadica sebifera</i> Chinese Tallow	5	0.30	4 x 4	M	D	Sym	A	3A	Low	2.77	1.79
<b>Assessment</b> Street trees form part of inconsistent street planting of the species. This tree has succumbed to repeated lopping for powerline clearance and has reflected on the SULE rating.											<b>Development Impact</b> See Section 7.1.1

Tree No. 5 is a street tree planting and property of Campbelltown City Council and will require consent from the owner for removal.
