The Driftway

Stage 1 - Procedure for Aboriginal Cultural
Heritage Consultation and Investigation

July 2024

New Richmond Bridge and traffic improvements - Stage 1

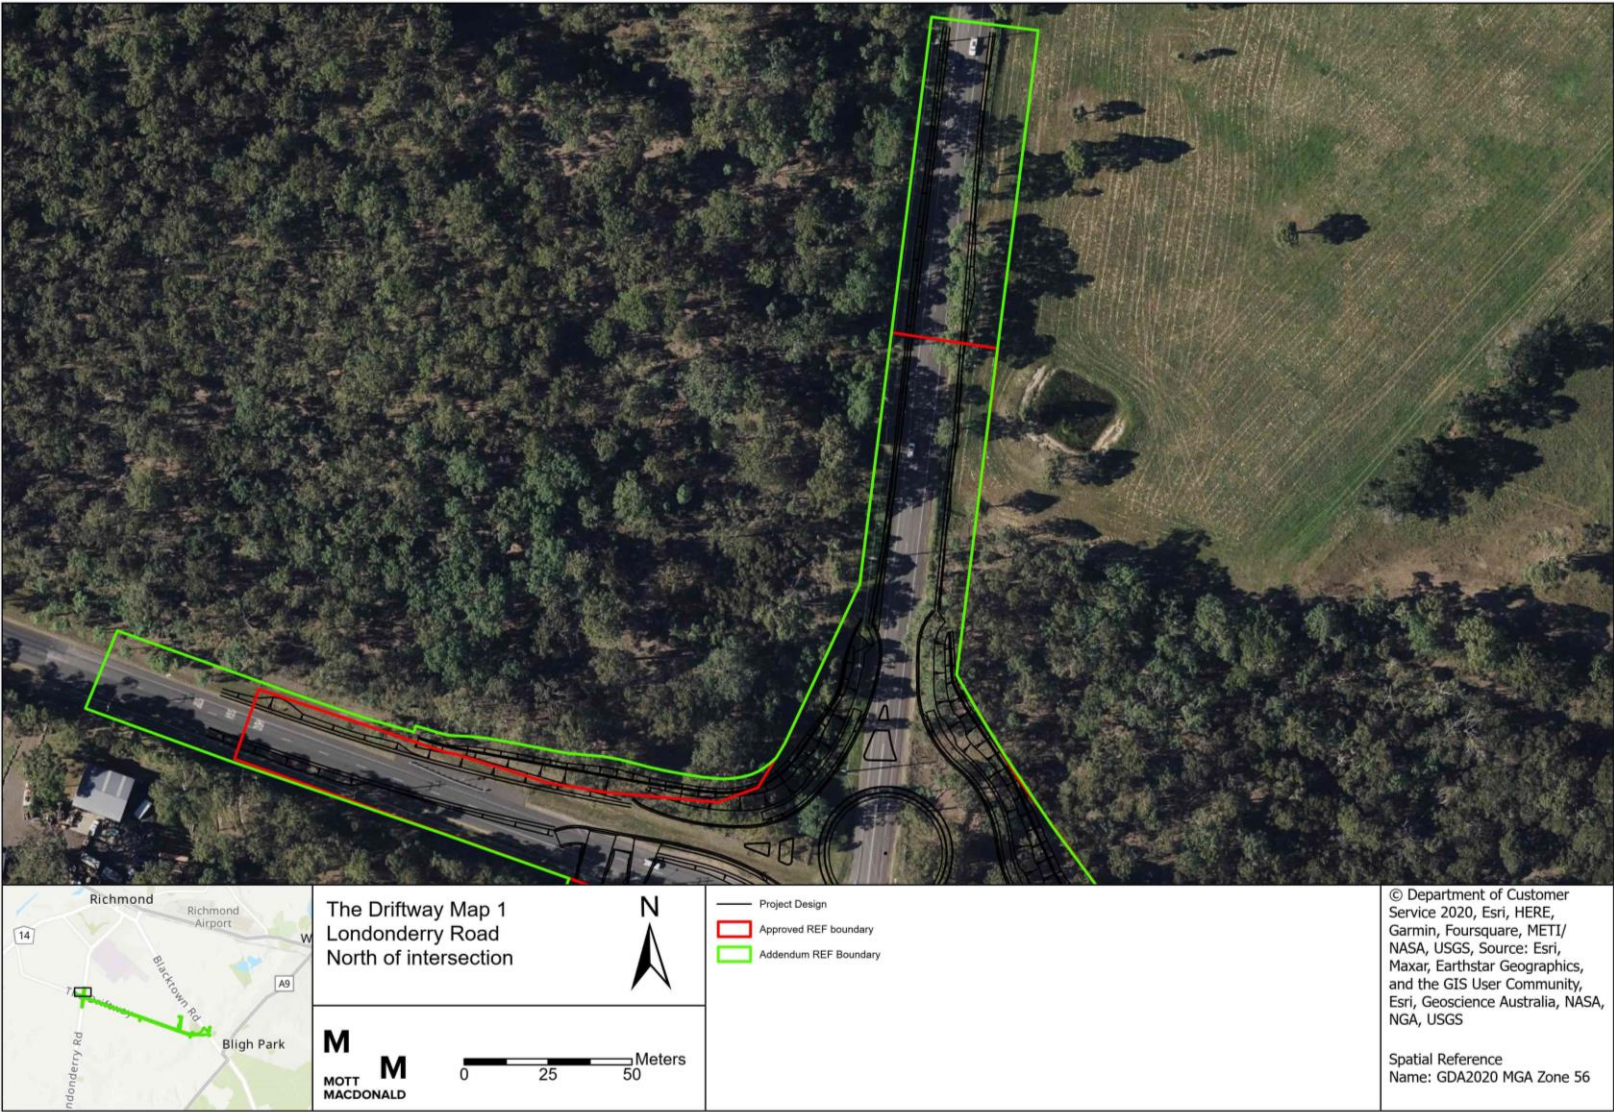
Figure 1-1 Londonderry Road north intersection Project boundary adjustments

The location of the approved Project REF boundary and AREF boundary adjusted for the proposed modifications are presented in Figure 1-1 to Figure 1-11.

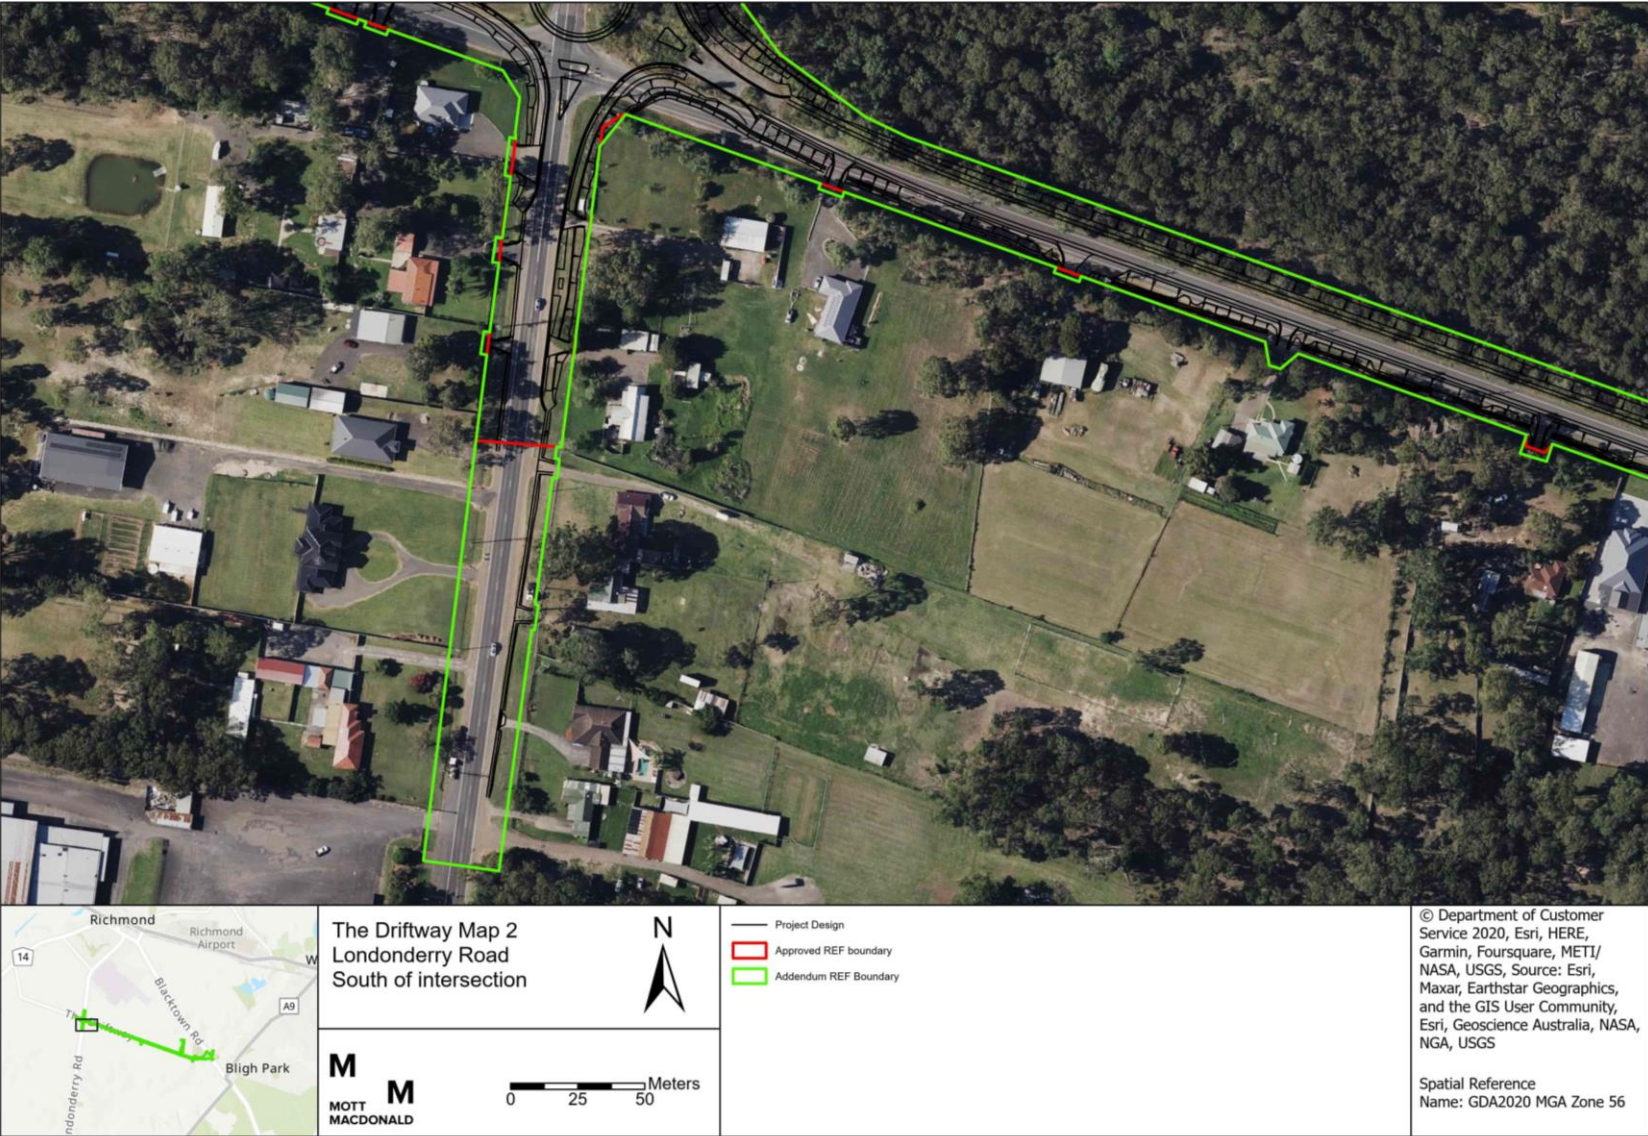
Figure 1-2 Londonderry Road south intersection Project boundary adjustments

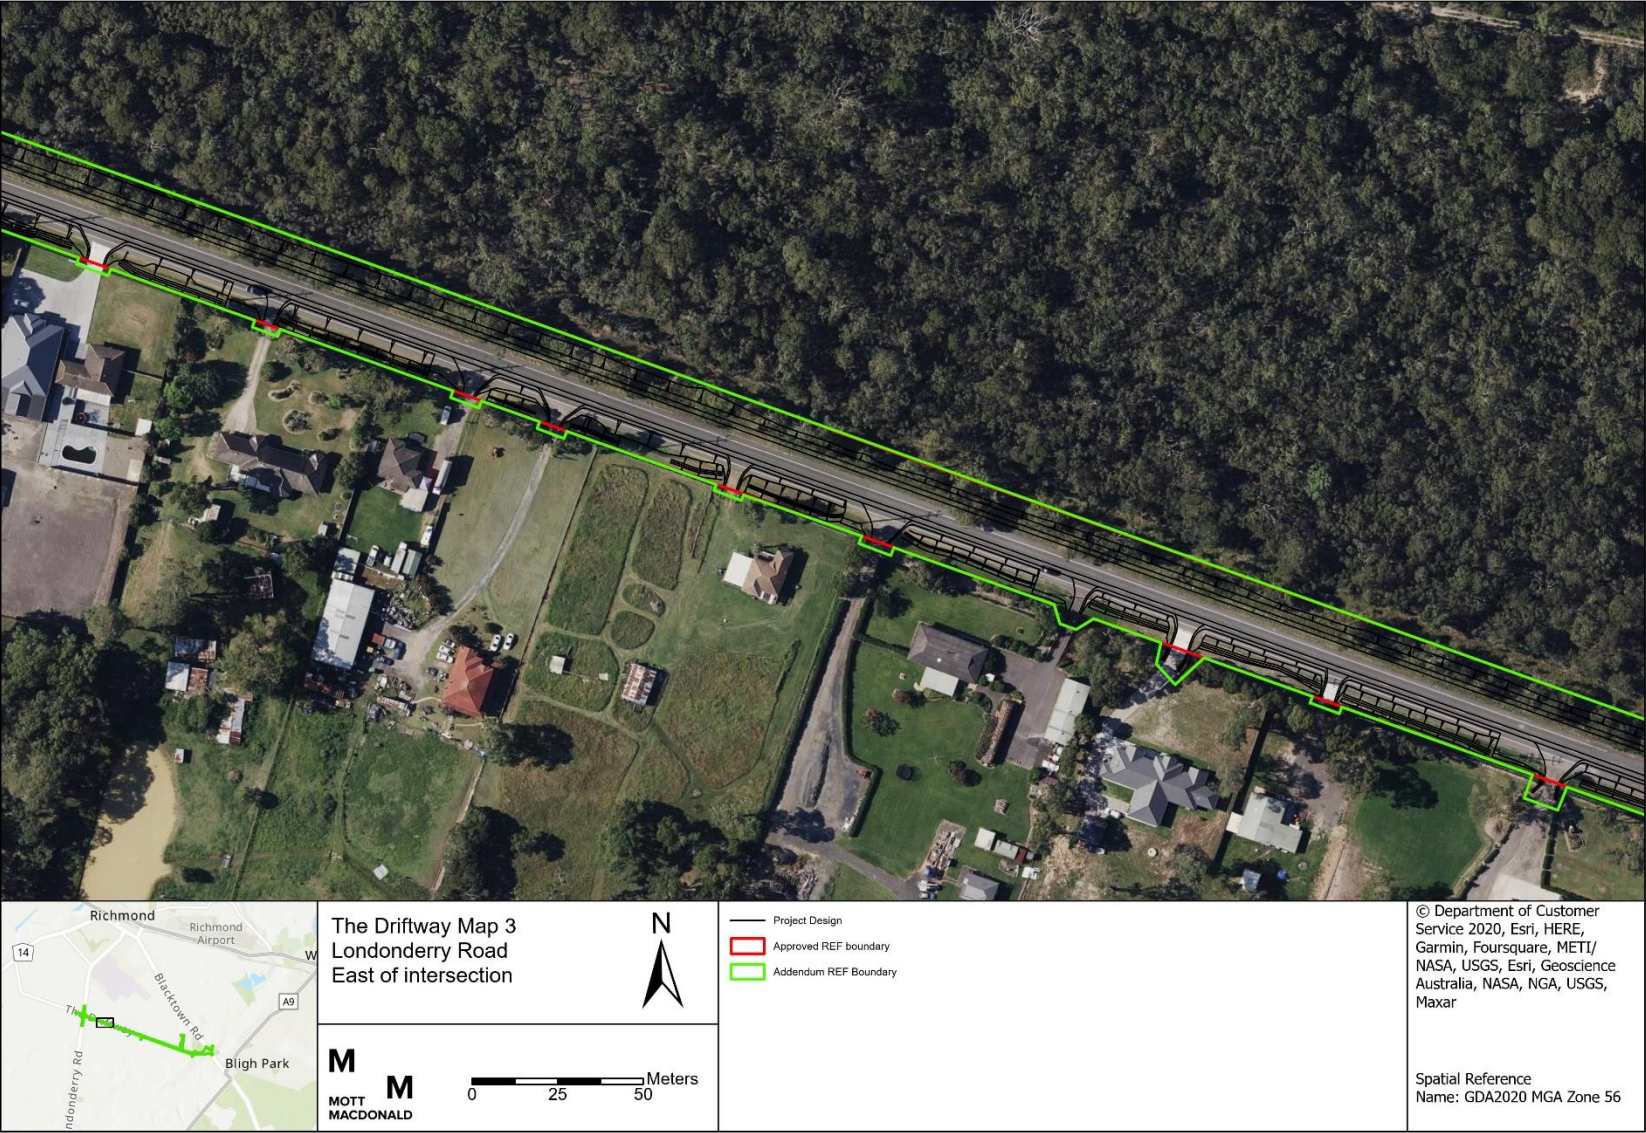
Figure 1-3 Londonderry Road east of intersection Project boundary adjustment

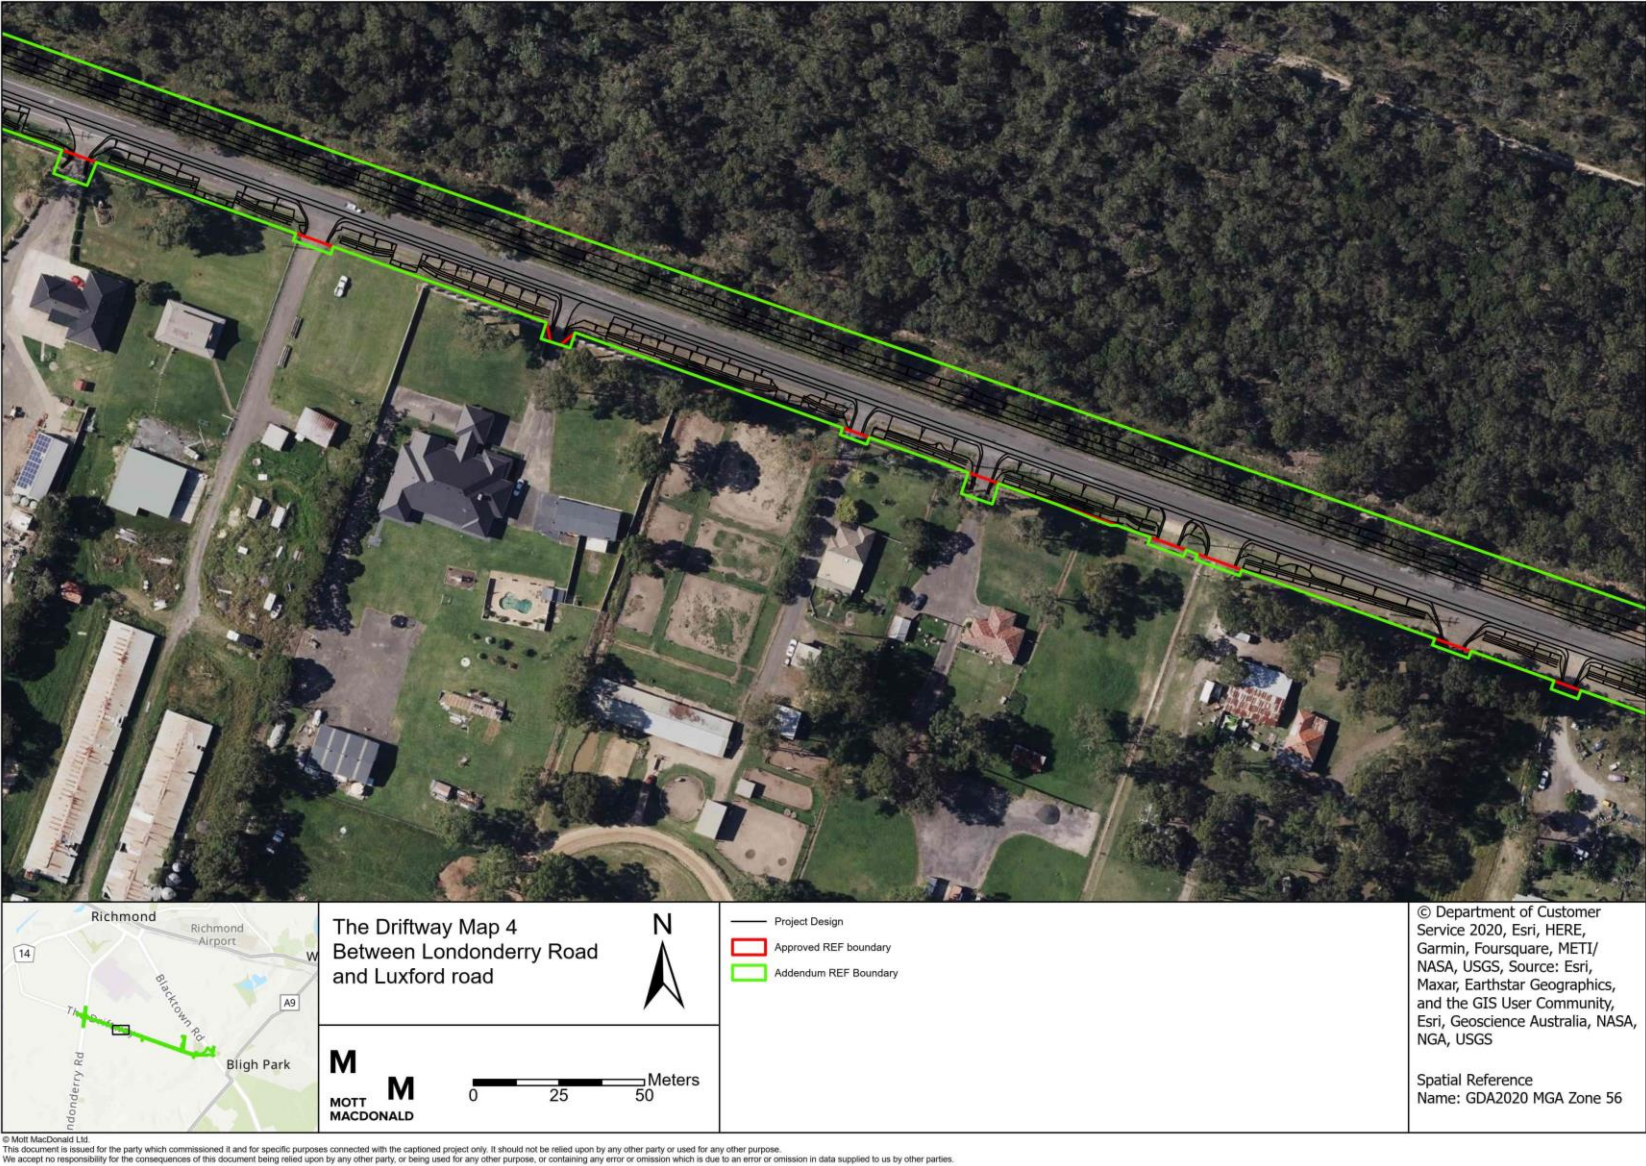
Figure 1-4 The Driftway between Londonderry Road and Luxford Road Project boundary adjustment

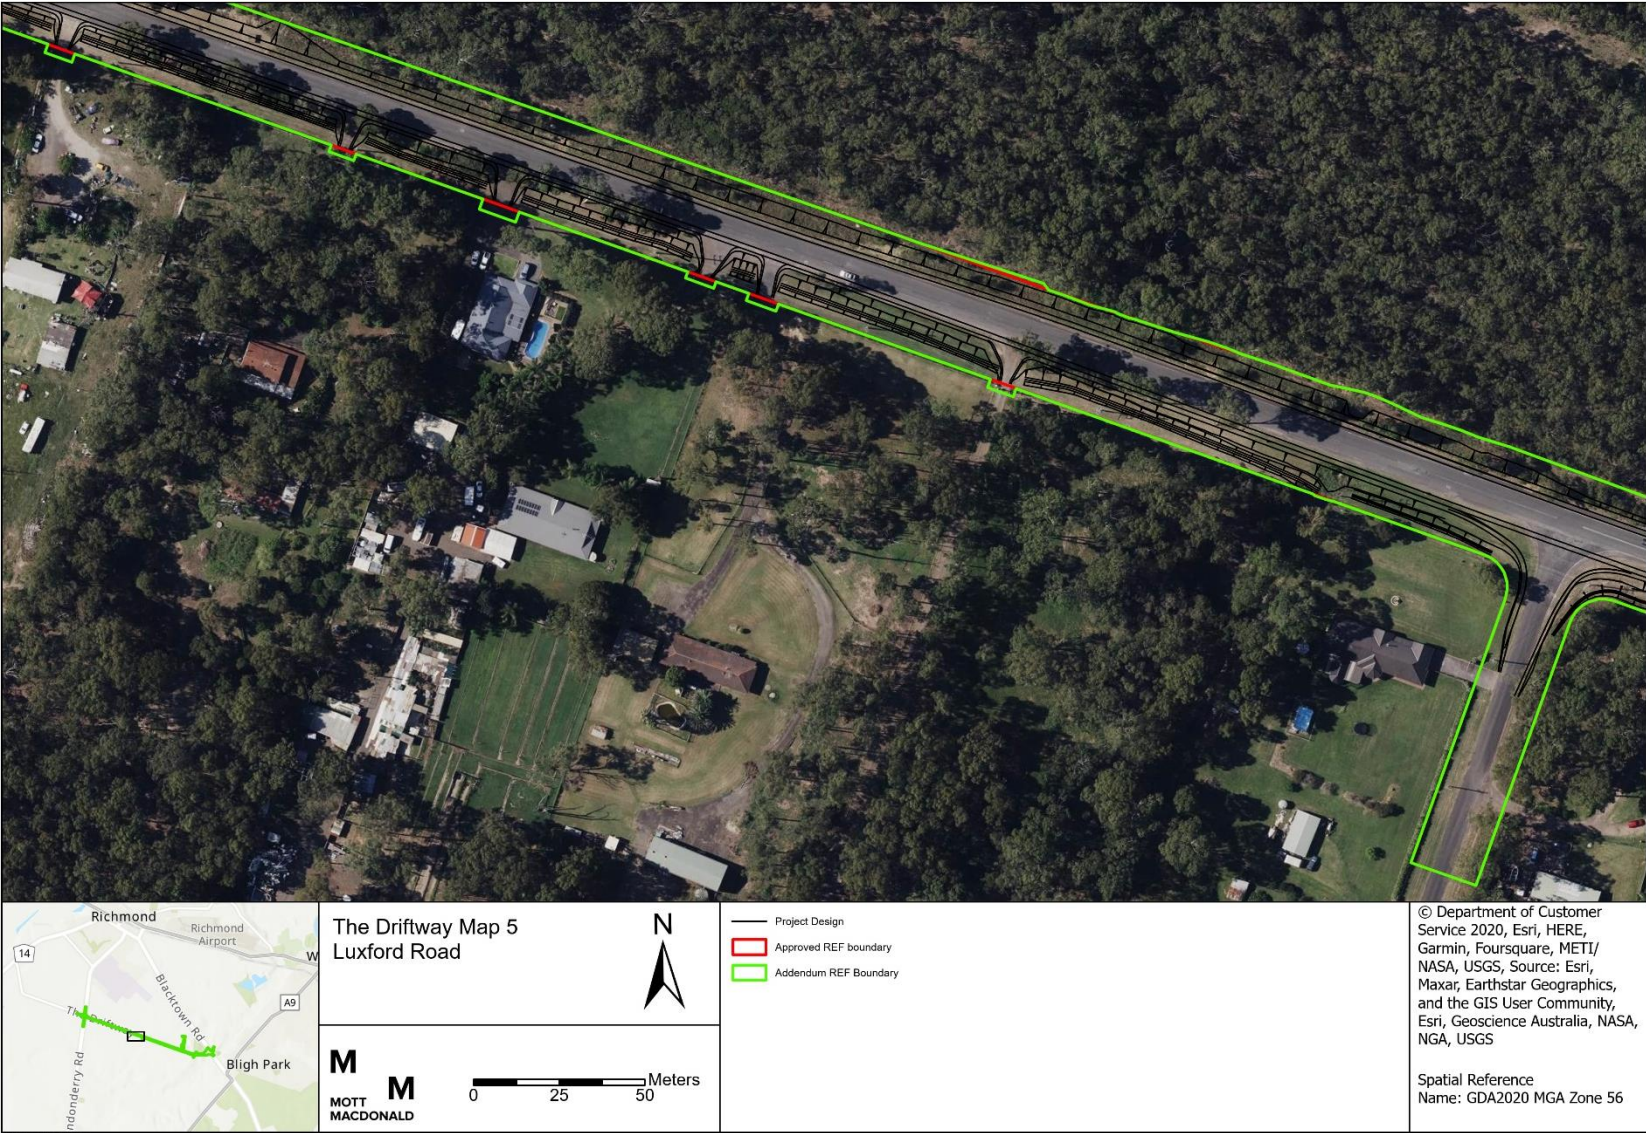
Figure 1-5 The Driftway and Luxford Road Project boundary adjustments

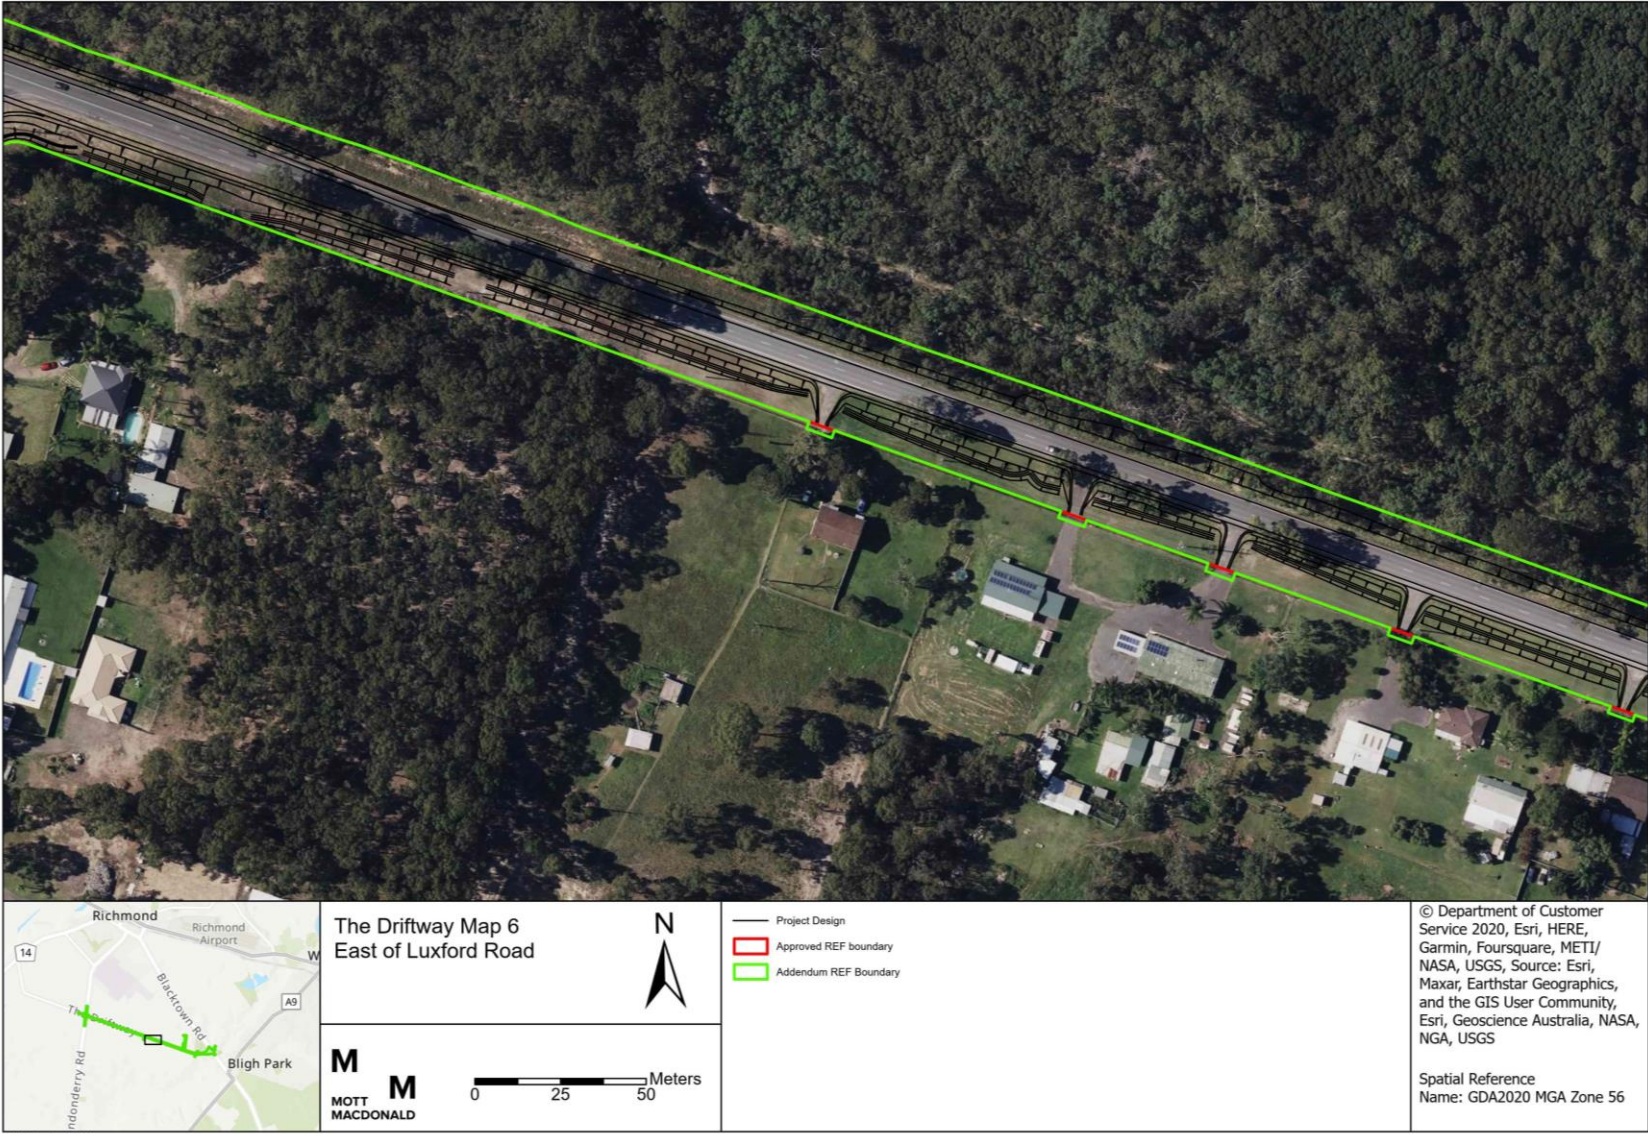
Figure 1-6 The Driftway east of Luxford Road Project boundary adjustments

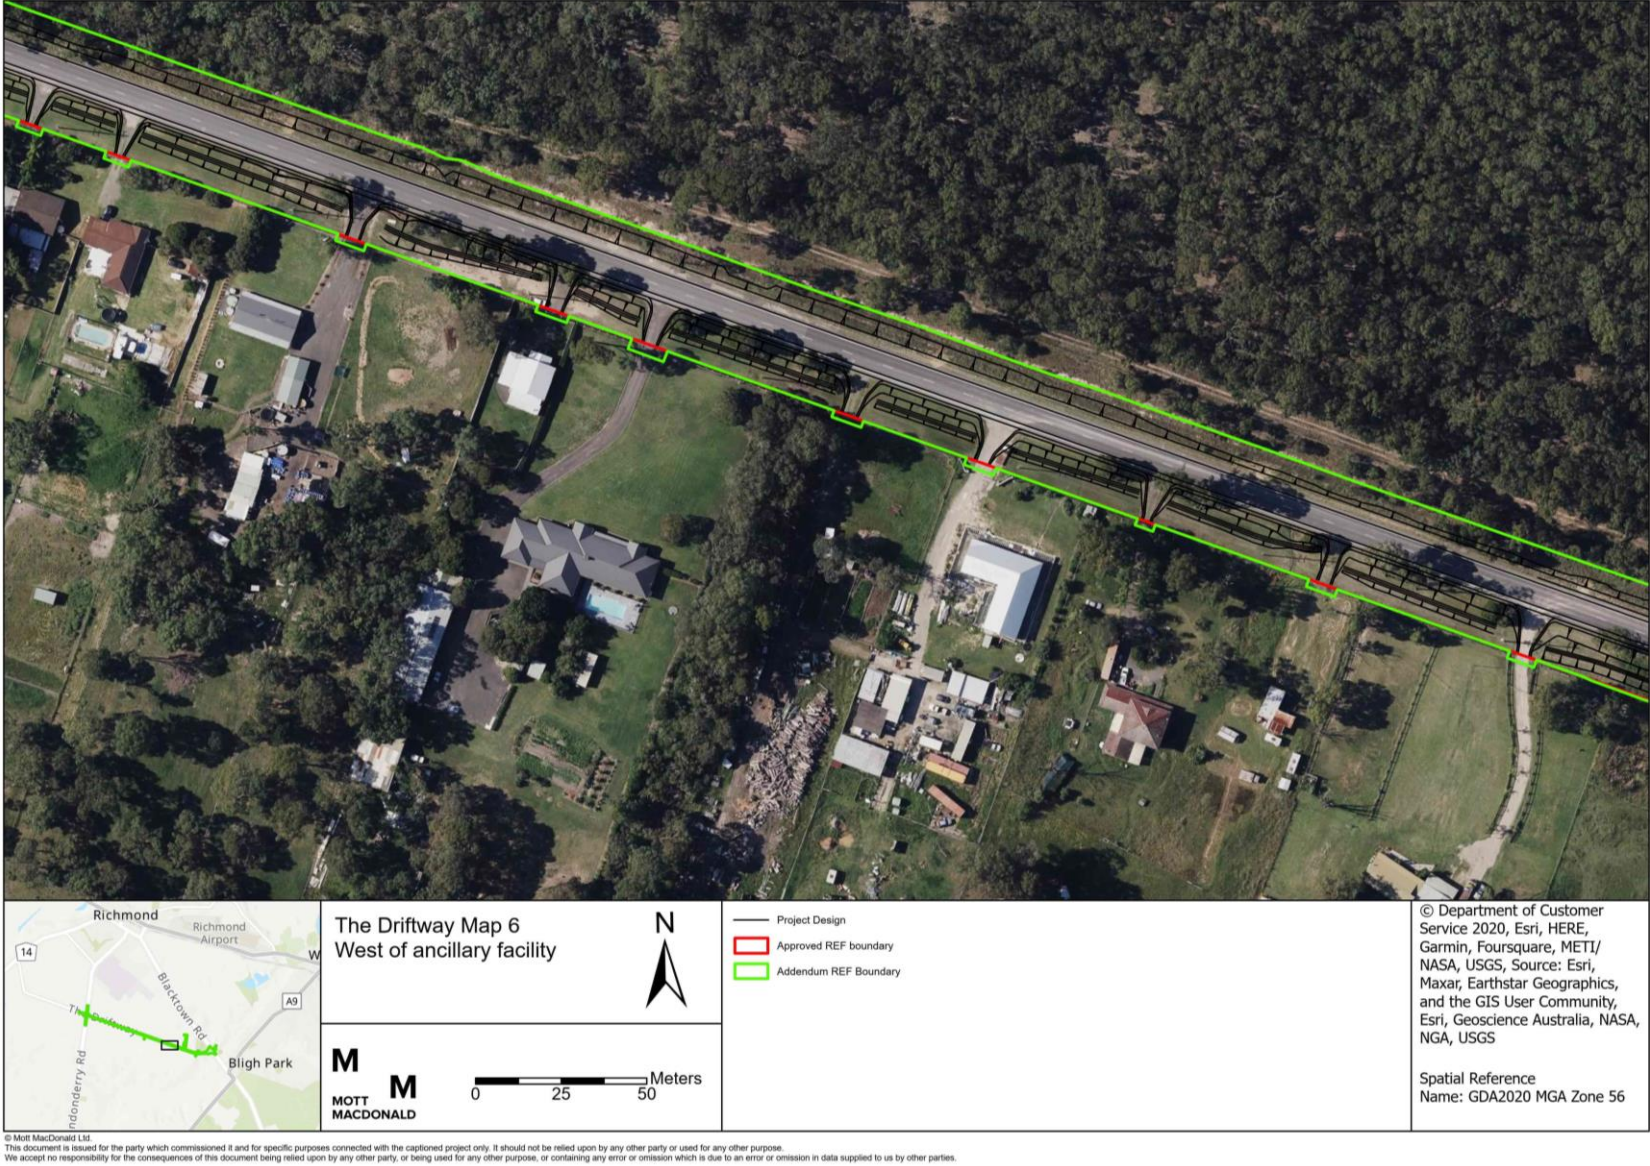
Figure 1-7 The Driftway west of ancillary facility Project boundary adjustments

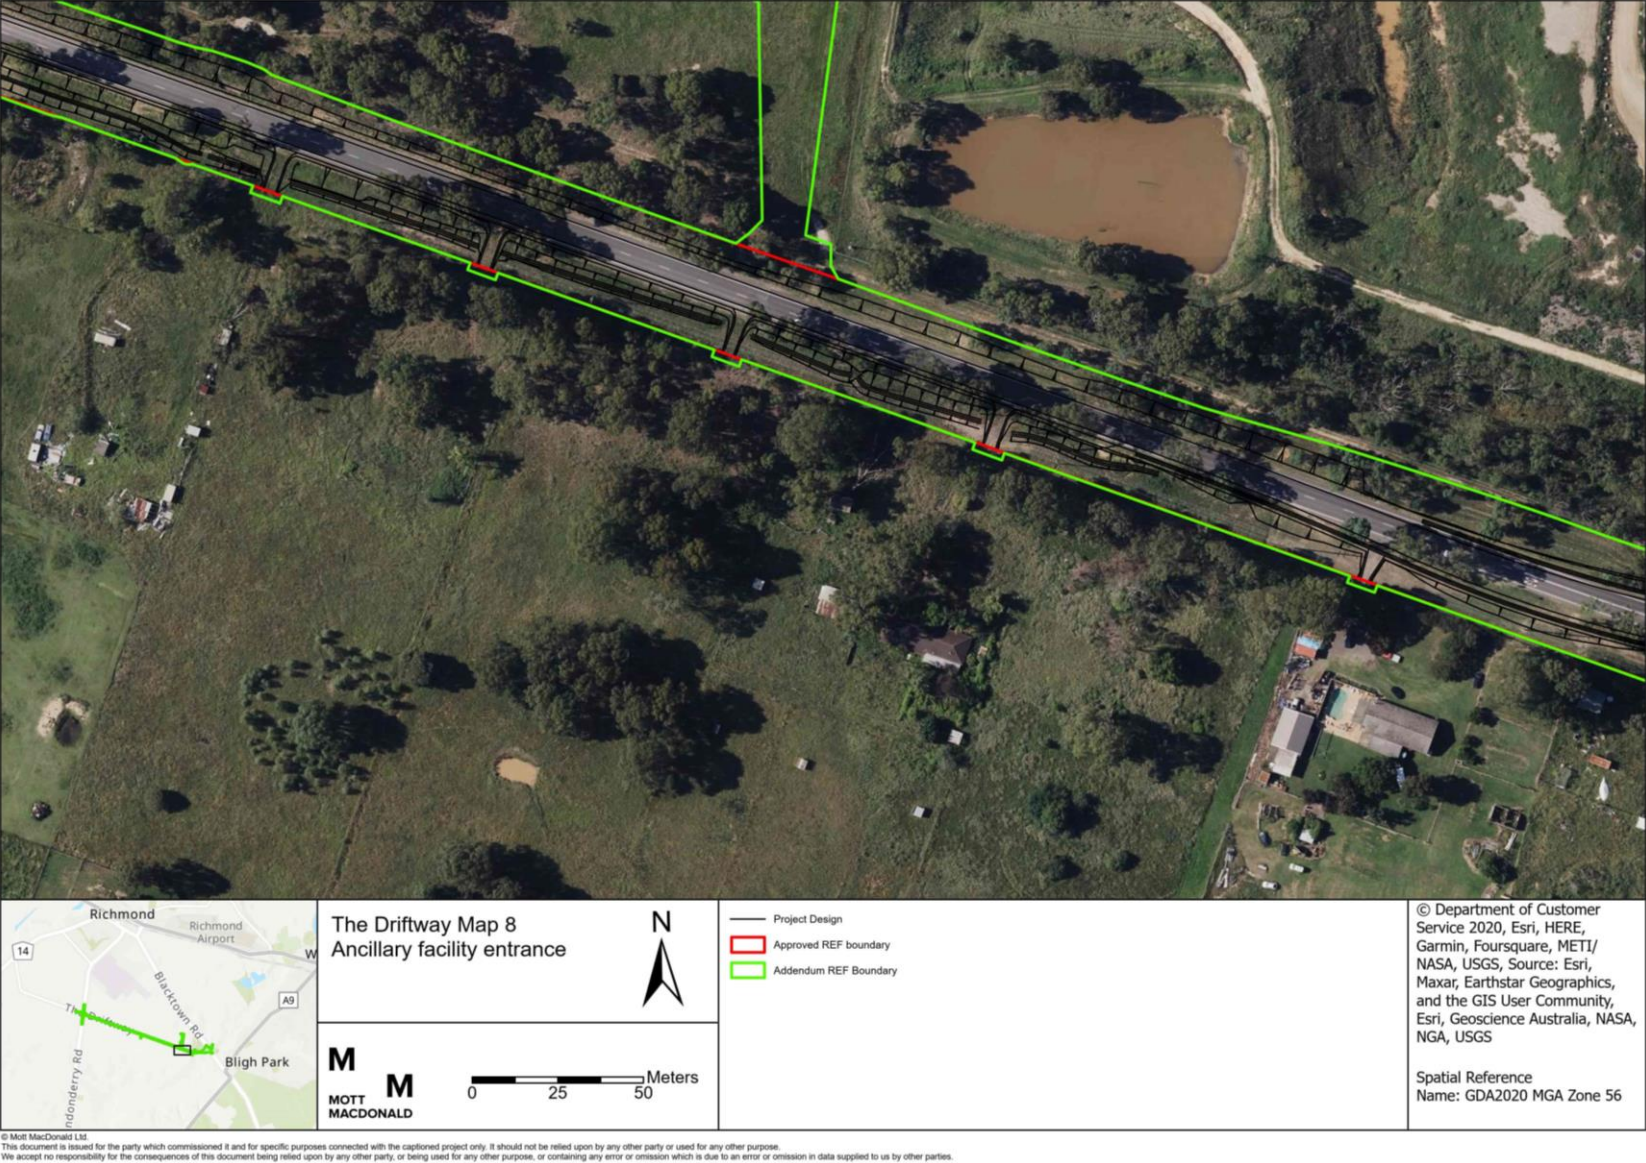
Figure 1-8 Ancillary facility Project boundary adjustments

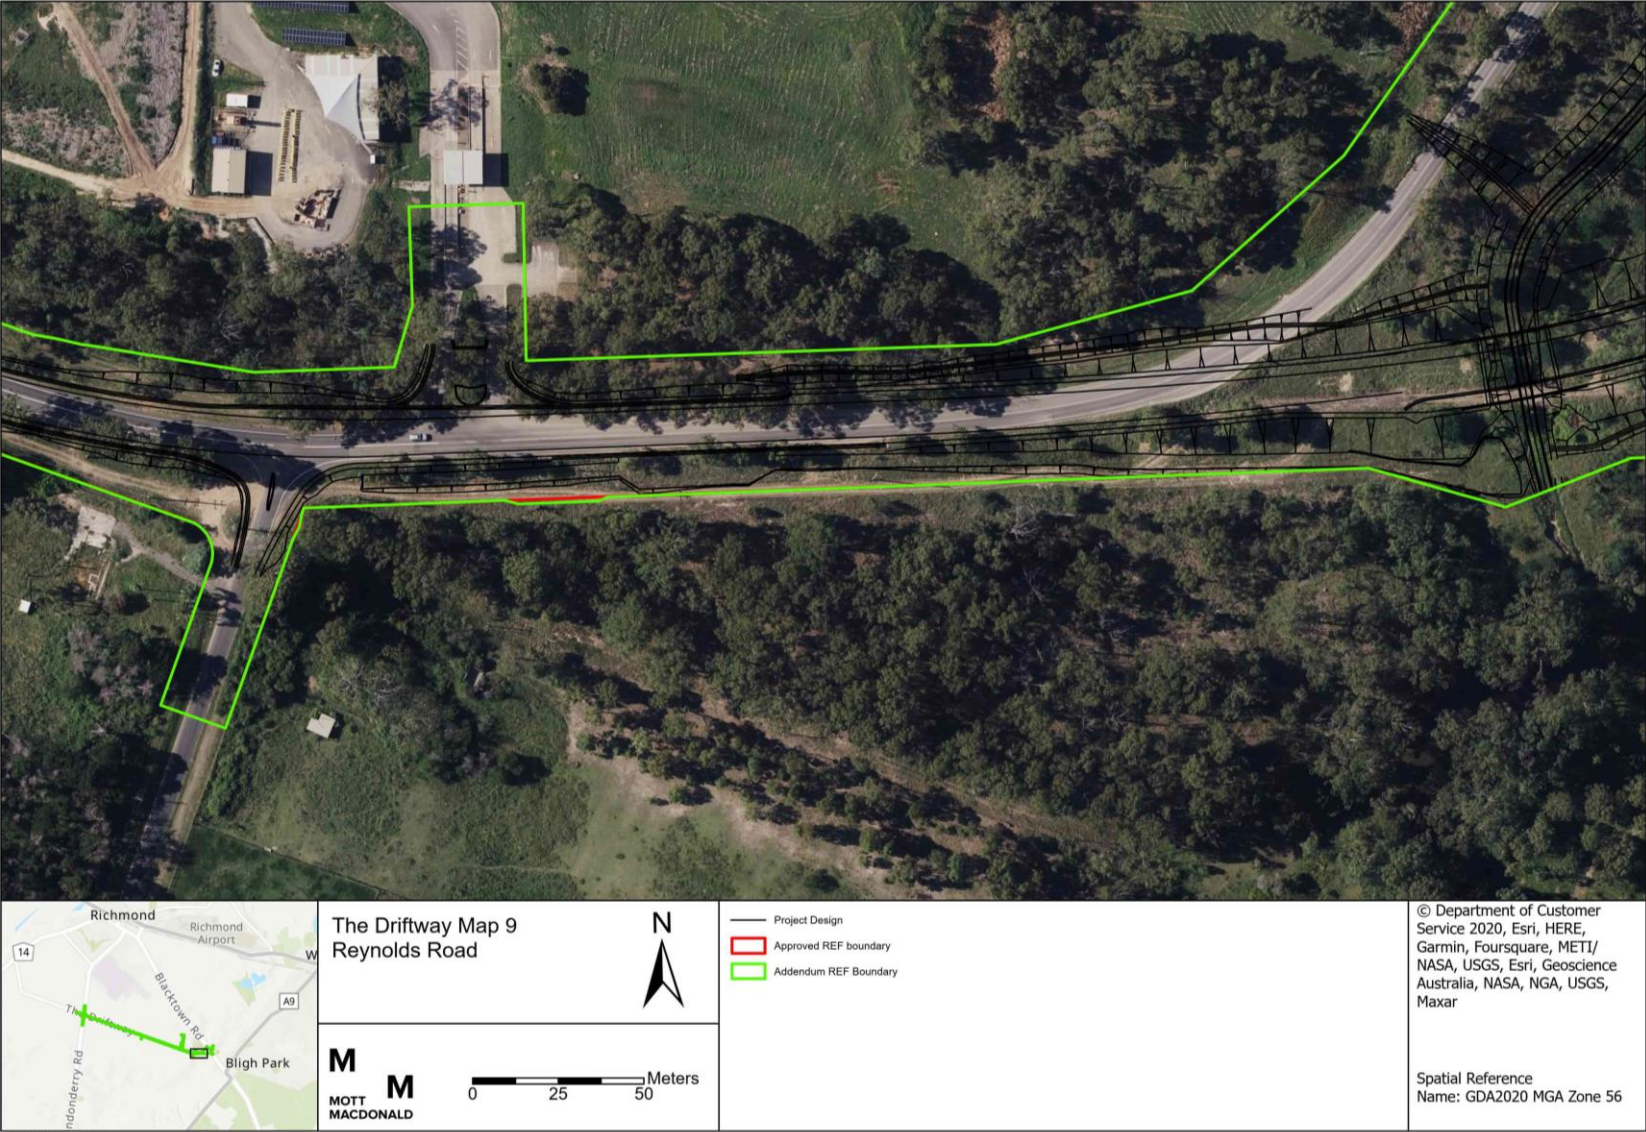
Figure 1-9 Reynolds Road Project boundary adjustments

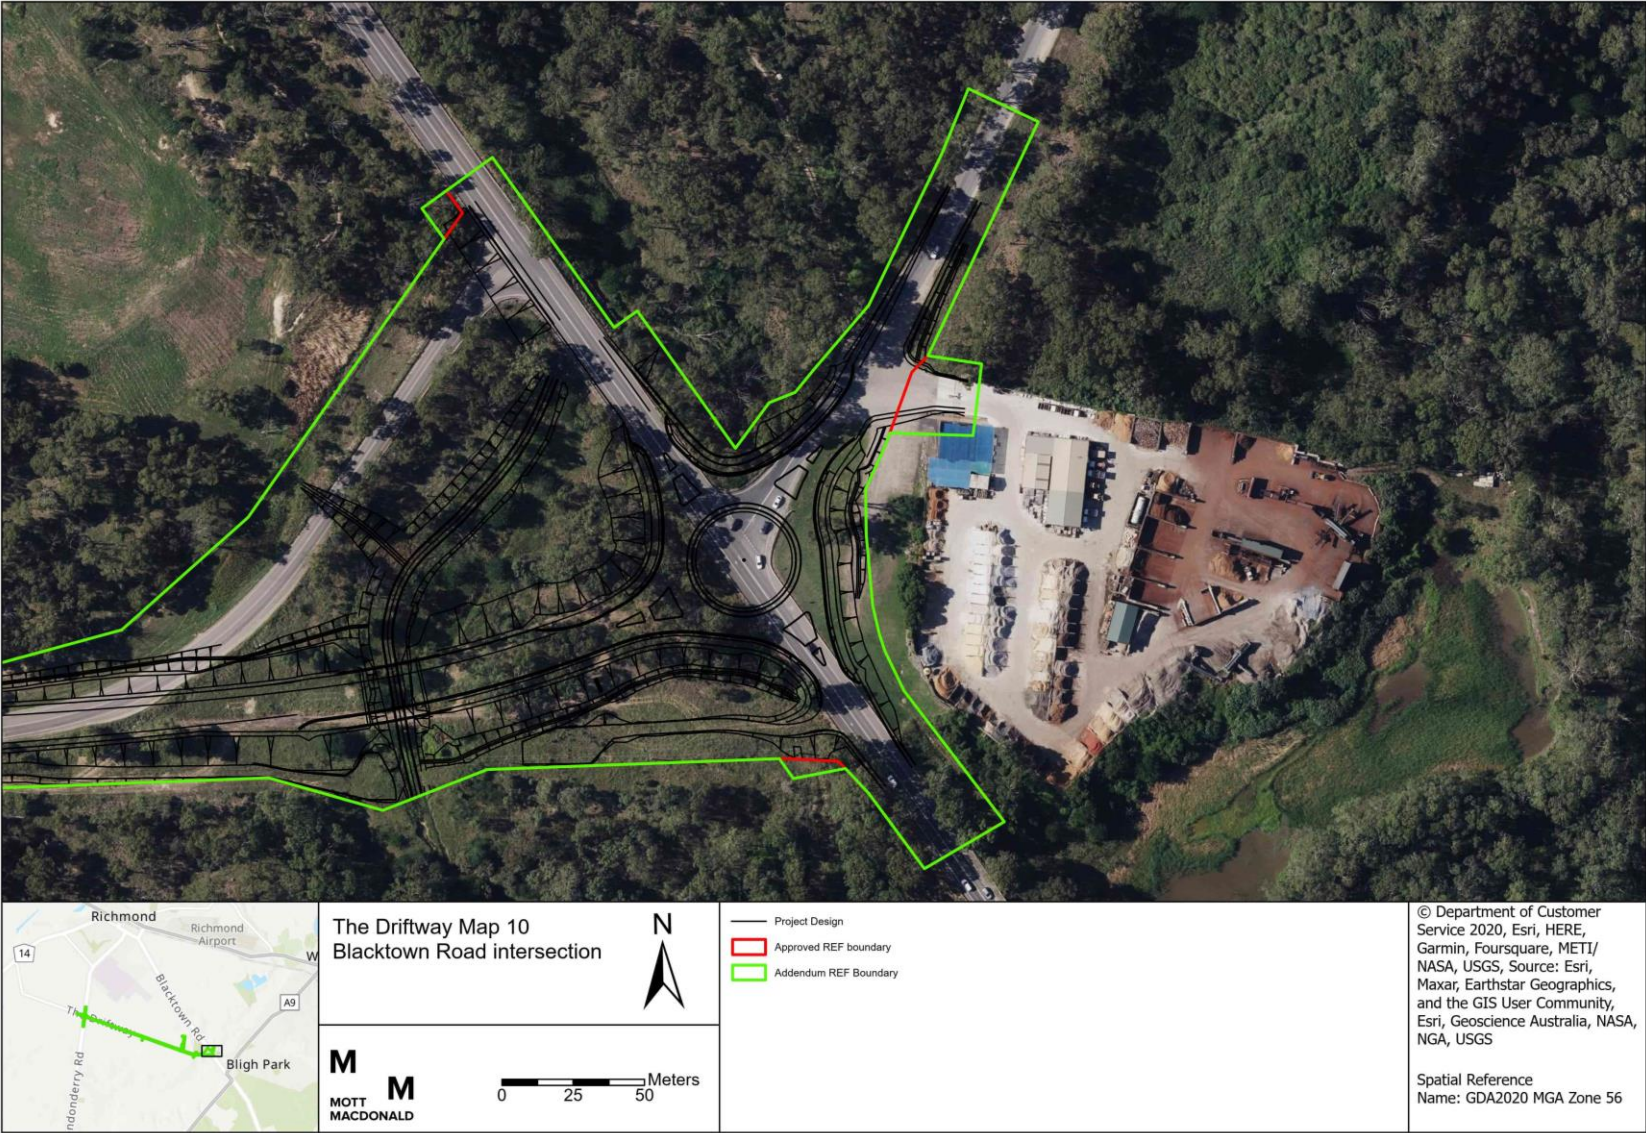
Figure 1-10 Blacktown Road Project boundary adjustments

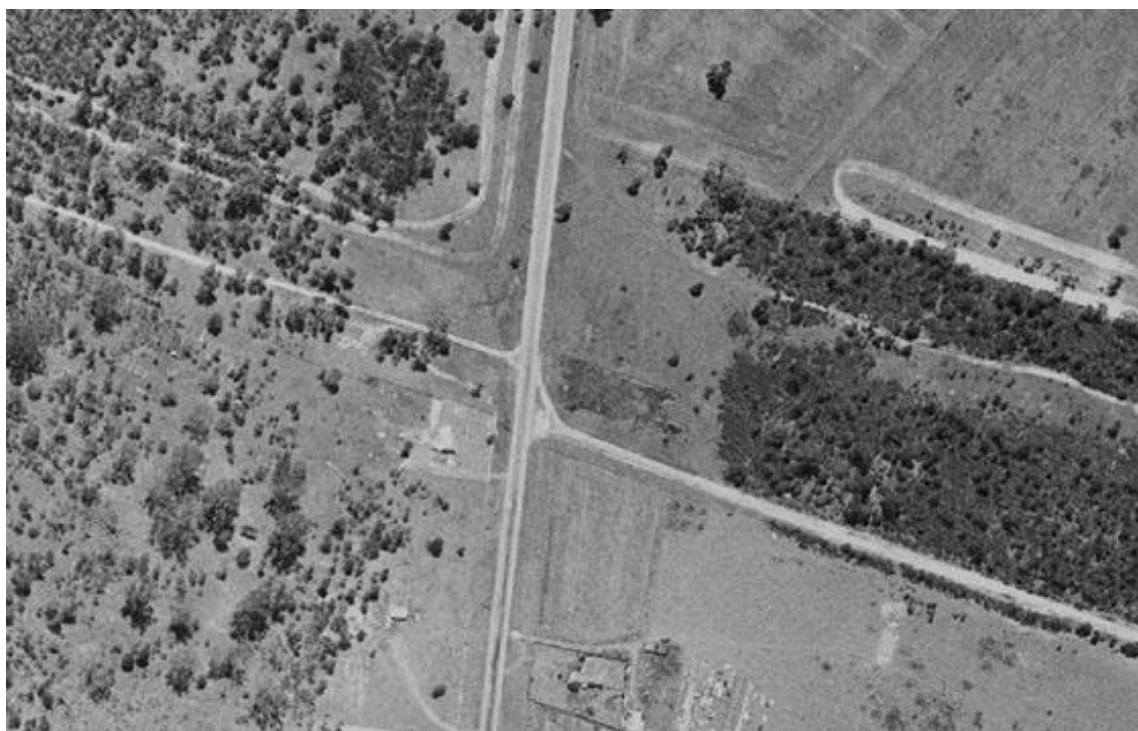
Figure 4-1 Aerial photography taken 1954 of the intersection of The Driftway and Londonderry Road.

A series of aerial photographs from 1947 to 1961 show that many areas now occupied by vegetation had been cleared during that period and the preceding decades. The intersection of the Driftway with Londonderry Road had largely been cleared a significant distance from the road by 1954 and was interspersed with dirt roads and trails. The area also contained several structures near the roadway, adding to the degree of disturbance (Figure 4-1).

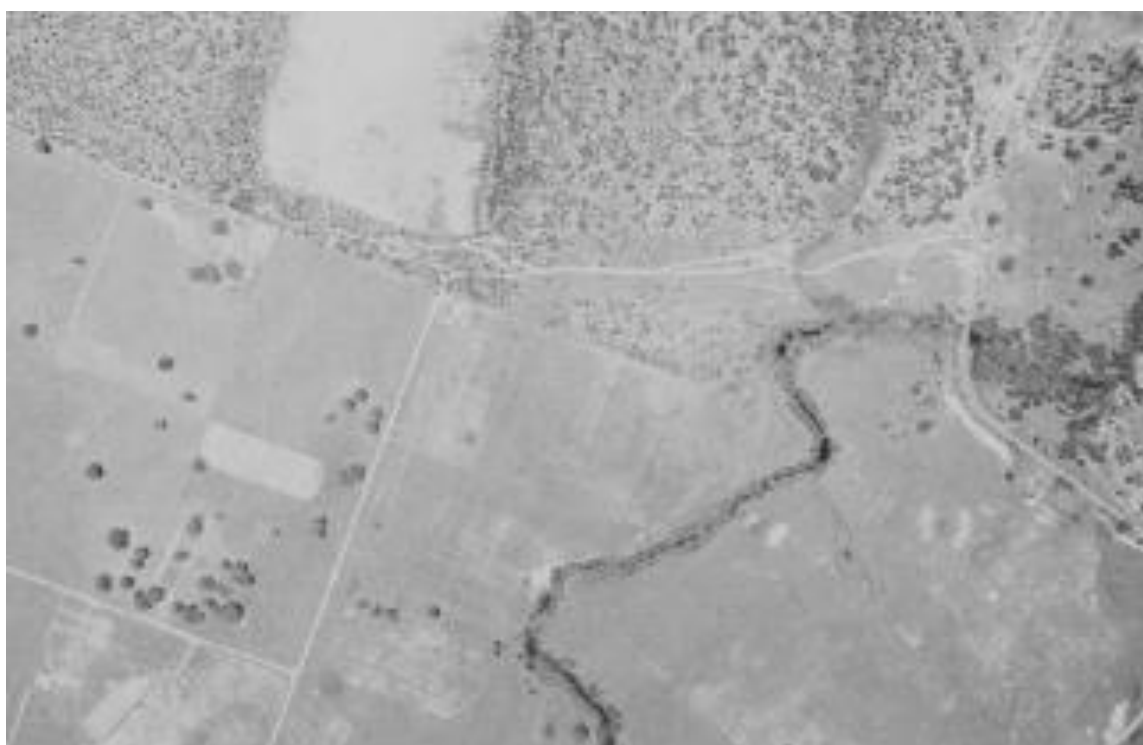
Figure 4-2 Aerial photography taken in 1954 displaying the area that is now the intersection of the Driftway and Blacktown Road.

As can be seen in Figure 4-2, the area surrounding and just south of the Blacktown Road intersection had also been cleared of most vegetation, up to the banks of Rickaby's Creek. Later developments included a sealed road and bridge over the Rickaby's creek crossing alongside the previous dirt road. The construction of the T-junction intersection of the Driftway with Blacktown Road in its current form also led to further disturbance in this area.

The southern edge of the Driftway was also utilised as agricultural land before becoming residential, resulting in further disturbance (Figure 4-2). In addition, several aerials from this period also reveal the construction of terraces and trails to the north of the Driftway, indicating moderate to high levels of disturbance in the areas in close proximity to and within the addendum REF Boundary (Figure 4-3).

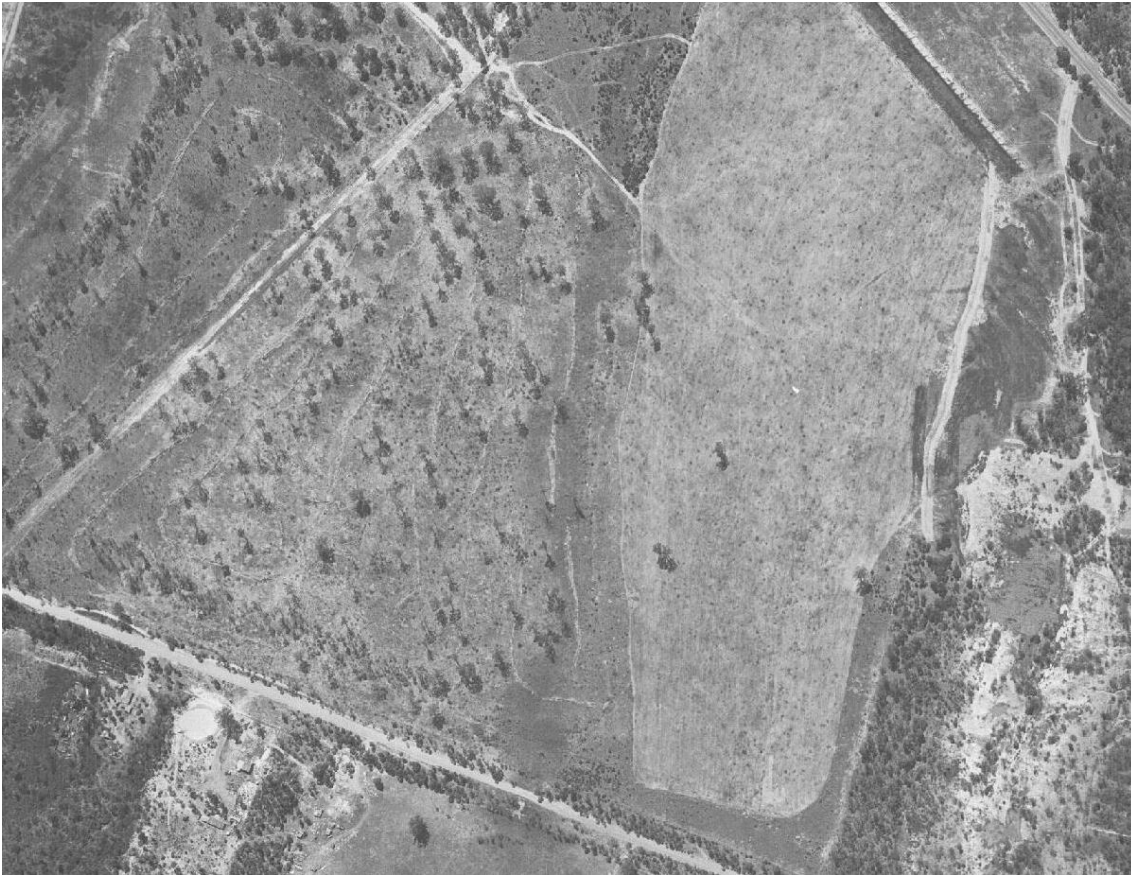
Figure 4-3 Aerial photography taken in 1961 to the north of the Driftway showing terraced and cleared areas.

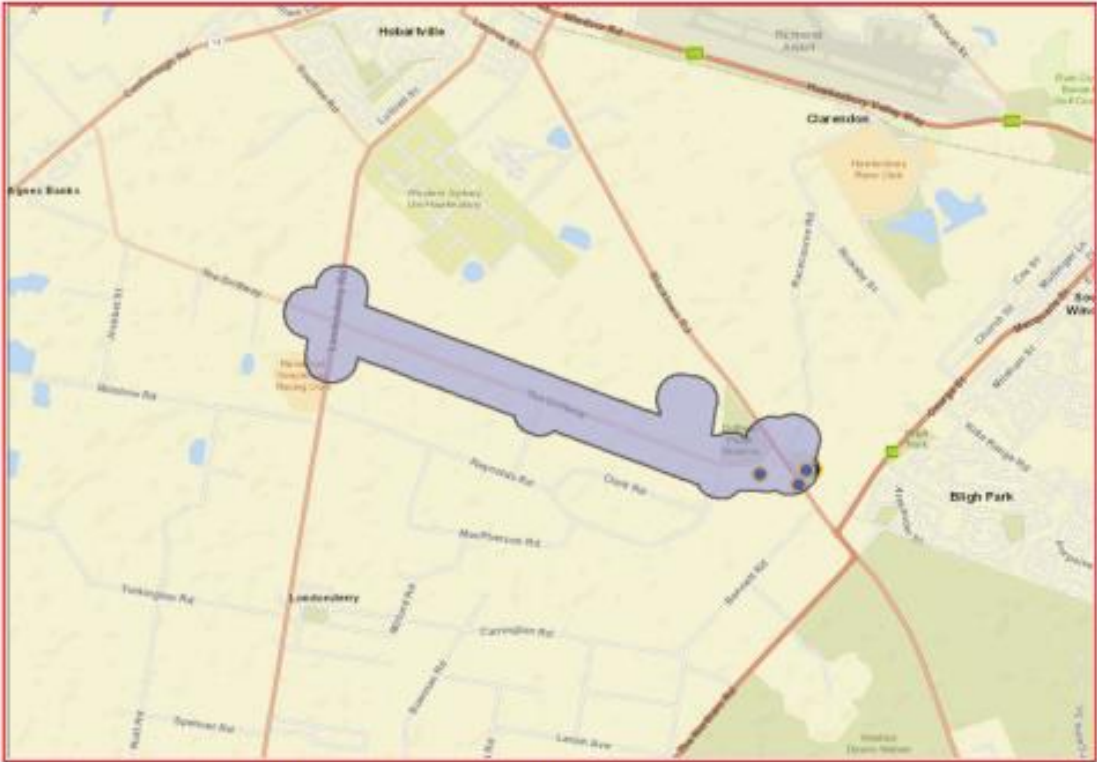
The context area of your search is shown in the map below. Please note that the map does not accurately display the exact boundaries of the search as defined in the paragraph above. The map is to be used for general reference purposes only.
