NEWCASTLE INNER CITY BYPASS: RANKIN PARK TO JESMOND (SSI-6888)
ENVIRONMENTAL REPRESENTATIVE MONTHLY REPORT
July 2024

Reporting Period: 1 to 31 July 2024.

This Environmental Representative (ER) Monthly Report is prepared in accordance with the Minister's Condition of Approval A26(k) for the Newcastle Inner City Bypass: Rankin Park to Jesmond (SSI-6888) and is consistent with the Environmental Representative Protocol (October 2018).

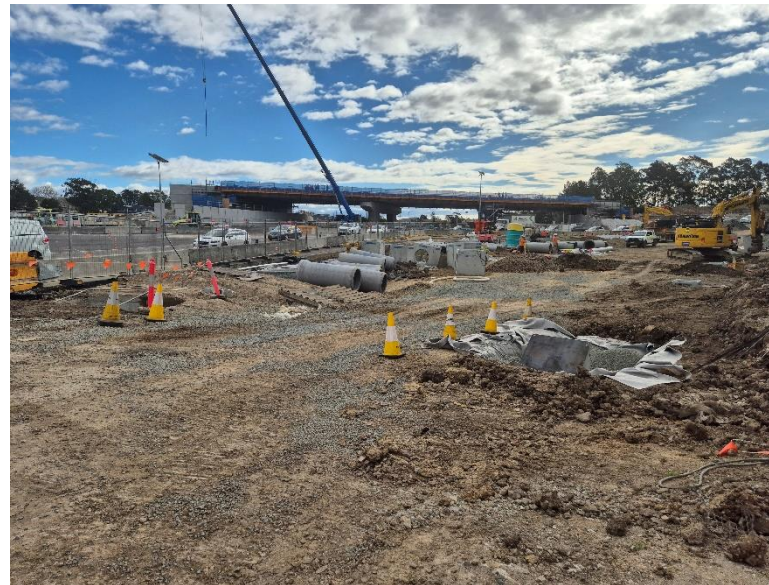
Image 1: Northern Interchange, photo is taken from the northeast corner (Robert Street) looking west across to the Newcastle Road roundabout and the new bridge girders.

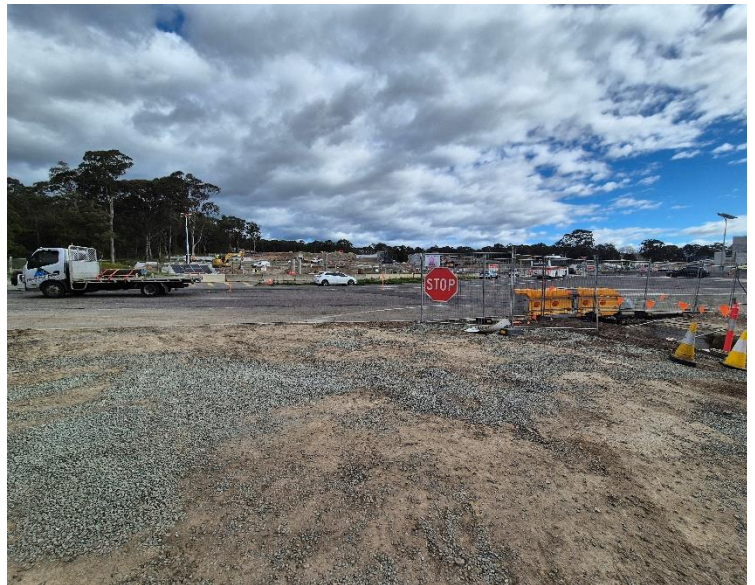
Image 2: Northern Interchange, photo is taken from the northeast corner (Robert Street) looking south across to the Newcastle Road and down the mainline.

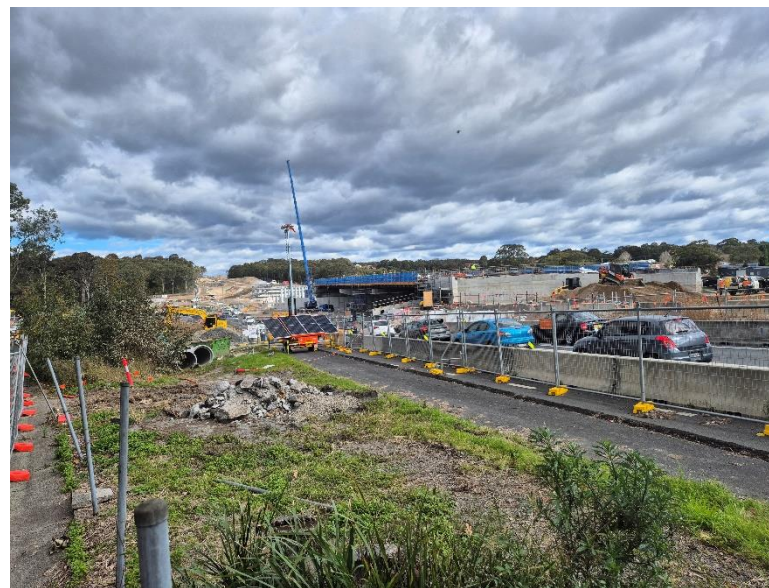
Image 3: Northern Interchange, photo is taken from the northeast corner (Robert Street) looking south across to Newcastle Road and the mainline.

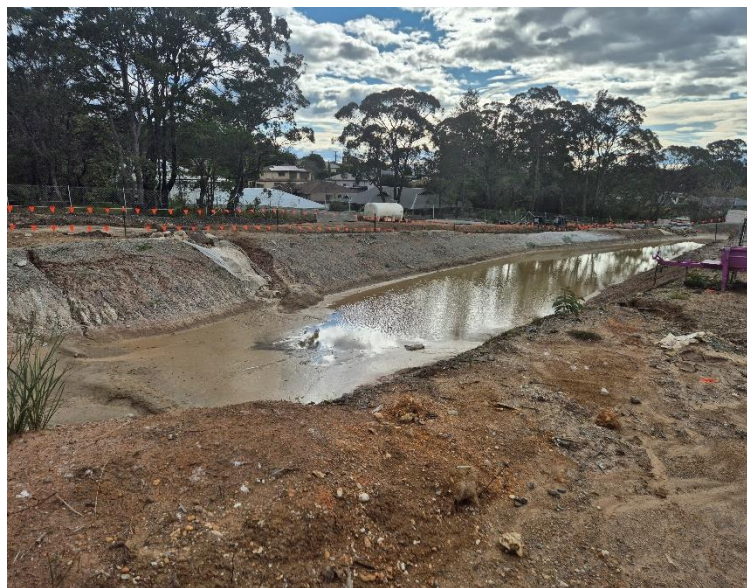
Image 4: Hollywood sediment basin at the northern end of the main showing damage that has occurred to the inlets. Work was being undertaken throughout the site to repair basins following rainfall events.

The project appears to be putting together consistent months of workflow. There has been a number of minor events this month, hence it is important for the site environmental team to remain on top of environmental management at the site. The team continues to show commitment to sound environmental management practises and again it is recommended to use this dry period to focus on repairs and maintenance of site controls and protocols.

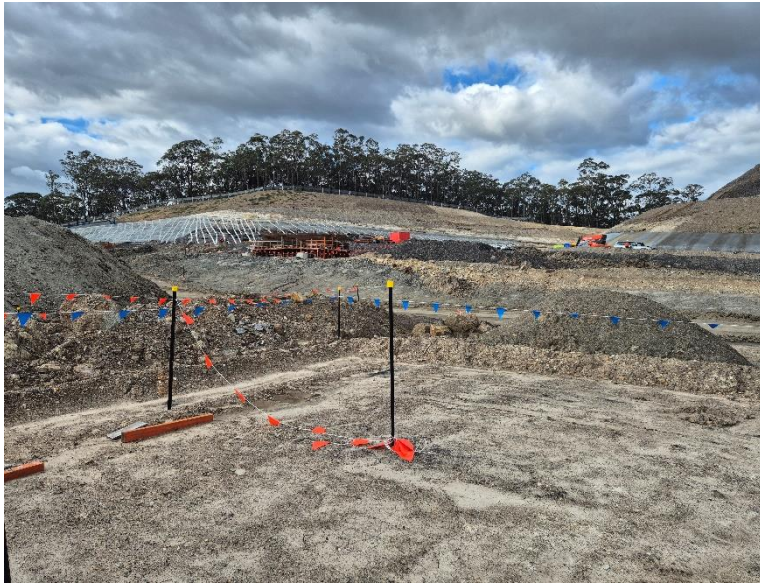
Image 5: View of the JHH traffic interchange from the mainline looking northeast towards the entry/exit.

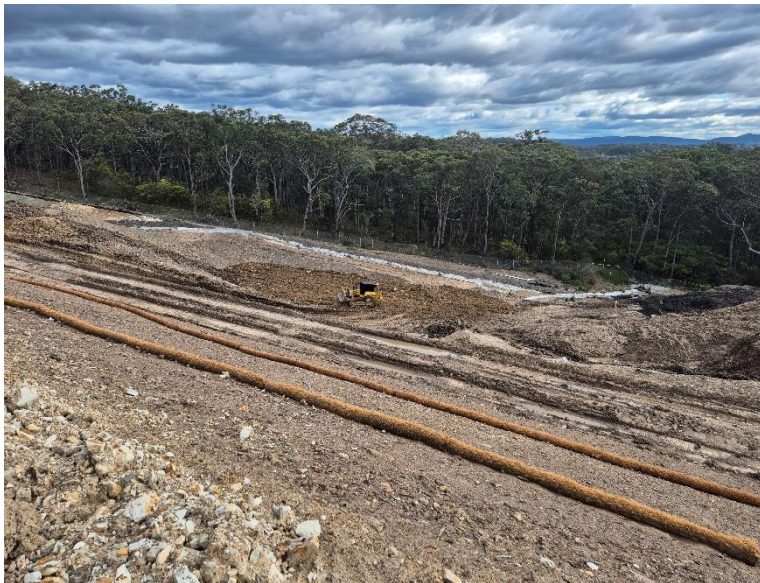
The dryer weather has continued which has allowed the site team to clean out and dewater basins and return them to full capacity. This is a somewhat ongoing process due to the historical wet weather. The removal of southern sediment basin at Fill 2 / Creek 3 on the eastern side of the main line works is complete and final landform and rehabilitation of this area is underway.

Image 7: View looking west from the mainline at the rehabilitation of the Fill 2 / Creek 3 sediment basin.

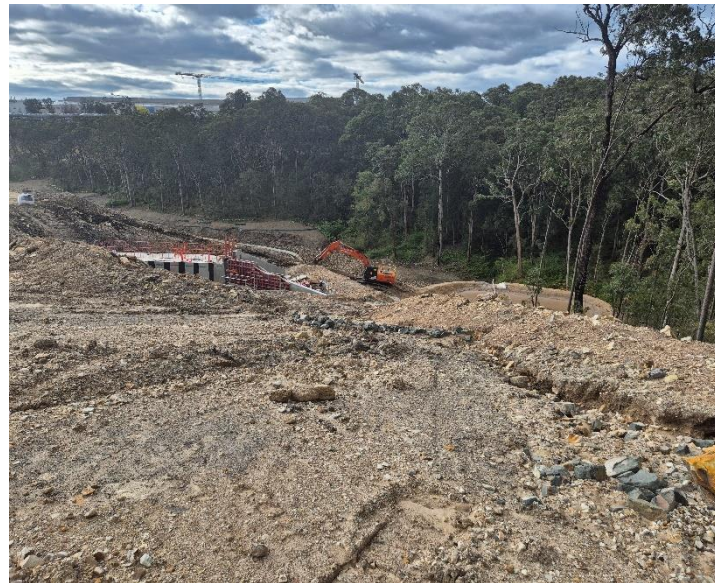
Image 8: View of the southern end of the mainline works looking north across to the eastern boundary. Excavators have been cleaning out sediment basins however constant rain has made access challenging.
