## Minor works REF addendum memo

[REDACTED]	[REDACTED]
[REDACTED]	[REDACTED]
[REDACTED]	[REDACTED]
[REDACTED]	[REDACTED]
[REDACTED]	[REDACTED]
[REDACTED]	[REDACTED]
<b>Priority</b>	ROUTINE
<b>Date</b>	19 December 2023
<b>Subject</b>	Minor works review of environmental factors addendum memo for Pennant Hills Road and North Rocks Road, Carlingford Intersection Upgrade Review of environmental factors

Modification to the Pennant Hills Road and North Rocks Road, Carlingford Intersection Upgrade Review of environmental factors

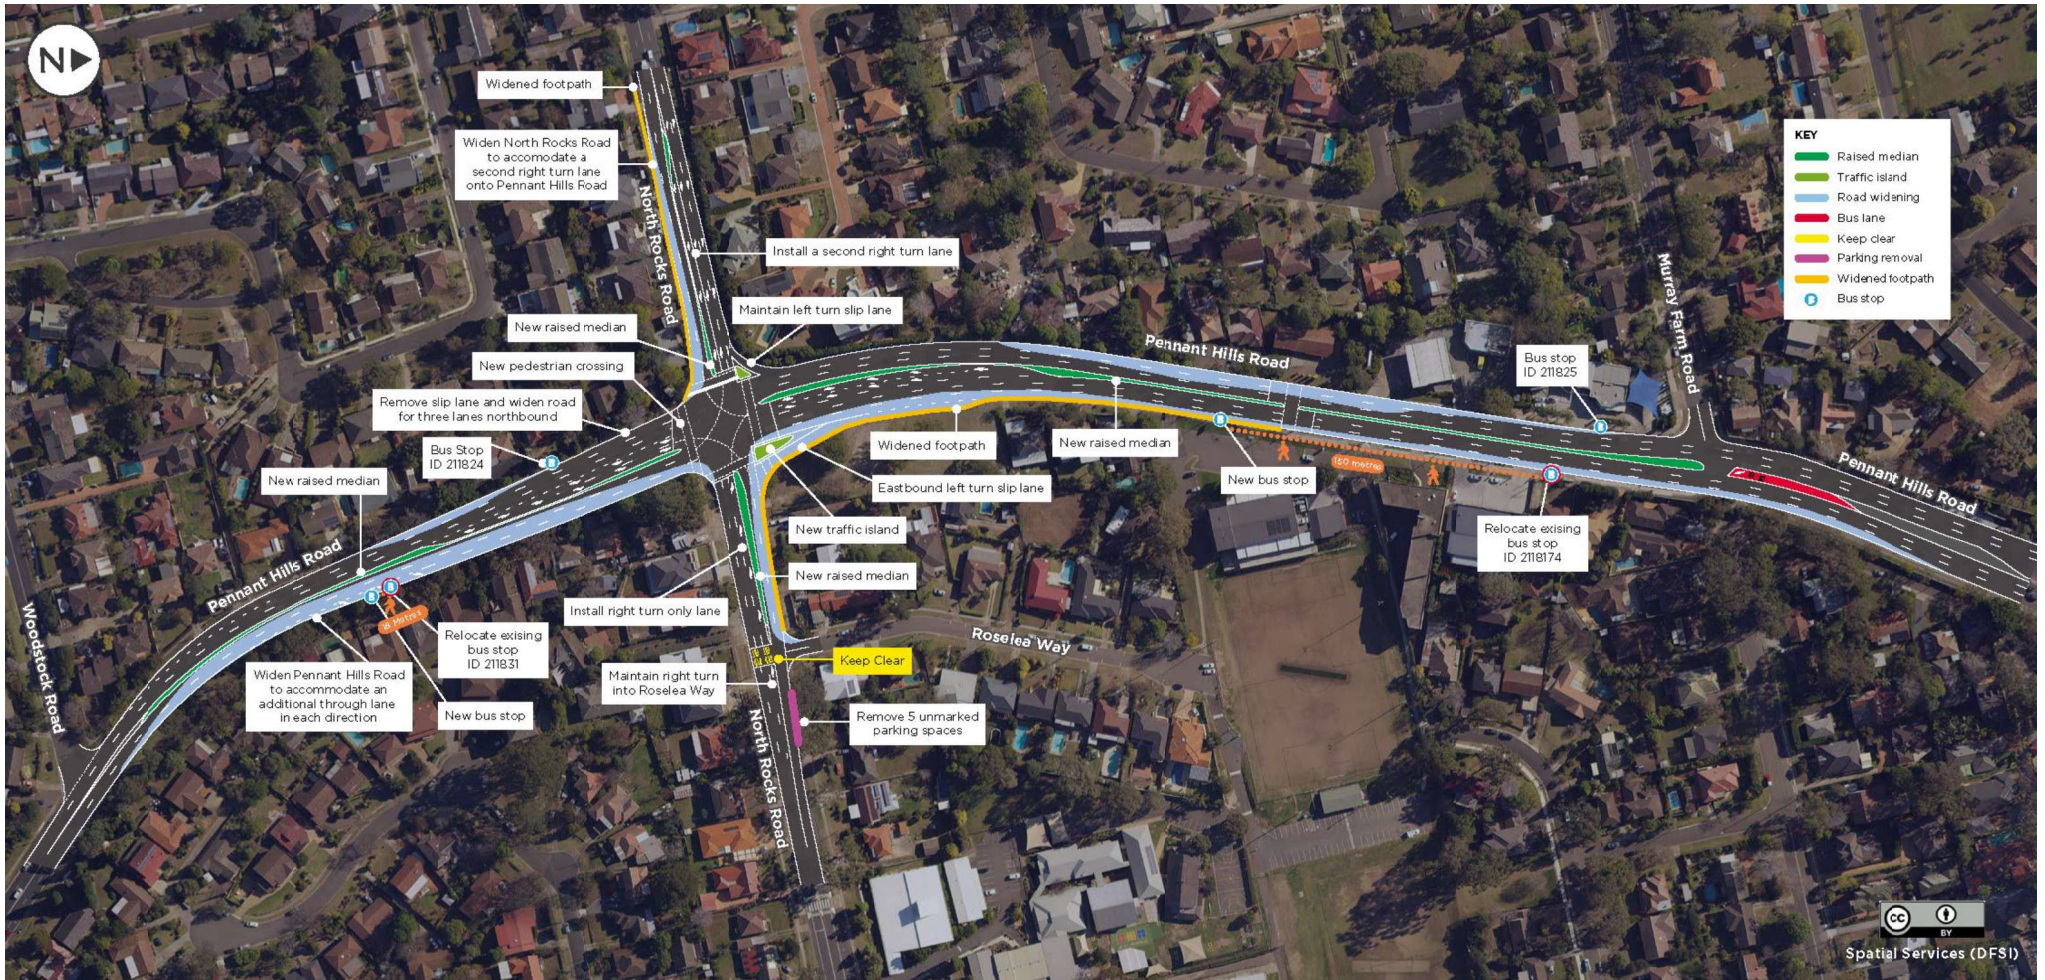
Figure 1. Determined project scope as assessed in project REF (April 2018) and one previous addendum REF (May 2021)

The determined project scope is shown in Figure 1. An overview of the proposed modification is shown in Figure 2 and Figure 3.

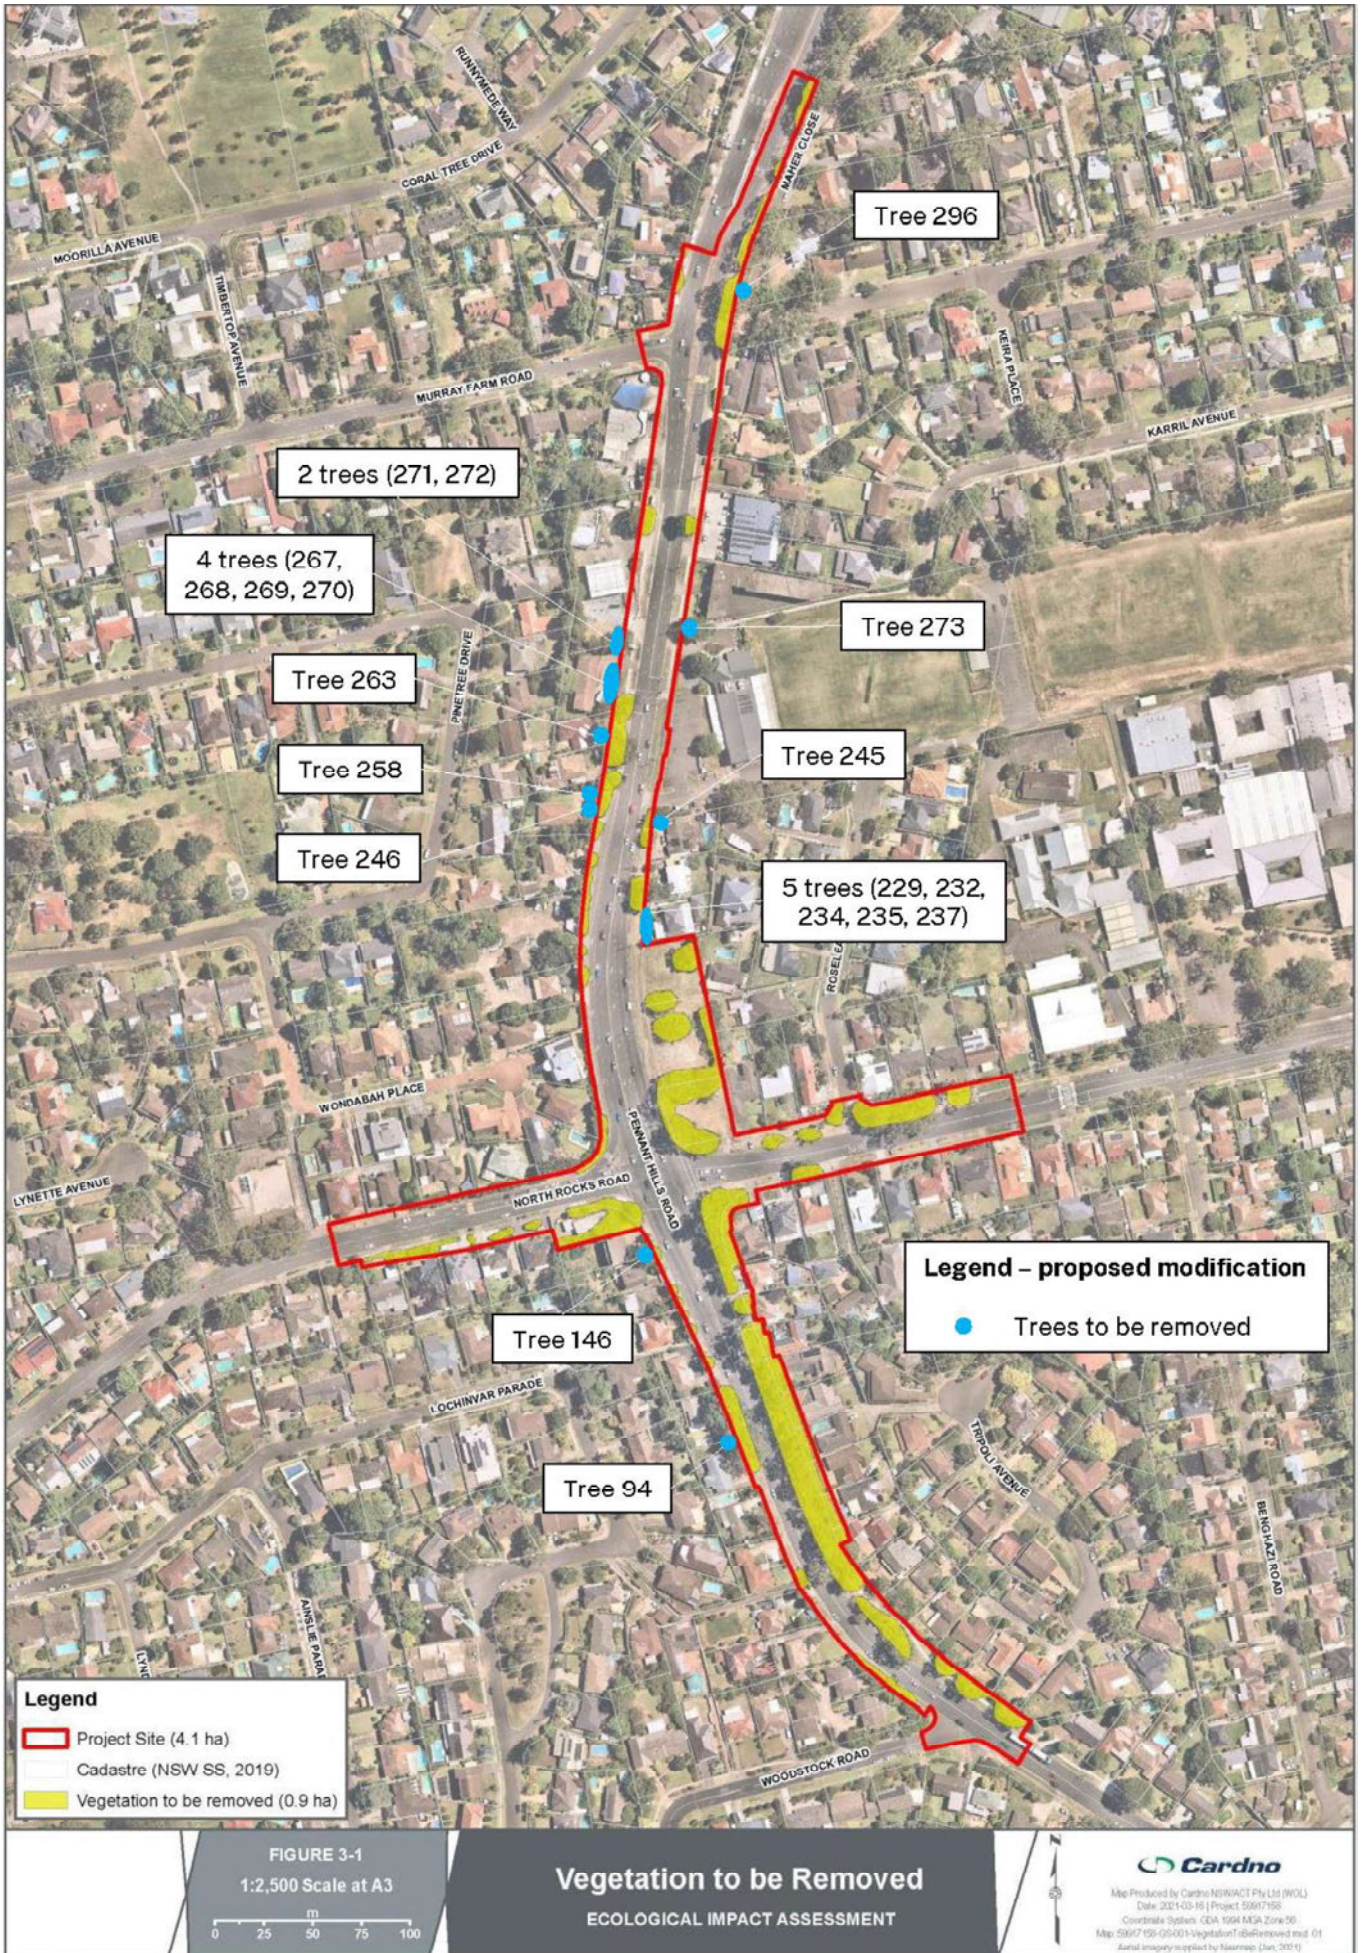
Figure 2 Proposed modification overview – trees to be removed

- Removal of 19 additional trees (ID 94, 146, 229, 232, 234, 235, 237, 245, 246, 258, 263, 267, 268, 269, 270, 271, 272, 273 and 296)
- Hauling of Telstra optical fibre cables along four existing cable routes. The works include cabling crews installing draw ropes and hauling through new cables. If the routes are blocked, then localised civil works (excavation and backfill) would be required in order to clear the blockage and allow the cabling to be undertaken. The four routes are as follows:

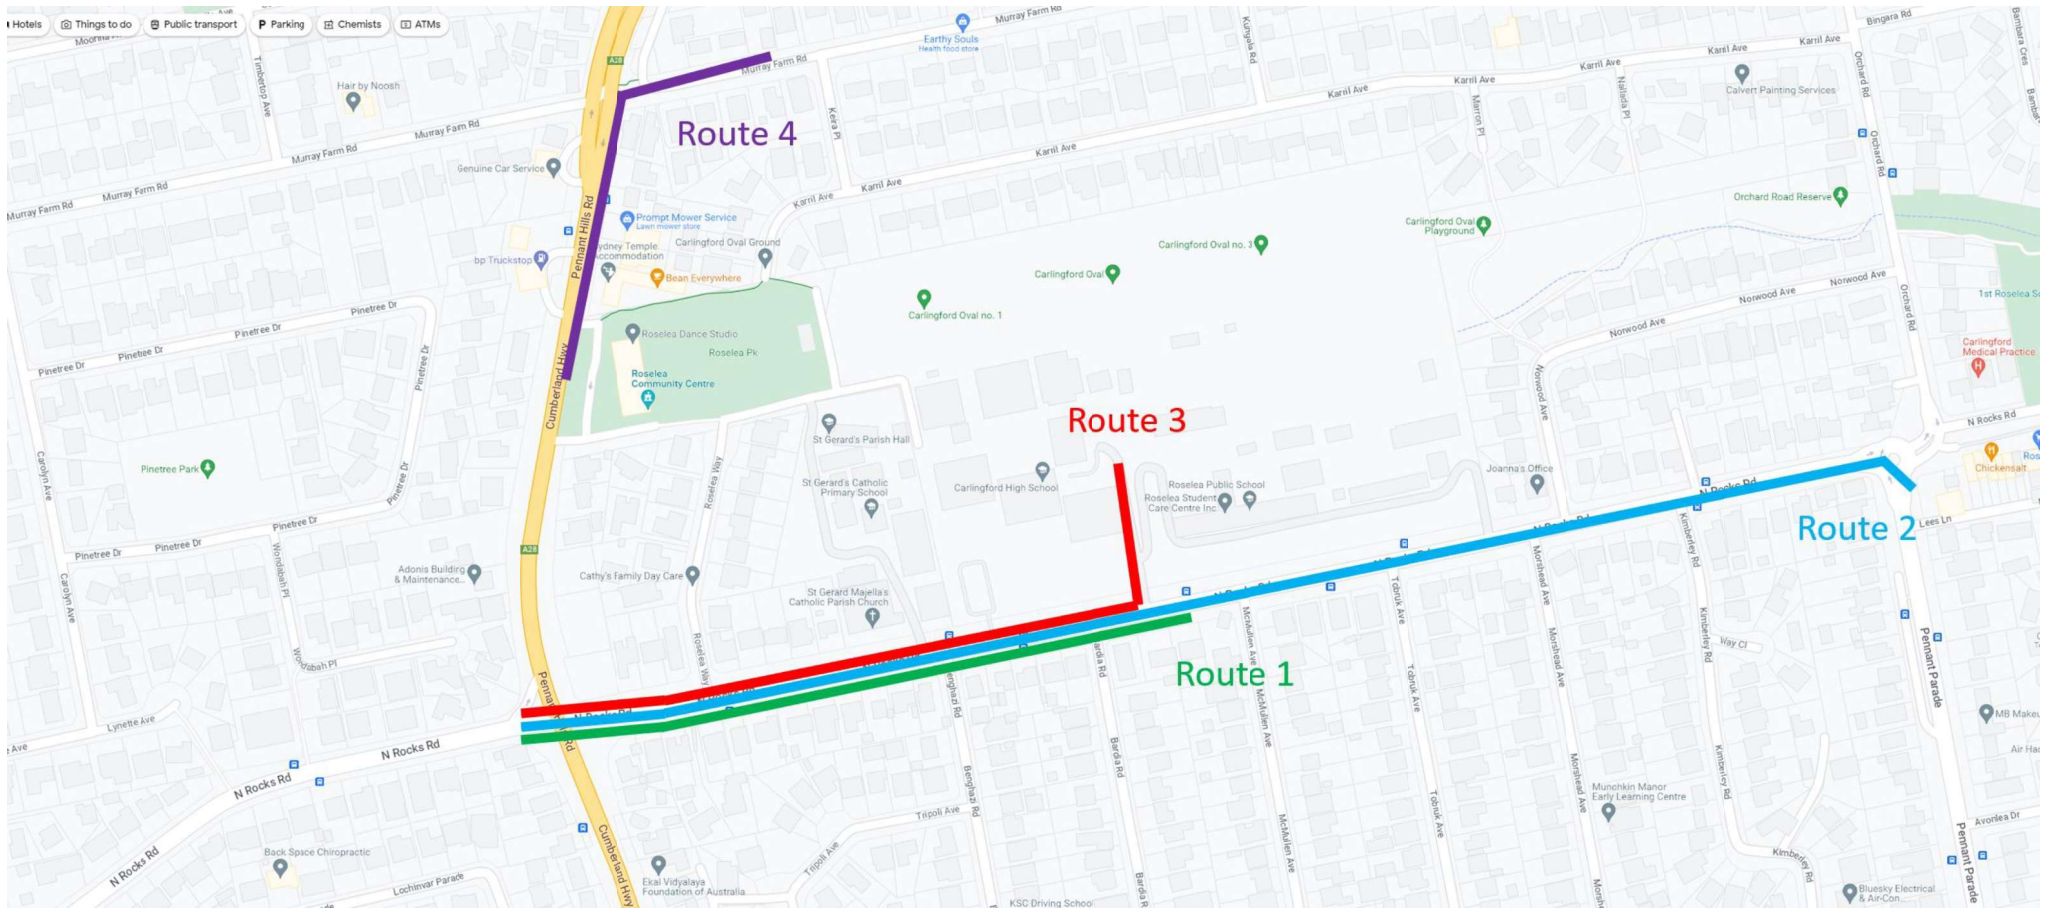
Figure 3. Proposed modification overview – Telstra optical fibre hauling routes

- Route 1 – northwest corner of the Pennant Hills Road/North Rocks Road intersection to Telstra pit outside Carlingford High School opposite 440 North Rocks Road via North Rocks Road

- Route 2 – northwest corner of Pennant Hills Road/North Rocks Road intersection to Telstra pit at the corner of Pennant Parade and North Rocks Road via North Rocks Road

- Route 3 – northwest corner of Pennant Hills Road/North Rocks Road intersection to Telstra Pit at the end of Roselea Way inside Carlingford High School via North Rocks Road

- Route 4 – Community Centre to Telstra Pit at 188 Murray Farm Road, Beecroft via Pennant Hills Road and North Rocks Road

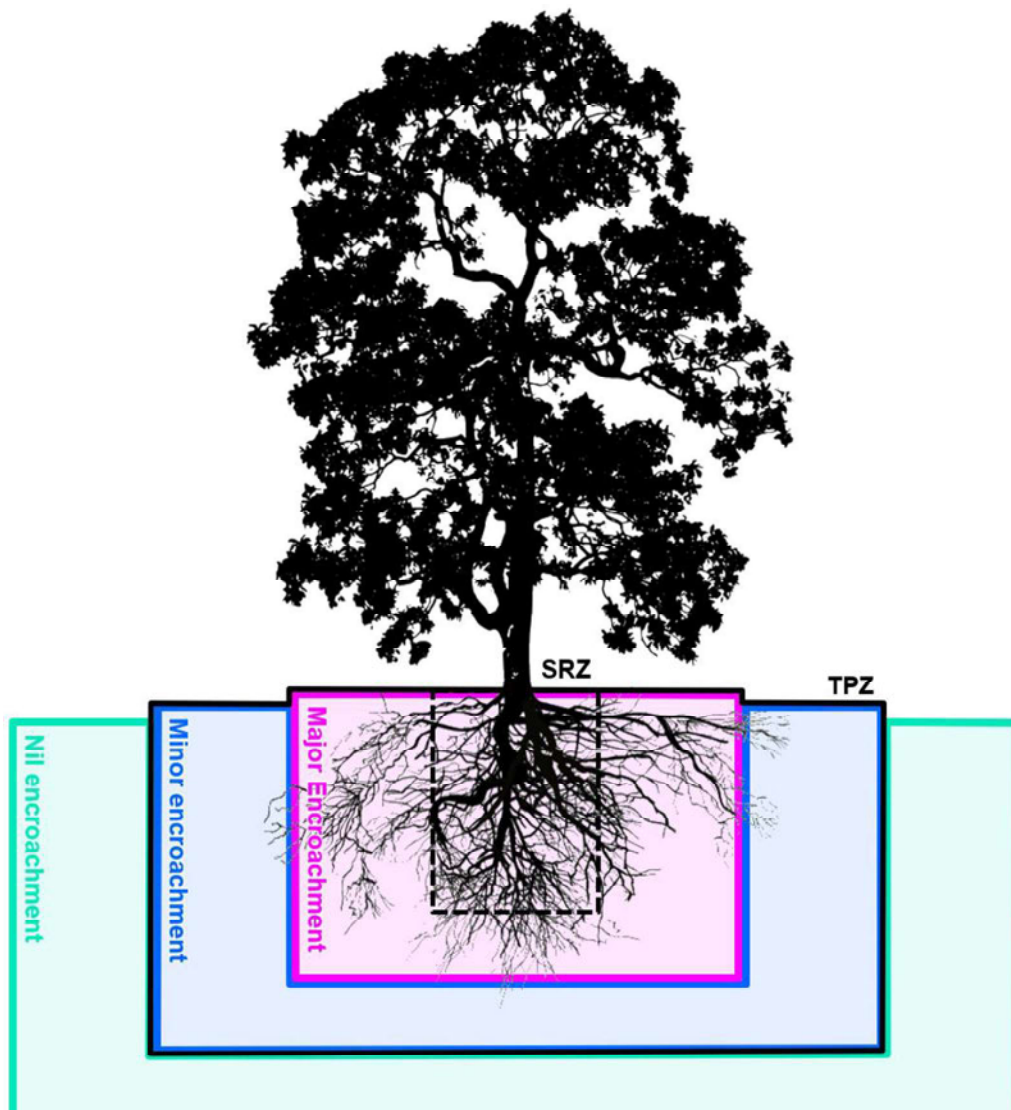
Encroachment within the TPZ is acceptable, providing that the arborist can demonstrate that the tree will remain viable. There are three (3) levels of encroachment defined by AS4970:

- **Nil encroachment (0%):** No encroachment within the TPZ.
- **Minor encroachment (<10%):** The encroachment is less than 10% of the TPZ.
- **Major encroachment (>10%):** The encroachment is greater than 10% of the TPZ.

Figure 1: Three (3) levels of encroachment

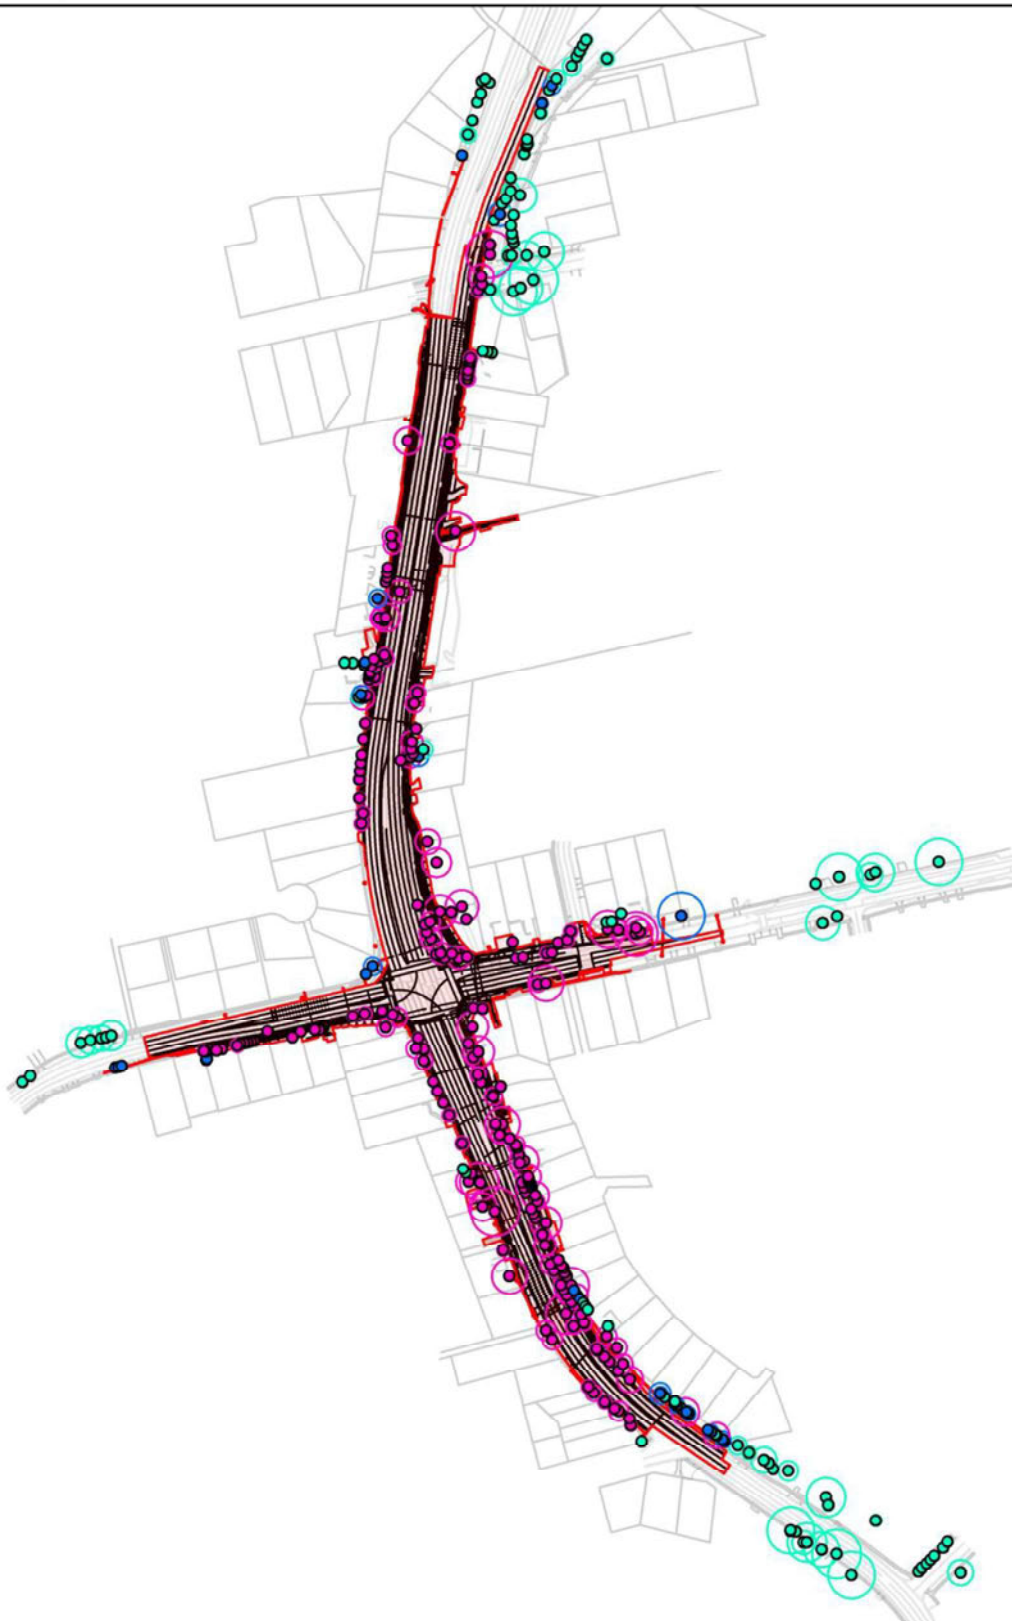
- **Retain:** A total of **32** trees will be subject to a major encroachment but are unlikely to be significantly impacted by the encroachment. The encroachments comprise primarily low-level landscaping and grading. Several site-specific mitigations for these encroachments have been outlined in the Tree Protection Plan. Under the current proposal, these trees can be successfully retained.
- **Remove:** A total of **170** trees will be subject to a major encroachment within the TPZ. These trees are located within, or directly adjacent to the proposed construction footprint and cannot be retained under the current proposal.

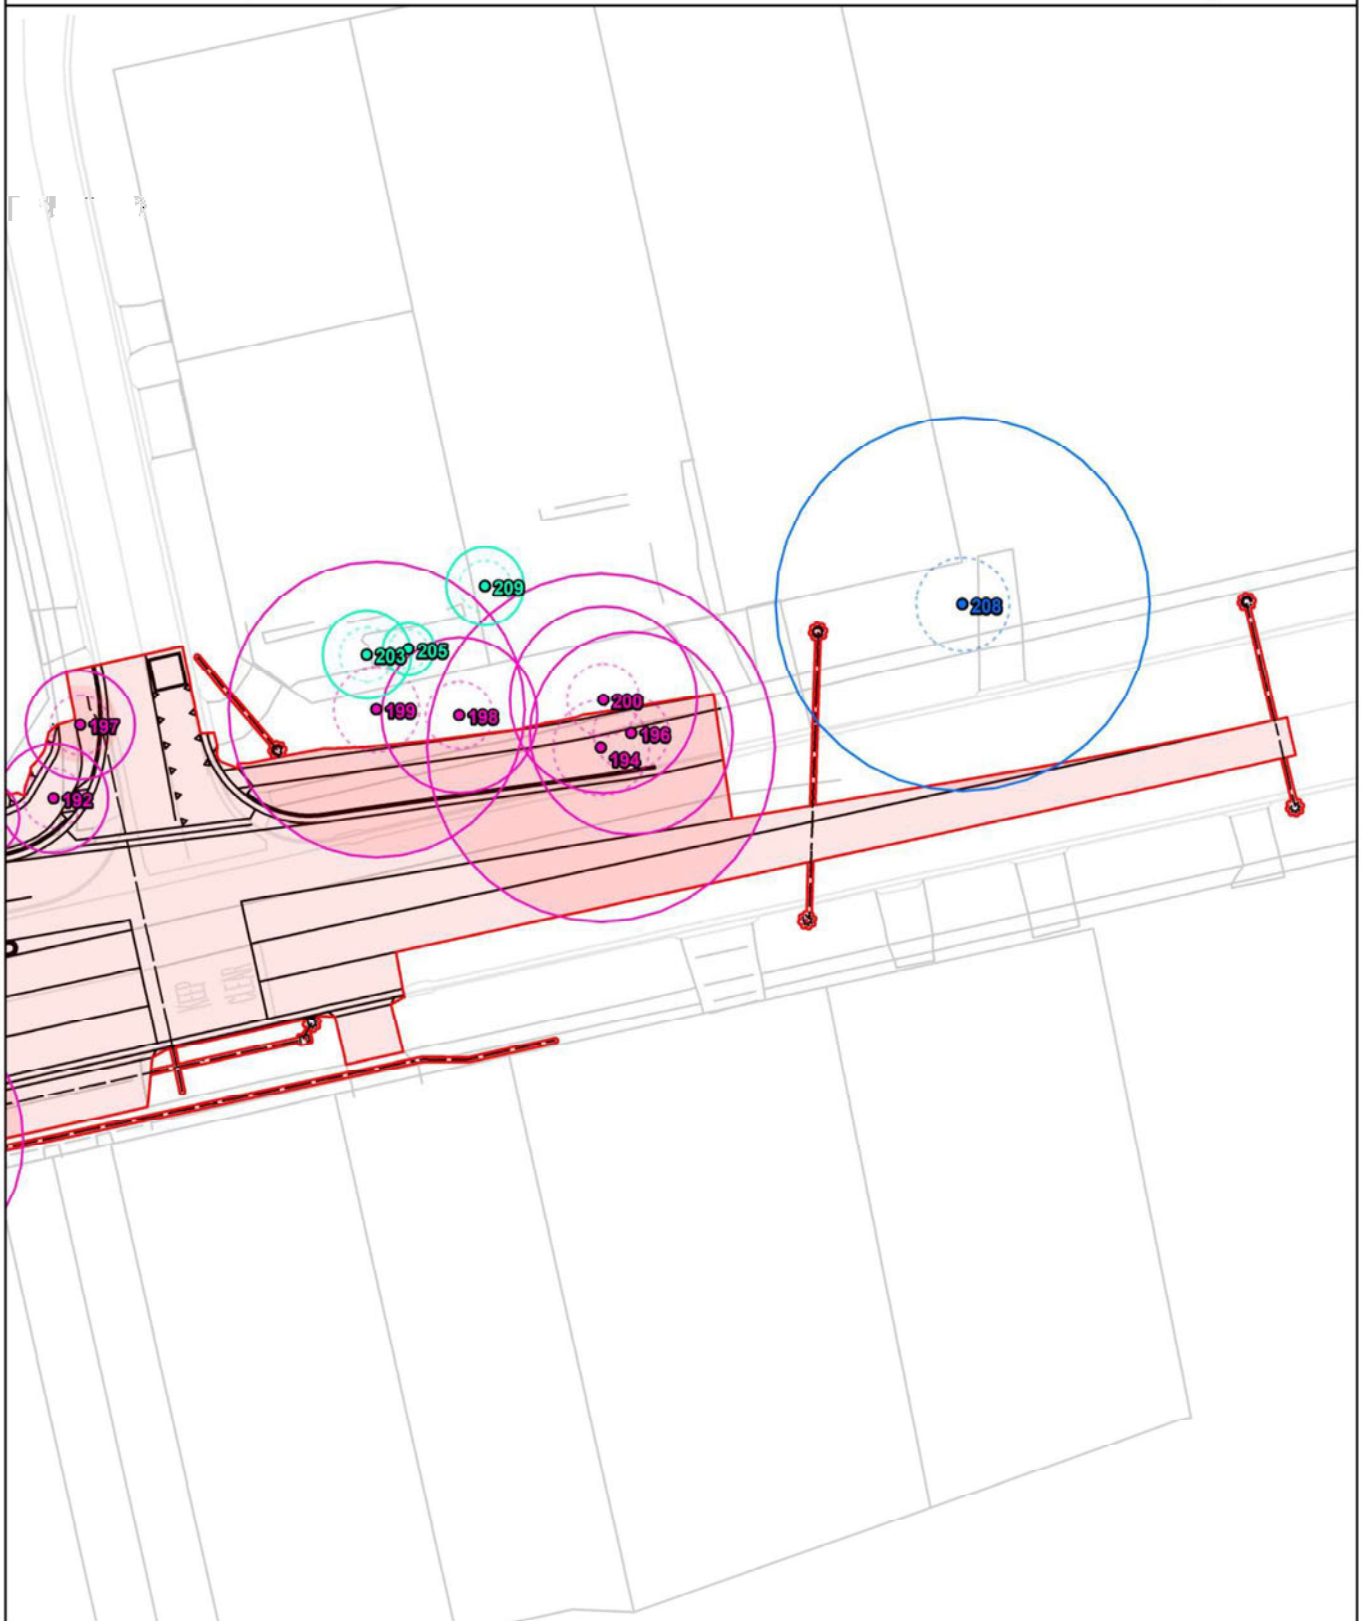
- Construction footprint
- Site plan (proposed)
- - Utilities (proposed)
- Site survey (existing)

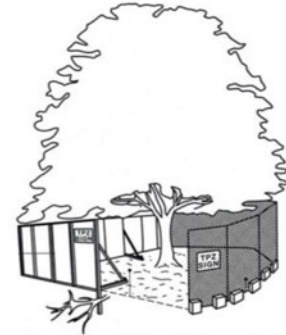
Tree protection fencing must be installed to protection trees that will be retained. Existing fencing, site hoarding, or structures (such as a wall or building) may be used as tree protection fencing, providing the TPZ remains isolated from the construction footprint. Tree protection fencing must be installed prior to site establishment and remain intact until the completion of works. Once erected, protective fencing must not be removed or altered without the approval of the project arborist. Specifications for the tree protection fencing are as follows:

- Temporary mesh panel fencing (minimum height of 1.8m).
- Installed prior to site establishment and remain intact until the completion of works.
- Protective fencing must not be removed or altered without the approval of the project arborist.
- Prominently signposted with 300mm x 450mm boards stating, "NO ACCESS - TREE PROTECTION ZONE."
- Certified and inspected by the project arborist.

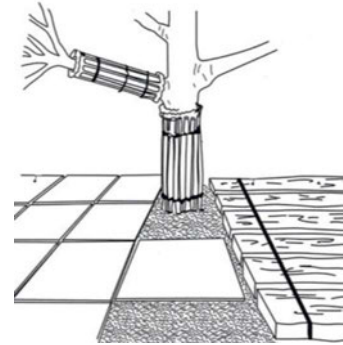
Specifications for trunk protection are as follows:

- A thick layer of carpet underfelt, geotextile fabric, or similar wrapped around the trunk to a minimum height of 2m.
- 1.8m lengths of softwood timbers aligned vertically and spaced evenly around the trunk (with a small gap of approximately 50mm between the timbers).
- The timbers must be secured using galvanised hoop strap (aluminium strapping).

The timbers shall be wrapped around the trunk but not fixed to the tree, as this will cause injury/damage to the tree.
