Picton Road upgrade between Nepean River and Almond Street, Wilton

Stage 1 Preliminary Site Investigation

Transport for NSW

January 2024

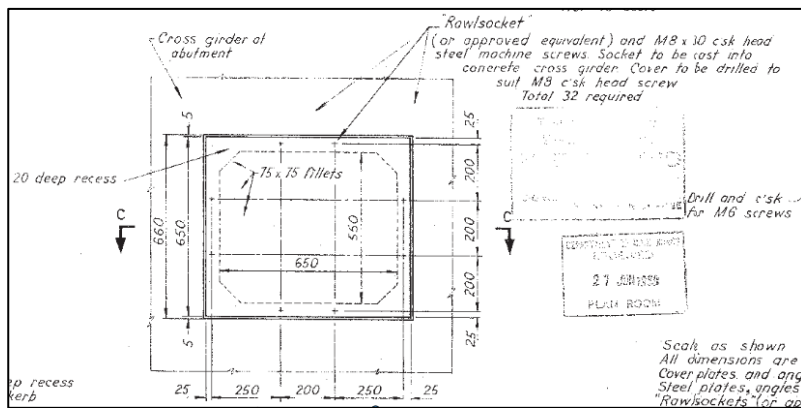
Figure 3.2 Manhole detail in the cross girder at bridge abutment

- **ACM in bridge manhole covers:** Works as executed drawings (drawing no. 6005496BC0155, titled 'Bridge Over Freeway F5 at Trunk Road No. 95, Deck-Miscellaneous Details', sheet 12 of 18, dated 8/9/1978) indicate that ACM was used in 20 mm thick manhole covers that occur on each bridge abutment for the Picton Road Bridge over the M31 Hume Motorway (refer to Figure 3.2 and Figure 3.3 below). There are two manhole covers on each abutment (i.e. total of four). Based on Google Street View (May 2023), one of the manhole covers appears to be missing on the eastern bridge abutment (refer to Figure 3.4 below).

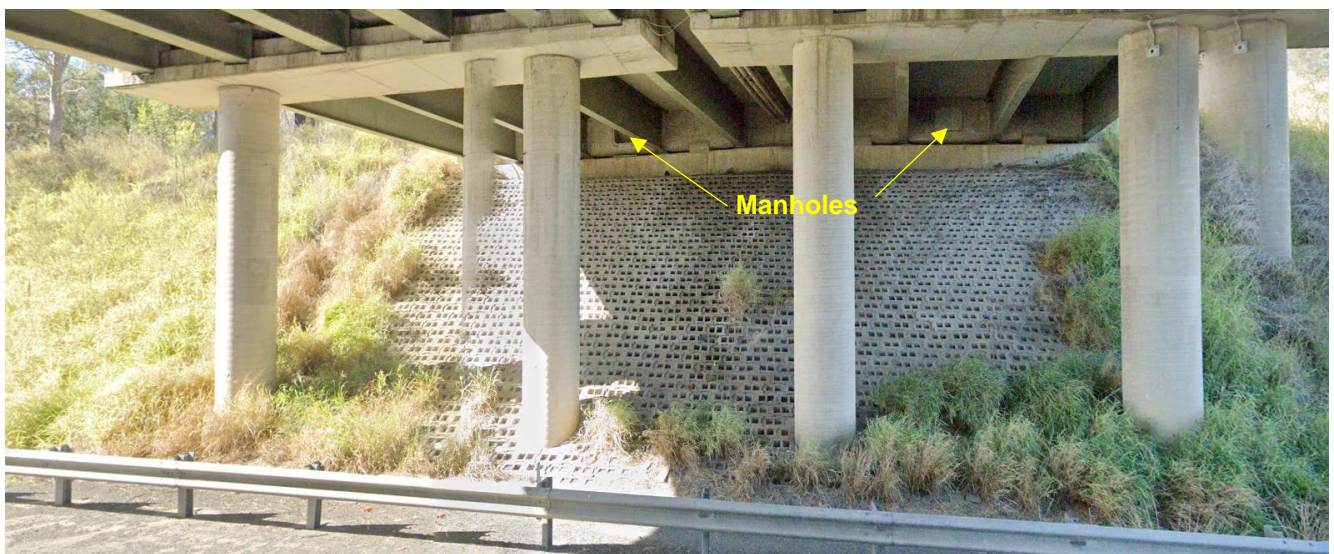
Figure 3.4 View of eastern bridge abutment and cross girder

Note: the northern manhole cover appears to be missing
Source: Google Street View, photo date May 2023

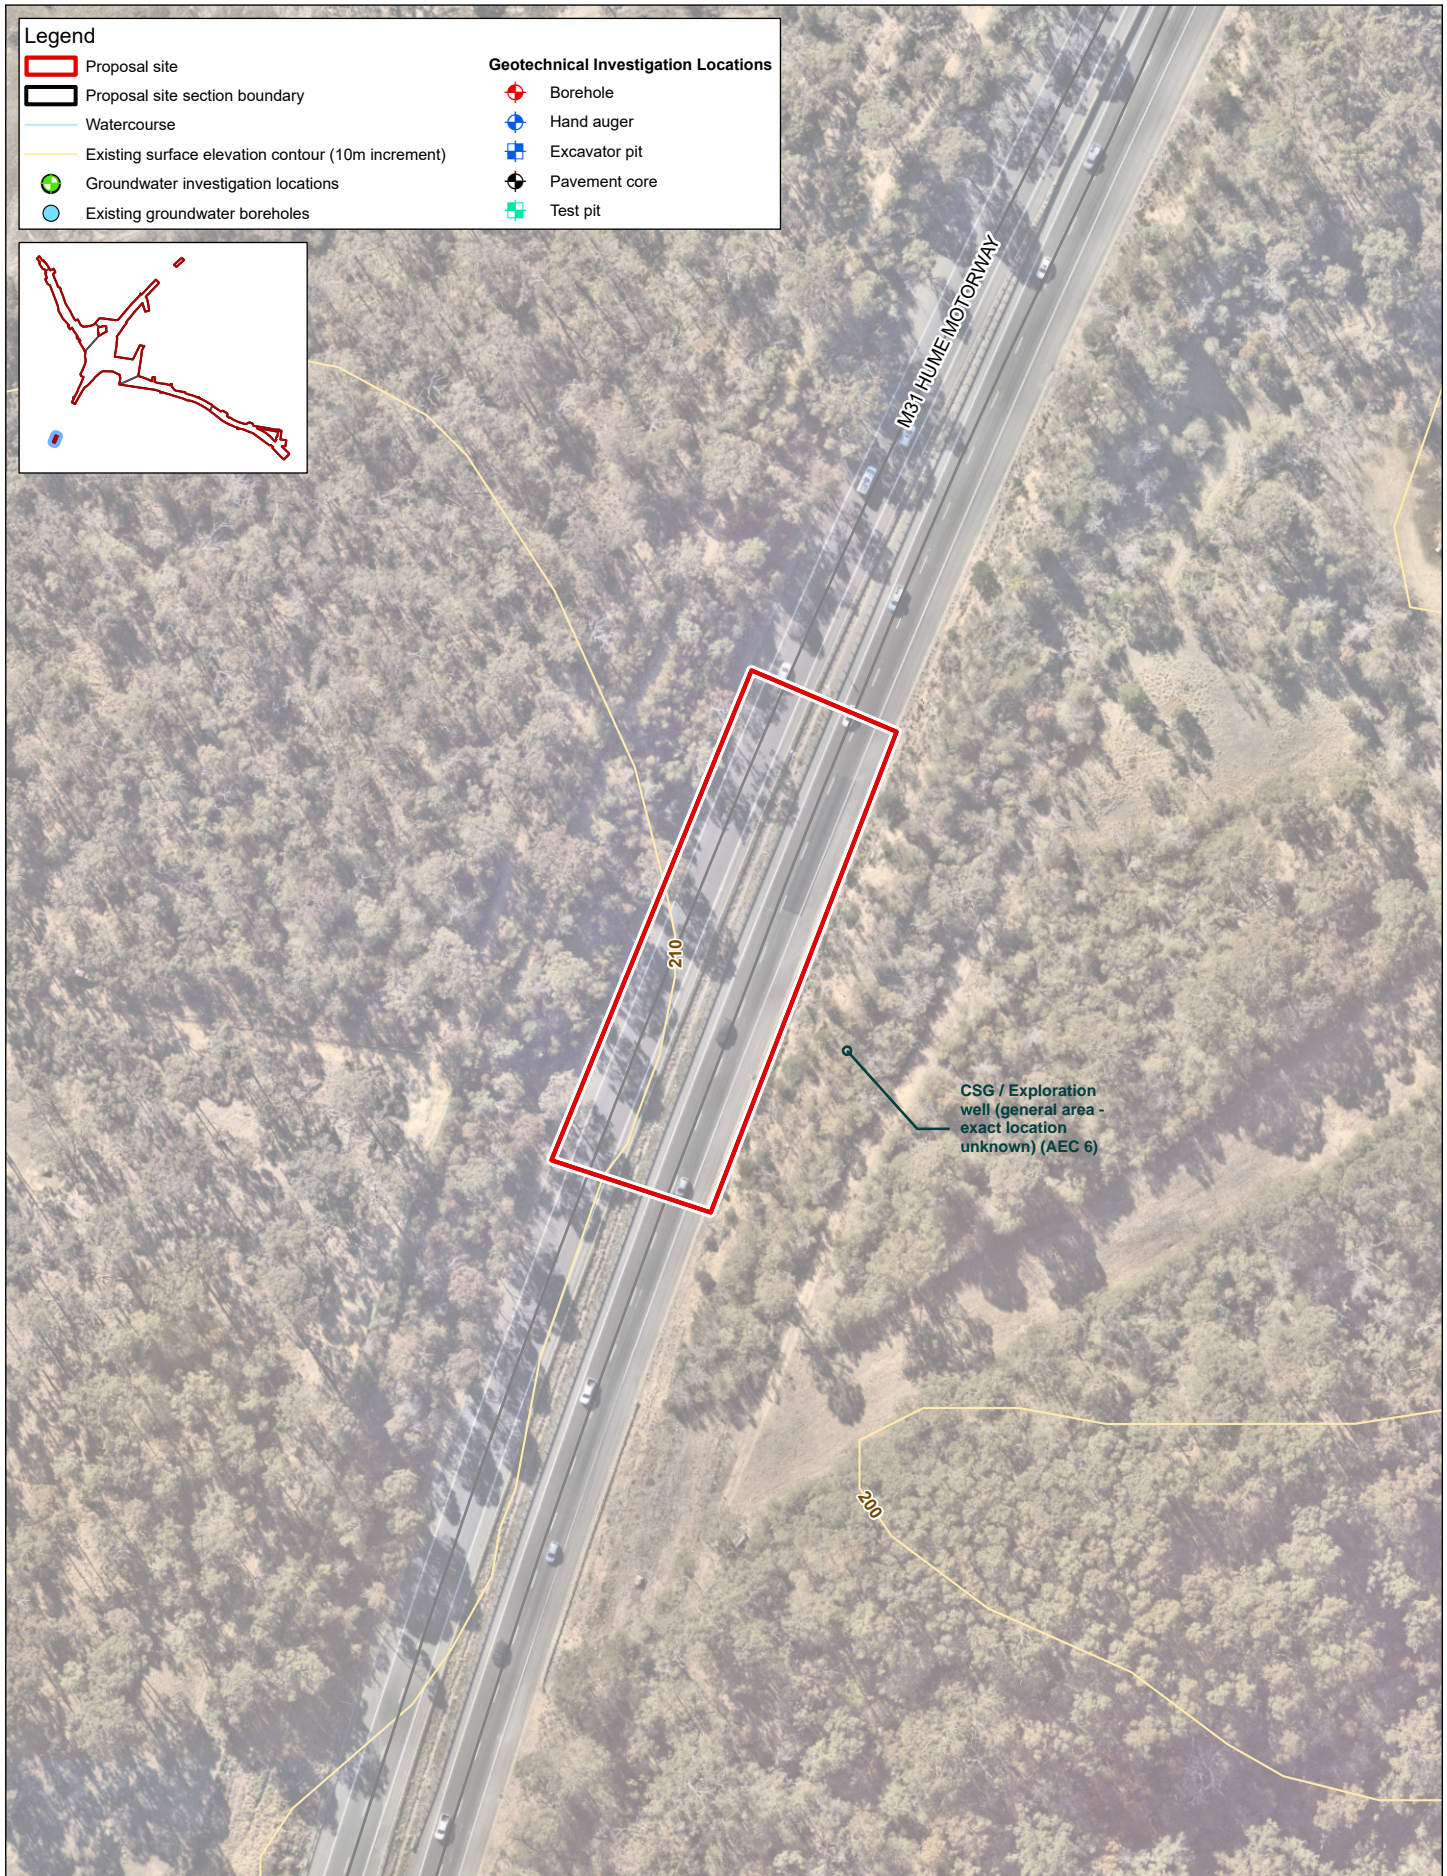
FIGURE 1.6

As part of the geotechnical investigation for the proposal, GHD installed nine groundwater monitoring wells (GHD, 2023a). Well installation details, subsurface conditions and standing water levels are summarised in Table 2.4 below. We note one additional groundwater monitoring well (BH047) was installed in March 2023 however was not sampled.

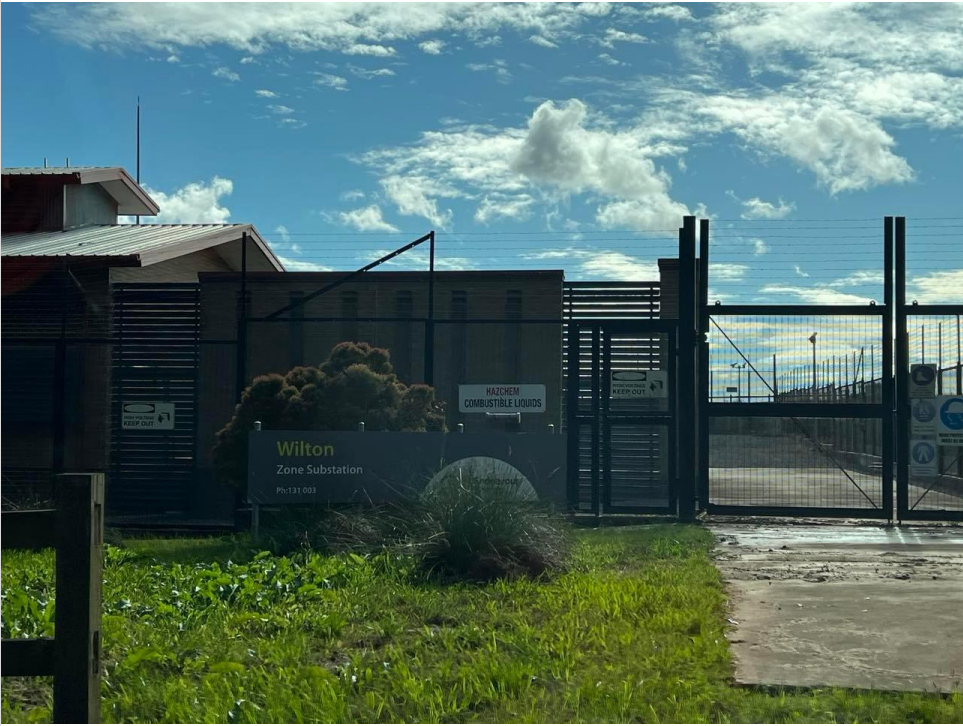
Description	Photograph
<p>Photograph 5 - 24 May 2022 Wilton Zone substation (AEC 9) (view towards north east)</p>

<p>A photograph showing the entrance to the Wilton Zone Substation. In the foreground, there is a grassy area with a sign that reads "Wilton Zone Substation Ph:131 003". Behind the sign is a black metal gate with a sign that says "HAZARDOUS COMBUSTIBLE LIQUIDS KEEP OUT". To the left of the gate is a building with a corrugated metal roof. The sky is blue with scattered white clouds.</p>
<p>Photograph 6 – 24 May 2022 Partial shot of Stockpile – group 1 across east of Hume Motorway (AEC 1) (view towards south east)</p>

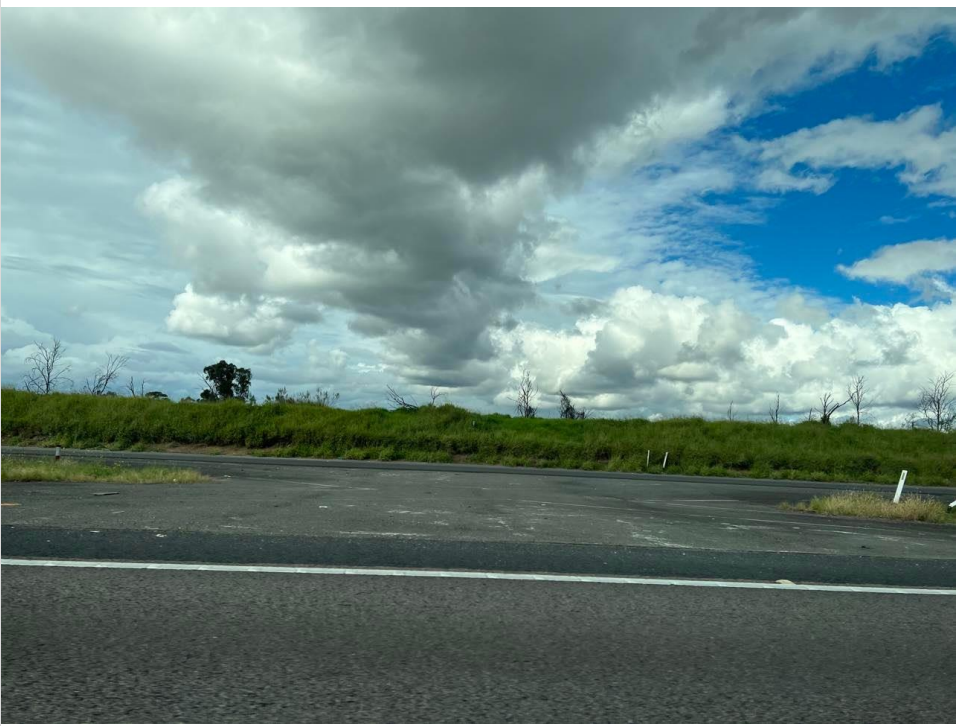
<p>A photograph showing a partial view of a stockpile area. The foreground is a paved asphalt road. In the middle ground, there is a grassy embankment. The background shows a large, open area under a blue sky with many white, fluffy clouds.</p>

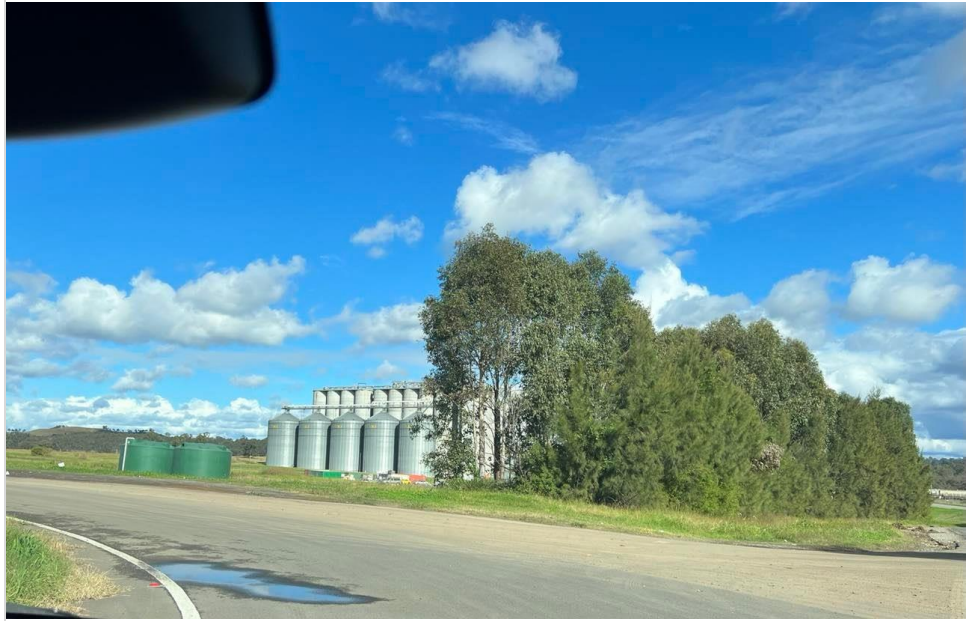
Description	Photograph
<p>Photograph 7 – 24 May 2022</p> <p>Allied Pinnacle Mills (view towards south west)</p>

- Allied Pinnacle Mills Agricultural processing facility (Photo 7, Appendix B) was observed on the southern side of Picton Road approximately 4 km west of the Picton Road/M31 Hume Motorway interchange (Section 3 of the proposal).

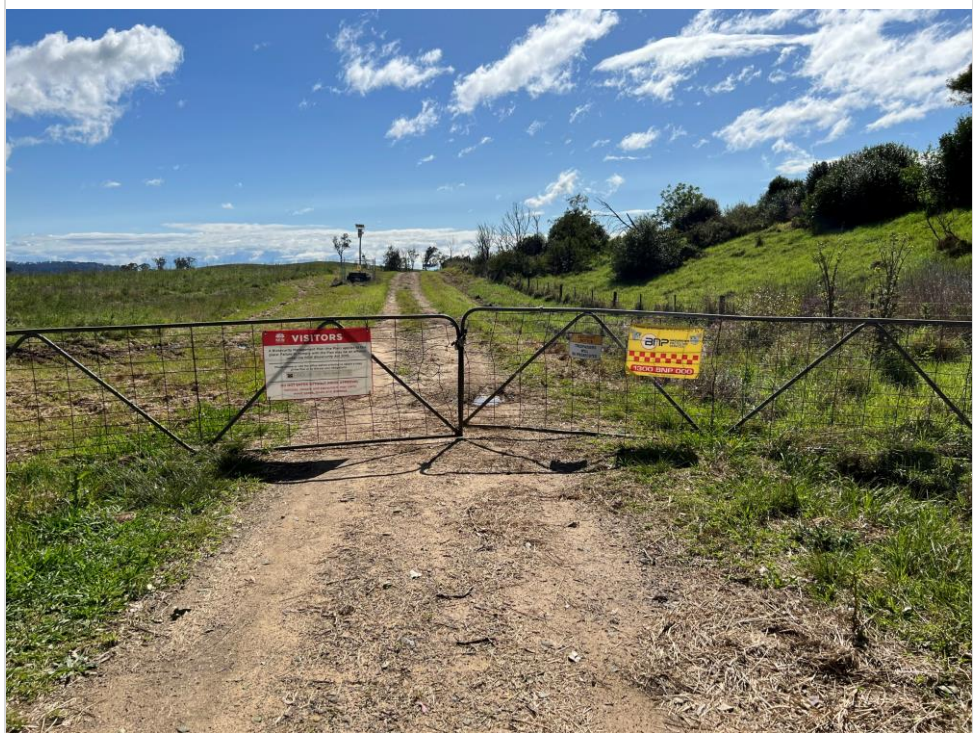
- M31 Hume Motorway north bound onramp (Section 3 of the proposal) – no visual or olfactory evidence of contamination was observed on the access track at the toe of the M31 Hume Motorway north bound onramp batter. The batter was covered by dense vegetation limiting visual assessment of the soils (Photo 14, Appendix B). The northern portion of the batter was within a biosecurity zone (Photo 15, Appendix B), therefore only a visual assessment was undertaken from outside the restricted area. This area is understood to be restricted for access due to being subject to a Biosecurity Management Plan under Wollondilly Shire Council.

**Photograph 15 -
14 October 2022**
Batter of Hume
Motorway entering lane
(view from middle of
access track on Sydney
Skydivers site and view
towards north east)
(AEC 1)
