# Kamay Ferry Wharves project

Seagrass Translocation, Rehabilitation  
and Monitoring

Seagrass Monitoring Report 2

February 2024

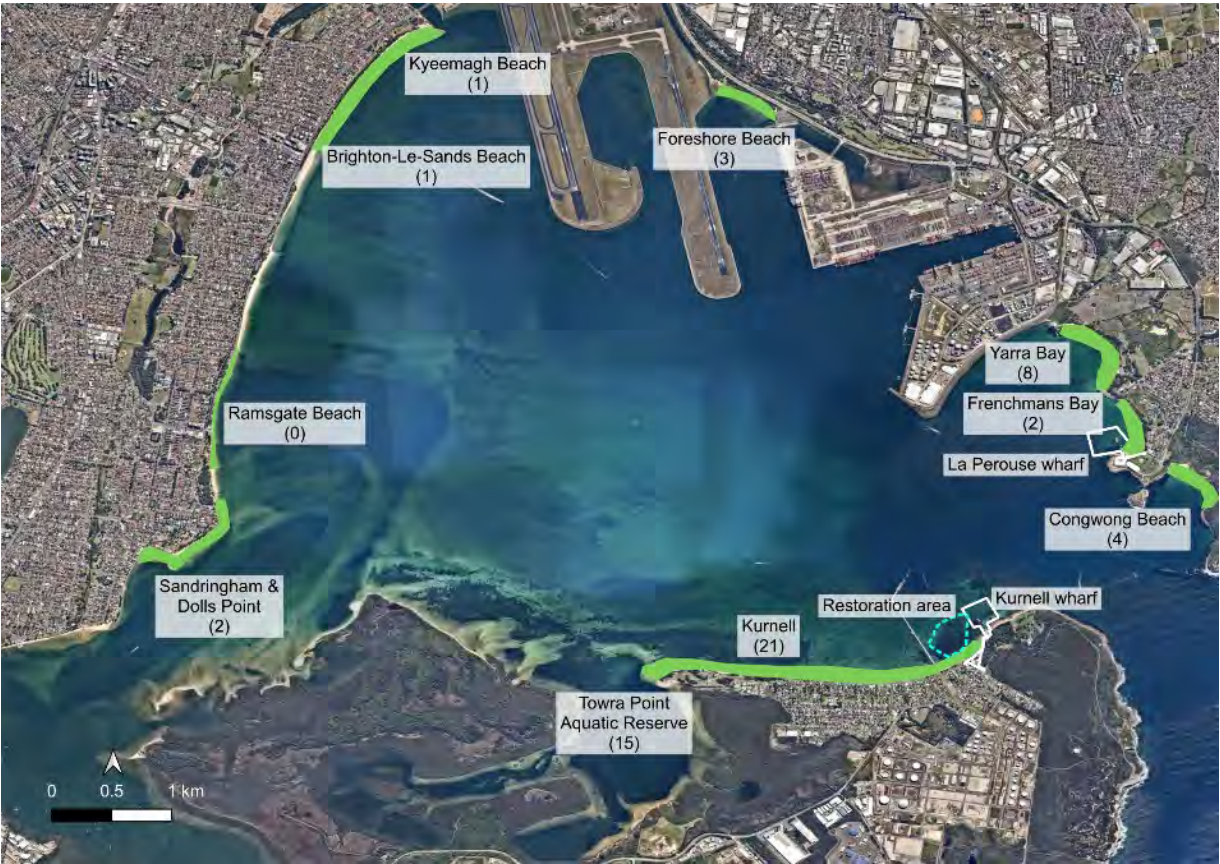
Figure 2-1: Locations and number of beach surveys carried out at each location to collect naturally detached *Posidonia australis* shoots from November 2023 to February 2024.

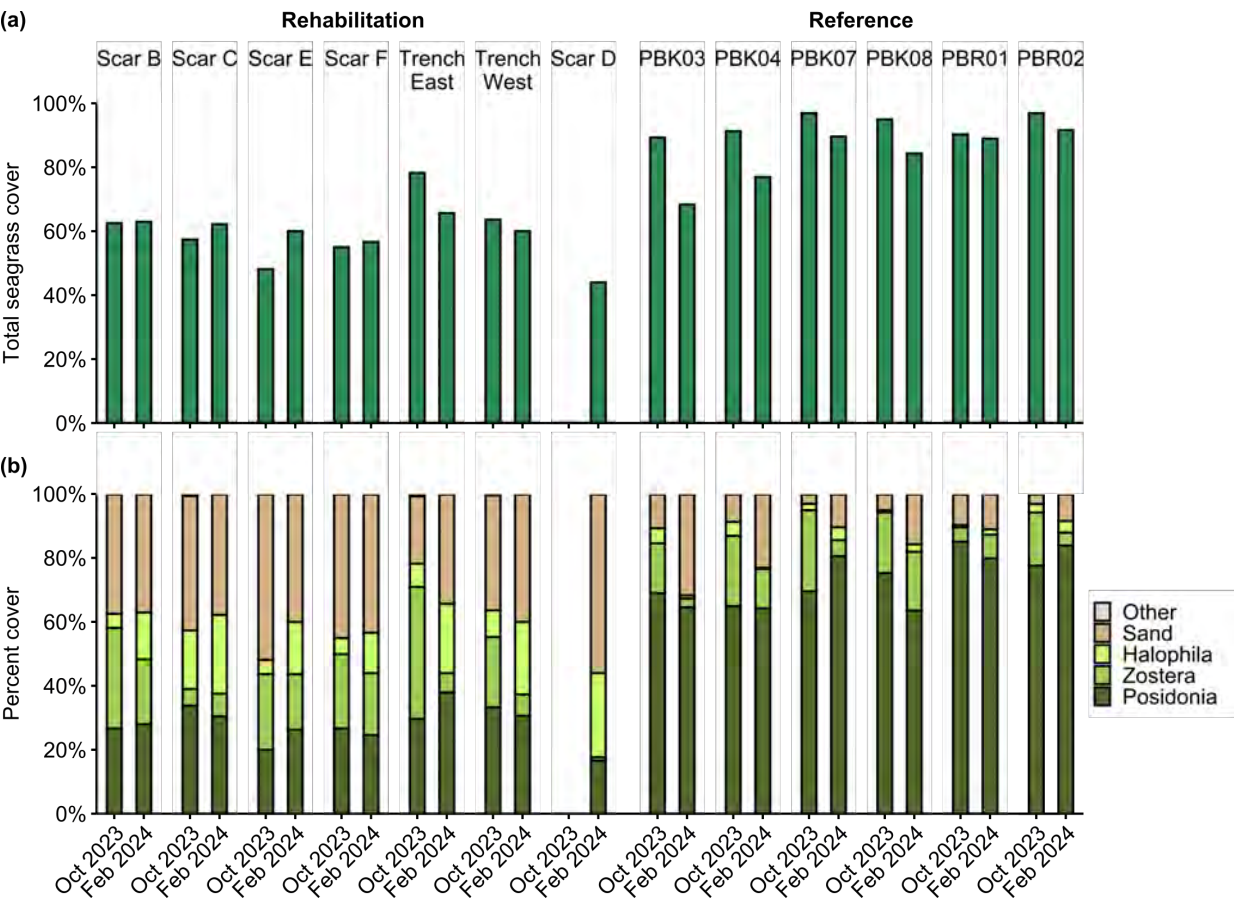
Figure 4-3: Comparison of (a) total seagrass cover and (b) benthic composition at the seven rehabilitation and six reference sites at Kurnell through time. Each time point represents a monitoring event; monitoring of benthic cover commenced in monitoring round 1 in October 2023. Restoration at rehabilitation site Scar D using naturally detached *Posidonia australis* commenced in early February 2024.
