Wallaga Lake Bridge

Review of Environmental Factors

January 2024

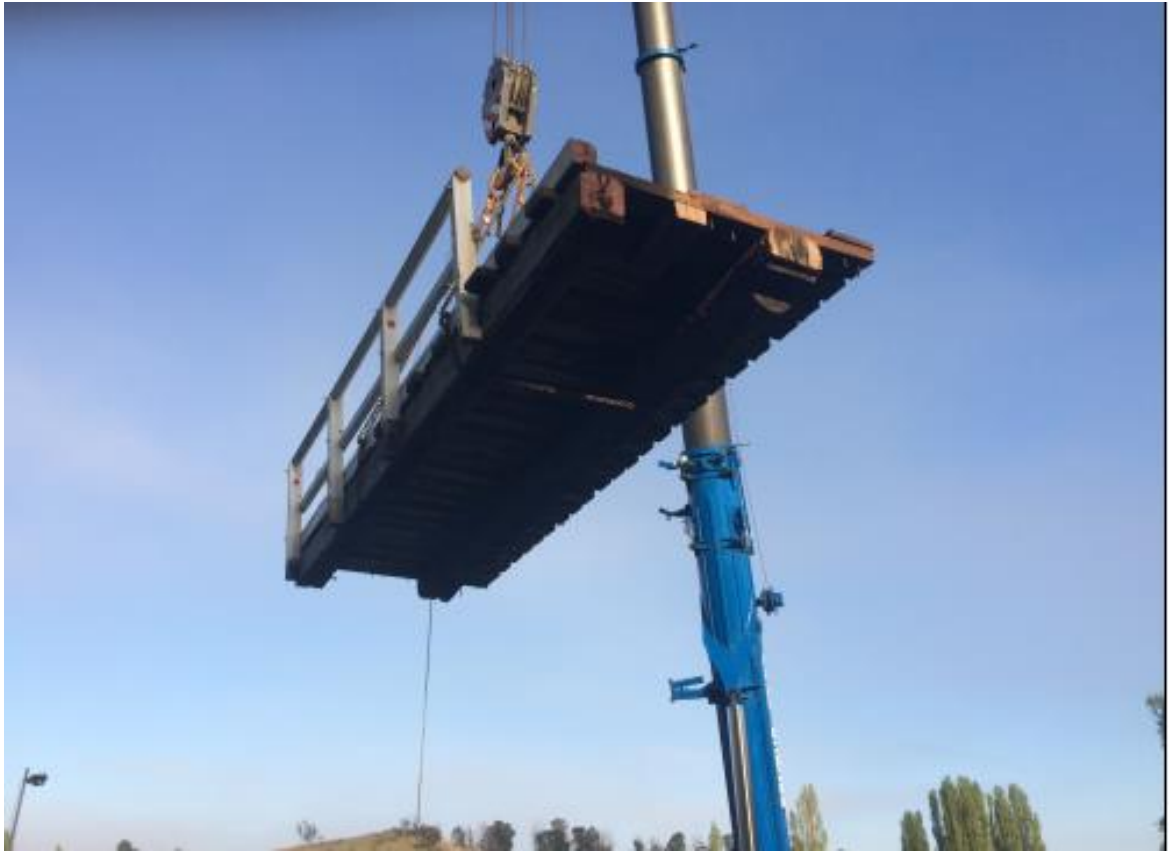
Figure 3-5: Example of deck removal in spans which encompasses 2 girders, cross decking, kerb and handrail

The removal of bridge decks would look similar to Figure 3-5: and follow the sequence below to completion:

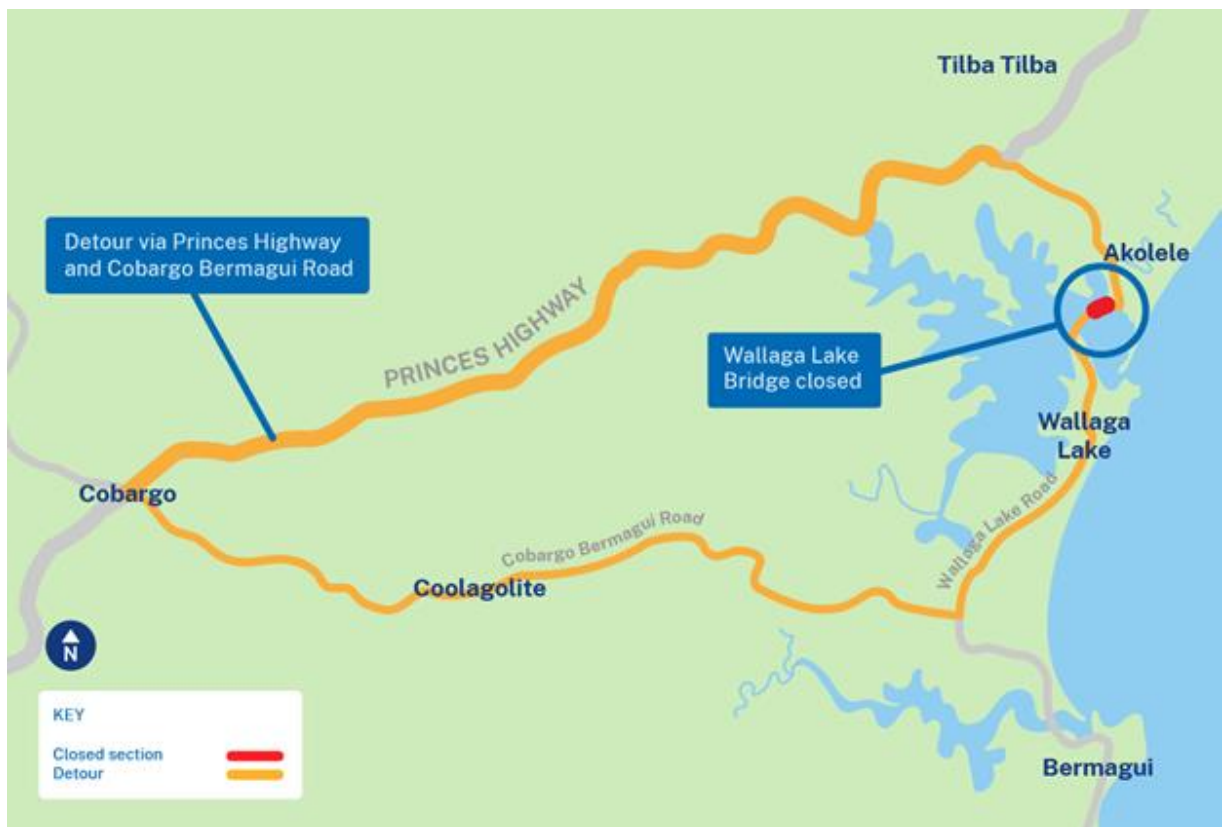
Figure 3-7: Detour route required during bridge closure periods

During the bridge closure periods, a detour will be in place via Wallaga Lake Road onto Bermagui Road and Princes Highway, then onto Cobargo Bermagui Road and back to Wallaga Lake Road as shown in Figure 3-7. This detour adds approximately one hour of extra travel time and 69km of travel if unmitigated.

During the bridge closures, a detour will be in place via Wallaga lake Road onto Cobargo Bermagui Road and Princes Highway then onto Cobargo Bermagui Road and back to Wallaga Lake Road as shown in Figure 3-7.

During the bridge closure periods, a detour will be in place via Wallaga lake Road onto Bermagui Road and Princes Highway, then onto Cobargo Bermagui Road and back to Wallaga Lake Road as shown in Figure 3-7. This detour adds approximately one hour of extra travel time and 69km of travel if unmitigated.

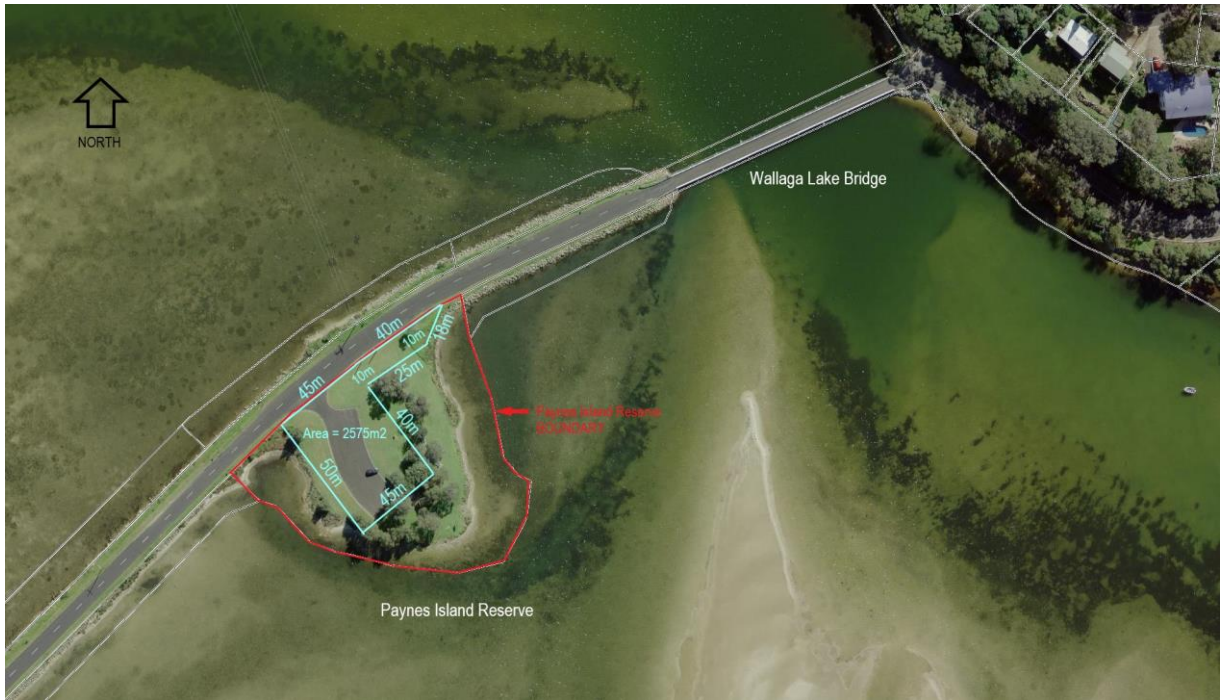
Figure 3-8: Paynes Island – main compound site

The location of the proposed ancillary facilities at Paynes Island Reserve is considered the most practicable due to the following factors:

- Within the existing road corridor and indicative construction boundary
- This location would have no public access during construction
- Has direct access from the Wallaga Lake Bridge and Princes Highway for the stockpile location. These sites have clear lines of site for entry and exit for deliveries
- Location does not obstruct construction vehicles
- Would not require levelling as the existing land is relatively flat
- Would not require clearing of native vegetation.

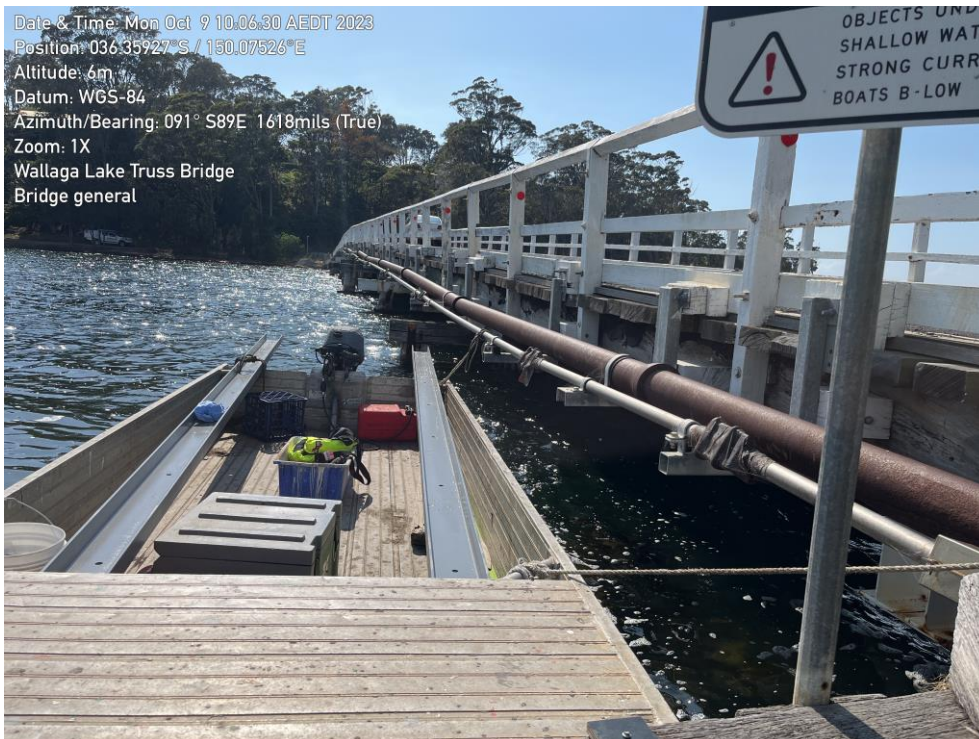
Figure 3-10: Bega Council sewer and drinking water lines

Council sewer and water supply pipelines run over the side of the bridge (as shown in Figure 3-10) and would be disconnected and reconnected to the temporary floating scaffold for the duration of Stage 3 construction works. The pipes would be reattached to the original position once the main bridge components are installed.

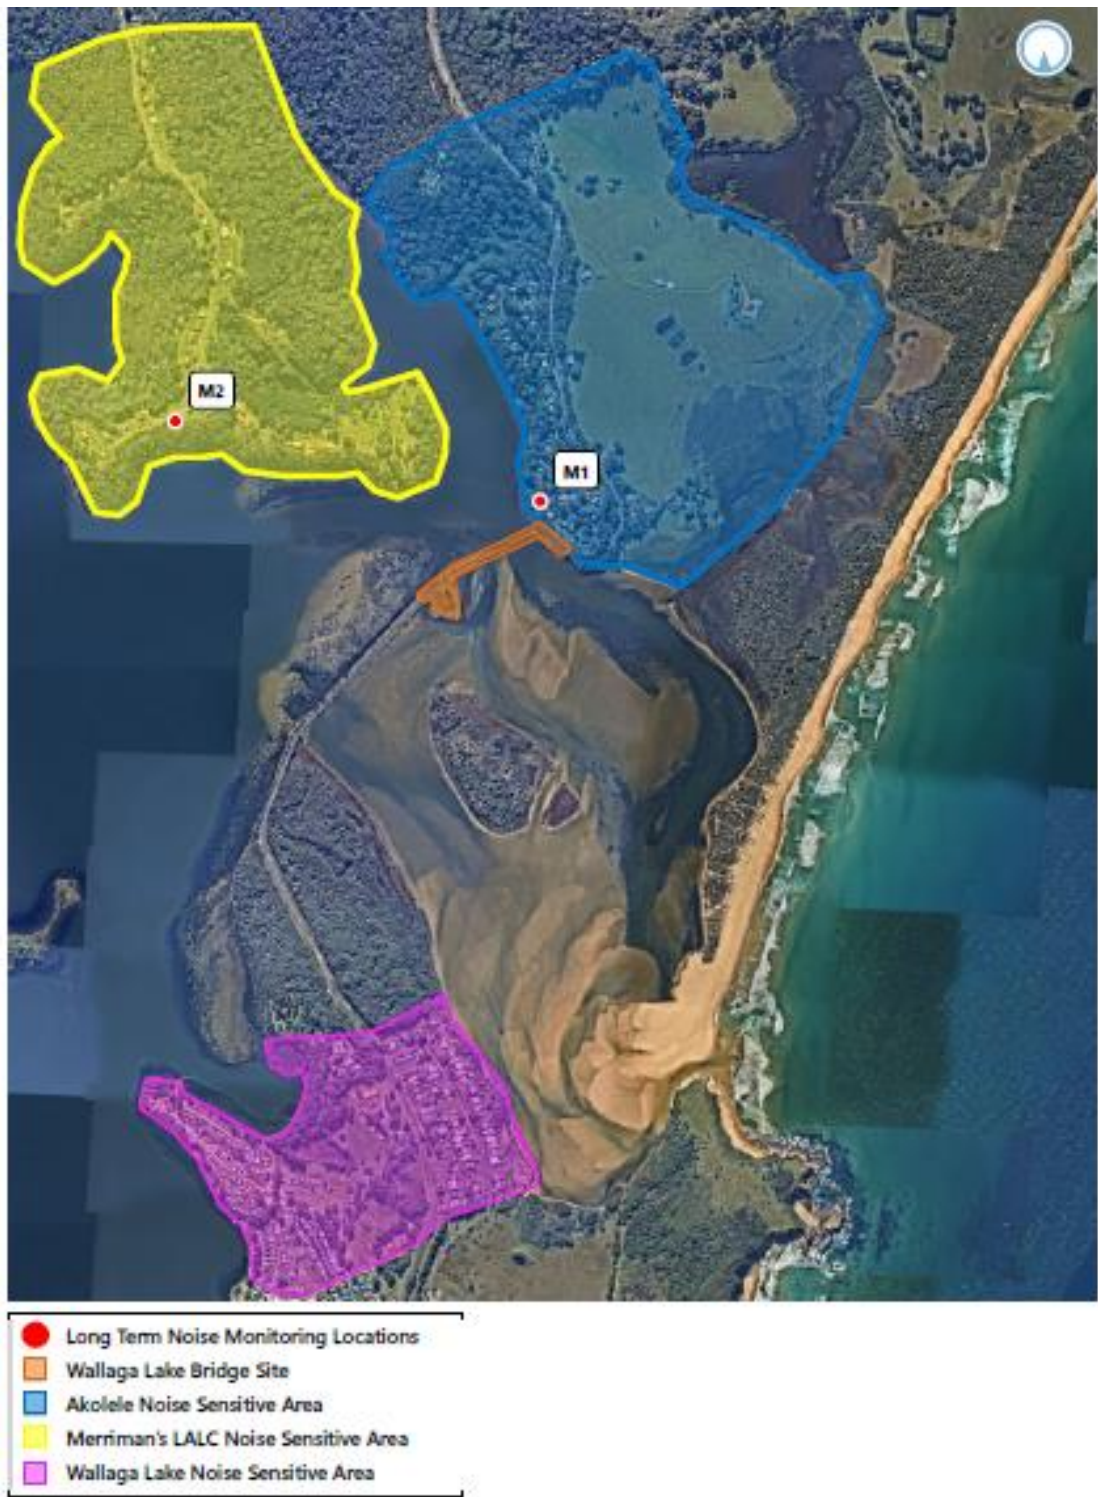
Figure 6-6: Site, Surrounds, Monitoring Locations and Receivers (Wallaga Lake Bridge Site)

Figure 6-6: and Figure 6-7: identifies the site, surrounds and monitoring locations and receivers.

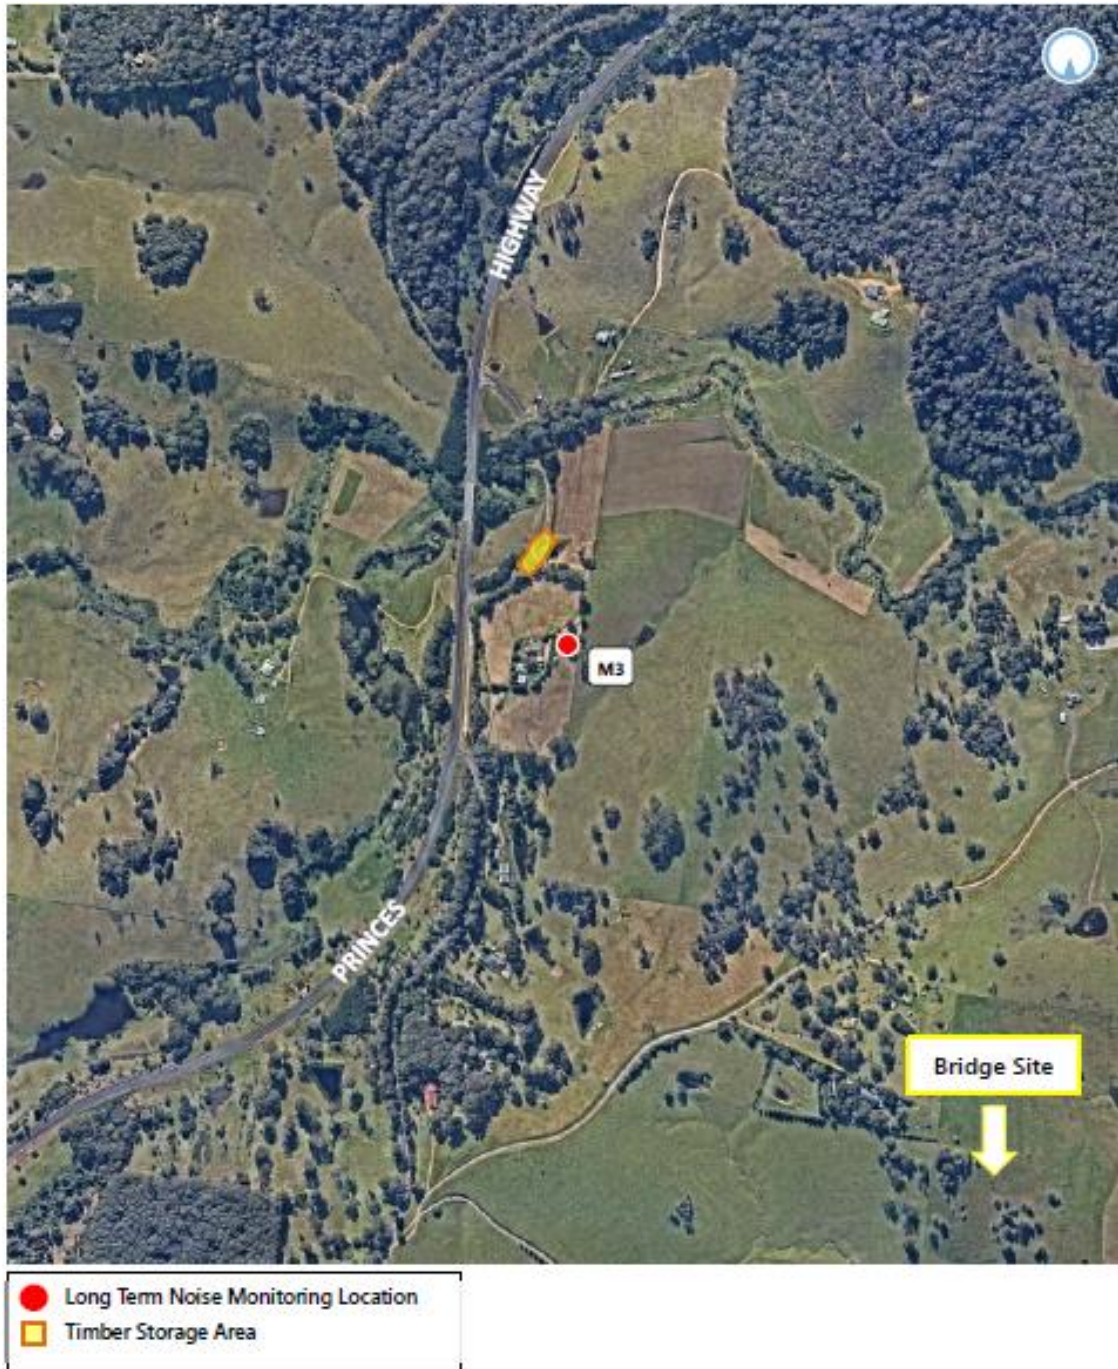
Figure 6-7: Site, Surrounds and Receivers (Timber Storage Site)

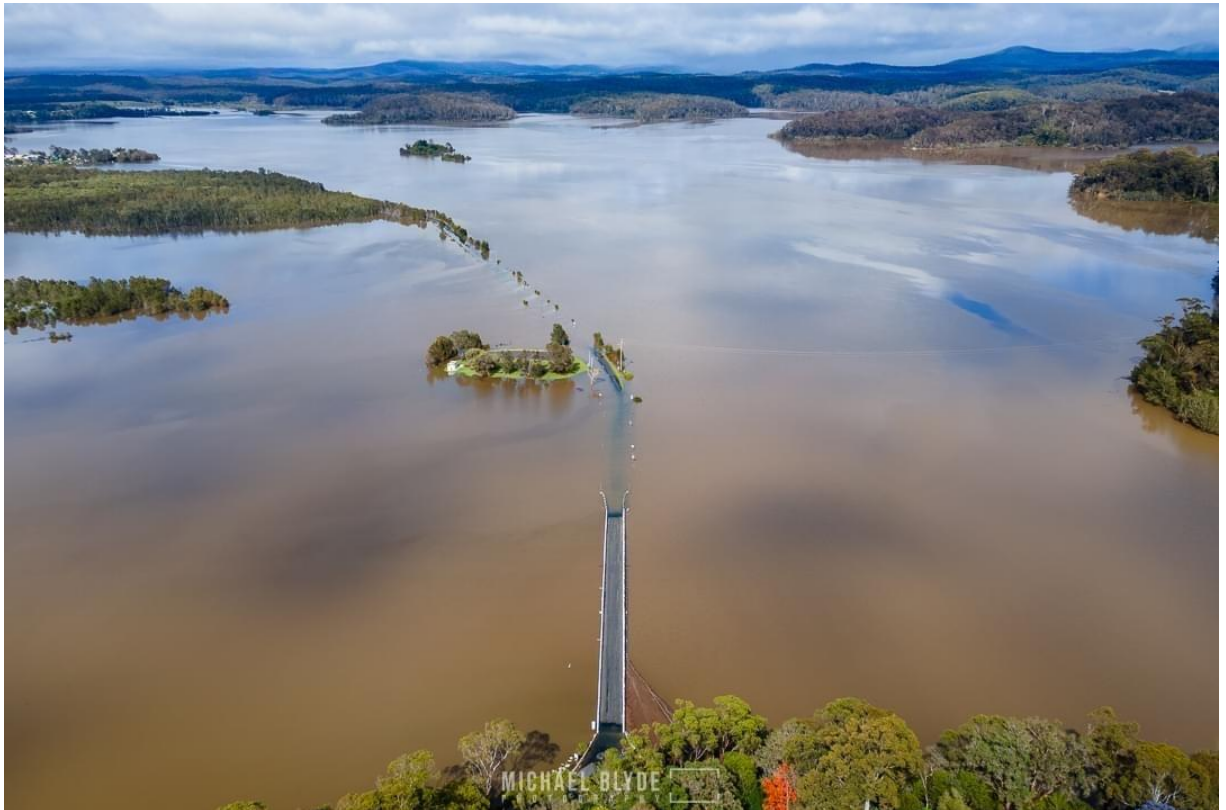
Figure 6-14: Flooding in Wallaga lake (Picture credit: Michael Blyde Photography)

A recent wet weather system (late November 2023) which brought about 185mm of rain to the region in 48 hours (Weatherzone, 2023) caused heavy flooding in the area. This flood event inundated the areas proposed for stockpiling materials and construction vehicles parking areas. The extent of this recent image is shown in Figure 6-14.

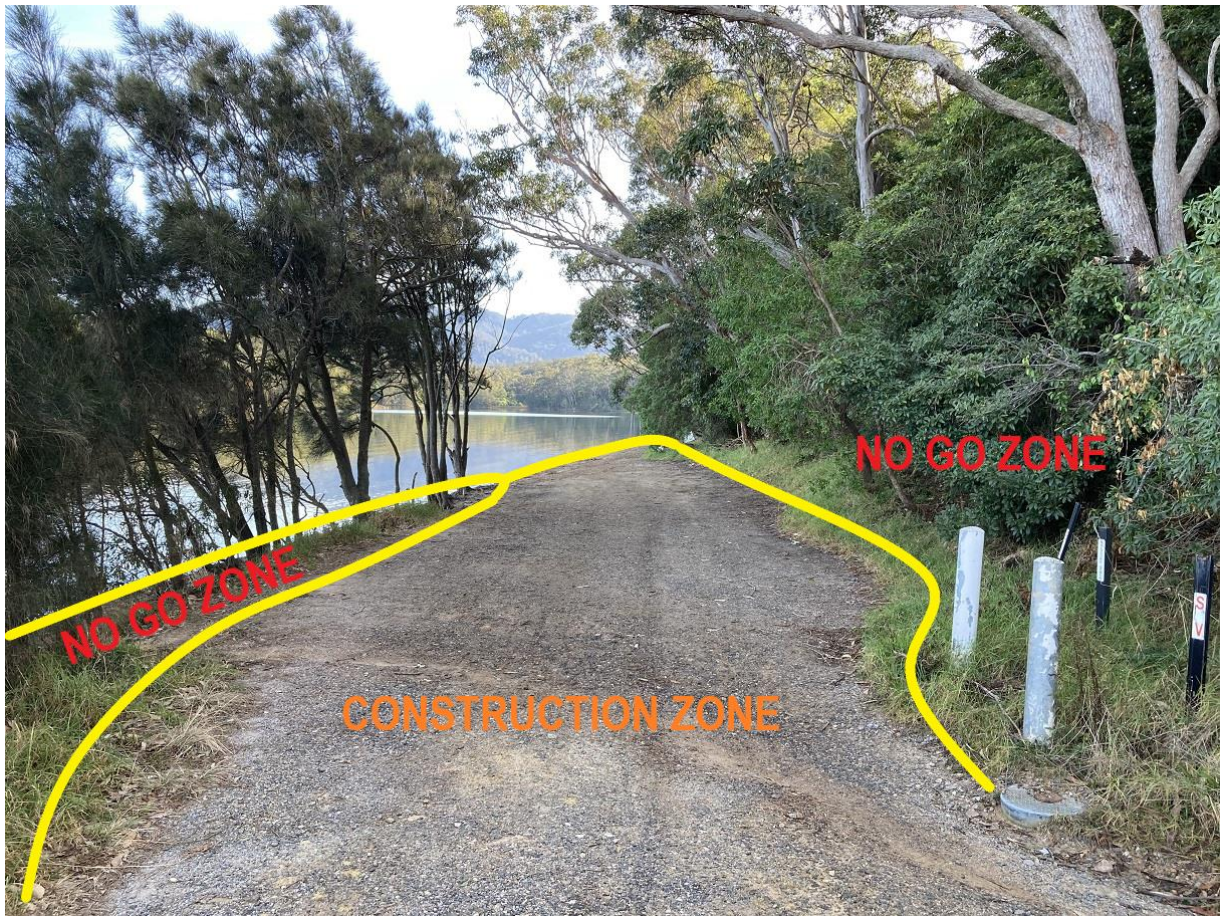
Figure 6-18: No-go areas on the left side of northern abutment

- The AHIMS search did not indicate Aboriginal objects in the study area
- The study area does contain landscape features that indicate the presence of Aboriginal objects, based on the Office of Environment and Heritage’s Due diligence Code of Practice for the Protection of Aboriginal objects in NSW and the Transport for NSW procedure. However, the cultural heritage potential of the study area appears to be reduced due to past disturbance. These areas are proposed to be a no-go areas and is shown in Figure 6-18.

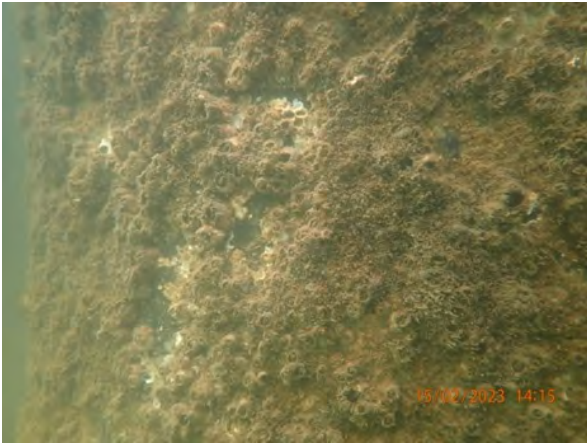
Photo 1. Barnacles were the dominant encrusting growth on piles followed by mussels.

- Bridge piles are characterised by encrusting growth dominated by filter feeding invertebrates barnacles and mussels.
- No taxa belonging to Syngnathiformes were recorded during the inspection survey and it is considered unlikely that Syngnathiformes would utilise the encrusting growth on the bridge piles.
- Twelve (12) fish taxa were observed at the bridge including yellowfin bream, silver sweep, luderick, leatherjacket and cryptic species Eastern fortescue, gobies and horned blenny. All species observed are commonly encountered in estuarine and nearshore marine habitats of south-eastern Australia.

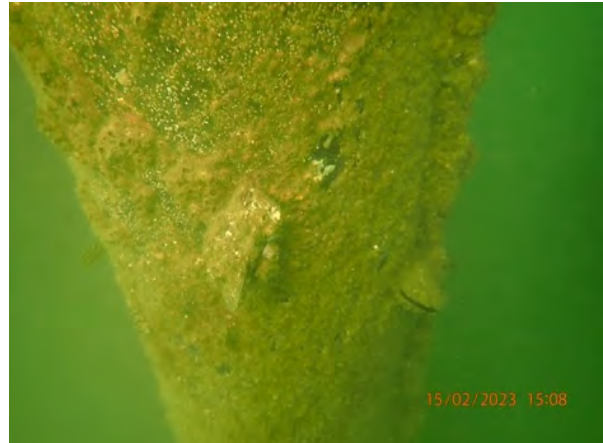
Photo 2. Typical pattern of marine growth on piles was limited to barnacles and mussels.

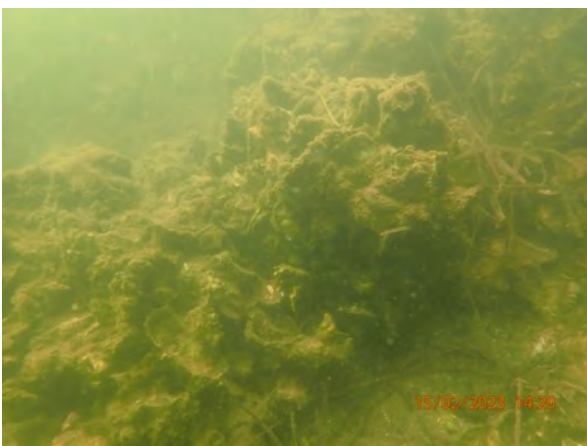
Photo 3. Sydney rock oysters at the base of abutment A.

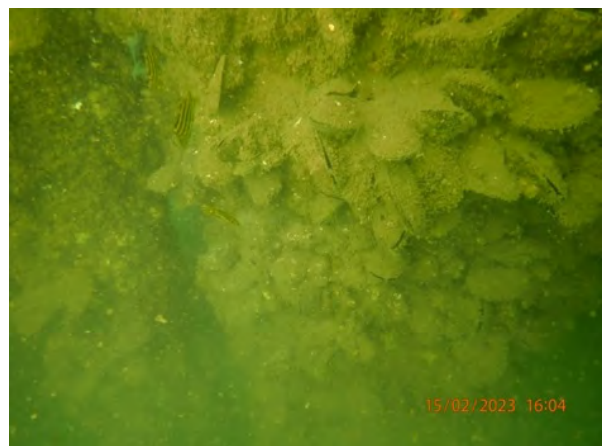
Photo 4. Mussels were common on all piles with abundant on piles of pier 6.

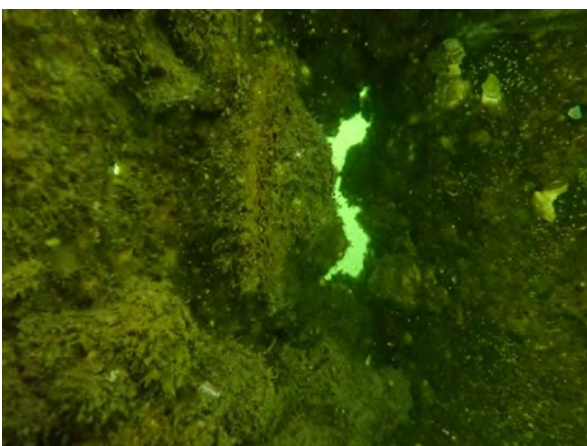
Photo 5. A single mud oyster (*Ostrea angasi*) observed on pile 6-46.

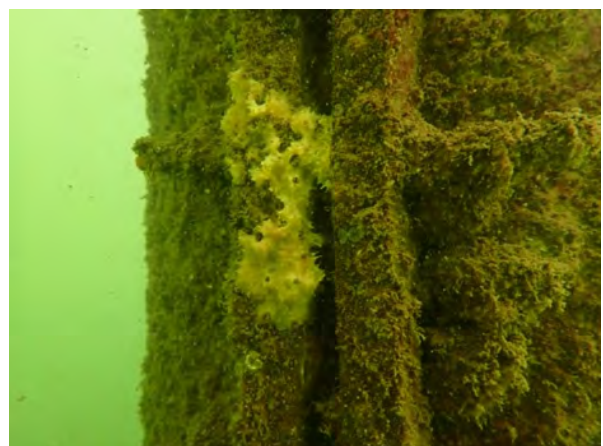
Photo 6. Encrusting yellow sponge.

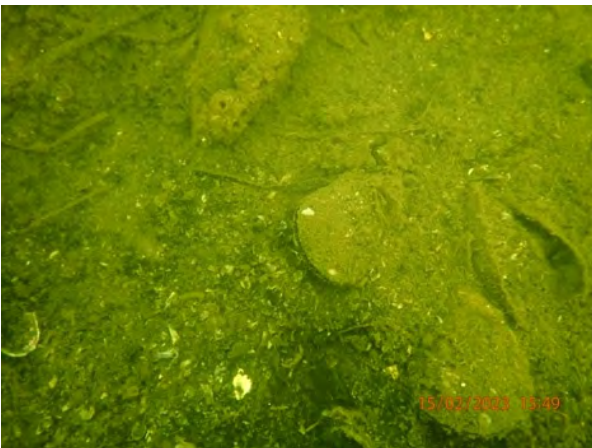
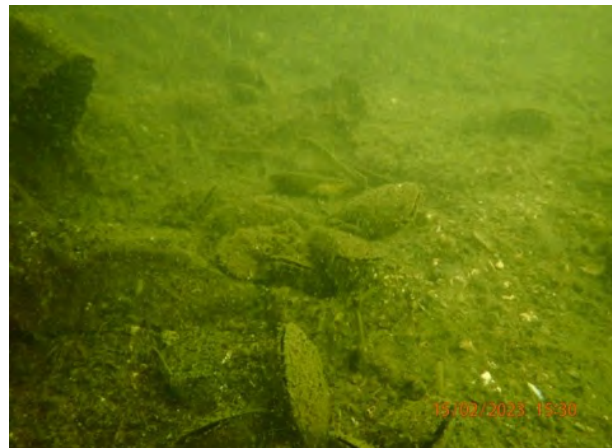
Plate 4. Typical images of bed sediments below the Wallaga bridge.

Example of the bed sediment characteristics adjacent to bridge piles.

Observations of bed sediment characteristics were recorded by divers at the base of piles. Bed sediments are characterised by fine sand and layer of fine silt with variable levels of shell (**Plate 4**). The layer of fine silt overlying sand was easily disturbed by divers and any agitation of the sediments during construction activities would cause a turbidity plume and result in a decline in water clarity.

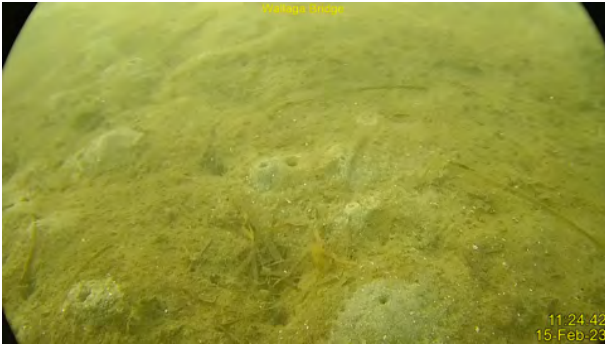
Photo 1. Example of unconsolidated sand substrate with faunal burrows.

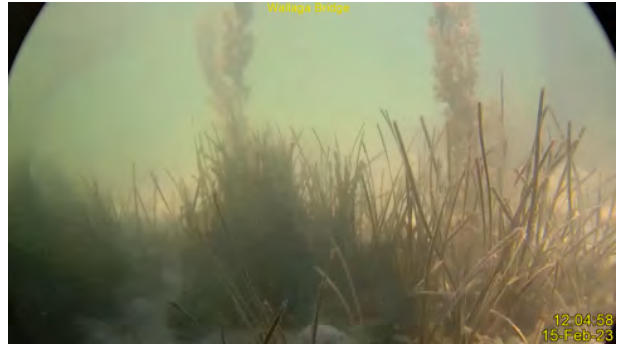
Photo 2. Seagrass *Zostera* and macroalgae habitat observed on the eastern side of bridge adjacent to Paynes Island.

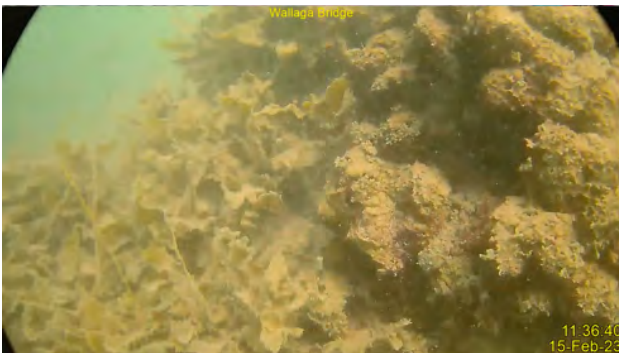
Photo 3. Example of consolidated rock substrate colonised by macroalgae observed at the northern shoreline east of the bridge.

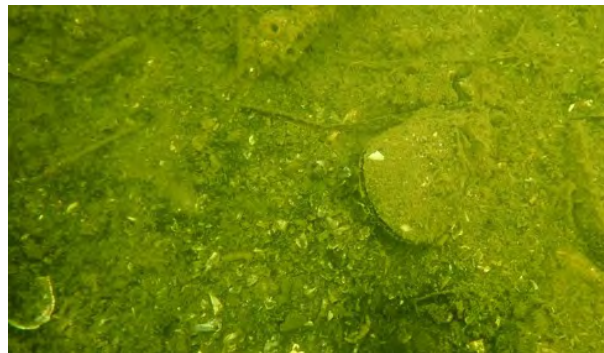
Photo 4. Deposits of dead shell in sediments were highest around the base of bridge piles.

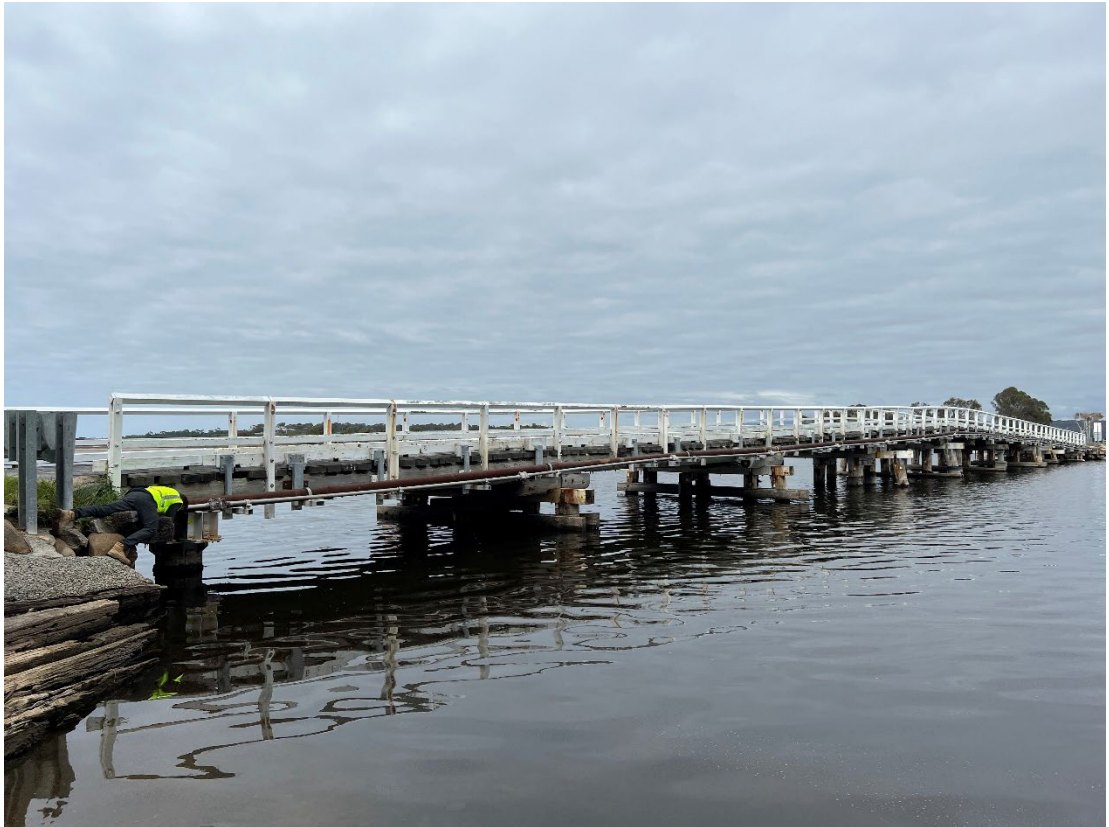
Figure 1-1: Wallaga Lake Bridge is a timber girder bridge.

Wallaga Lake Bridge (B6168) on the Bega to Tilba Road (MR272) is a timber girder bridge built in the 1890s that carries single lane traffic (Figure 1-1). The bridge is located about 11 kilometres north of Bermagui (Figure 1-2). Transport for NSW (Transport) proposes a major rehabilitation of the bridge. Previous work on Wallaga Lake Bridge has been carried out to maintain safety. While the bridge has been deemed safe for road users there has been a 22.5 tonne load limit in place since 2018 due to severe defects that require rehabilitation. The proposed major rehabilitation of Wallaga Lake Bridge will ensure that the bridge is repaired so it remains safe for all road users. The proposal is located within both the Bega Valley Shire Council local government area (LGA) and the Eurobodalla Shire Council LGA.

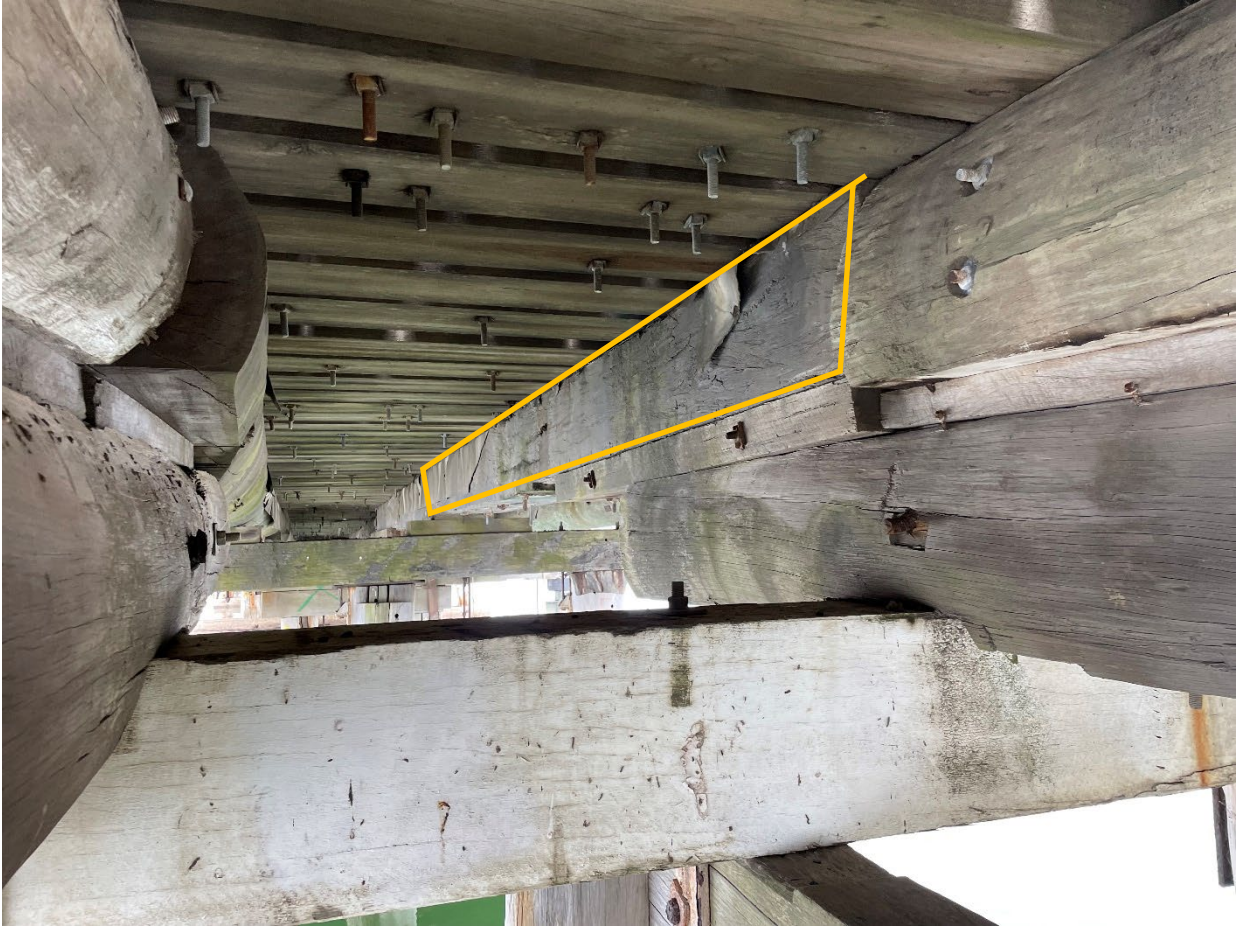
Figure 1-4: Photograph of Girder 19 (currently labelled as Girder 20 due to temporary girders having been installed) – to be referred to as Girder 19 within this document.

To retain and reinstate the microbat habitat within girder 19. To reinstate girder 19 to allow use of the girder by the microbats (Figures 1-4 and 2-4) on completion of the project.

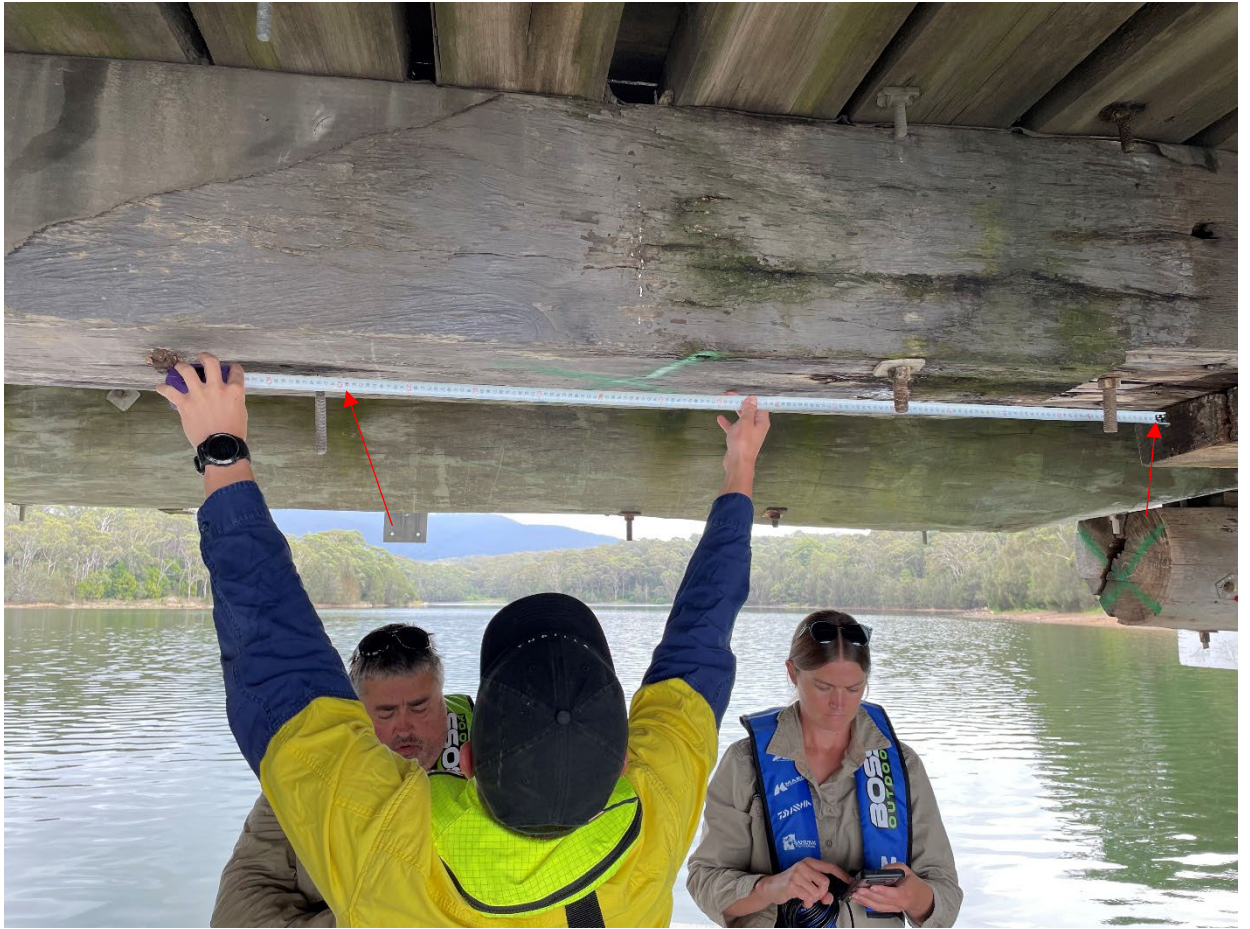
Figure 1-5: Photograph of Girder 19 detailing gap between the two entry holes used by Southern Myotis to enter this girder.

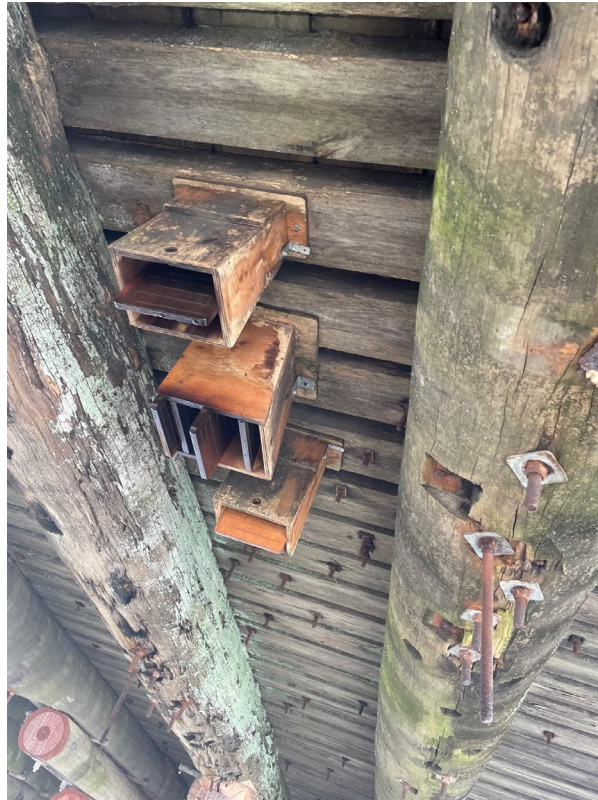
Figure 2-2: Example of two and four chambered bat boxes installed on a Transport bridge project

Figure 2-2 provides an example of the microbat boxes used for Southern Myotis on other bridge projects including the Barrington Bridge Removal. The installation locations on the existing bridge should be as follows:

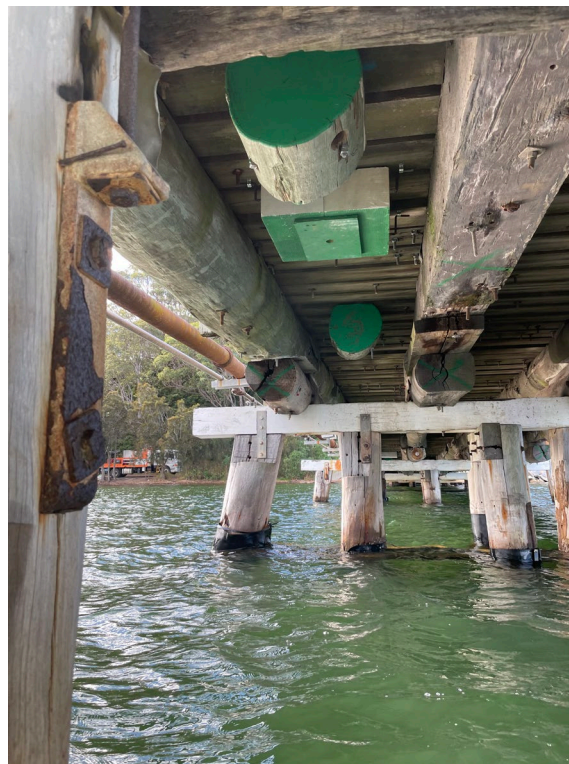
Figure 2-3: Example of Transport fabricated boxes – Timber and Hebel boxes.

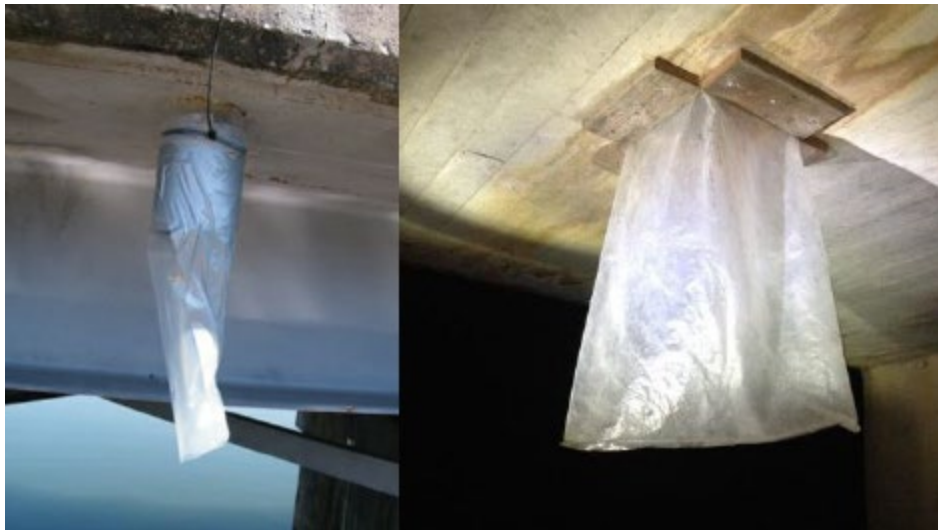
Figure 2-4: Examples of a one-way exclusion device.

- iii. Install a one-way exclusion device (during the day – the day after the exclusion barrier is installed) to allow microbats that did not leave the roost at the previous stage (refer ii above) to leave but not re-enter the roost (under Project Ecologist supervision). Leave for 2 weeks subject to Project ecologist's advice. Refer to Figure 2-4 as an example of a one-way device.

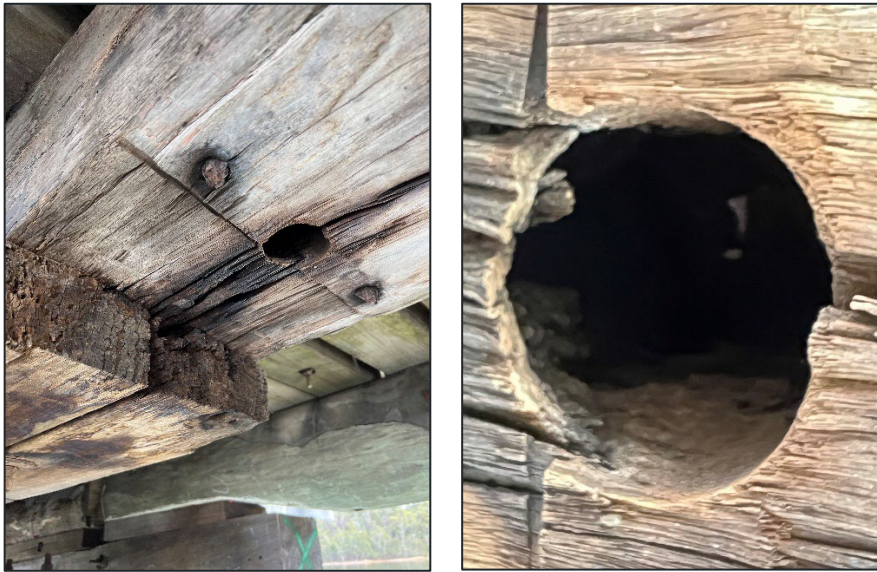
Figure 2-4: One of the exit locations within girder 19.

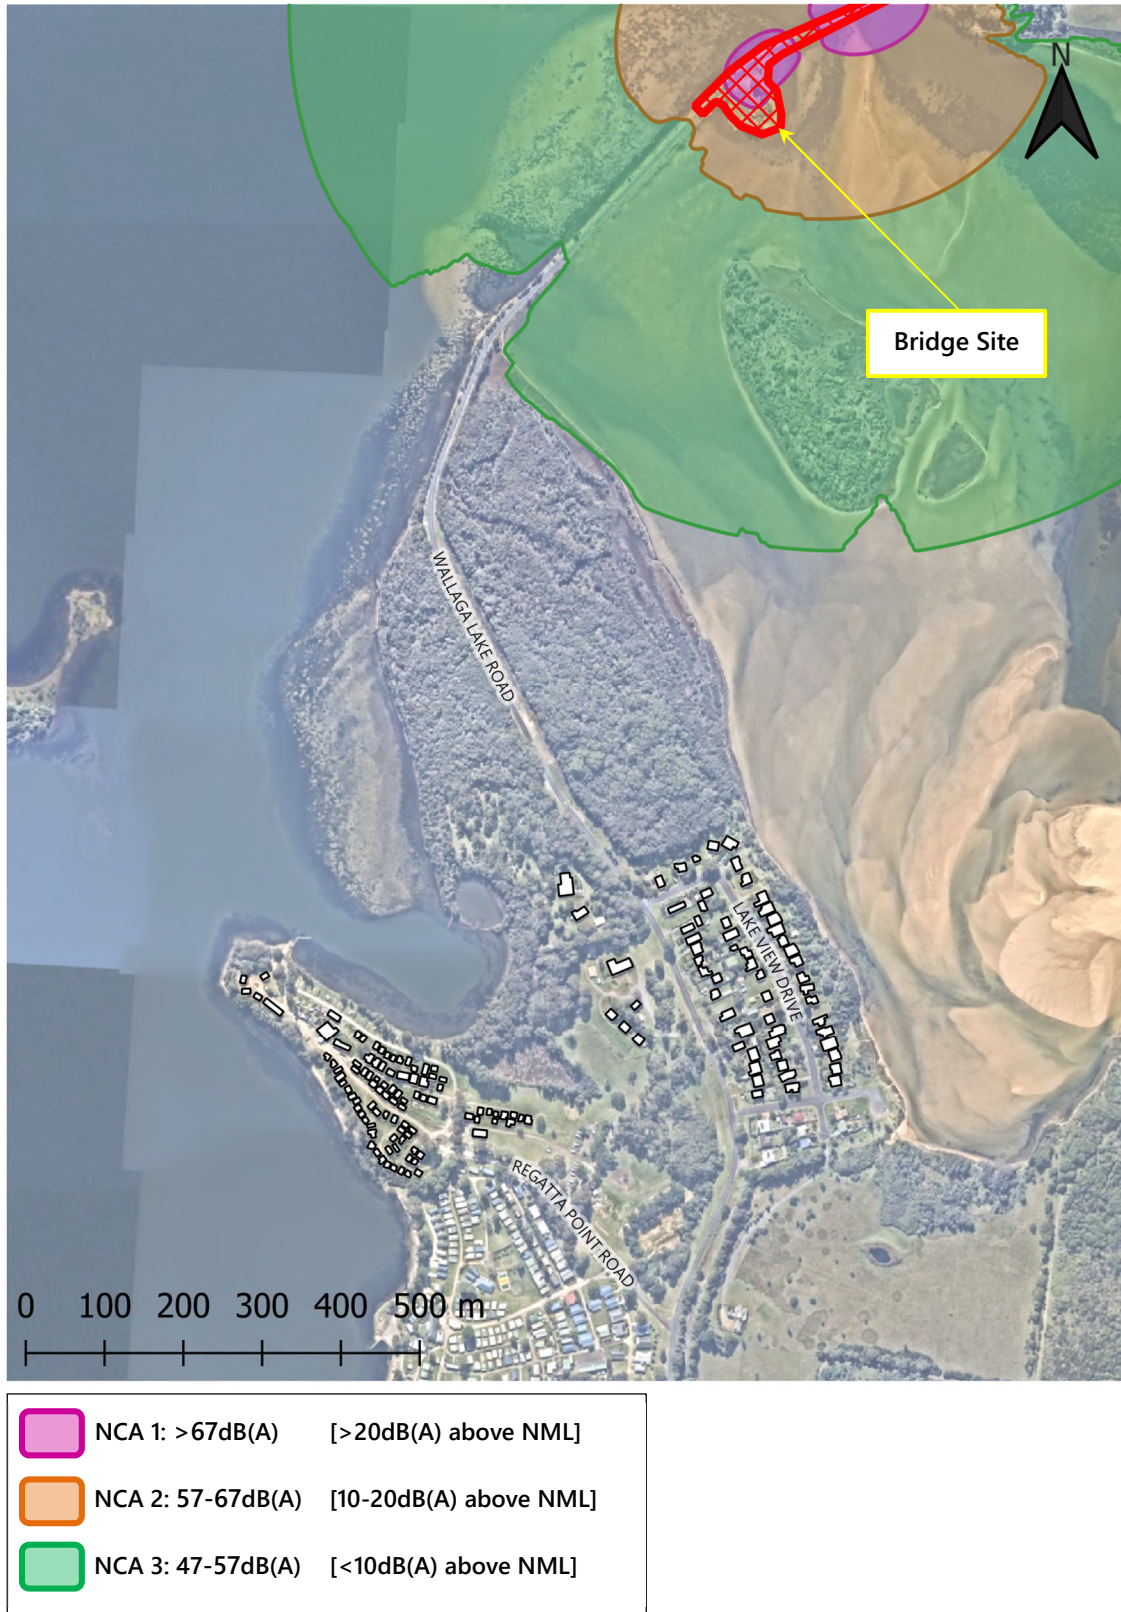
Figure 15 – NCAs Based on L_{Aeq} (15min) Noise Levels – Finishing Works – Wallaga Lake (Day)

Figure 13, Figure 14 and Figure 15 present the predicted noise impacts to the Akolele, Merriman's LALC and Wallaga Lake noise sensitive areas, respectively, and the corresponding NCAs as described in Table 2.1 for finishing works.

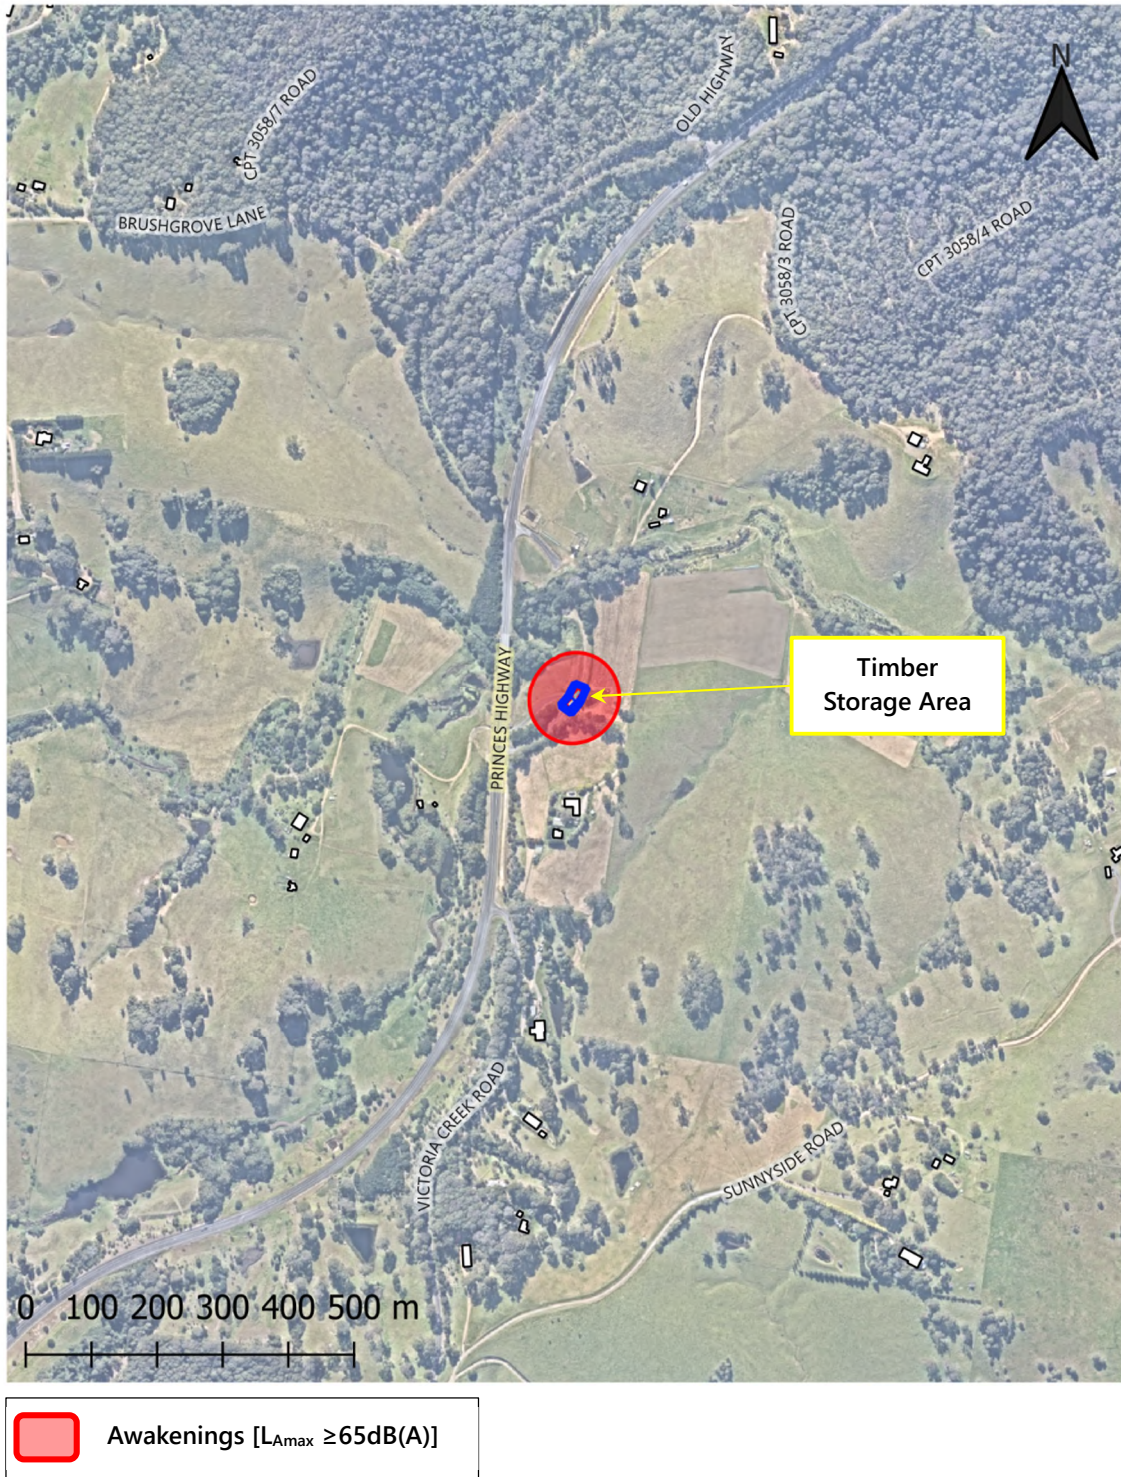
Figure 19 – Areas Impacted by Maximum Noise Levels (L_{Amax}) – Timber Storage Area

Maximum noise level predictions for activities at the timber storage area have been based on the proposed construction plant and equipment to be used during the night, as presented in Table 4.4. The highest L_{Amax} noise source level during the night time activities at the timber storage area was used to predict the maximum noise level impacts and provide a conservative assessment. Figure 19 presents the predicted L_{Amax} noise levels that could cause awakenings [i.e. $\geq 65\text{dB(A)}$] at residential receivers during the night time activities at the timber storage area.
