Wallaga Lake Bridge

Review of Environmental Factors

January 2024

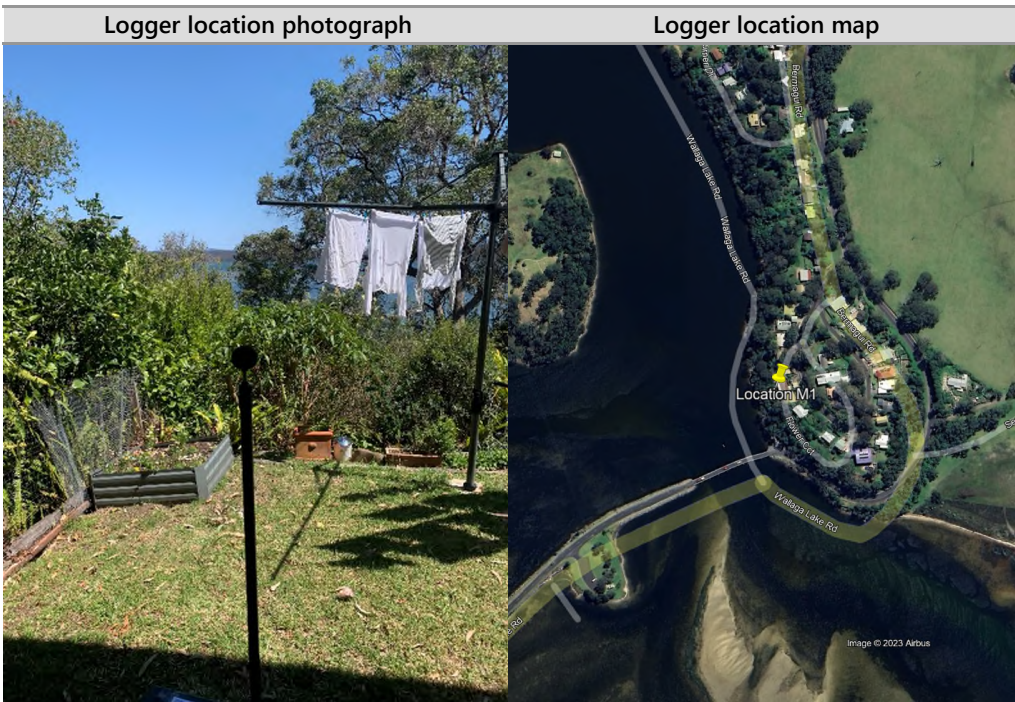
Unattended Noise Monitoring Results

15 Flower Circuit, Akolele - Rearyard

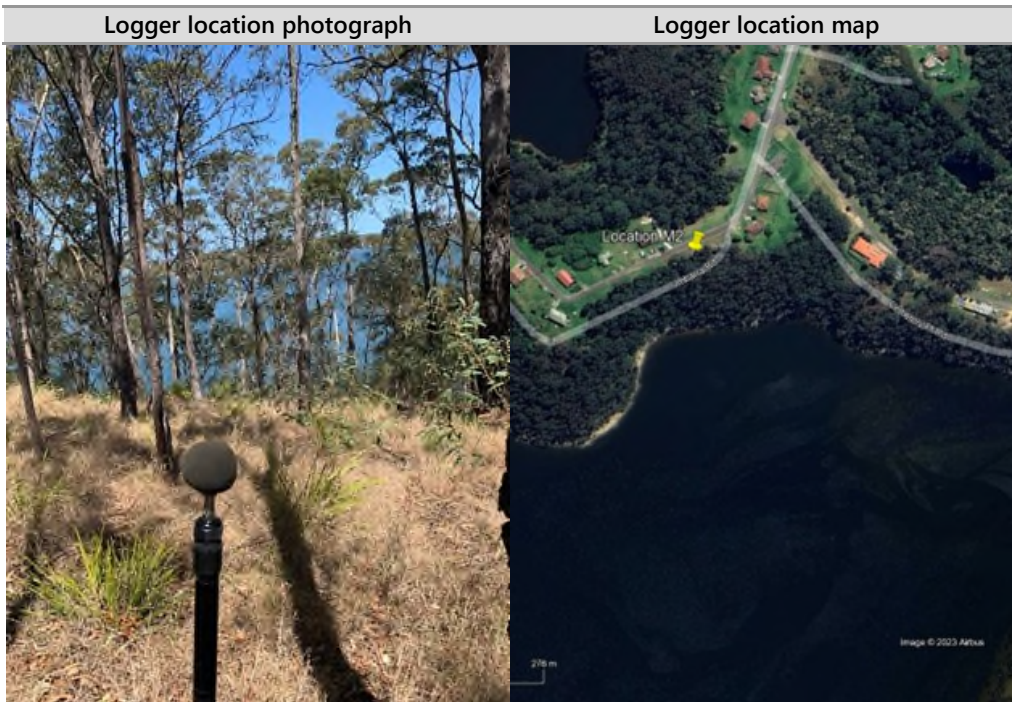
Unattended Noise Monitoring Results

Merriman's Local Aboriginal Land Council - Frontyard

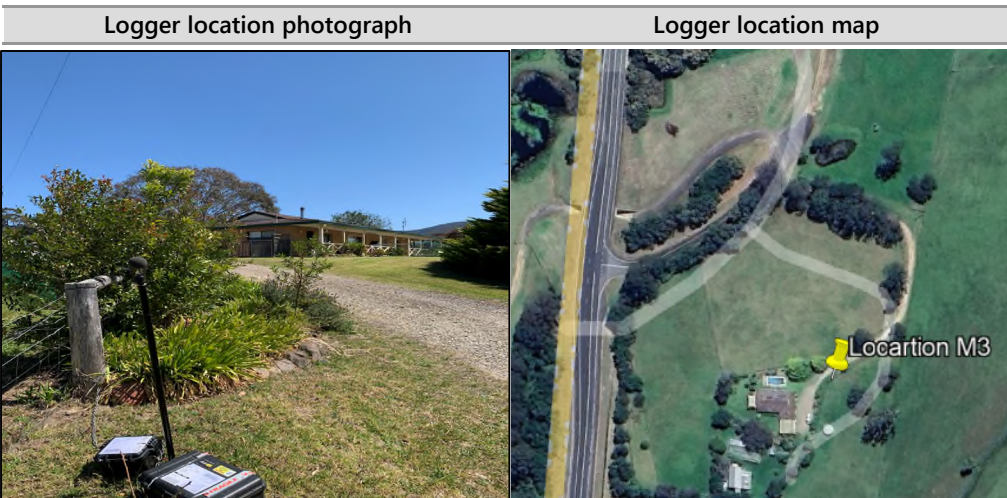
Unattended Noise Monitoring Results

8217 Princes Highway, Central Tilba - Front Yard

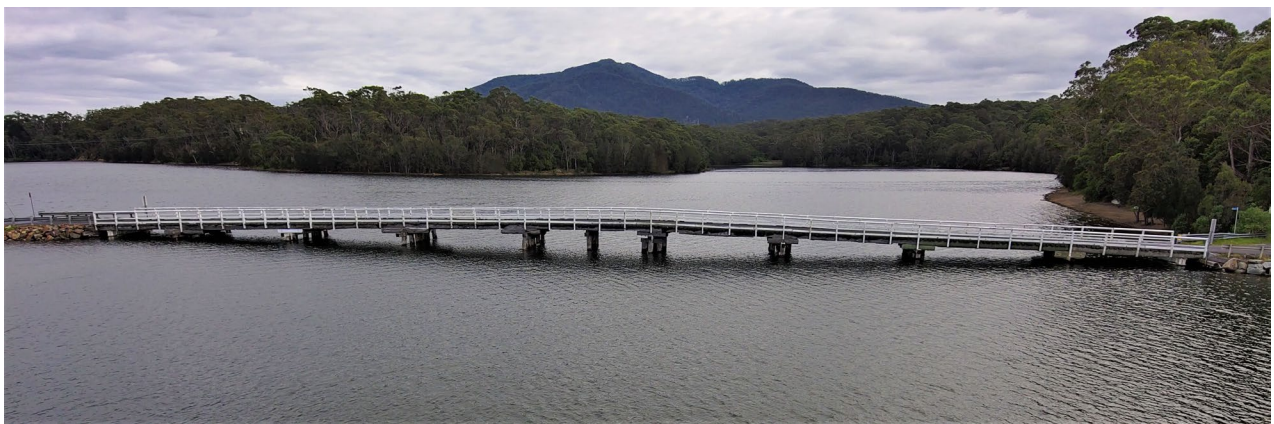
Figure 1: Profile view of bridge structure looking west in 2020.

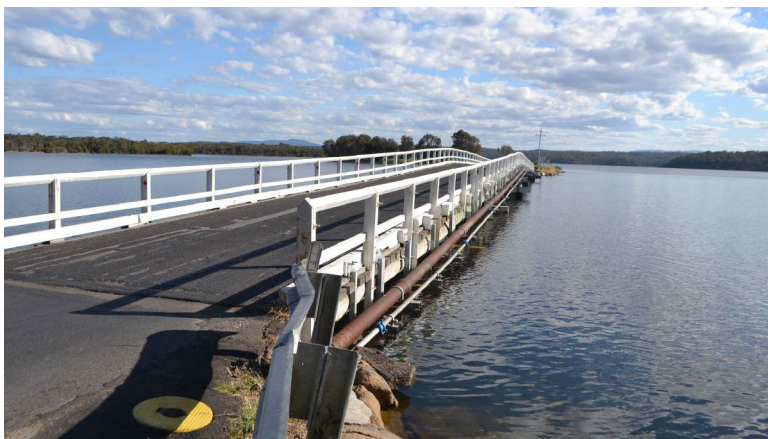
Figure 2: View of the bridge looking south detailing the subtle arch of the deck and superstructure along with attached services.

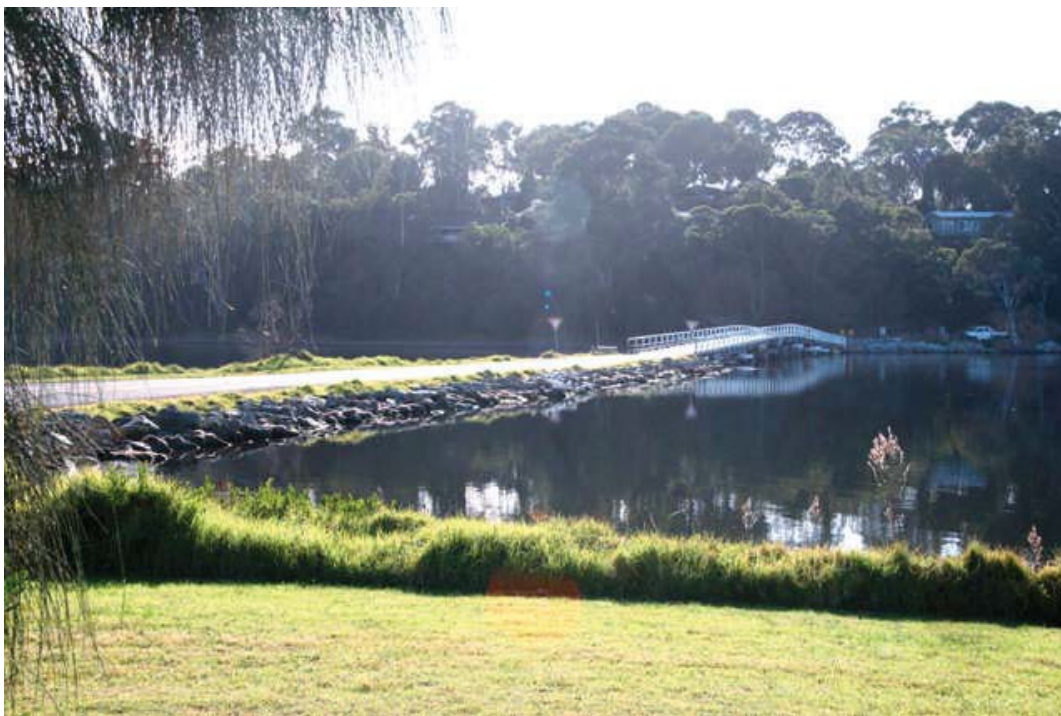
Figure 3: View looking north showing causeway and bridge.

In 1936 the long causeway which forms the southern approach to the bridge was raised (**figure 3**). The periodic submergence of this roadway by the lake's waters, for at times as long as two months, had been the cause of much local inconvenience. The contract for the raising of the causeway by two feet was let to contractor G.A. Armstrong of Bega, with work funded by the Unemployment Relief Council.

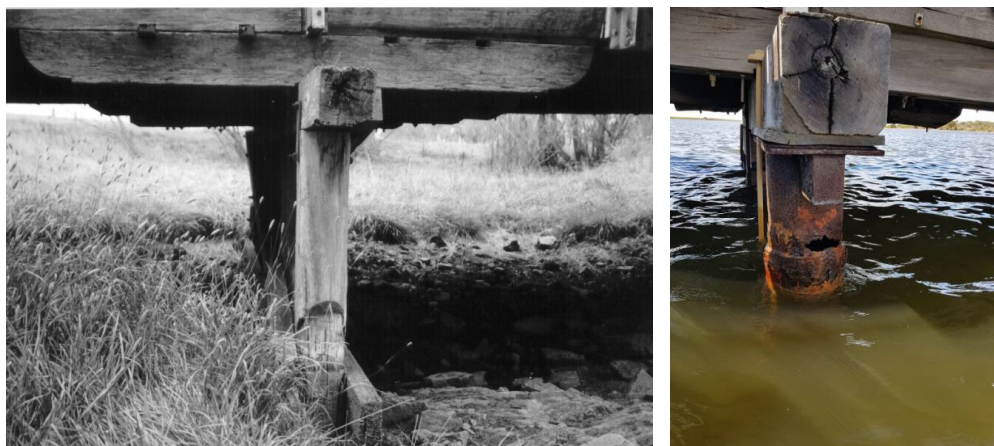
Figure 4a: Typical early headstock detail at top of pier. **Figure 4b:** Same headstock detail in place on Wallaga Lakes Bridge.

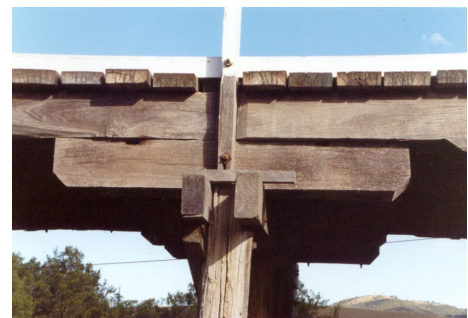
Figure 5a: Typical arrangement of a post-1894 timber beam design detailing the bridge components described in the text. **Figure 5b:** Allan's improved headstock design featuring two capwales.

Beyond the headstocks the form of construction follows the standardized designs in use for timber beam bridges of the period with the separate components labelled in **figure 5a**. The headstocks support lateral corbel members which in turn carry the main longitudinal timbers which are round. The deck consists of transverse planks with longitudinal planks forming the running surface. Timber kerbs are raised to allow drainage and there is a two-rail traditional timber rail. The bridge carries a utility pipe on its western side. There have been no substantial modifications to the deck and superstructure and these are assessed as being of **High** significance.

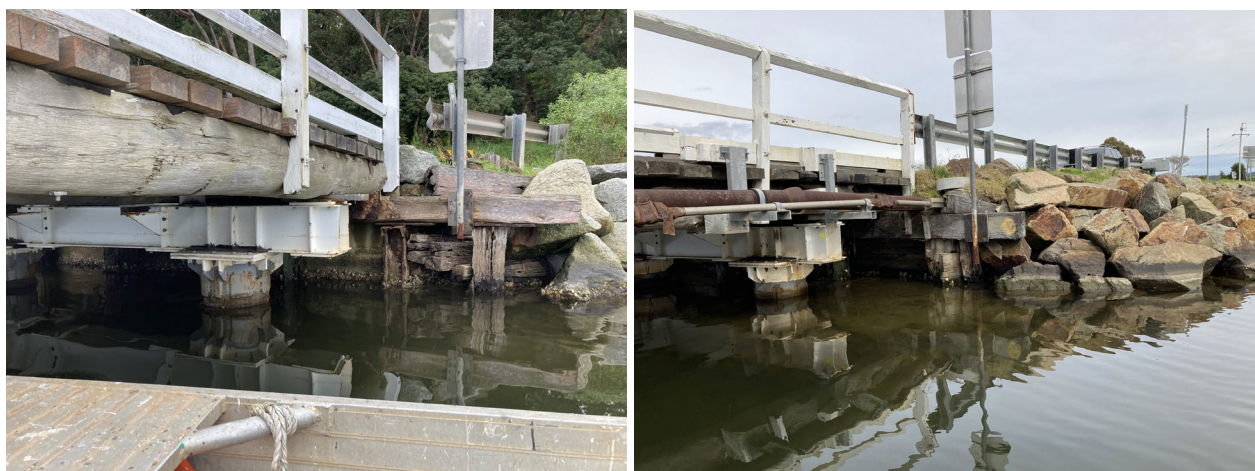
Figure 7a: Northern abutment face and eastern wingwall. **Figure 7b:** Southern abutment.

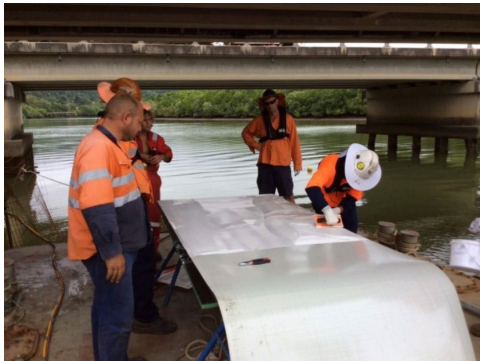
Figure 8a: Laminate being cut to size- note while white is shown, grey would be used at Wallaga Lakes Bridge. **Figure 8b:** Side and top views of works once completed.
