# Appin Road and St Johns Road Intersection Upgrade

## **Statement of Heritage Impact**

Prepared by Extent Heritage Pty Ltd

March 2025 - Final 05

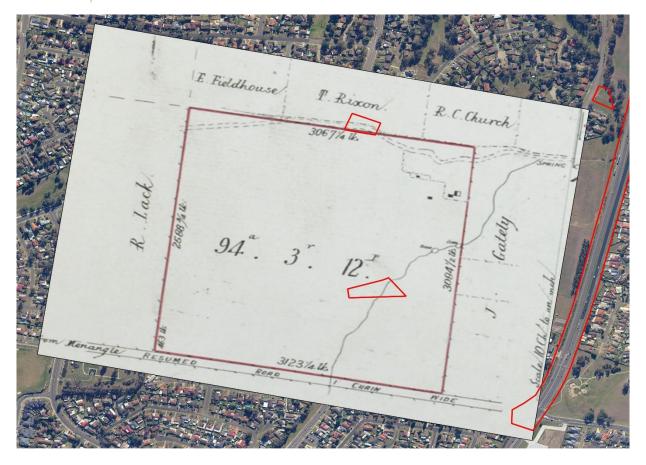
Figure 5. Certificate of Title issued to curator of Agnes Lennox's estate, 1896 (Source: Vol. 1184 Fol. 43).

James Gordon's 85-acre grant was purchased by Simpson in 1828 and held by the Simpson family until the 1860s. It was purchased by Alexander, a shoemaker, and Agnes Lennox in 1878, and held by Agnes until her death in 1892 (Primary Application 9680). The land was transferred to the curator of her estate in 1896, with the certificate of title depicting built structures and fencing in the north-east corner of the property between the fork of two creeks, and dams established along the creek line at the eastern boundary (Vol. 1184 Fol. 43). The structures are outside of the study area, east of the compound sites along Copperfield Drive. An auction advertisement for the property in 1897 noted that the farm contained a four-room weatherboard cottage (*The Daily Telegraph* 1897, 2). It is not known if the structures were established by the Lennoxs' or by previous occupants.

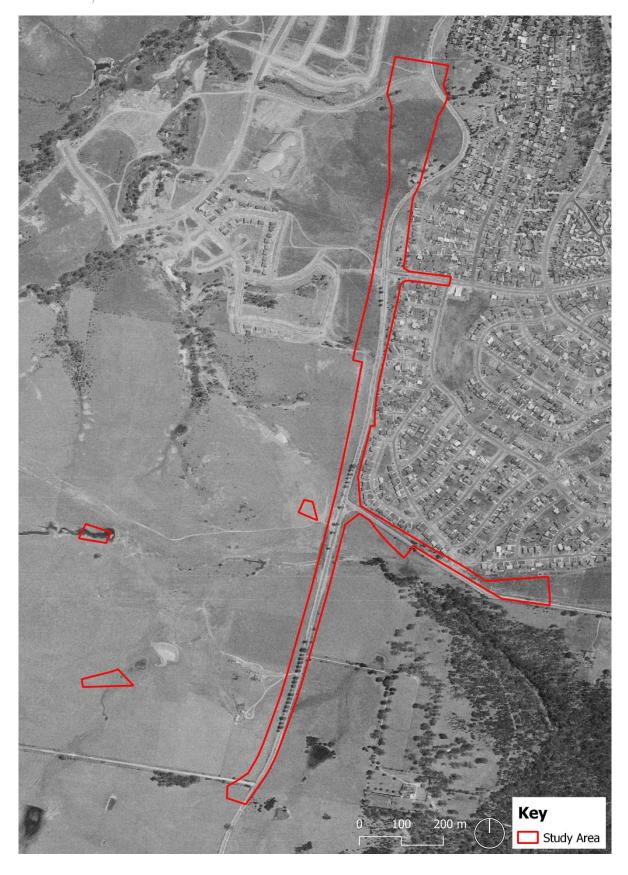
Figure 12. 1975 aerial image.

The 1961, 1972, and 1975 aerial images show that the study area was predominantly farmland during these decades (Figure 10, Figure 12). Fields were used for a combination of grazing and crops with evidence of plough marks across much of the study area. Evidence of scouring around the waterway directly south of St Johns Road indicate a moderate level of ground disturbance.

During the second half of the twentieth century, residential housing had begun to populate both sides of Appin Road. Large open spaces remained and, over time, these become established parks (Figure 12-Figure 14).

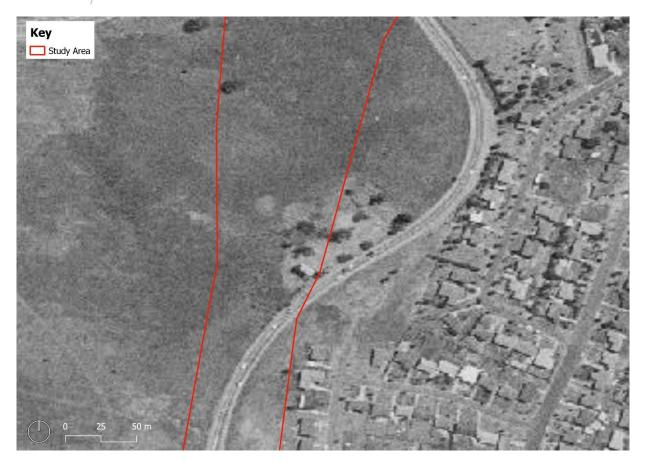
Figure 13. Detail, 1975 aerial image, showing the silos (extant) but house and outbuildings as demolished.

The 1975 aerial image shows the area directly following the demolition of Simpson's cottage and the associated shed (Figure 13). The area around the silos has been cleared. While demolition works will have disturbed, truncated, and/or removed shallow and non-substantial archaeological remains, it is possible for contexts to survive within the immediate vicinity of the silos. The site visit and later aerials indicate that disturbance in the area appears to be low overall. As such, there is a limited potential for evidence of these resources to survive within the study area.

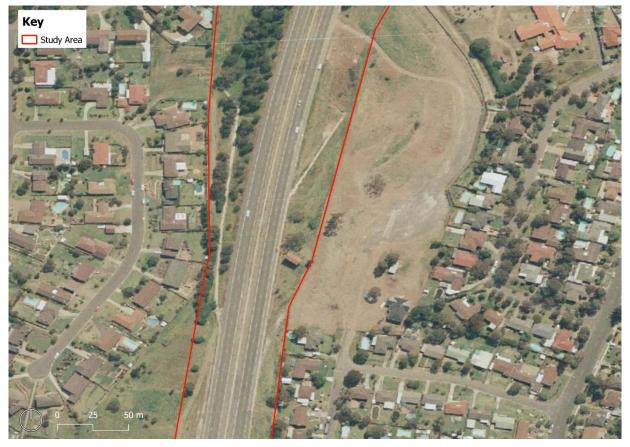
Figure 15. Detail, 1990 aerial image, showing realignment of Appin Road, and retained silos at centre of image.

The majority of Appin Road has maintained its original alignment since its establishment, however there is a deviation to the original alignment contained within the northern portion of the study area (Figure 1). Appin Road was also subject to upgrades during the 1970s as suburban residential development led to the widening of the road corridor to the present 40m (Clouston Associates 2018, 22). This development led to the demolition of the house that was associated with the silos.

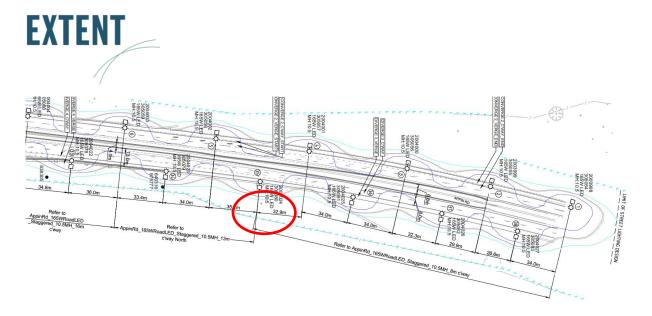
Figure 46. Lighting design layout, location of Silos indicated in red (Source: AECOM 2023).

Lighting upgrades are the only proposed works that have the potential to cause visual impact on the locally heritage item 'Silos' within the study area. No ground disturbance will occur within the curtilage of the 'Silos' (Figure 48). No impacts to any additional heritage items located outside the study area are anticipated.

To comply with street light standards AS/NZS 1158.1.1:2022, a total of 35 new streetlight columns and 4 replacement luminaries are required and 2 floodlight to cover the pedestrian zebra crossings (AECOM 2023, 25).

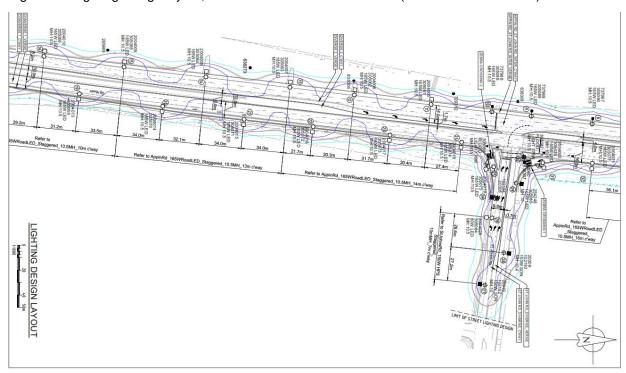
Figure 47. Lighting design layout (Source: AECOM 2023)

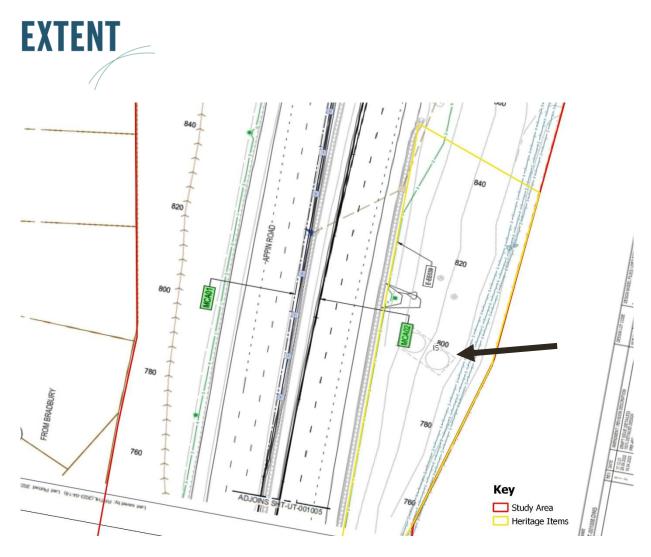
Figure 48. Lighting design layout in relation to silos (black arrow) and I5 heritage curtilage (yellow) (Source: AECOM 2023)

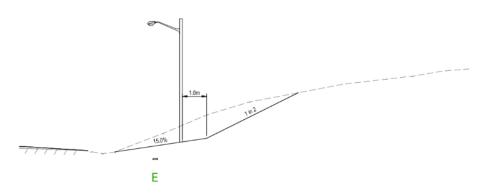
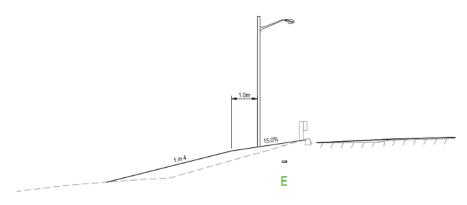
Figure 14: Typical Street lighting post in cut

Figure 15: Typical Street lighting post in fill

Figure 49. Typical street lighting (Source: AECOM 2023, 20).

As part of the street lighting, the design proposes to flatten the areas where street lighting posts are proposed to 1(V):6(H) maximum for maintenance accessibility that extends 1 m behind each post as requested by Endeavour Energy. As some of street lighting posts are proposed on steep slopes, localised earthworks are required to tie into the existing surface (AECOM 2023, 19).

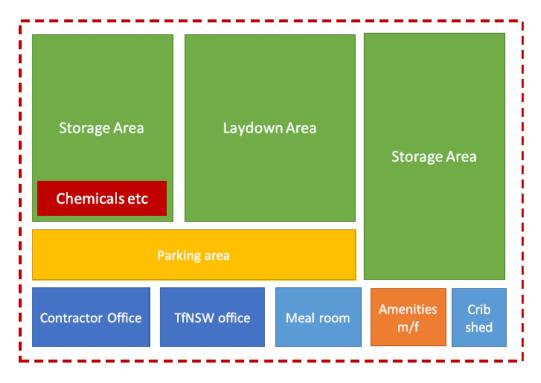
Figure 50. Indicative site compound layout (Source: BD Infrastructure 2023).

To assist with these works, five compounds will be located on the eastern side of Appin Road and along St Johns Road. These compounds would temporarily hold storage and laydown areas, parking area, and offices. As the sites are relatively flat, there is no need for significant subsurface works to establish the site compound. However, some site preparation including minor earthworks to create level pads, access roads, and parking areas may be required. Following the completion of the project, the sites would reinstate the site to its previous condition, including removal of imported material, replacement of topsoil and undertaking reseeding. An indicative compound layout is presented in Figure 50.
