Kamay Ferry Wharves Seagrass Monitoring Program

Construction Monitoring Survey 2 - technical memo

Prepared for Transport for NSW | 29/12/2024

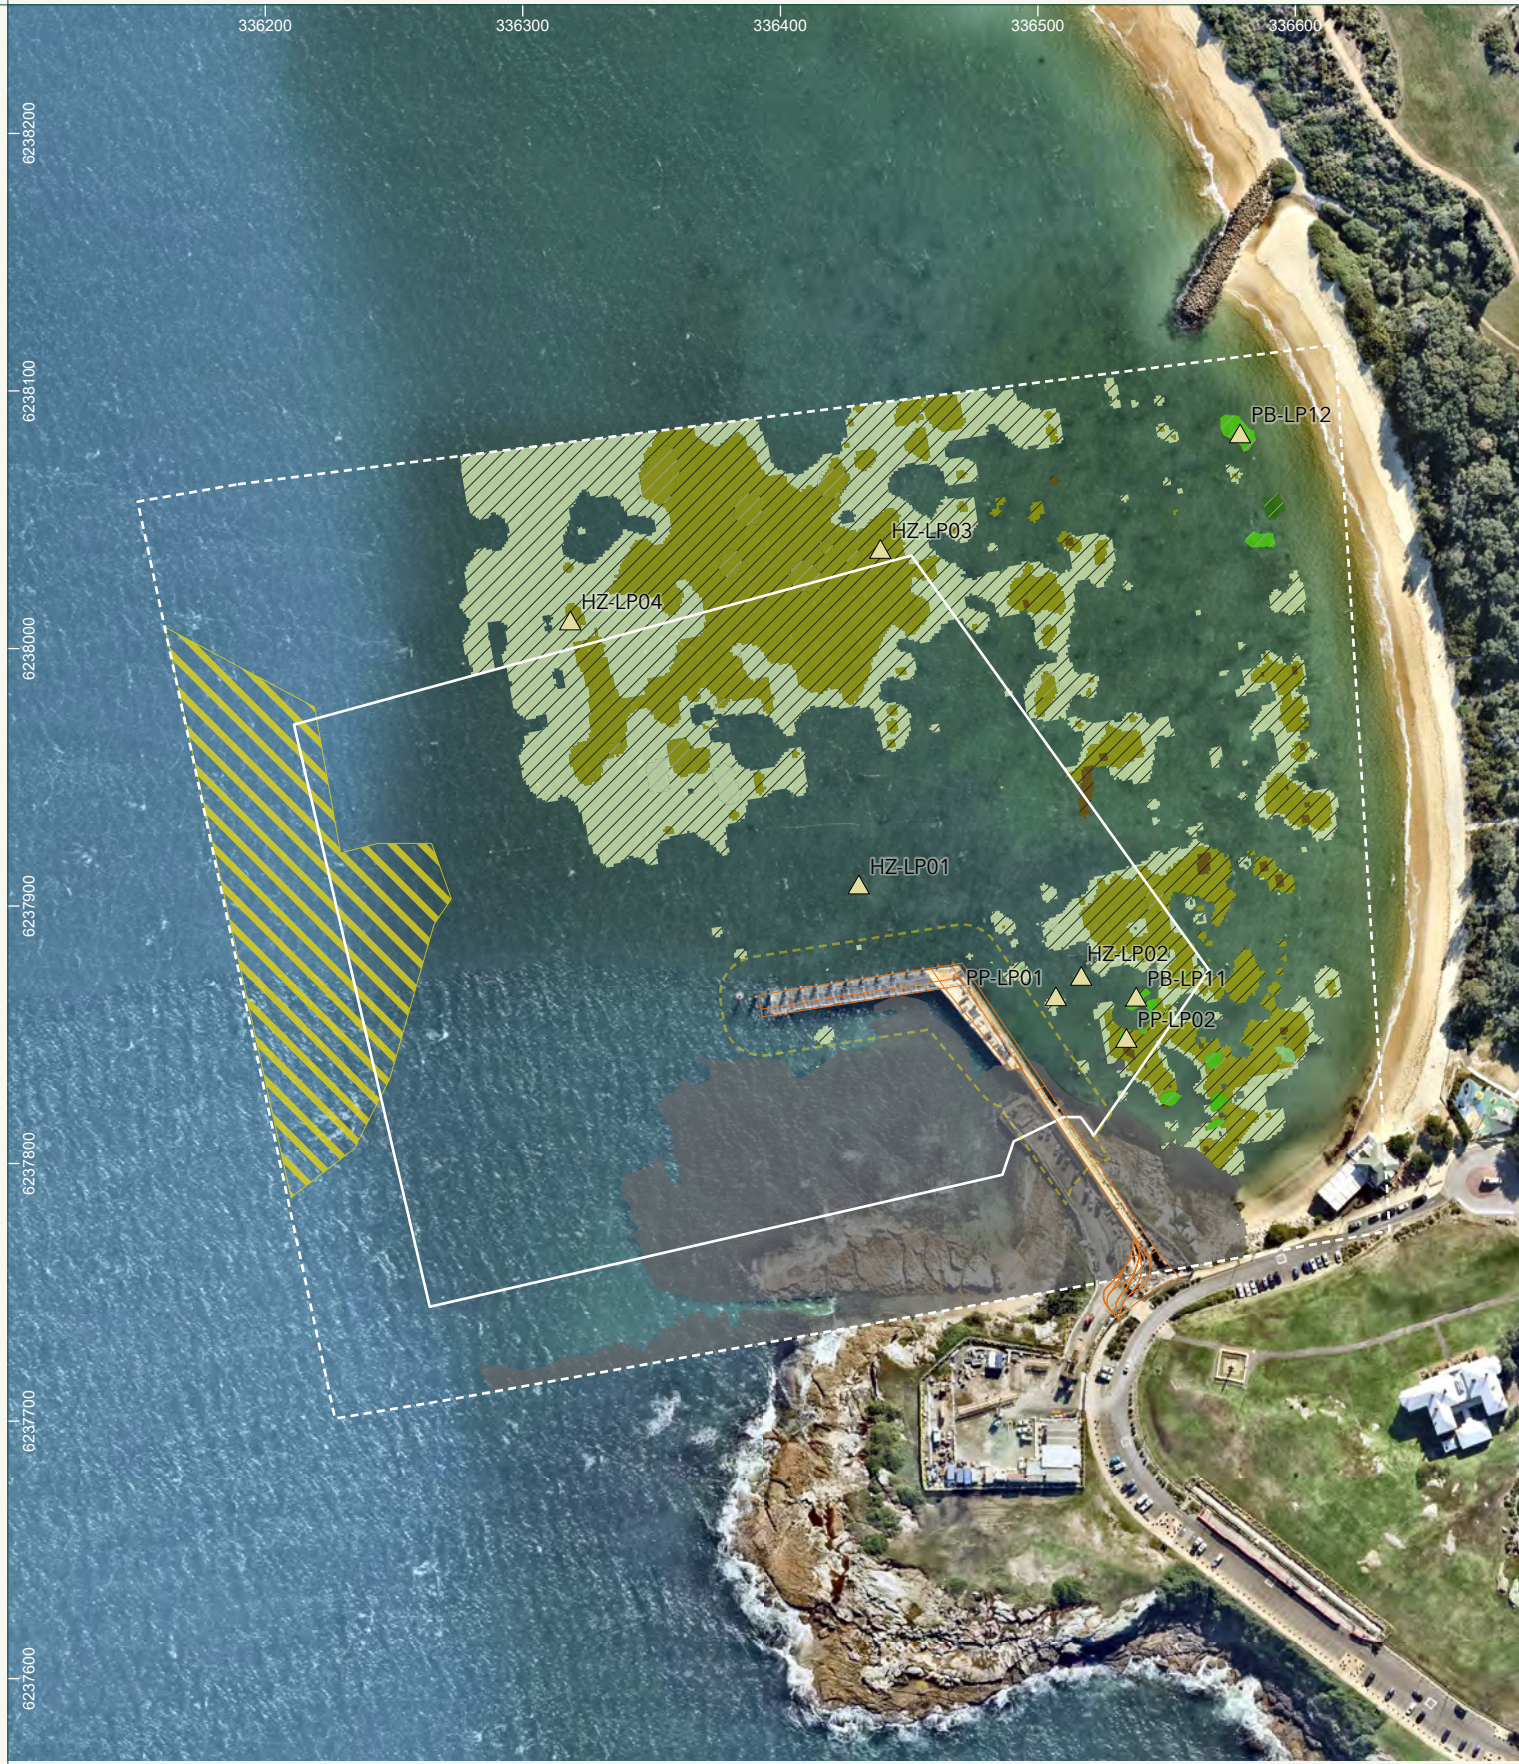
Figure 1
Survey Sites and Habitat Mapping Winter 2024
La Perouse
 Kamay Ferry seagrass monitoring

Monitoring sites are shown for La Perouse in Figure 1, and for Kurnell in Figure 2. All sites are consistent with those applied in Baseline Surveys of the Seagrass Monitoring Program (Table 5), with the exception of *Posidonia* patches within the Buffer Area, which have since been removed and transplanted to new locations (PP-K04, PP-K08, PP-K09, PP-K11).

During the Construction 2 surveys, a combined total of 150,464 m² of seagrasses was mapped within the combined Survey Areas, Project Boundaries and Buffer Areas at La Perouse and Kurnell (Table 6, Figure 1, Figure 2).

The majority of seagrass mapped within the Project Boundaries at La Perouse and Kurnell was comprised of *Halophila* and *Zostera* / *Halophila* beds (Table 6, Figure 1, Figure 2).

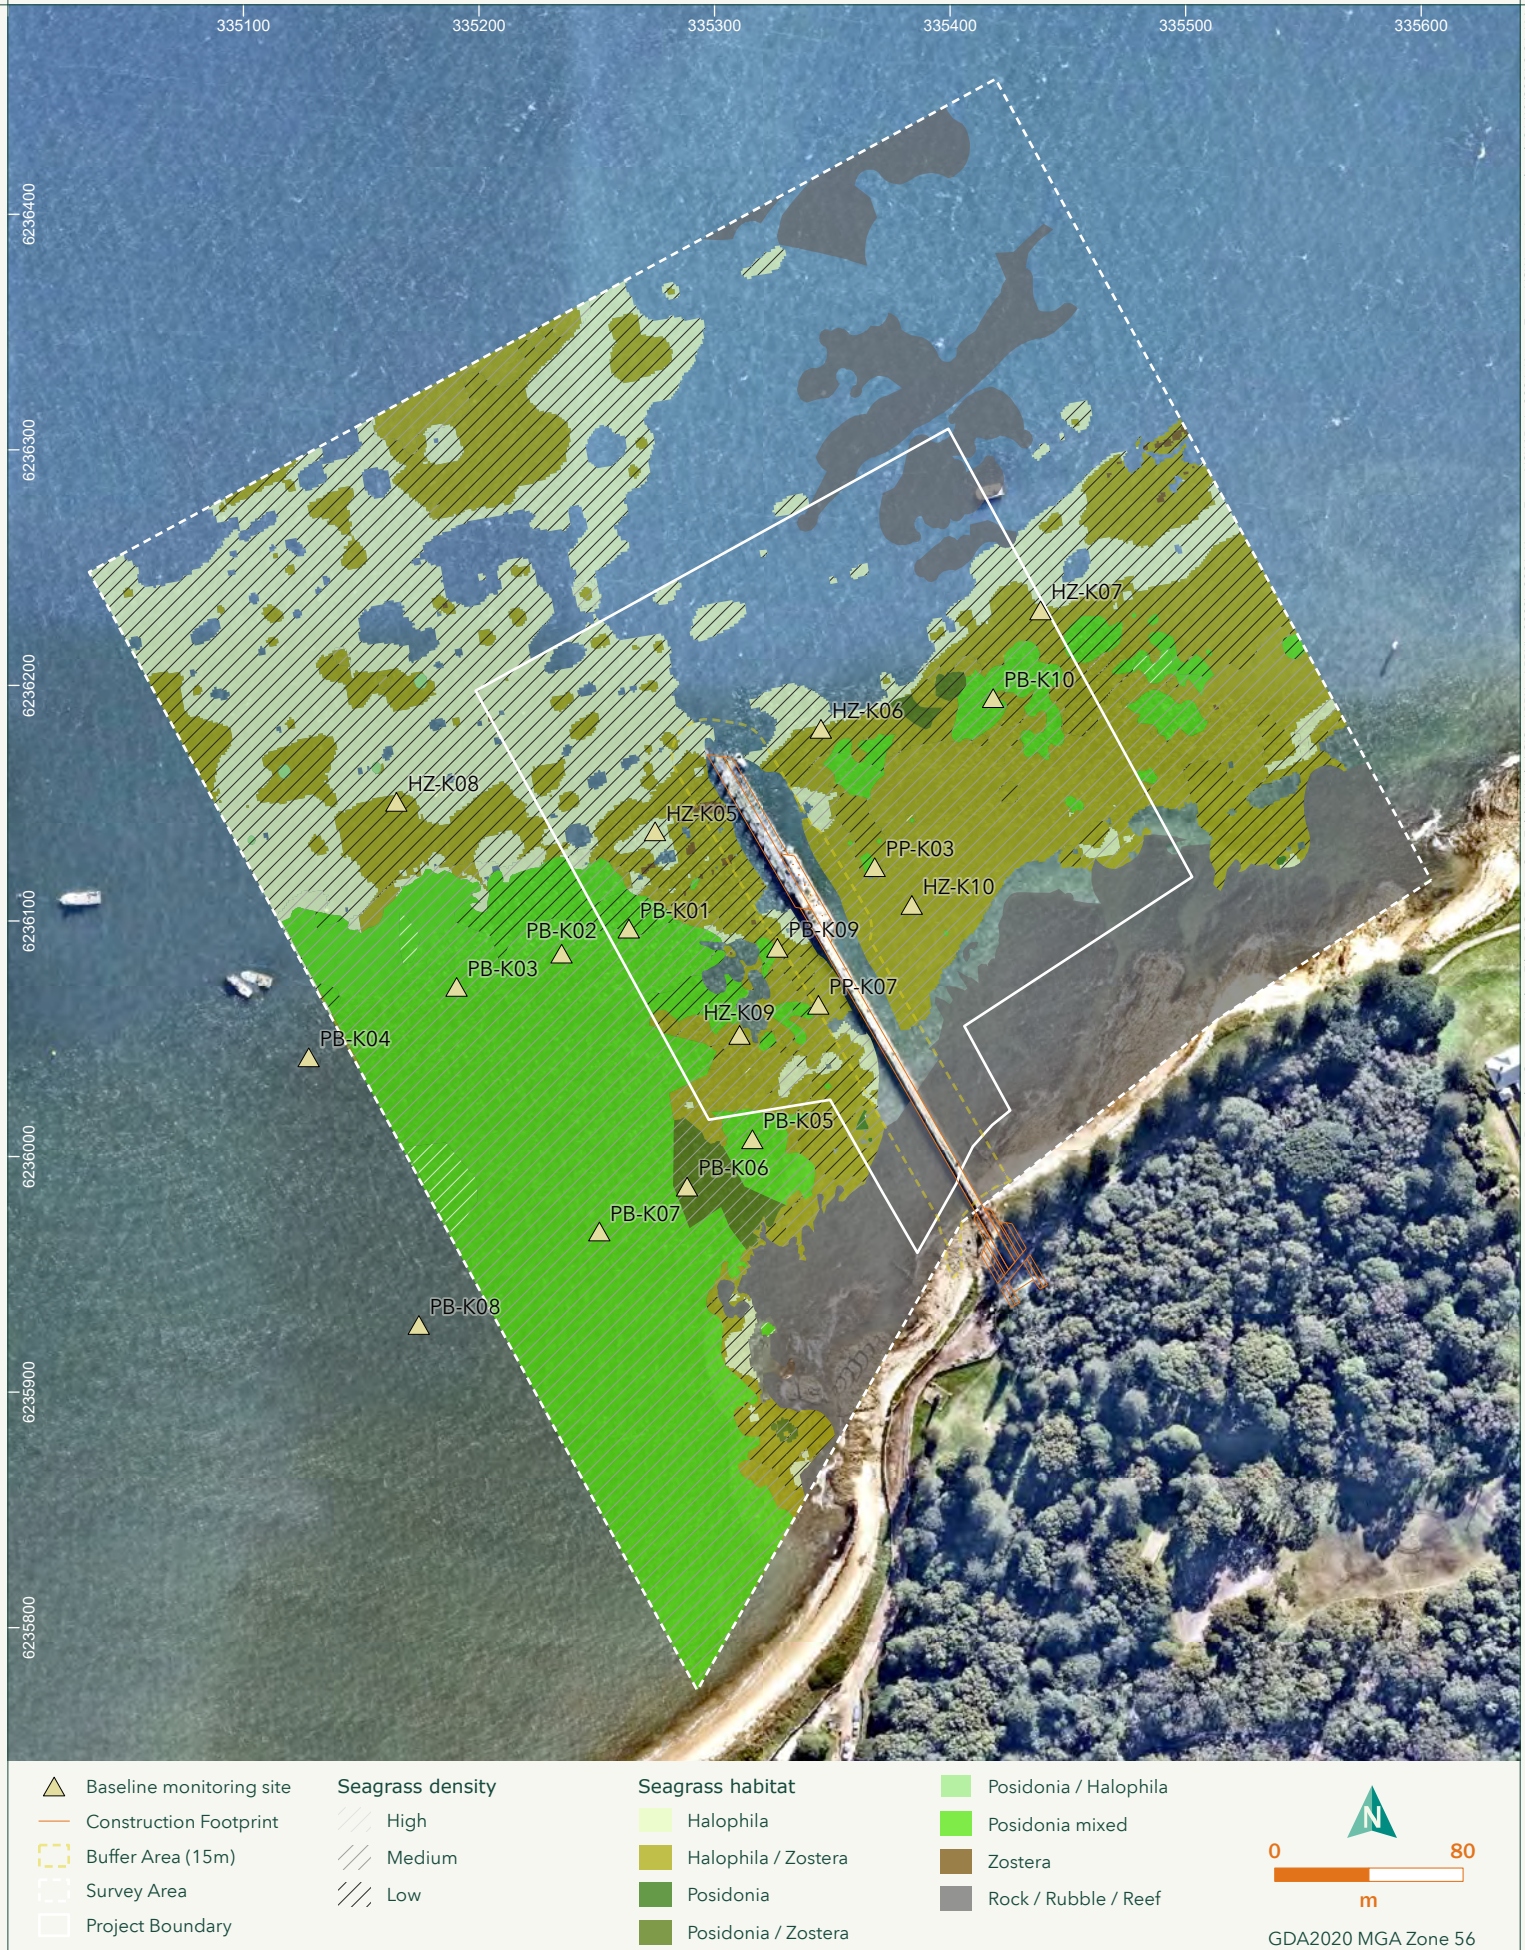
Figure 2

Survey Sites and Habitat Mapping Winter 2024
Kurnell
 Kamay Ferry seagrass monitoring

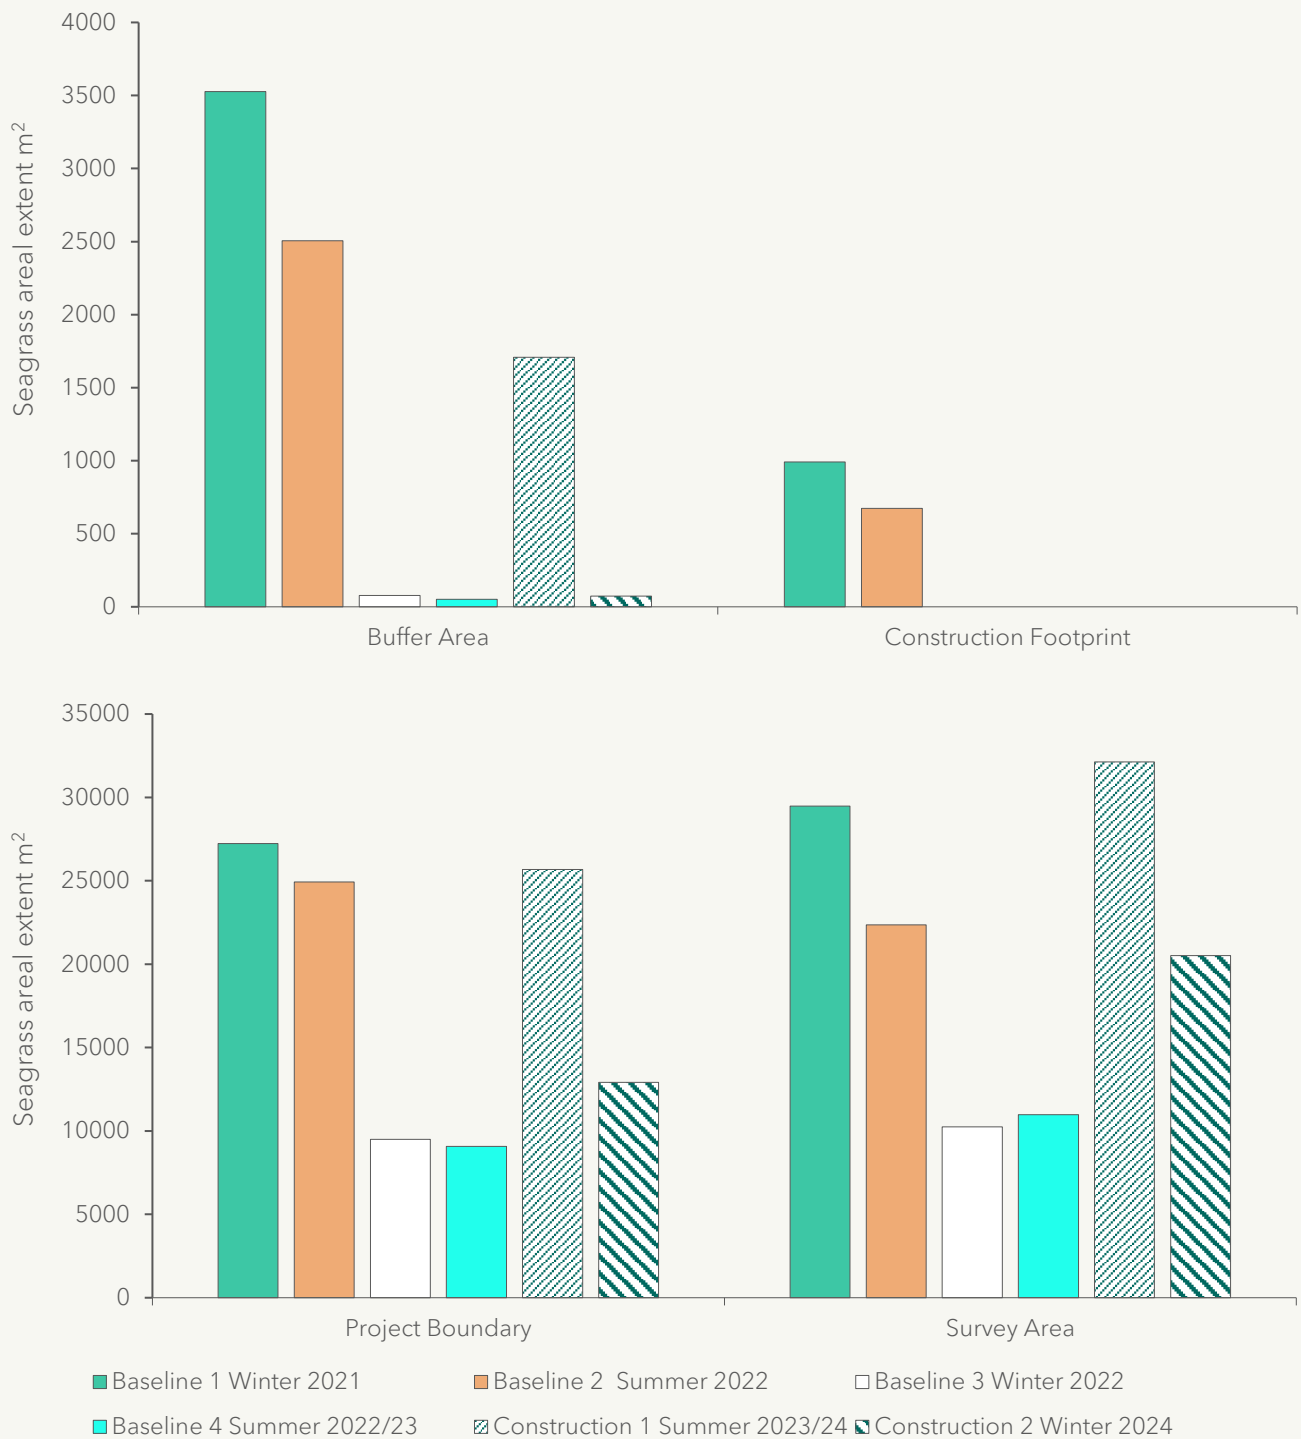
Figure 3 Areal extent of *Halophila* and *Zostera* at La Perouse

At La Perouse for the Construction Survey 2, areas of *Halophila* and *Zostera* reduced to lower levels than those recorded in Construction 1 in the Buffer Area, Project Boundary and Survey Area, but remained above that recorded in Baseline 4 (Figure 3).

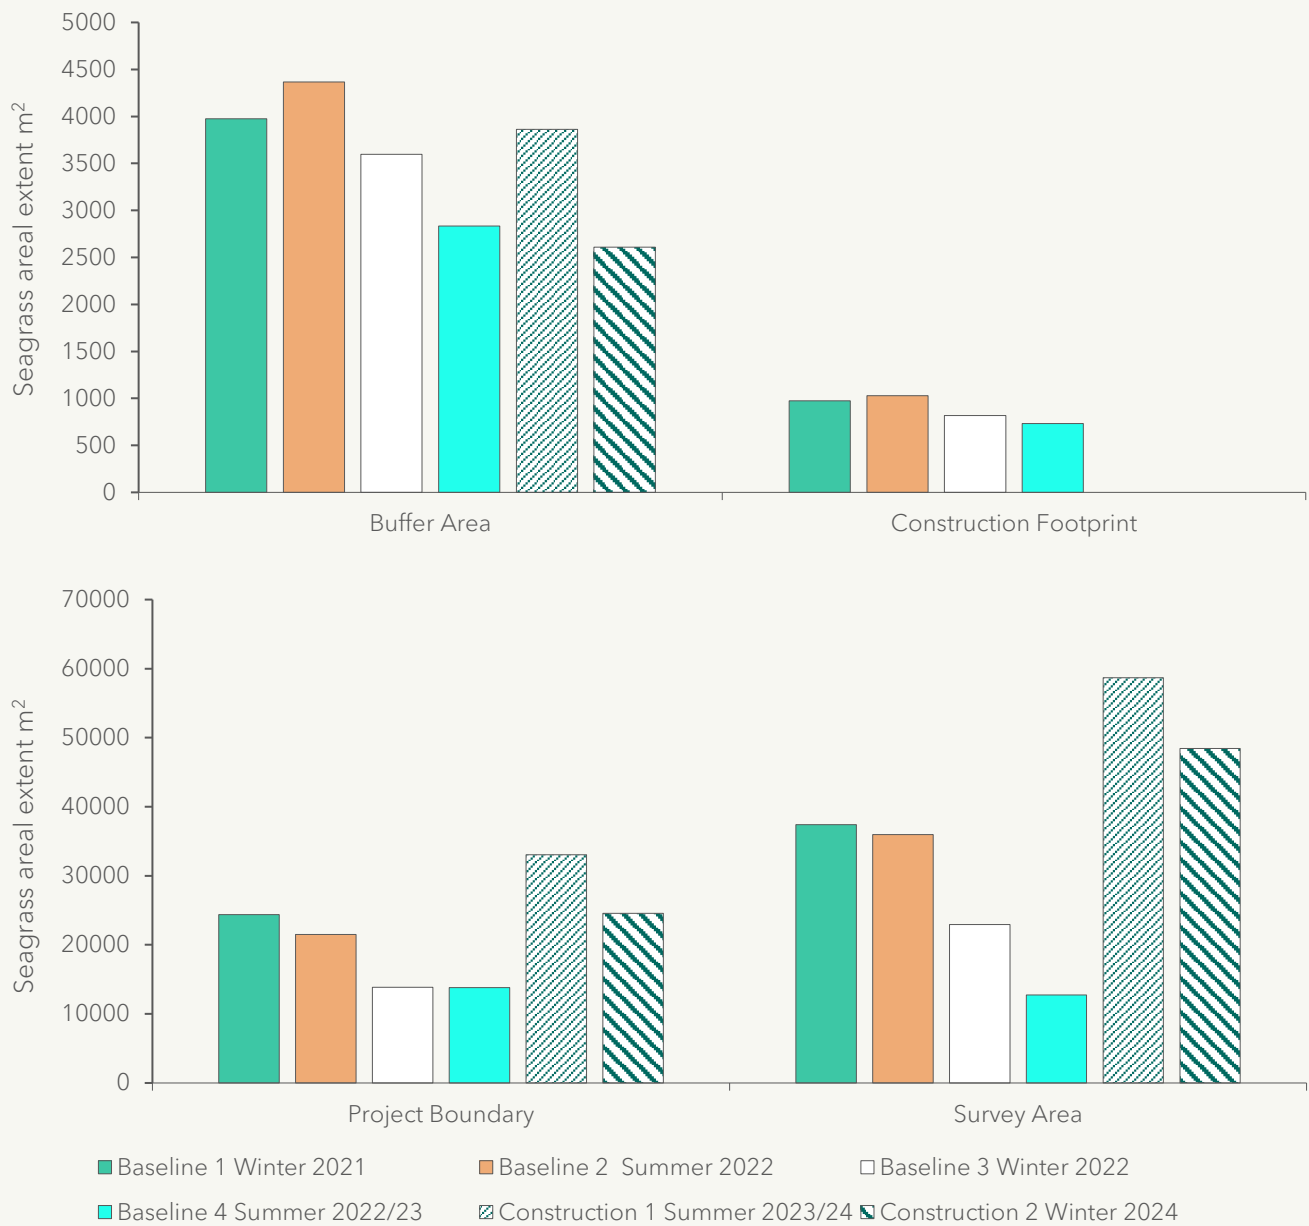
Figure 5 Areal extent of *Halophila* and *Zostera* at Kurnell

At Kurnell, the area of *Halophila* and *Zostera* within the Project Boundary and Survey Area decreased between Construction Survey 1 and Construction Survey 2, although these remained above that recorded in Baseline Survey 4 (Figure 5). The area of these seagrass species recorded within the Buffer Area were slightly below that of Baseline Survey 4. The total area of *Posidonia* seagrasses in the Project Boundary and Survey Area at Kurnell in Construction Survey 2 is slightly higher than in Construction Survey 1 and is comparable to Baseline levels (Figure 6). At Kurnell, no *Posidonia* seagrass was recorded within the Buffer Area, this is a result of the planned removal and transplantation of these seagrasses elsewhere. Direct comparisons over time are limited for the Buffer Area, as the entirety of this area cannot be surveyed due to the construction operations, however the area of seagrasses present are considered to be overall comparable to that recorded in Baseline 4.

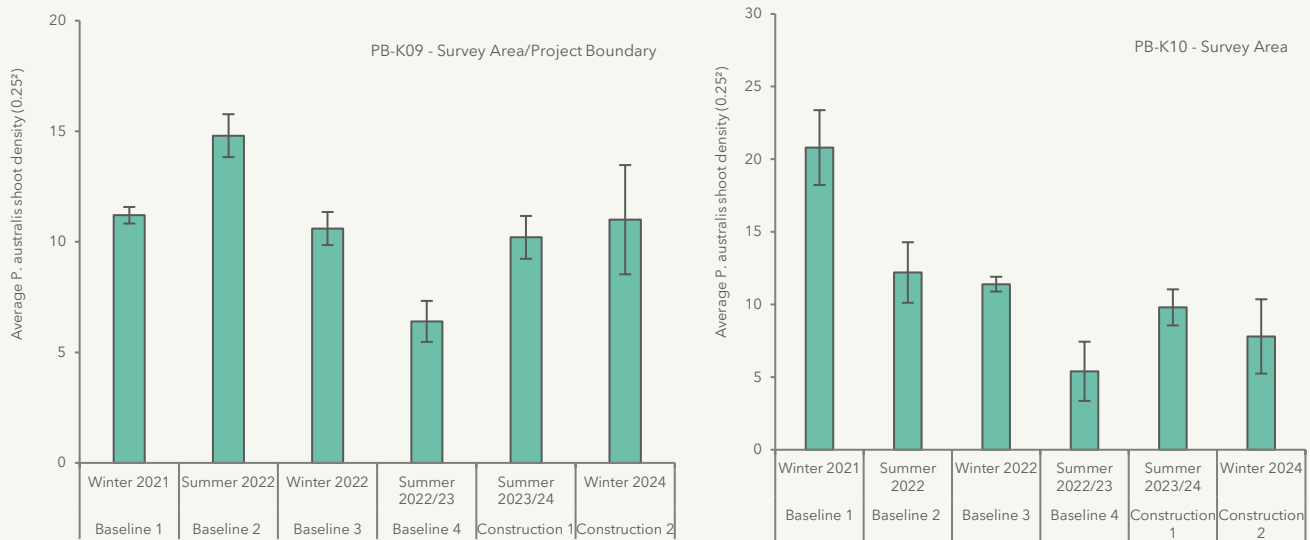
Figure 10 Mean shoot density of *Posidonia* shoots at the Kurnell *Posidonia* bed monitoring sites

Posidonia density values at the majority of *Posidonia* monitoring beds at Kurnell remain higher than Baseline 4 (Figure 10). Although *Posidonia* density has reduced noticeably at site PB-K08, located outside of the Project Boundary. Of the three sites inside the Project Boundary, two sites showed increased shoot density (PB-K01 and PB-K09) while site PB-K10 showed a decrease since Construction 1. Within the main *Posidonia* bed, sites PB-K01, PB-K02, PB-K03, PB-K04 did not show any visual negative relationship between *Posidonia* density and proximity to the construction footprint. Closer to shore, also within the main *Posidonia* bed, sites PB-K07 and PB-K08 (furthest from the Buffer Area) showed decreases in density, while sites PB-K05 and PB-K06 (closer to the construction footprint) showed increases in shoot density.
