# Sydney Terminal Building Revitalisation

Aboriginal Cultural Heritage  
Assessment

## PRELIMINARY FINAL Report

February 2023

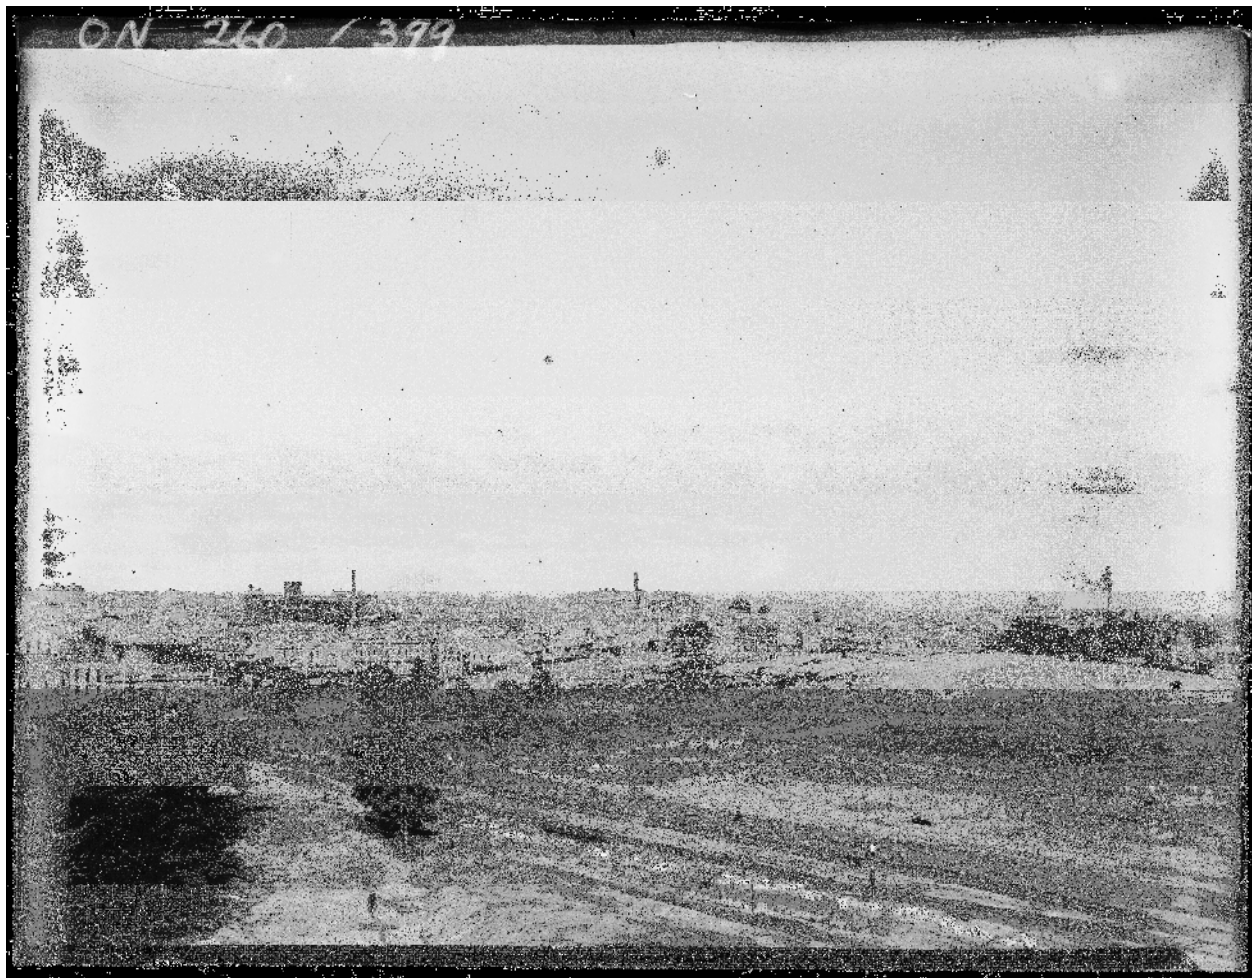
Figure 7-5 Construction of Eddy Avenue and Sydney Terminal, with sand dunes visible.

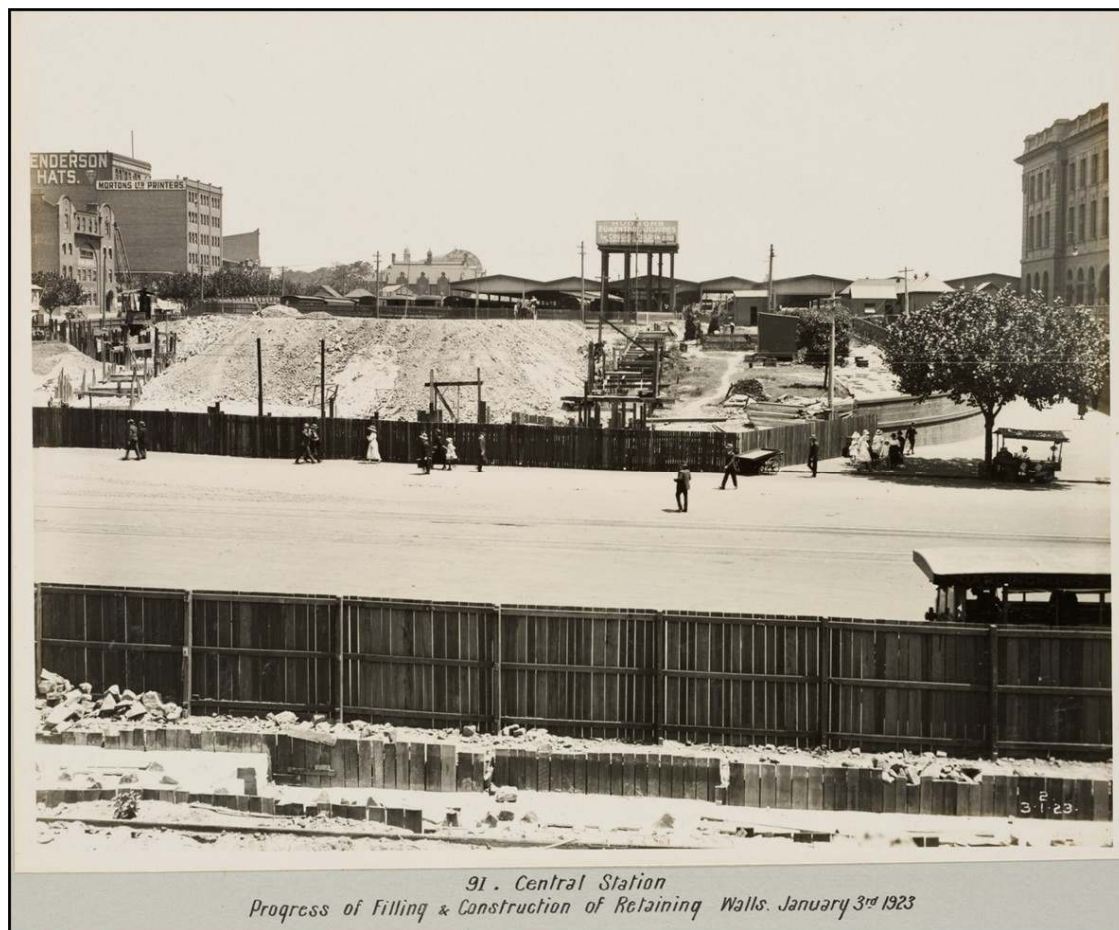
Figure 7-7 Construction of the City Railway, with the Sydney Terminal Building and Eddy Avenue Plaza to the right of the picture (Source: Bradfield 1923)

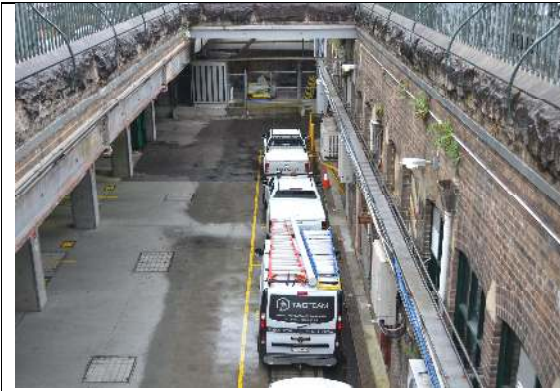
Figure 7-20 View downwards to vehicle access space along Pitt Street side of the Western Forecourt.

As can be seen in Figure 7-20, Figure 7-21 and Figure 7-22 the entrance to the station from the Western Forecourt is elevated, and the areas below having been excavated to allow vehicle access and parking, located at current street level.

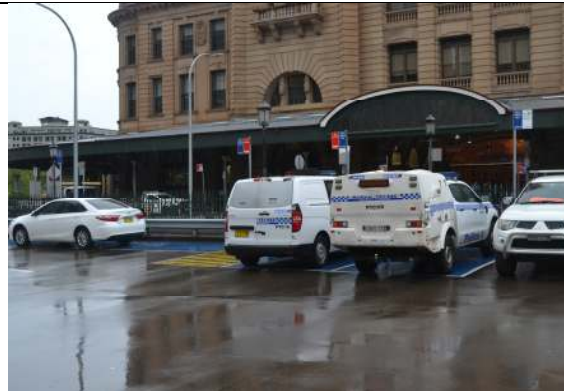
Figure 7-21 View of the entrance to the station from the above ground.

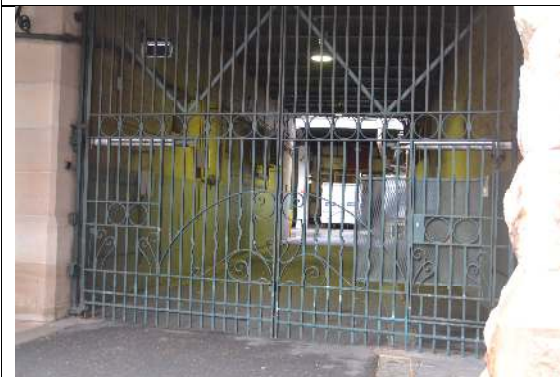
Figure 7-22 View into the vehicle access space from Pitt Street.

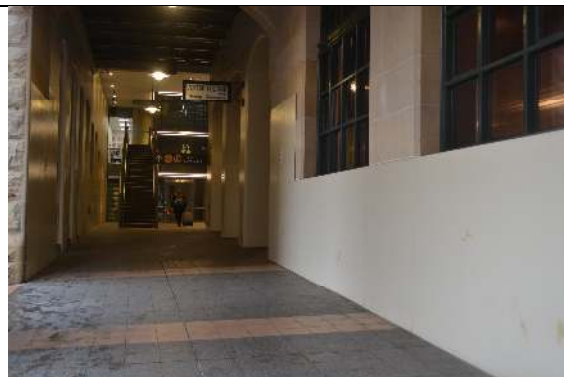
Figure 7-23 Eddy Avenue, looking to escalators from Pitt Street.

At Eddy Avenue (see Figure 7-23) additional access to the station is provided by escalators connecting the street level to the concourse. This was achieved through deep excavation below the original natural ground surface along Pitt Street and Eddy Avenue (see Figure 7-27).

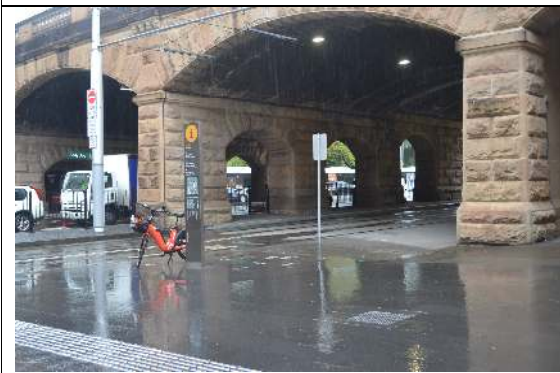
Figure 7-24 Eddy Avenue, street view with tram and vehicle access.

No natural soil was observed within in the northern construction footprint. The area has been developed, and consists of station buildings, car parking, light rail, vehicle and pedestrian access, and retail spaces with above ground landscaping (see Figure 7-20 to Figure 7-27).

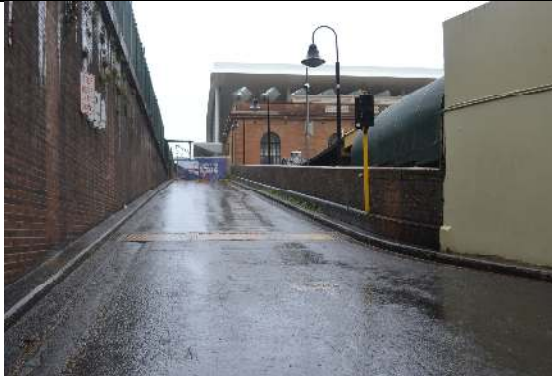
<p>Figure 7-26 Ramp at eastern side of the Sydney Terminal Building.</p>	<p>Figure 7-27 Depth of wall constructed on Pitt Street indicating the depth of excavation undertaken to build the ramp up to the Western Forecourt.</p>

In conclusion, no Aboriginal artefacts were identified, and no original soils were observed. The depth of the wall constructed on Pitt Street (see Figure 7-27) indicates that there is no surviving ground surface on the western side of the northern construction footprint.

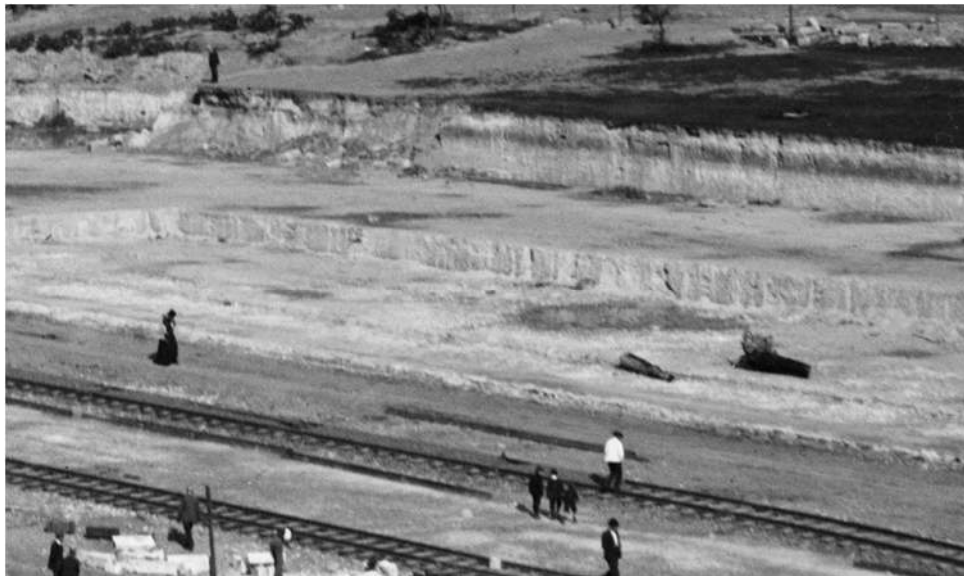
Figure 8-1: Screenshot of a portion of historical photograph taken from Belmore Park area looking south-east, showing stepped excavation for Sydney Terminal building footprint. [picture]. (nla.gov.au)

Historical photographs dating to the construction of Sydney Terminal show what appears to be significantly cut natural contexts within the building footprint (see Figure 8-1). Landscape modification for construction of Sydney Terminal and later construction of the City Railway are likely to have resulted significant modification to the soil landscape context in the northern construction footprint.

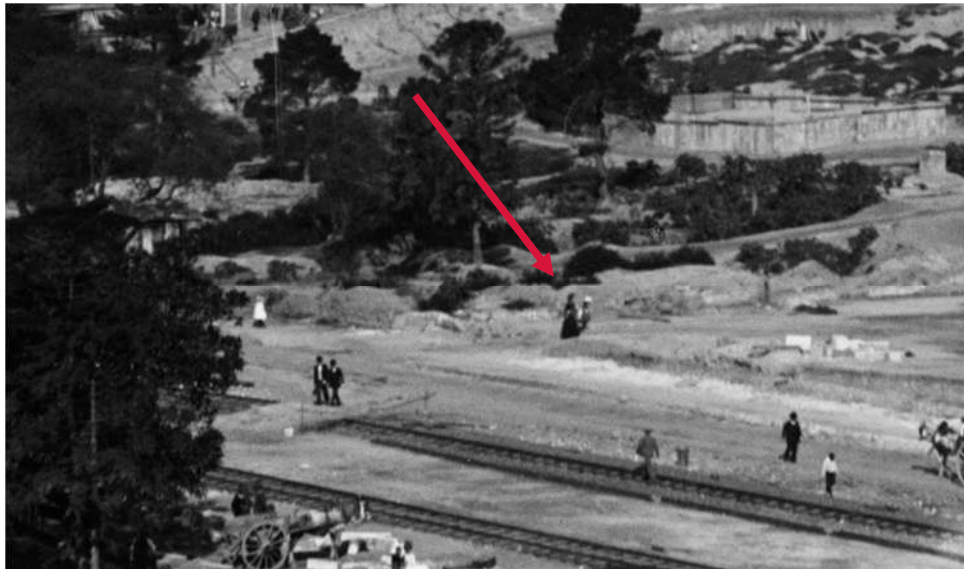
Figure 8-2: Screenshot of a portion of historical photograph taken from Belmore Park area looking southeast, showing western end of Sydney Terminal building in approximate area where Eddy Avenue Plaza is located (red arrow)

Figure 8-3 shows a photo taken in c.1903(?) looking south within the cutting for Sydney Terminal. The photo possible post-dates the image in Figure 8-2, as it appears to show a deeper cutting closer to the western extent of the building footprint.

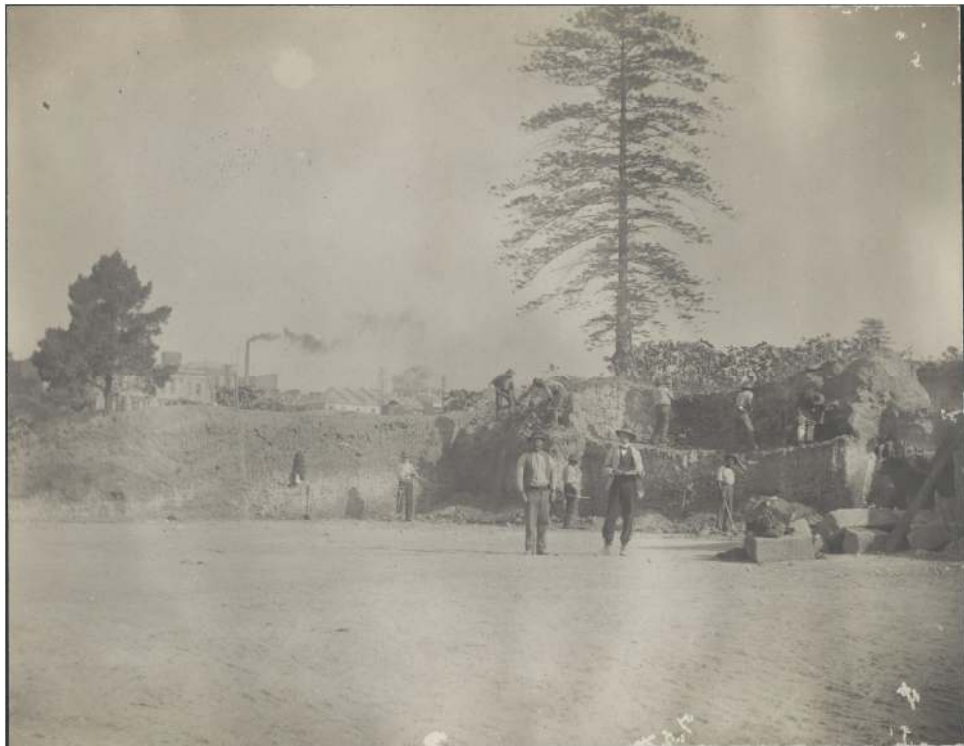
Figure 8-3: Unidentified workers cutting sandstone blocks during the construction of Central railway station, Sydney, 1903? [picture]. (nla.gov.au)
