# EASING SYDNEY CONGESTION WILSON STREET CYCLEWAY ARBORICULTURAL REPORT

DOCUMENT NUMBER: ESCWSCYDD-SNJV-0193-EO-RPT-000004-D

## Arboricultural Report

The Wilson Street Cycleway Newtown - Detail Design Development Scope

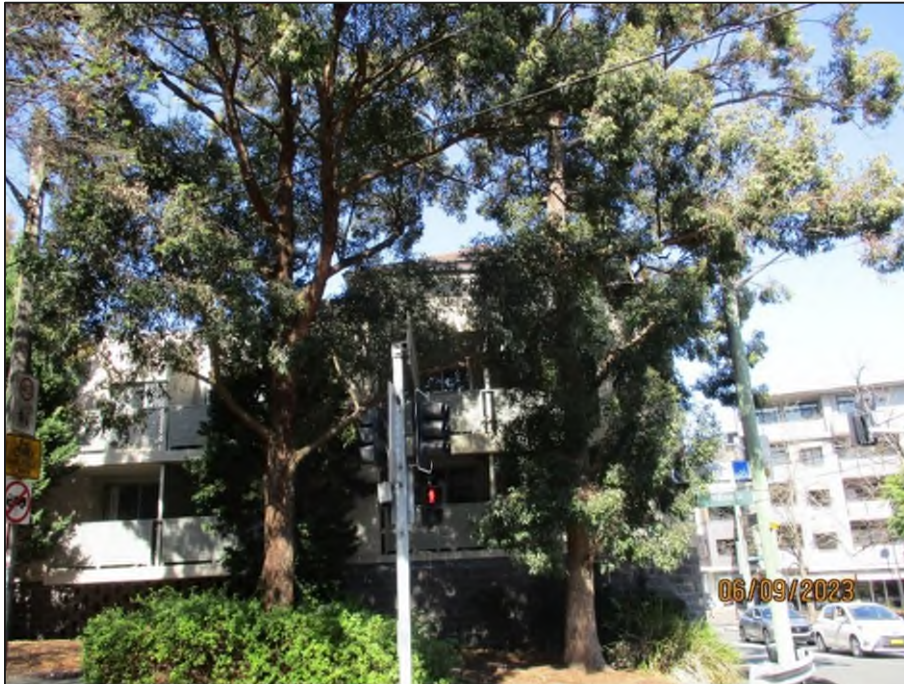
Plate 1: Two large Tallowwoods (trees 11 and 13), growing in small patch of parkland, corner Erskineville Road and Wilson Street (facing south)

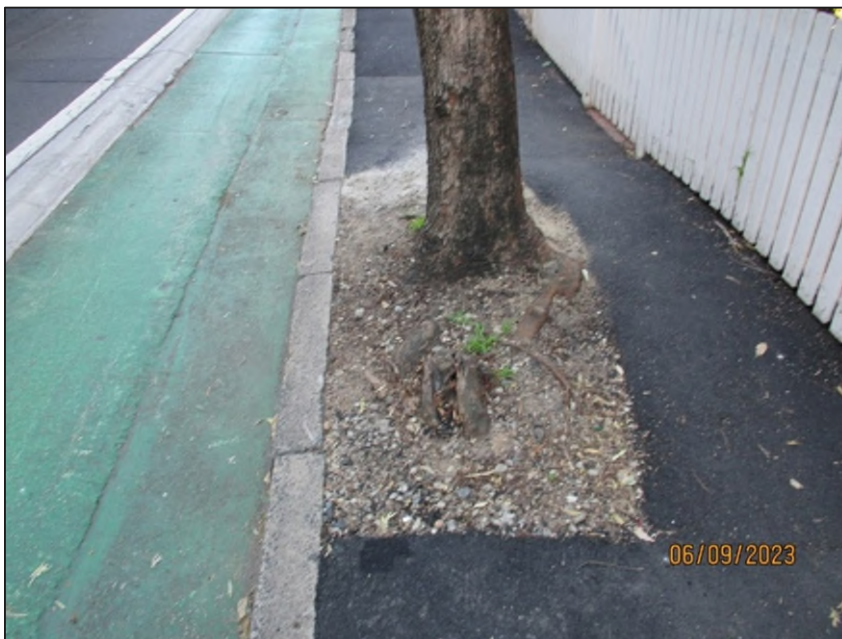
Plate 2: Street tree with small, unsealed area over part of the SRZ. Note exposed surface roots (facing east)

- Milling of pavement in the TPZ of trees will be completed under the supervision of a project arborist. Any exposed roots should be covered to protect them from drying out, such as with hessian. The roots should be wetted to keep them moist while exposed

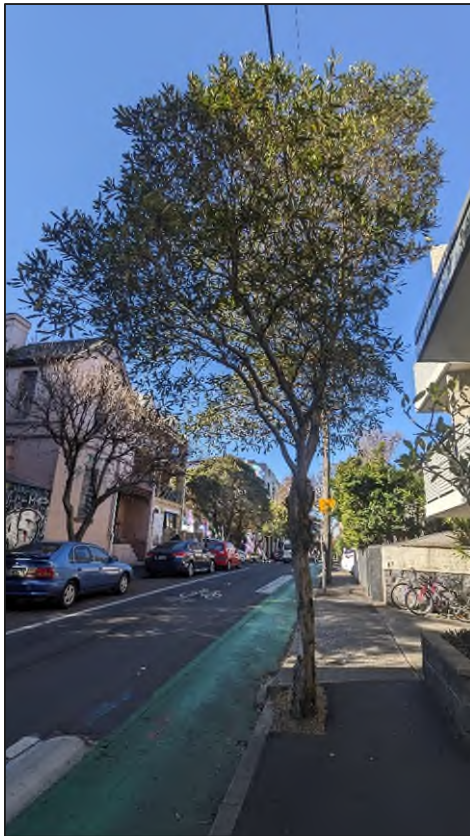
Plate 3: Water gum - Tree 7 (facing east)

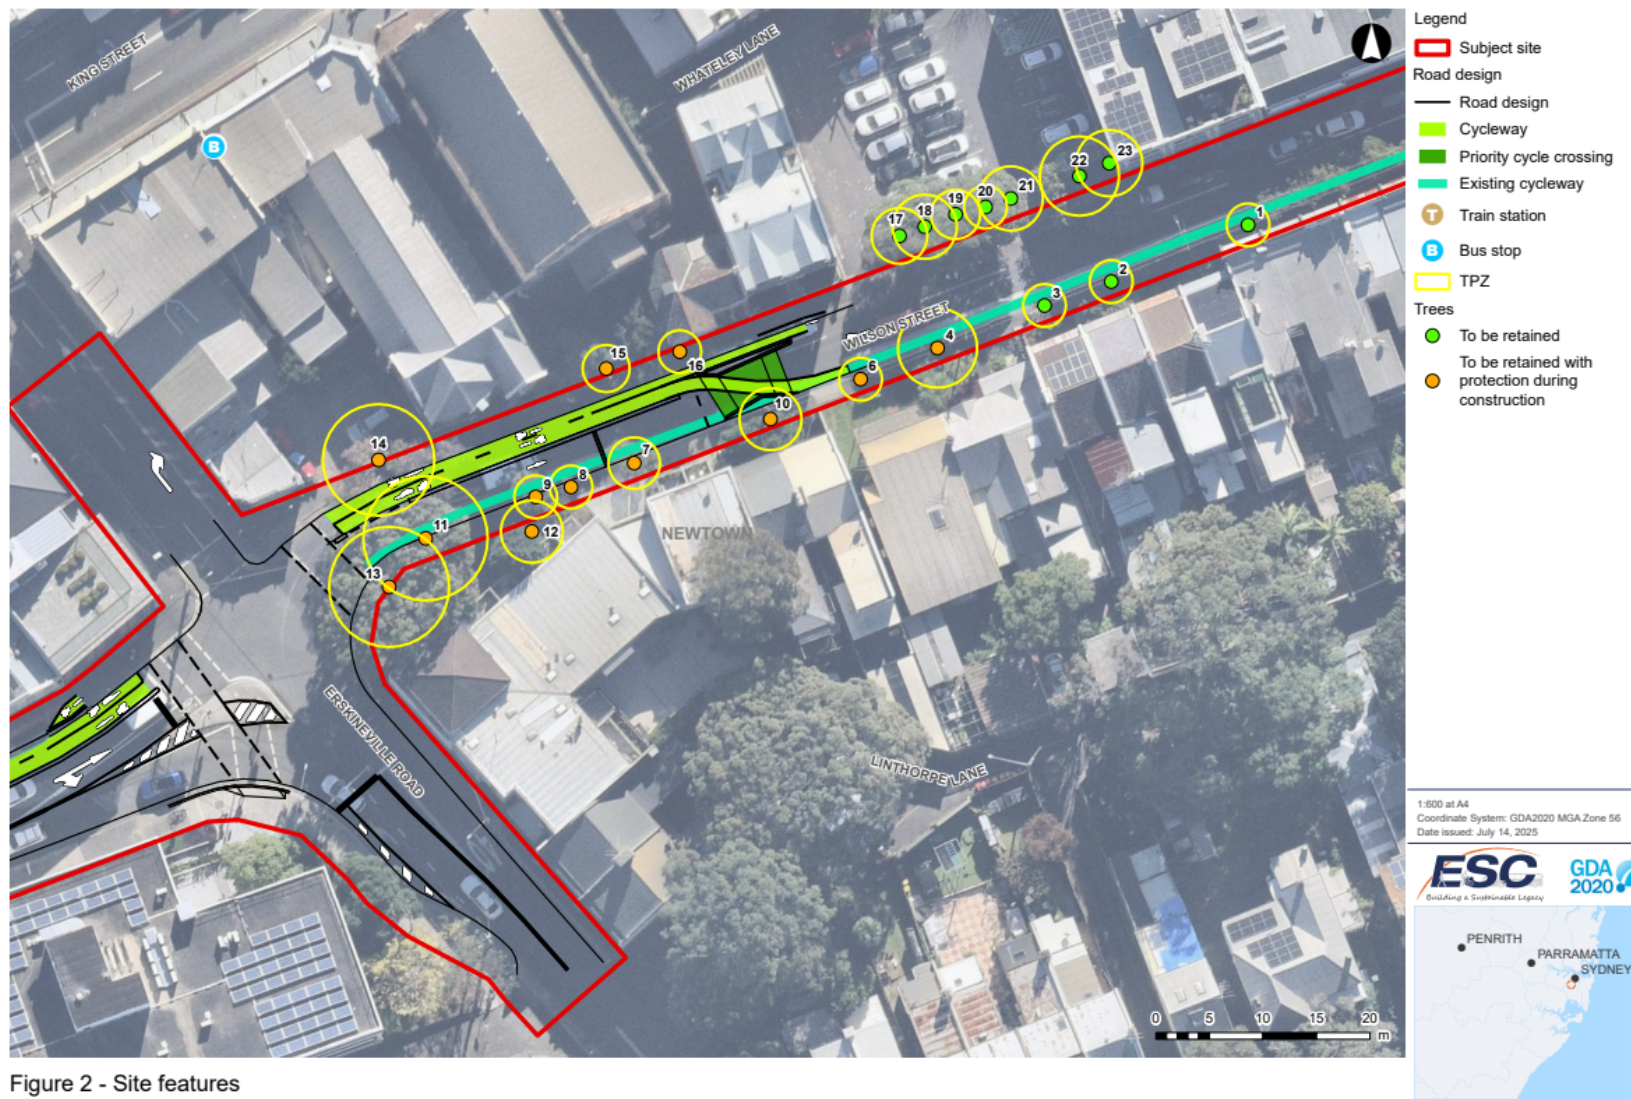
Figure 2 - Site features

Figure 2: Subject trees in the subject site

The trees surveyed for this report are the individual trees which are identified and shown on Figure 2.

The details of individual trees were documented in a tree schedule with reference to the unique numerical identifier indicated on Figure 2.

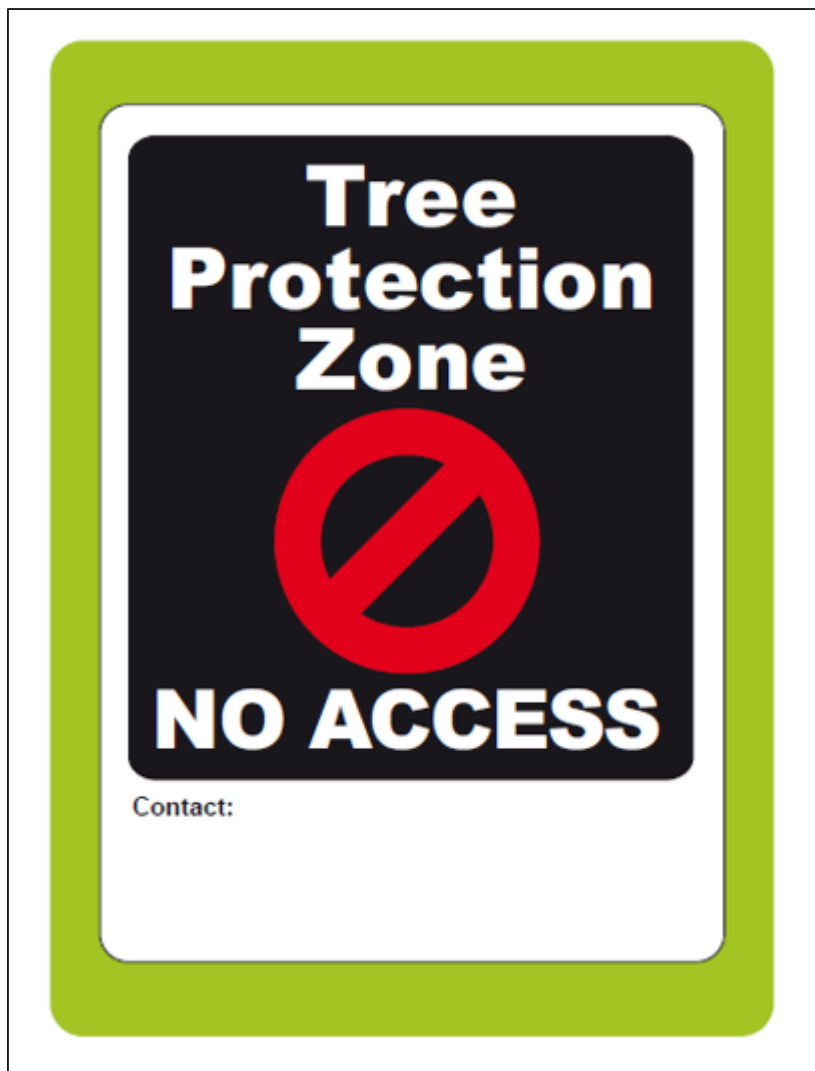
Figure 5: AS4970:2009 example of tree protection zone fencing
